**Encana Interim Reclamation Submittal**

Site Name: Frederiksen 63N-68W/1A-28H  
Location ID#: 422731  
Location: SENE 28 3N 68W  
Lat./Long: 40.19794/-104.99929

Associated Wells:  
Frederiksen # 1A-28H API # 05-123-33363 (previously drilled in 2011)  
Frederiksen # 1B-28H-H368 API # 05-123-37667  
Frederiksen # 1C-28H-H368 API # 05-123-37668

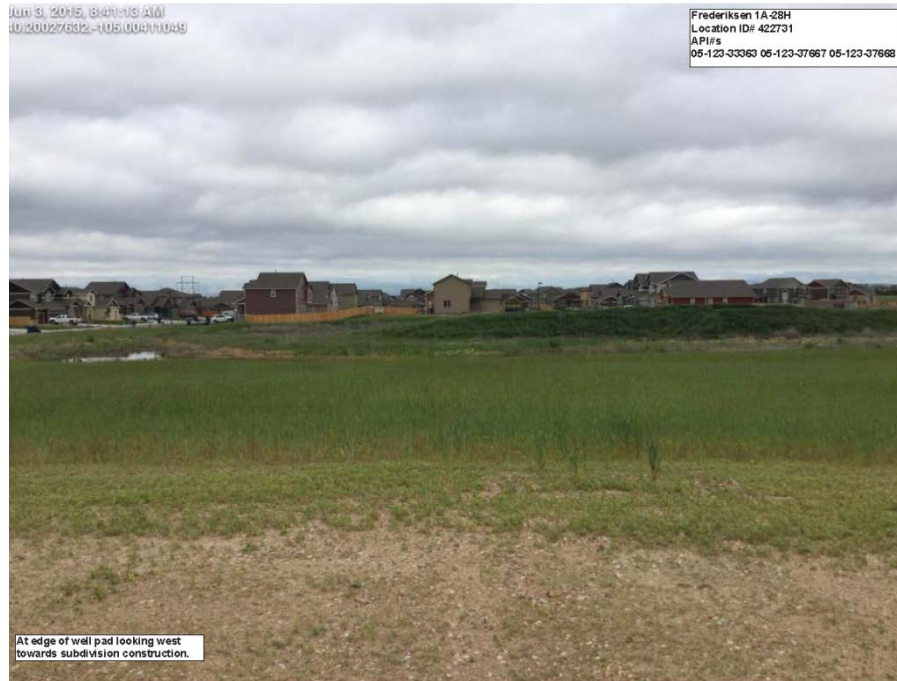
Facing west

At edge of well pad looking west towards subdivision construction.

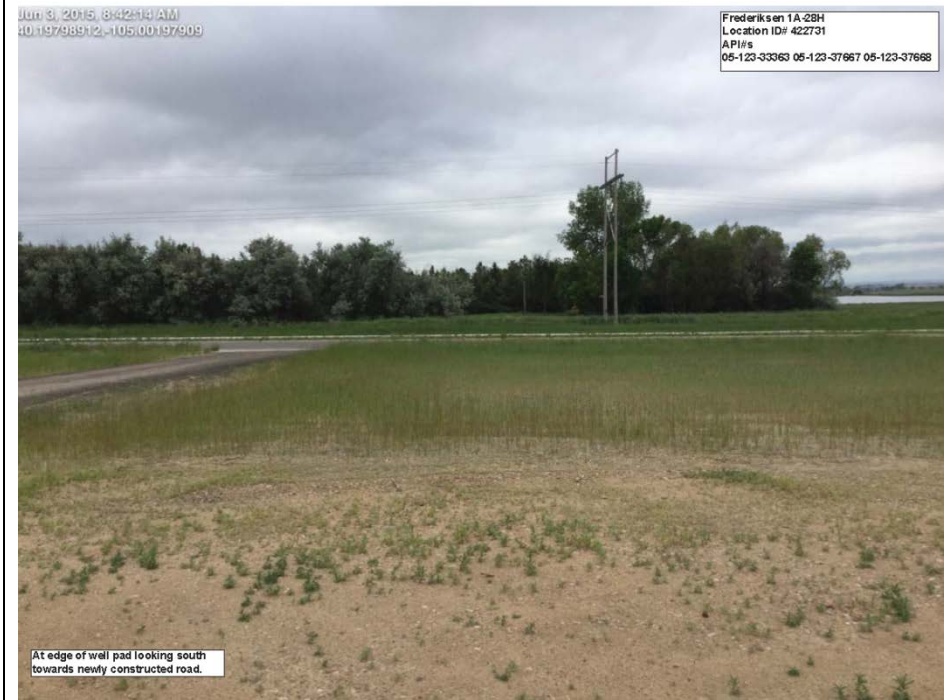
Facing south

At edge of well pad looking south towards newly constructed road.

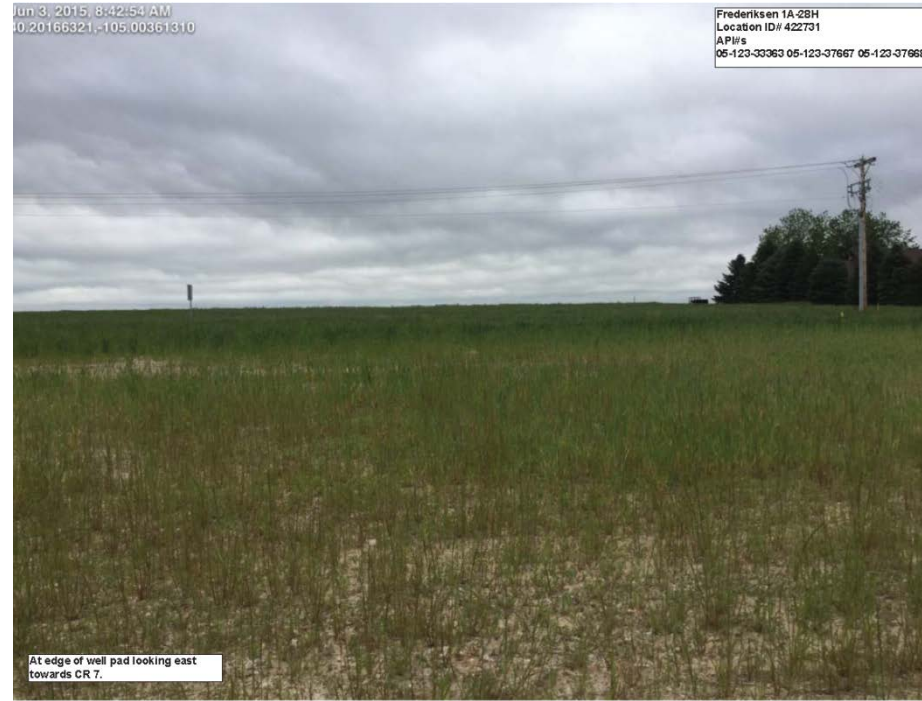
Facing east

At edge of well pad looking east  
towards CR 7.

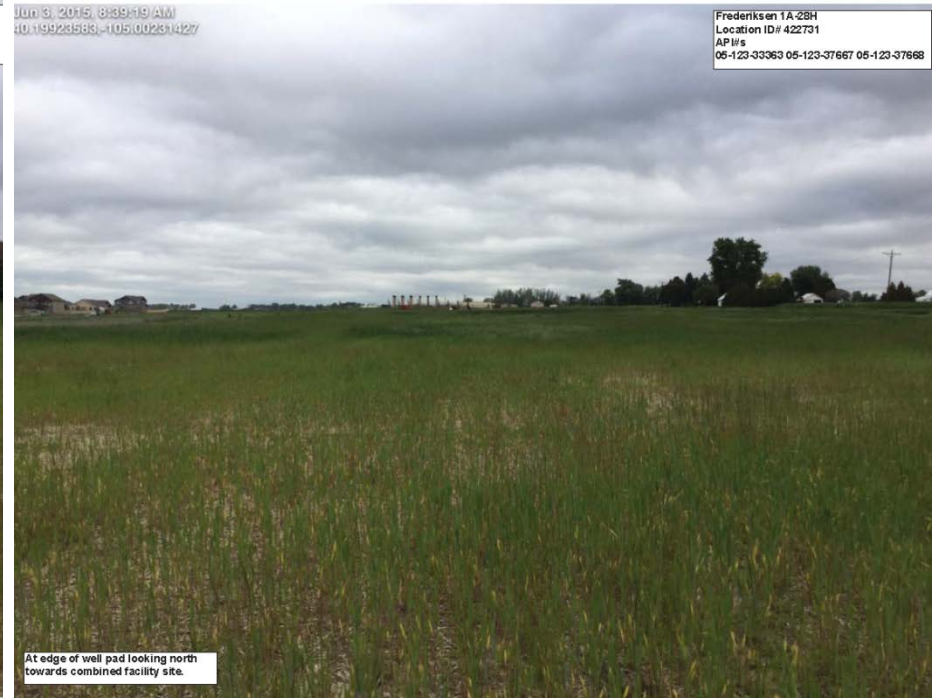
Facing north

At edge of well pad looking north  
towards combined facility sRe.

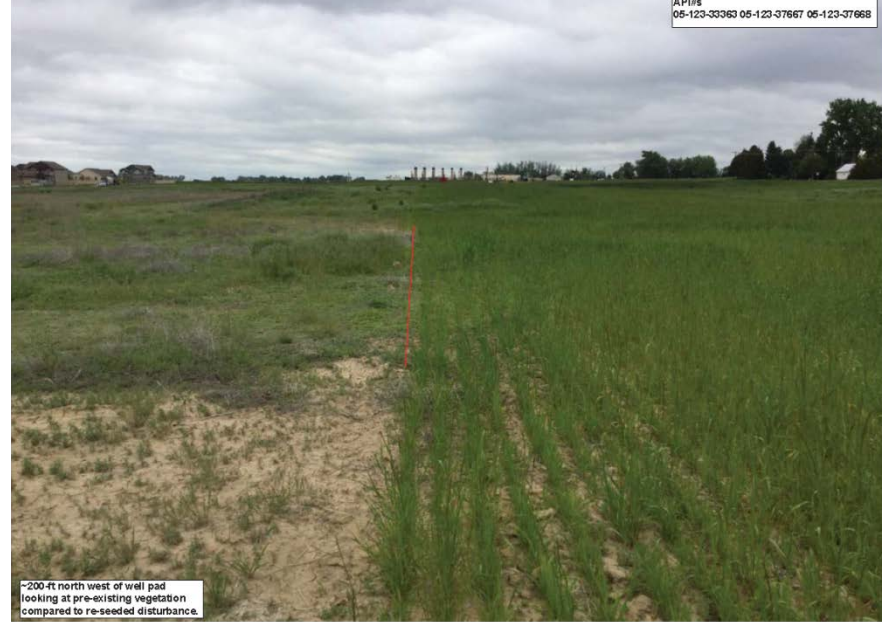
~200 ft north west of well pad  
looking at pre-existing vegetation  
compared to re-seeded disturbance.

New vegetation compared to old vegetation adjacent on west side facing north

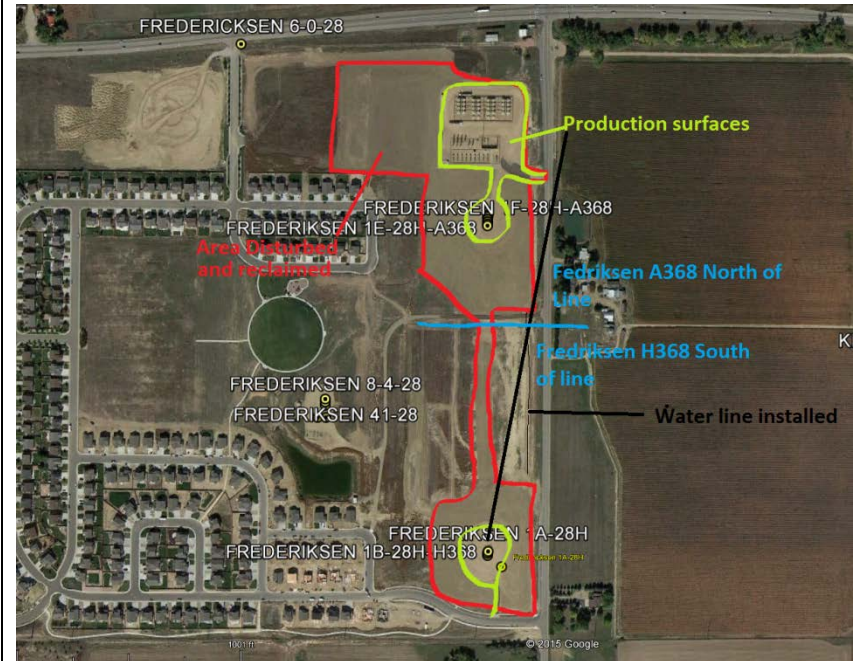
Area reclaimed and area used for production
