Follow Up Inspection

12/07/2015

Operator: Western Operating Co.

Location ID: 435387

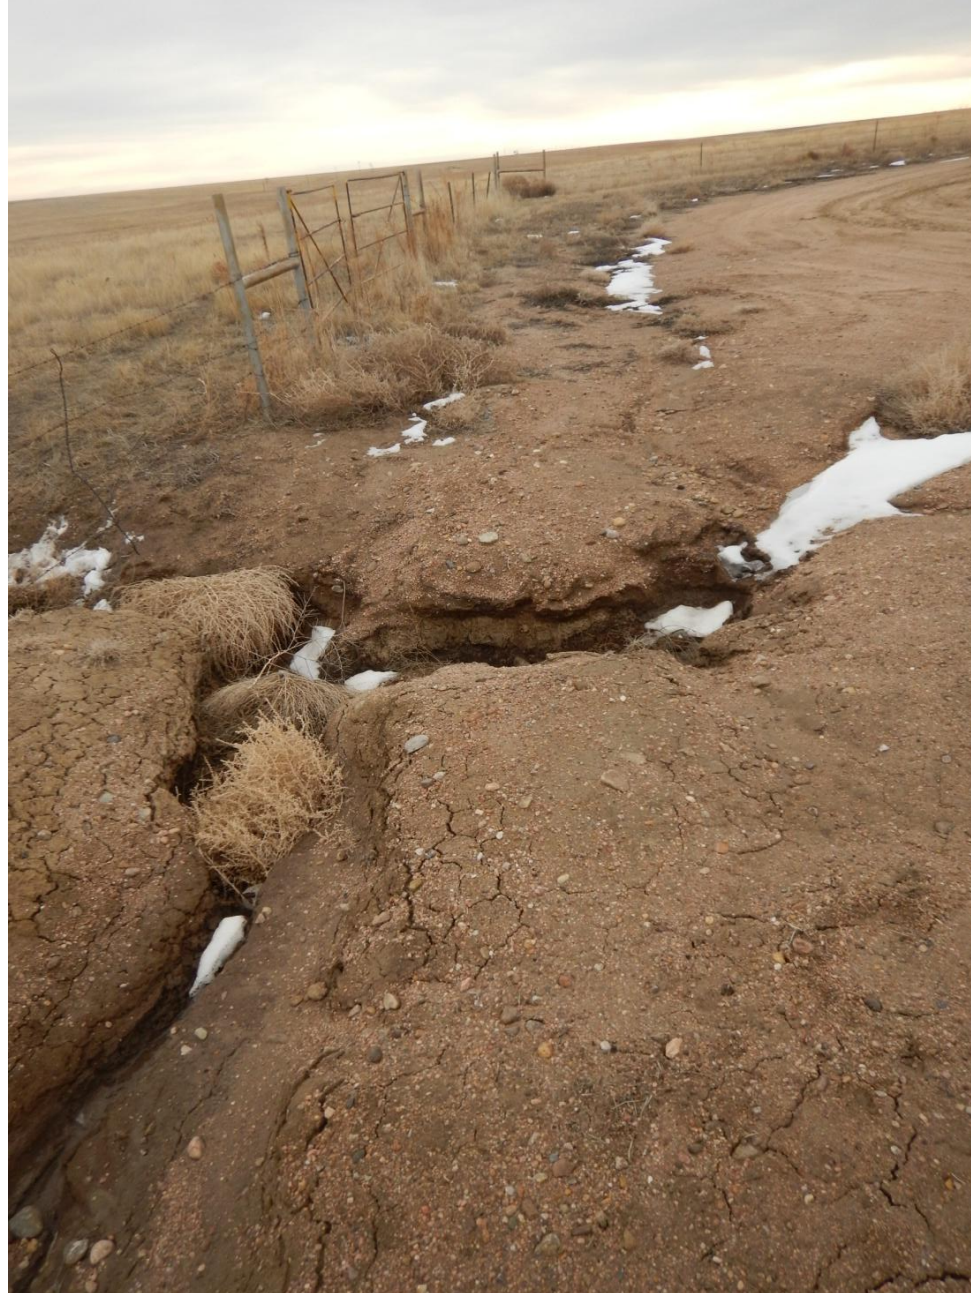
Figure 1: Photo taken from east end of location, facing north. Photo of gully formation. Note Russian thistle weed debris and insufficient stormwater BMPs.

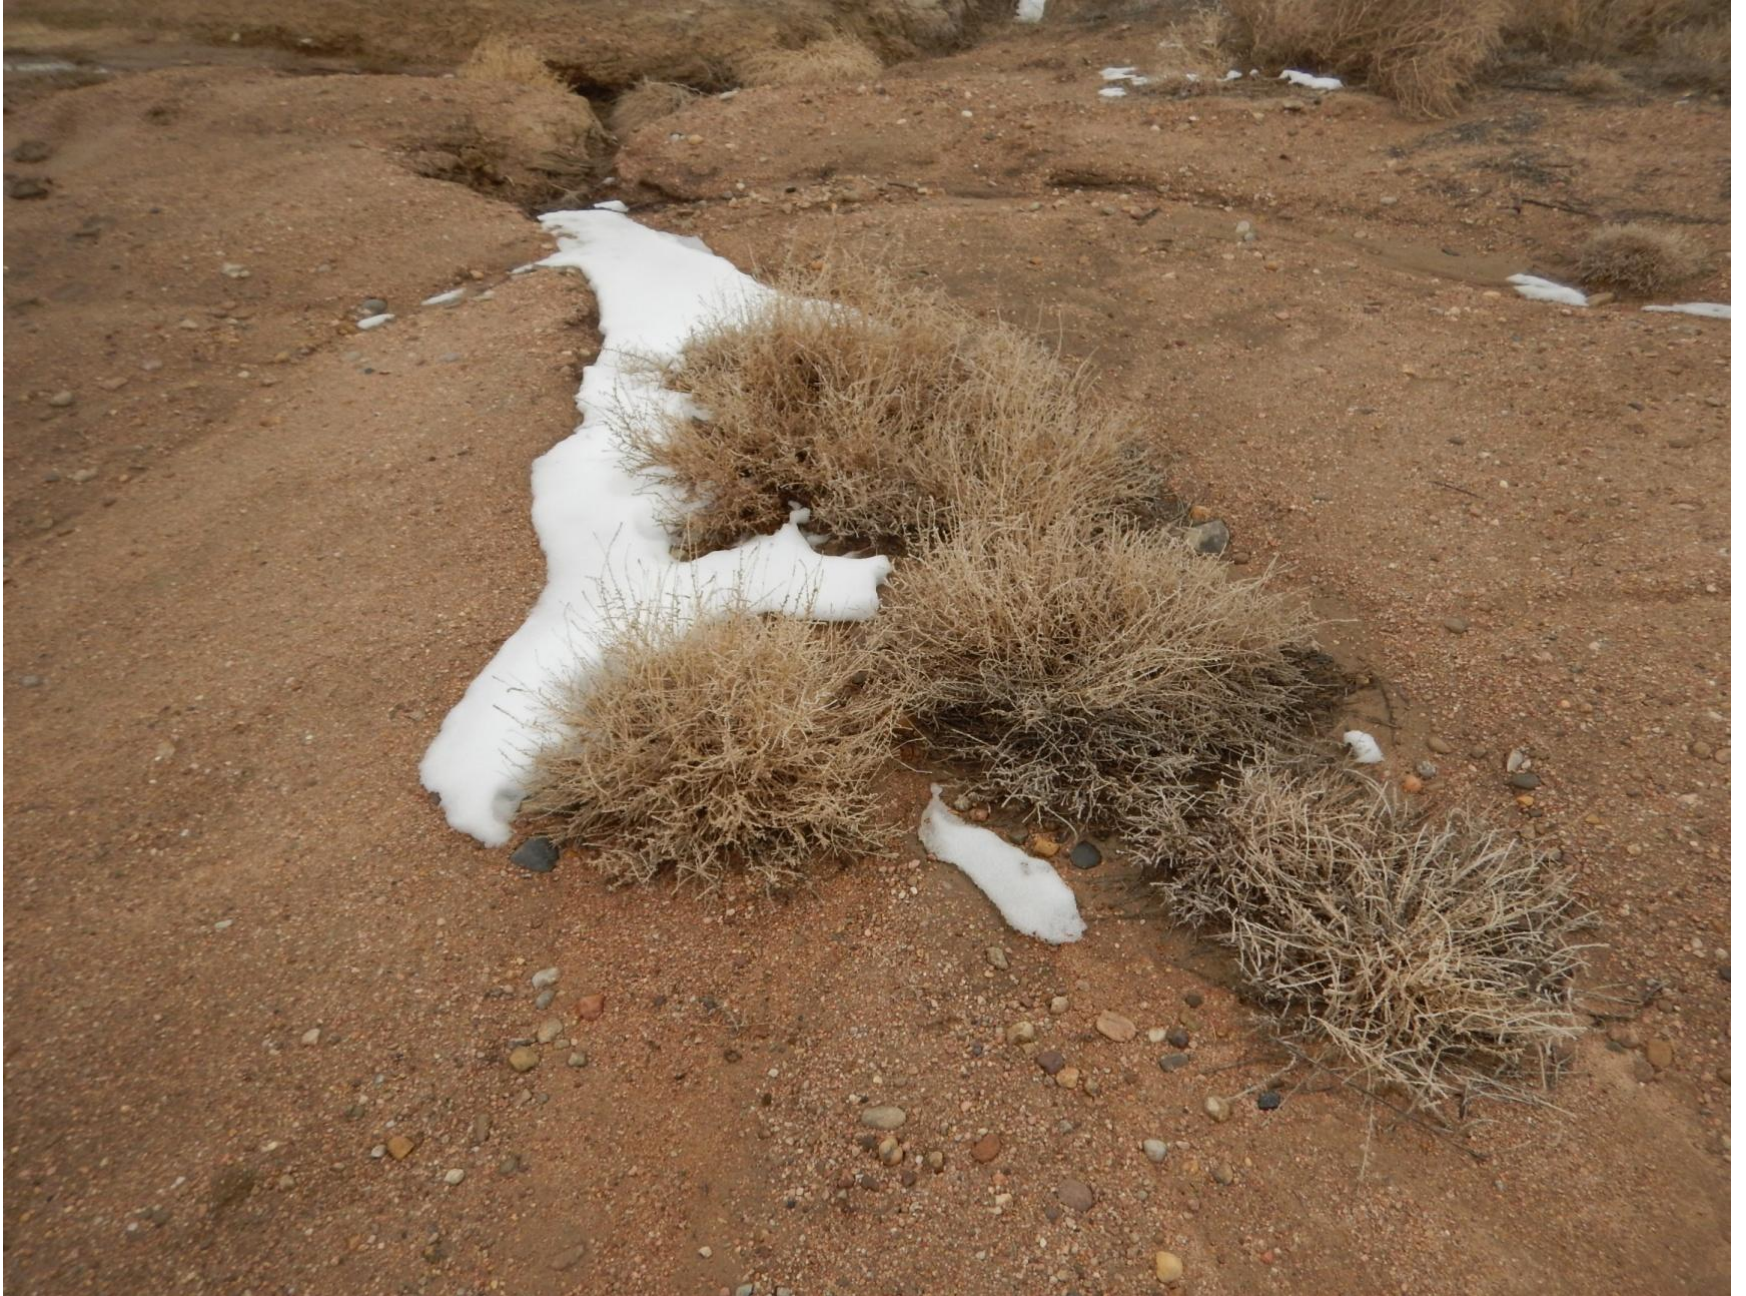
Figure 2: Photo taken from east end of location. Photo of gully formation, Russian thistle weed debris and insufficient stormwater BMPs.

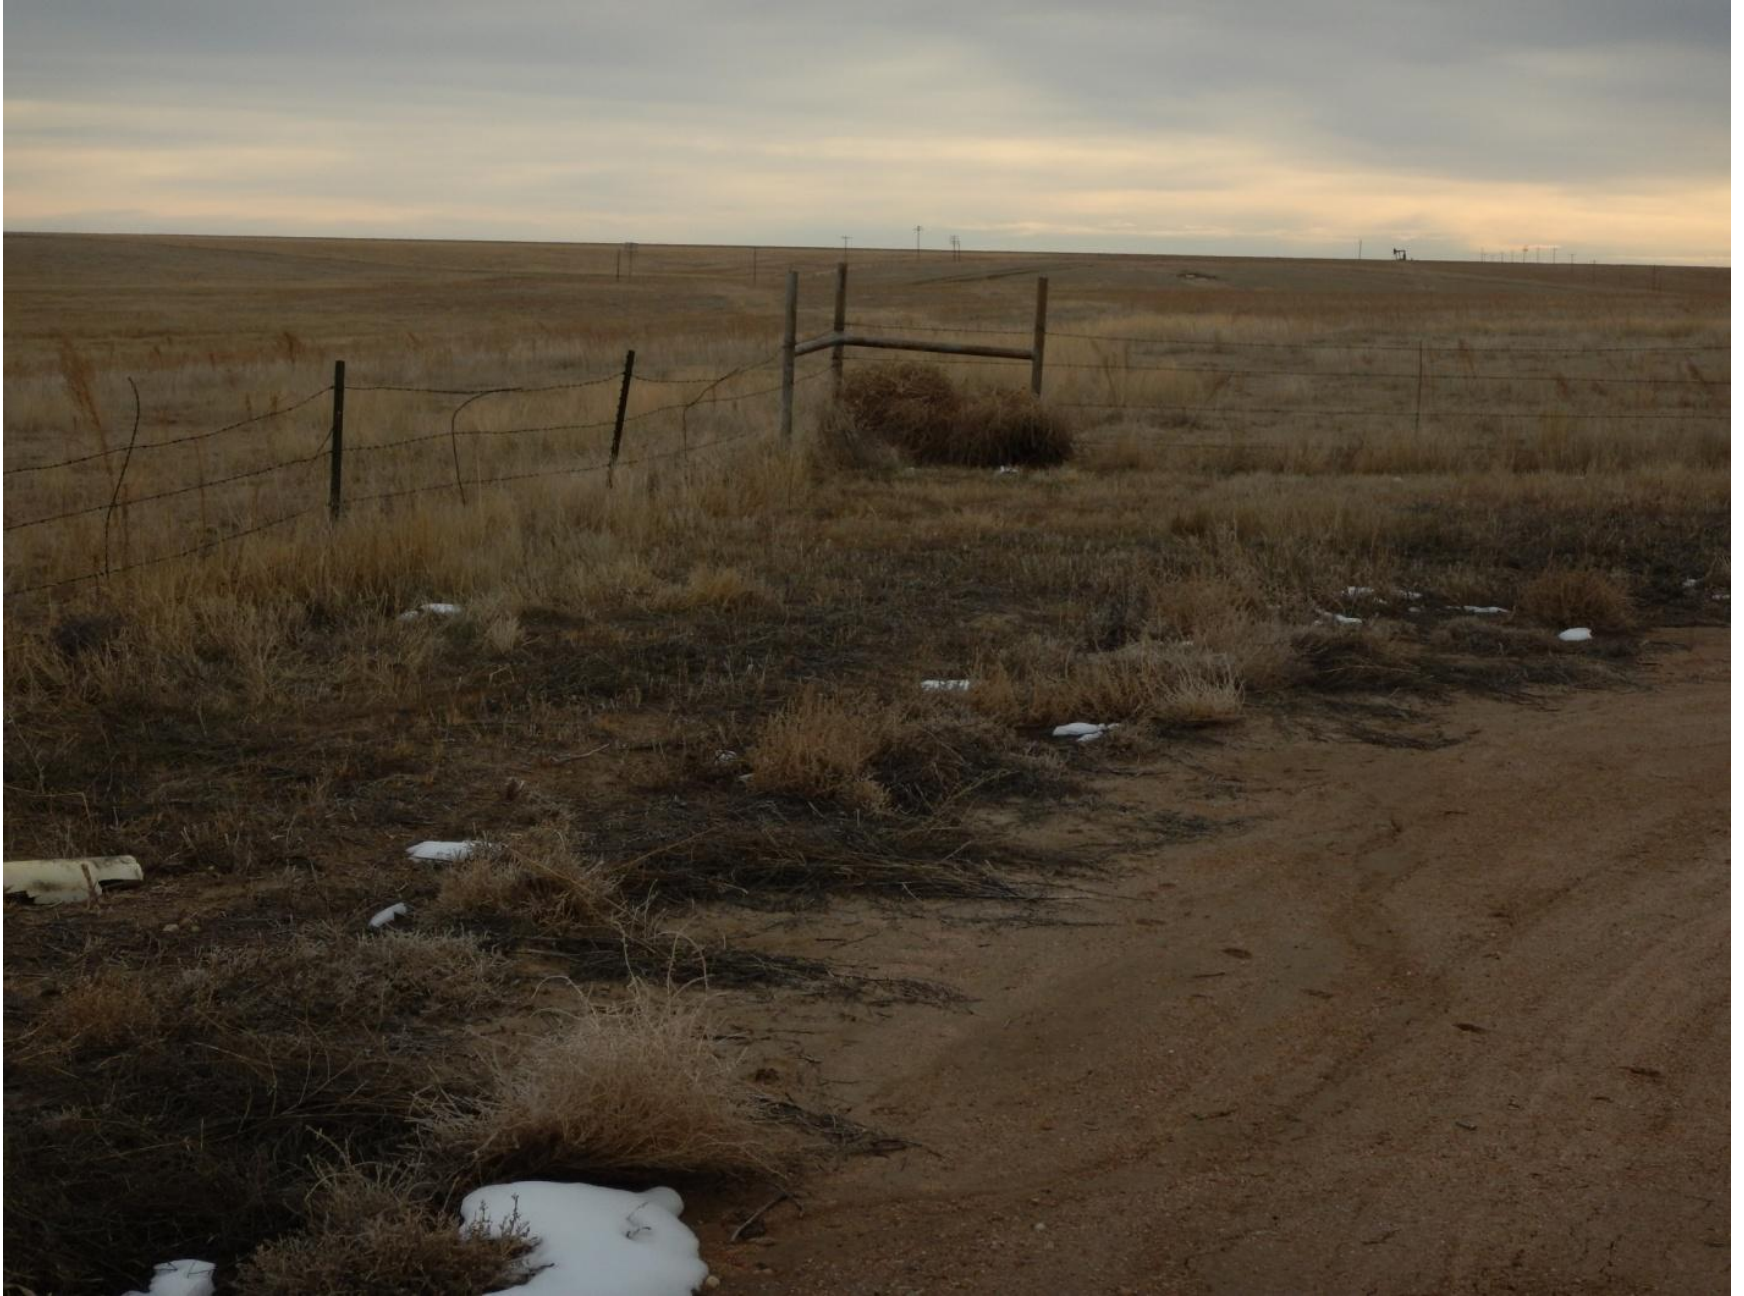
Figure 3: Photo taken from east end of location facing north. Photo of Russian thistle weed debris caught in fence.

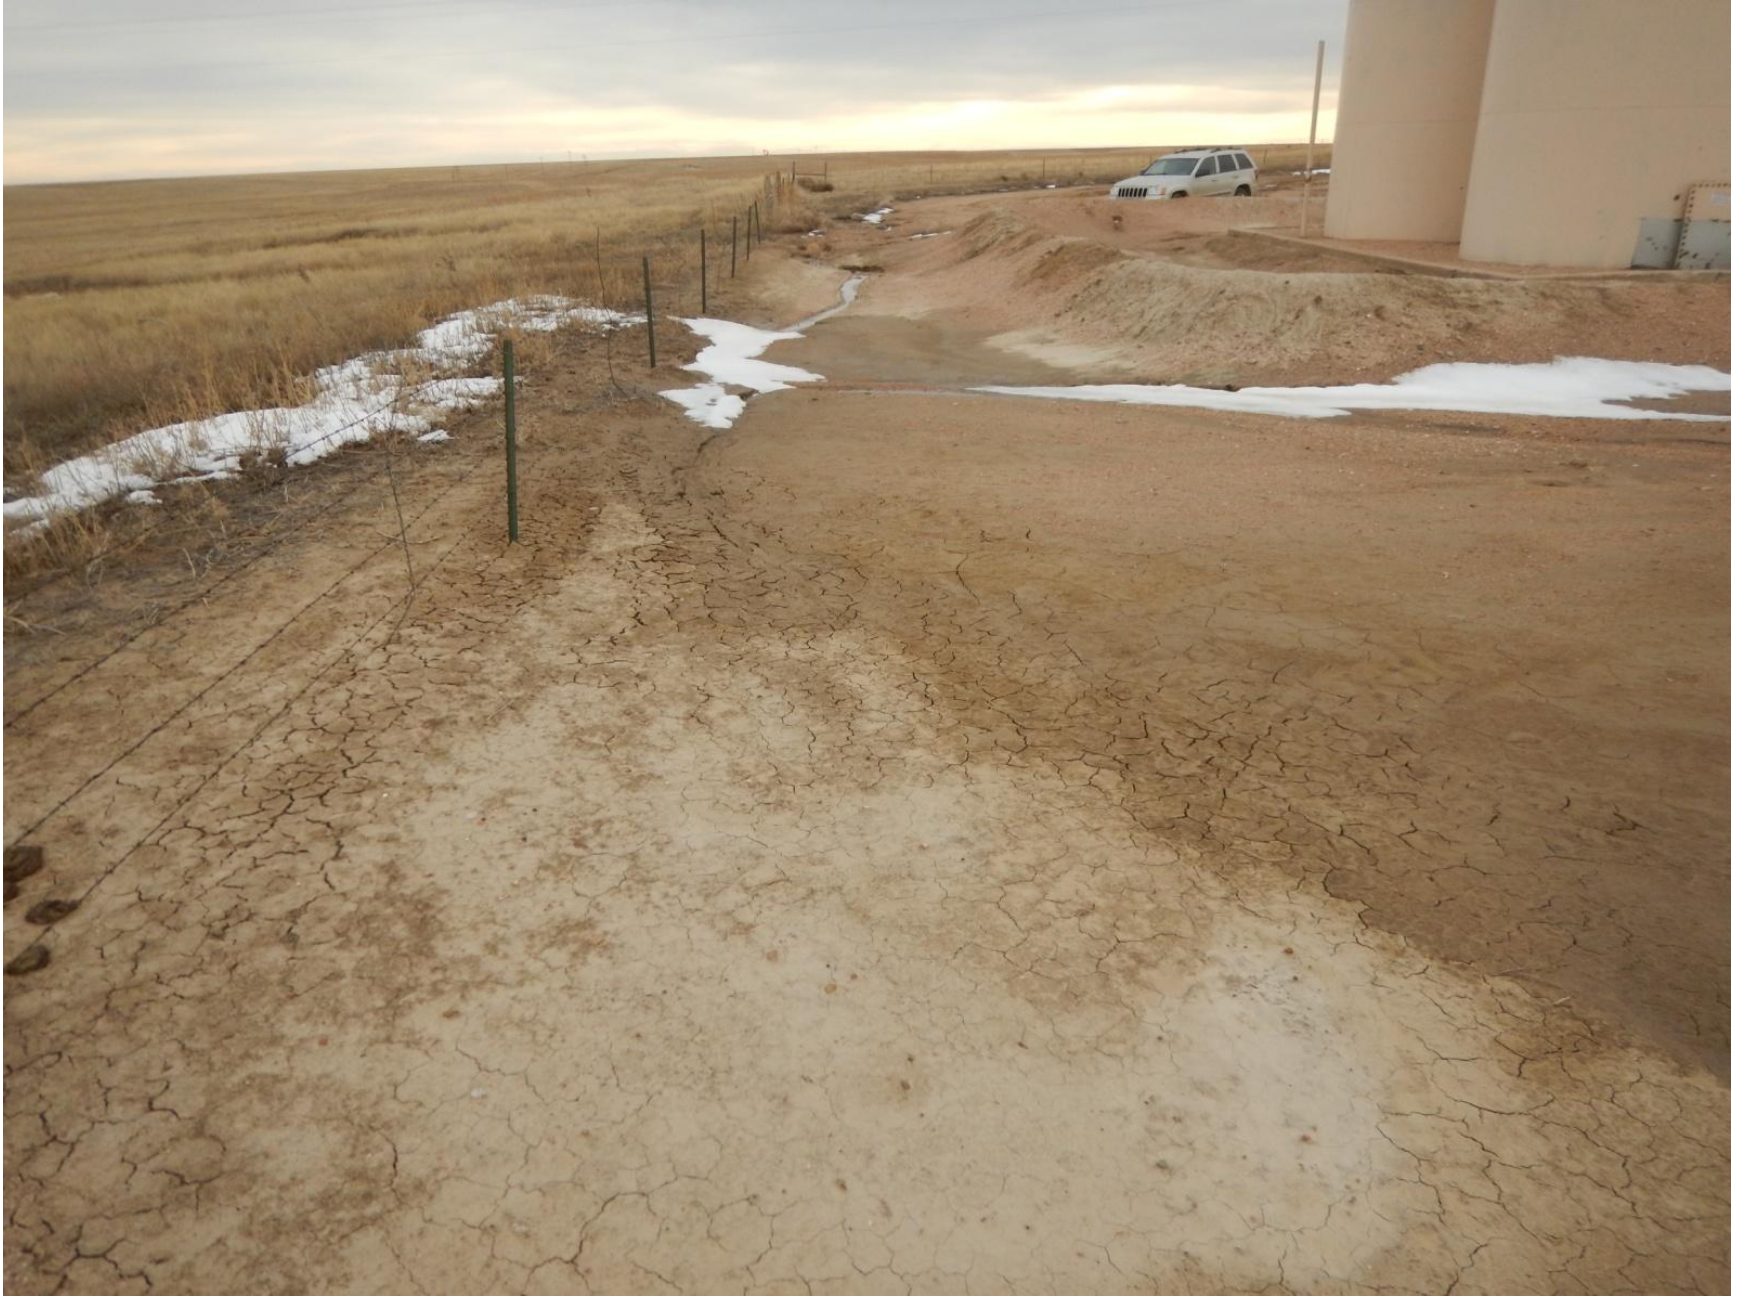
Figure 4: Photo taken from northeast end of location facing south. Photo shows surface erosion on location and insufficient stormwater BMPs.

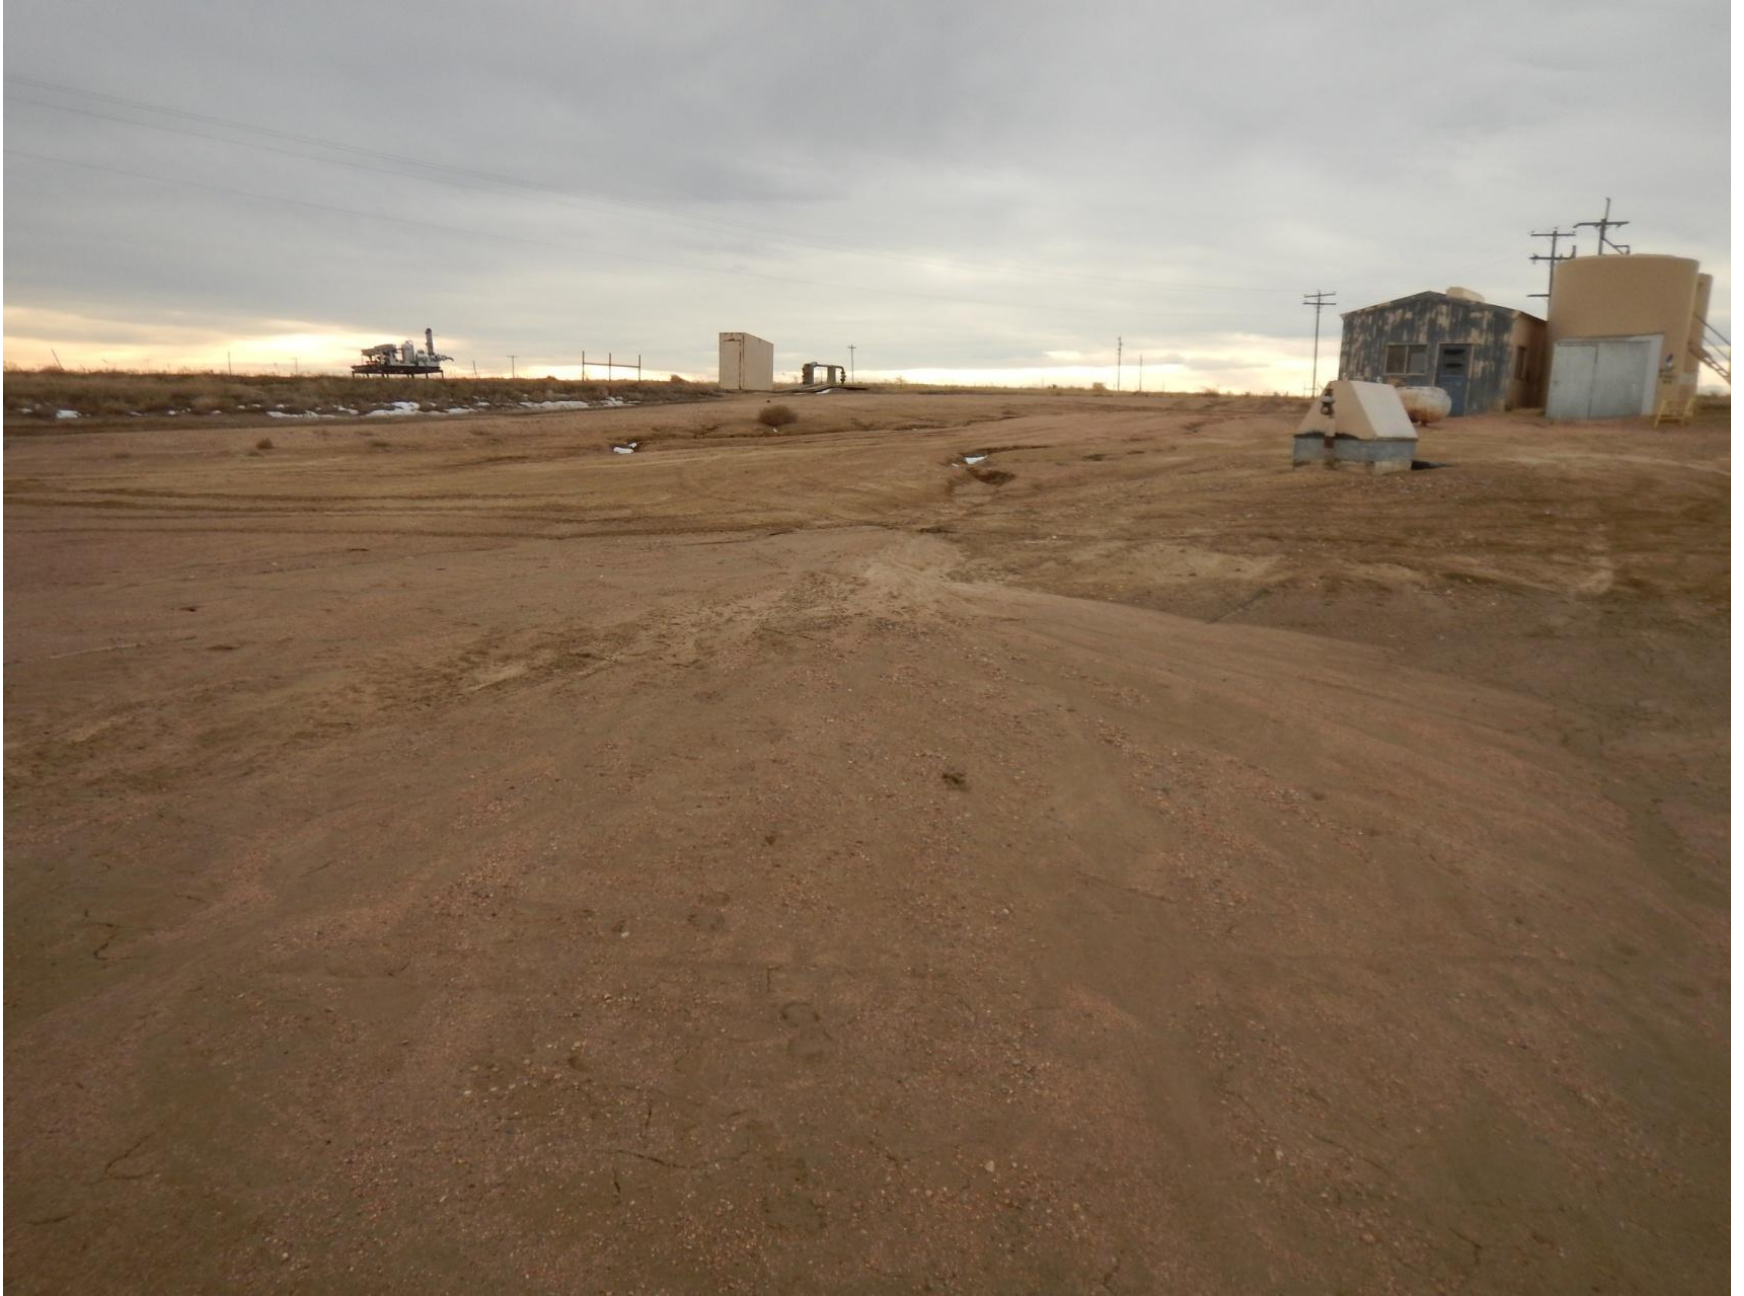
Figure 5: Photo taken from north end of location facing southwest. Photo shows surface erosion on location and insufficient stormwater BMPs.

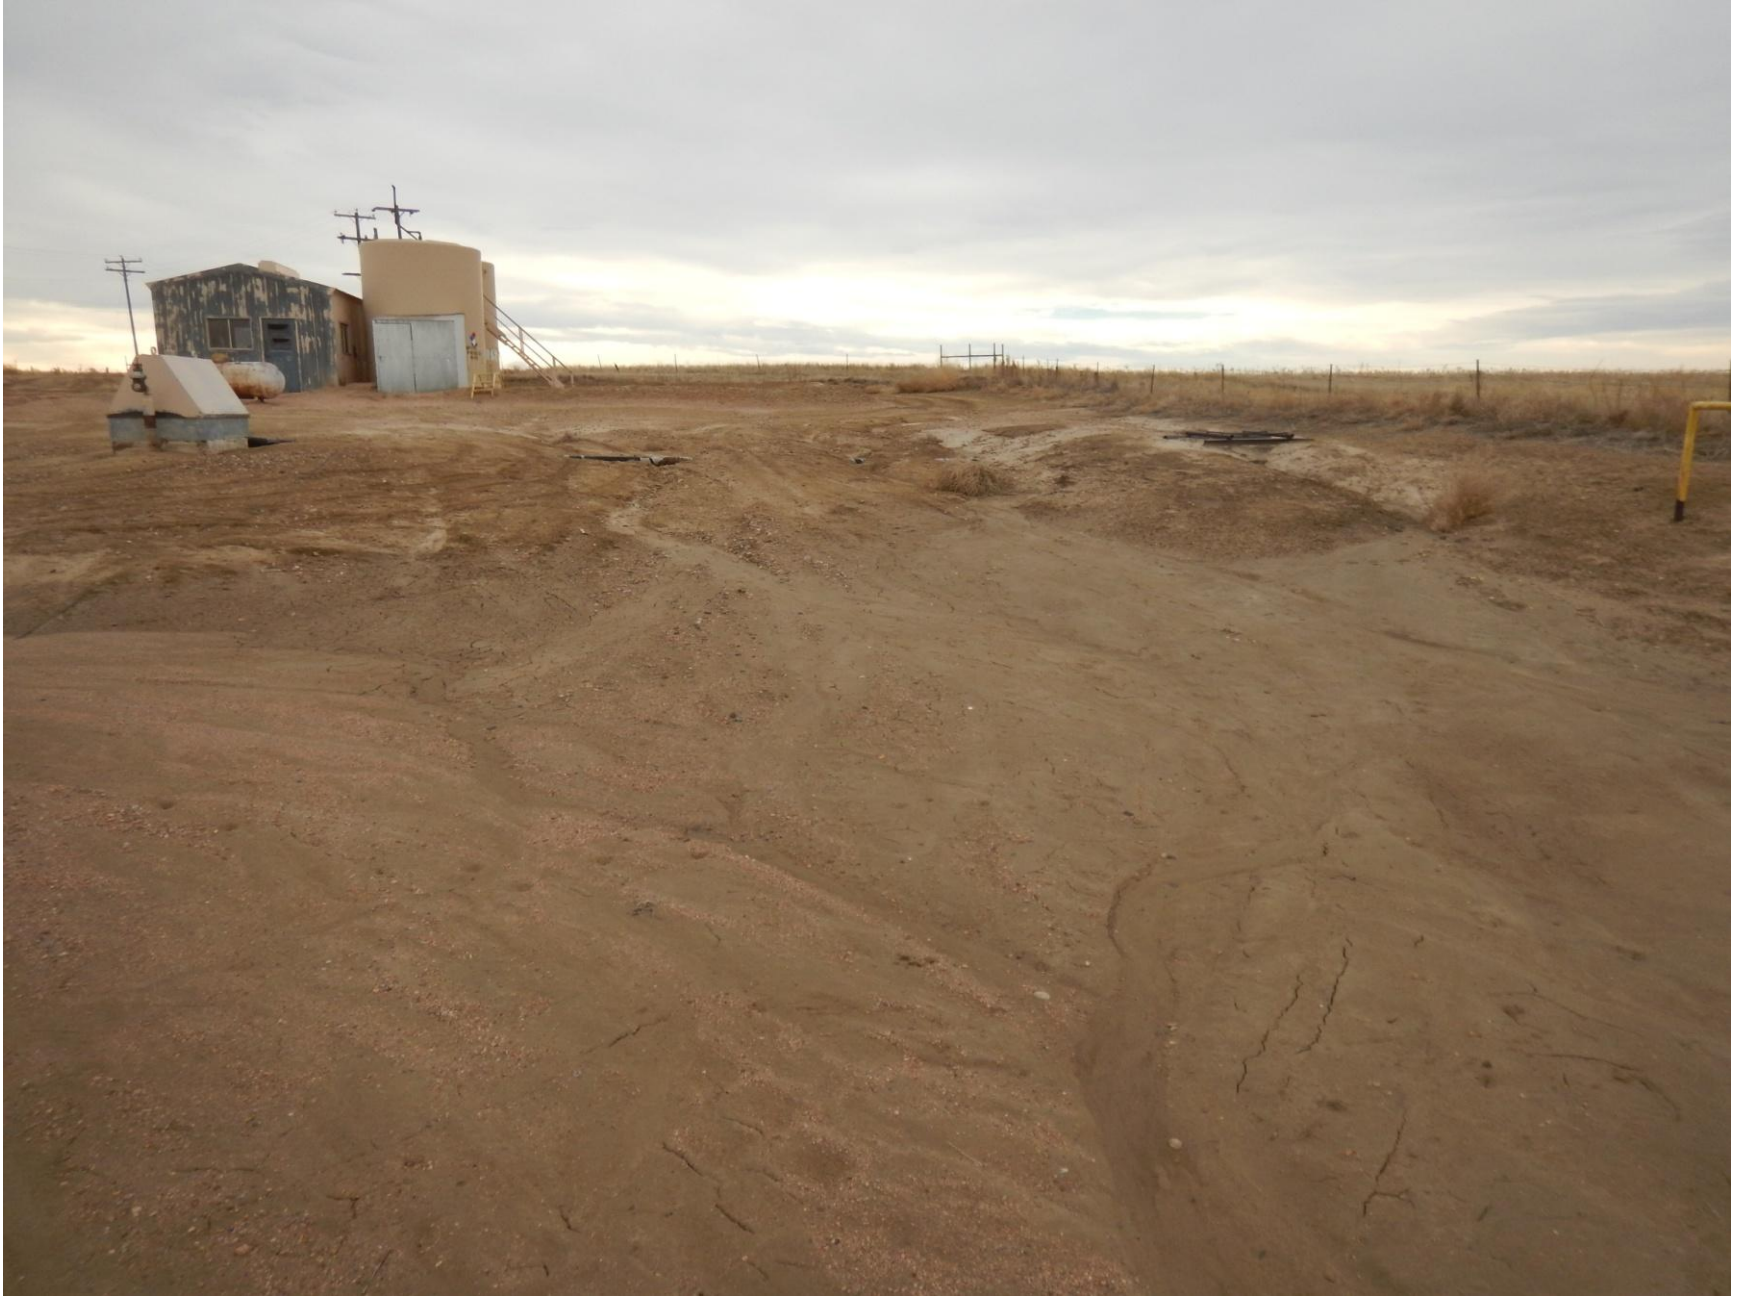
Figure 6: Photo taken from north end of location facing west. Photo shows surface erosion on location and insufficient stormwater BMPs.

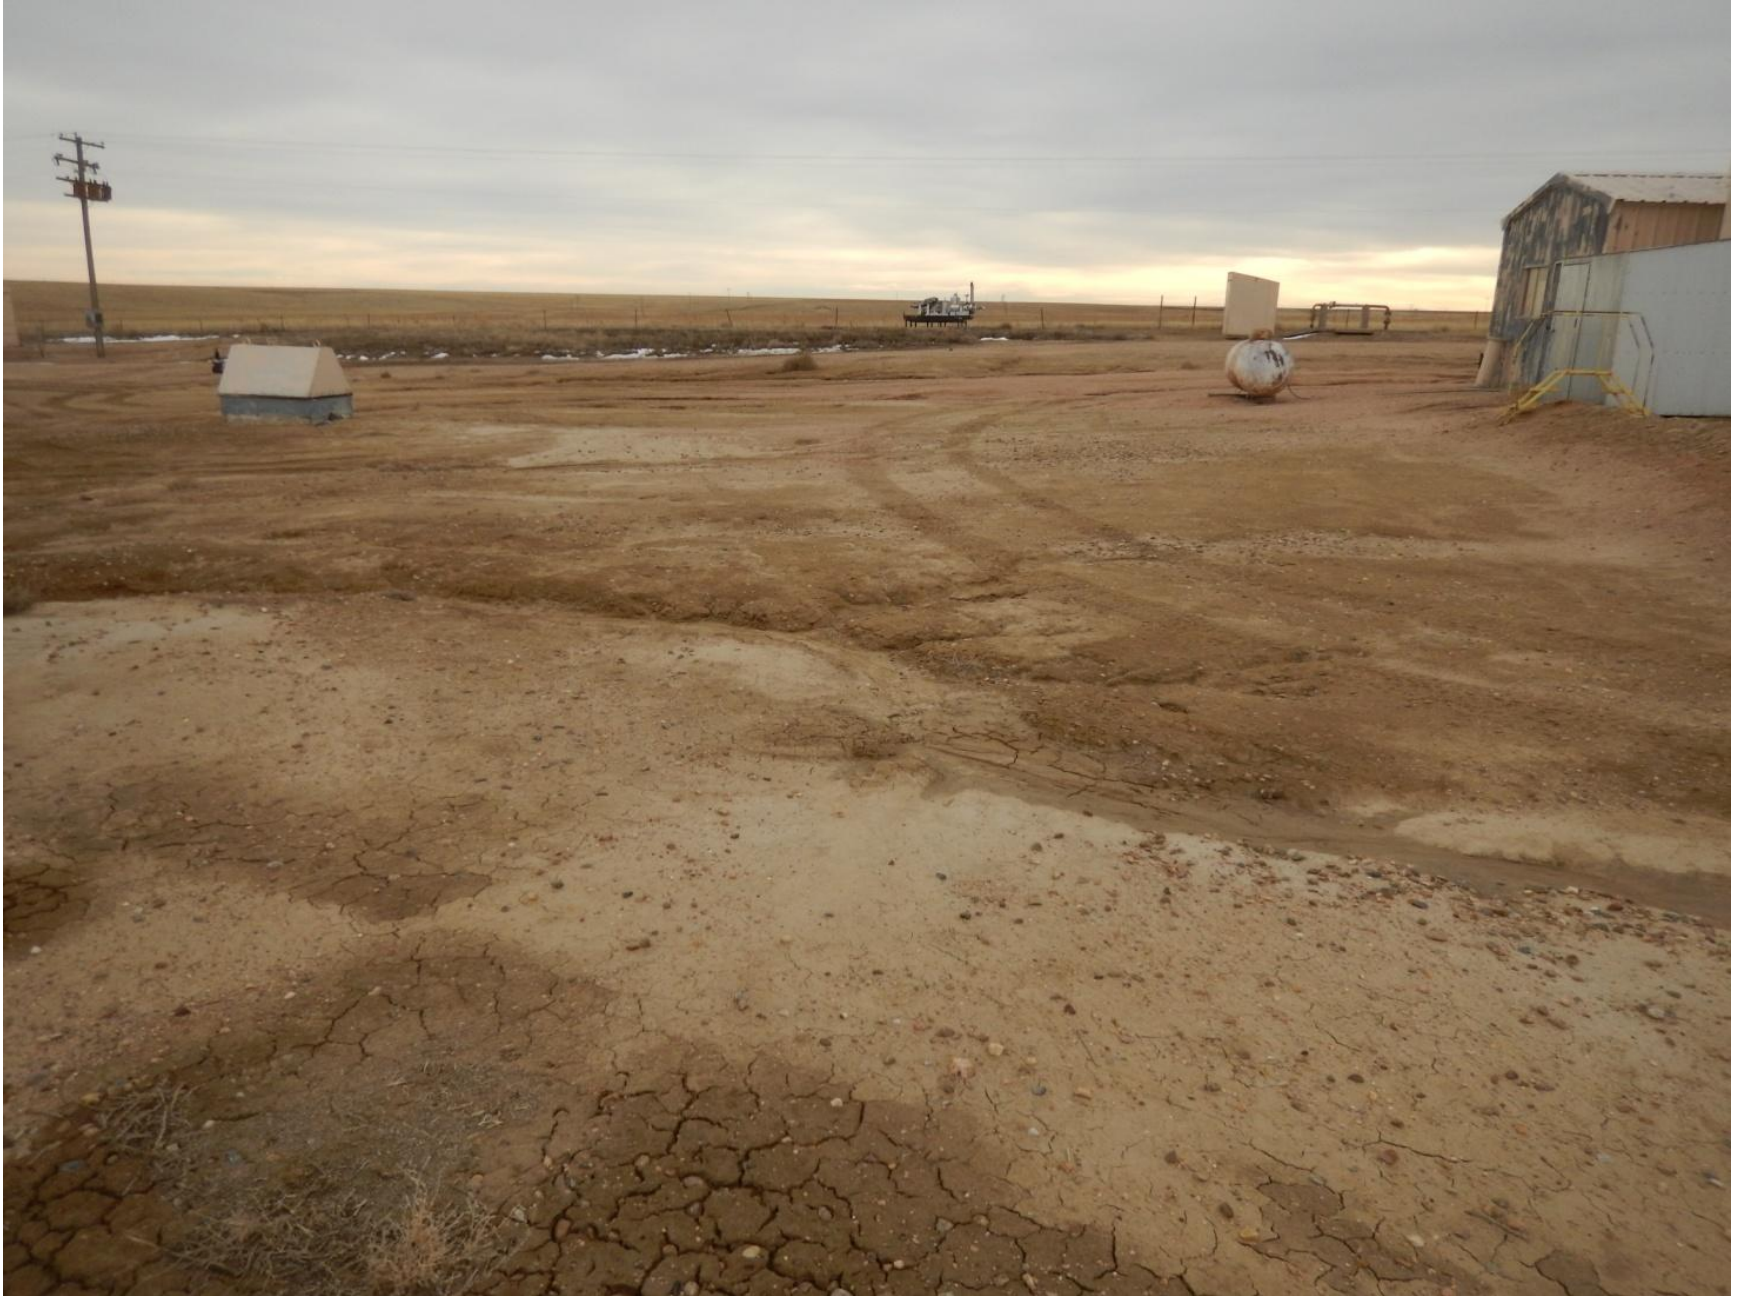
Figure 7: Photo taken from north end of location facing south. Photo shows surface erosion on location and insufficient stormwater BMPs.

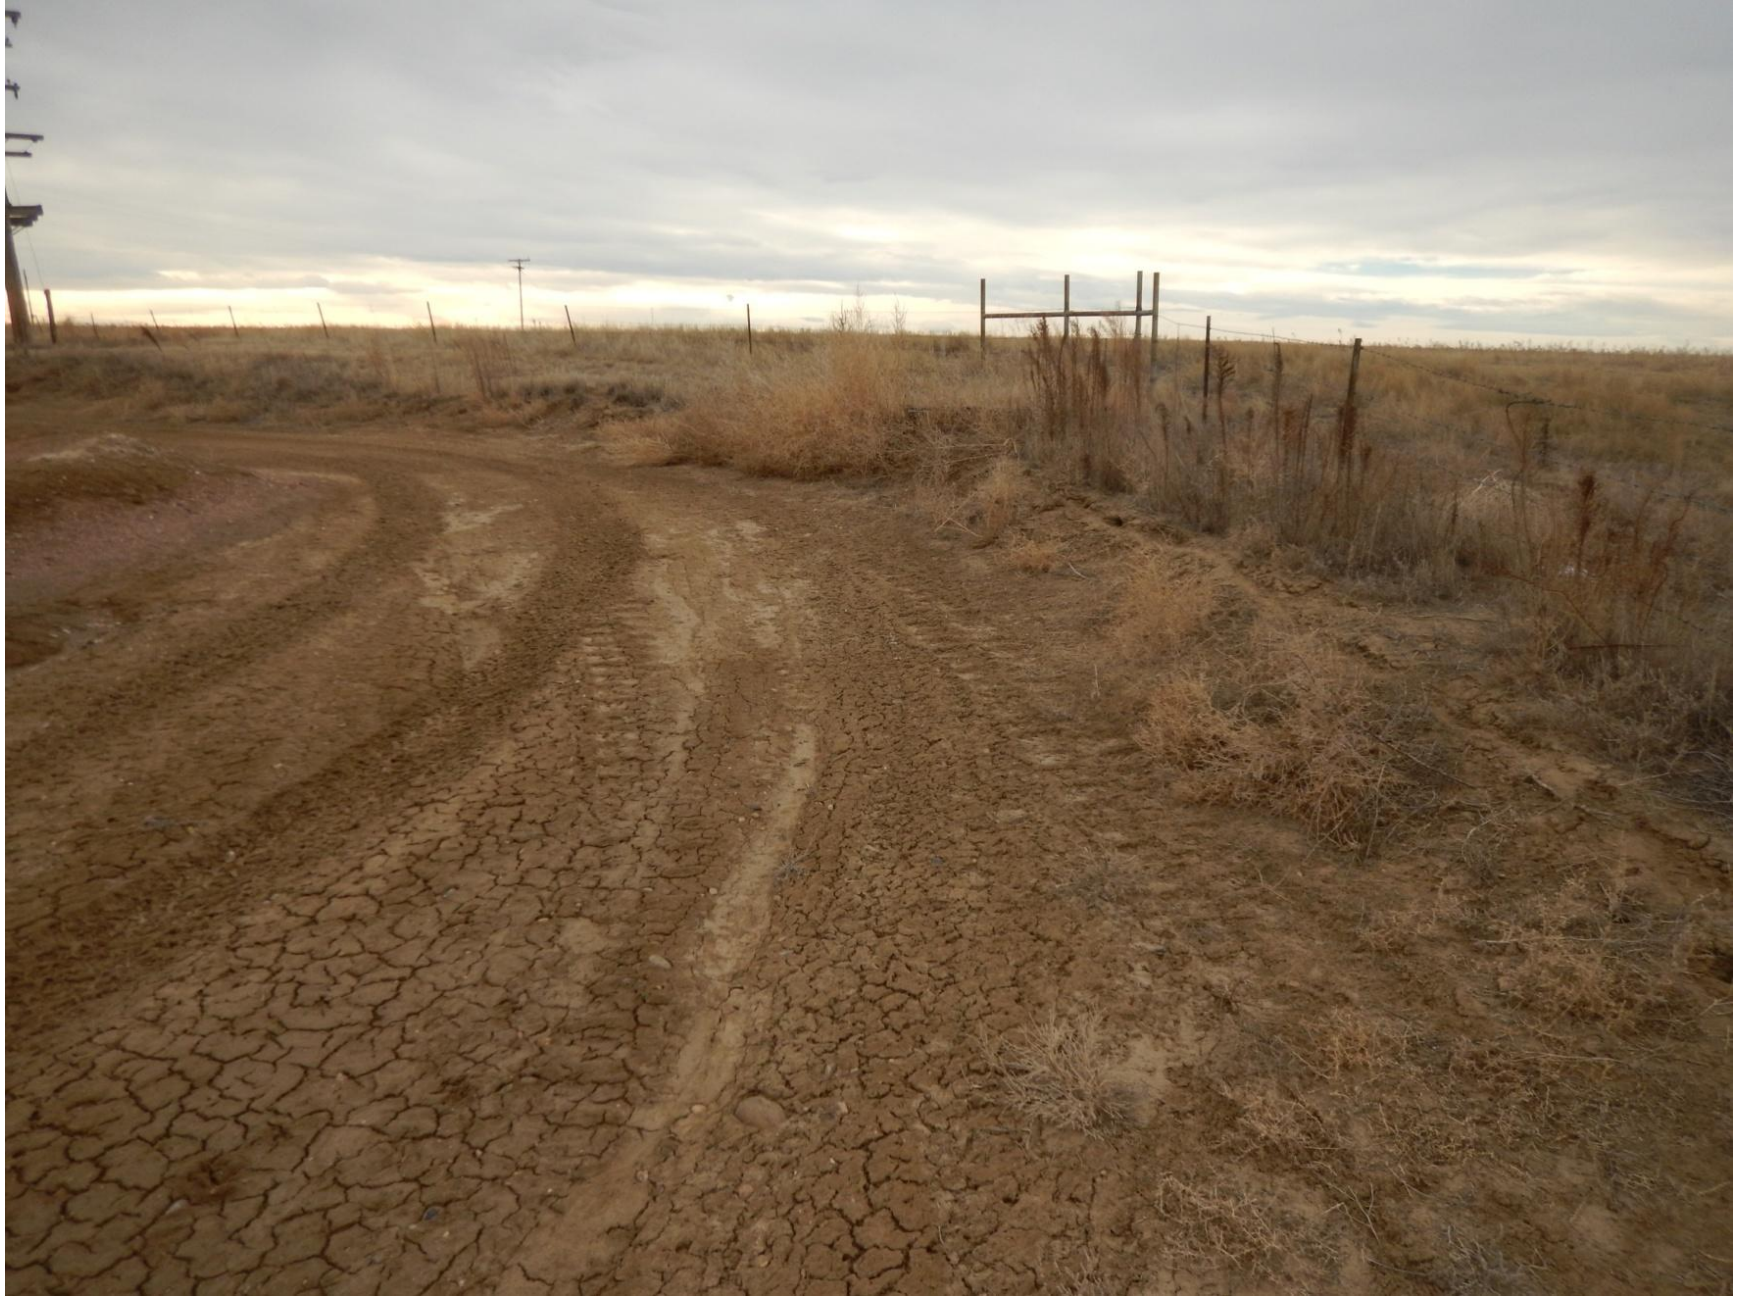
Figure 8: Photo taken from north end of location facing west. Photo of Russian thistle and Kochia weed debris.

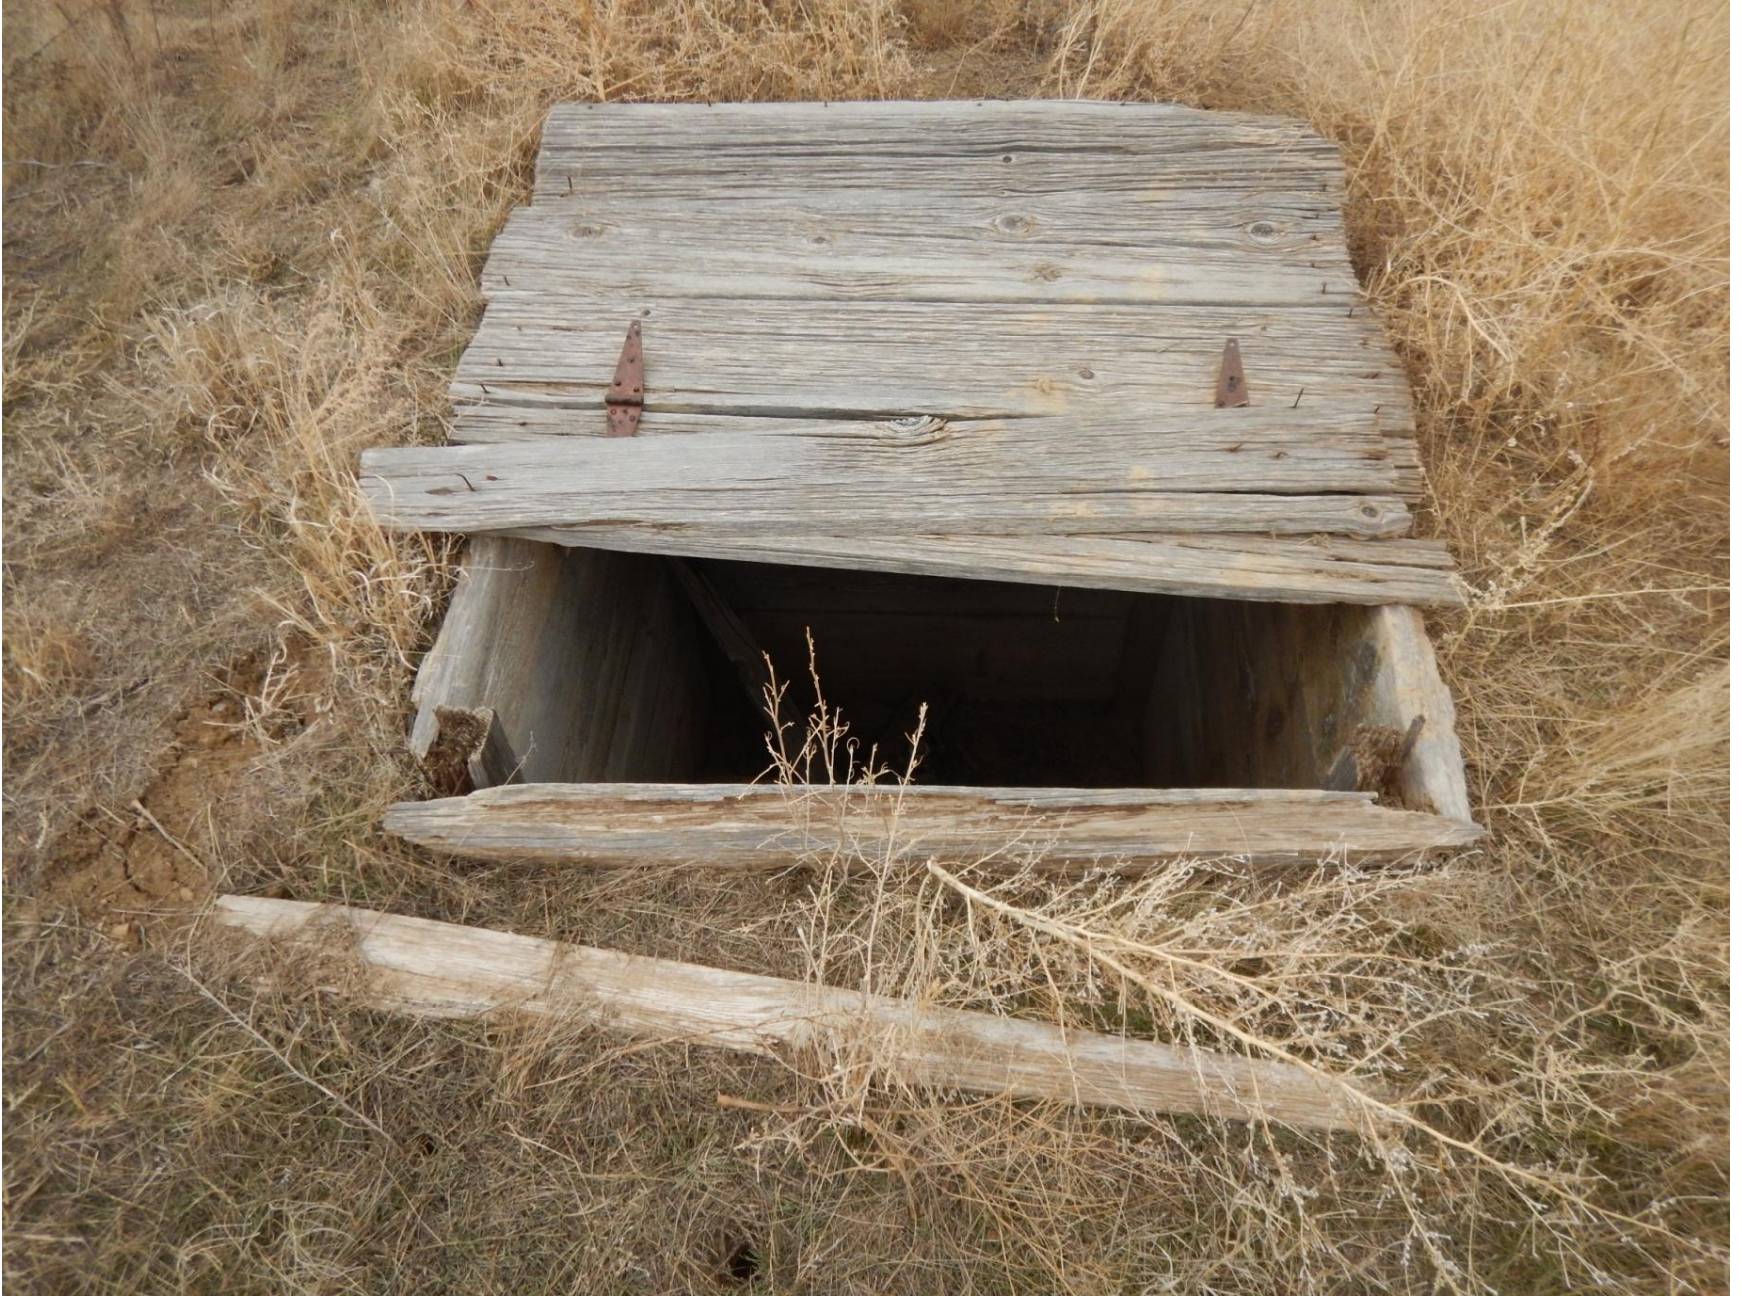
Figure 9: Photo taken from northwest end of location. Photo shows broken door of wooden sub-surface structure. This poses a hazard to wildlife and human safety.

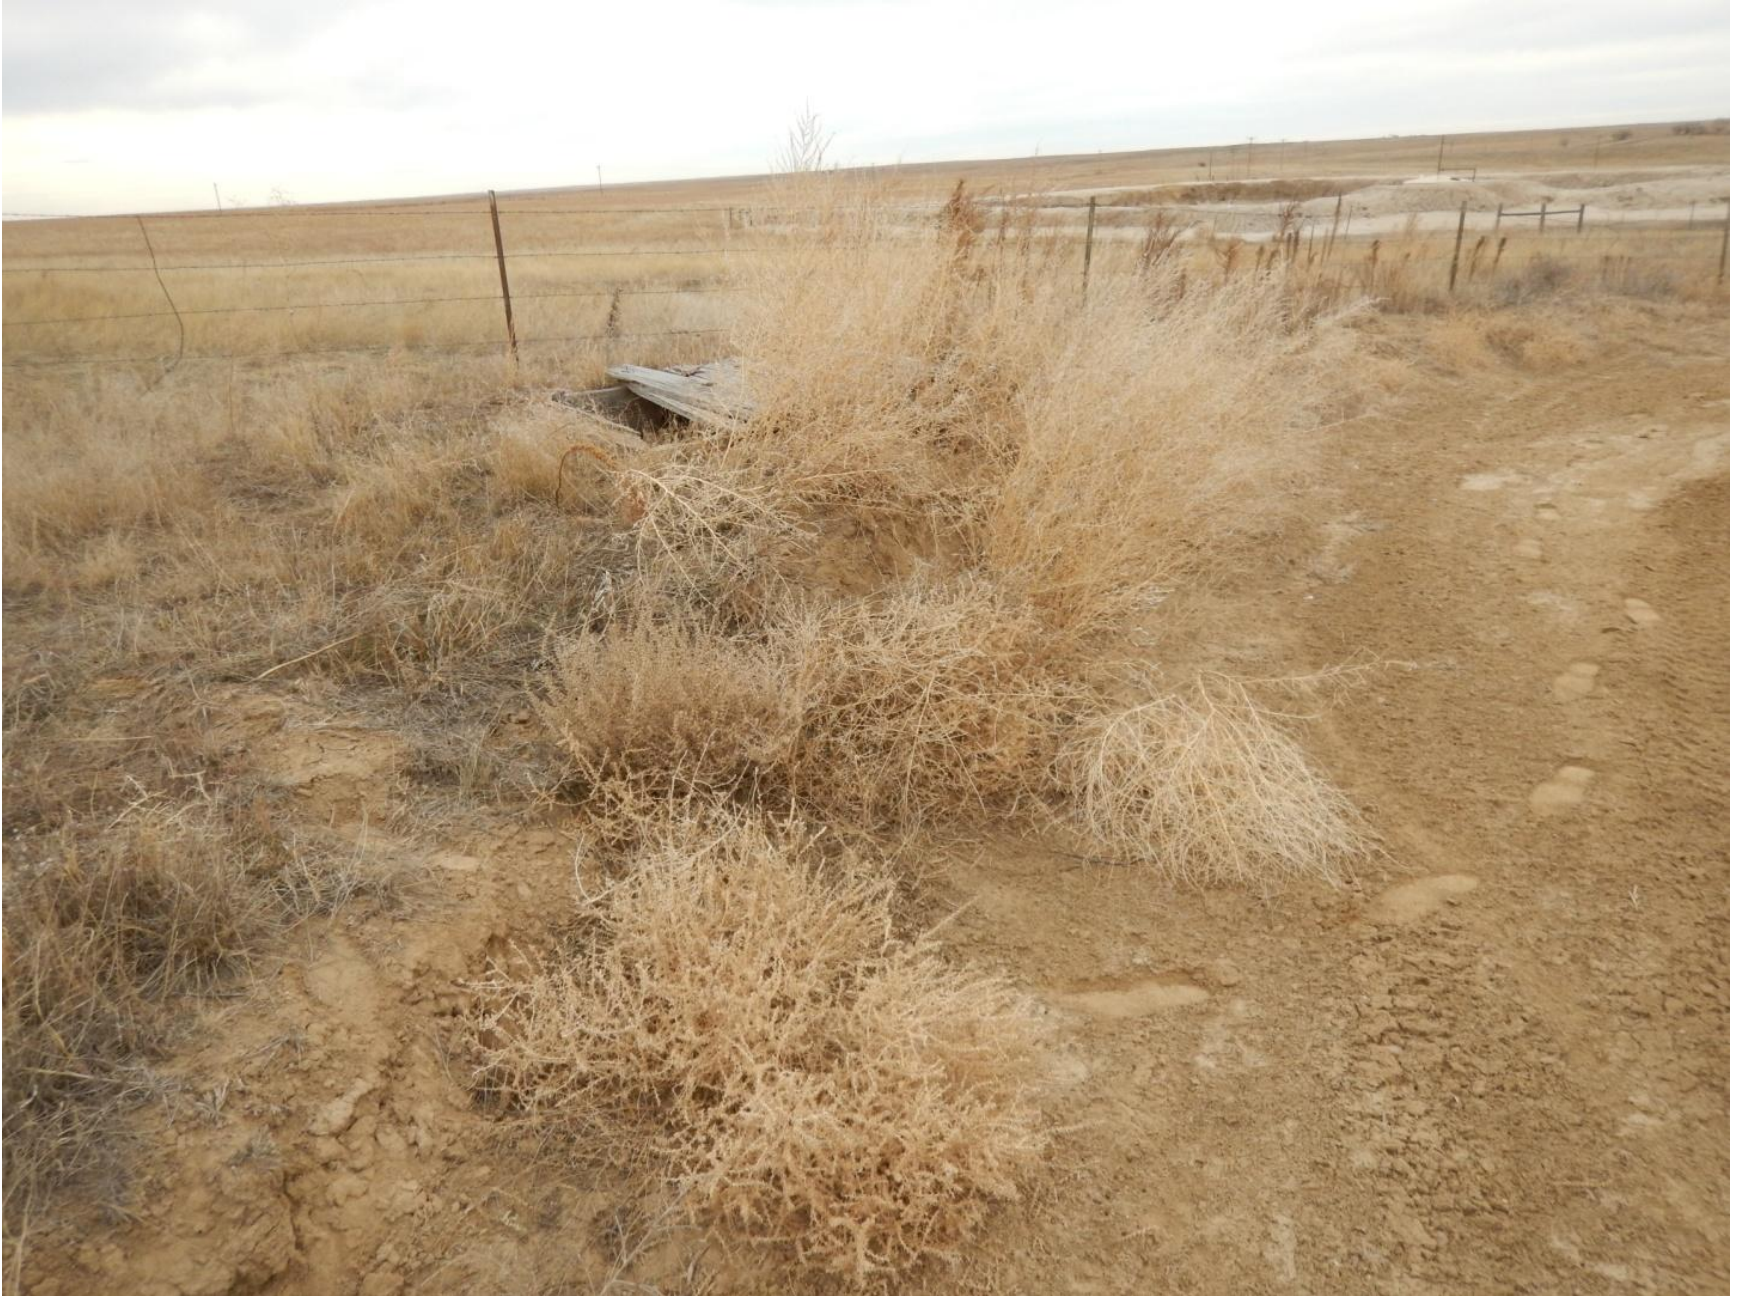
Figure 10: Photo taken from northwest end of location. Photo shows broken door of wooden sub-surface structure, and weed debris.
