Follow Up Inspection

12/07/2015

Operator: Western Operating Co.

Location ID: 435387

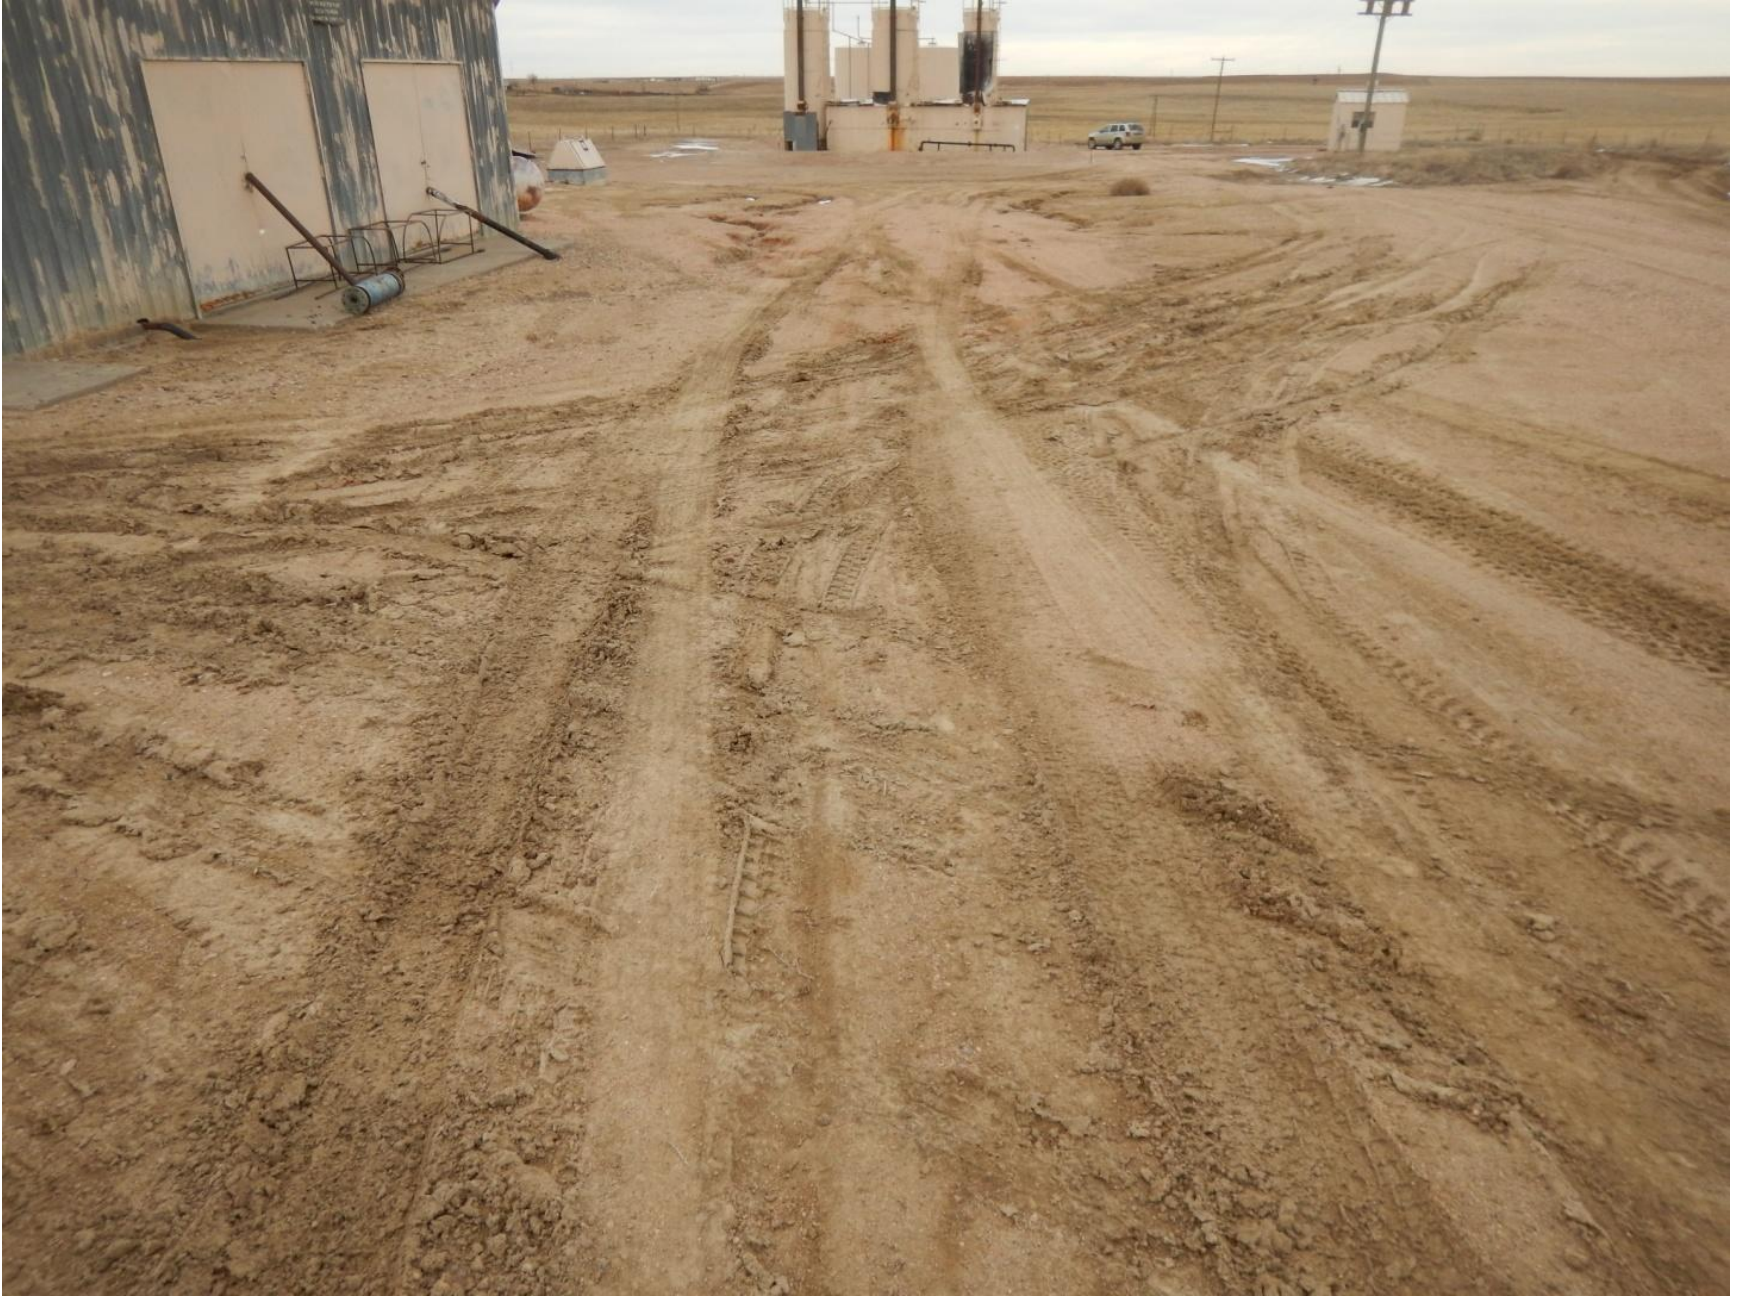
Figure 11: Photo taken from west end of location. Photo shows surface erosion on location and insufficient stormwater BMPs.

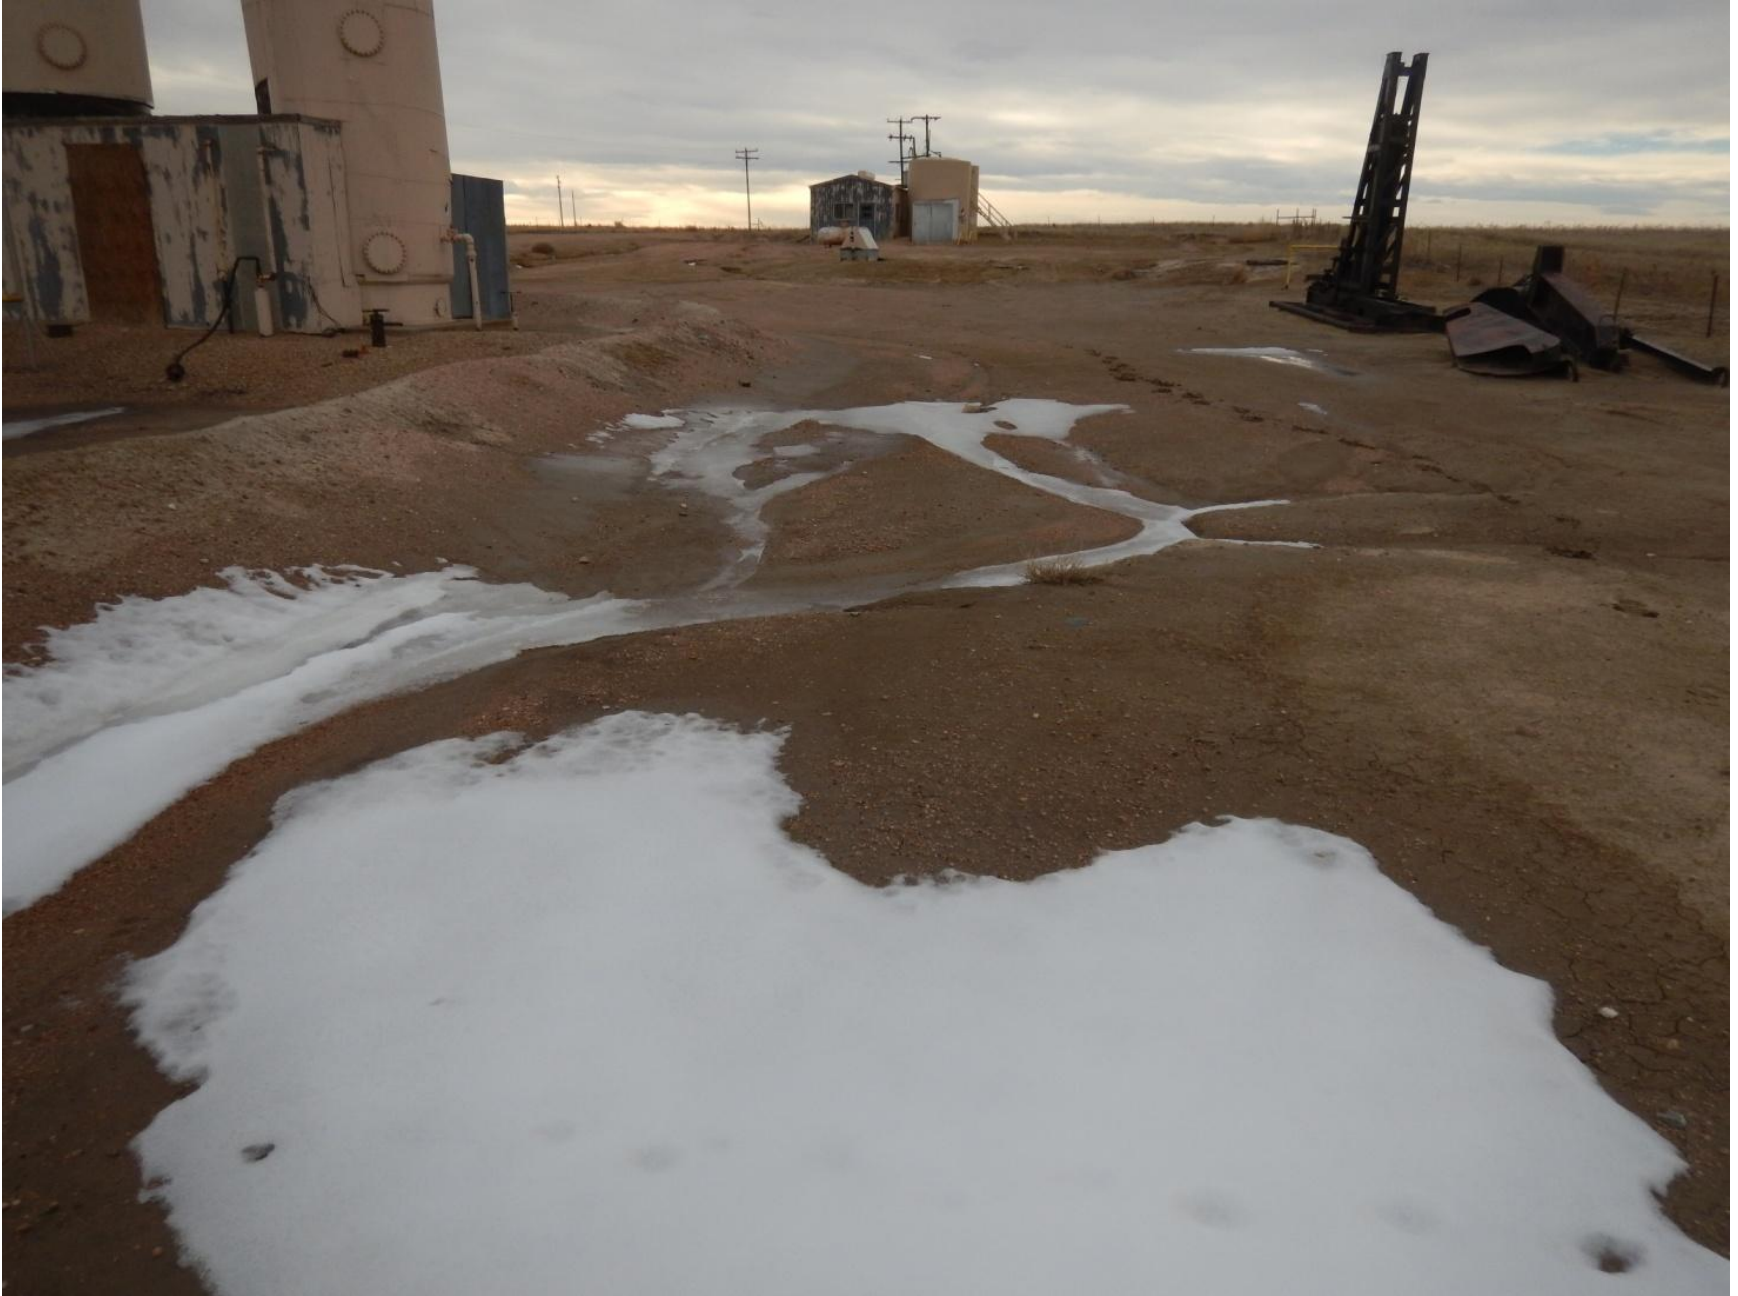
Figure 12: Photo taken from northeast end of location. Photo shows surface erosion on location and insufficient stormwater BMPs.

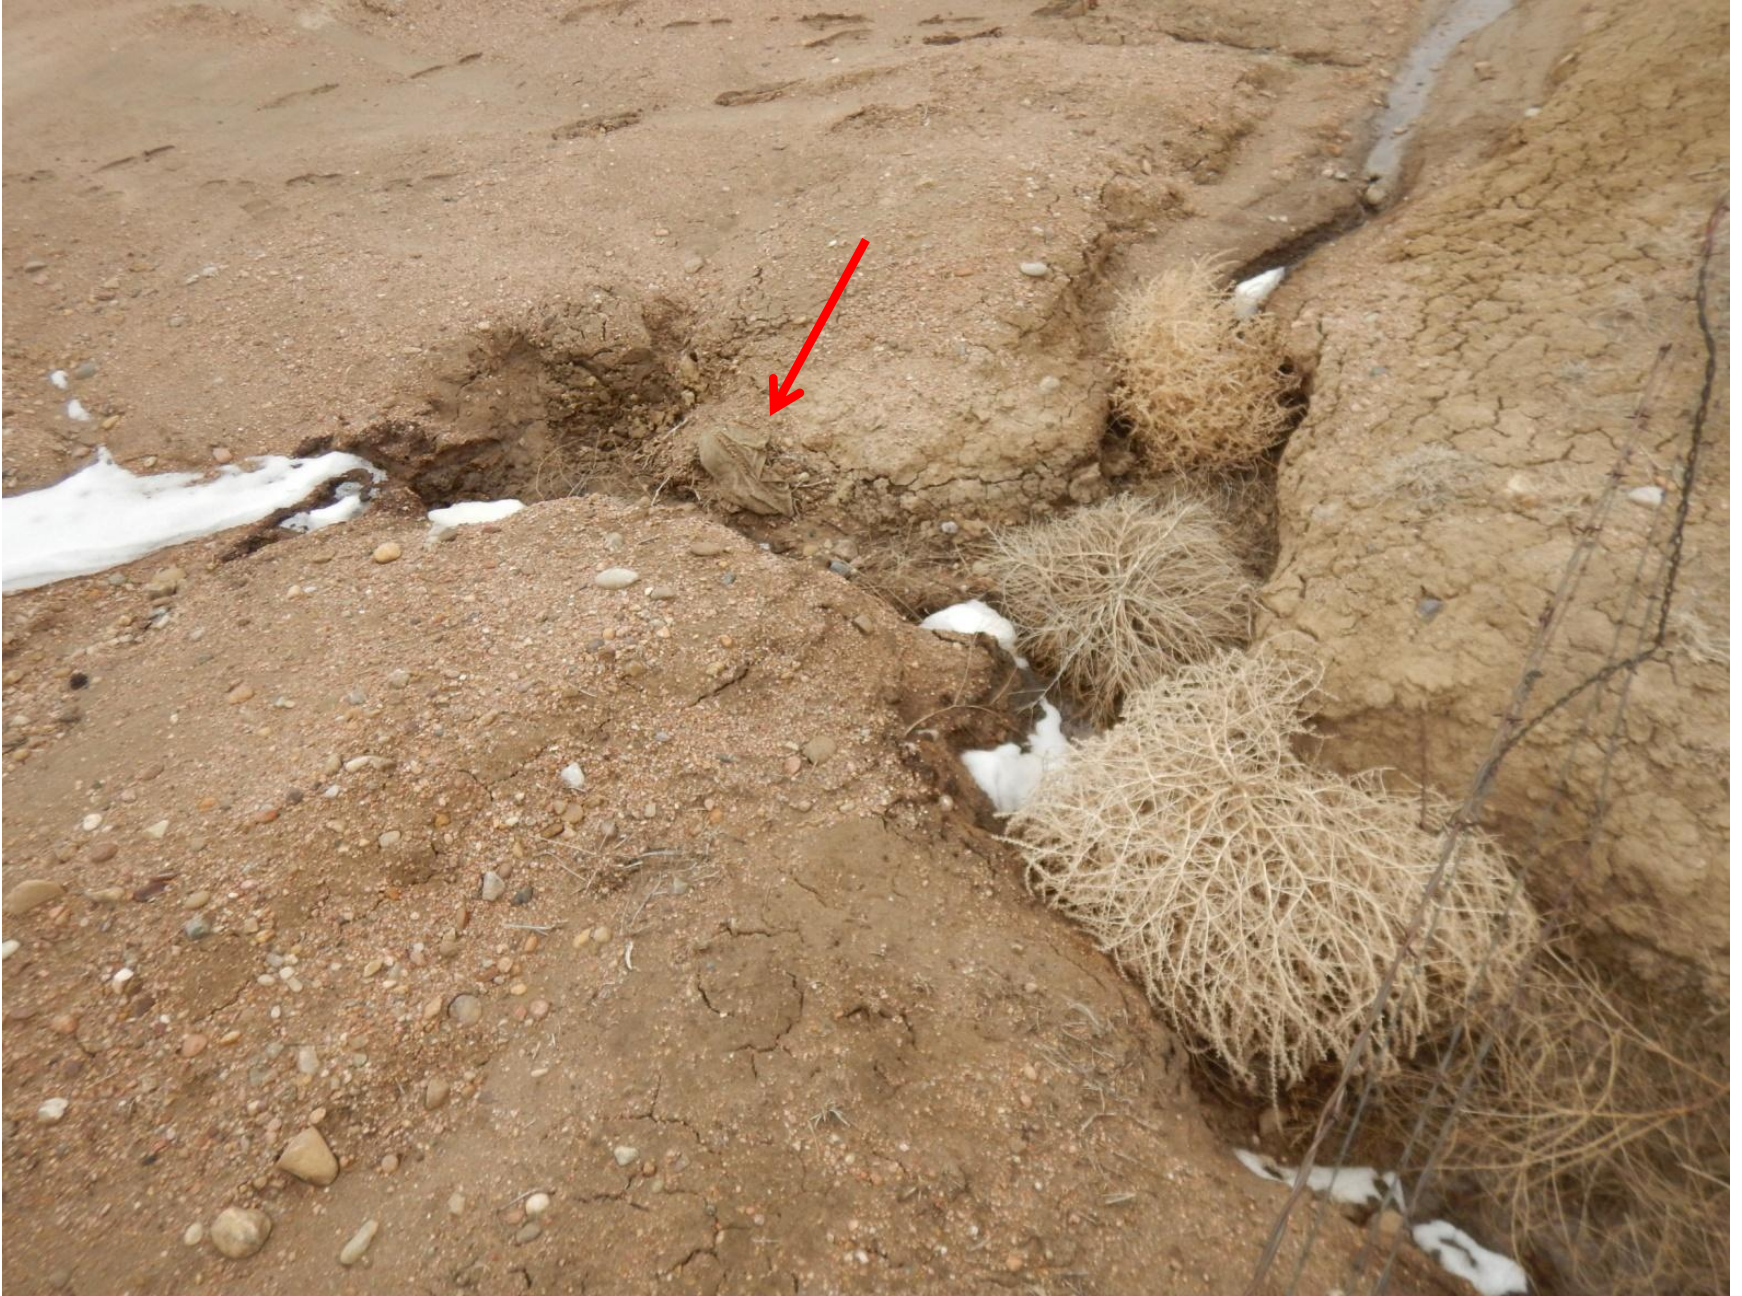
Figure 13: Photo taken from east end of location. Photo of trash debris (indicated by arrow). Trash debris appears to be cloth material.

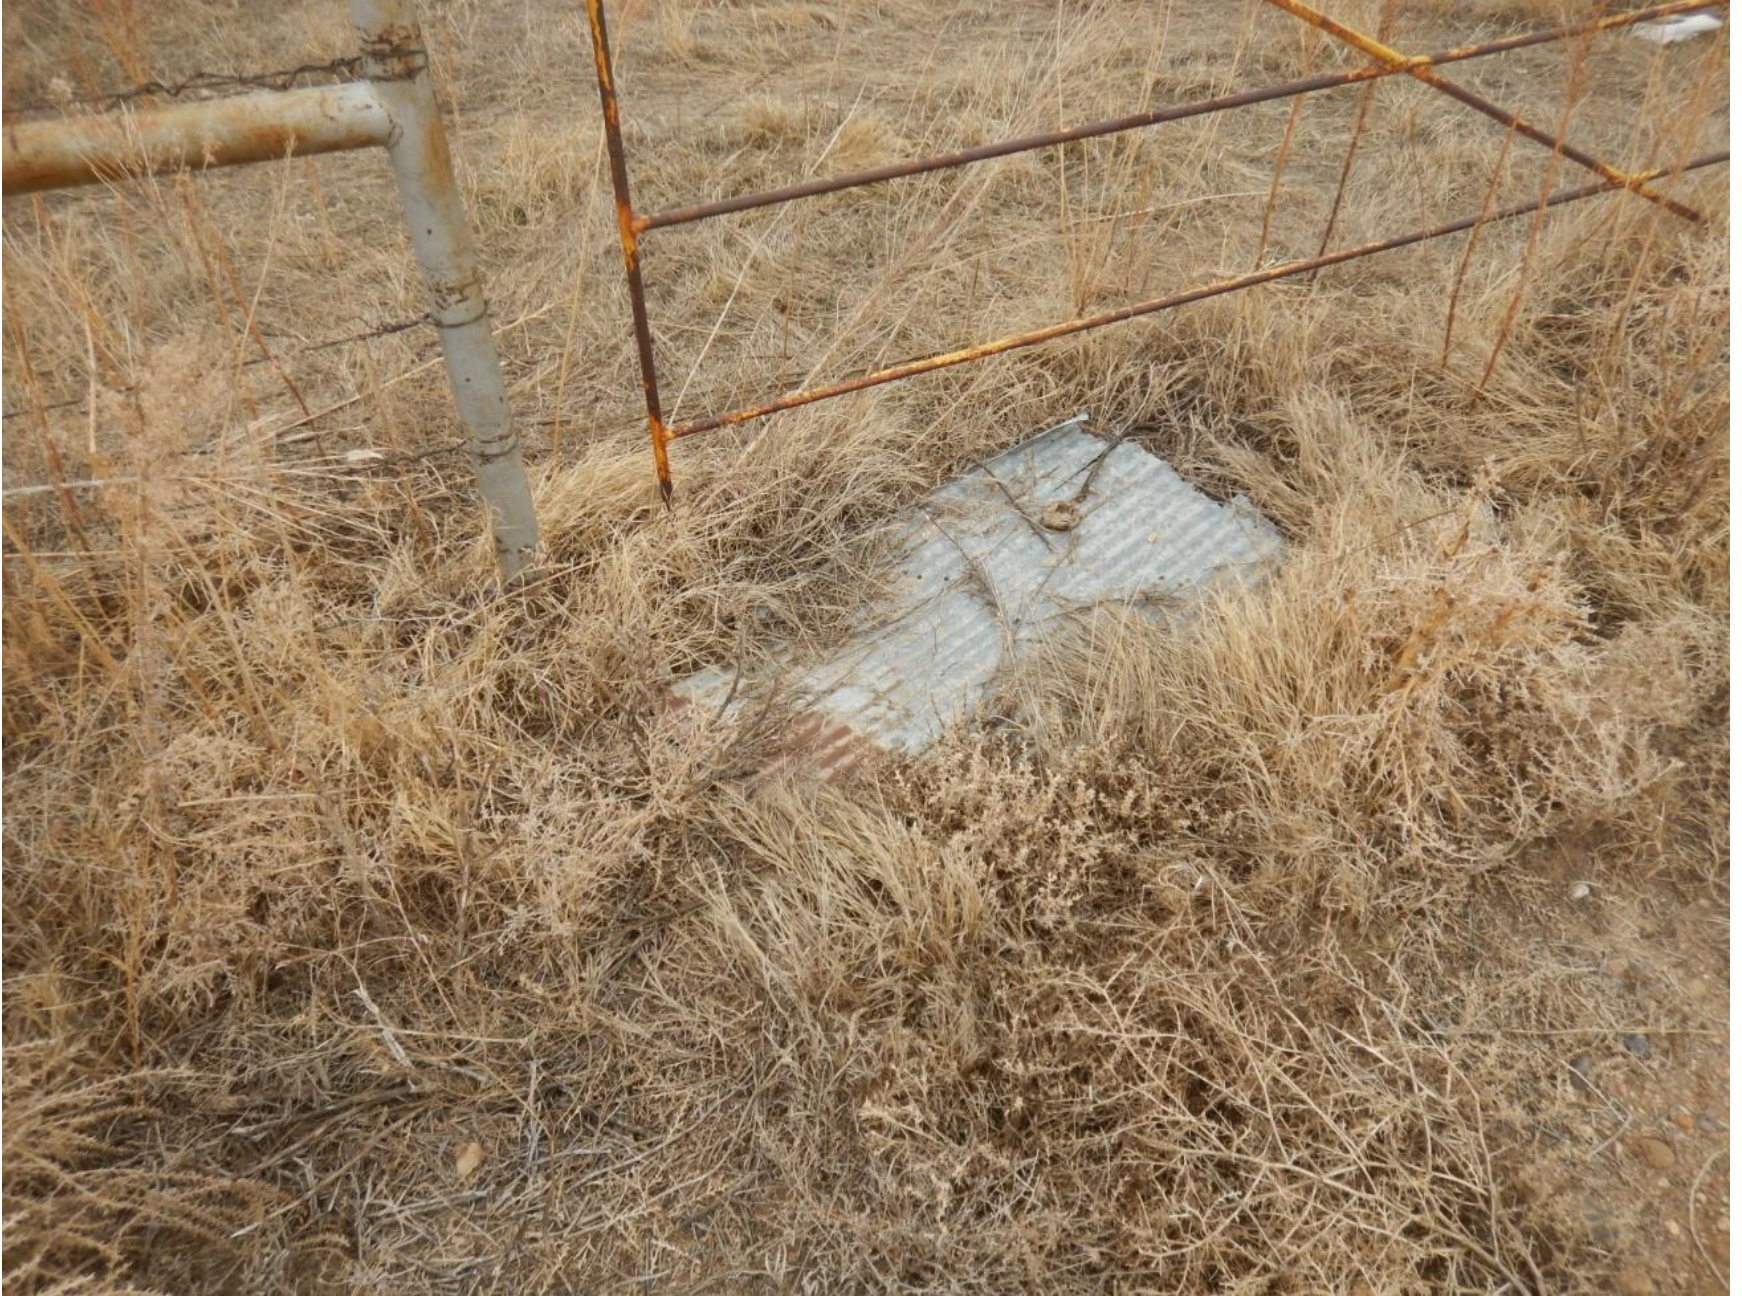
Figure 14: Photo taken from east end of location. Photo of trash debris. Trash debris appears to be metal paneling.

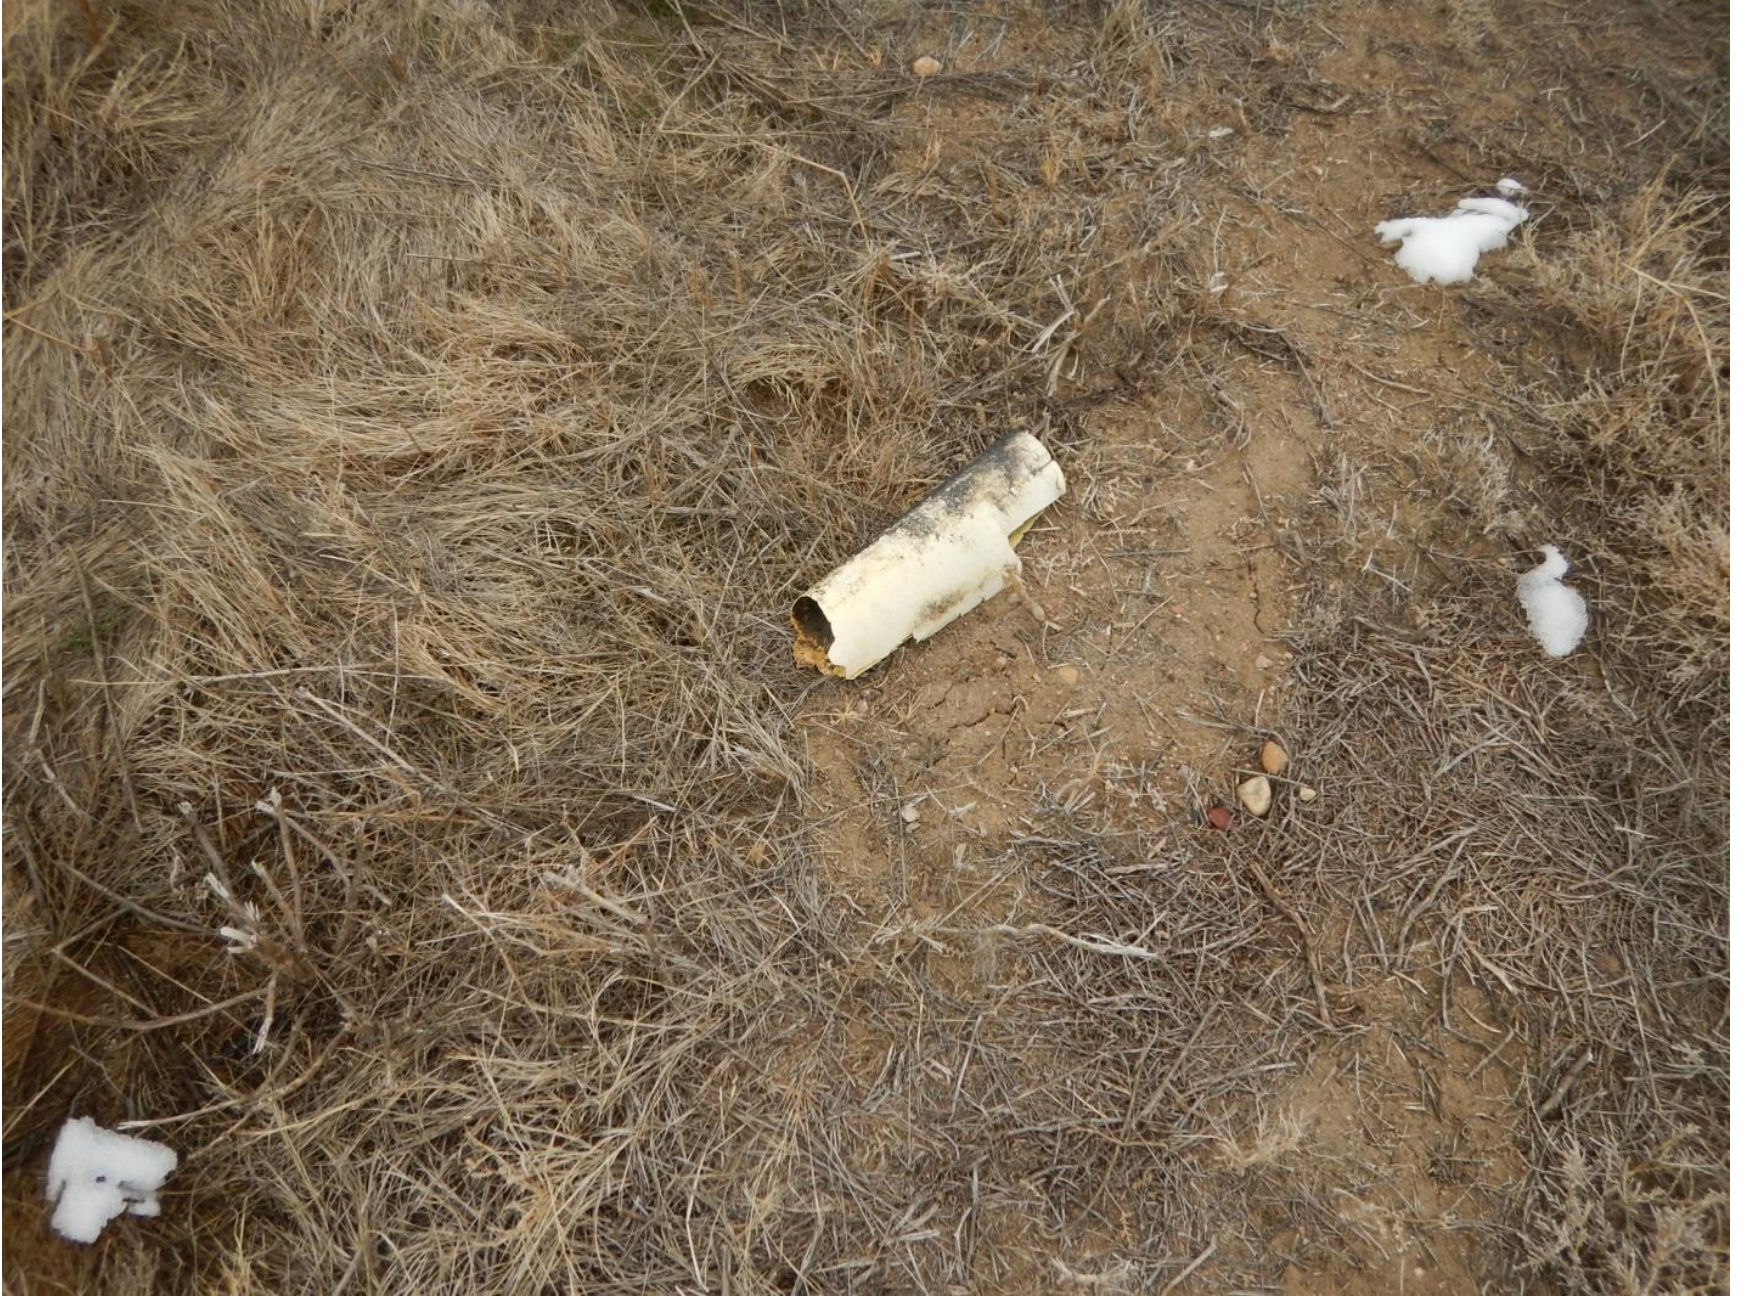
Figure 15: Photo taken from east end of location. Photo of trash debris. Trash debris appears to be plastic tubing.

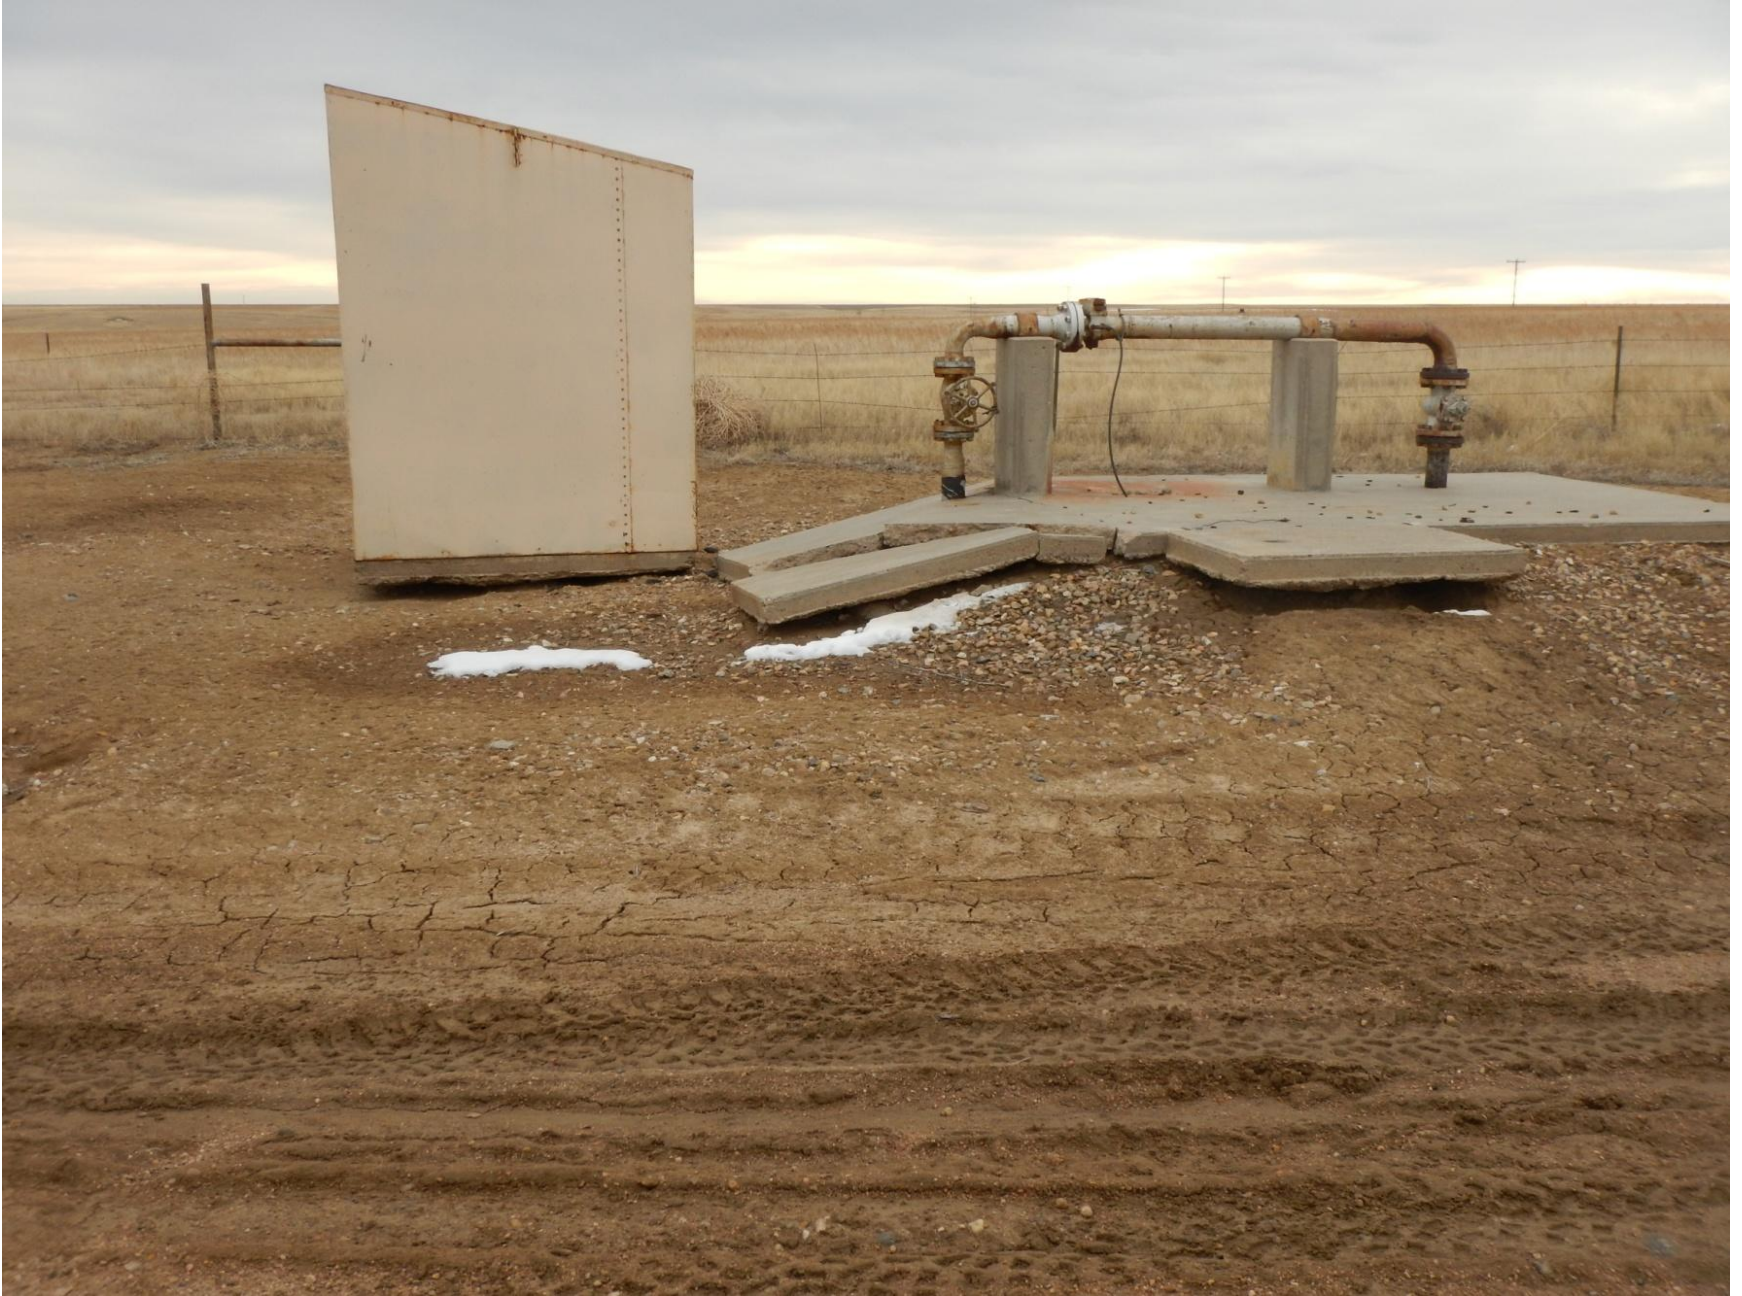
Figure 16: Photo taken from south end of location. Photo of sediment erosion occurring under concrete structure.

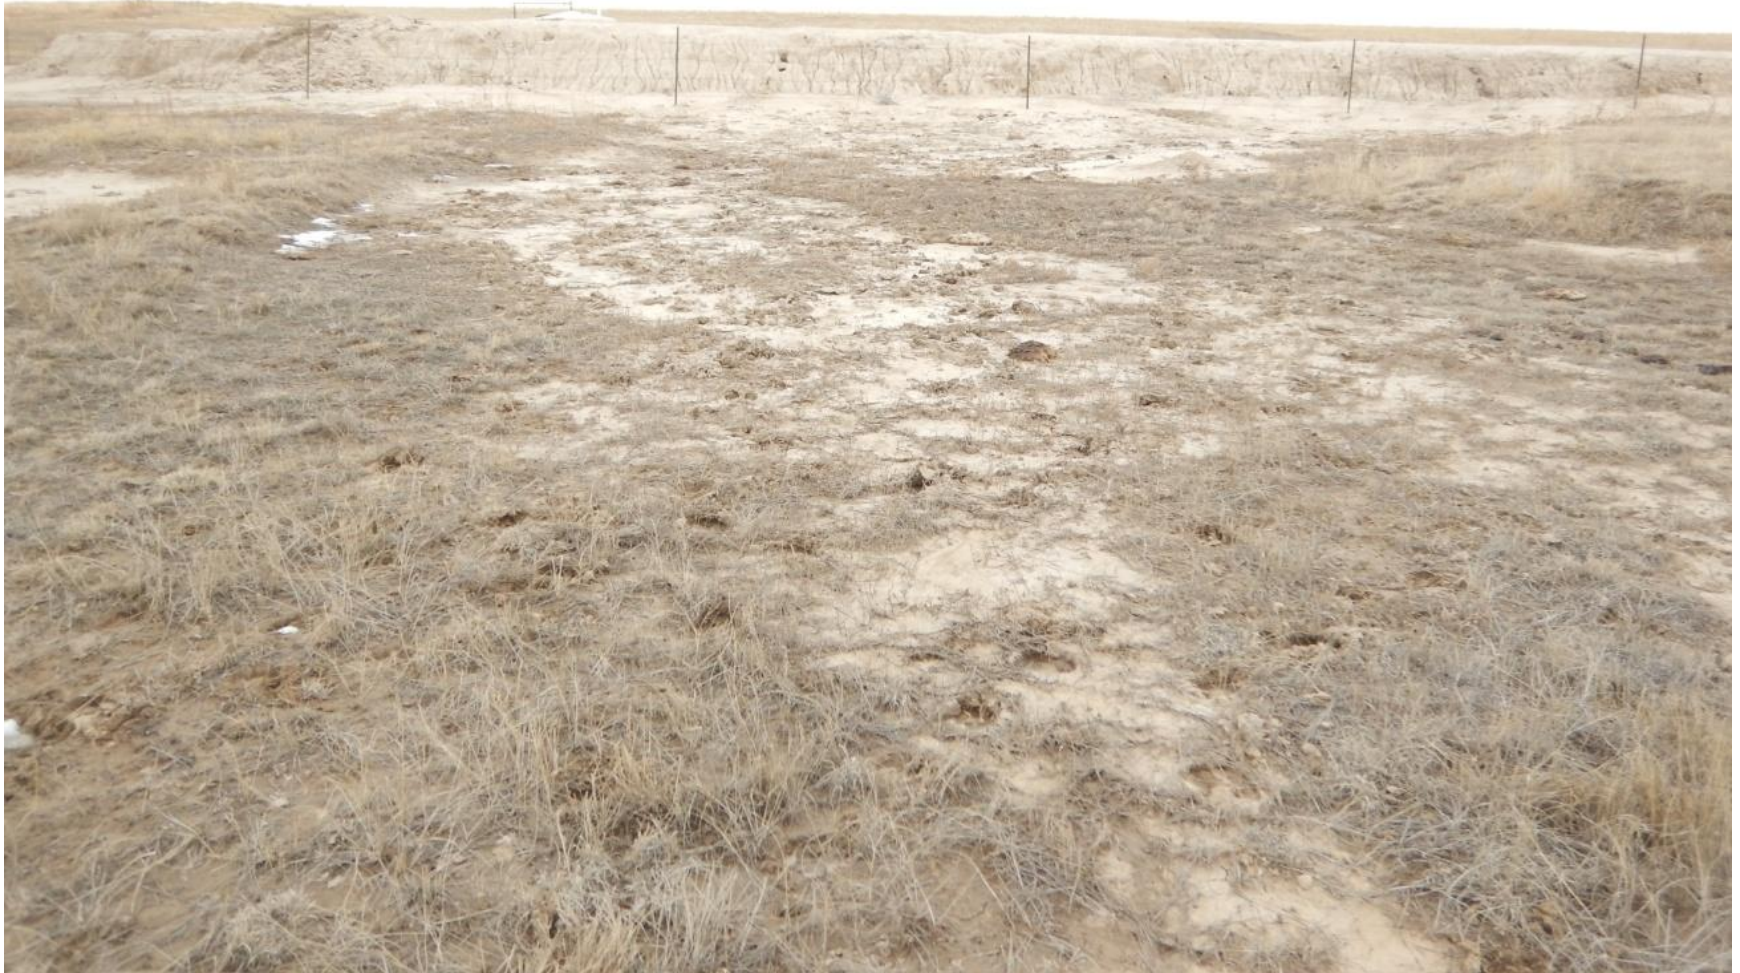
Figure 17: Photo taken from east of pit location facing west. Photo shows stormwater erosion on pit's containment berm, sediment deposition off of location, and insufficient stormwater BMPs.

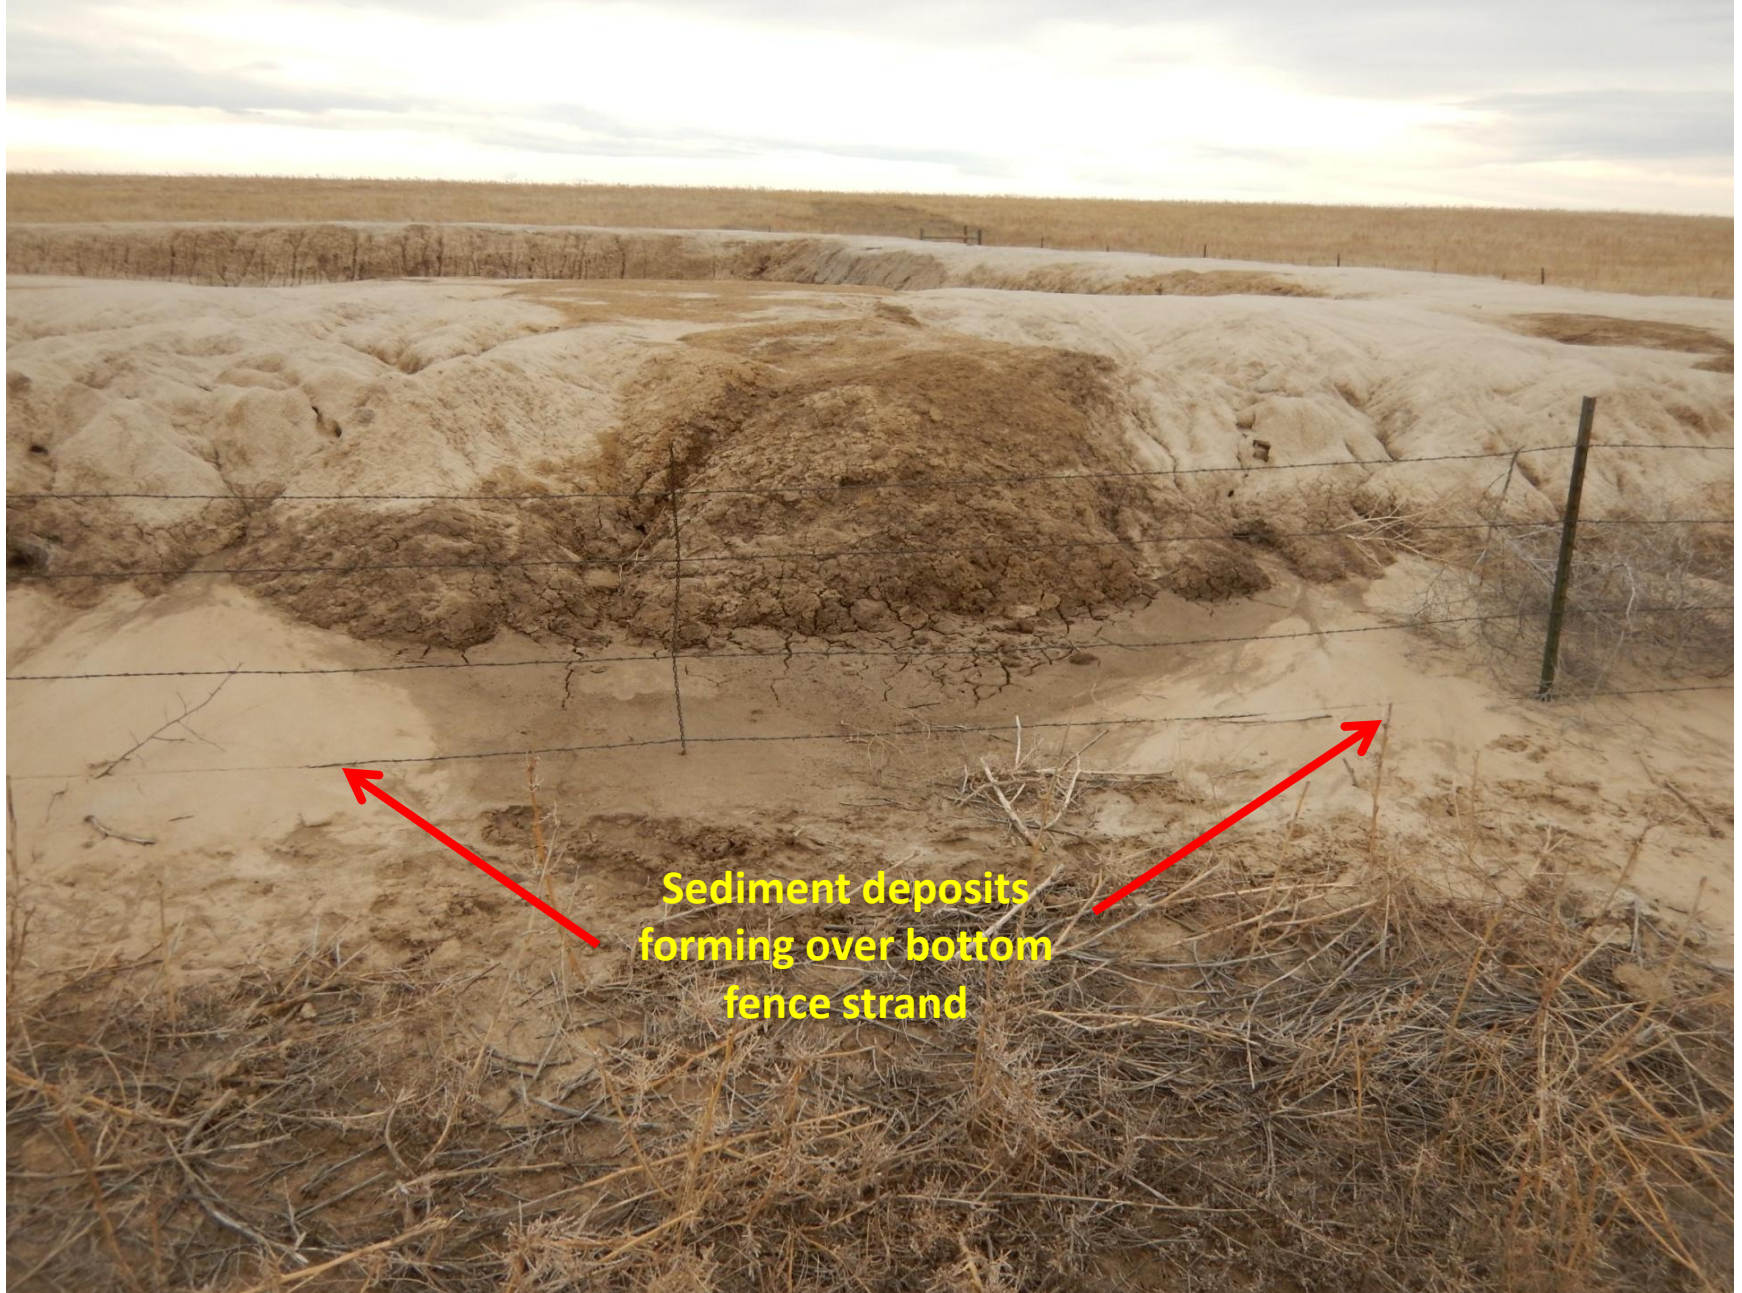
Sediment deposits
forming over bottom
fence strand

Figure 18: Photo taken from east end of pit location. Photo shows stormwater erosion on pit's containment berm, sediment deposition off of location, and insufficient stormwater BMPs.

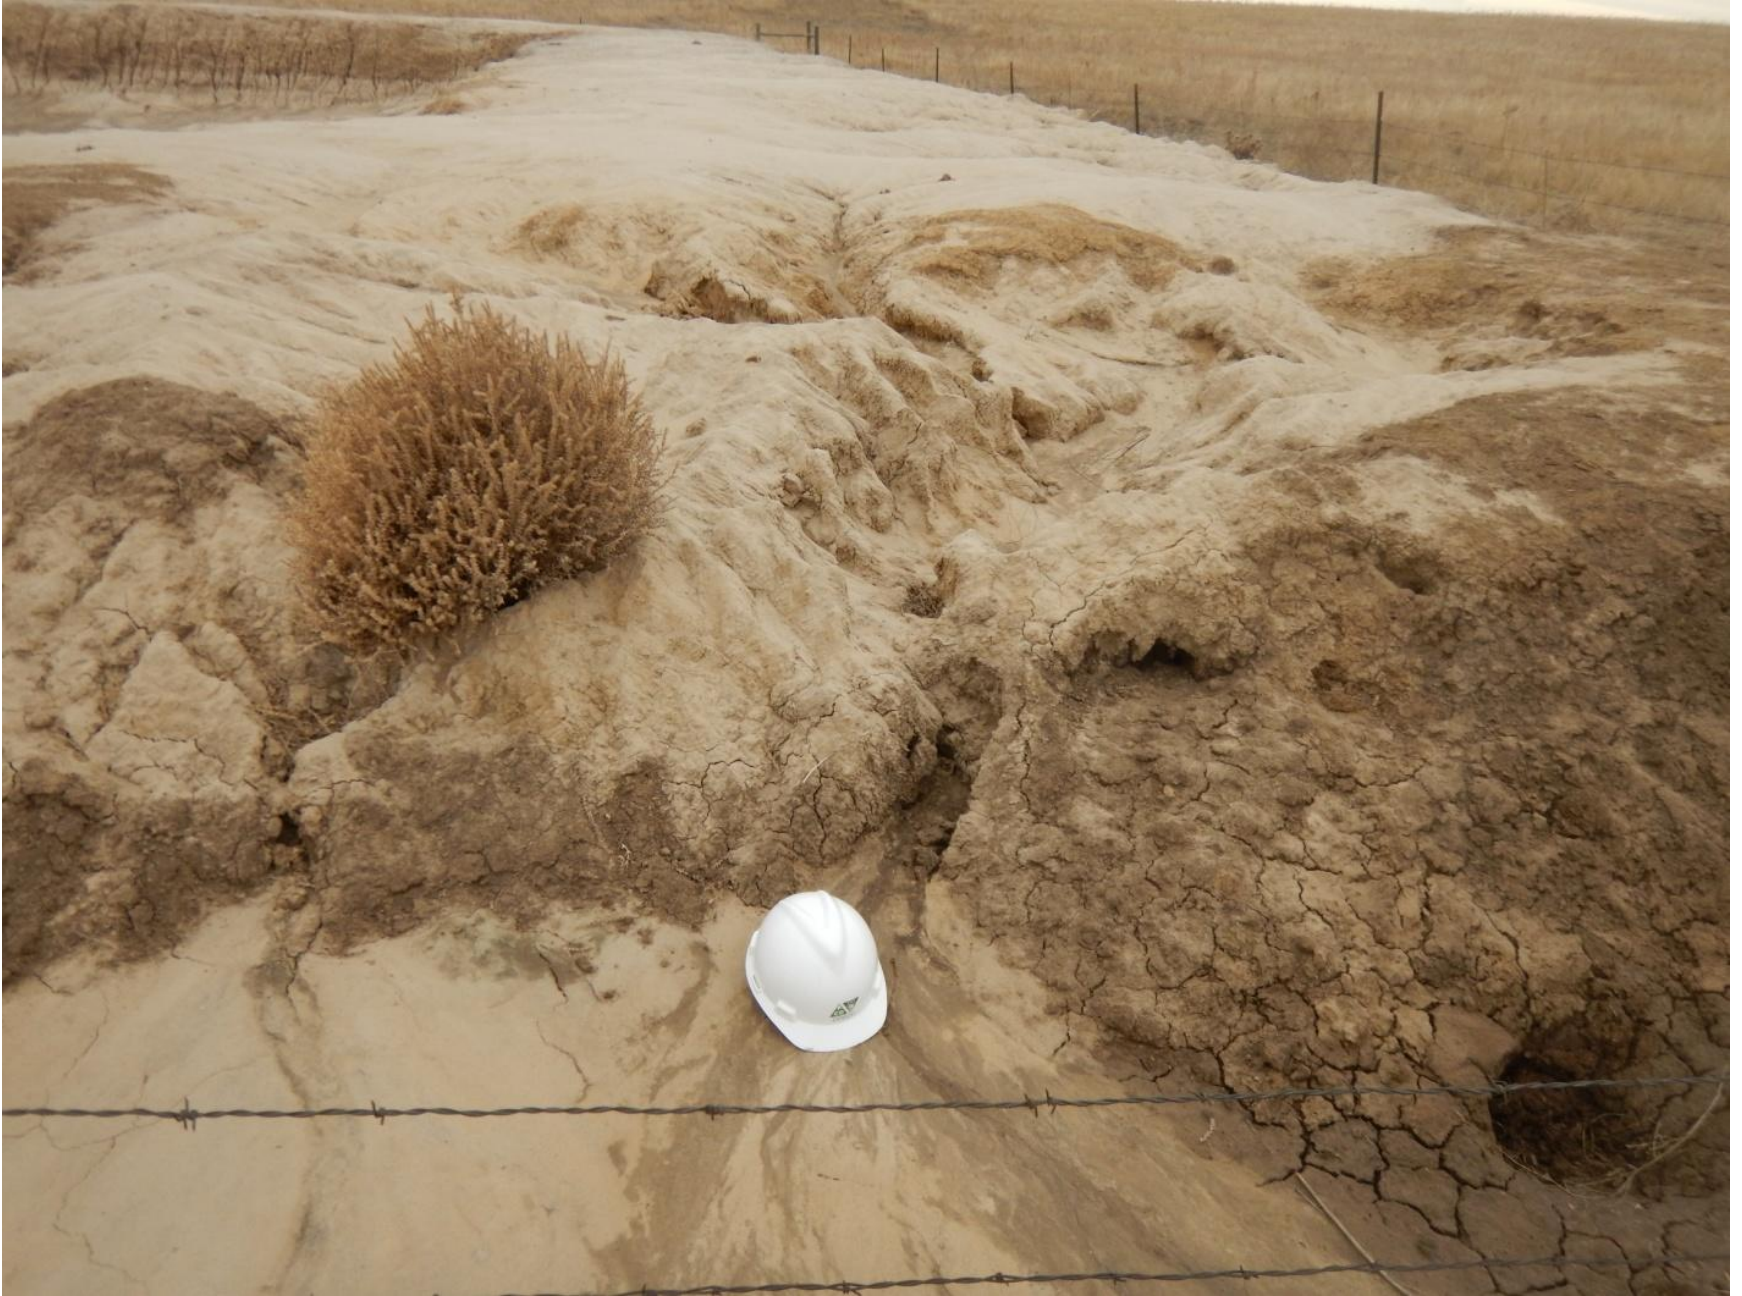
Figure 19: Photo taken from northeast end of pit location. Photo shows stormwater erosion on pit's containment berm and insufficient stormwater BMPs.

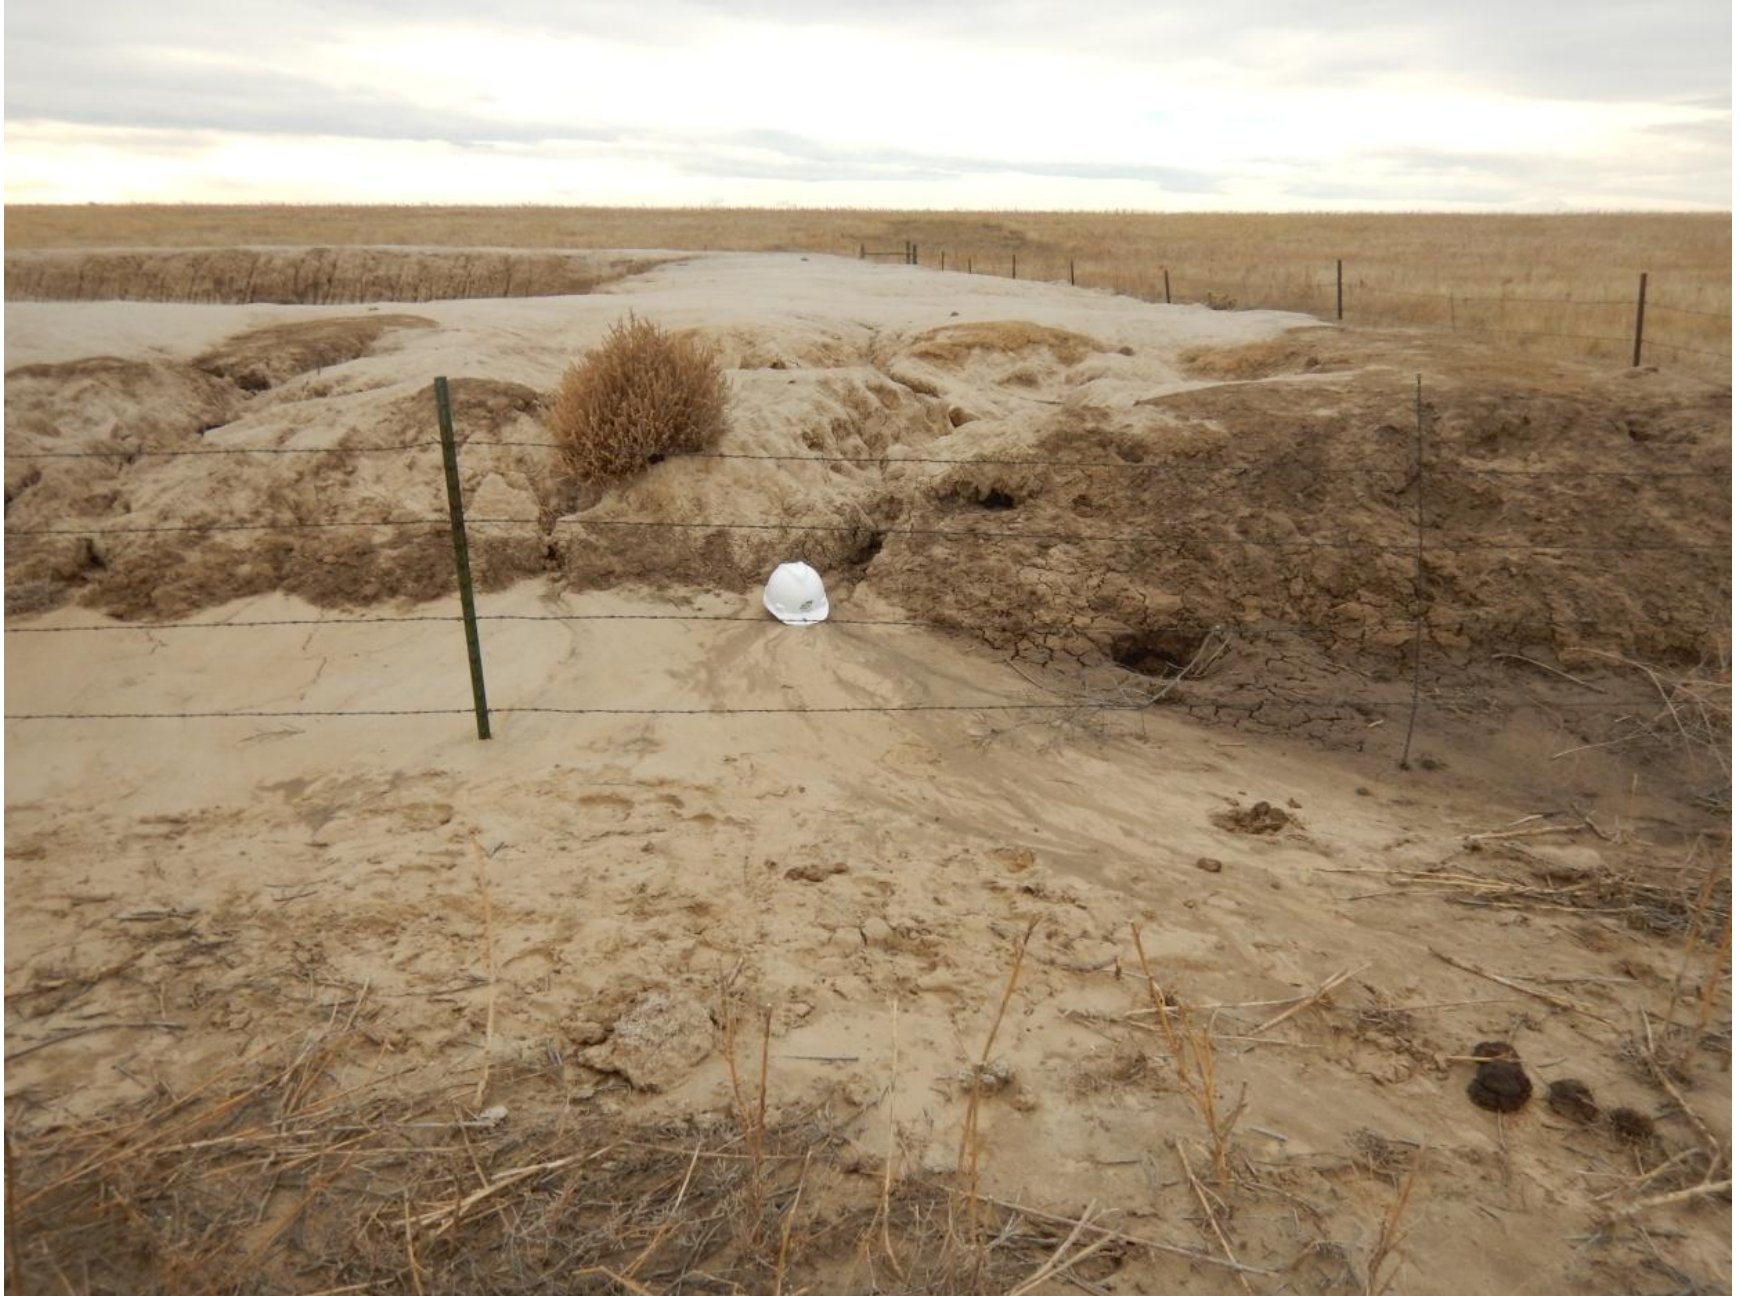
Figure 20: Photo taken from northeast end of pit location. Photo shows stormwater erosion on pit's containment berm, sediment deposition off of location, and insufficient stormwater BMPs.
