Follow Up Inspection

12/07/2015

Operator: Western Operating Co.

Location ID: 435387

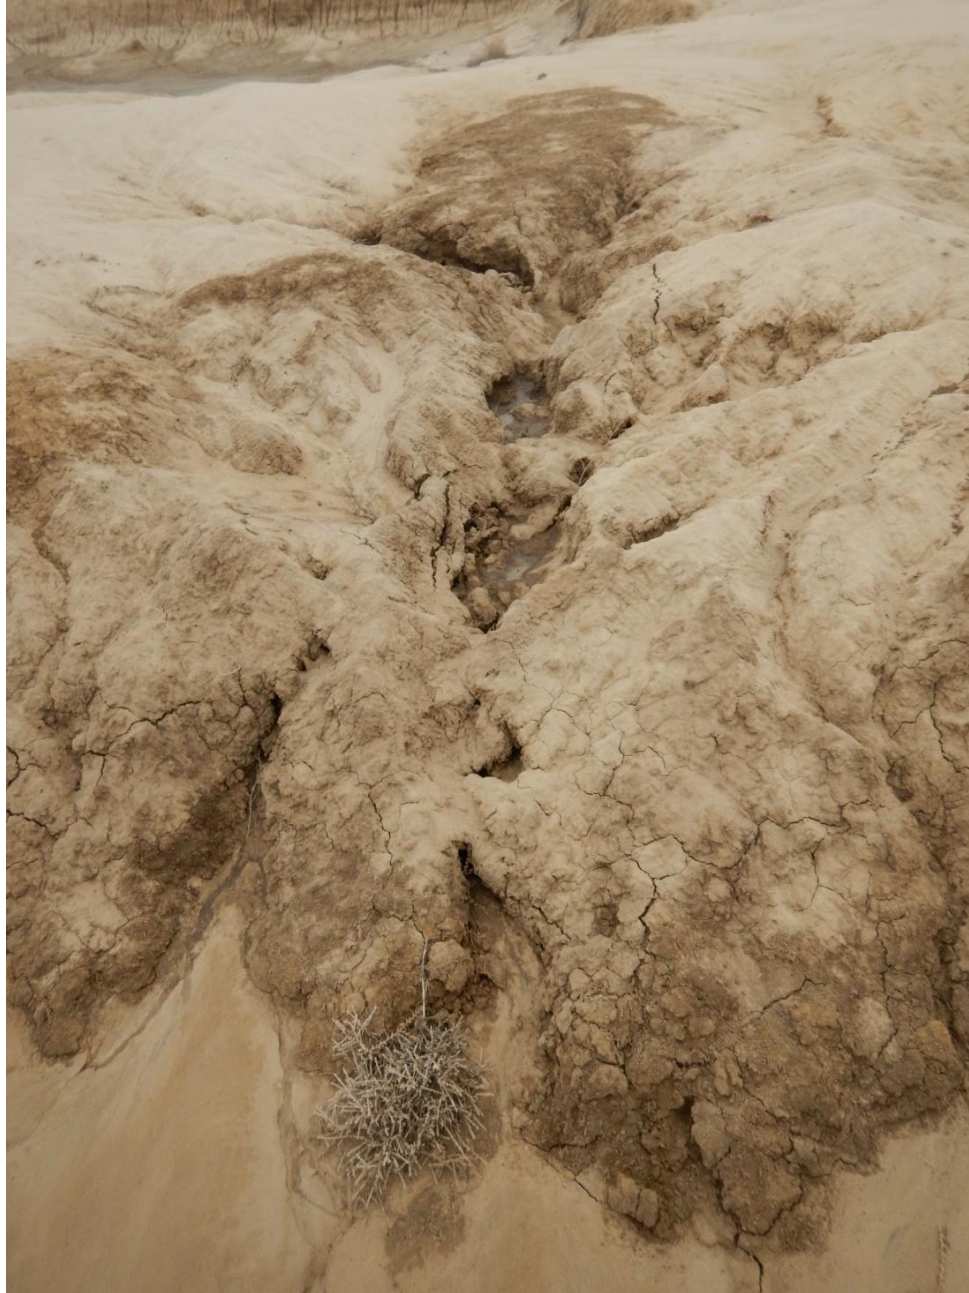
Figure 21: Photo taken from east end of pit location. Photo shows stormwater erosion on pit's containment berm. Stormwater flow occurring on surface, as well as the subsurface of the berm.

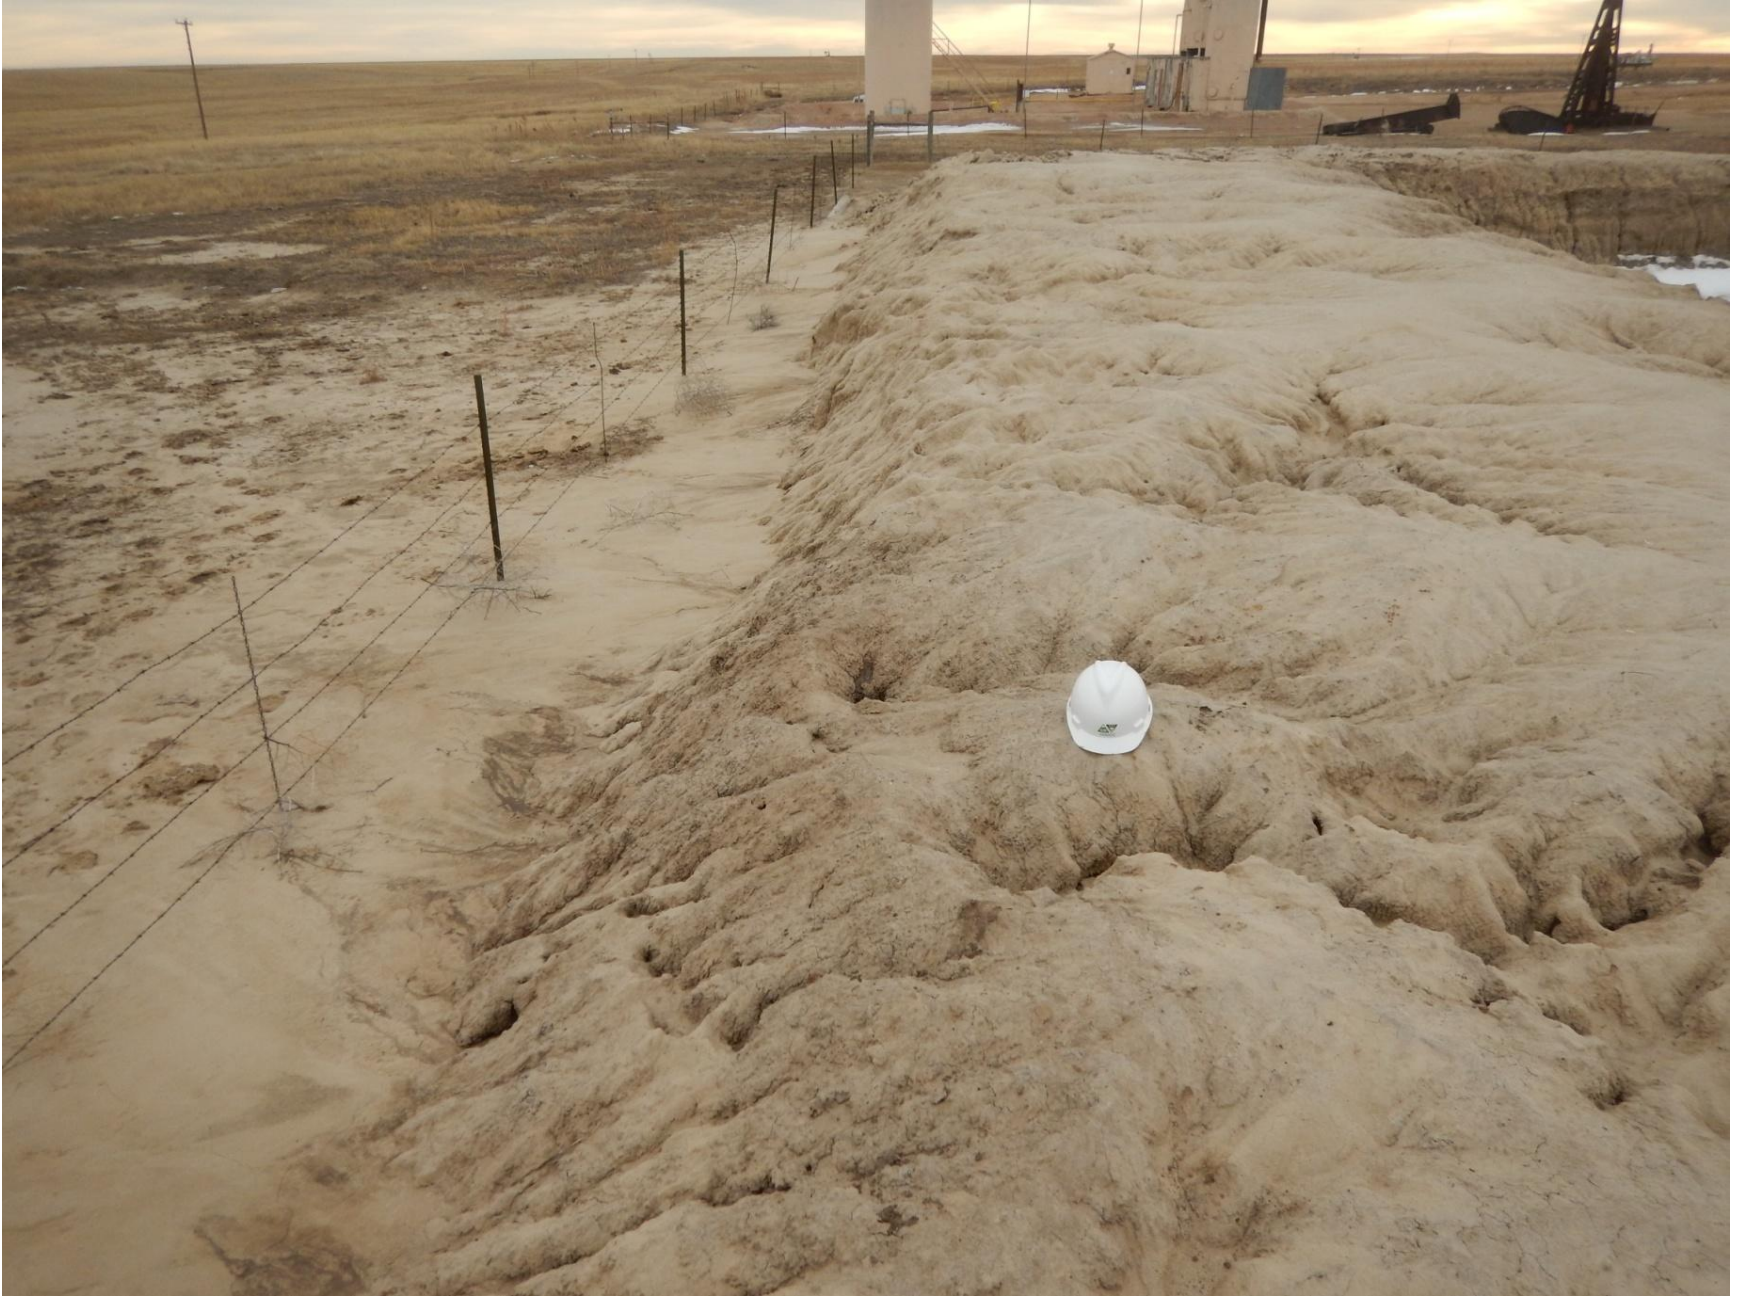
Figure 22: Photo taken from east end of pit location. Photo shows stormwater erosion on pit's containment berm. Stormwater flow occurring on surface, as well as the subsurface of the berm.

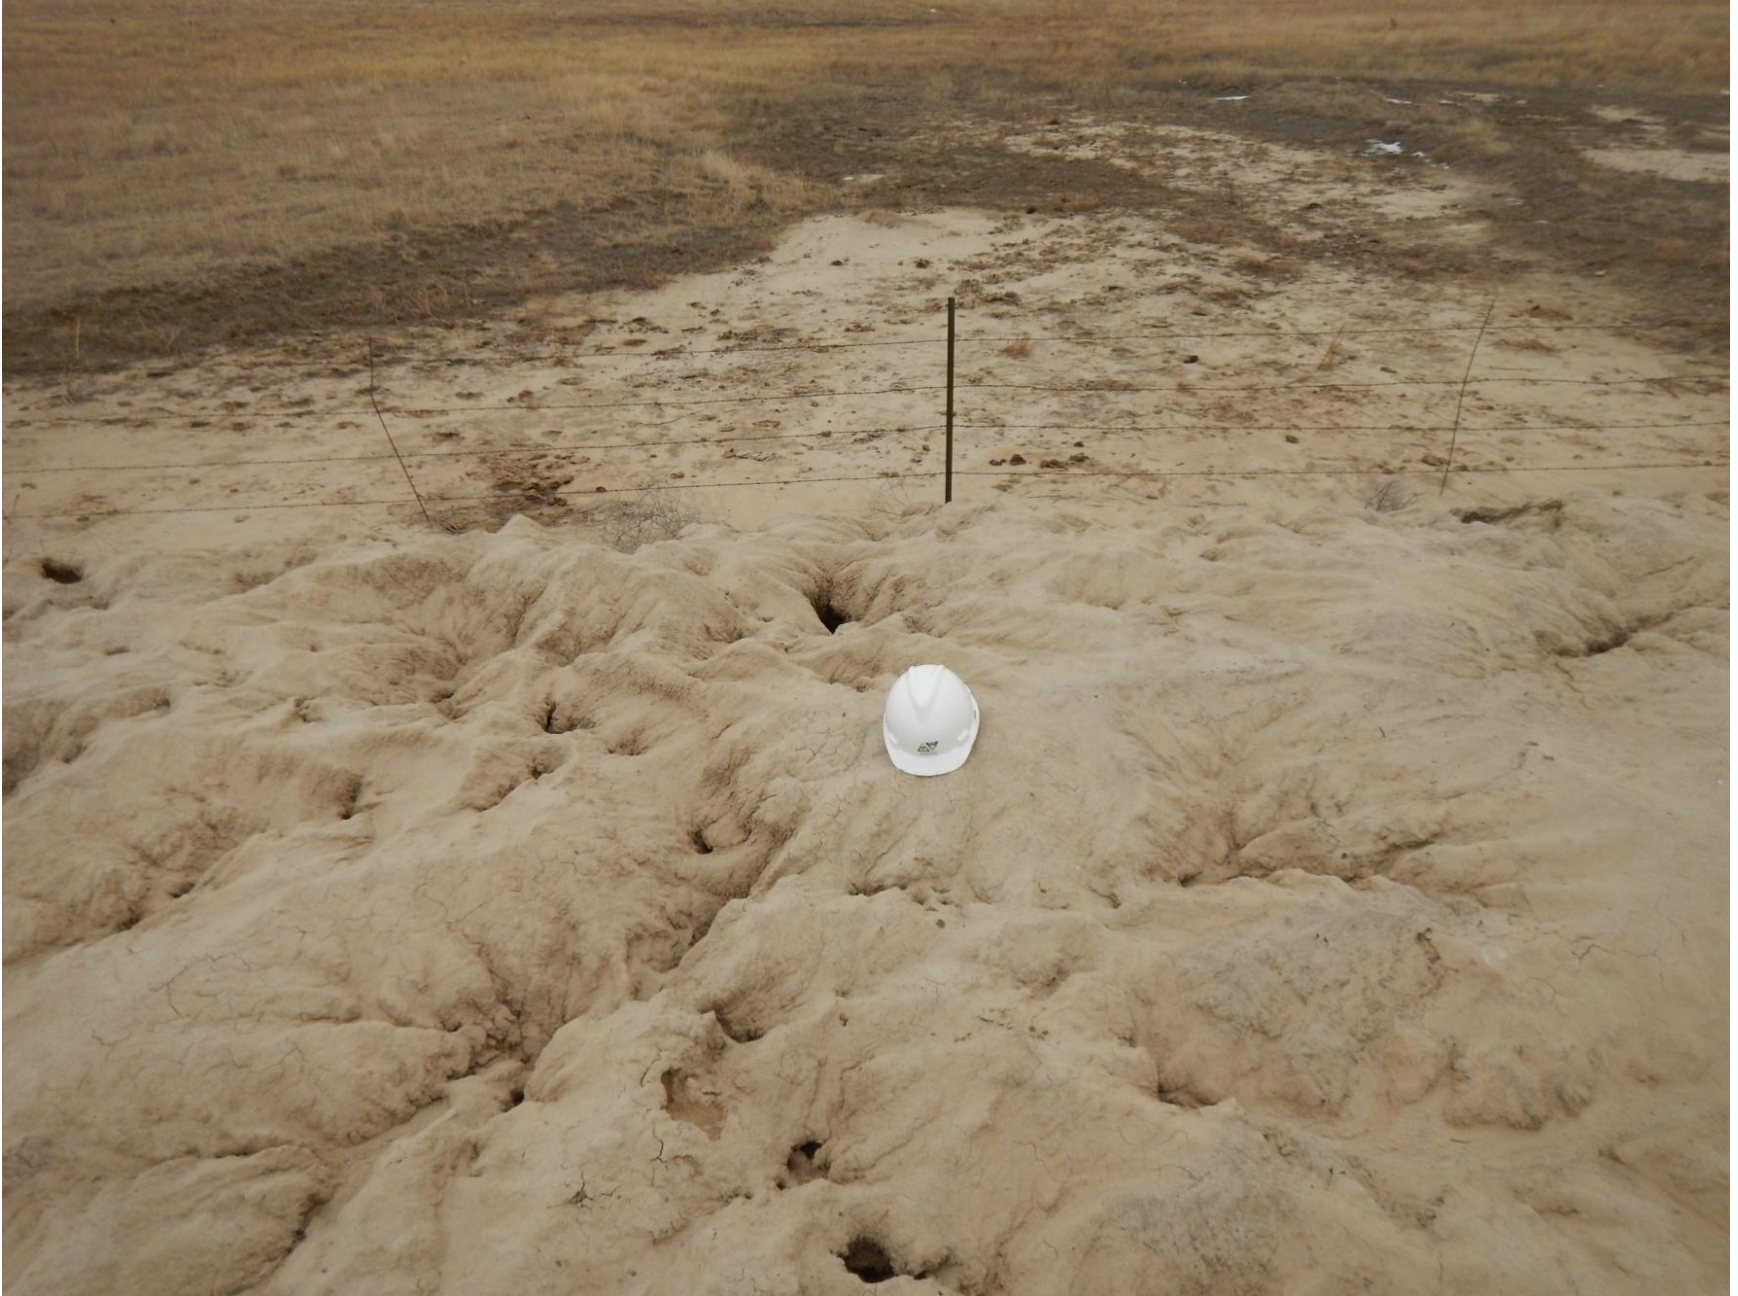
Figure 23: Photo taken from east end of pit location facing east. Photo shows stormwater erosion on pit's containment berm and sediment deposition off the site.

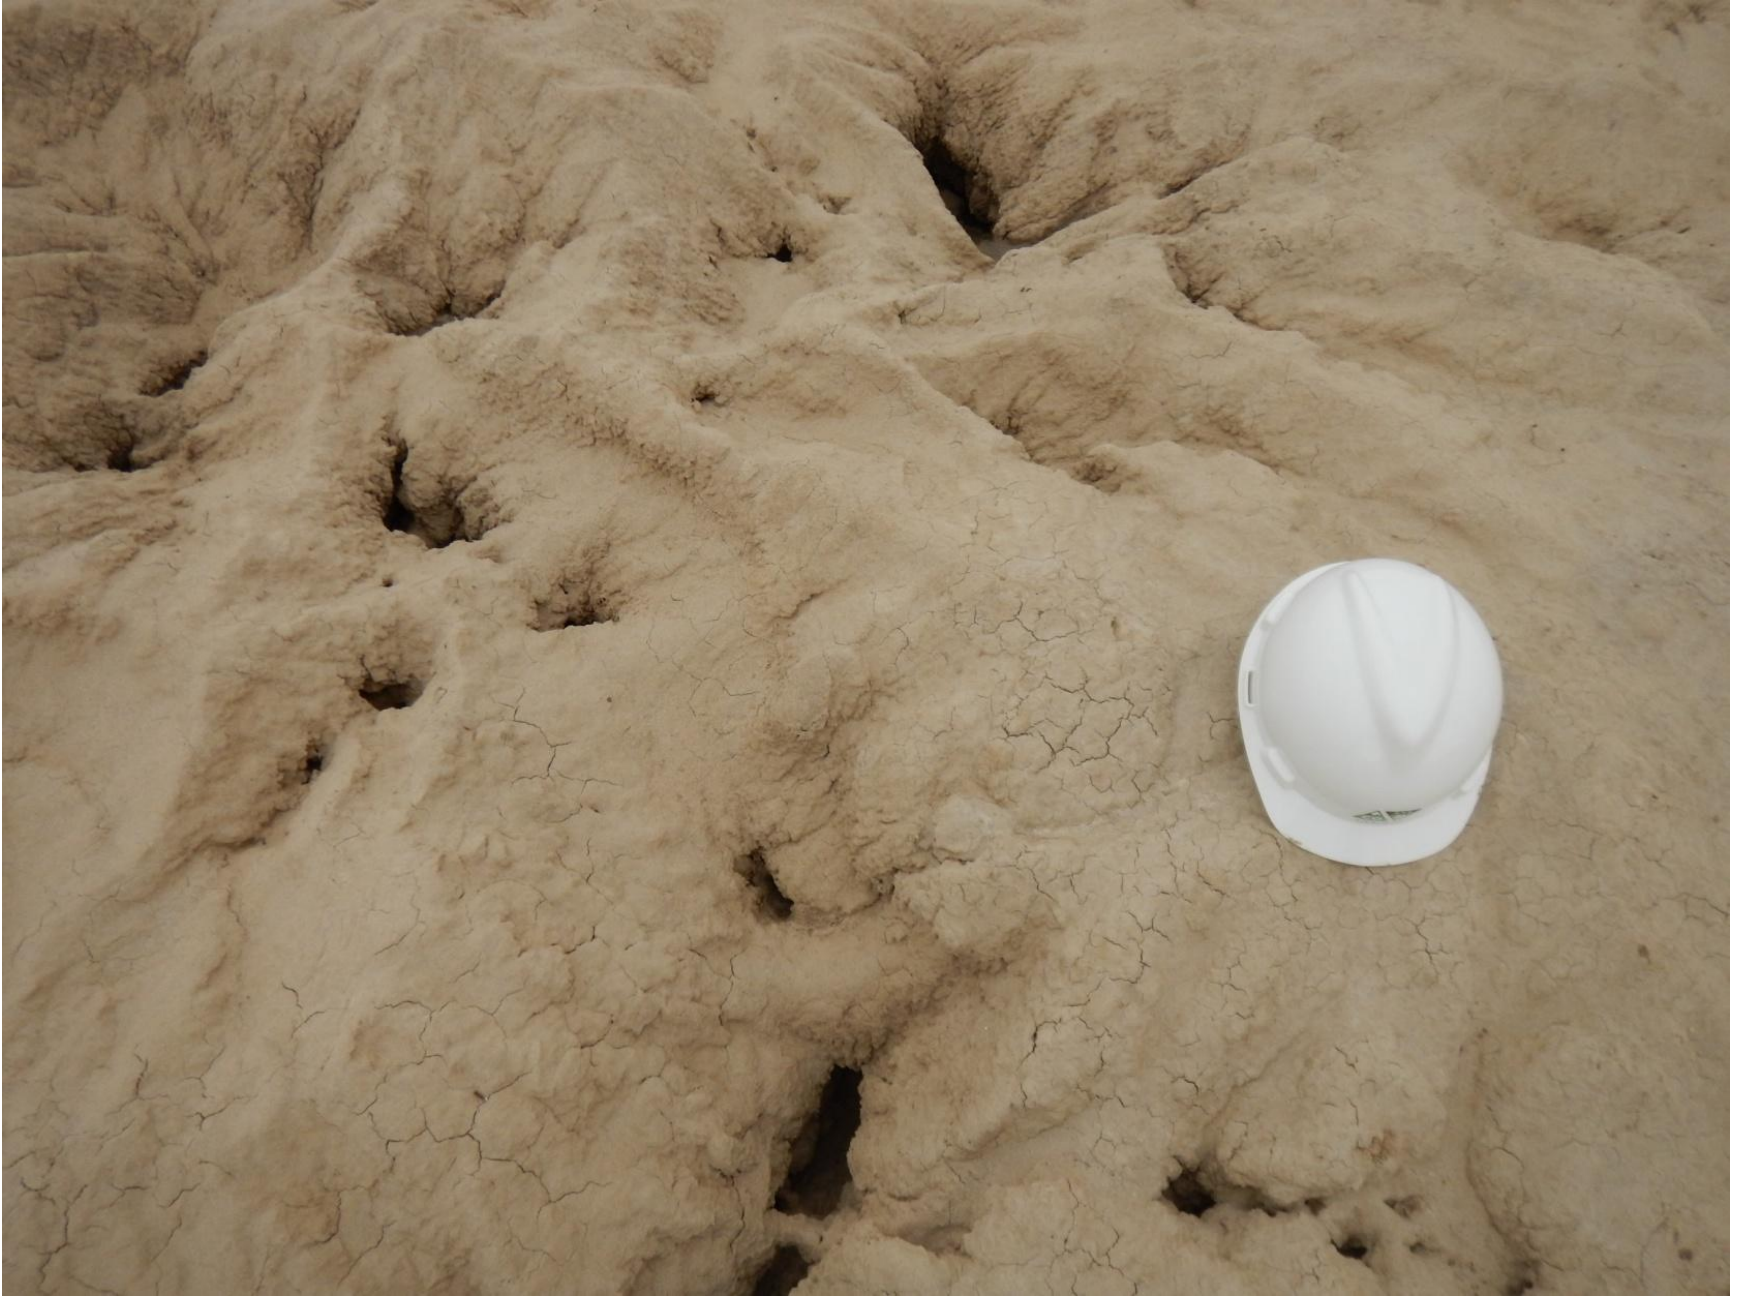
Figure 24: Photo taken from east end of pit location . Photo shows stormwater erosion on pit's containment berm. Stormwater flow occurring on surface, as well as the subsurface of the berm

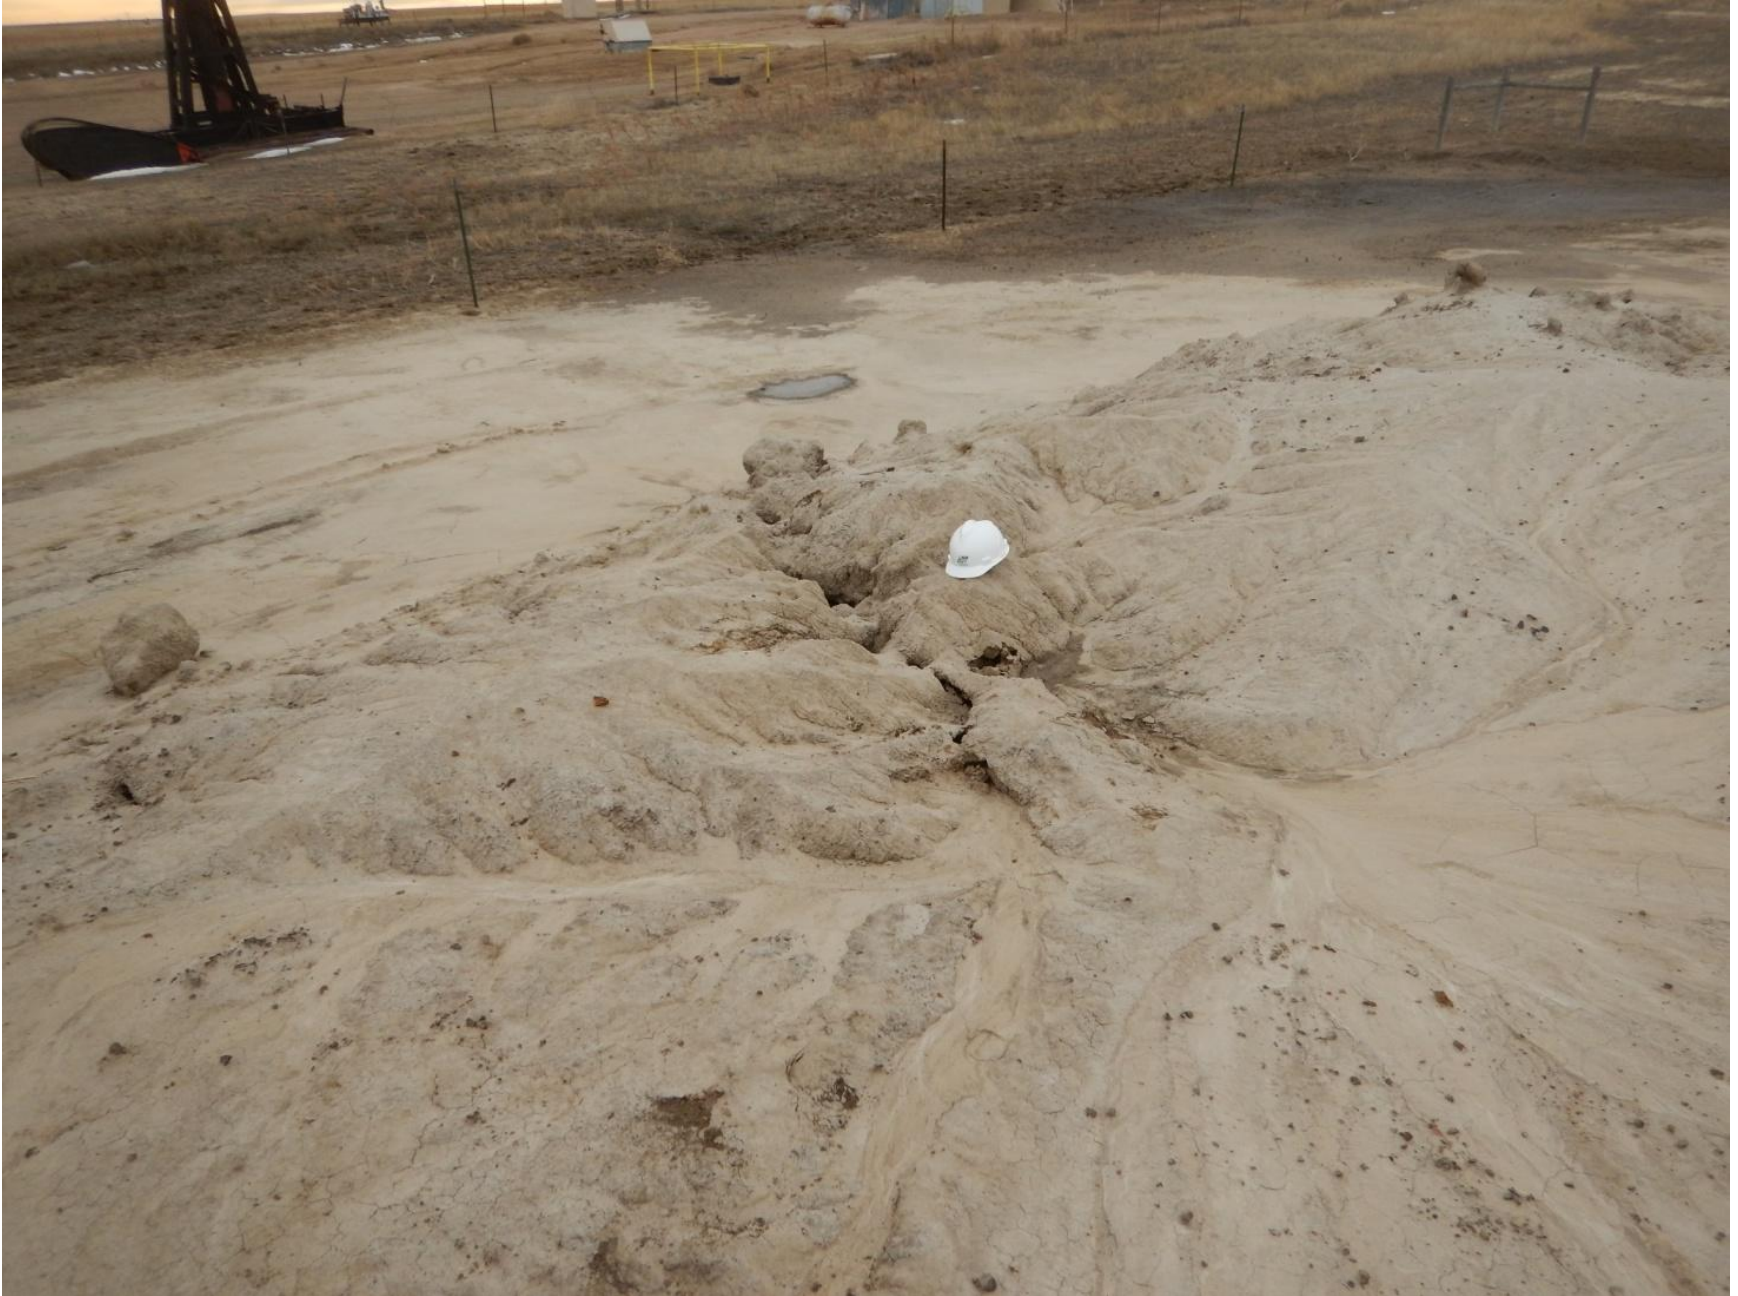
Figure 25: Photo taken from southwest end of pit location. Photo shows stormwater erosion on pit's containment berm, sediment deposition off of location, and insufficient stormwater BMPs.

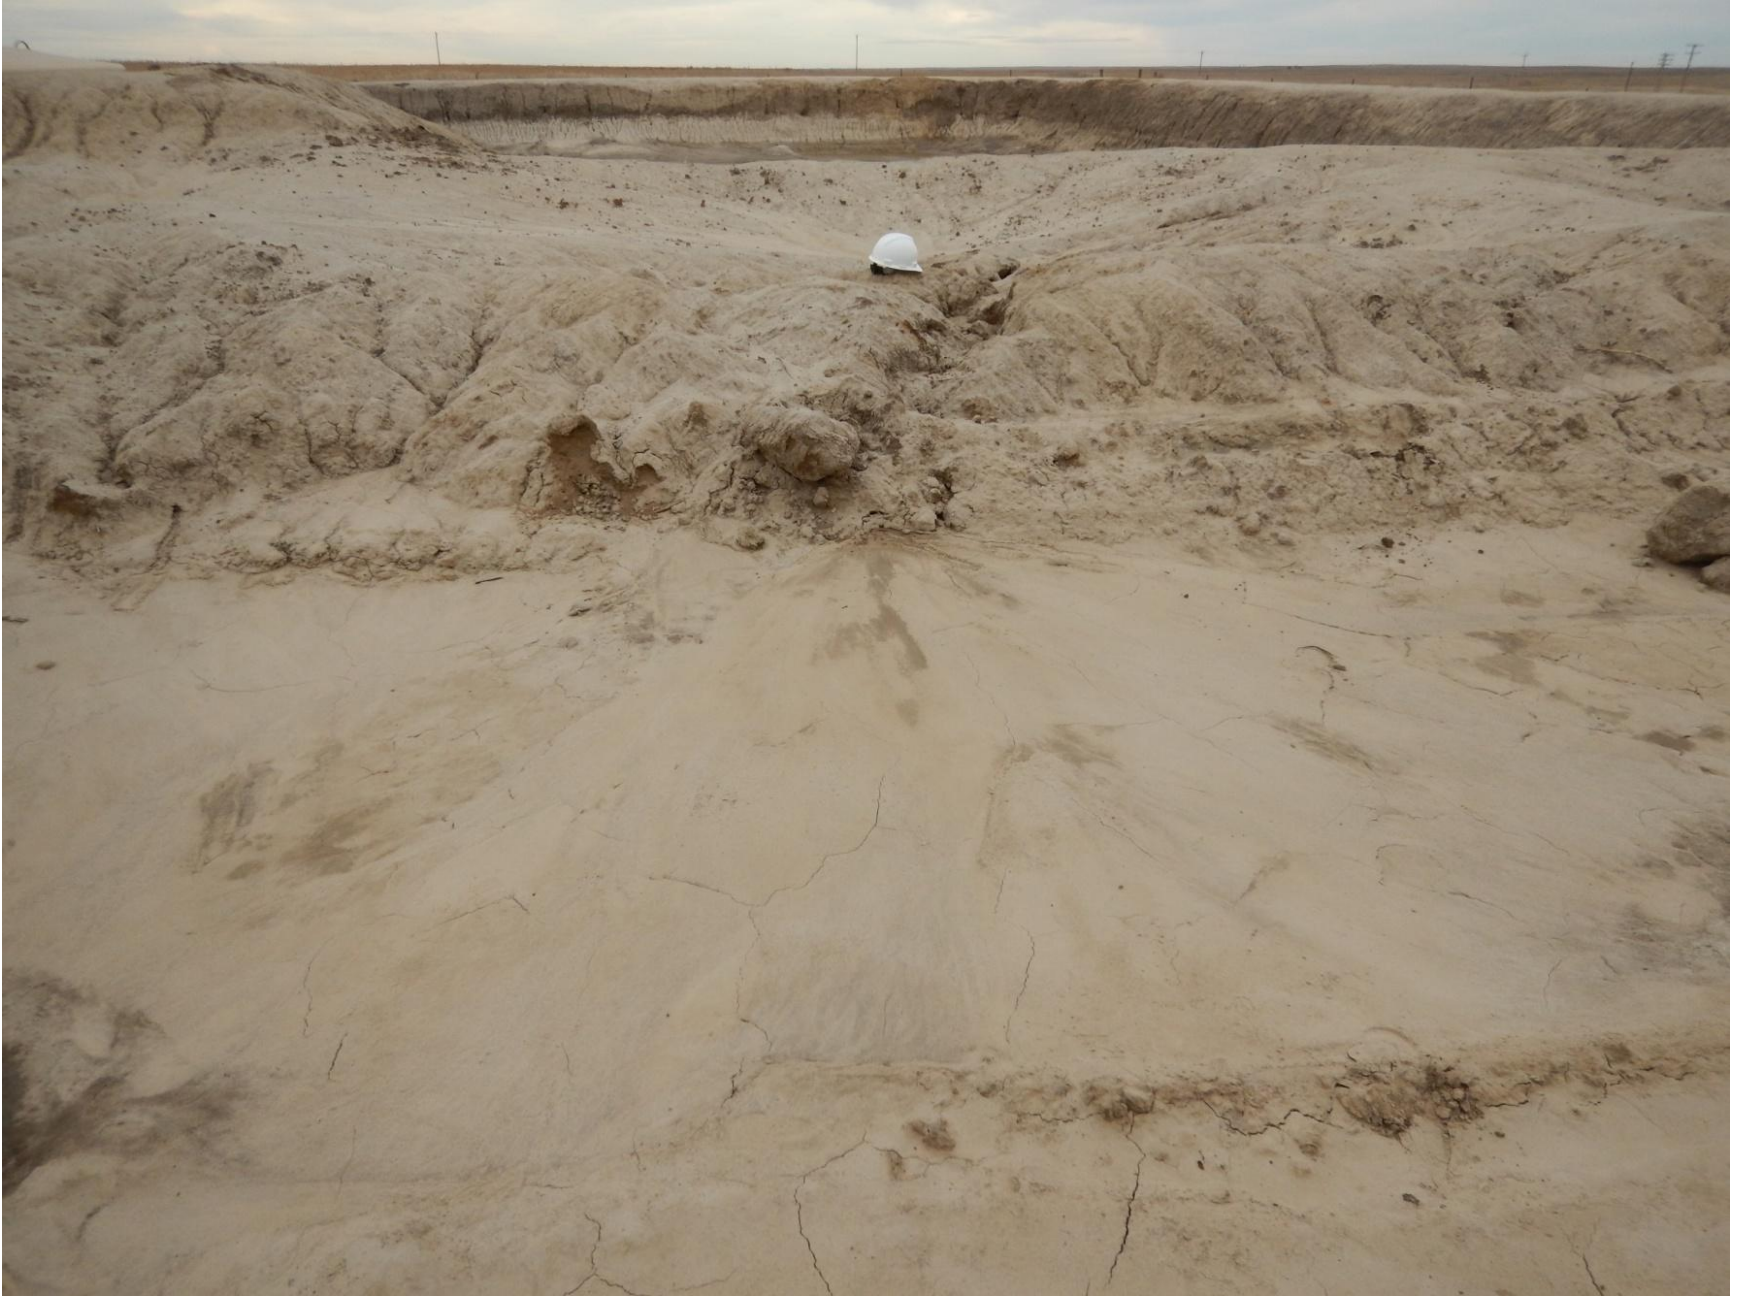
Figure 26: Photo taken from southwest end of pit location facing north. Photo shows stormwater erosion on pit's containment berm, sediment deposition, and insufficient stormwater BMPs.

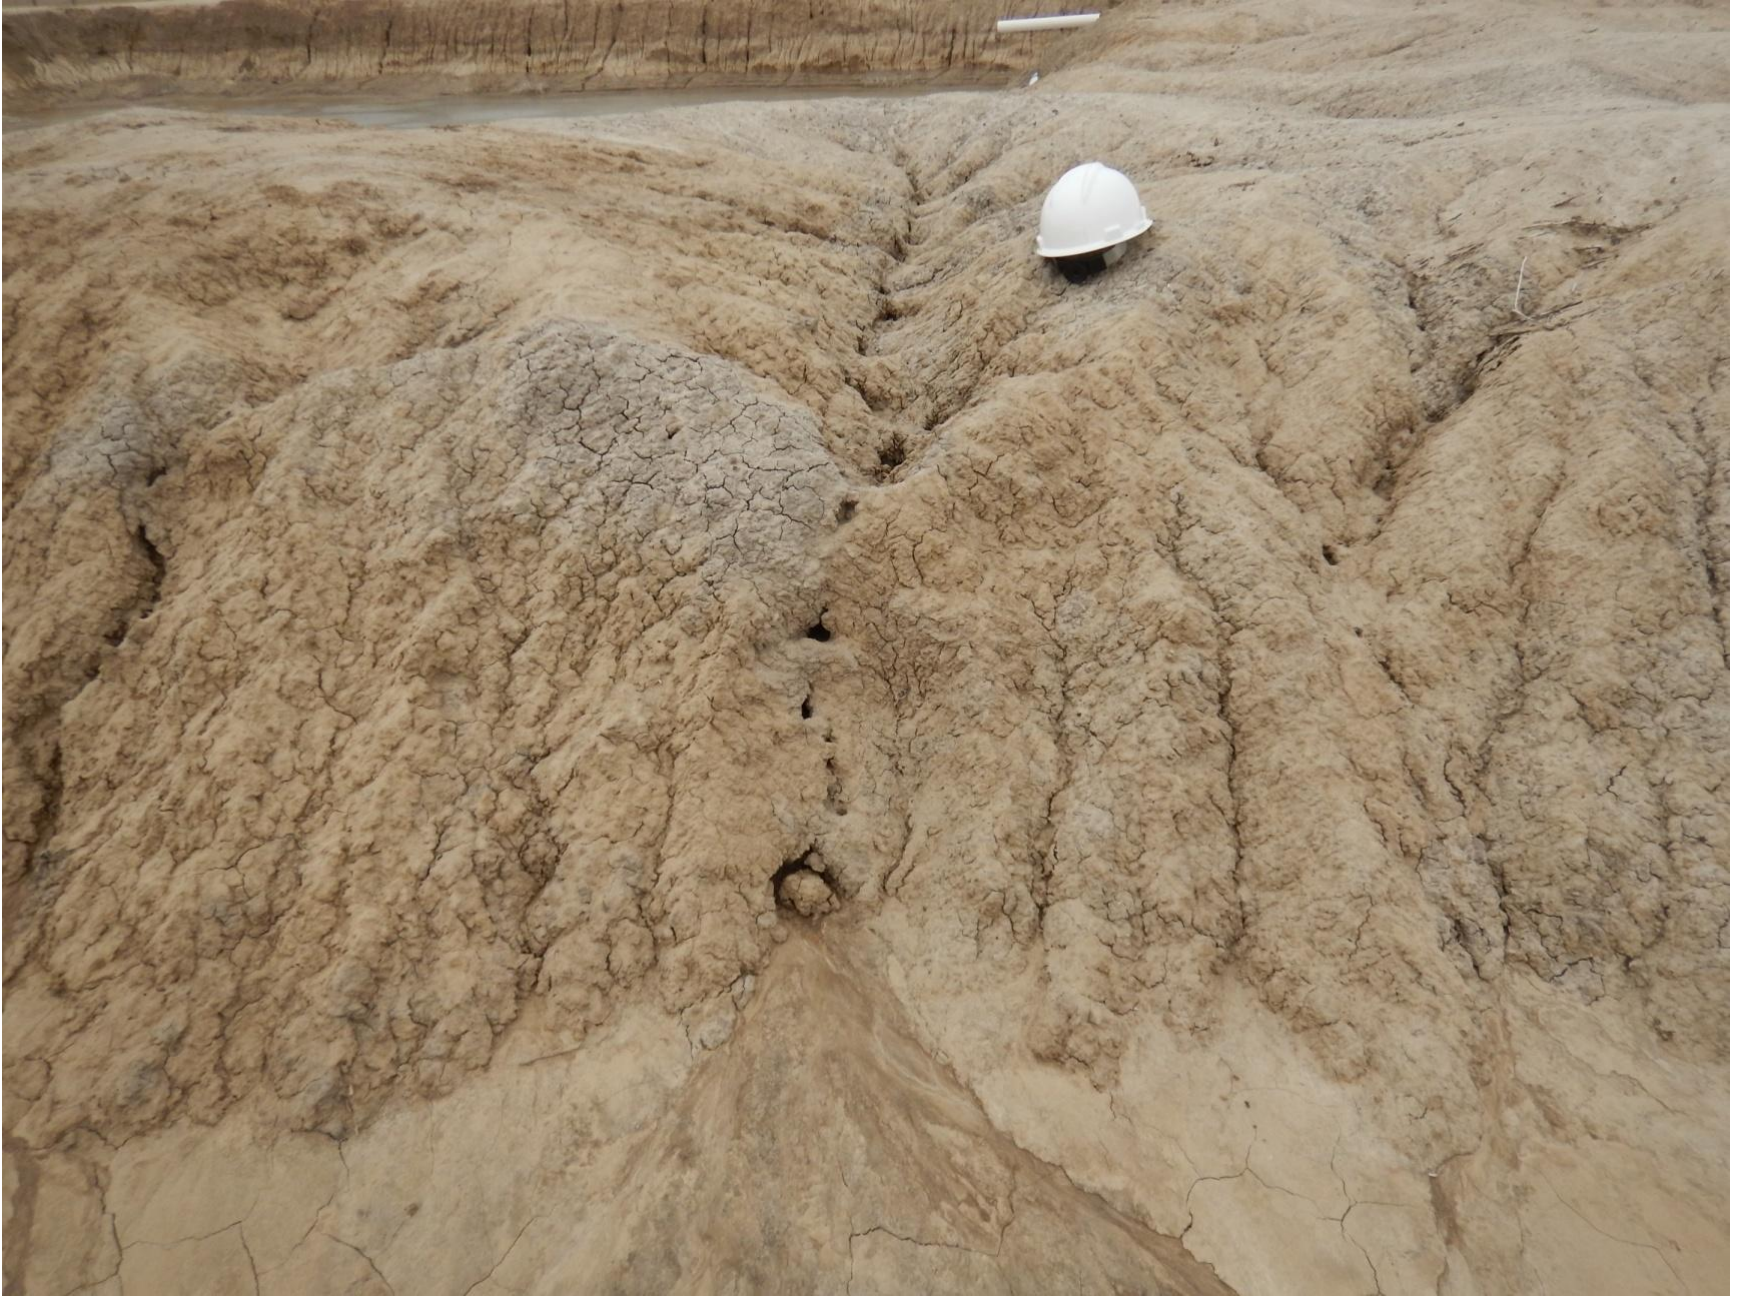
Figure 27: Photo taken from west end of pit location . Photo shows stormwater erosion on pit's containment berm. Stormwater flow occurring on surface, as well as the subsurface of the berm

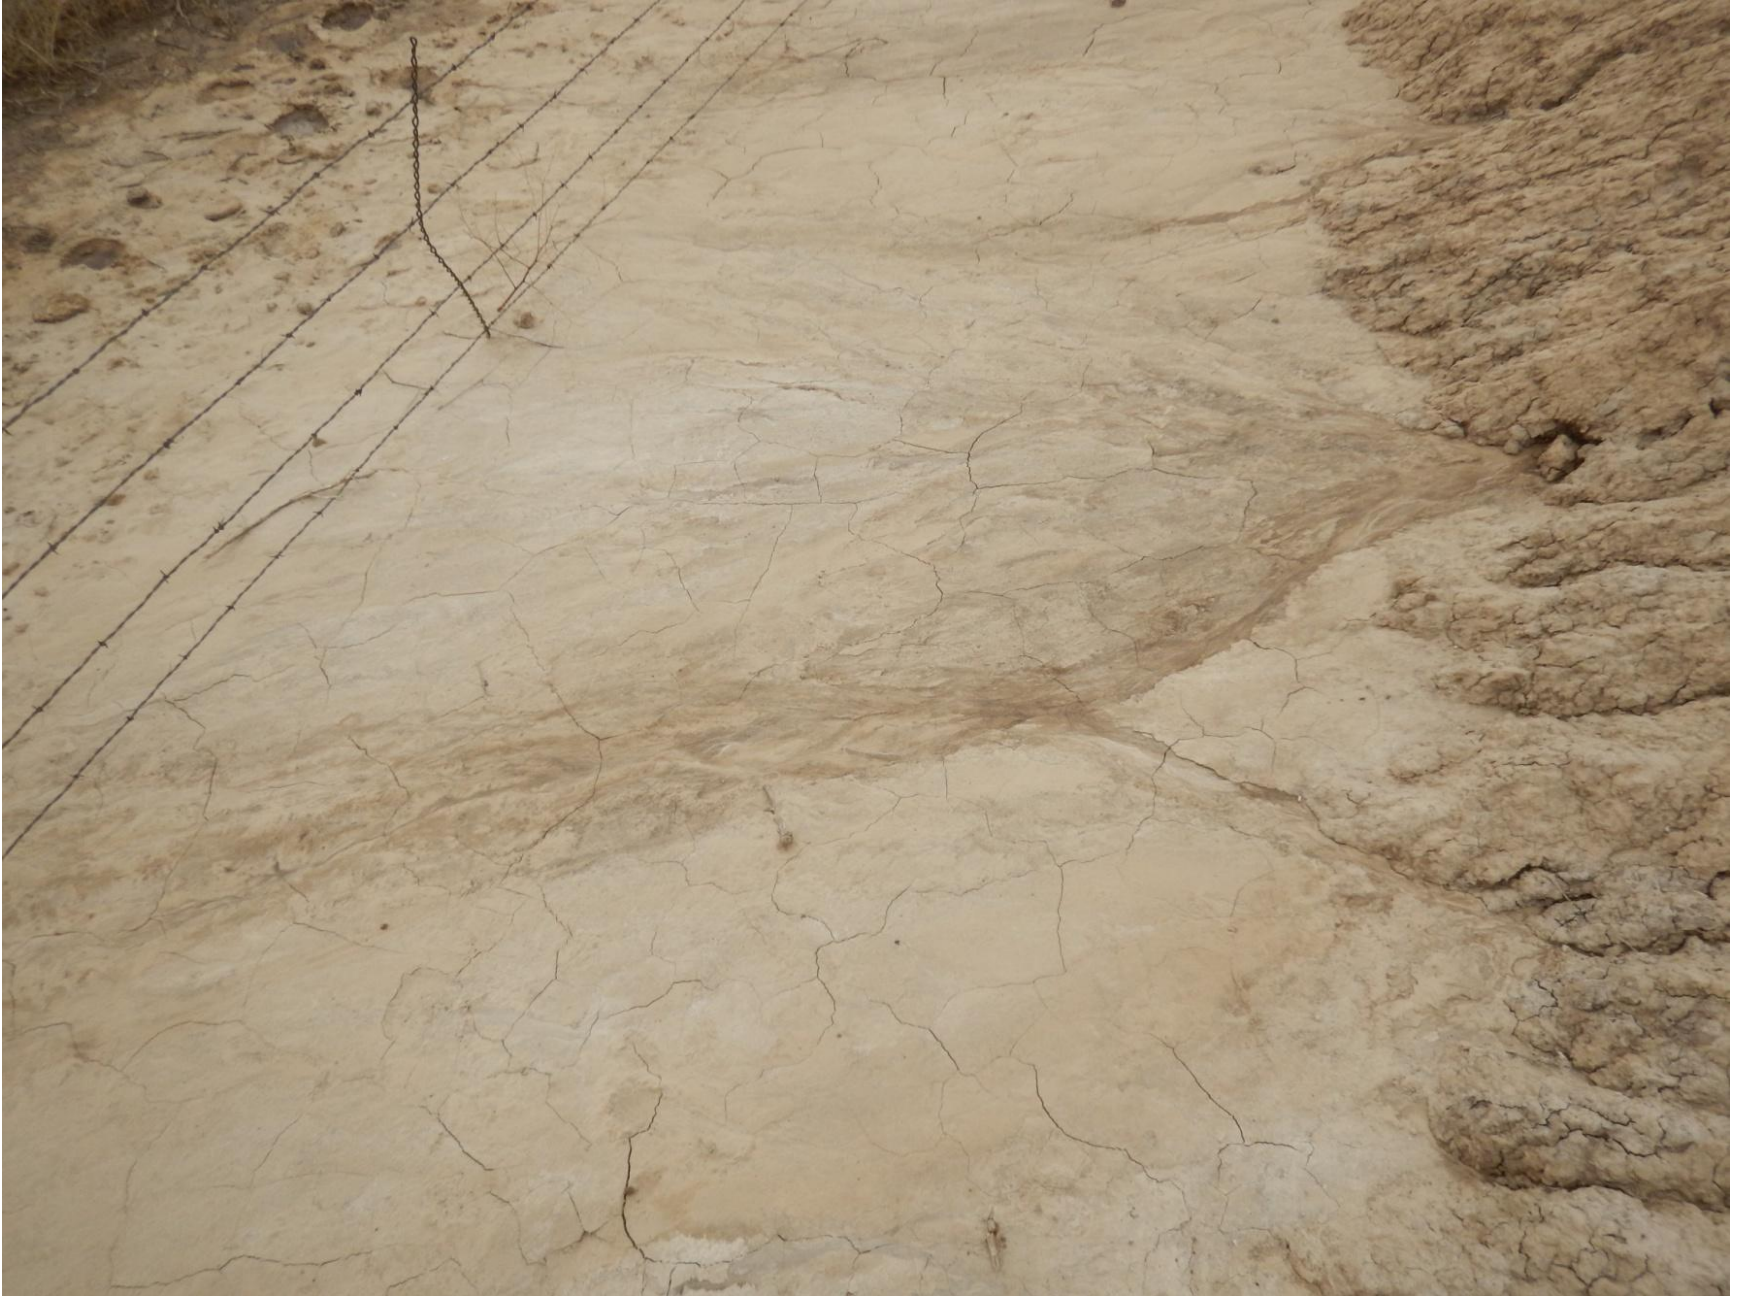
Figure 28: Photo taken from west end of pit location . Photo shows stormwater erosion on pit's containment berm and sediment deposition off of location.

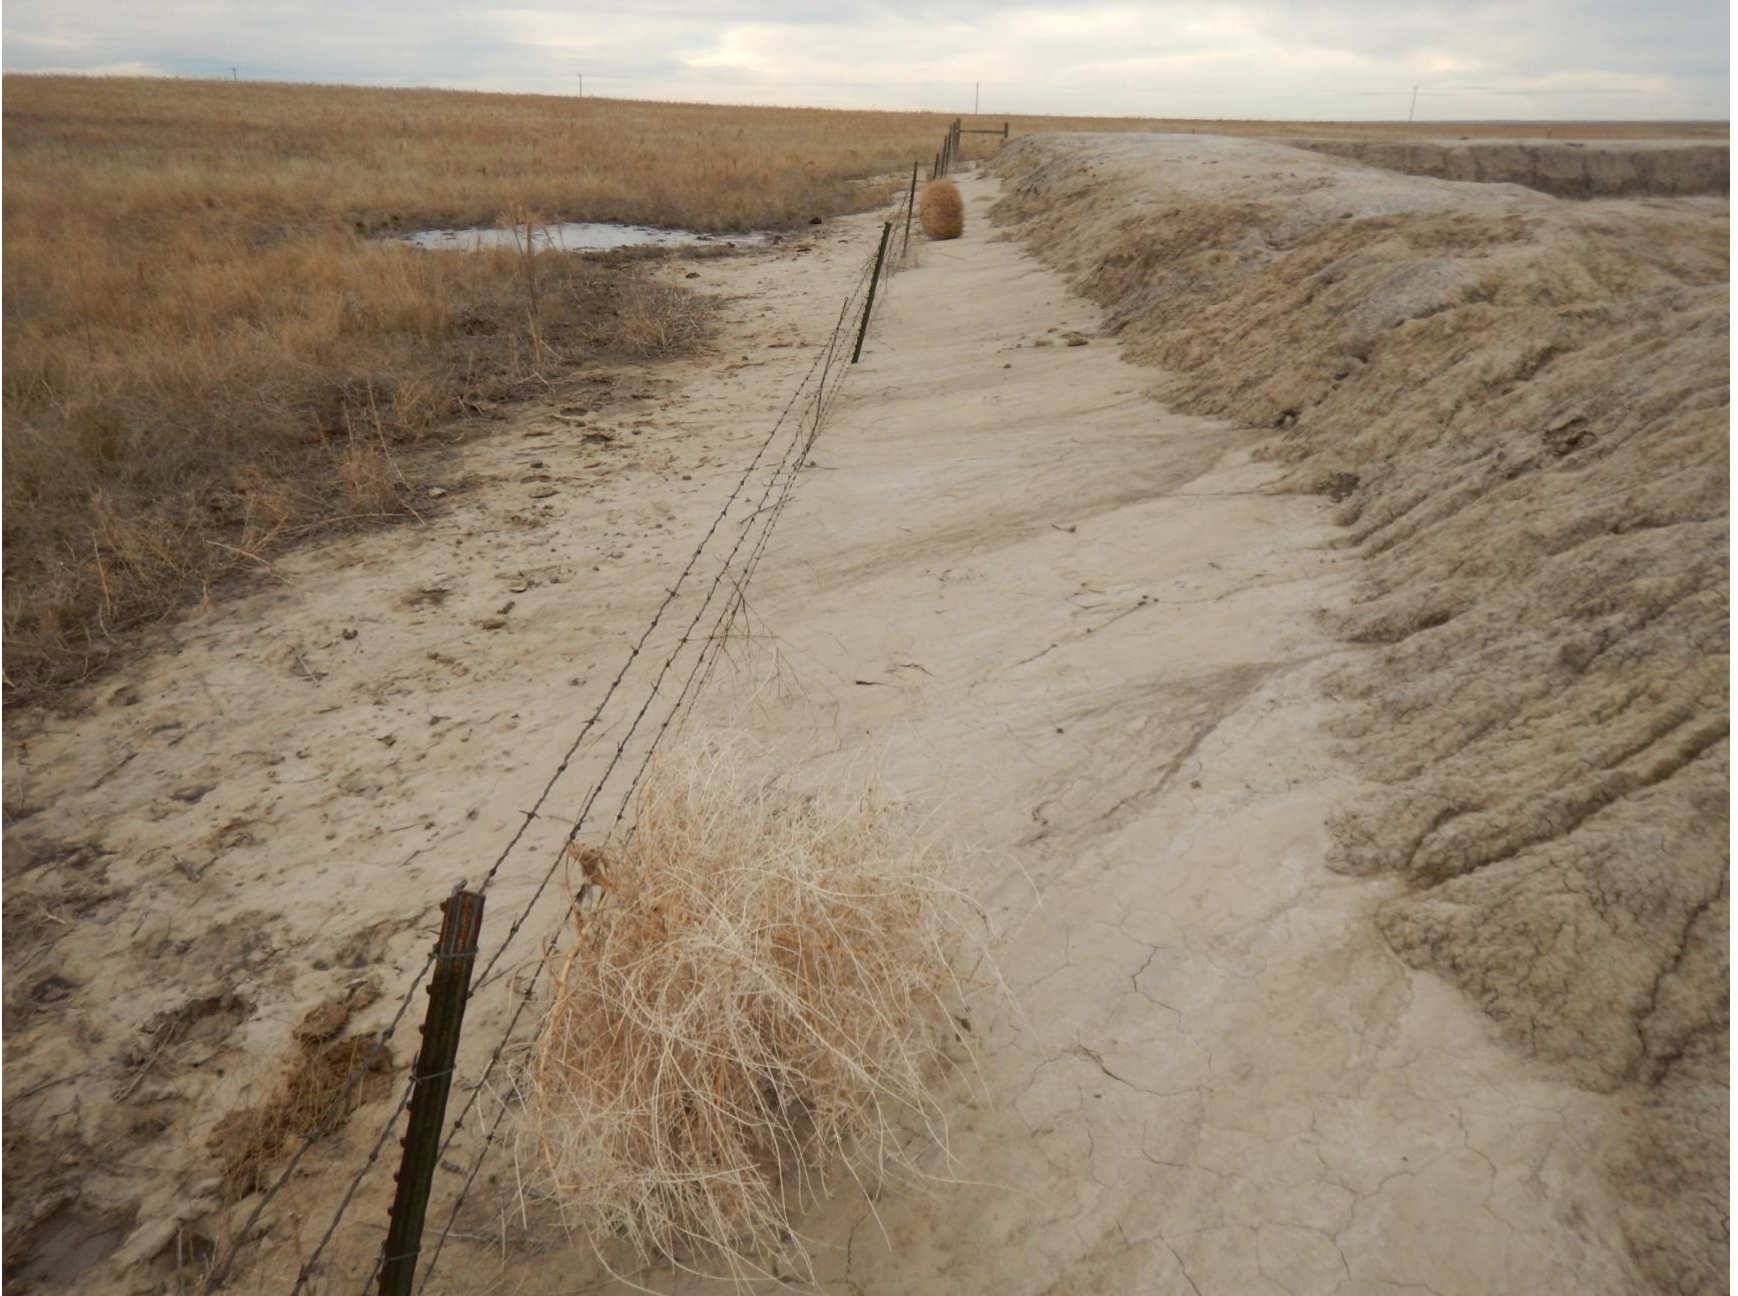
Figure 29: Photo taken from west end of pit location facing north . Photo shows stormwater deposition off of location, insufficient stormwater BMPs and weed debris.

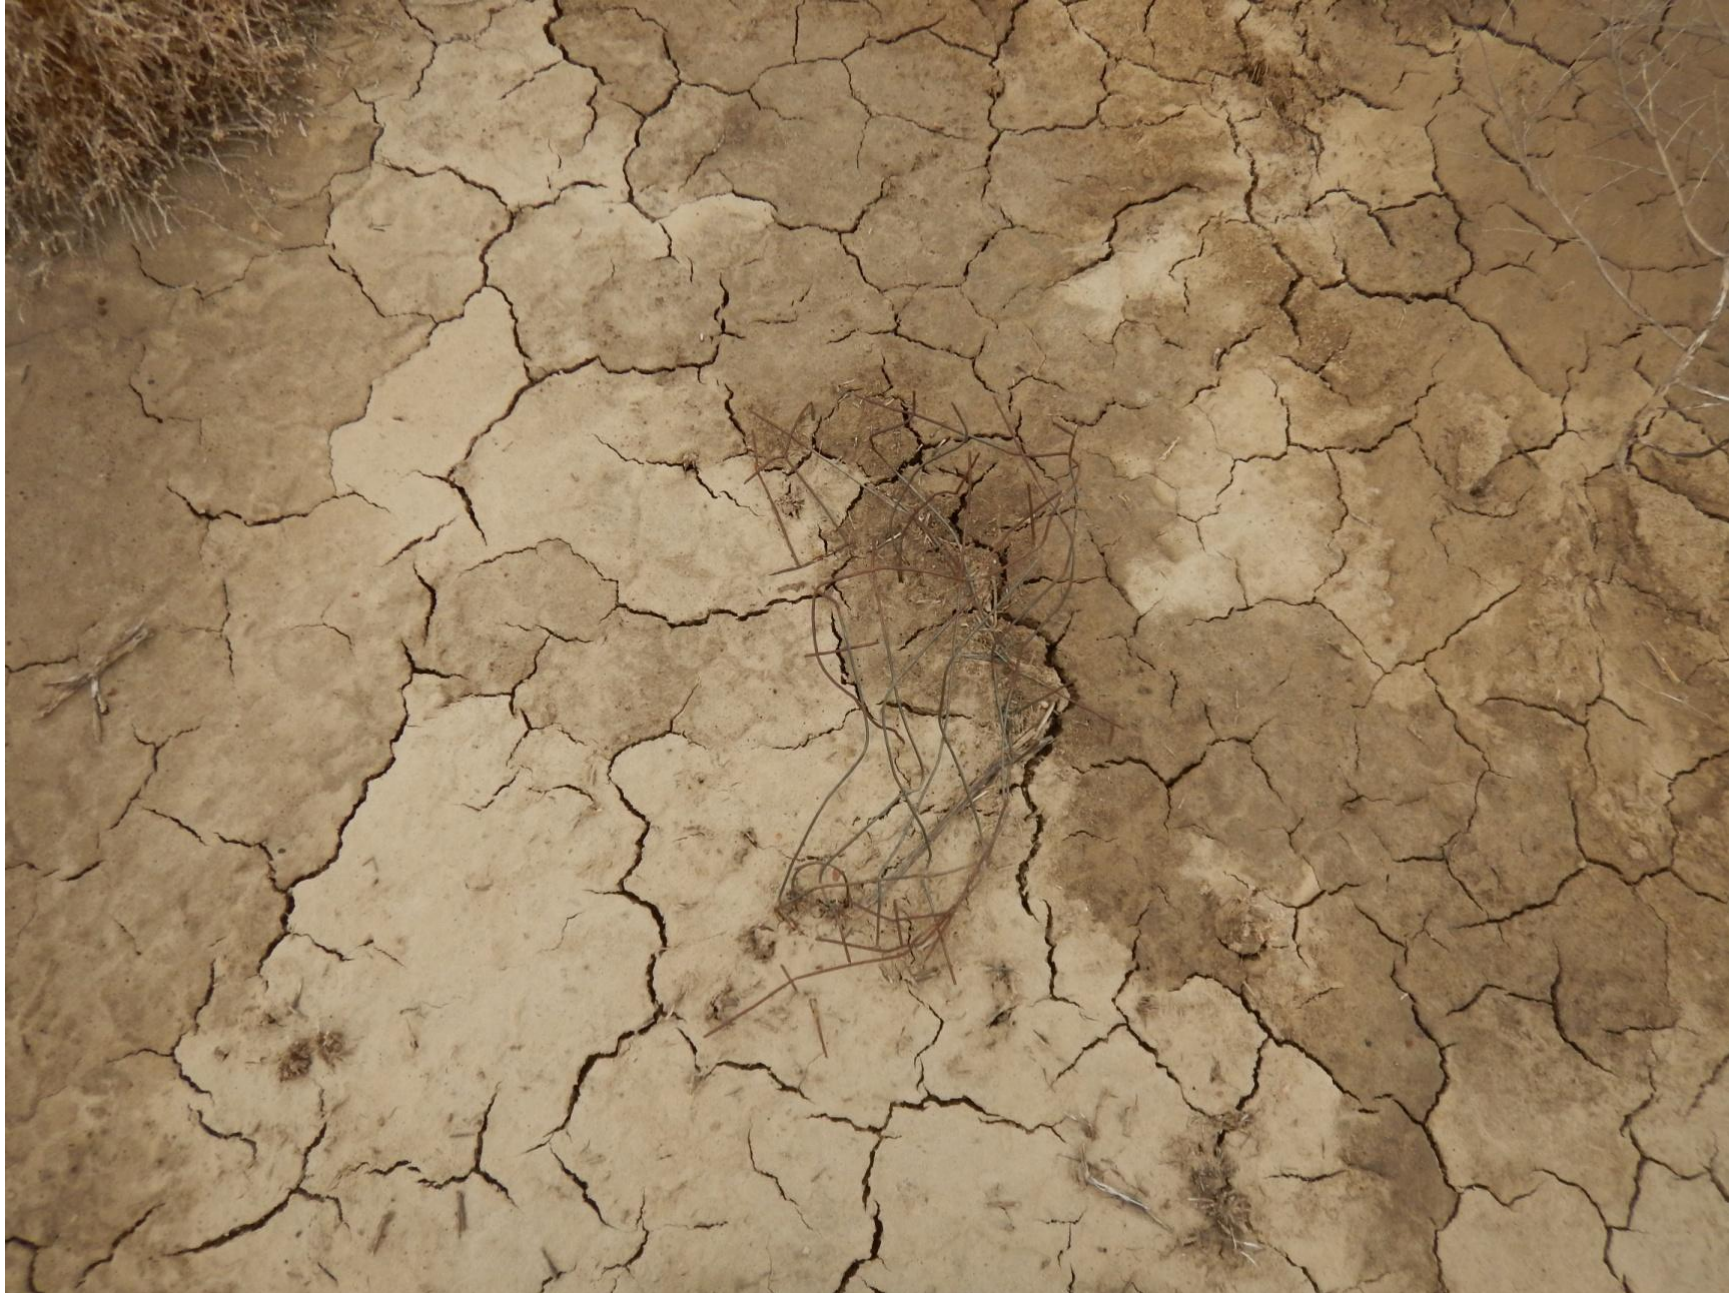
Figure 30: Photo taken from south end of pit location facing north . Photo trash debris. Trash debris appears to be metal wire.
