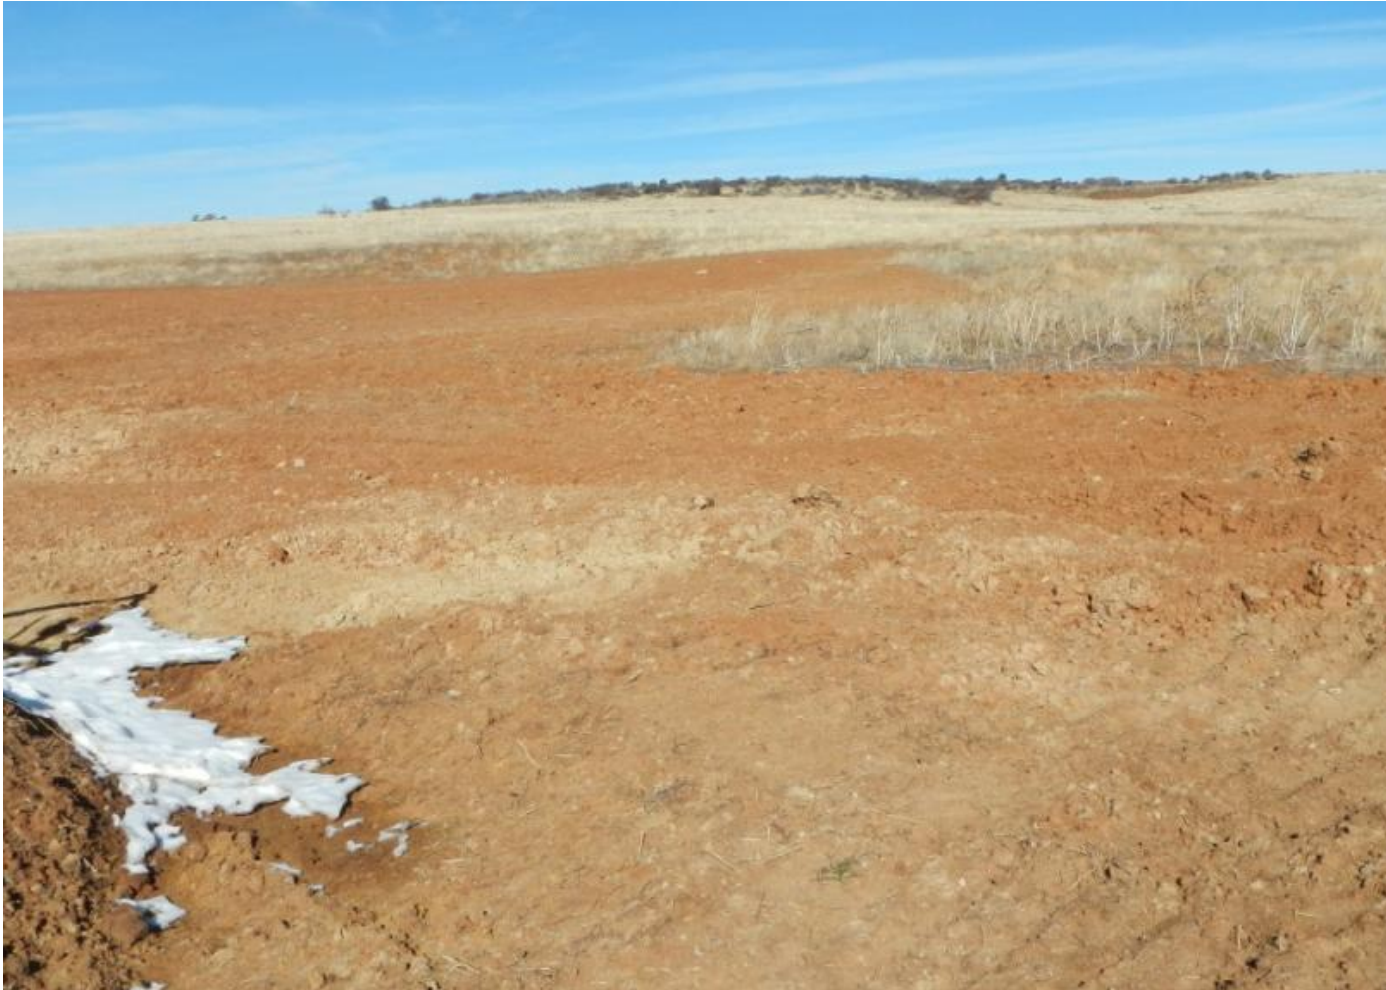
Photo 1. View of the eastern portion of the project area from the southeastern corner facing northward. Musk thistle from the previous season can be seen in the mid-ground.

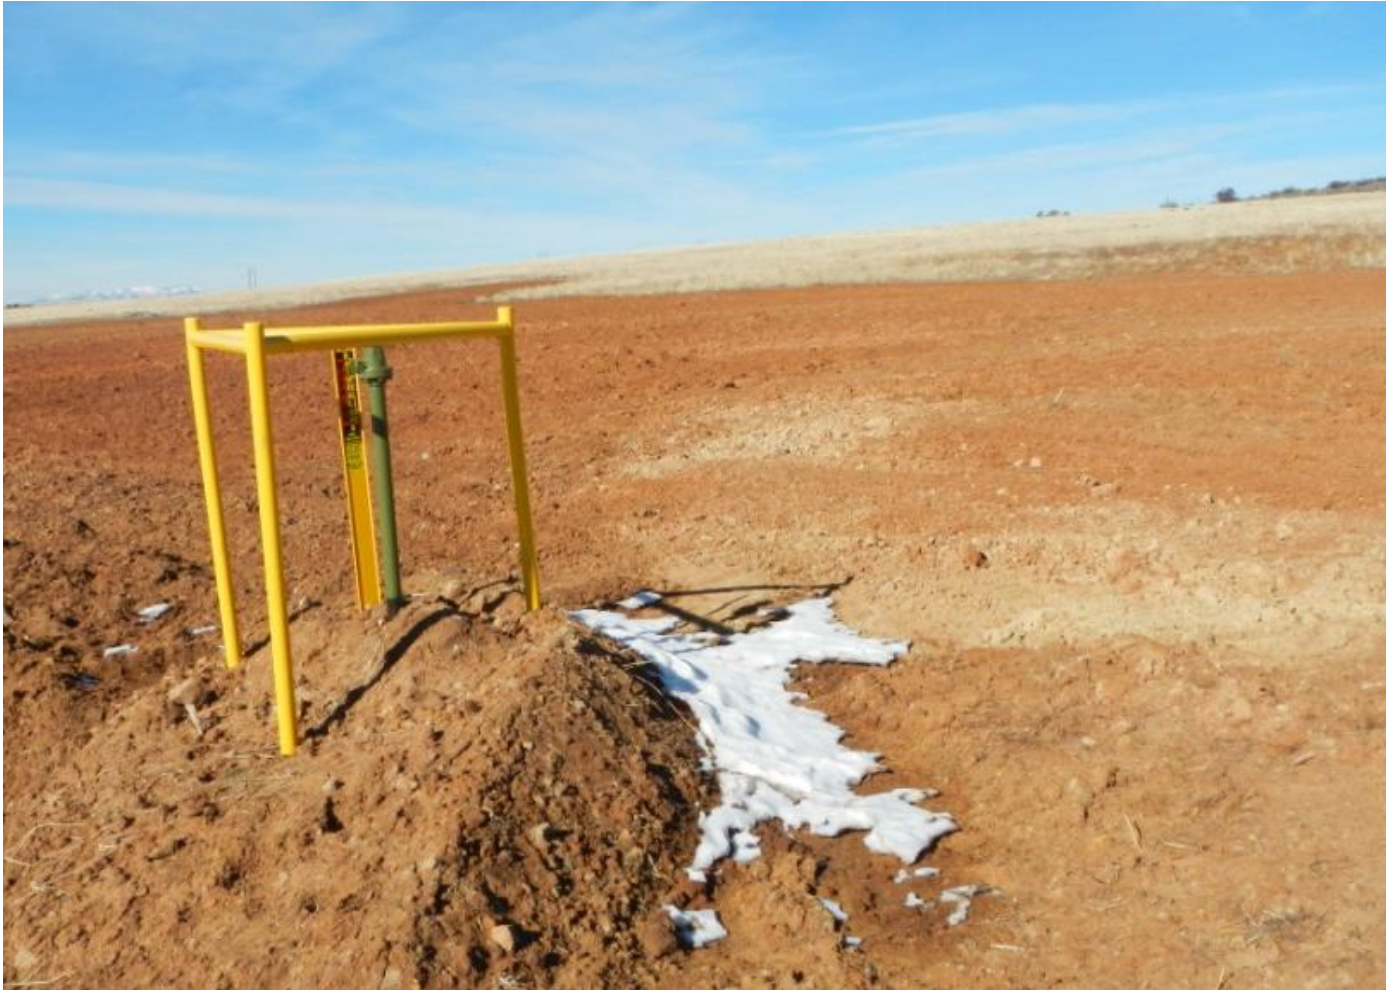
Photo 2. View of project area from the southeastern corner facing center. Pipeline riser in foreground needs removal. The well pad has been contoured and is currently furrowed.

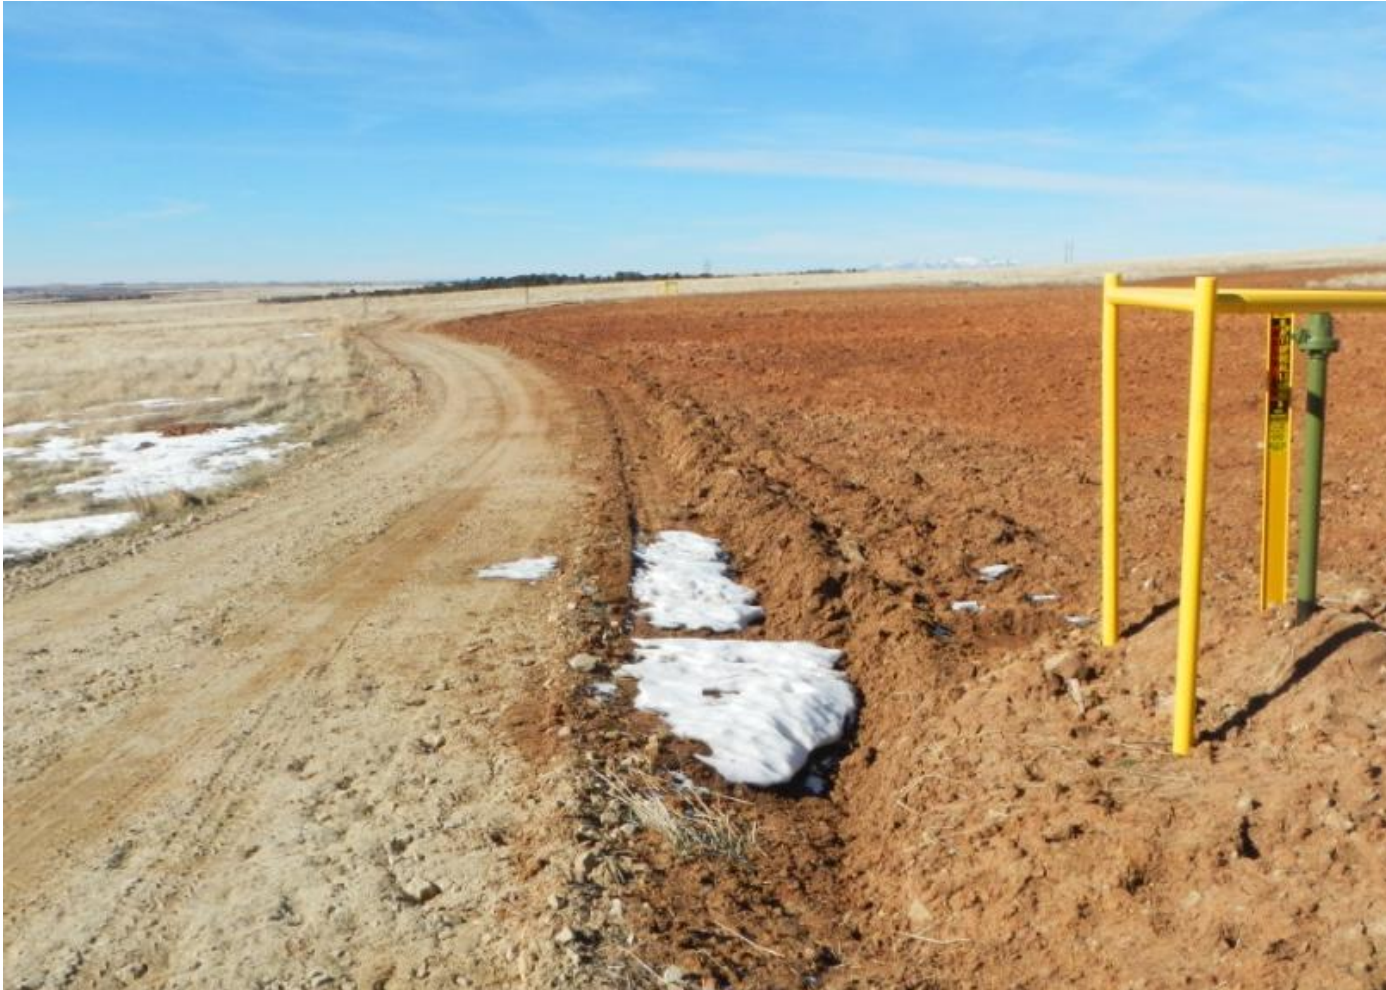
Photo 3. View of the southern portion of the project area from the southeastern corner facing westward. Access road on left leads to 083-06637 location that was also recently plugged and abandoned.

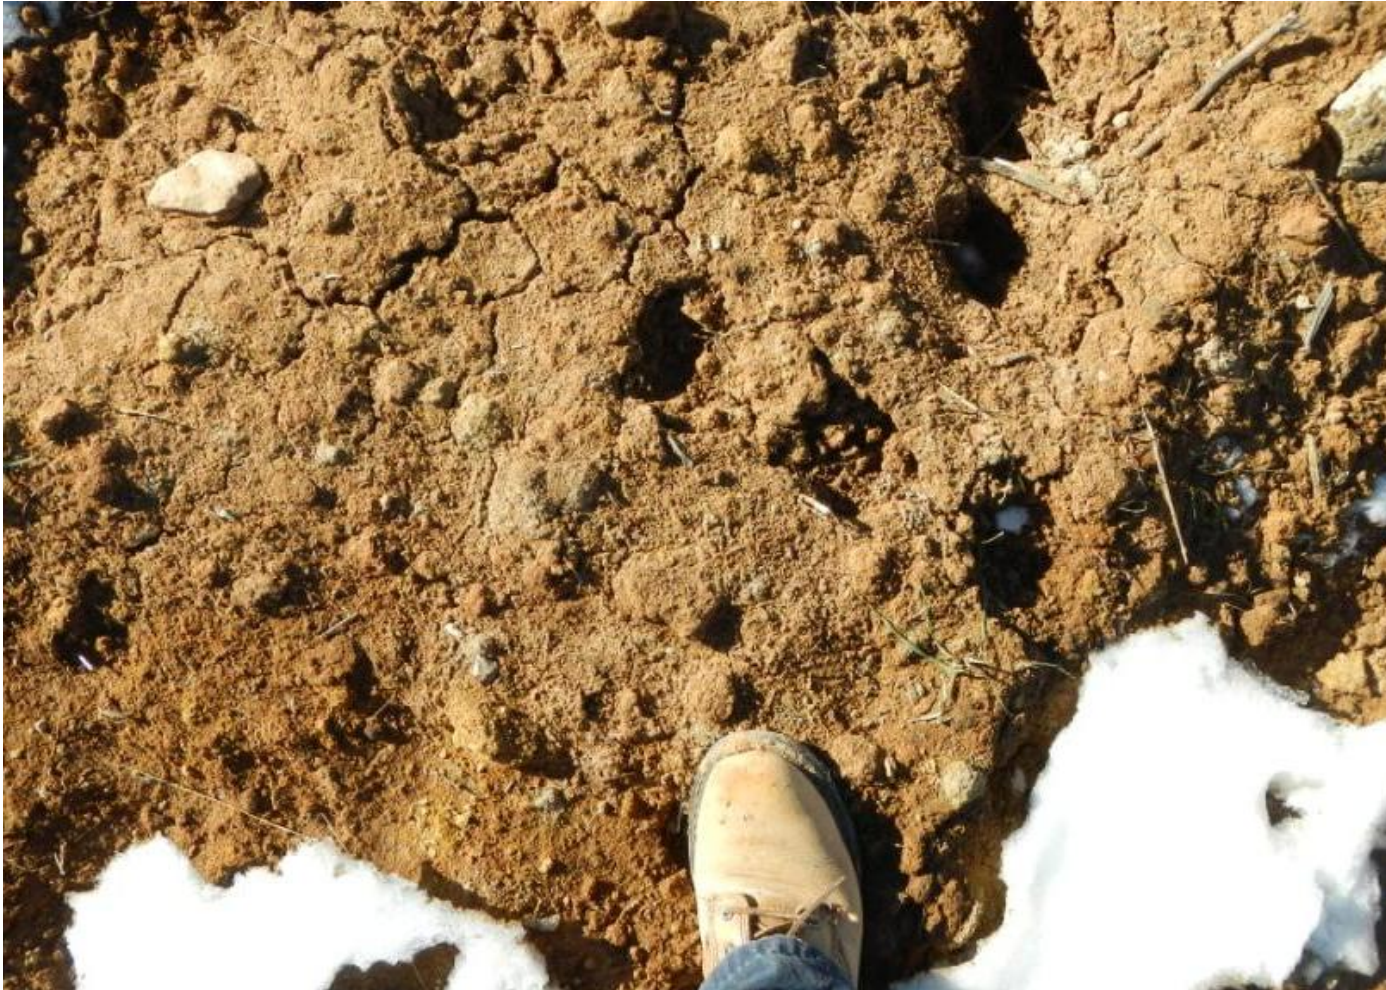
Photo 4. Birdseye view of soil surface on well pad in process of reclamation. It does not appear that seeding has been completed.

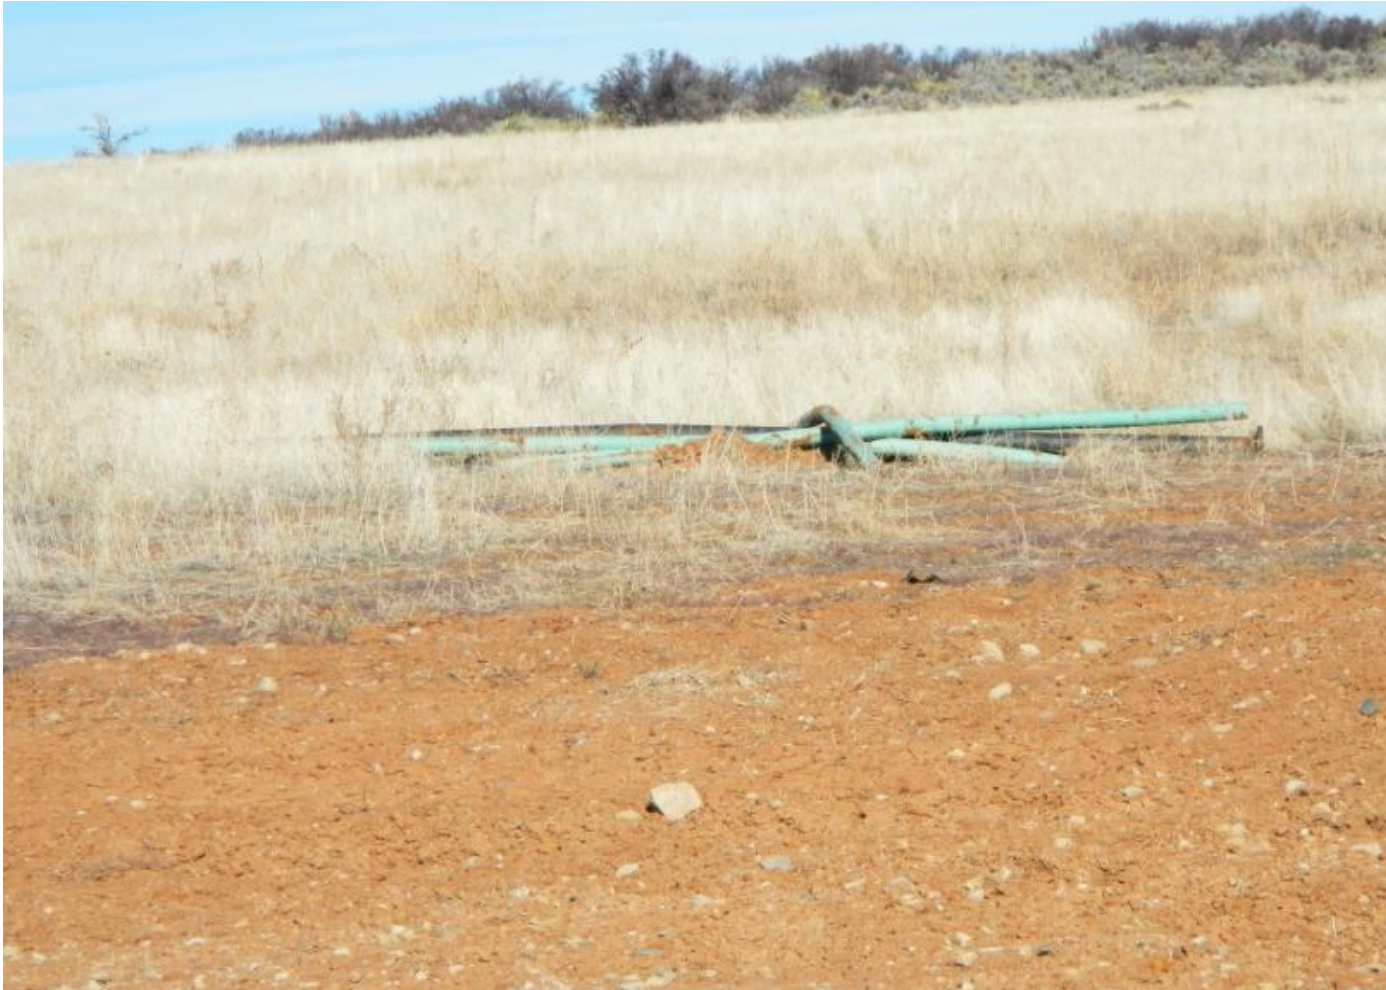
Photo 5. View of pipe debris within the northwestern portion of the project area.
