# Stormwater and Construction Inspection

Inspection 1 of 2

Operator: Wiepking-Fullerton

Location ID: 443145

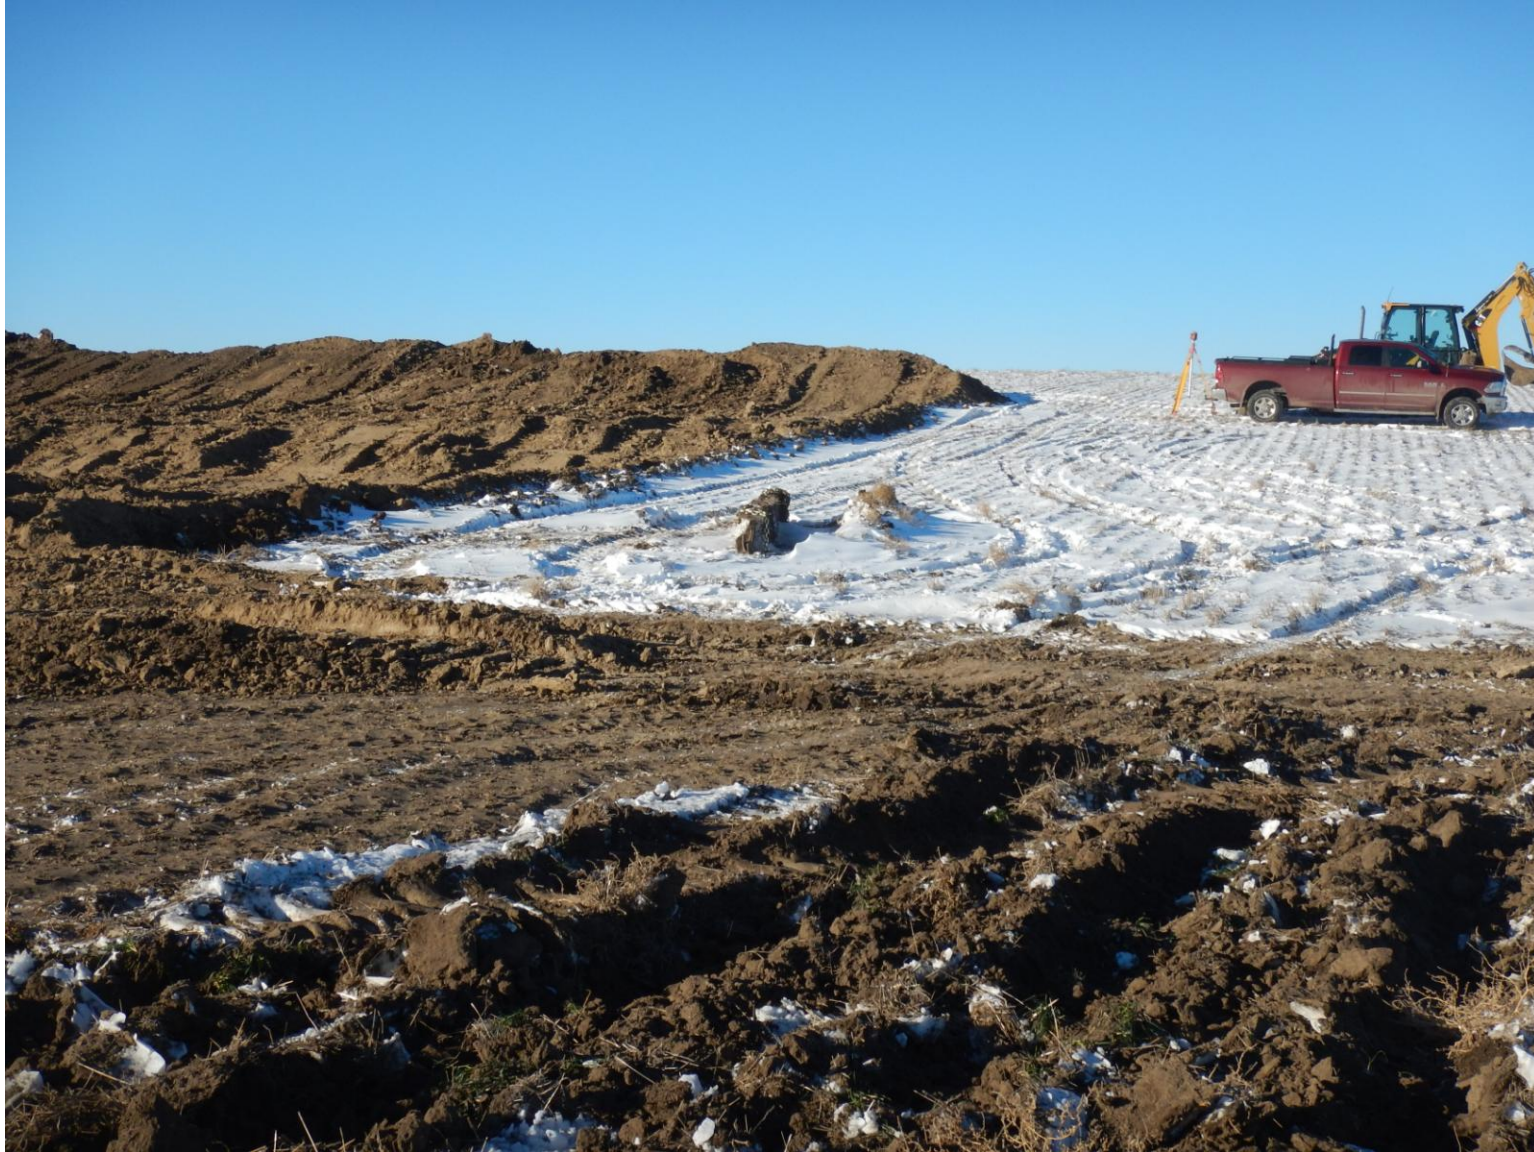
**Figure 5:** Photo taken from northern area of location, facing west. Photo shows insufficient stormwater BMPs on northwest portion of location prior to construction activities.

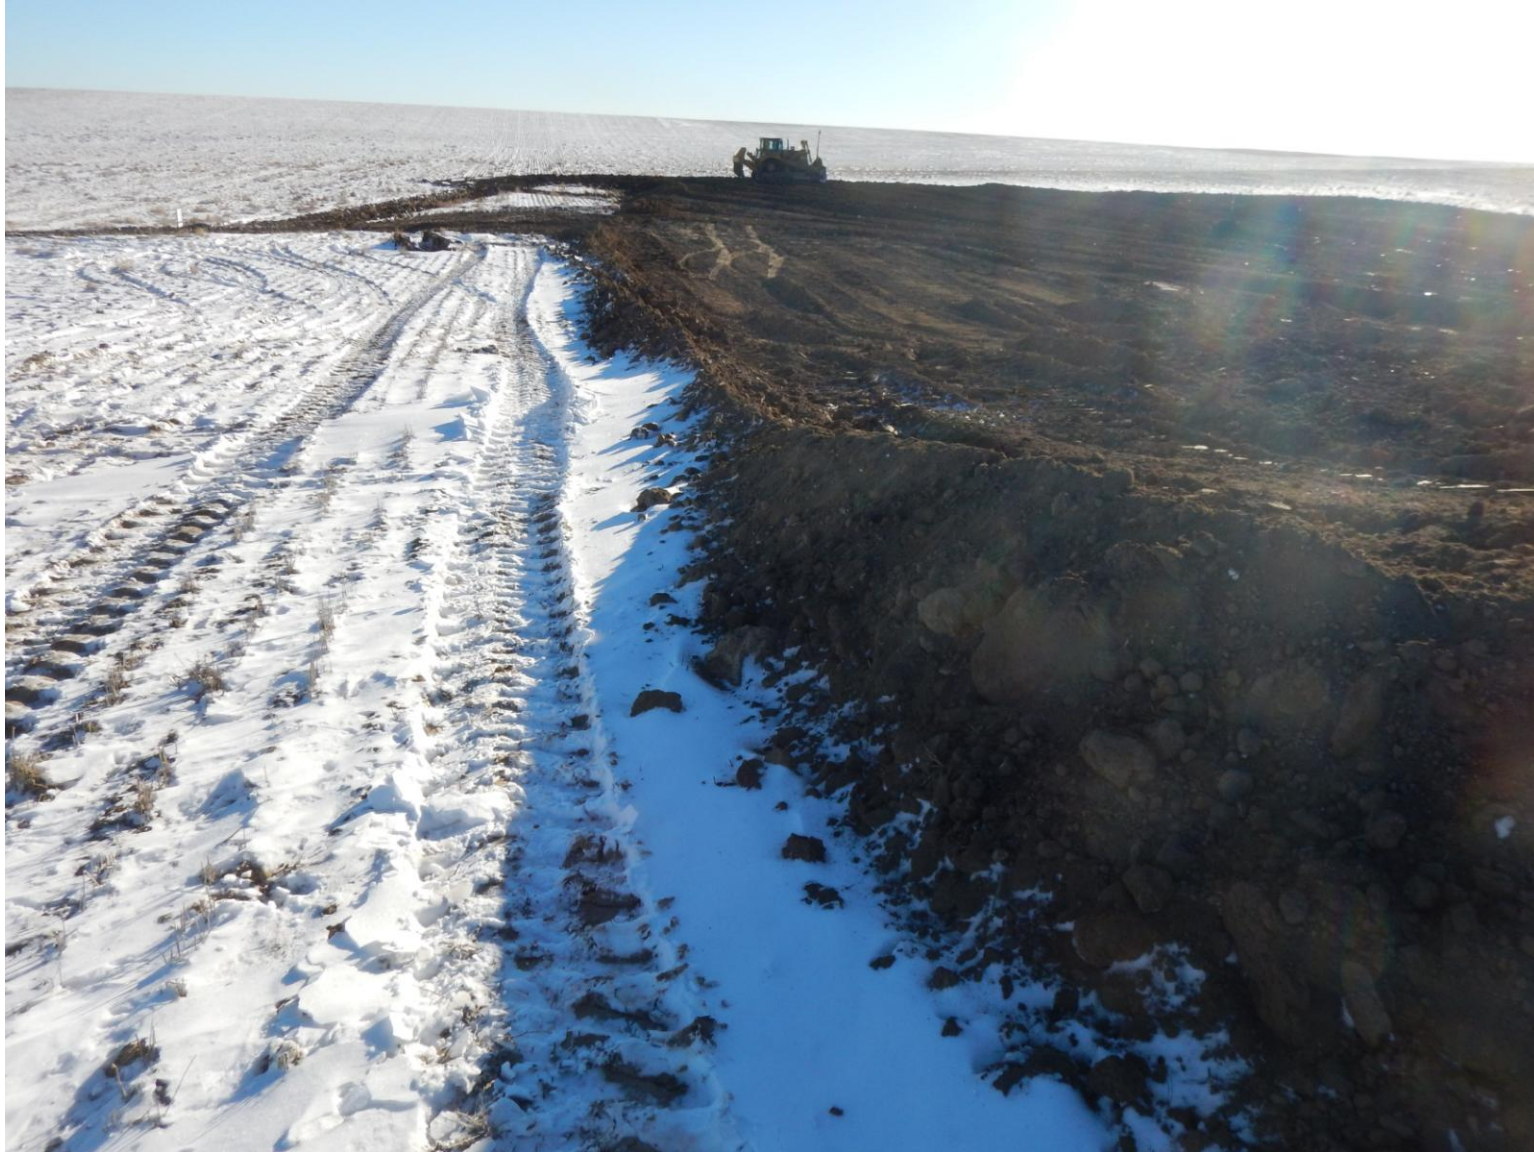
**Figure 6:** Photo taken from northwest corner of location, facing east. Photo shows insufficient stormwater BMPs for site prior to construction activities. .

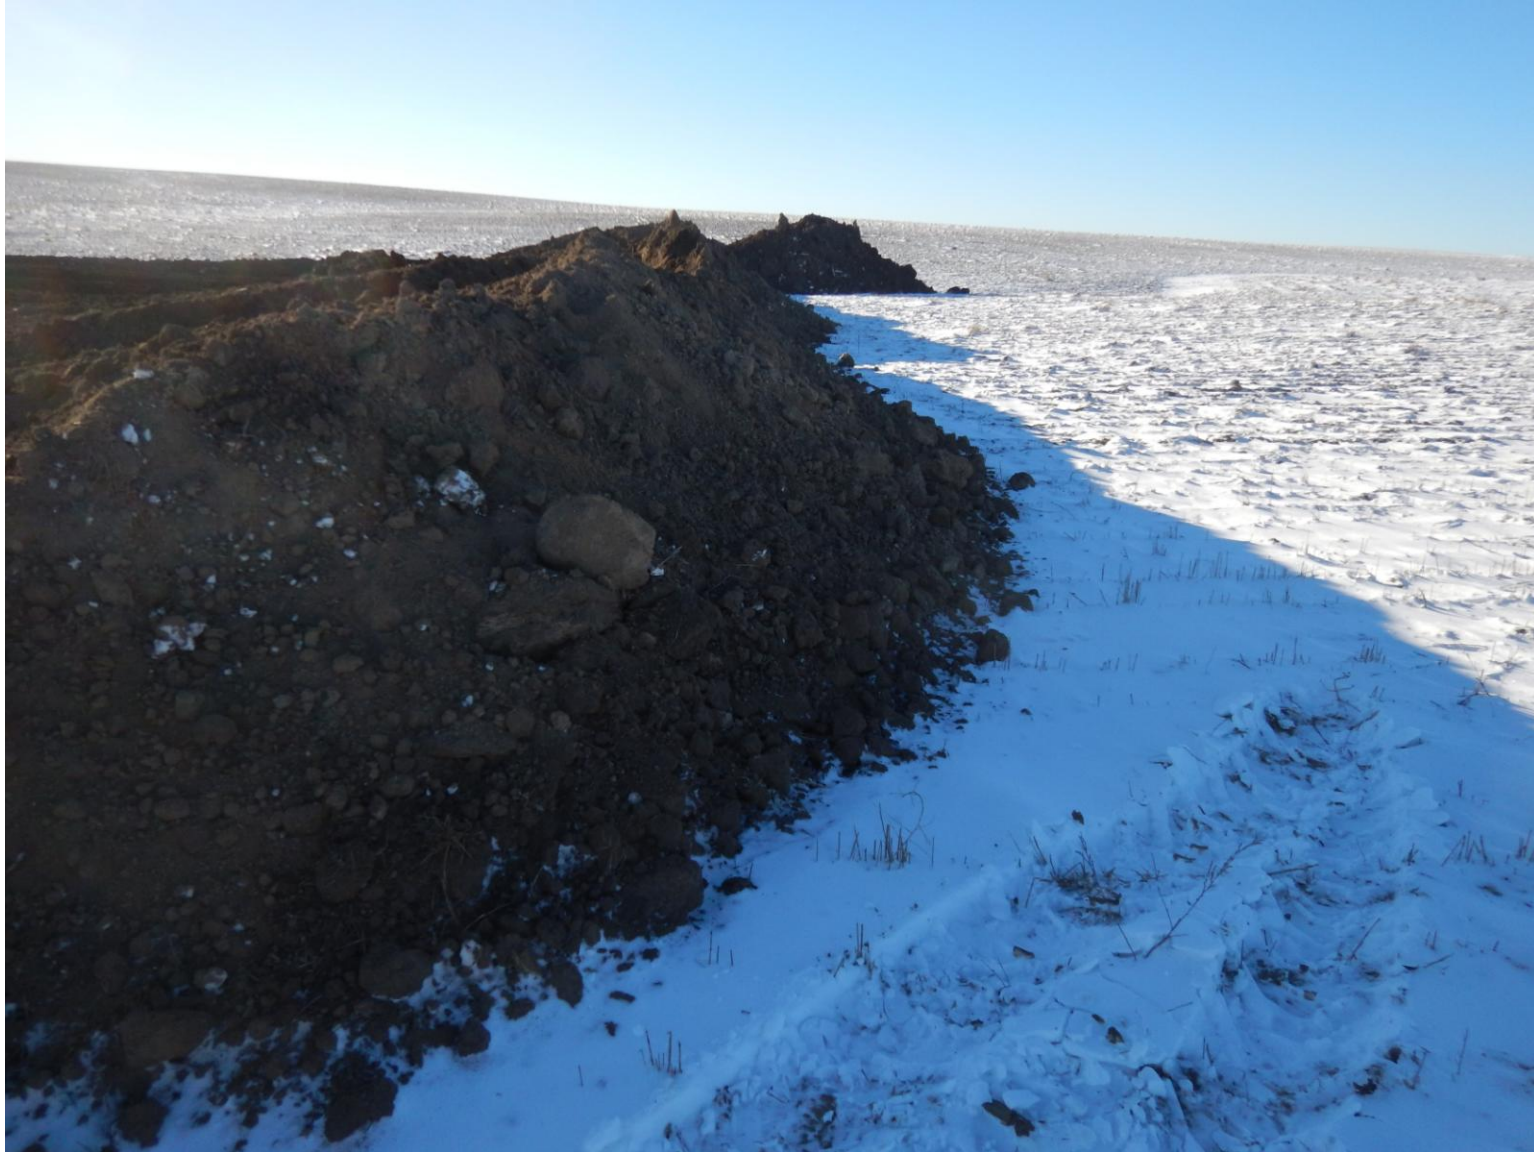
**Figure 7:** Photo taken from northwest corner of location, facing south. Photo of topsoil berm being constructed. Photo shows insufficient stormwater BMPs for site on western end of location prior to construction activities.

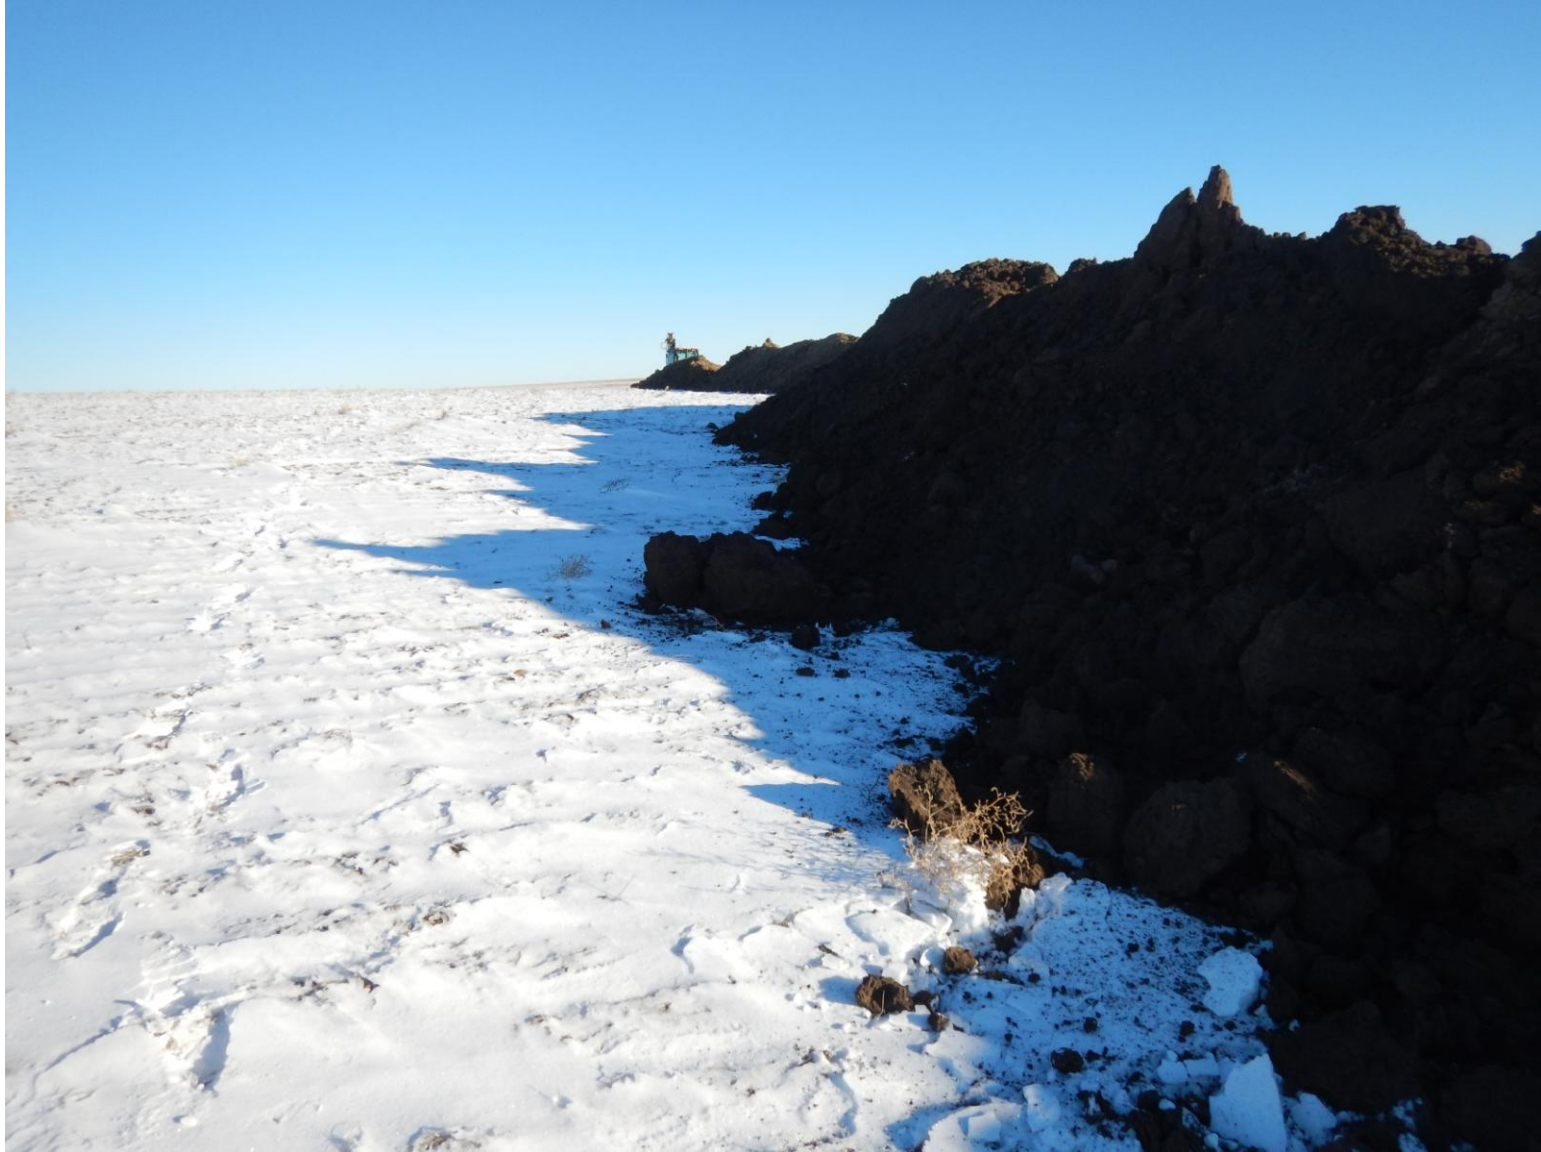
**Figure 8:** Photo taken from western end of location, facing north. Photo of topsoil berm being constructed. Photo shows insufficient stormwater BMPs for site on western end of location prior to construction activities. .

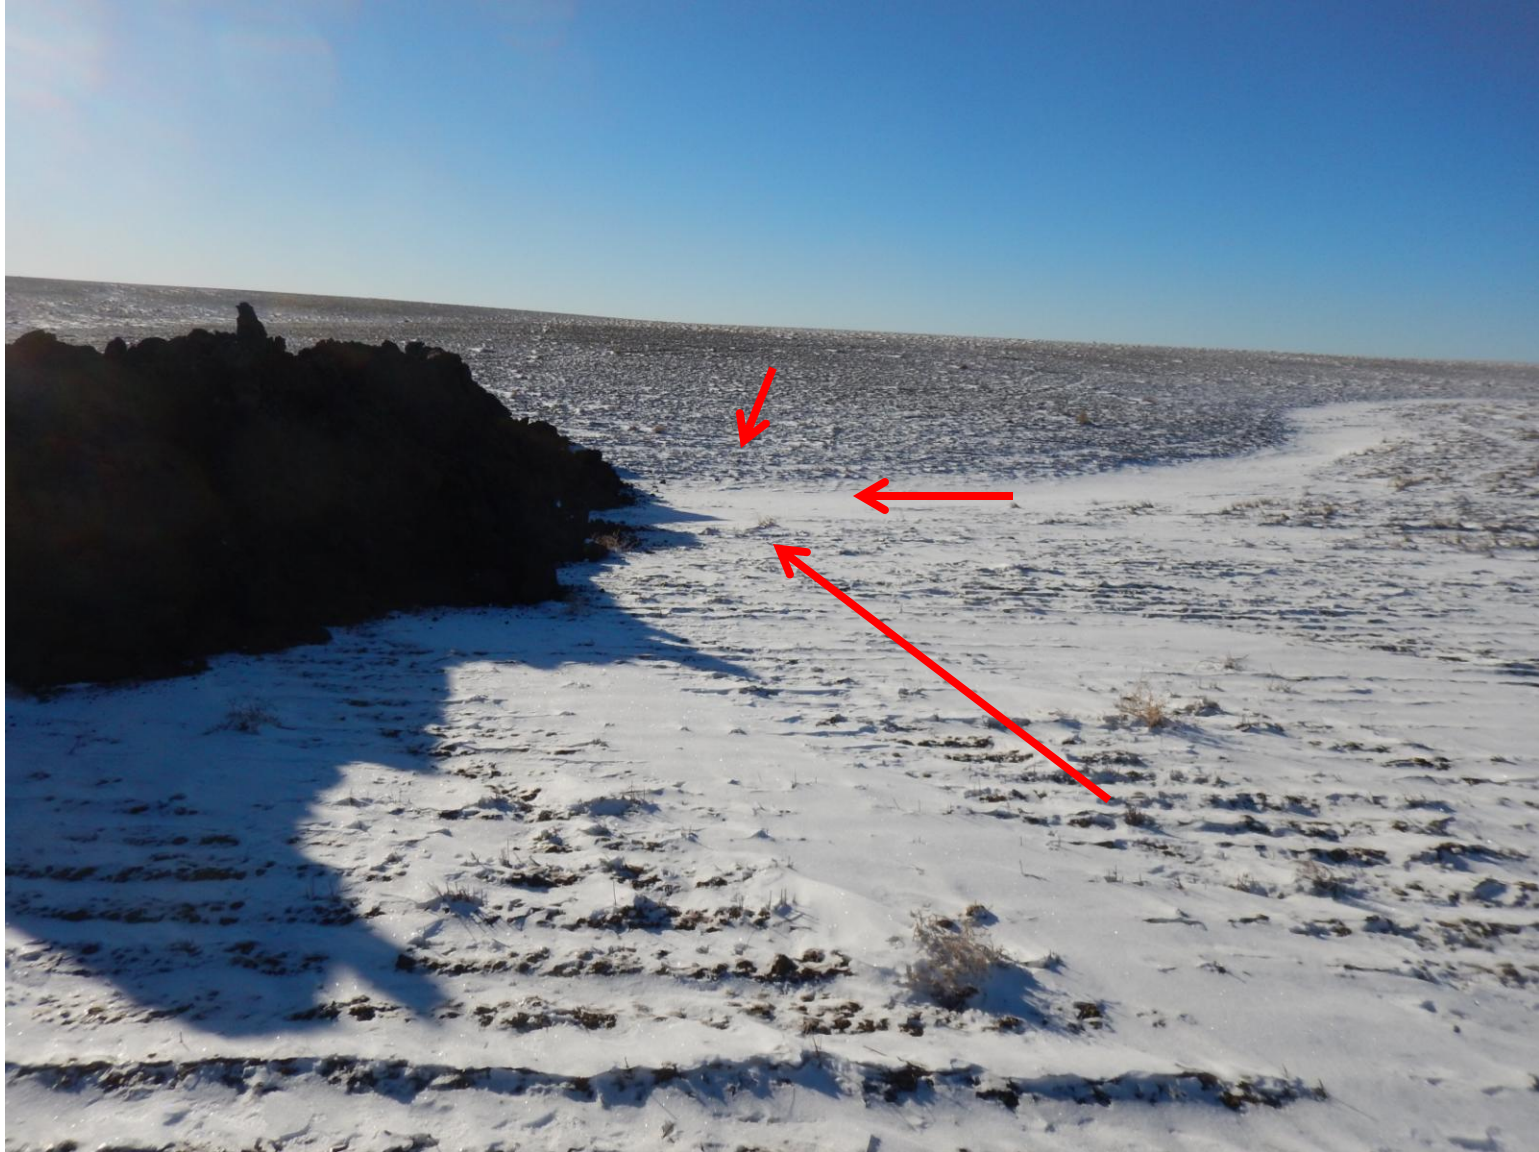
**Figure 9:** Photo taken from western end of location, facing south. Photo shows insufficient stormwater BMPs for site on western end of location. Note location appears to be built within a drainage. Arrows indicate direction of slope.

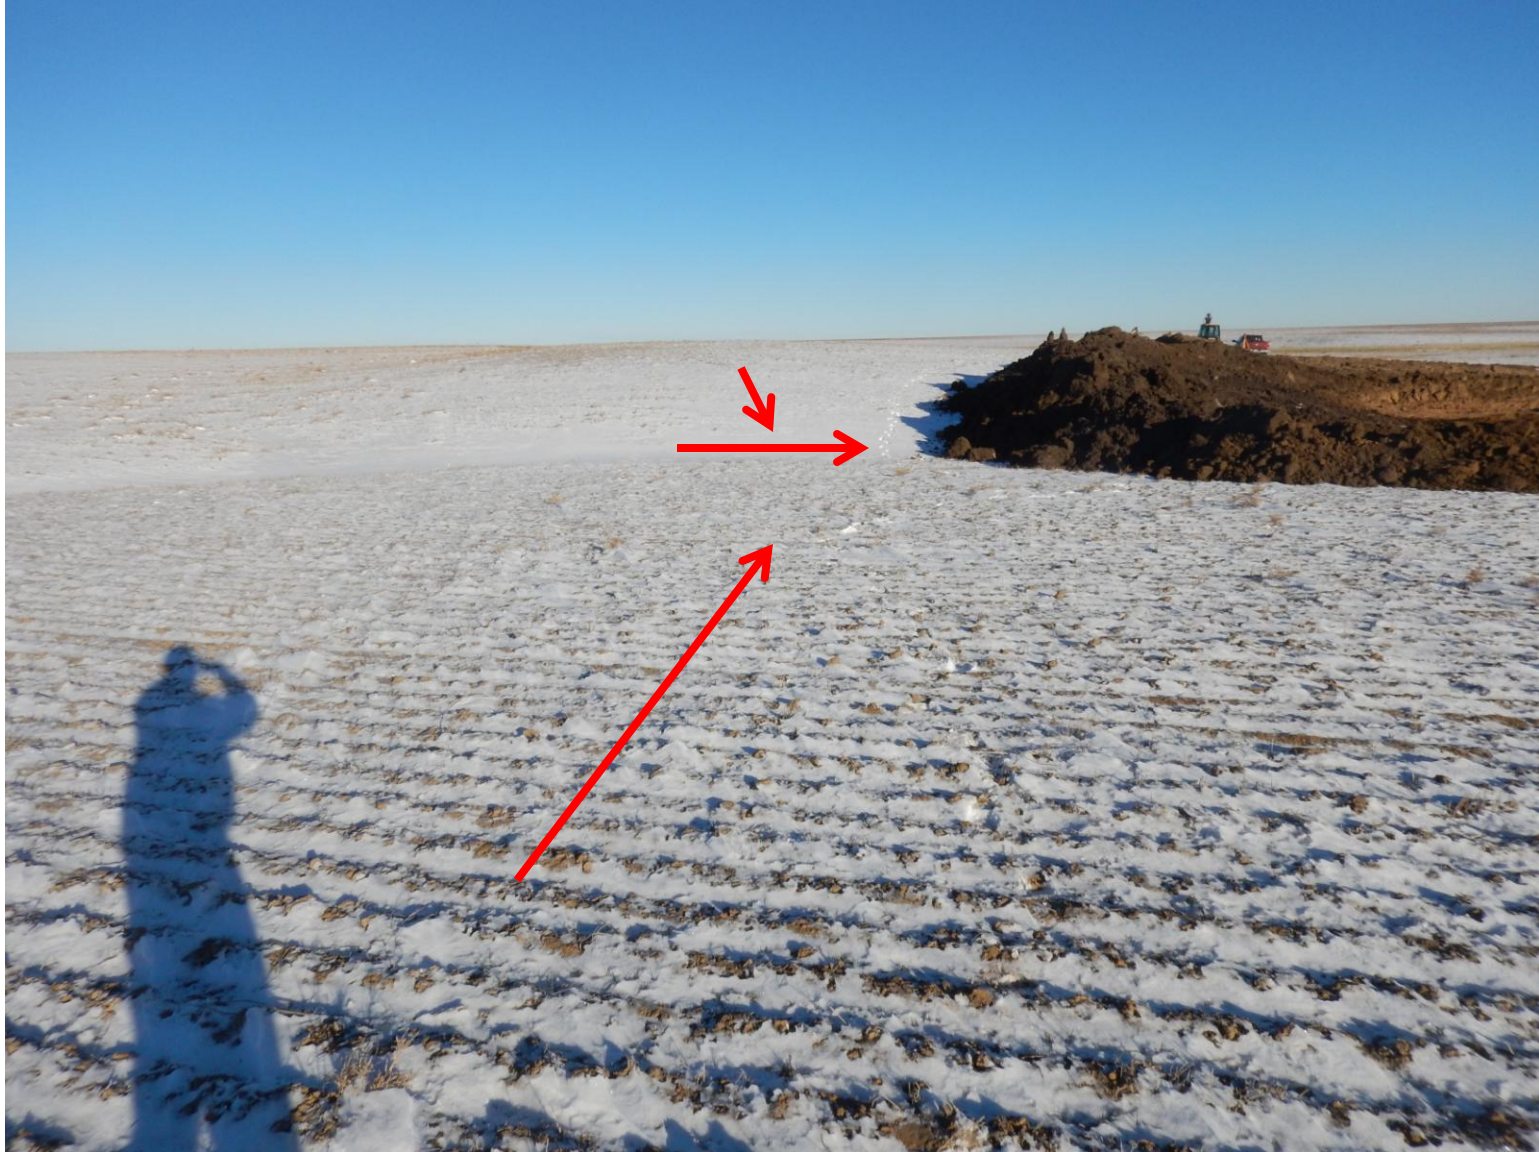
**Figure 10:** Photo taken from southwest corner of location, facing north. Photo shows insufficient stormwater BMPs for site on western end of location. Note location appears to be built within a drainage. Arrows indicate direction of slope.

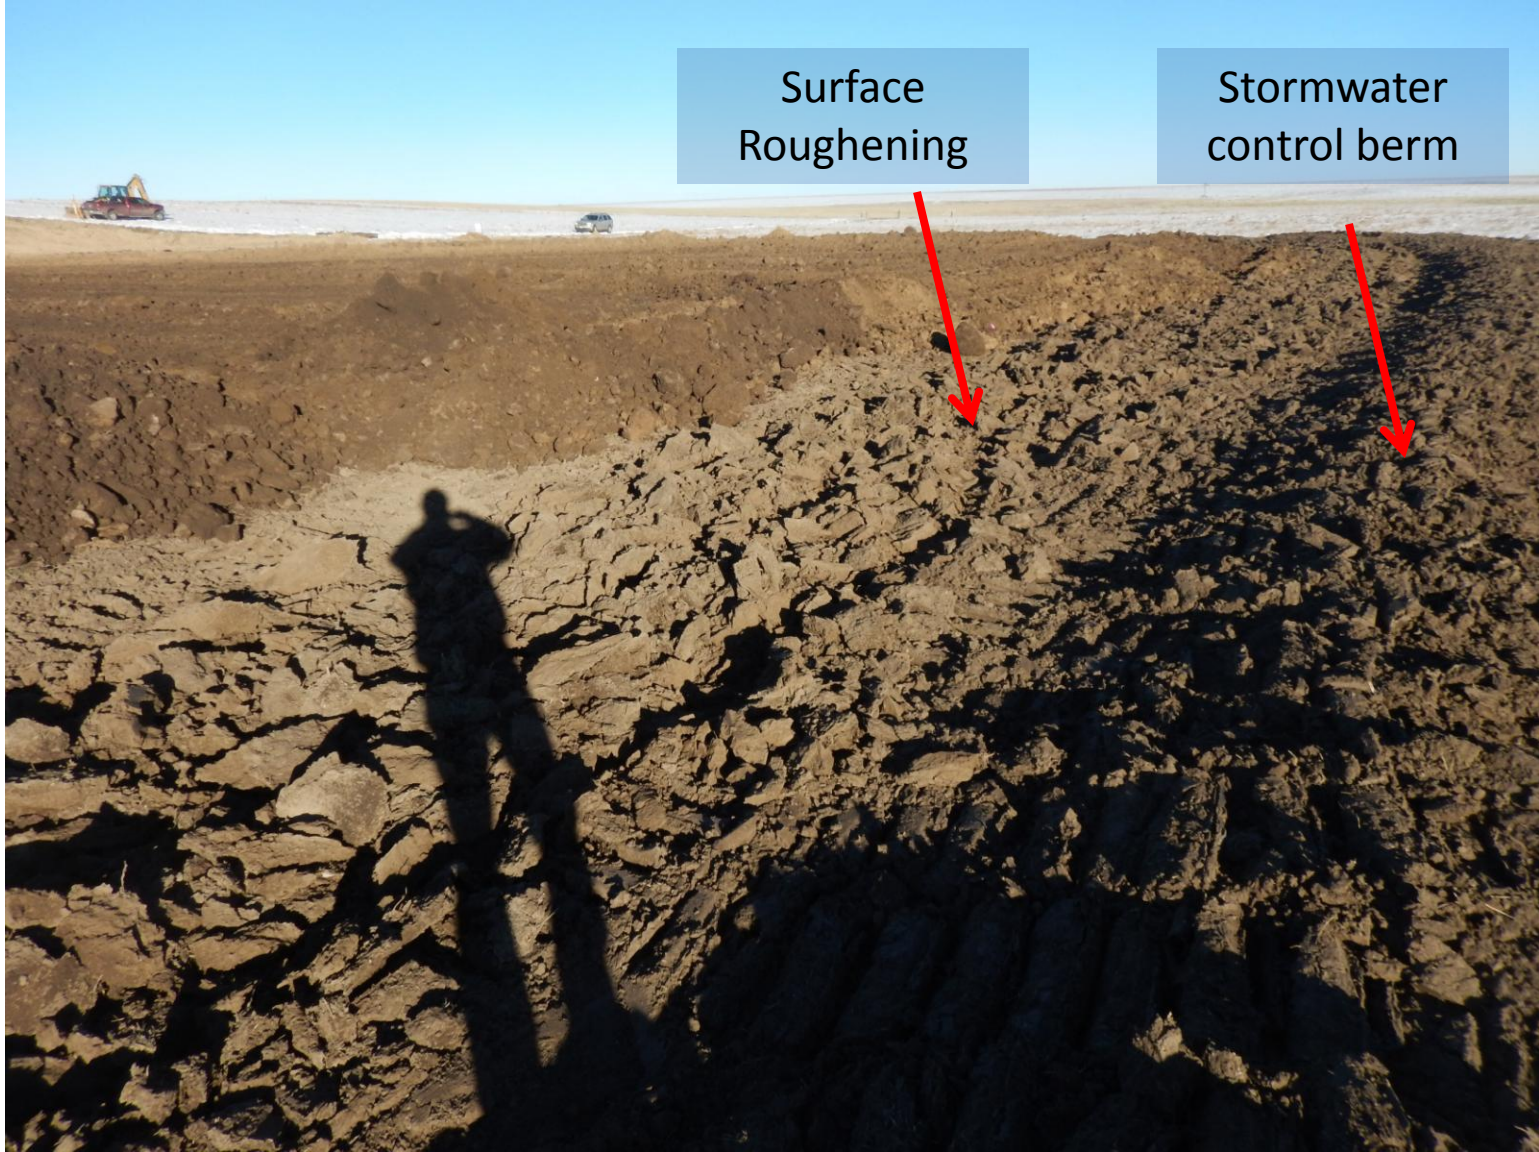
**Figure 14:** Photo taken from stormwater control berm on east end of location, facing north. Photo of adequate surface roughening BMP up slope of stormwater control berm..

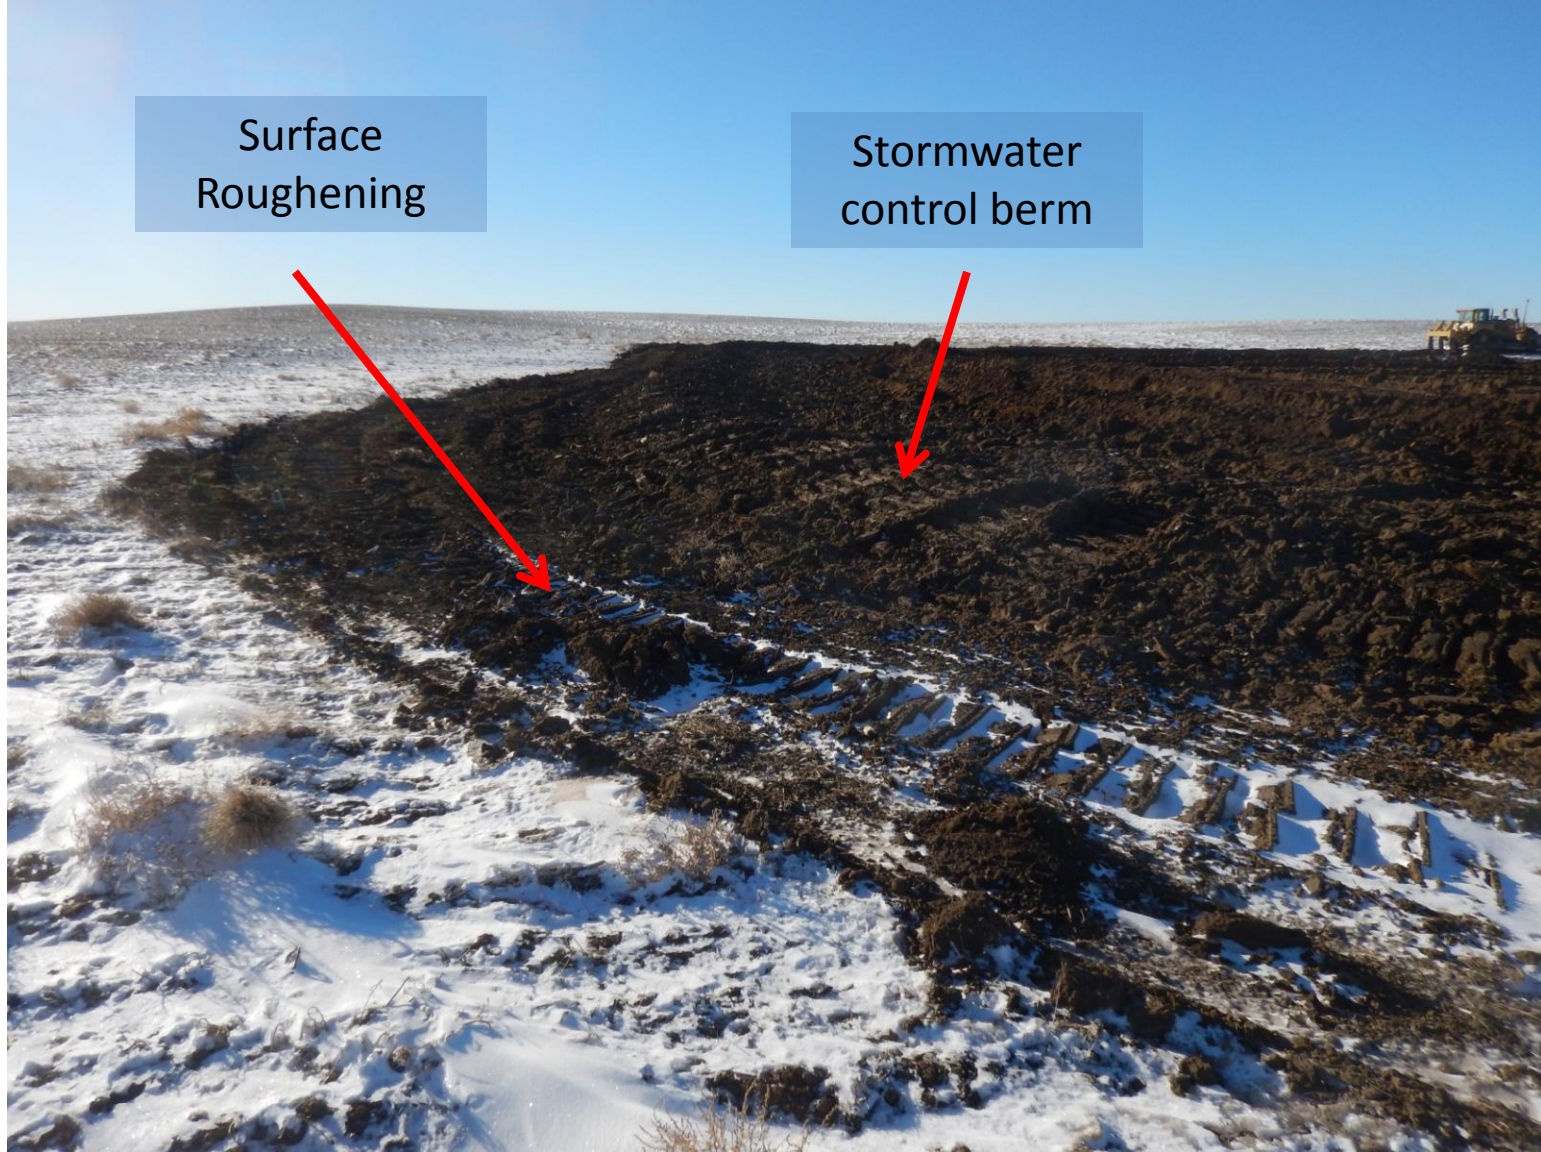
**Figure 15:** Photo taken from northeast corner of location, facing south. Photo of stormwater BMPs. Note inadequate surface roughening, downslope of stormwater control berm.

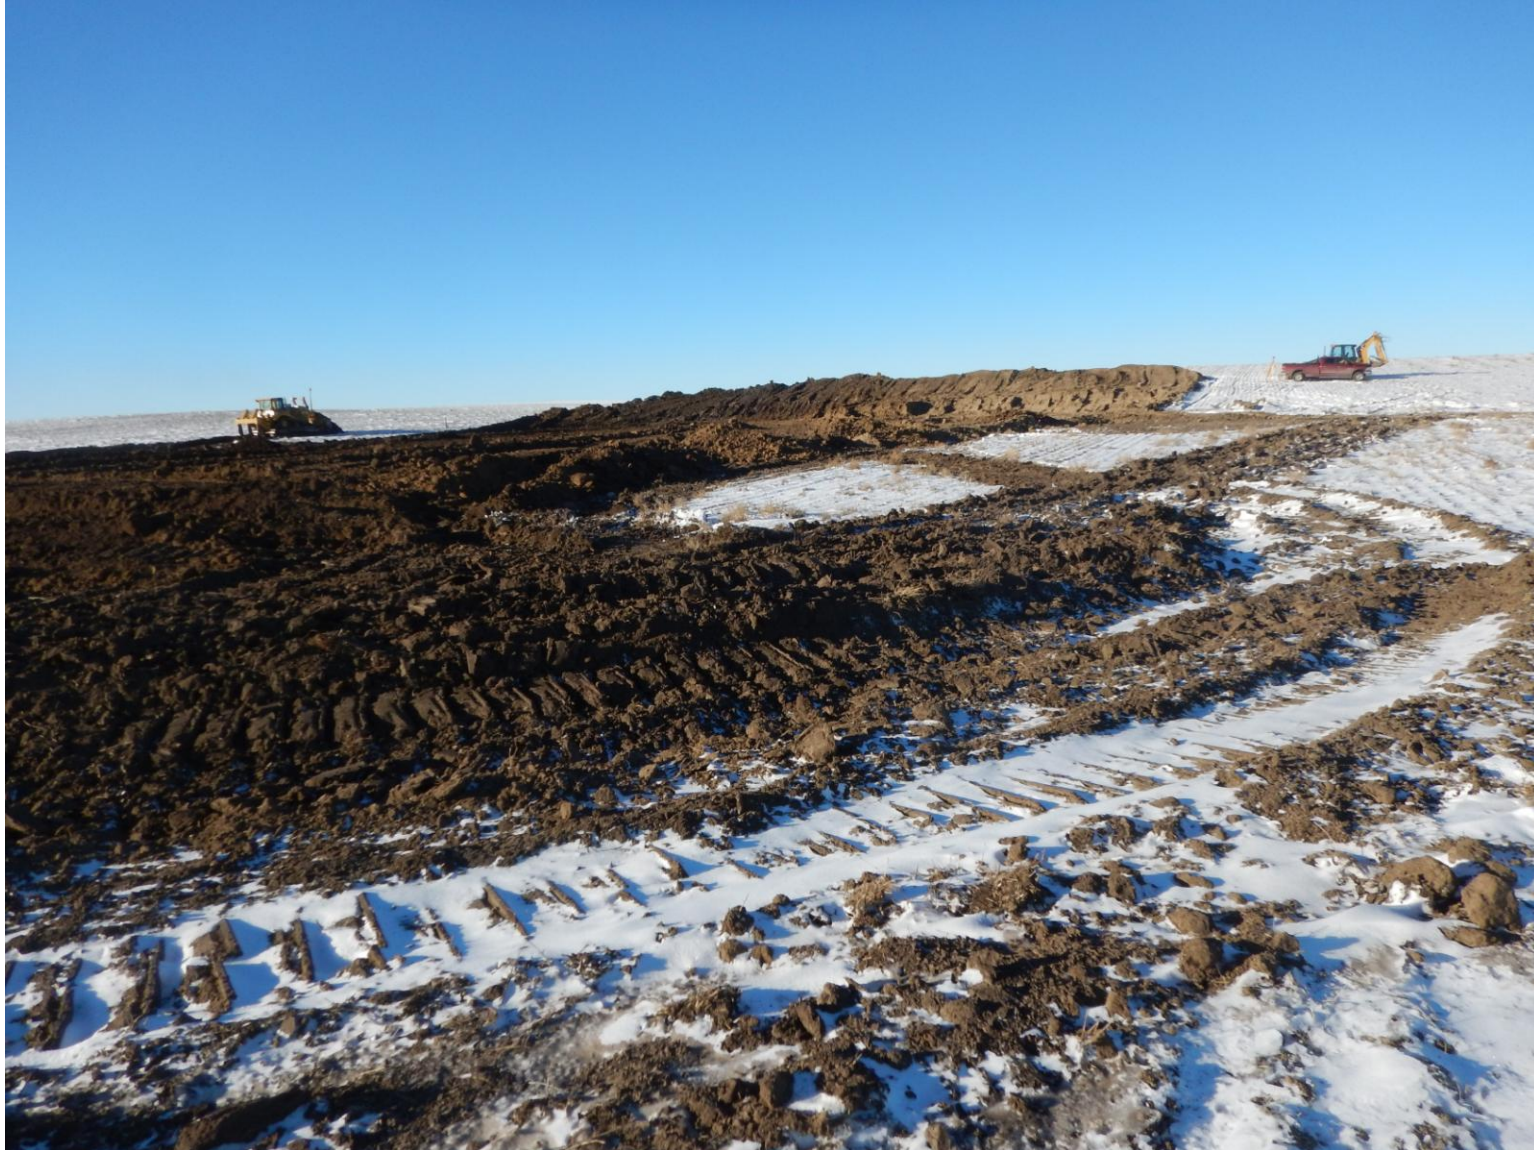
**Figure 16:** Photo taken from northeast corner of location, facing west. Photo shows disturbed areas exceeding stormwater BMPs.
