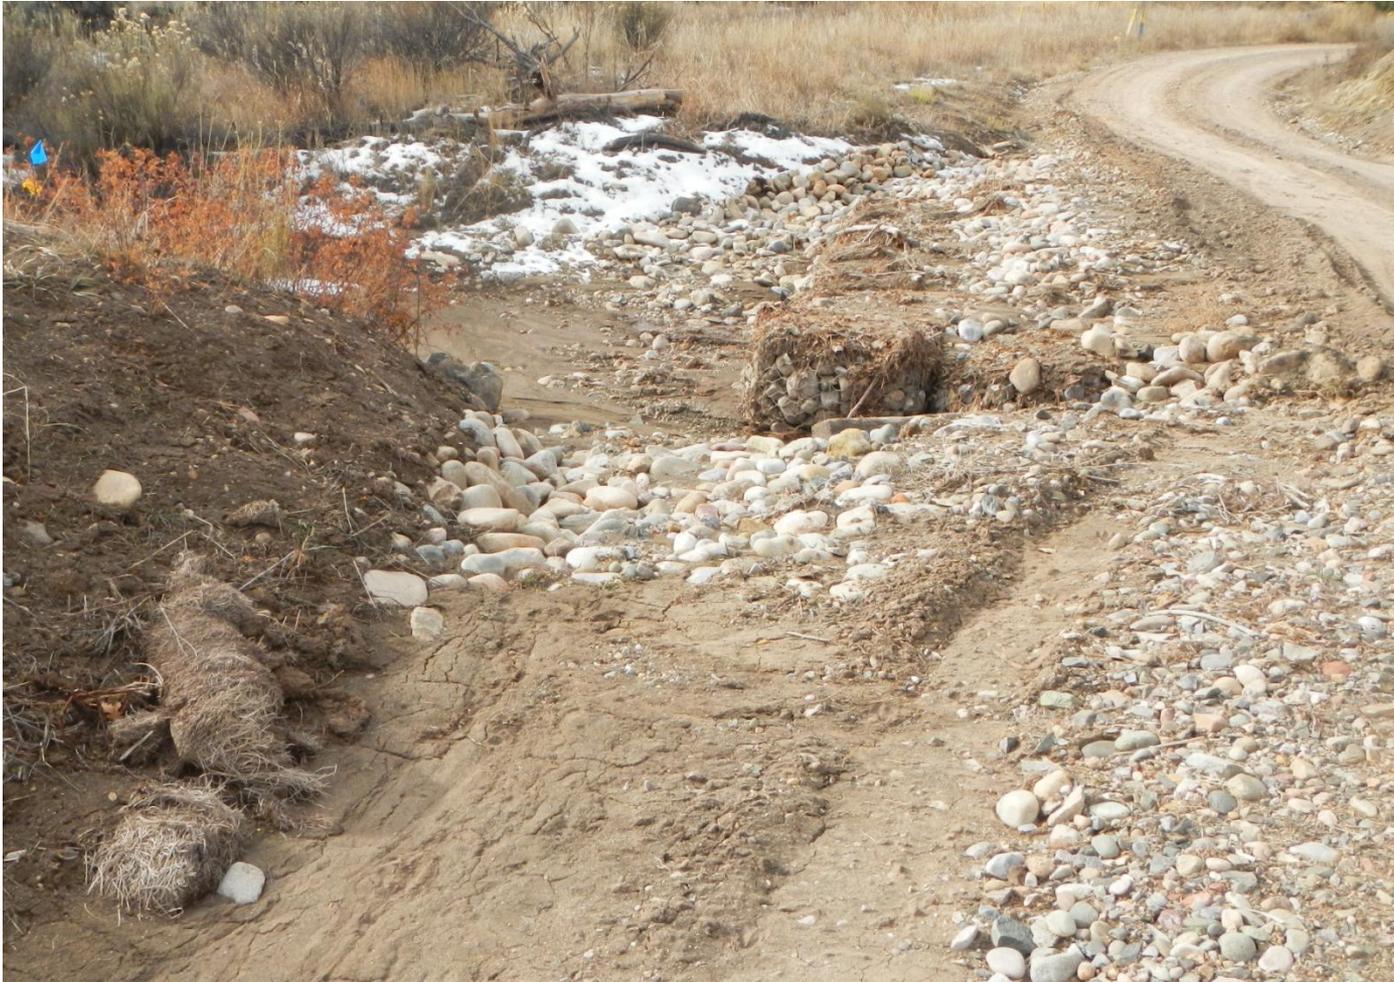
Photo 1. View of downstream portion of stream at the low water crossing along Budd Road. A dilapidated straw wattle is present on the left hand side of photo and erosion is occurring where stormwater flows around the gabions and erodes at the edges.

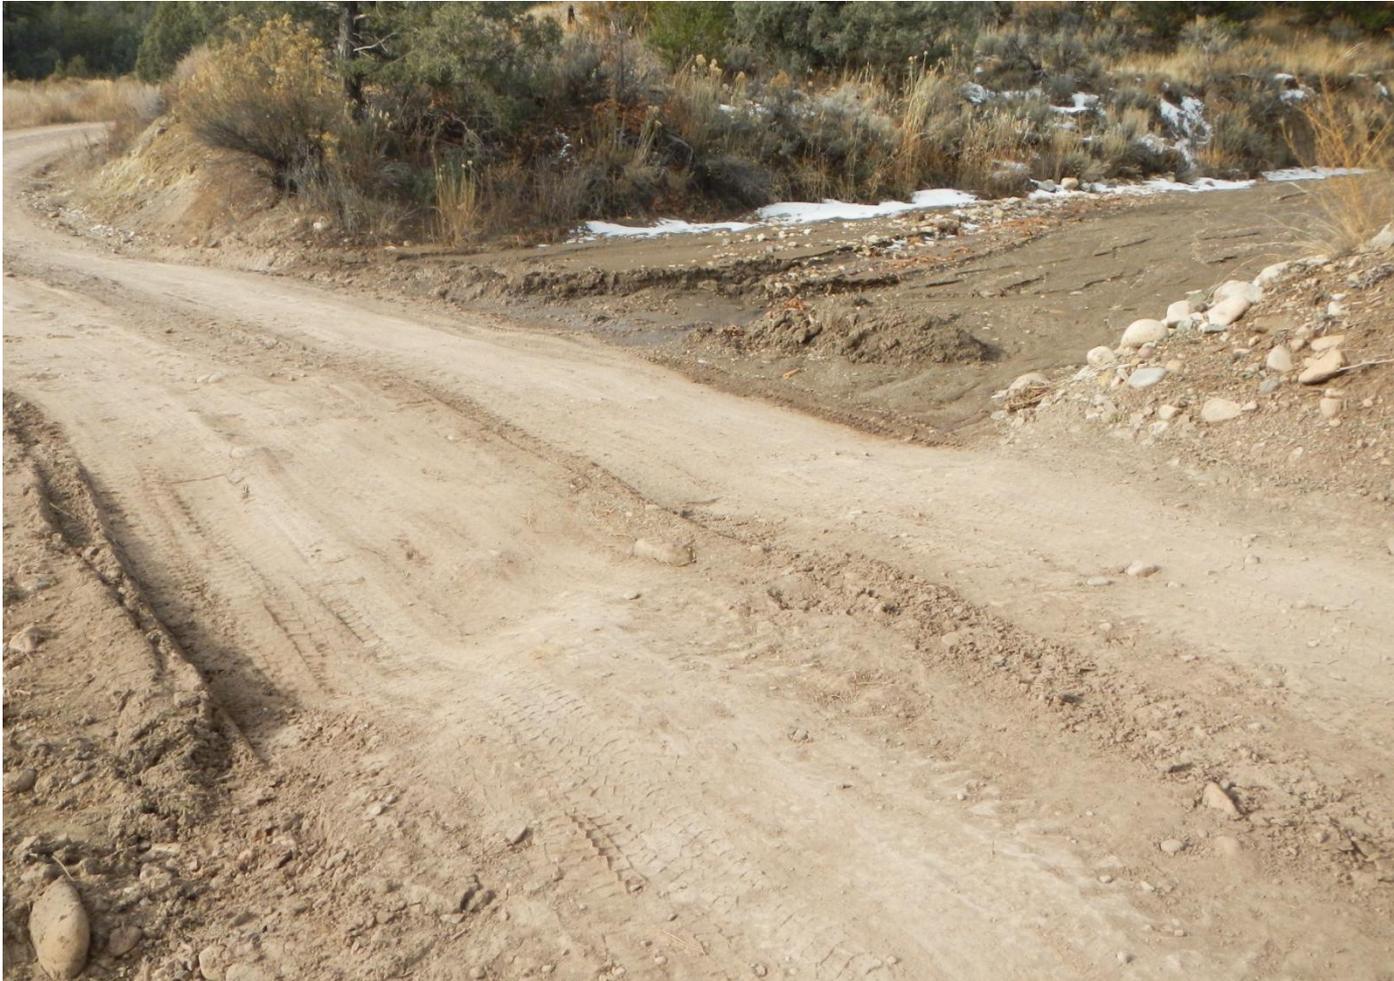
Photo 2. View of upstream portion of the low water crossing along Budd Road. Sediment deposits indicate that the bottom of the upstream channel are approximately 4-5 inches higher than the elevation at the crossing. This indicates that the low water crossing likely fills with sediment during storm events and becomes impassable.

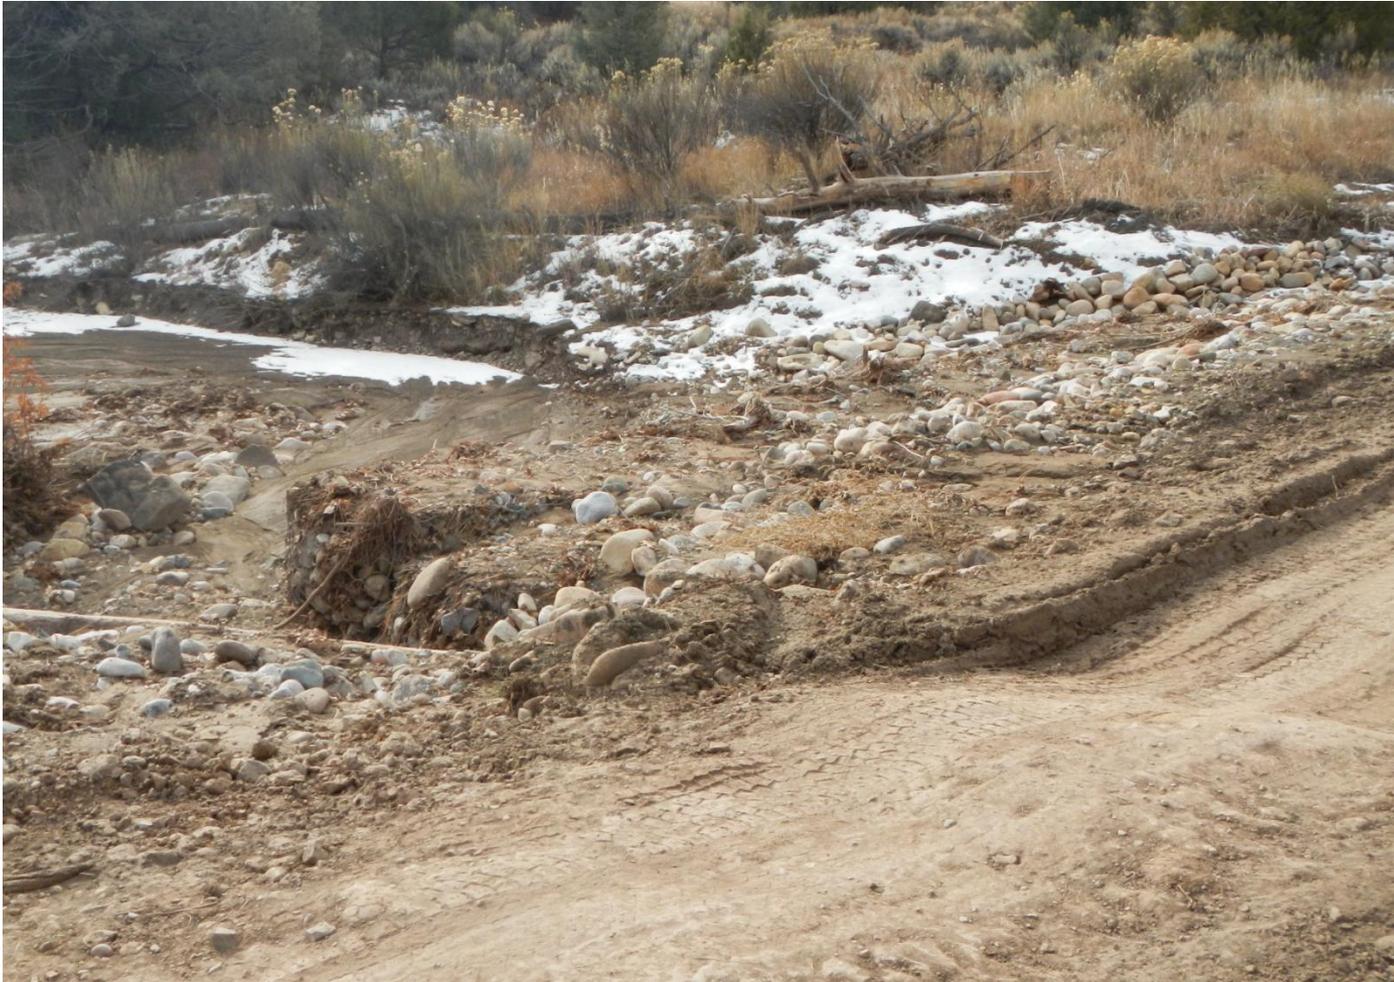
Photo 3. View of area where stormwater flows over the road and erodes the edges of the gabions facing downstream.

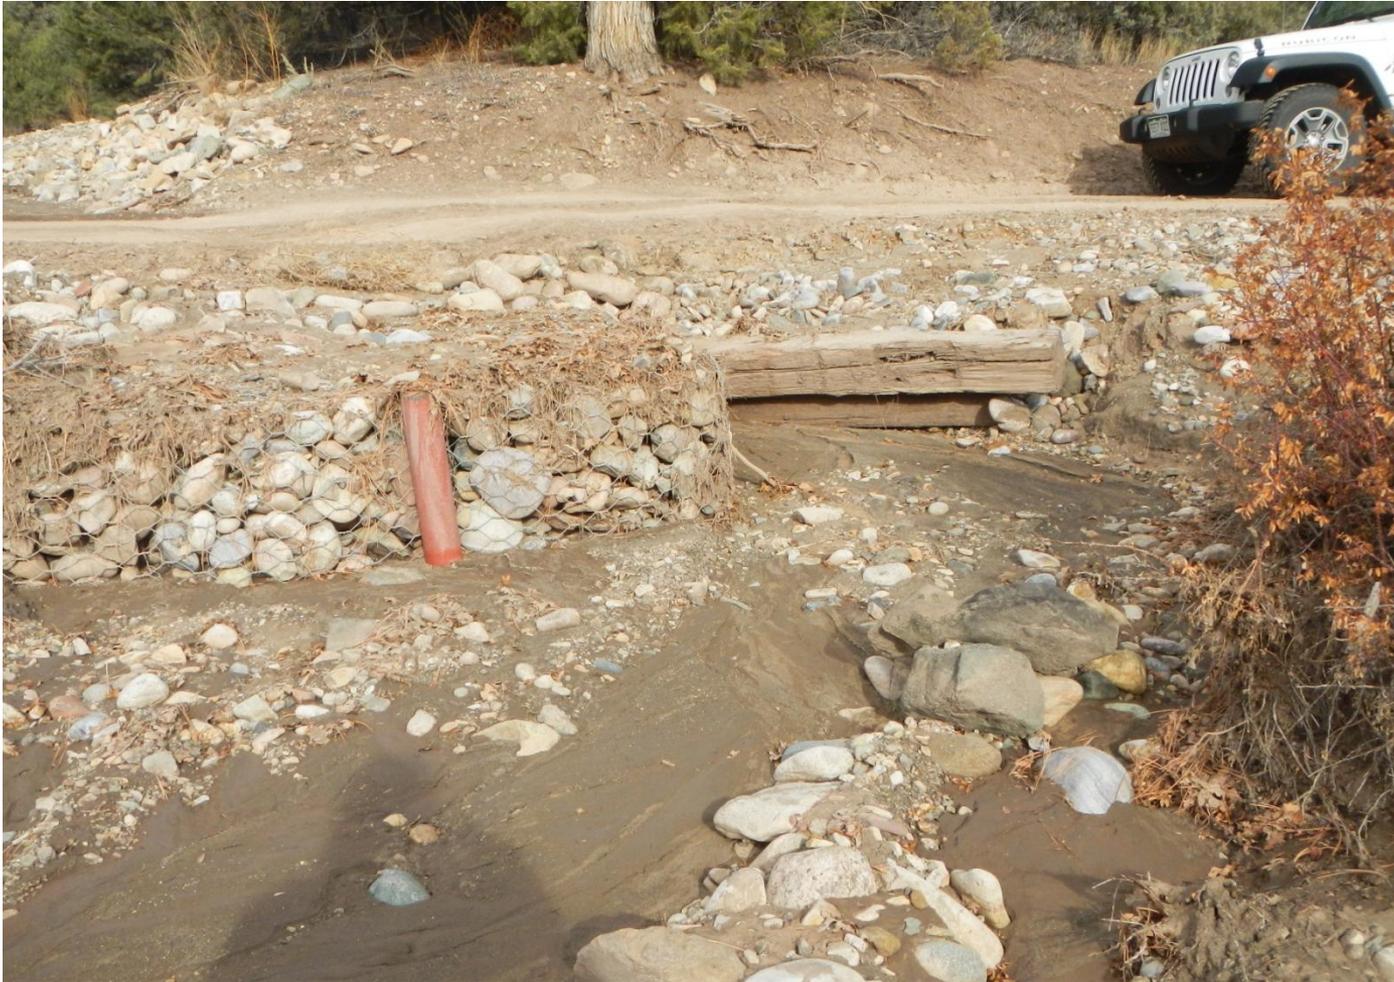
Photo 4. View of area where stormwater flows are eroding around gabions facing upstream toward crossing.
