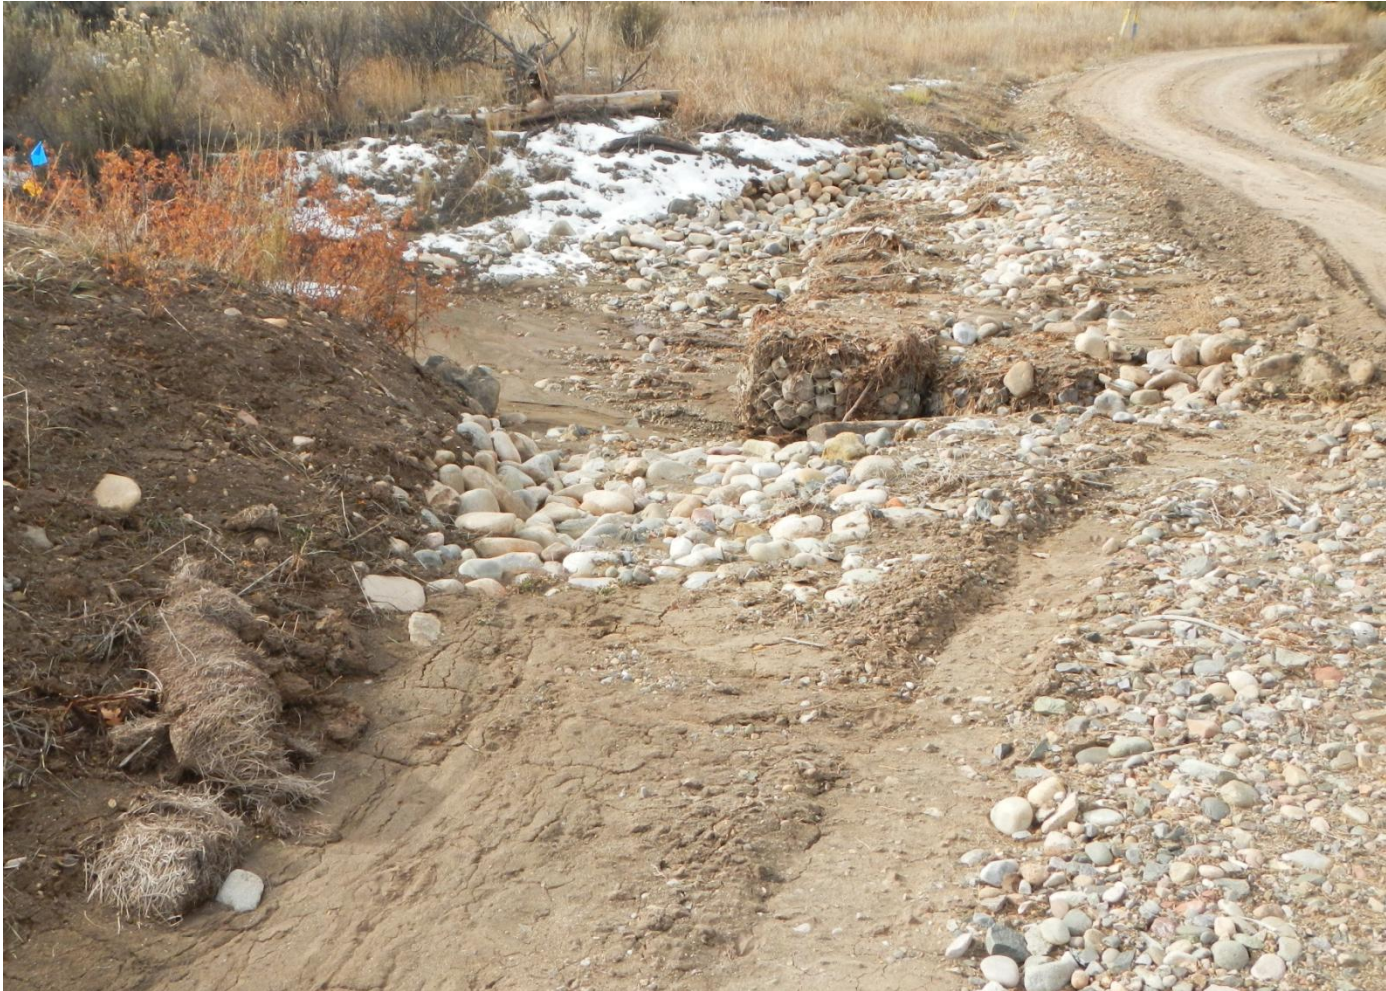
Photo 1. View of downstream portion of the low water crossing along Budd Road. A dilapidated straw wattle is present on the left hand side of photo and erosion is occurring where stormwater flows around the gabions and erodes at the edges.

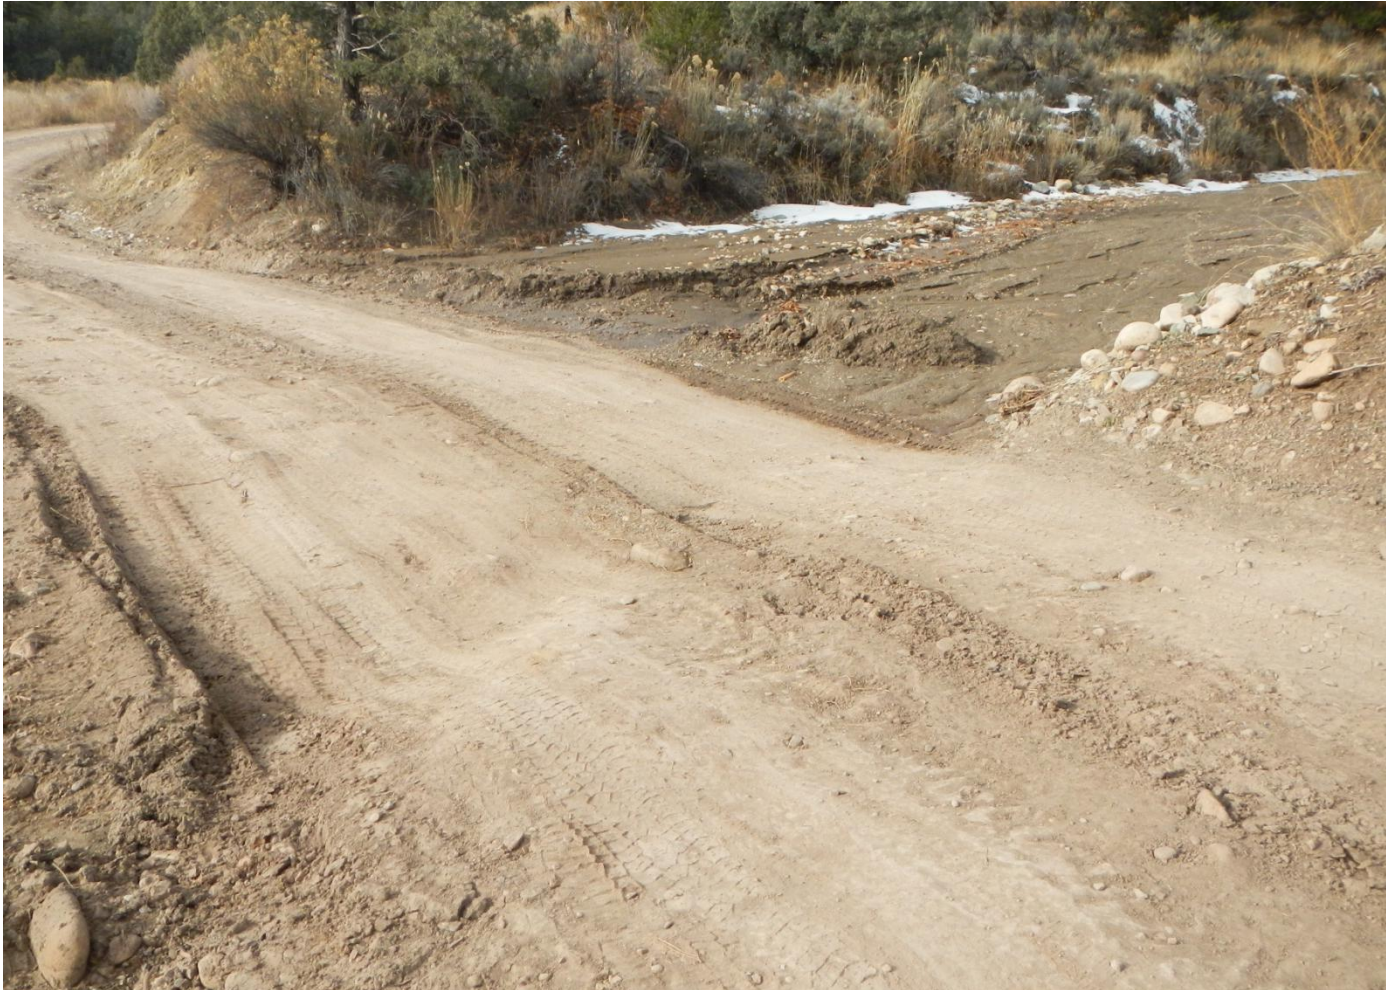
Photo 2. View of upstream portion of the low water crossing along Budd Road. Sediment deposits indicate that the bottom of the upstream channel are approximately 4-5 inches higher than the elevation at the crossing. This indicates that the low water crossing likely fills with sediment during storm events and becomes impassable.

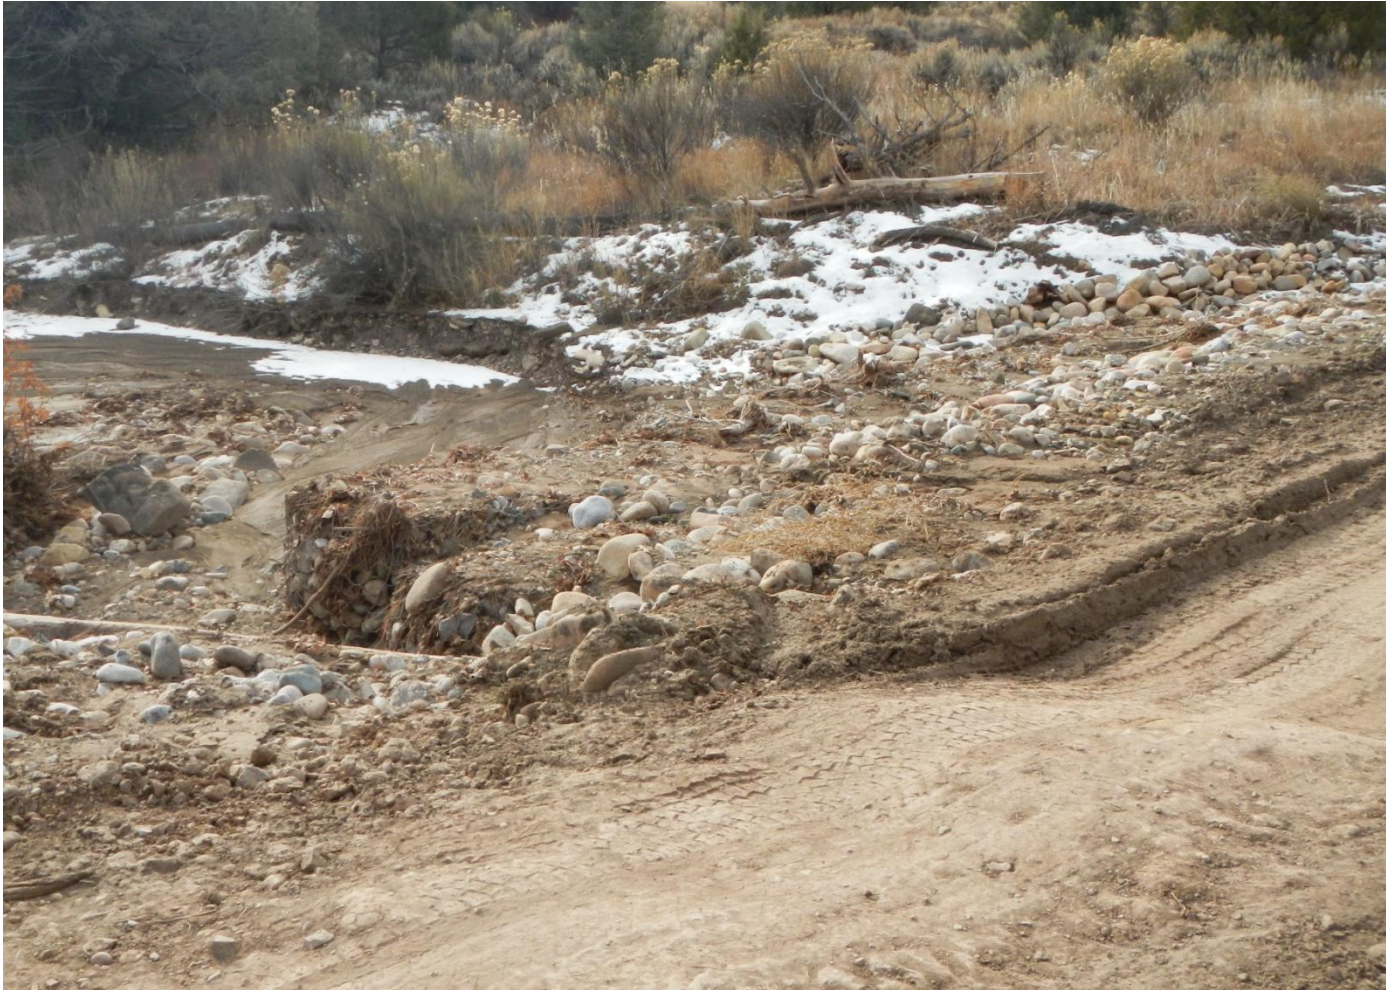
Photo 3. View of area where stormwater flows over the road and erodes the edges of the gabions facing downstream.

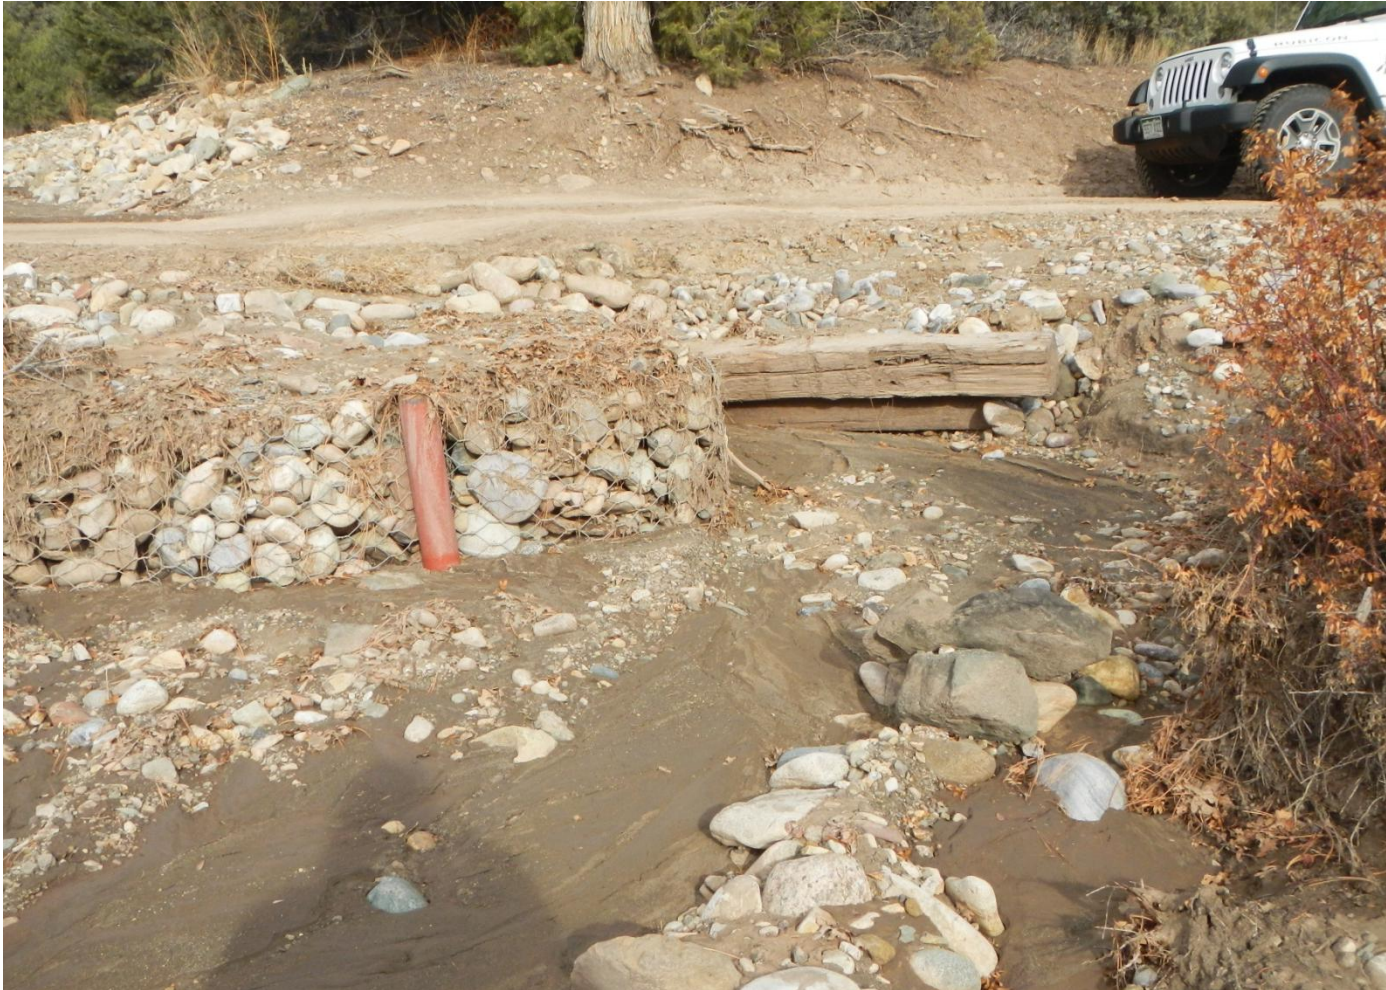
Photo 4. View of area where stormwater flows are eroding around gabions facing upstream toward crossing.

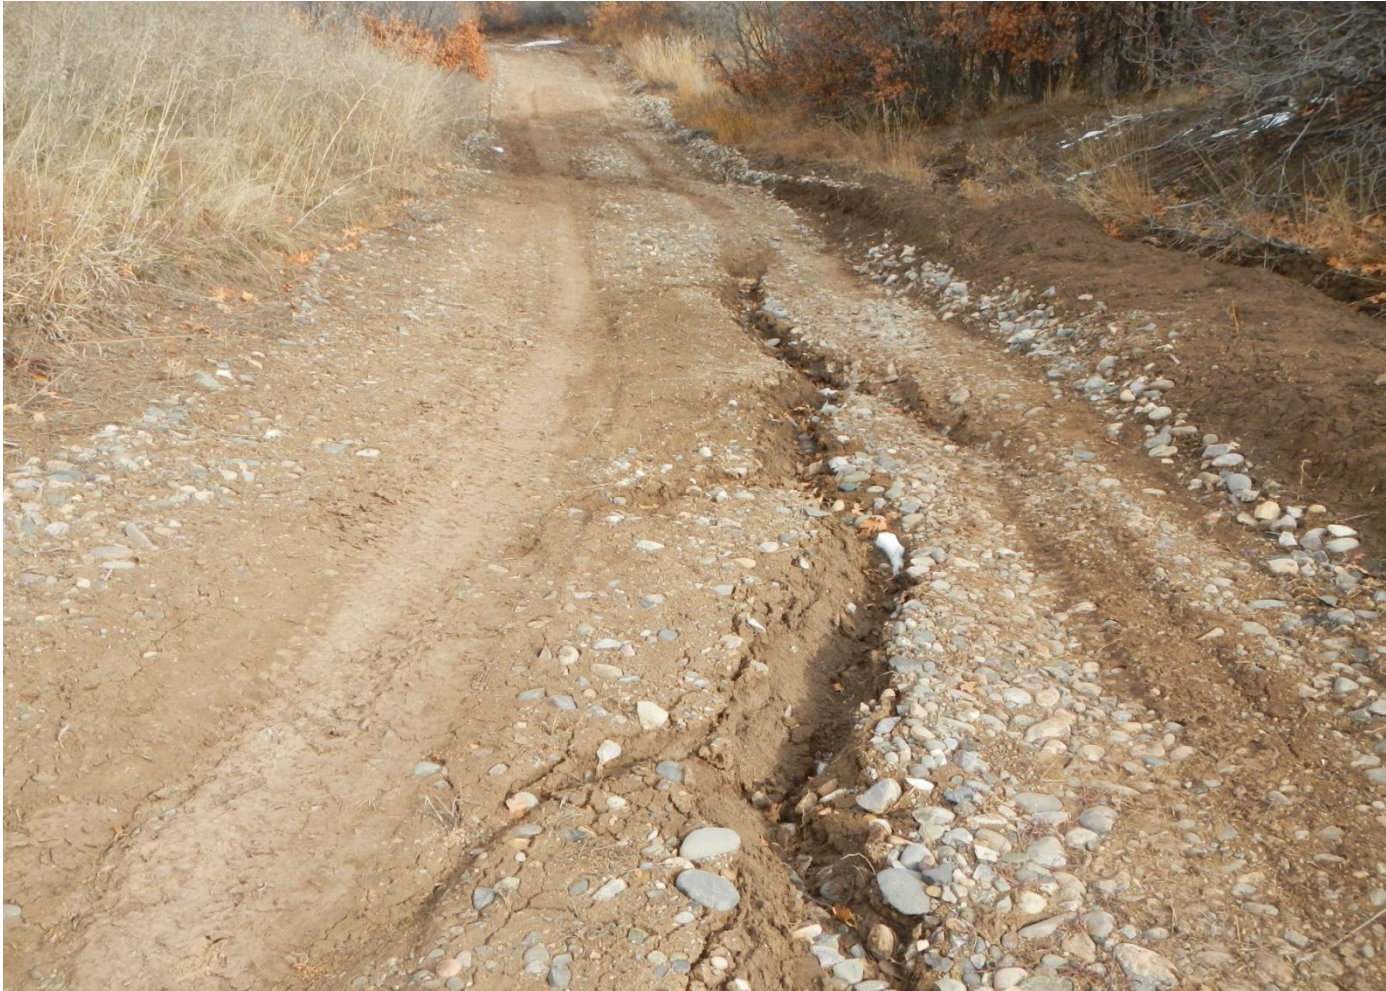
Photo 5. View of access road near well pad entrance facing northward. Stormwater erosion is occurring on the access road surface.
