Interim Reclamation Inspection

12/10/2015

Operator: Bill Barrett Corporation

Location ID: 439466

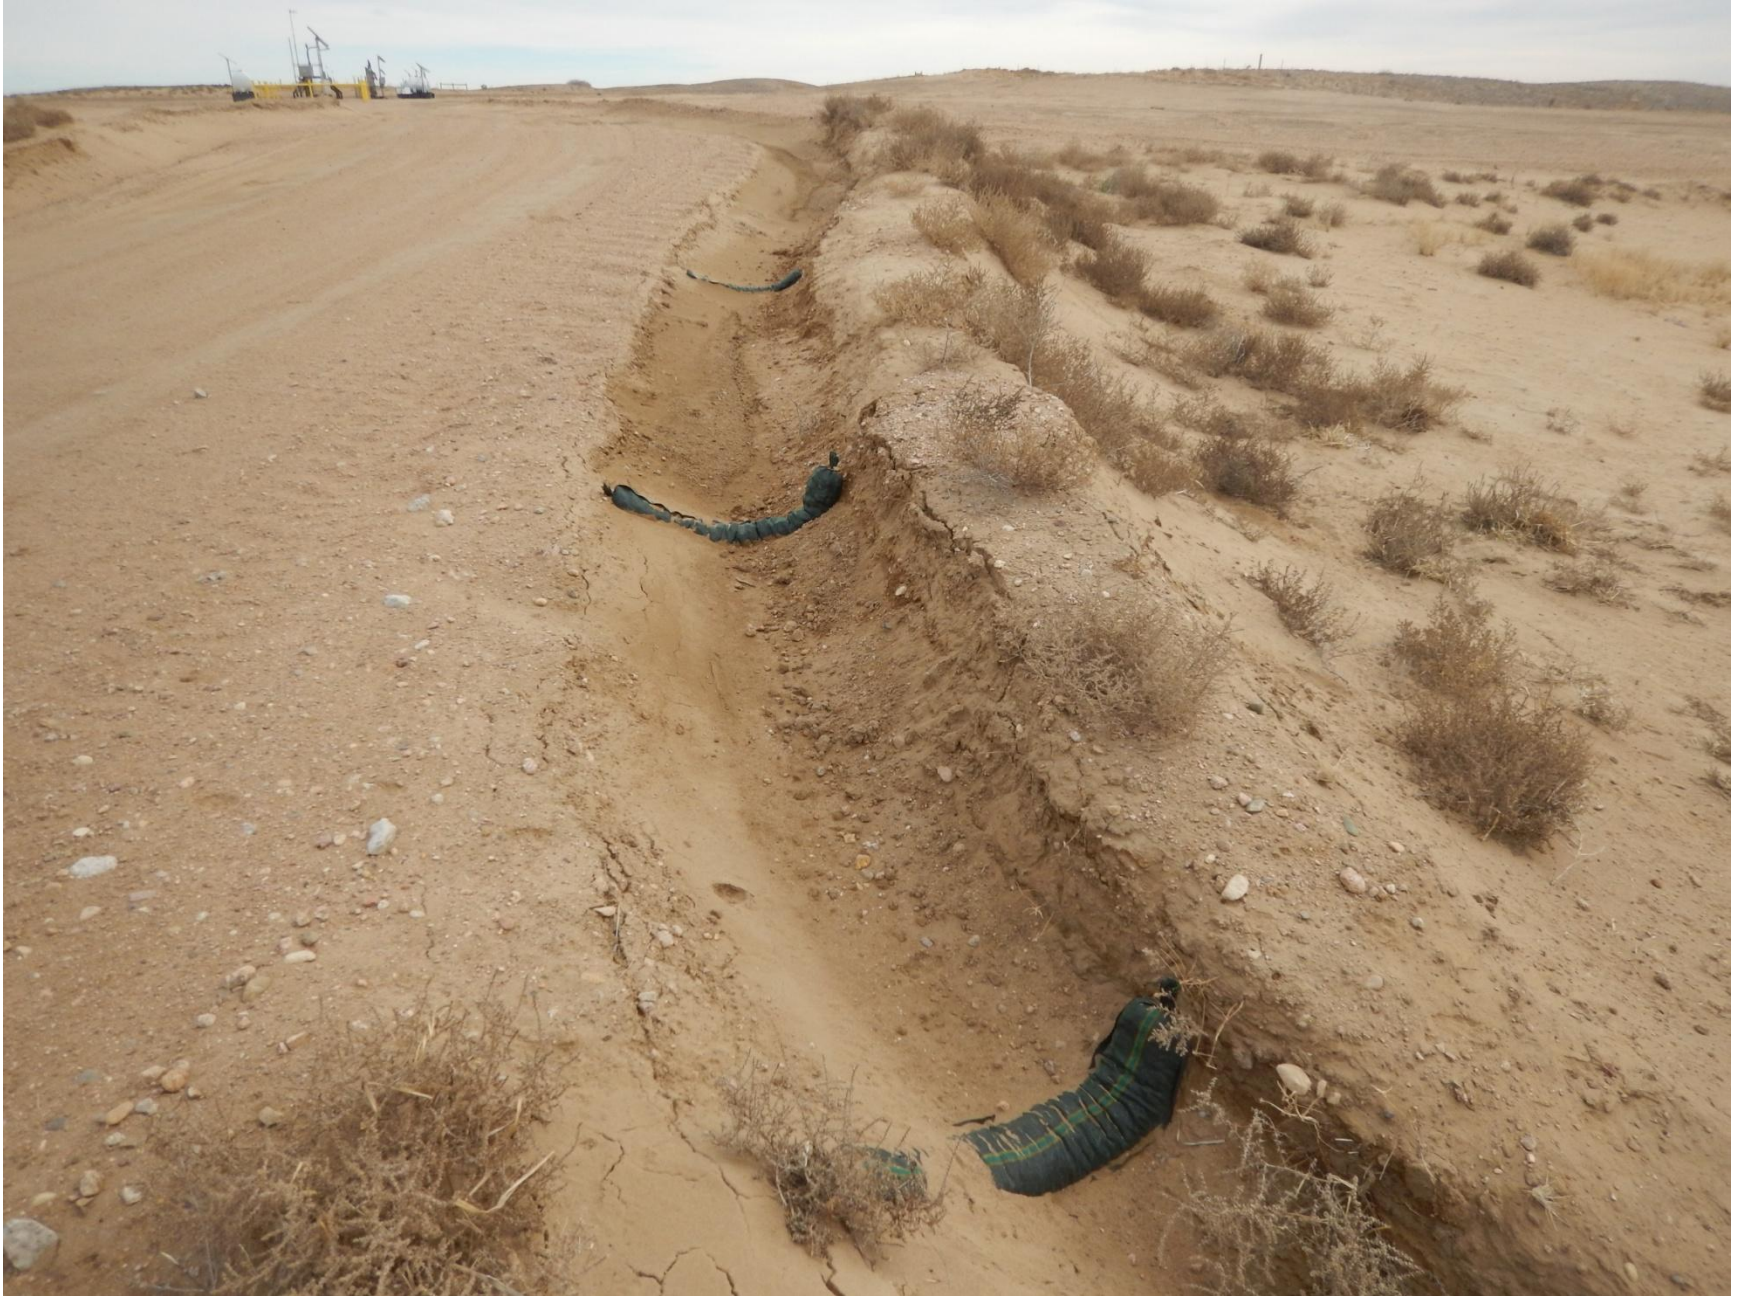
Figure 2: Photo taken from southwest end of location, facing east. Photo of stormwater and sediment control BMP on access road. Photo shows sediment filling, and flowing over BMPs.

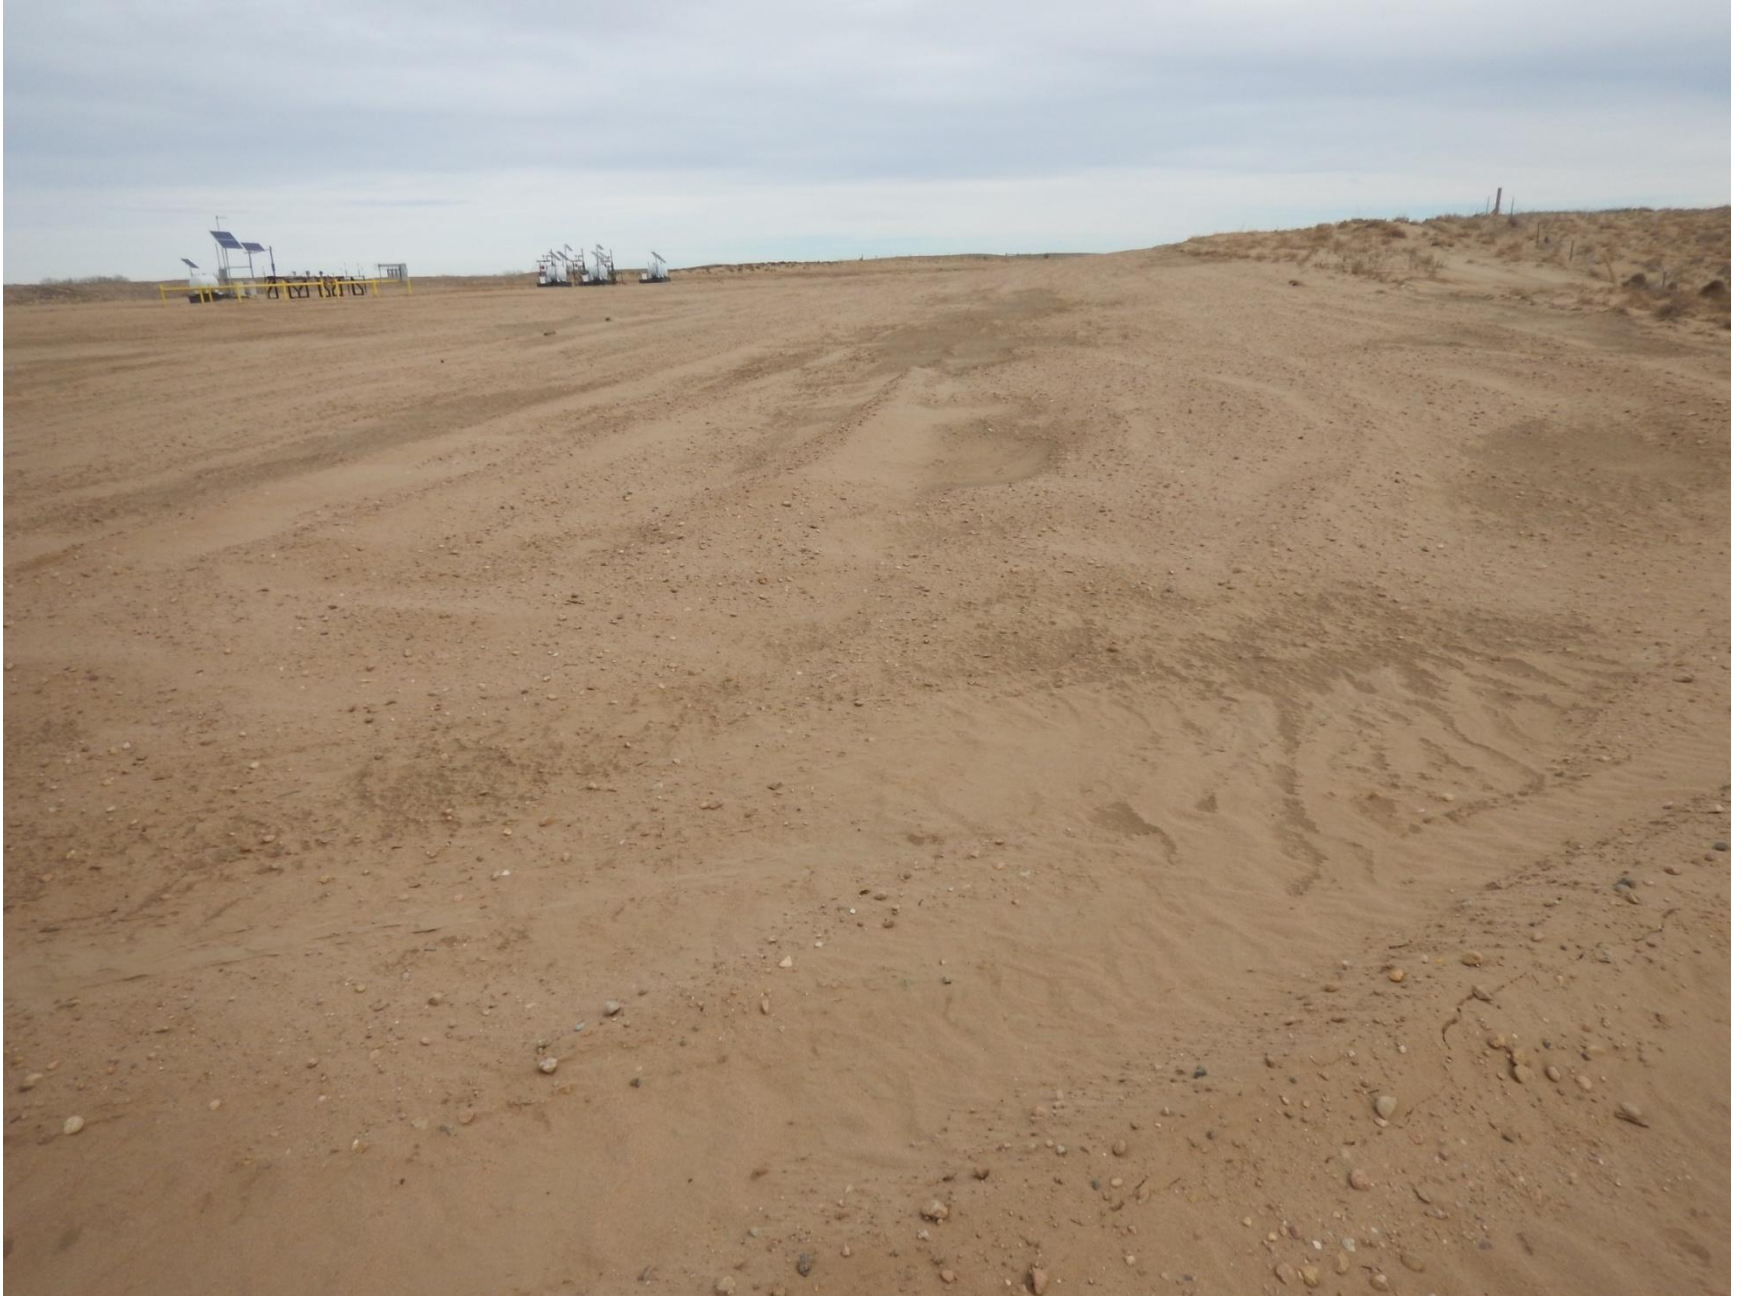
Figure 3: Photo taken from south end of location, facing east. Photo of interim area. No evidence of germination.

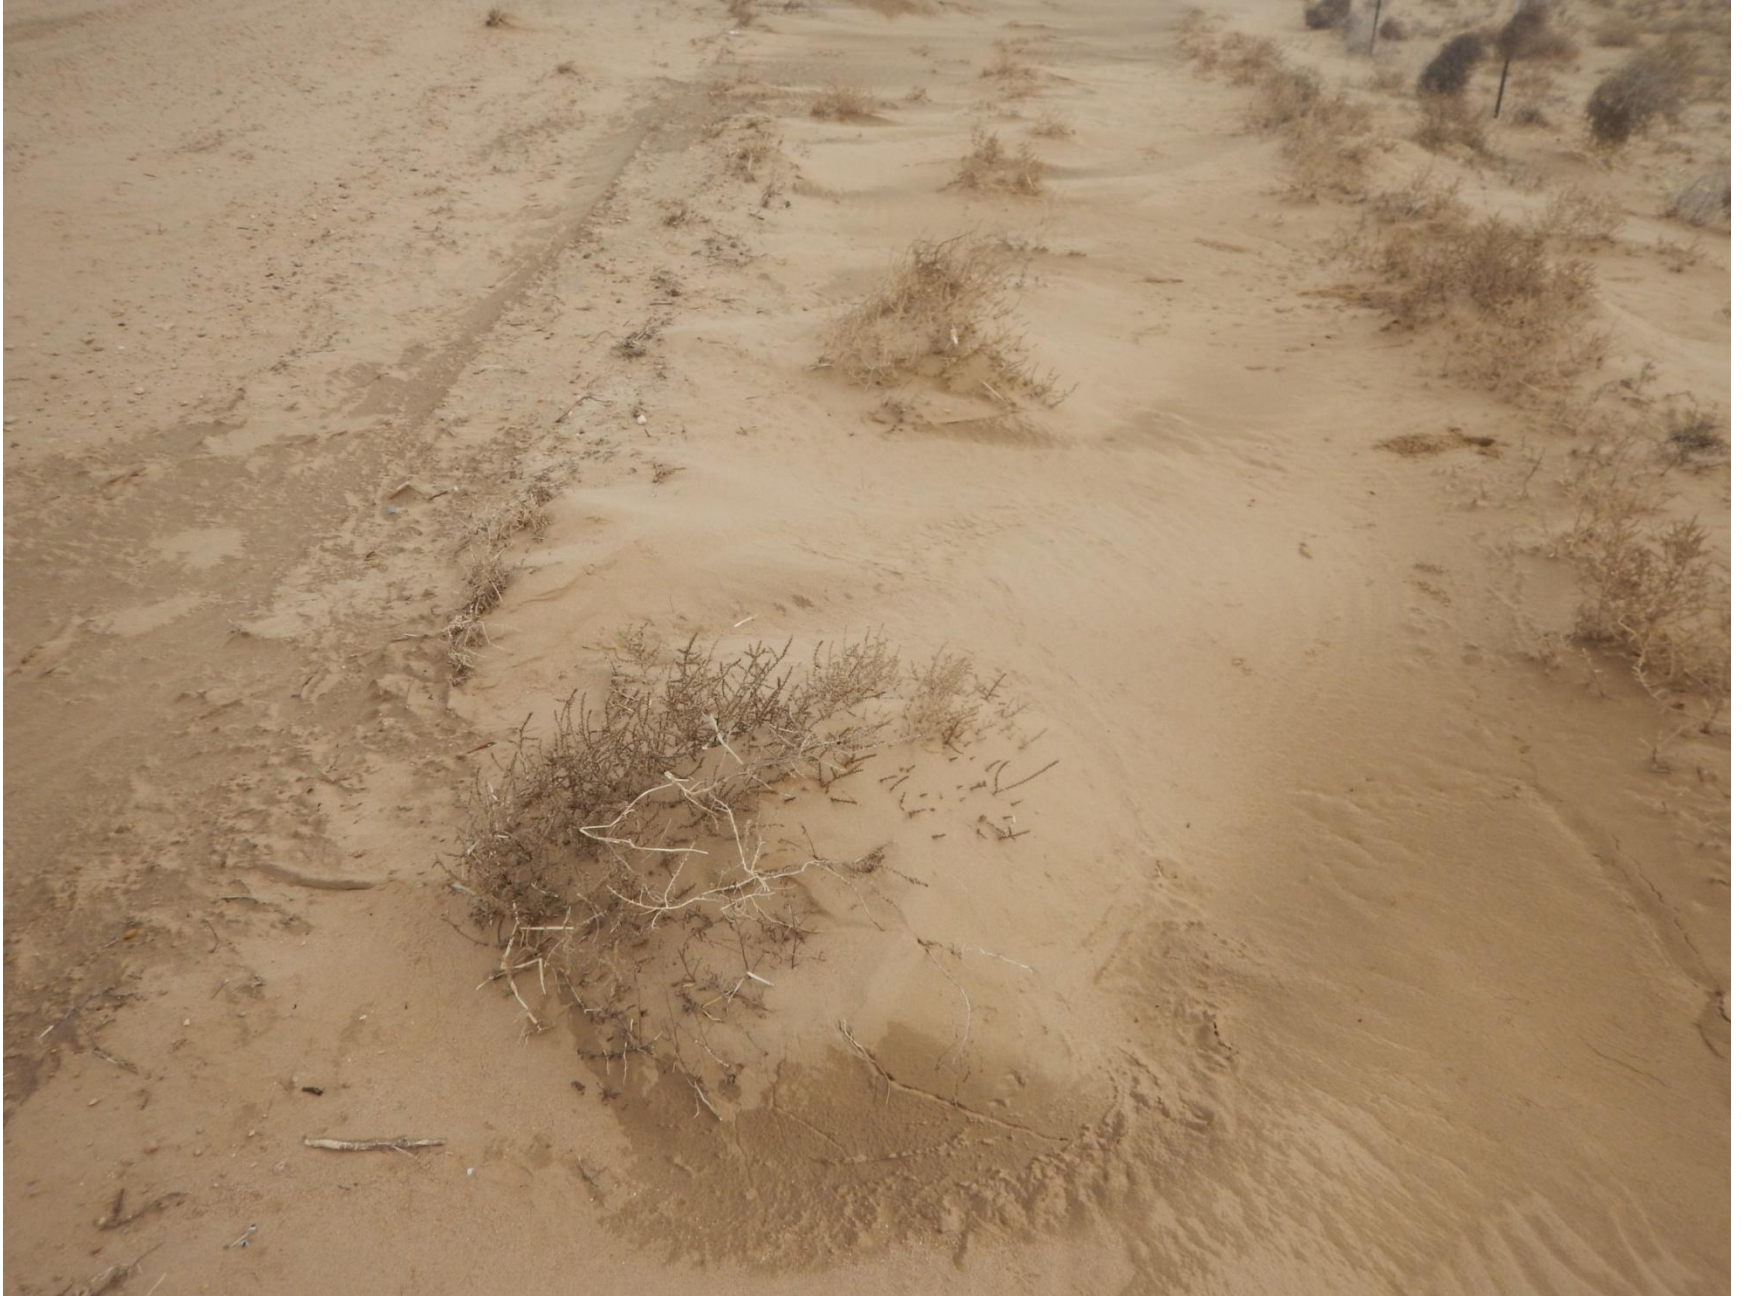
Figure 4: Photo taken from south end of location, facing east. Photo shows evidence of eolian deposition and insufficient stormwater and sediment control BMPs.

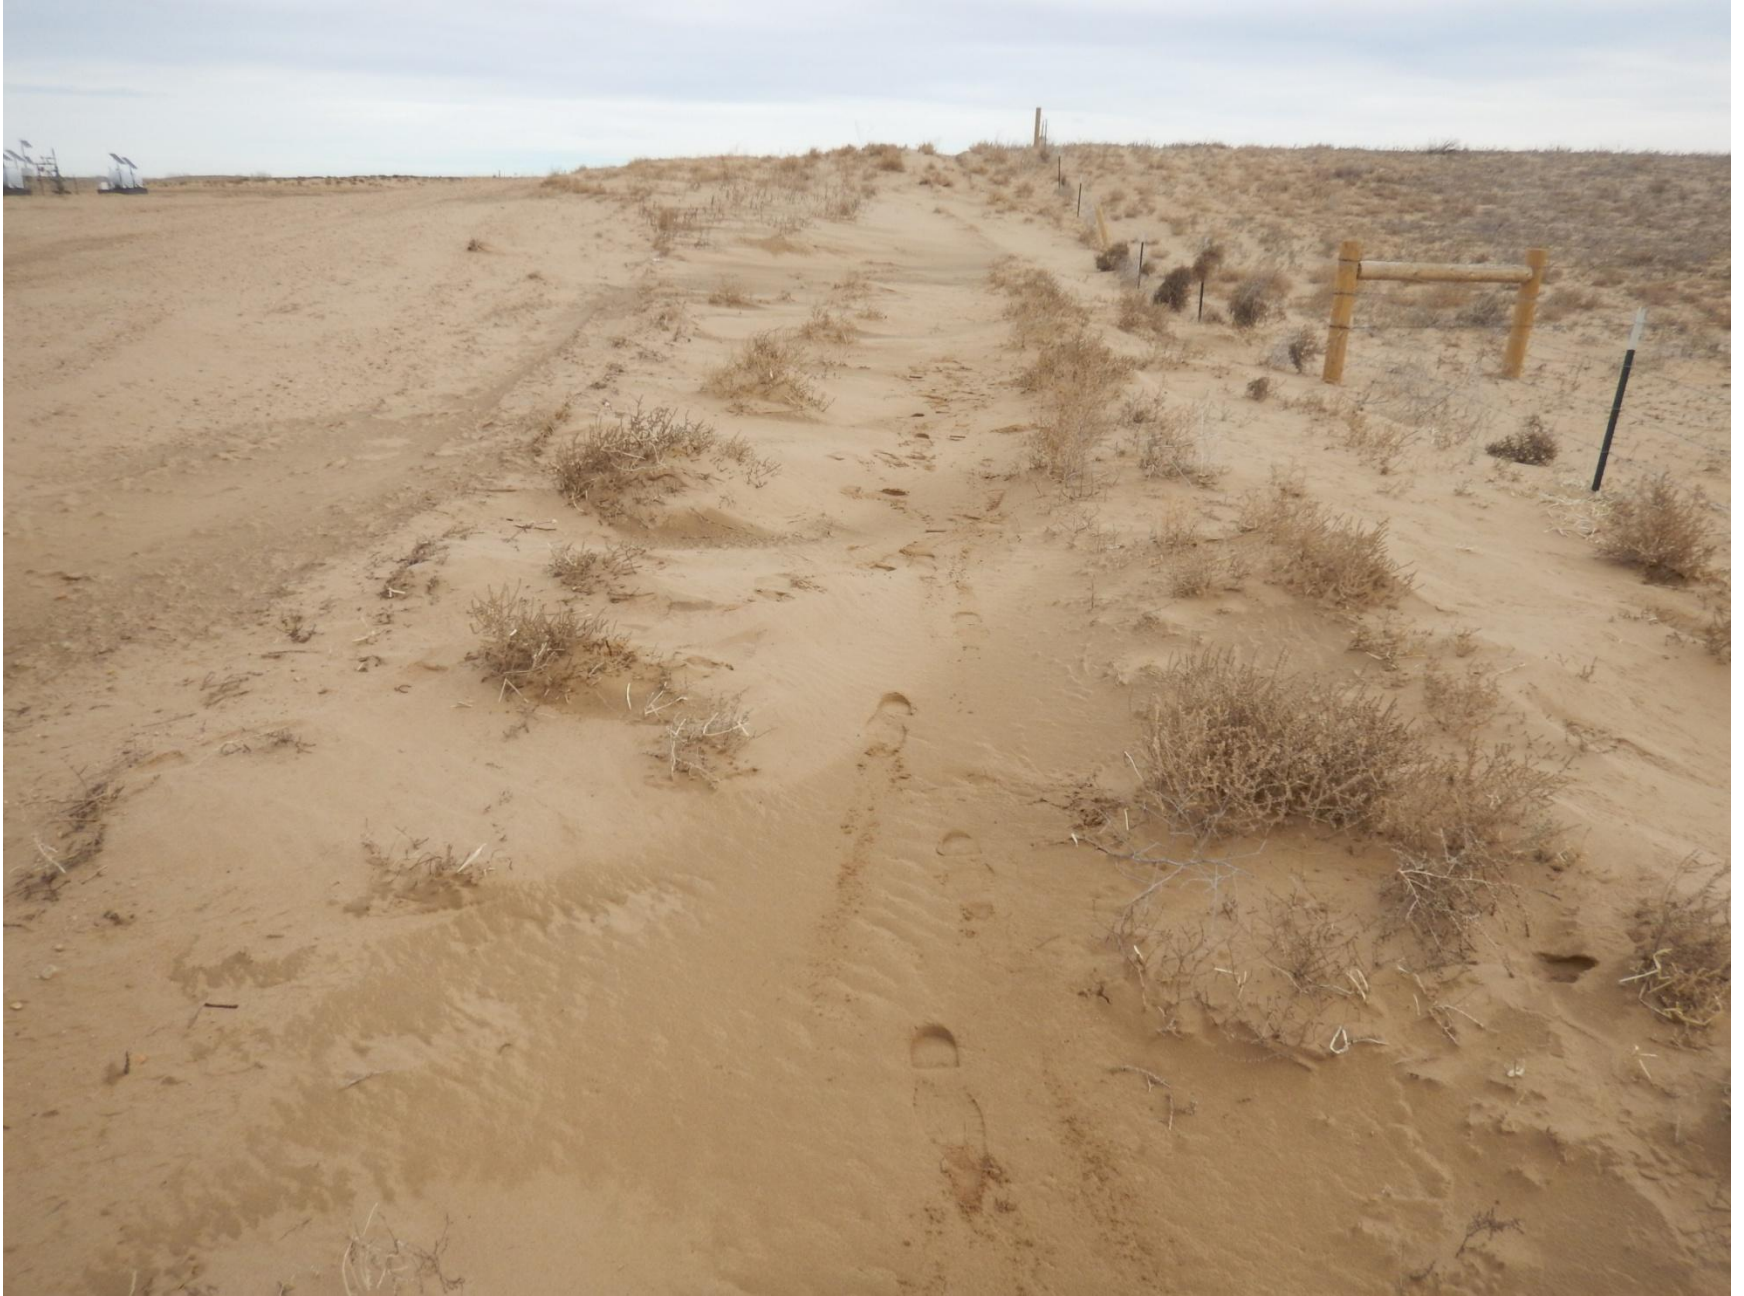
Figure 5: Photo taken from south end of location, facing east. Photo shows evidence of eolian deposition and insufficient stormwater and sediment control BMPs.

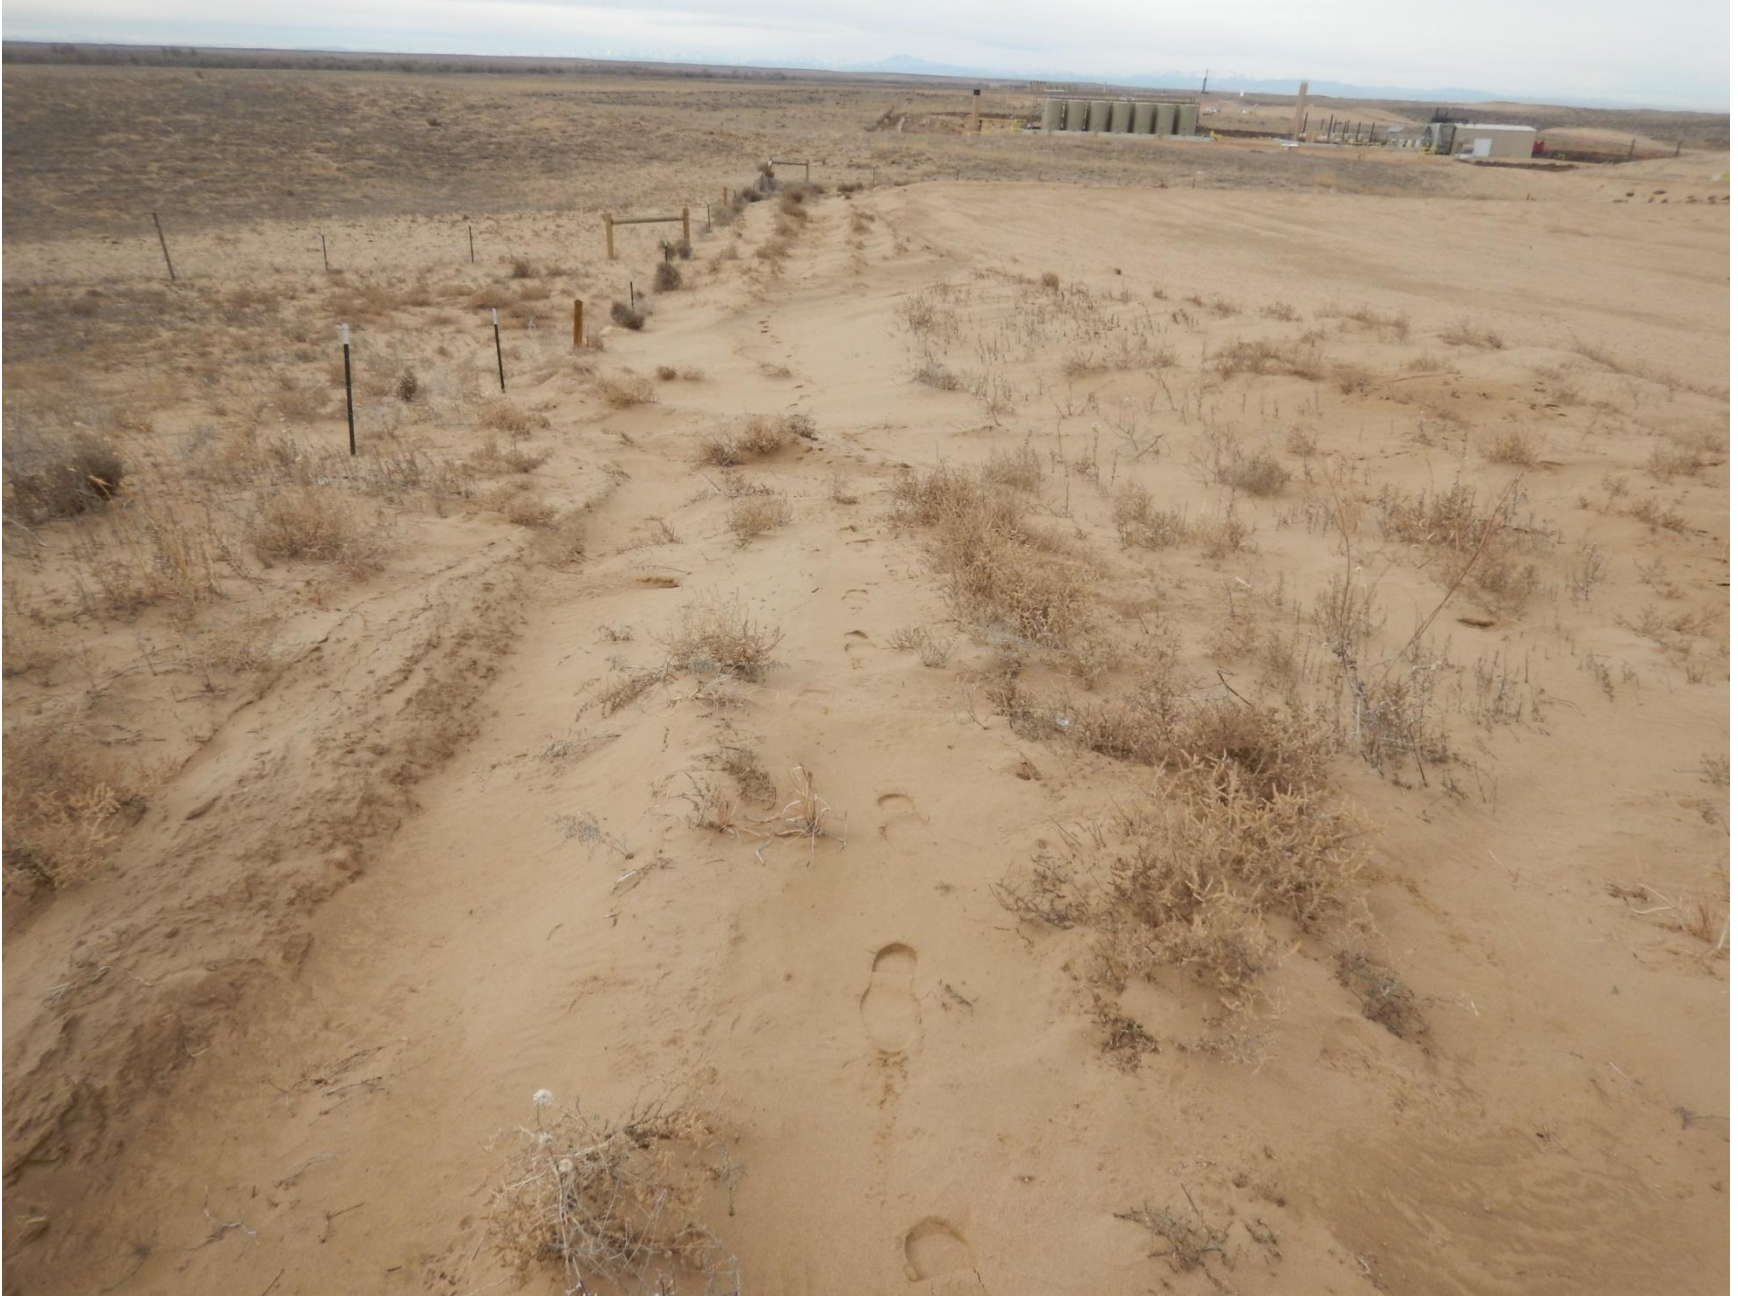
Figure 6: Photo taken from south end of location, facing west. Photo shows evidence of eolian deposition and insufficient stormwater and sediment control BMPs.

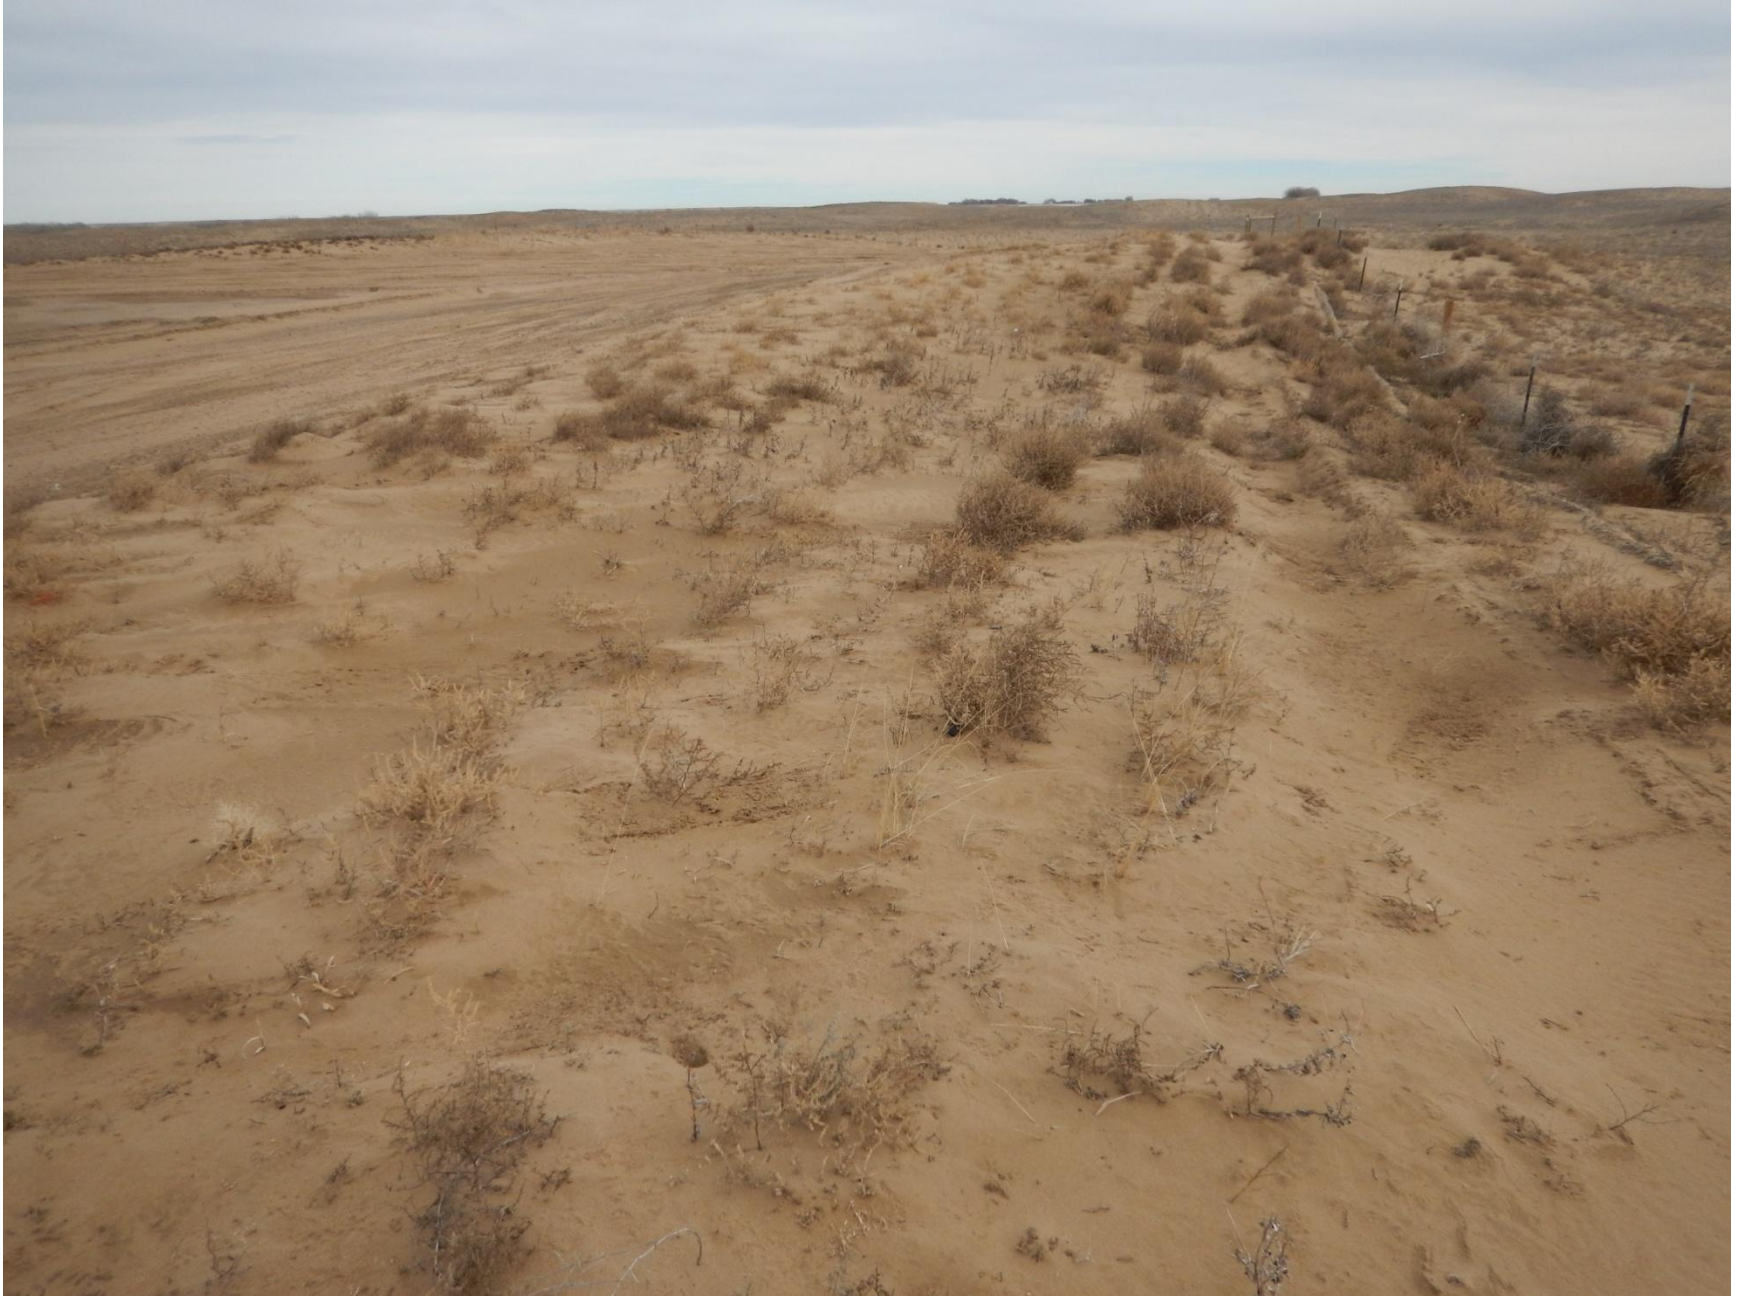
Figure 7: Photo taken from south end of location, facing east. Photo shows undesirable plant species and insufficient perennial vegetation on interim area.

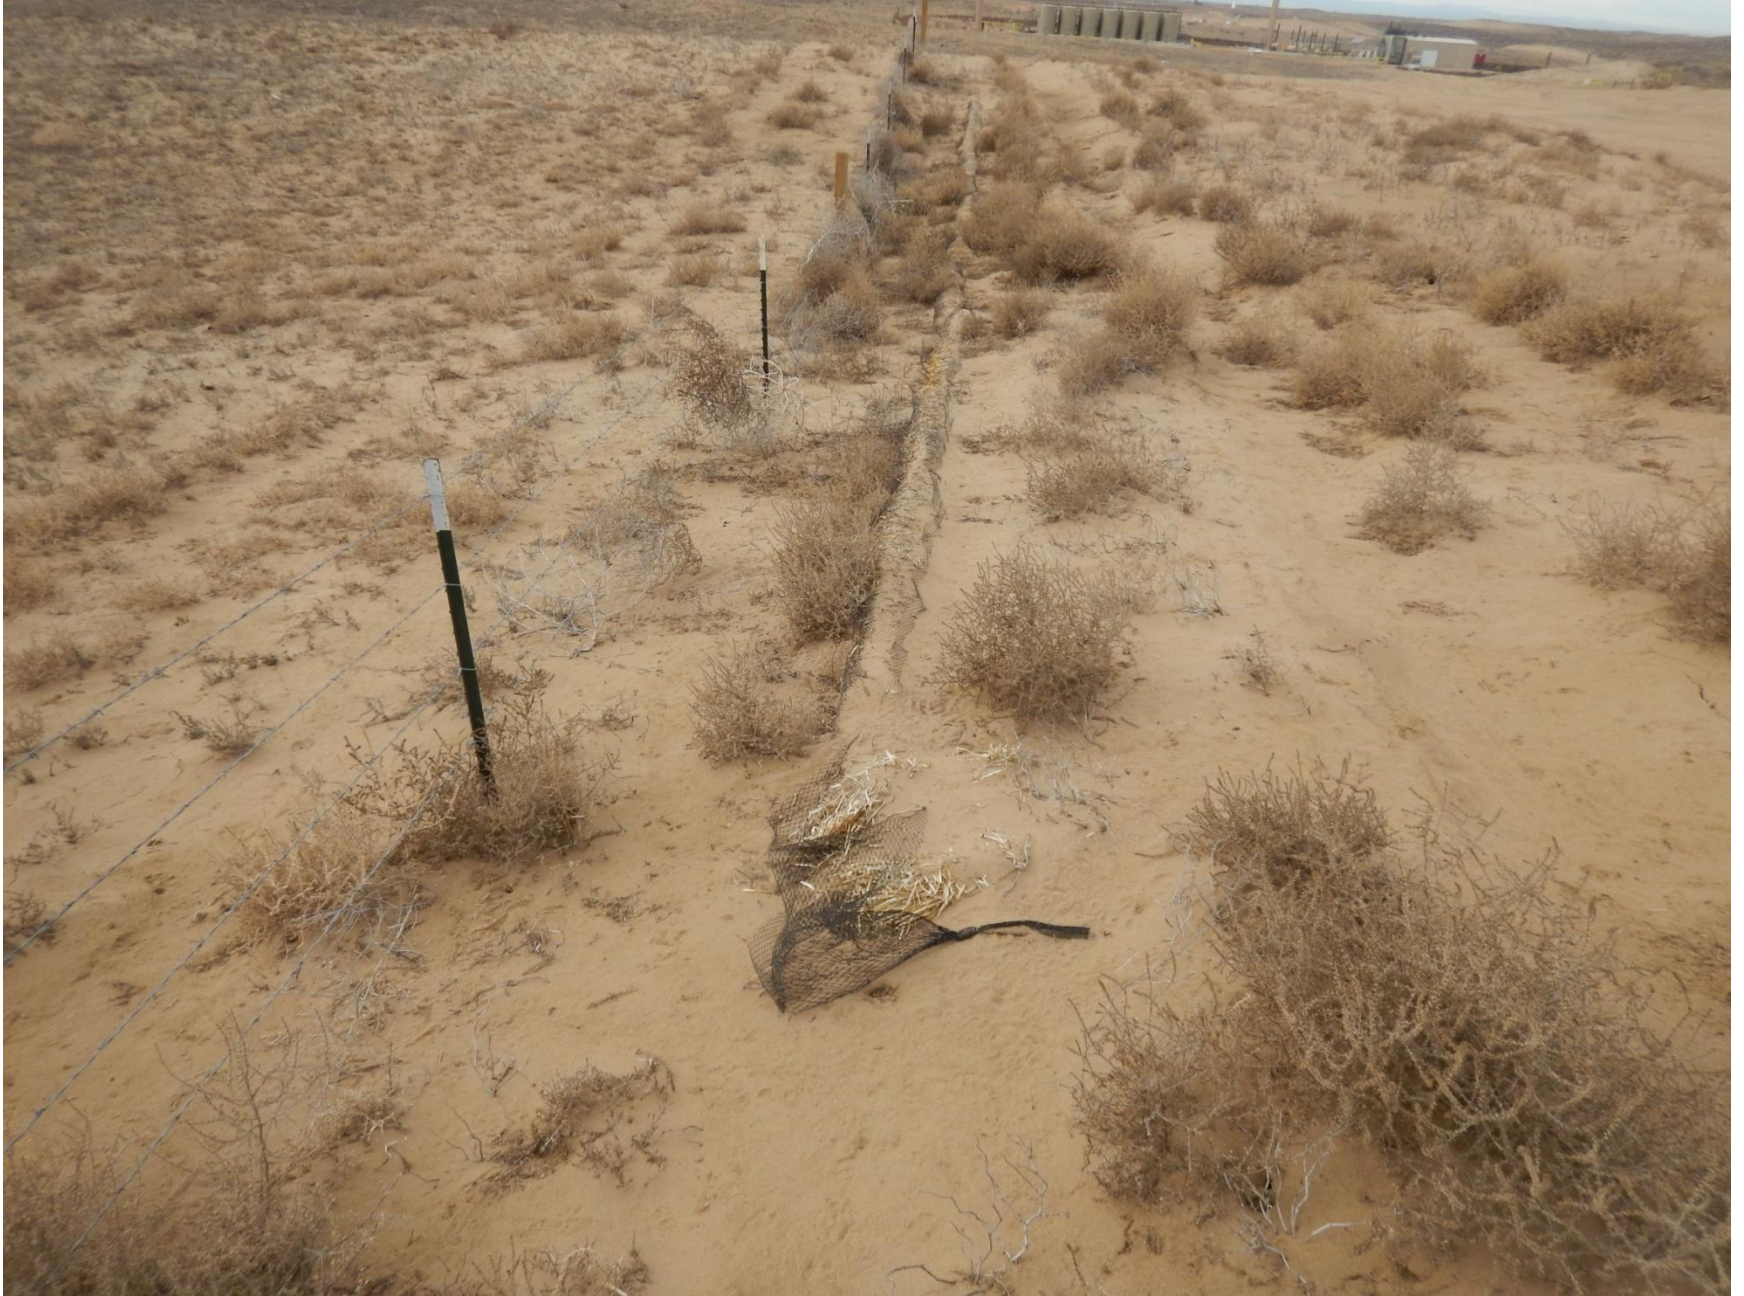
Figure 9: Photo taken from south end of location, facing west. Photo shows stormwater and sediment control BMP in disrepair.

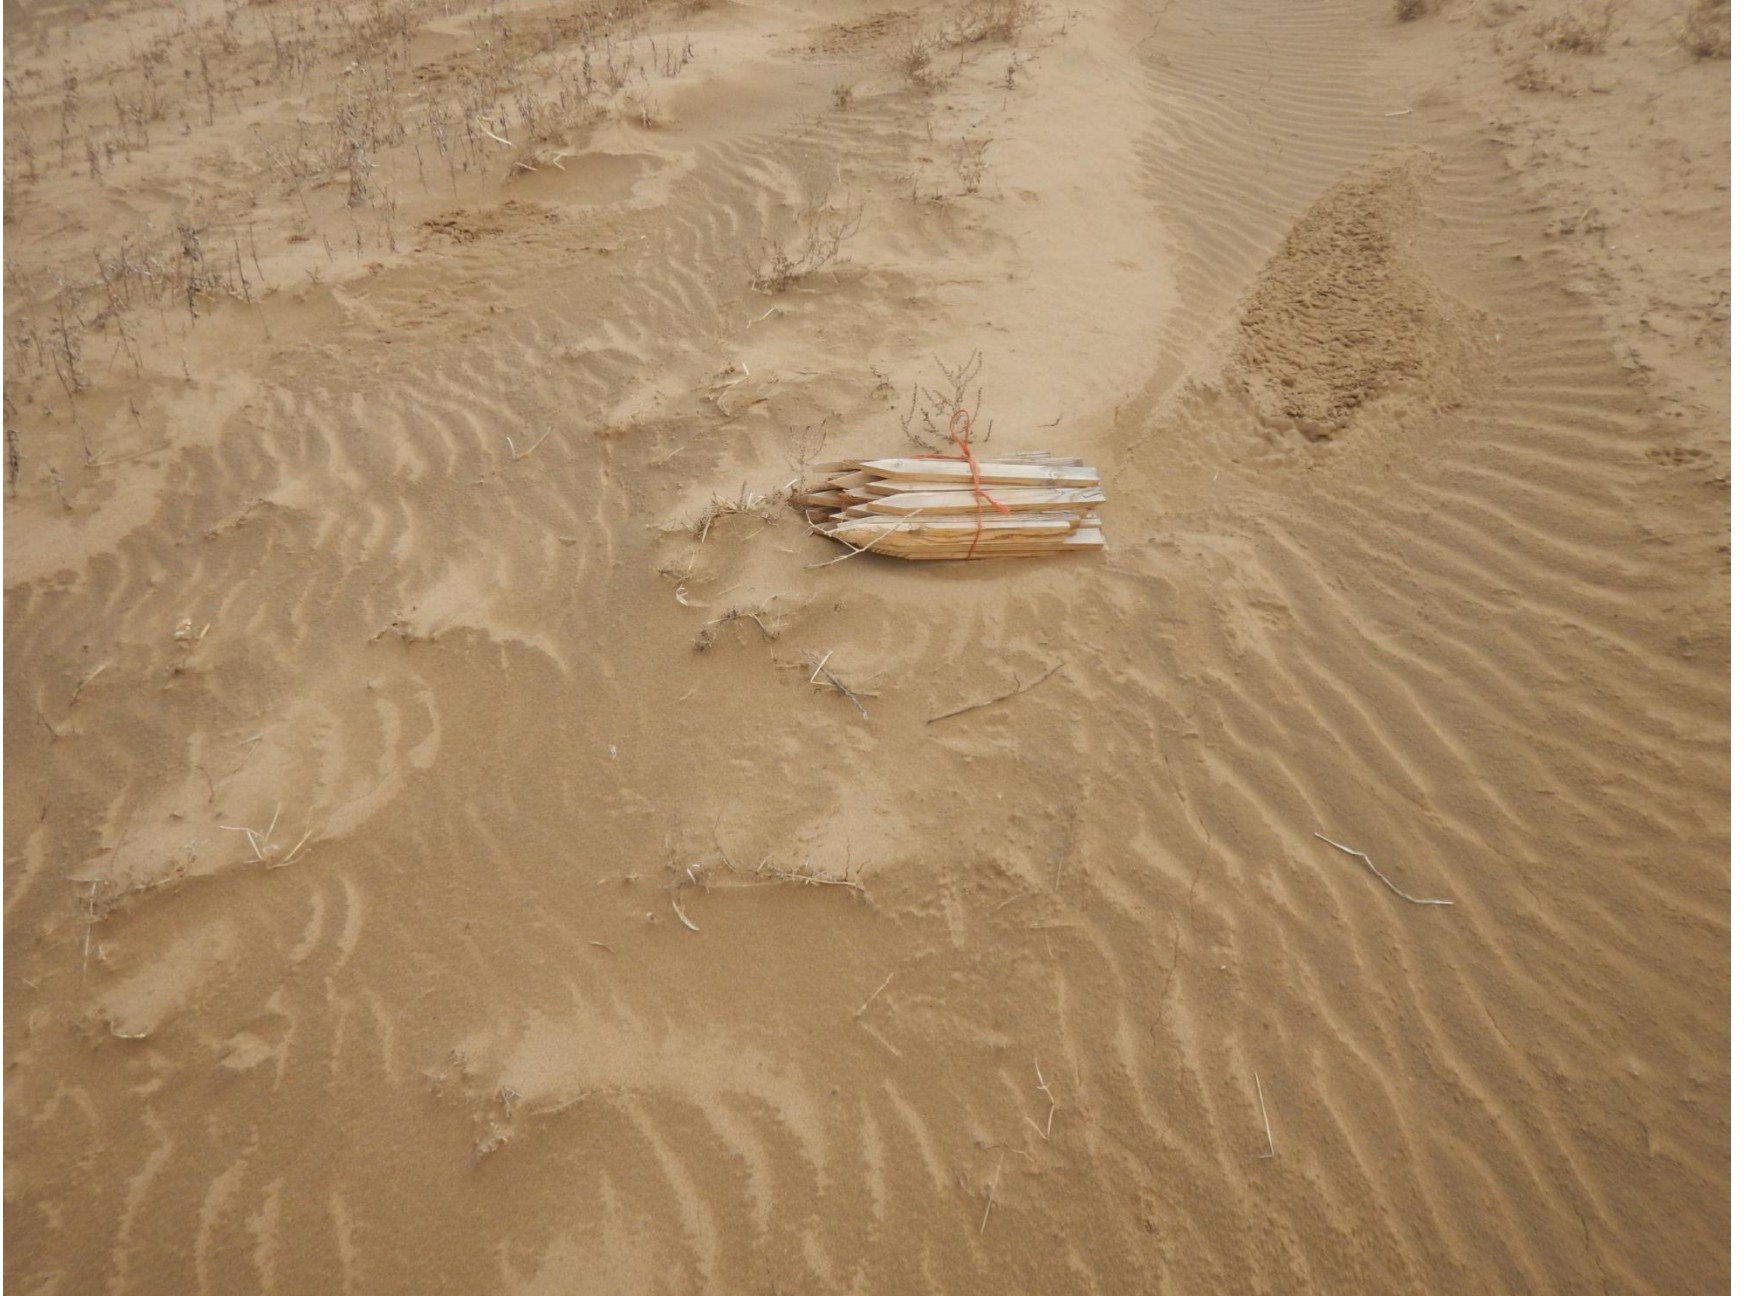
Figure 10: Photo taken from south end of location. Photo of trash debris on interim area.

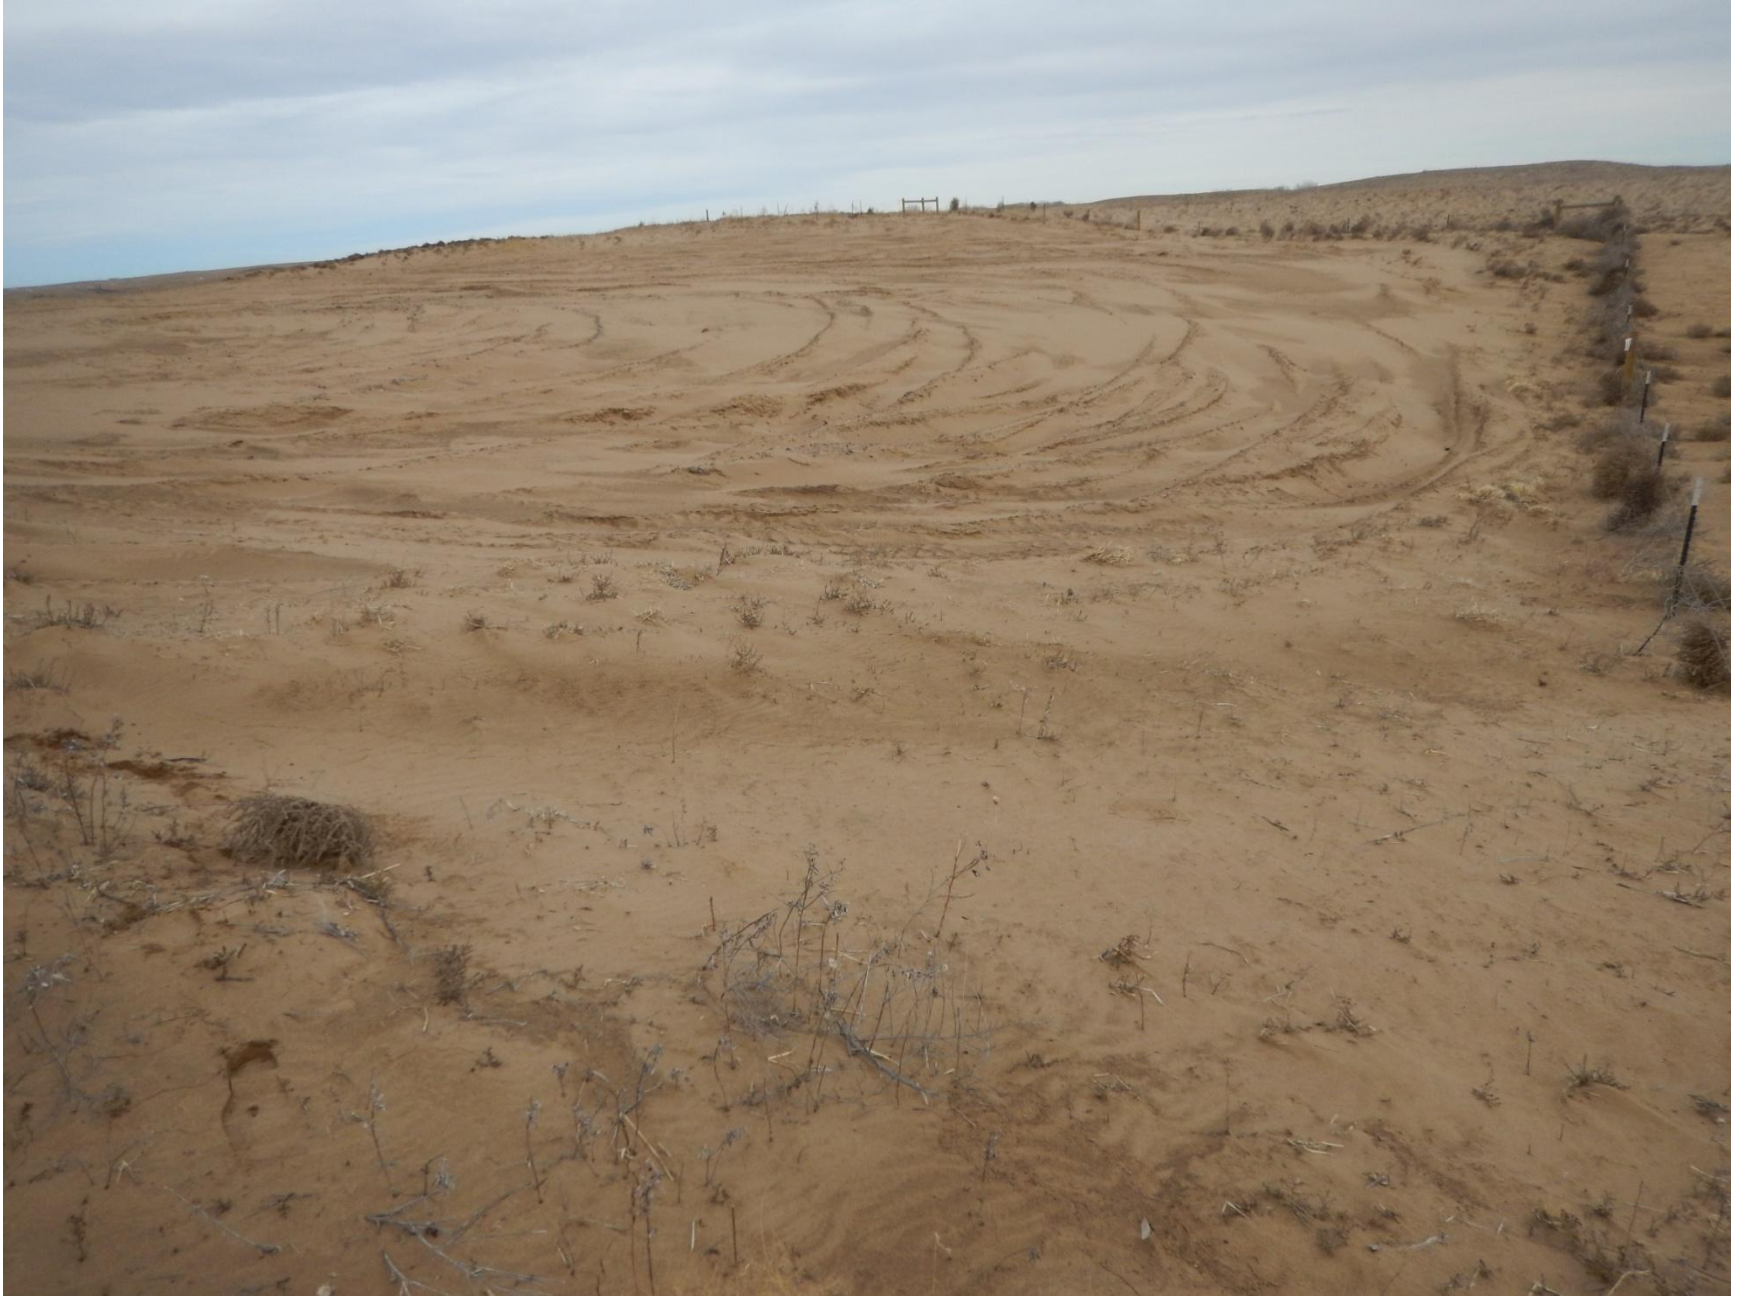
Figure 11: Photo taken from southeast end of location, facing east. Photo shows insufficient stormwater and sediment control BMPs on interim area.

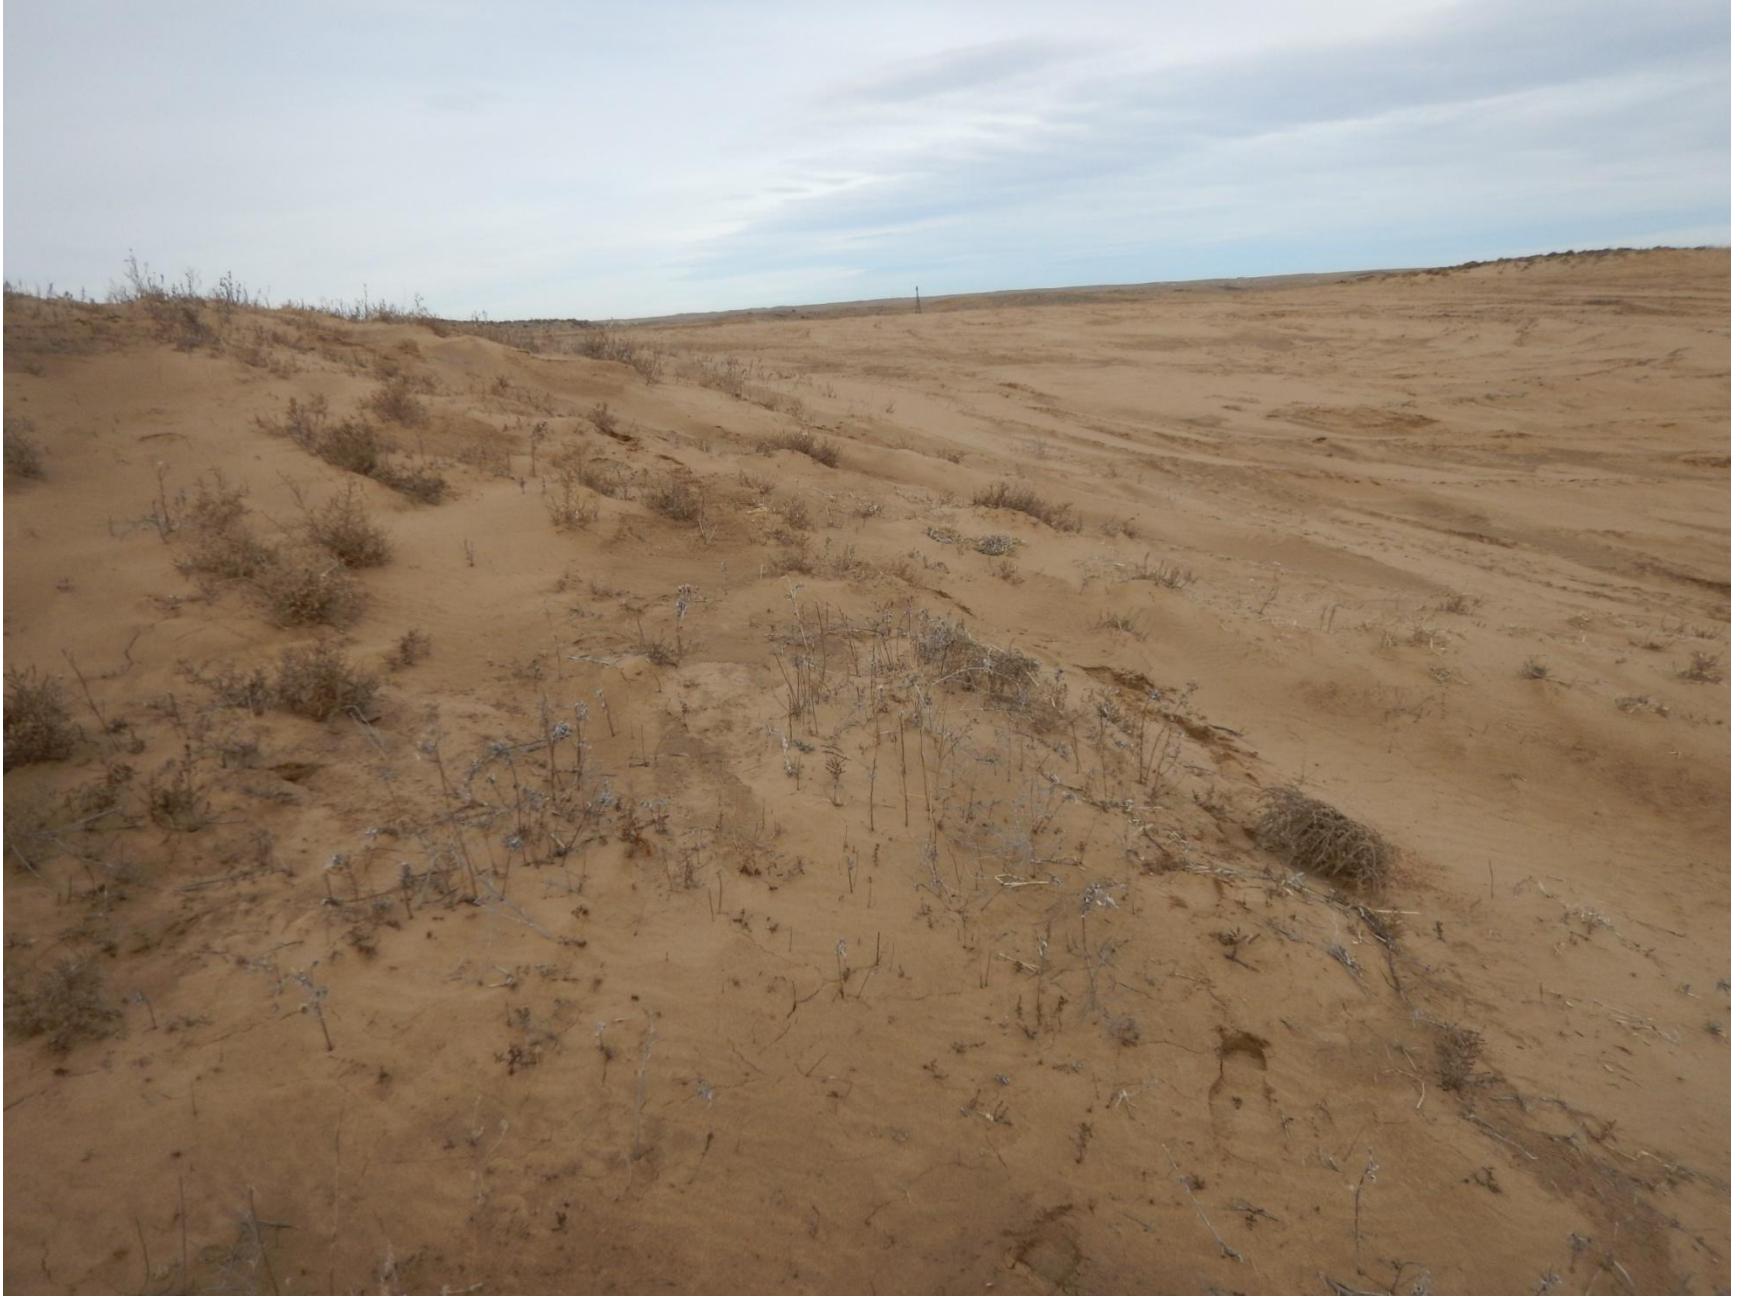
Figure 12: Photo taken from southeast end of location, facing north. Photo shows undesirable plant species and insufficient perennial vegetation on interim area.
