Interim Reclamation Inspection

12/10/2015

Operator: Bill Barrett Corporation

Location ID: 439466

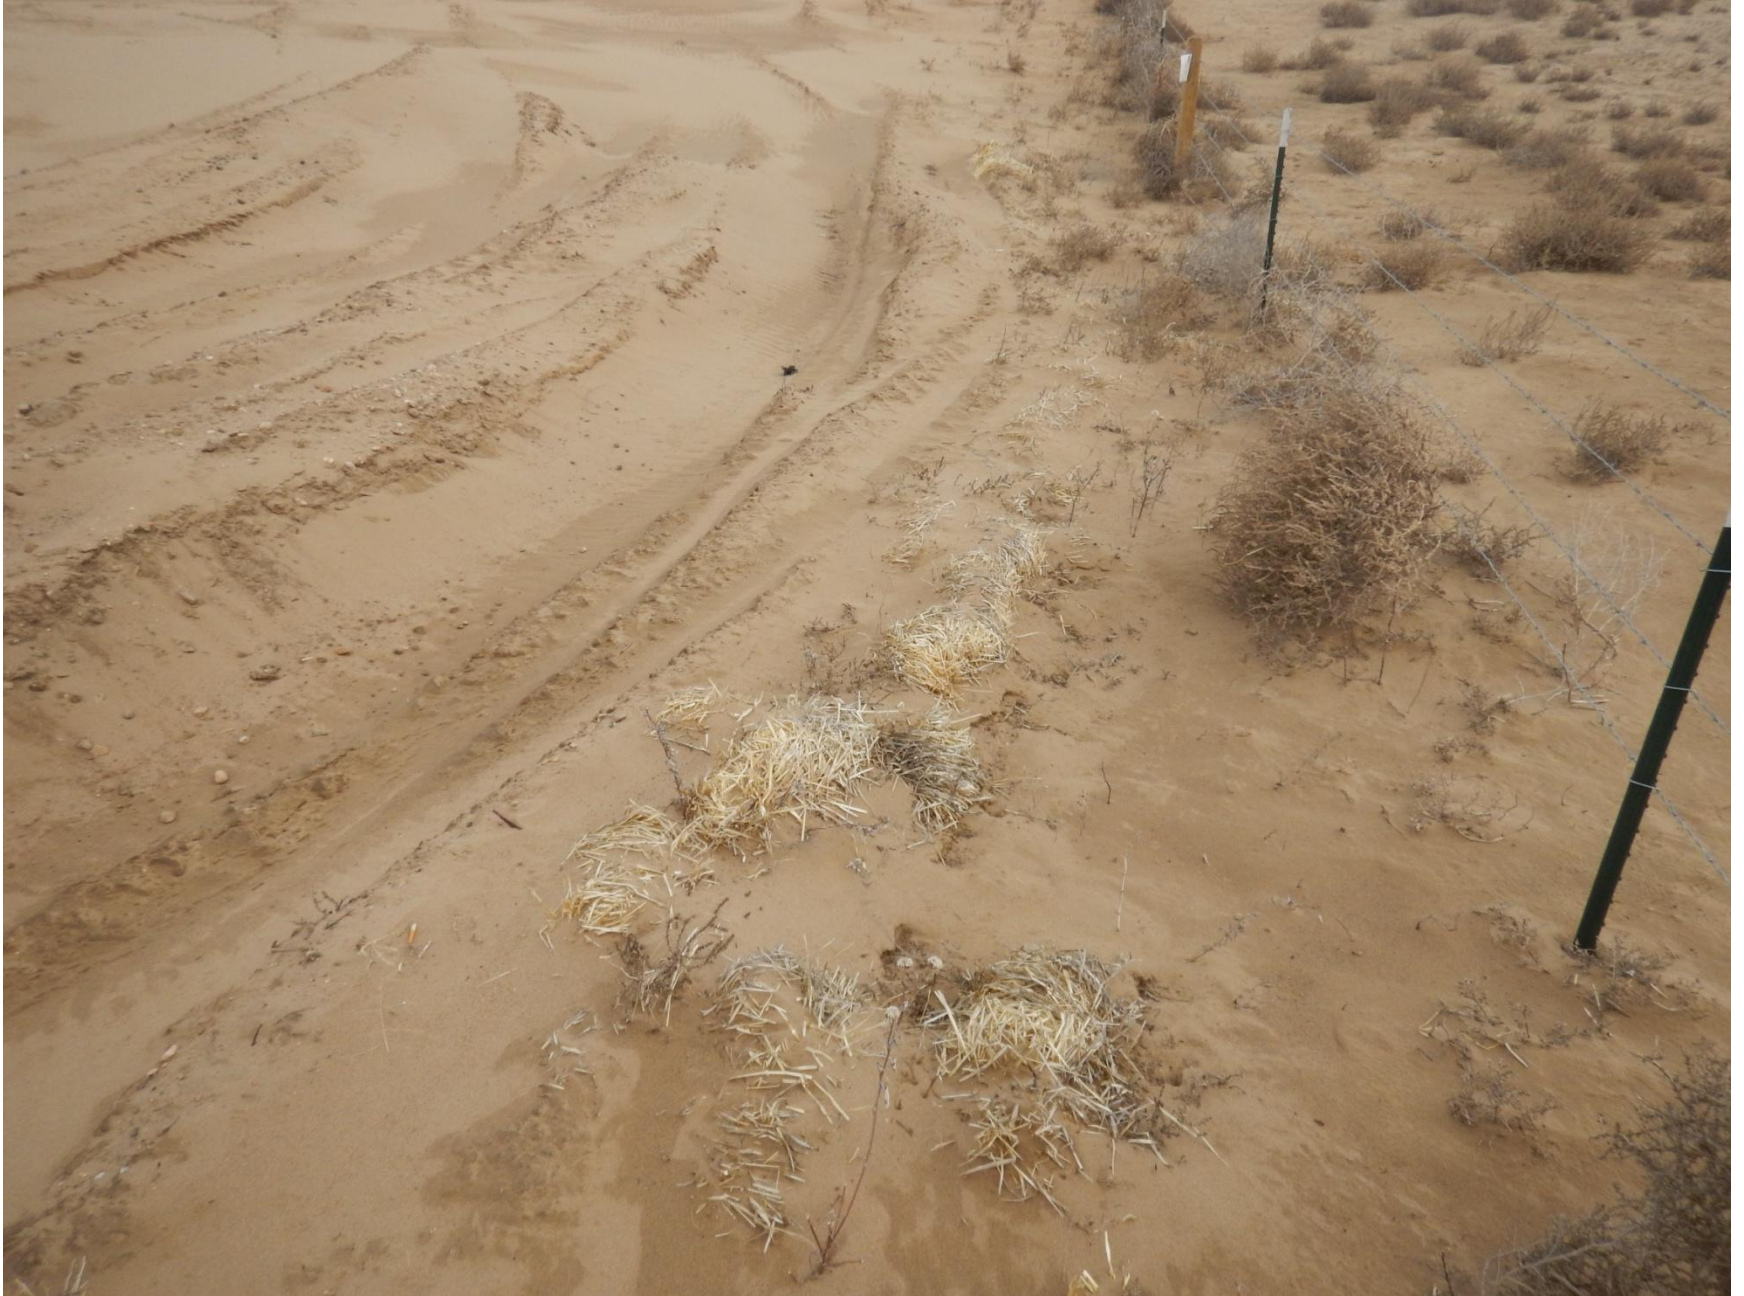
Figure 13: Photo taken from southeast end of location. Photo shows stormwater and sediment control BMP in disrepair.

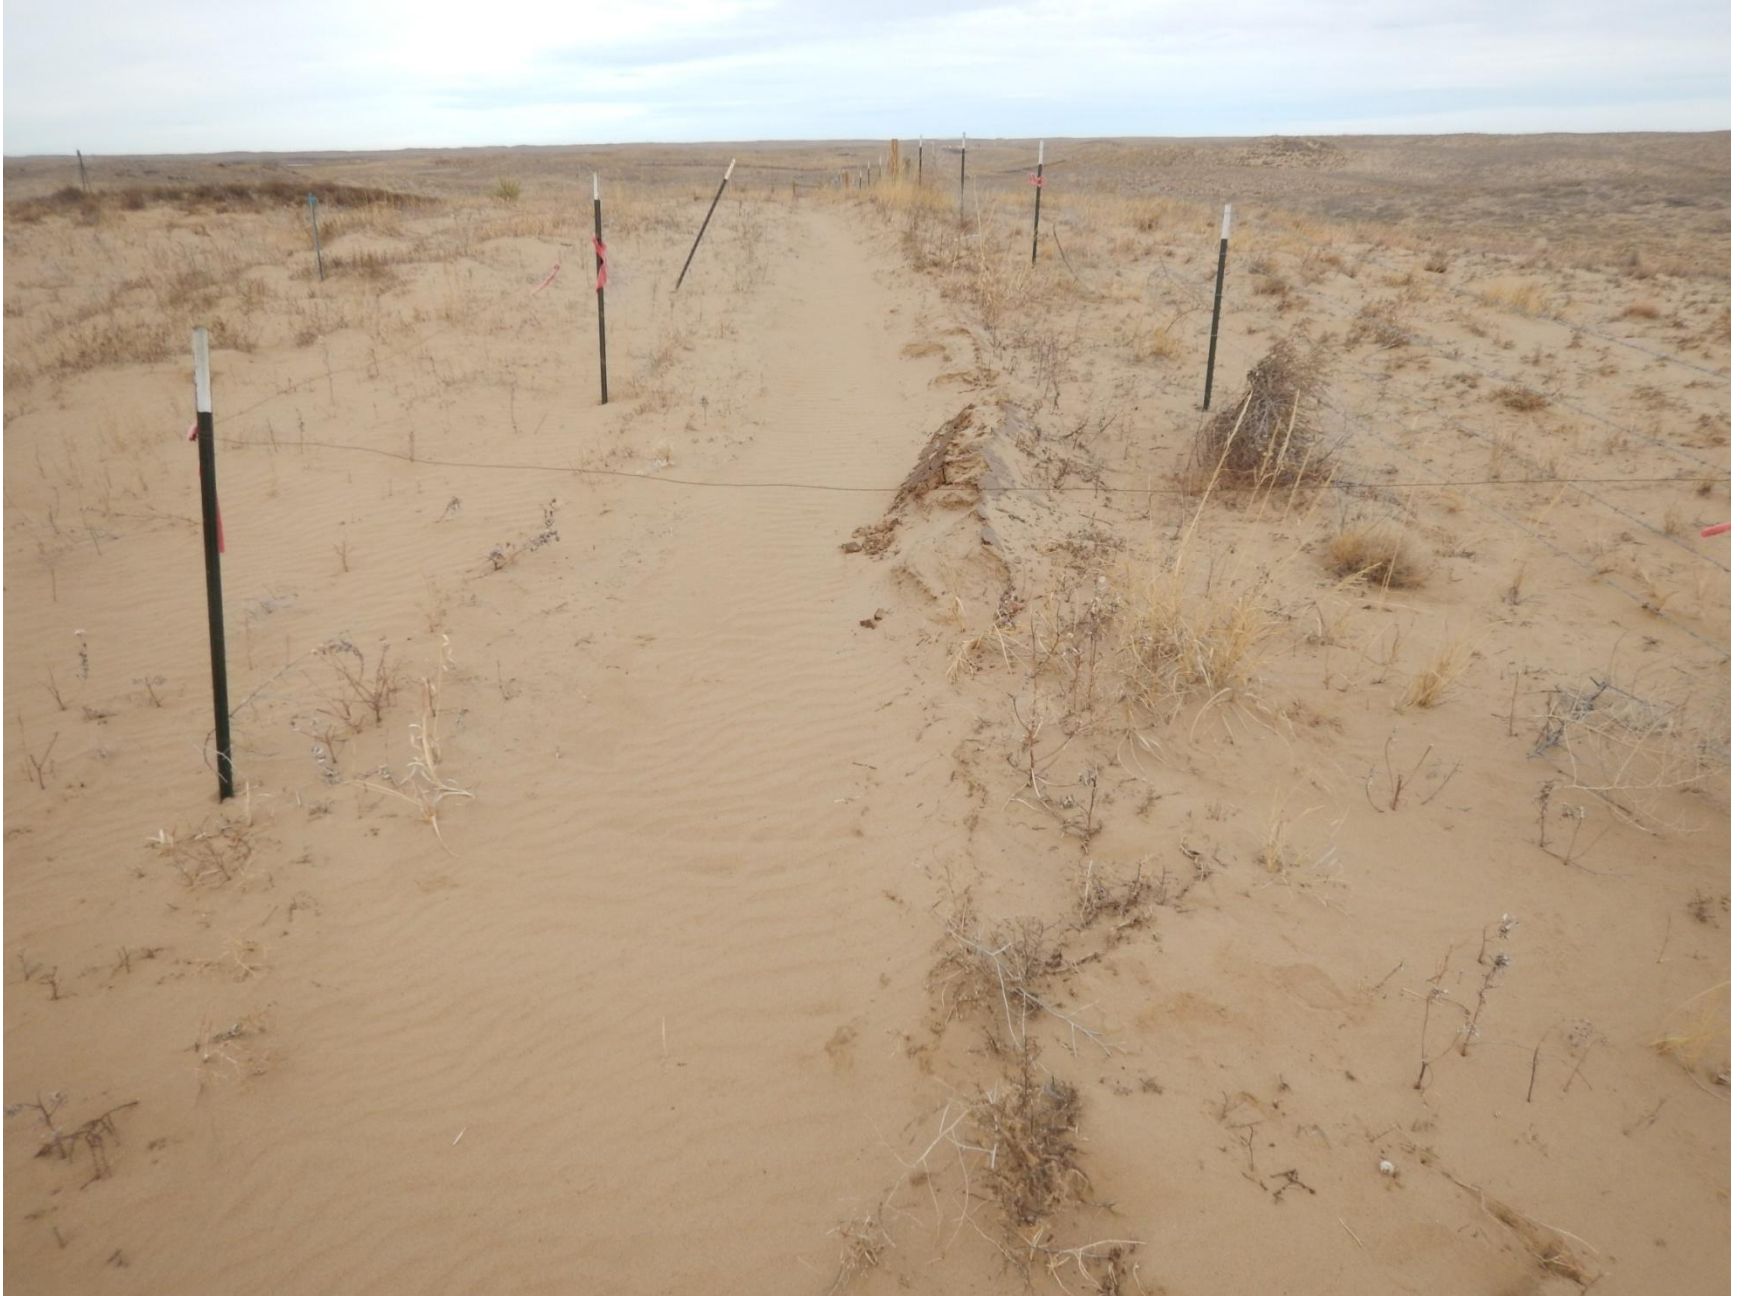
Figure 14: Photo taken from east end of location, facing north. Photo of fenced off portion of interim area, and stained soil.

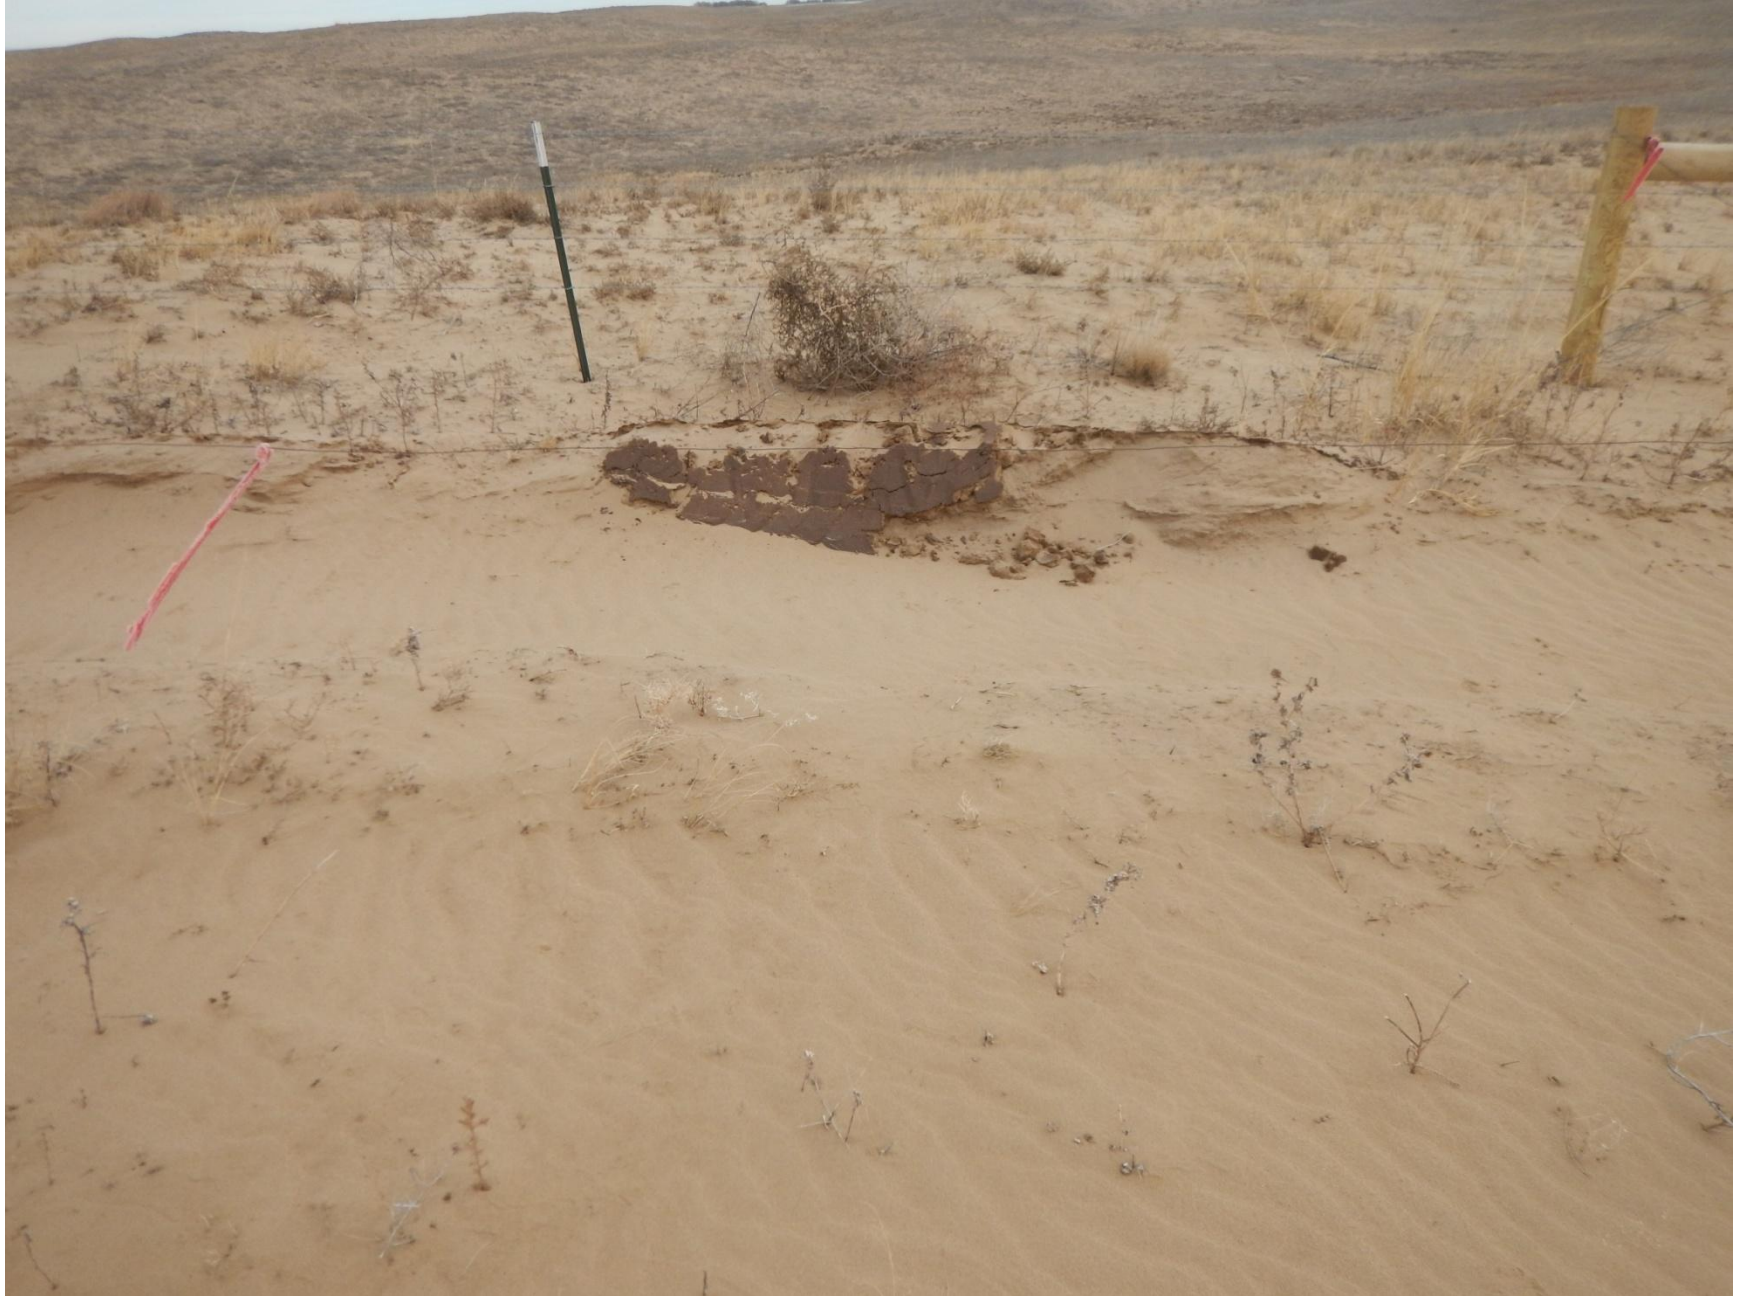
Figure 15: Photo taken from east end of location, facing east. Photo of fenced off portion of interim area, and stained soil.

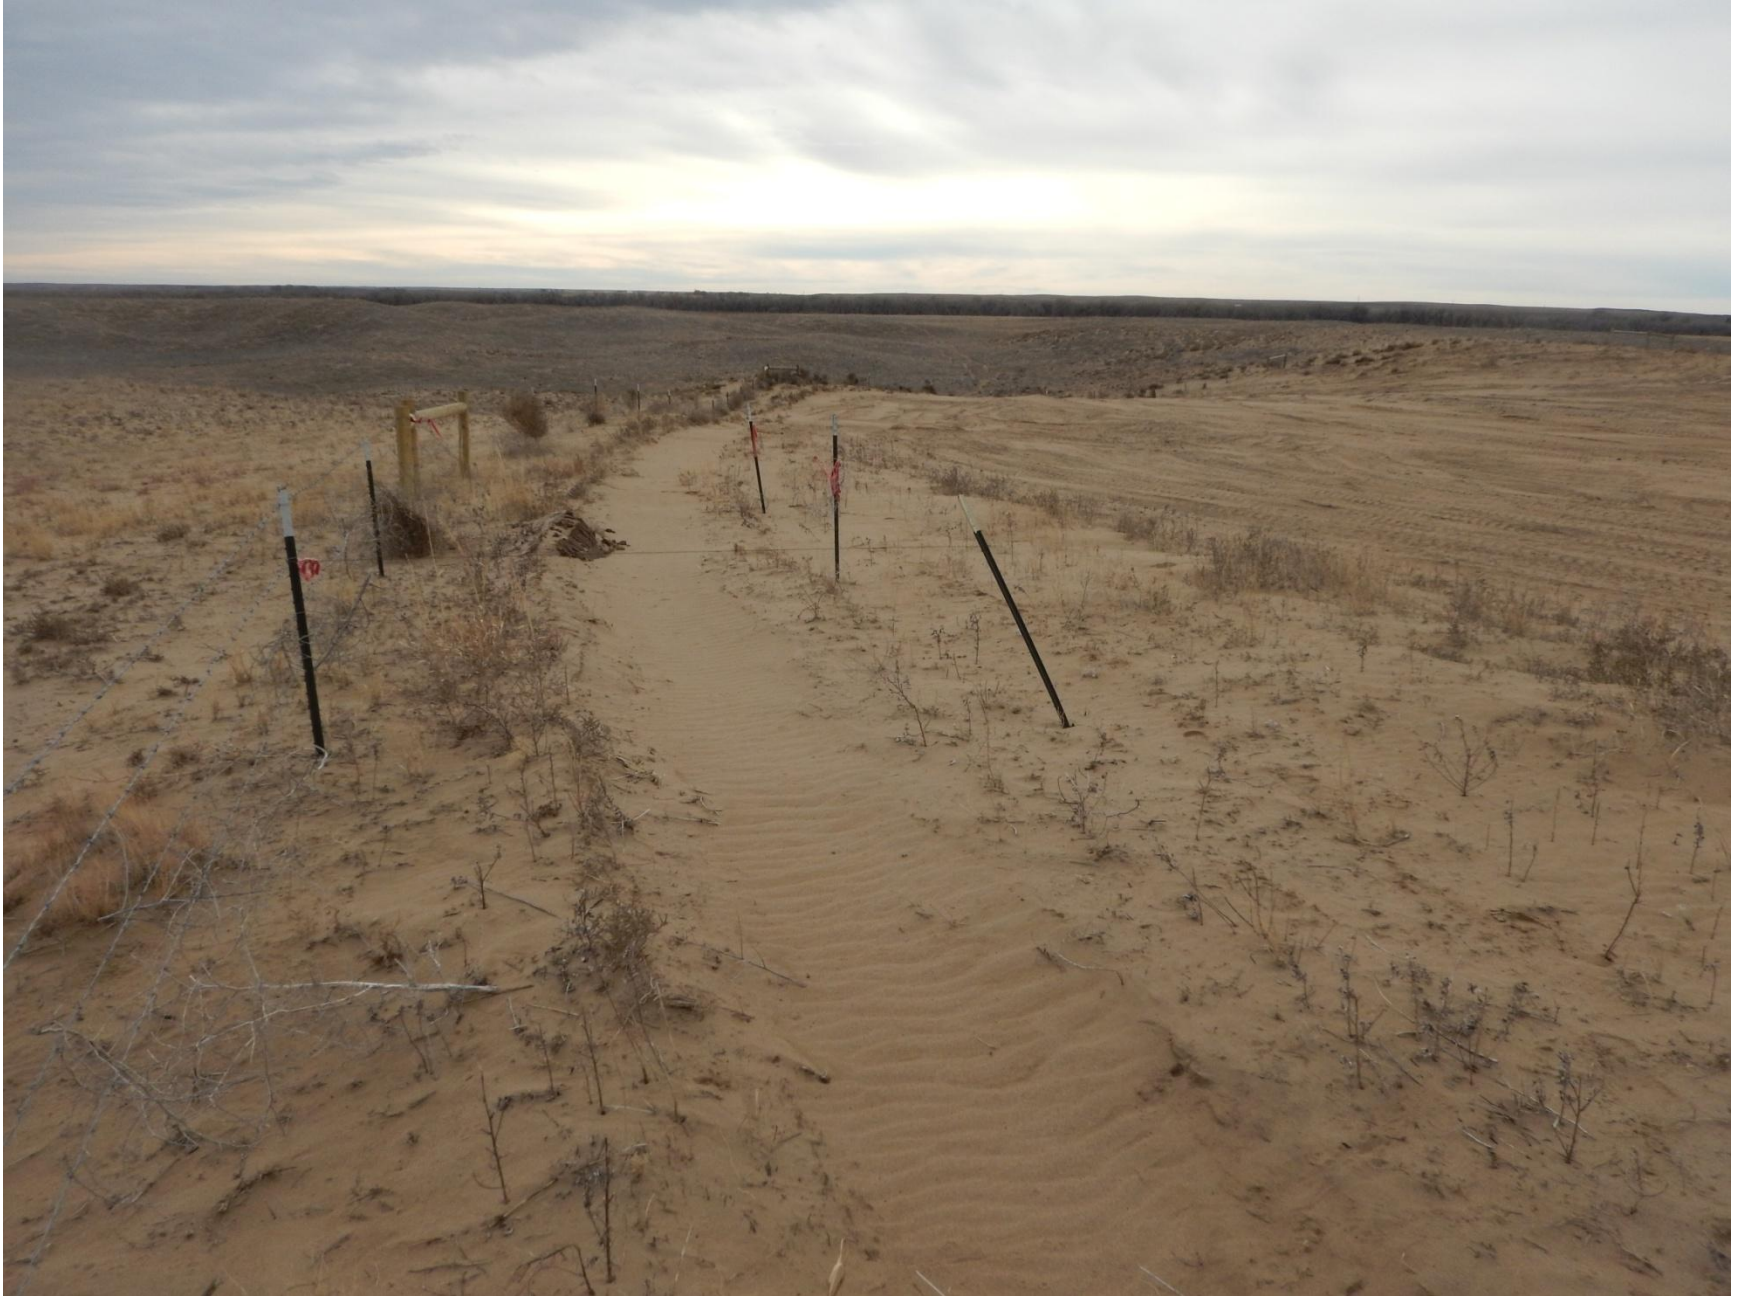
Figure 16: Photo taken from east end of location, facing south. Photo of fenced off portion of interim area, and stained soil.

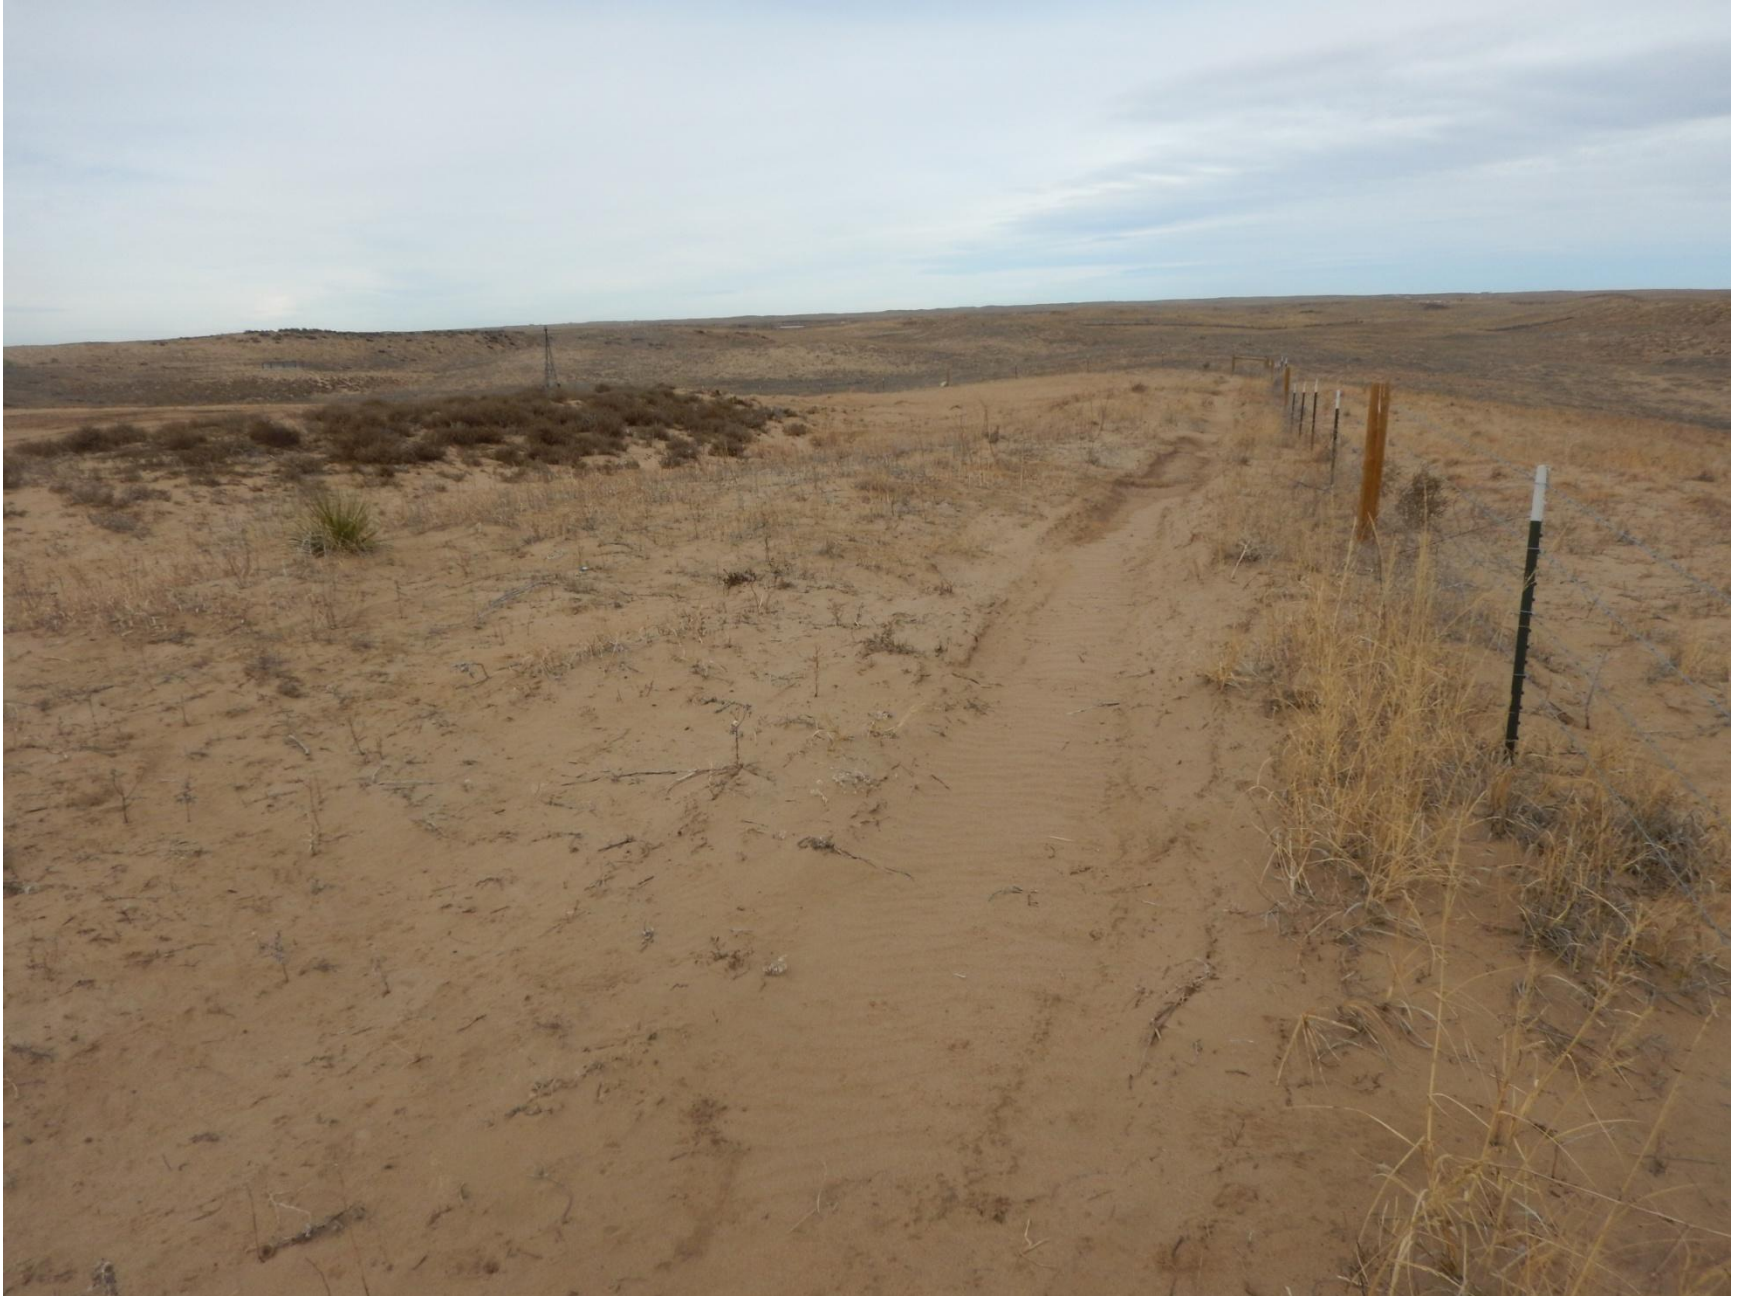
Figure 18: Photo taken from east end of location, facing north. Photo shows stormwater and sediment control BMPs have filled in with sediment, and are no longer sufficient.

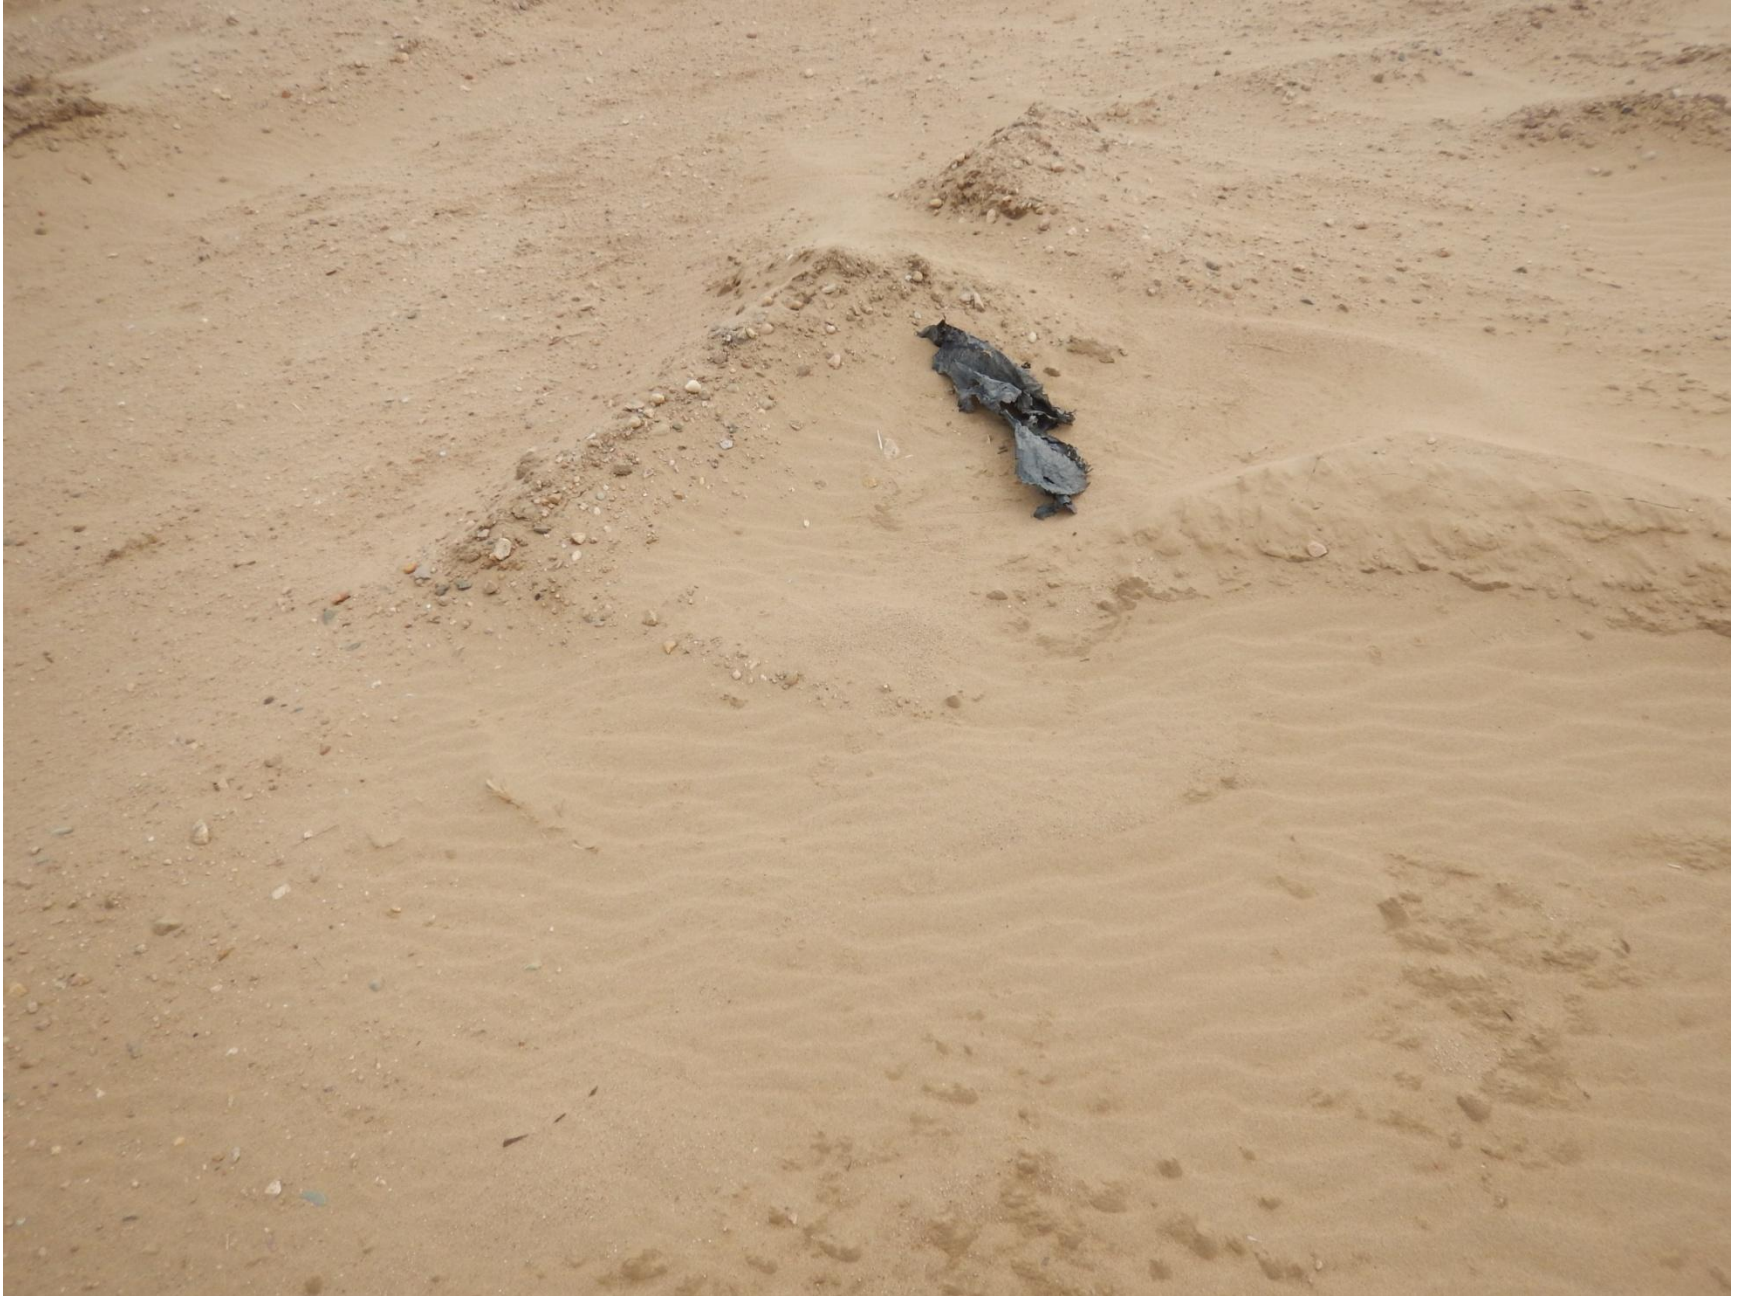
Figure 20: Photo taken from the north end of location. Photo of trash debris on interim area.

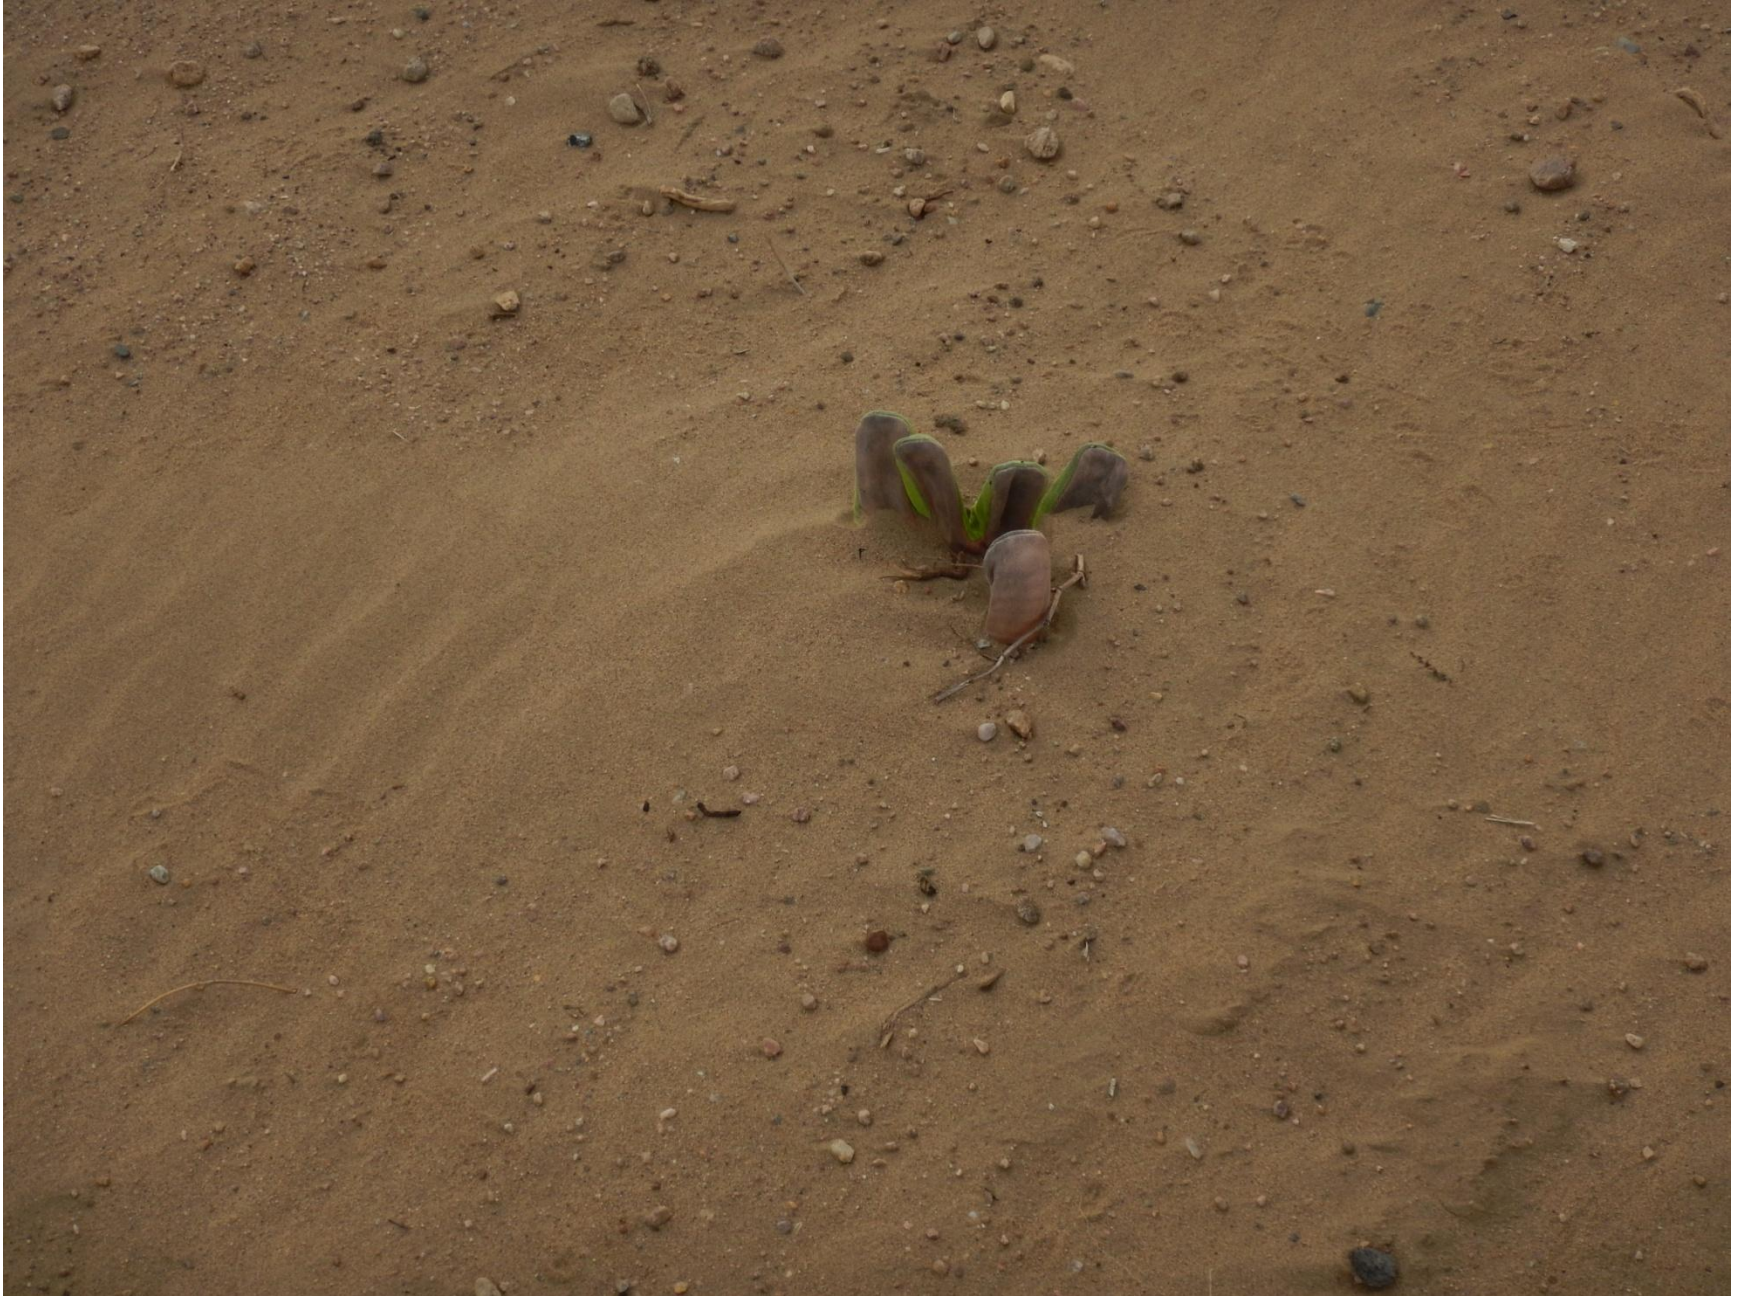
Figure 21: Photo taken from the north end of location. Photo of trash debris on interim area.

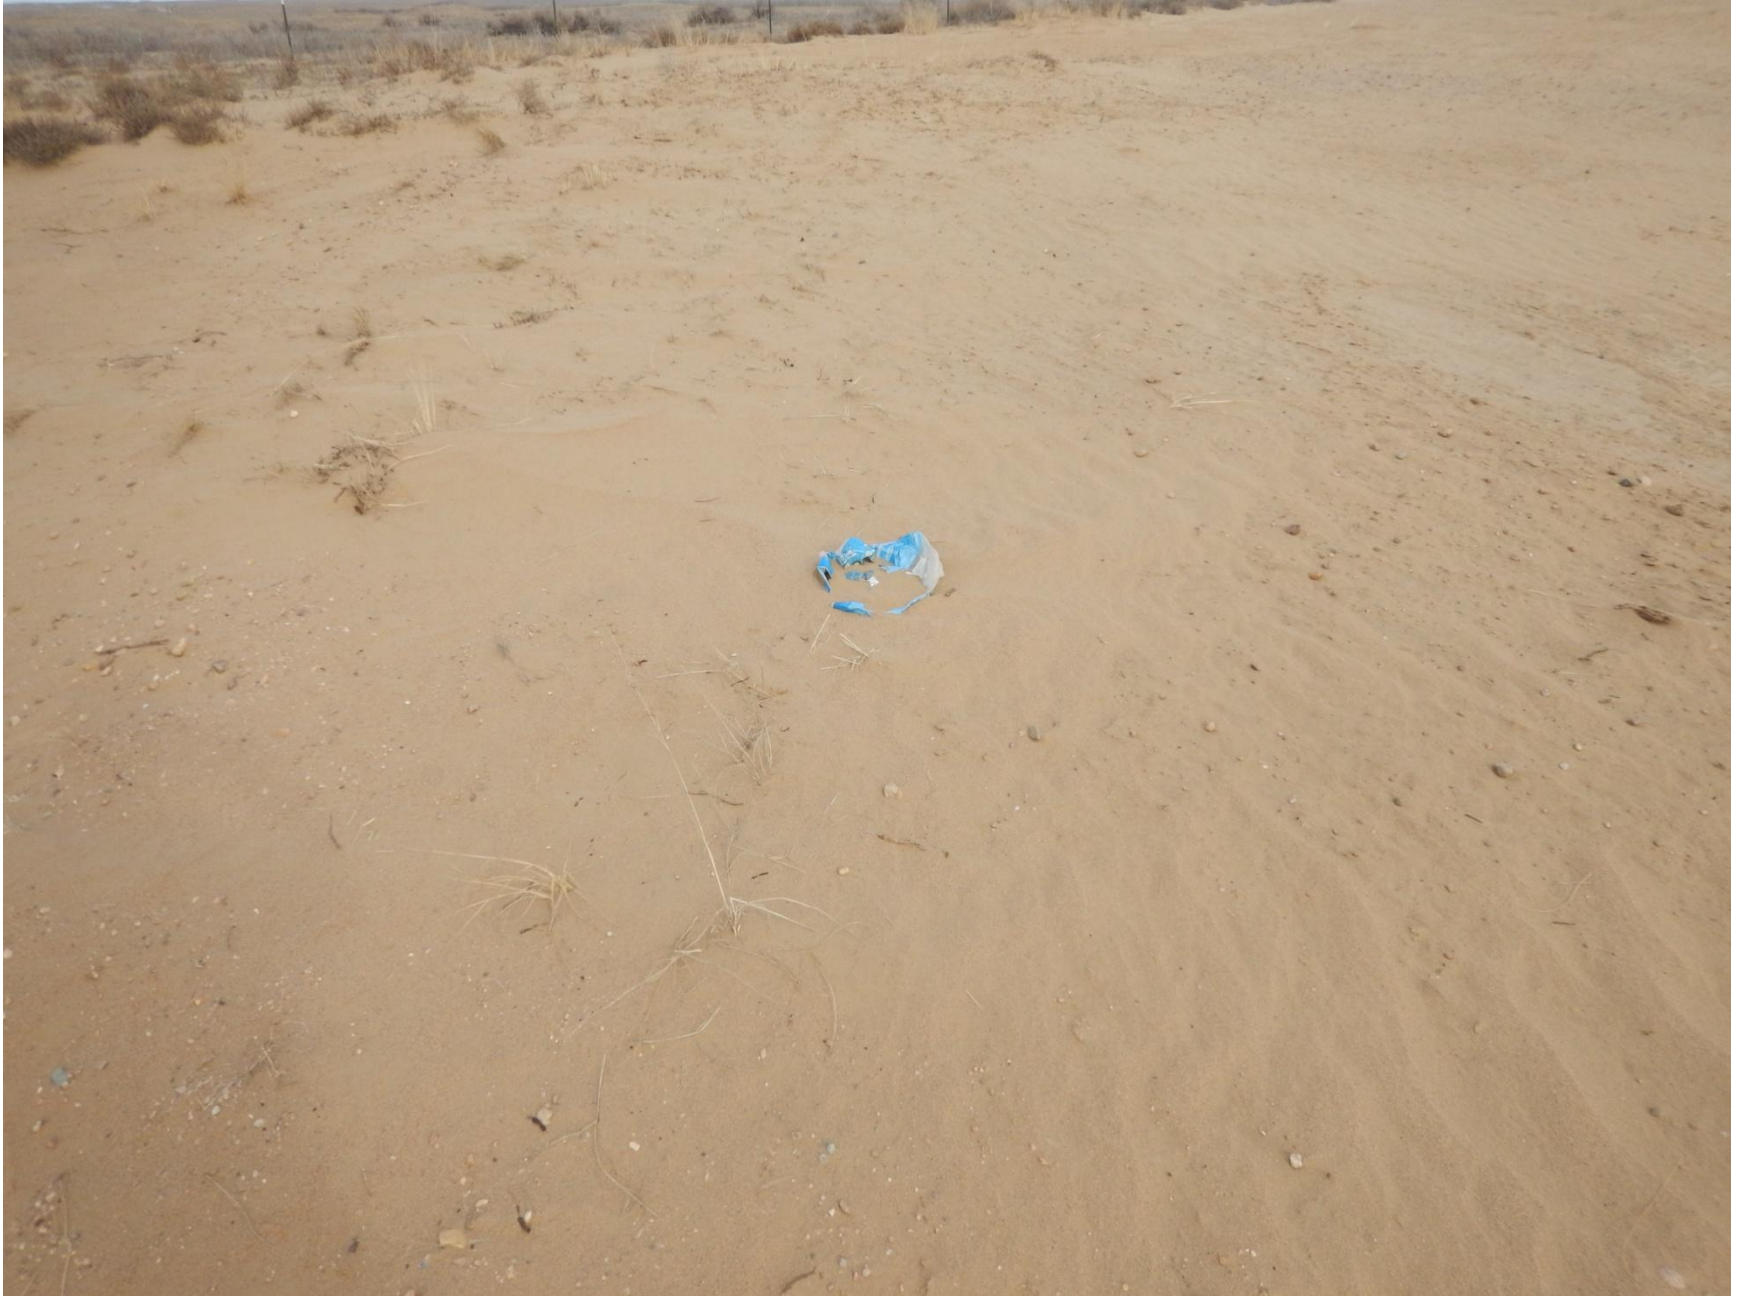
Figure 26: Photo taken from the west end of location. Photo of trash debris on interim area.

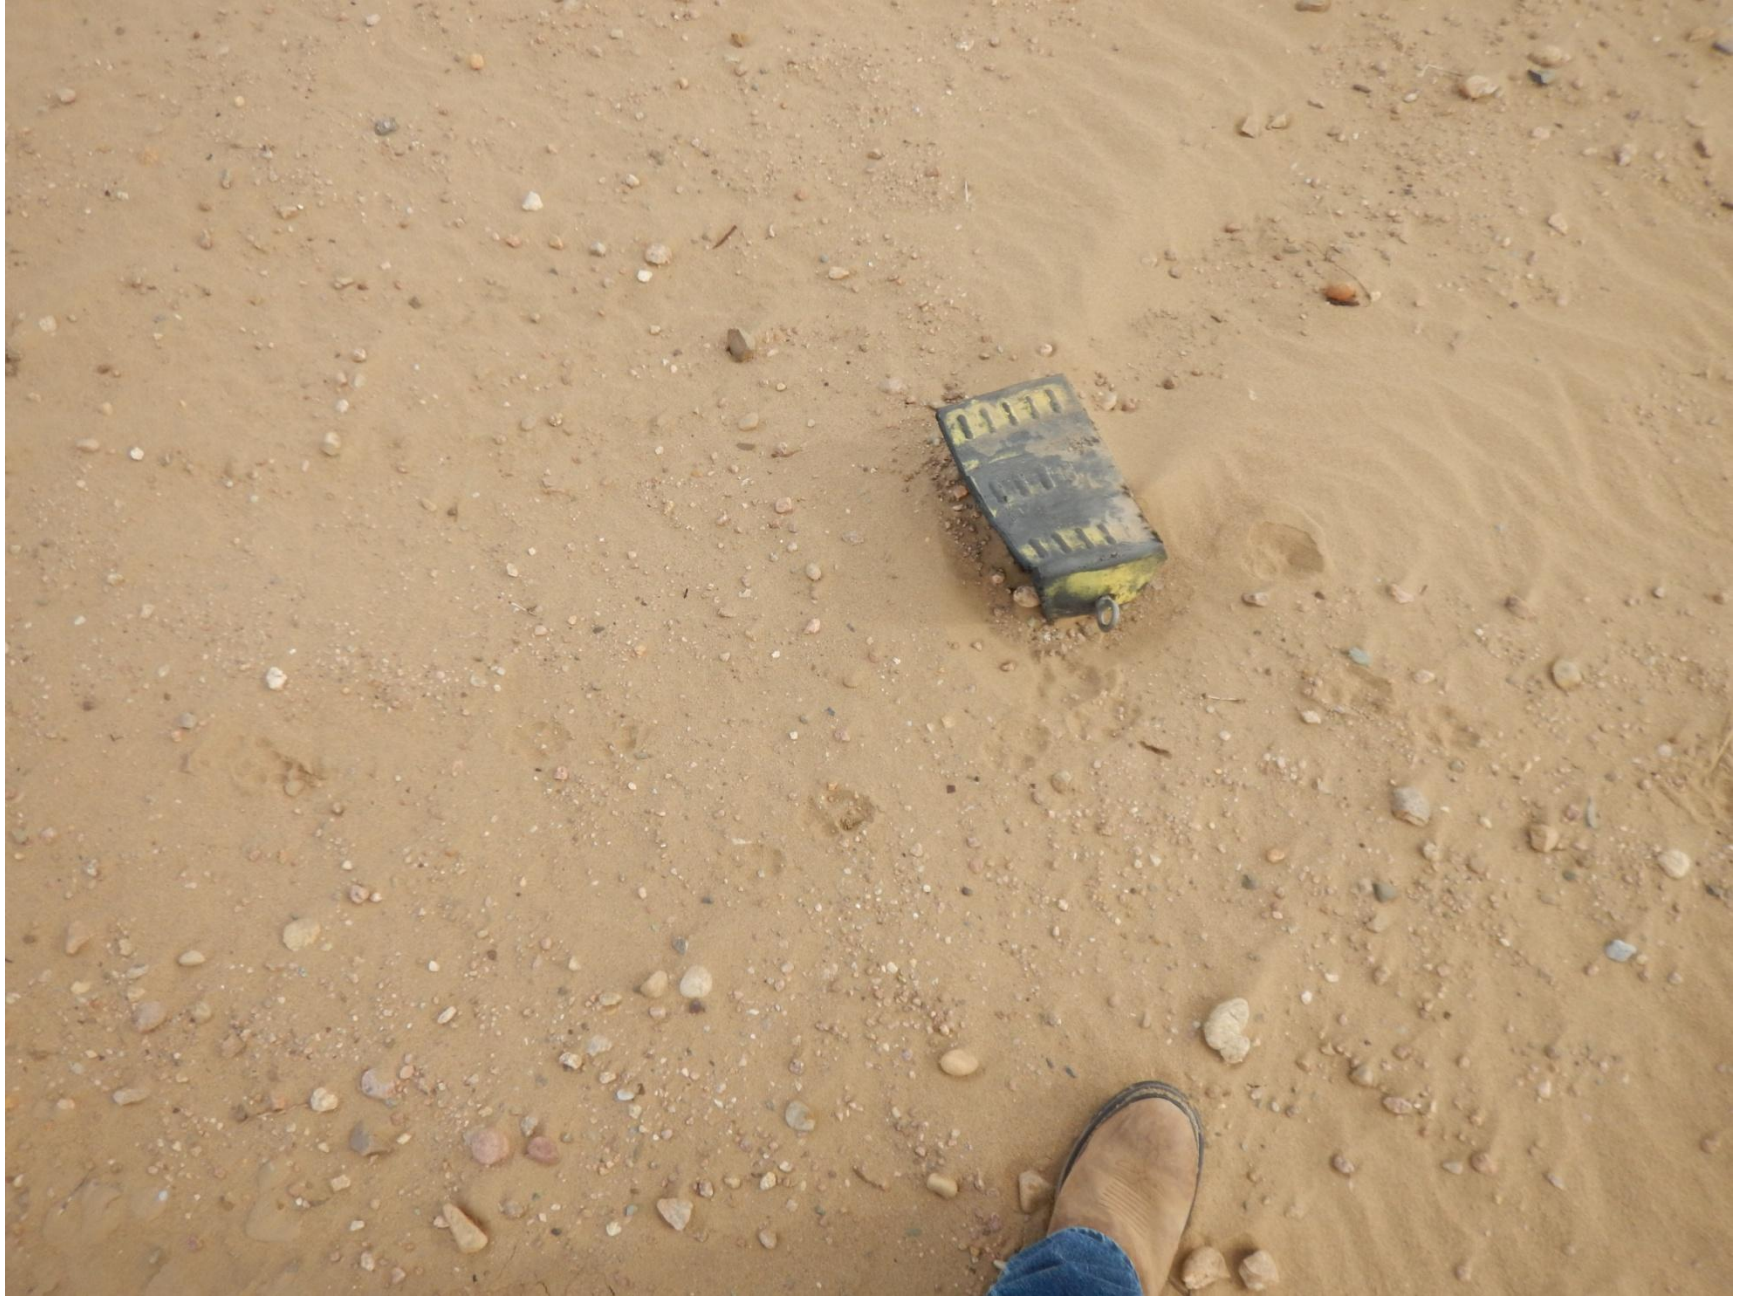
Figure 27: Photo taken from the west end of location. Photo of trash debris on interim area.

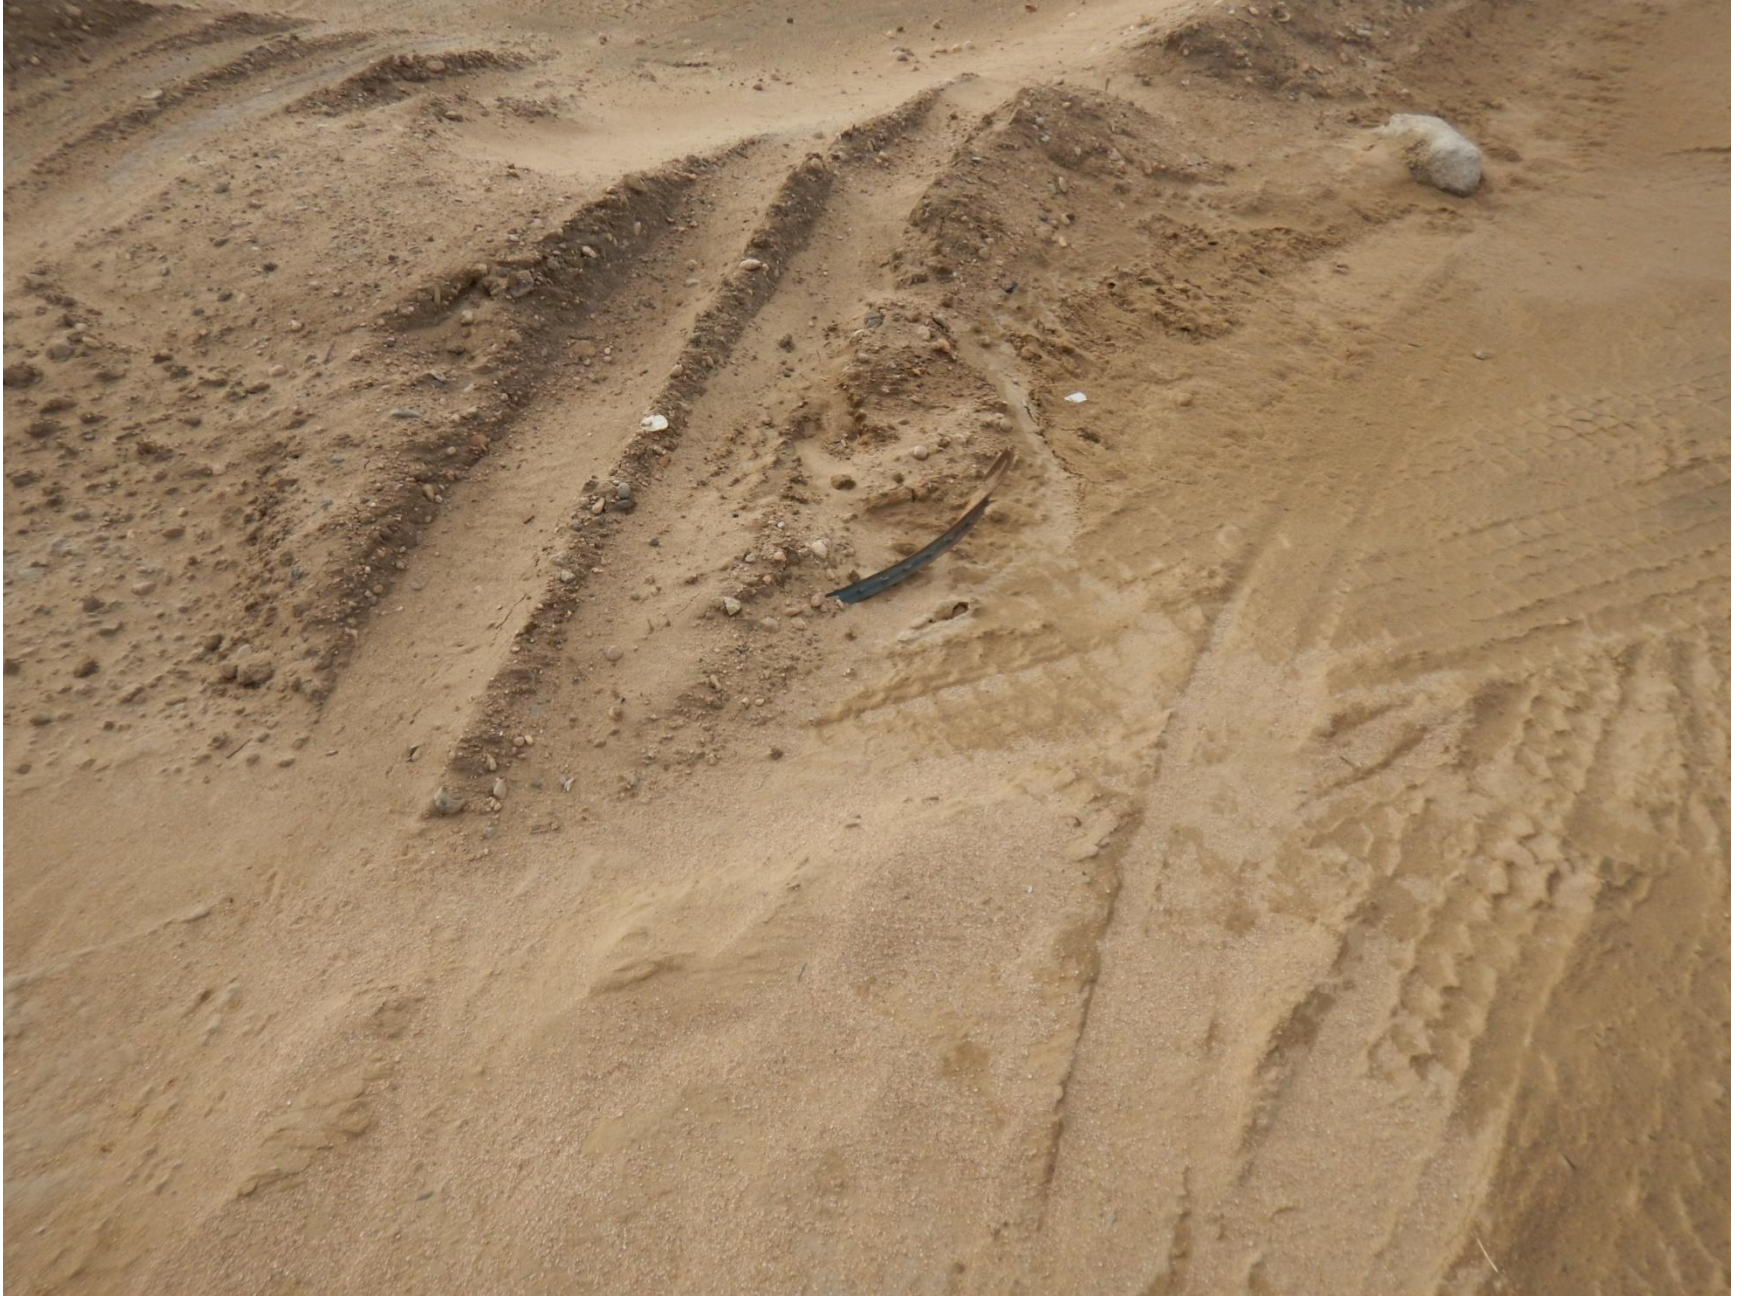
Figure 28: Photo taken from the south end of project area. Photo of trash debris on project area.
