Interim Reclamation Inspection

12/10/2015

Operator: Bill Barrett Corporation

Location ID: 439466

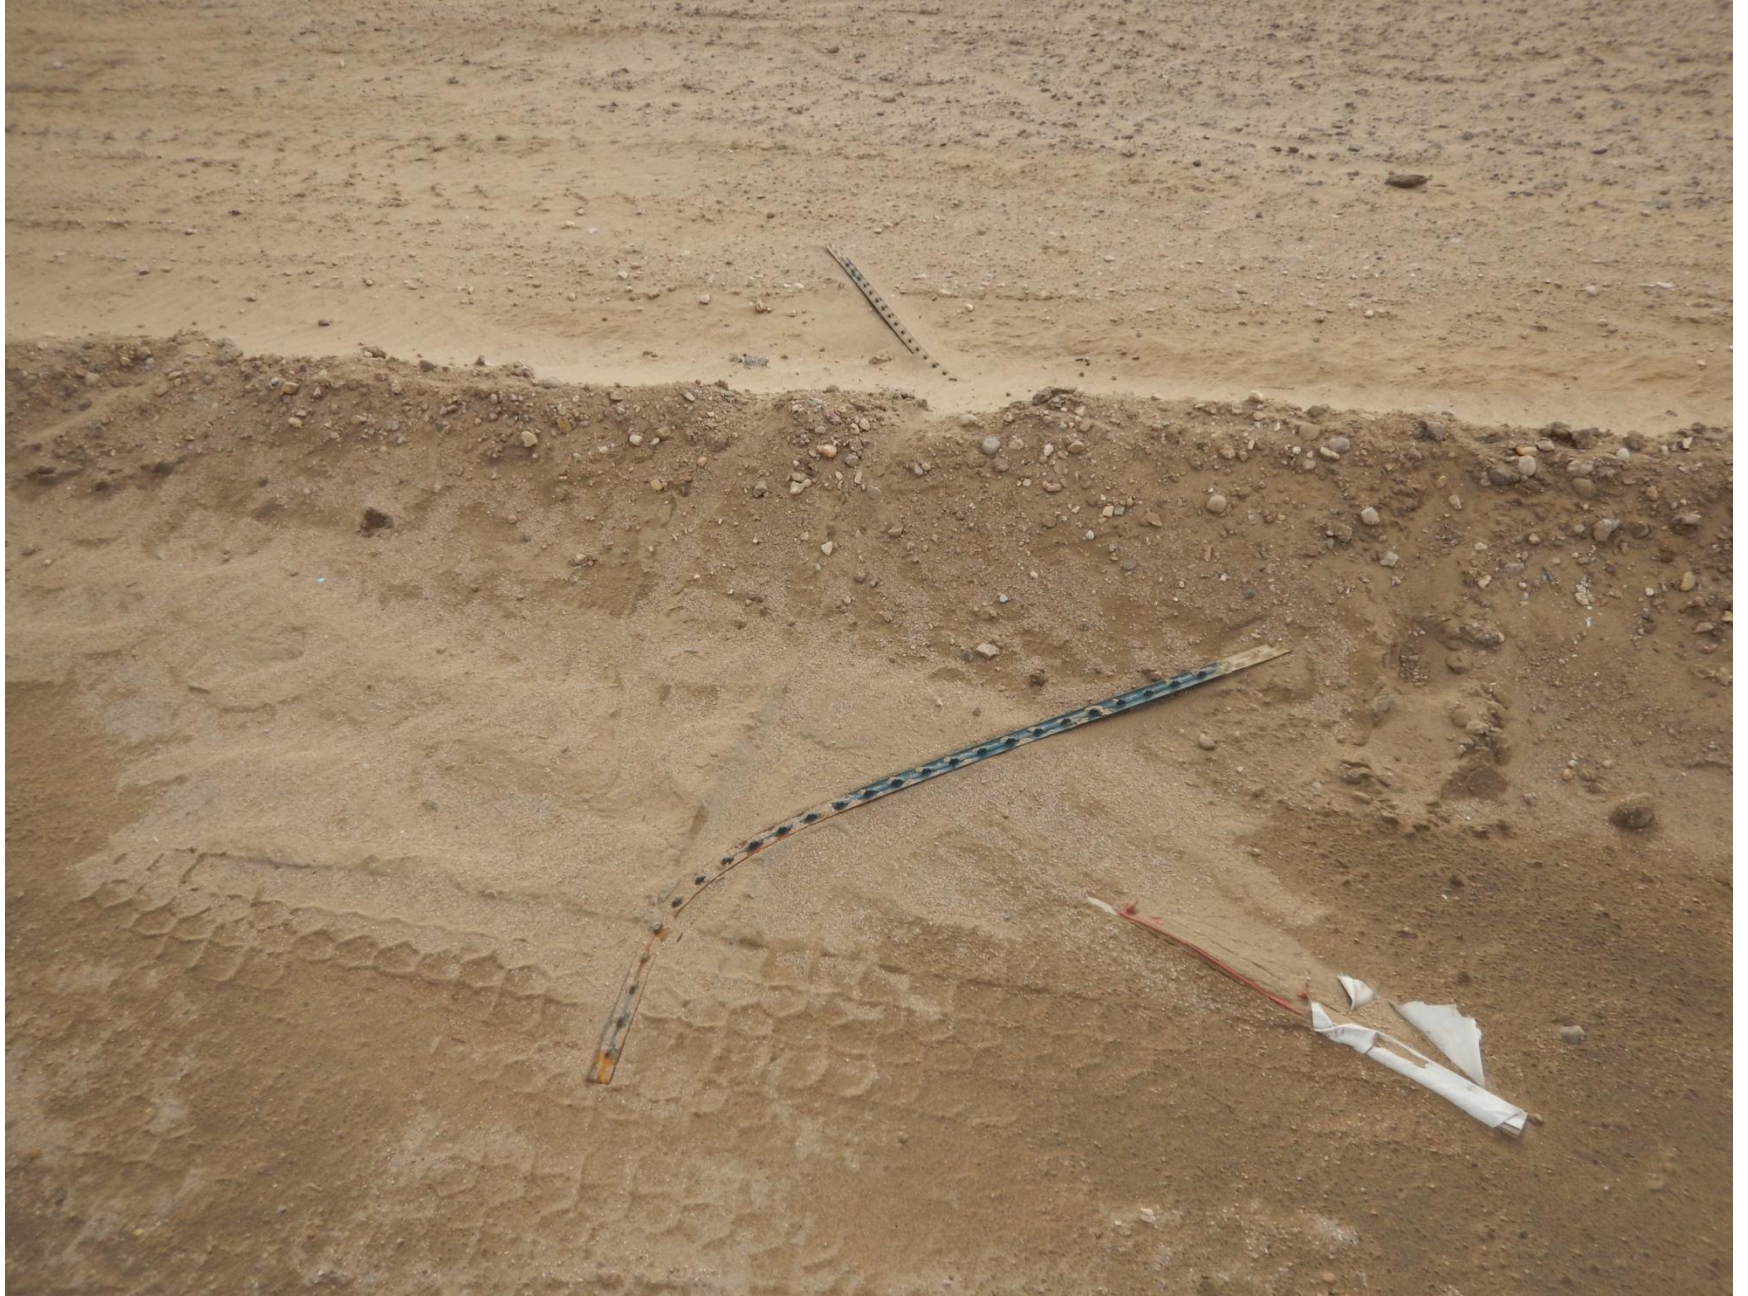
Figure 29: Photo taken from the south end of project area. Photo of trash debris on project area.

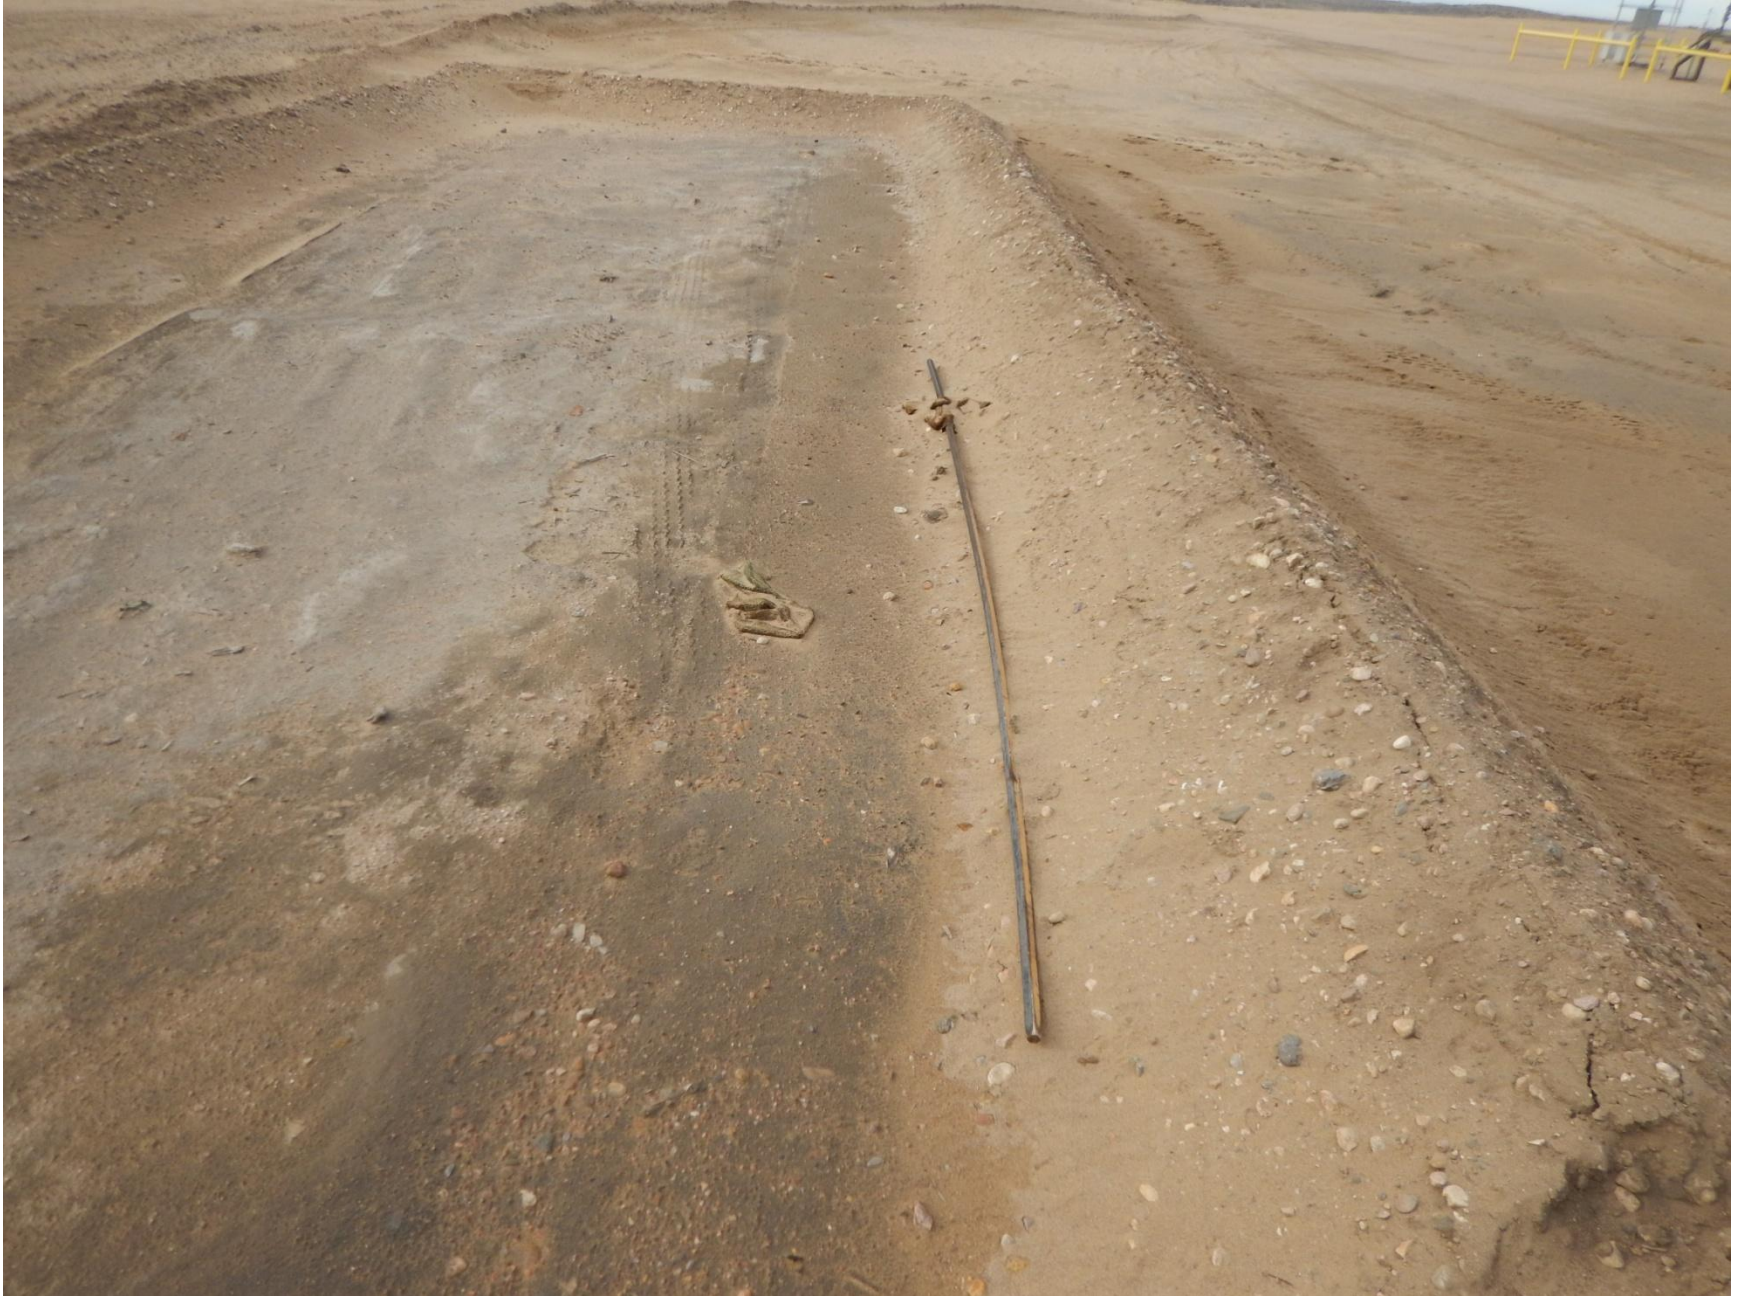
Figure 30: Photo taken from the south end of project area. Photo of trash debris on project area.
