USA-Clark – Millison 1

Inspection# 673402729

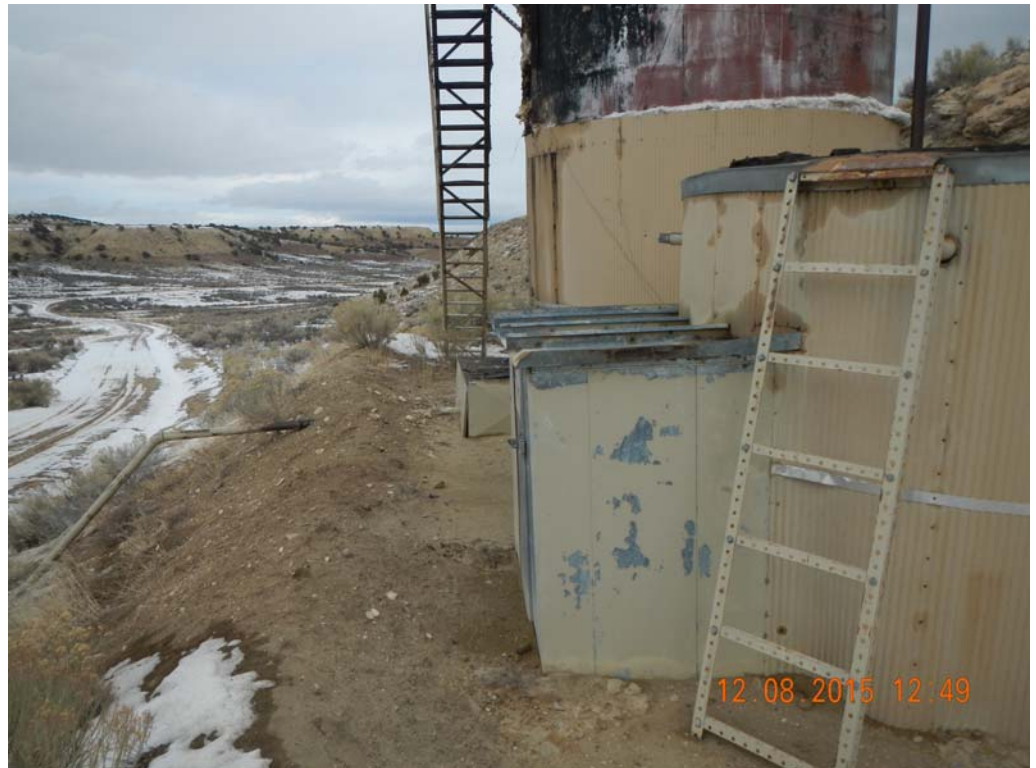
Inspection 673402729

Low berm.

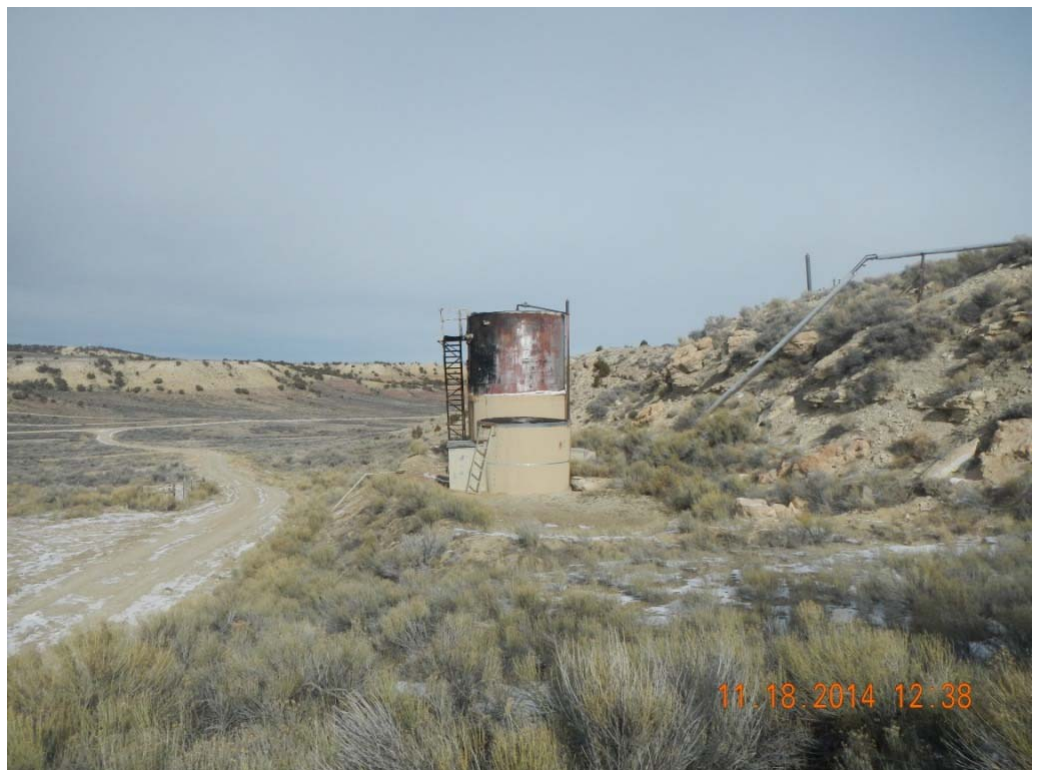
Inspection 673401414

Compromised and
overgrown berm.

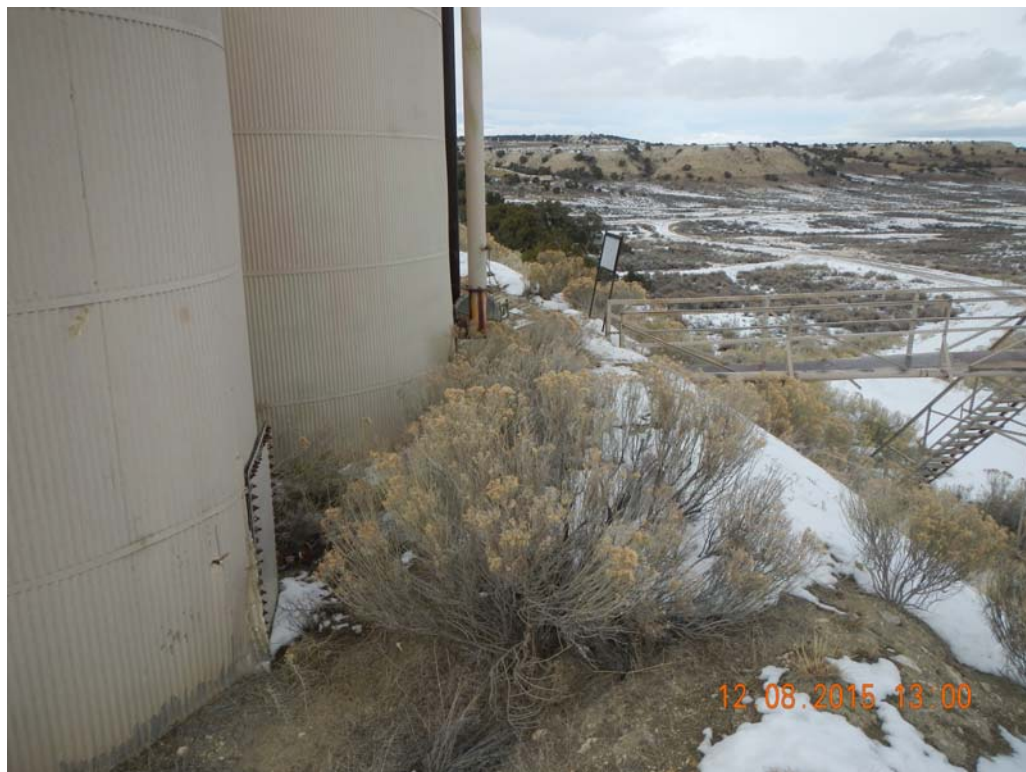
Inspection 673402729

Overgrown berm.

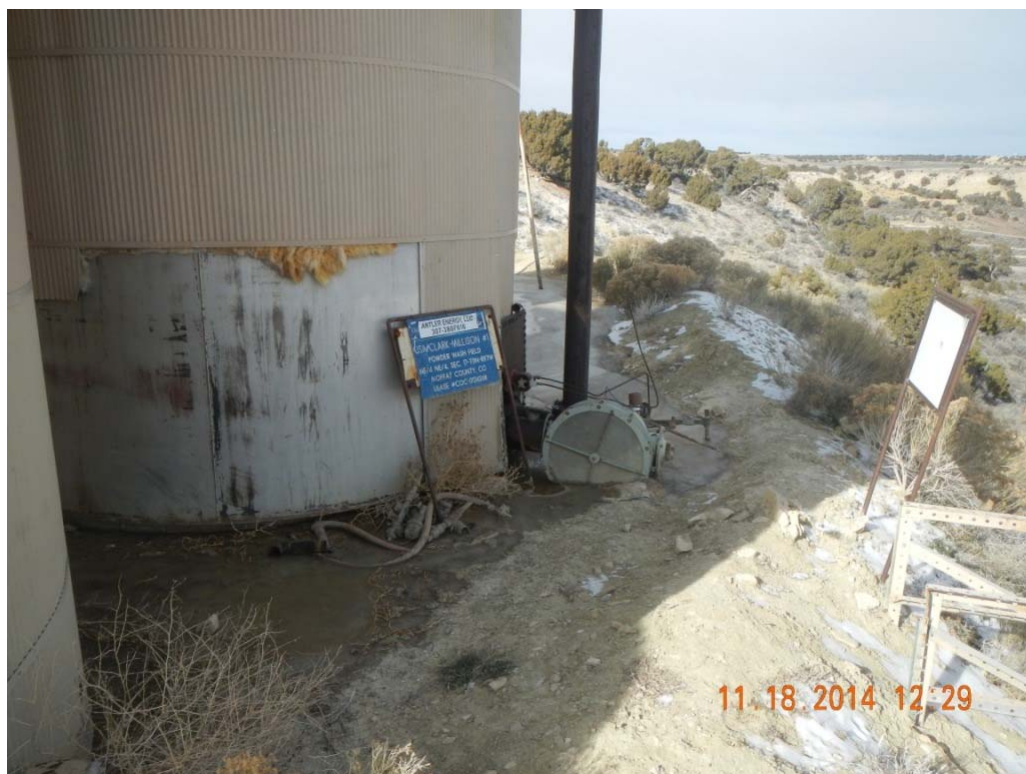
Inspection 673401414

Overgrown berm.

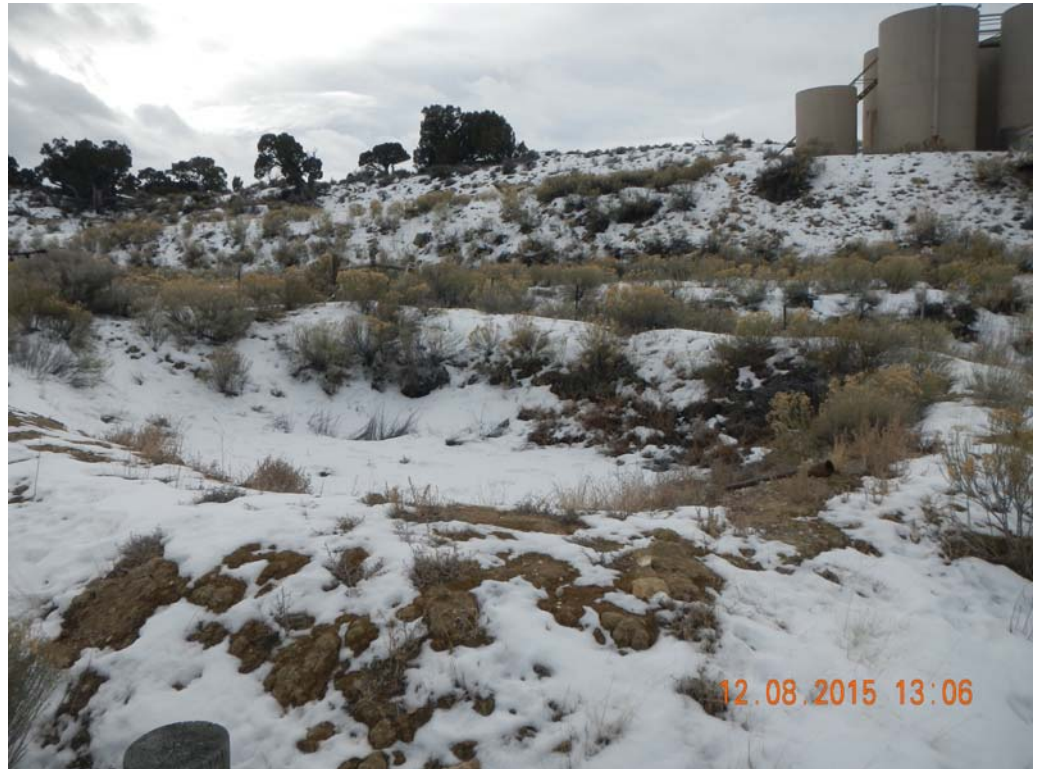
Inspection 673402729

Pit on east side of brown
tanks.

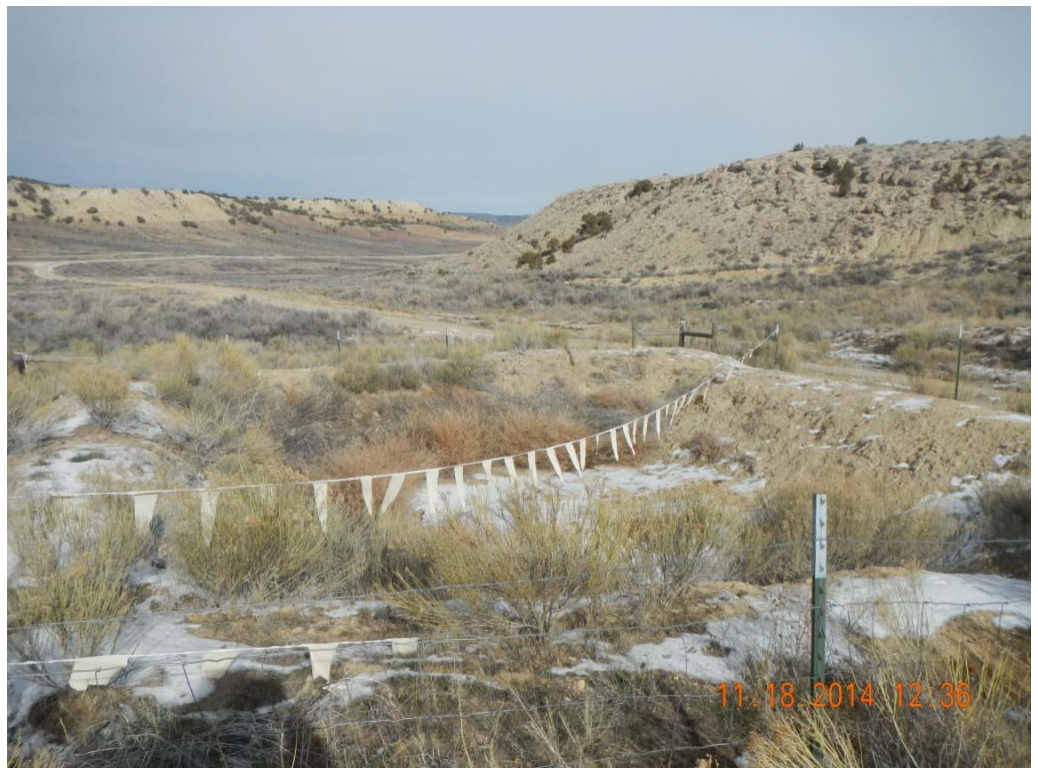
Inspection 673401414

Pit on east side of brown
tanks.

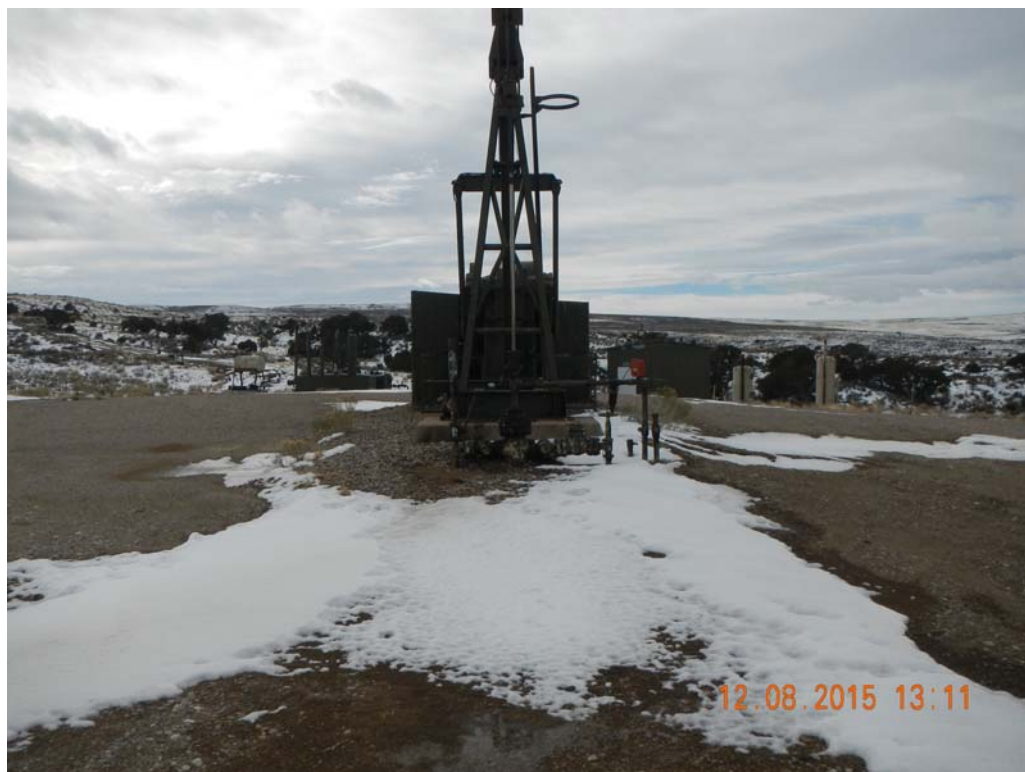
Inspection 673402729

No wellhead sign.

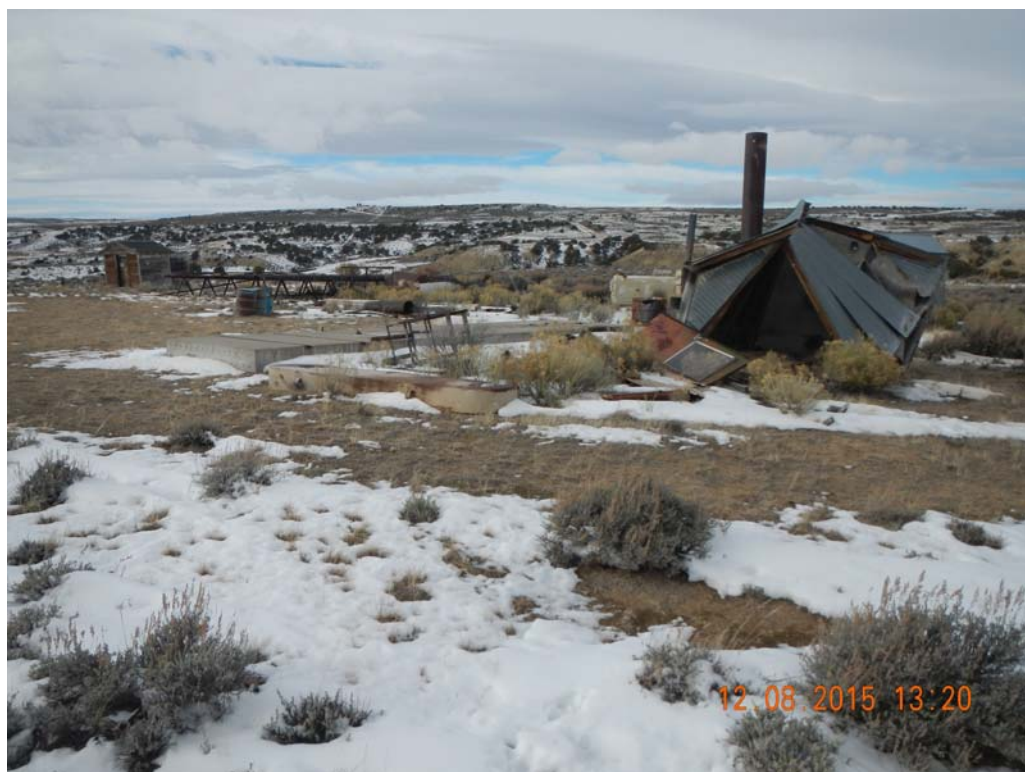
Inspection 673402729

Equipment stored on location.

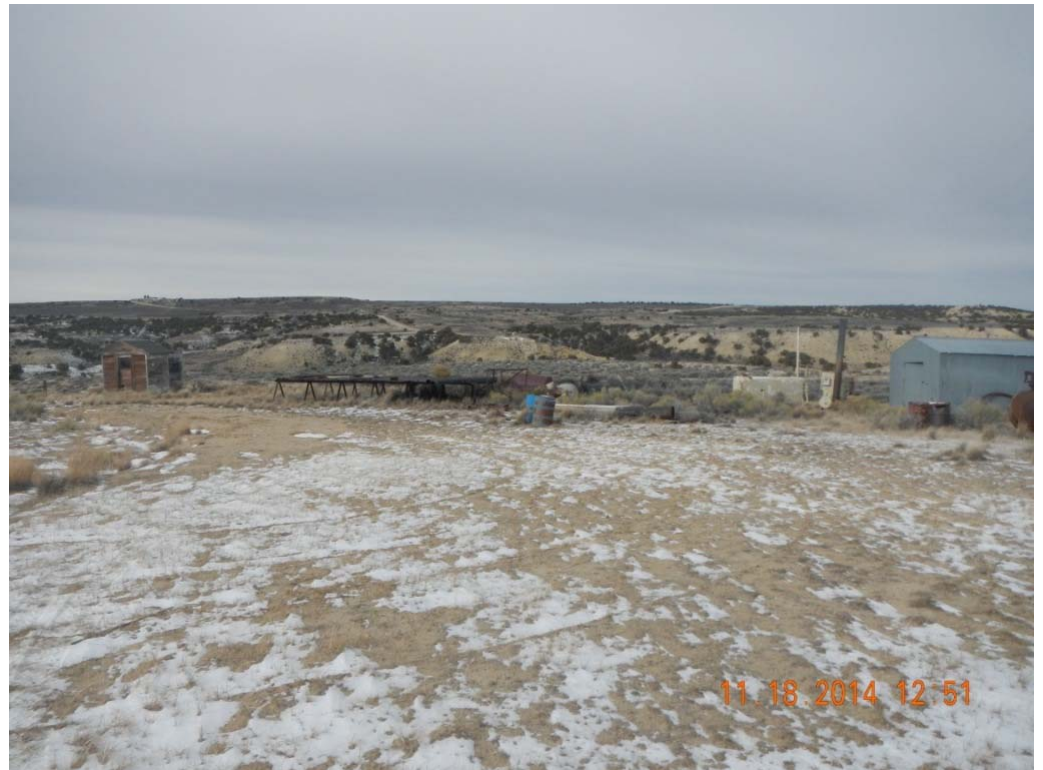
Inspection 673401414

Equipment stored on
location.

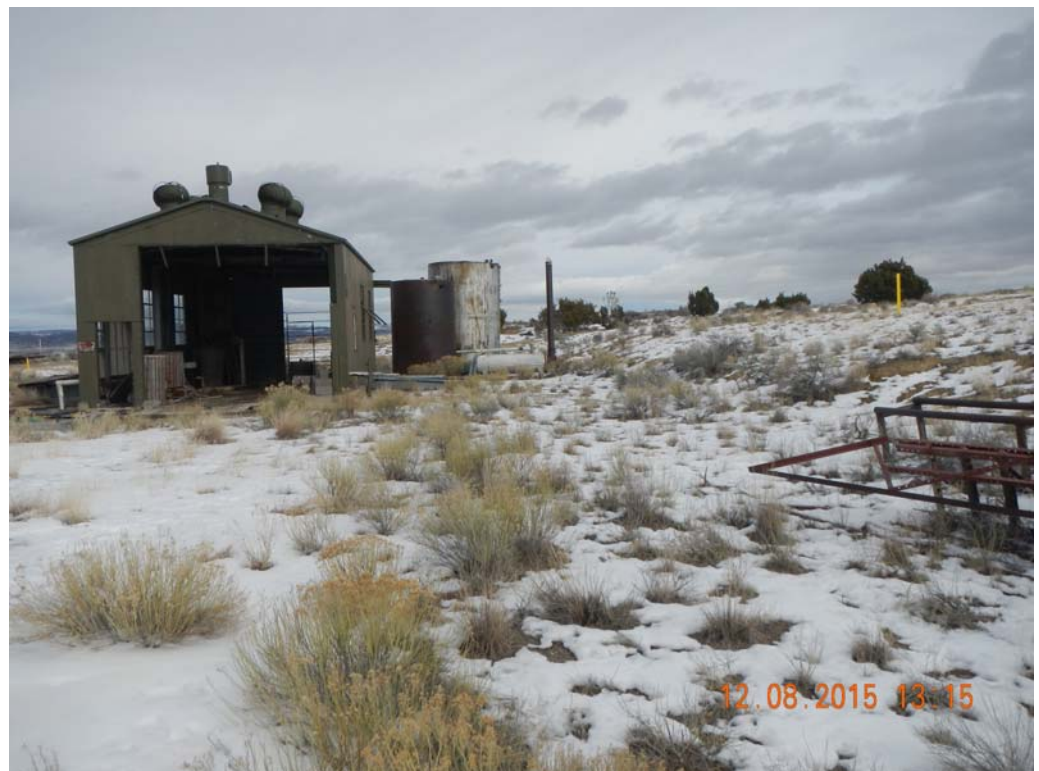
Inspection 673402729

Equipment stored on
location.

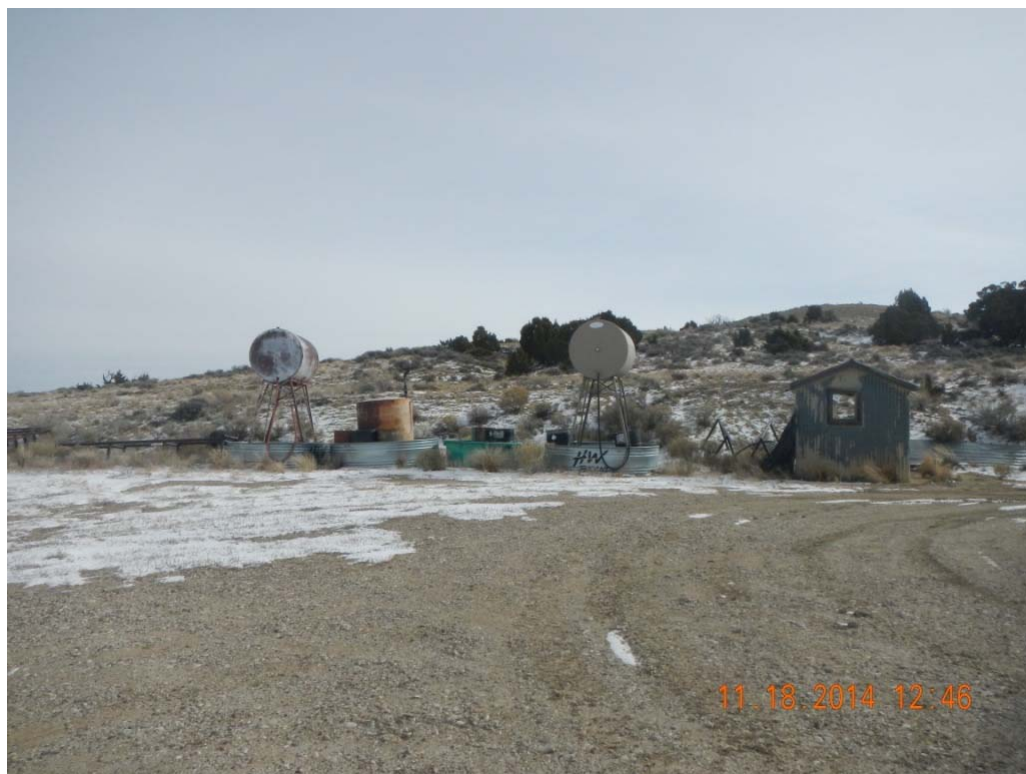
Inspection 673401414

Equipment stored on
location.

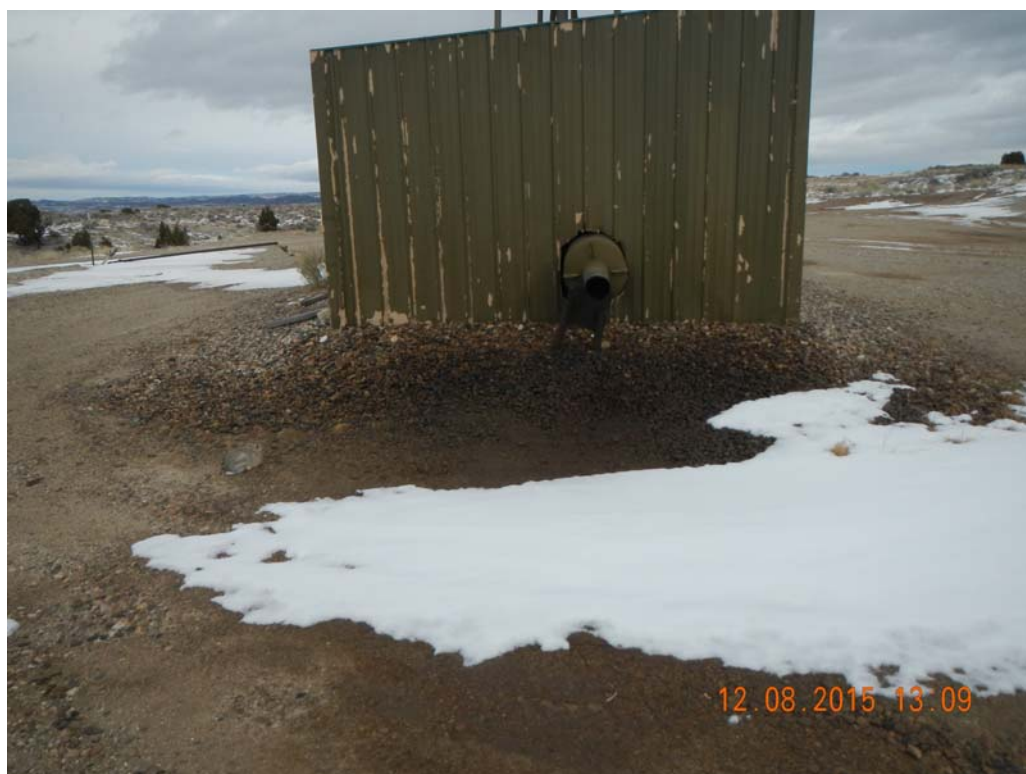
Inspection 673402729

Stained soil from pumpjack
exhaust.

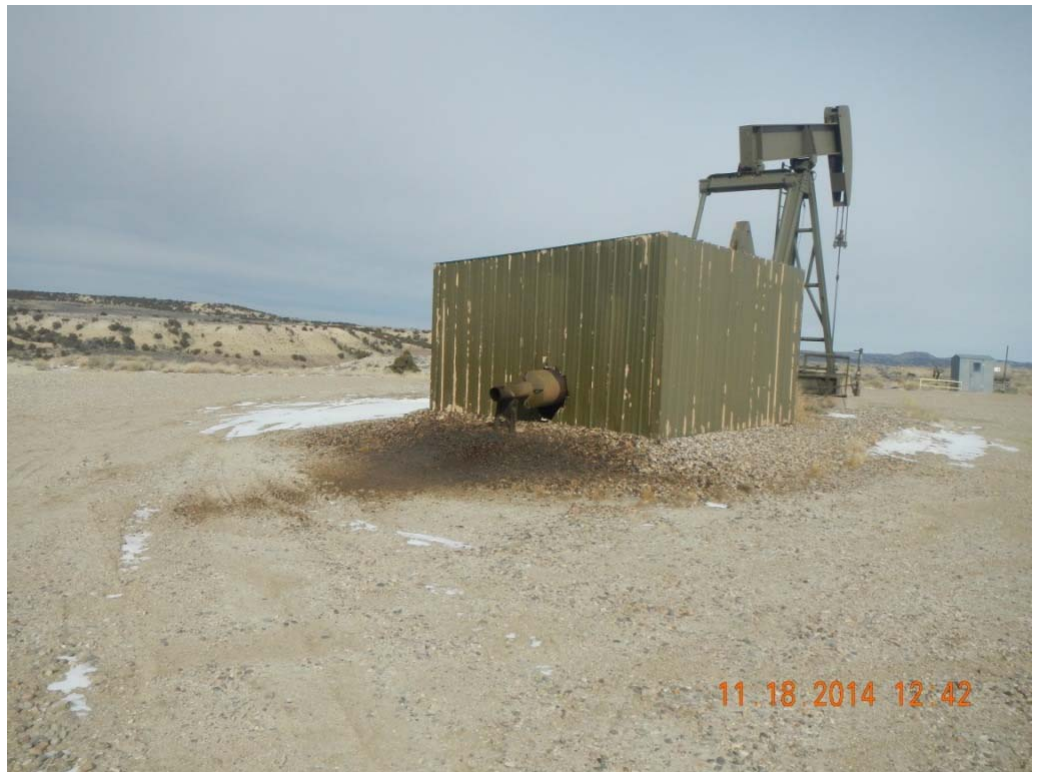
Inspection 673401414

Stained soil from pumpjack
exhaust.

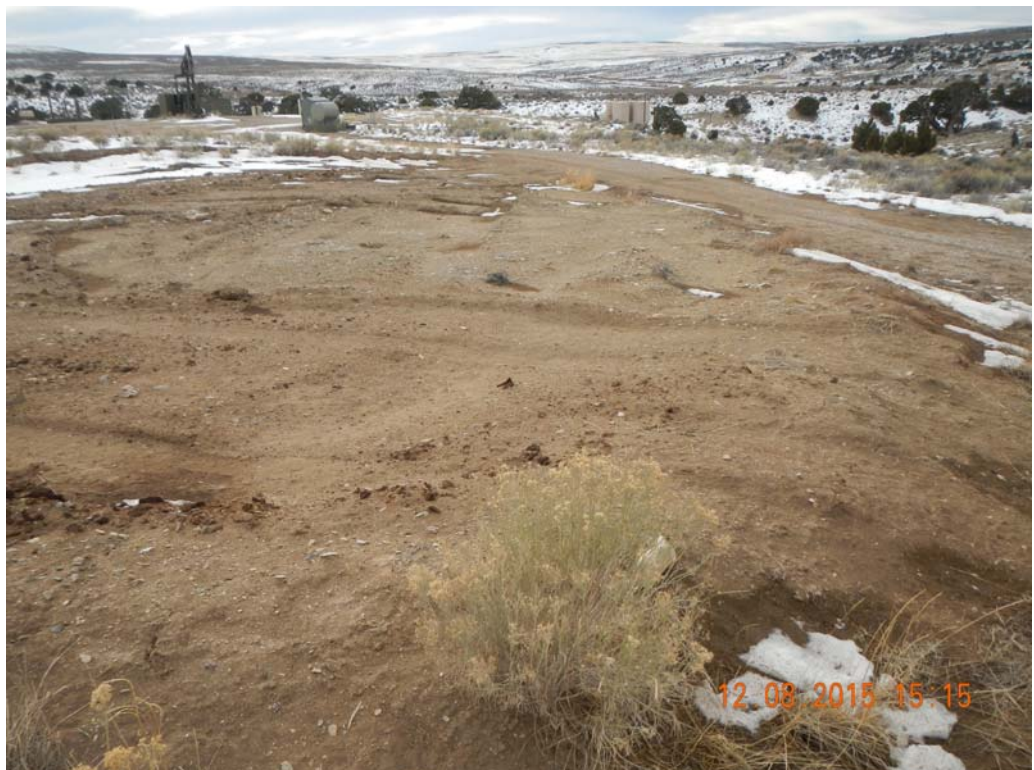
Inspection 673402729

Landfarm area.

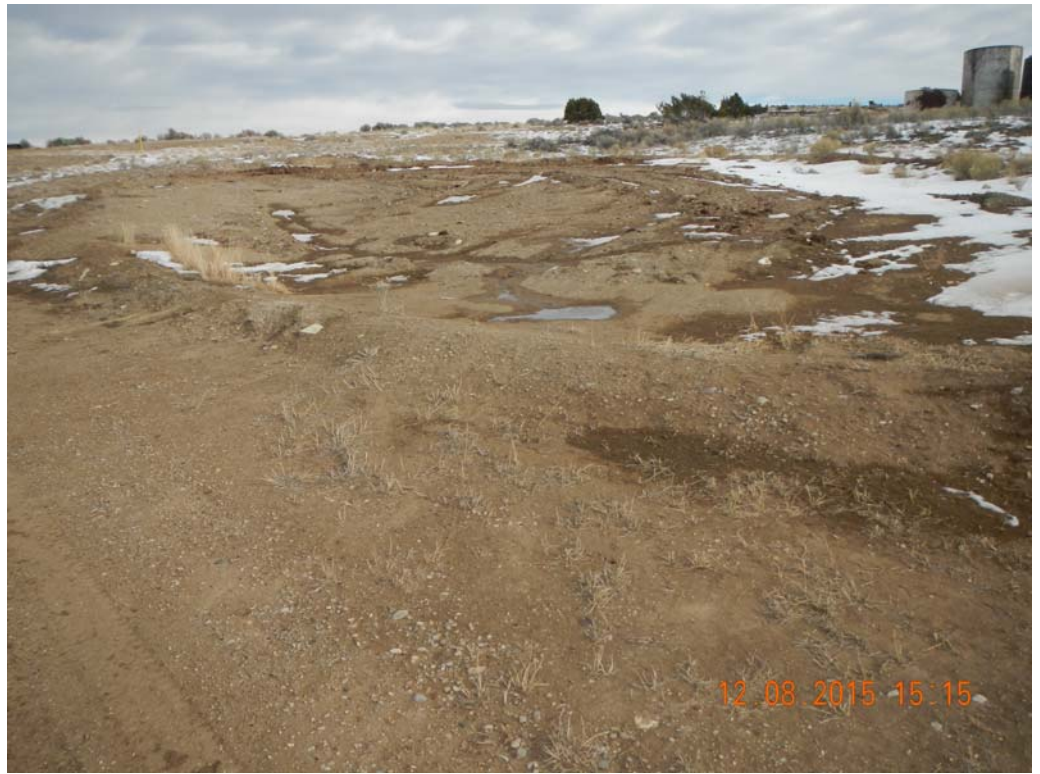
Inspection 673402729

Landfarm with sediment
leaving bermed area and
migrating off location.
Equipment storage in
background.

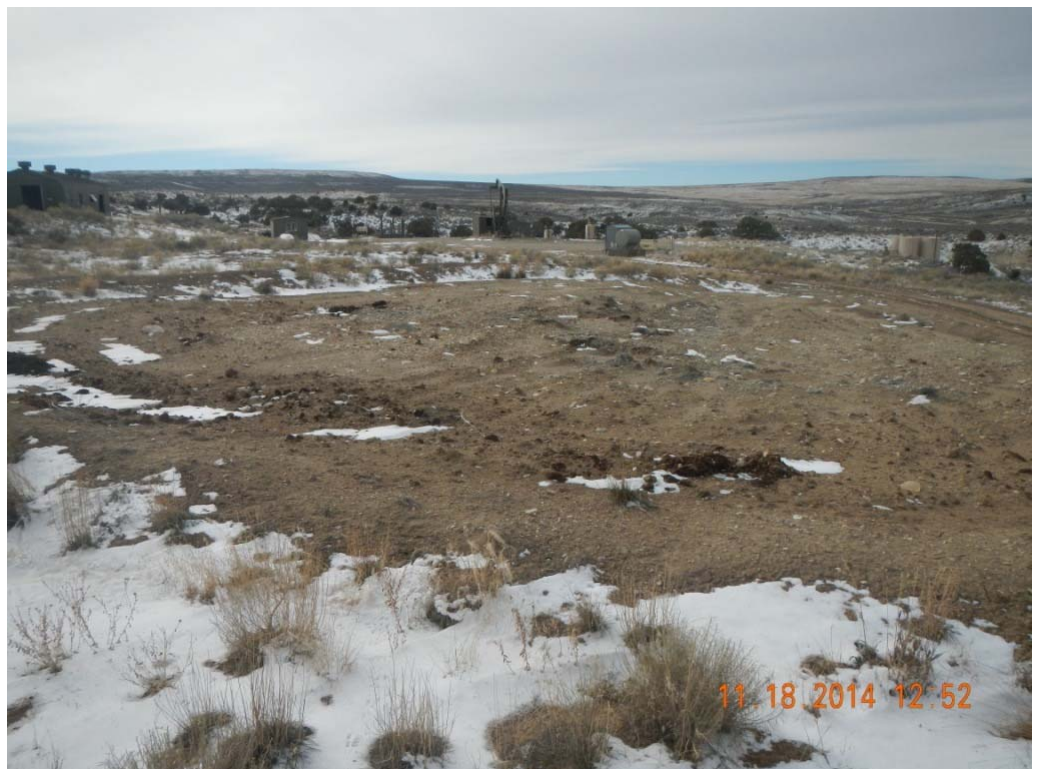
Inspection 673401414

Landfarm area.
