Interim Reclamation Inspection

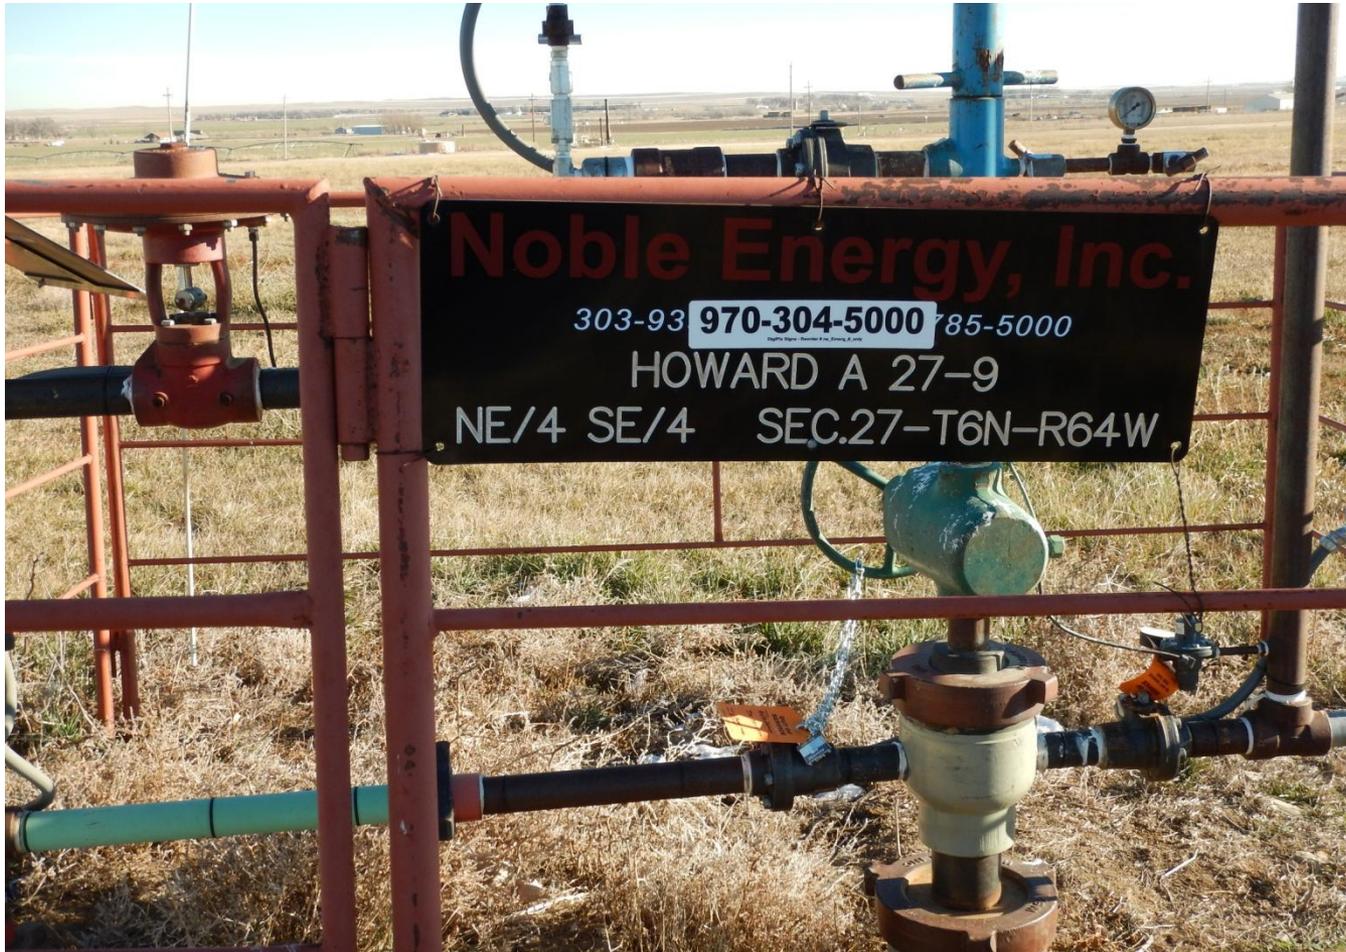
Photo 1. Photo taken of well sign for 123-22832.

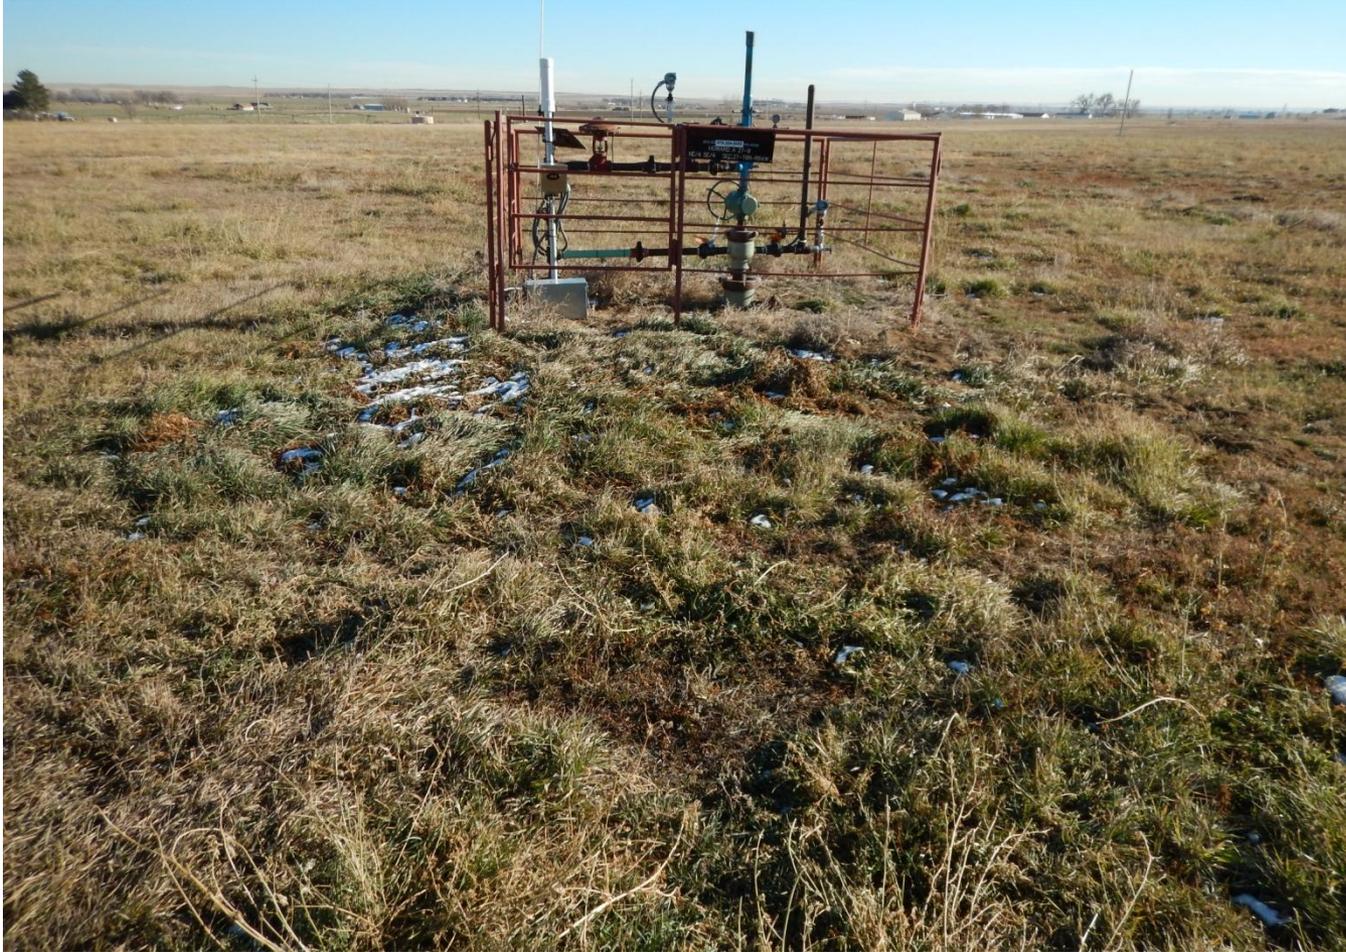
Photo 2. Photo taken from northern location, facing South. Interim vegetative growth is representative of the reference area.

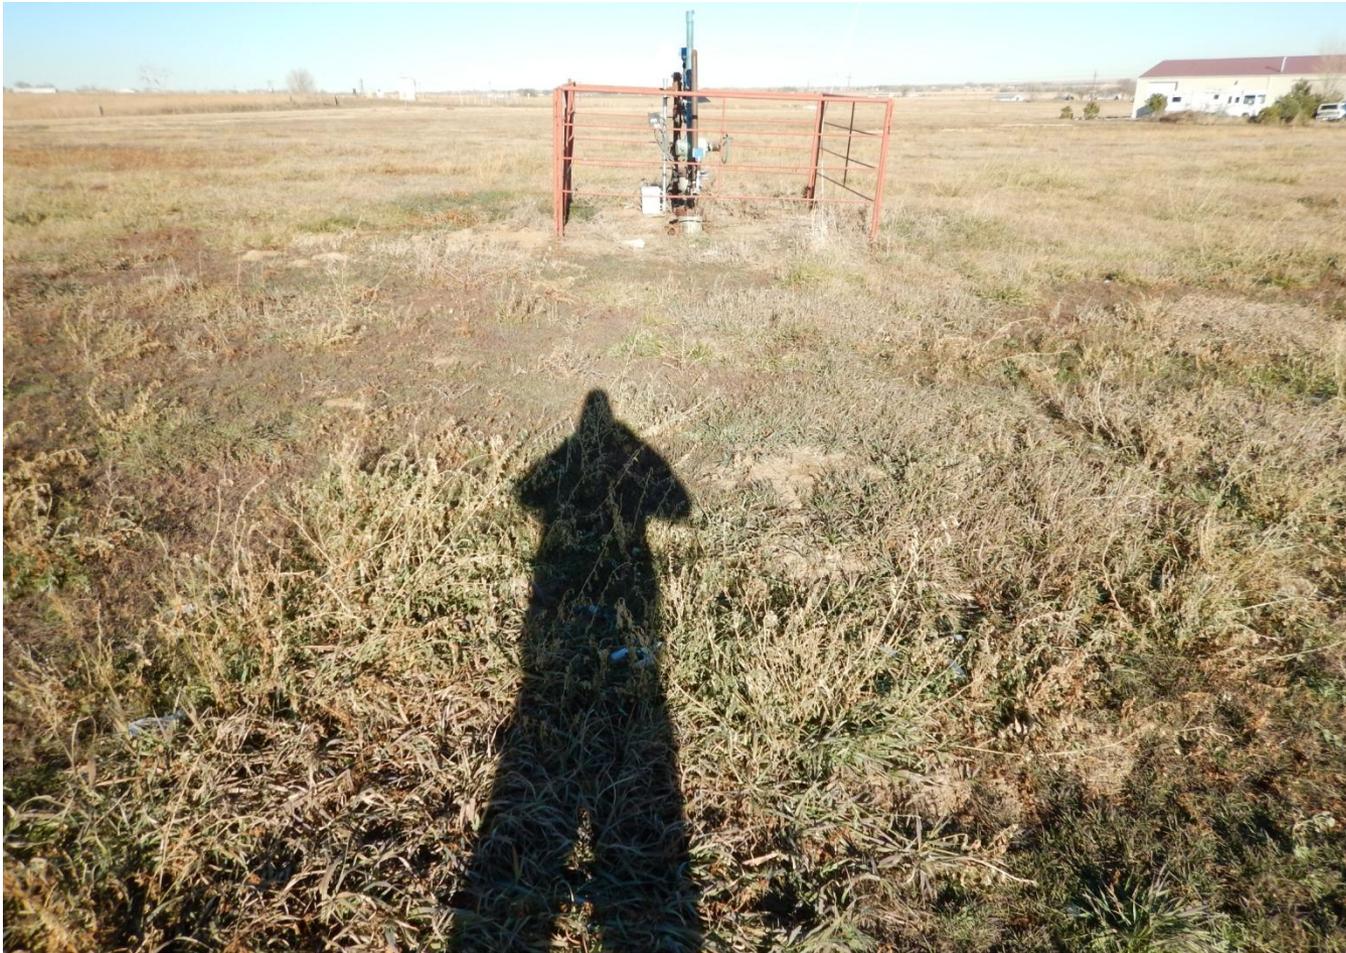
Photo 3. Photo taken from western location, facing East. Interim vegetative growth is representative of the reference area.

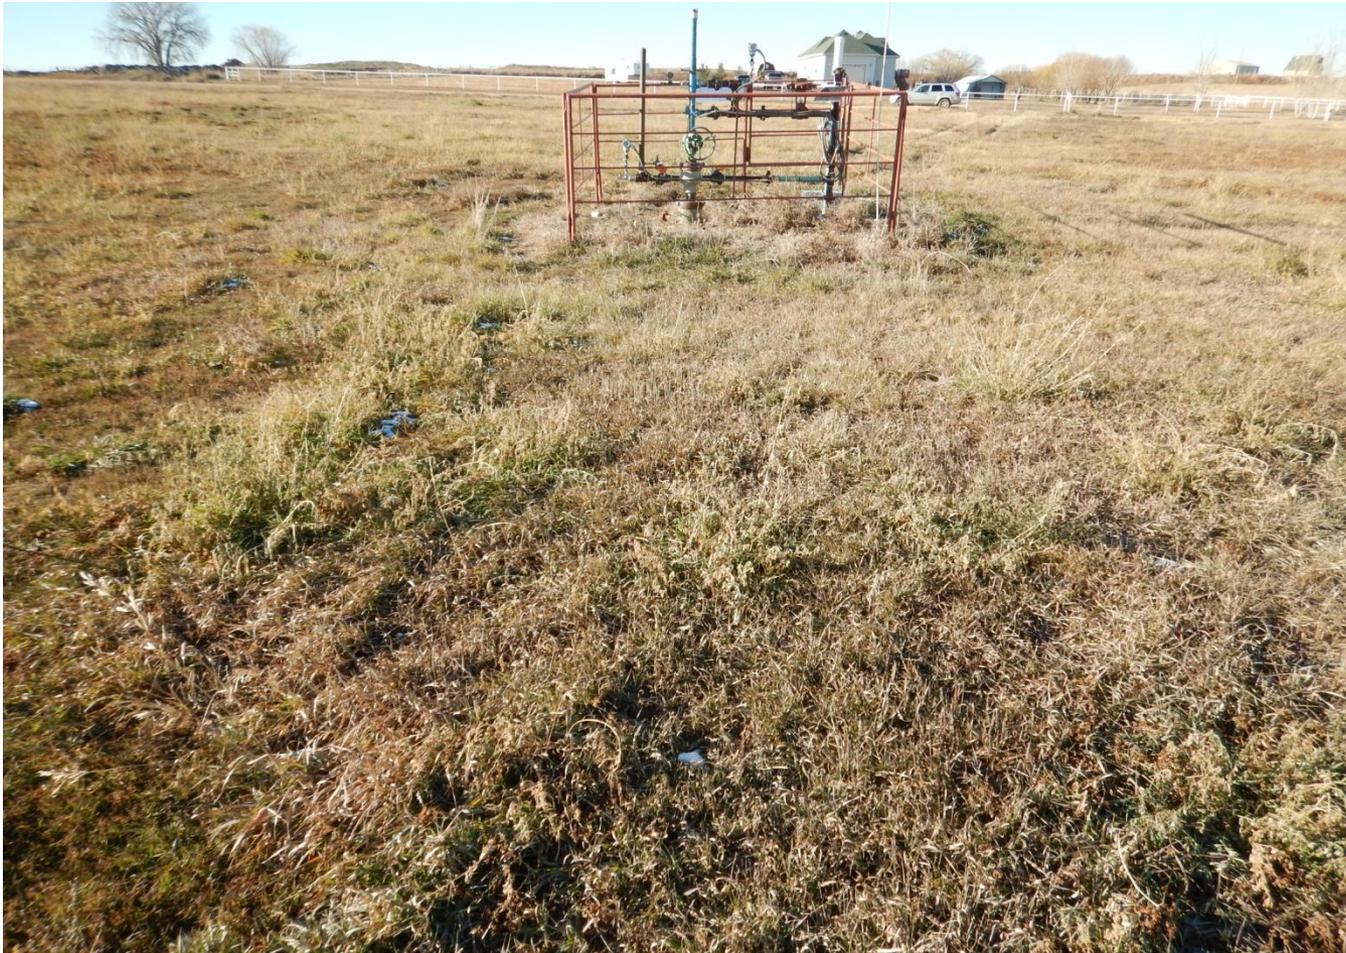
Photo 4. Photo taken from southern location, facing North. Interim vegetative growth is representative of the reference area.

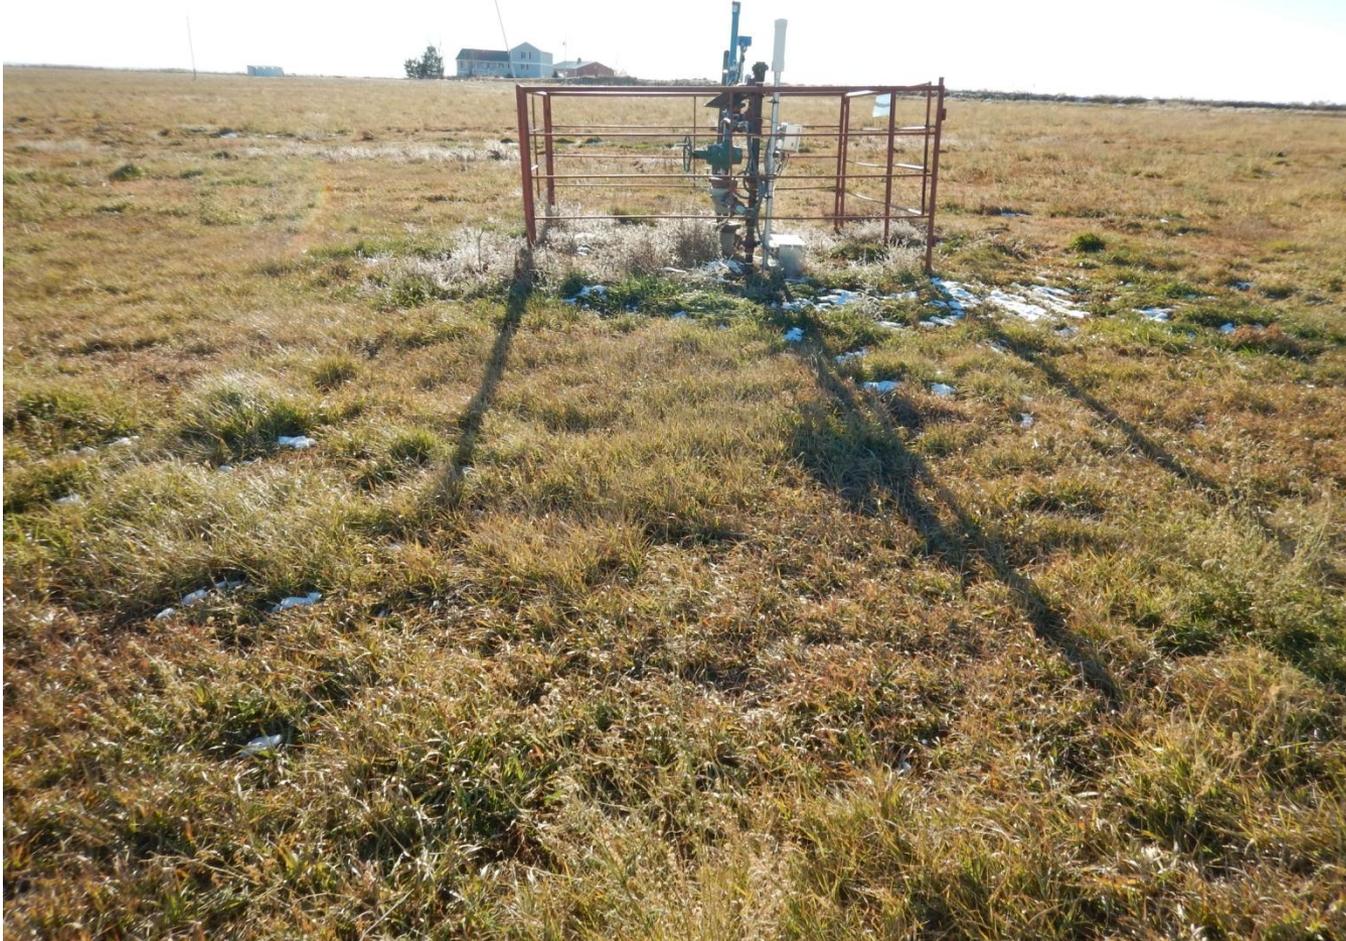
Photo 5. Photo taken from eastern location, facing West. Interim vegetative growth is representative of the reference area.

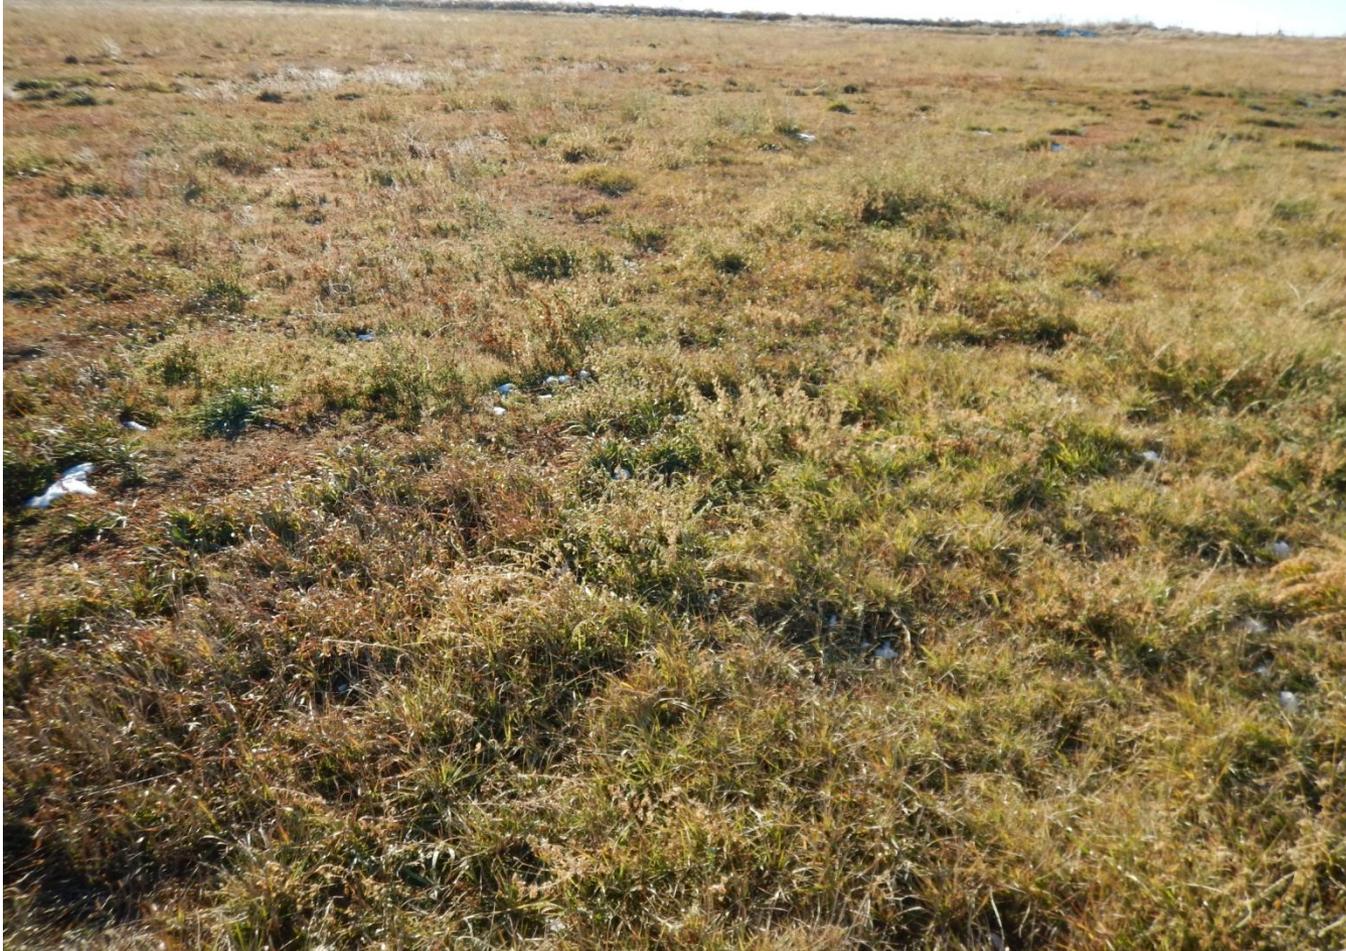
Photo 6. Reference photo taken 50 meters northwest of 123-22832 . Reference area vegetative growth is representative of the interim area-123-22832.
