## Construction Inspection

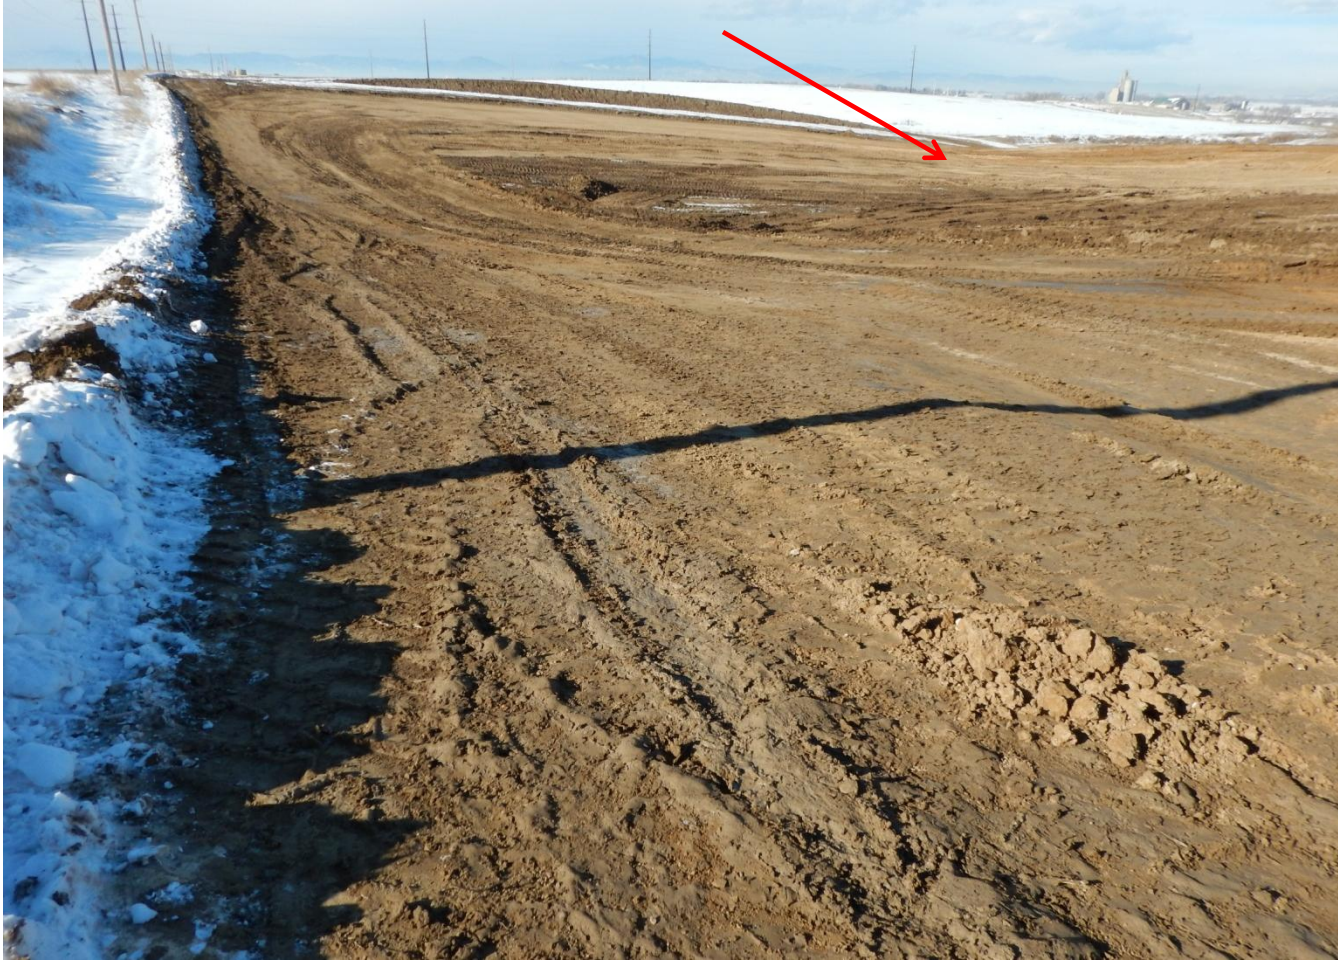
**Photo 1.** Photo taken from west drill pad, facing West. Notice the slope funnels towards the northwest.

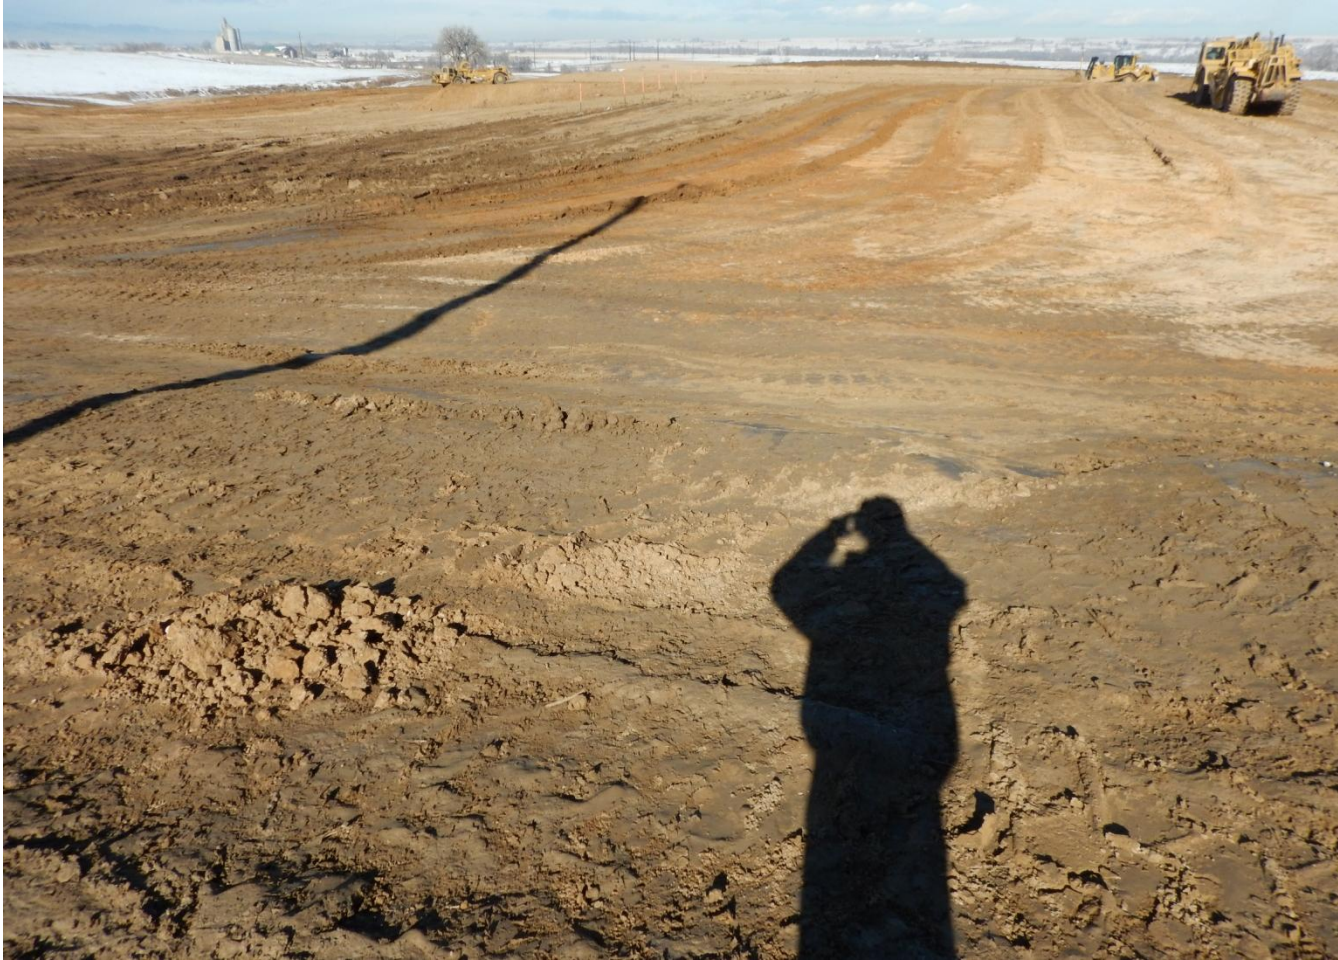
**Photo 2.** Photo taken from west drill pad, facing North. Construction underway.

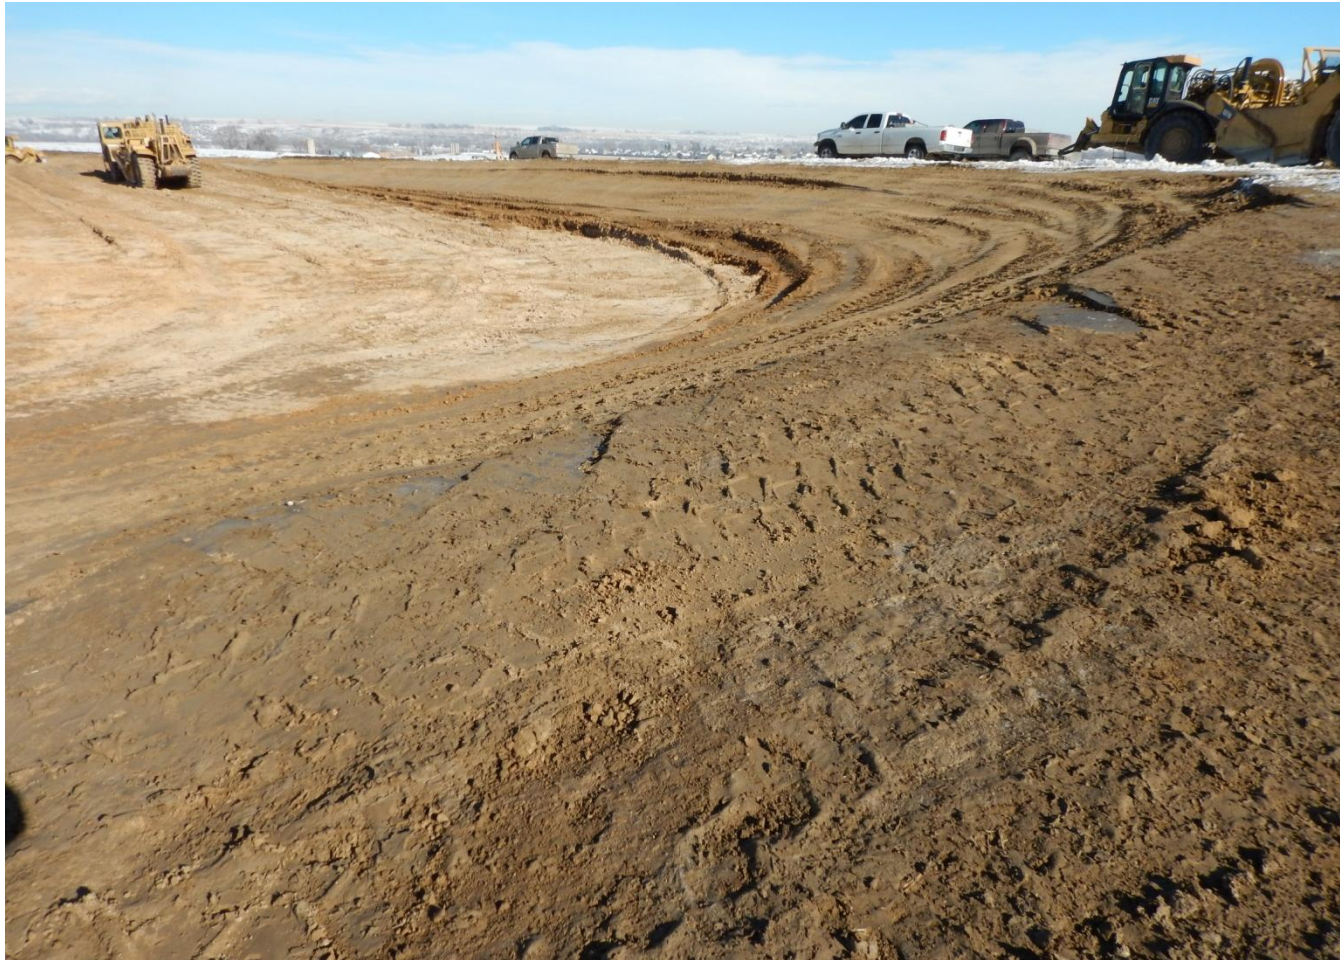
**Photo 3.** Photo taken from west drill pad, facing Northeast. Construction underway.

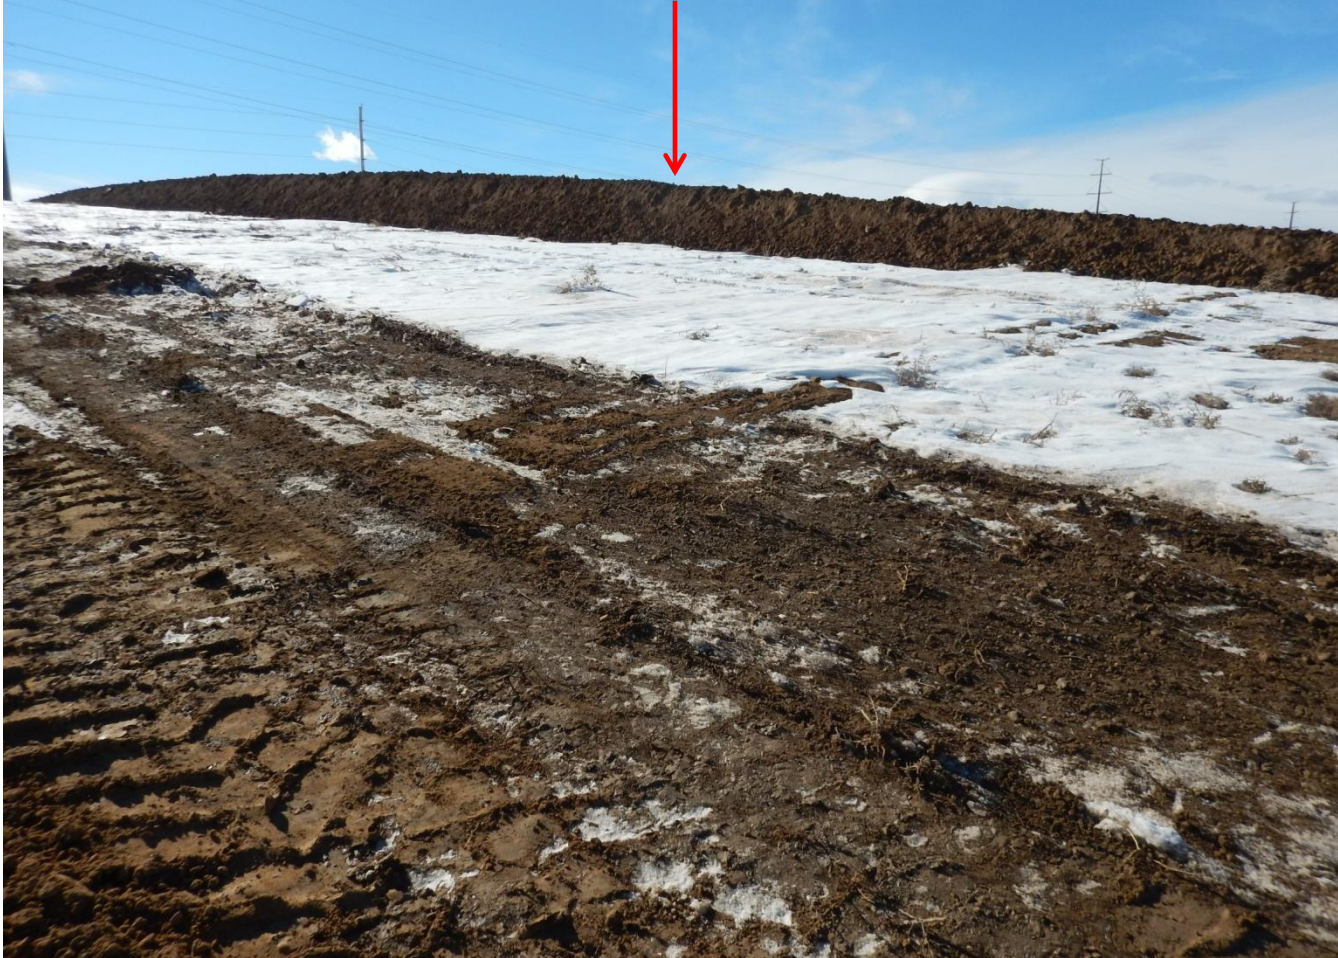
**Photo 4.** Photo taken from western area of west drill pad, facing West. Topsoil stockpile in center of photo.

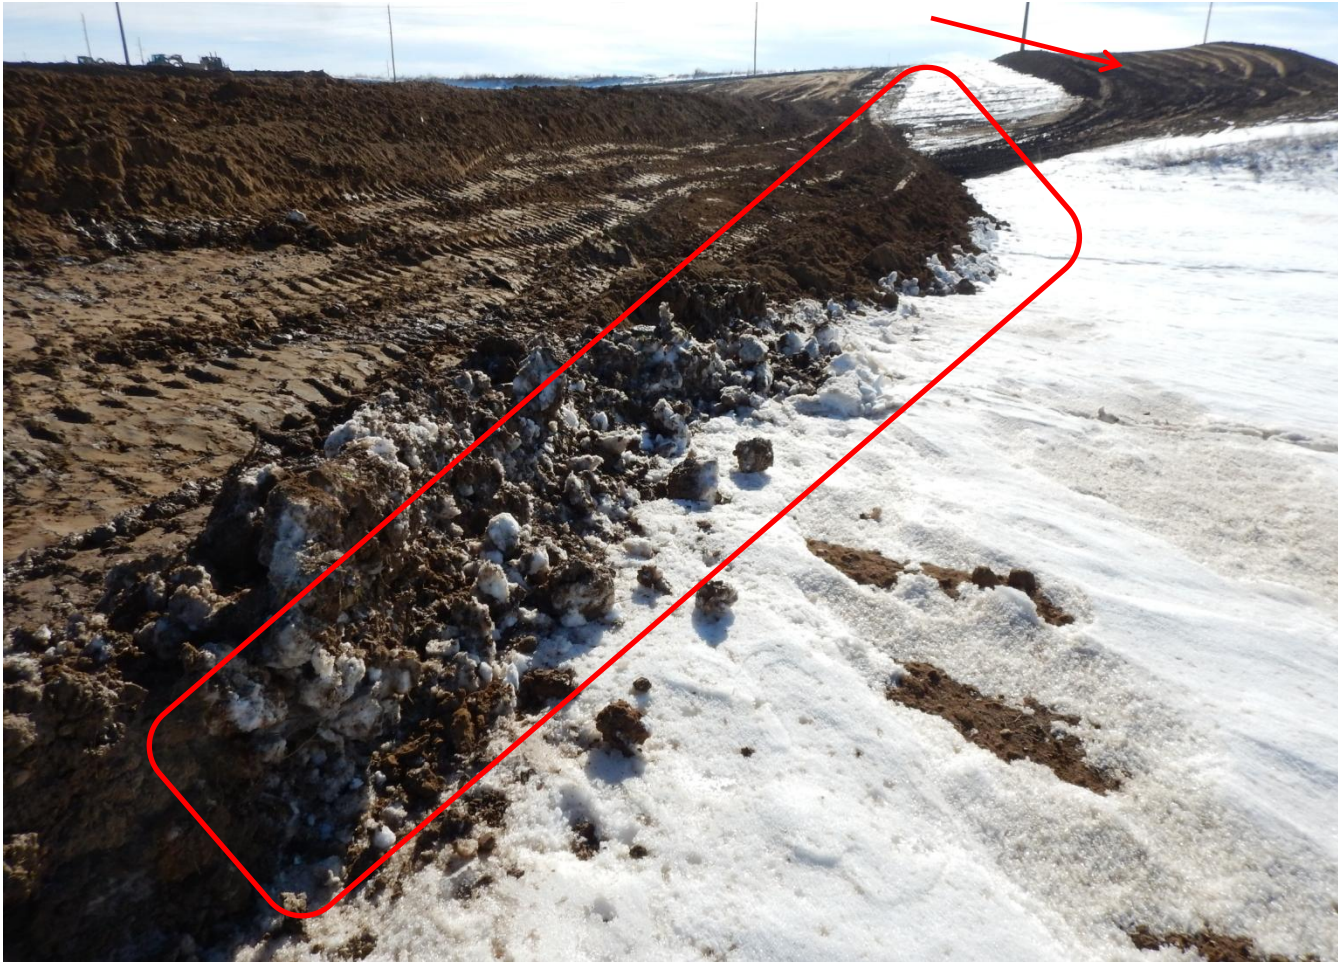
**Photo 5.** Photo taken from western area of west drill pad, facing South. Topsoil stockpile towards the right of the picture. Stormwater BMPs have not been installed prior to construction.

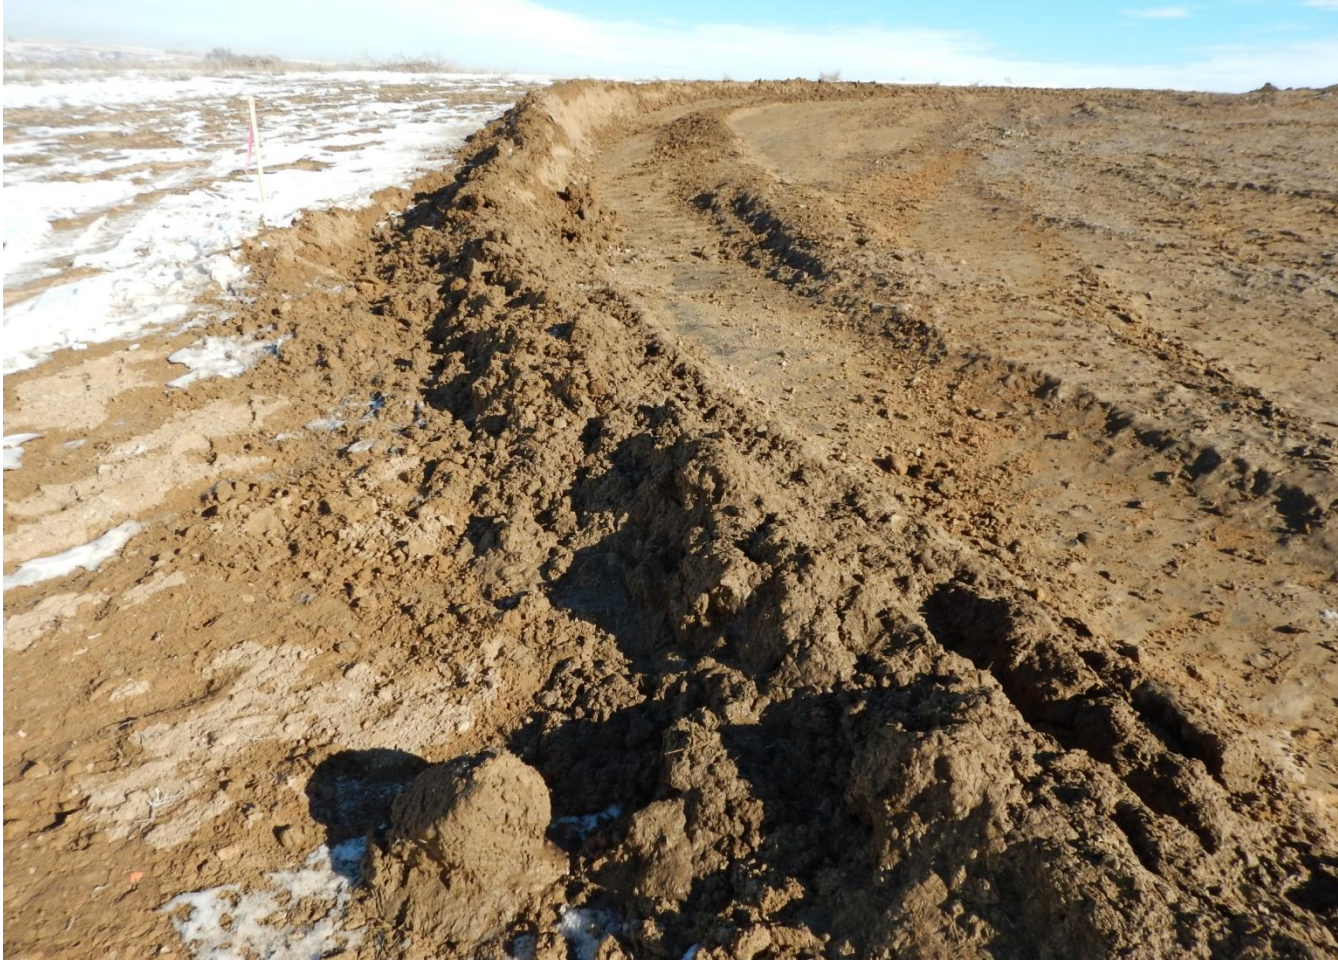
**Photo 6.** Photo taken from northwestern area of west drill pad, facing North. Stormwater BMPs have not been installed prior to construction.

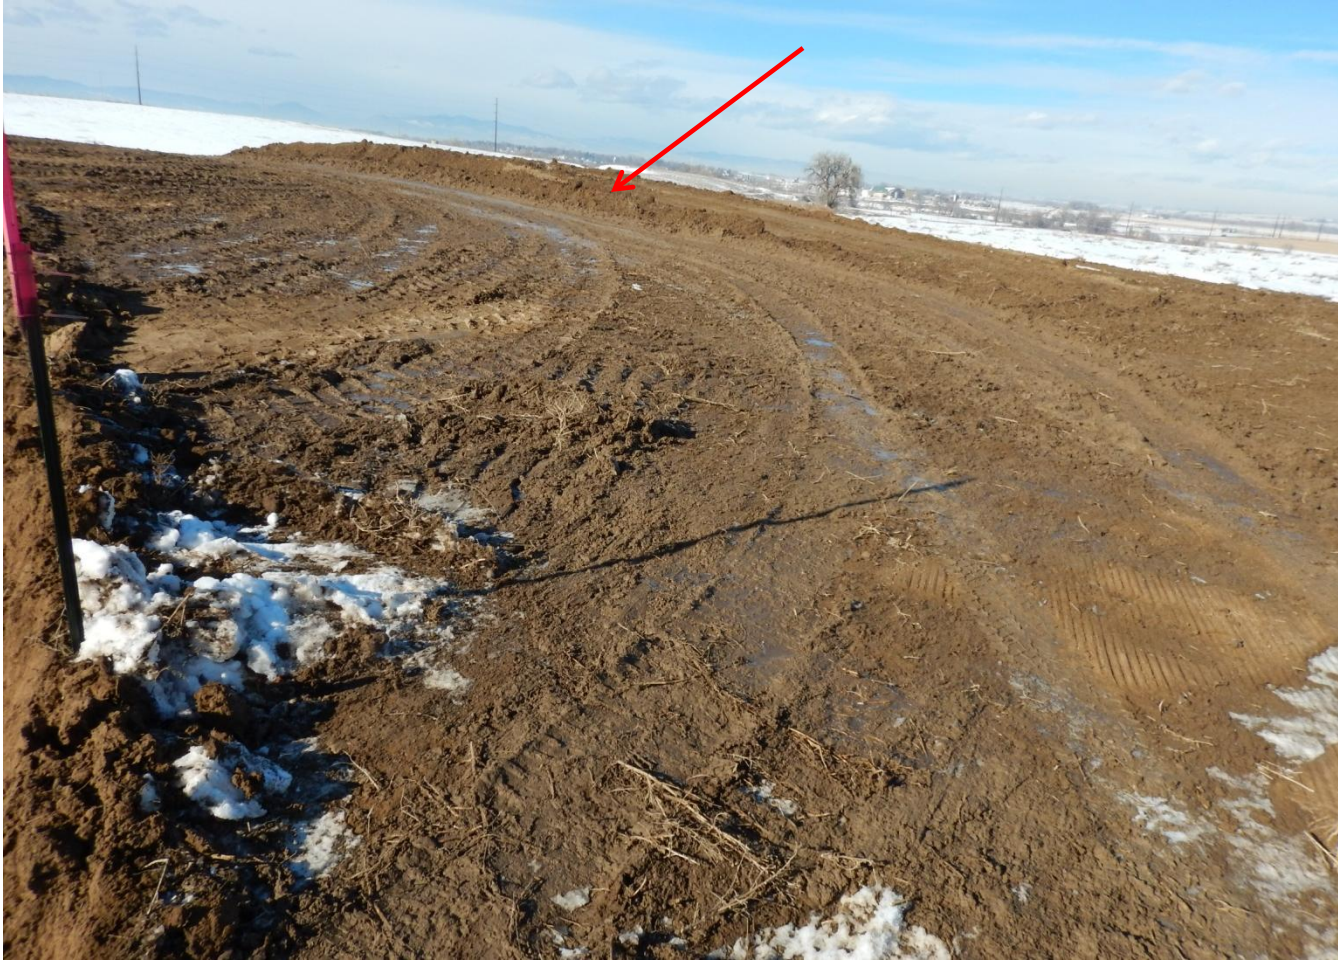
**Photo 7.** Photo taken from northern area of west drill pad, facing West. Topsoil stockpile towards the right of the picture.
