Construction Inspection

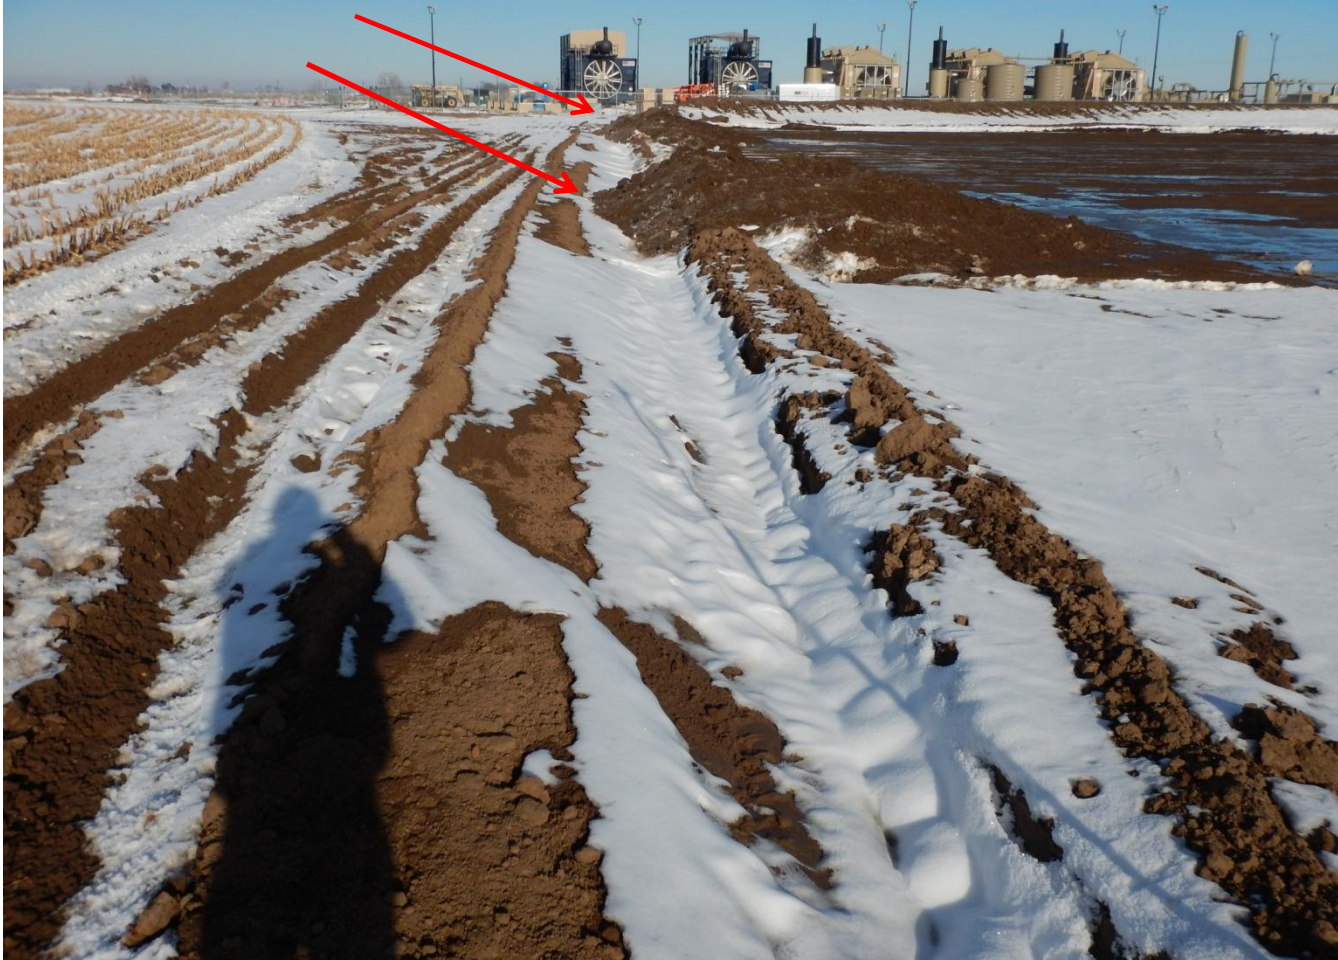
Photo 1. Photo taken from western location, facing North. Stormwater BMP installed in center of photo. DO NOT scrape sediment into stormwater ditches. Stormwater ditches need to be maintained. Refer to close up photos 2-3.

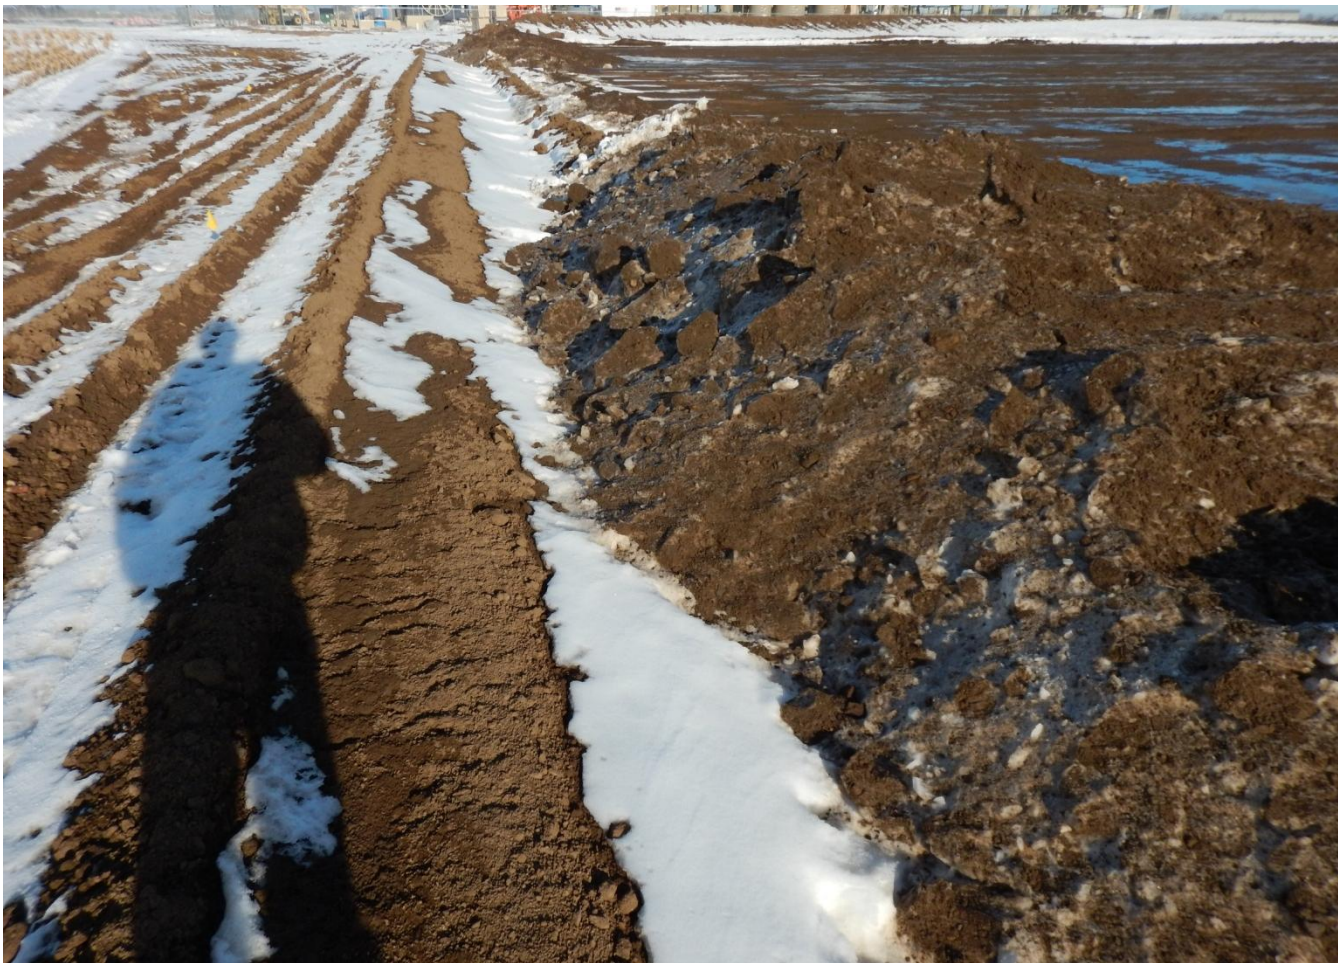
Photo 2. Photo taken from western location, facing North. DO NOT scrape sediment into stormwater ditches. Stormwater ditches need to be maintained.

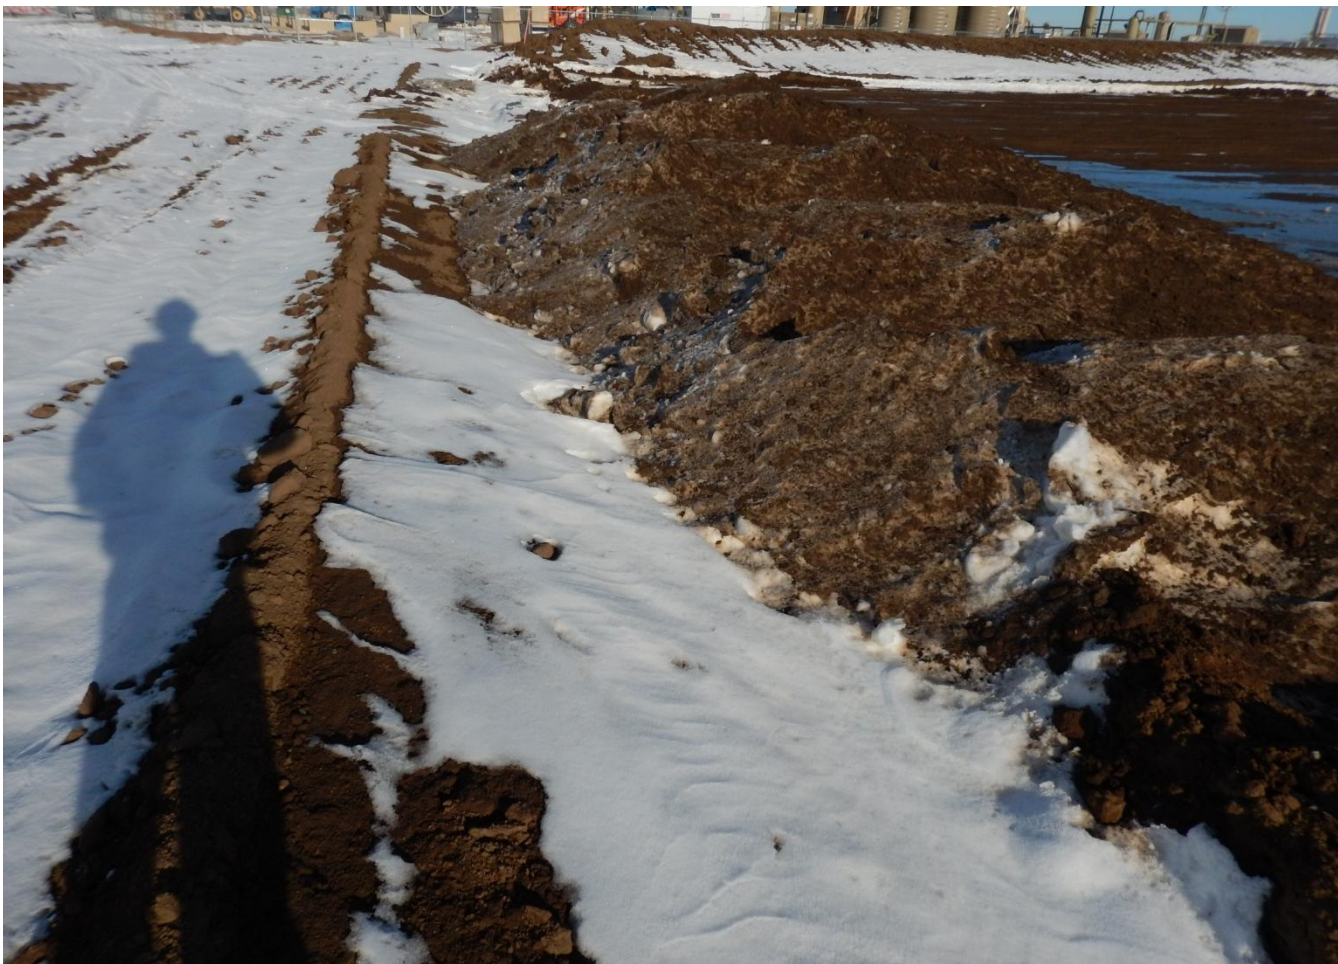
Photo 3. Photo taken from western location, facing North. DO NOT scrape sediment into stormwater ditches. Stormwater ditches need to be maintained.

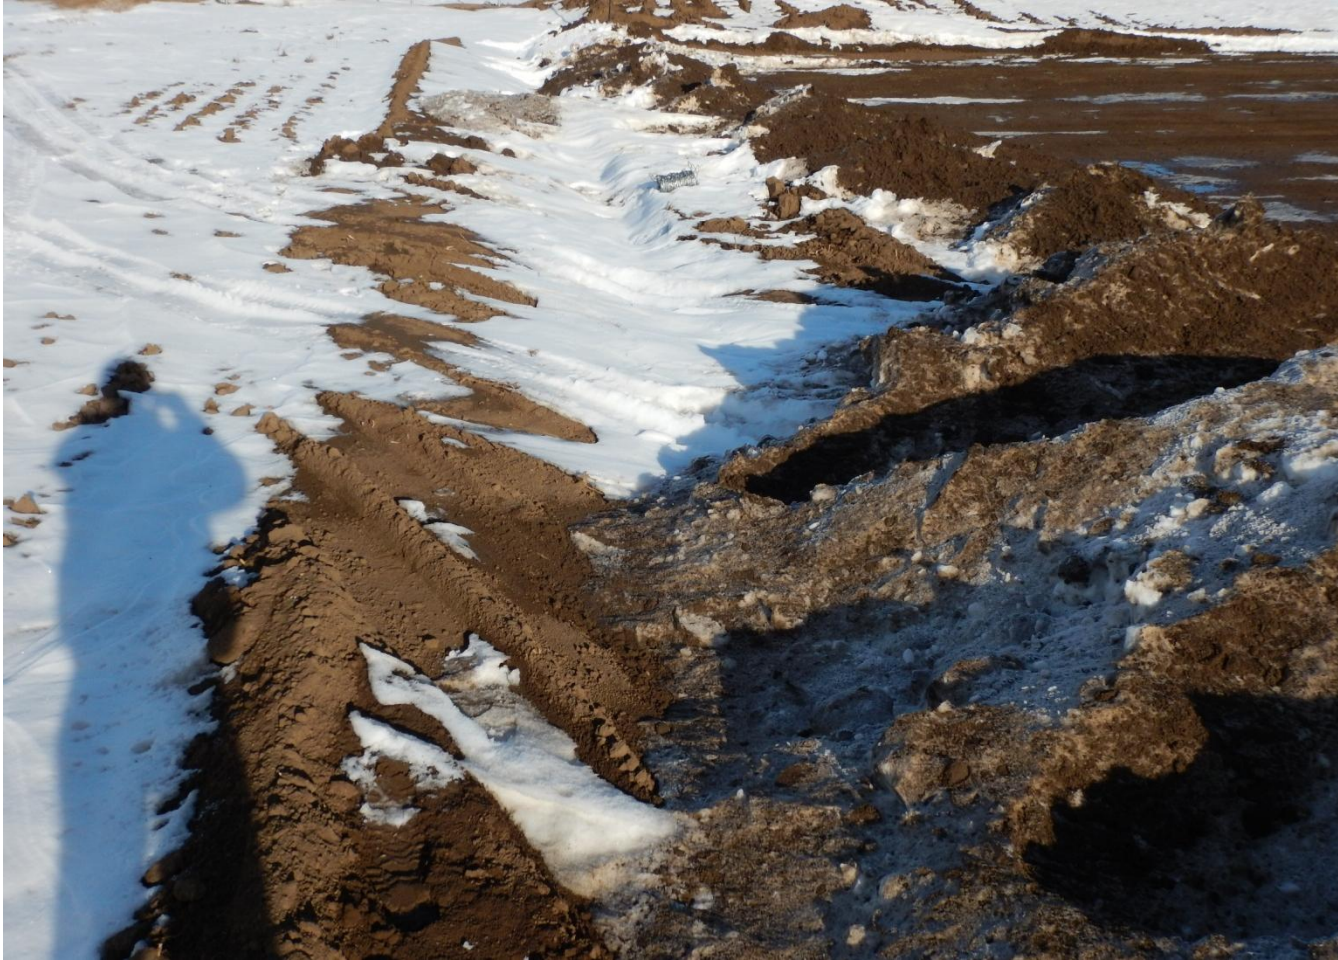
Photo 4. Photo taken from western location, facing North. Only access/exit southern main location. Western vehicle traffic is damaging stormwater ditches. Stormwater ditches need to be maintained.

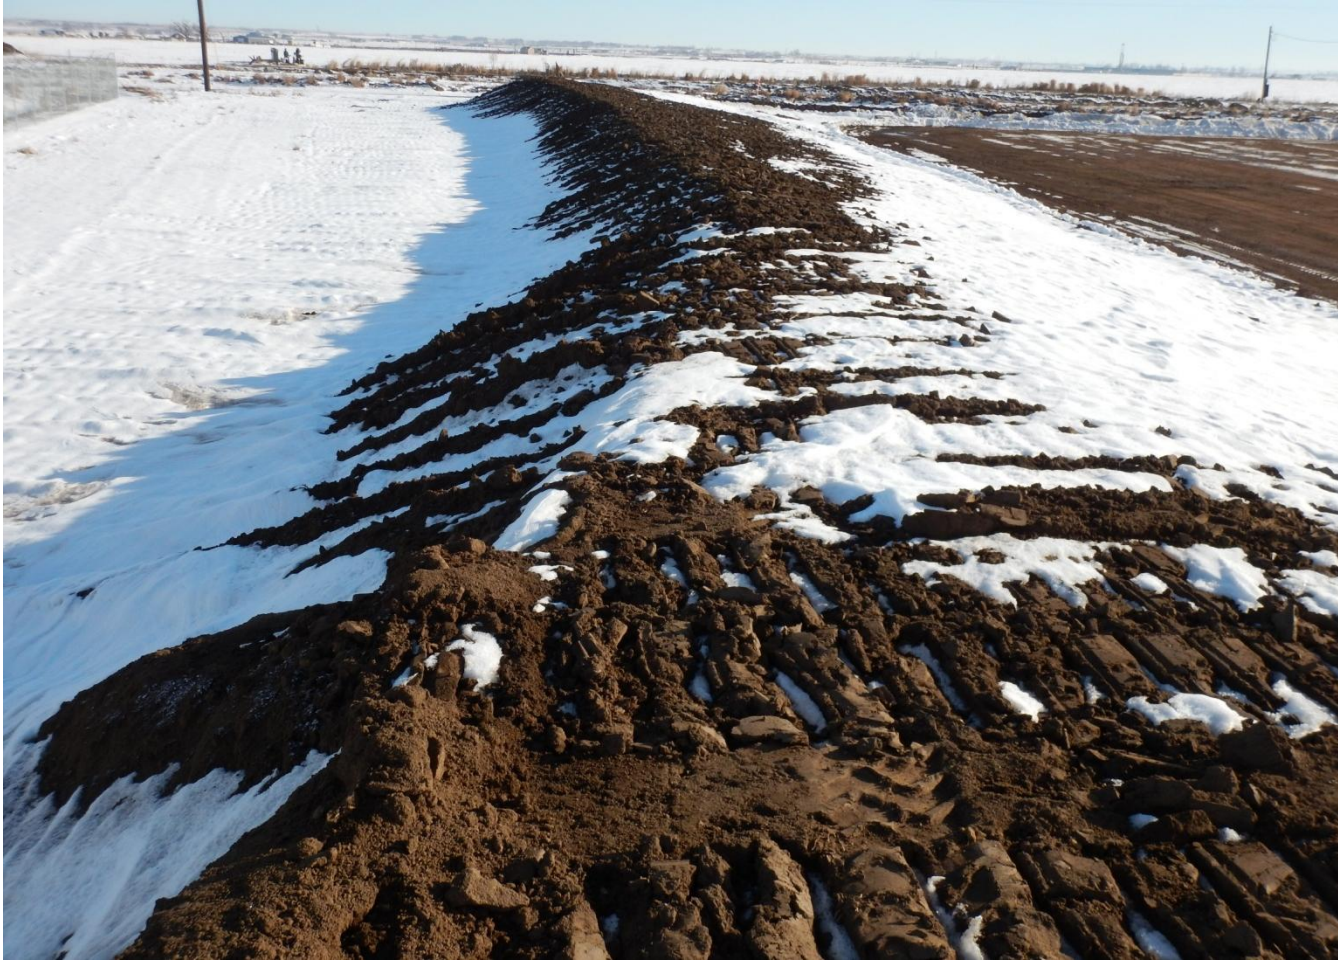
Photo 5. Photo taken from northern location, facing East. Topsoil stockpile located in center of photo.
