# Follow Up Inspection

12/21/2015

Operator: Wiepking-Fullerton

Location ID: 443145

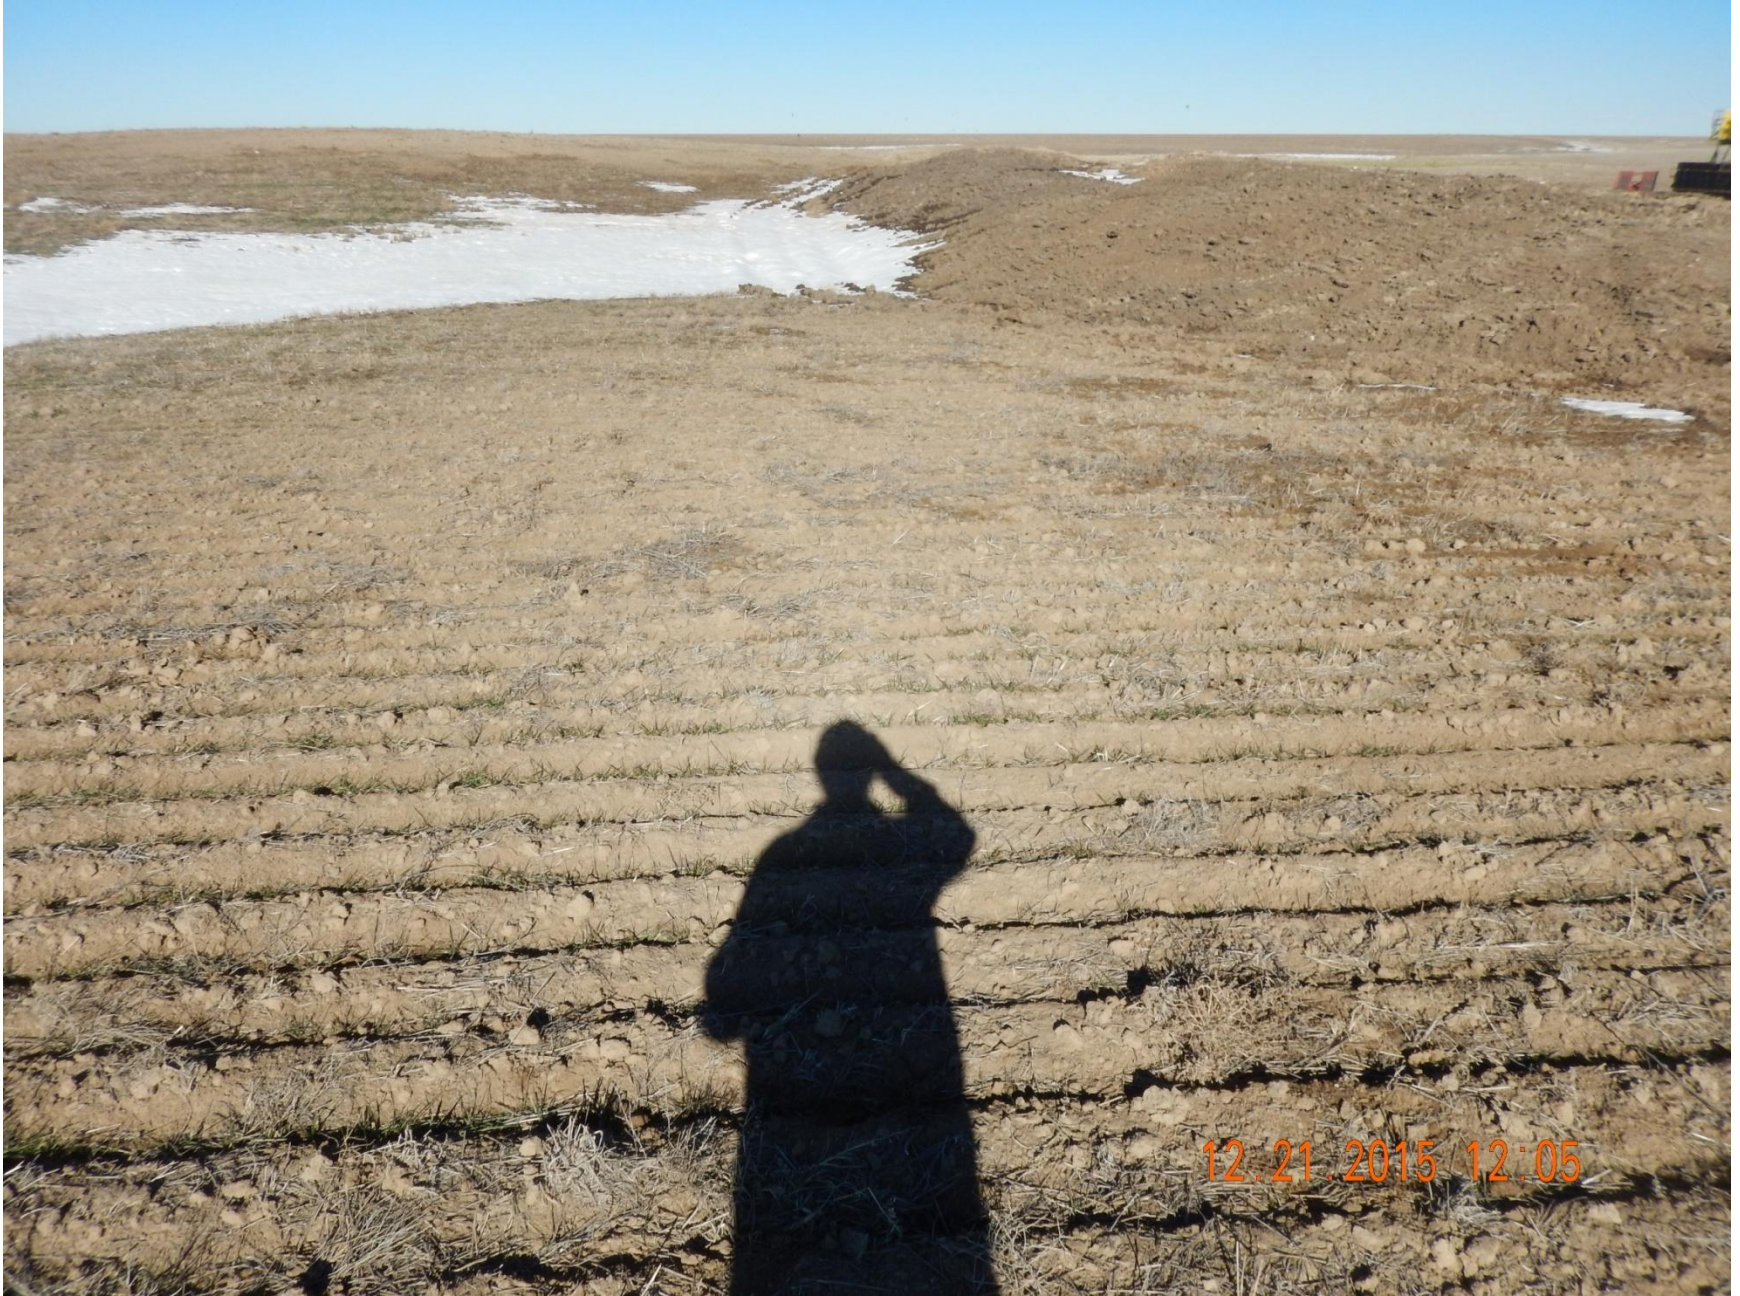
**Figure 1:** Photo taken from Southwest of location, facing north. Photo of western drainage at location. Photo for monitoring purposes.

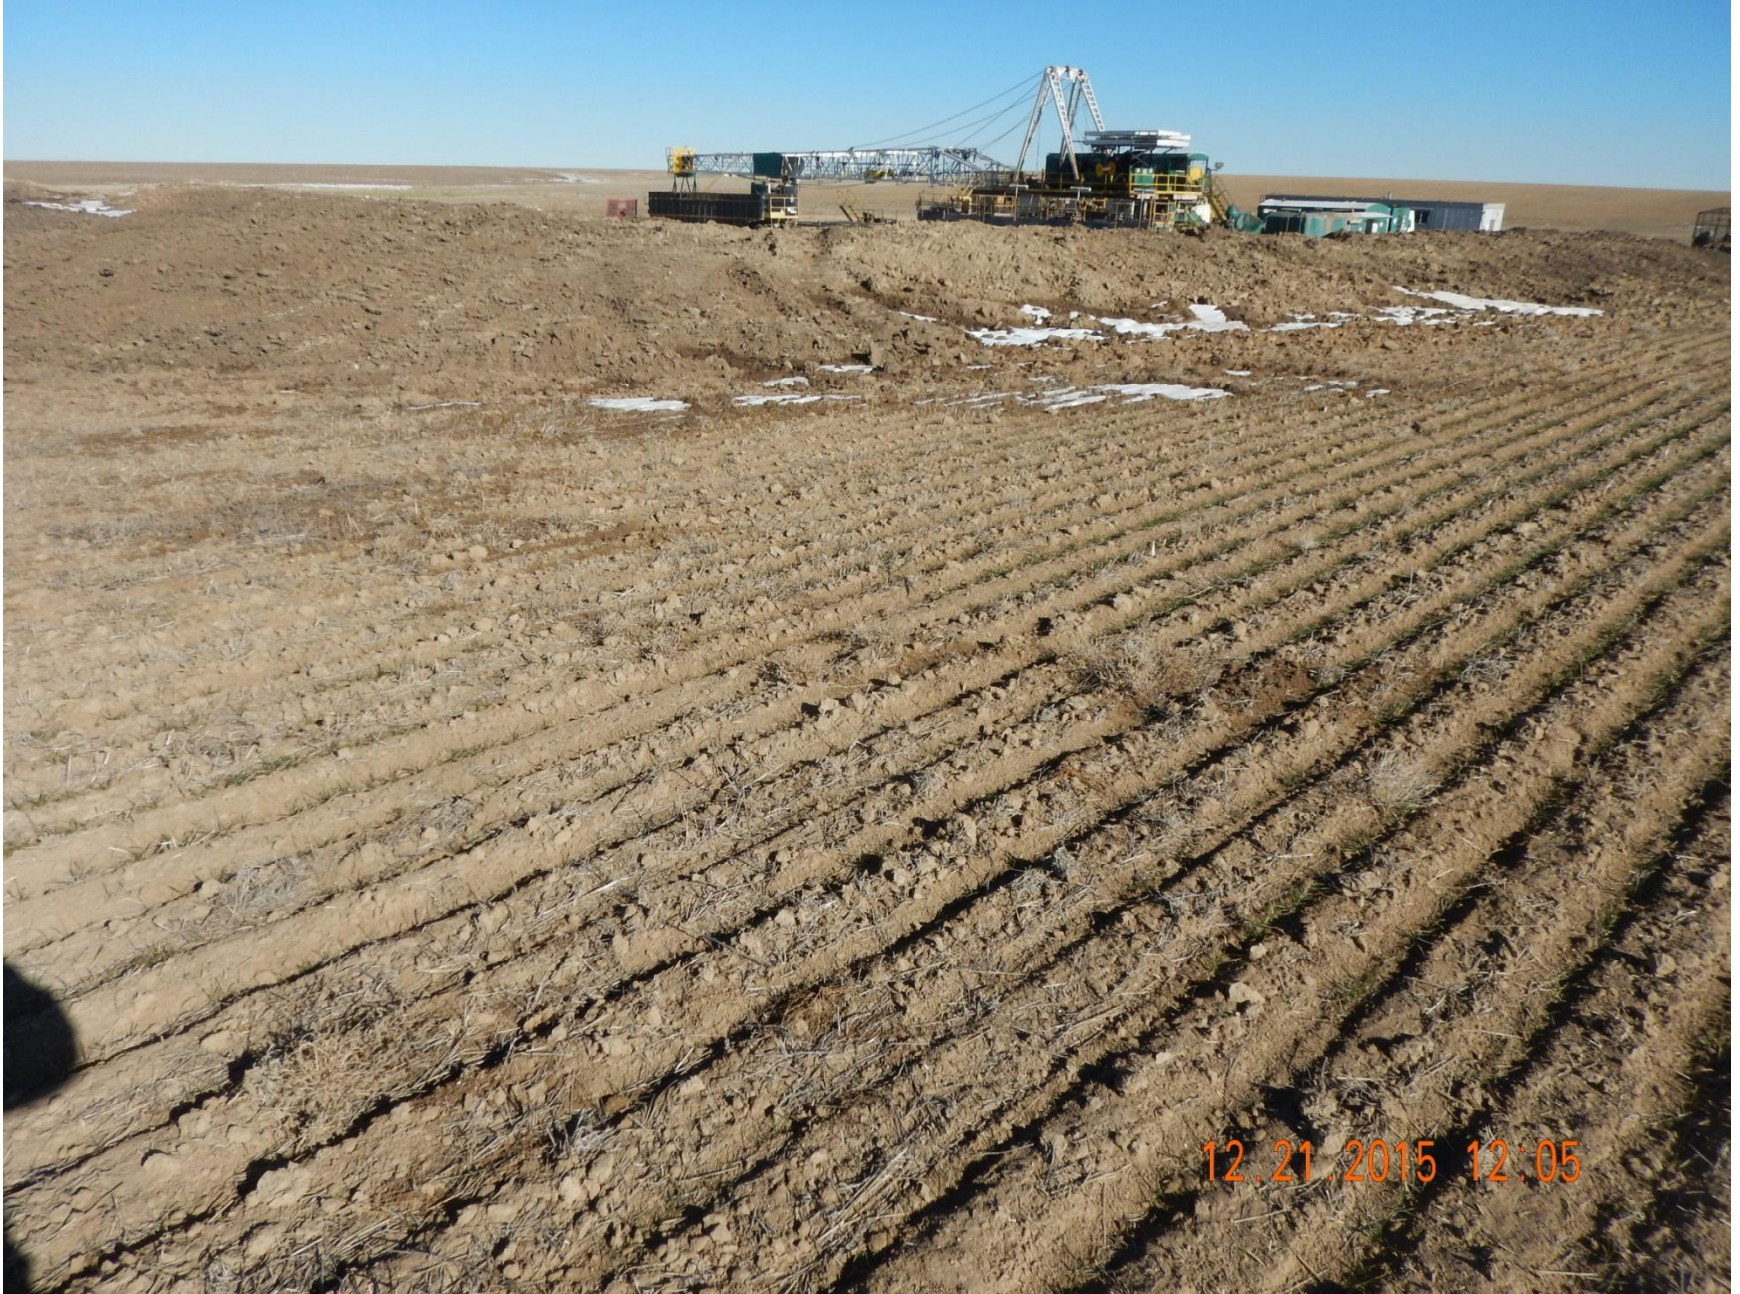
**Figure 2:** Photo taken from Southwest of location, facing northeast. Photo shows location and drill rig. Photo for monitoring purposes.

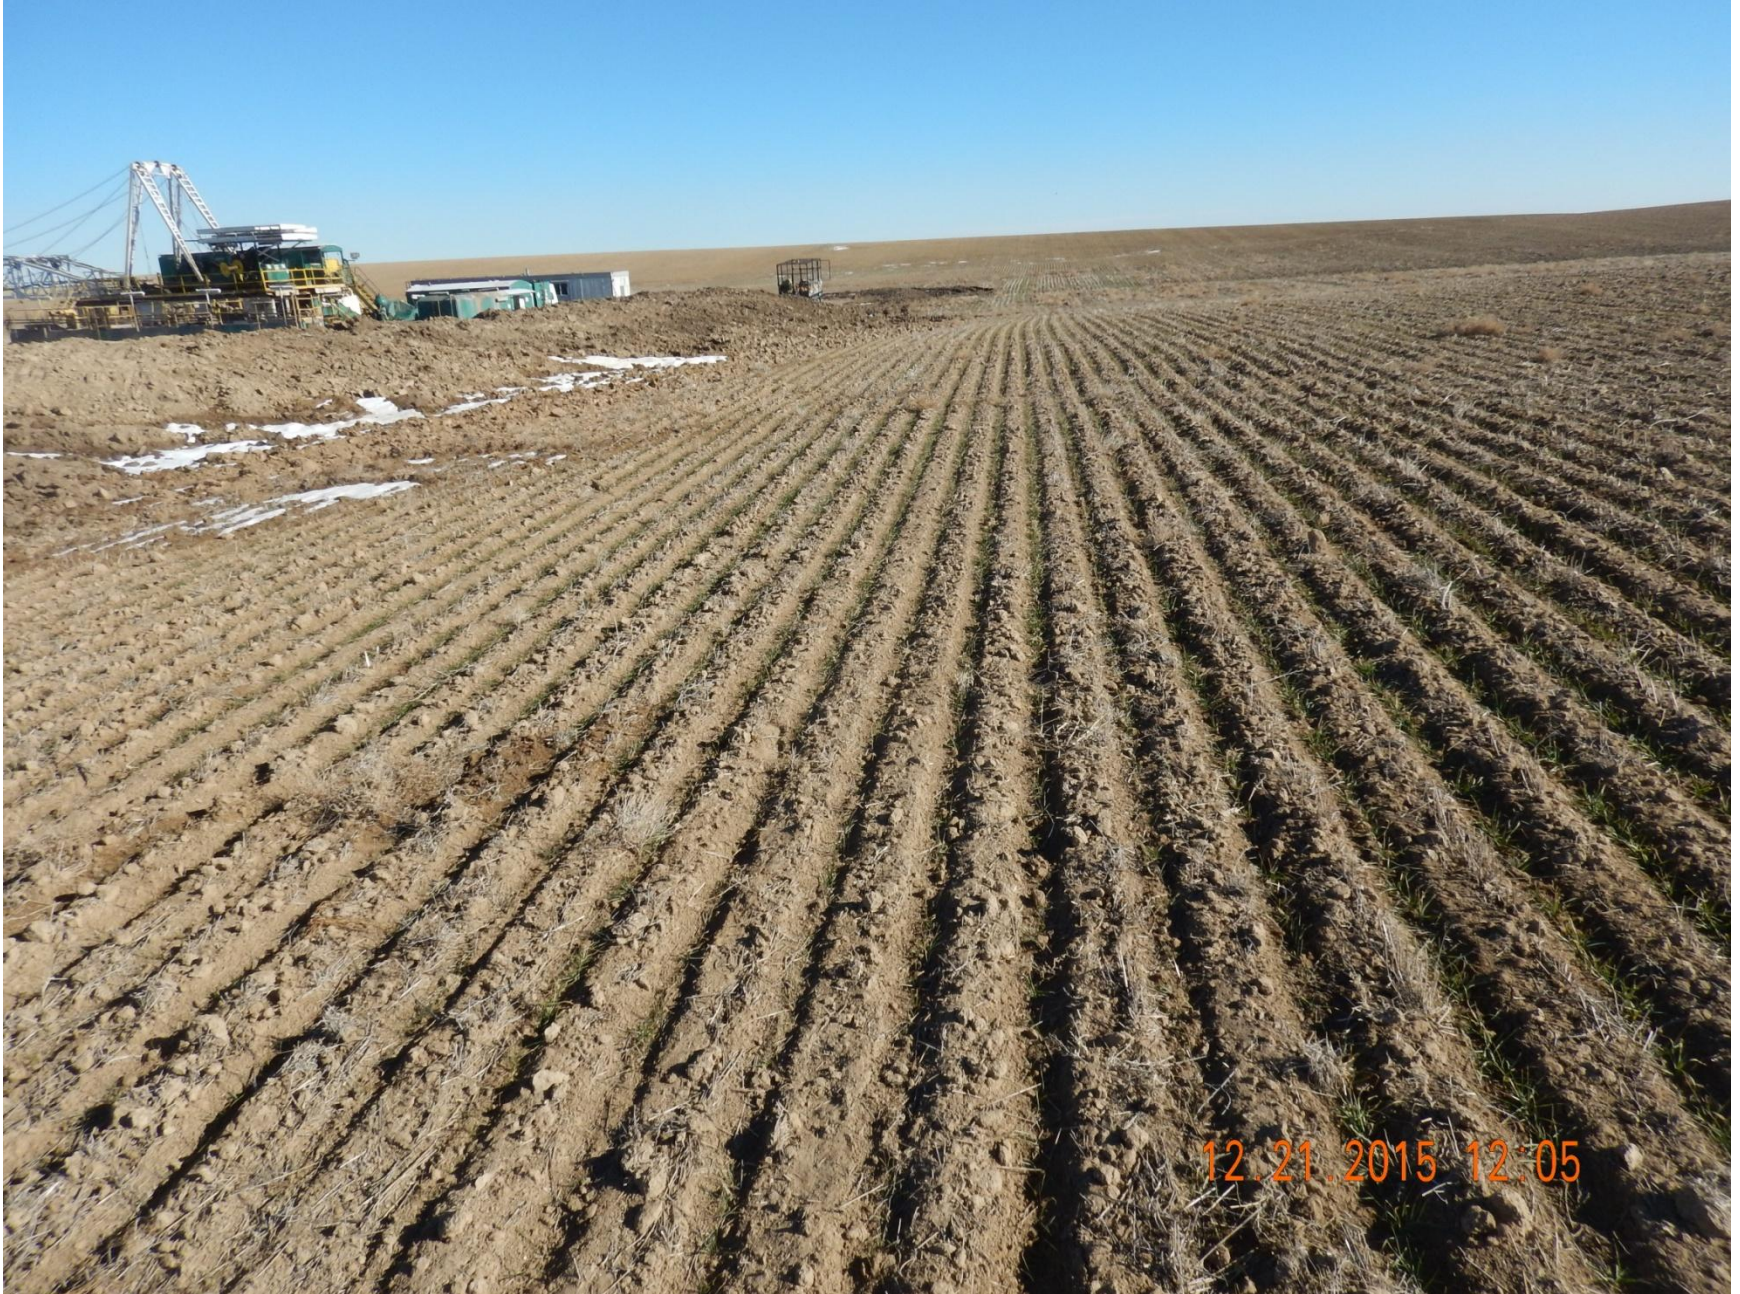
**Figure 3:** Photo taken from Southwest of location, facing east. Photo of southern drainage at location. Photo for monitoring purposes.

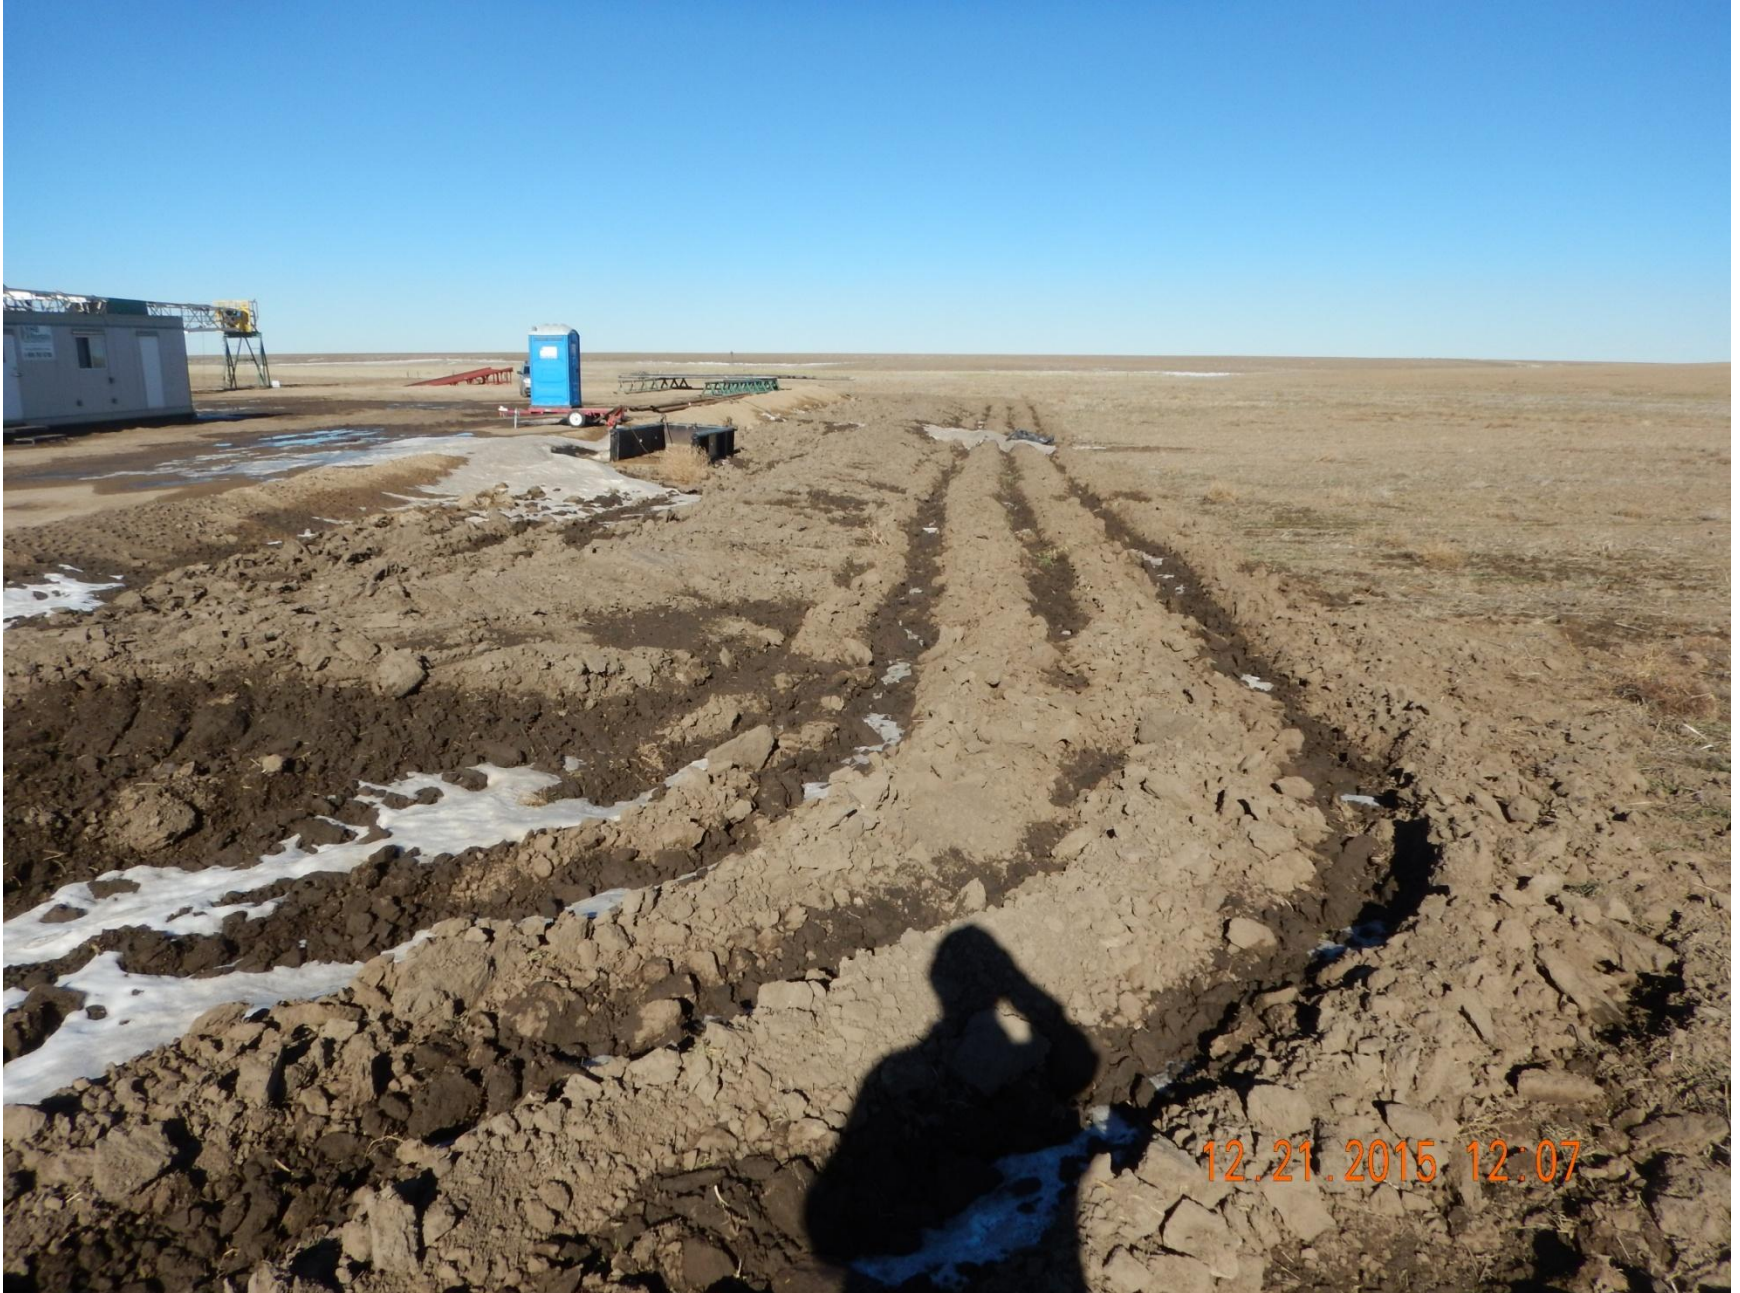
**Figure 4:** Photo taken from southeast end of location, facing north. Photo of stormwater BMPs

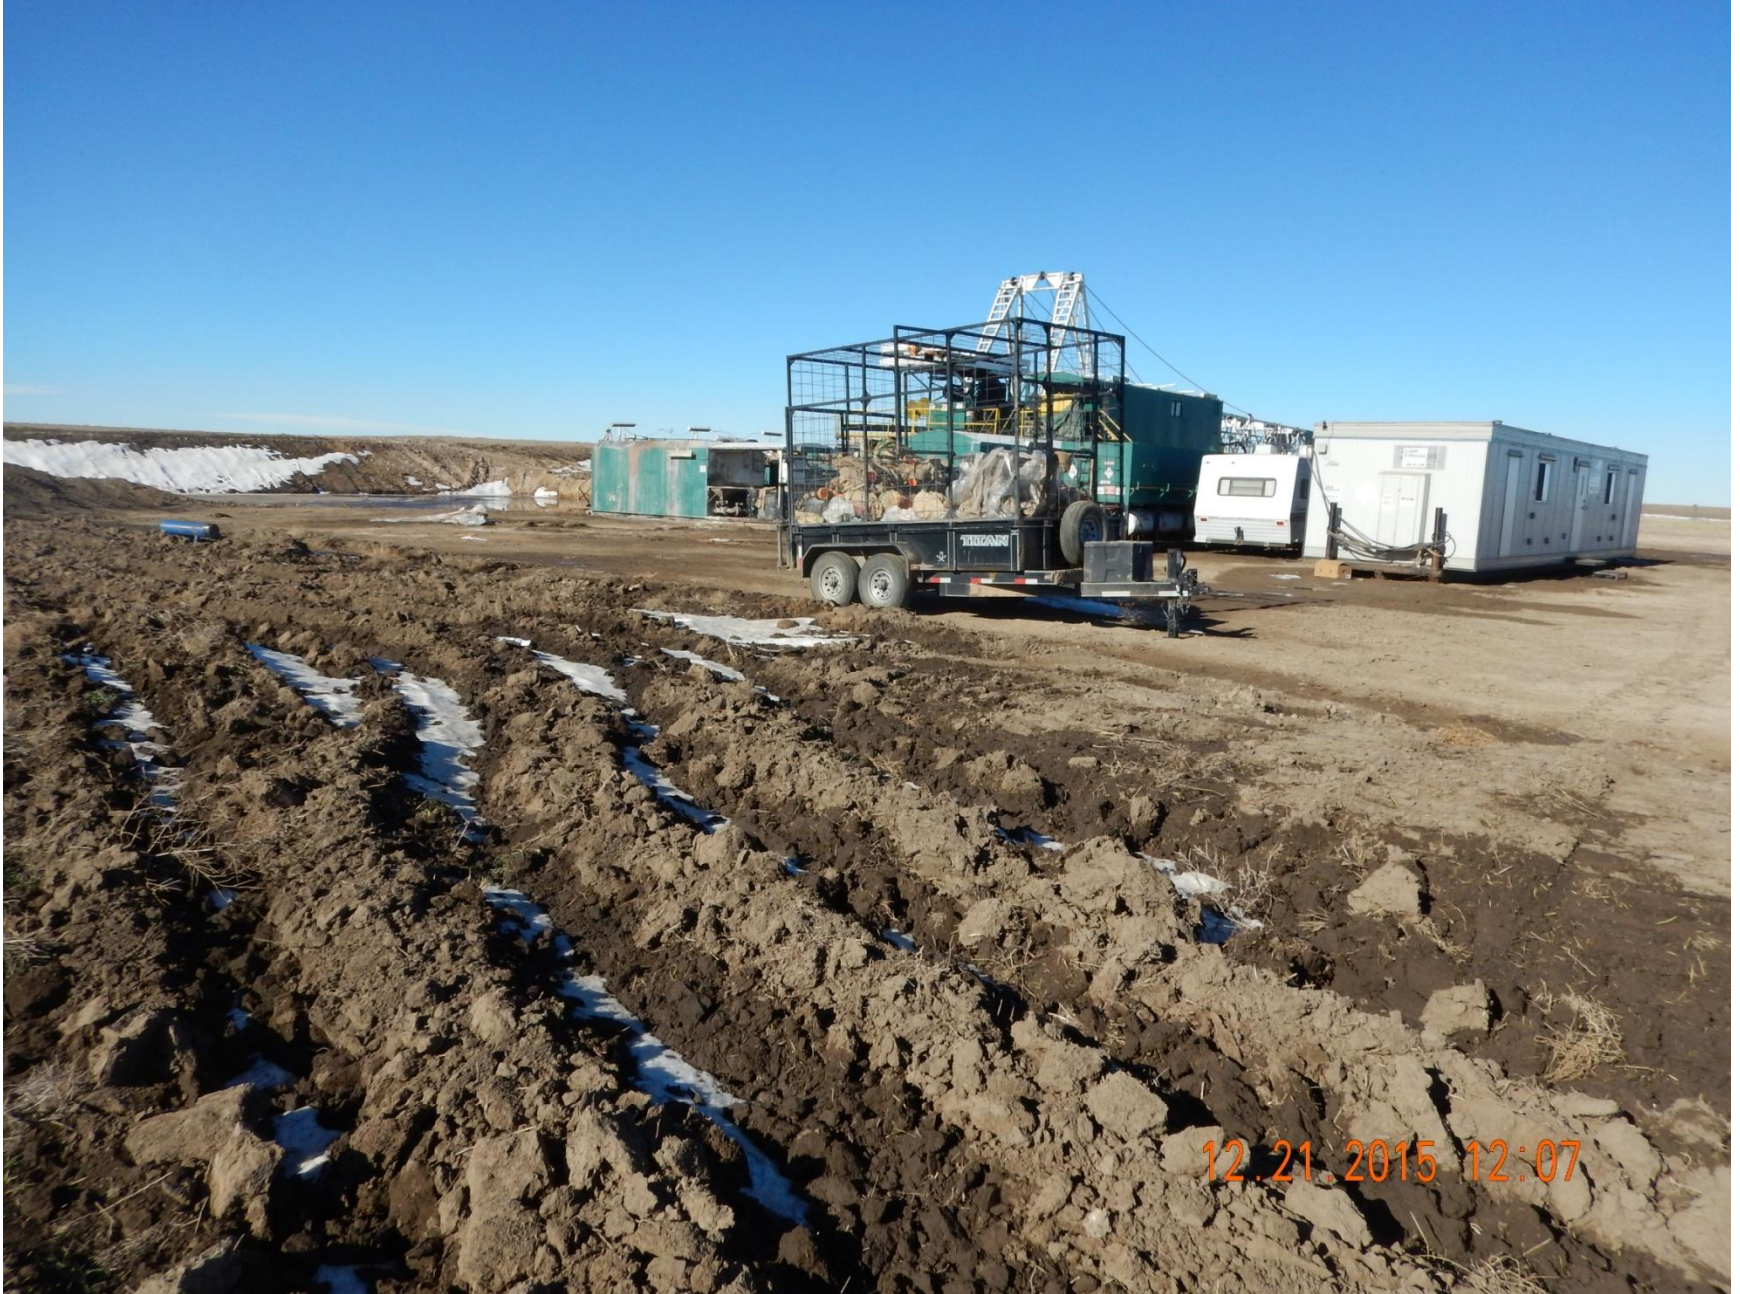
**Figure 5:** Photo taken from southeast end of location, facing northwest. Photo shows caged-trailer used for debris management. Note door to cage not properly shut.

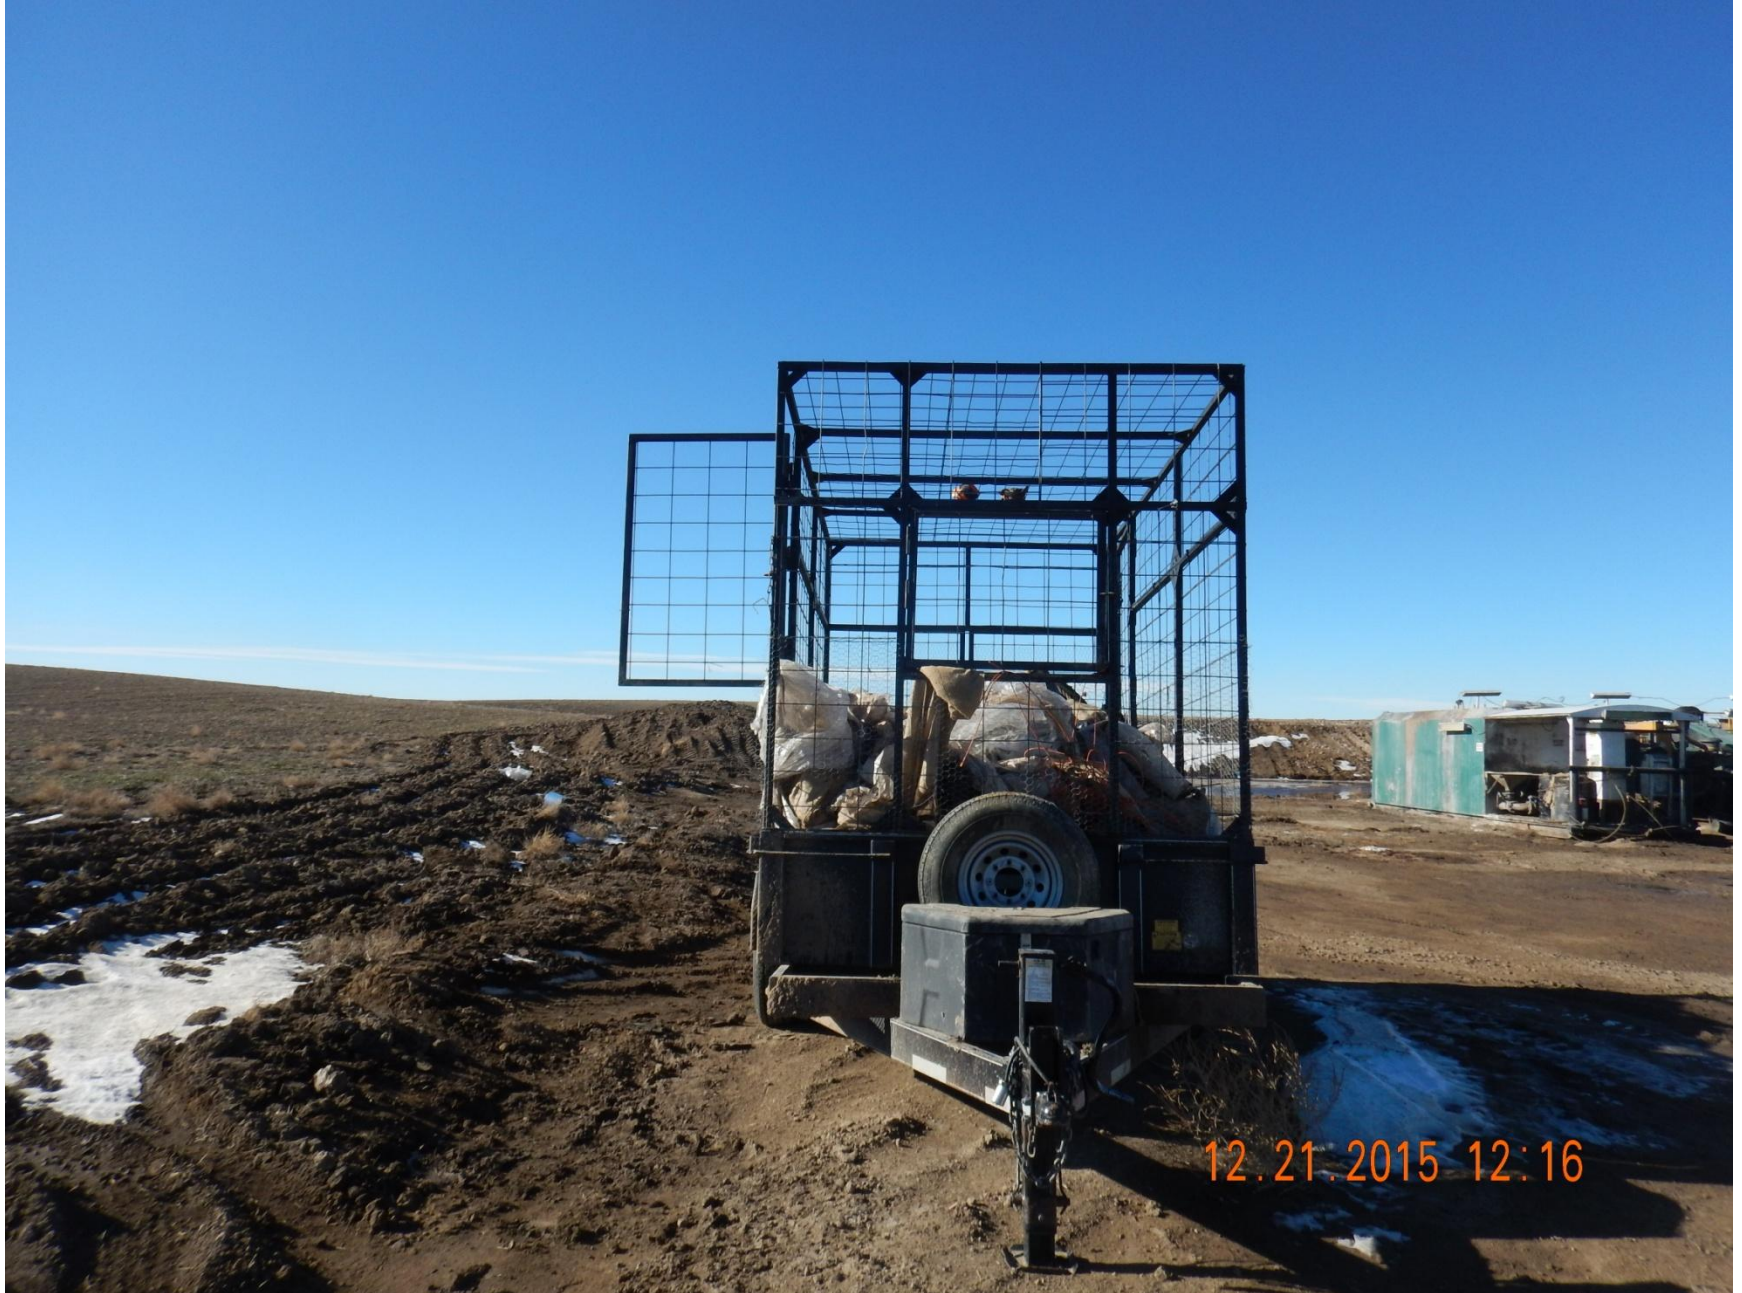
**Figure 6:** Photo taken from southeast end of location, facing west. Photo shows caged-trailer used for debris management. Note door to cage not properly shut.

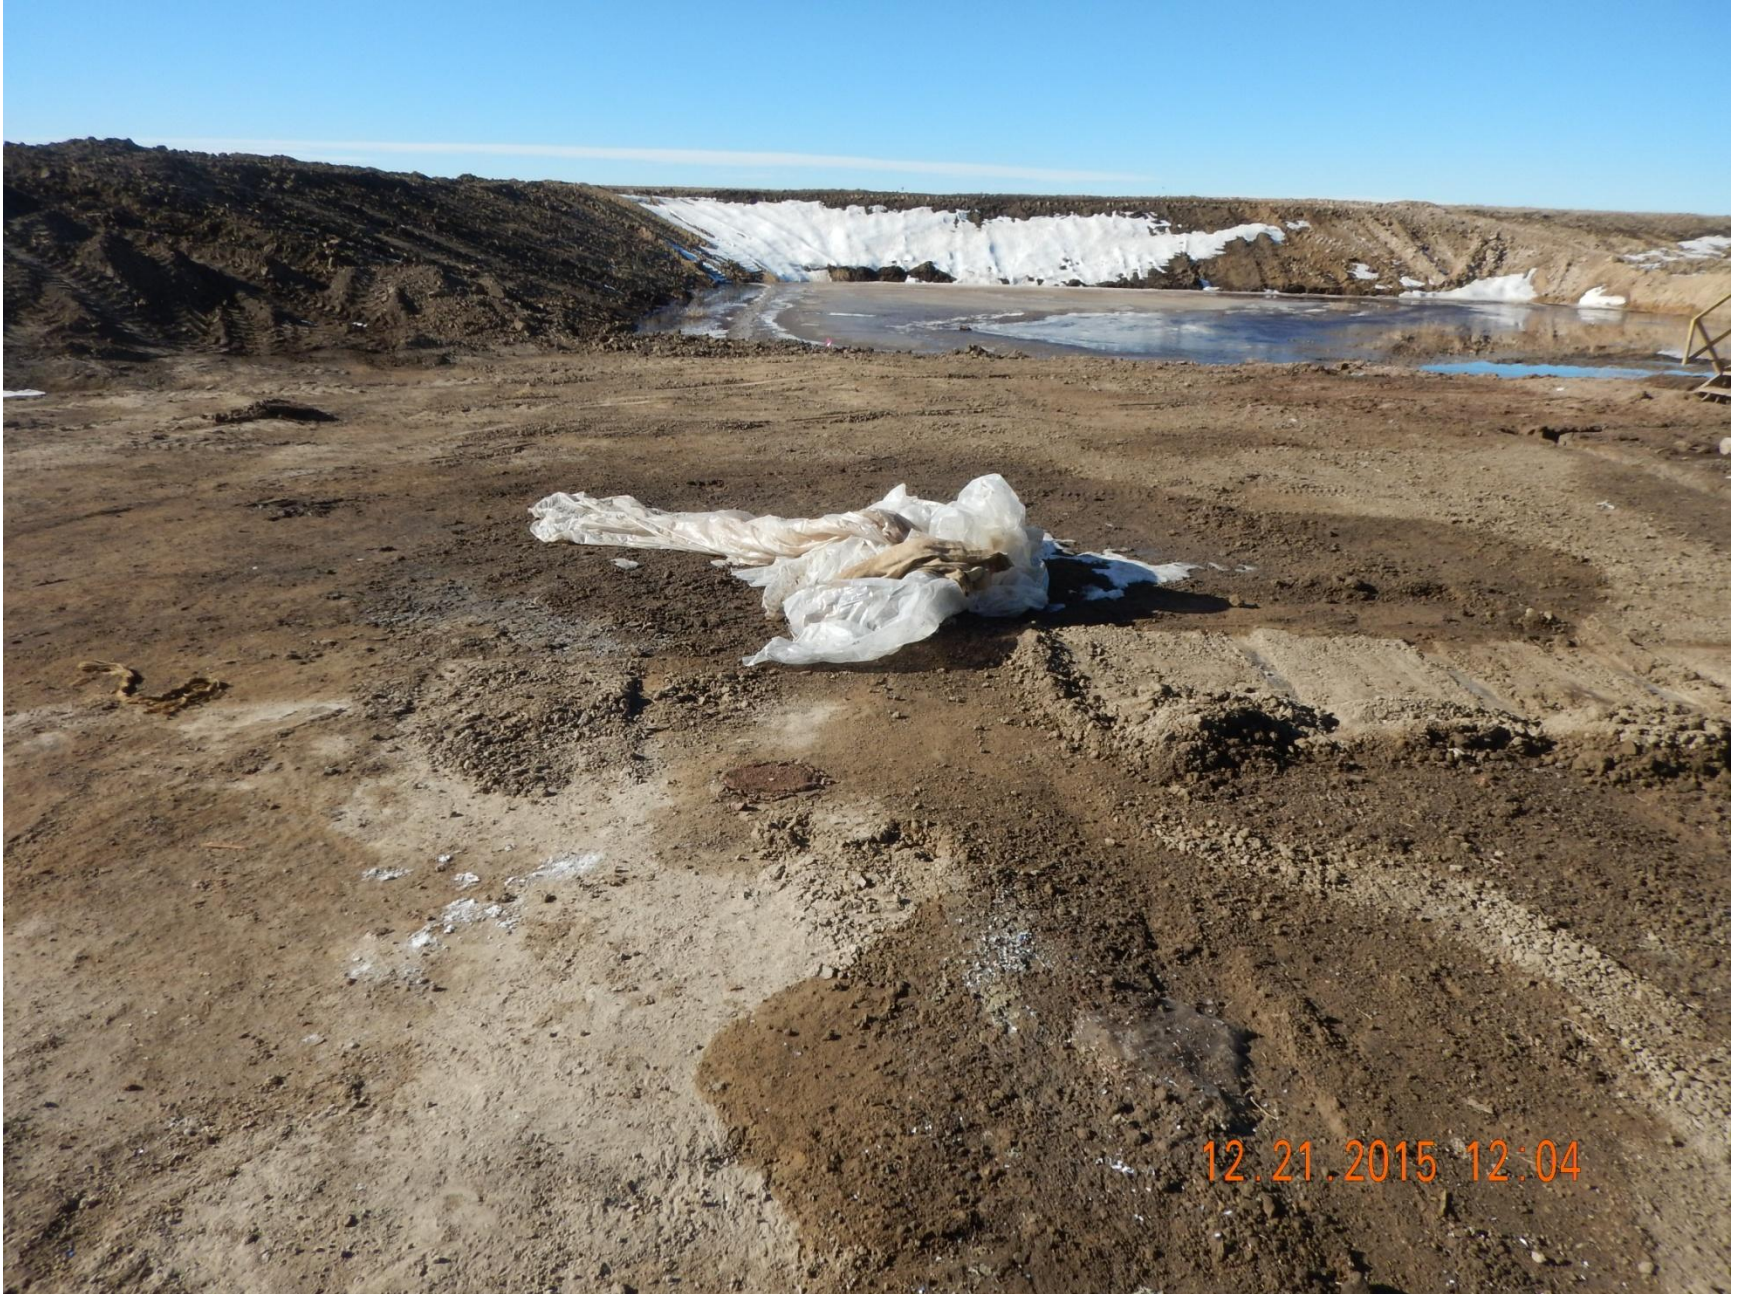
**Figure 7:** Photo taken from southern end of location, facing west. Photo of trash debris in project area.

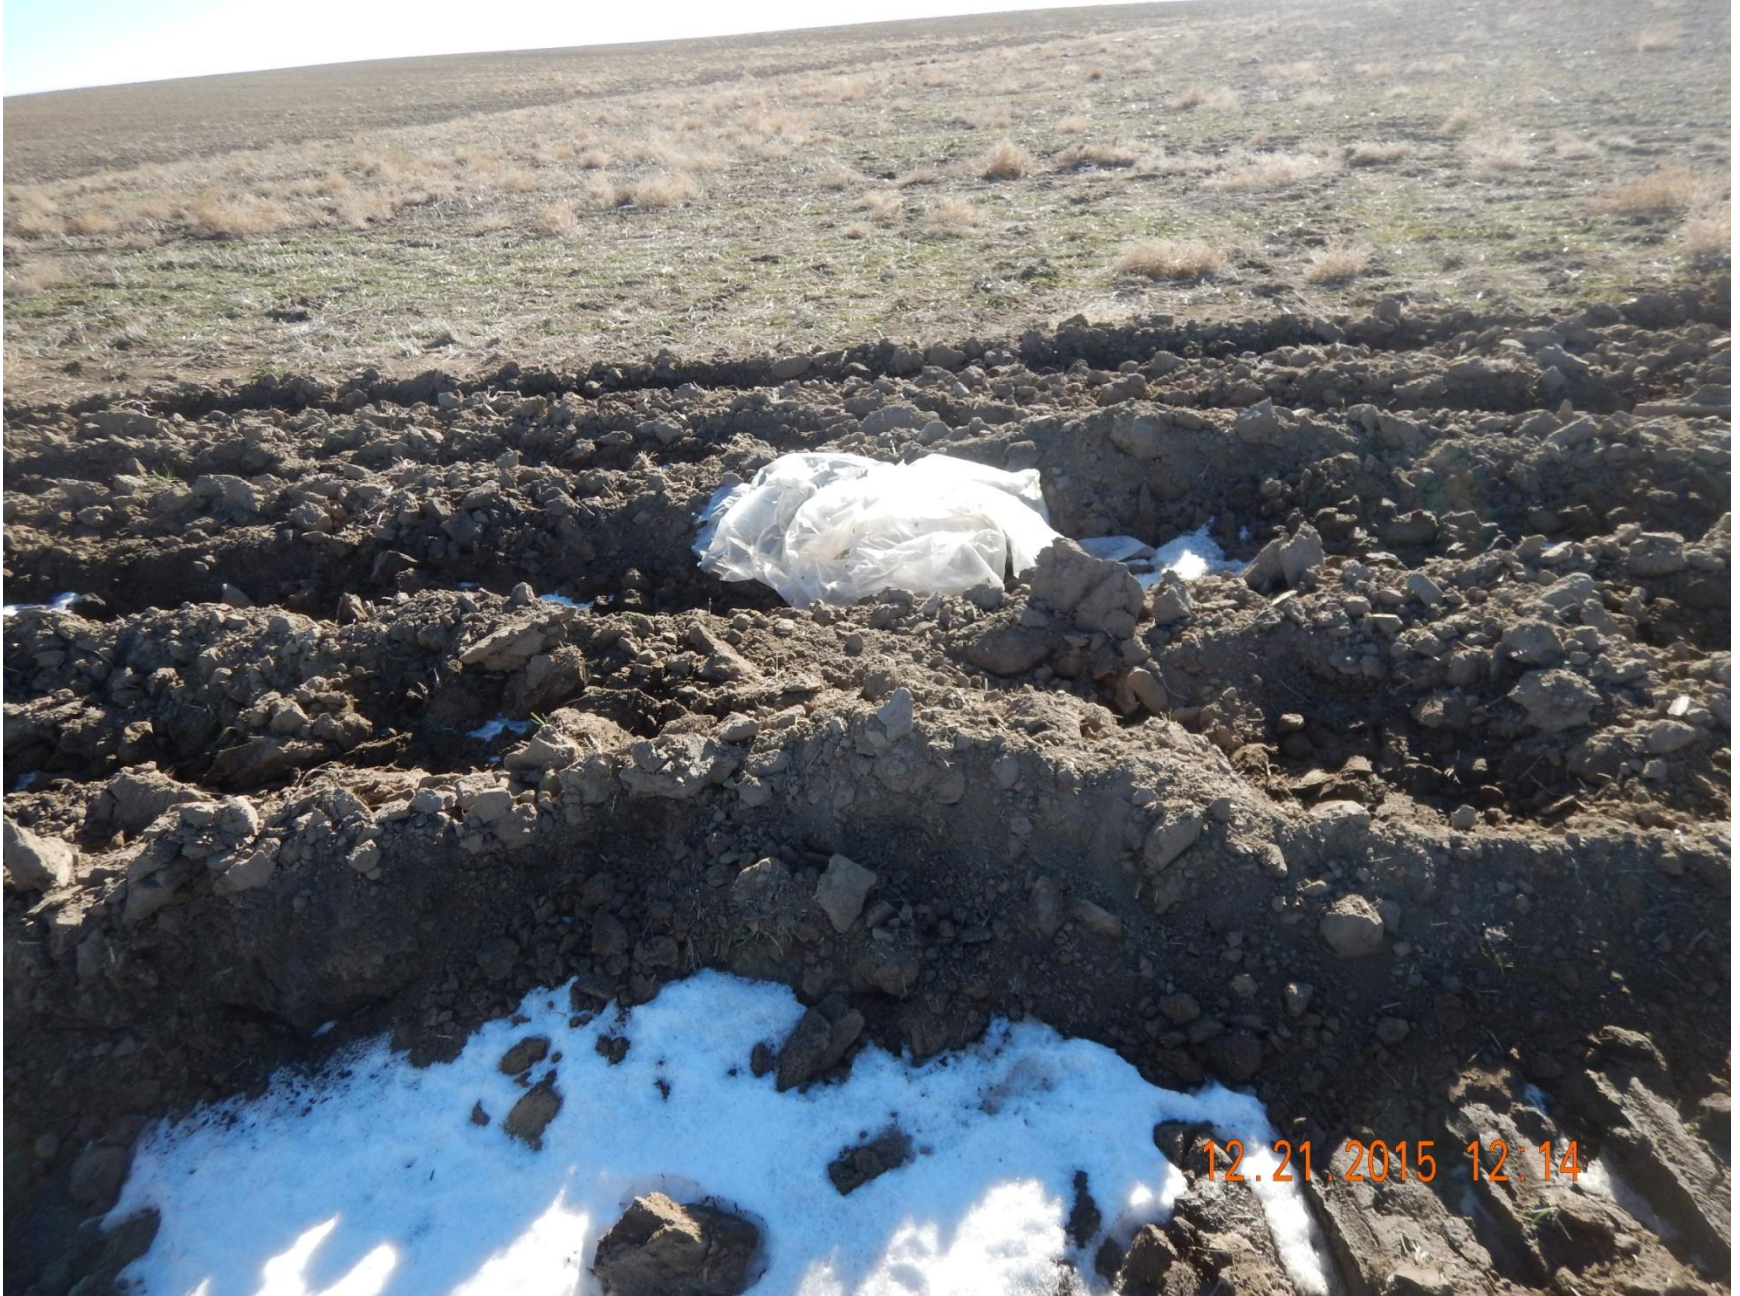
**Figure 8:** Photo taken from southern end of location, facing south. Photo of trash debris on stormwater BMP.

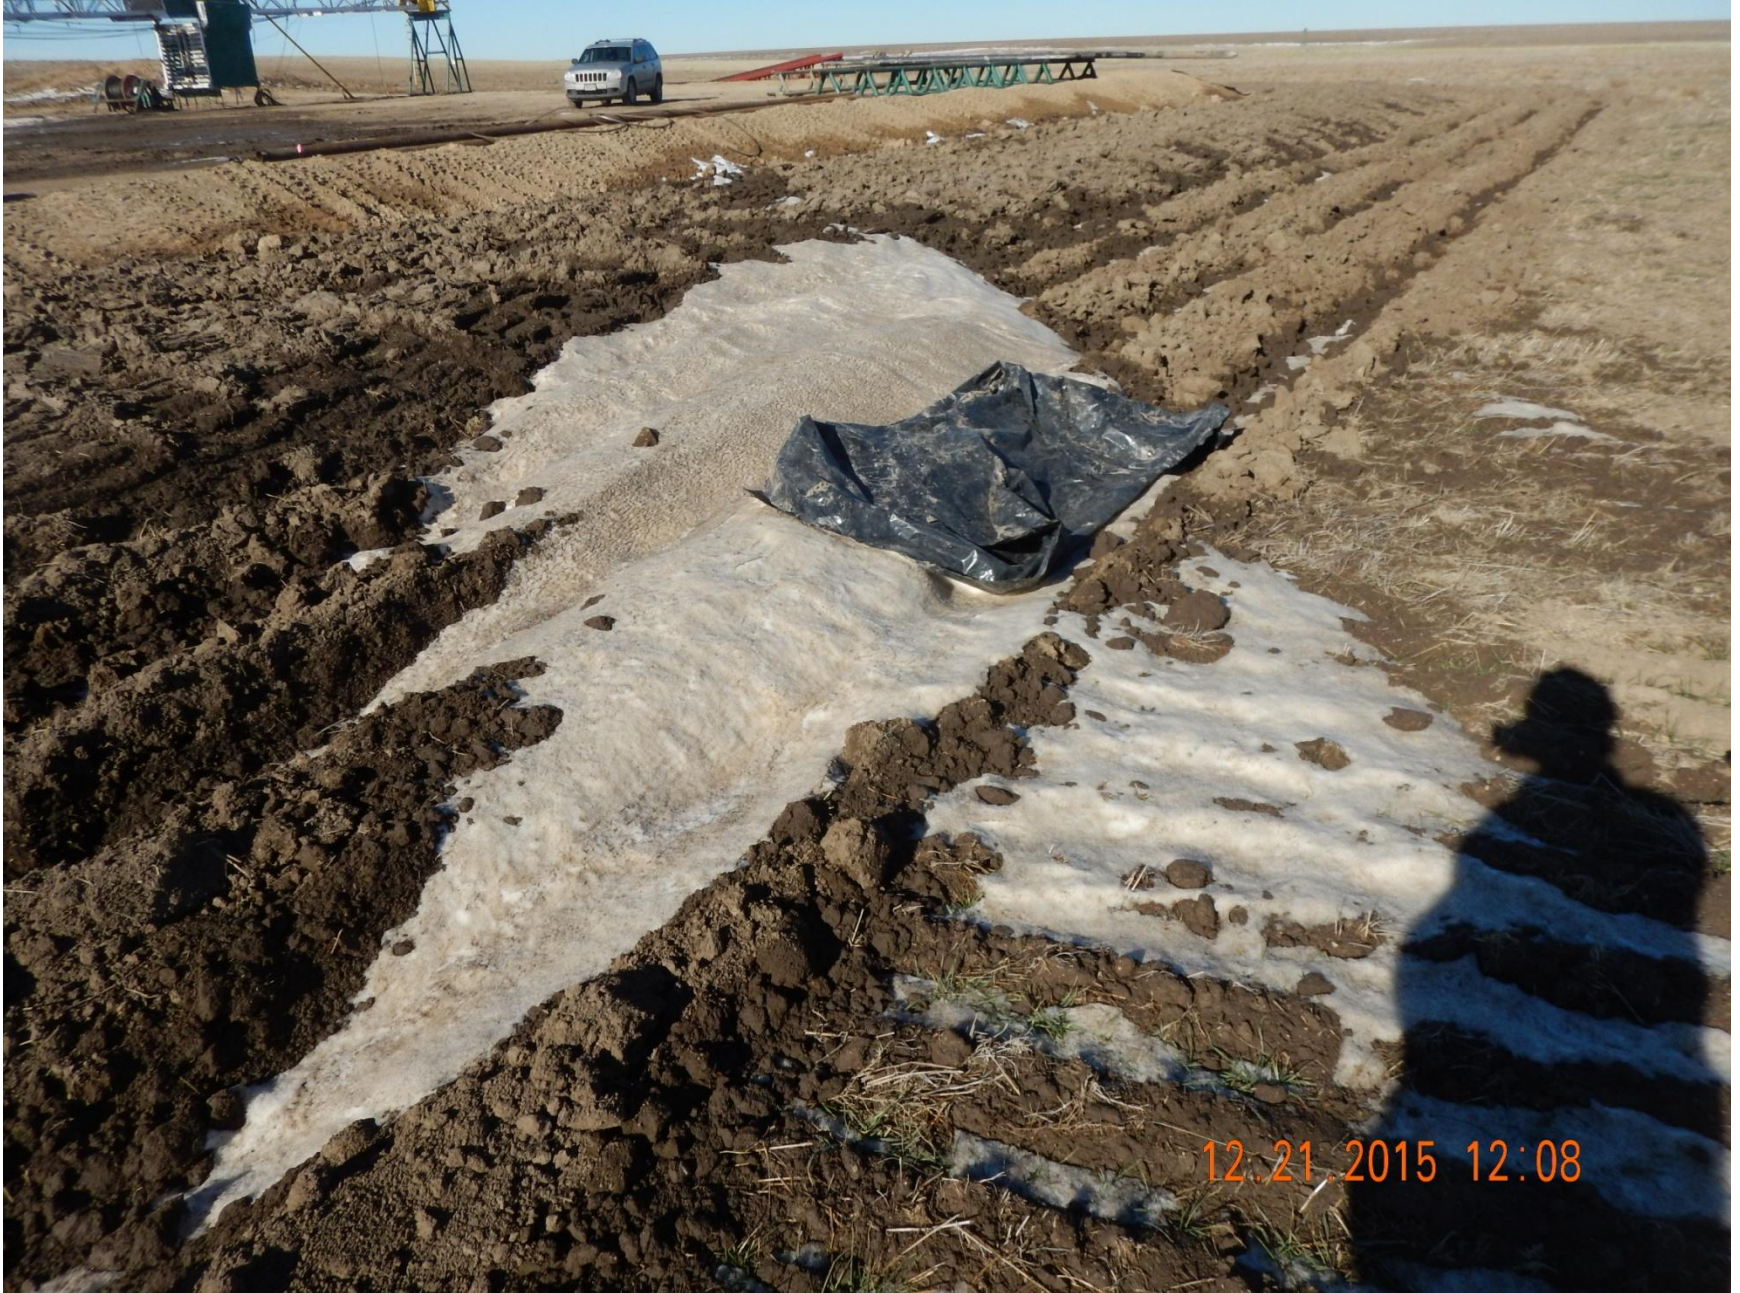
**Figure 8:** Photo taken from eastern end of location, facing north. Photo of trash debris on stormwater BMP.

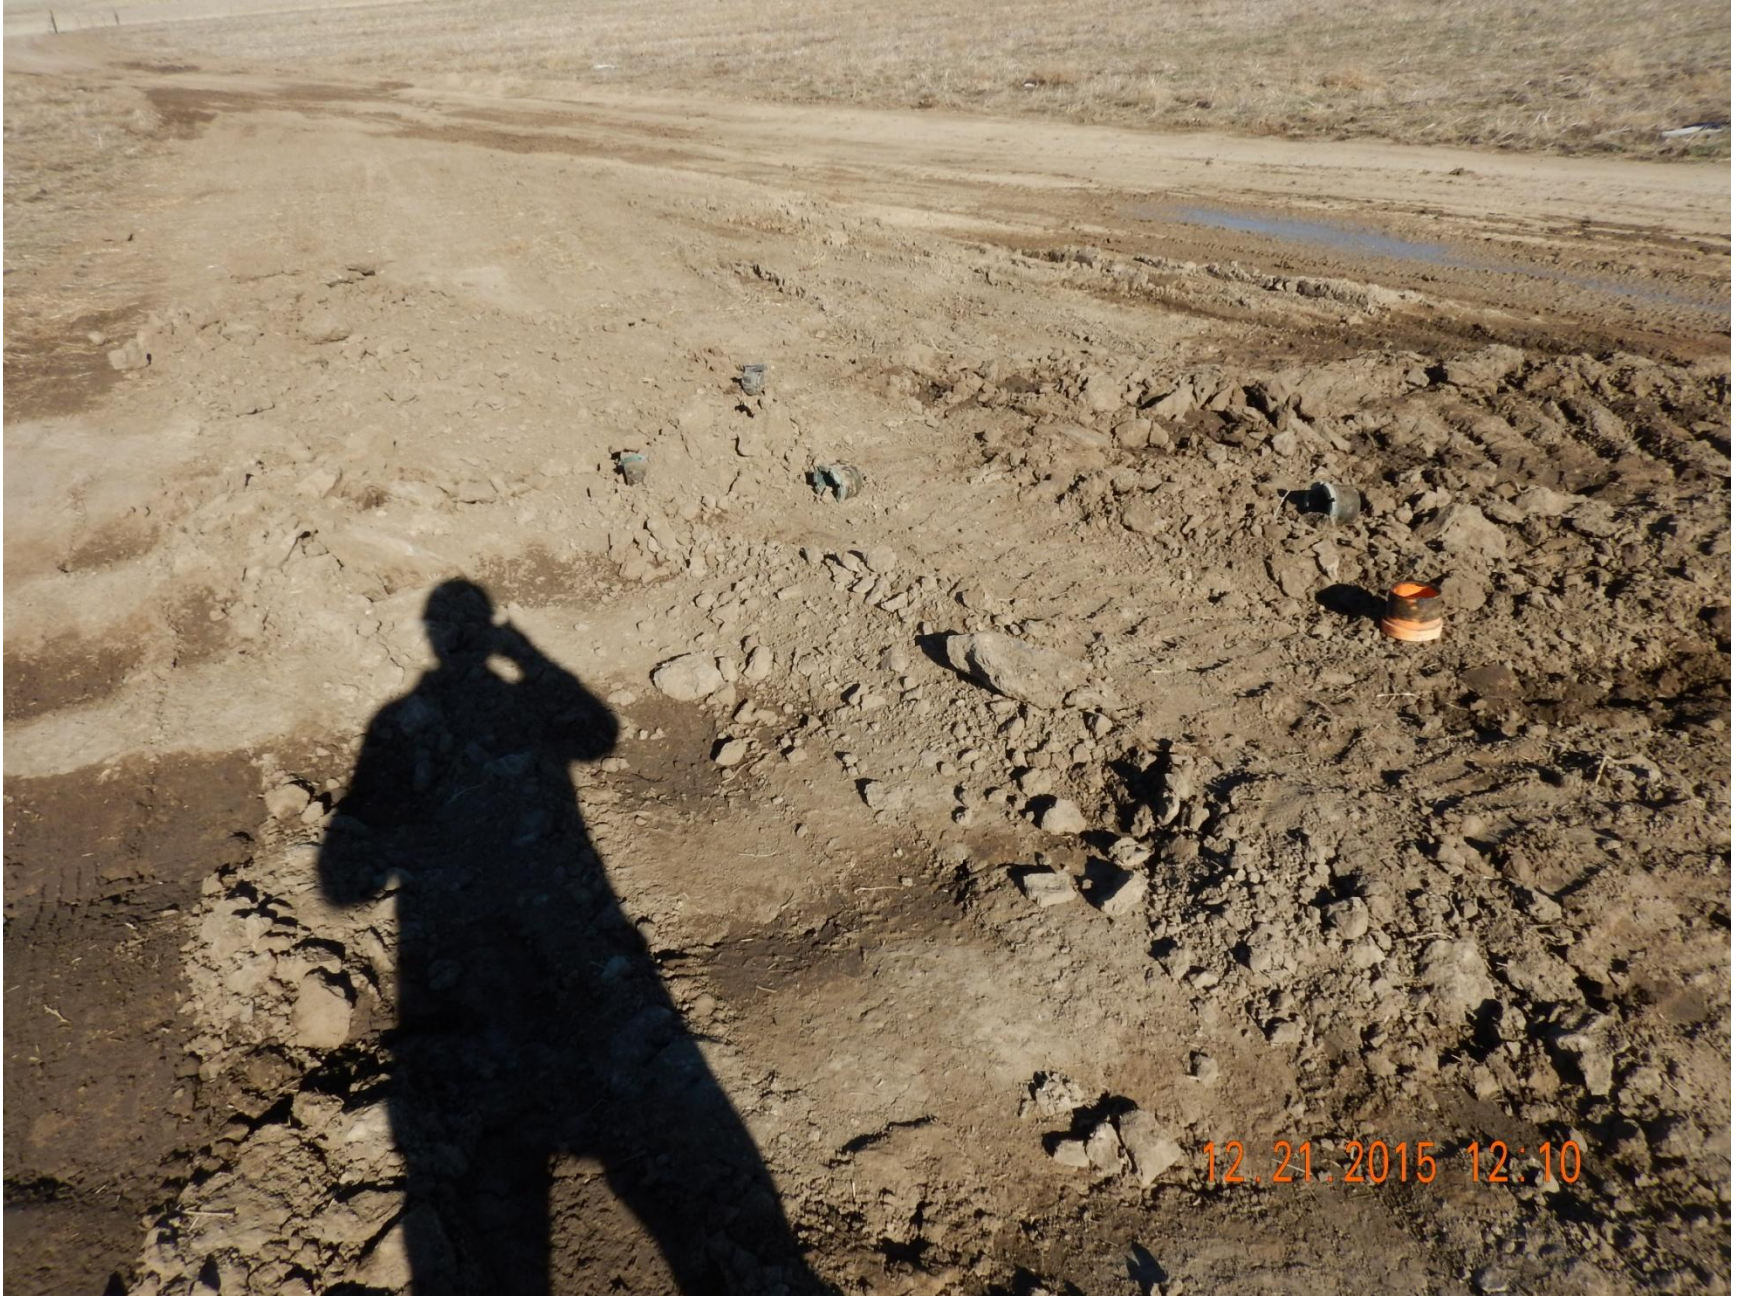
**Figure 10:** Photo taken from north end of location, facing northeast. Photo of trash debris.
