# Follow Up Inspection

12/21/2015

Operator: Wiepking-Fullerton

Location ID: 443145

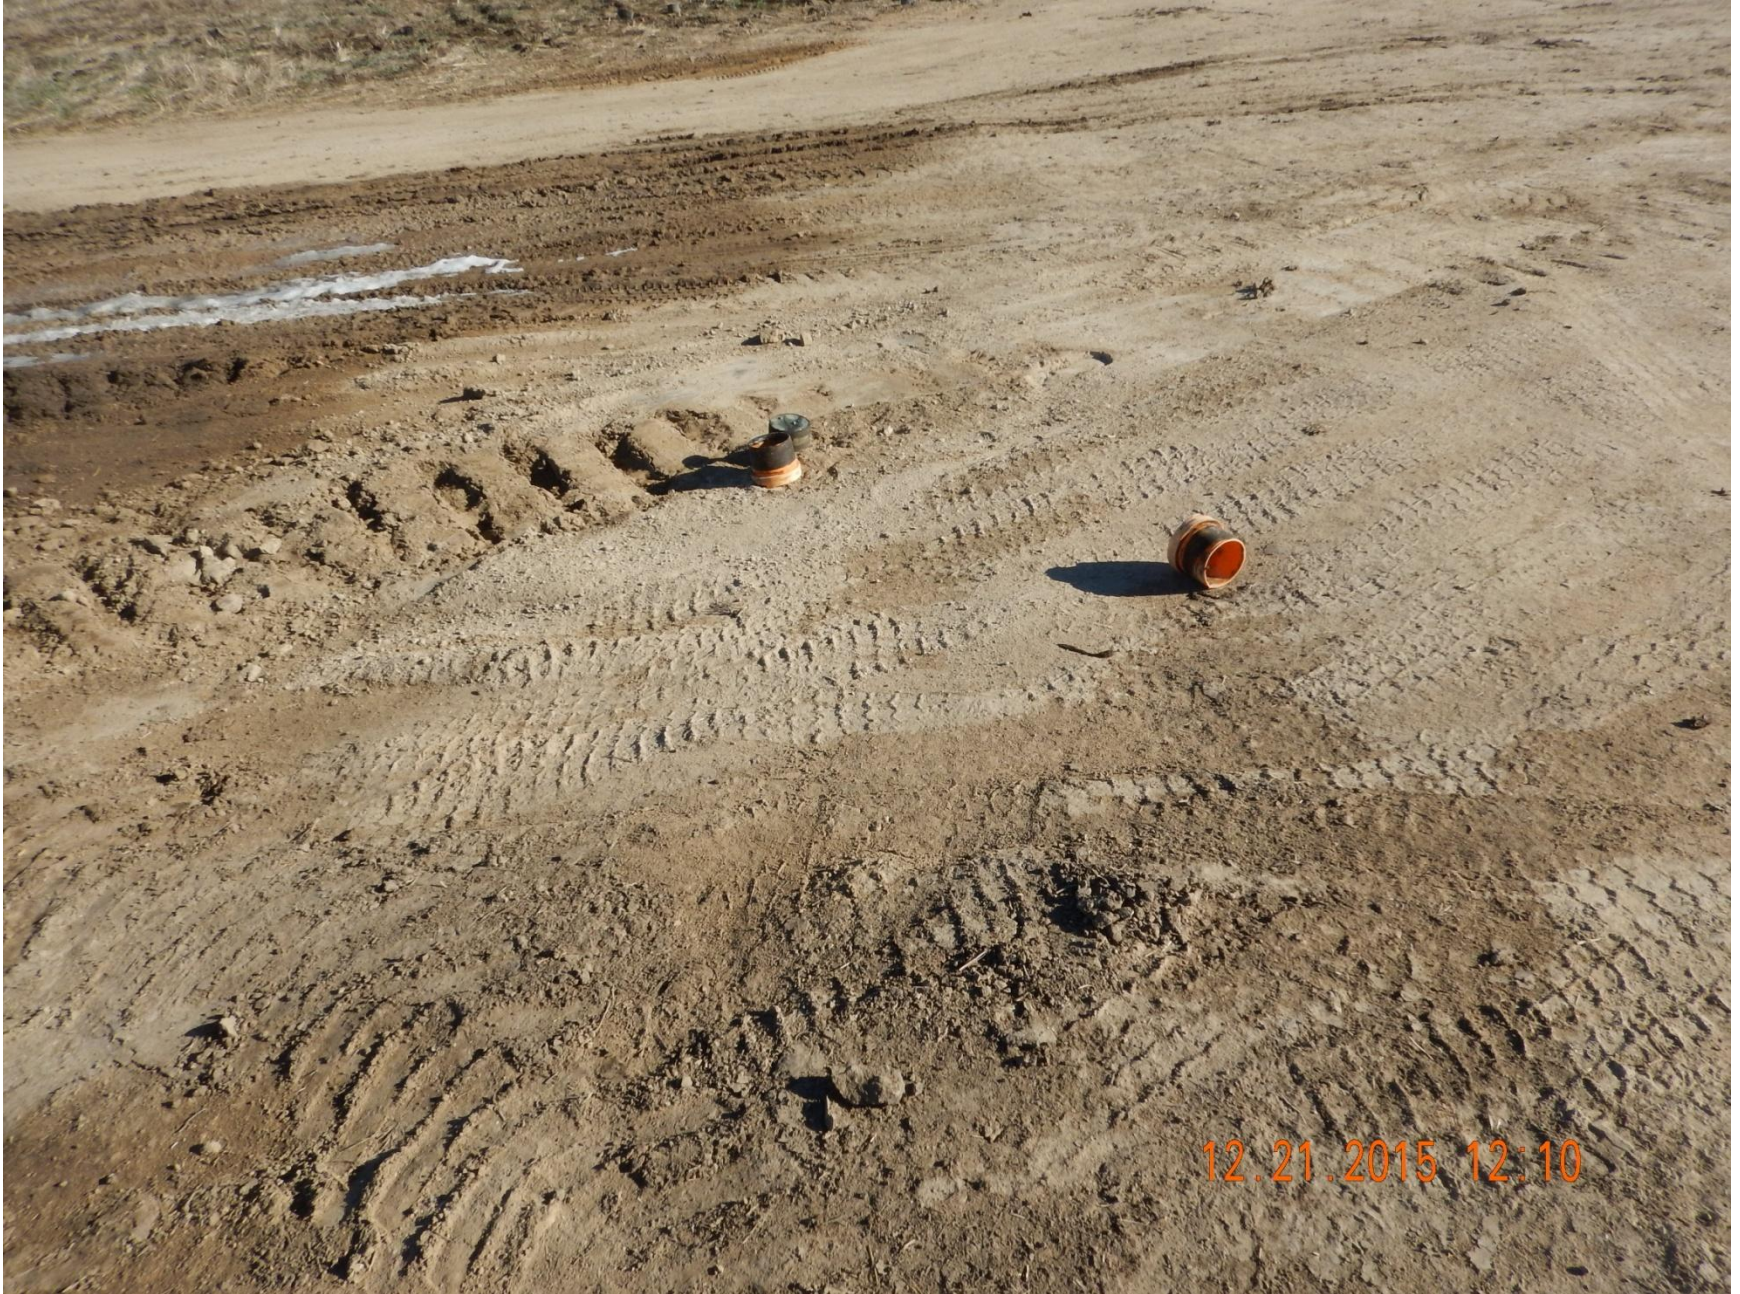
**Figure 11:** Photo taken from north end of location. Photo of trash debris.

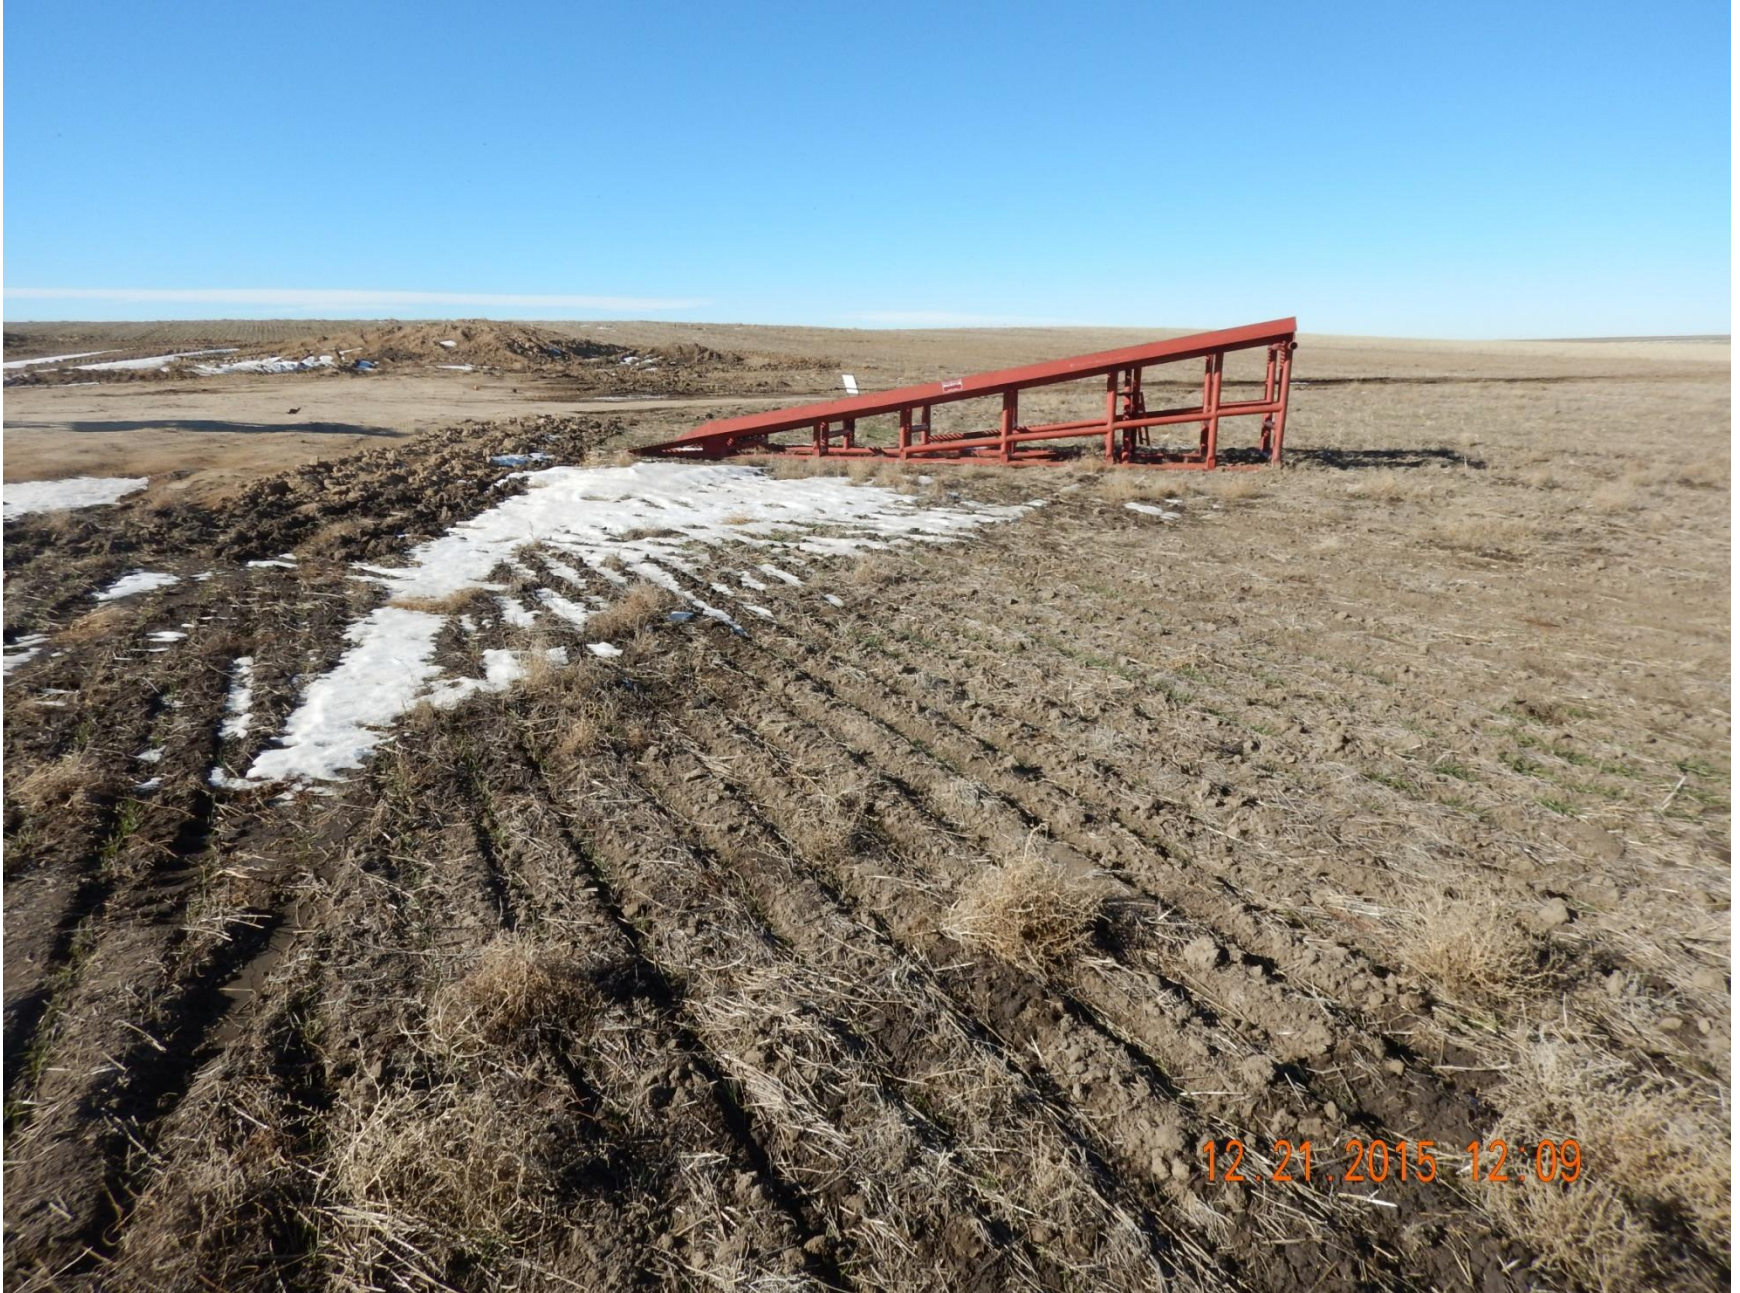
**Figure 12:** Photo taken from northeast end of location, facing west. Photo shows equipment being stored off-site of project area.

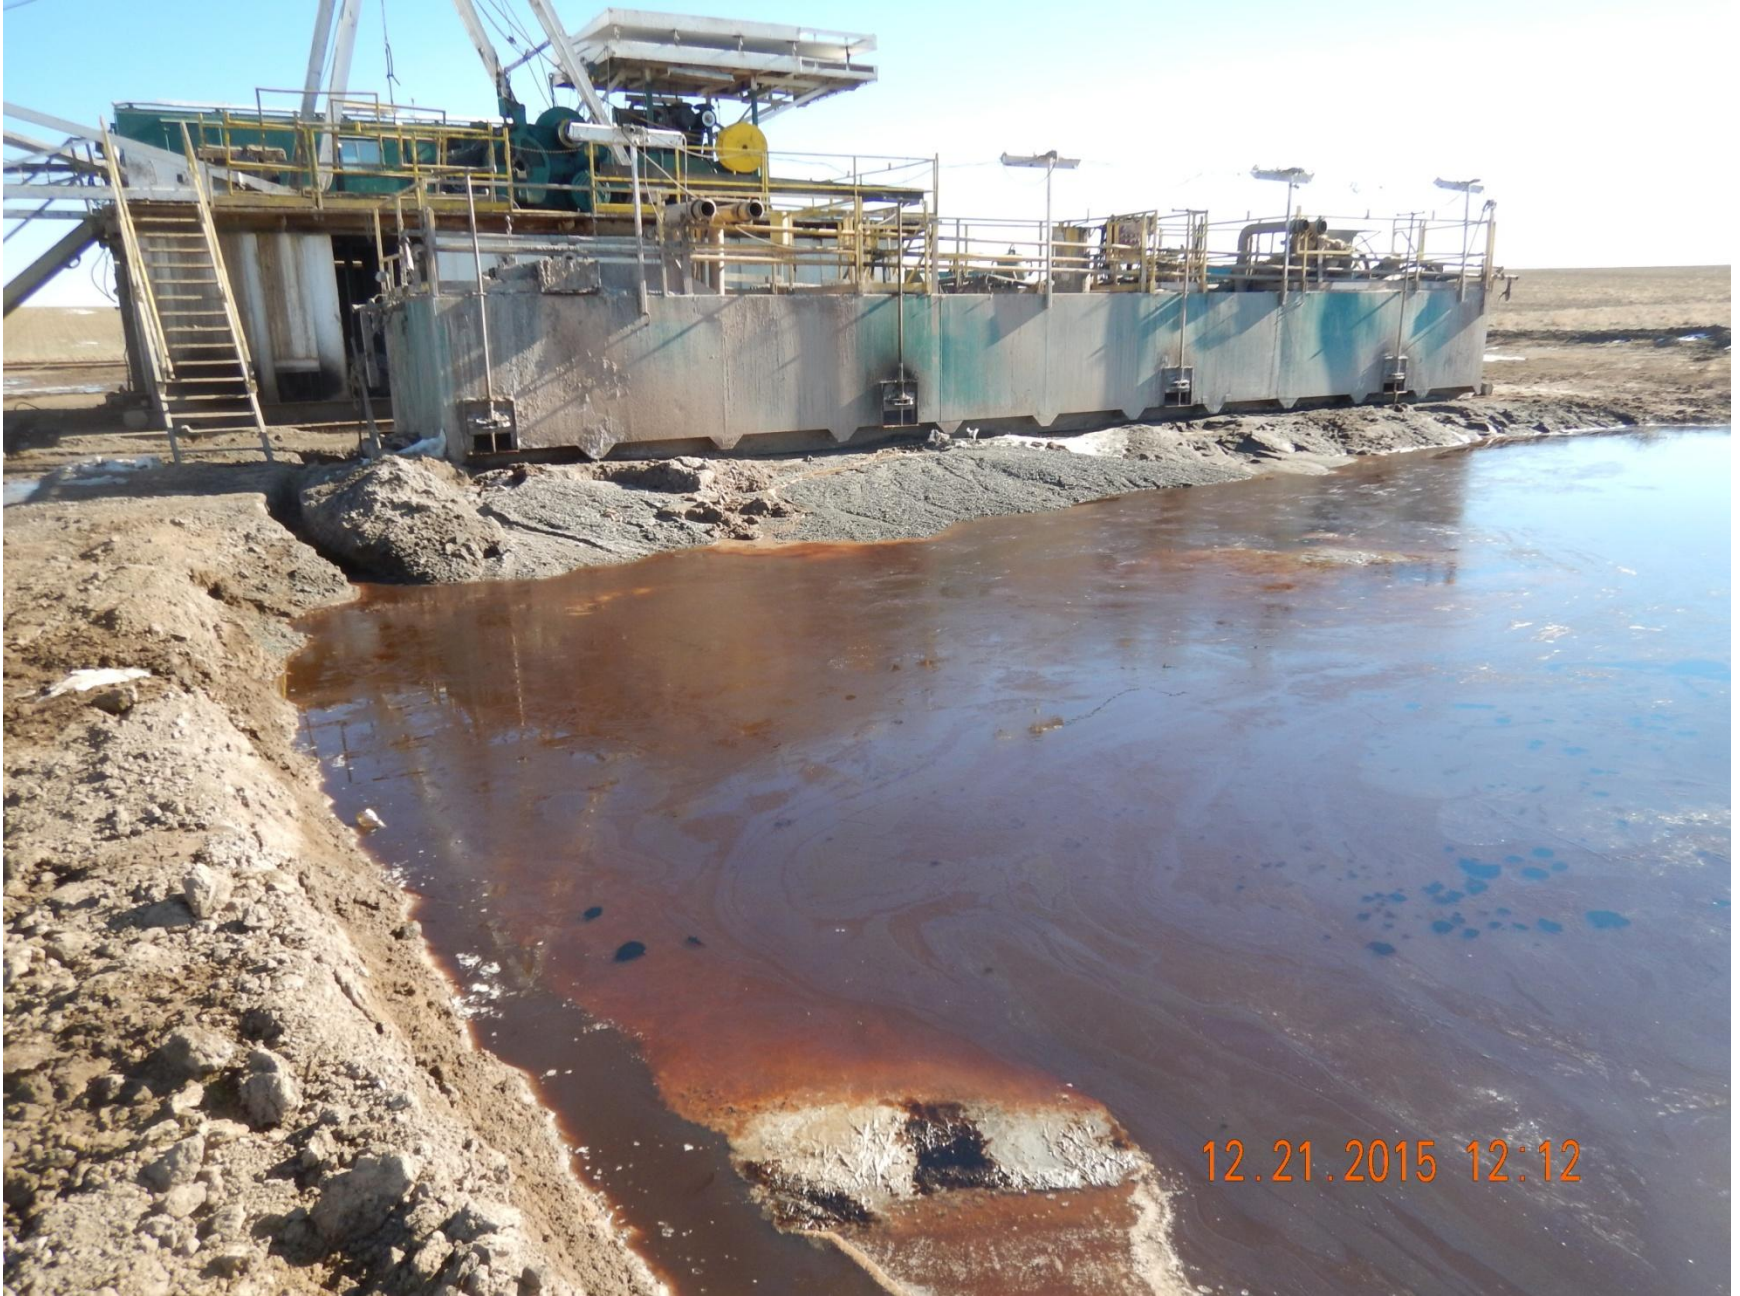
**Figure 13:** Photo taken at southern pit. Photo shows oily water. Pit does not appear to be lined.

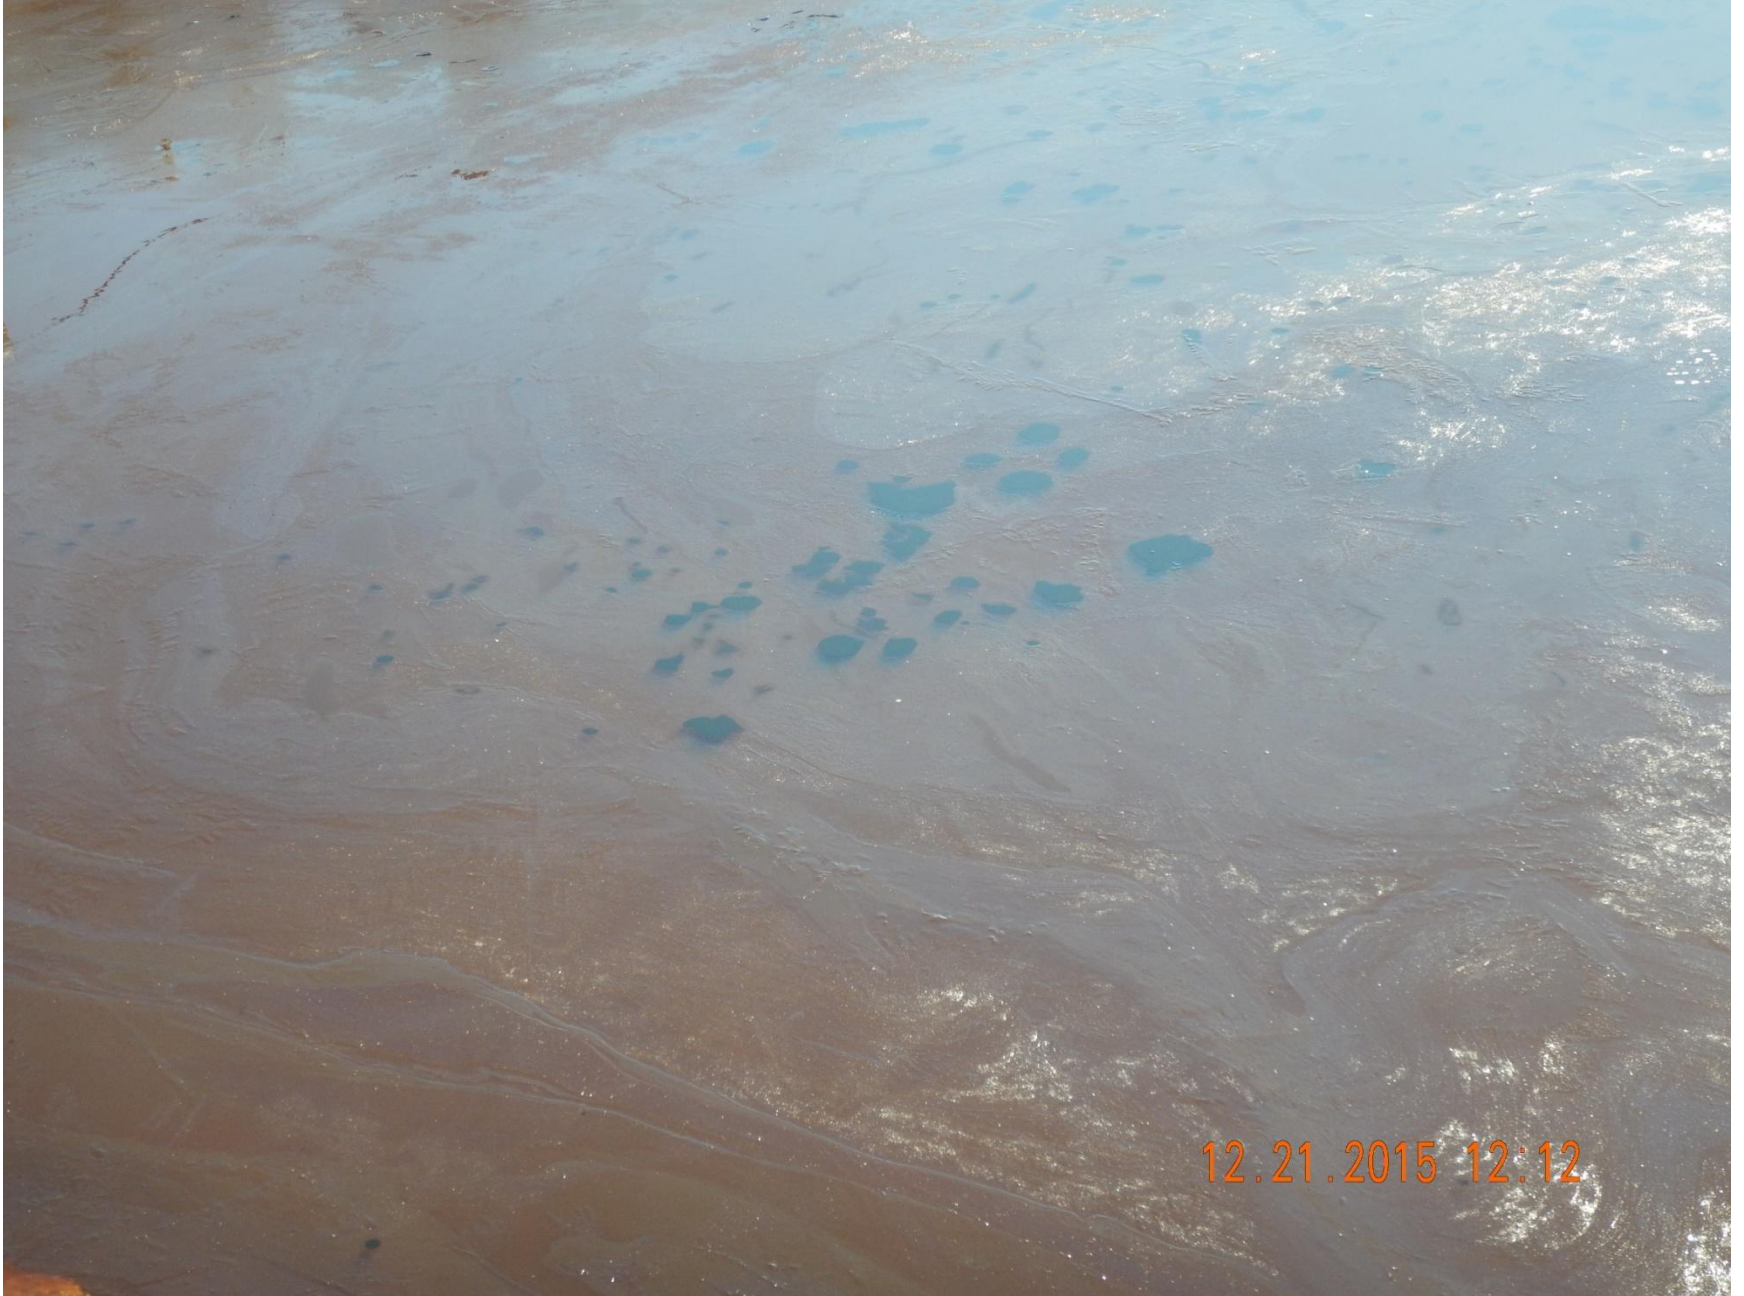
**Figure 14:** Photo taken at southern pit. Photo shows oily water.

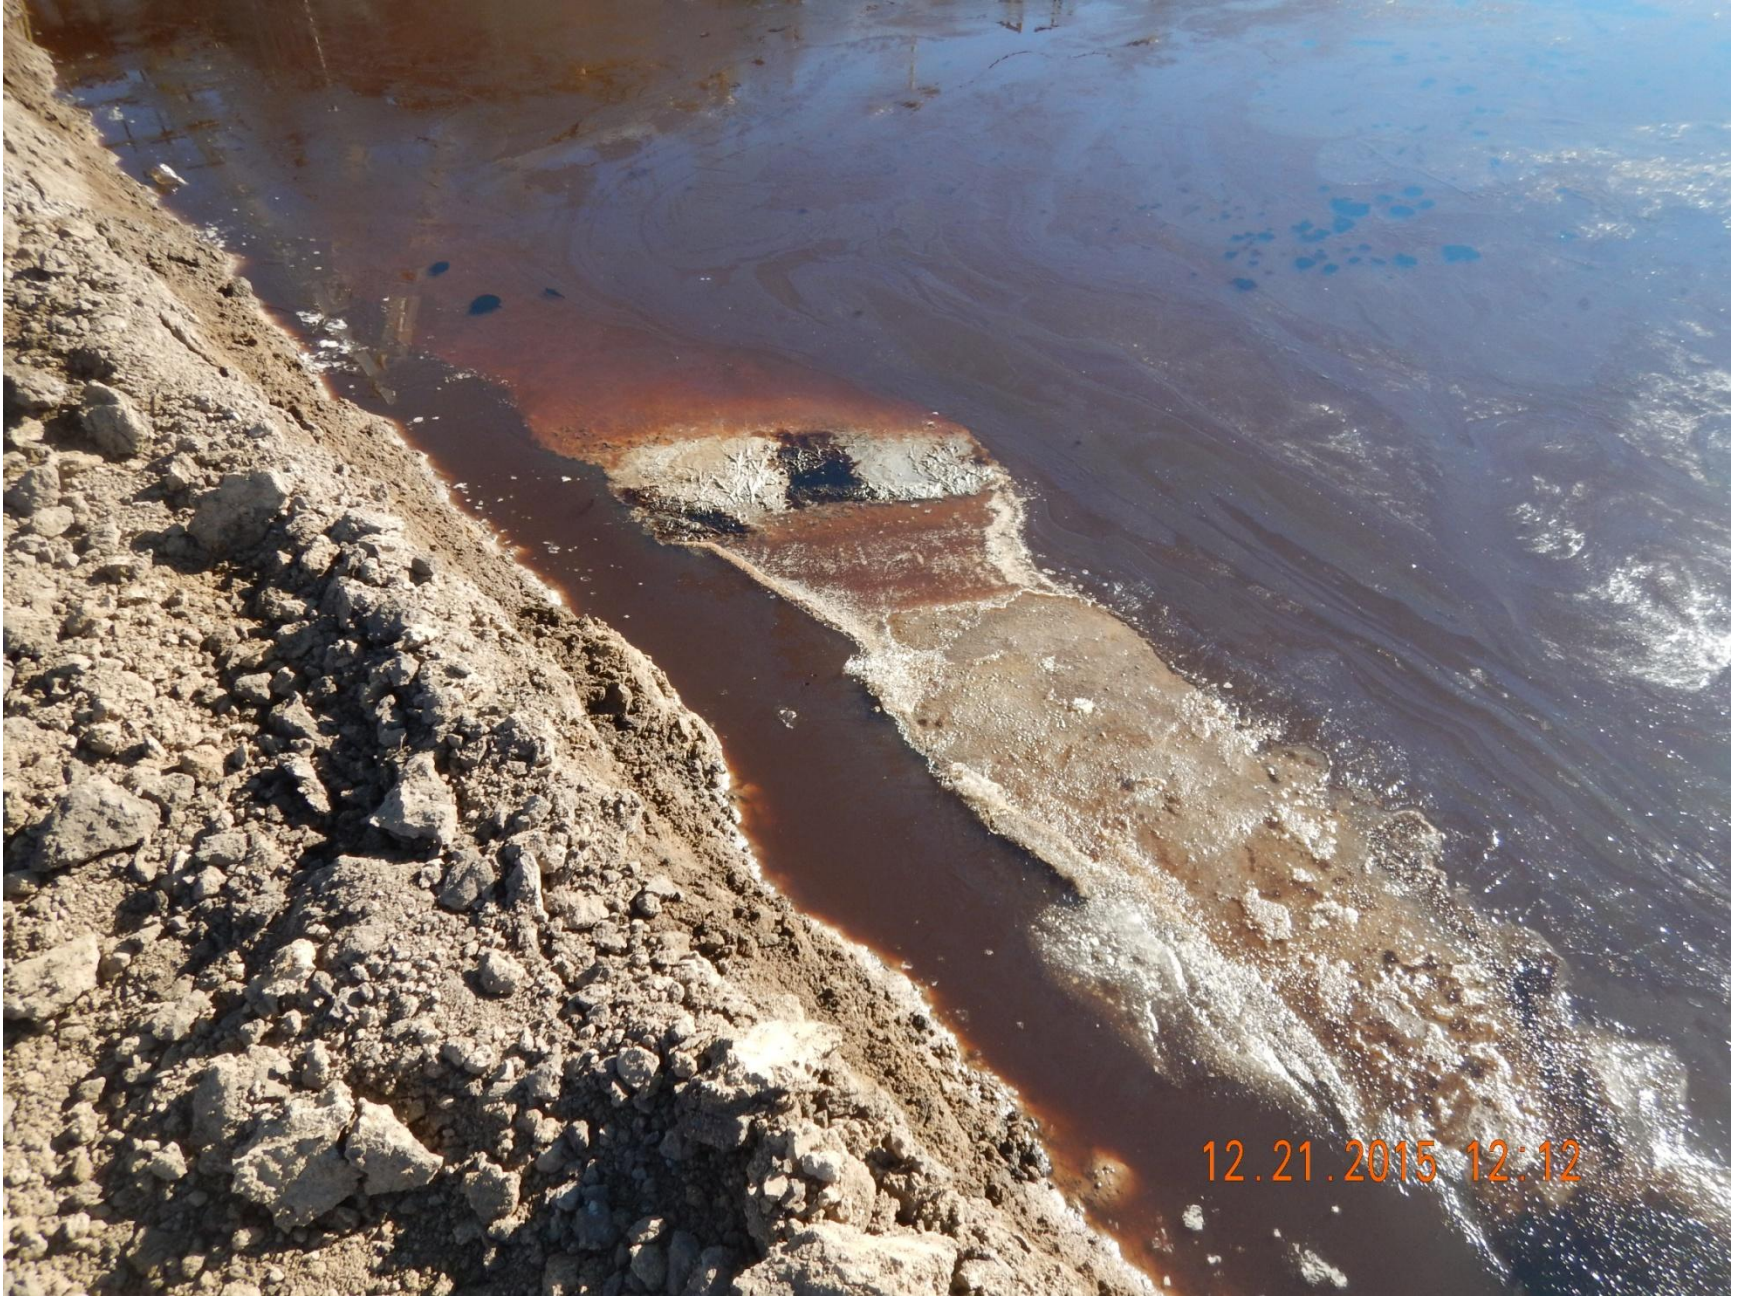
**Figure 15:** Photo taken at southern pit. Photo shows oily water. Pit does not appear to be lined.

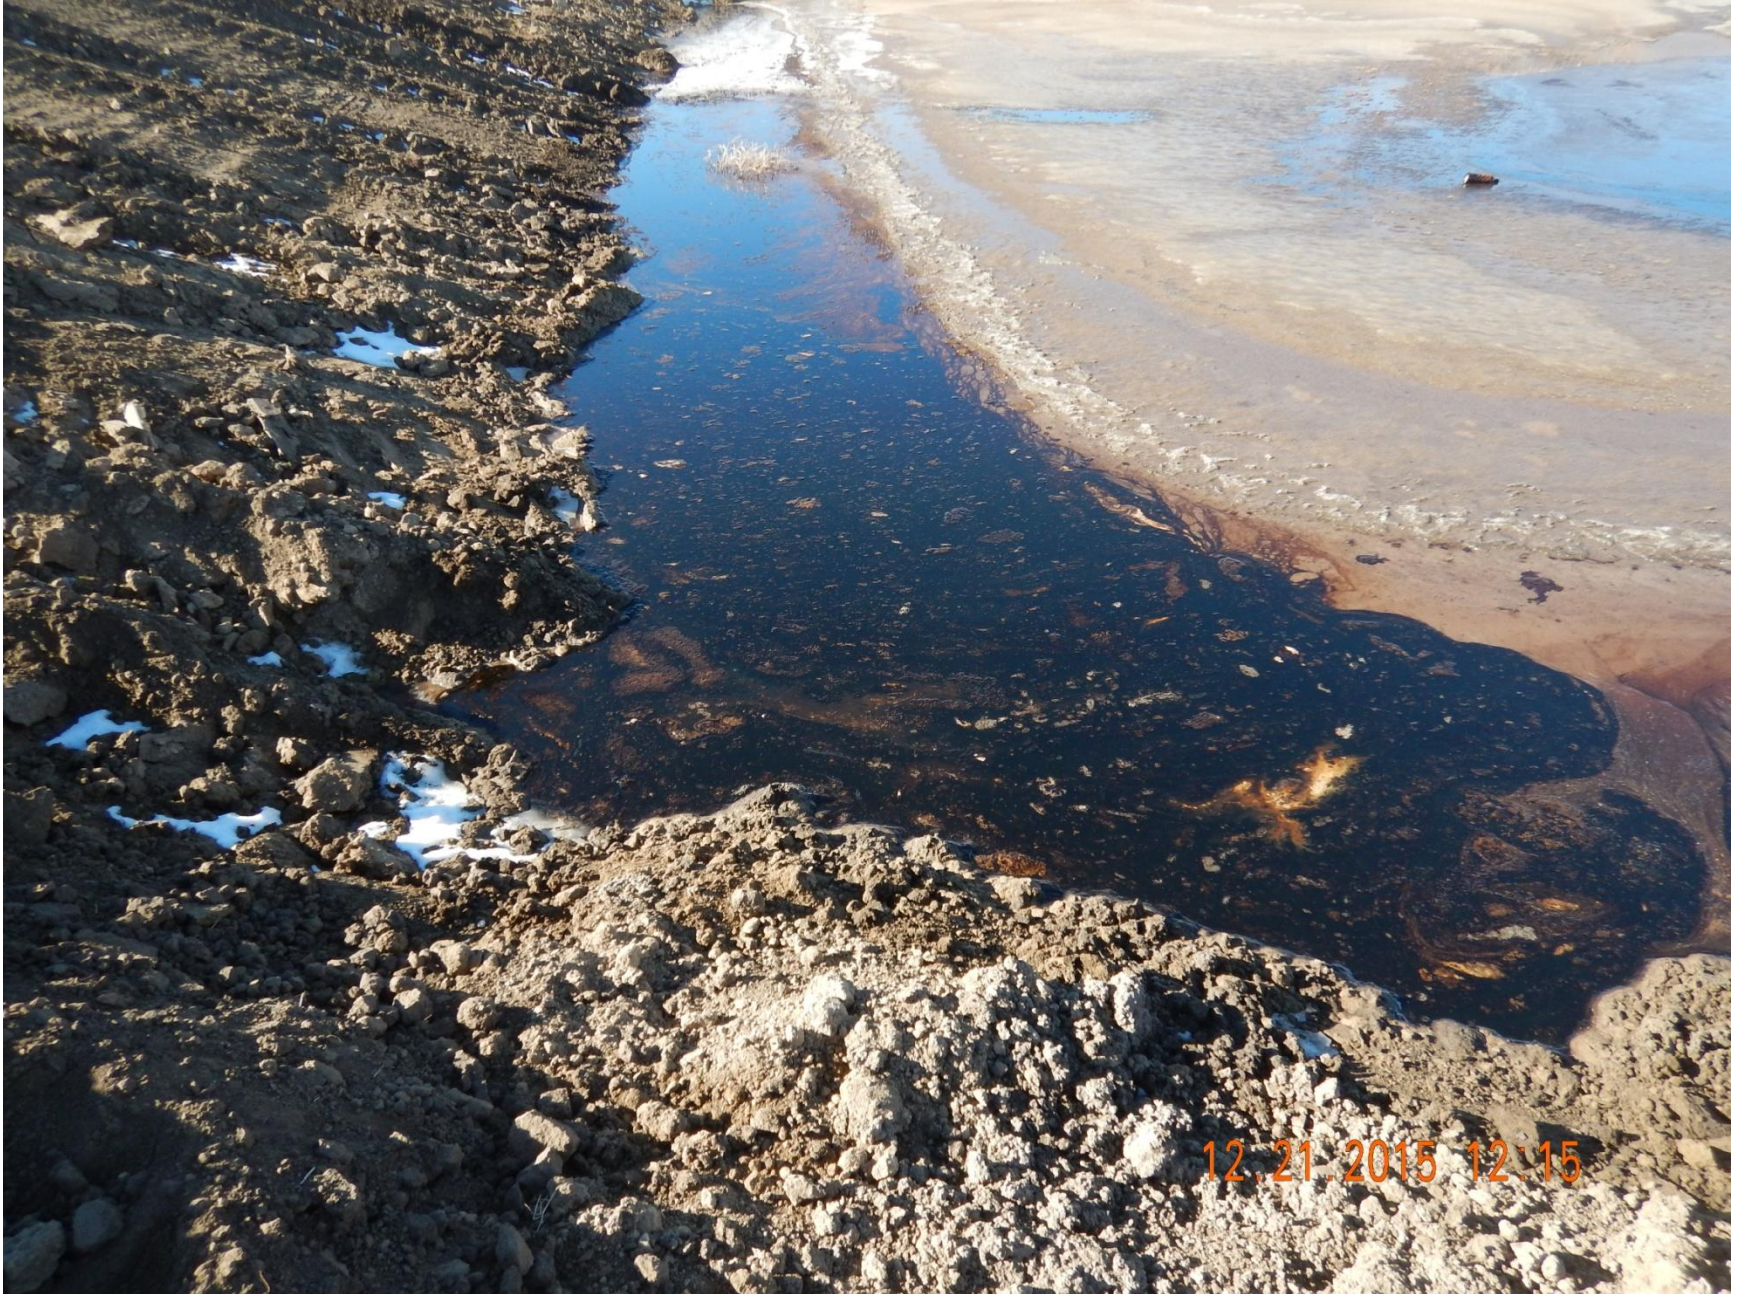
**Figure 16:** Photo taken at southern pit. Photo shows oily water. Pit does not appear to be lined.

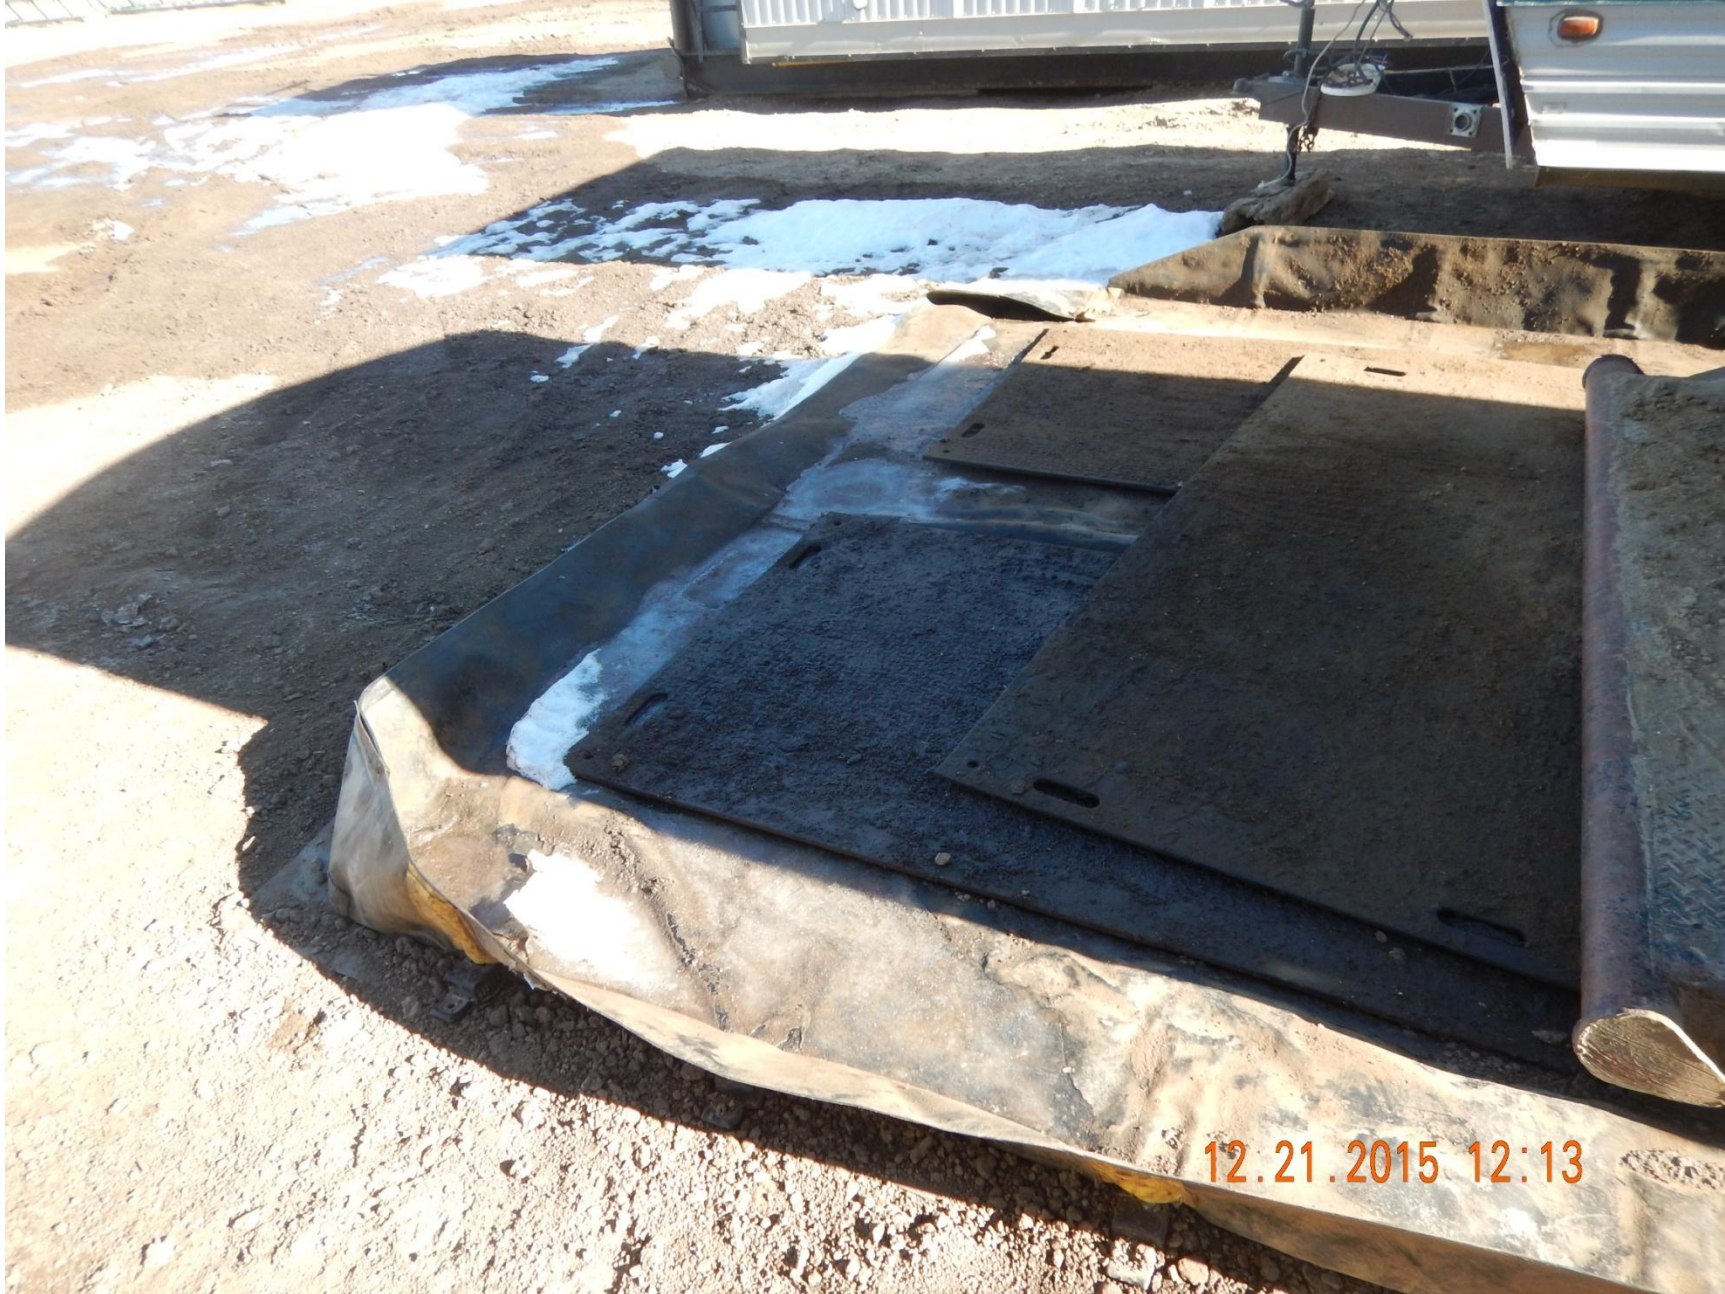
**Figure 17:** Photo taken at tanks on the south end of location. Photo shows containment BMP not properly functioning.

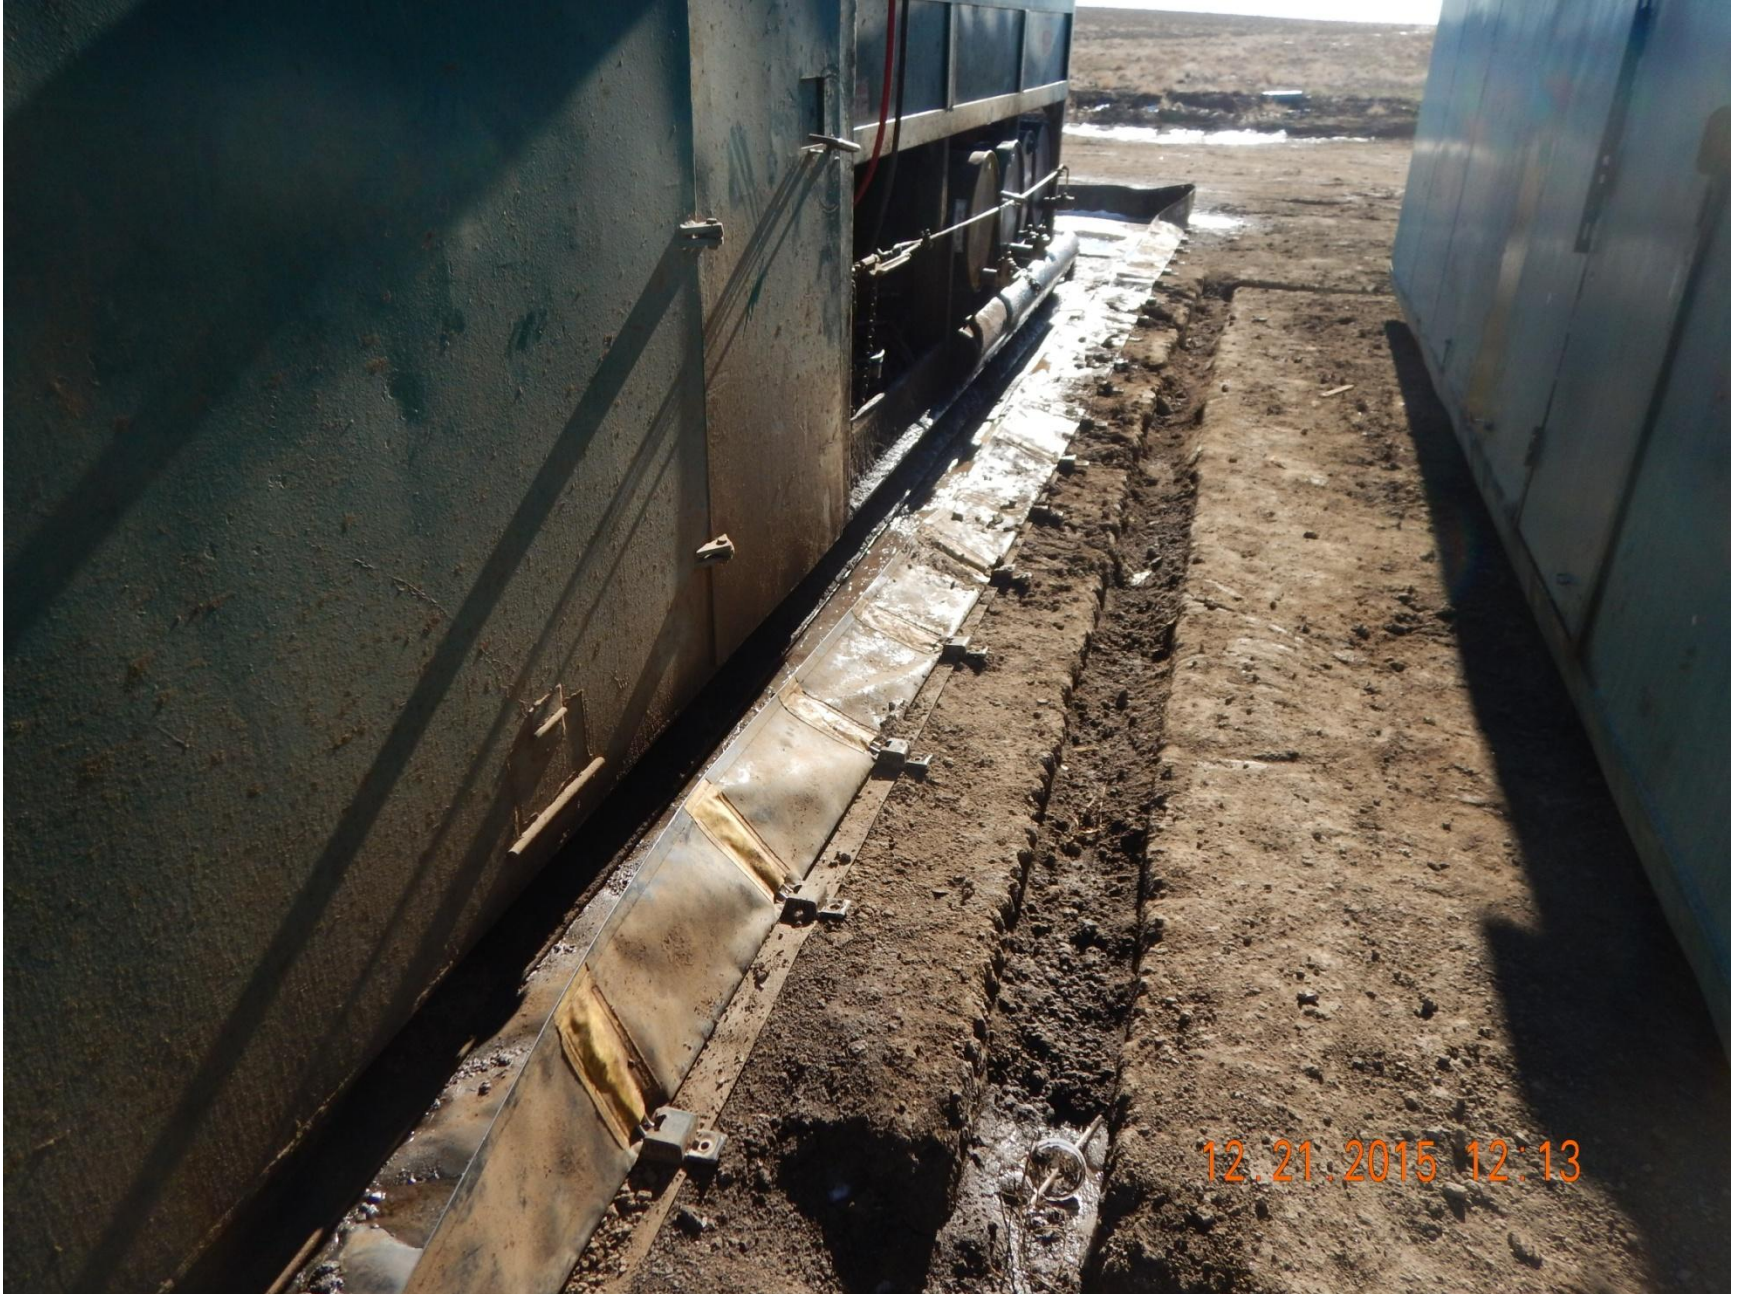
**Figure 18:** Photo taken at tanks on the south end of location. Photo shows containment BMP not properly functioning.

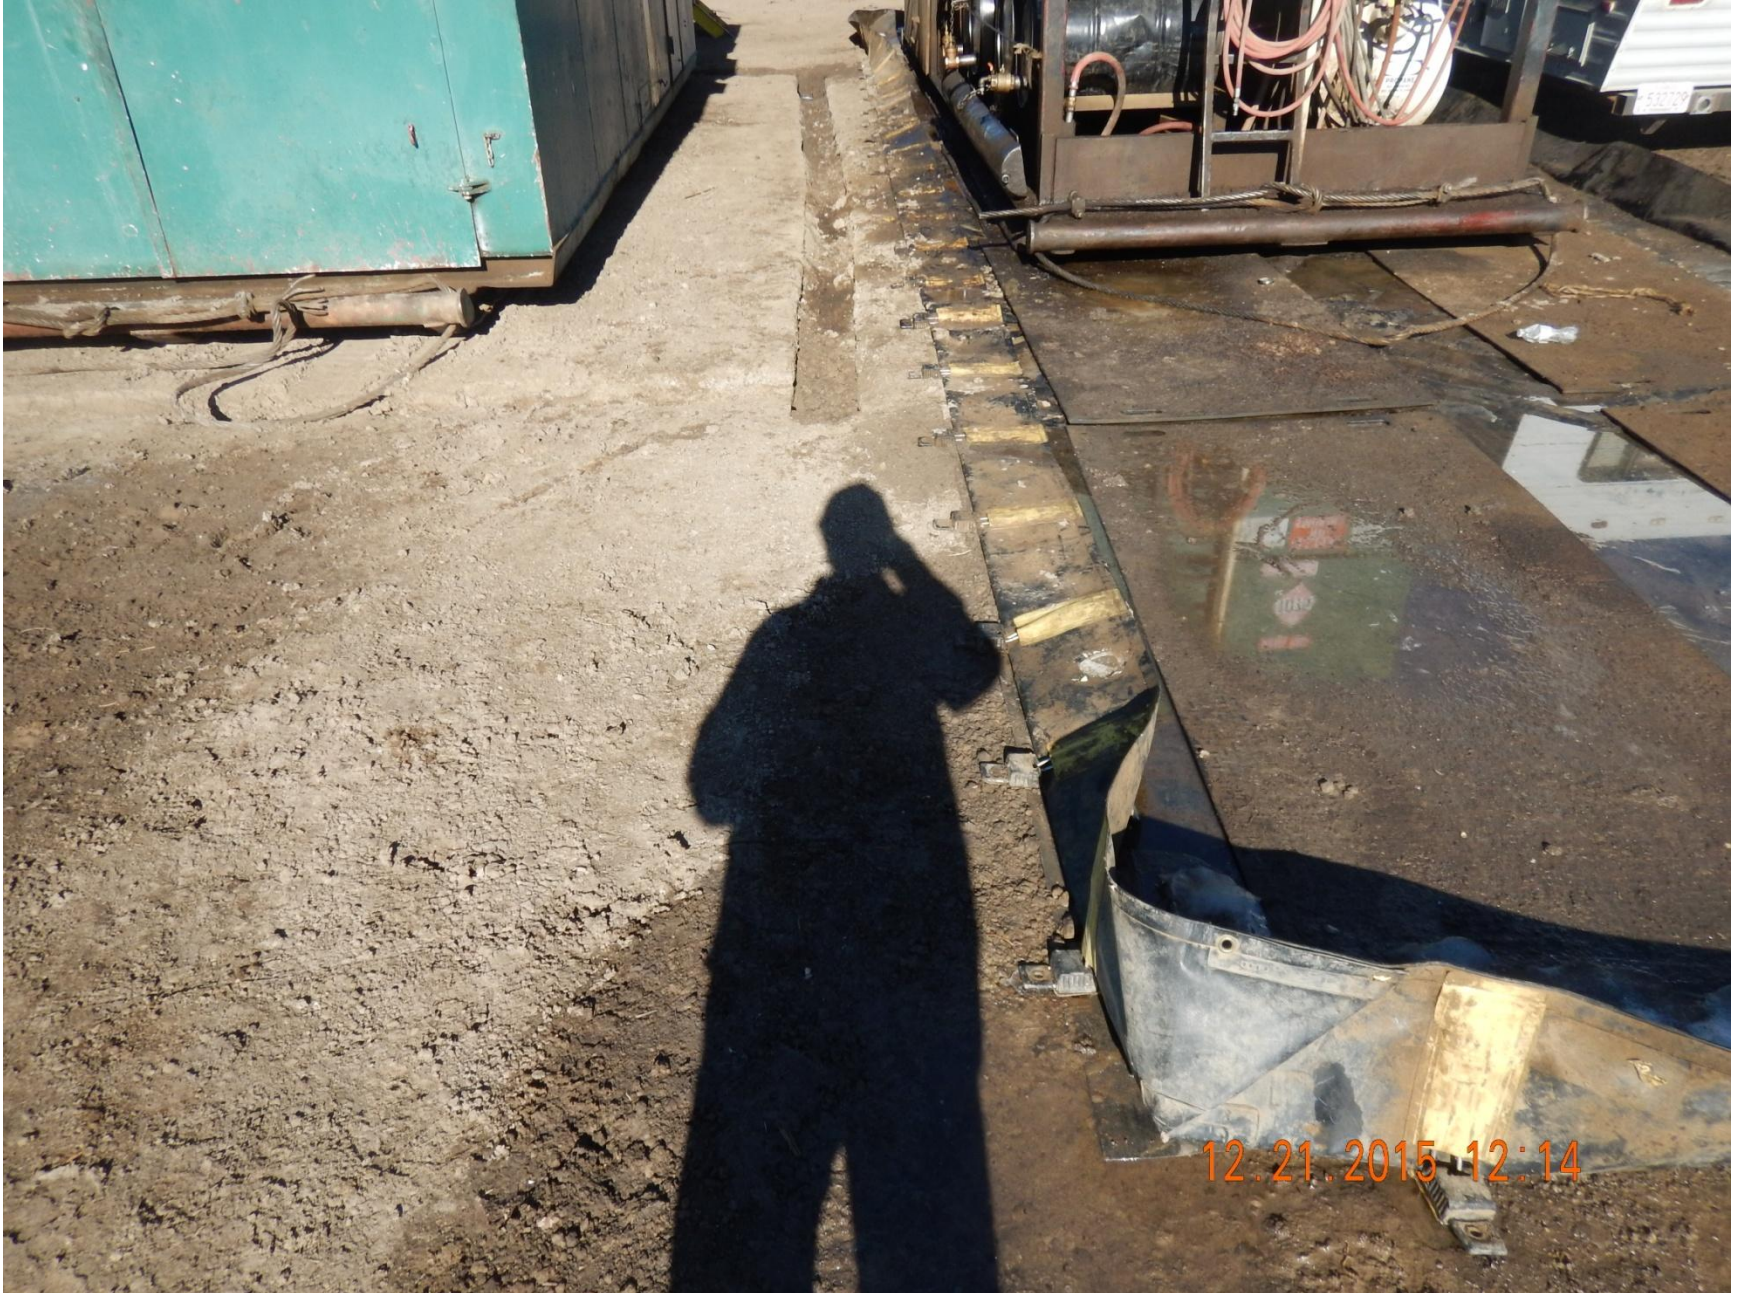
**Figure 19:** Photo taken at tanks on the south end of location. Photo shows containment BMP not properly functioning.

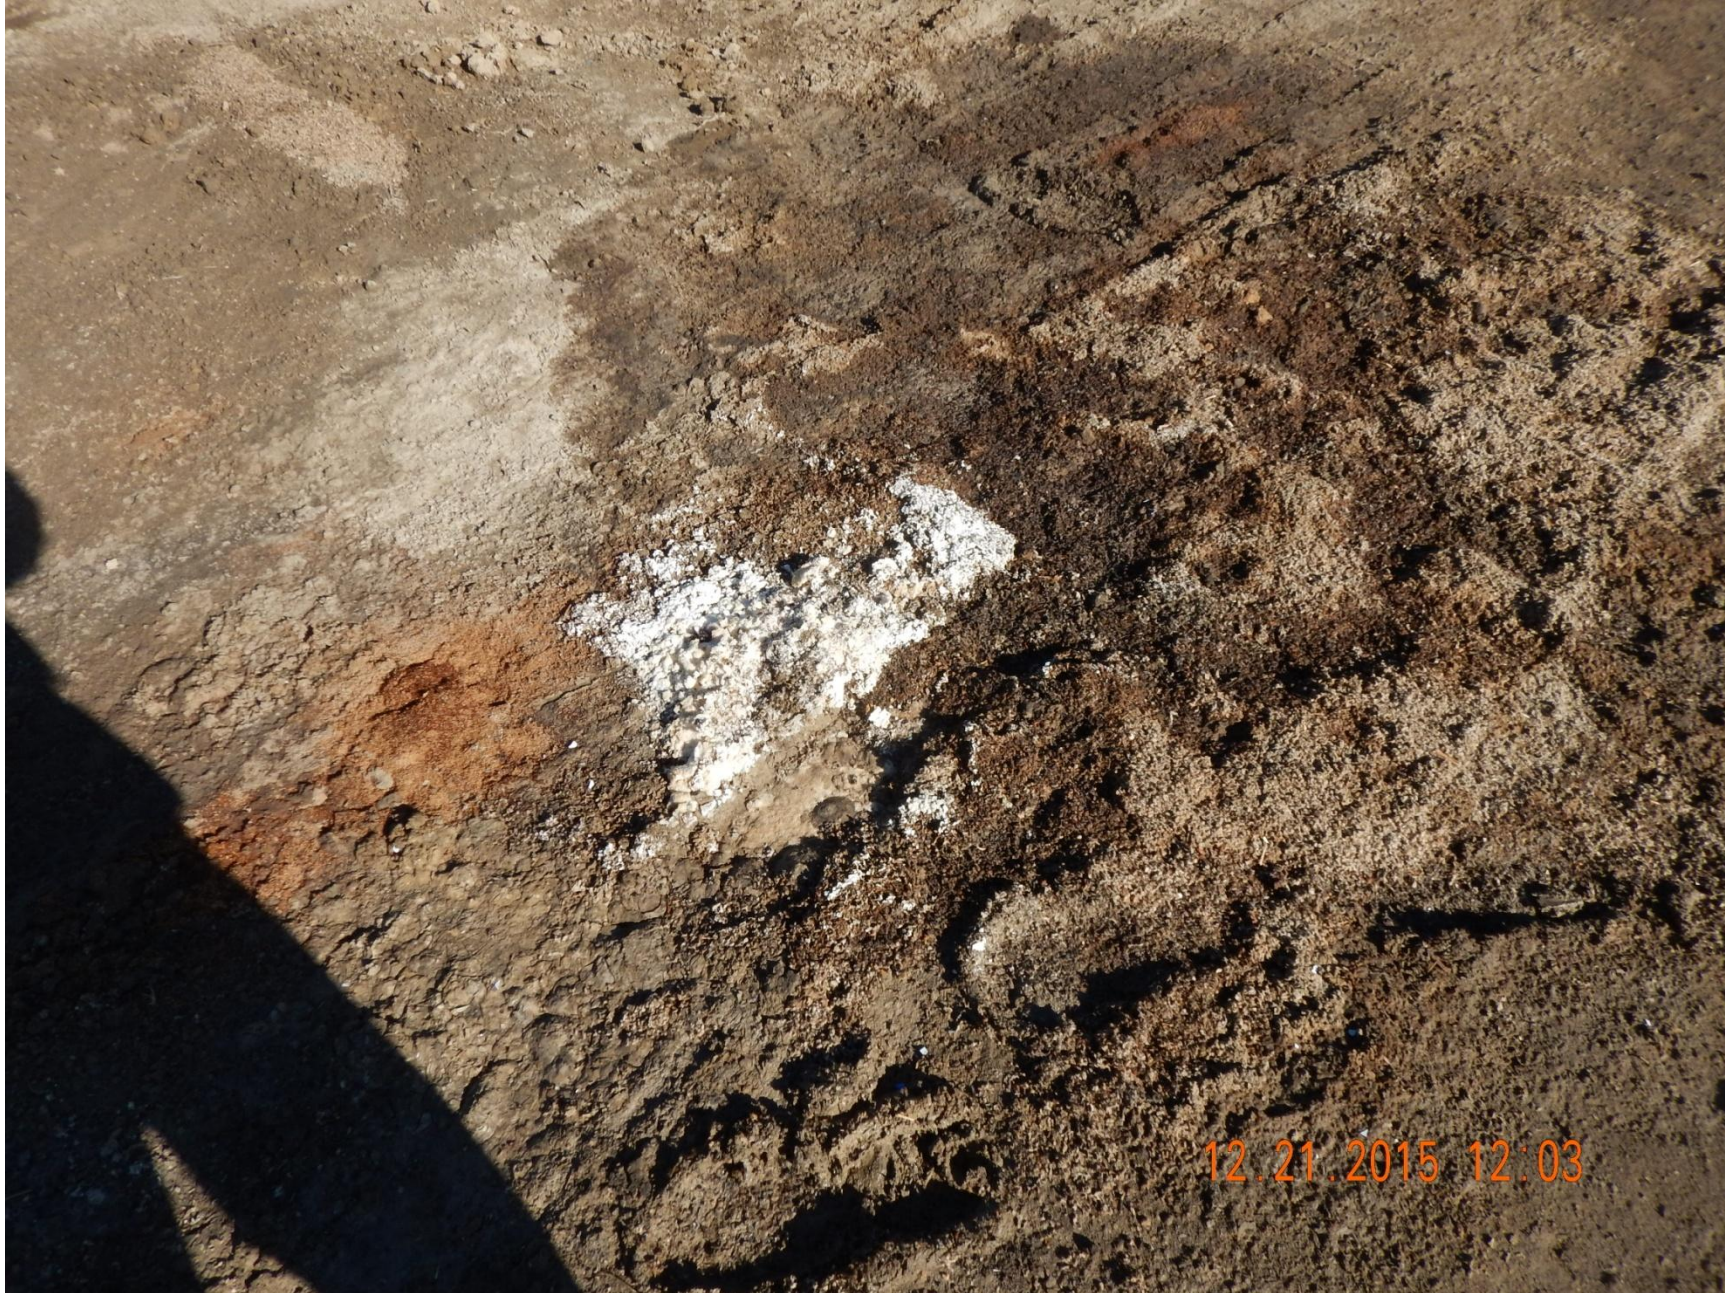
**Figure 20:** Photo taken from south end of location. Photo shows white chemical substance. Chemical had a smell similar to that of battery acid.
