# Follow Up Inspection

12/21/2015

Operator: Wiepking-Fullerton

Location ID: 443145

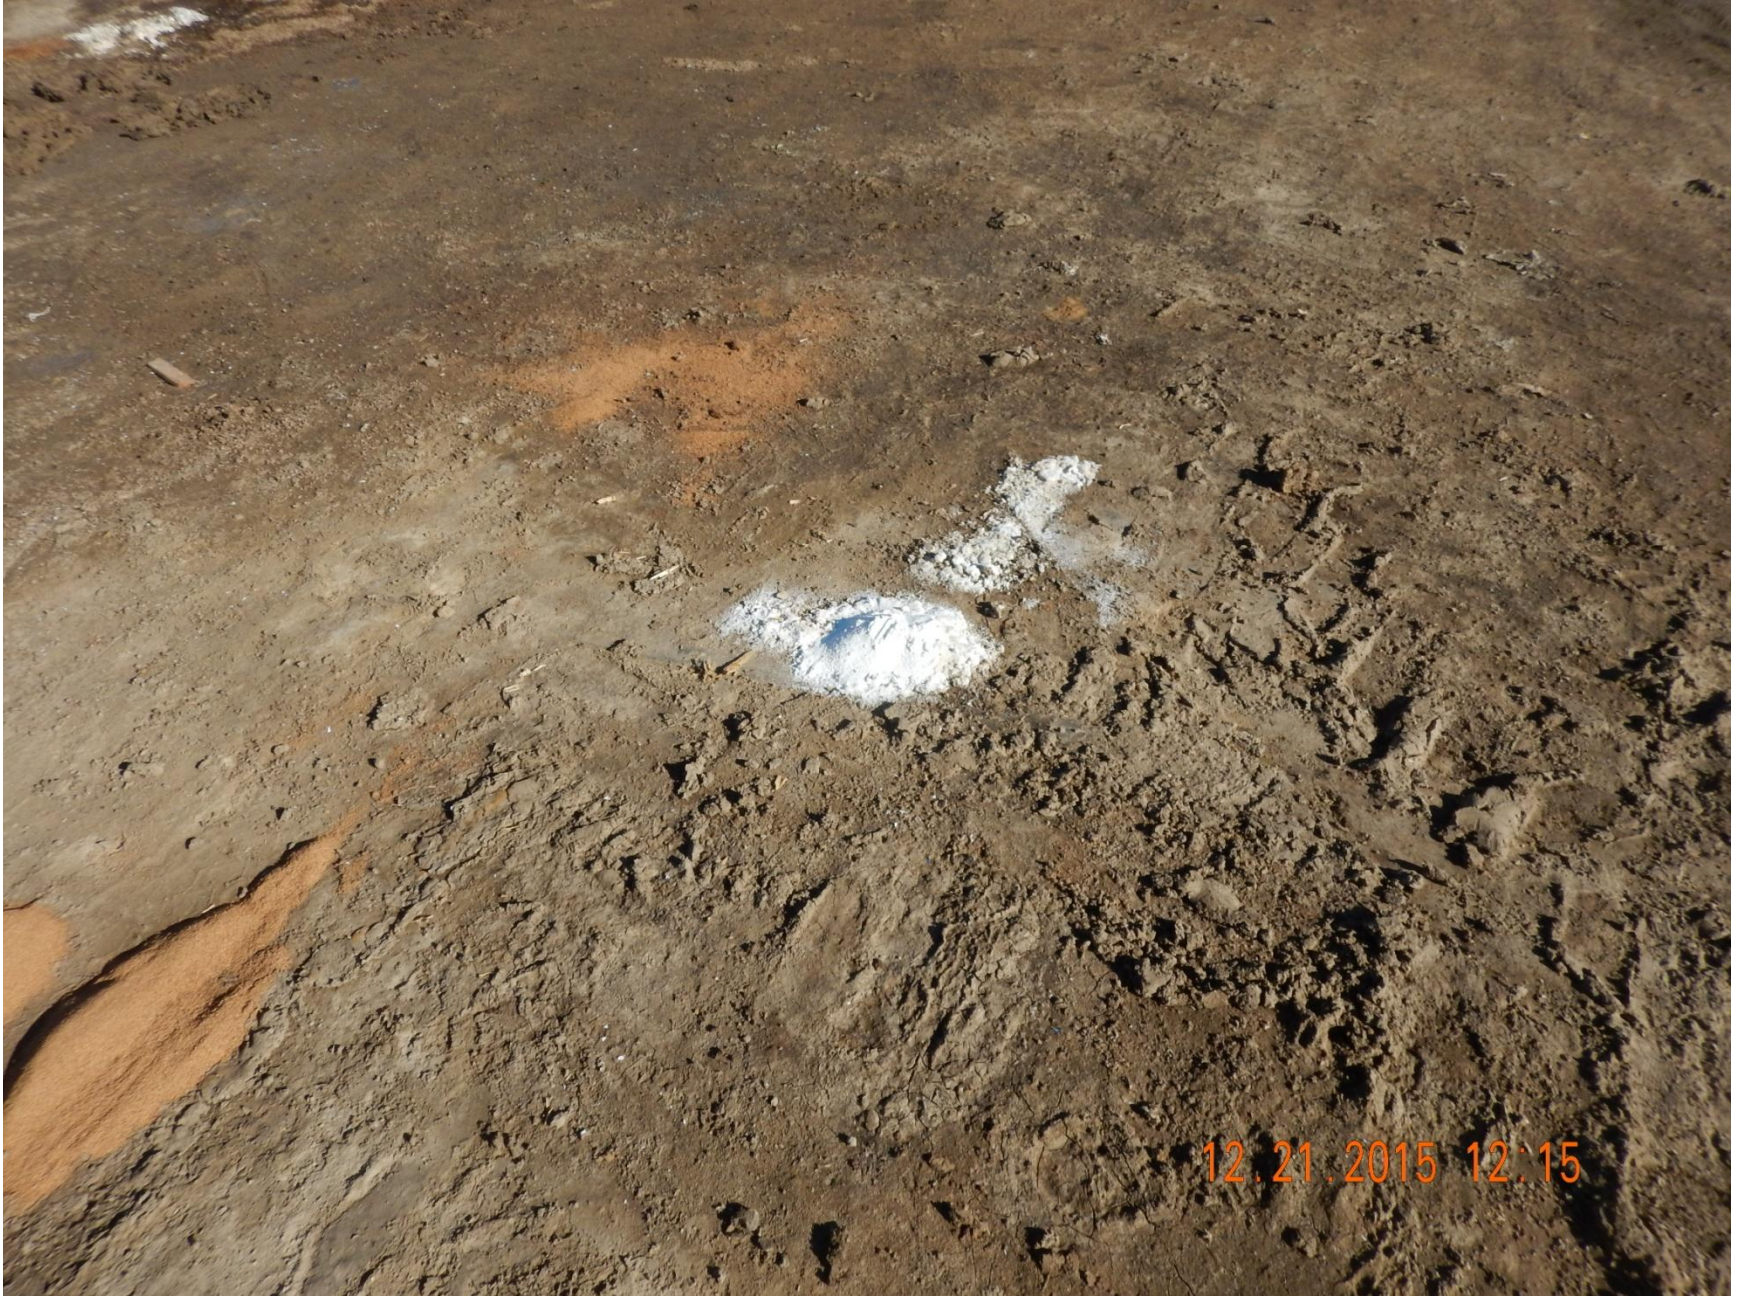
**Figure 21:** Photo taken from south end of location. Photo shows white chemical substance. Chemical had a smell similar to that of battery acid.

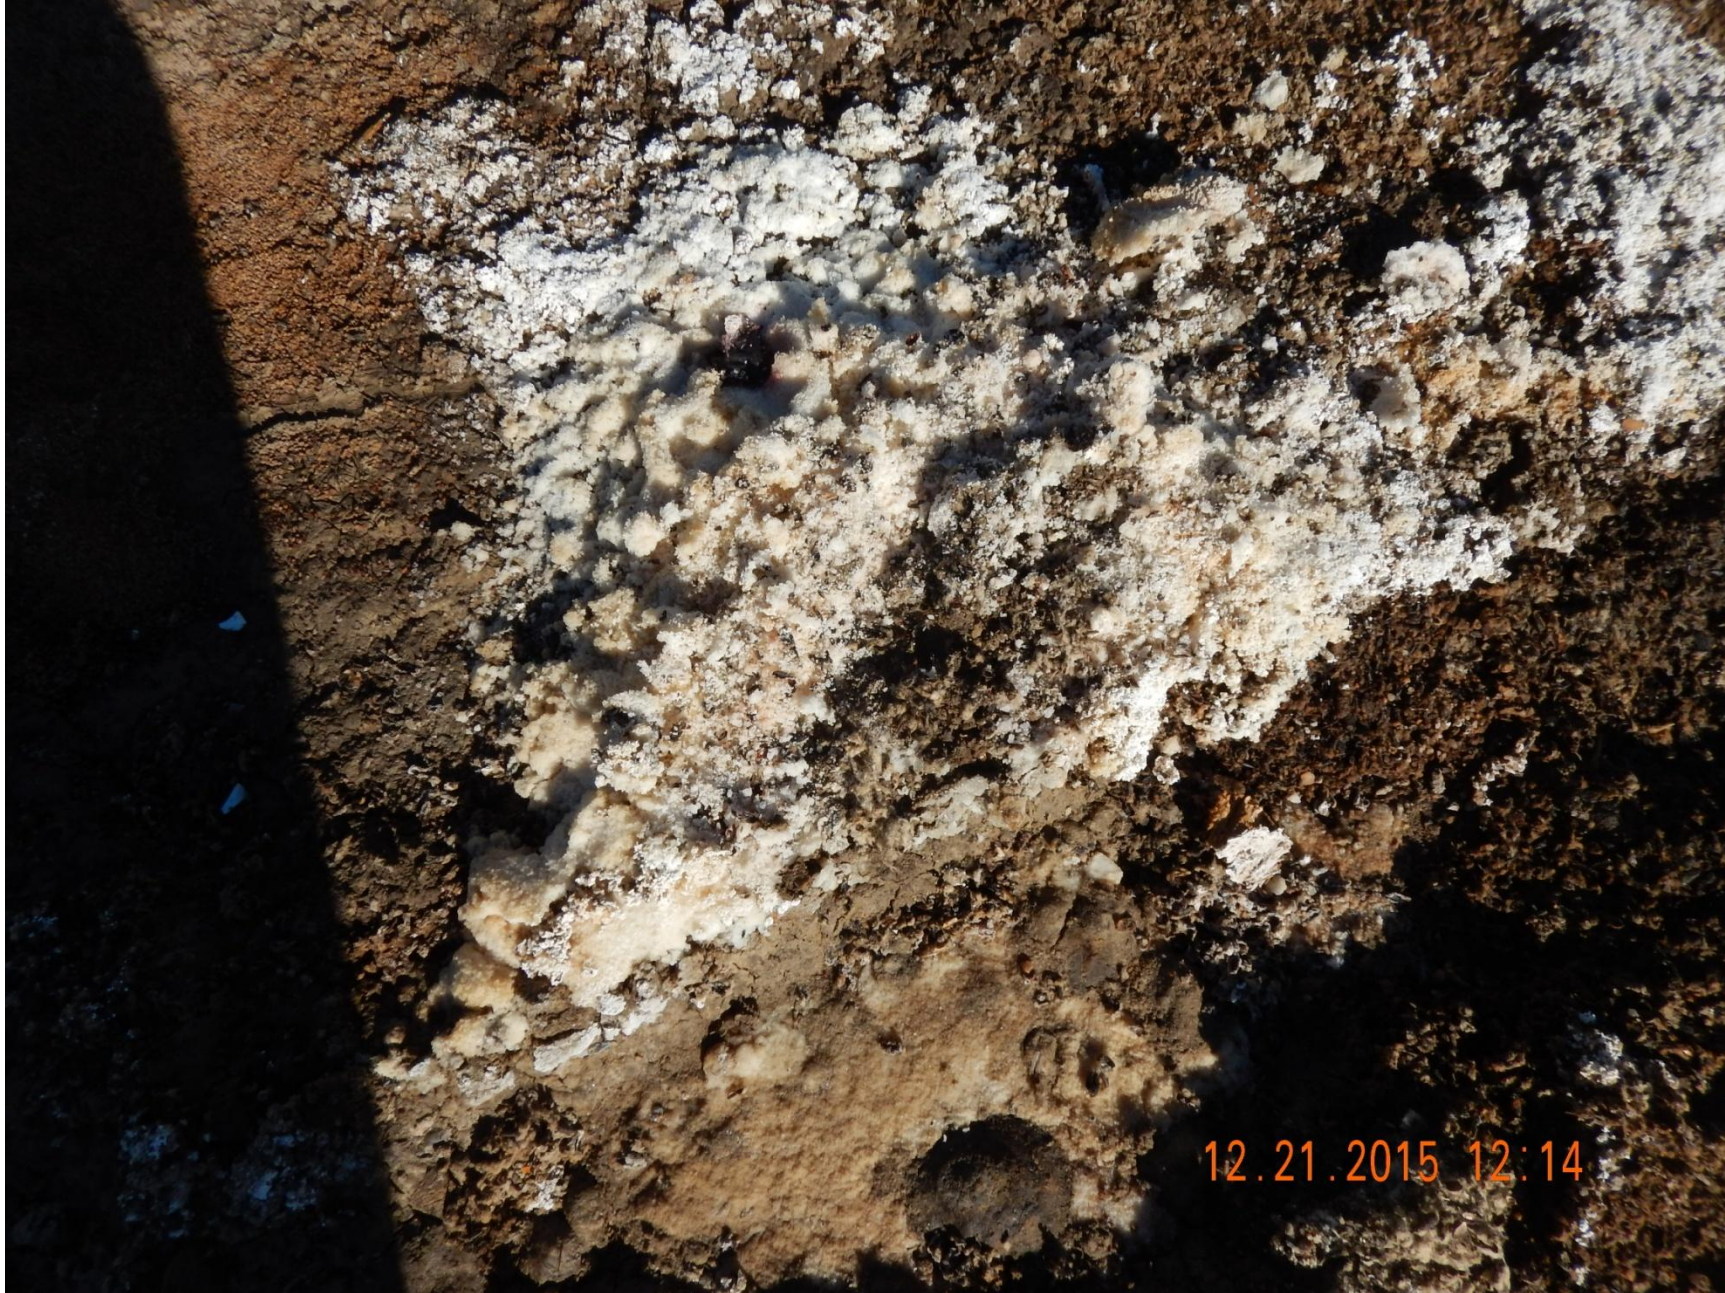
**Figure 22:** Photo taken from south end of location. Photo shows white chemical substance. Chemical had a smell similar to that of battery acid.
