Interim Reclamation Inspection

Inspection Date: 12/22/2015

Operator: Noble Energy Inc.

Location ID: 421847

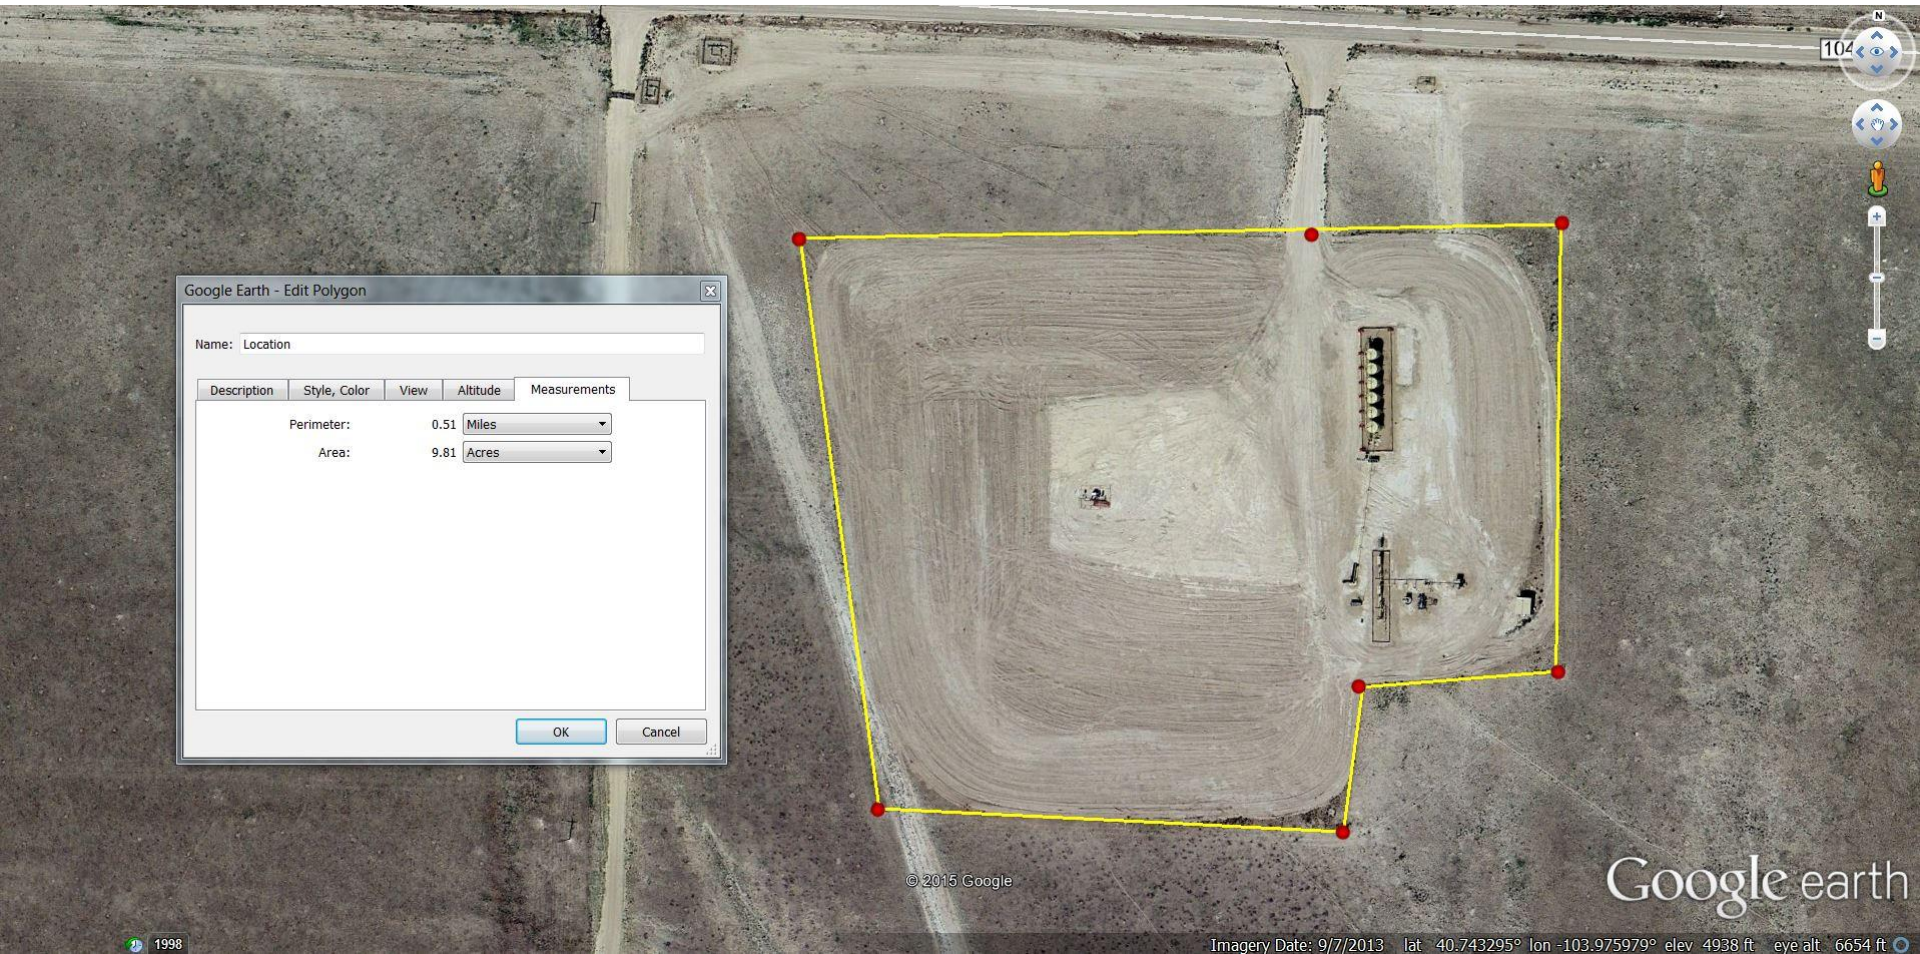
Figure 1: Aerial image of location. Area of location pre-interim reclamation was approximately 9.8 acres.

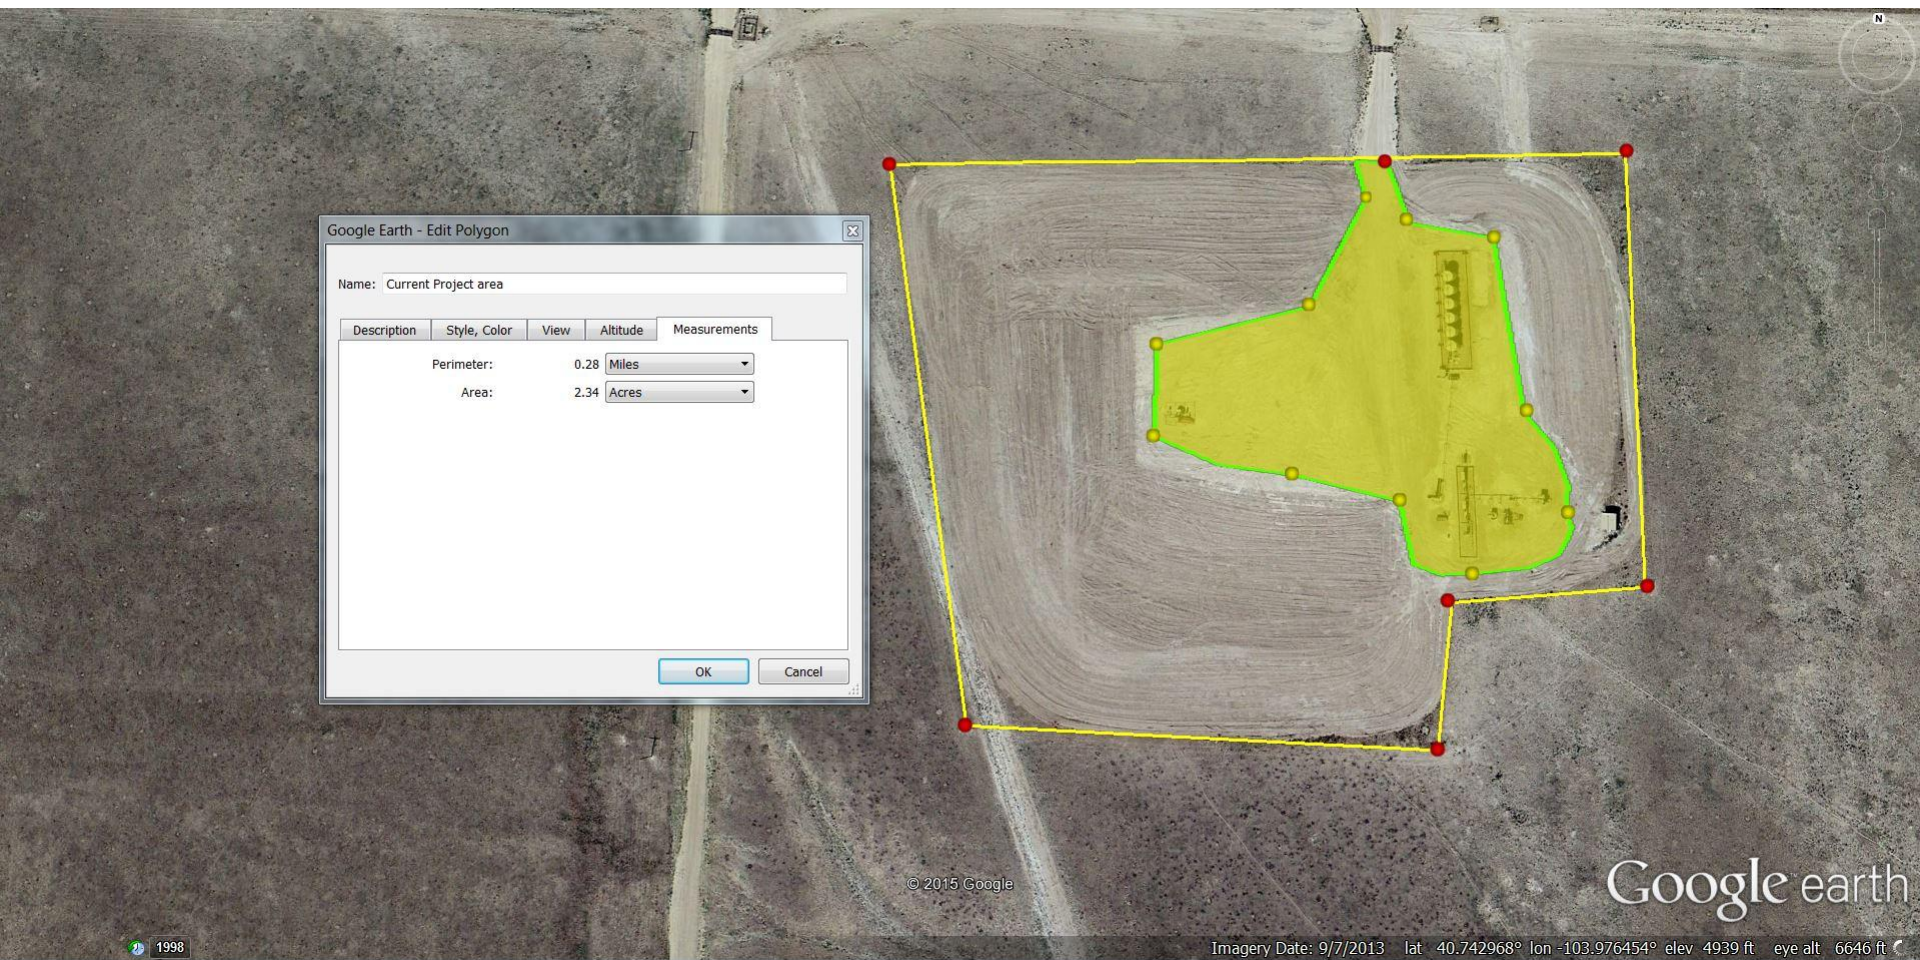
Figure 2: Aerial image of location. Current size of project area is approximately 2.3 acres.

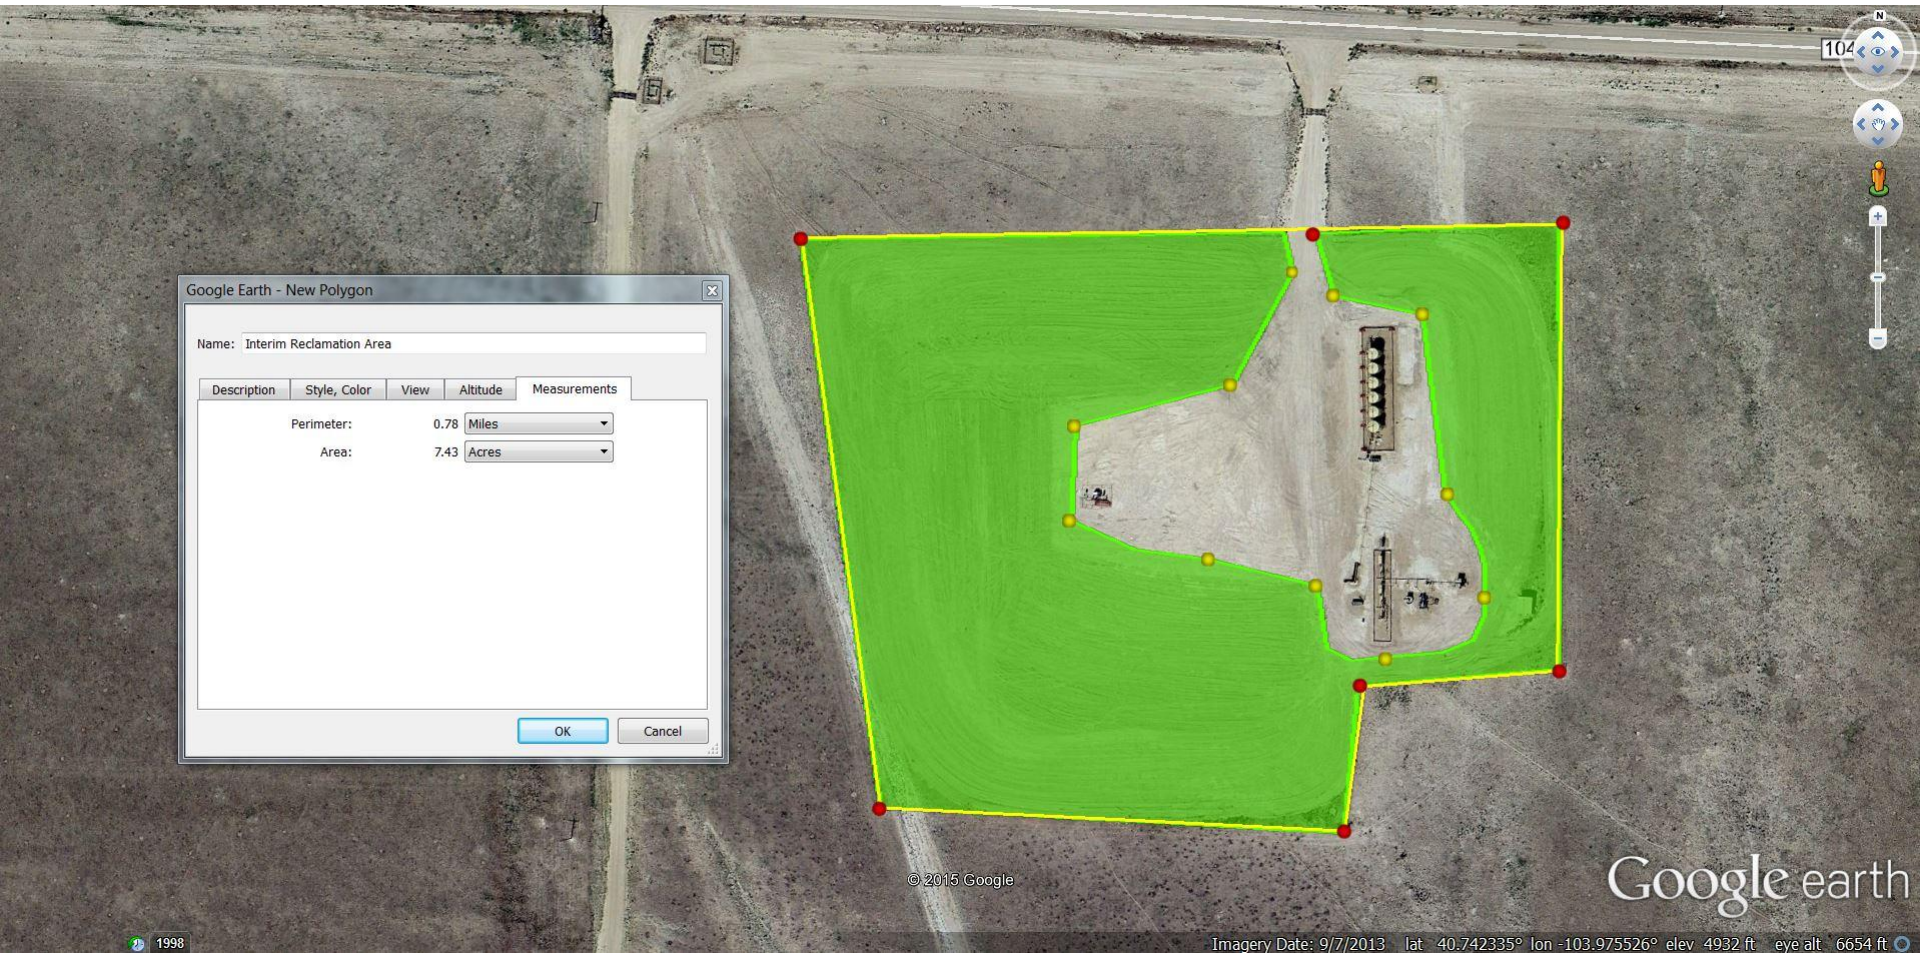
Figure 3: Aerial image of location. Image shows current size of interim reclamation in process is approximately 7.4 acres.

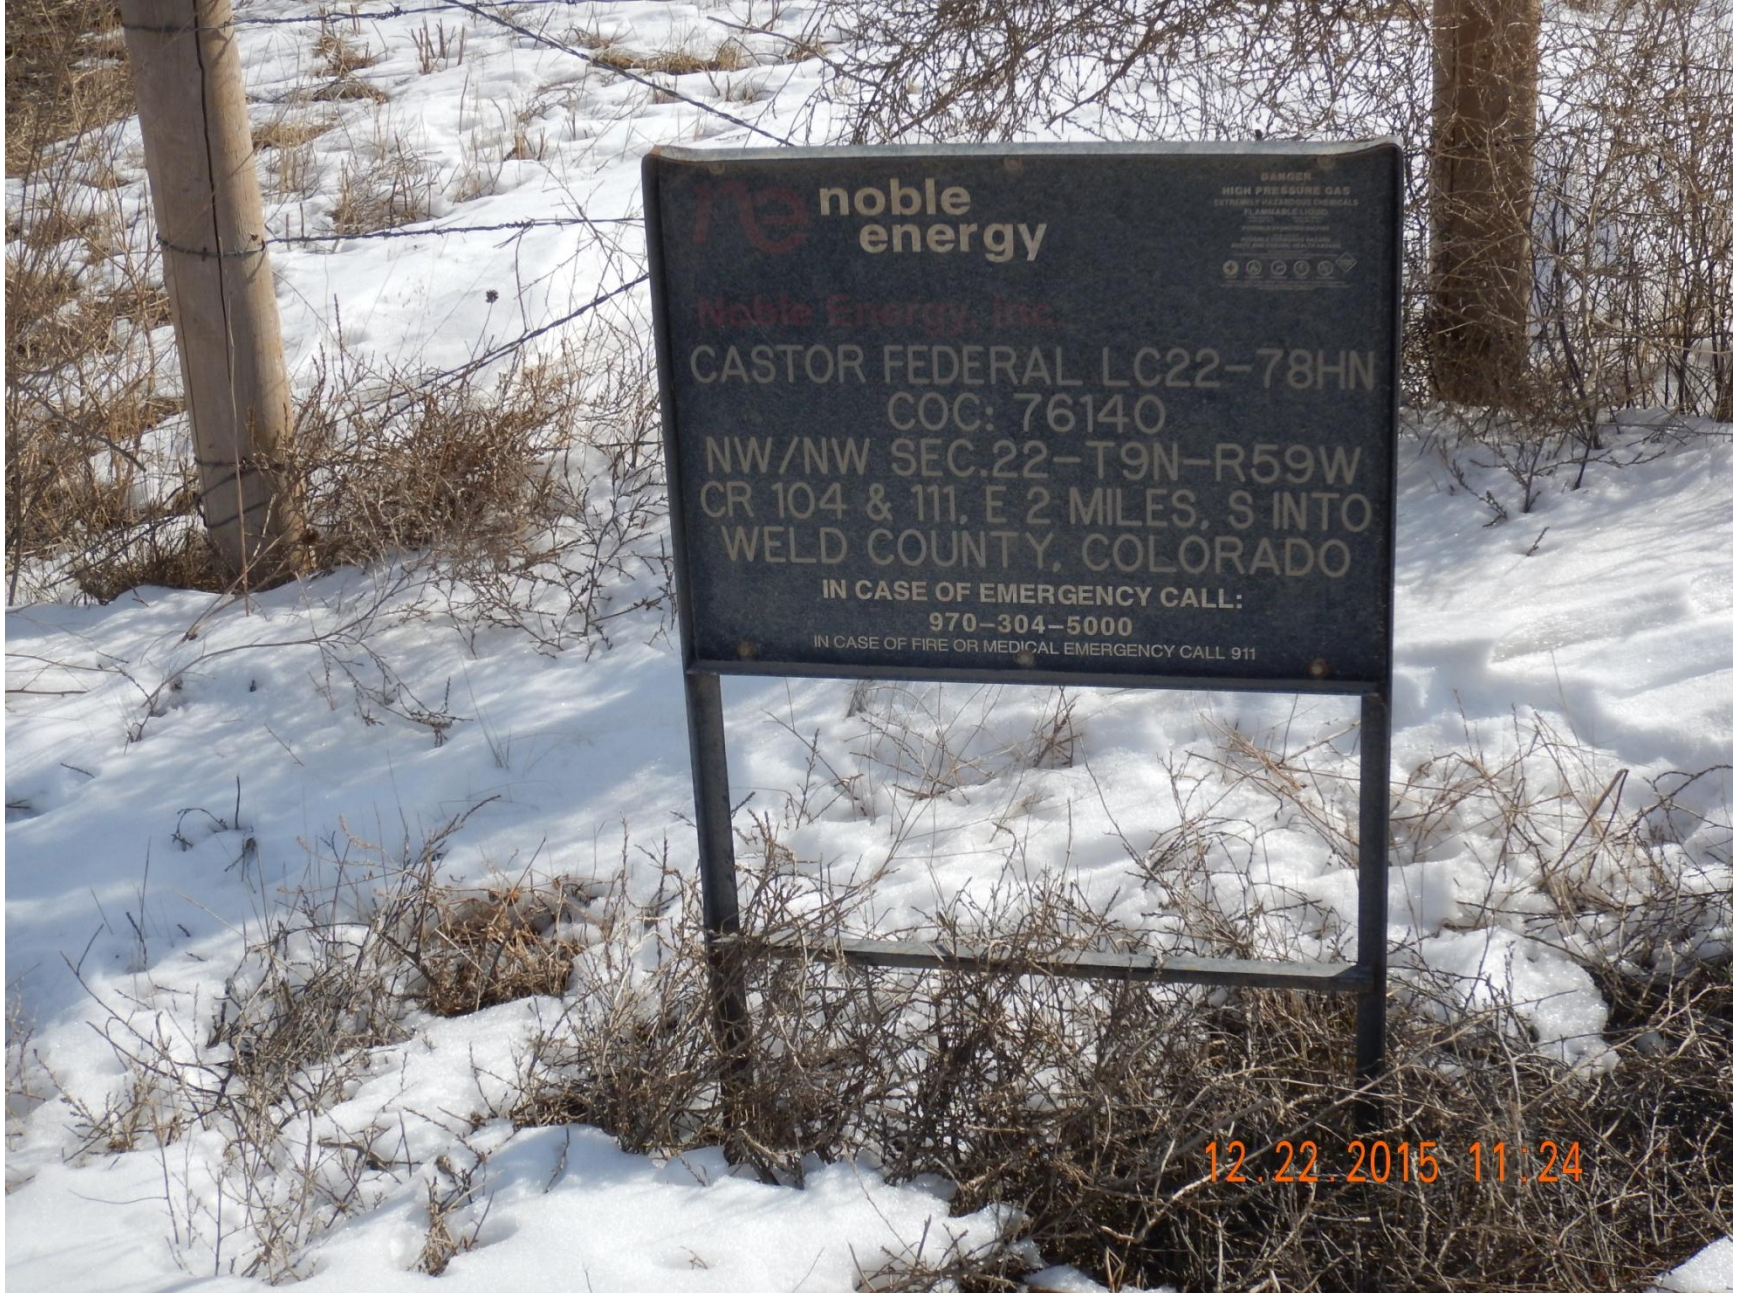
Figure 4: Photo taken from northern end of location. Photo of sign at location entrance.

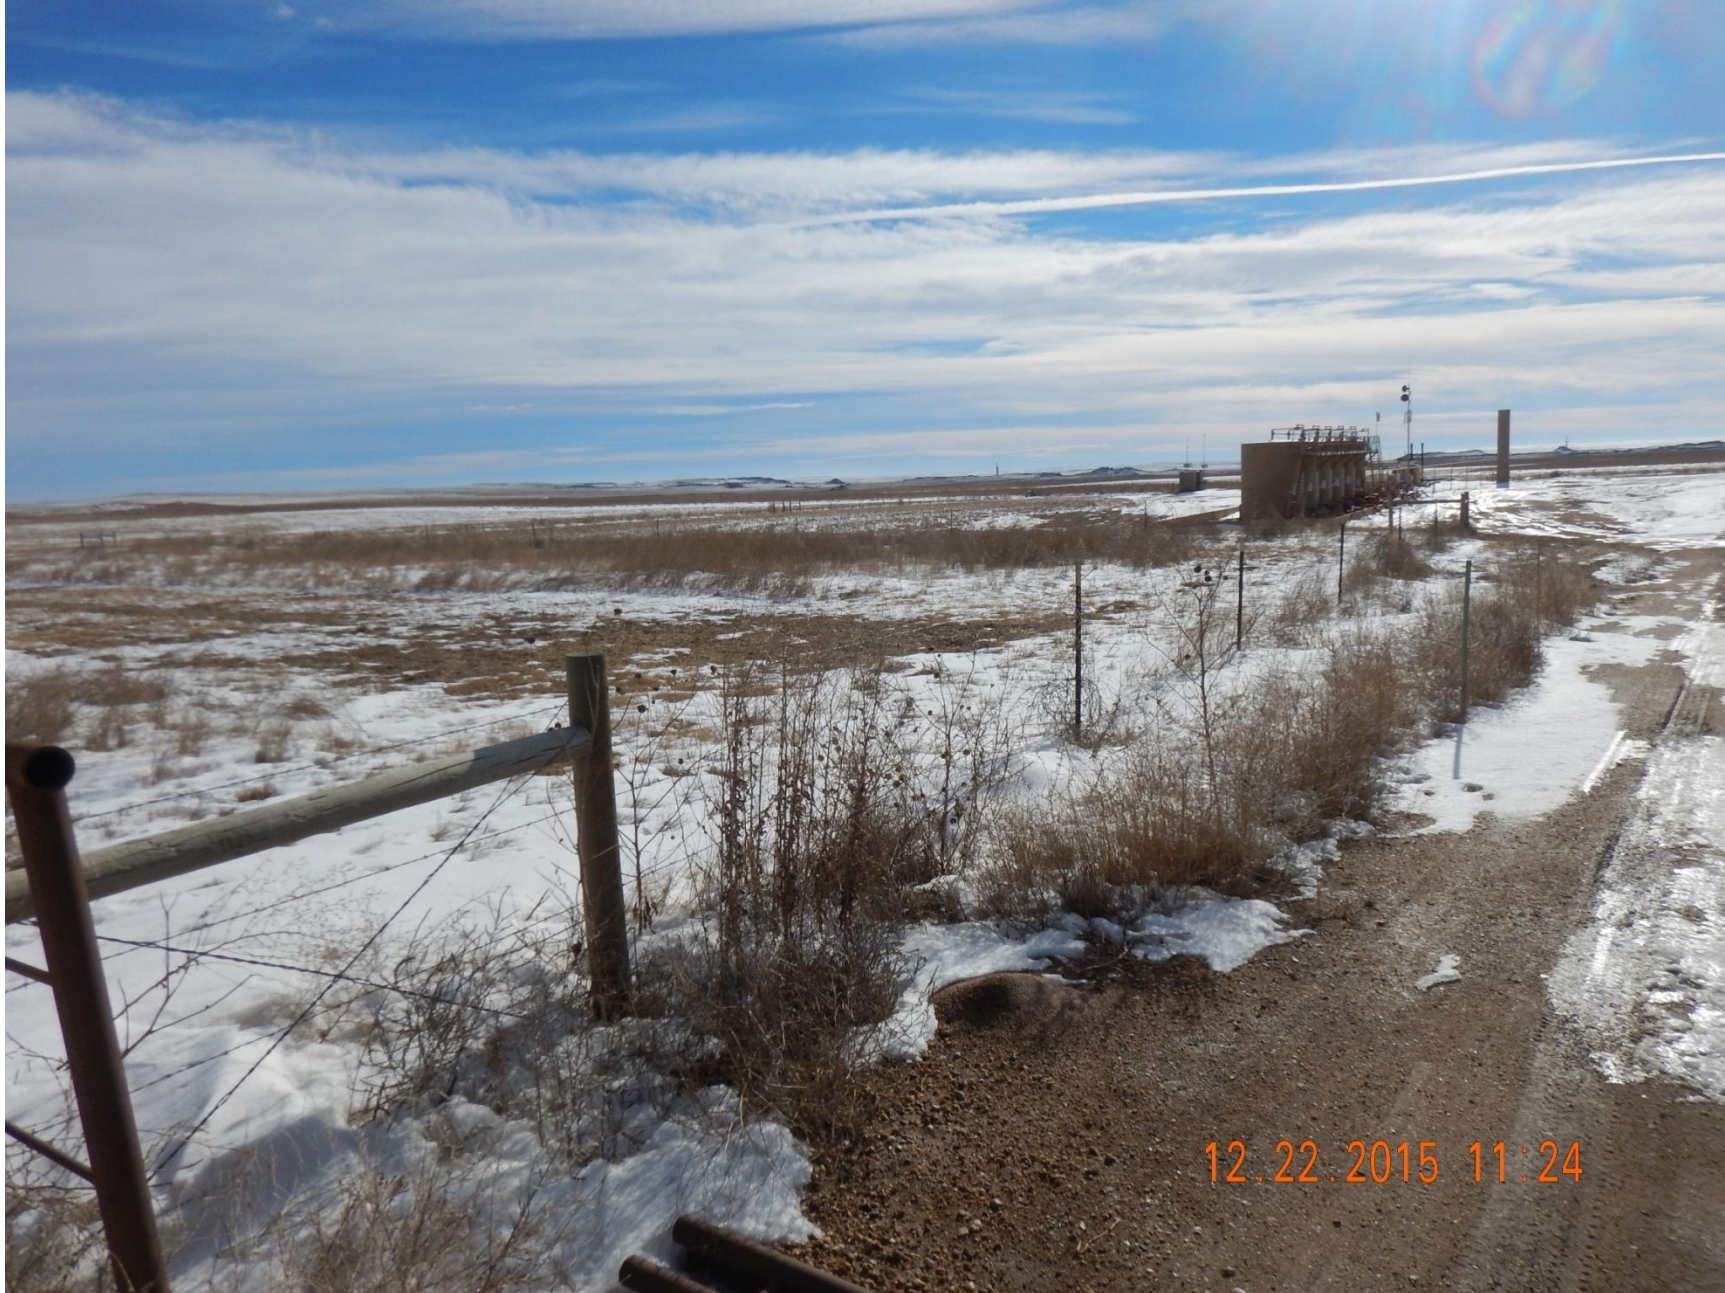
Figure 5: Photo taken from the northern end of location, facing southeast. Photo shows location and interim area.

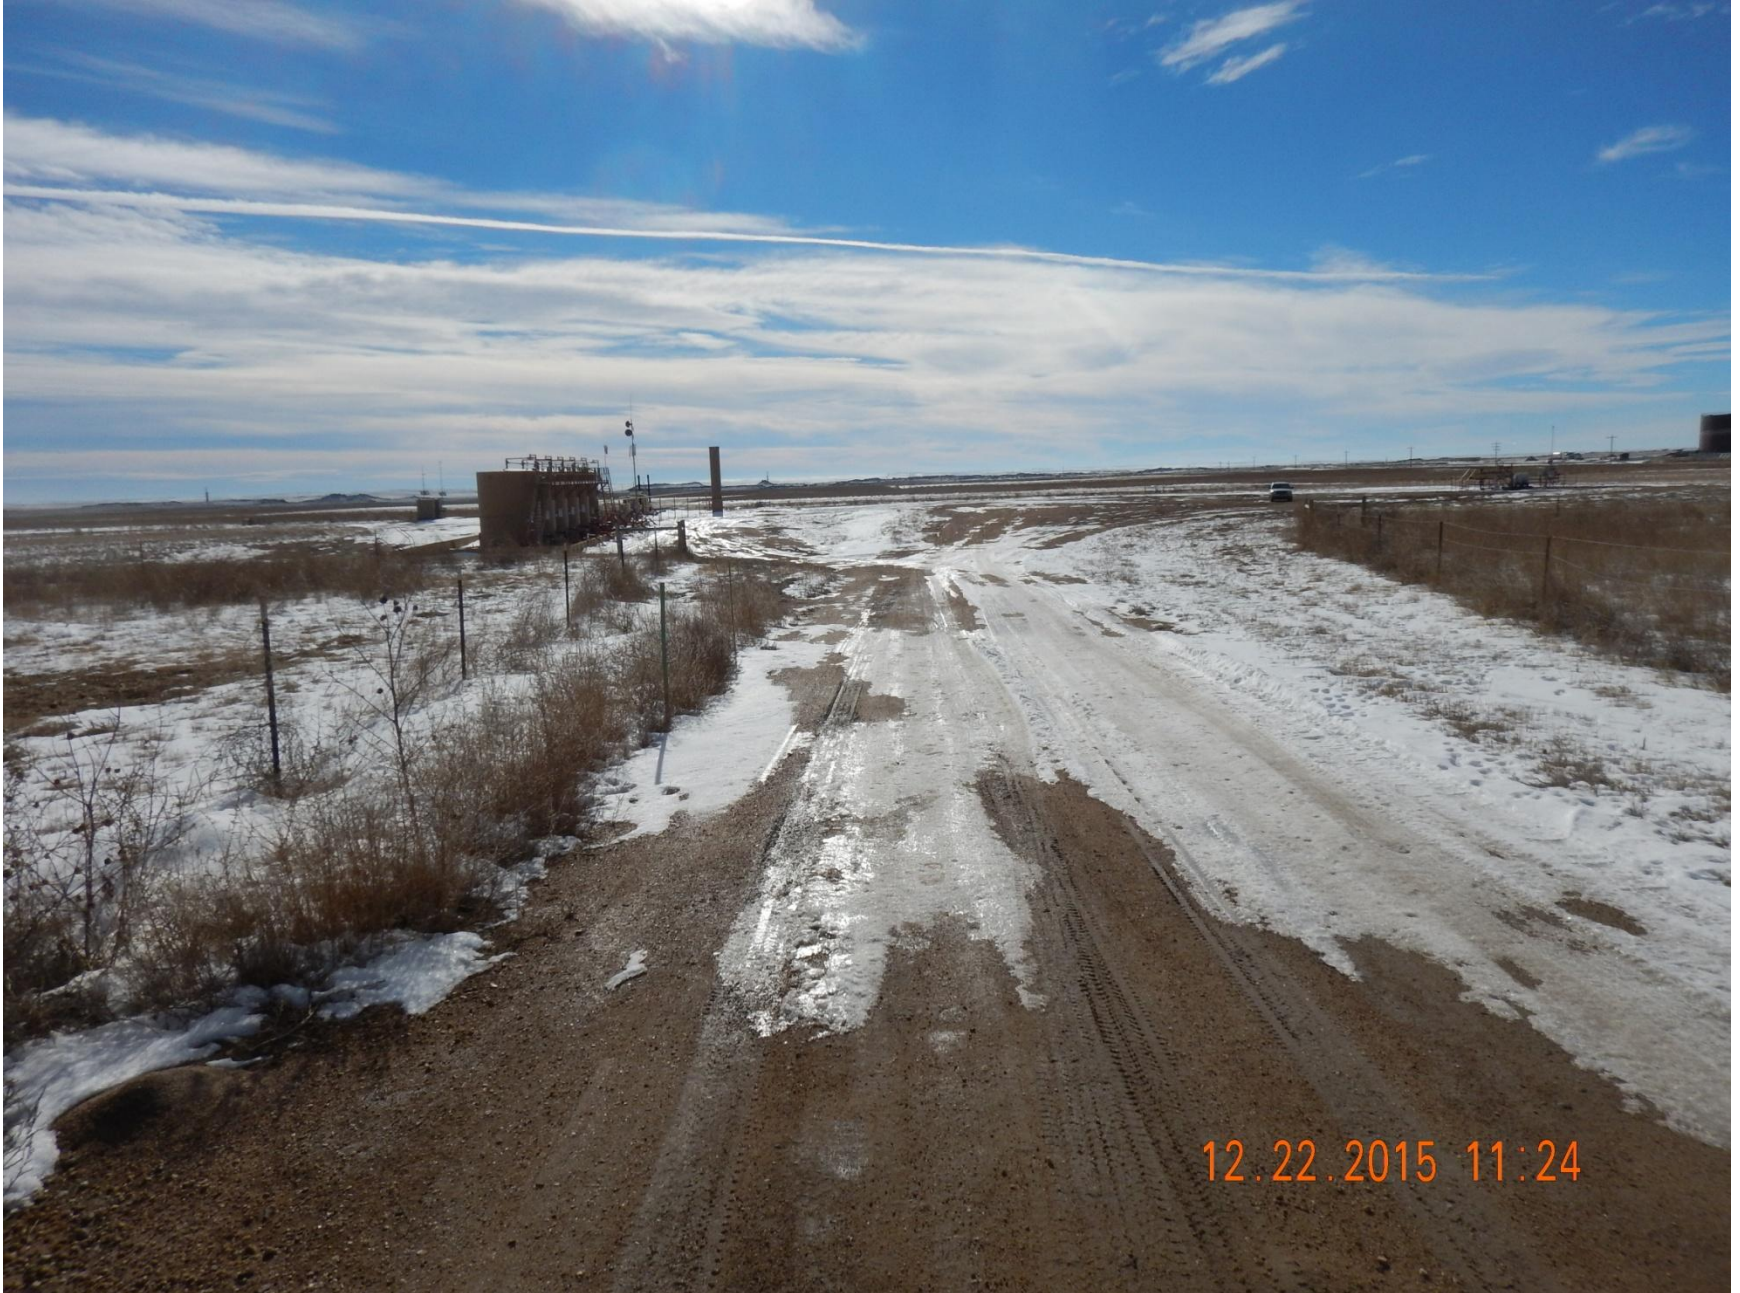
Figure 6: Photo taken from the northern end of location, facing south. Photo shows location and interim area.

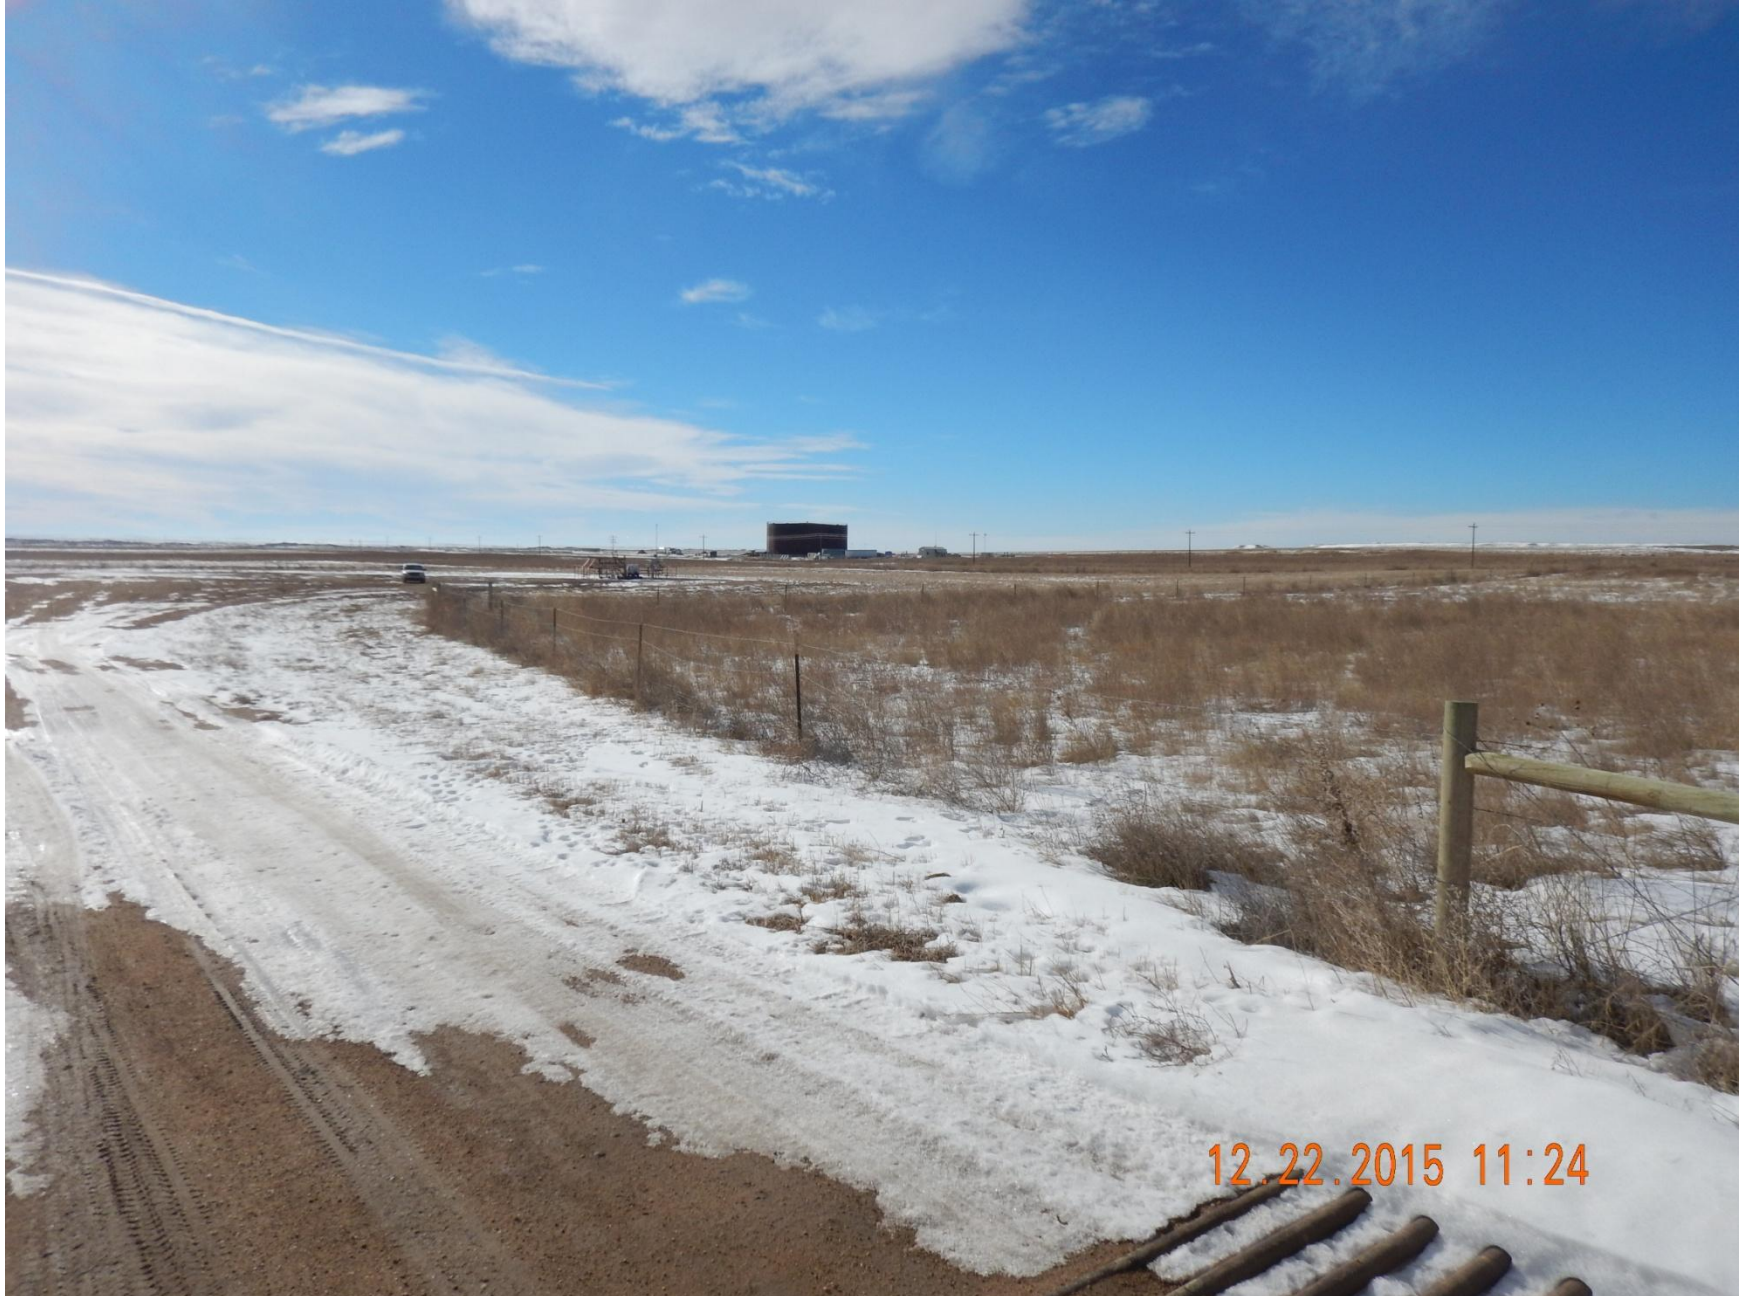
Figure 7: Photo taken from the northern end of location, facing southwest. Photo shows location and interim area.

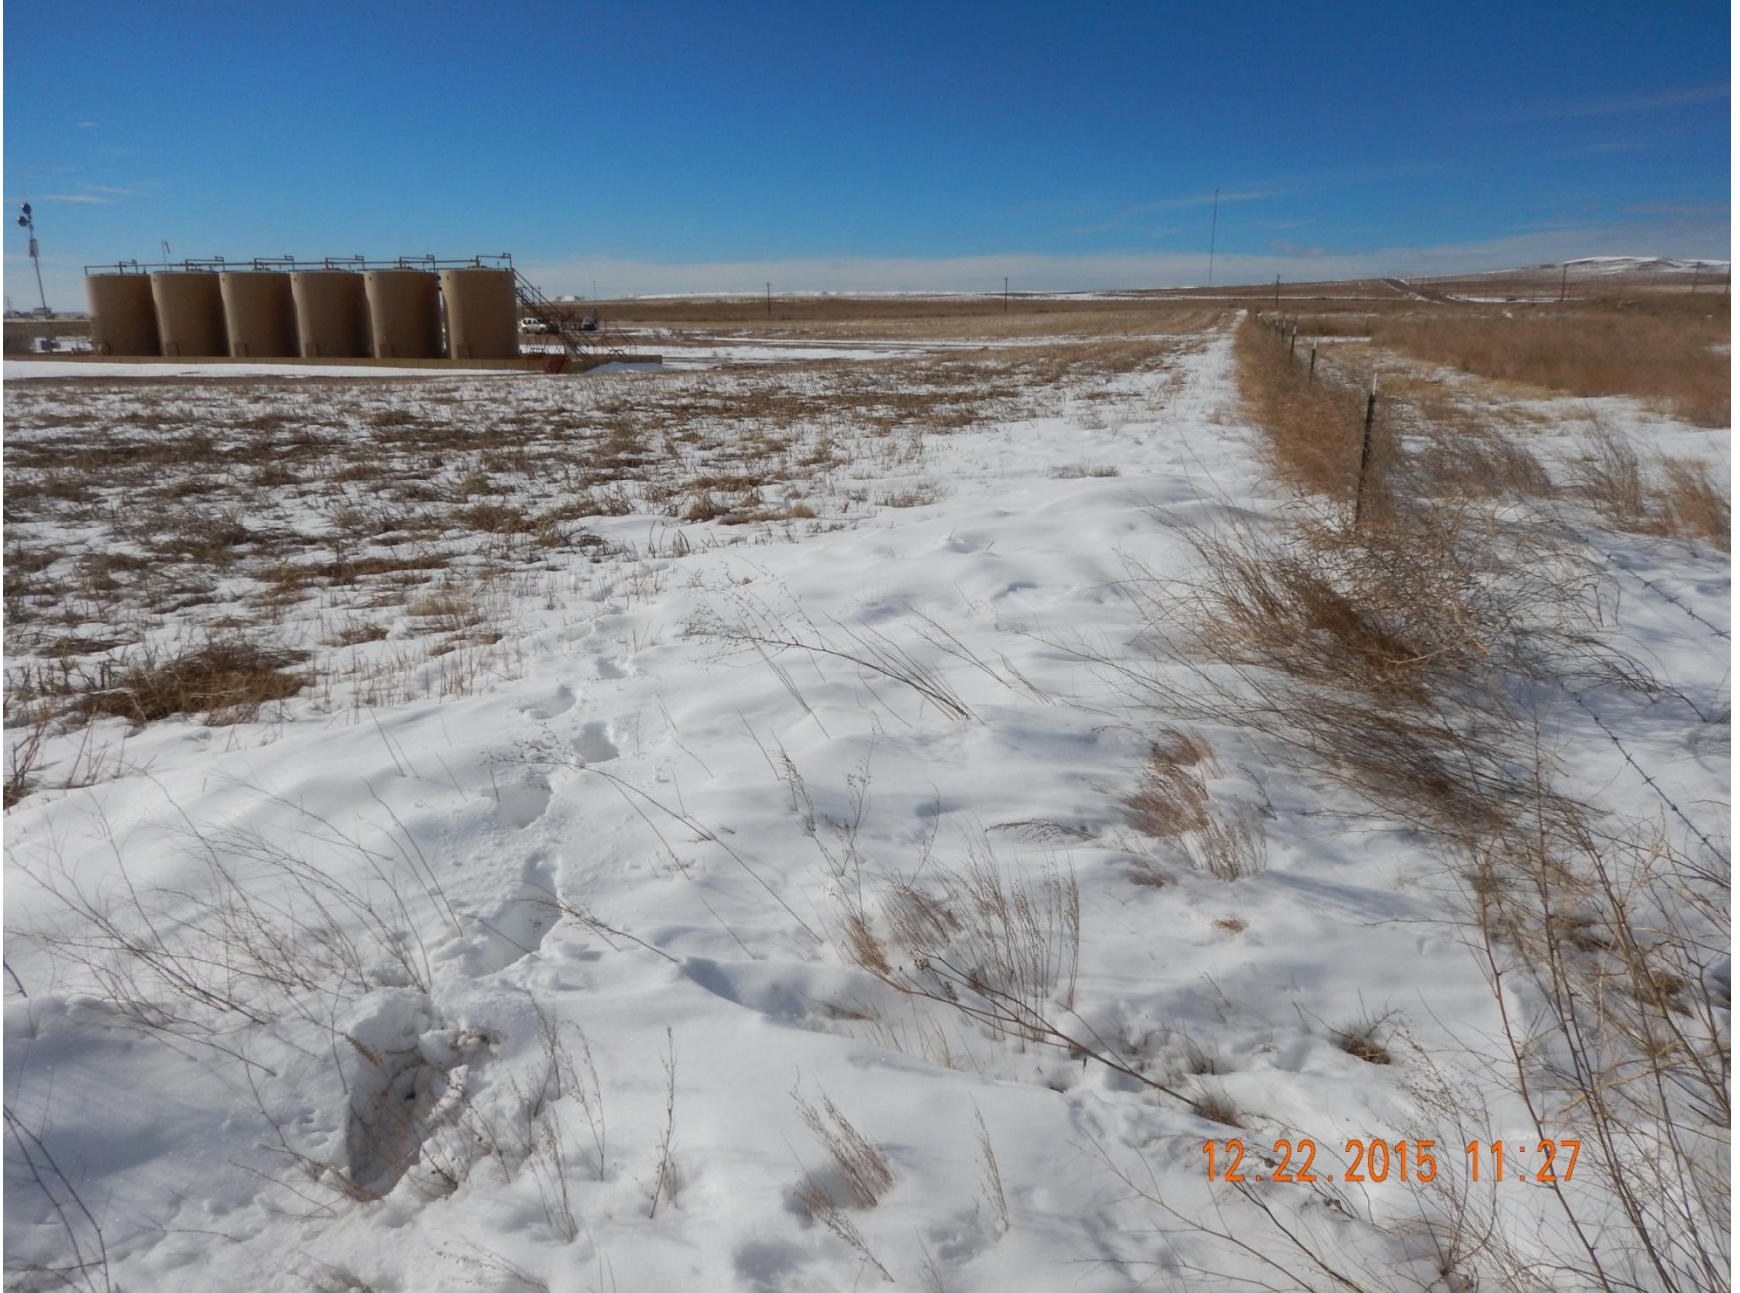
Figure 8: Photo taken from northeast corner of location, facing west. Photo shows interim reclamation in process.

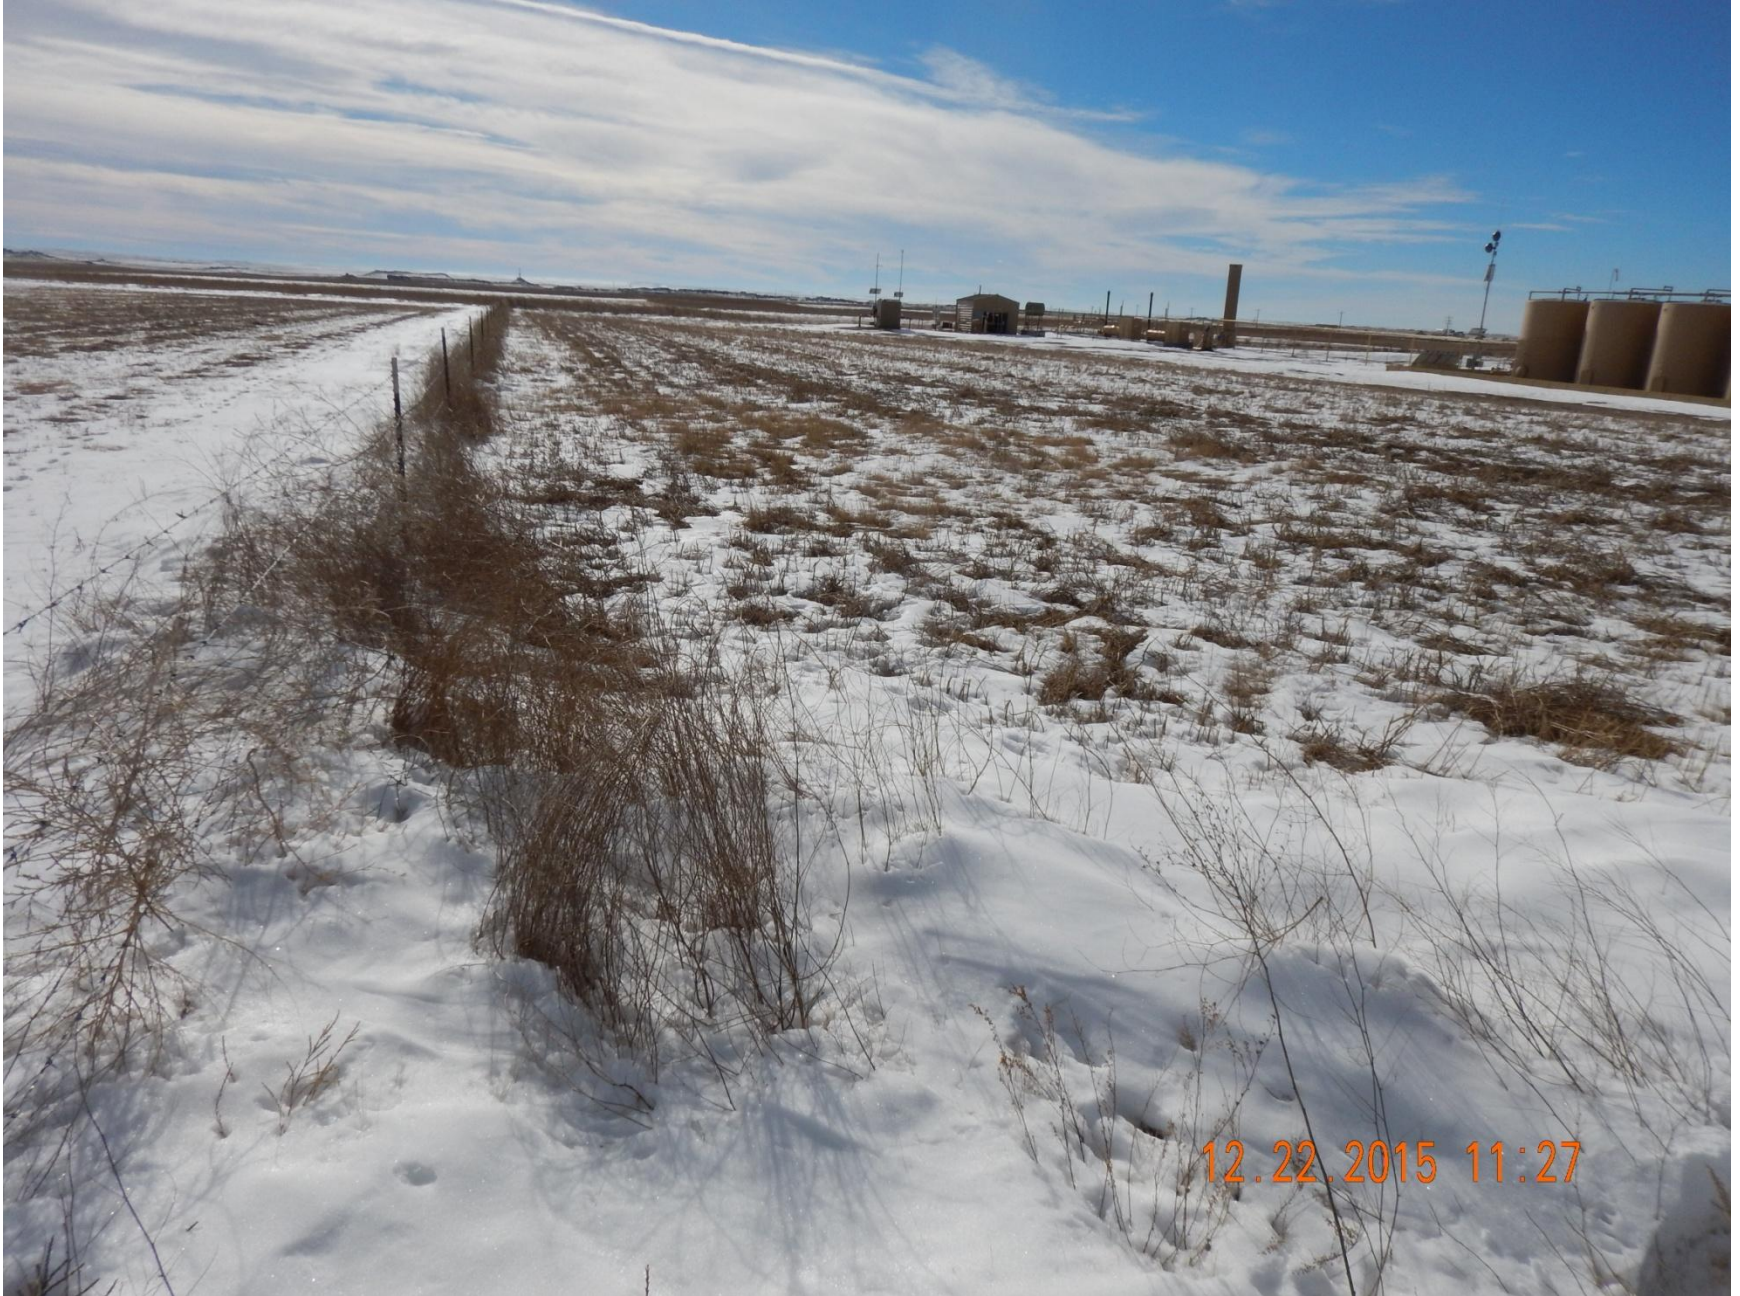
Figure 9: Photo taken from northeast corner of location, facing south. Photo shows interim reclamation in process.

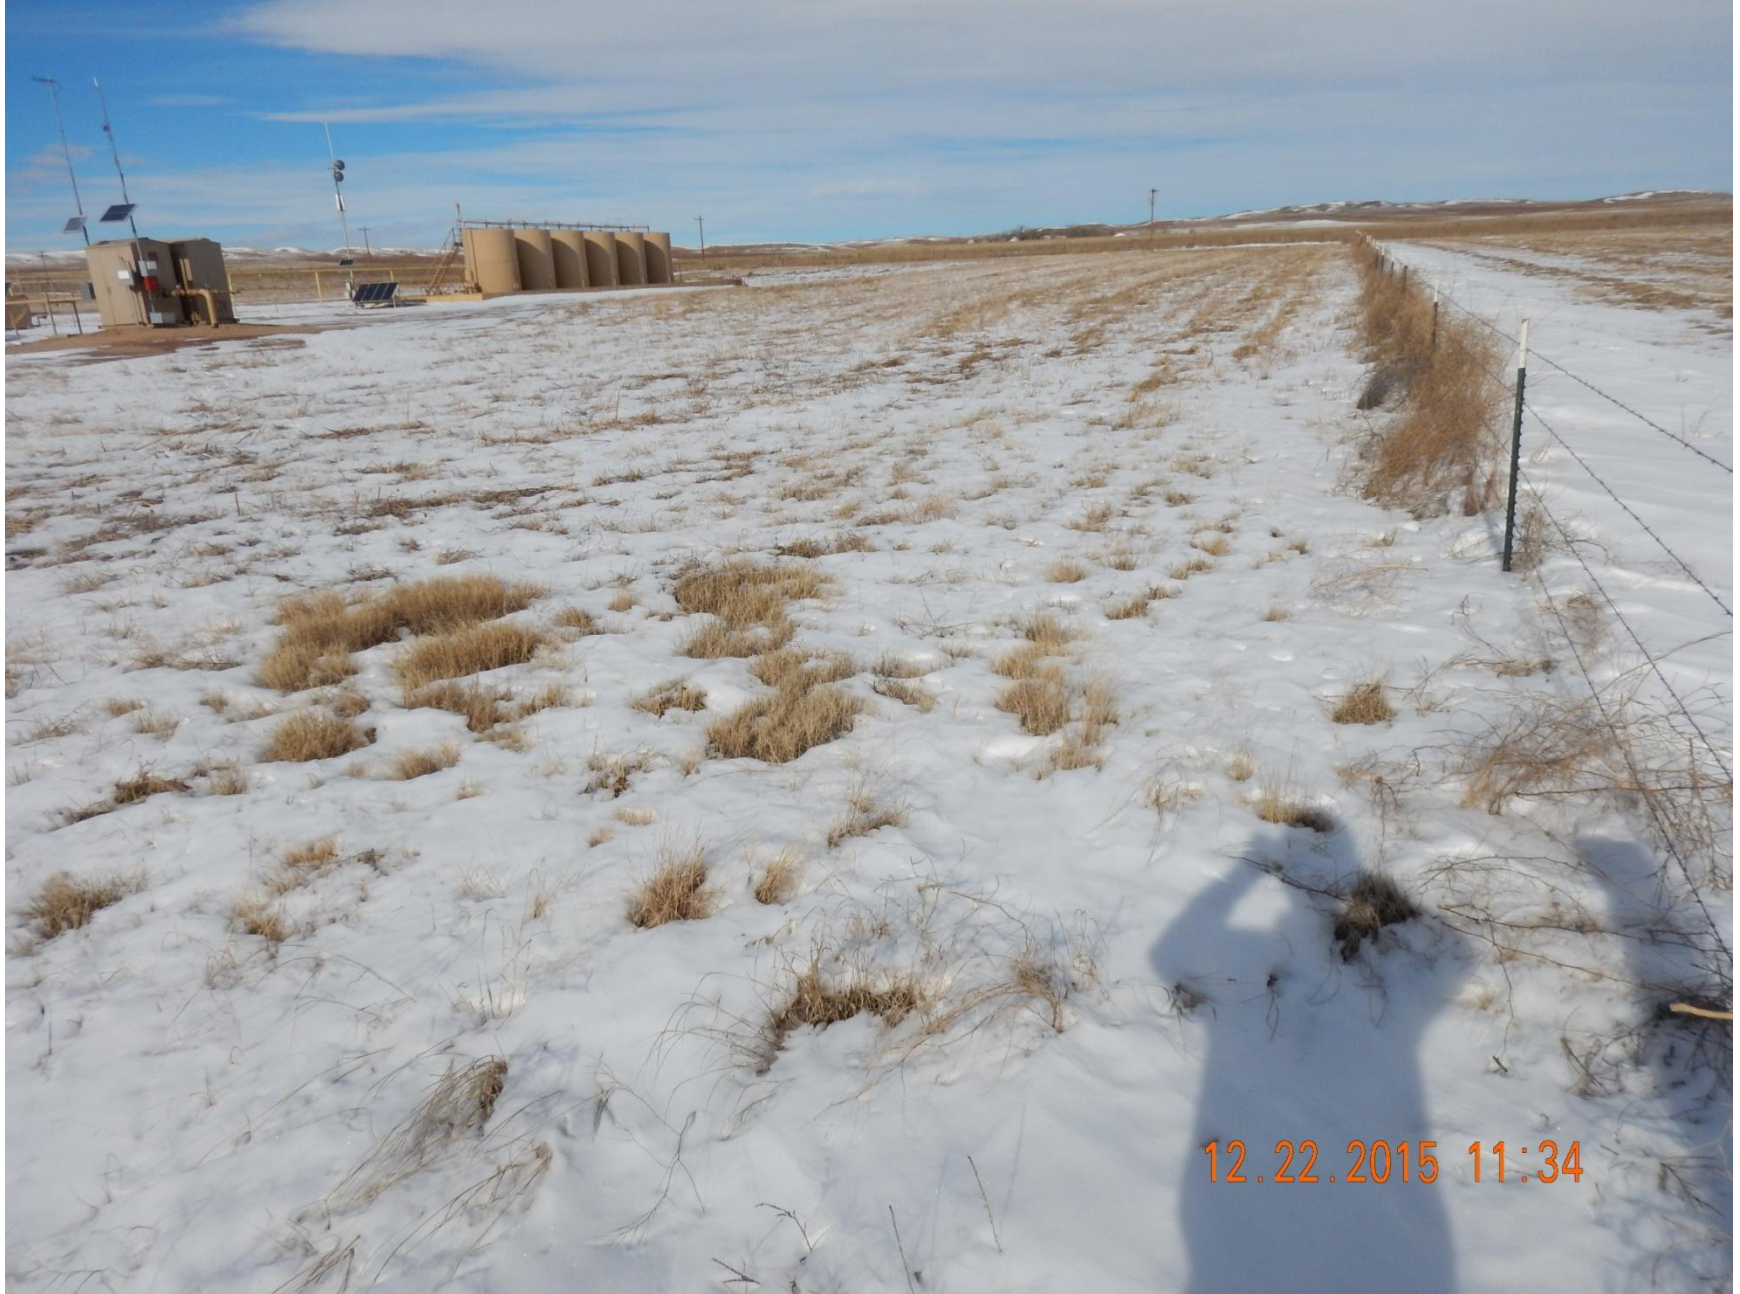
Figure 10: Photo taken from southeast corner of location, north west. Photo shows interim reclamation in process.
