Interim Reclamation Inspection

Inspection Date: 12/22/2015

Operator: Noble Energy Inc.

Location ID: 421847

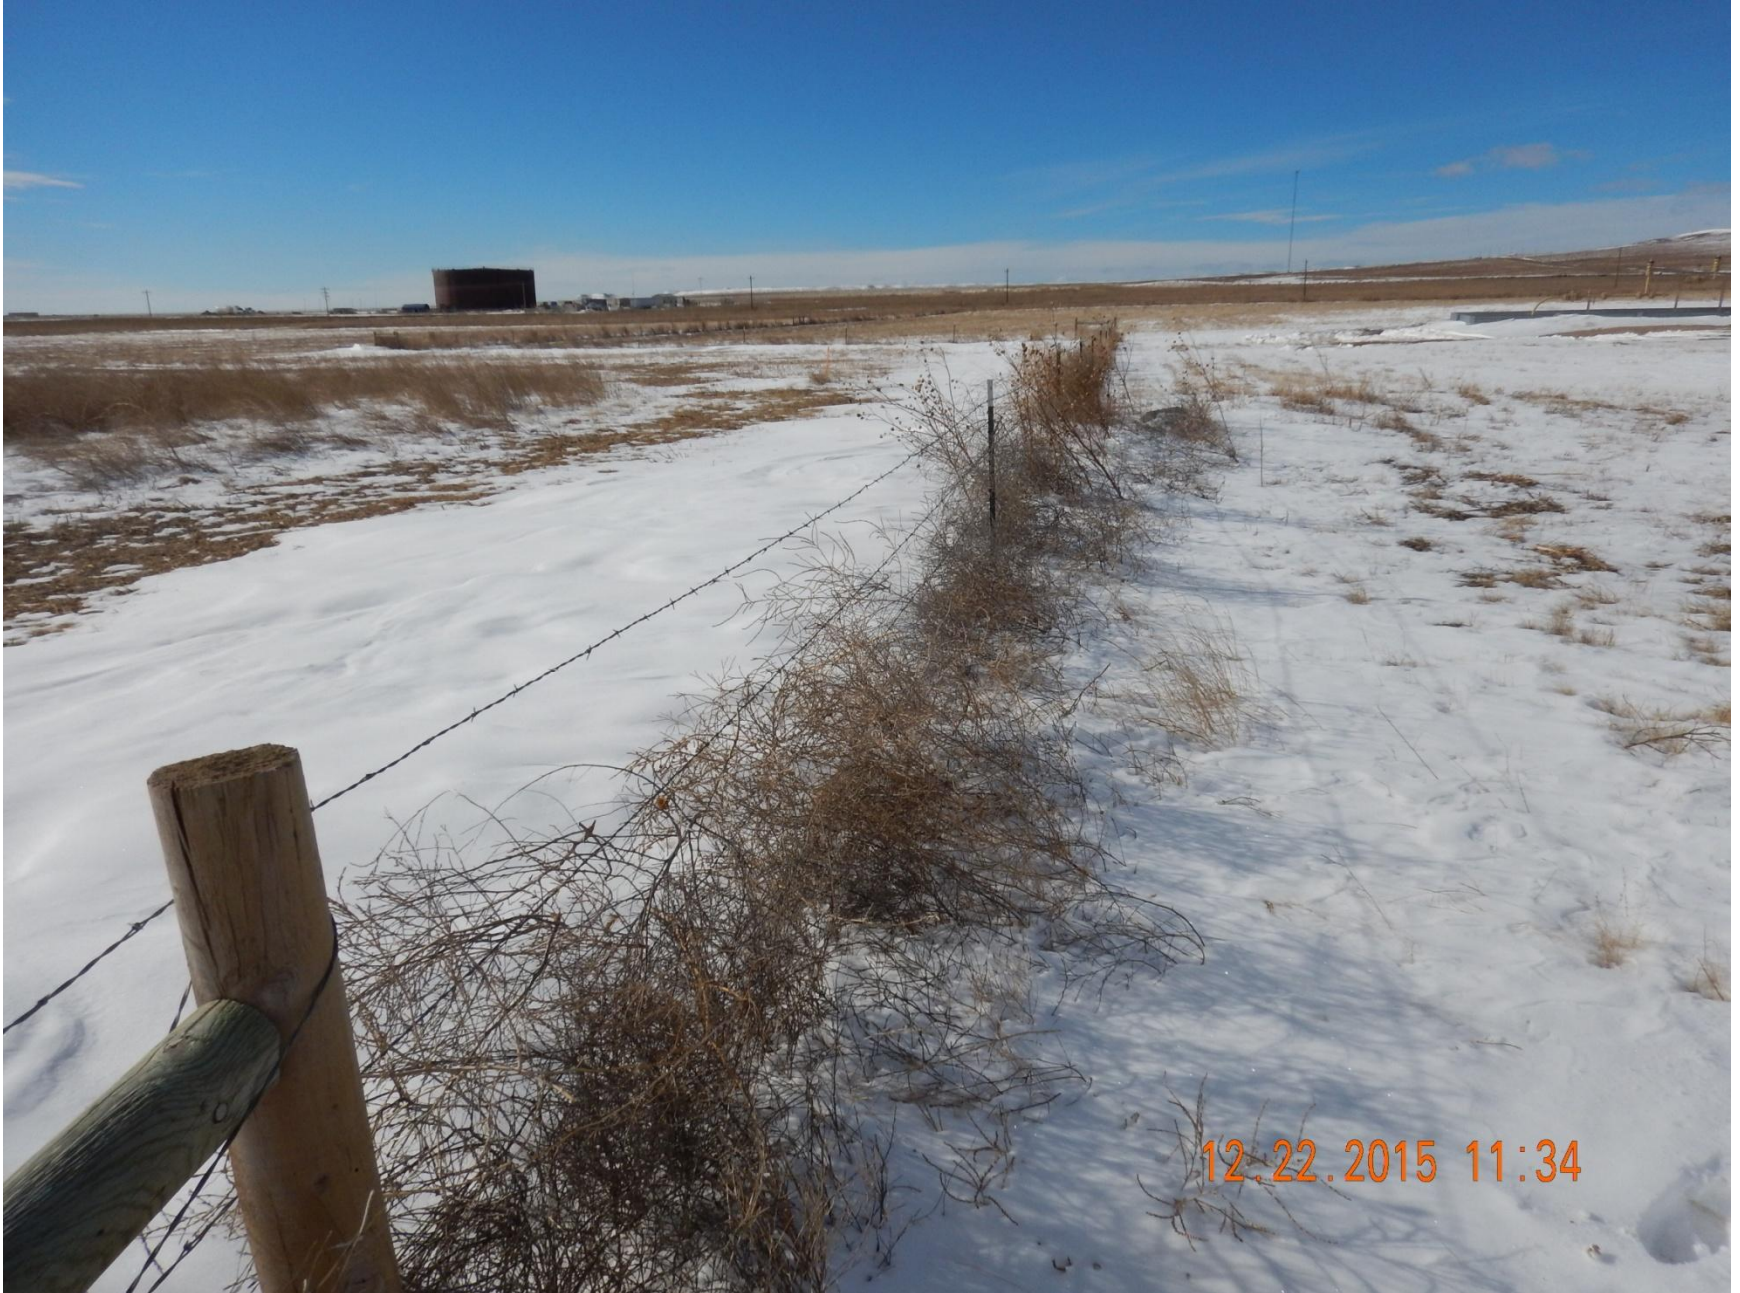
Figure 11: Photo taken from southeast corner of location, facing west. Photo shows interim reclamation in process.

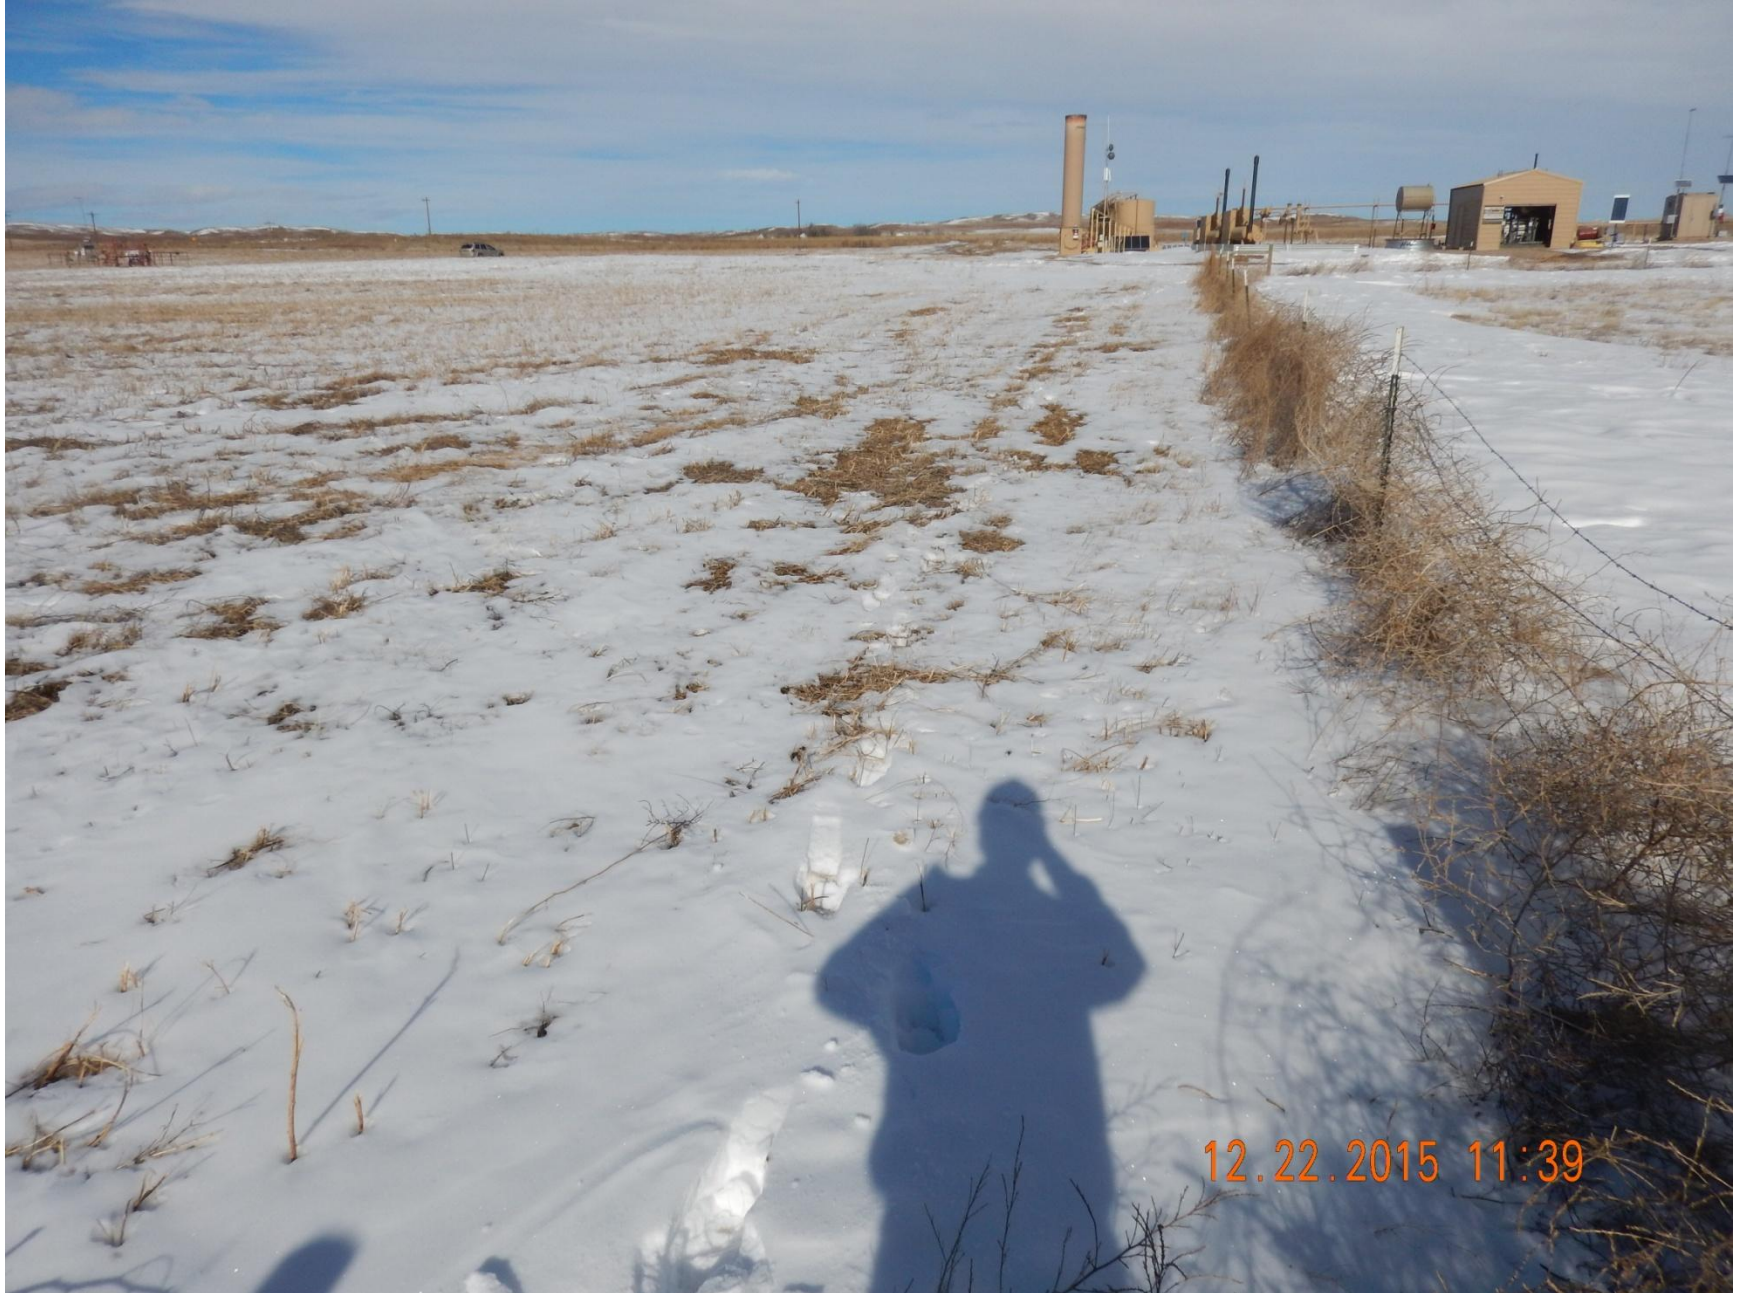
Figure 12: Photo taken from southern end of location, facing north. Photo shows interim reclamation in process.

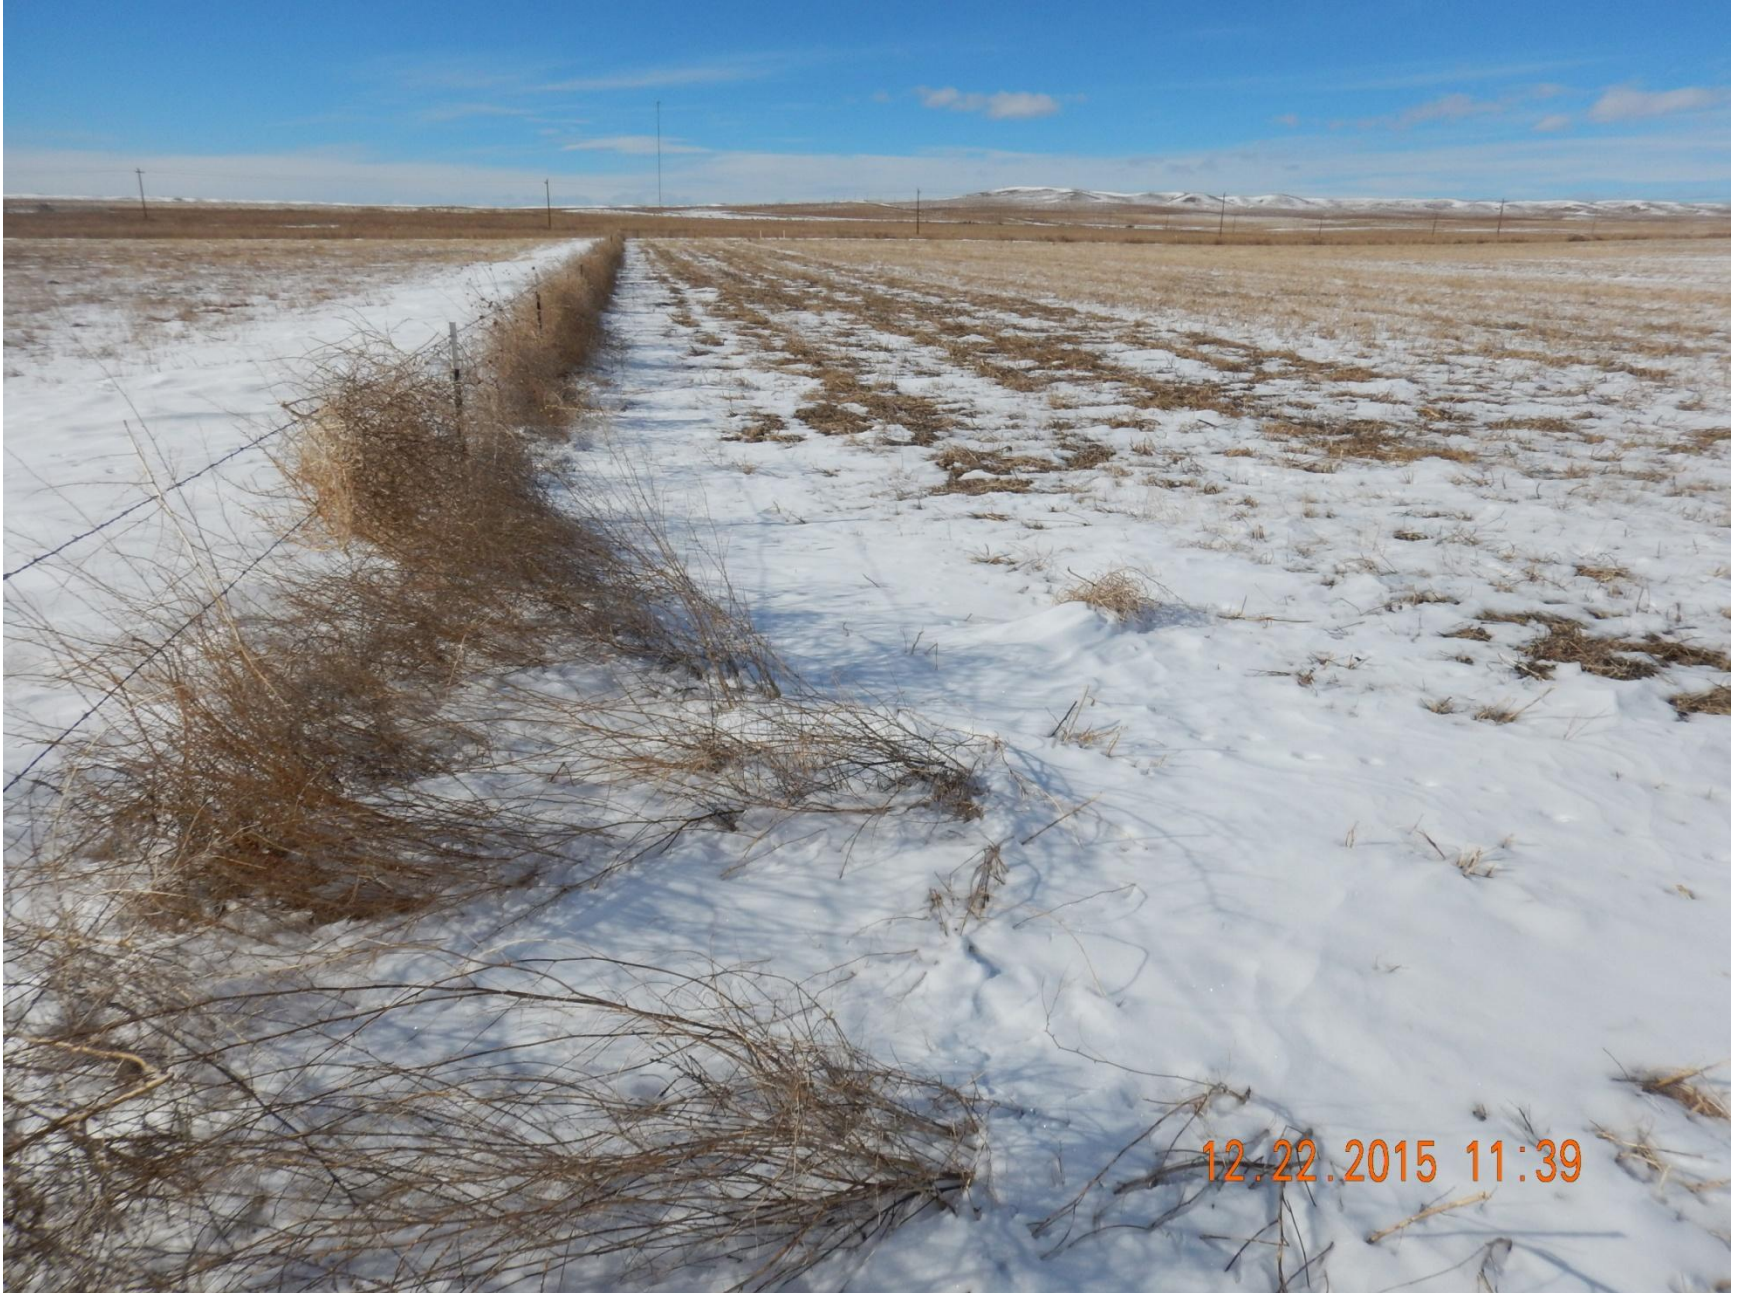
Figure 13: Photo taken from southern end of location, facing west. Photo shows interim reclamation in process.

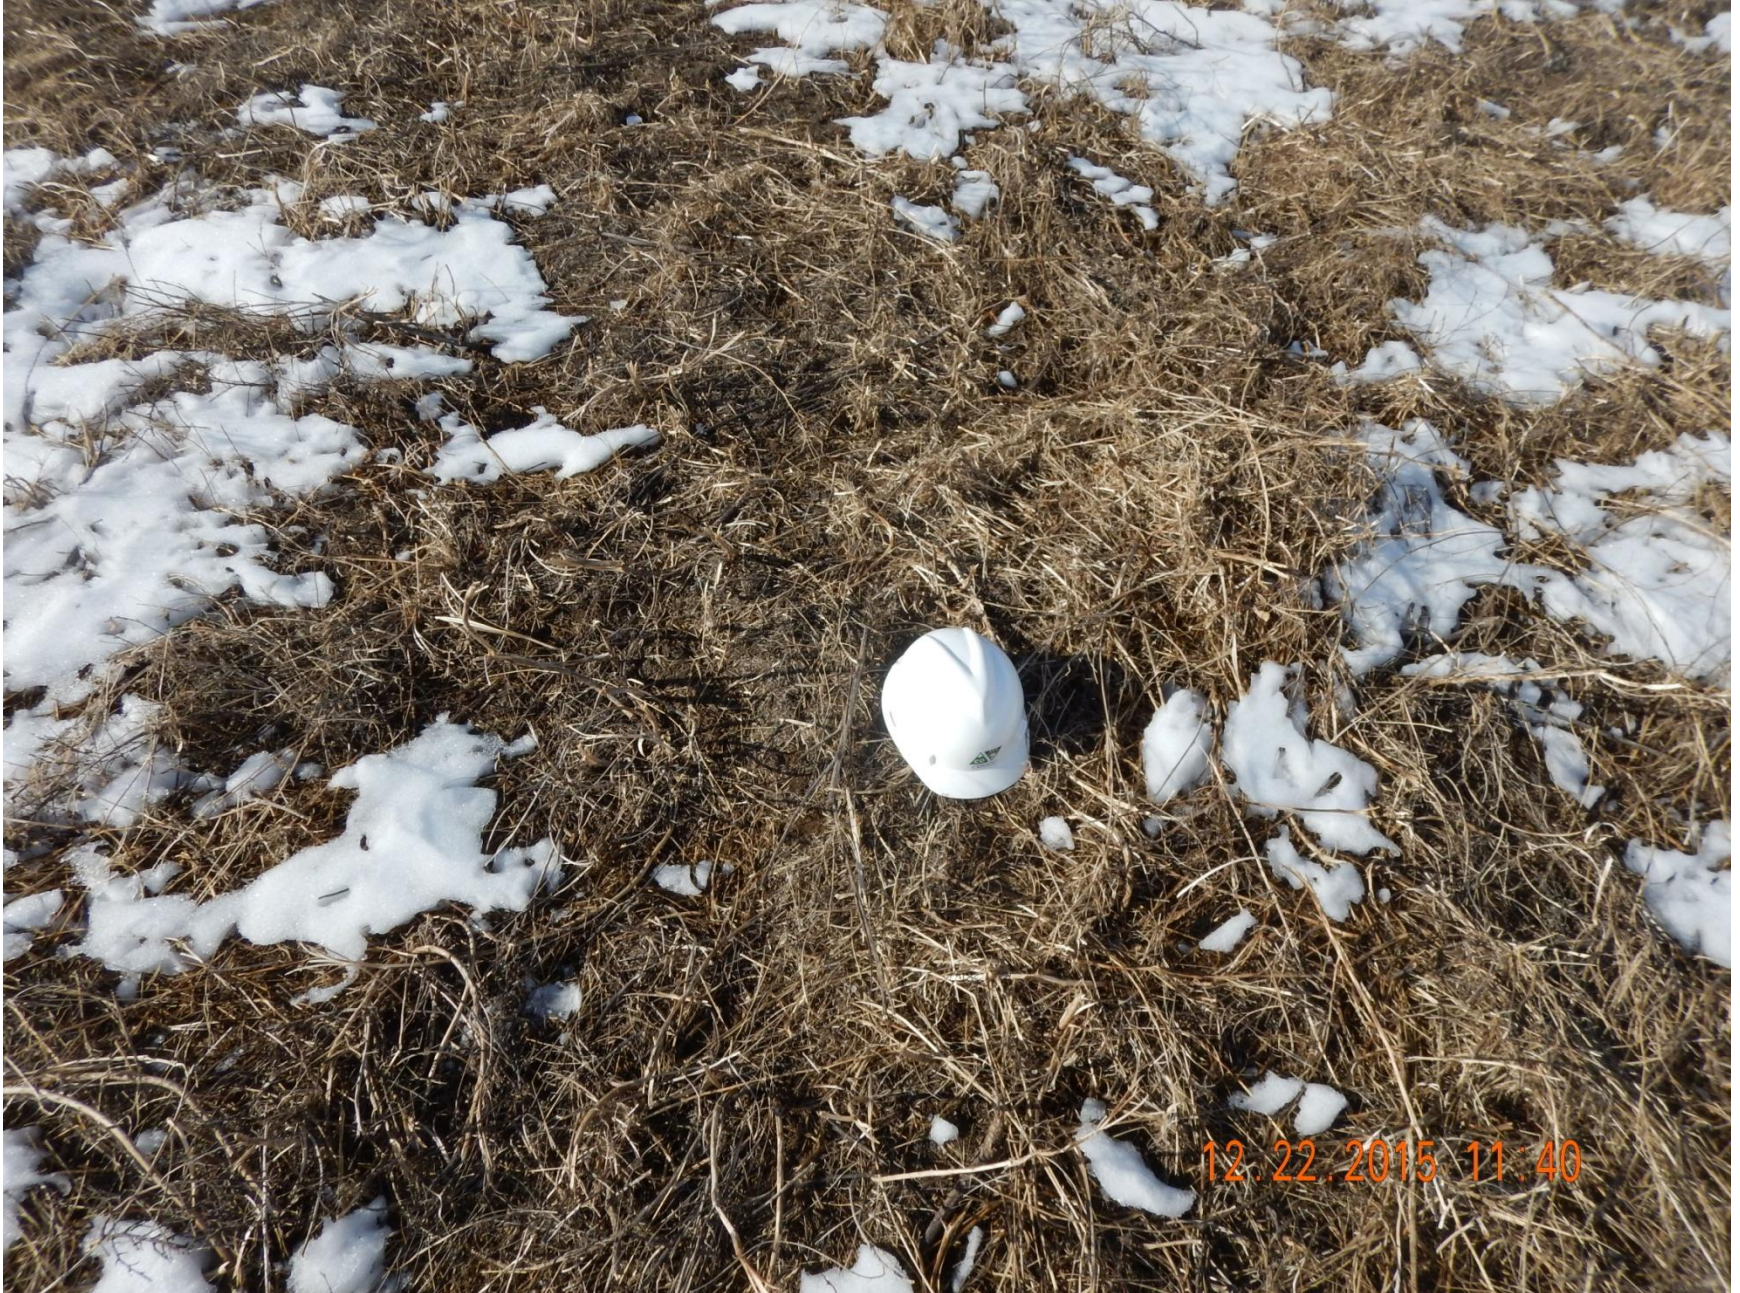
Figure 14: Photo taken from southern end of location. Photo shows current vegetation is predominantly undesirable, weedy plant species. This is common throughout location.

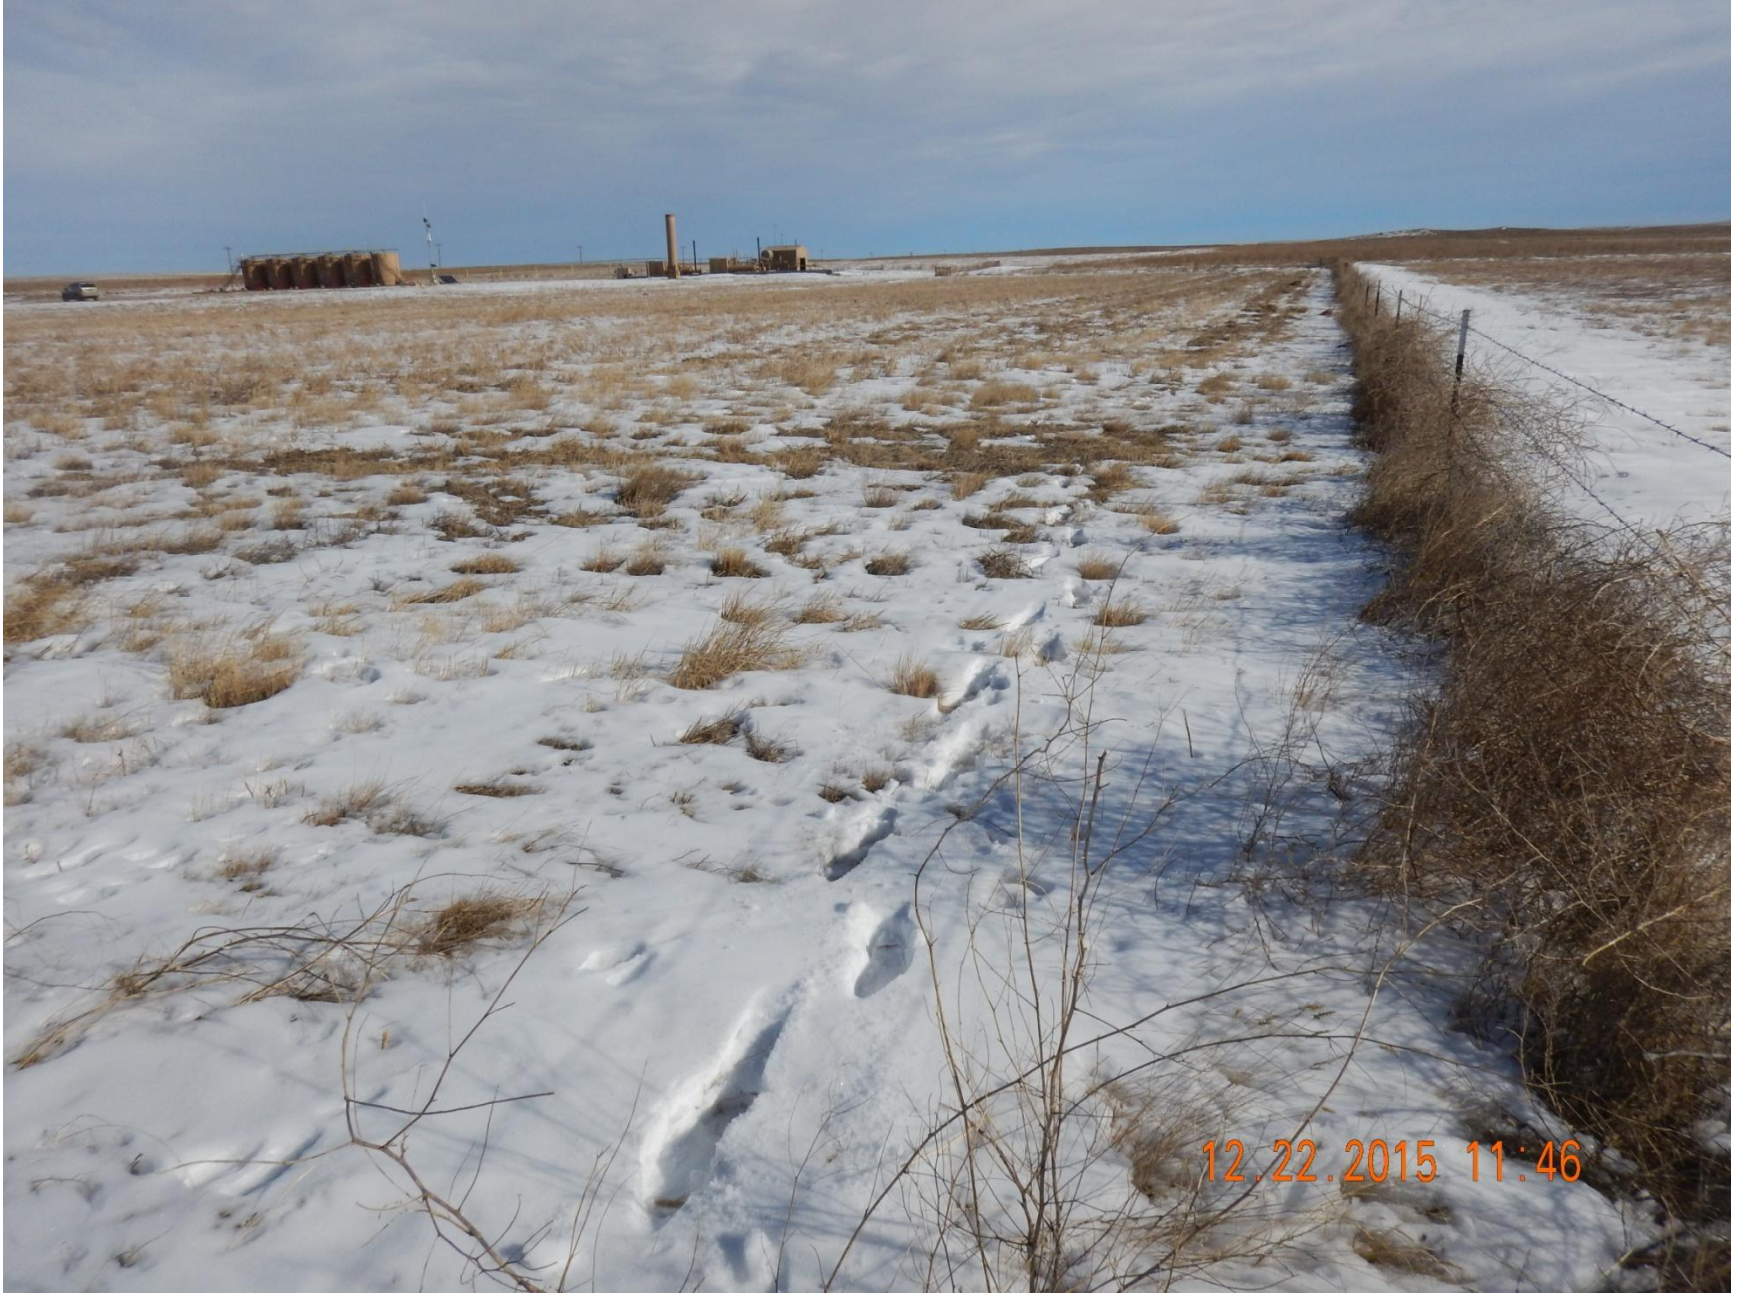
Figure 15: Photo taken from southwest corner of location, facing east. Photo shows interim reclamation in process.

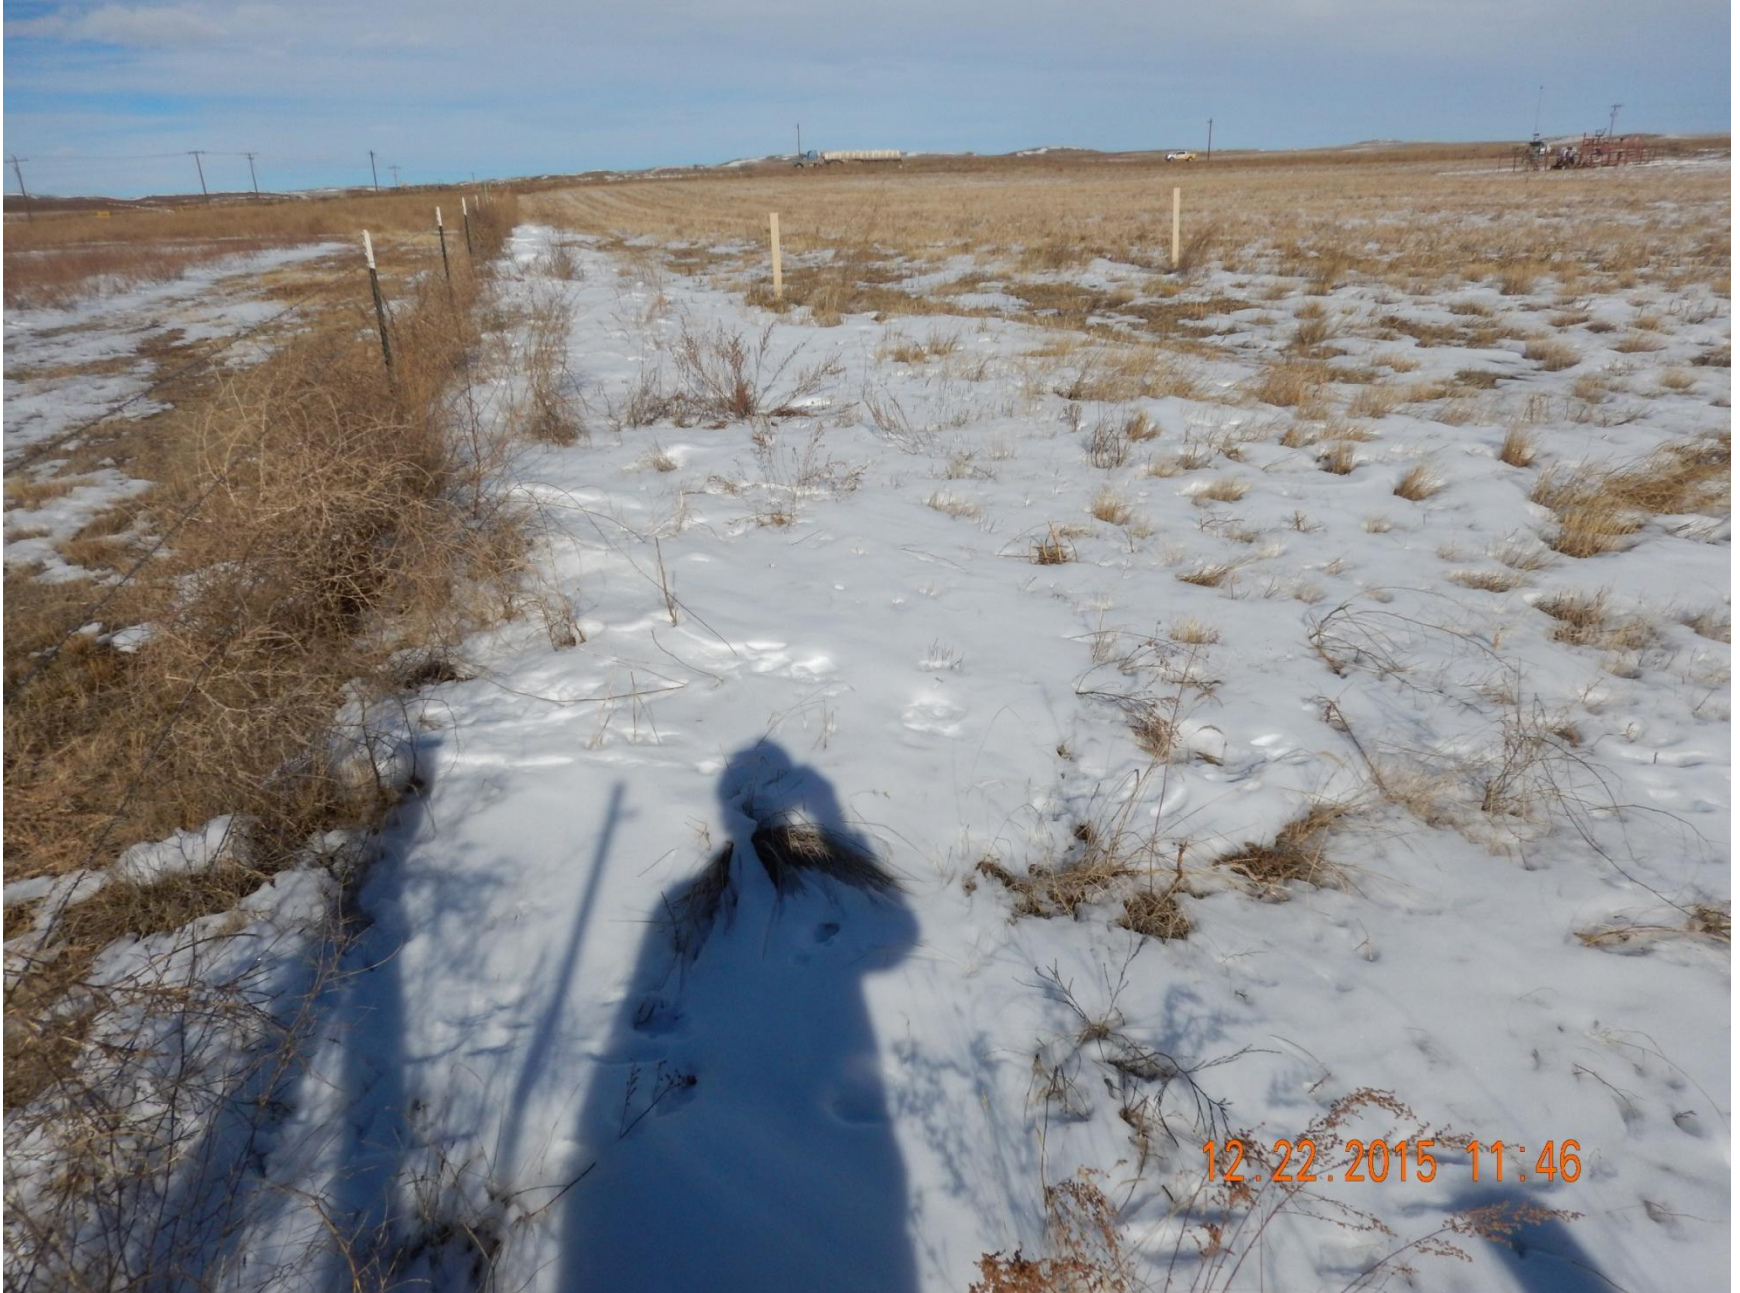
Figure 16: Photo taken from southwest corner of location, facing north. Photo shows interim reclamation in process.

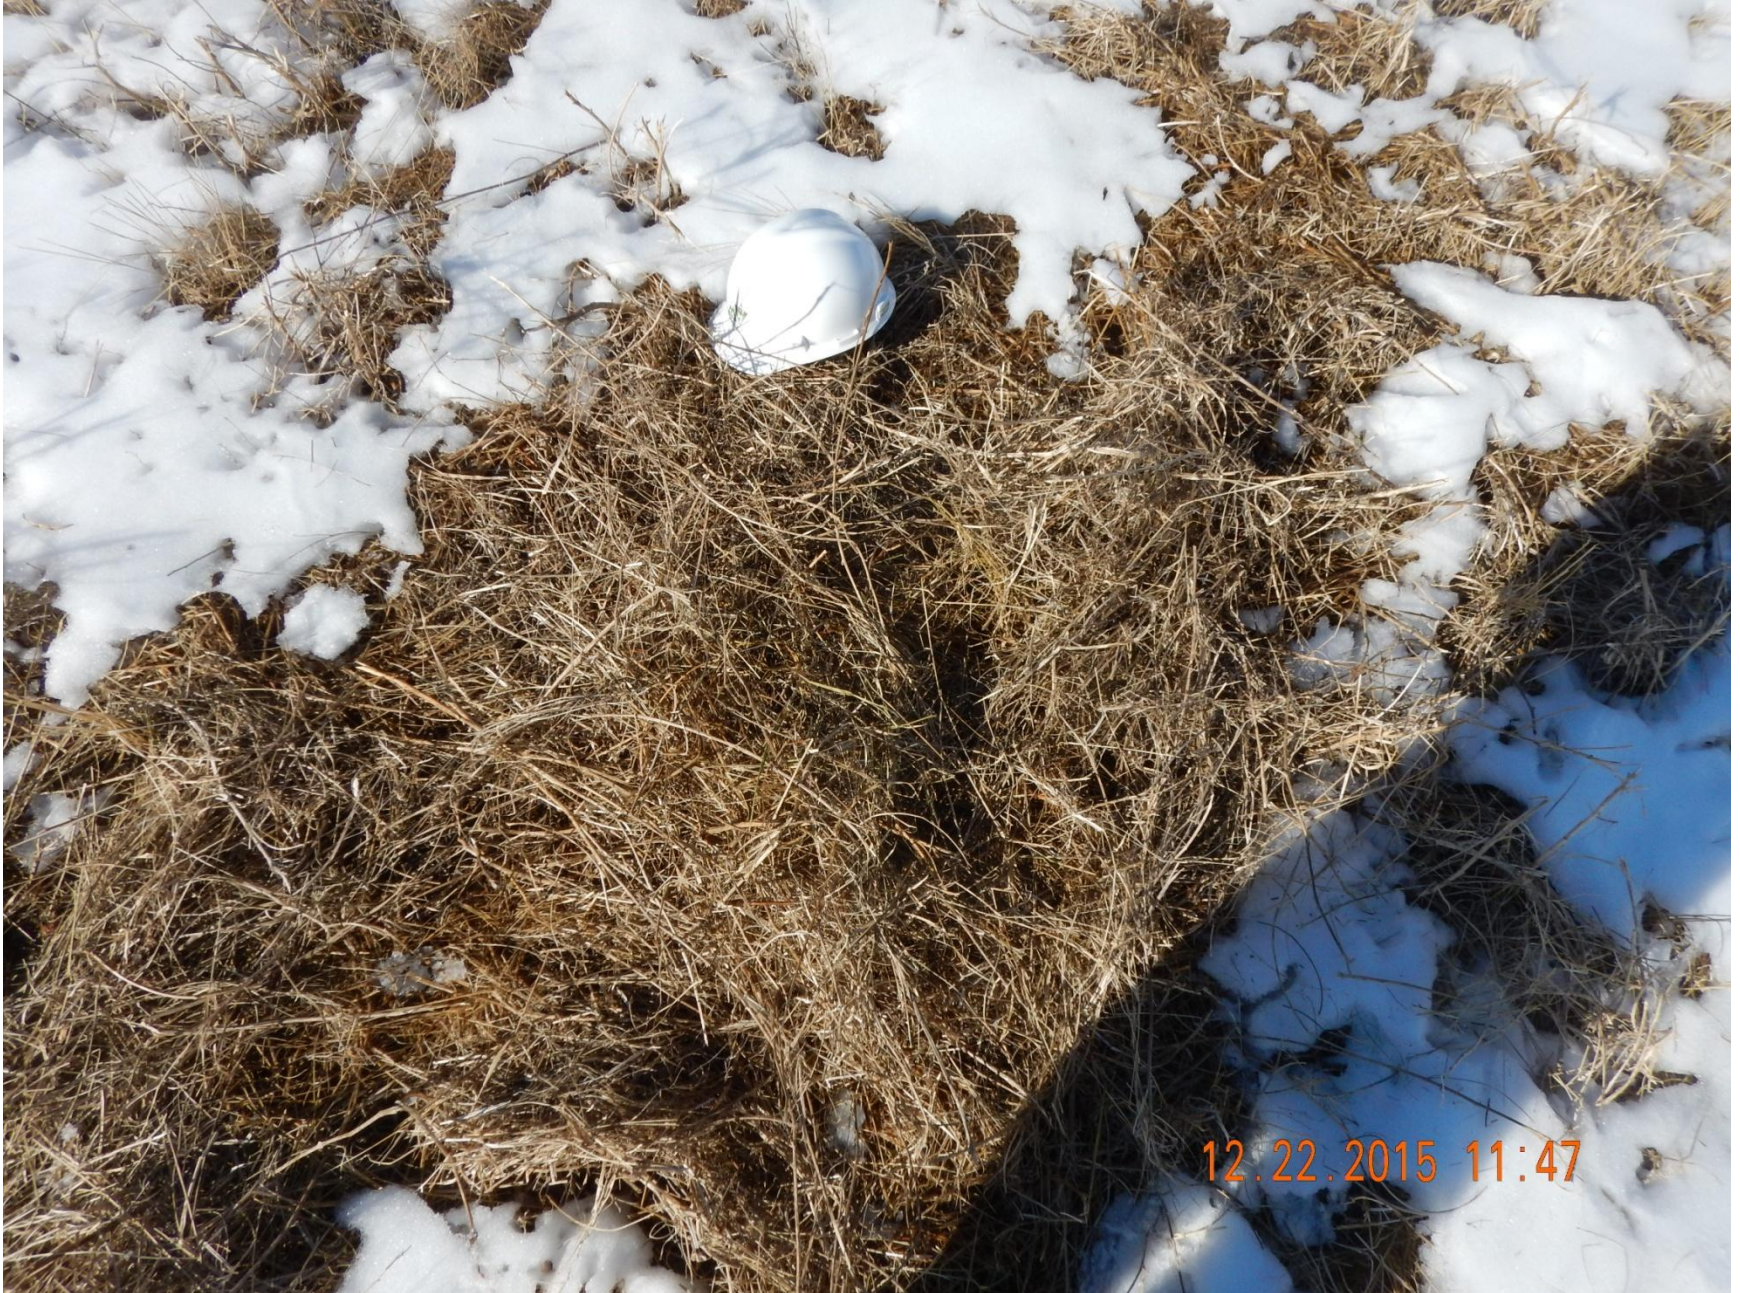
Figure 17: Photo taken from west end of location. Photo shows current vegetation is predominantly undesirable, weedy plant species. Photo continues on figure 18.

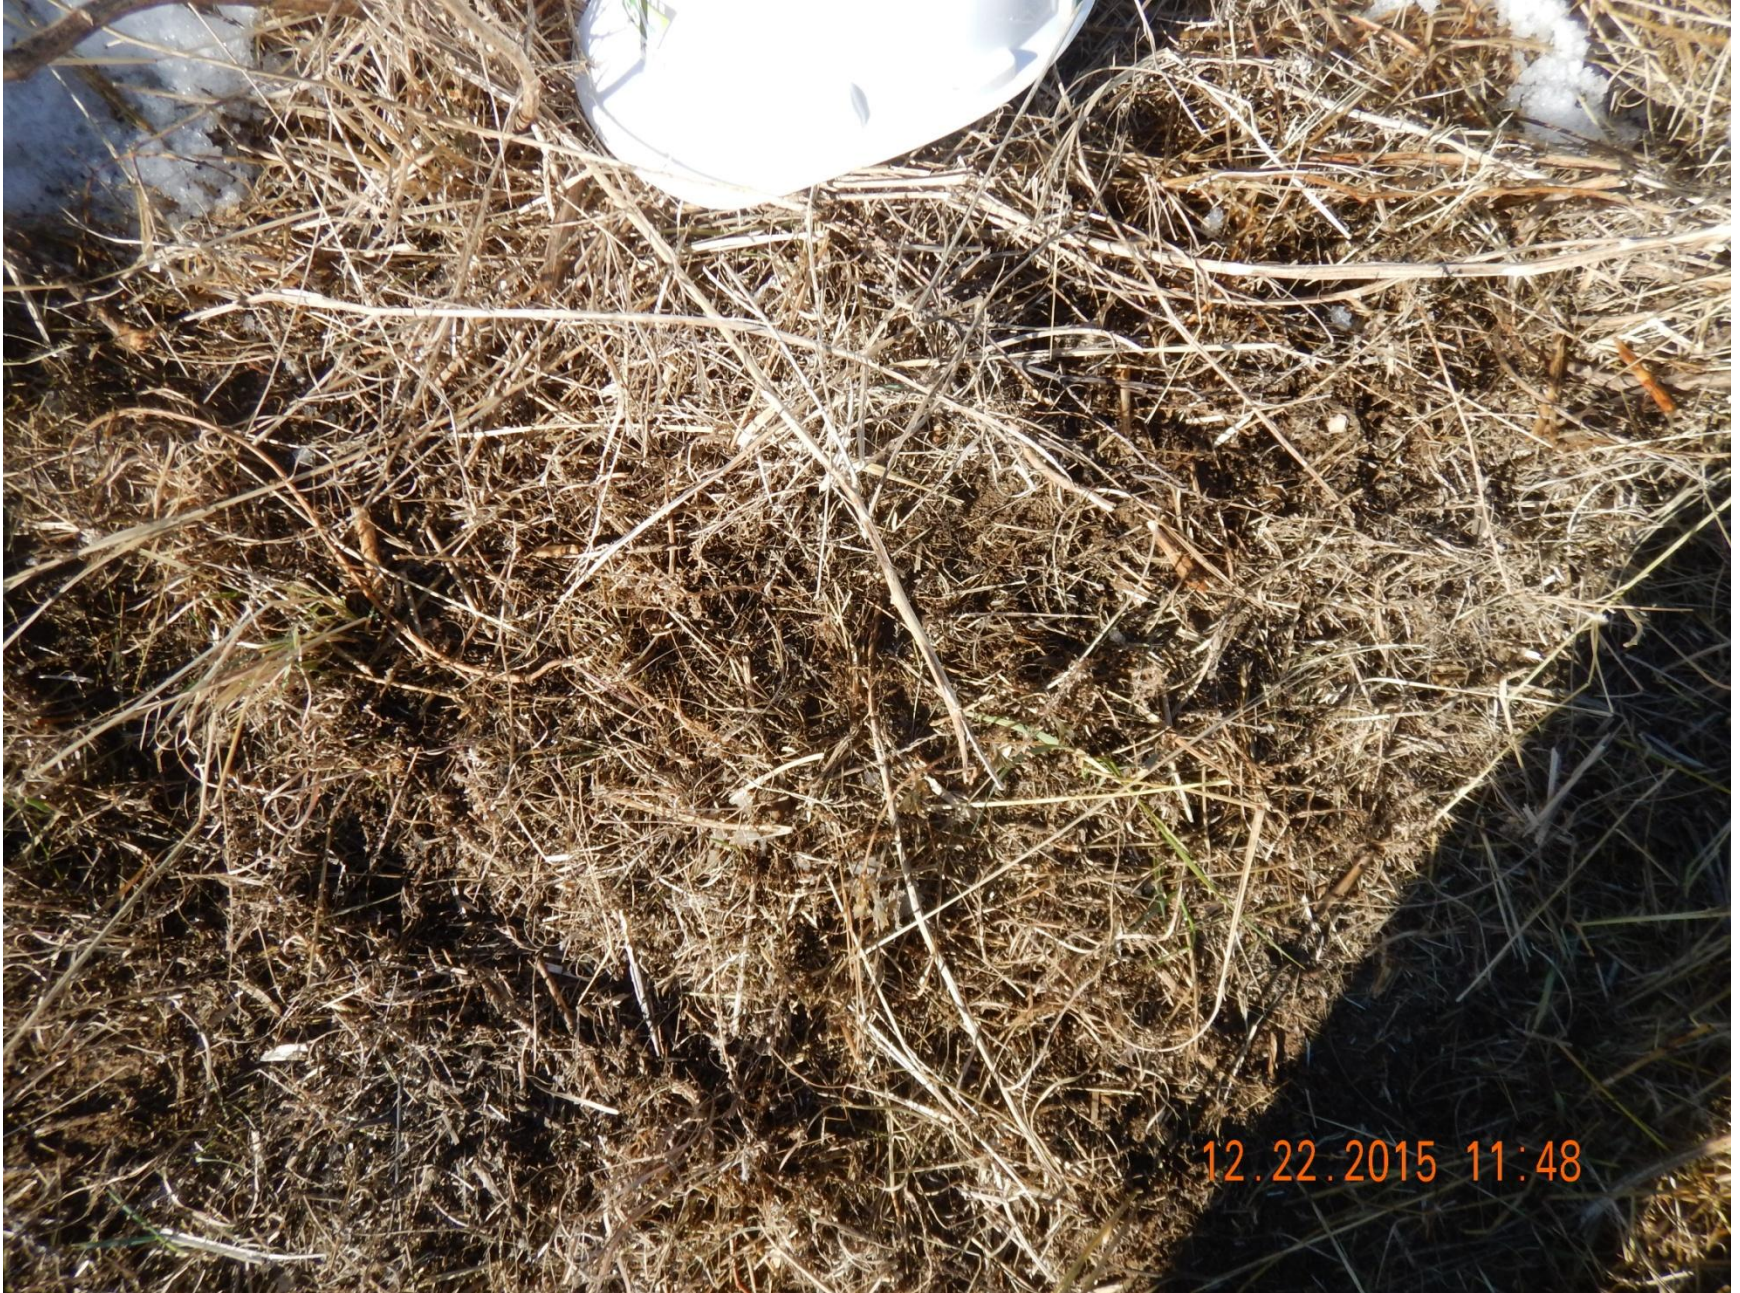
Figure 18: Continuation from figure 17. Photo shows some evidence of germination of perennial grass beneath weed debris.

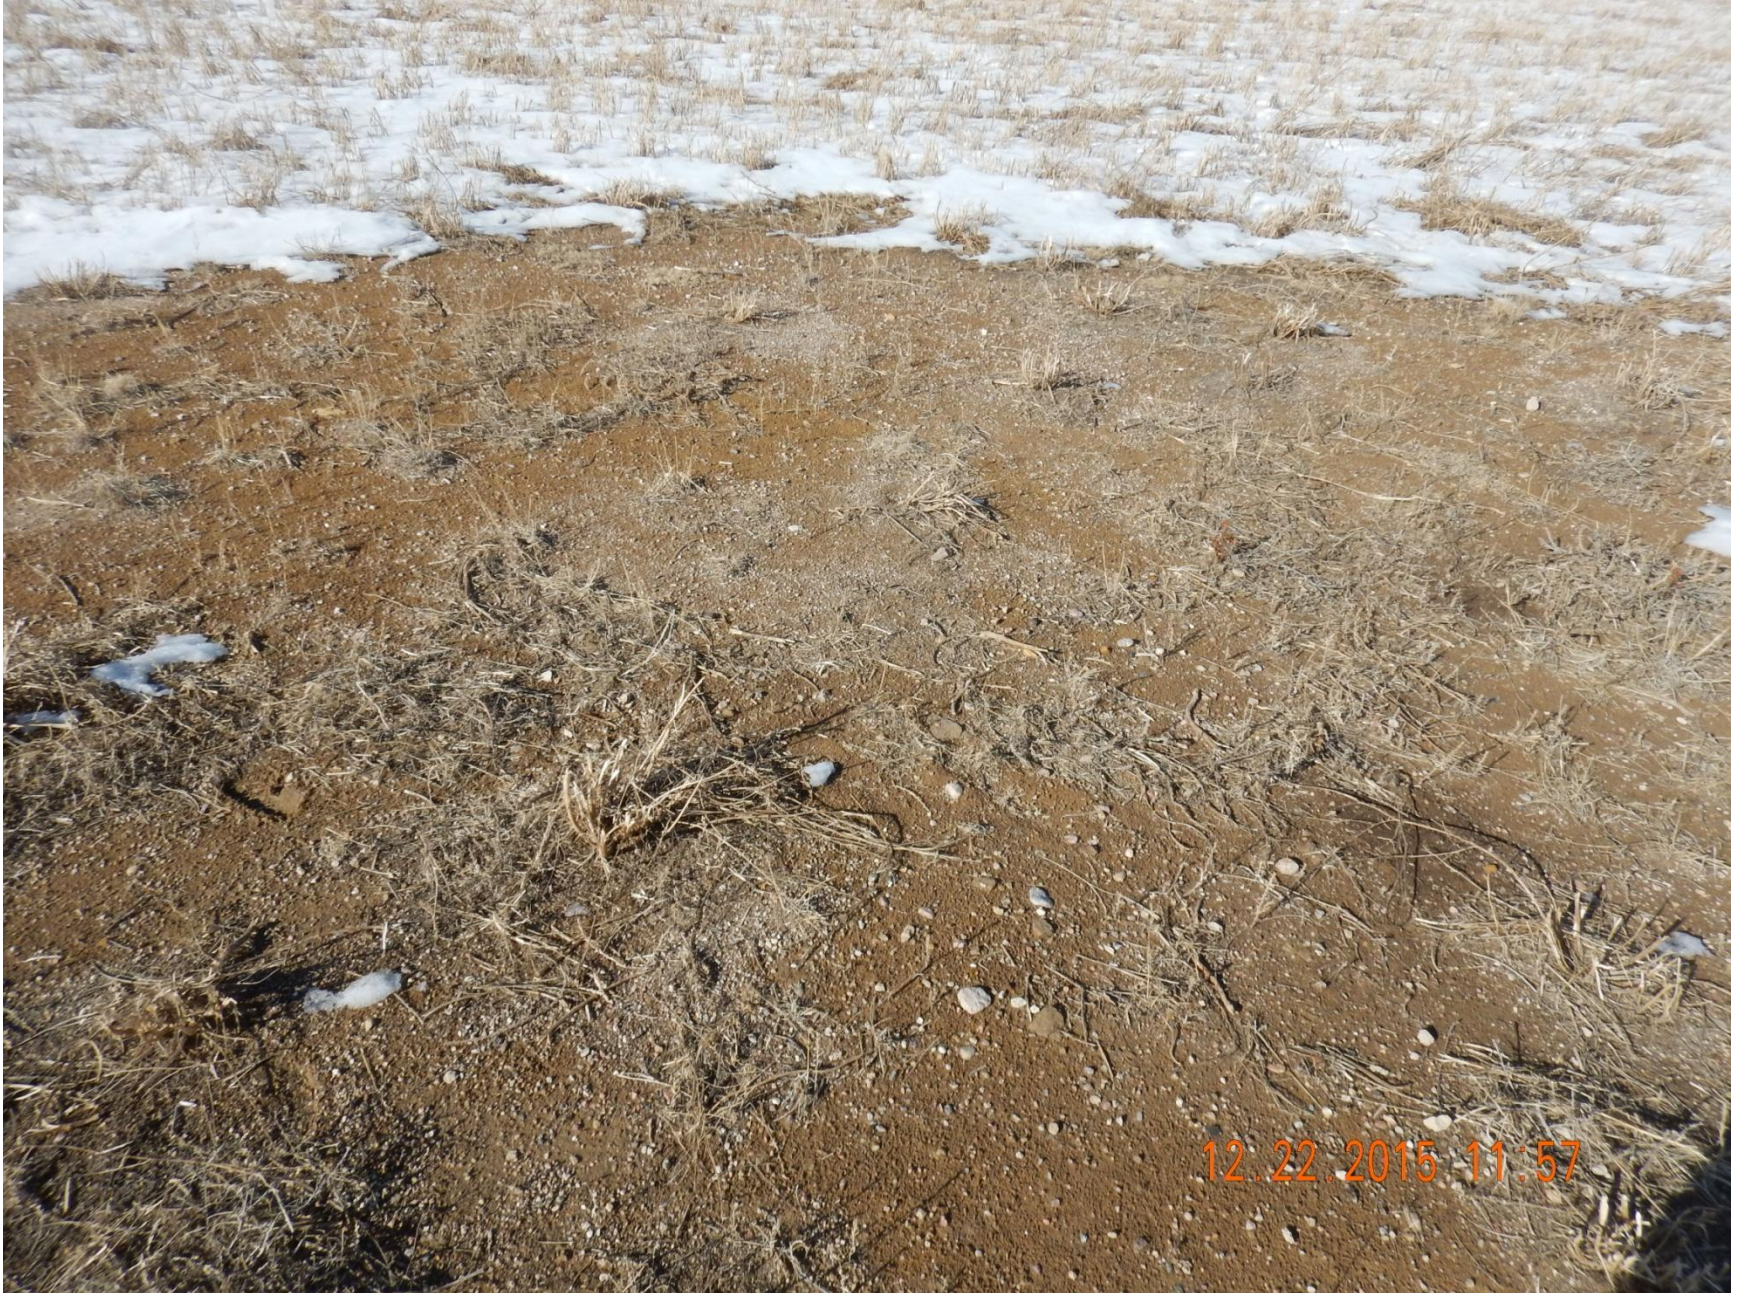
Figure 19: Photo taken from north end of location. Photo shows example of some areas of the interim reclamation with no evidence of perennial growth or germination.
