Construction Inspection

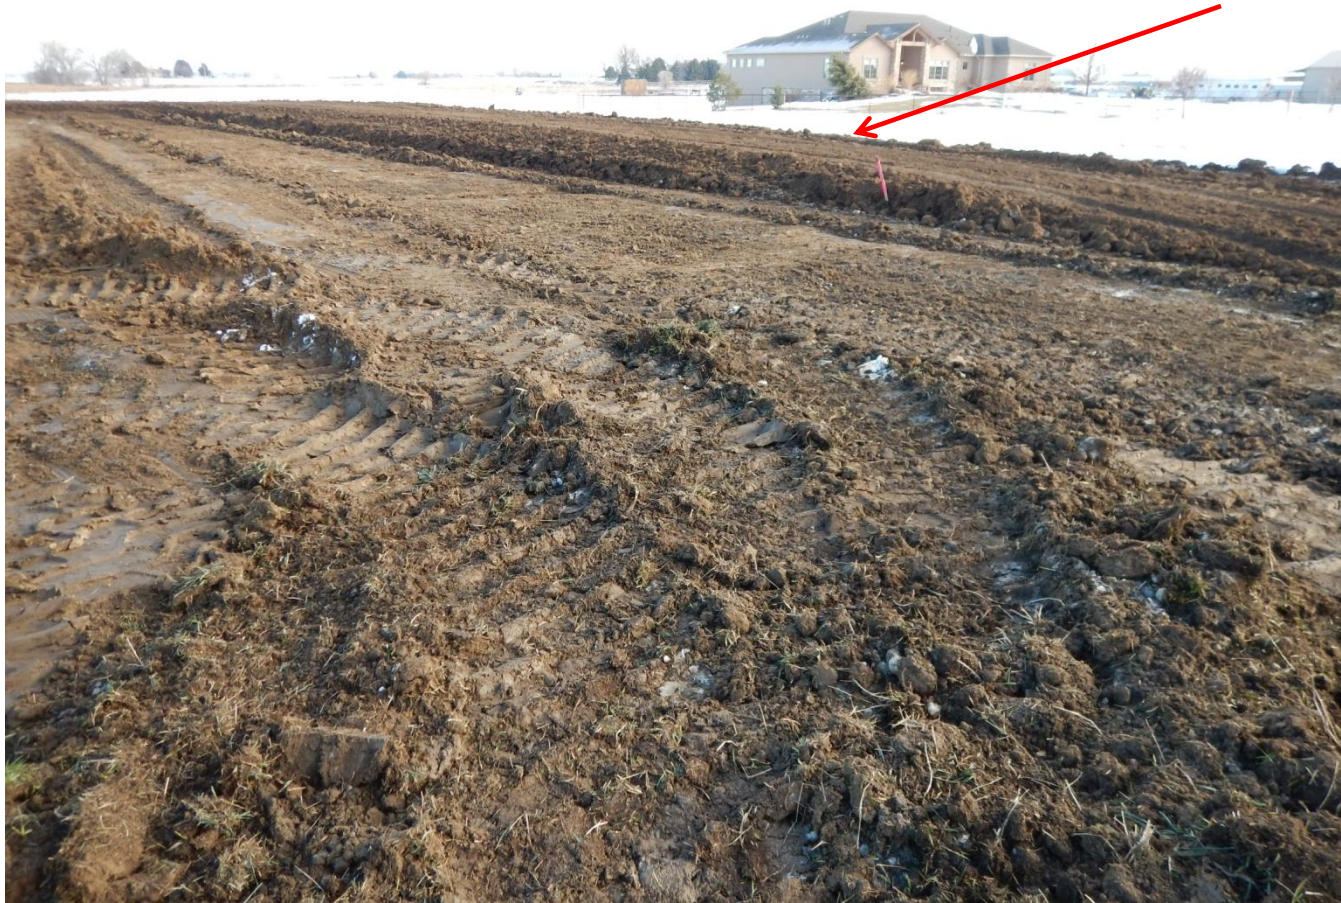
Photo 1. Photo taken from southwestern location, facing Southeast. Topsoil stockpile in center of photo.

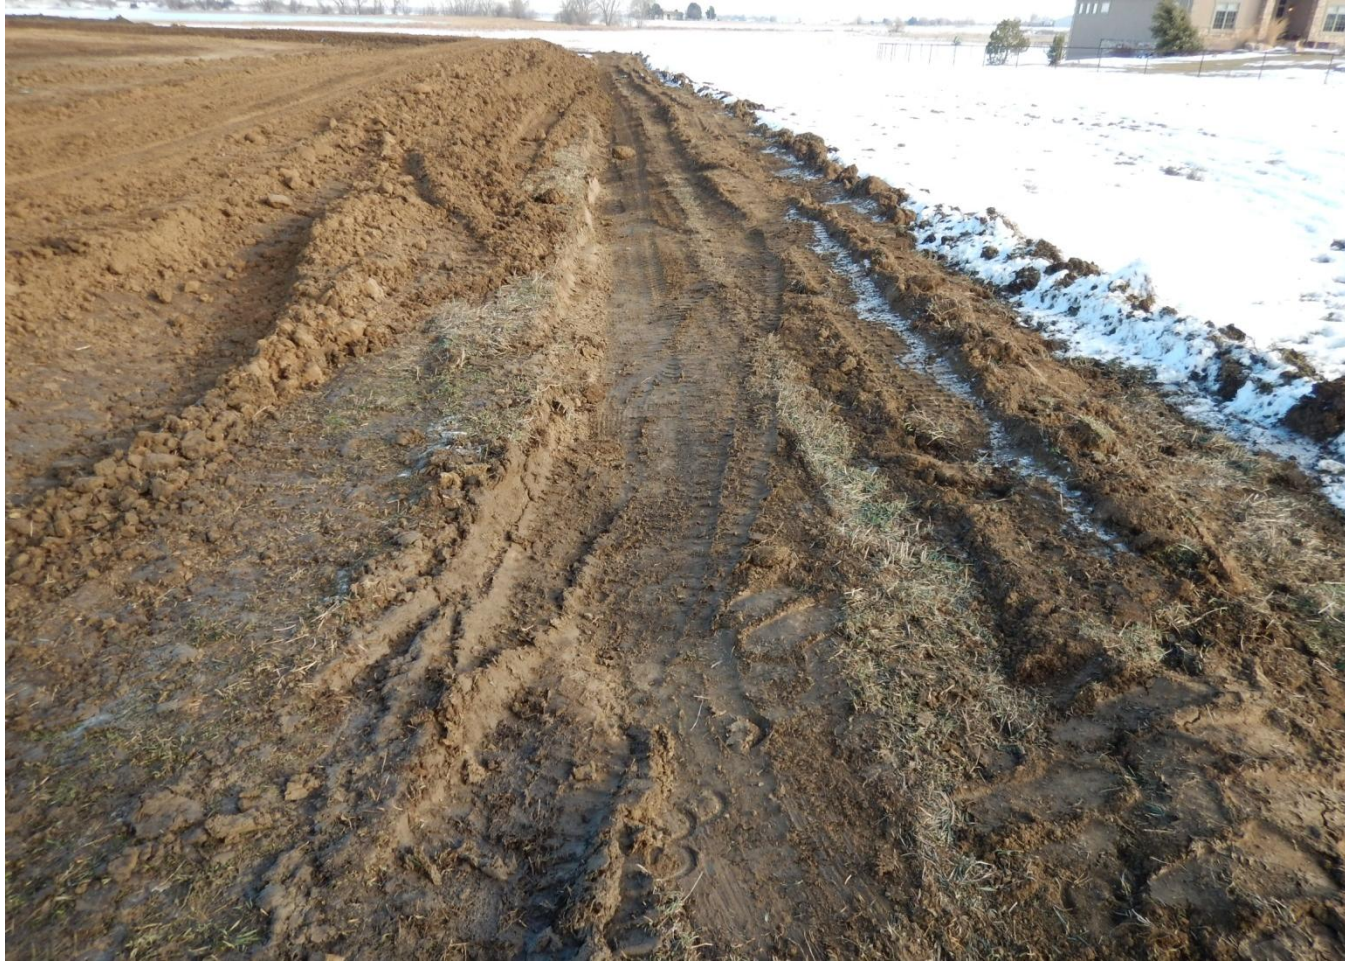
Photo 2. Photo taken from southwestern location, facing East. Stormwater BMP in center of photo.

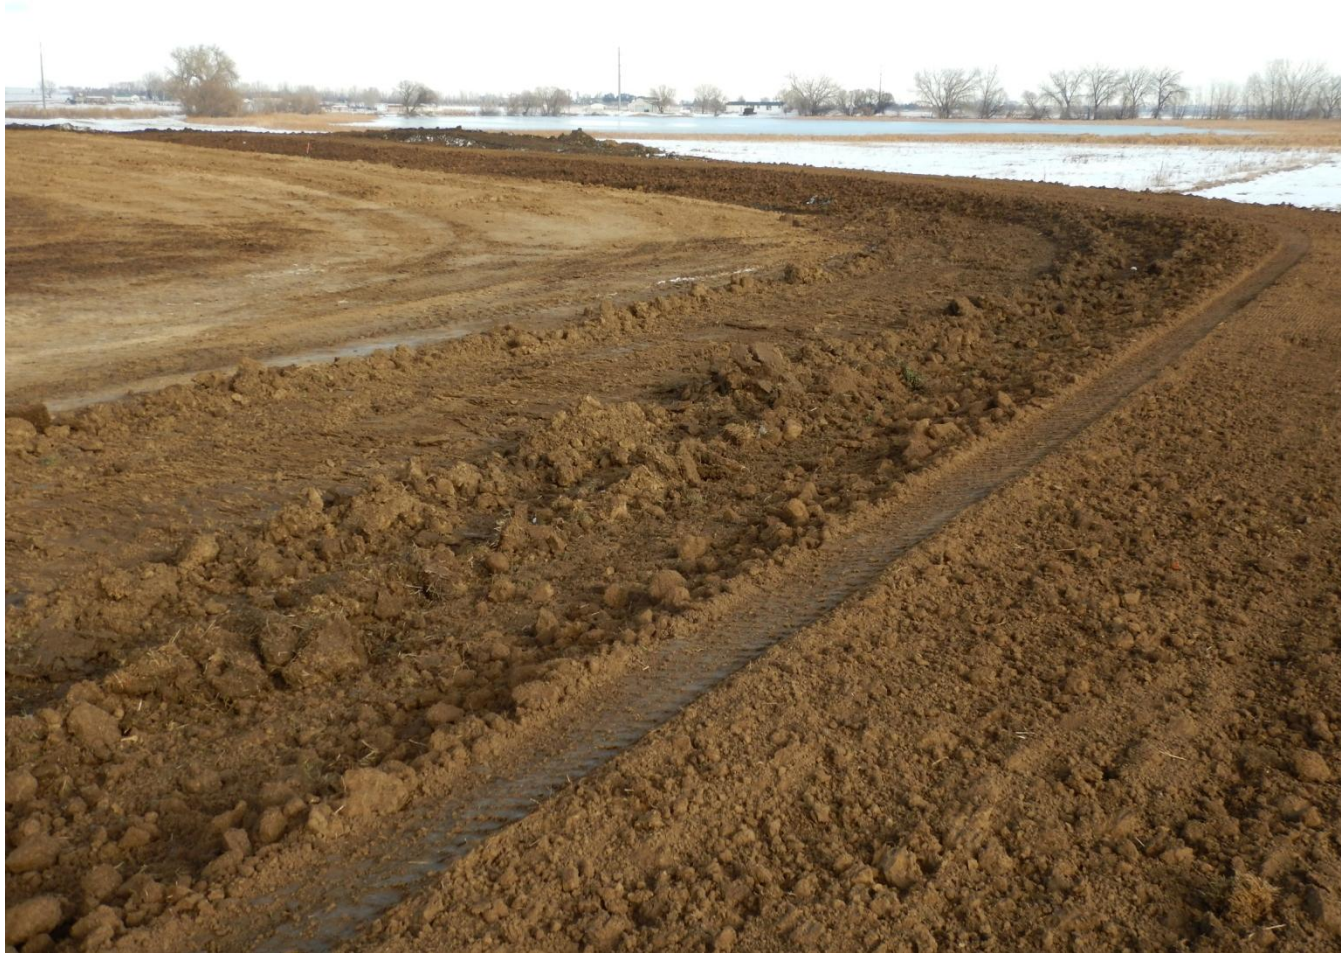
Photo 3. Photo taken from south location, facing Northeast. Topsoil stockpile storage around perimeter of location.

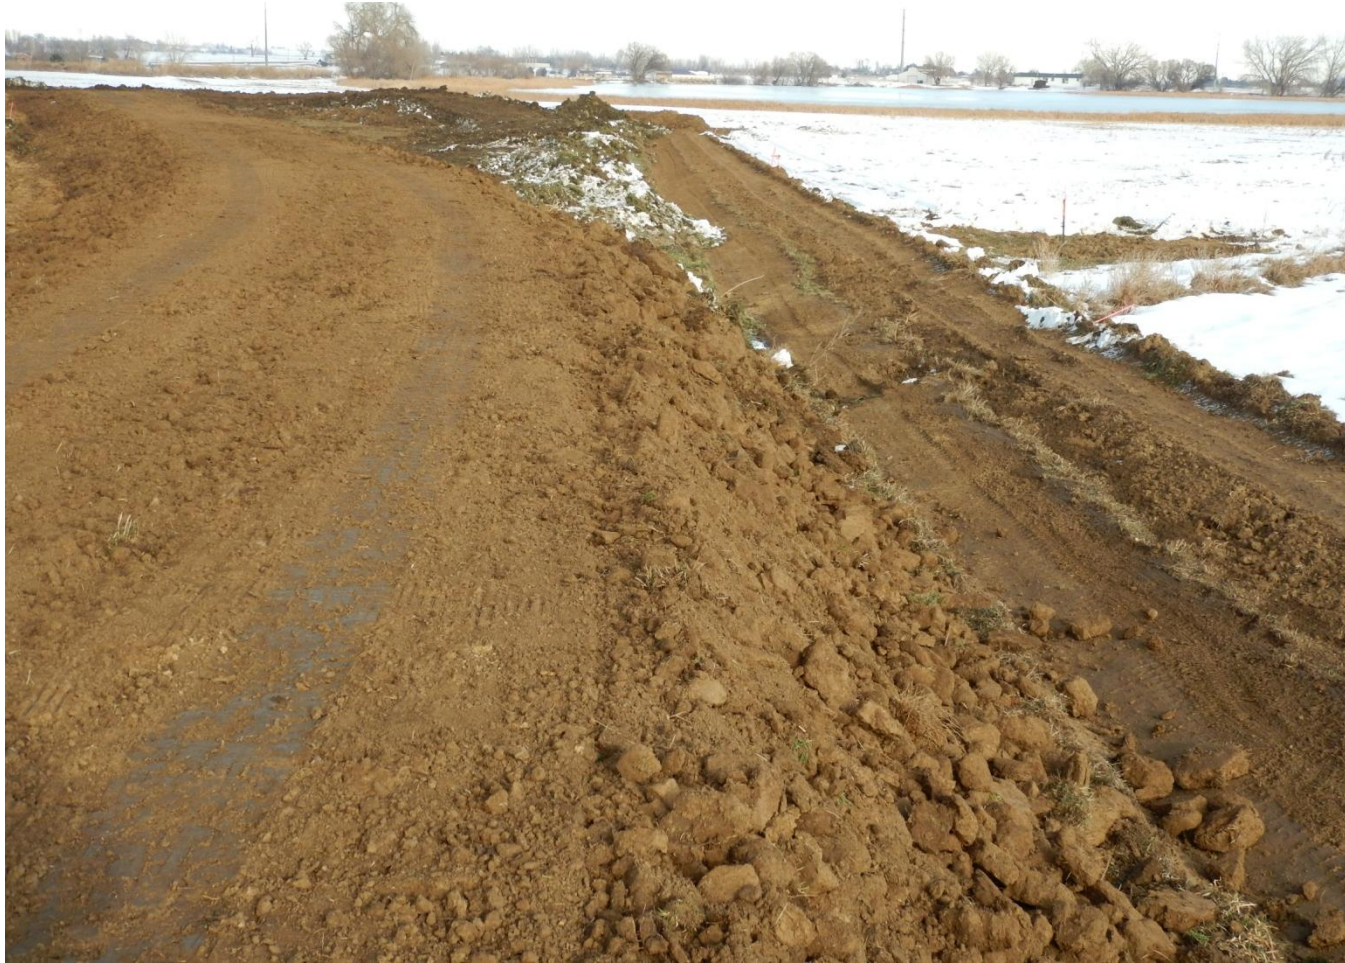
Photo 4. Photo taken from southeast location, facing North. Stormwater BMP in center of photo.

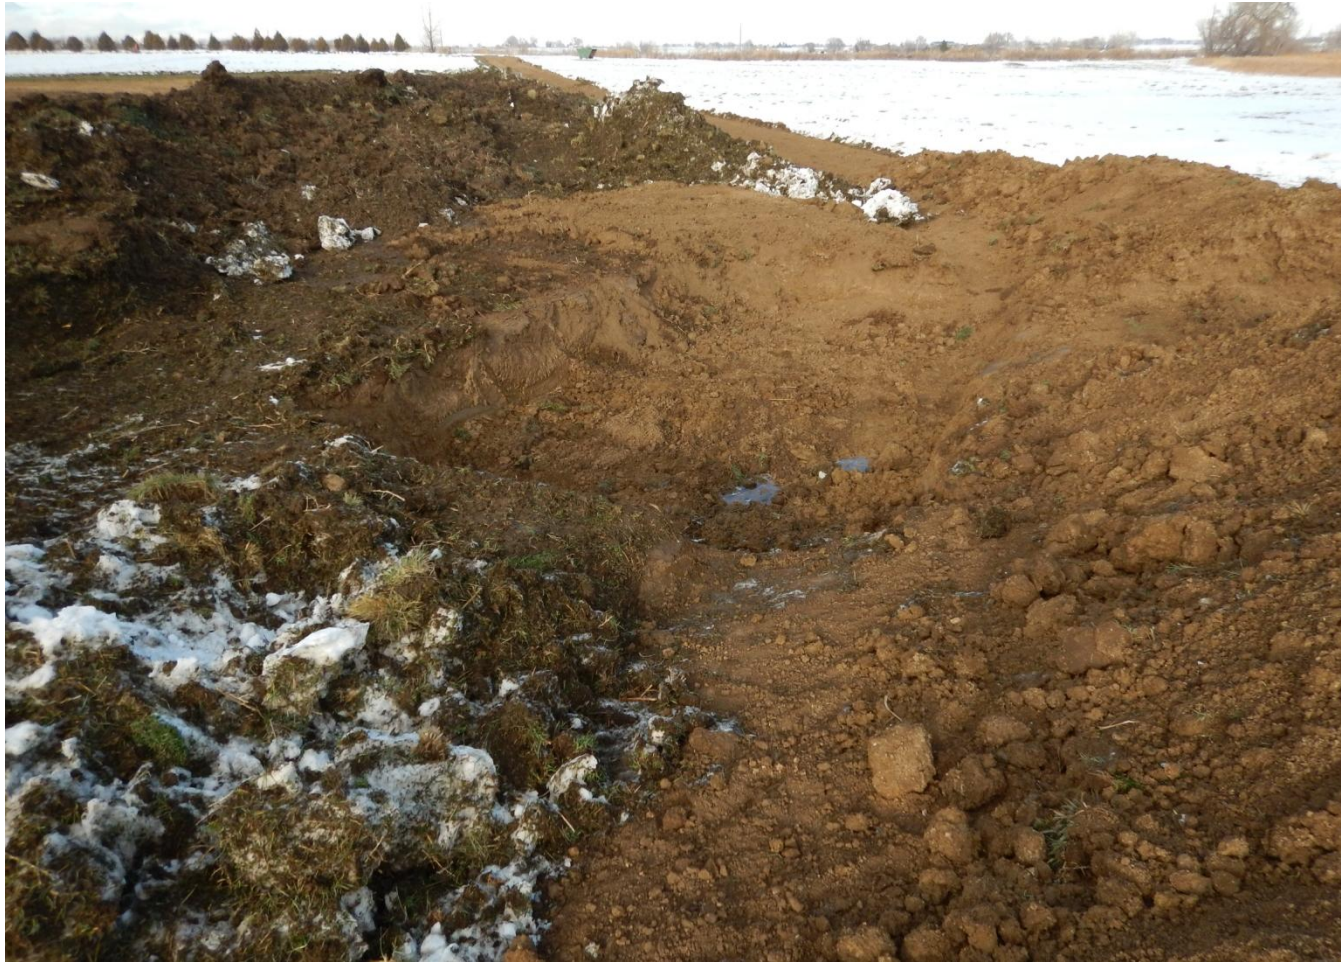
Photo 5. Photo taken from eastern location, facing North. Stormwater BMP in center of photo.

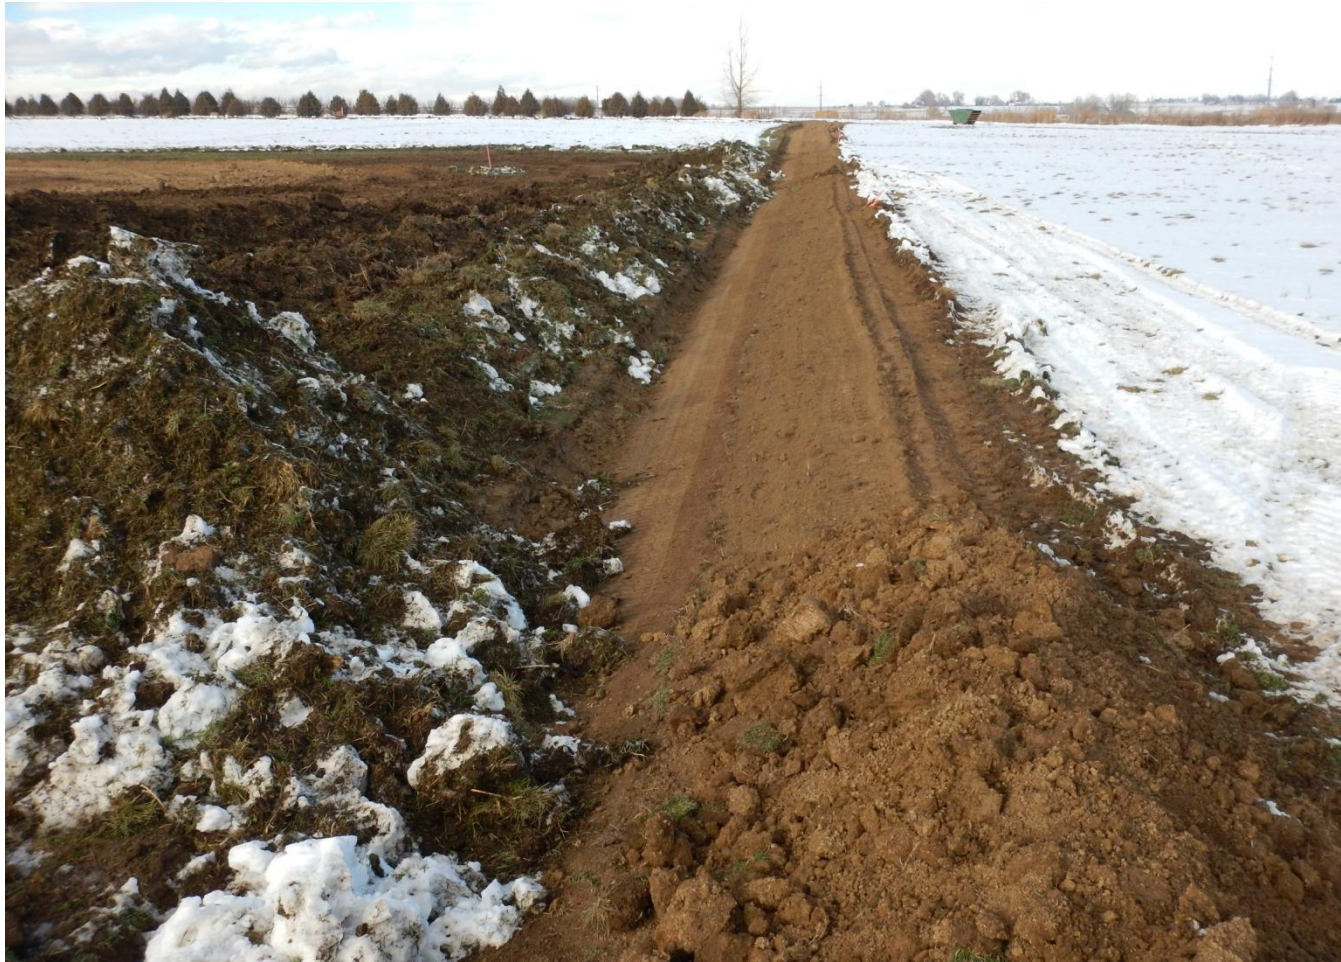
Photo 6. Photo taken from eastern location, facing North. Stormwater BMP in center of photo.

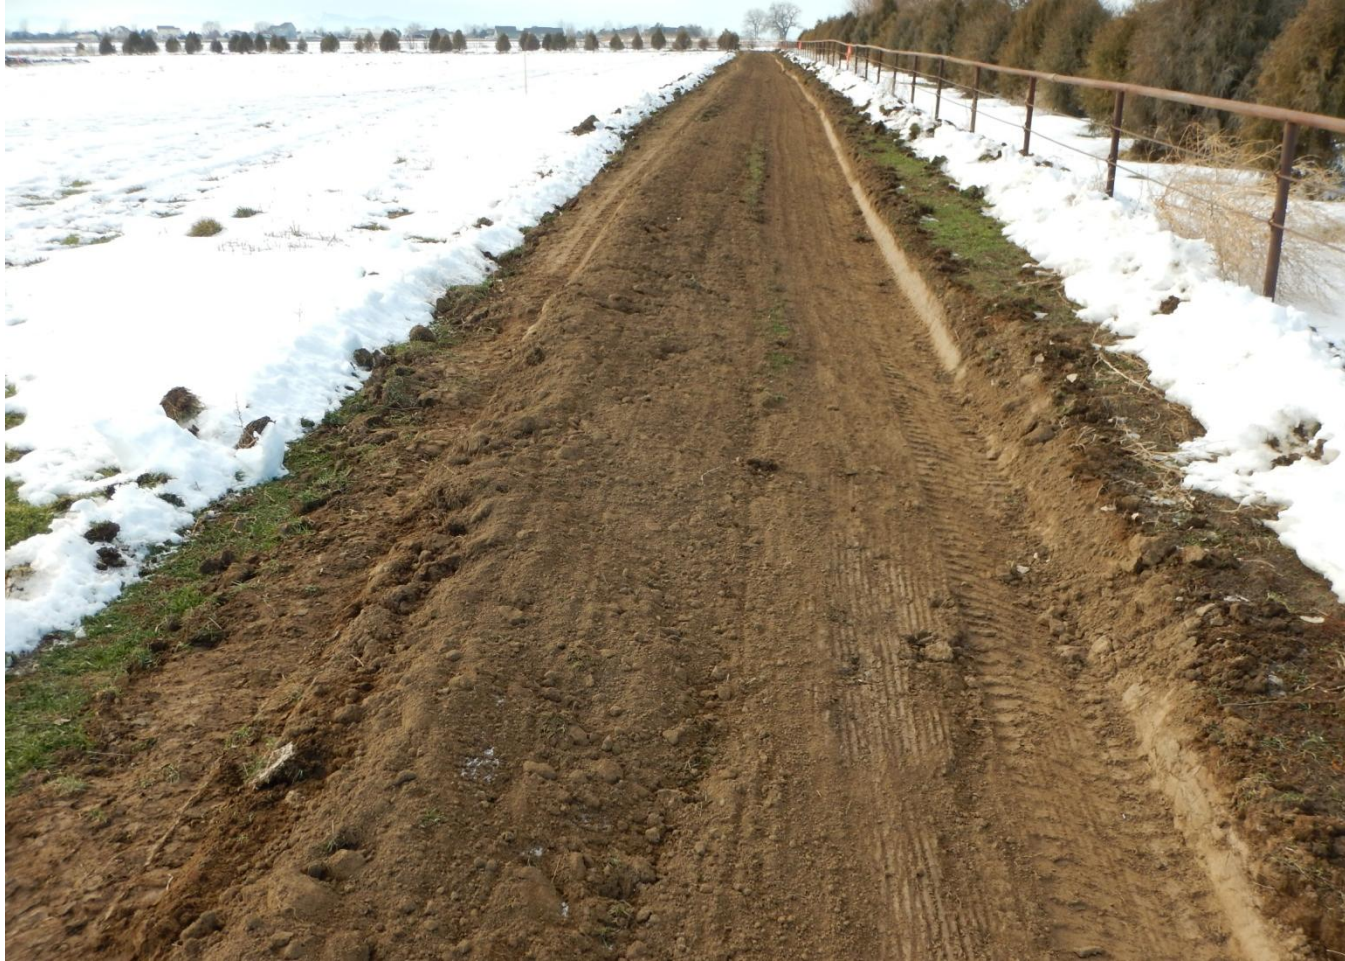
Photo 7. Photo taken from northeast location, facing West. Stormwater BMP in center of photo.

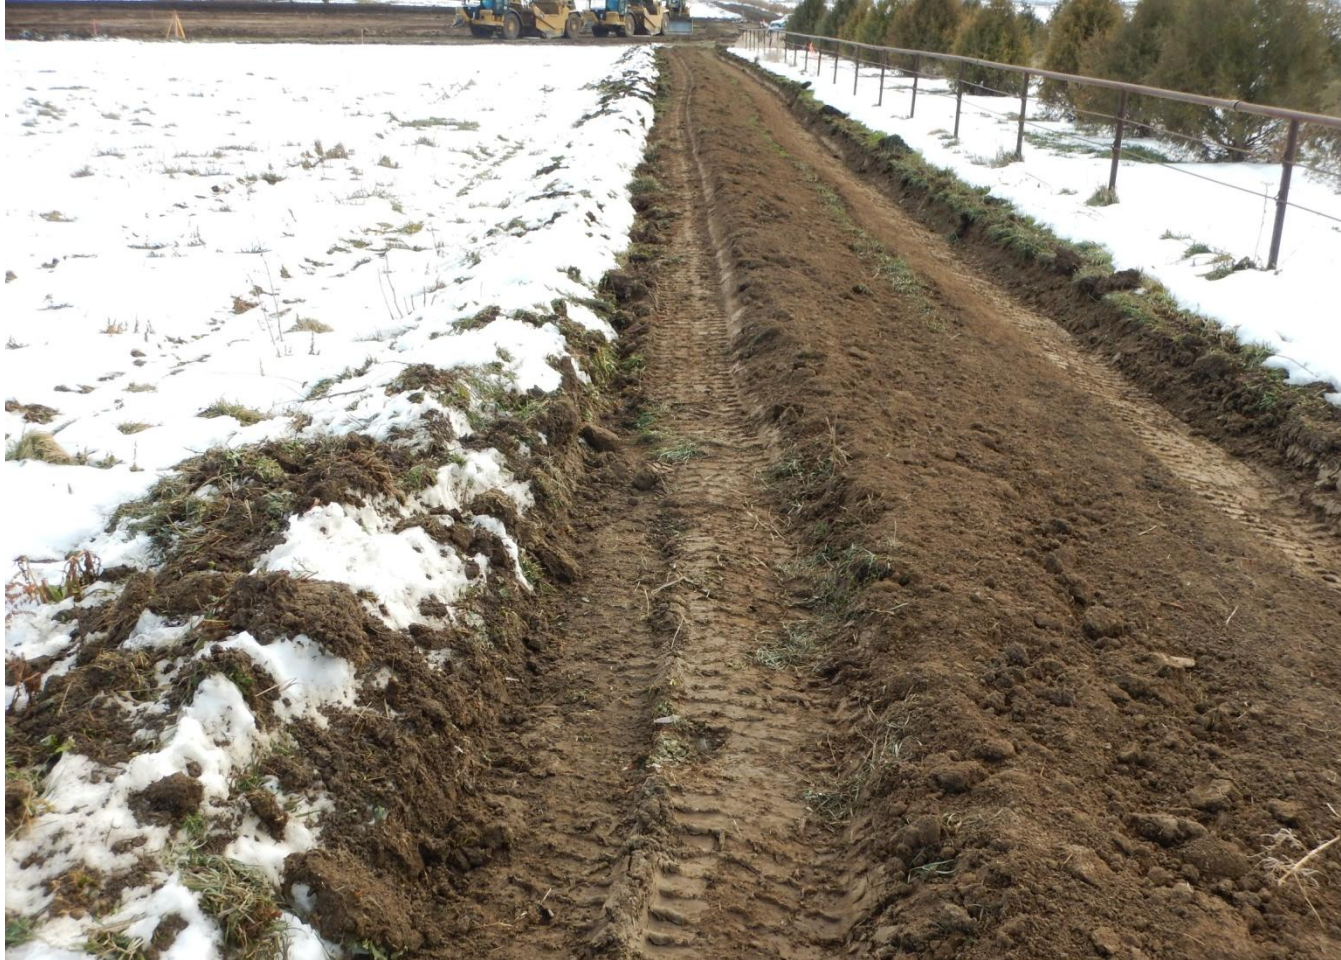
Photo 8. Photo taken from northern location, facing South. Stormwater BMP in center of photo.

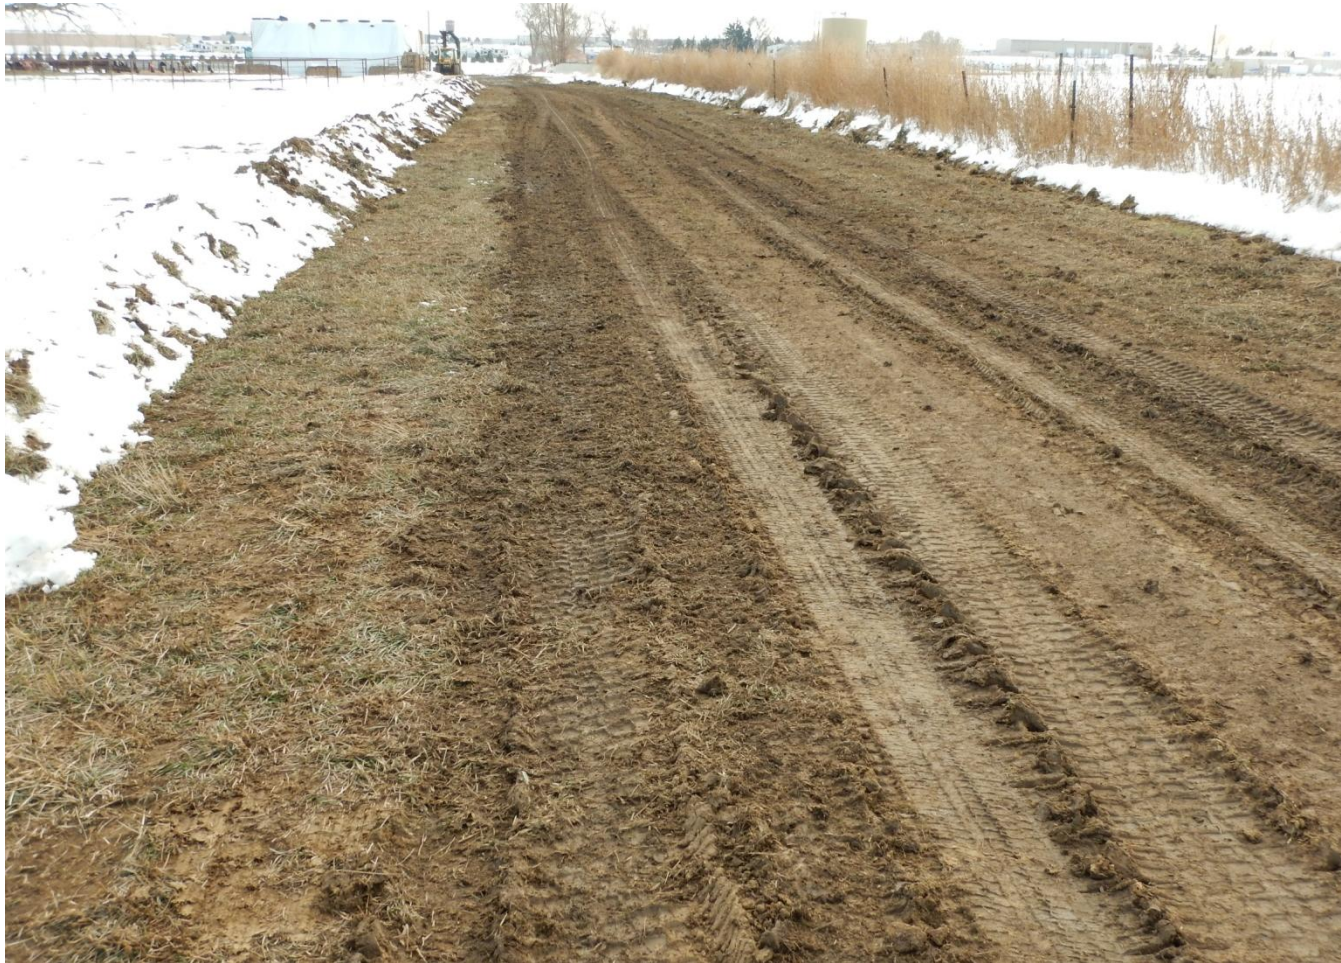
Photo 9. Photo taken from western location, facing South along access road. Operator plans to install gravel to minimize rutting and tracking, and control potential sediment discharge.
