## Interim Reclamation Inspection

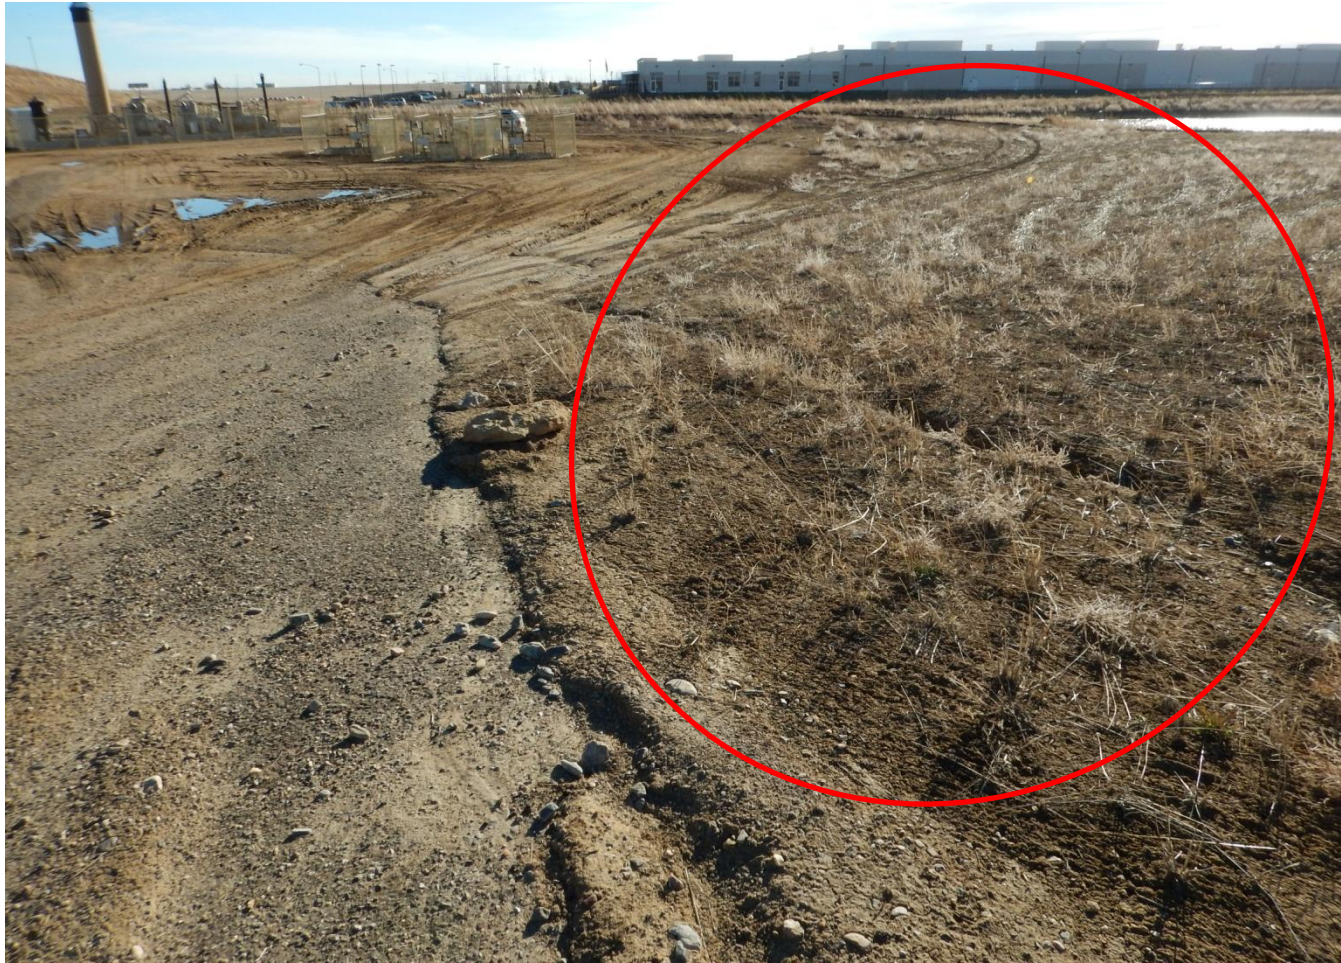
**Photo 1.** Photo taken from northern entrance, facing Southwest. Interim reclamation area lacks perennial vegetative growth. Refer to photo 3.

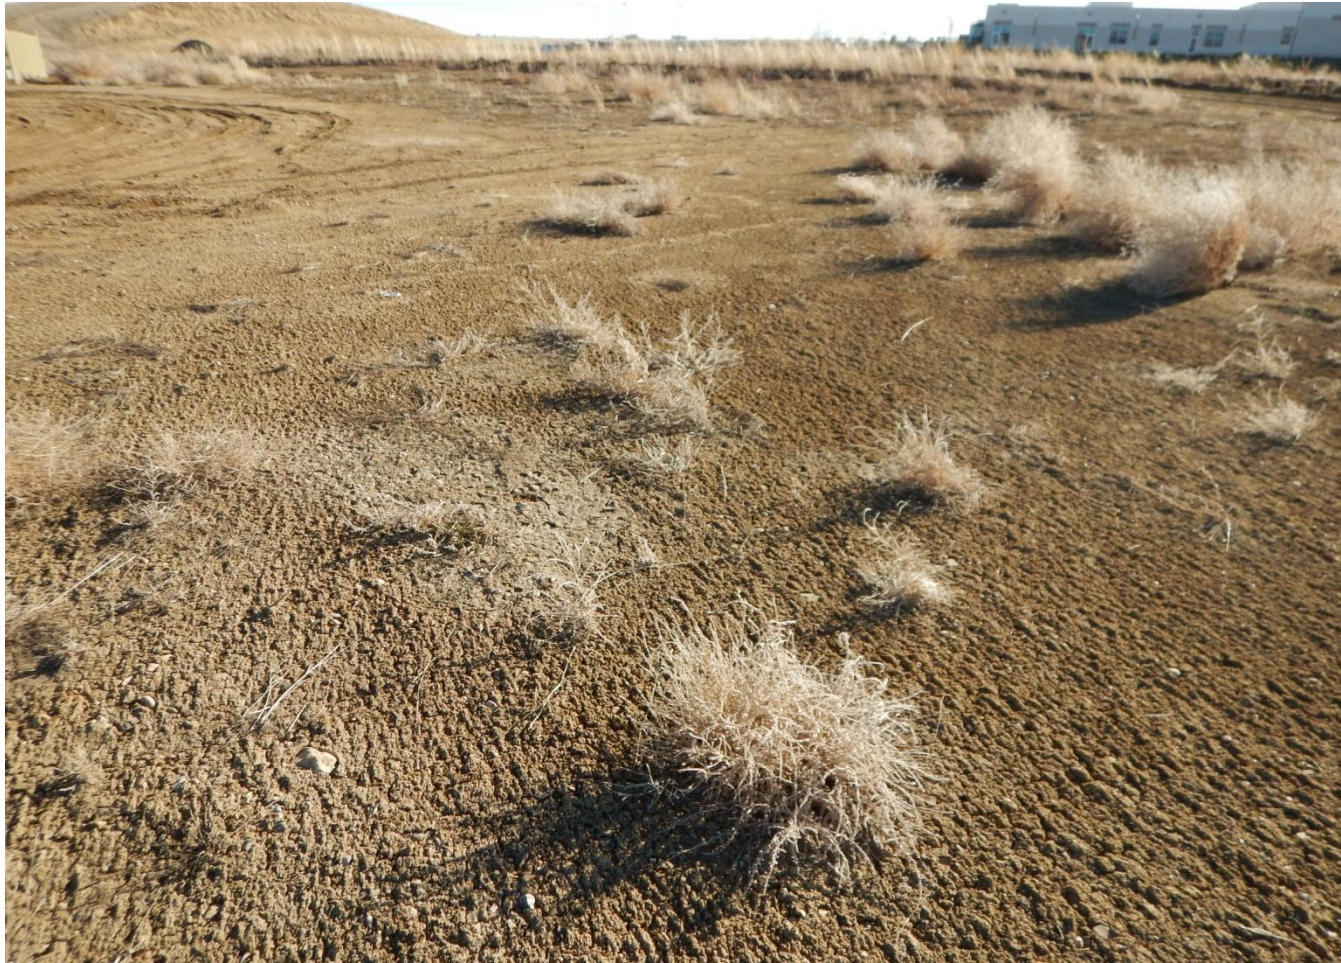
**Photo 3.** Photo taken from southwest location, facing South. Interim reclamation lacks perennial vegetative growth. Need to manage undesirable plant species (tumbleweeds) to ensure perennial vegetative establishment and to control undesirable species from spreading onto other adjacent lands.

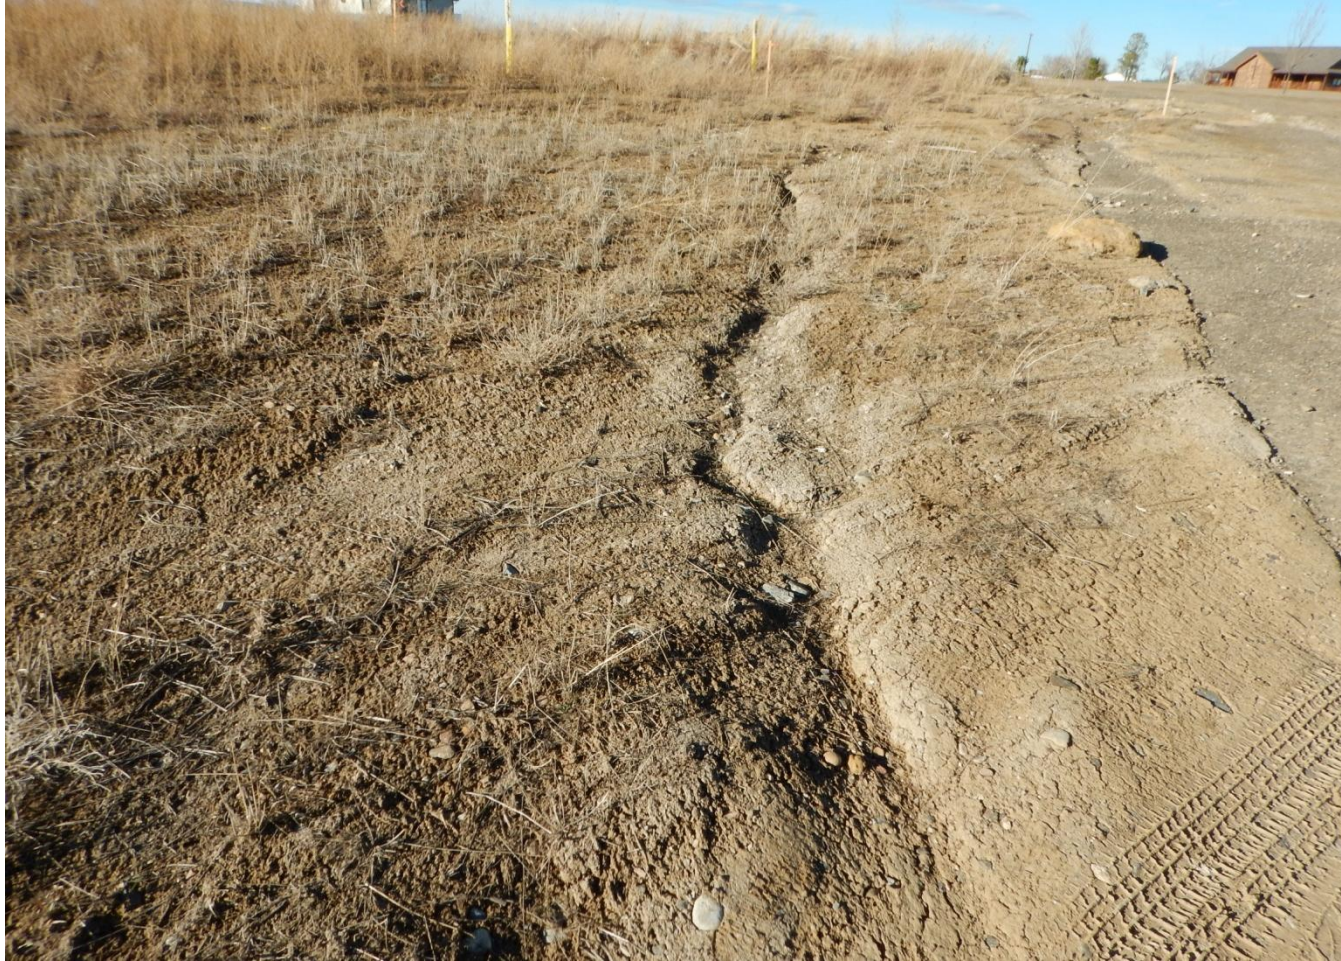
**Photo 4.** Photo taken from northern entrance, facing North. Need to stabilize and control erosion.

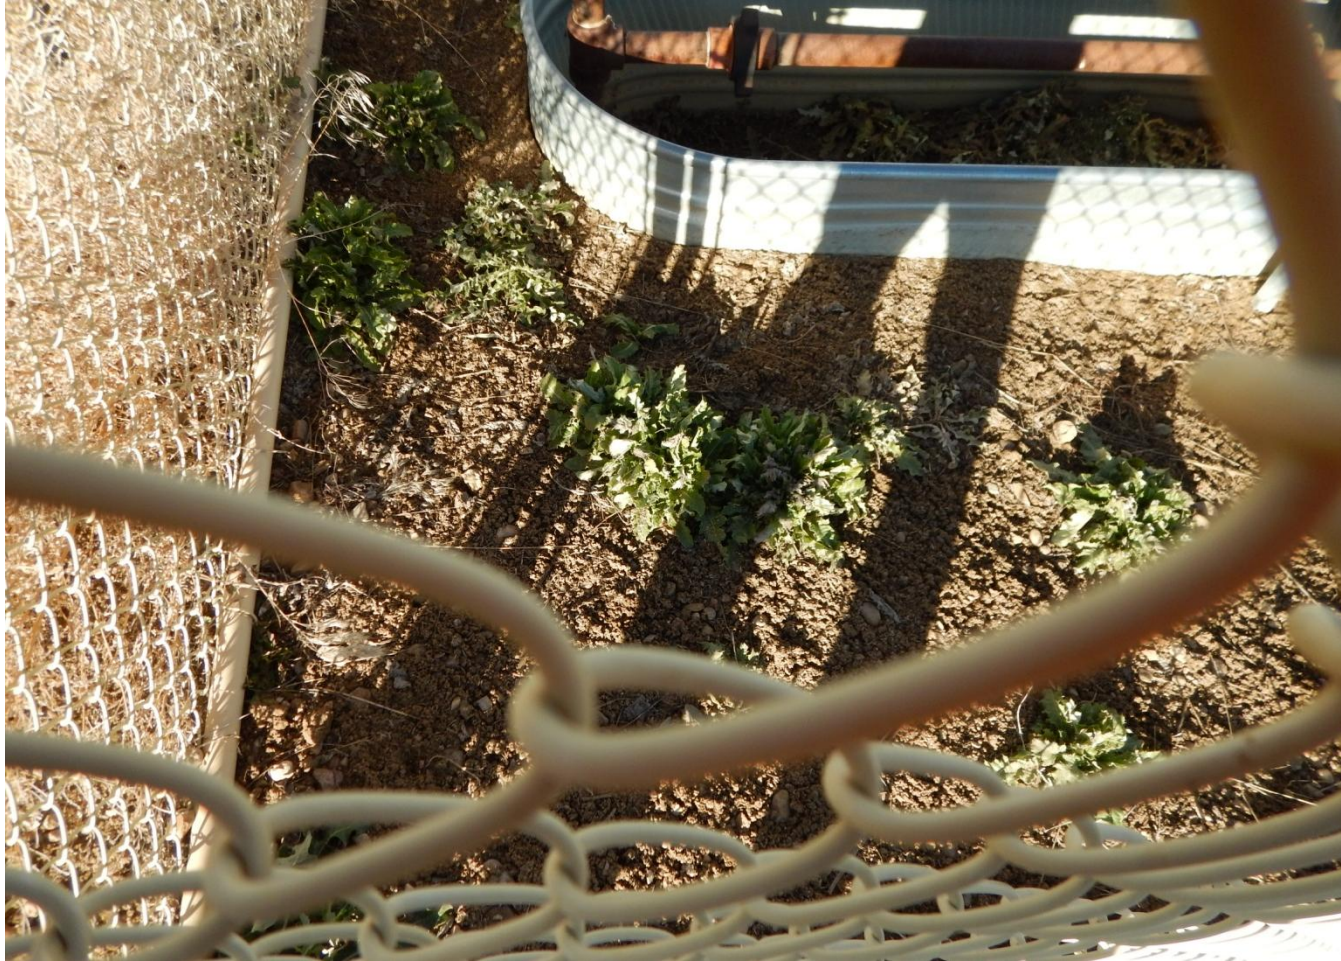
**Photo 5.** Photo taken of fenced in well area. Need to manage noxious weeds per COGCC 1003 rules.

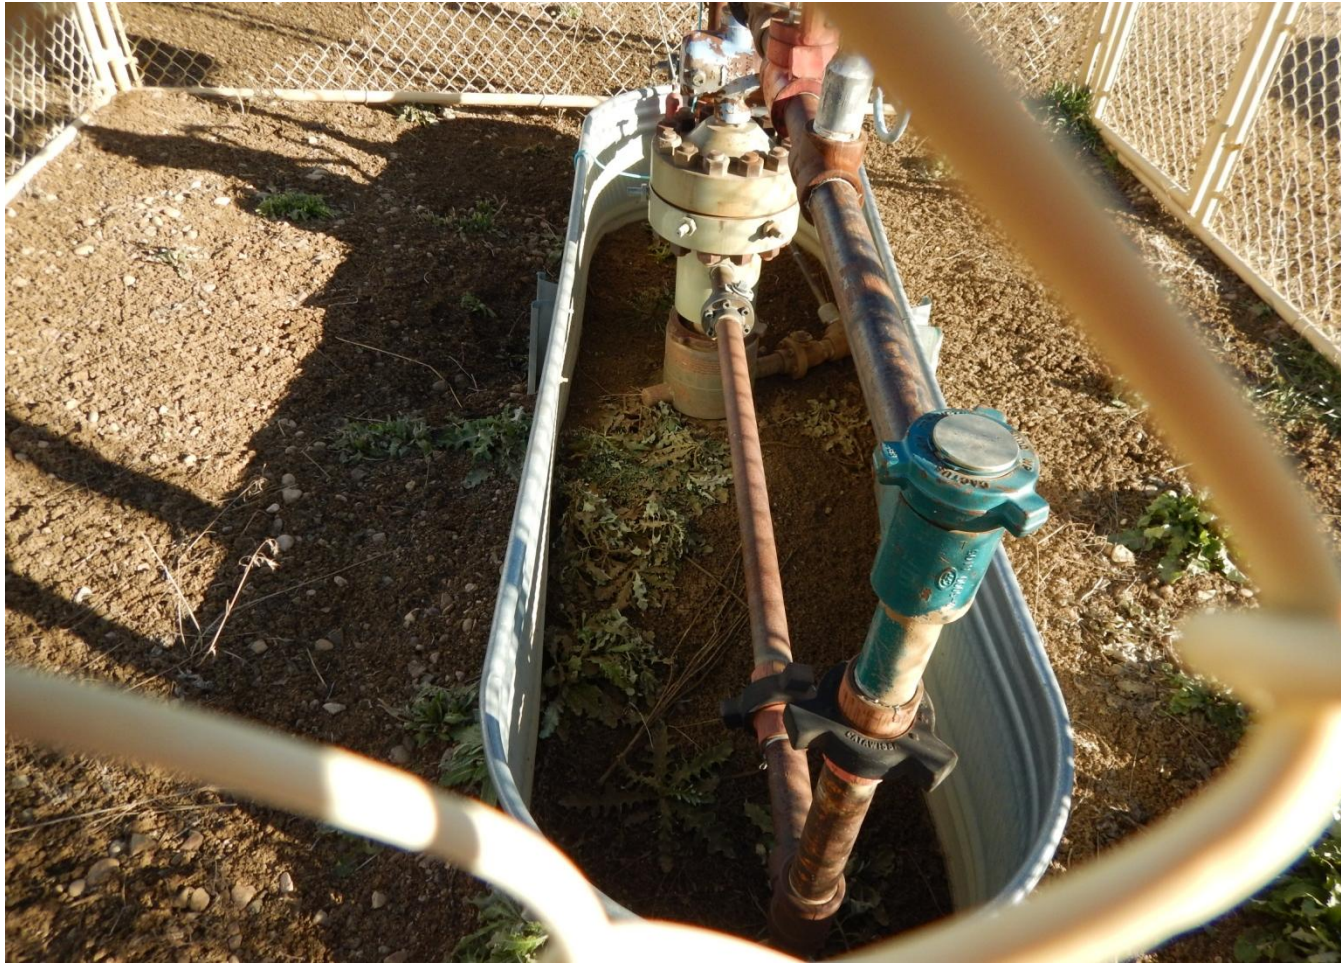
**Photo 6.** Photo taken of fenced in well area. Need to manage noxious weeds per COGCC 1003 rules.

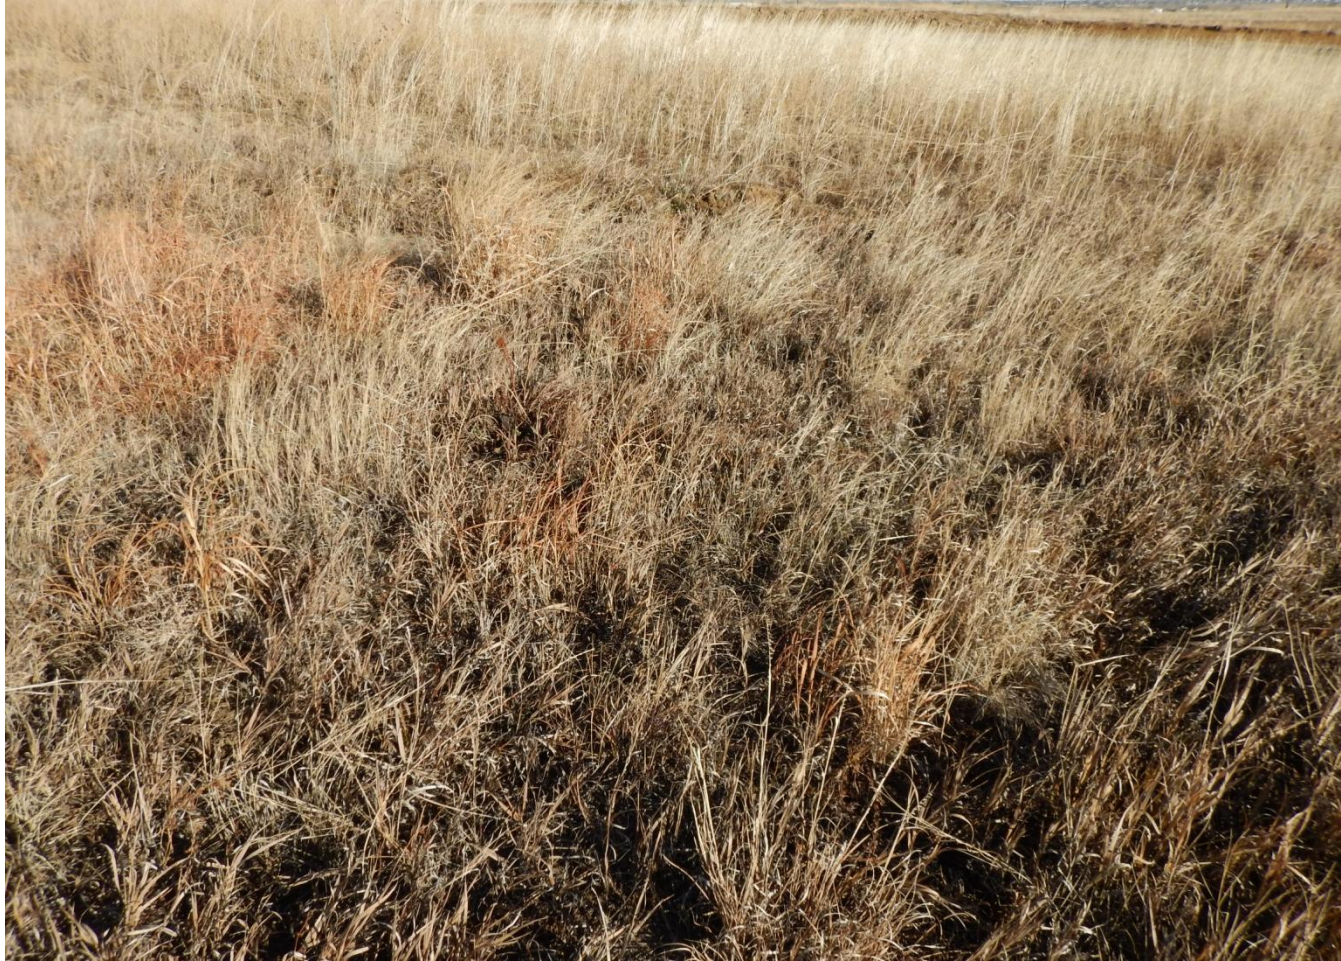
**Photo 7.** Reference photo taken east of location. Notice the uniform perennial vegetative growth.
