Construction Inspection

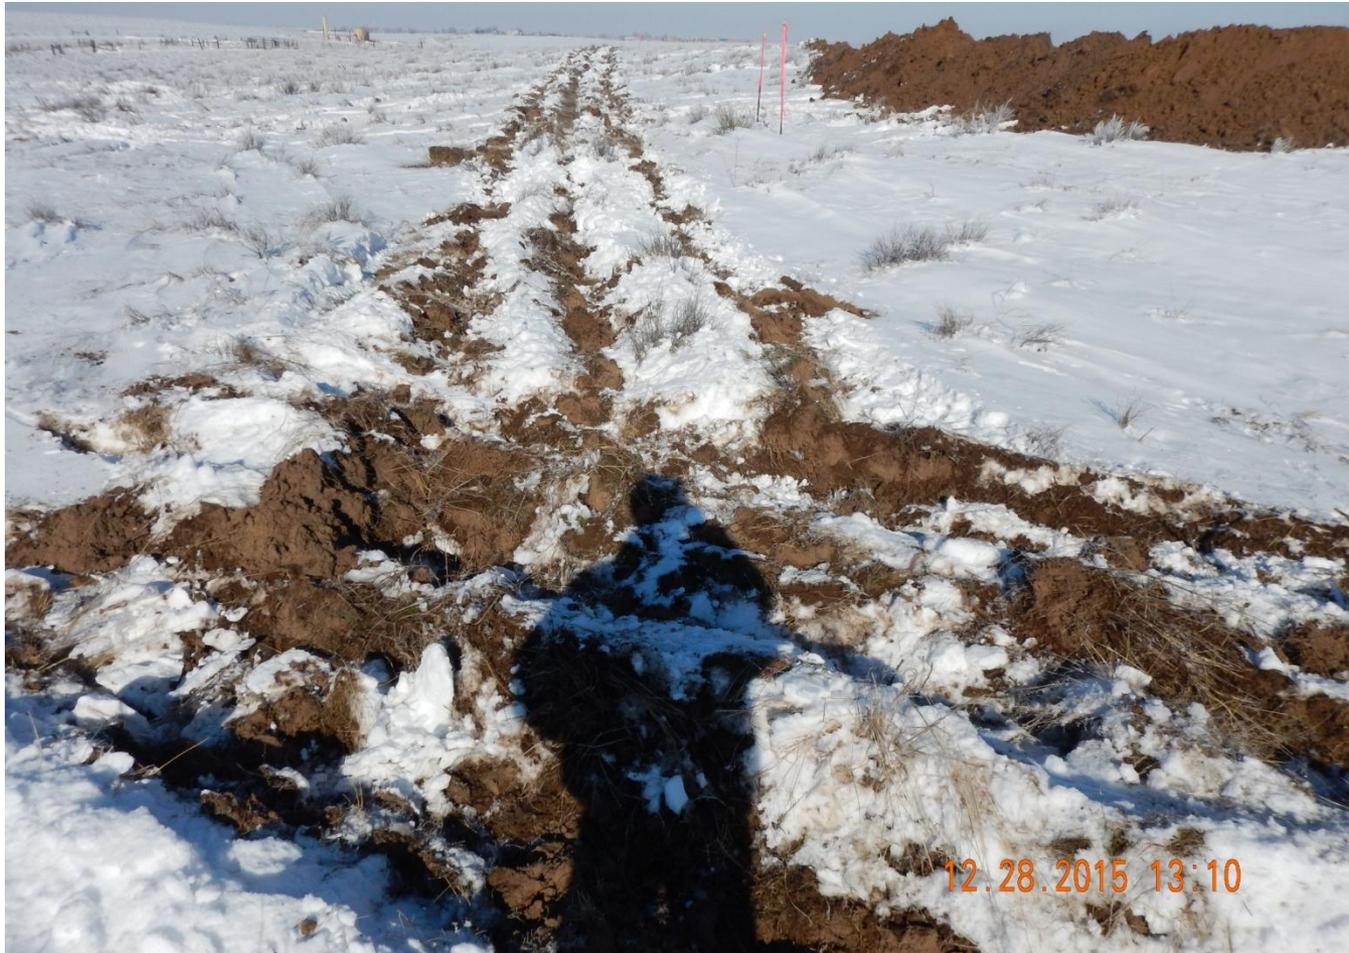
Photo 1. Photo taken from southwest location, facing North. Surface water drainage located cross- and down-gradient from disturbance (Refer to photo 8). Surface roughening (ripping) is a temporary BMP and should be used in conjunction with other BMPs. Western edge of disturbance should incorporate additional BMPs because of surface water drainage.

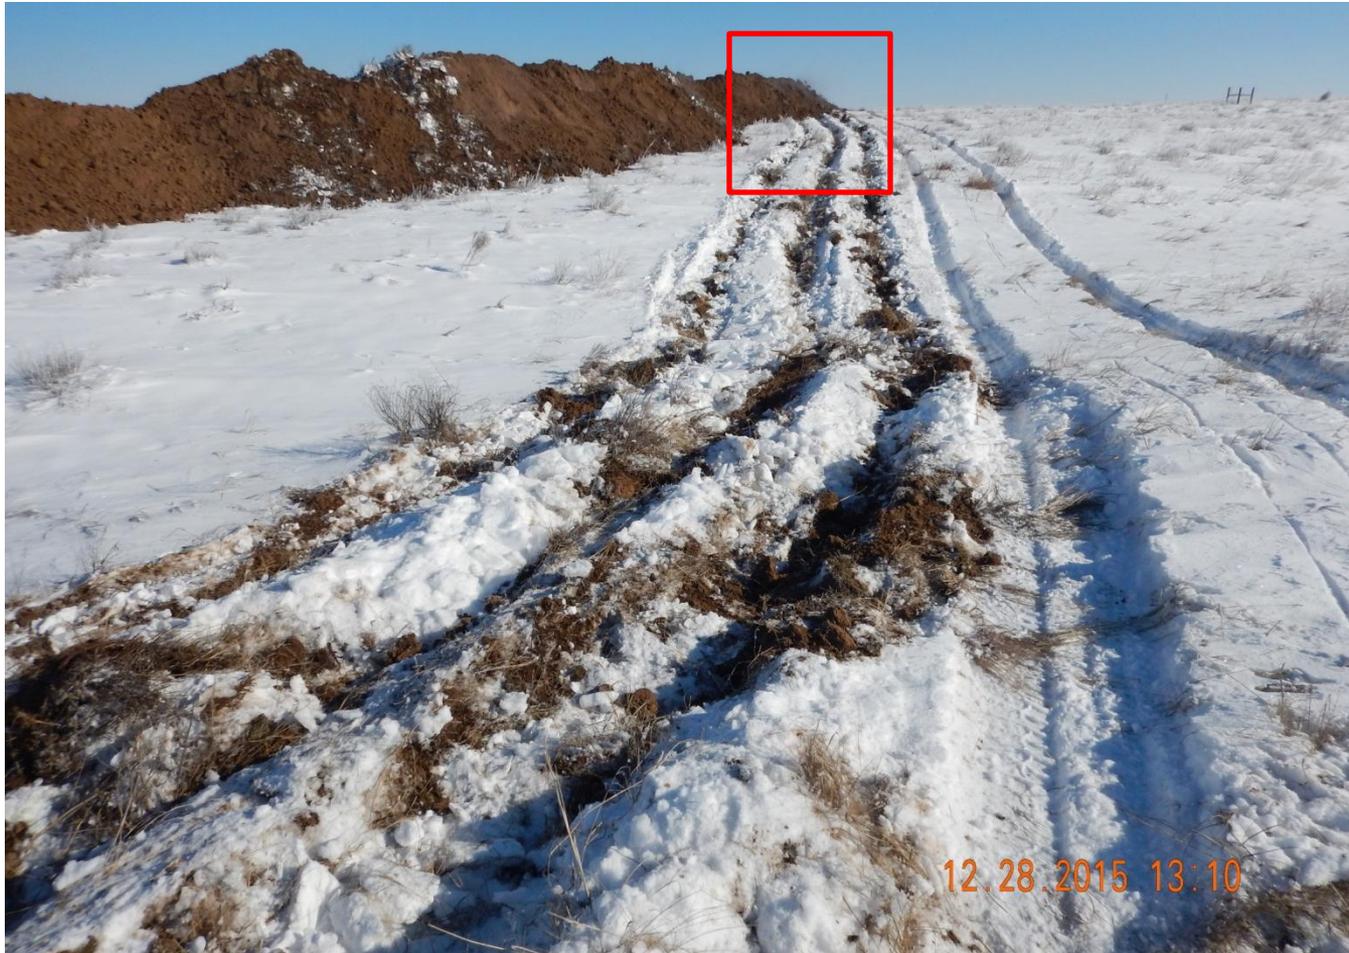
Photo 2. Photo taken from southwest location, facing East. Surface water drainage located cross- and down-gradient (Refer to photo 8). Surface roughening (ripping) is a temporary BMP and should be used in conjunction with other BMPs. Southern edge of disturbance should incorporate additional BMPs because of surface water drainage. Do not fill or drive over stormwater BMPs. Operator fixed issue while I was onsite. Refer to photo 7.

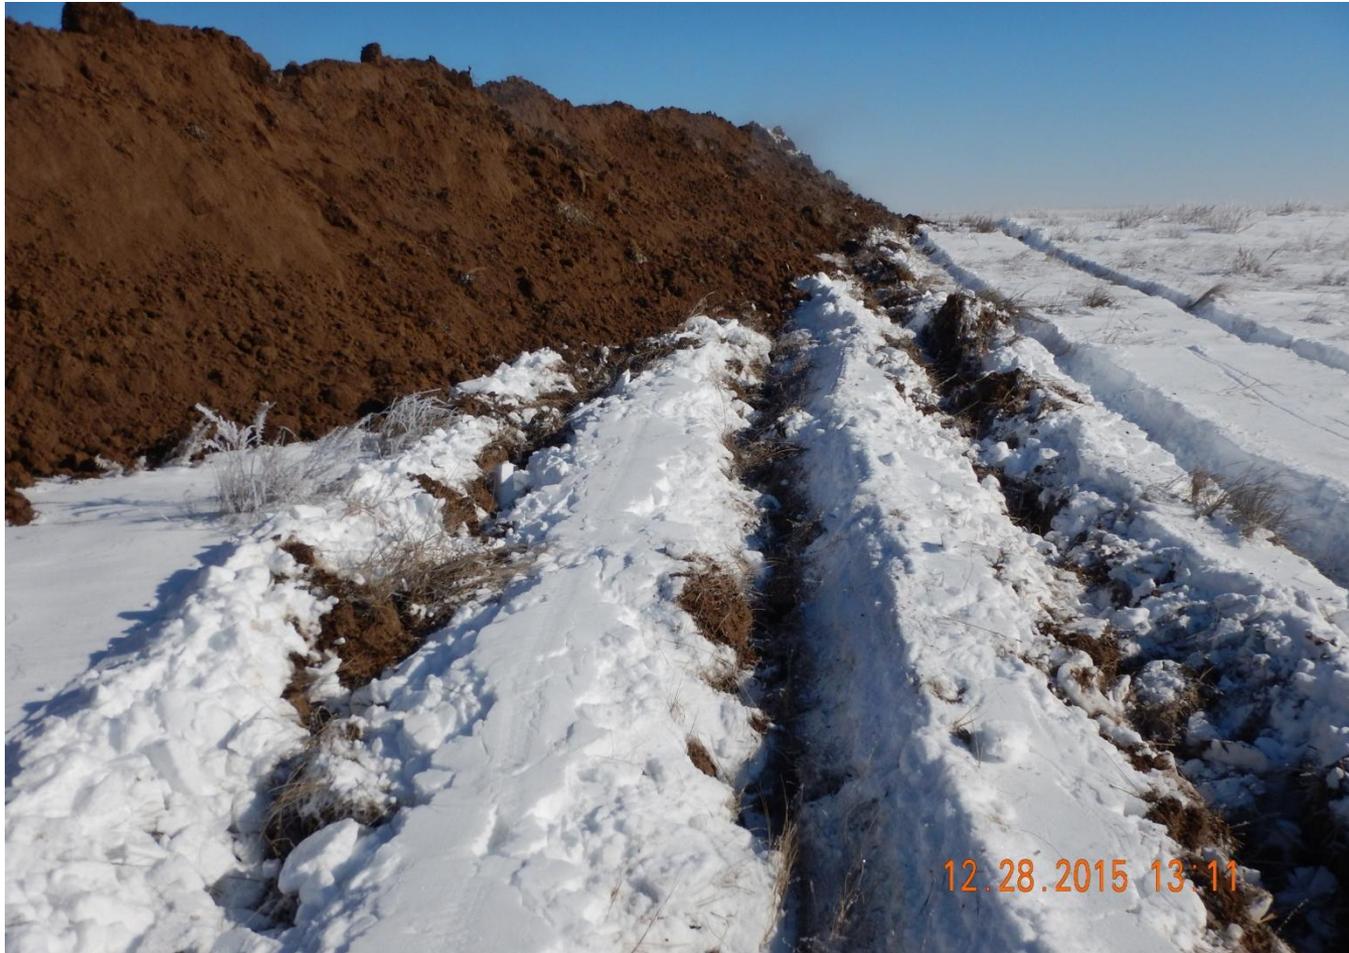
Photo 3. Photo taken from southern location, facing East. Do not fill or drive over stormwater BMPs. Operator fixed issue while I was onsite. Refer to photo 7.

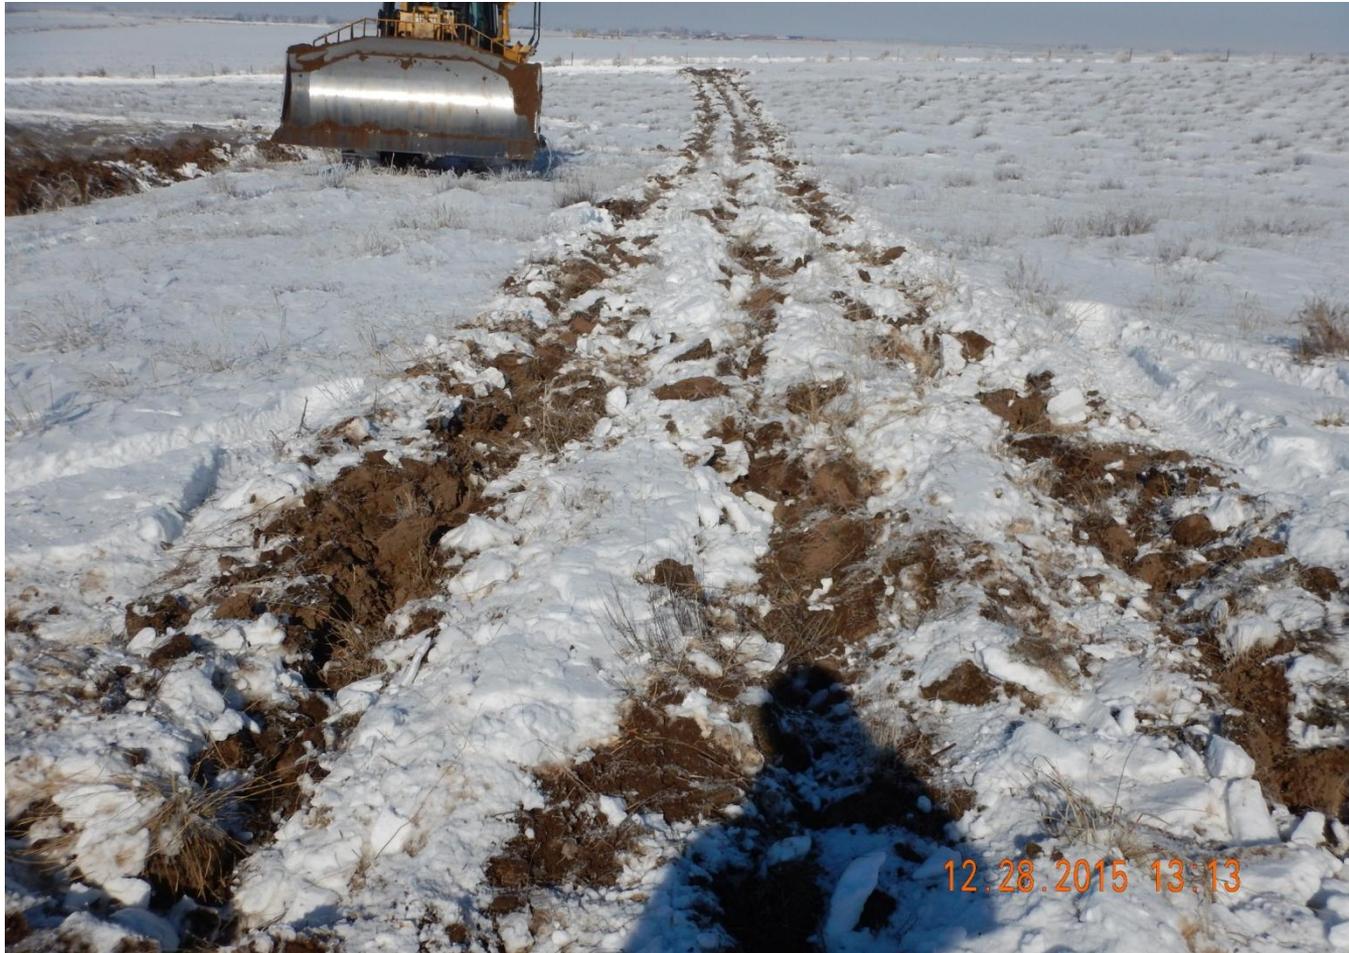
Photo 4. Photo taken from southeast location, facing North. Surface roughening (ripping) is a temporary BMP. May need additional stormwater BMPs because of surface water drainage located cross- and down-gradient from disturbance.

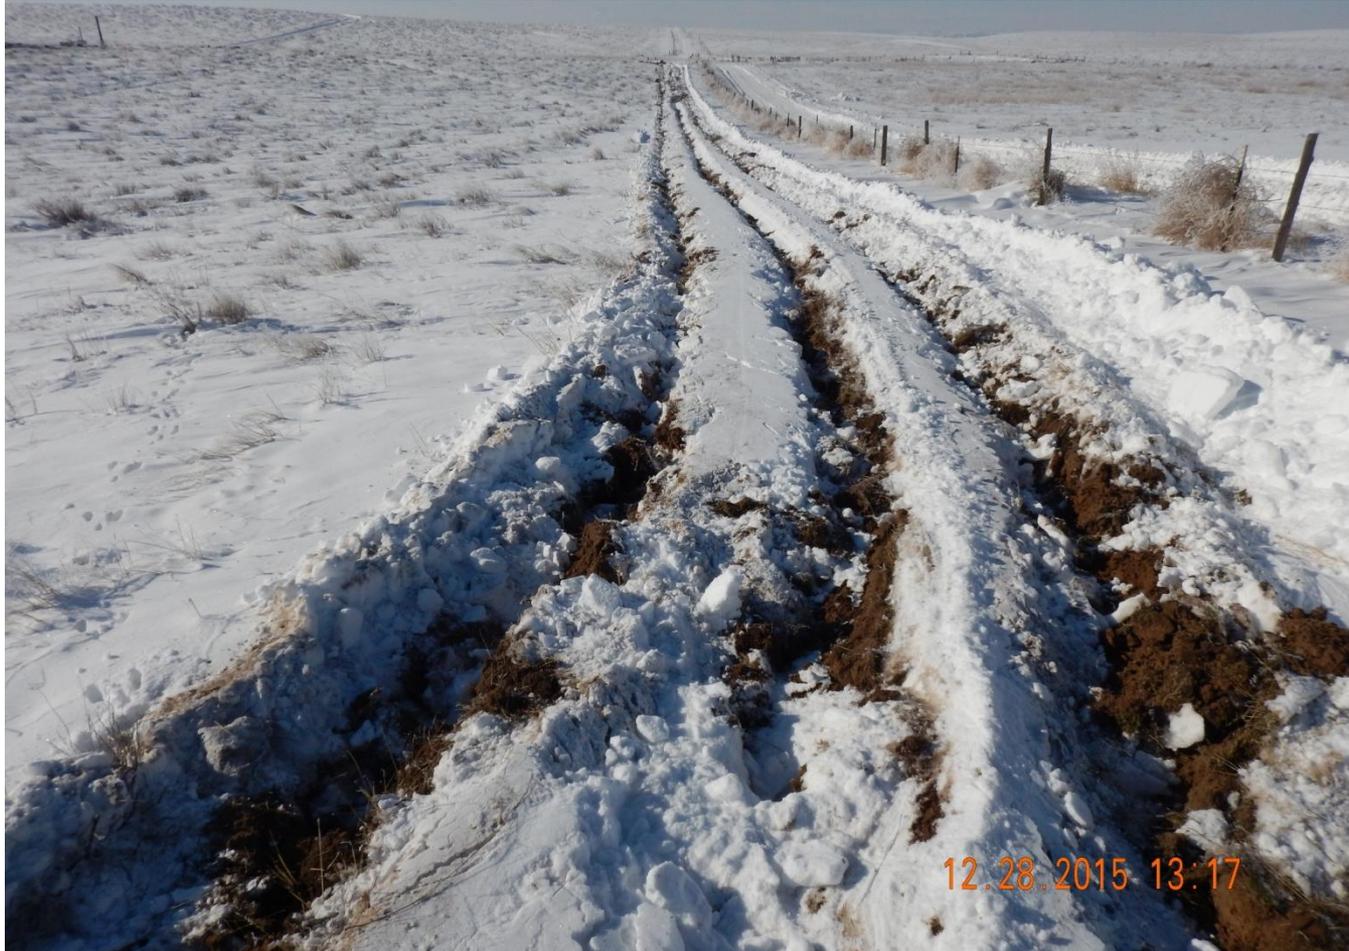
Photo 5. Photo taken from northeast location, facing West. Surface roughening (ripping) is a temporary BMP. May need additional stormwater BMPs because of surface water drainage located cross- and down-gradient from disturbance.

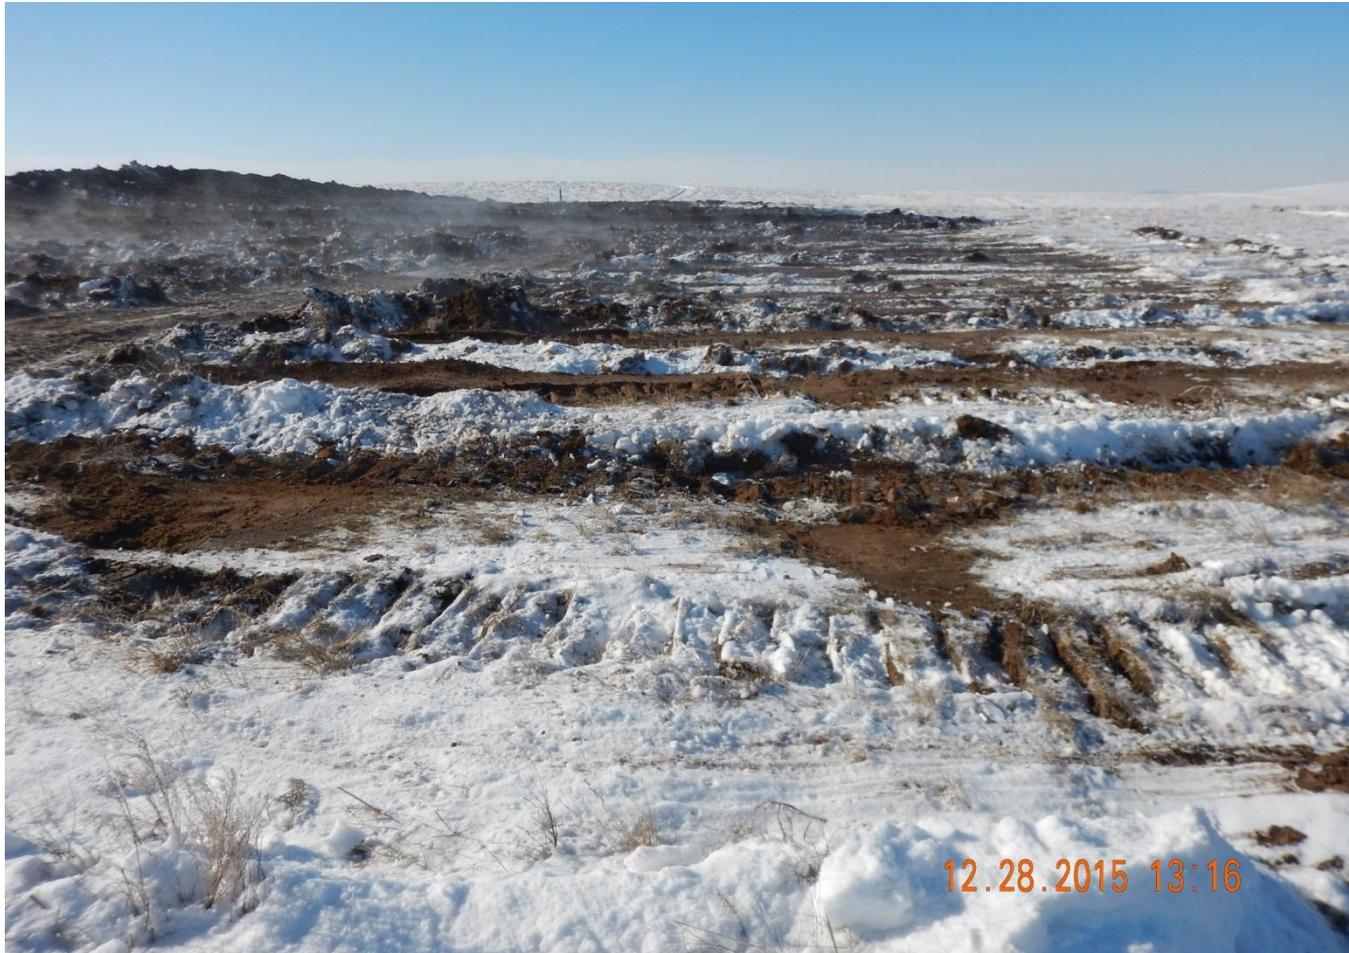
Photo 6. Photo taken from eastern location, facing West. Topsoil removal in process.

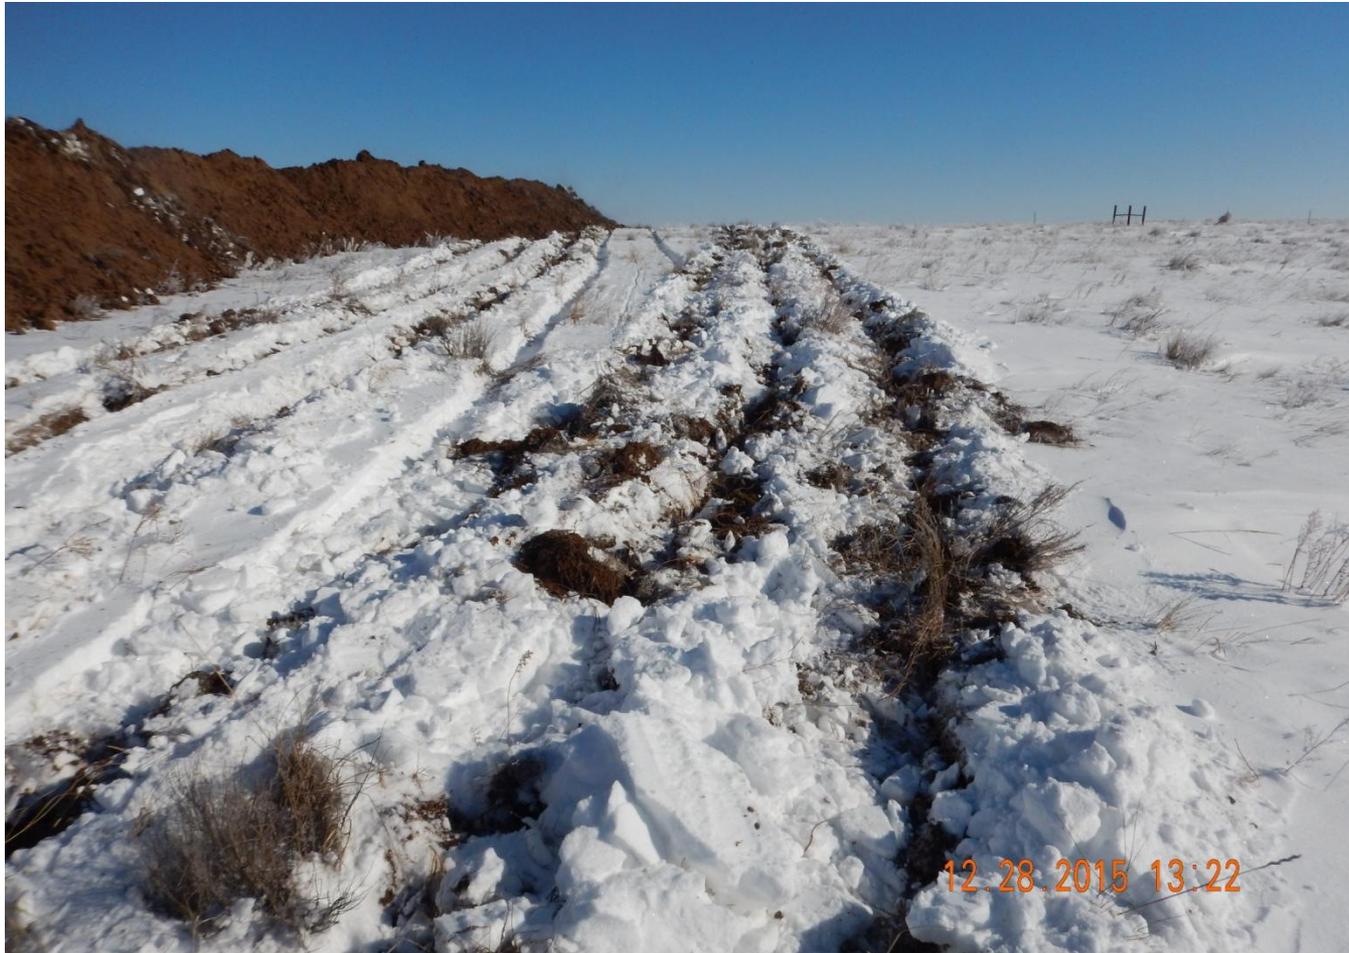
Photo 7. Photo taken from southern location, facing East. Operator reinstalled stormwater BMP

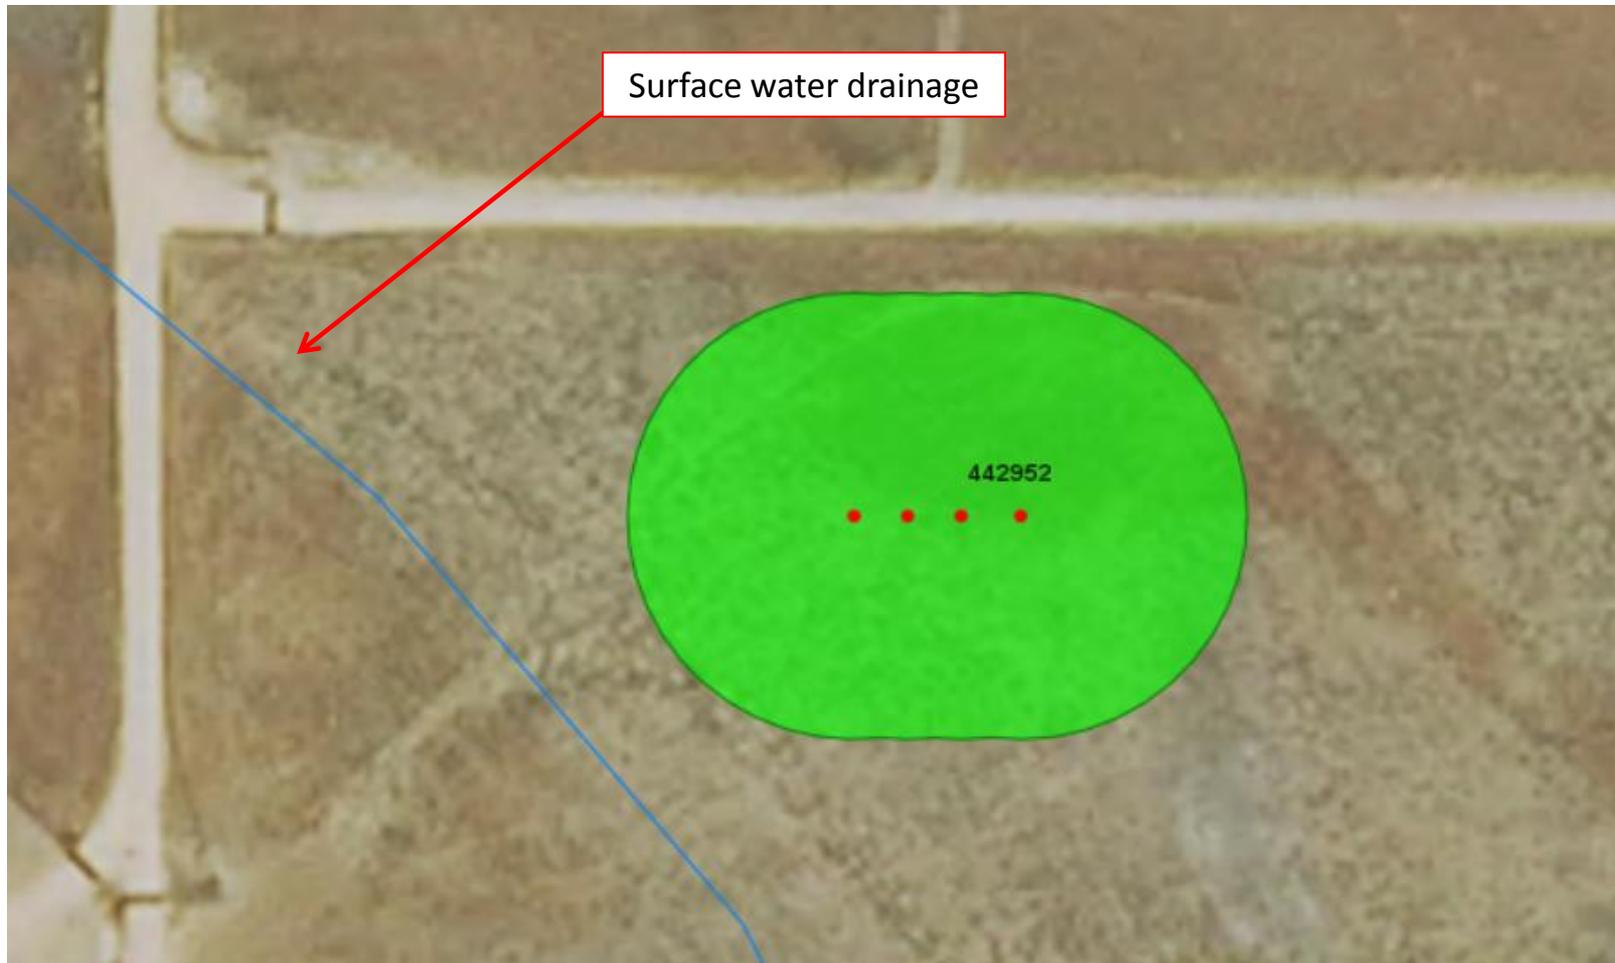
Photo 8. Photo taken from COGCC database indicating surface water drainage located cross- and down-gradient from disturbance location. Condition of Approval states the operator shall use tertiary containment along the cross- and down-gradient perimeters of the edge of disturbance.
