# Stormwater Inspection

1/4/2016

Operator: Western Operating

Location ID: 435387

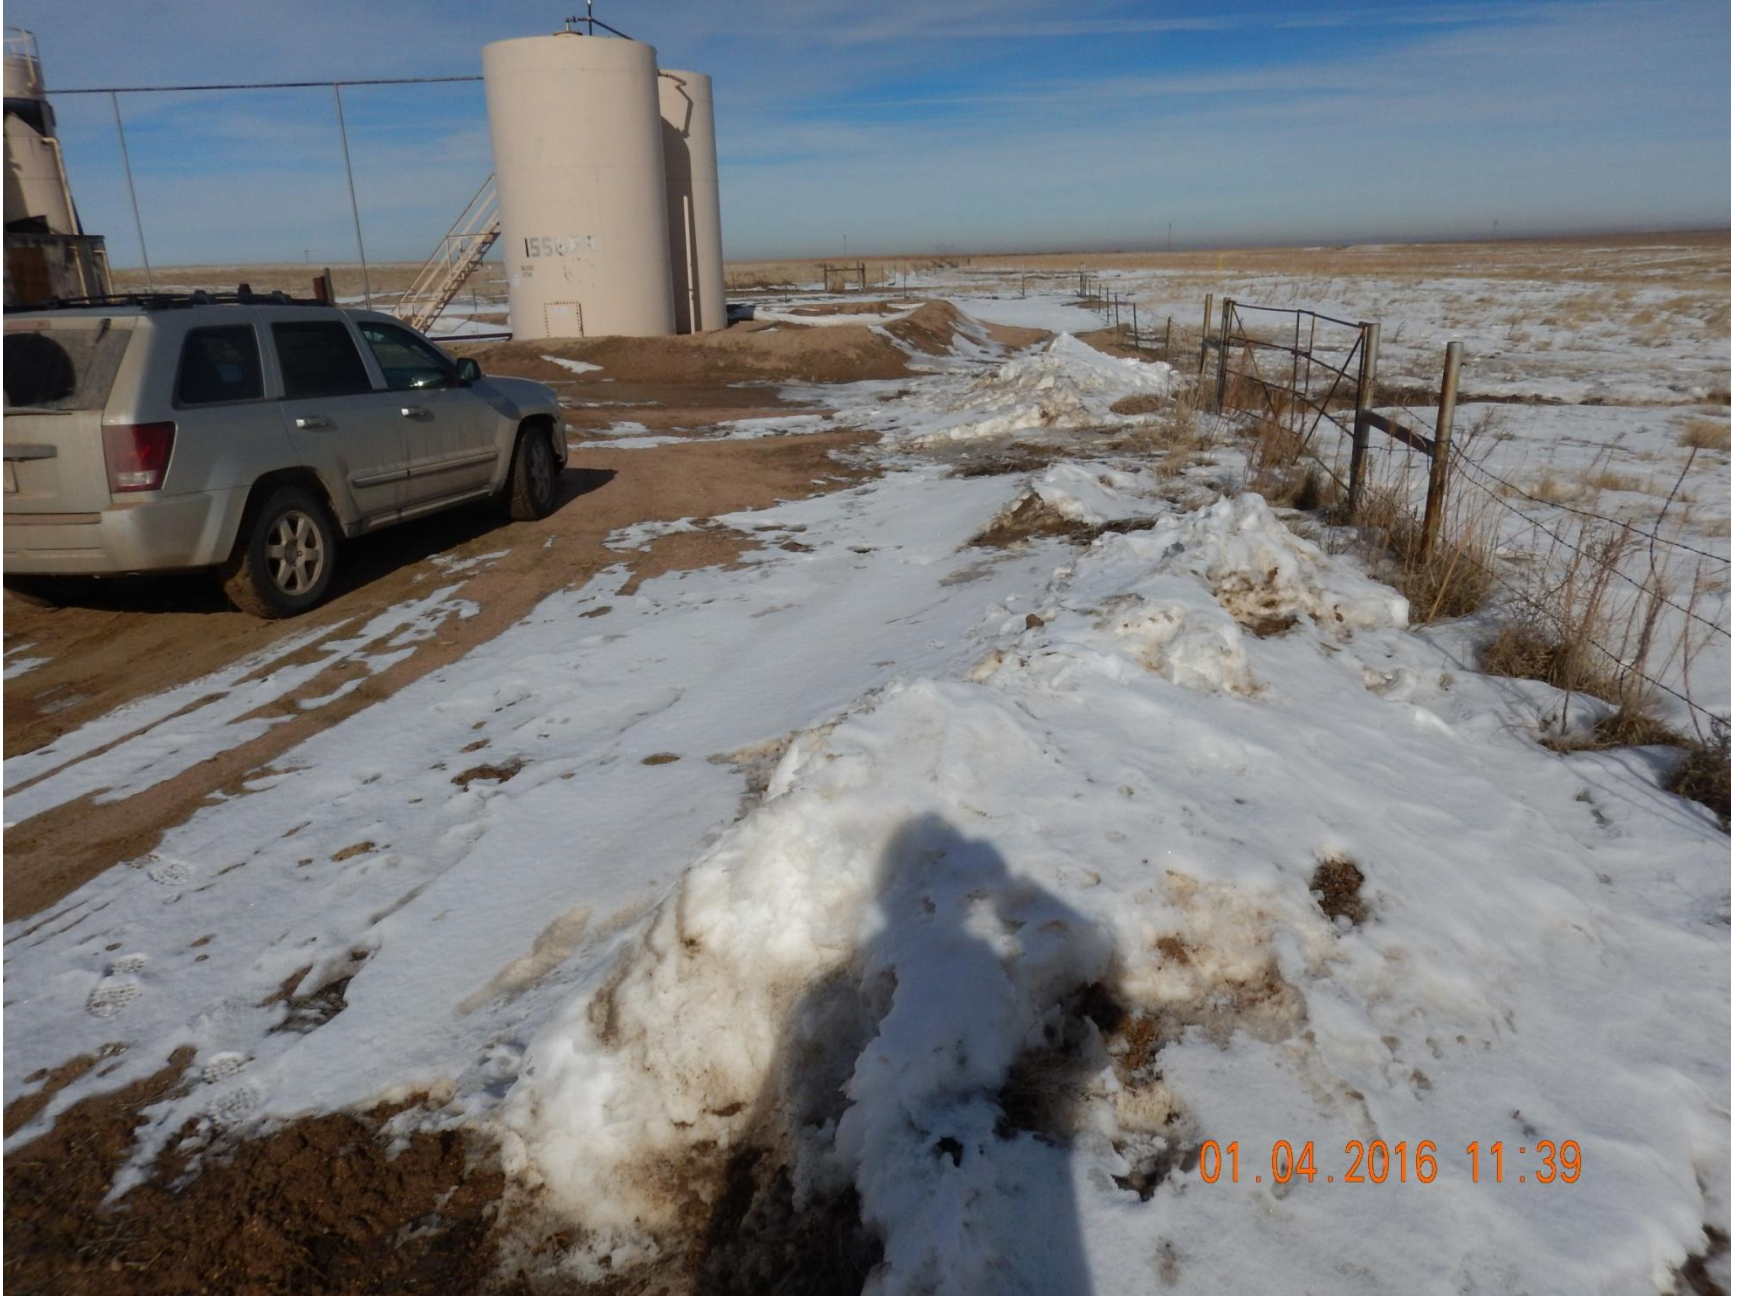
**Figure 2:** Photo taken from east end of location facing north. Photo shows stormwater and sediment control BMPs have not been installed.

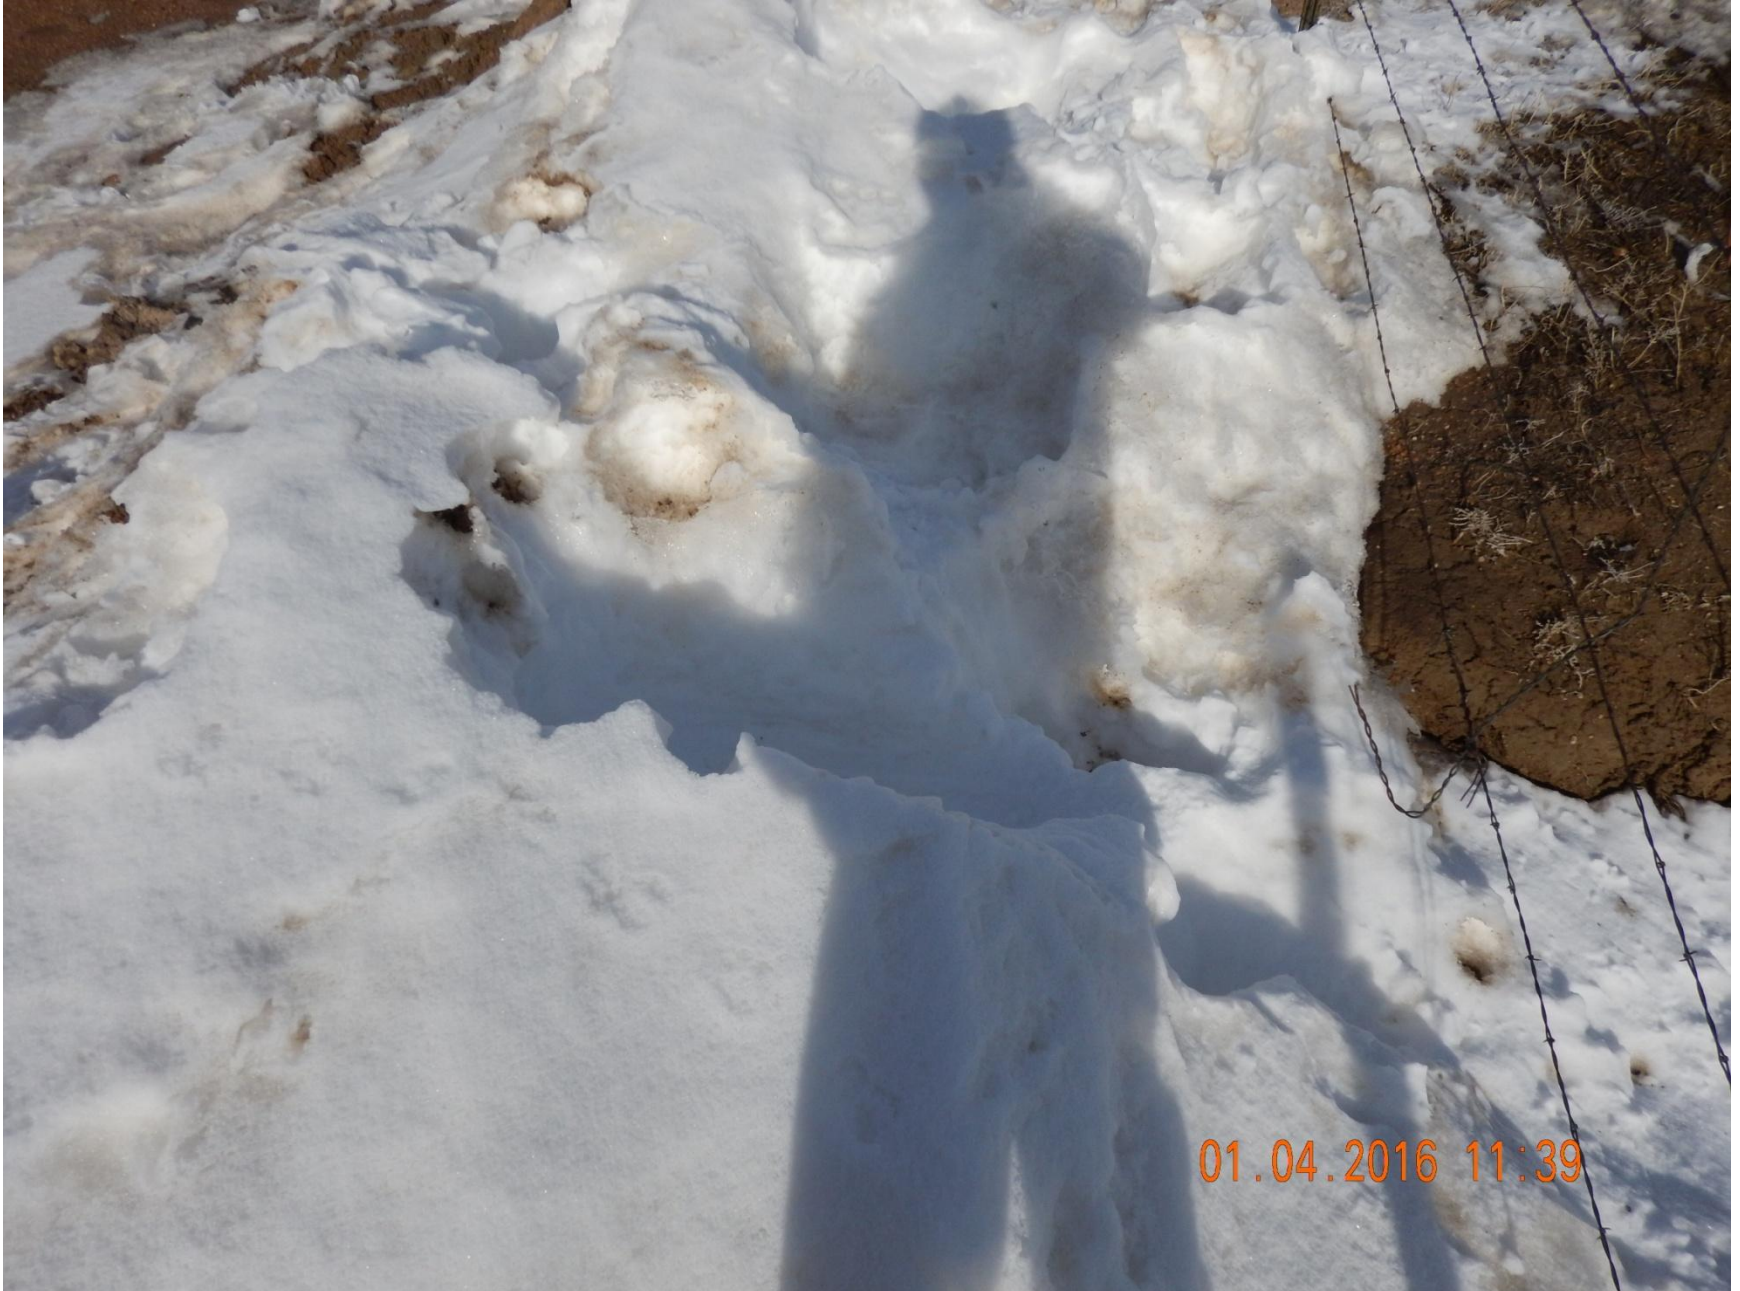
**Figure 3:** Photo taken from east end of location. Initially though pile was a berm installed for stormwater management. After digging it was determined berm was a snow stock pile, not a stormwater and sediment control BMP.

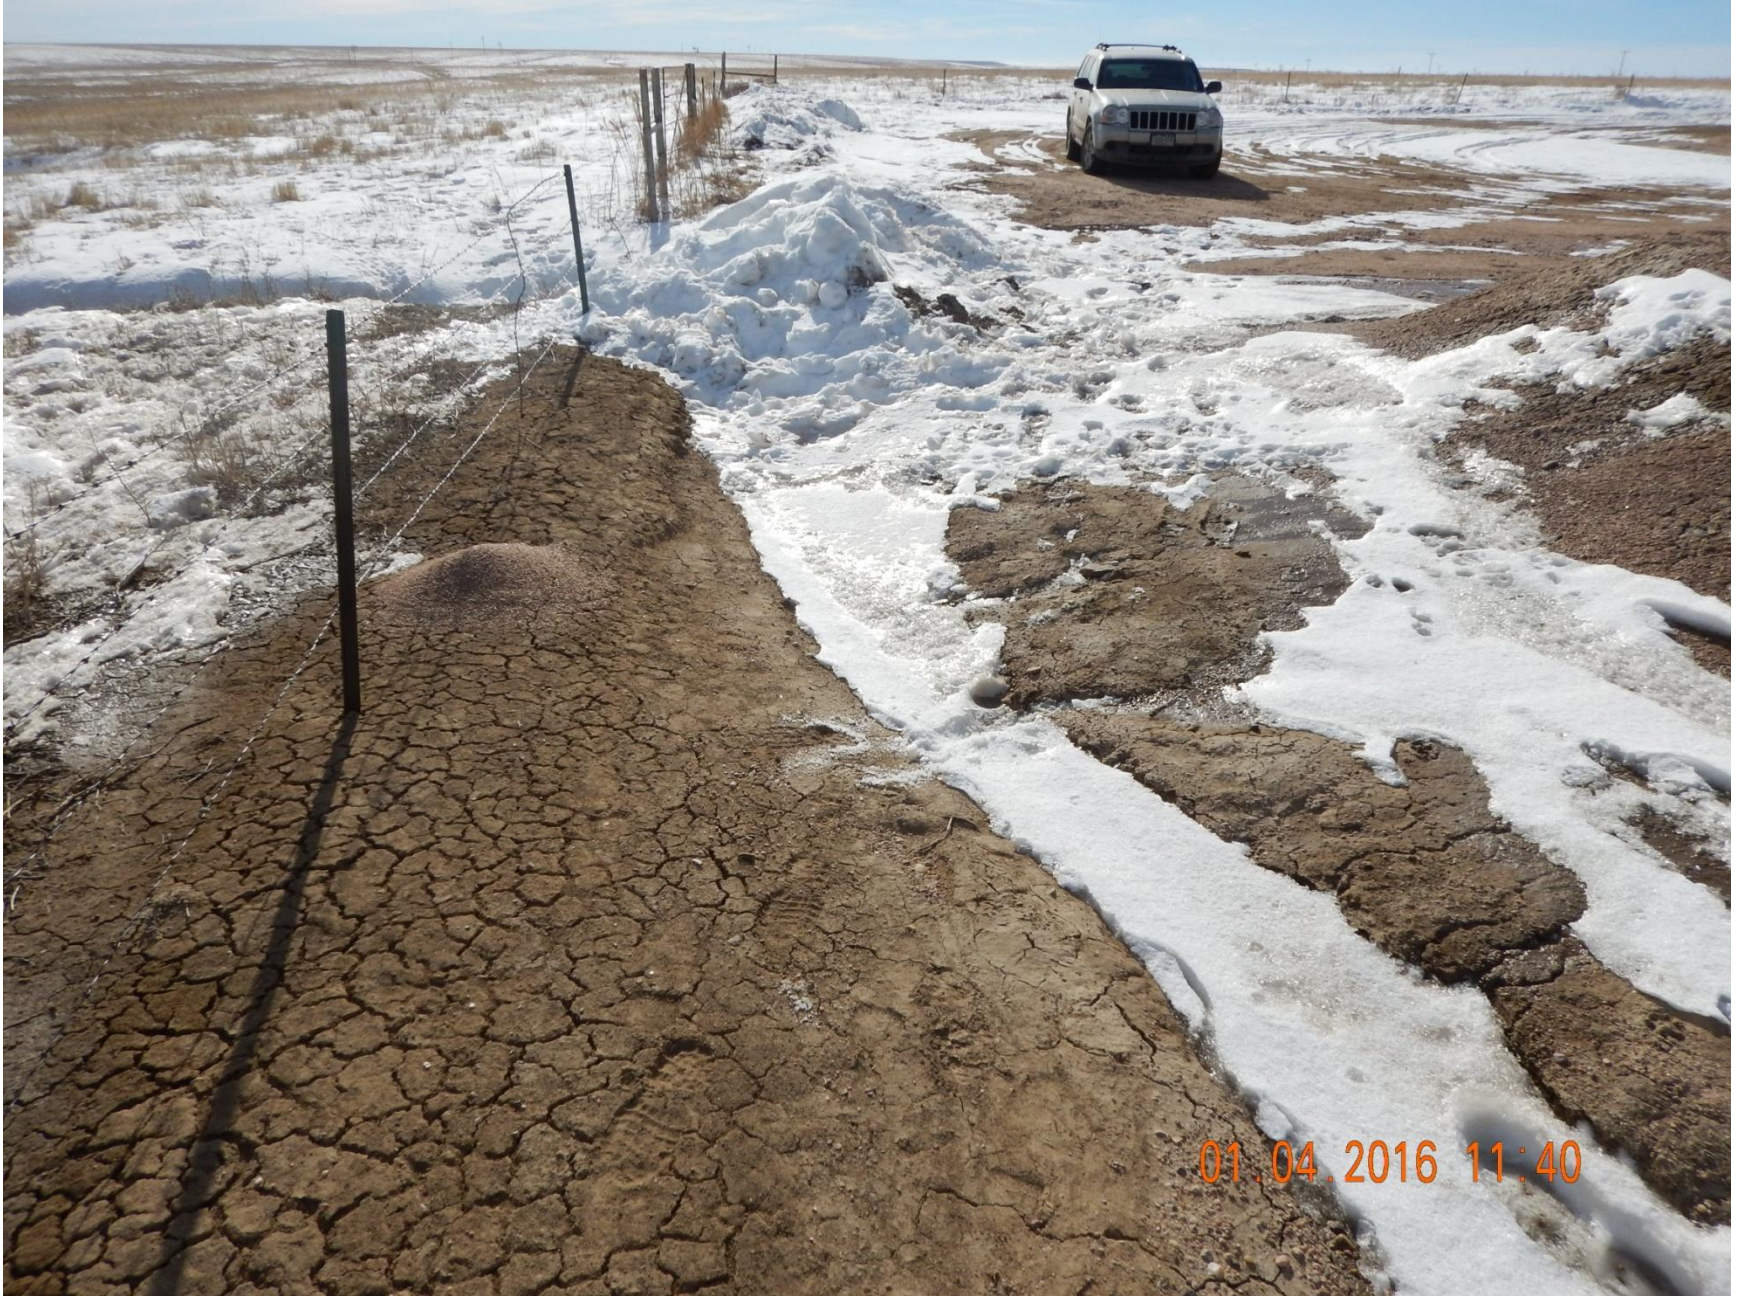
**Figure 4:** Photo taken from east end of location, facing south. Photo shows stormwater and sediment control BMPs have not been installed.

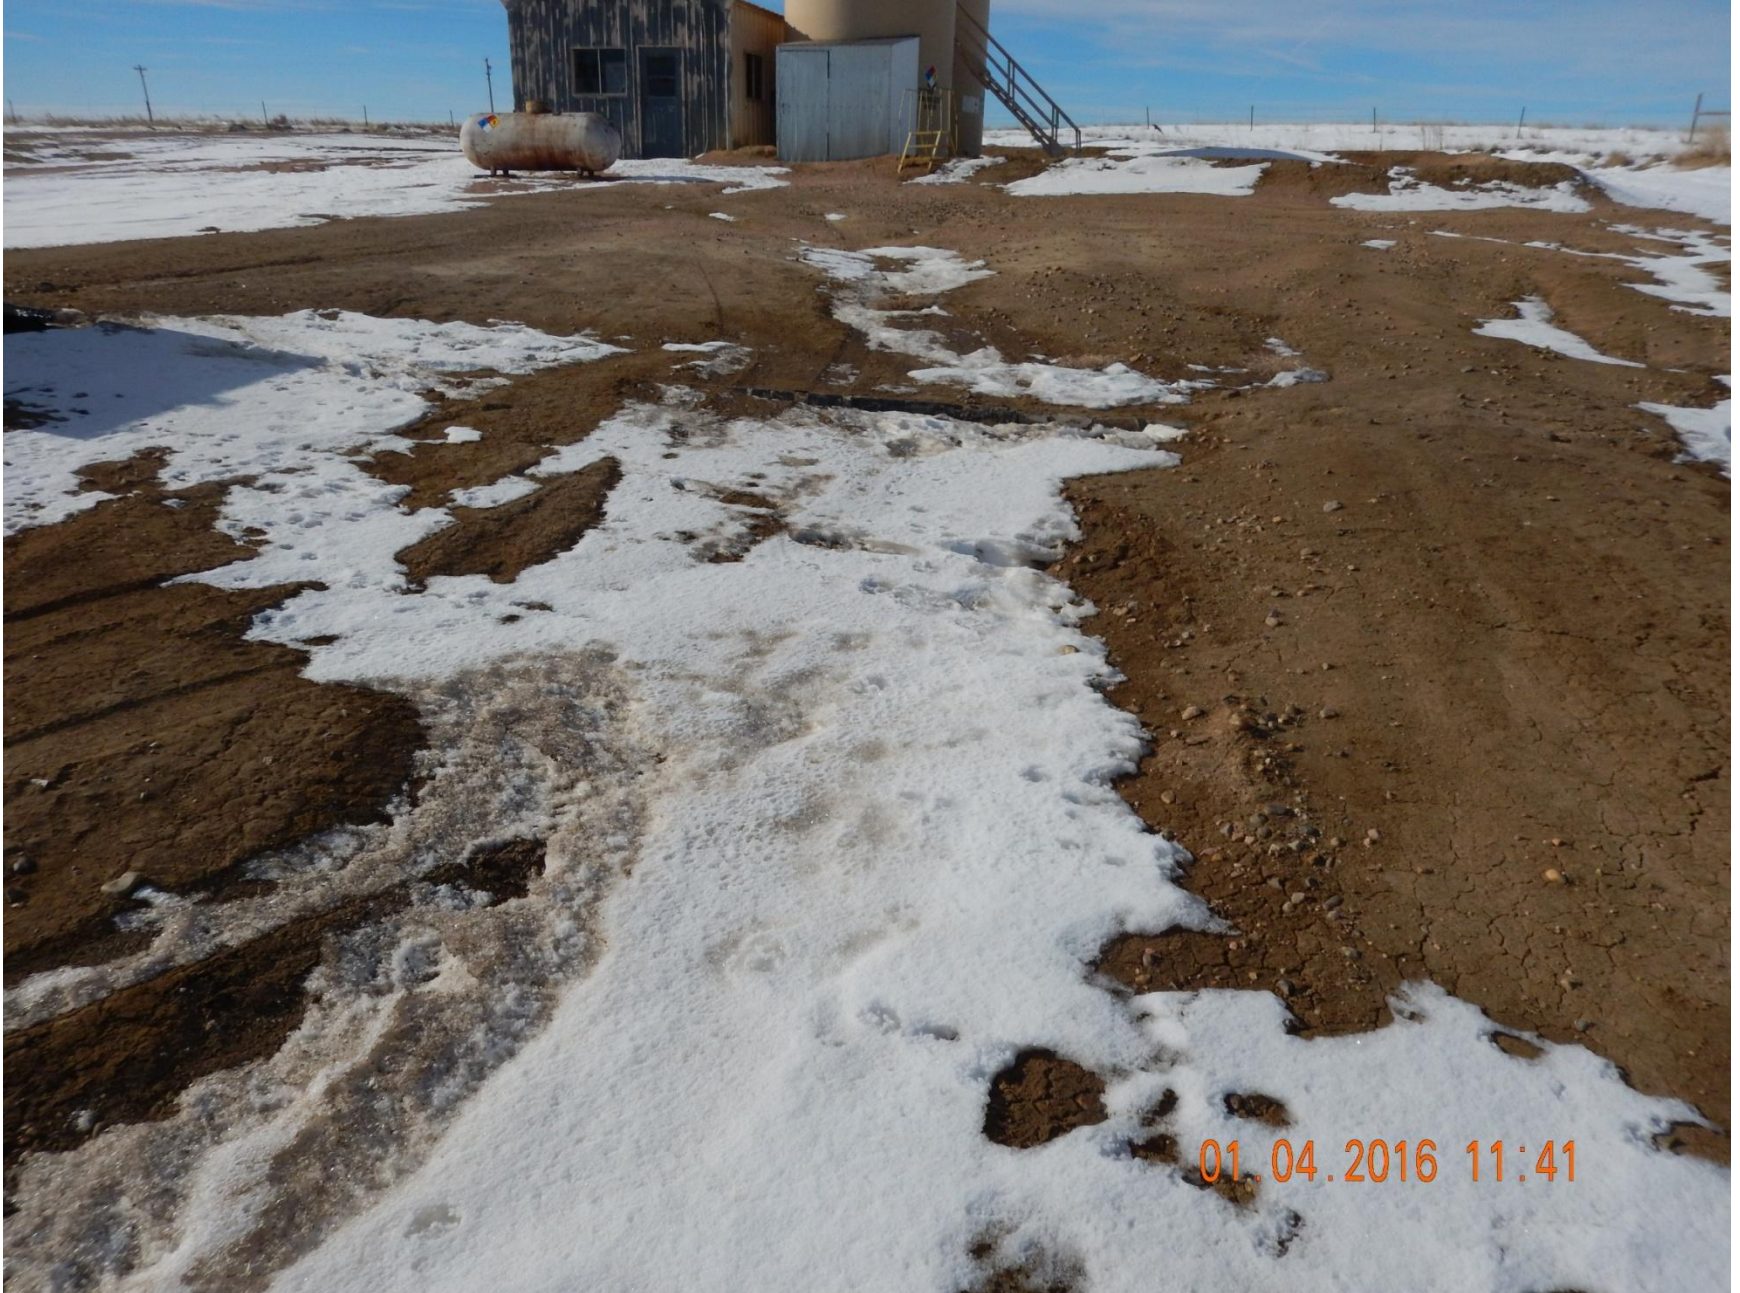
**Figure 5:** Photo taken from north end of location, facing west. Photo of erosion and exposed pipe.

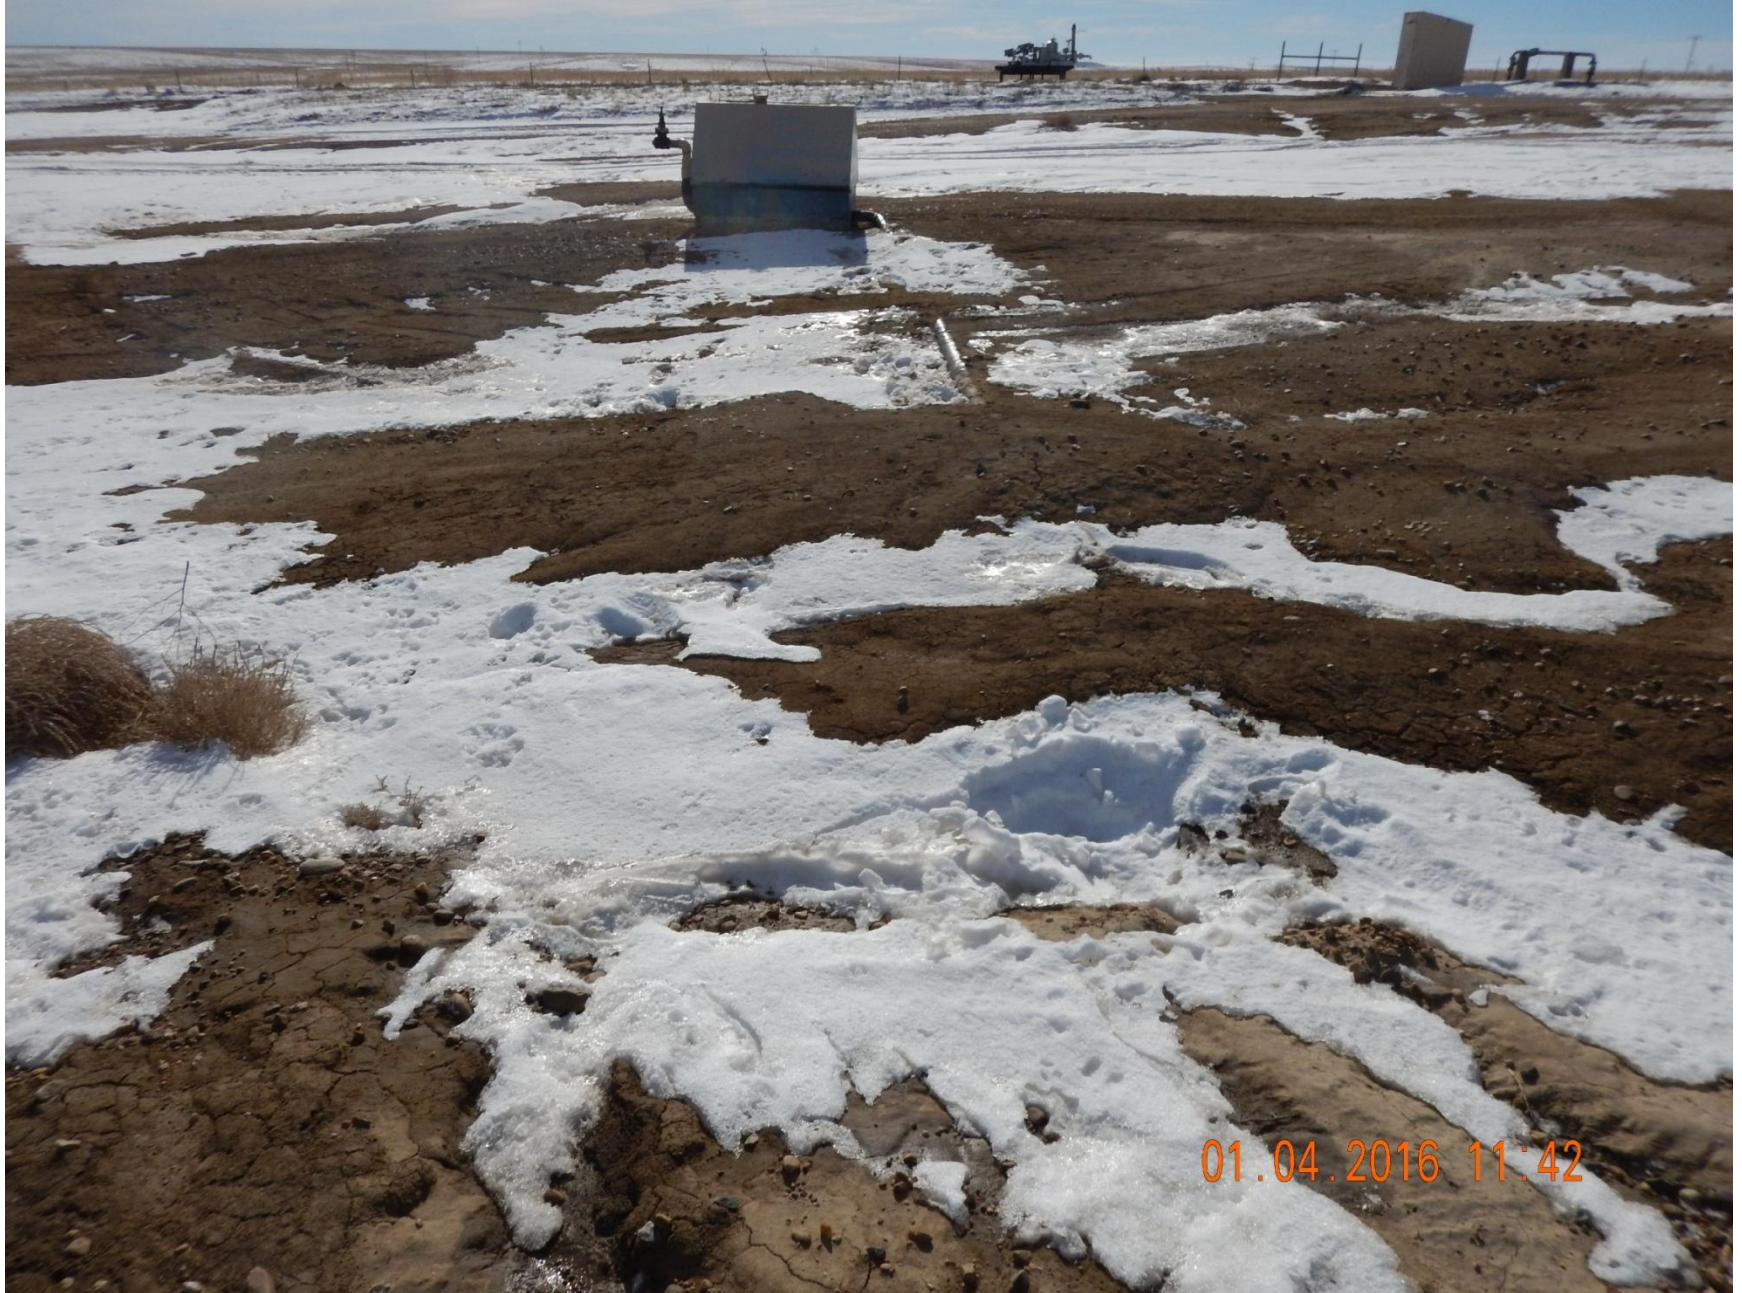
**Figure 6:** Photo taken from north end of location, facing south. Photo of erosion and exposed pipe.

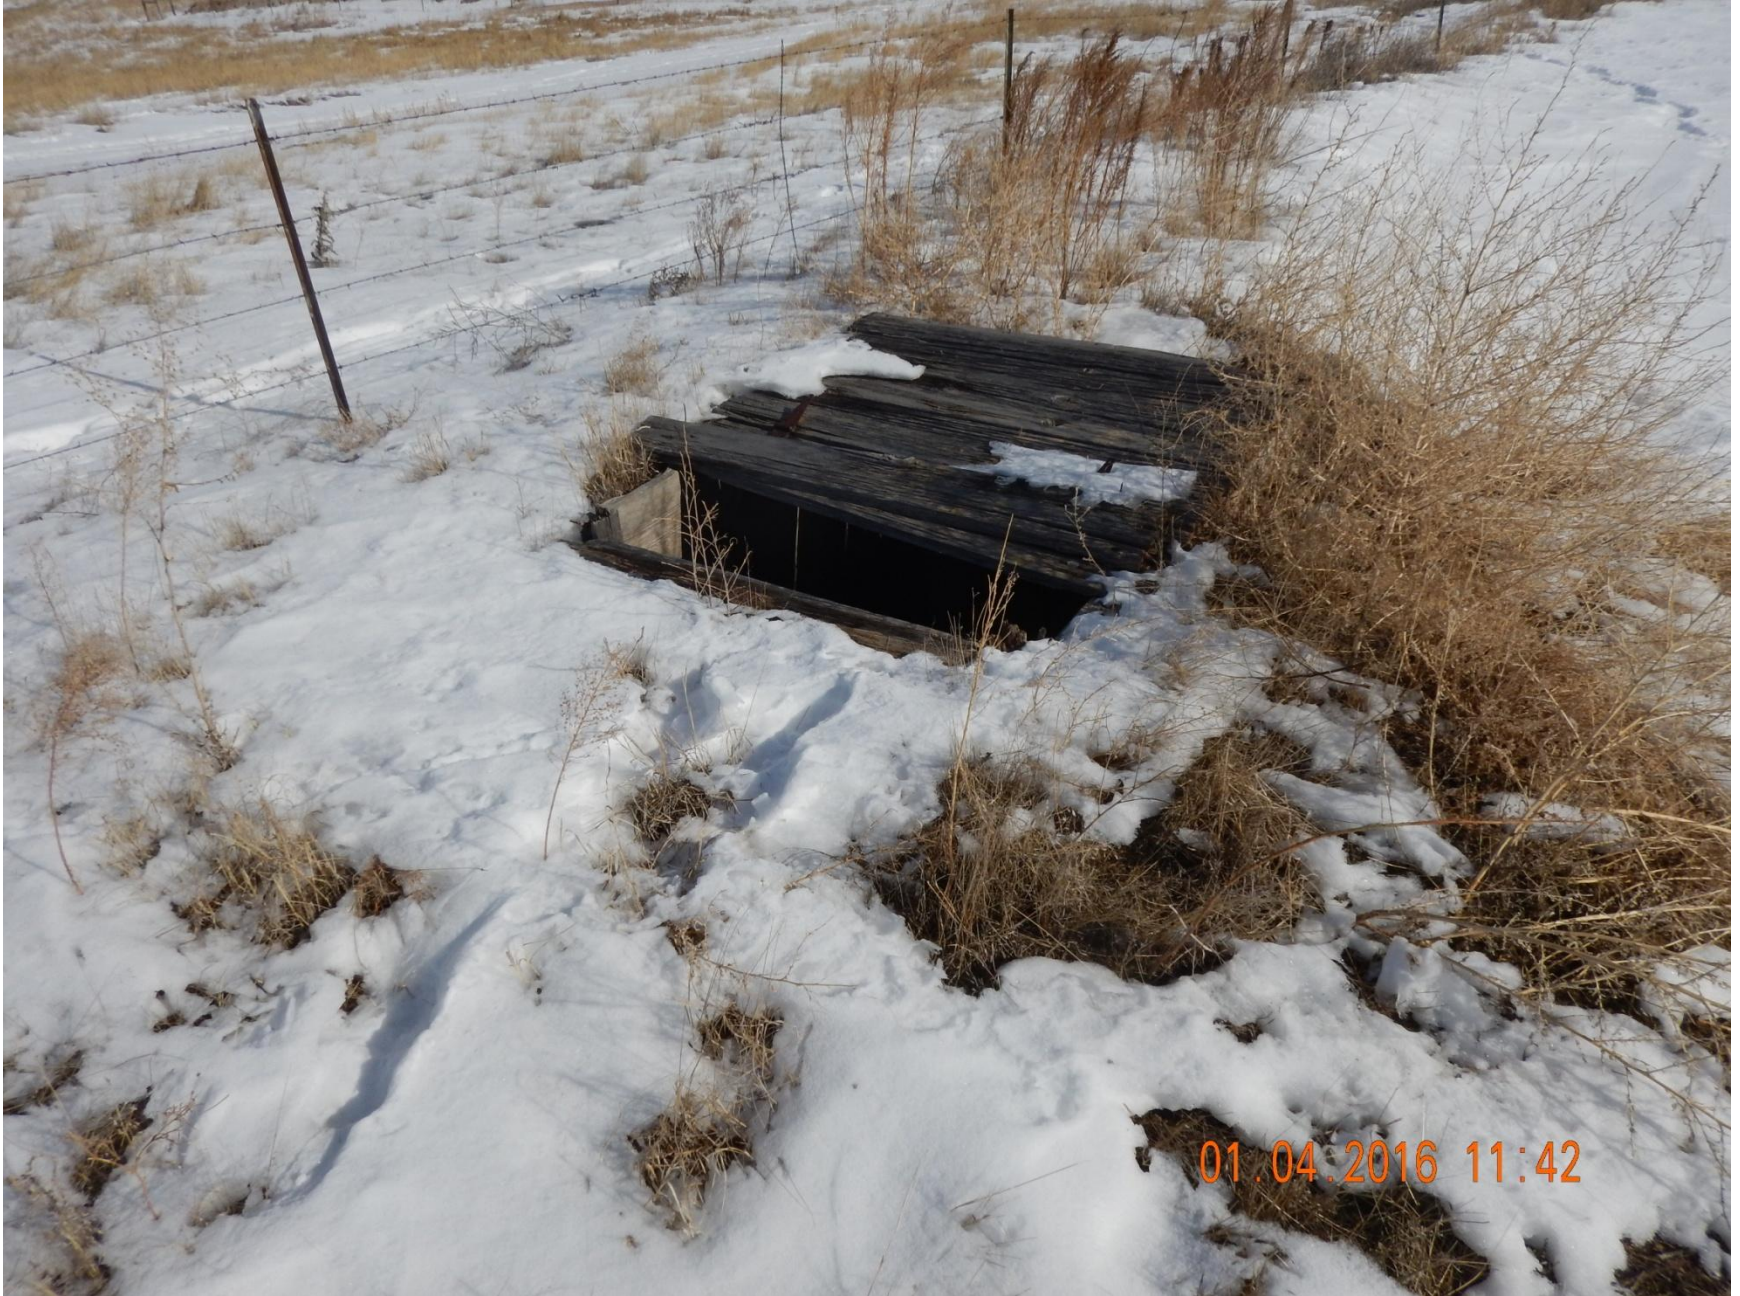
**Figure 7:** Photo taken from northwest portion of location, facing south. Photo shows door to box-framed subsurface structure remains in disrepair.

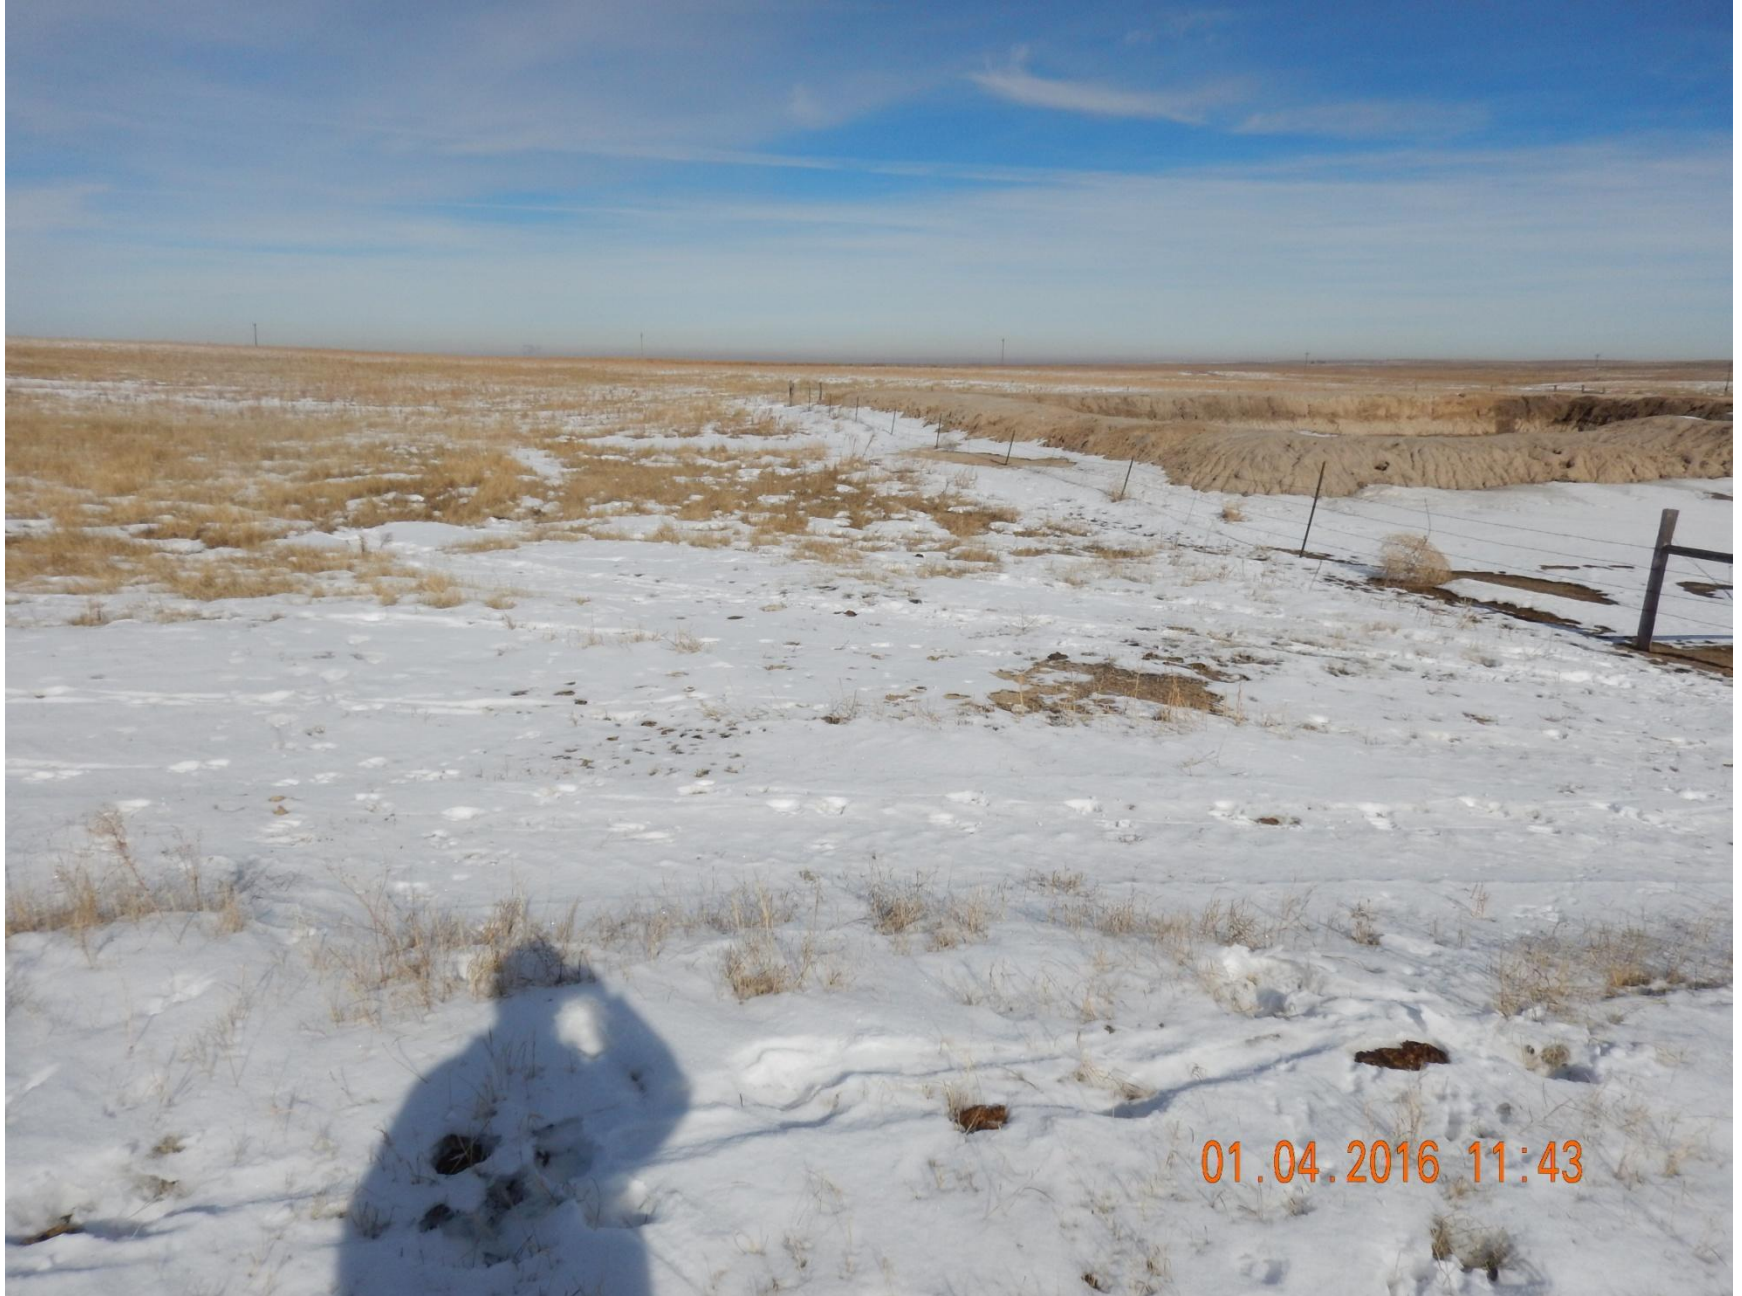
**Figure 8:** Photo taken from southwest of pit location, facing north. Photo shows stormwater and sediment control BMPs have not been installed.

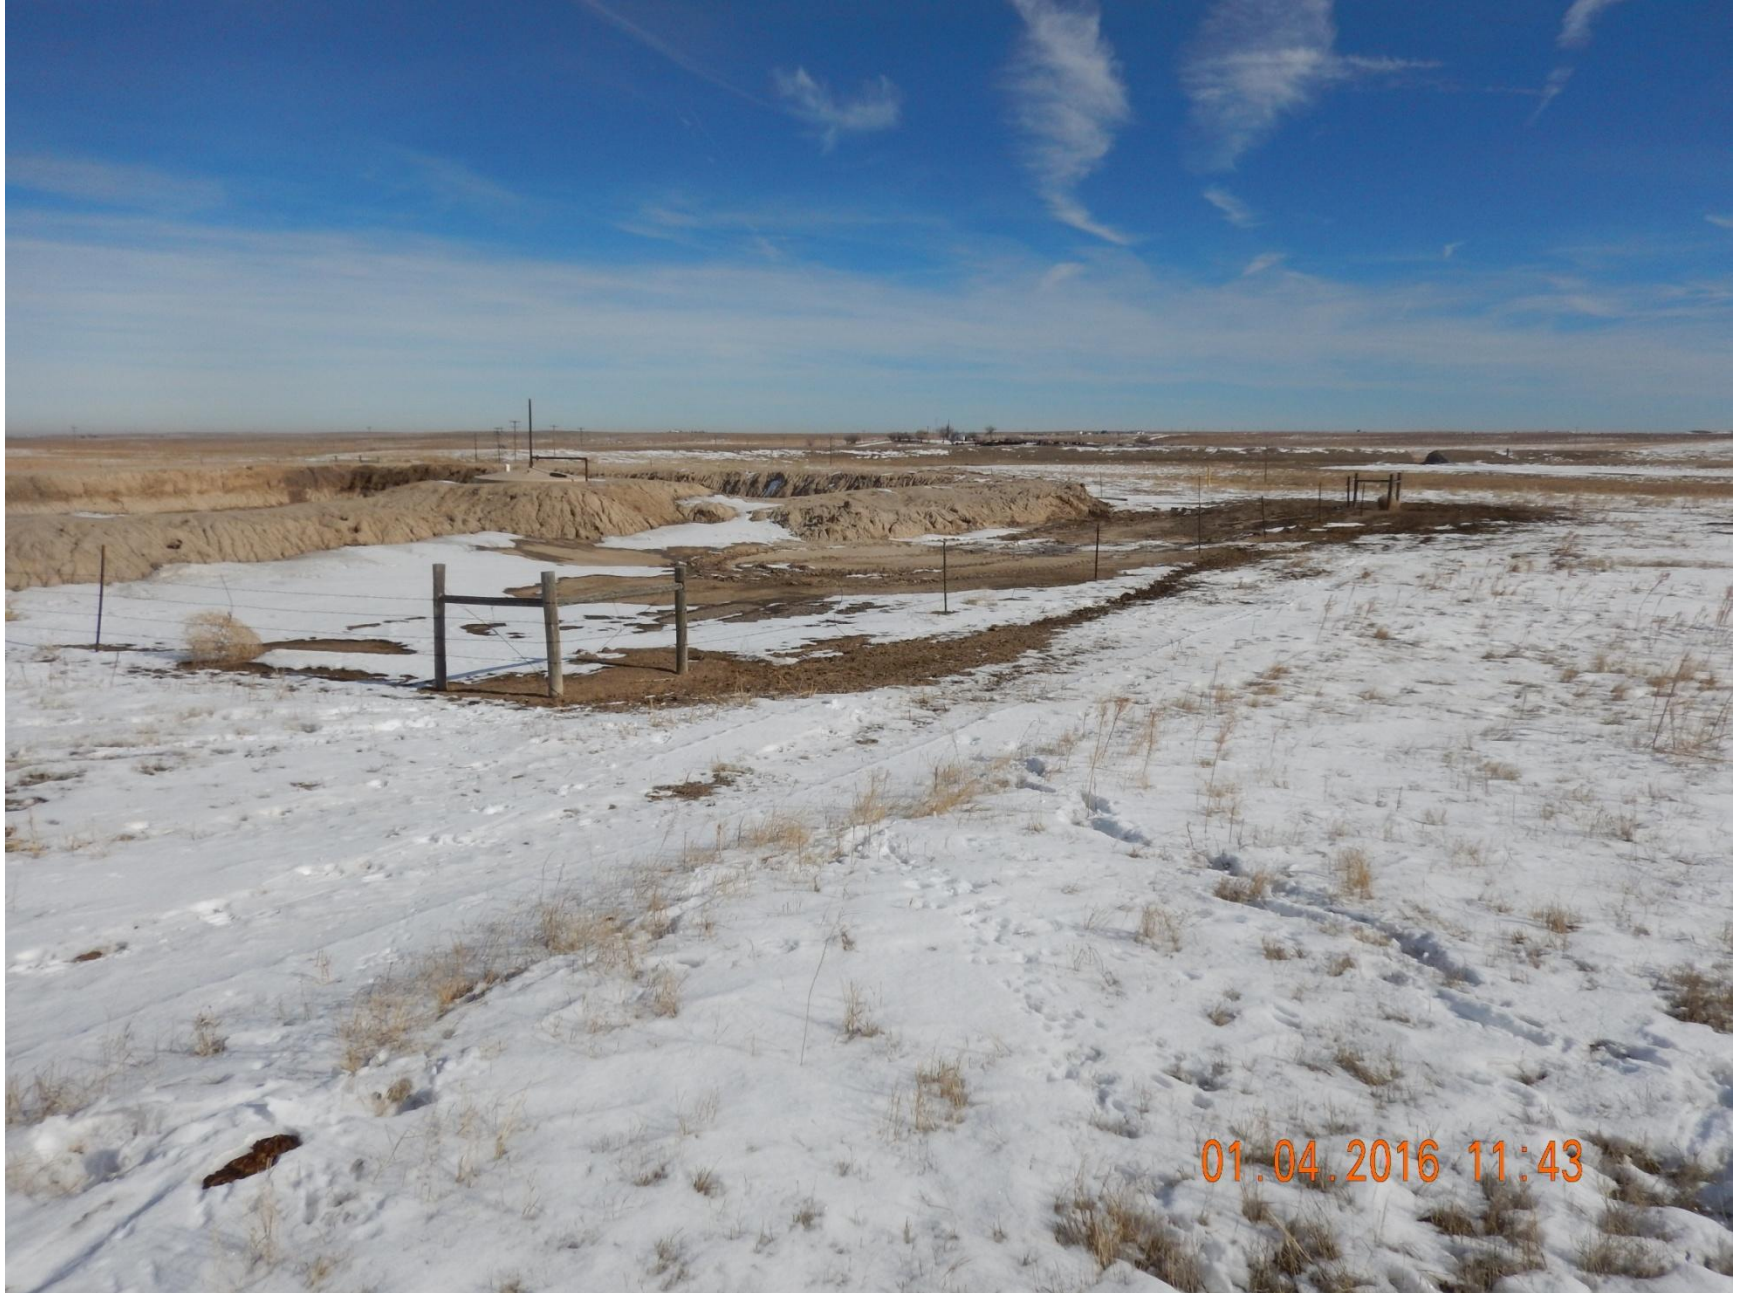
**Figure 9:** Photo taken from southwest end of pit location, facing northeast. Photo shows stormwater and sediment control BMPs have not been installed.

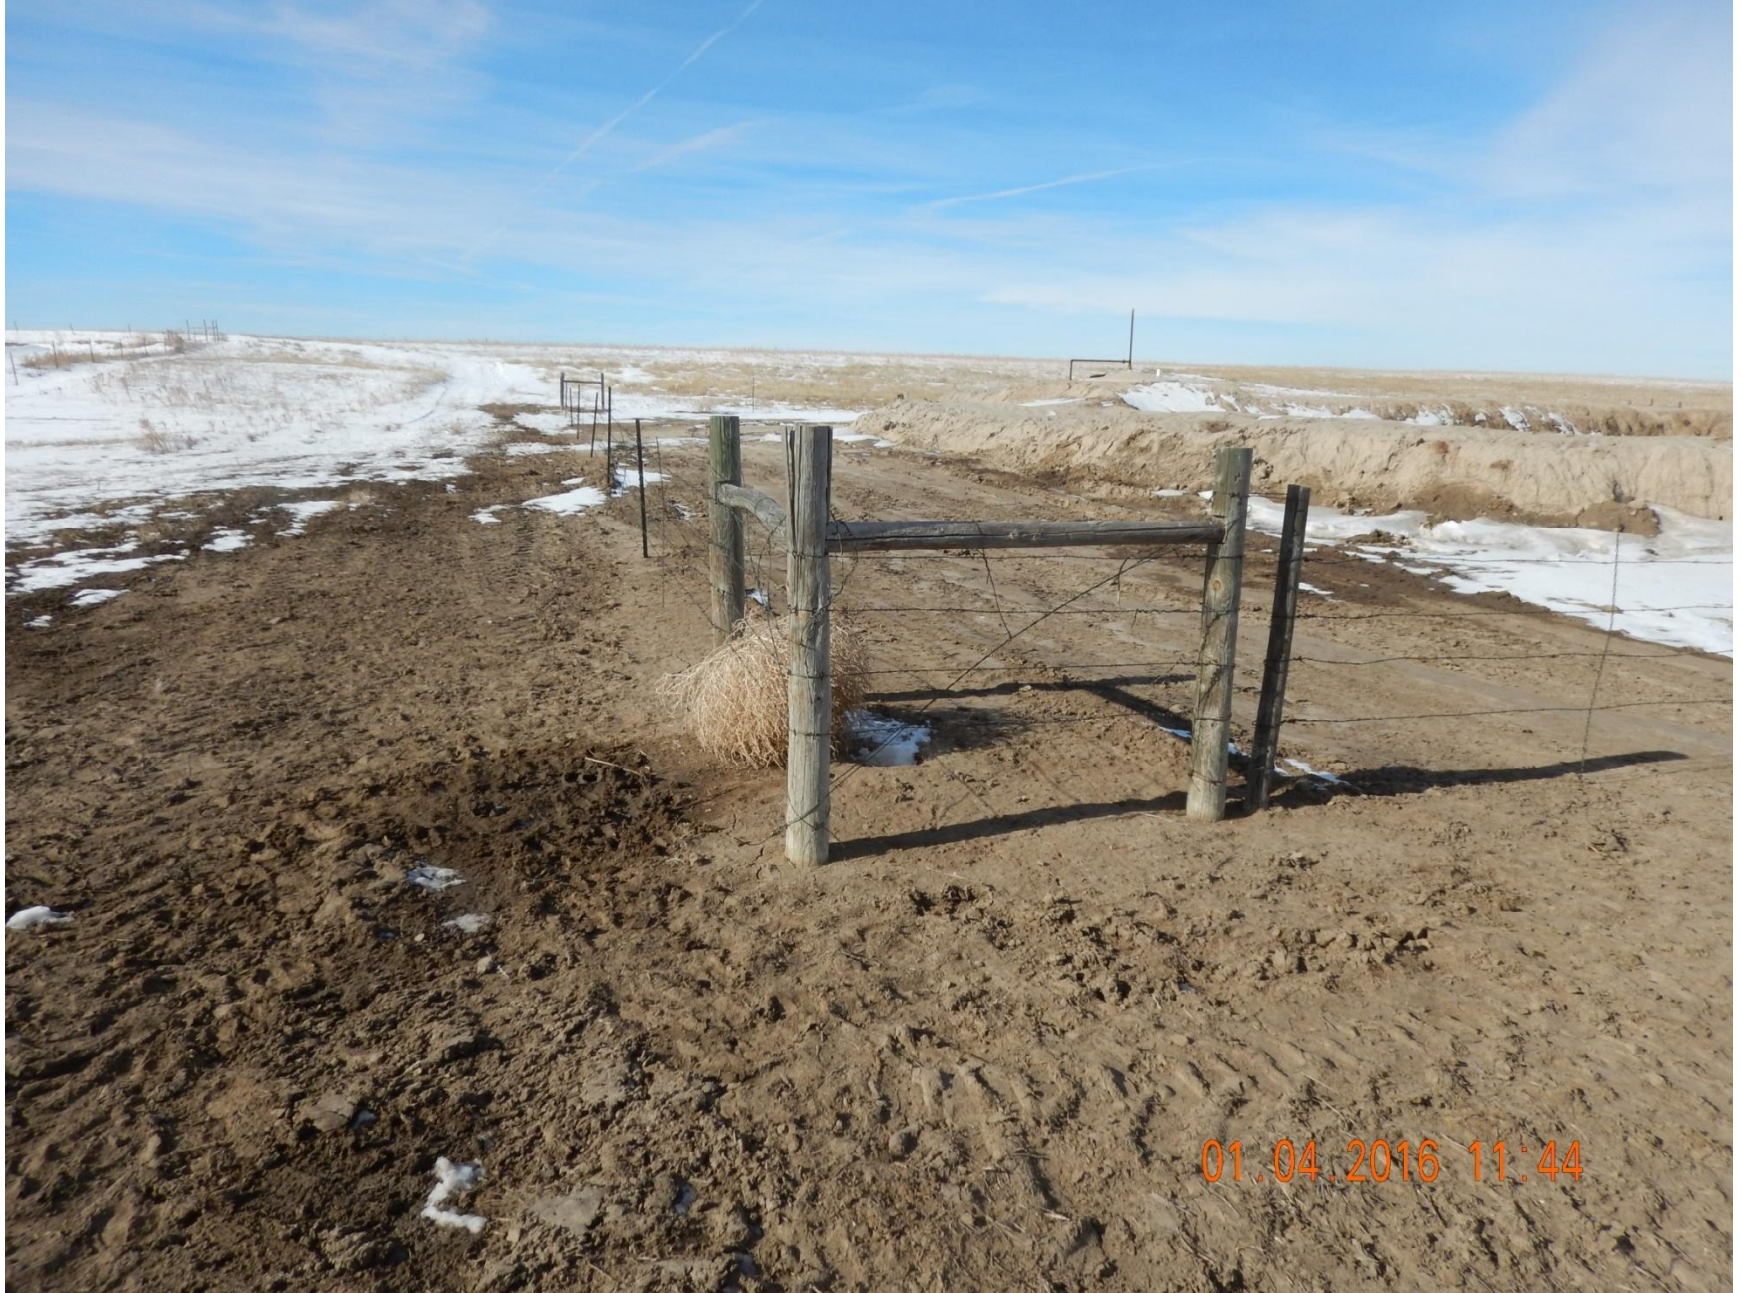
**Figure 10:** Photo taken southeast end of pit location, facing west. Photo shows stormwater and sediment control BMPs have not been installed.

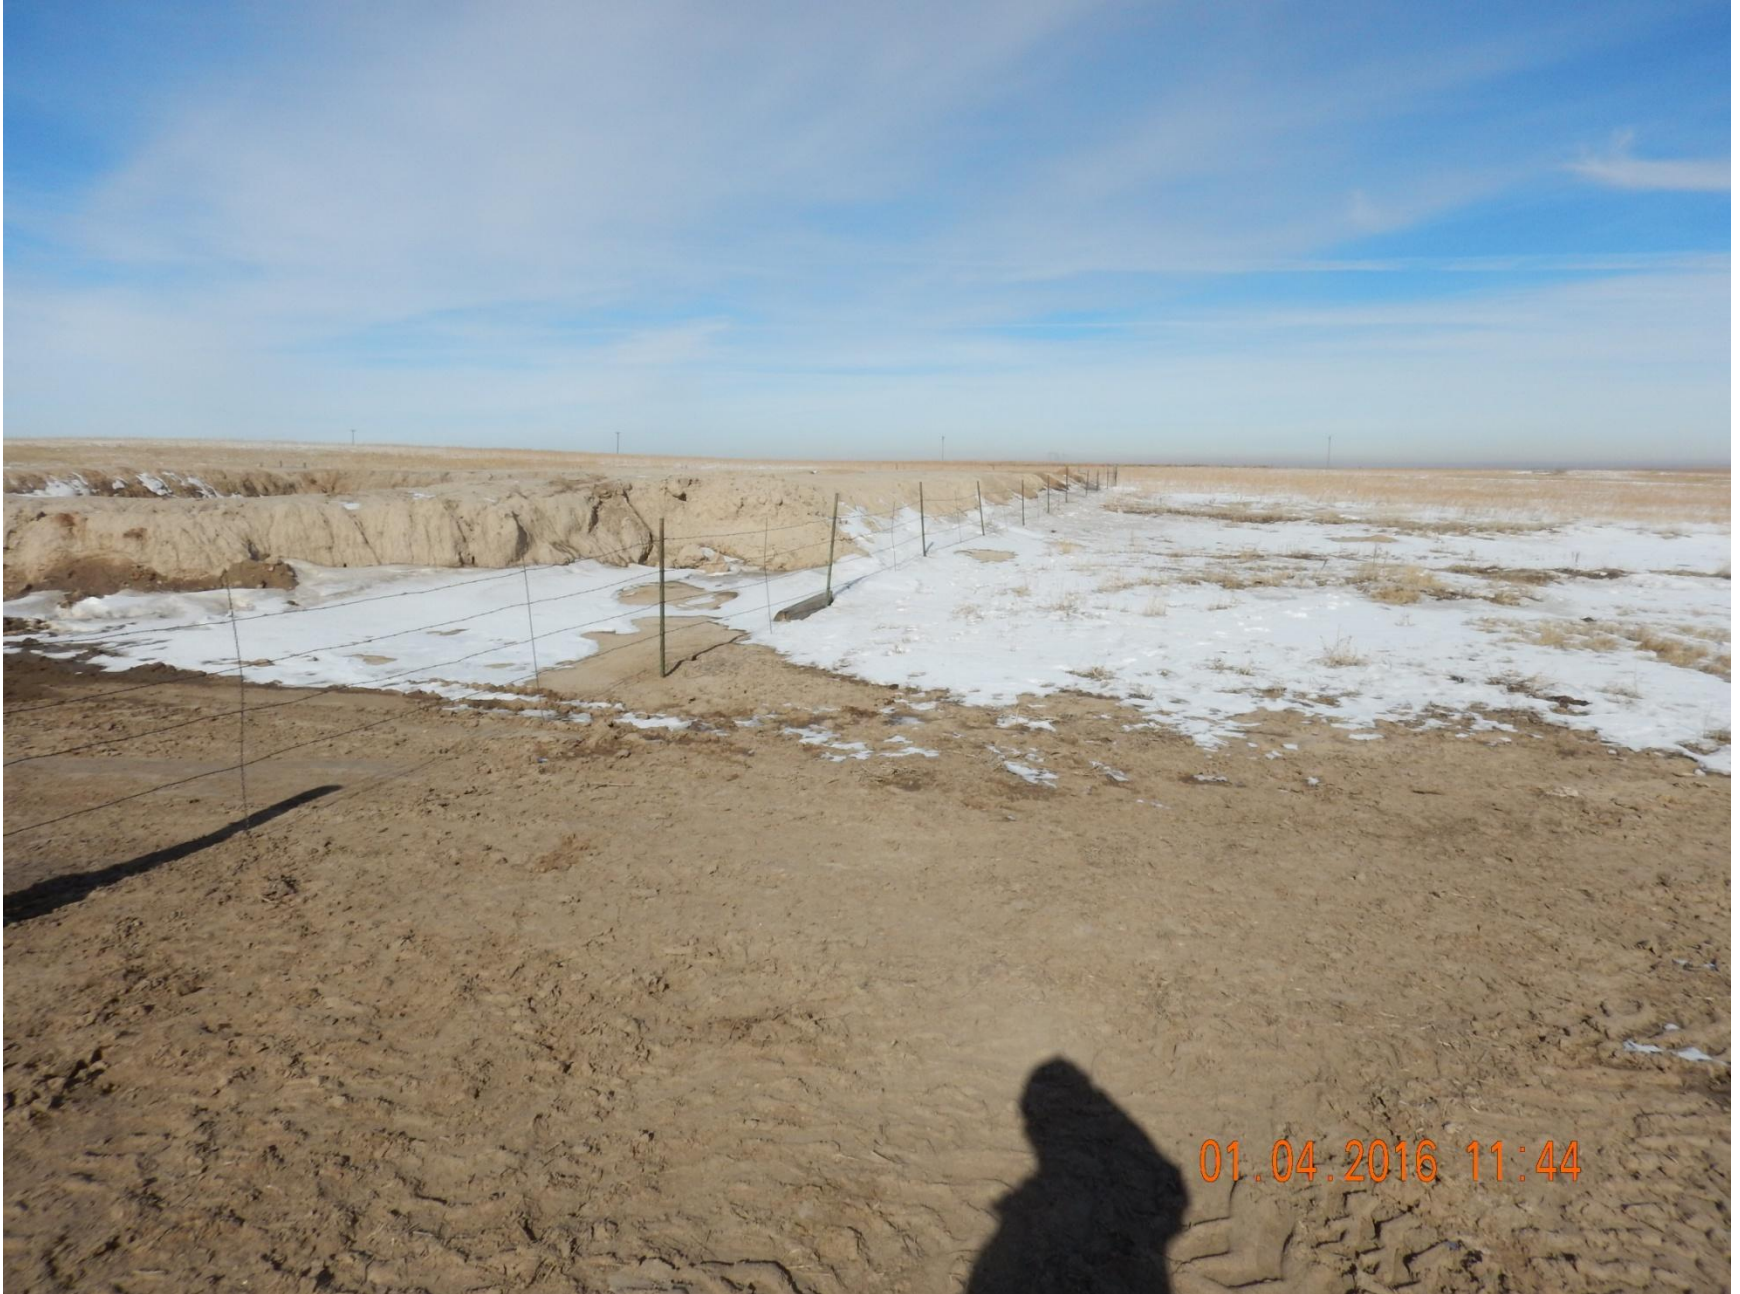
**Figure 11:** Photo taken southeast end of pit location, facing north. Photo shows stormwater and sediment control BMPs have not been installed.
