# Stormwater Inspection

1/4/2016

Operator: Western Operating

Location ID: 435387

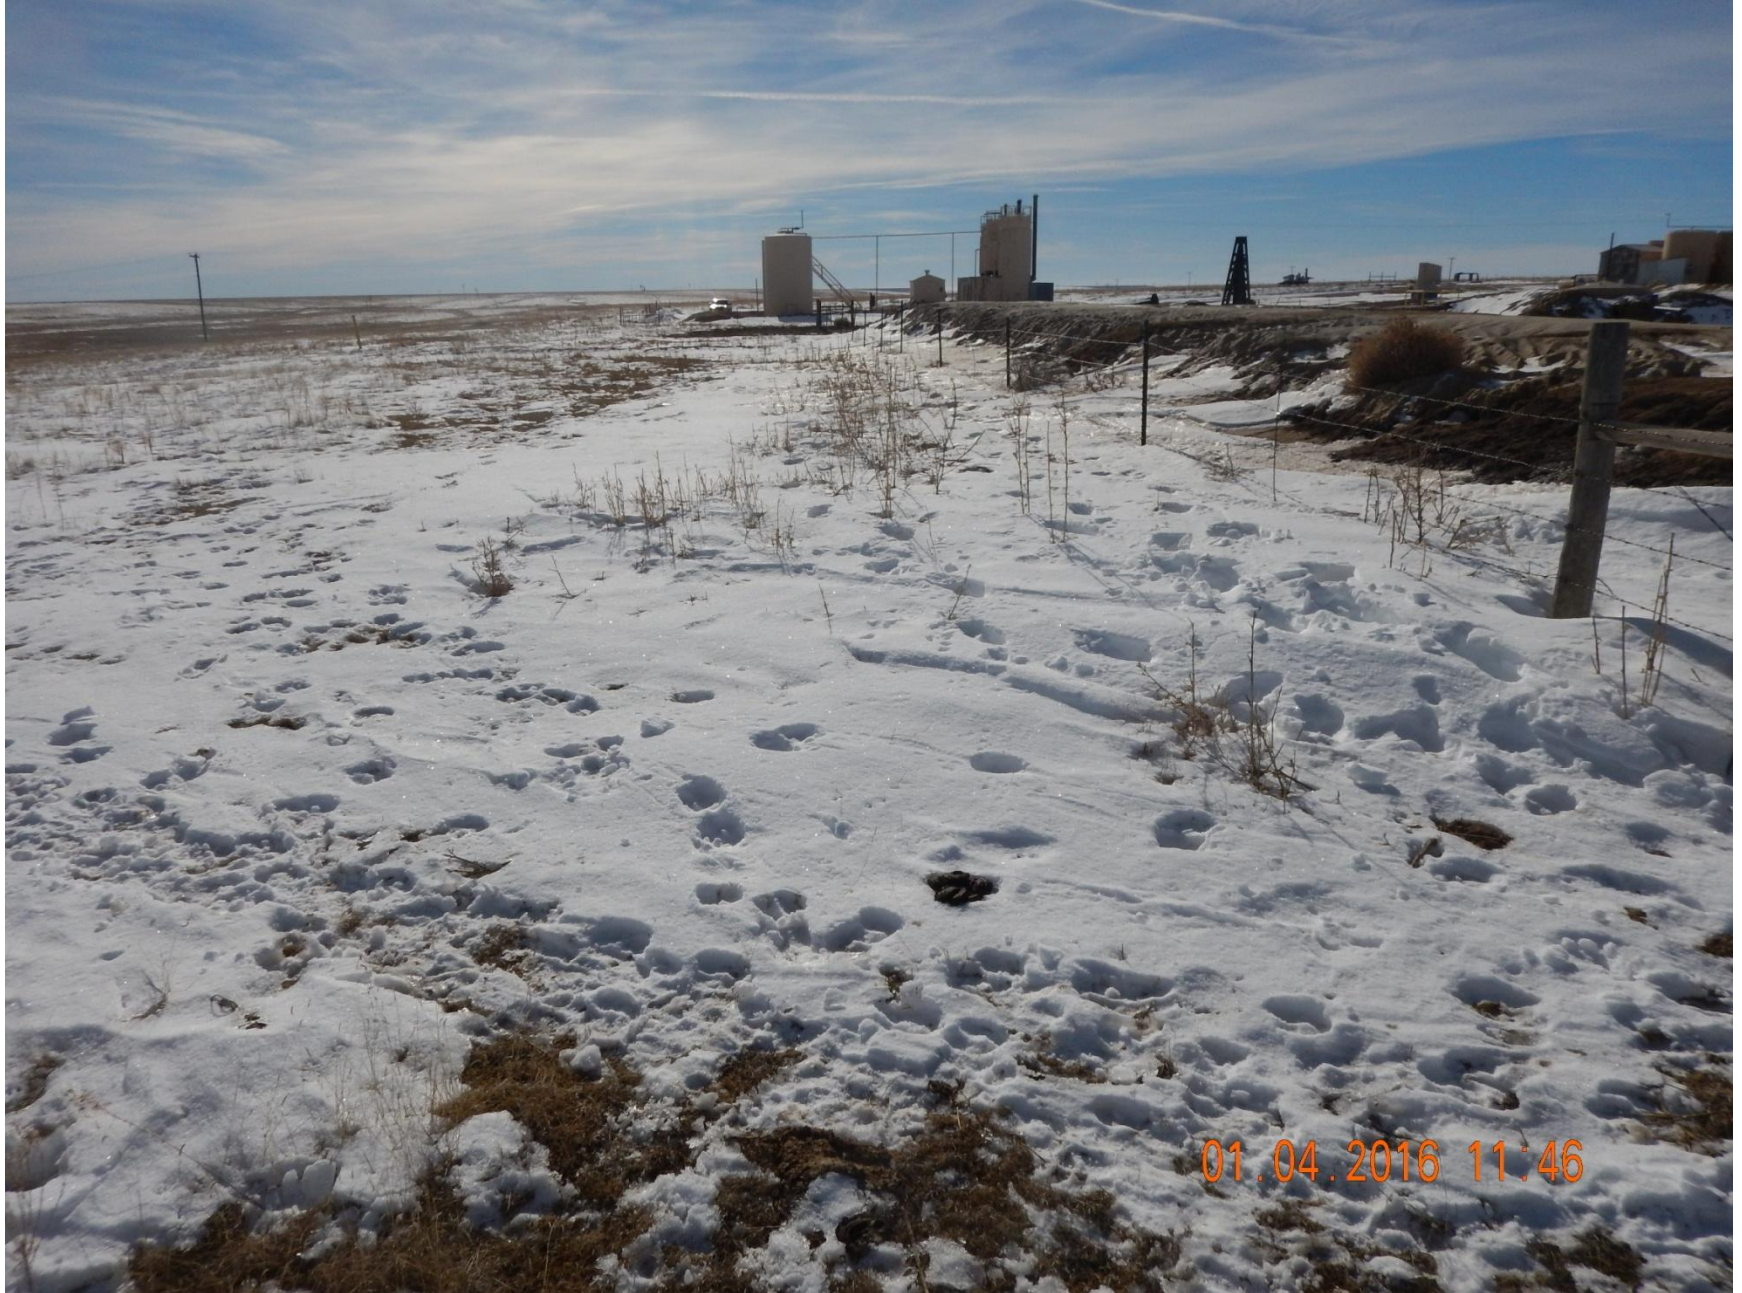
**Figure 12:** Photo taken from northeast end of pit location, facing south. Photo shows stormwater and sediment control BMPs have not been installed.

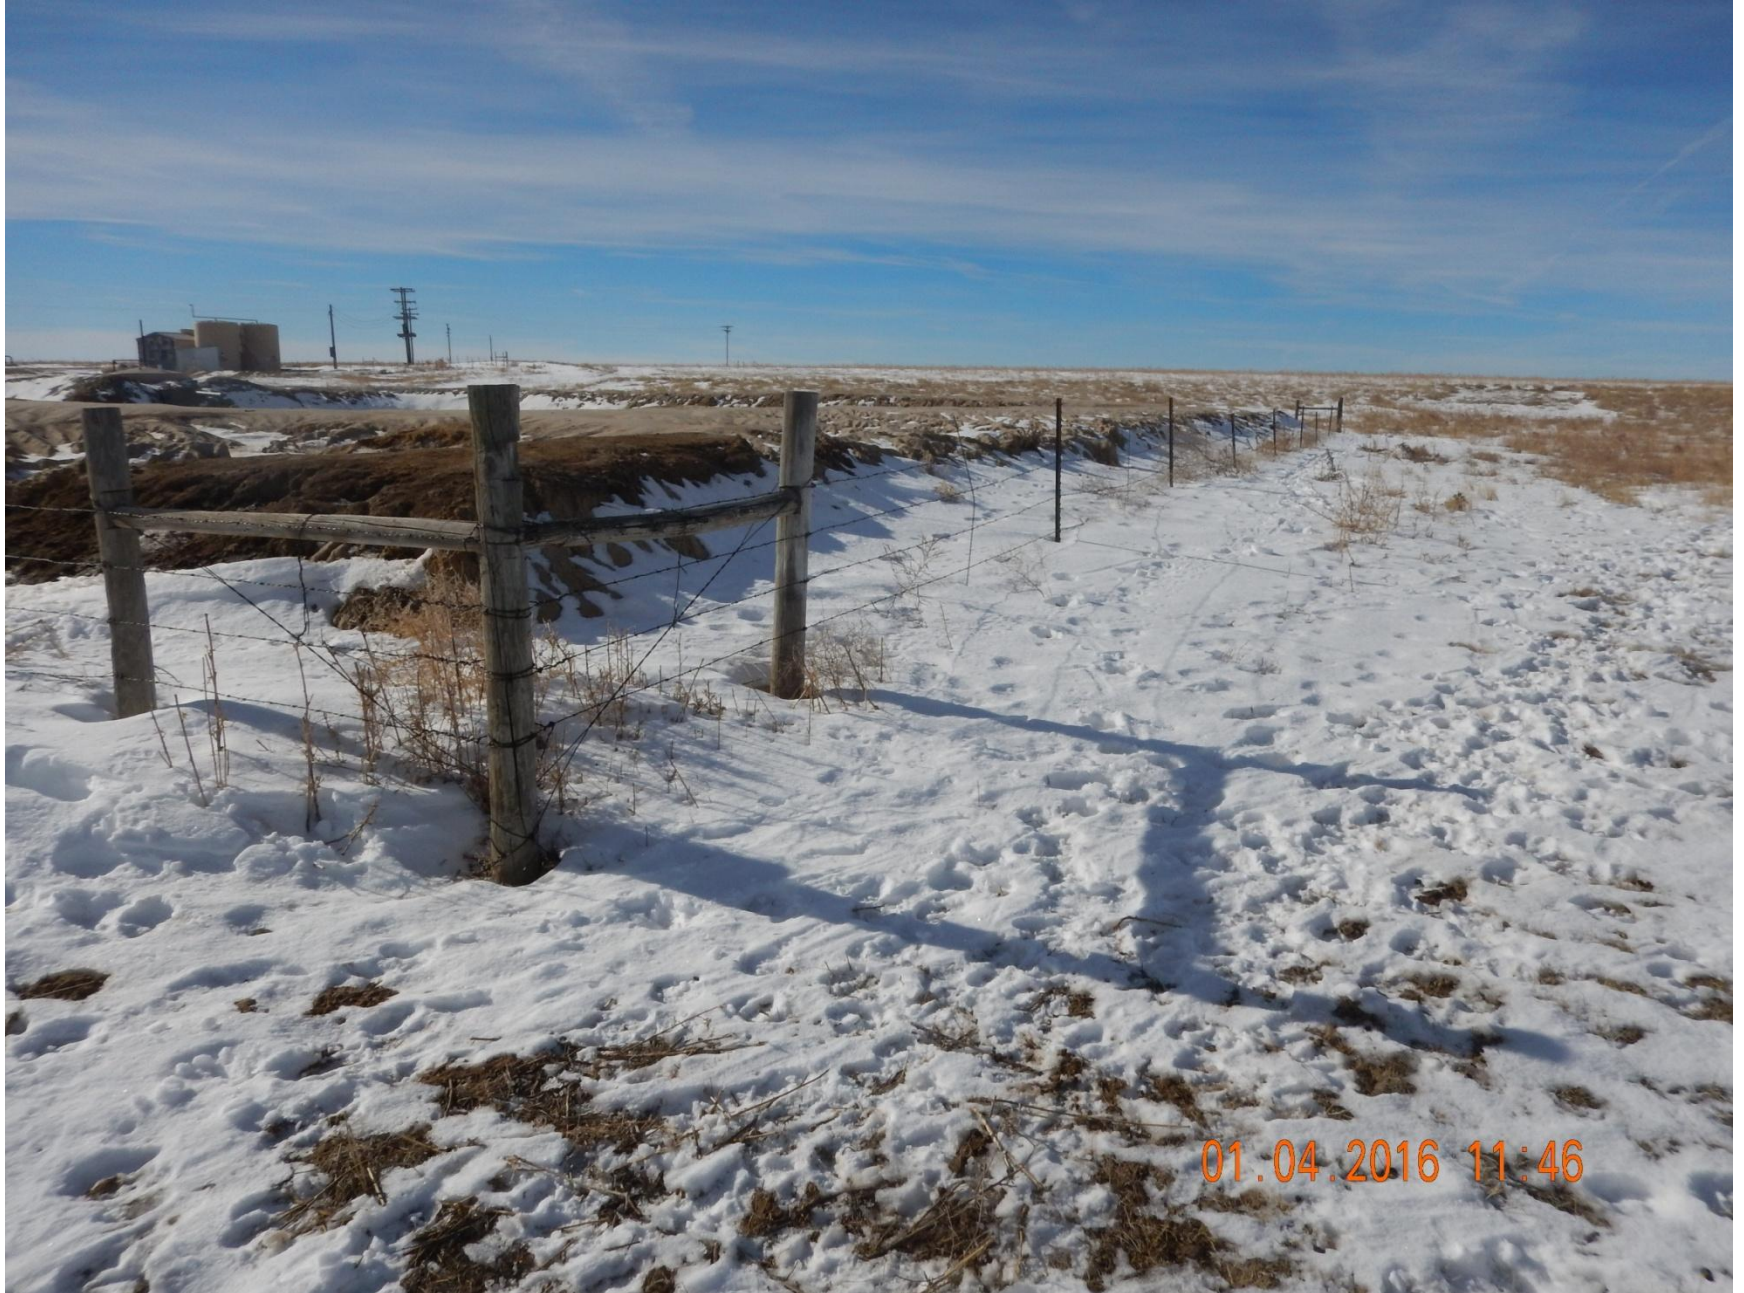
**Figure 13:** Photo taken northeast end of pit location, facing west. Photo shows stormwater and sediment control BMPs have not been installed.
