## Construction Inspection

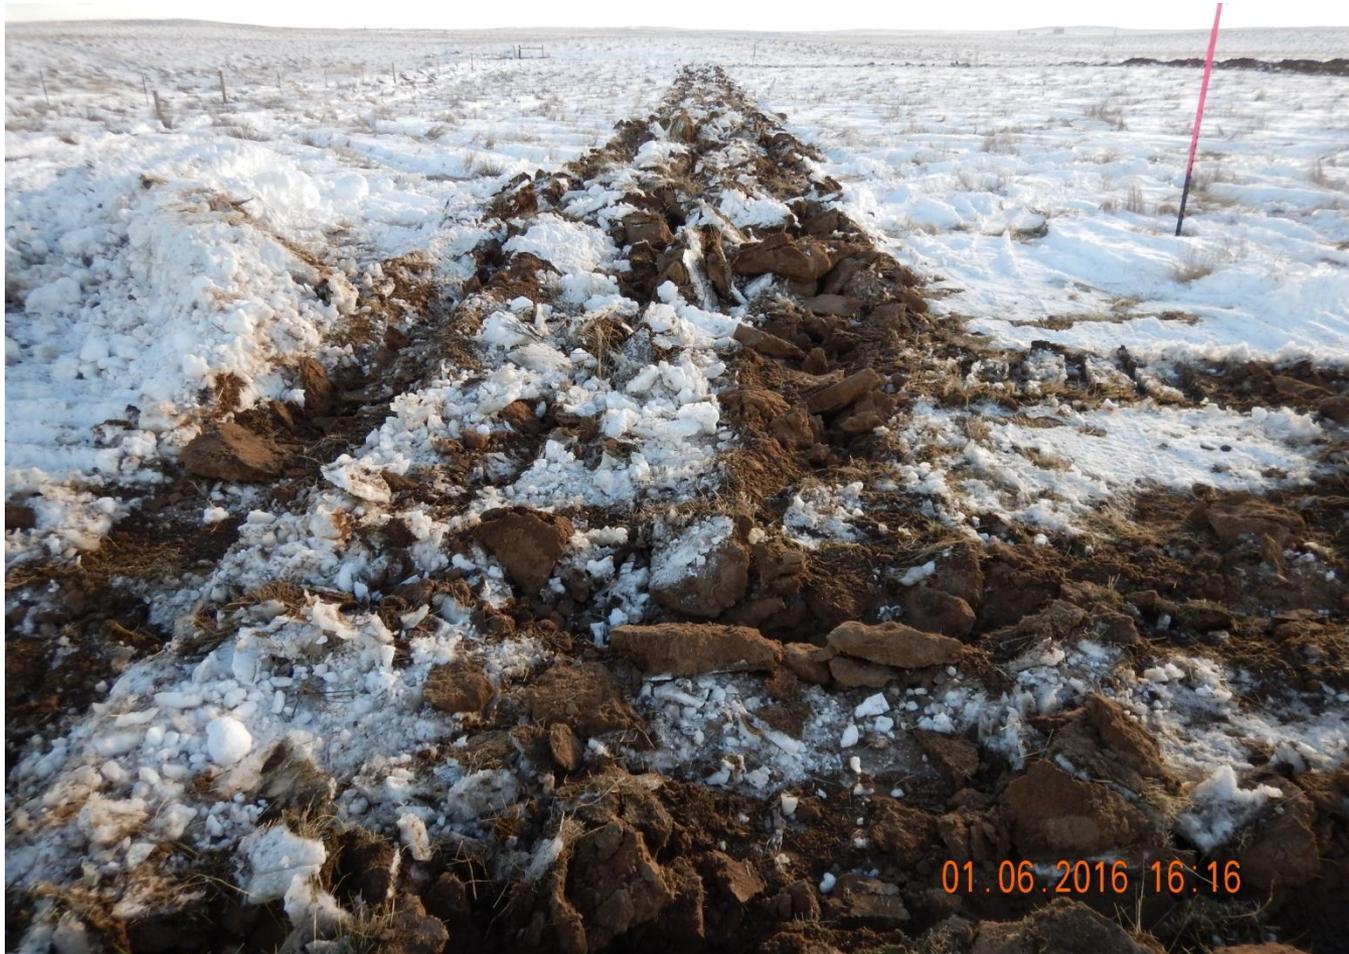
**Photo 1.** Photo taken from northeast location, facing South. Stormwater BMPs installed before construction.

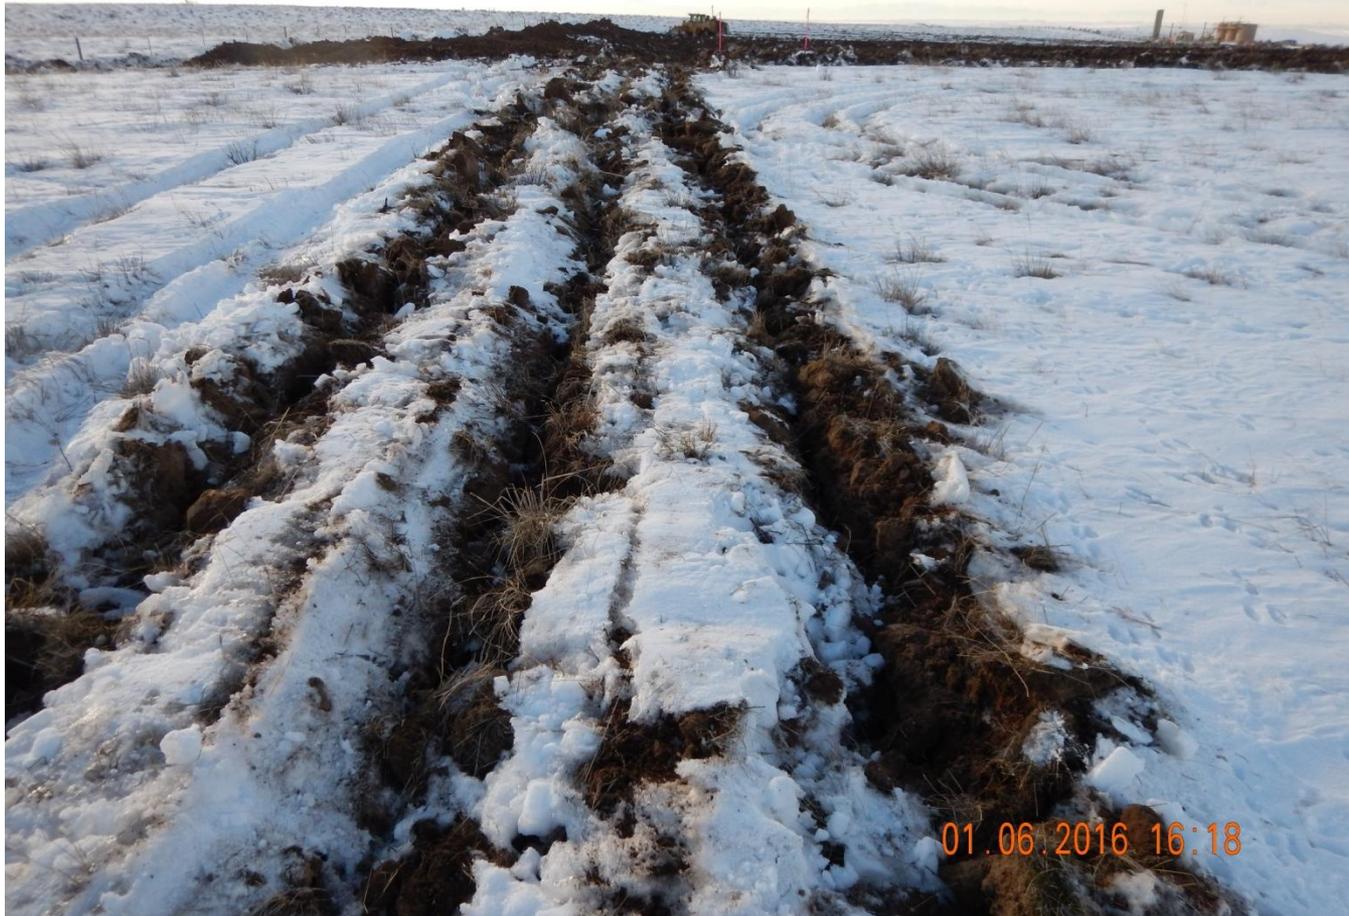
**Photo 2.** Photo taken from southeast location, facing West. Stormwater BMPs installed before construction.

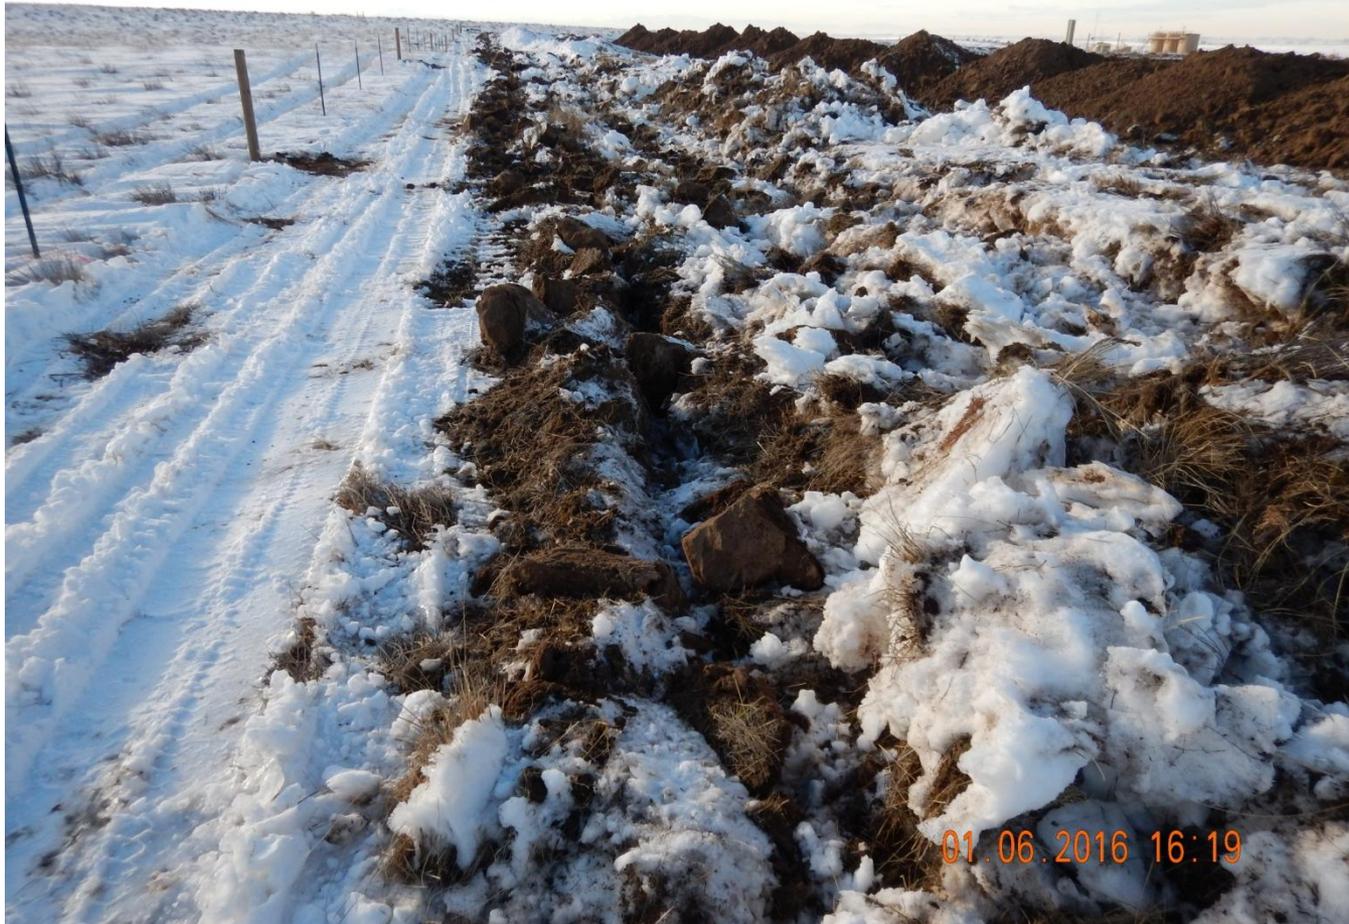
**Photo 3.** Photo taken from northern location, facing West. Stormwater BMPs installed before construction.

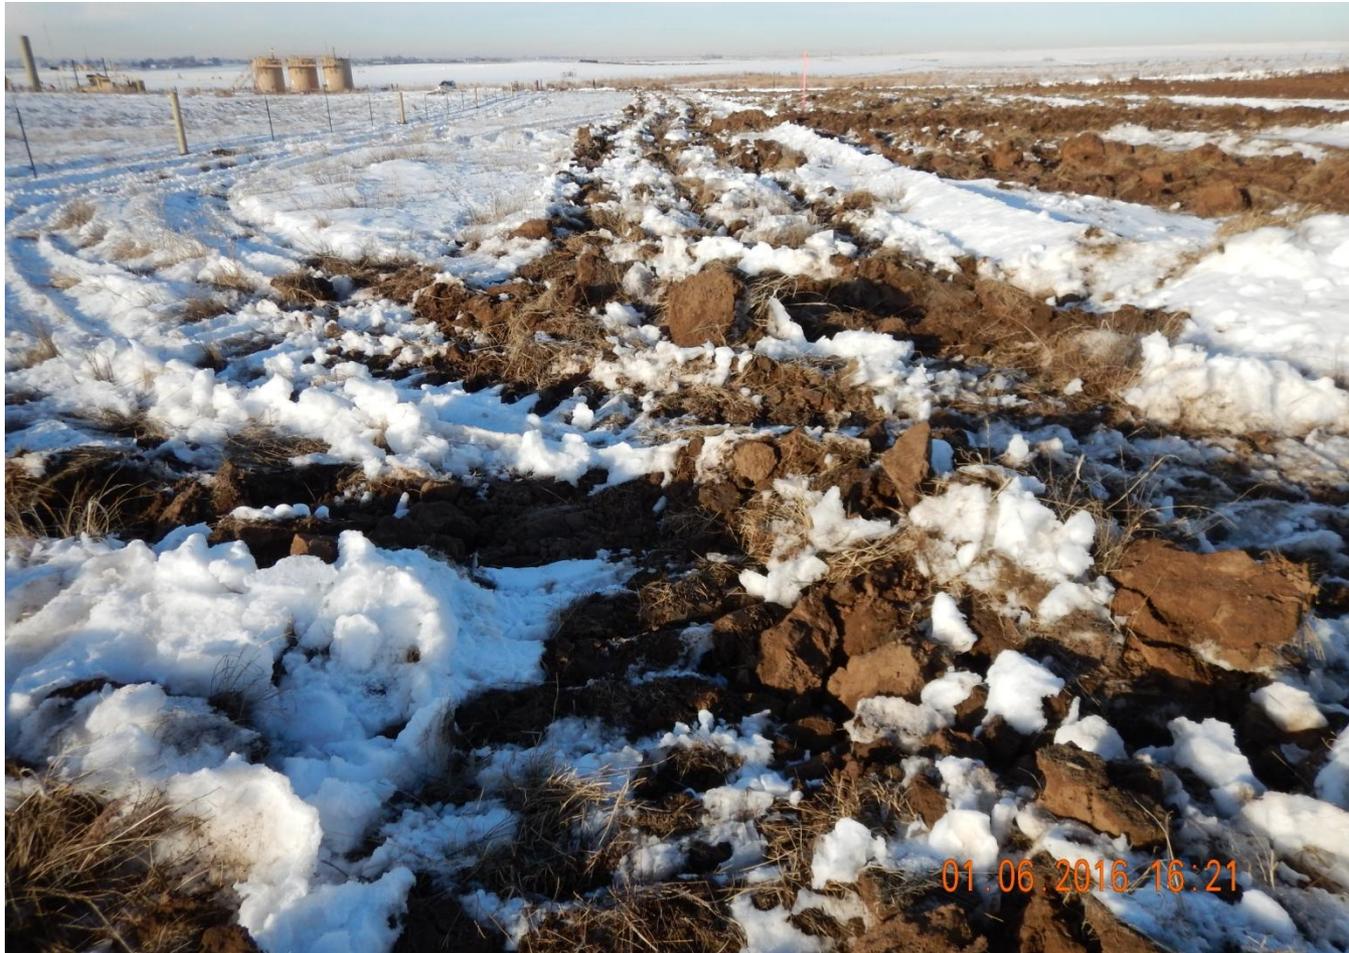
**Photo 4.** Photo taken from southwest location, facing North. Stormwater BMPs installed before construction.

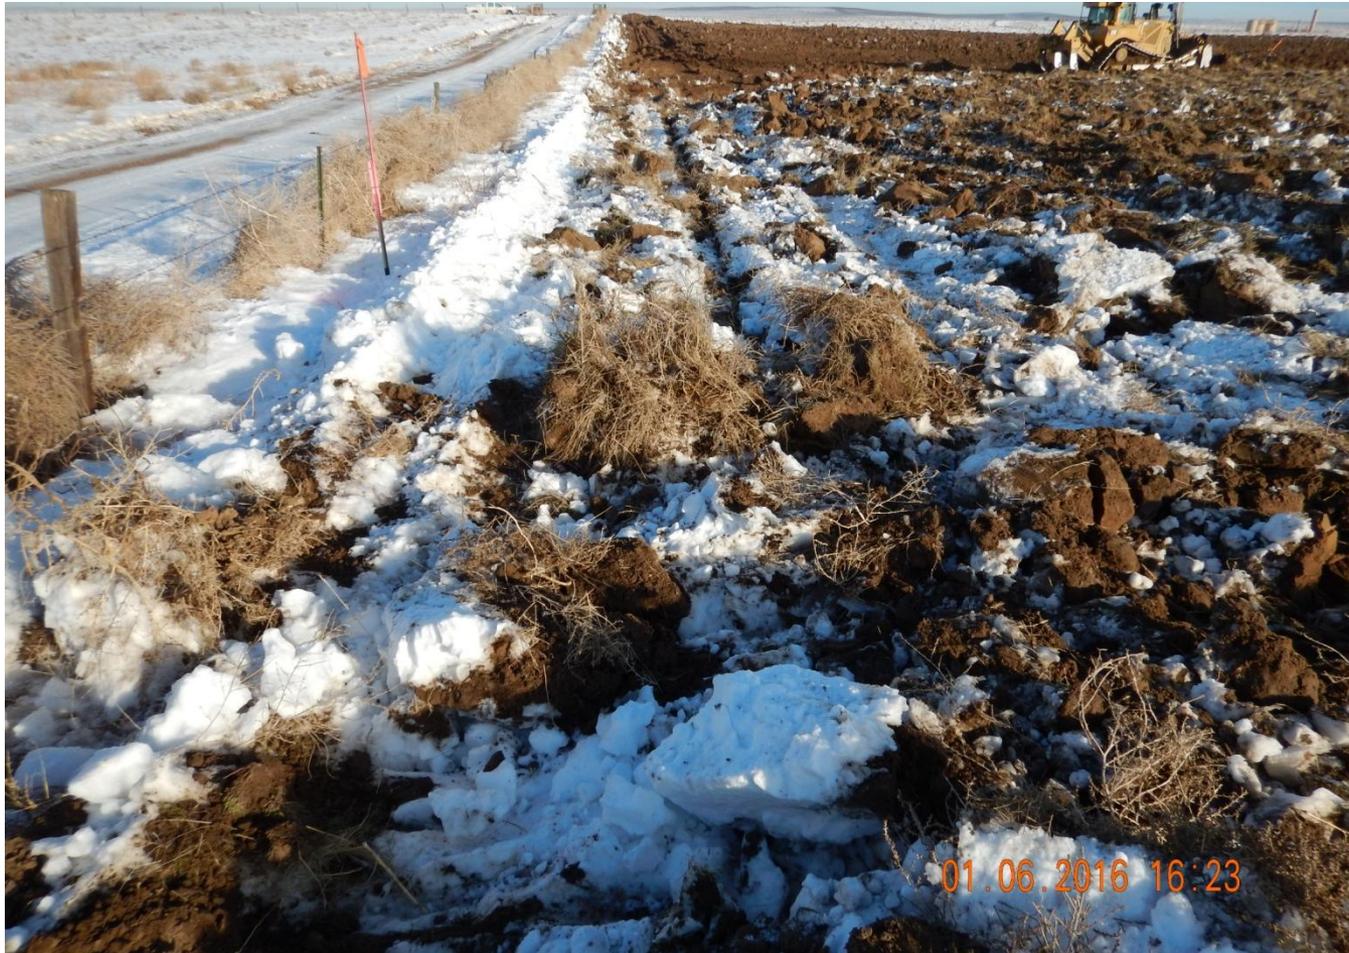
**Photo 5.** Photo taken from northwest location, facing East. Stormwater BMPs installed before construction.

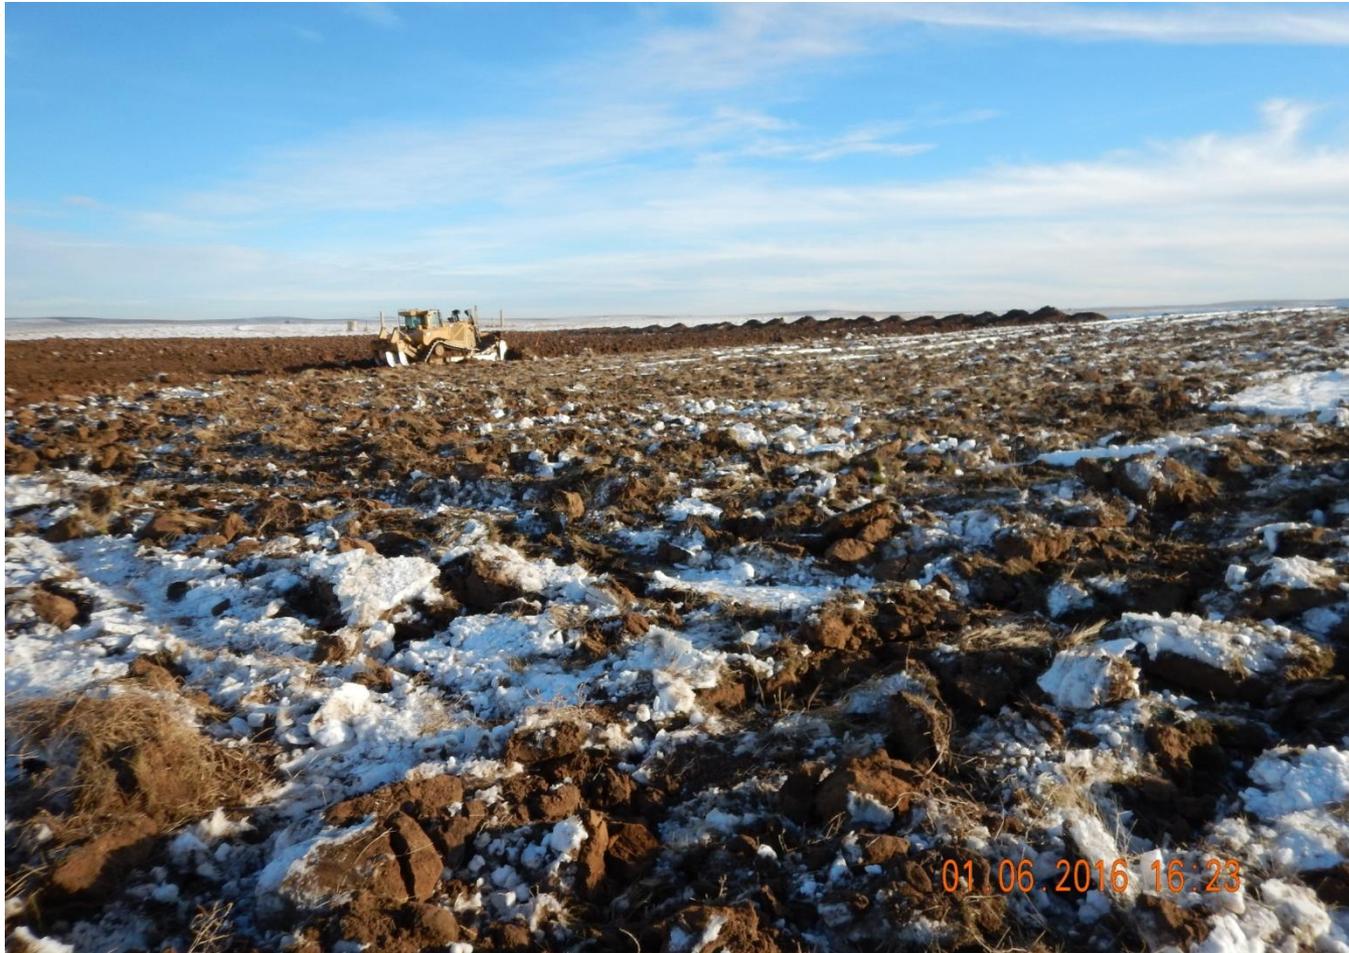
**Photo 6.** Photo taken from northwest location, facing Southeast. Topsoil salvage in process.
