# Construction Inspection

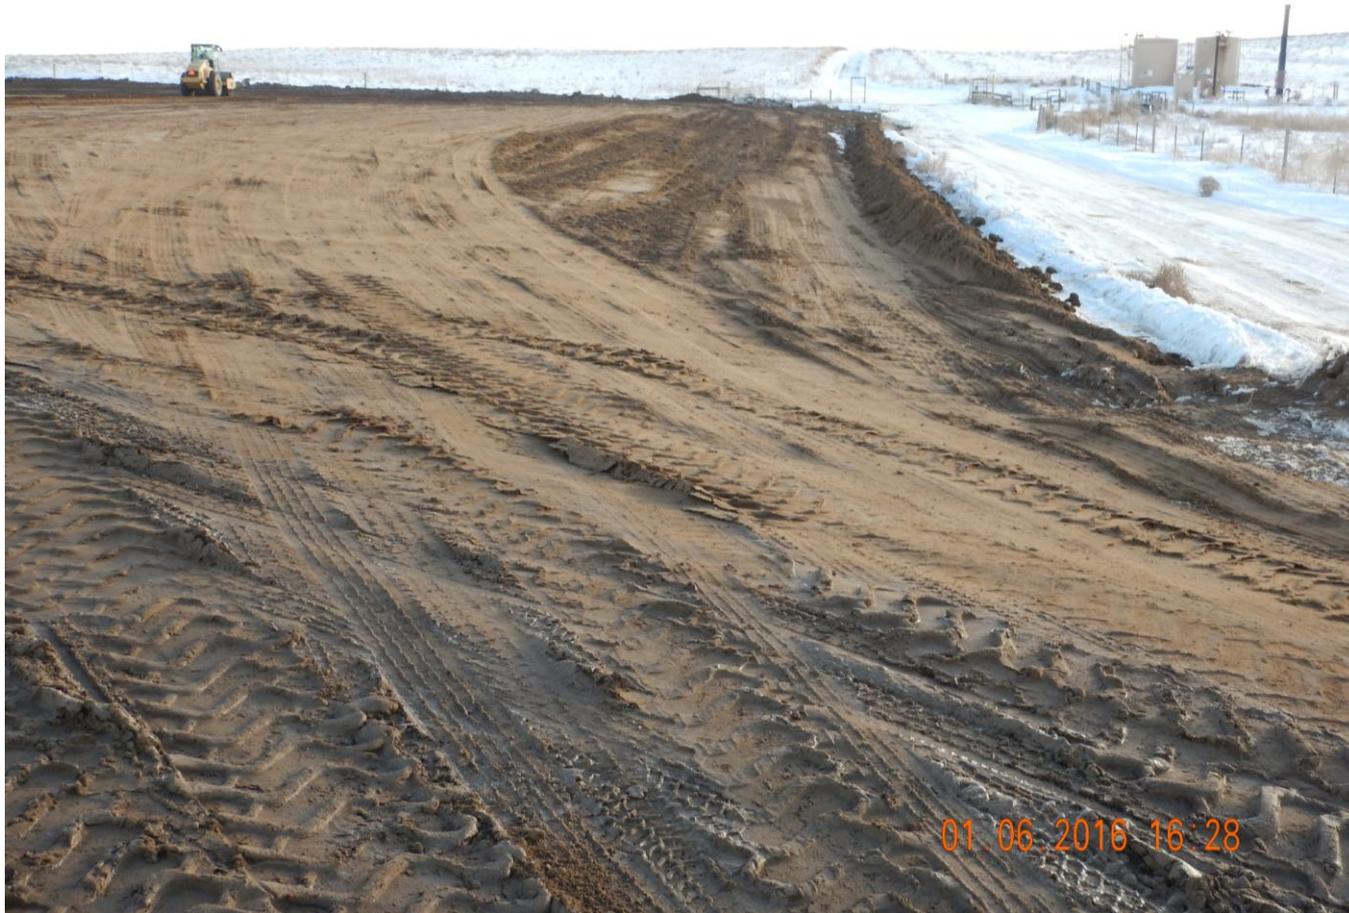
**Photo 1.** Photo taken from northwest location, facing South. Stormwater BMPs installed in center of photo.

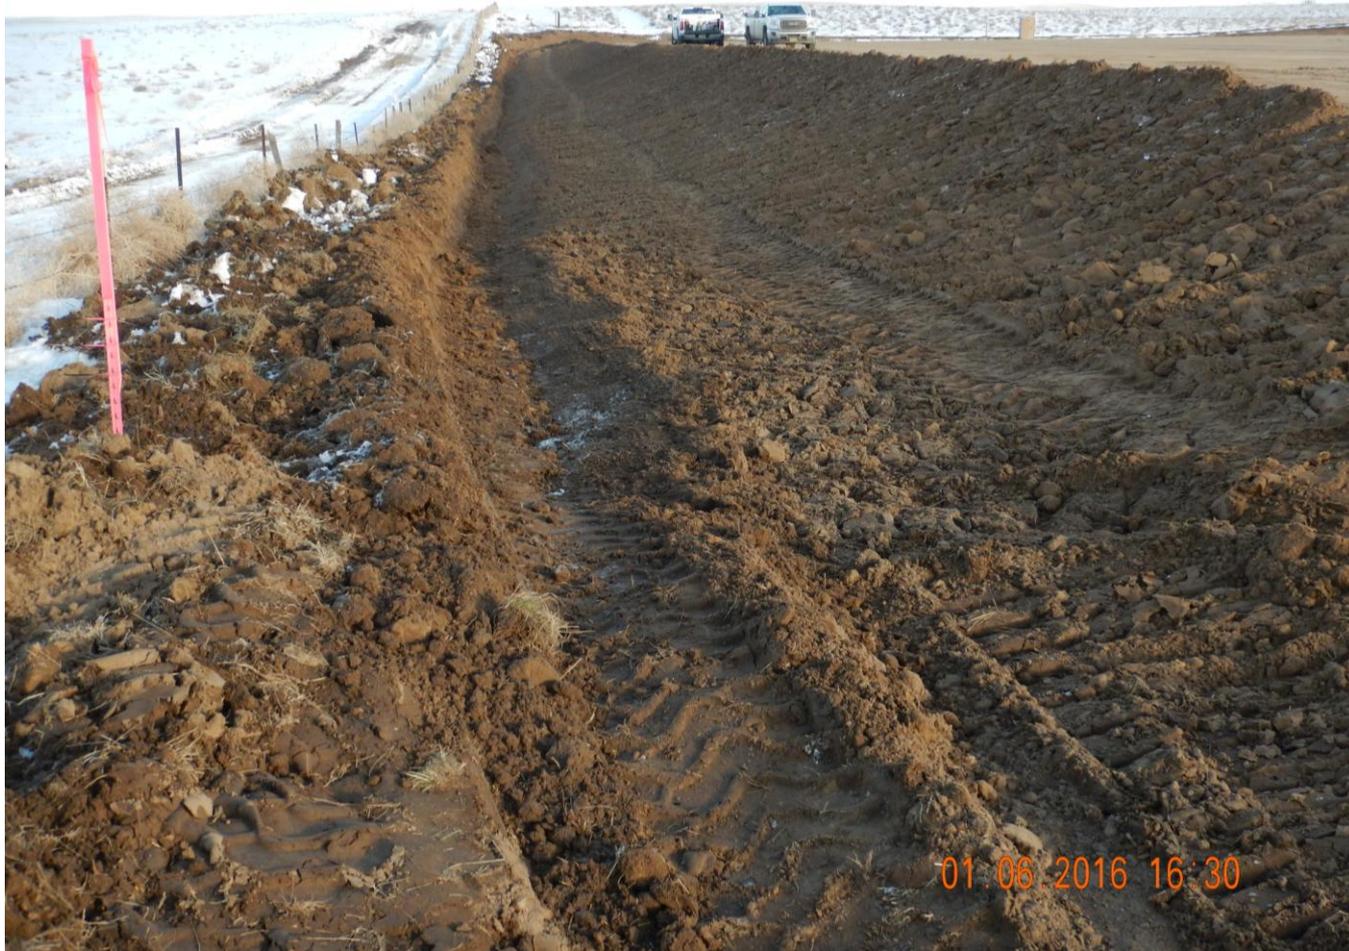
**Photo 2.** Photo taken from northwest location, facing East. Stormwater BMPs installed in center of photo.

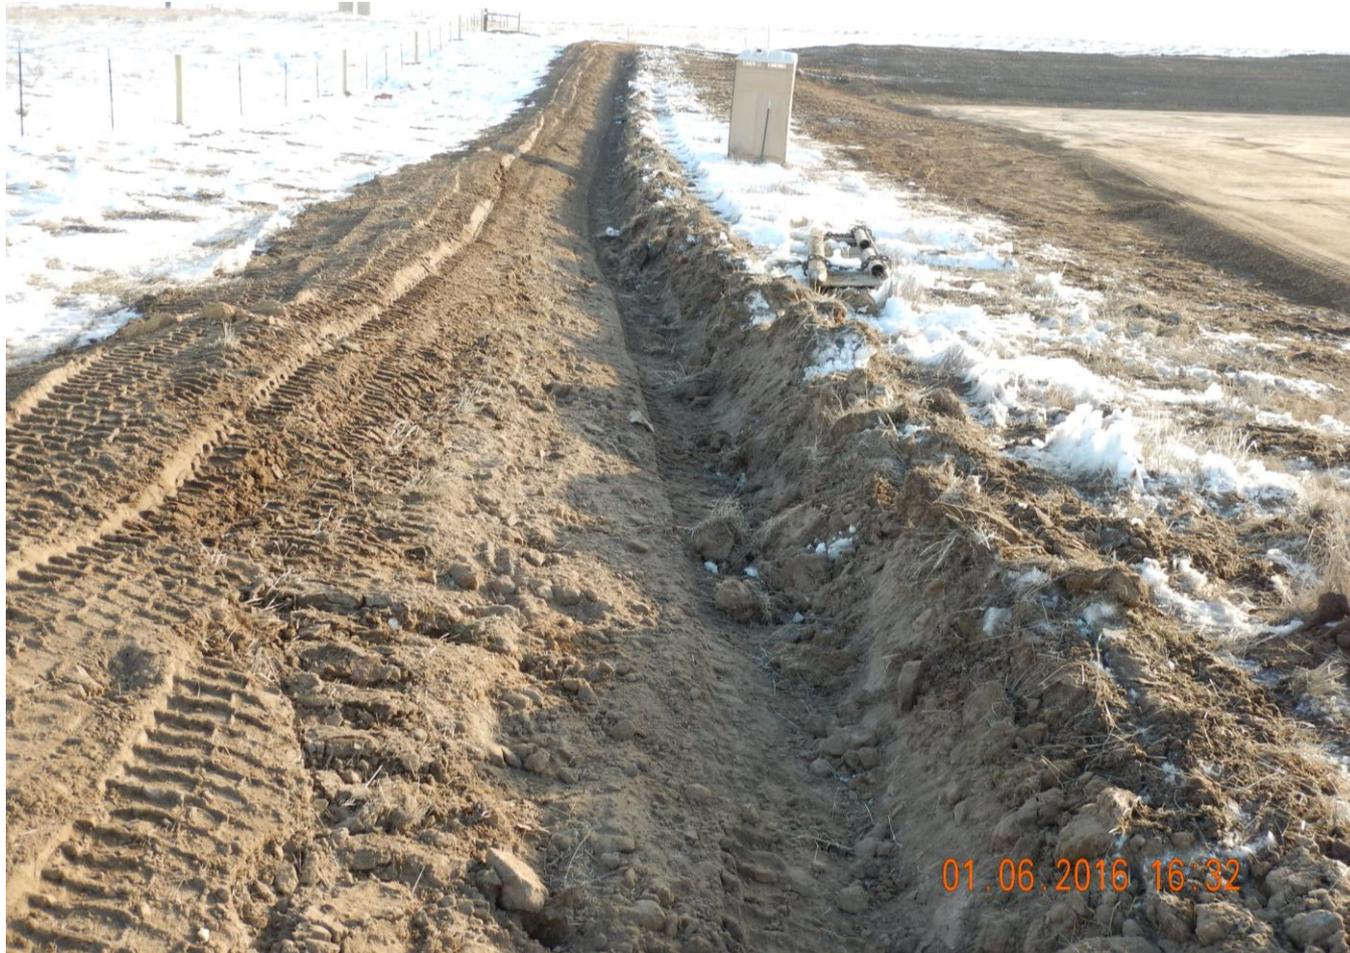
**Photo 3.** Photo taken from northeast location, facing South. Stormwater BMPs installed in center of photo.

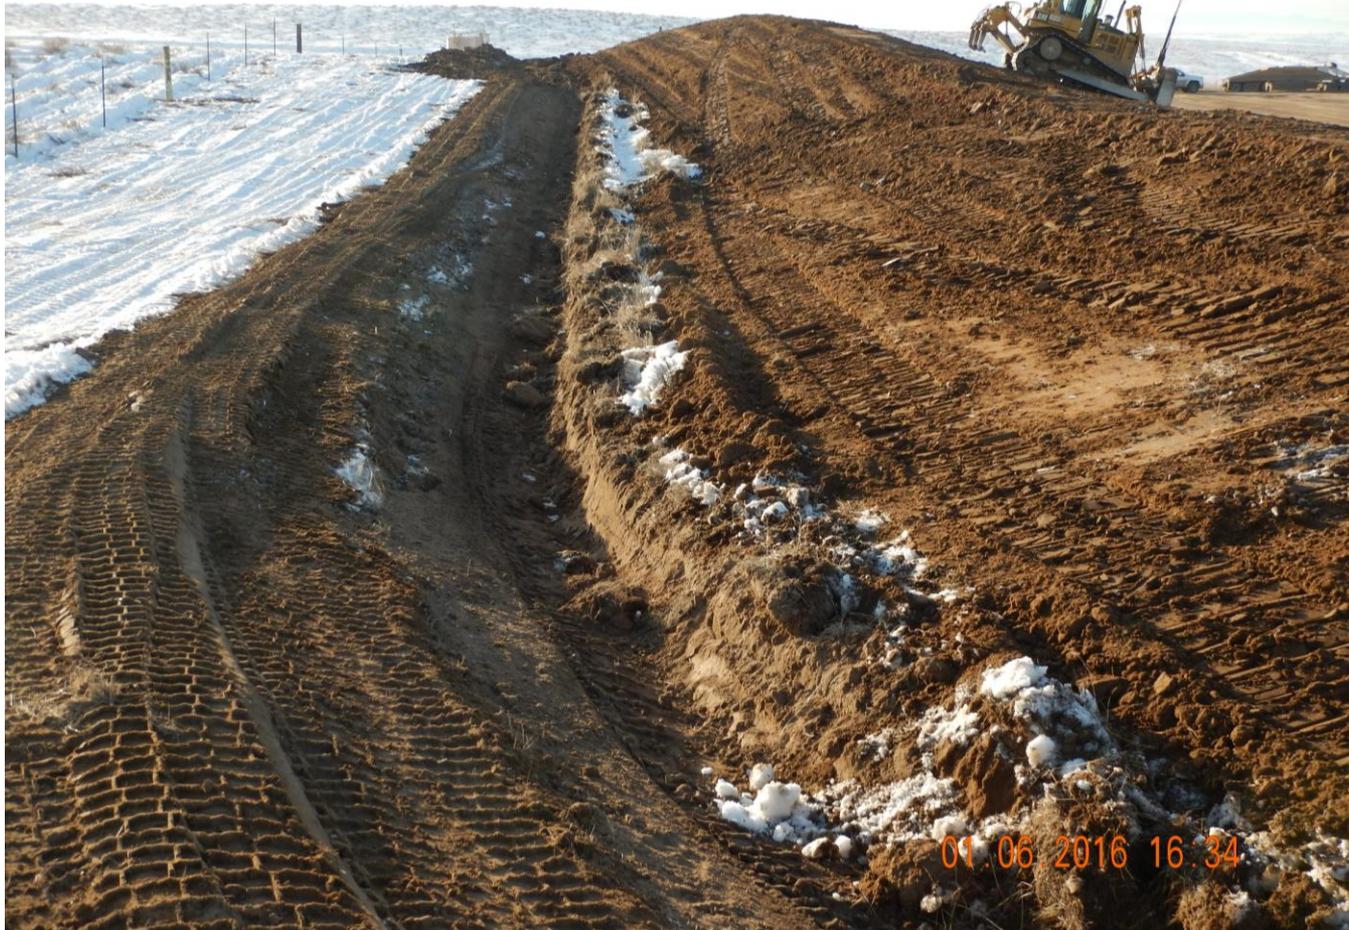
**Photo 4.** Photo taken from southeast location, facing West. Stormwater BMPs installed in center of photo.

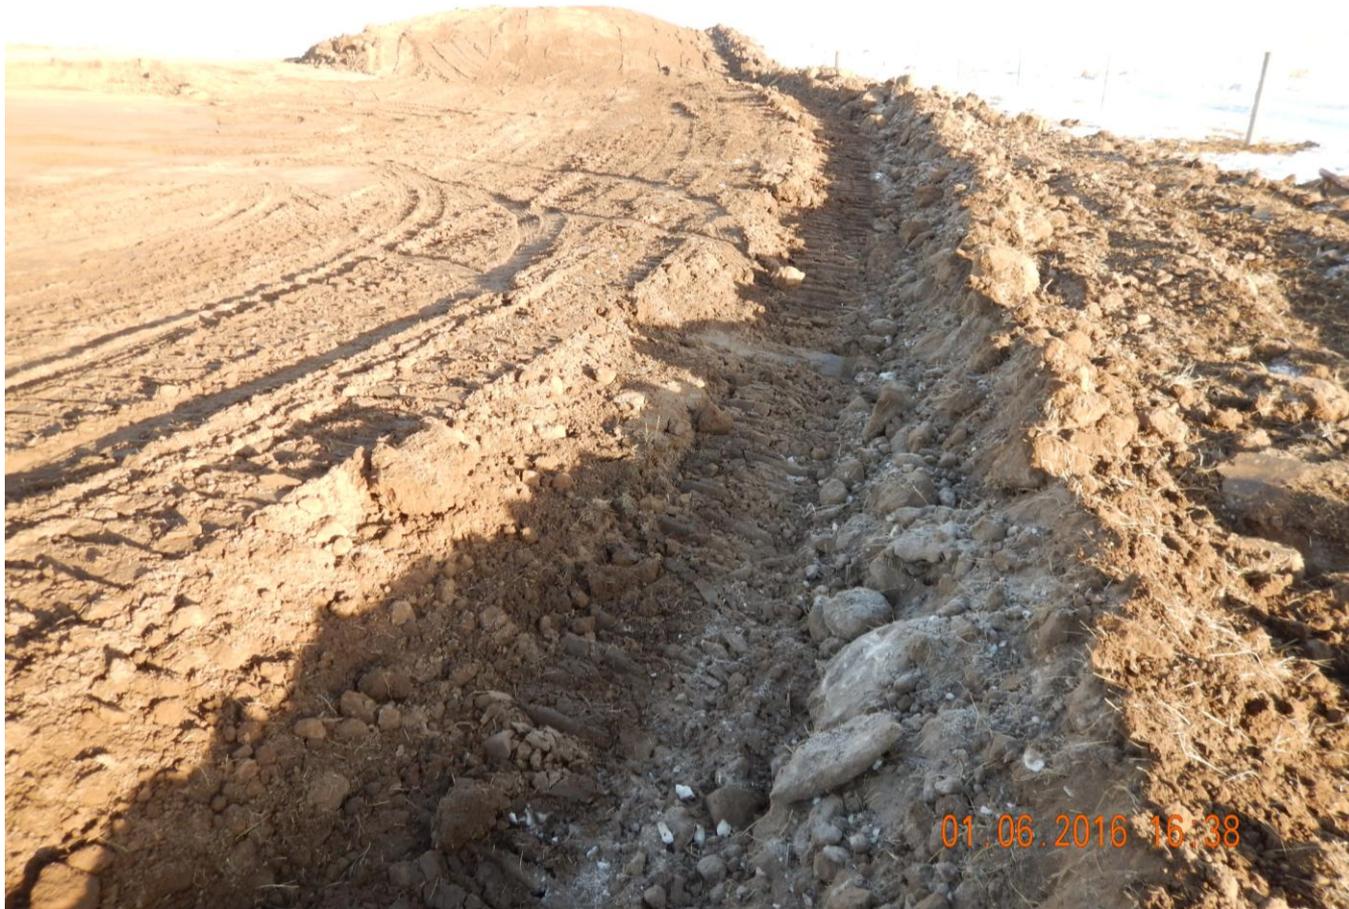
**Photo 5.** Photo taken from southwest location, facing East. Stormwater BMPs installed in center of photo.

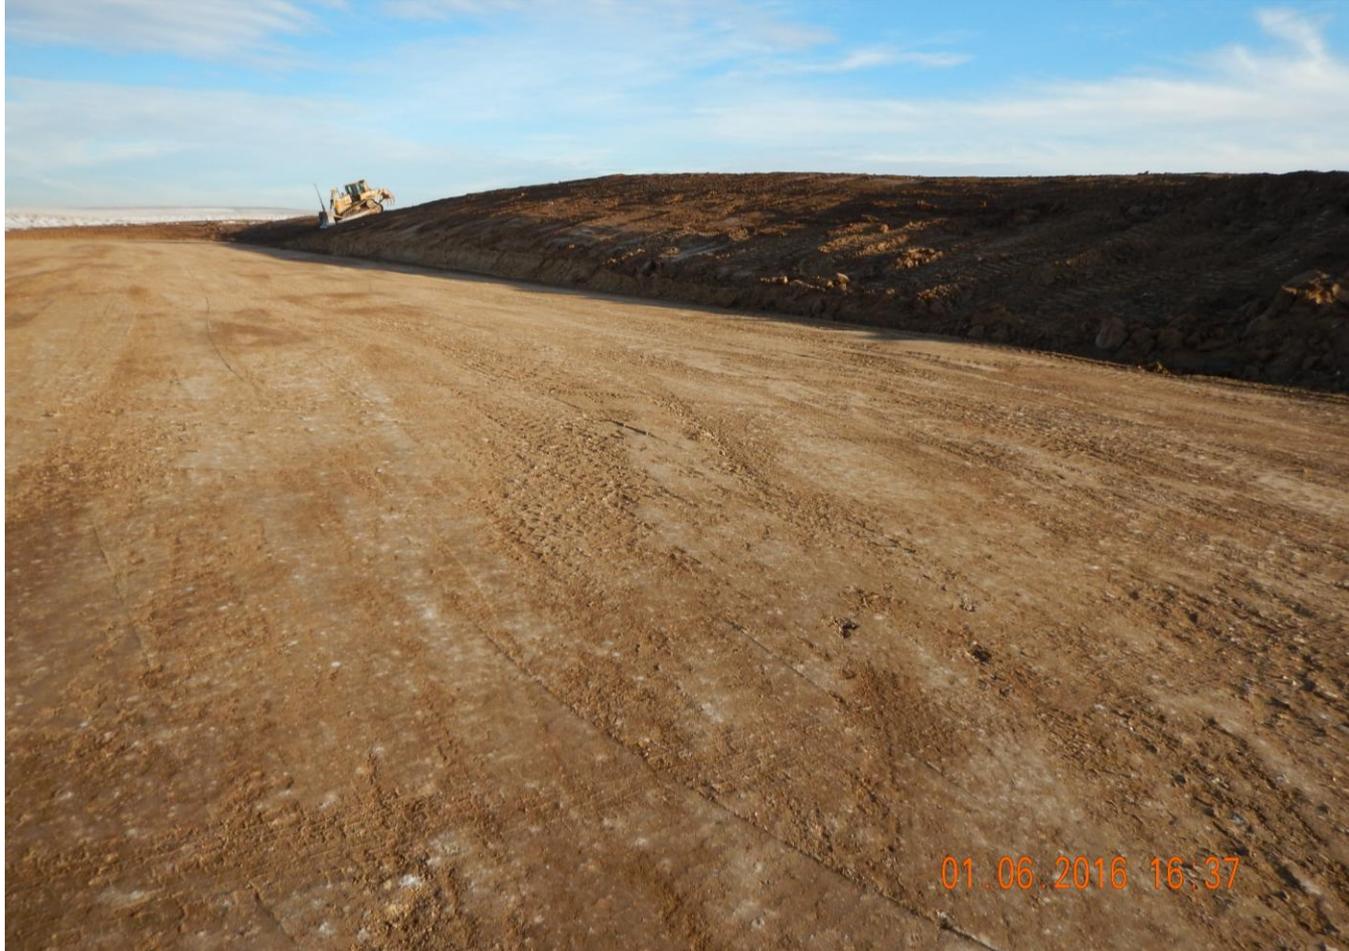
**Photo 6.** Photo taken from the western location, facing Southeast. Topsoil stockpile stabilized.
