Construction Reinspection

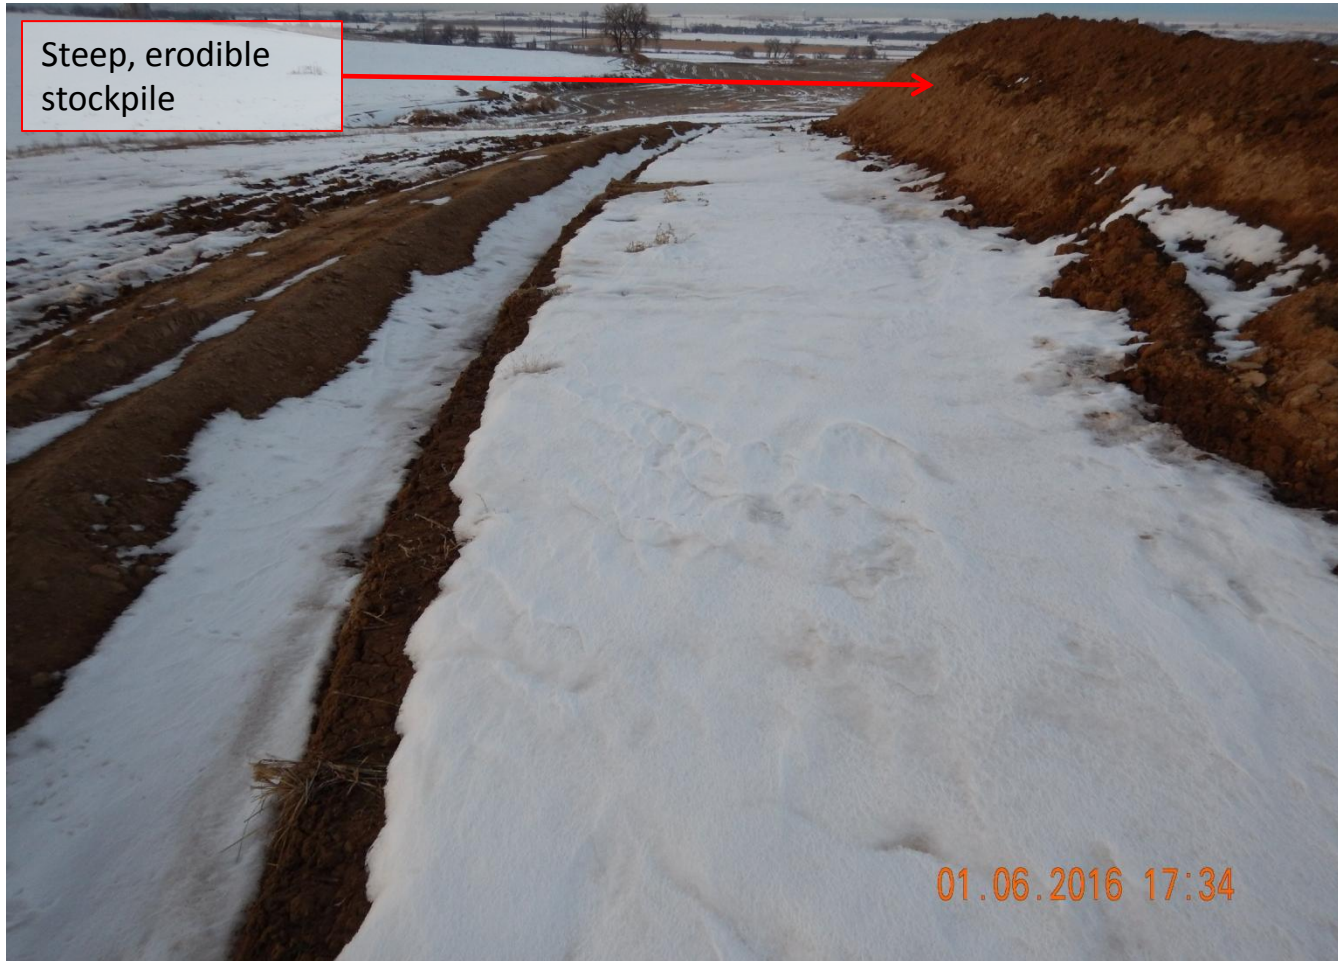
Photo 1. Photo taken from southwestern location, facing North. Stormwater BMP installed in center of photo. All stockpiled soils shall be protected from degradation. The west-facing topsoil stockpile is steep and erodible. Refer to photo 2.

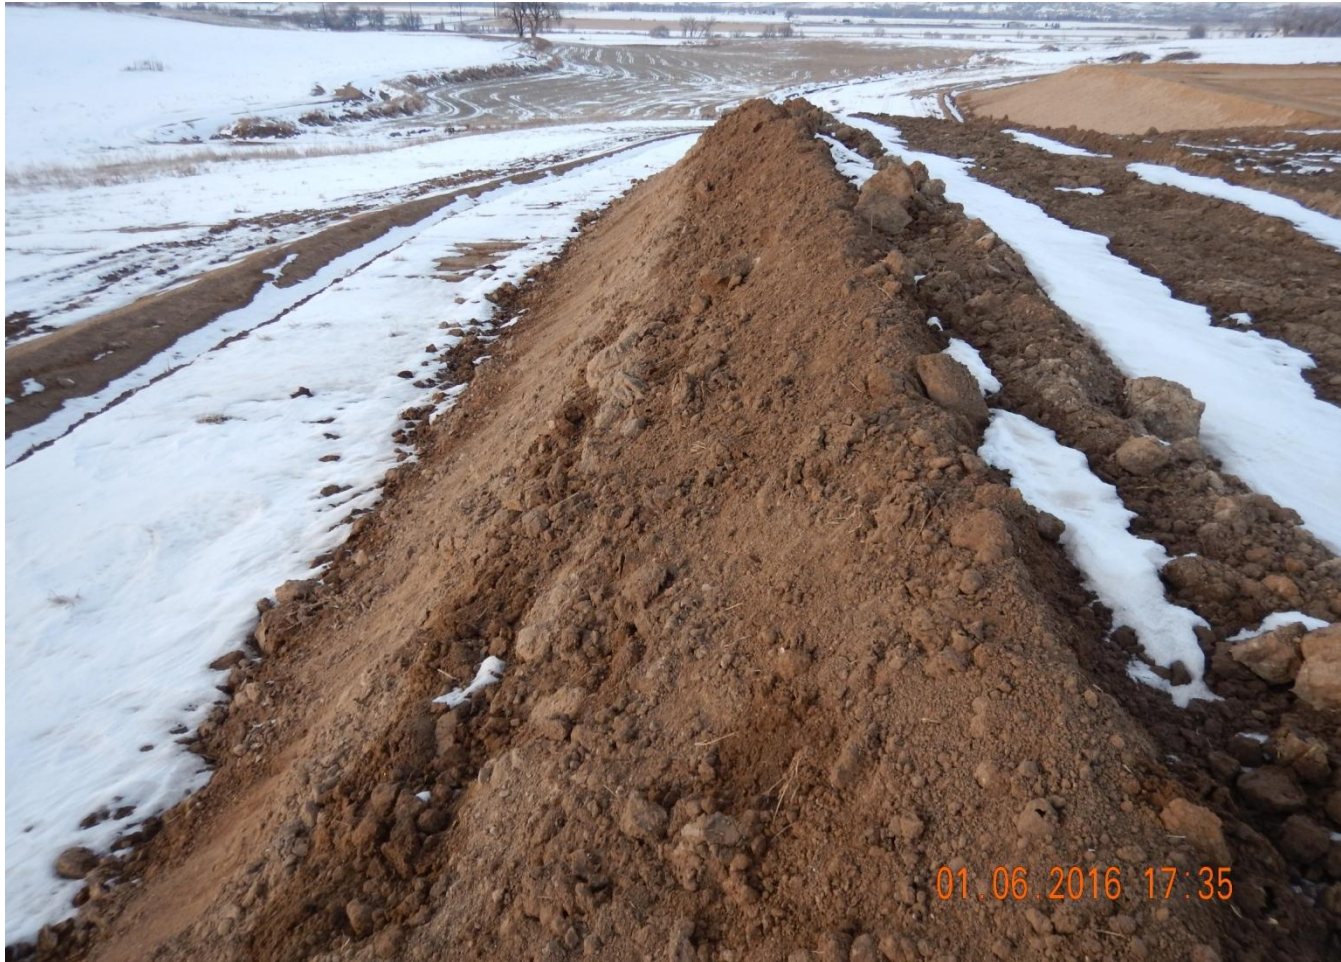
Photo 2. Photo taken from southwestern topsoil stockpile, facing North. All stockpiled soils shall be protected from degradation. The west-facing topsoil stockpile is steep and erodible. May need to stabilize slope like the east-facing slope (Refer to Photo 3).

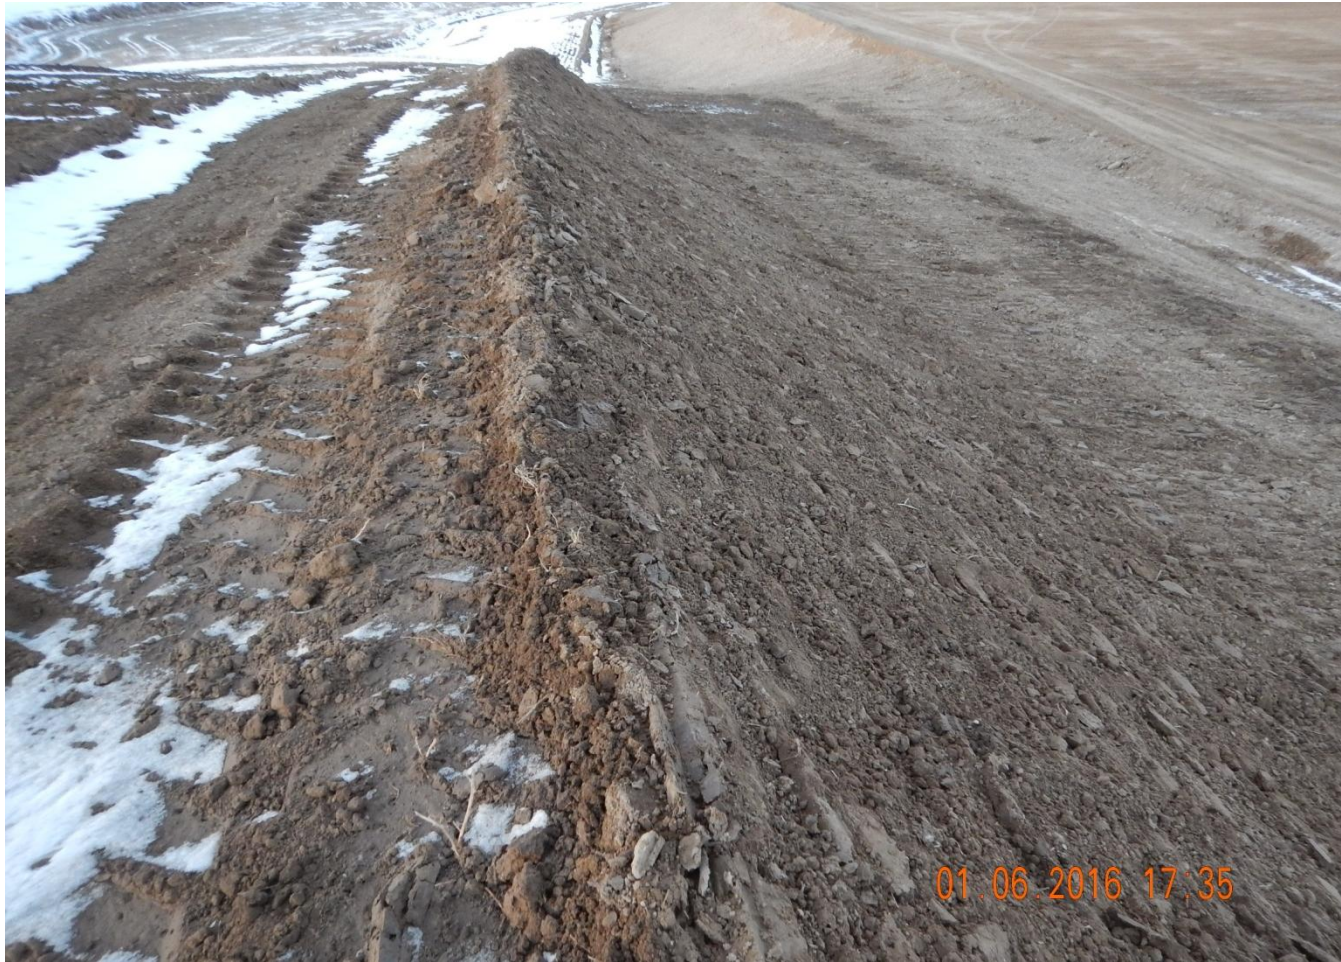
Photo 3. Photo taken from southwestern topsoil stockpile, facing North. East-facing topsoil stockpile properly tracked and slope is not too steep.

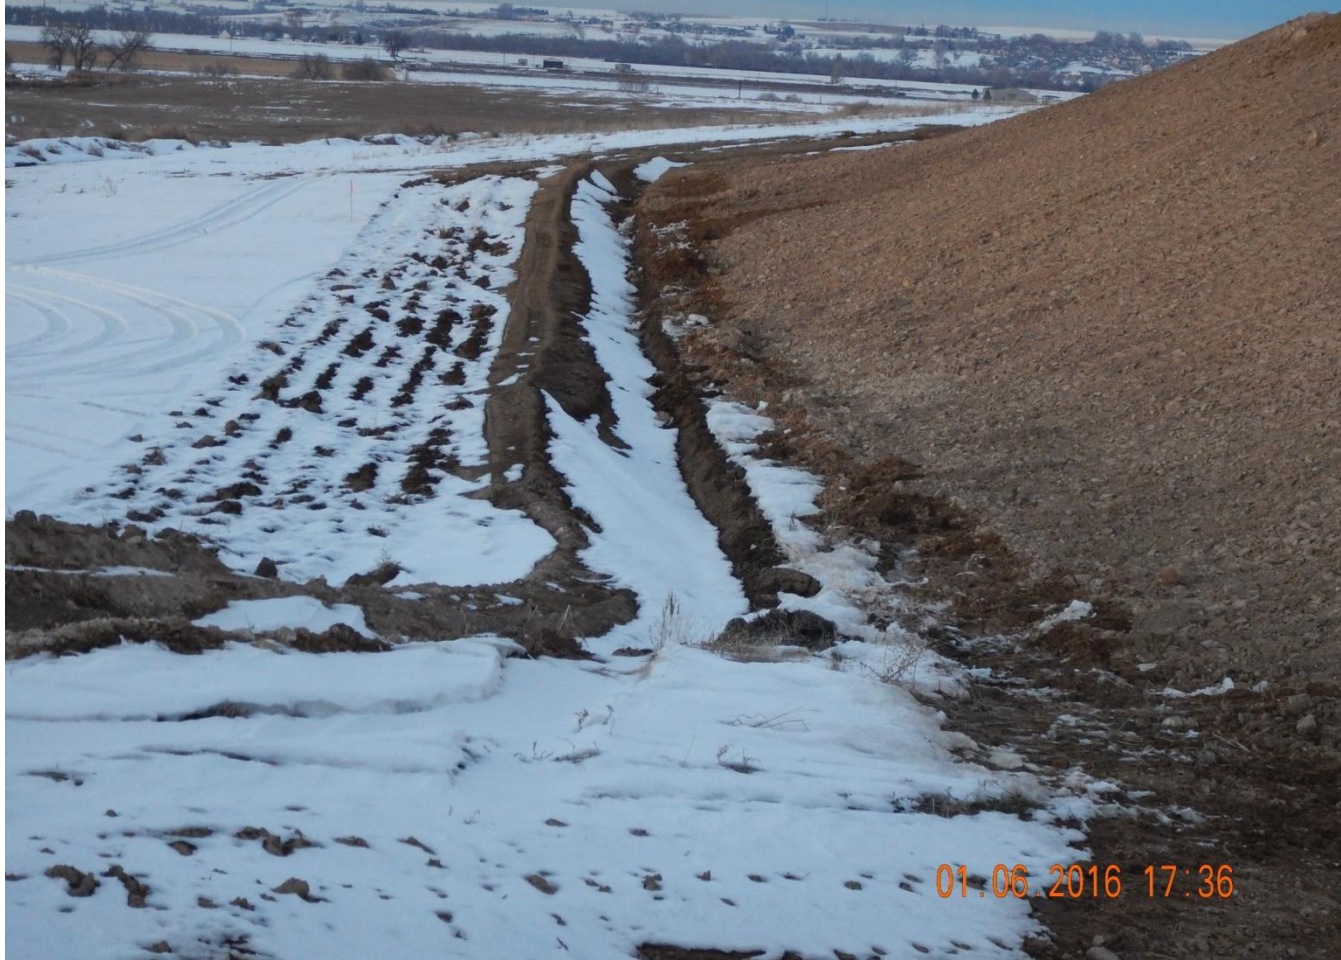
Photo 4. Photo taken from western location, facing North. Stormwater BMP in center of photo.

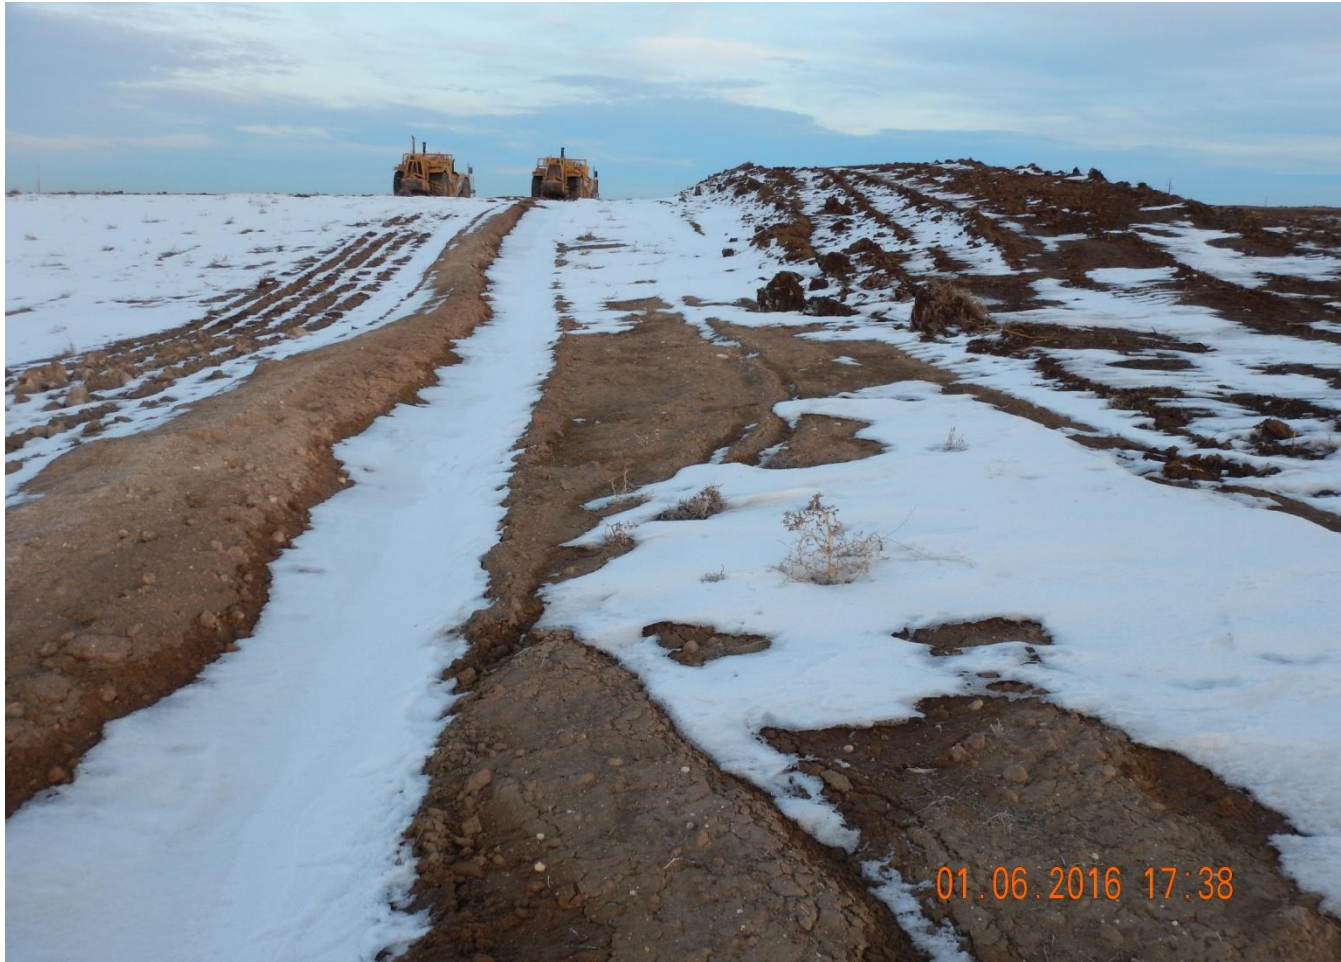
Photo 5. Photo taken from northwest location, facing East. Stormwater BMP installed in center of photo.

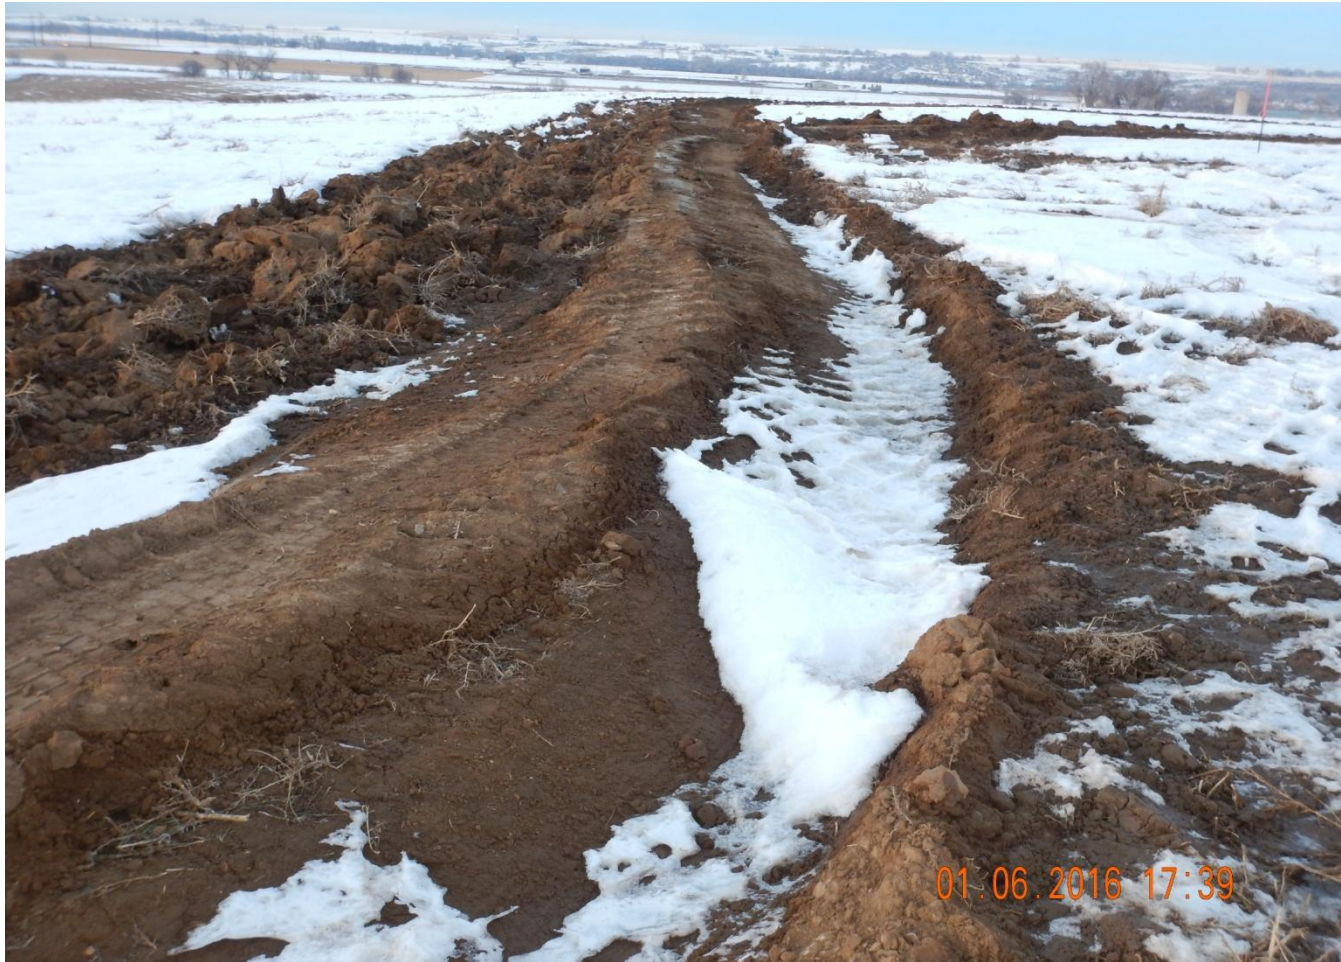
Photo 6. Photo taken from north-central location, facing North. Stormwater BMP installed in center of photo.

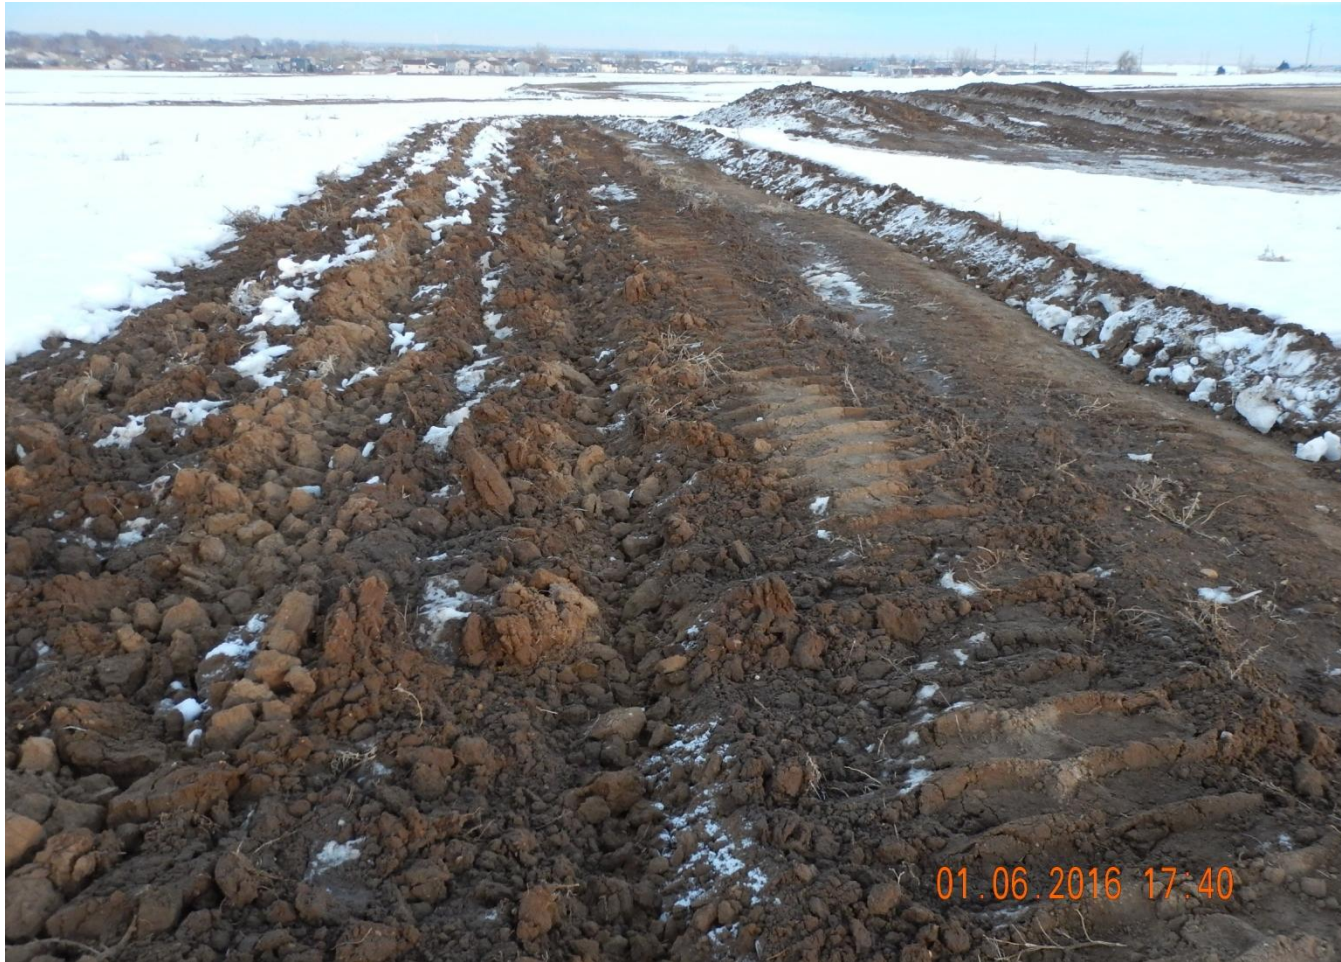
Photo 7. Photo taken from north-central location, facing East. Stormwater BMP installed in center of photo.

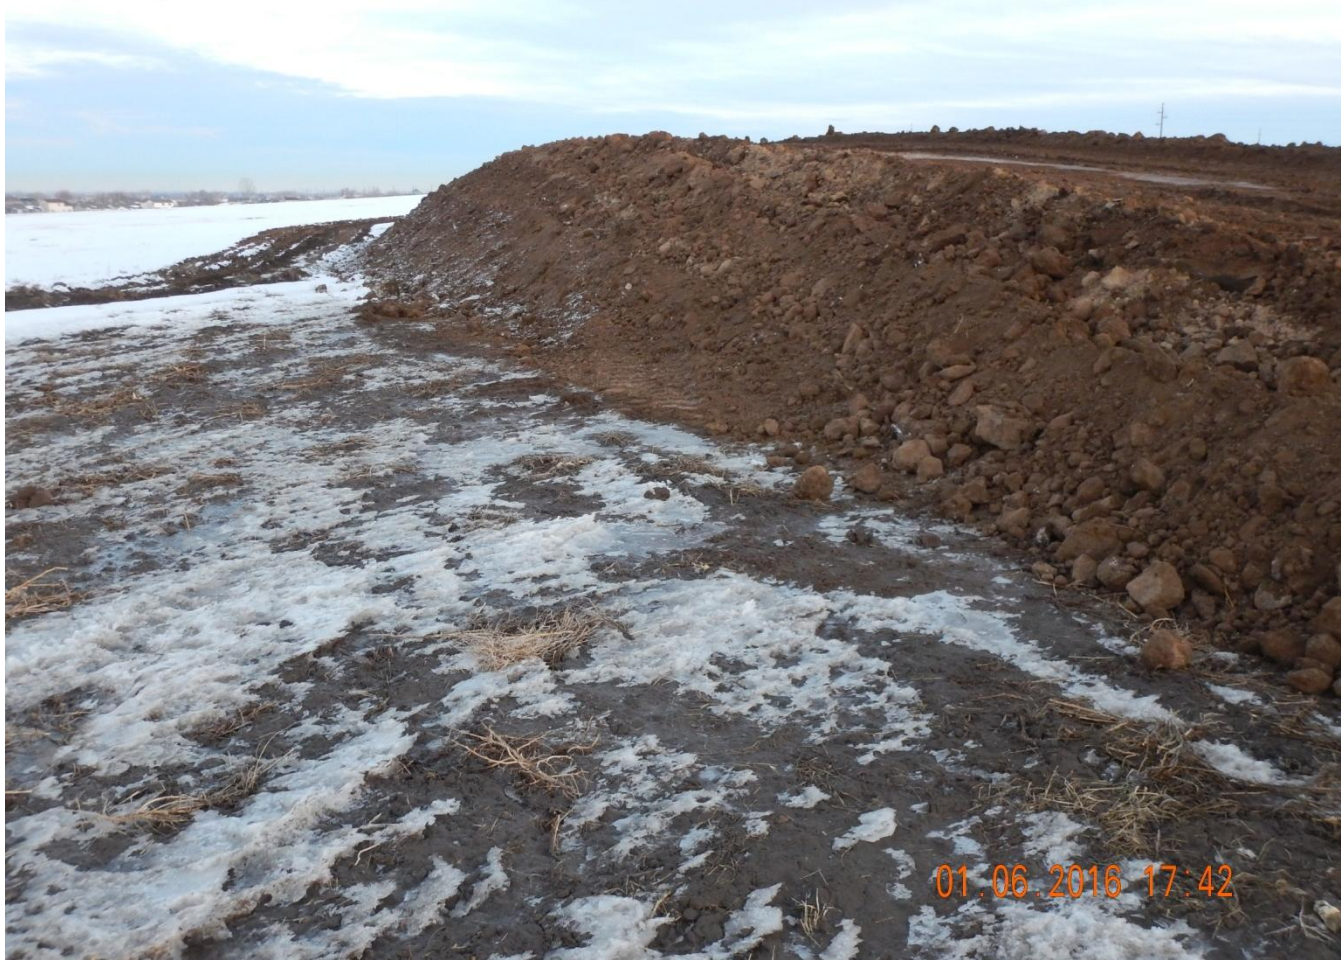
Photo 8. Photo taken from northeast topsoil stockpile, facing East. All stockpiled soils shall be protected from degradation and to maintain soil microbial activity shall be implemented. The north-facing topsoil stockpile is steep and erodible. Also, the topsoil stockpile is piled high which could negatively affect soil microbial activity. May need to stabilize and reduce the height of the pile to around 6' in the future.

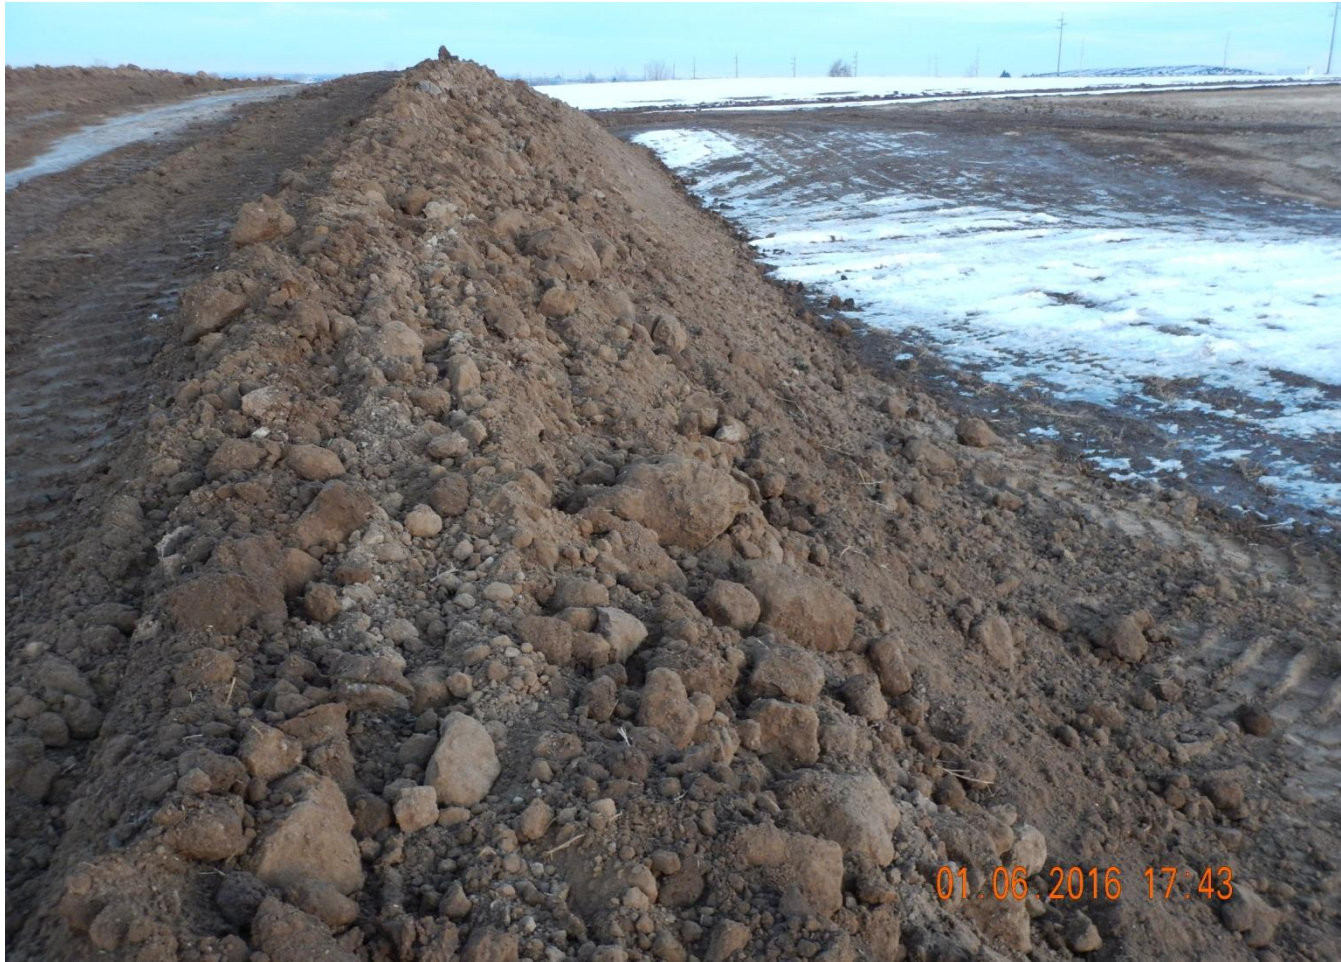
Photo 9. Photo taken from northeast topsoil stockpile, facing East. All stockpiled soils shall be protected from degradation and to maintain soil microbial activity shall be implemented. The south-facing topsoil stockpile is steep and erodible. Also, the topsoil stockpile is piled high which could negatively affect soil microbial activity. May need to stabilize and reduce the height of the pile to around 6' in the future.

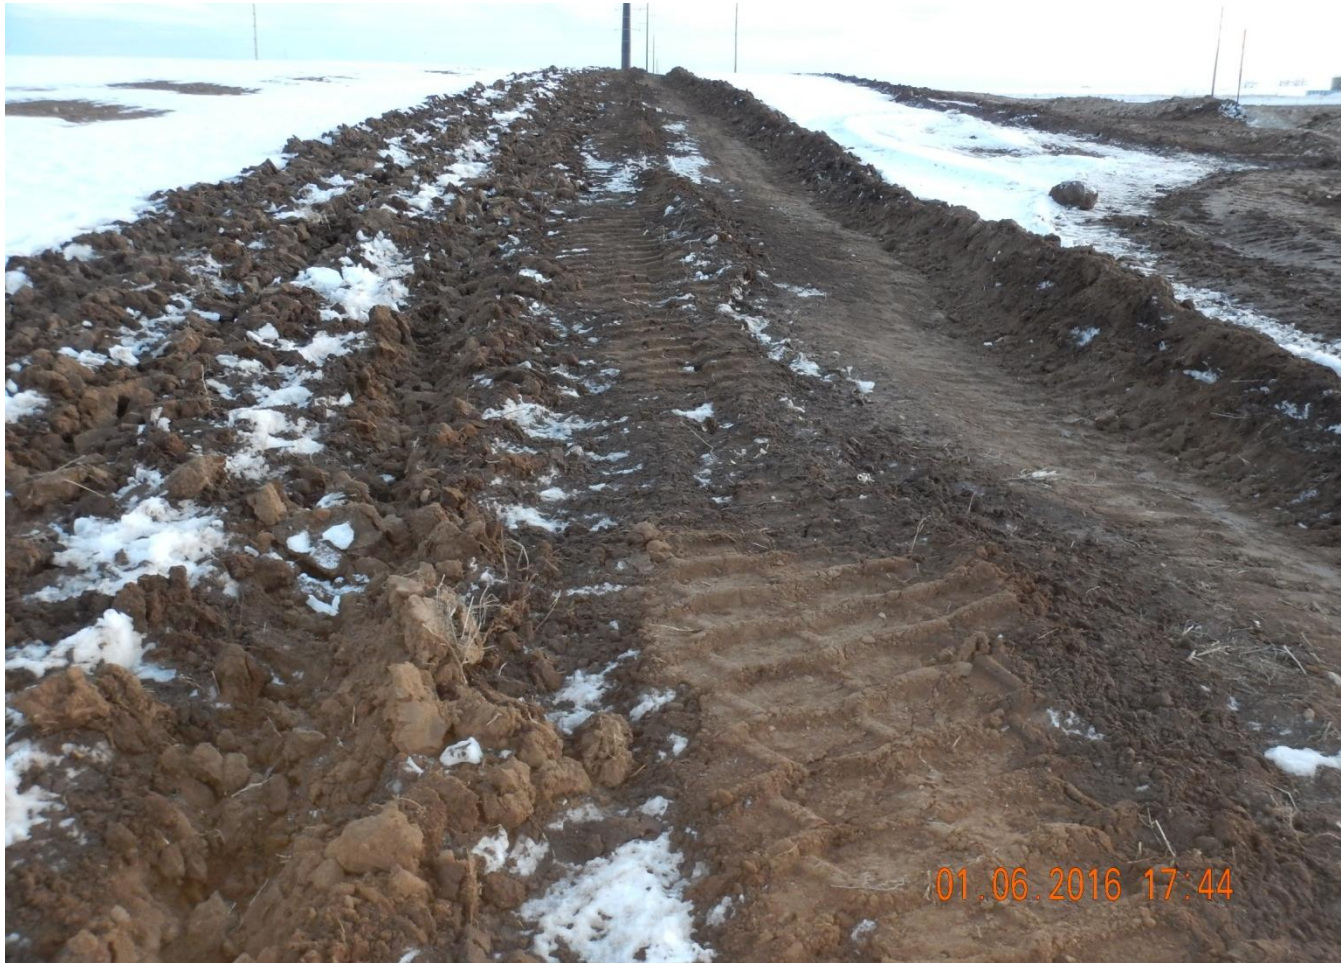
Photo 10. Photo taken from northeastern location, facing South. Stormwater BMP installed in center of photo.

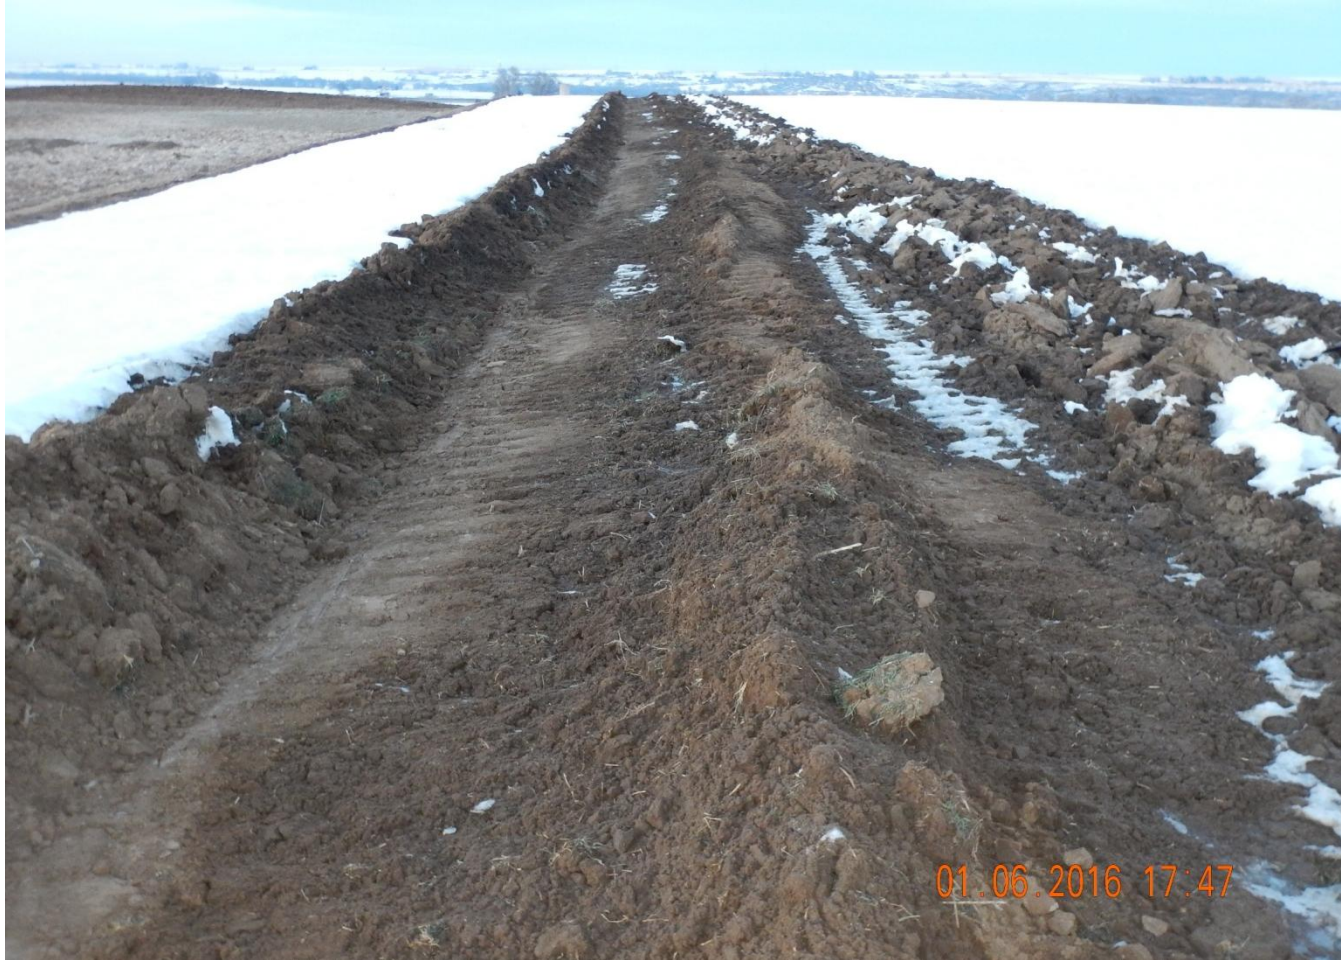
Photo 11. Photo taken from southeastern location, facing North. Stormwater BMP installed in center of photo.
