Esperanza 8-10

Inspection Doc# 675202430

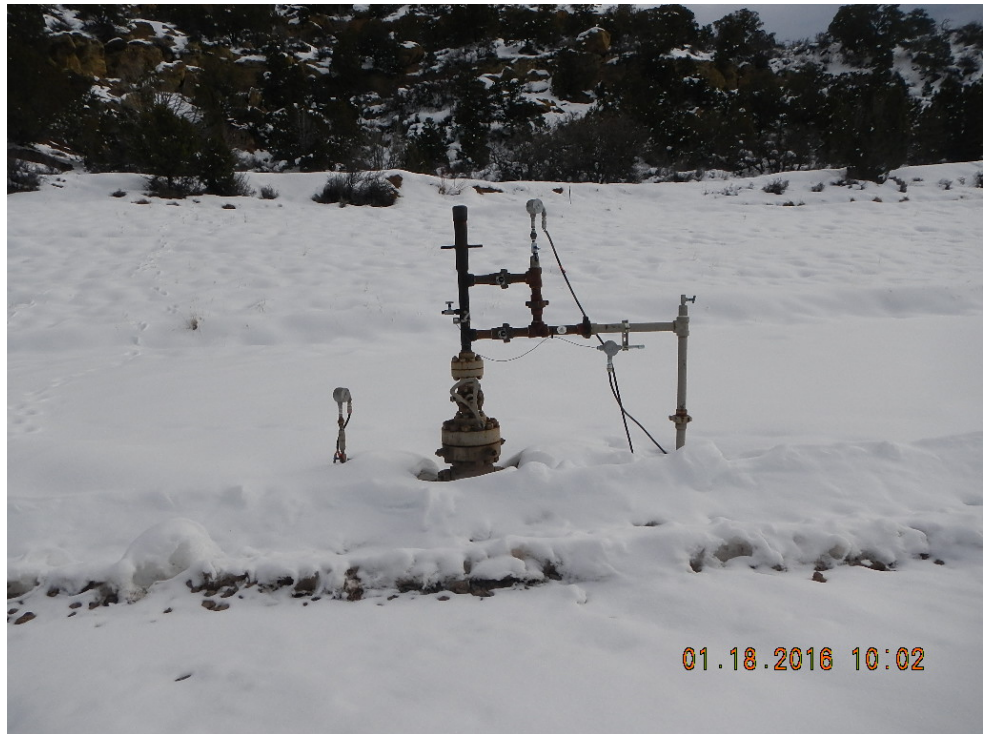
Wellhead with no sign

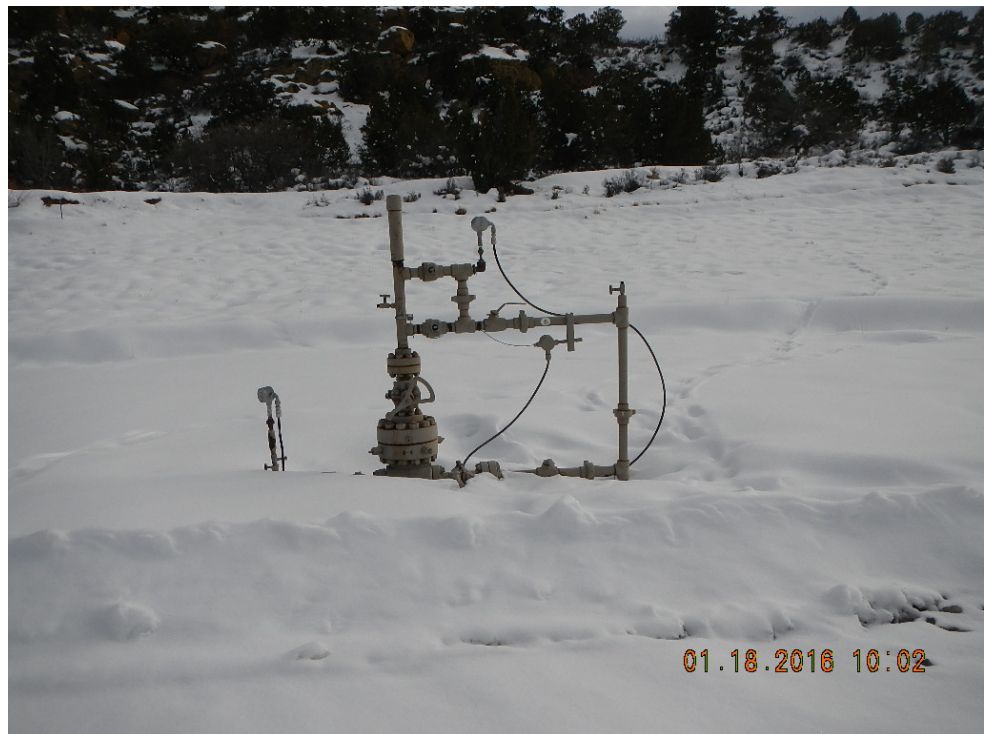
Wellhead with no sign

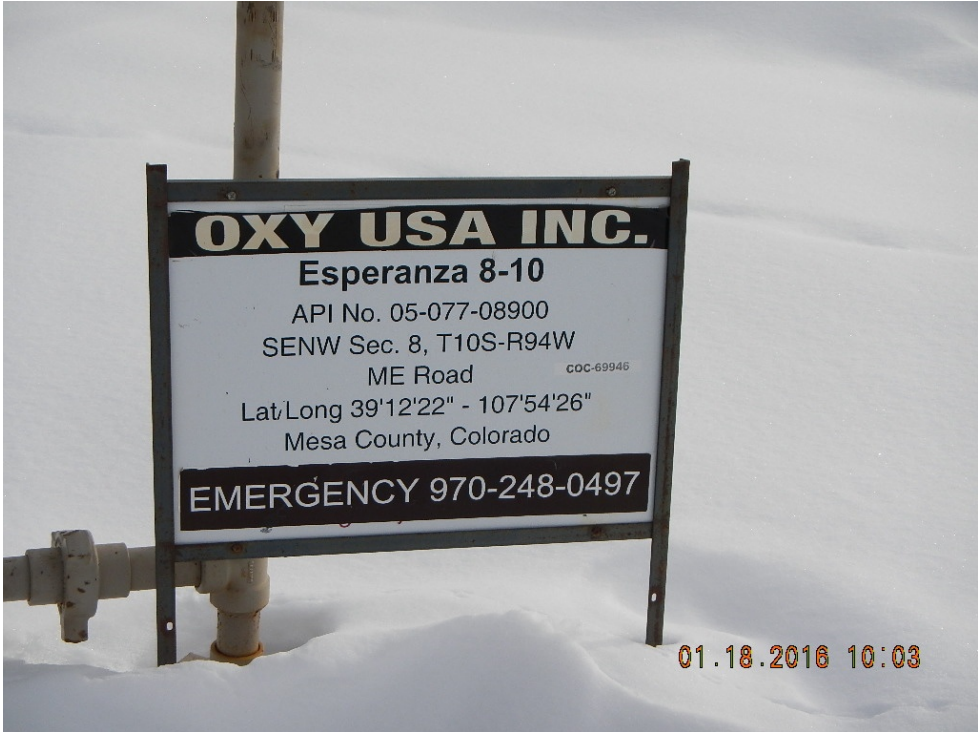
Sign with incorrect API number
