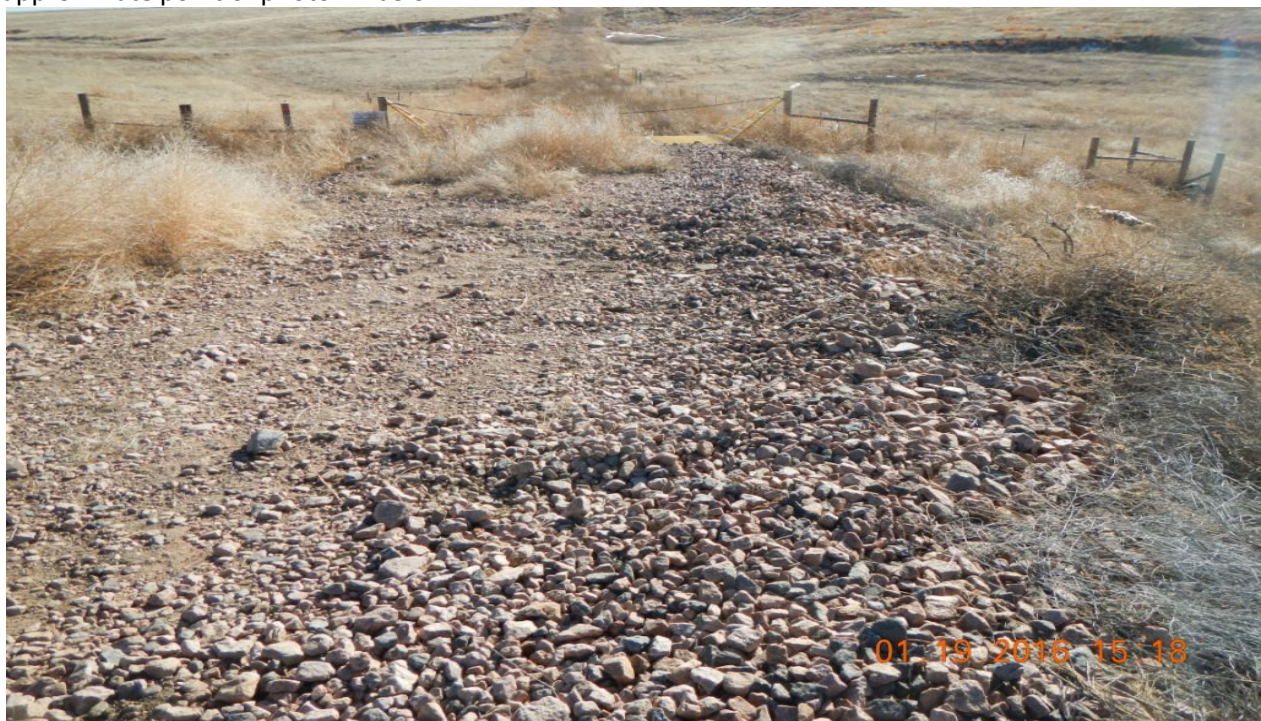
photo 2: Beginning of the access road facing south. Large rock/ tracking pad remains.

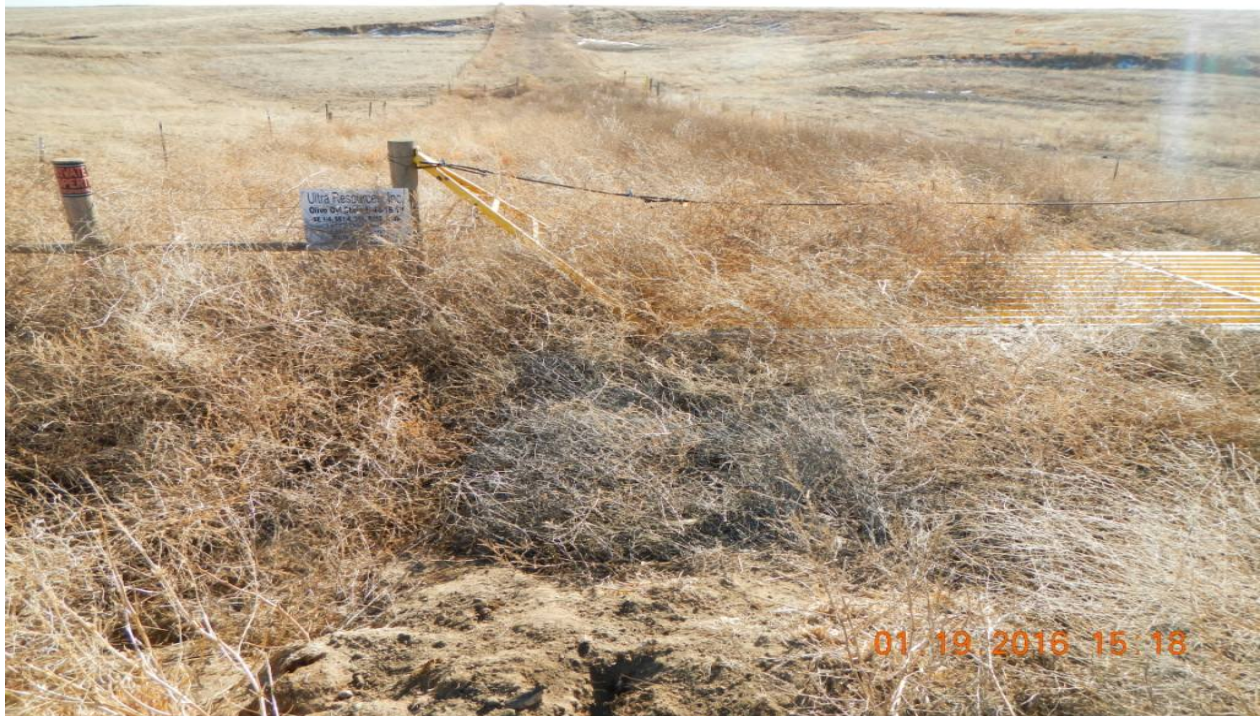
photo 3: Cattle guard remains at the beginning of the access road. Notice abundance of weed debris.

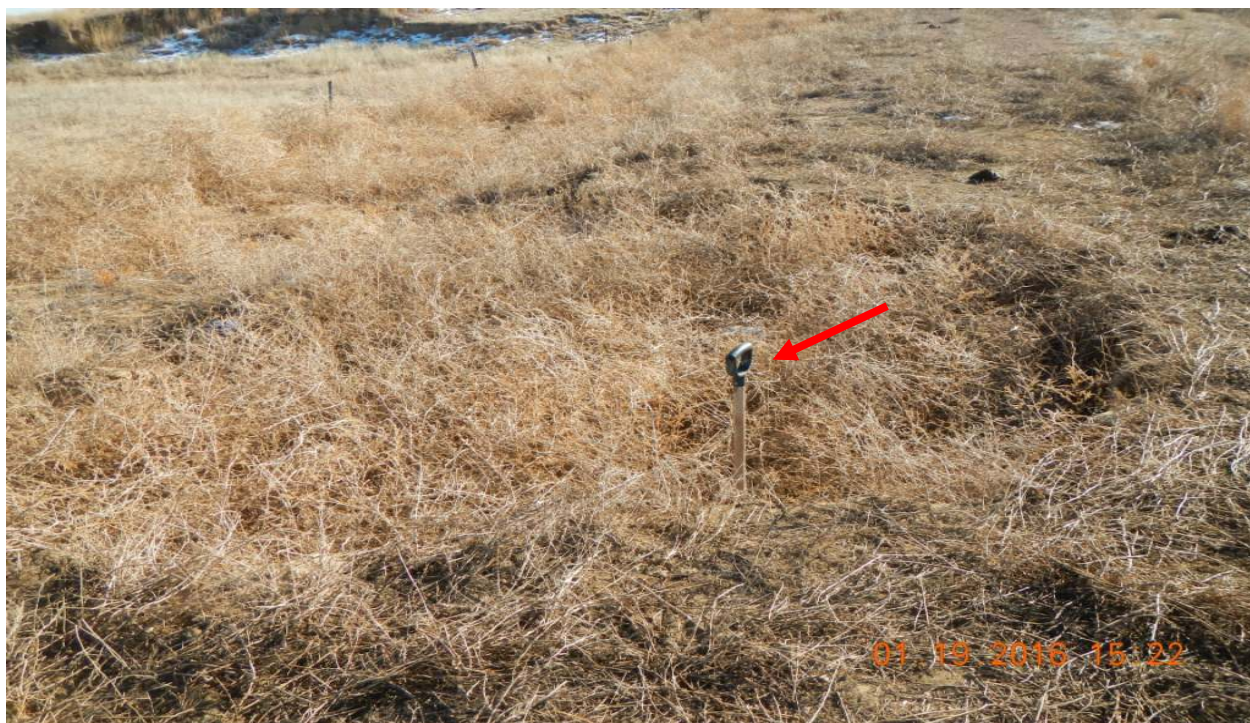
photo 5: An area of subsidence was noticed along the access road which is obscured by weed debris. Arrow indicates 3ft. shovel placed in the hole. Lat/Long: 38.74998,-104.55221

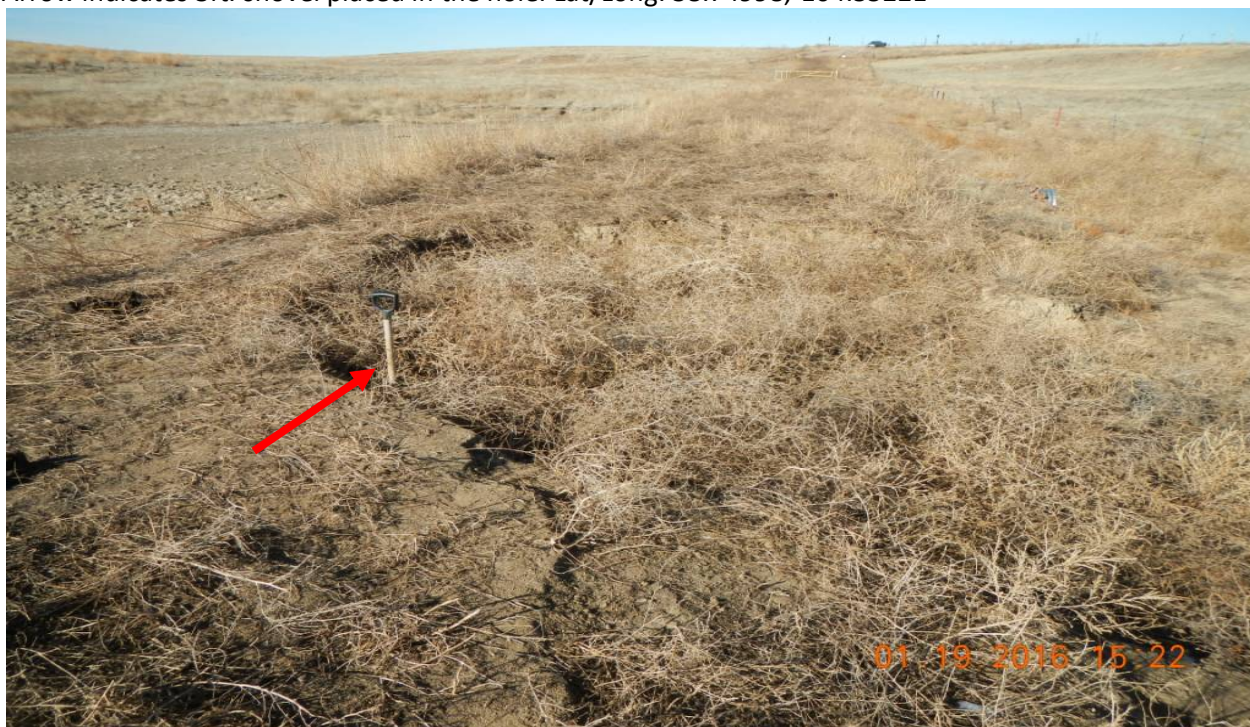
photo 6: Facing back towards the north at the area of subsidence along the access road. Arrow indicates 3ft. shovel placed in the hole. Lat/Long: 38.74998,-104.55221

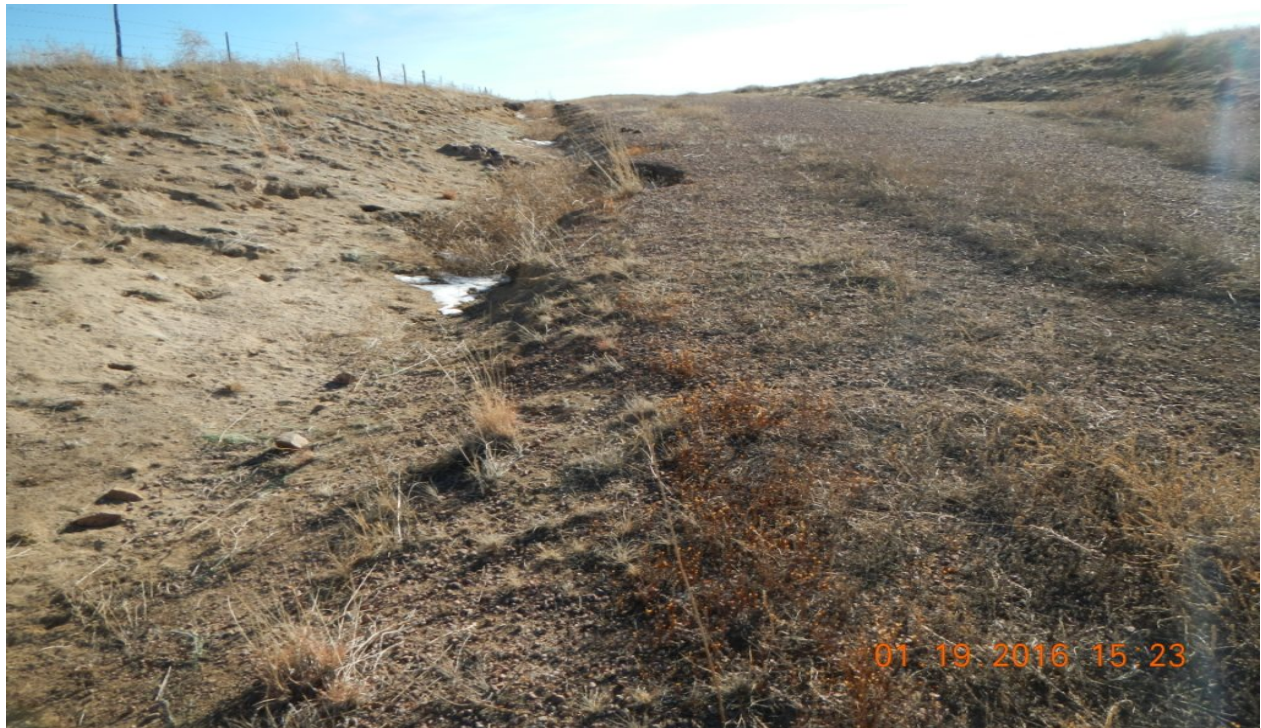
Photo 7: Facing south along the access road. Erosion is occurring along both sides of the access road in this area. Lat/Long: 38.74923,-104.55223

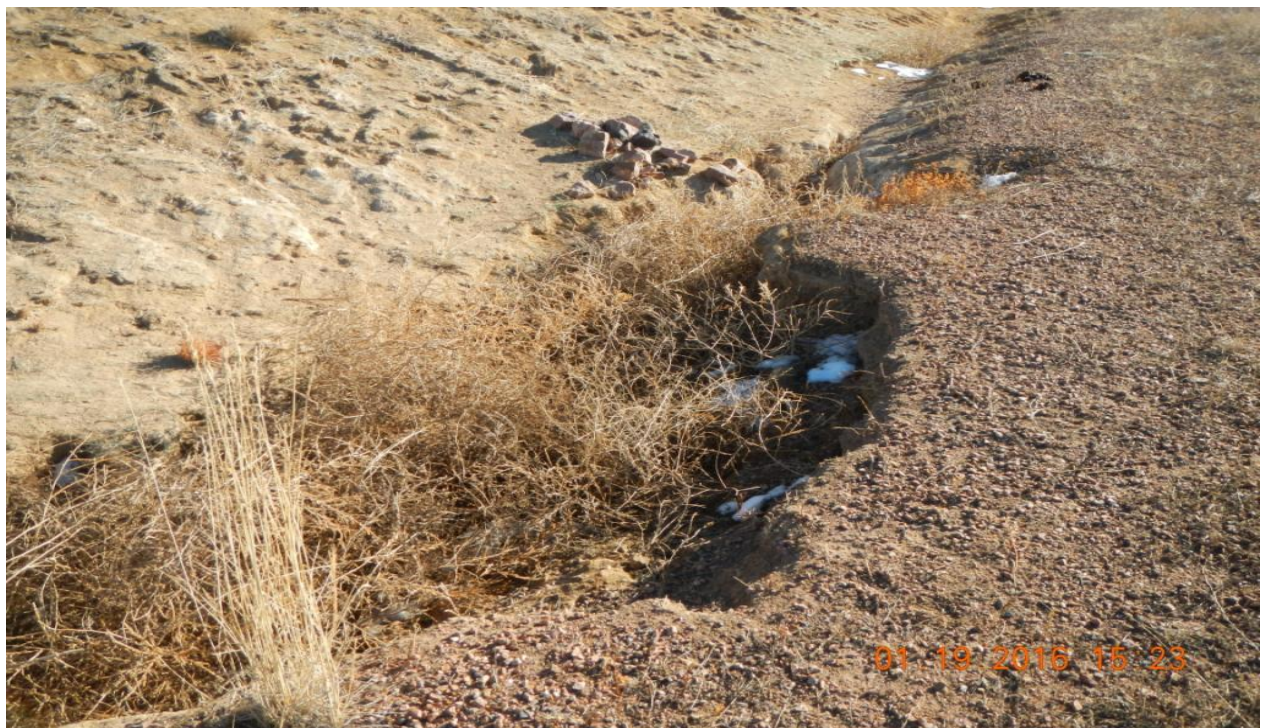
Photo 8: Erosion occurring along the east side of the access road. Rock check dams have been washed away.

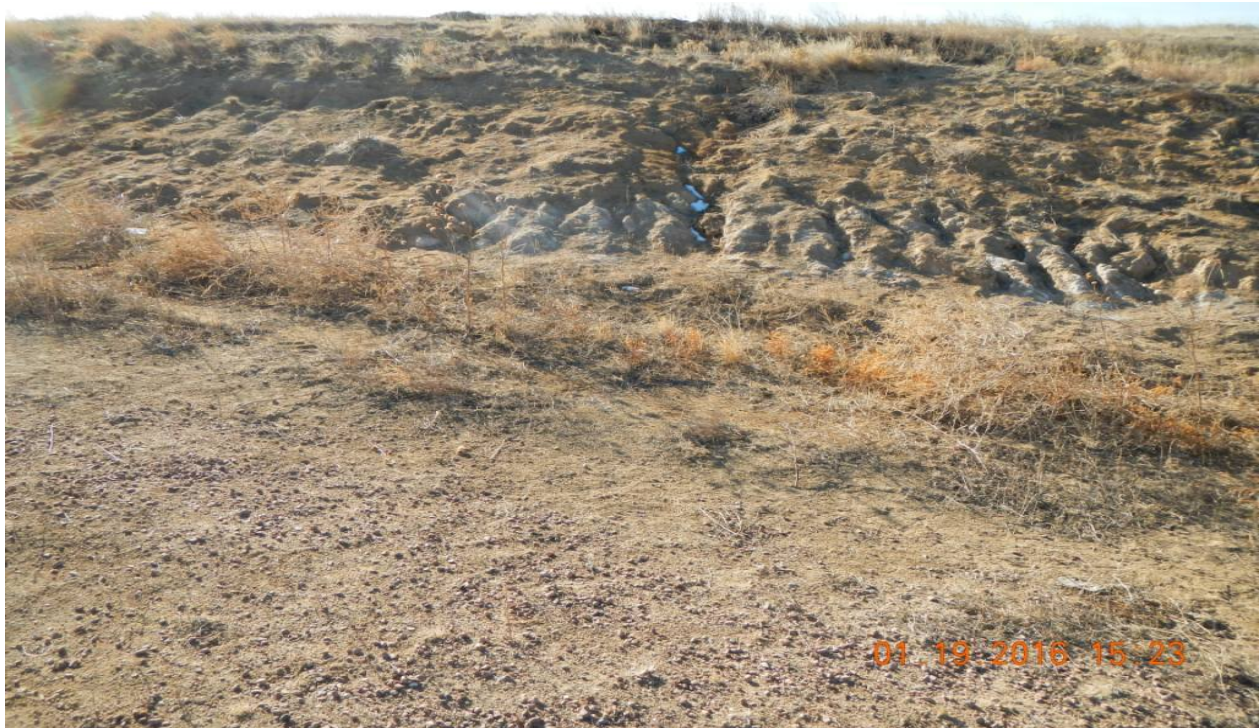
Photo 9: Erosion occurring along the west side of the access road.

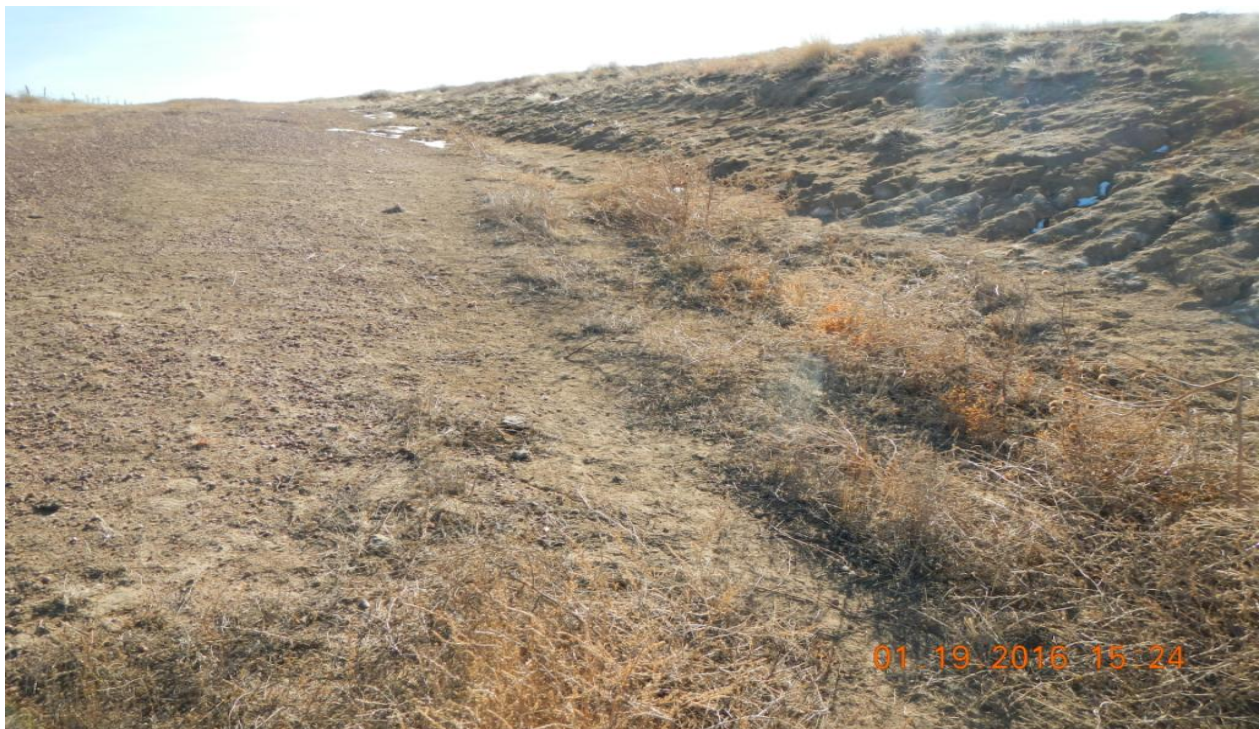
Photo 10: Erosion occurring along the west side of the access road.

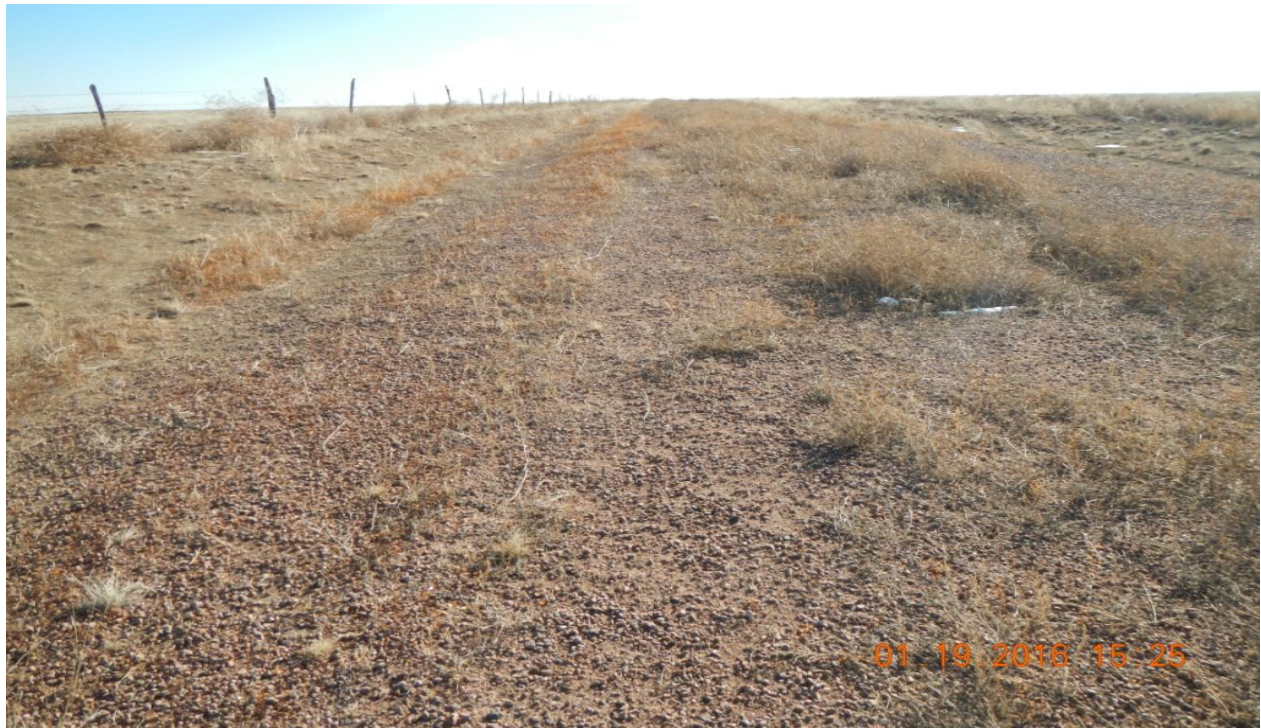
Photo 11: Facing south along the access road. Access road has not been reclaimed.

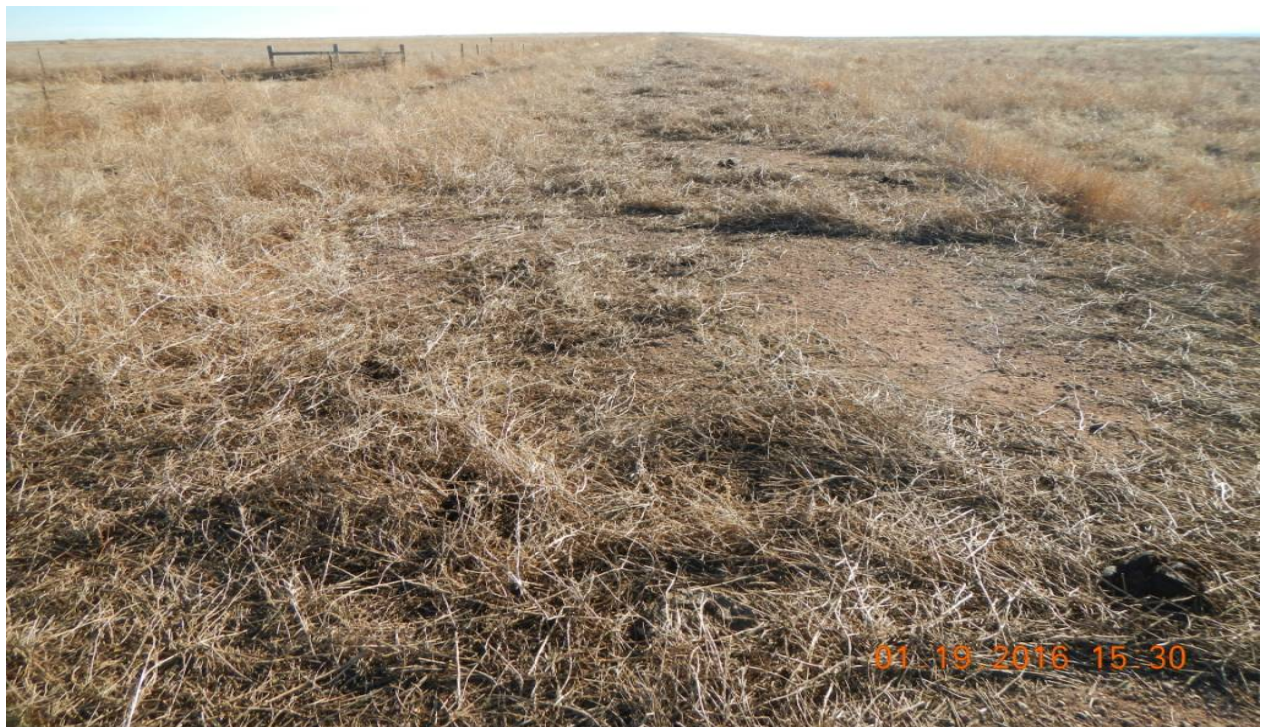
Photo 12: Facing south along the access road. Weed debris has accumulated along the road.

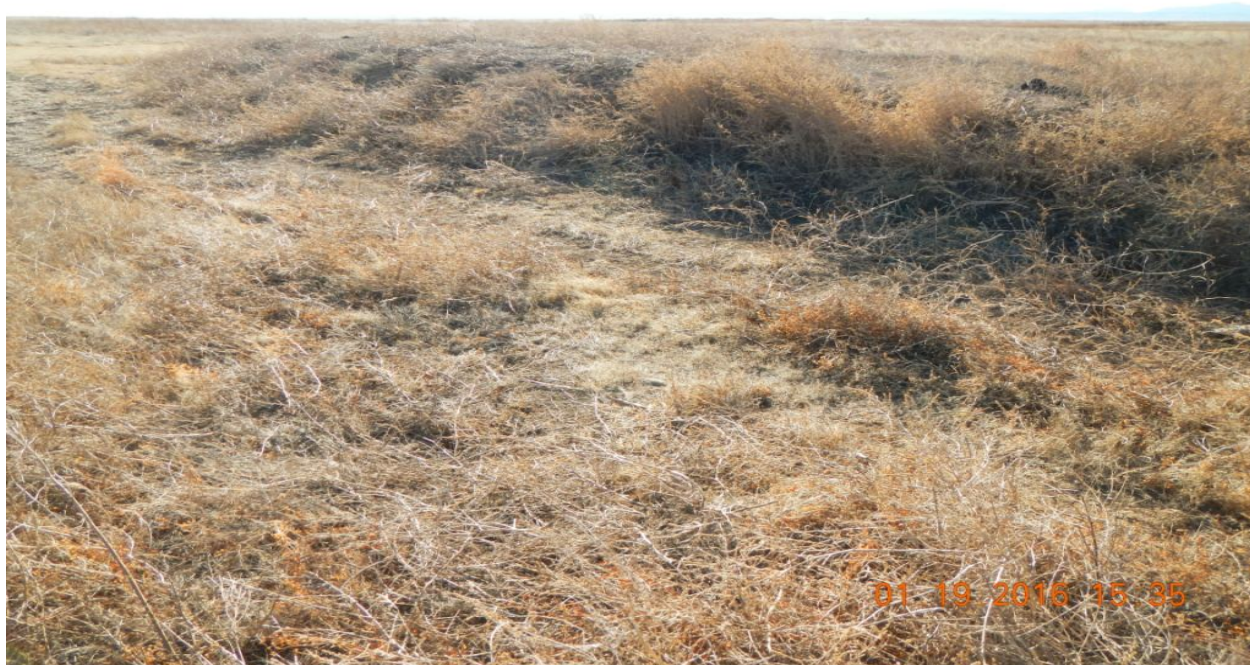
Photo 15: A dirt/gravel pile approximately 100'x20' remains near the access road.

Lat/Long:38.74037,-104.55209

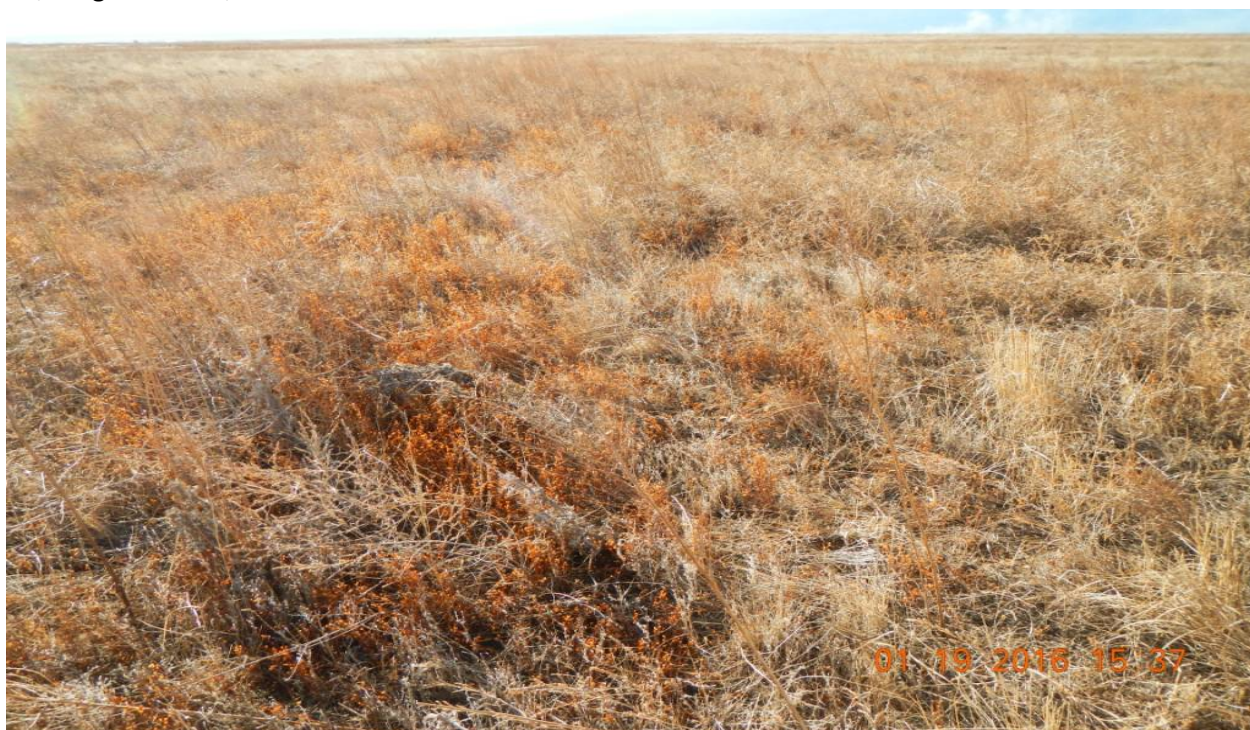
Photo 16: Facing southwest at the point where access road has been reclaimed. However, there is an abundance of weed growth (Russian thistle) along this area.

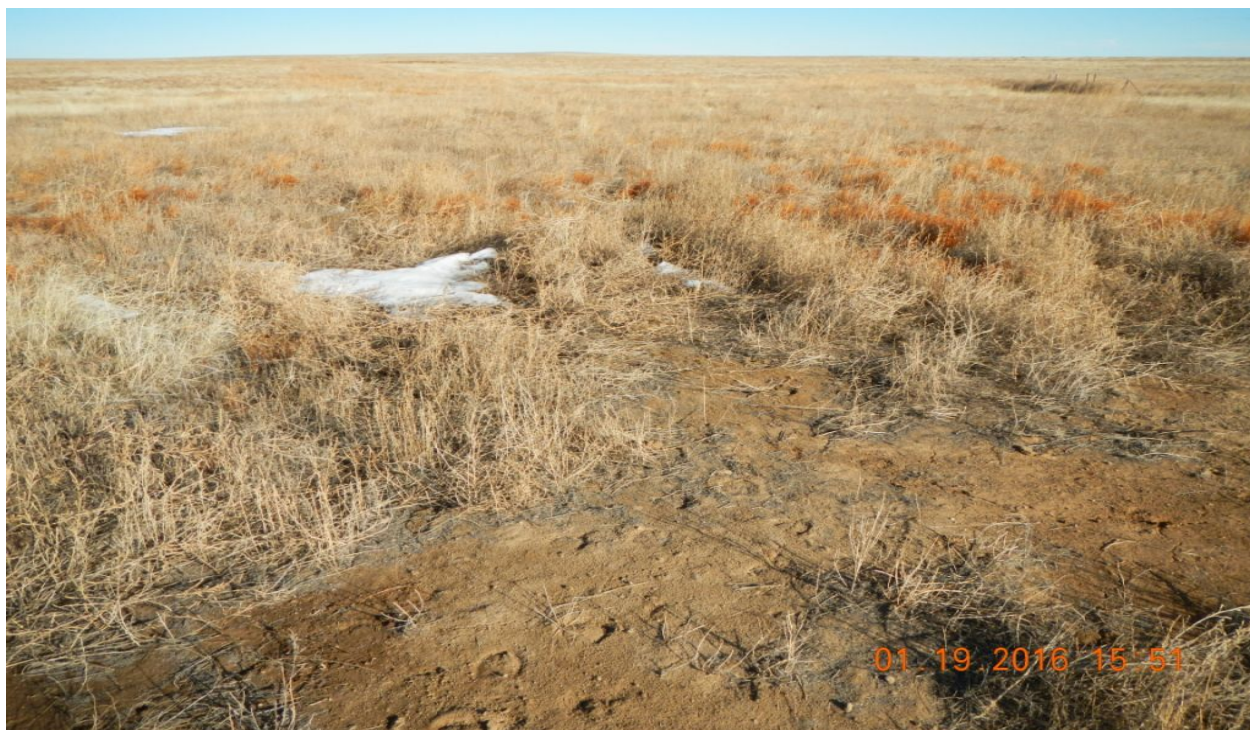
Photo 17: Facing east toward the area of disturbance northwest of the location. This area was reclaimed but is predominately weed growth (Russian thistle). See aerial photo #13 for reference.

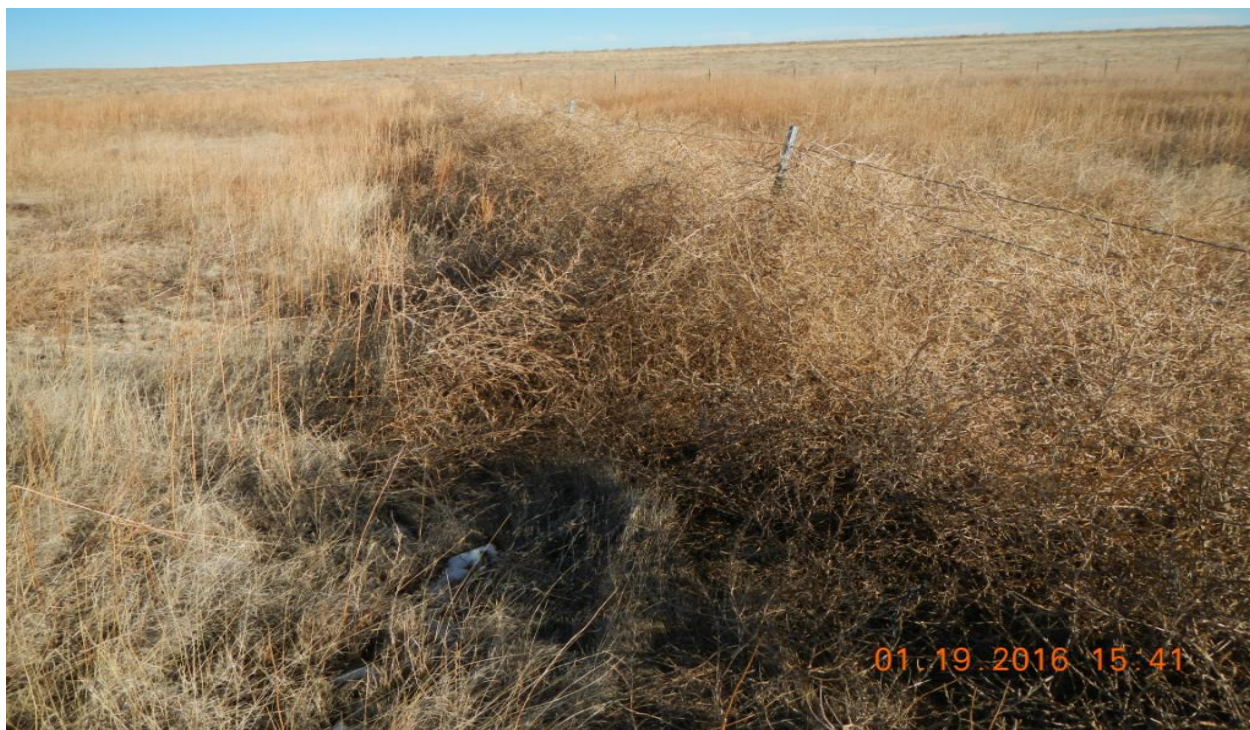
Photo 19: Weed debris has accumulated along the fence line around the location.

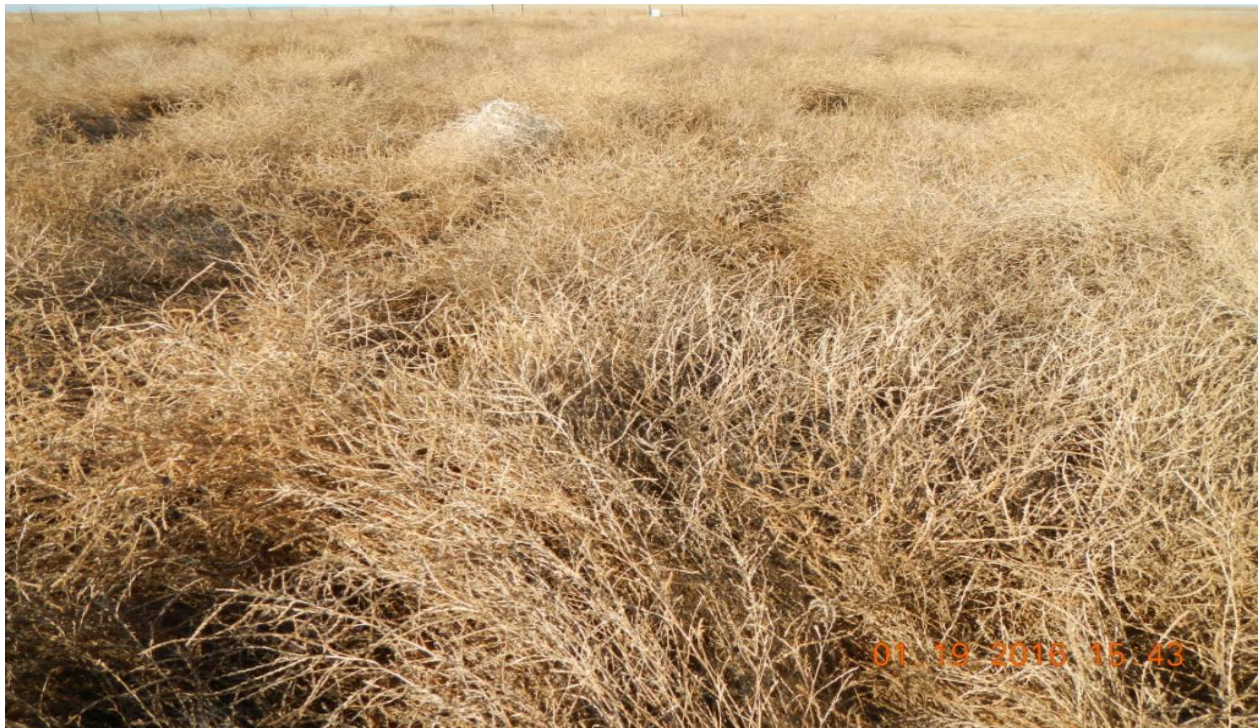
Photo 21: Center of the location facing northwest. Notice vegetation growth is predominately weeds.

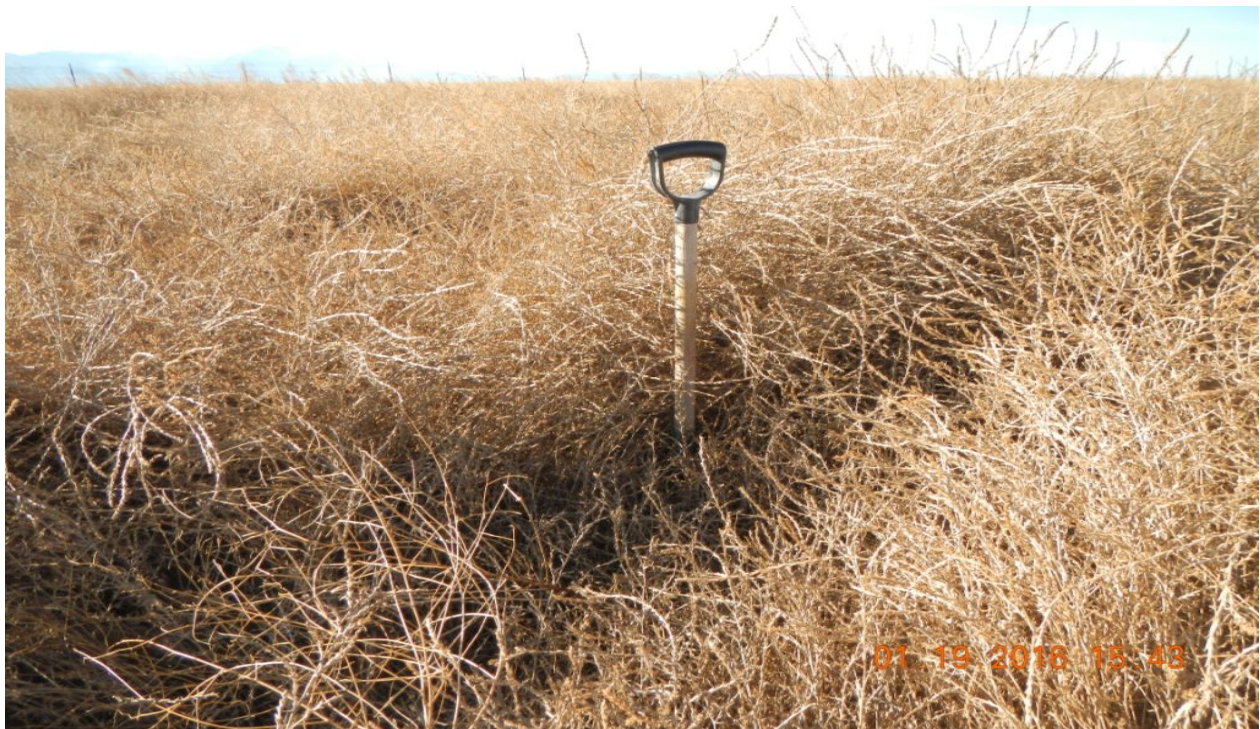
Photo 22: Center of the location facing west. Shovel (3ft.) indicates weed debris (Russian thistle) height and accumulation.

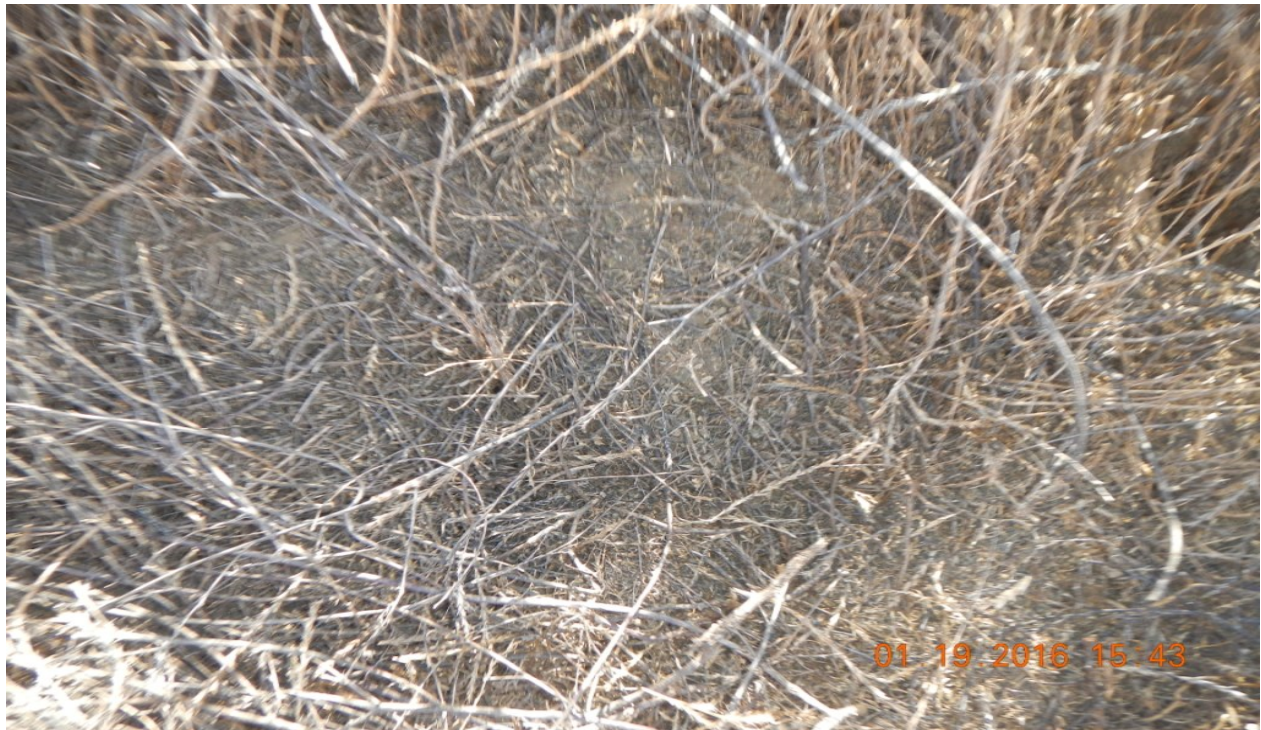
Photo 23: No desirable vegetation was noticed underneath the weed debris.

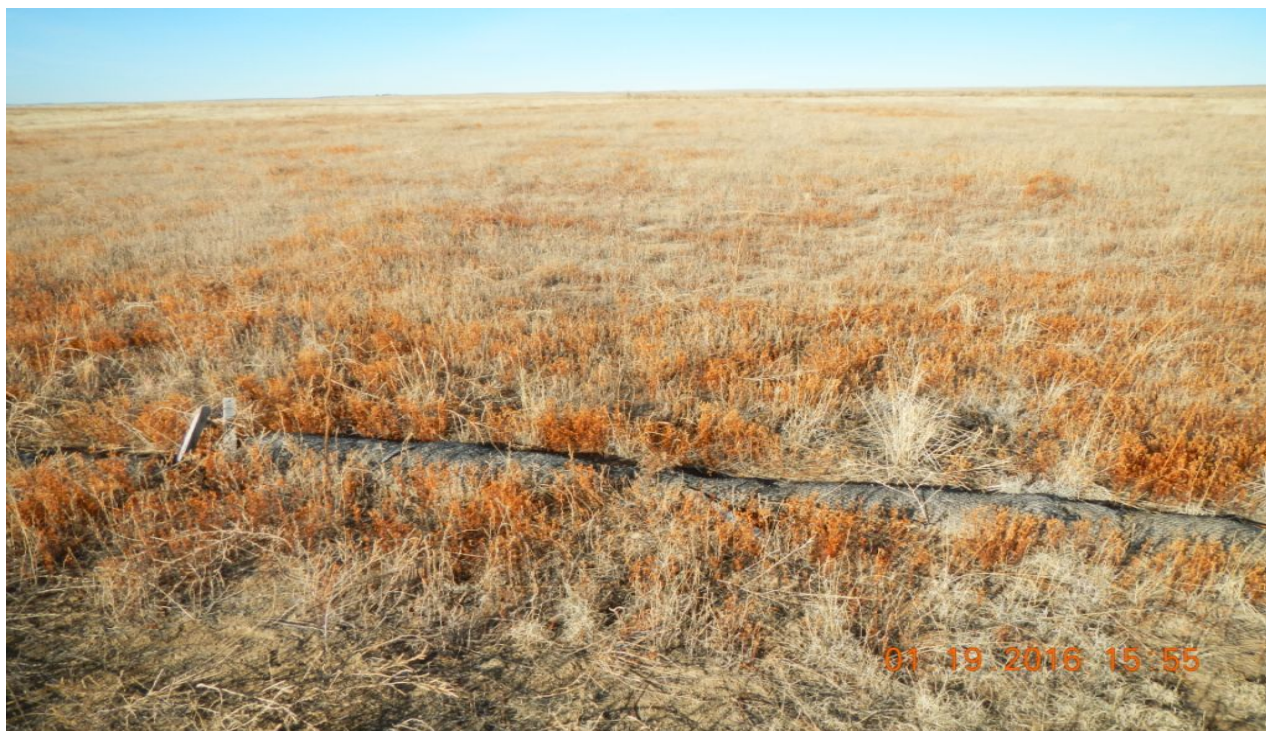
Photo 28: Facing north at the disturbance area south of the fenced location. See aerial photo #13. Degraded wattles remain around this area.

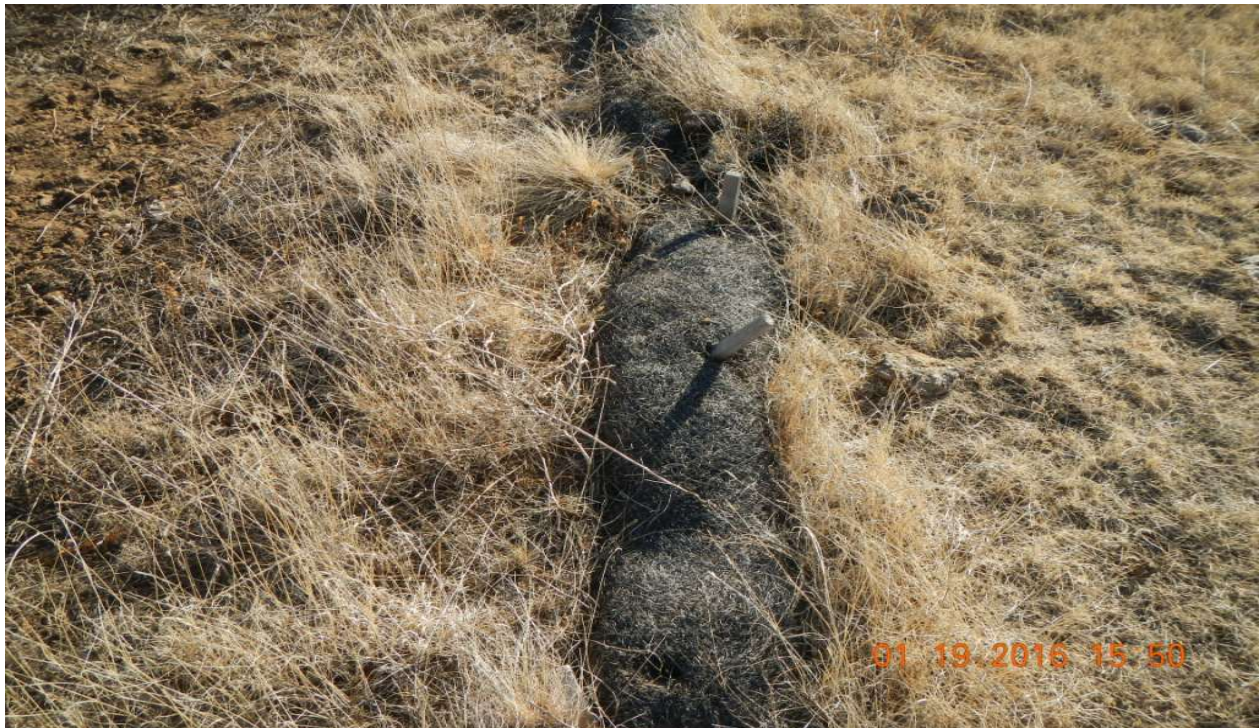
Photo 29: Degraded wattles remain around the perimeter of disturbance areas.

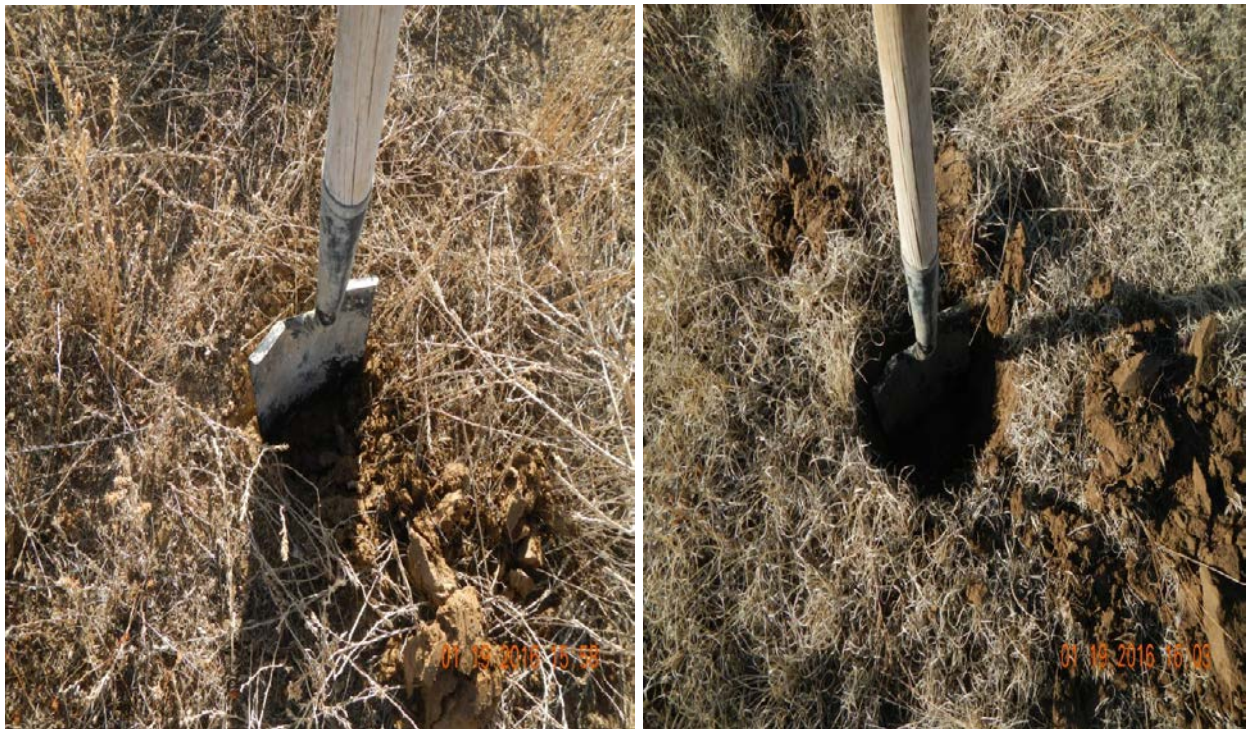
Photo 30: Soil compaction comparison indicated soils are more compacted at the disturbed location in comparison to the undisturbed soils. Photo on left is at location. Photo on the right is off location.
