## Abandoned Location Inspection

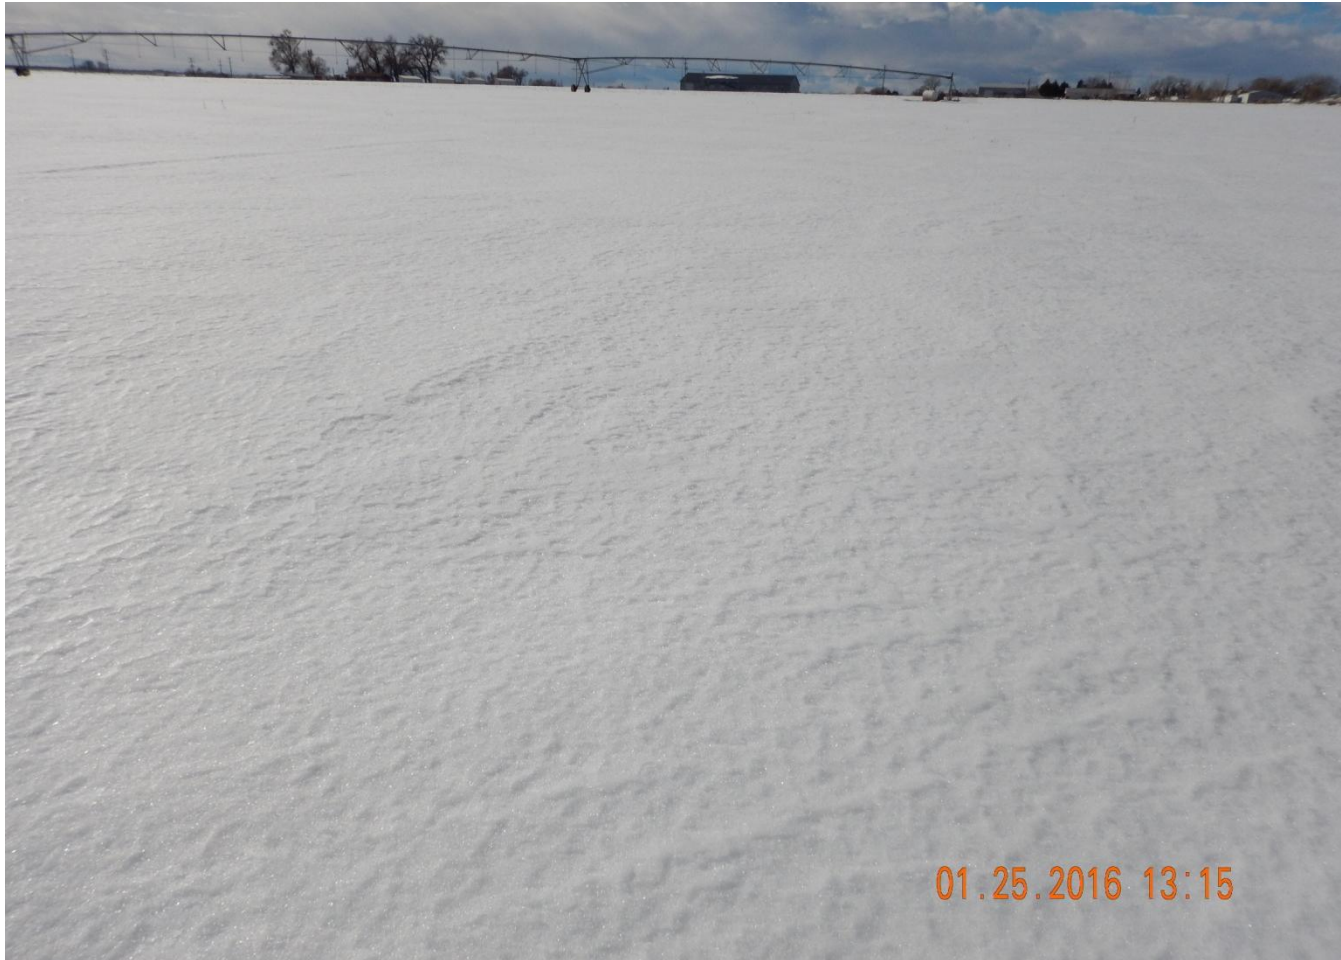
**Photo 1.** Photo taken from center of location, facing West. It appears the location was never built.

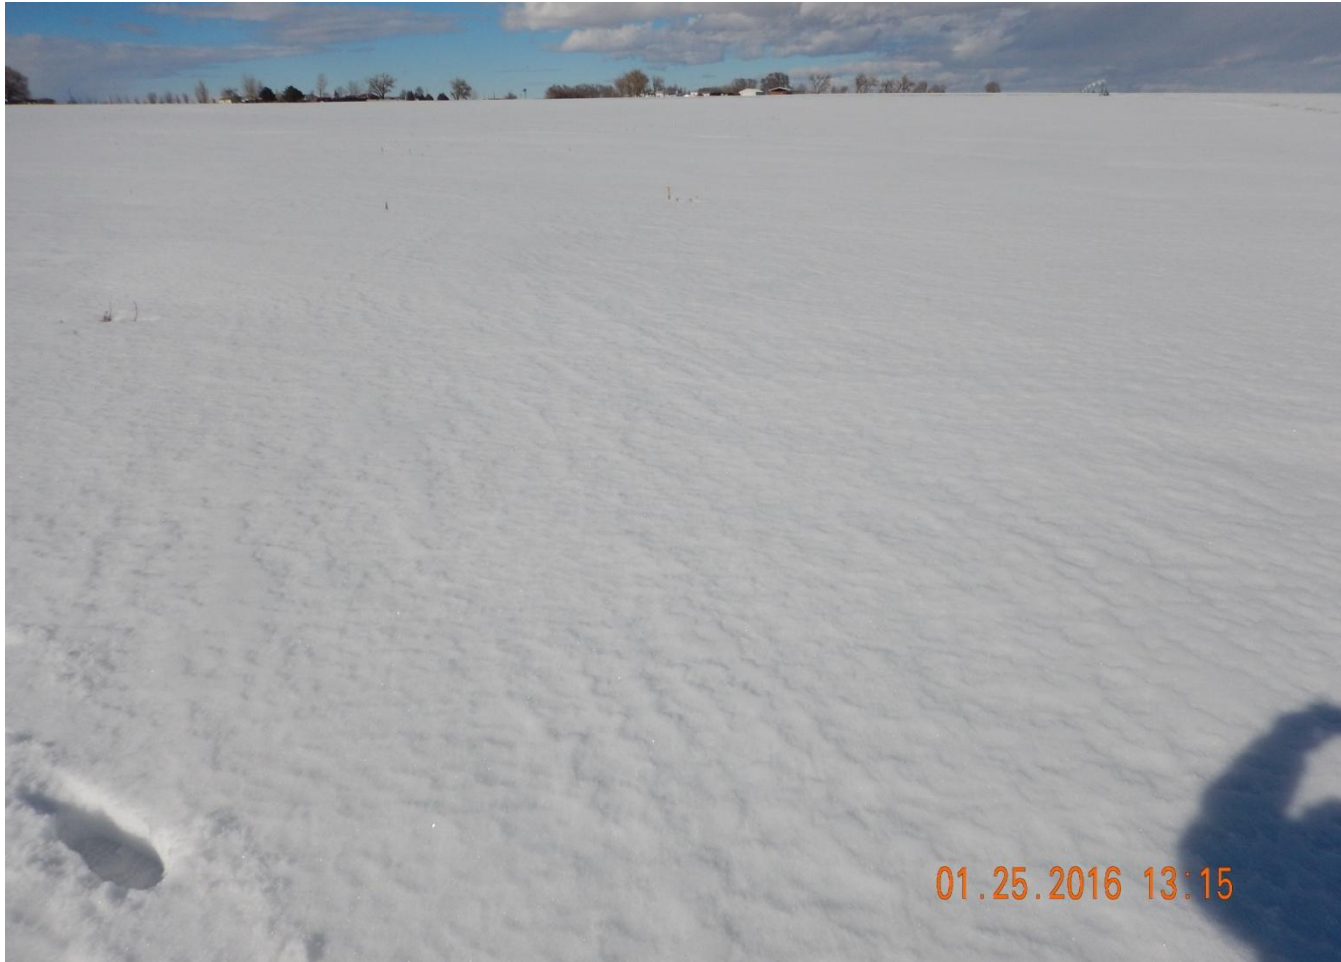
**Photo 2.** Photo taken from center of location, facing North. It appears the location was never built.

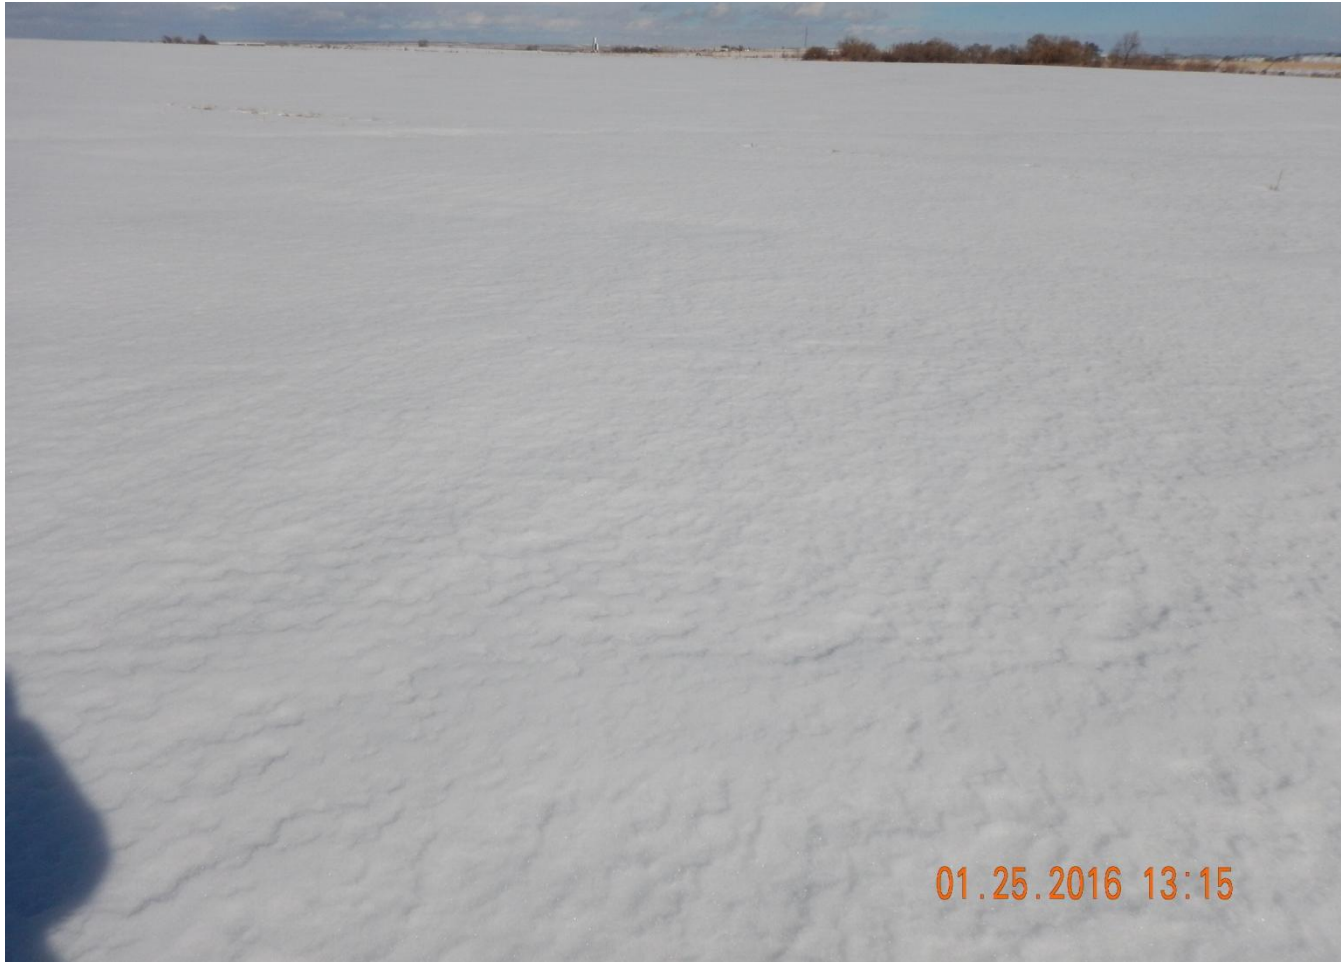
**Photo 3.** Photo taken from center of location, facing East. It appears the location was never built.

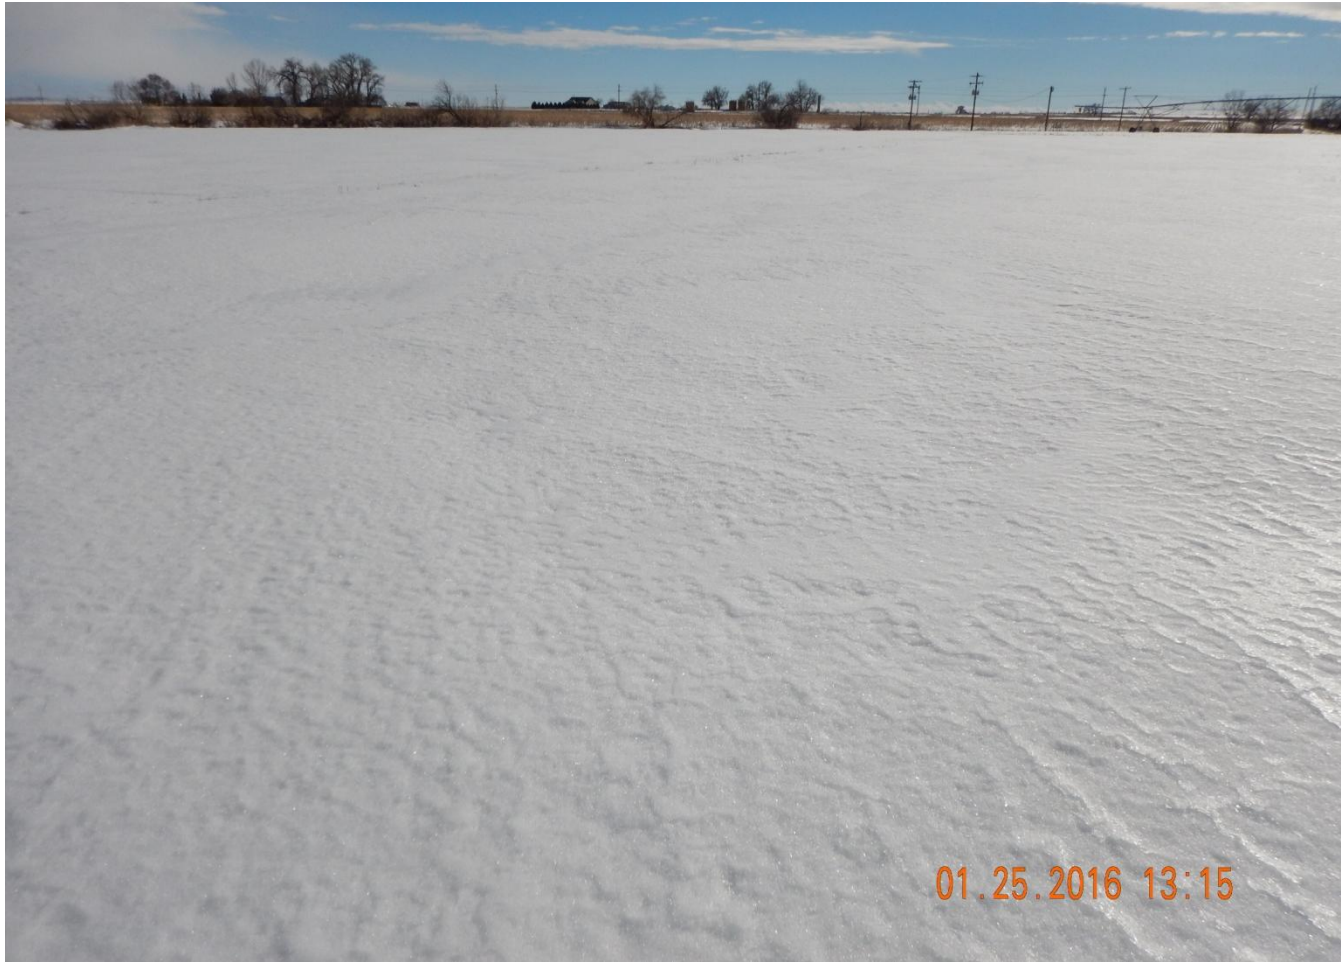
**Photo 4.** Photo taken from center of location, facing South. It appears the location was never built.

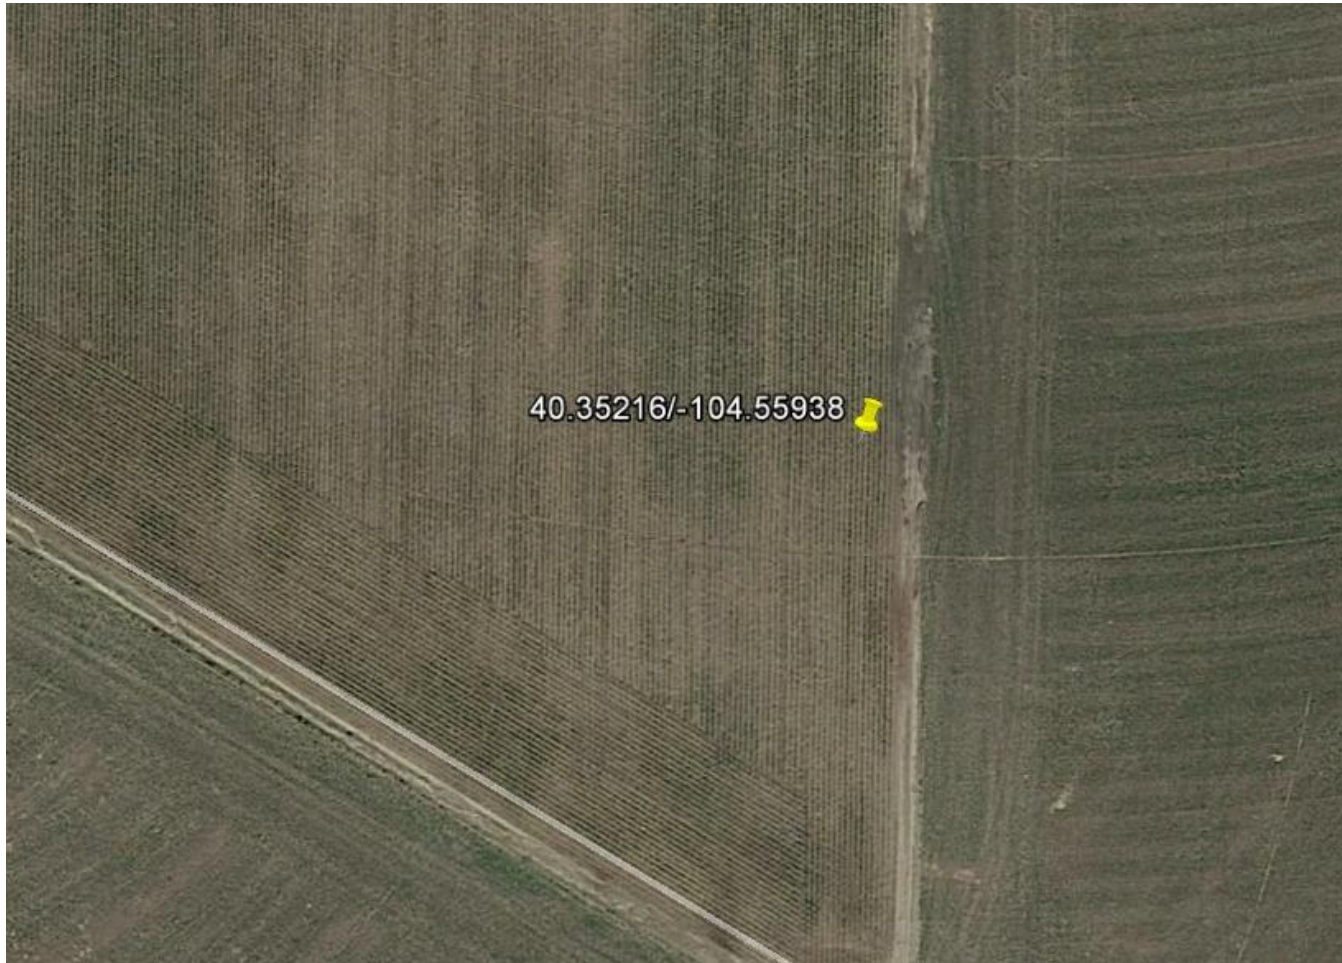
**Photo 5.** Google Earth aerial photo taken 6/19/2014. It appears the location was never built based off aerial imagery and field observations.
