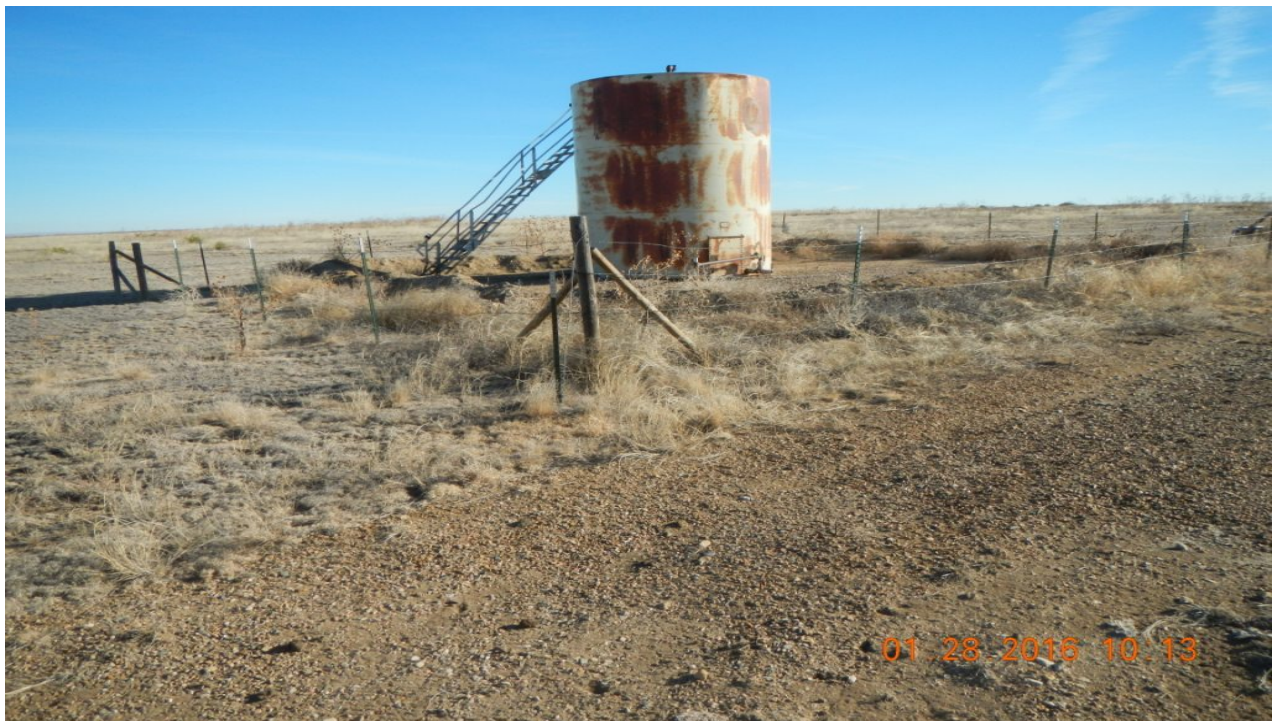
photo 4: Tank battery remains near the west side of the location

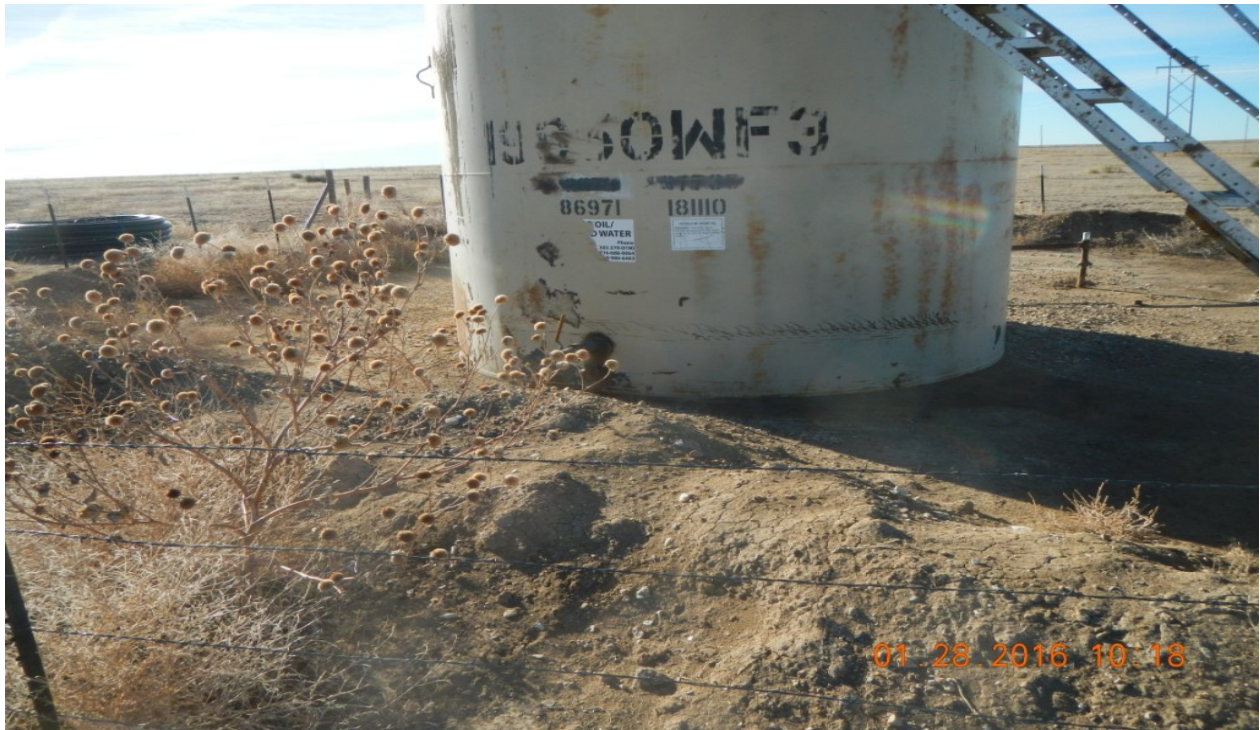
photo 5: Tank was not properly labeled and did not have a sign. Tank does not appear to be in use.

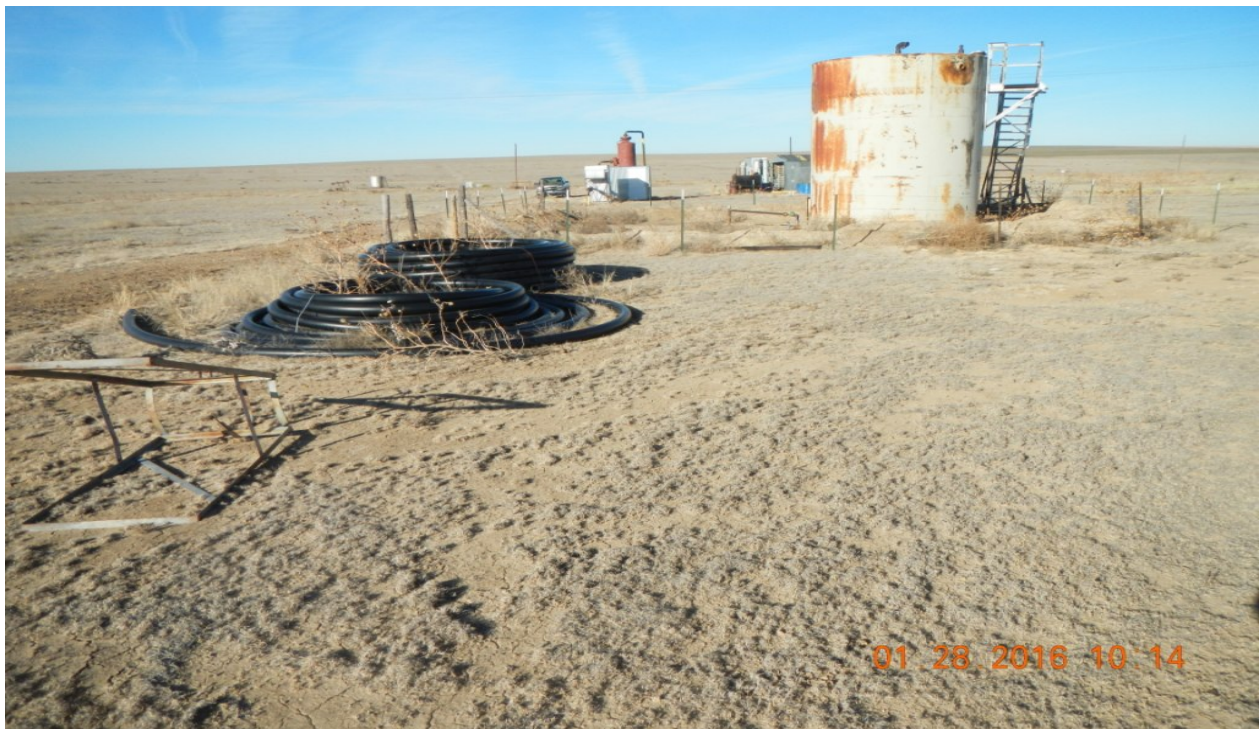
photo 6: Facing west. Unused equipment is being stored near the tank battery.

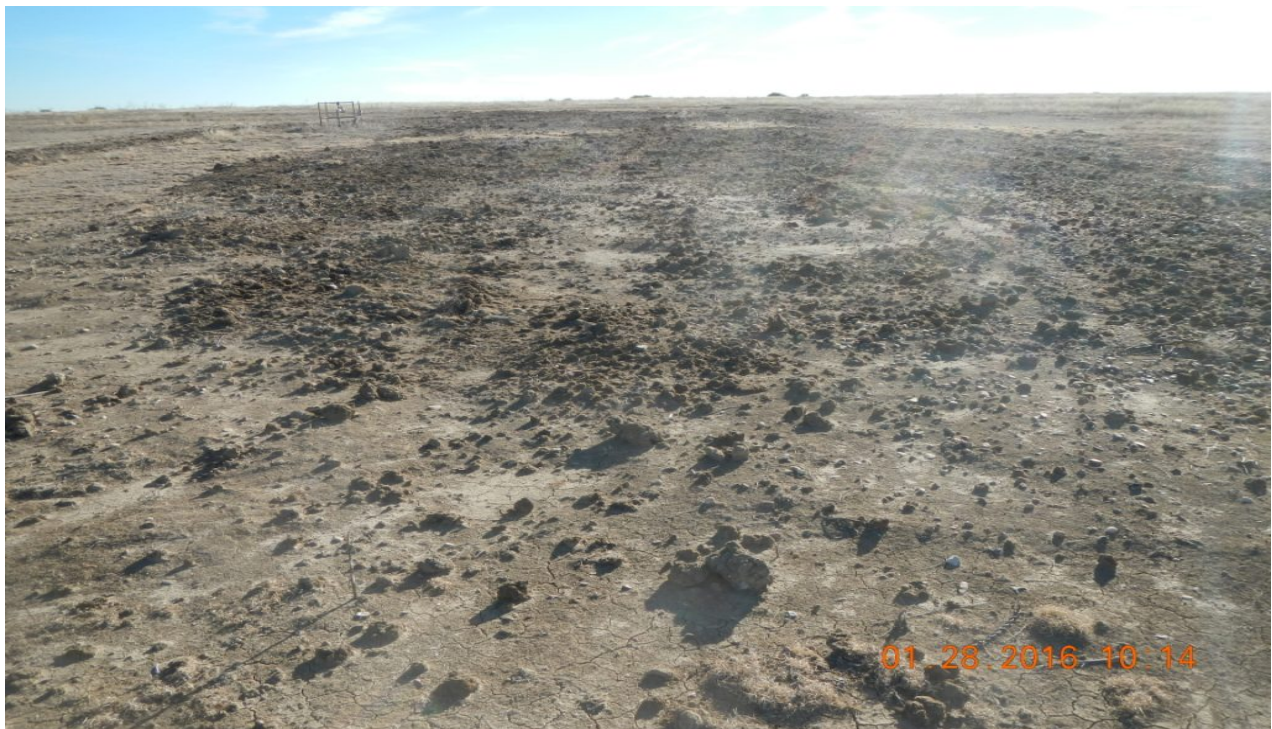
photo 8: Facing east toward the location. Manure has been spread over the location.

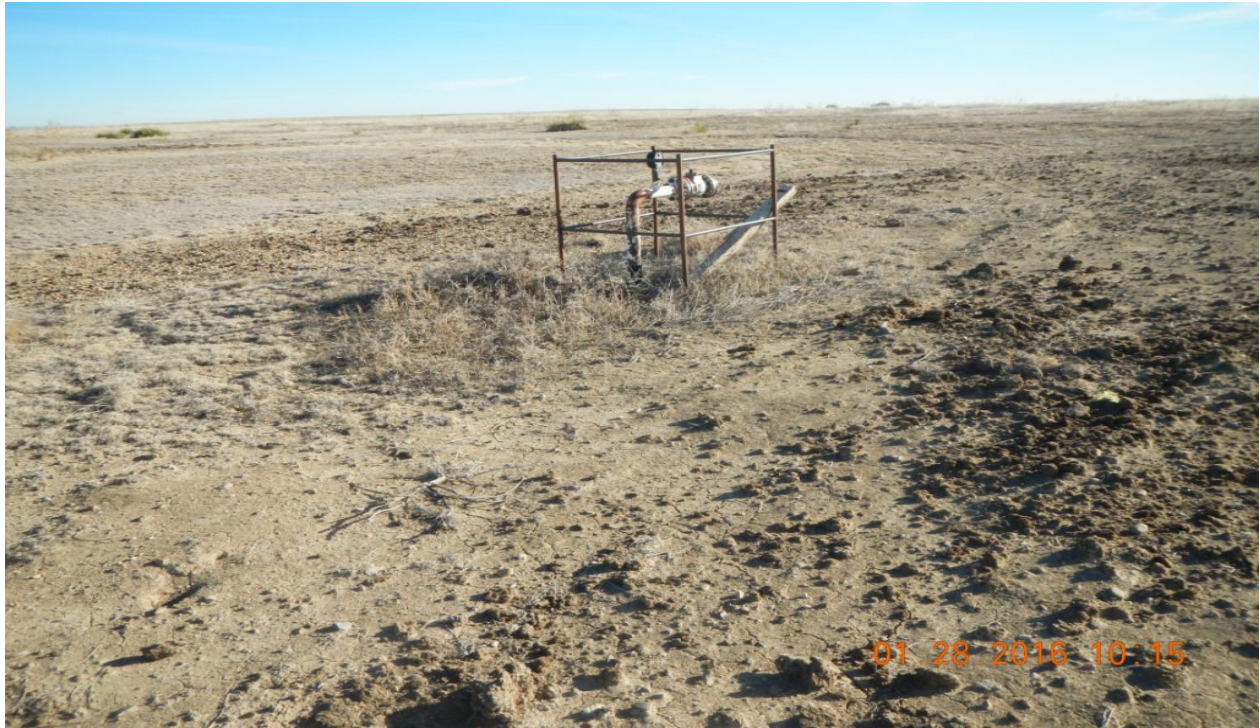
photo 9: Pipe riser remains at the center of the location. Lat/Long:37.95992,-102.50066

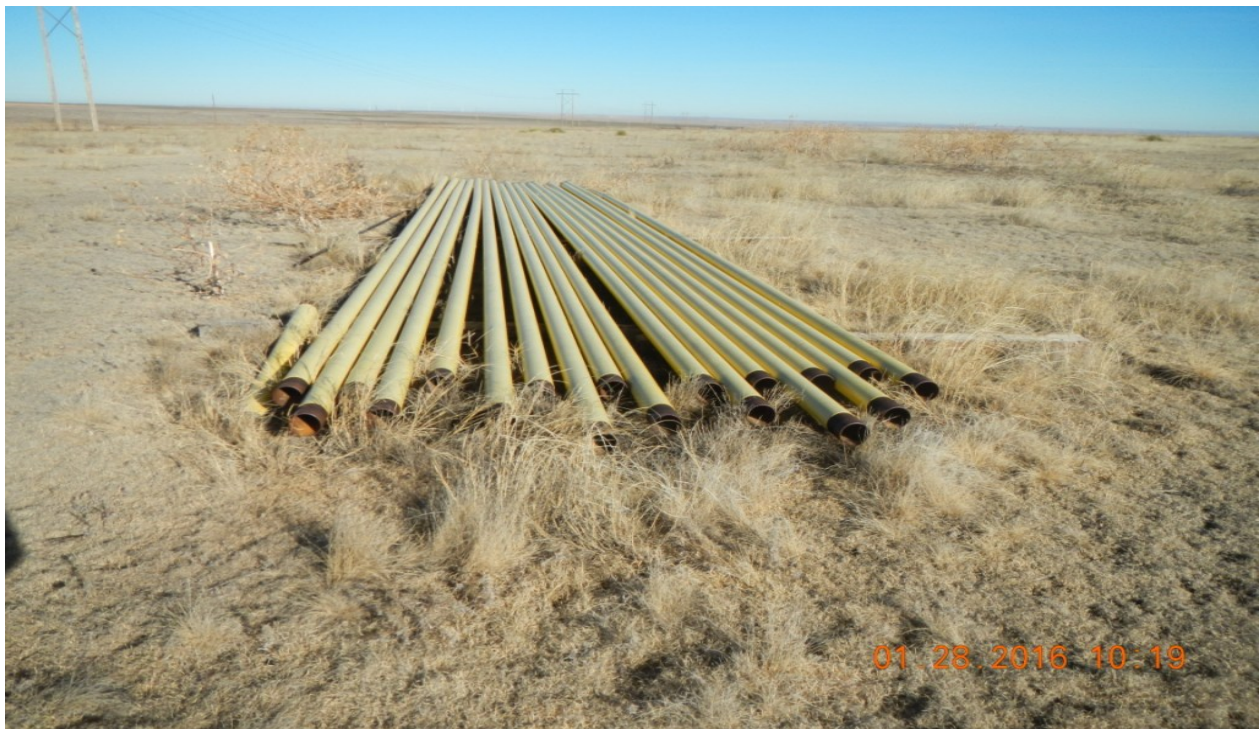
photo 12: Unused pipe was found between the compressor and the tank battery.
