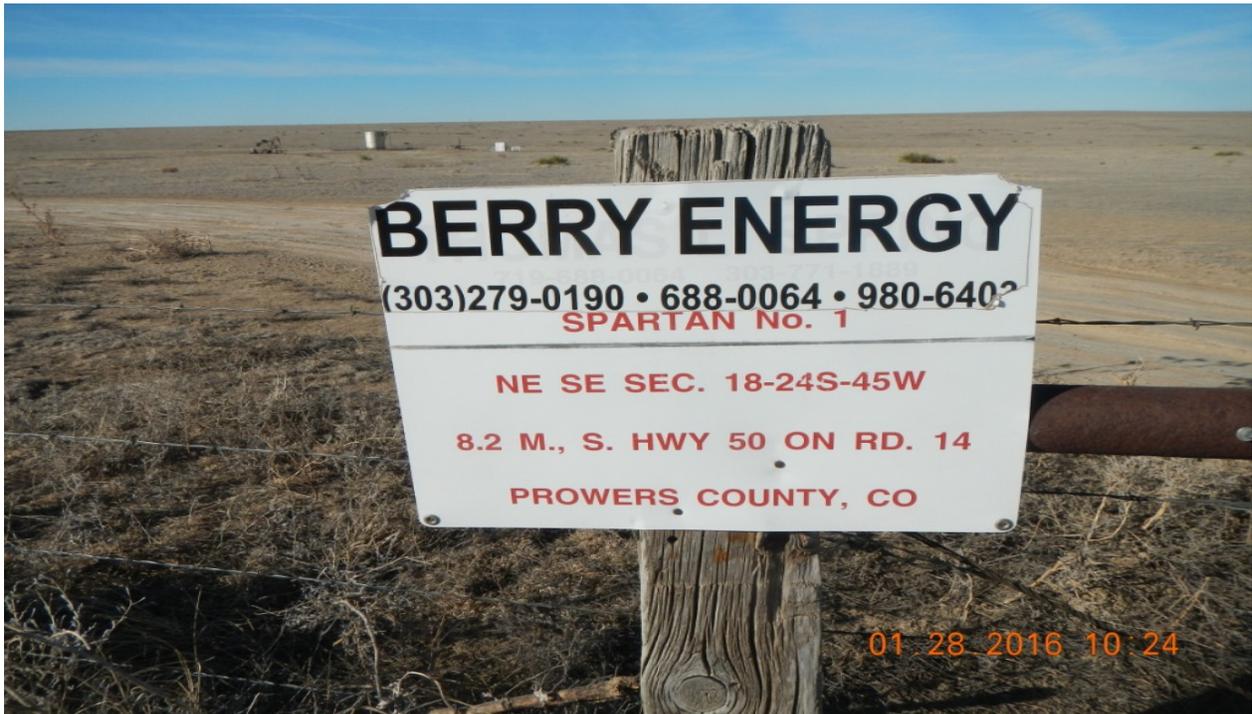
**photo 1:** Well sign at the beginning of the access road at the county road.

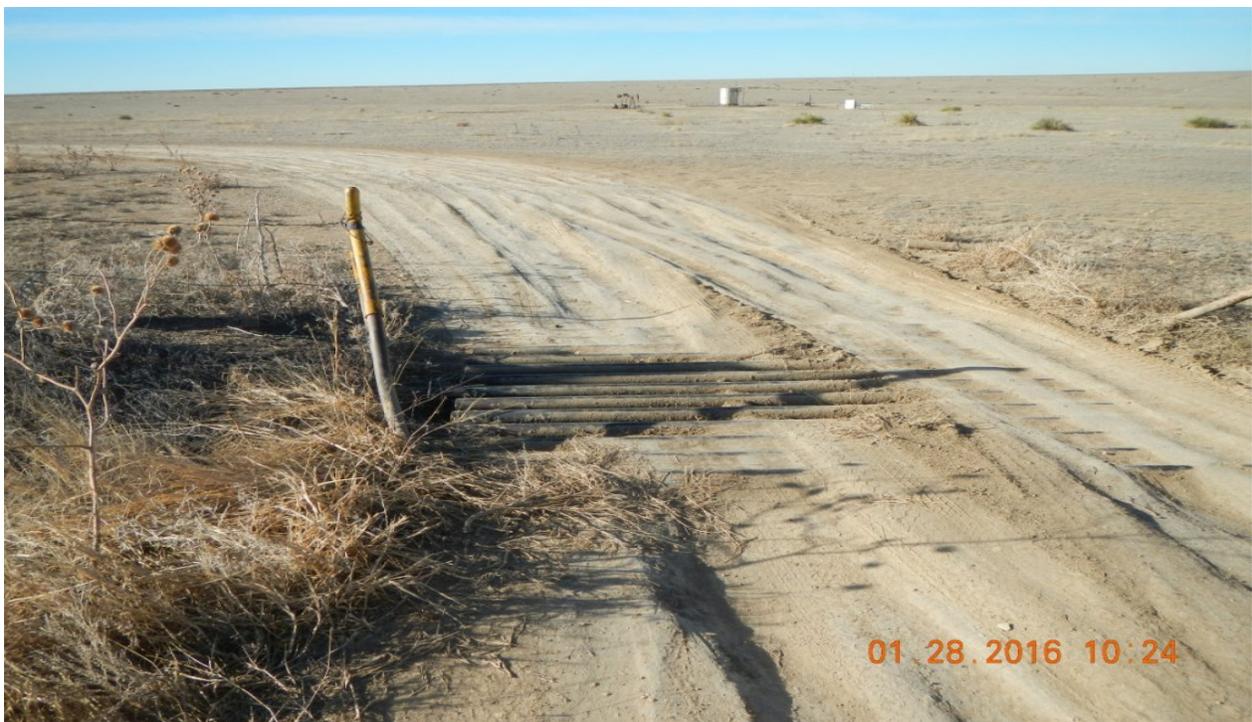
**photo 2:** Beginning of the access road facing southwest.

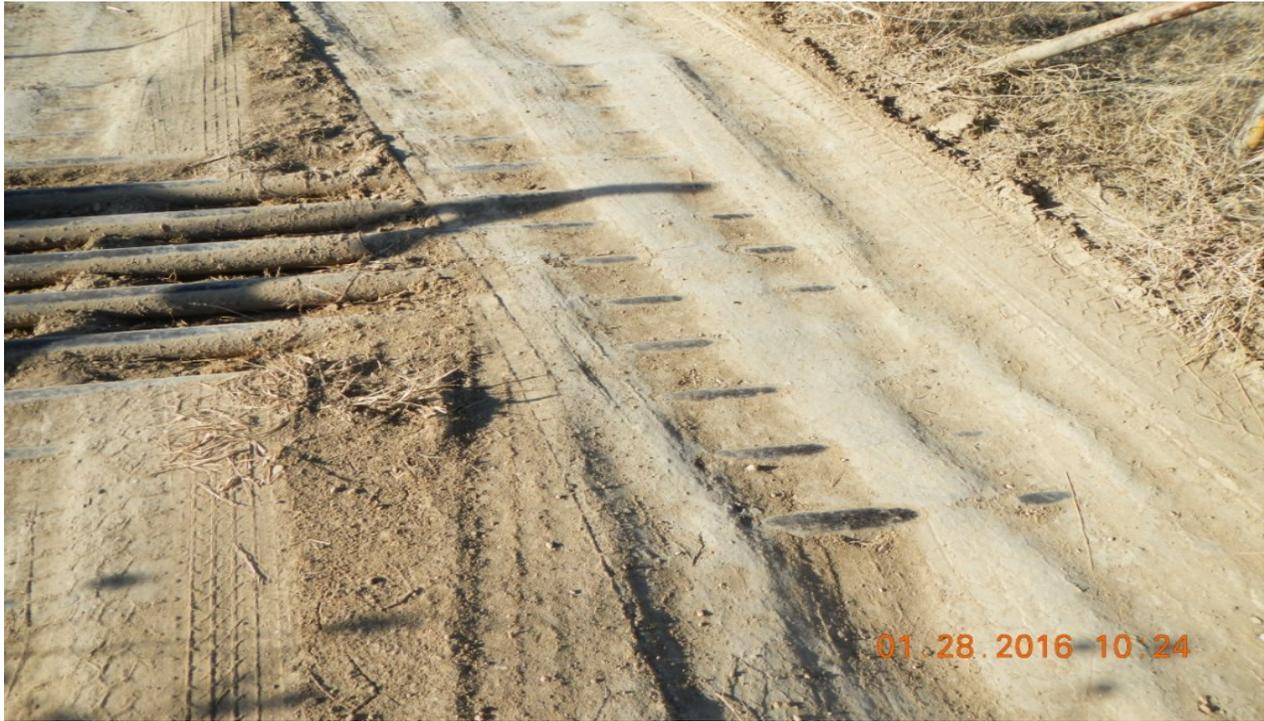
**photo 3:** Cattle guard at beginning of the access road is not maintained.

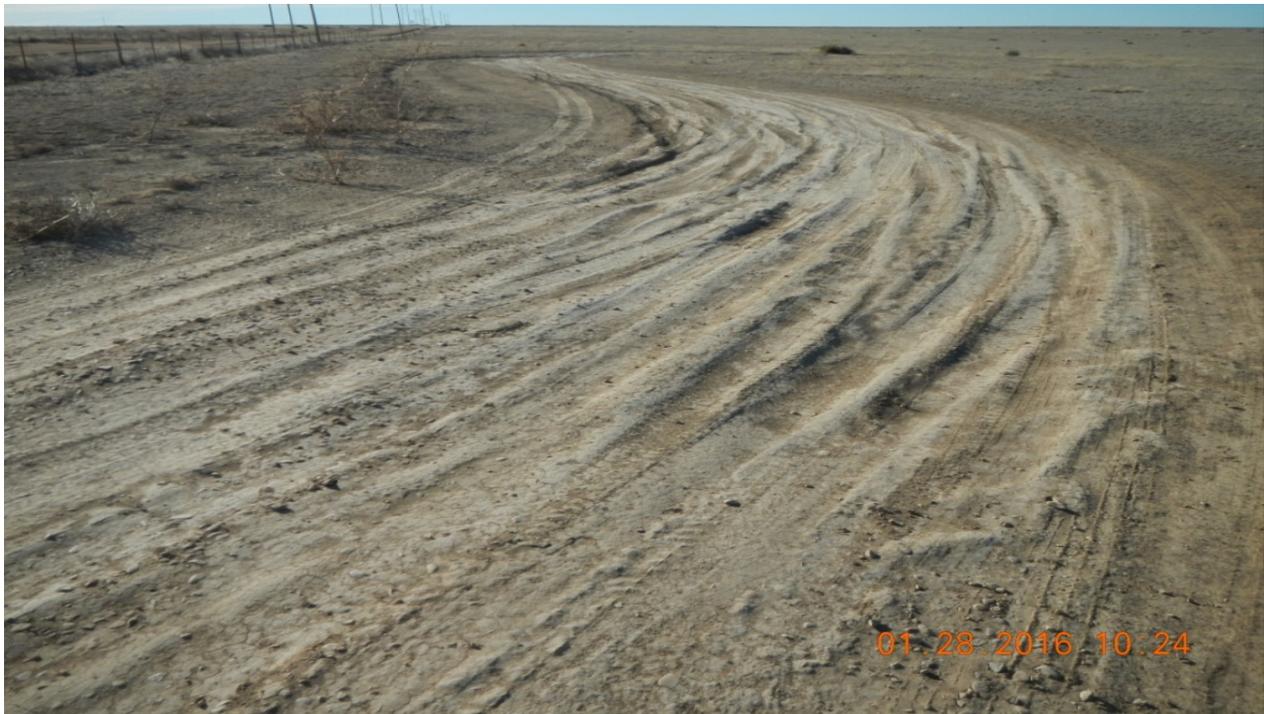
**photo 4:** Evidence of rutting occurring along the access road.

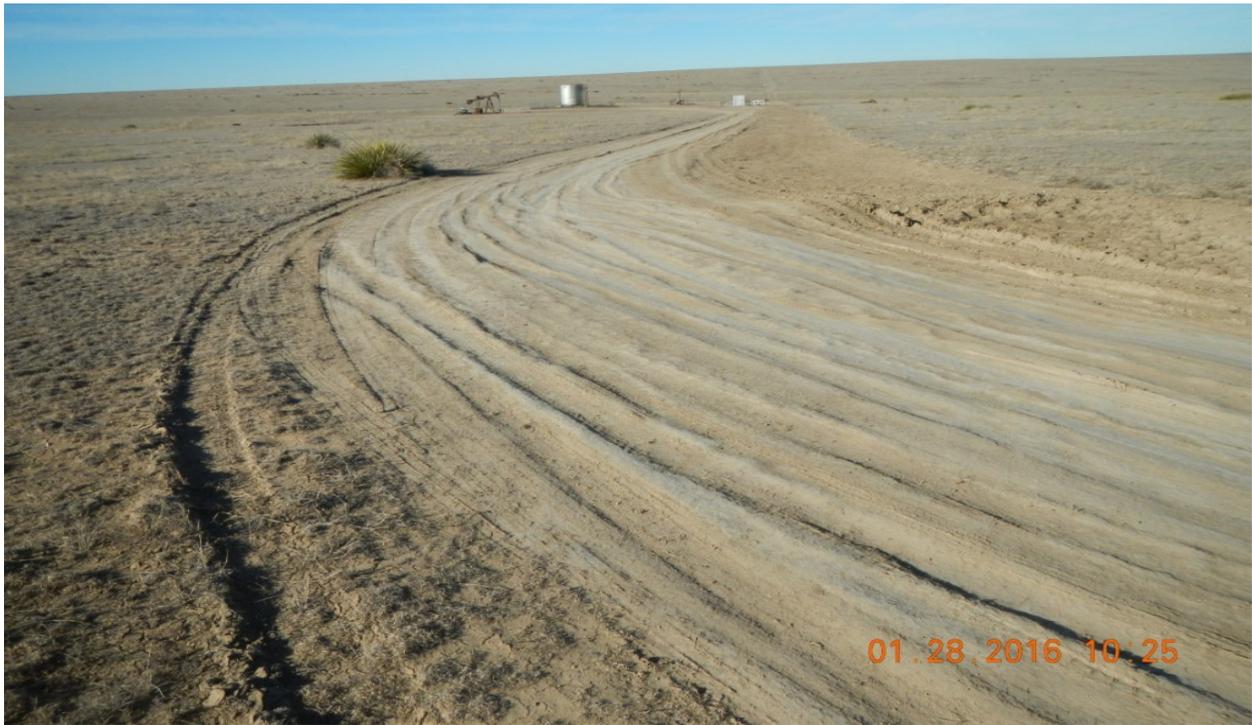
**photo 5:** Access is not being restricted along the access road. Evidence of rutting exists.

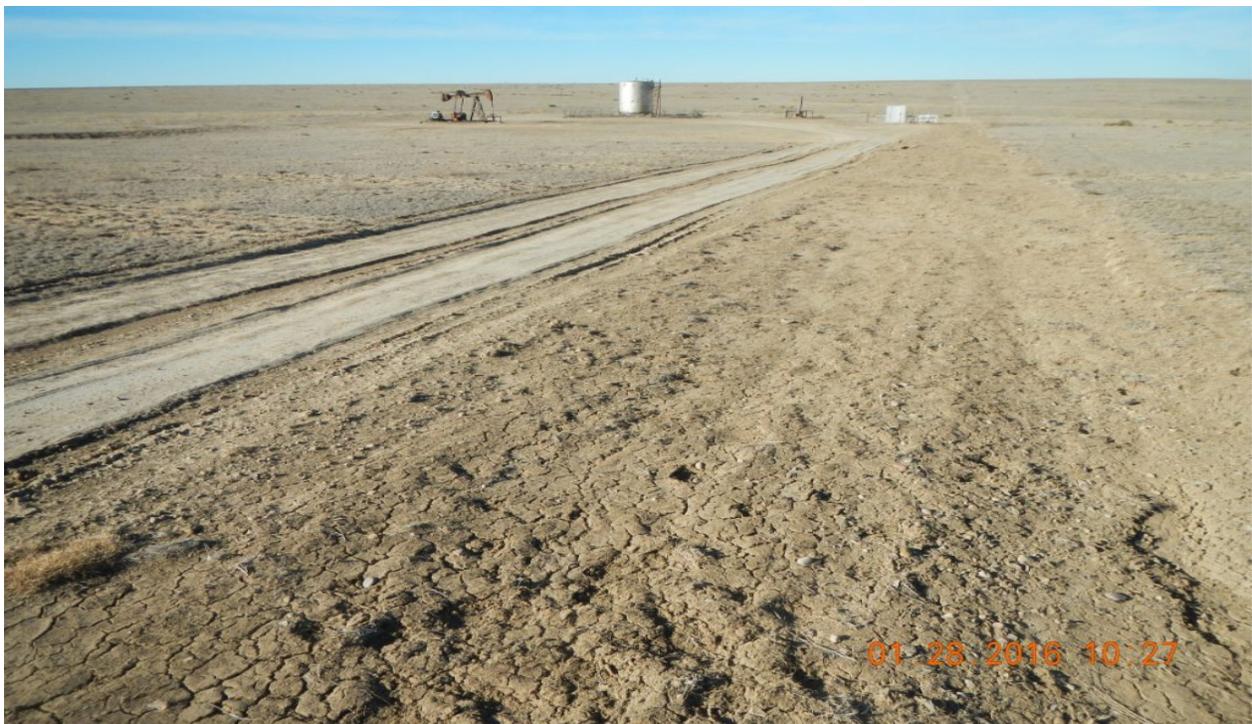
**photo 6:** Area adjacent to the access road looks to have been regraded since the previous inspection.

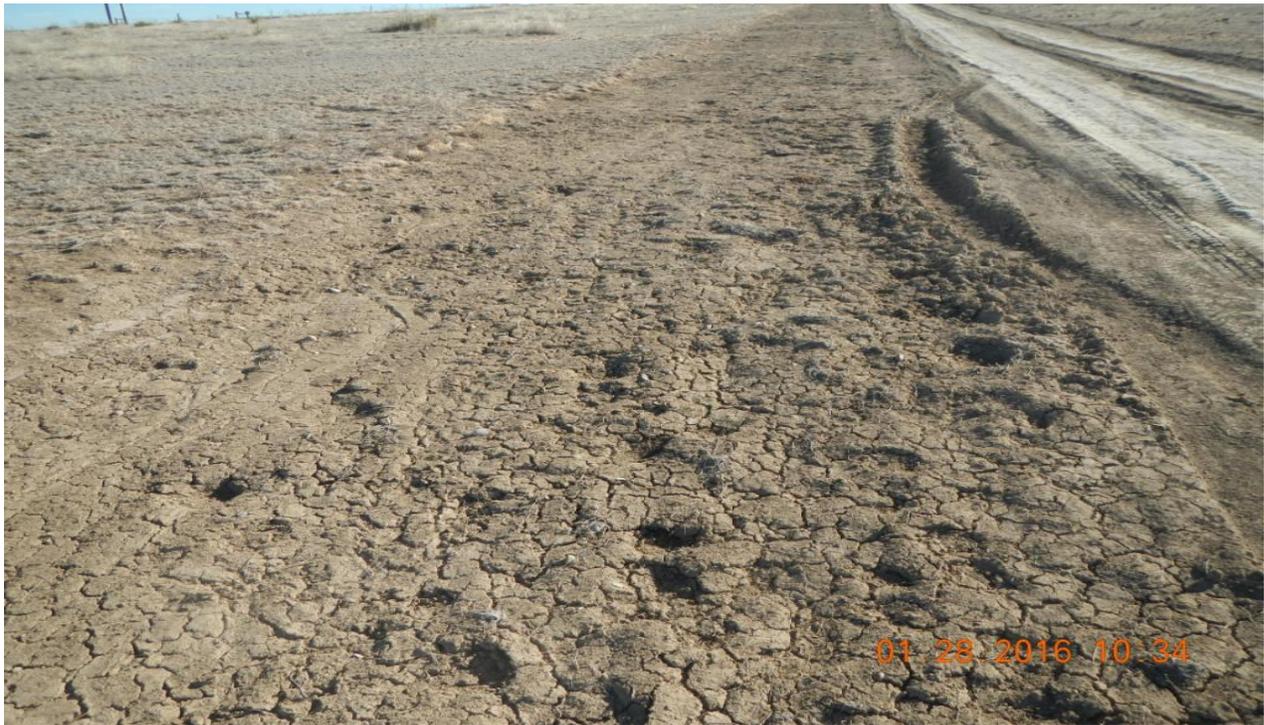
**photo 7:** No vegetation has established along the disturbed area adjacent to the access road.

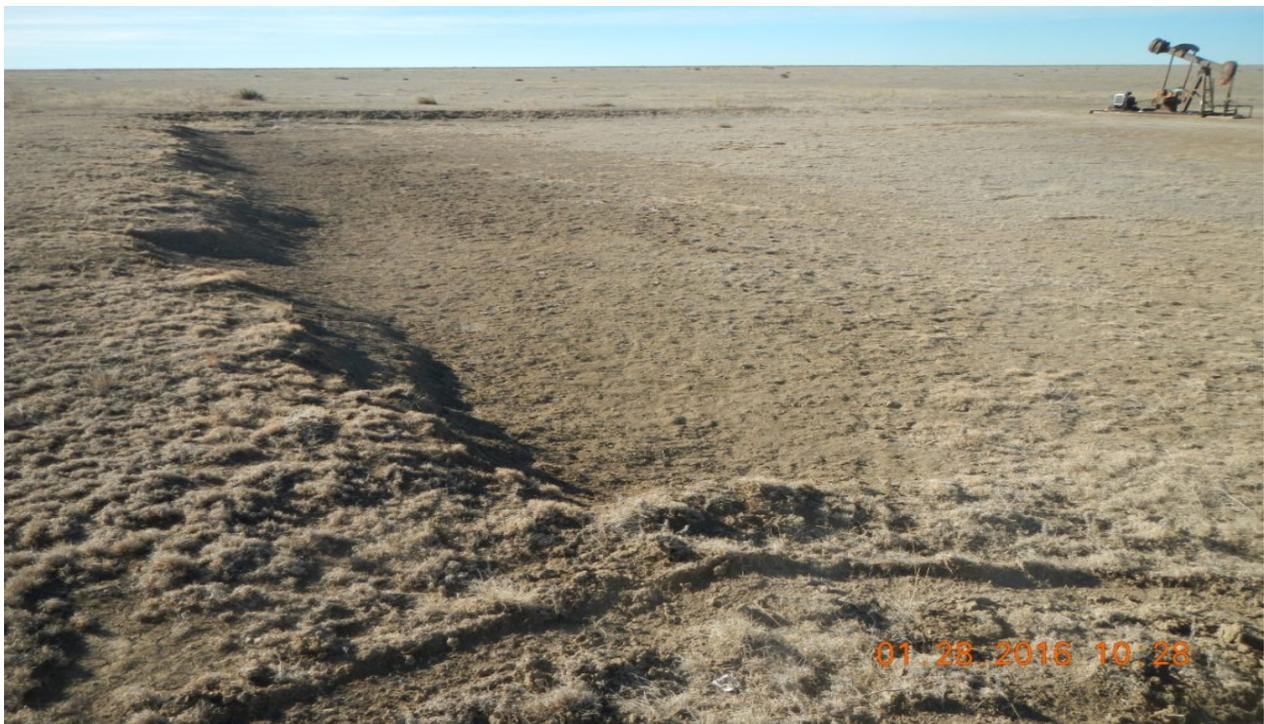
**photo 8:** Northeast corner of the location facing southwest. Note: the east side of the location has not been recontoured.

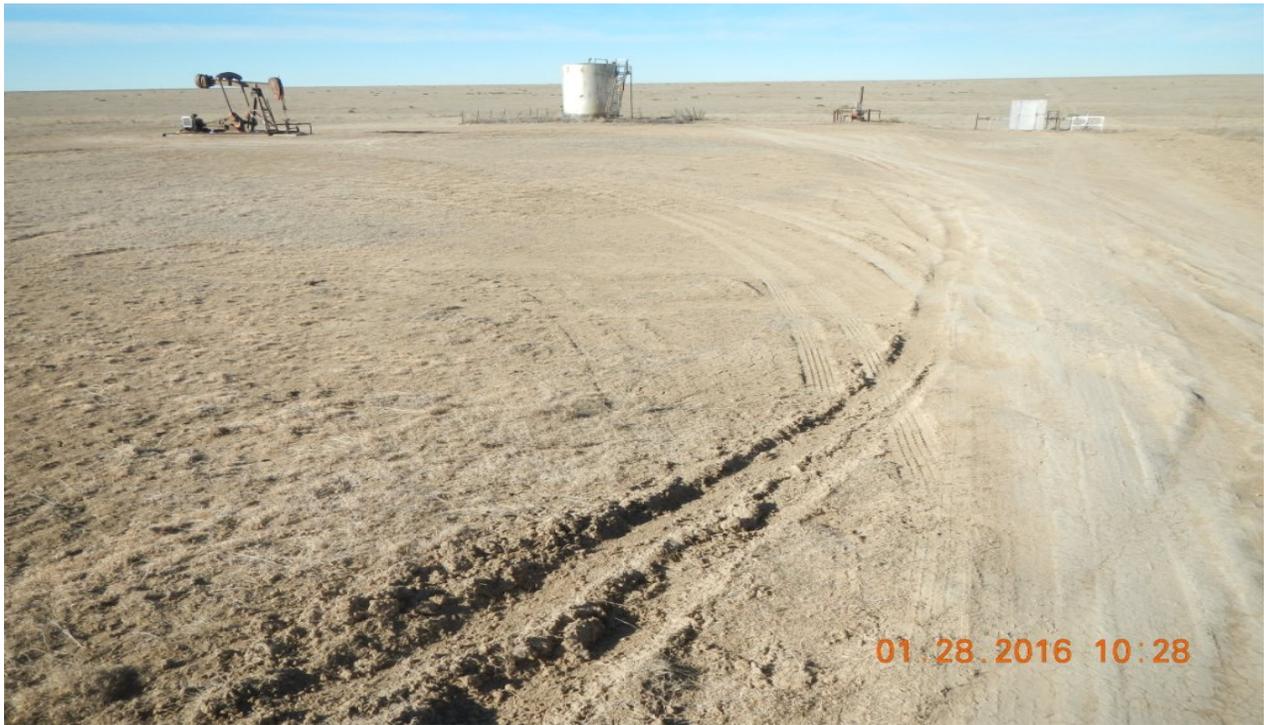
photo 9: Facing southwest toward the location.

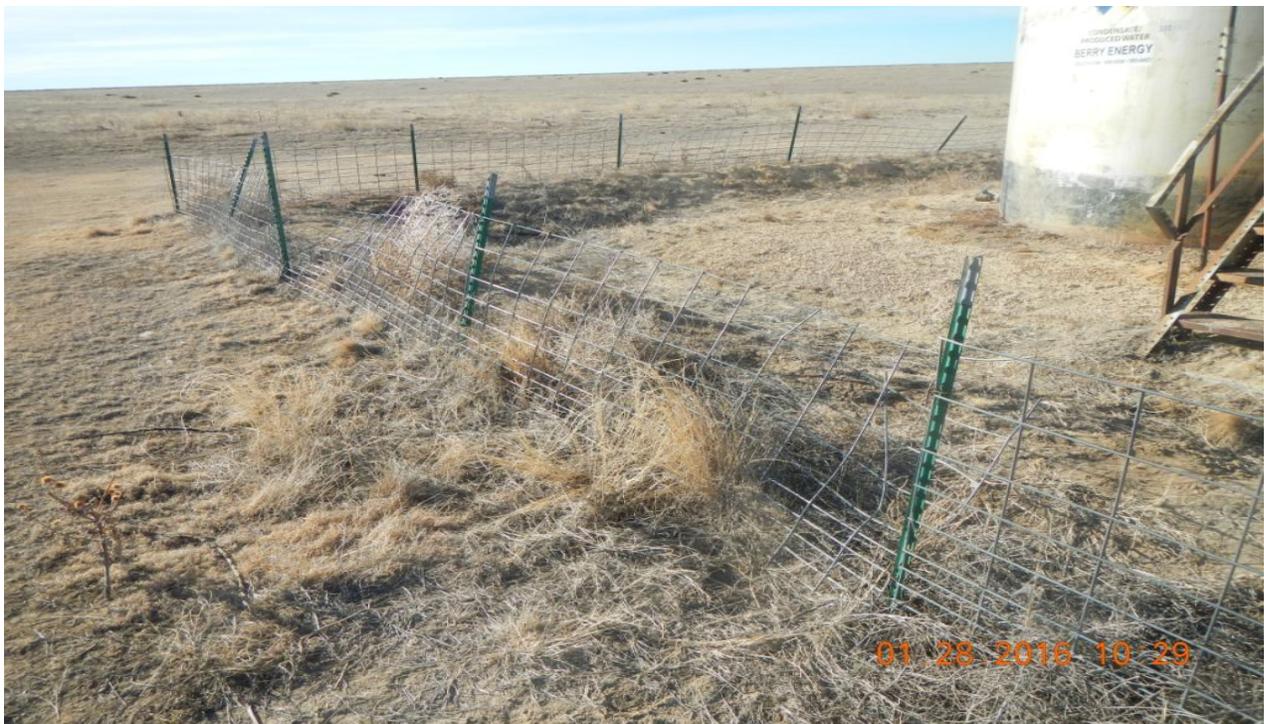
photo 10: Fence around the tank battery is in disrepair.

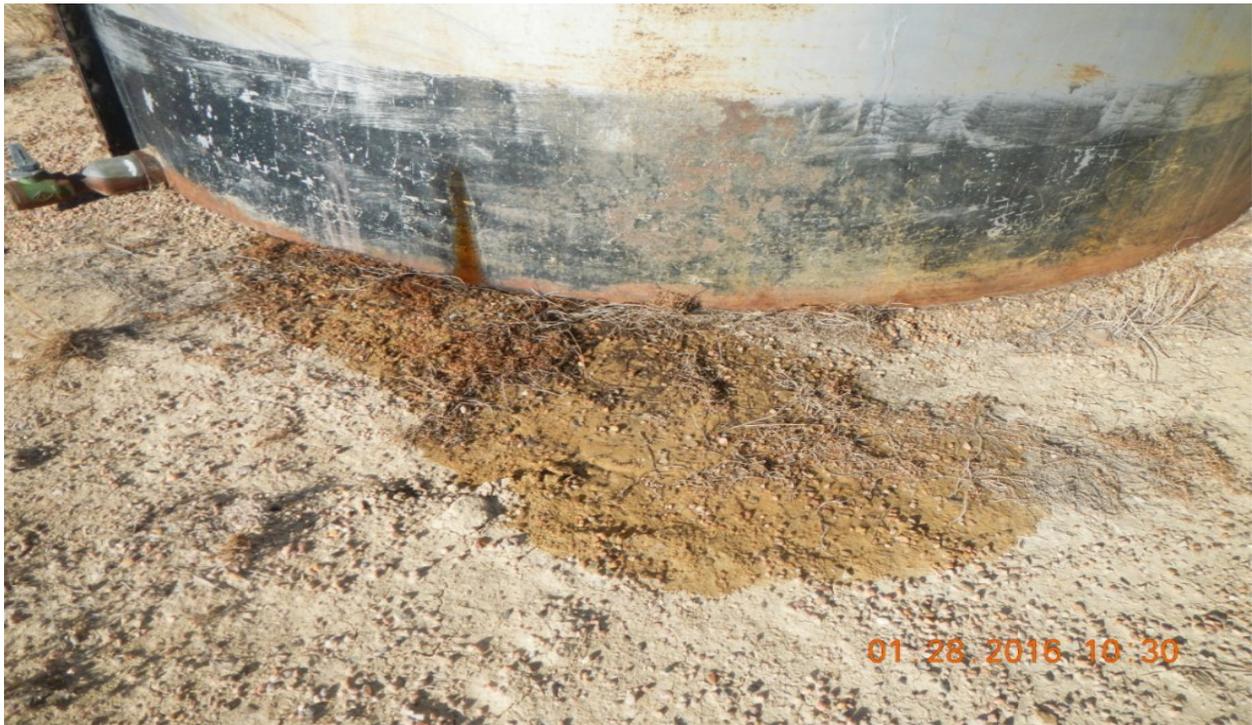
**photo 11:** There is an area (~3'x1') of oil stained soil next to the tank battery.

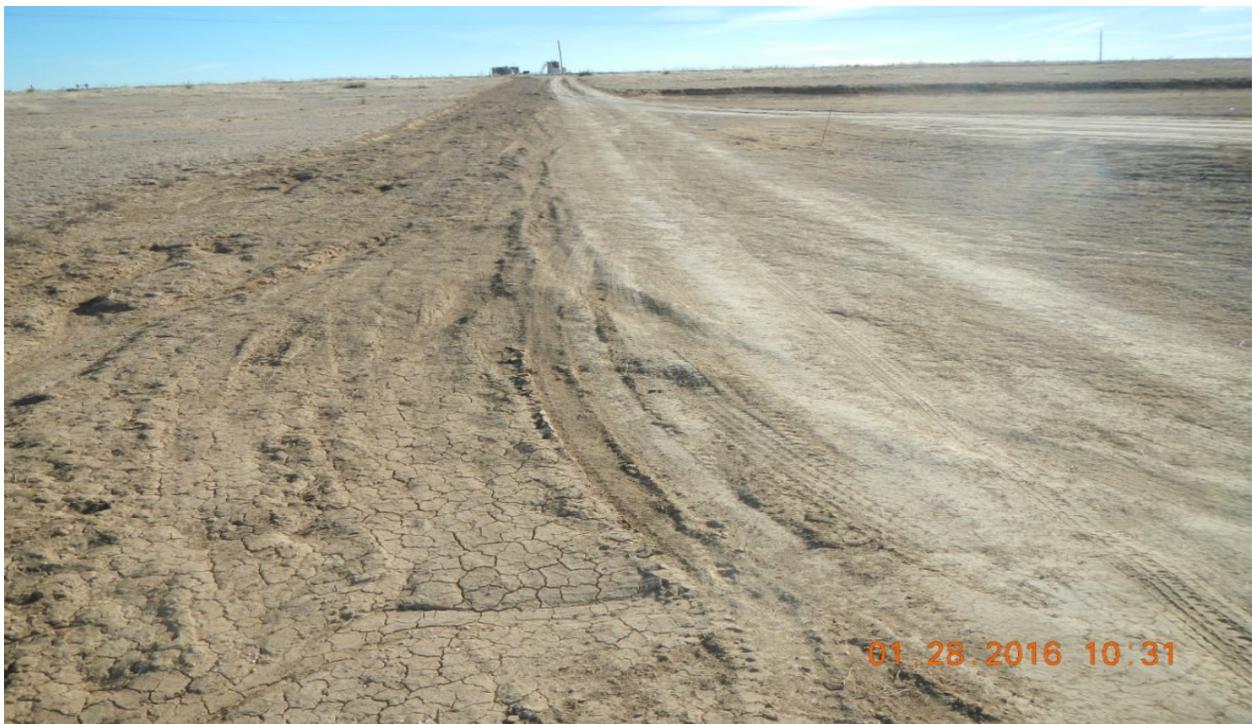
**photo 12:** Facing east from the northwest corner of the location.
