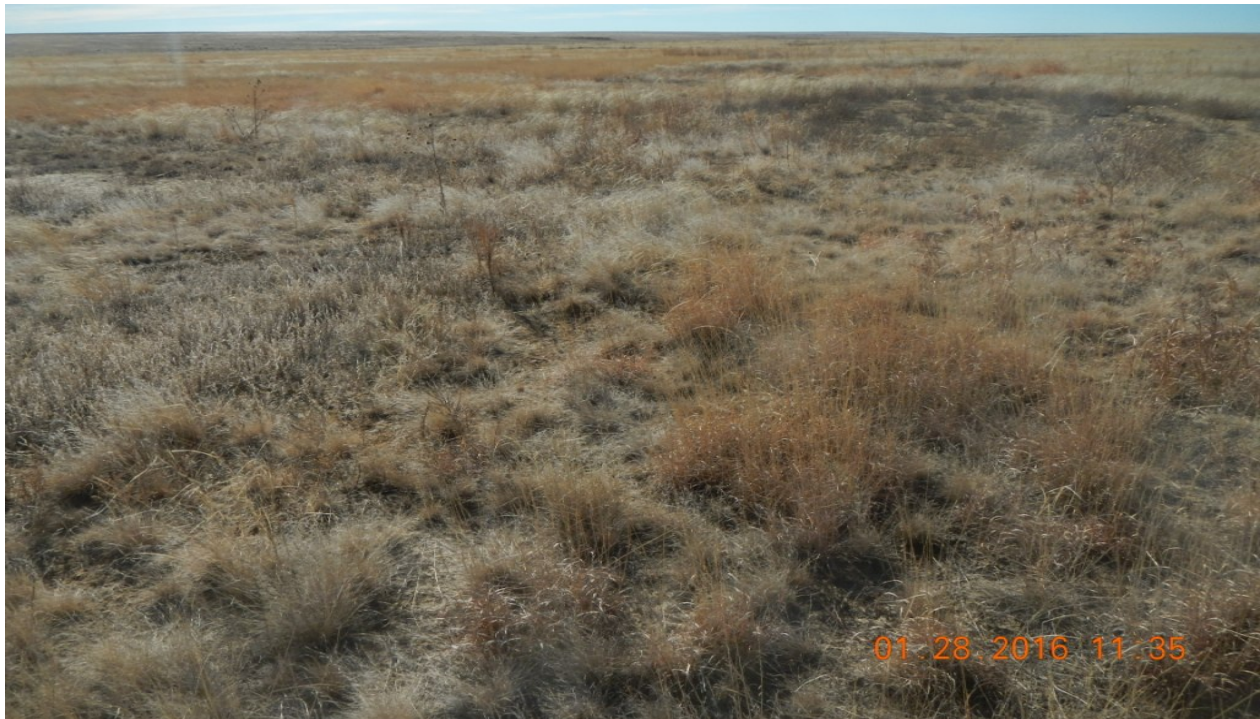
photo 1: Facing south toward the location..

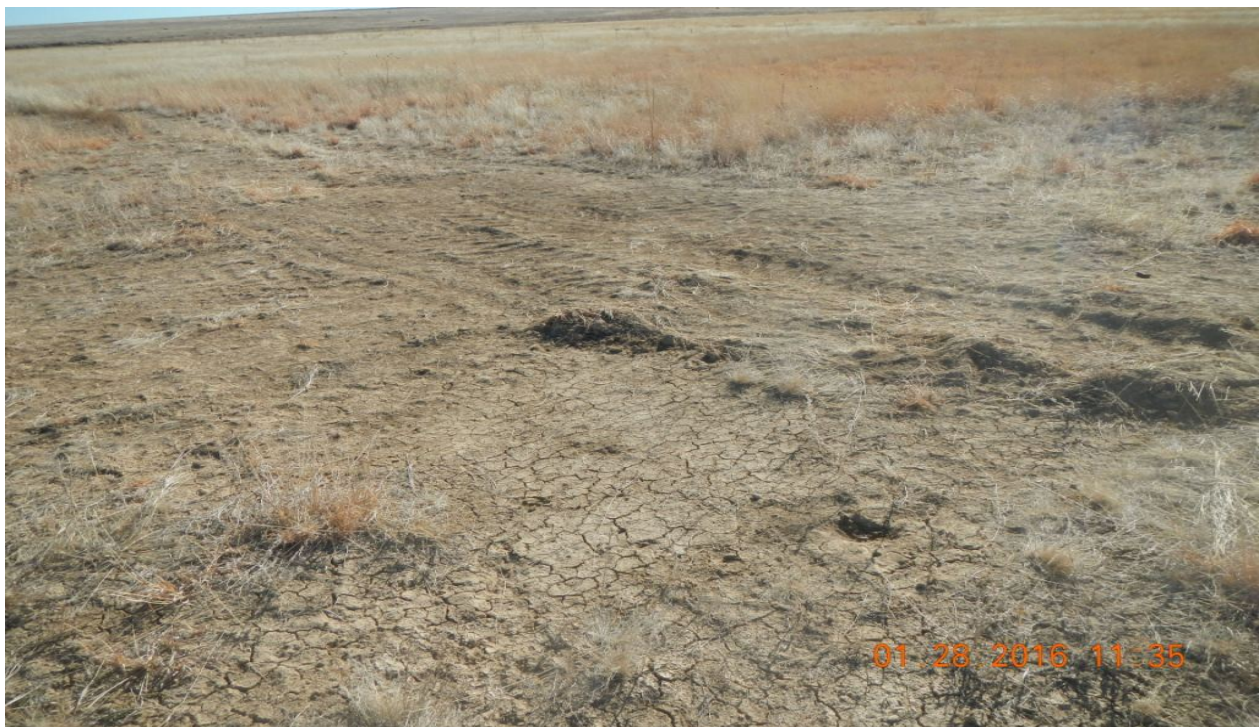
photo 2: Location where pipe riser was noted in the previous inspection has been removed.

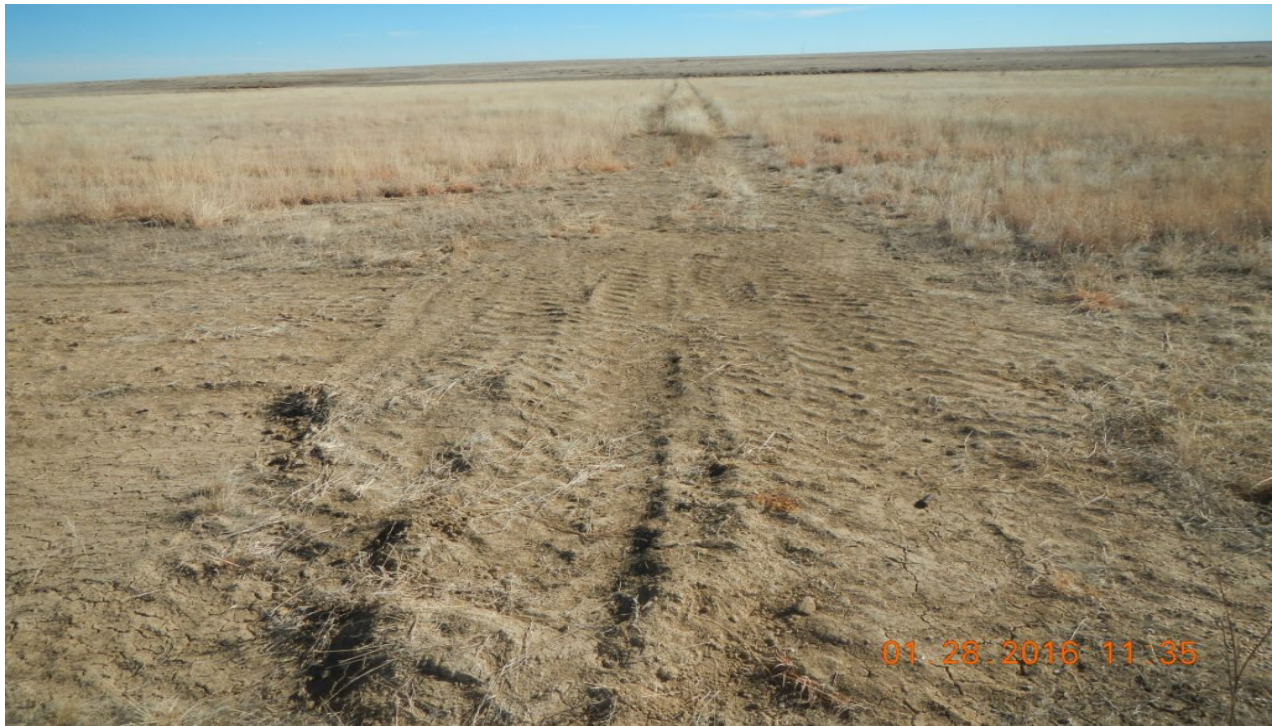
photo 3: Location where pipe riser was noted in the previous inspection has been removed.

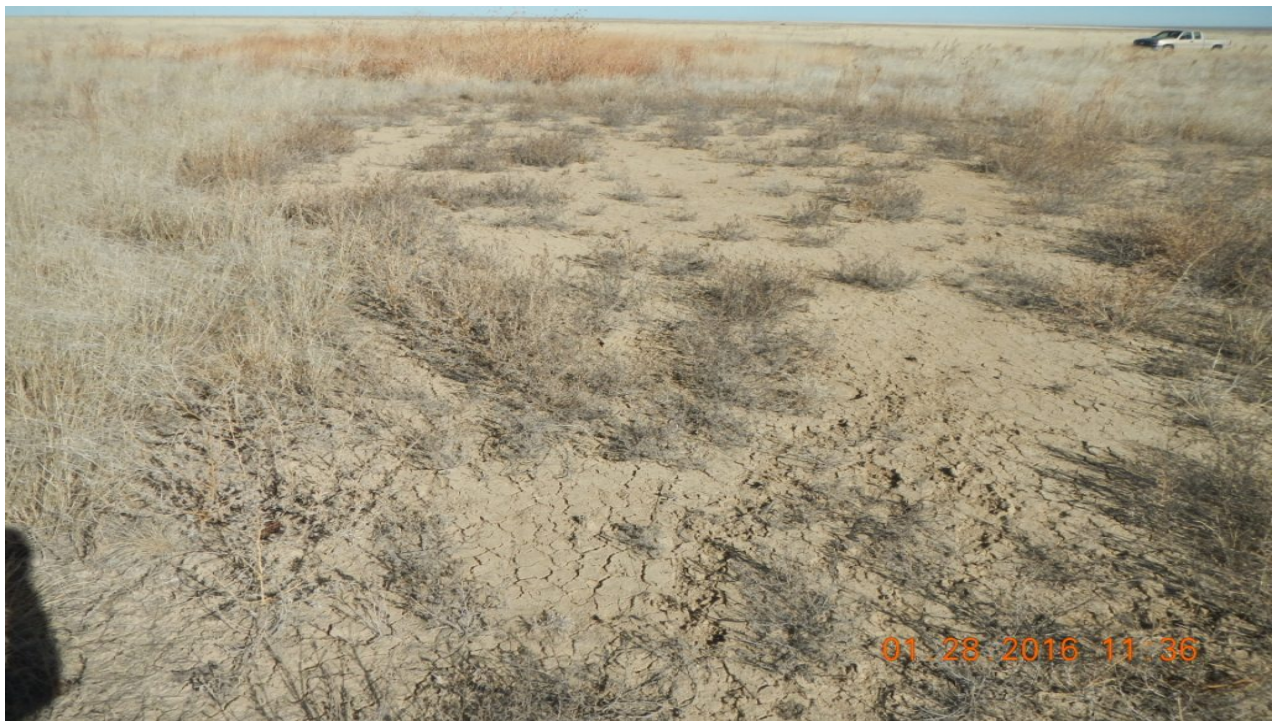
photo 4: Area at the center of the location with minimal vegetation growth.

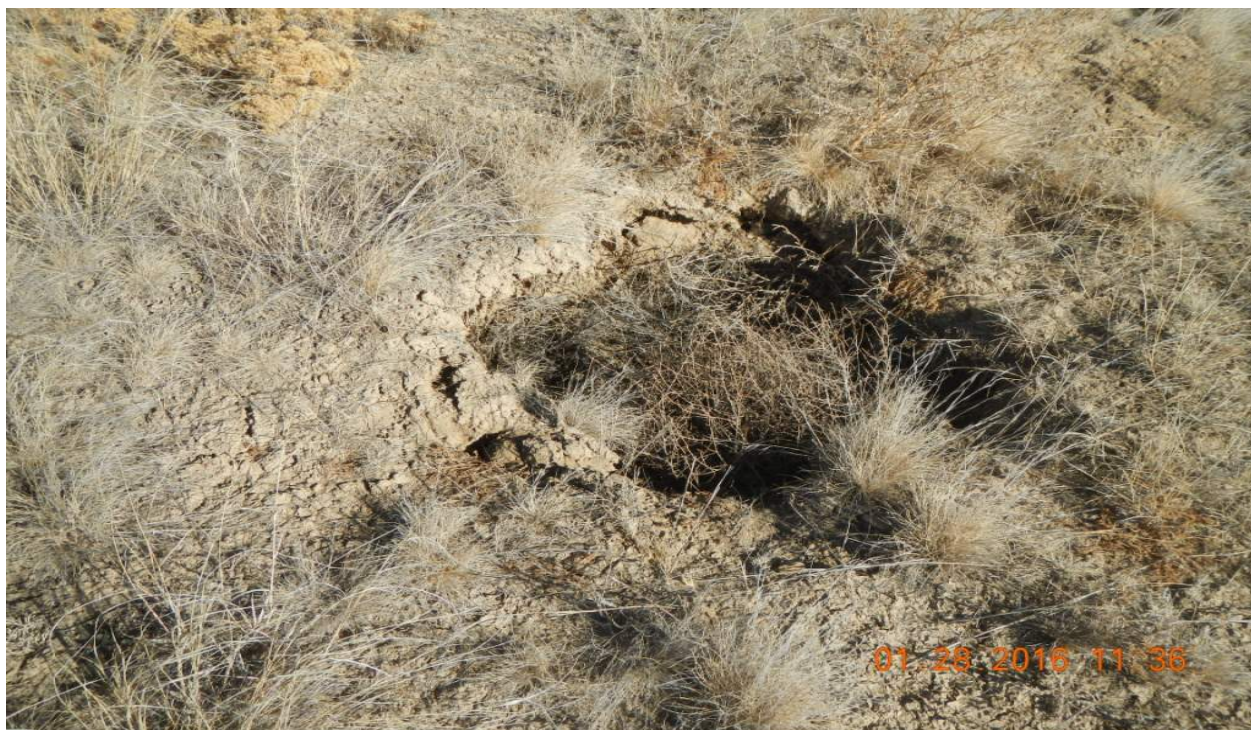
photo 5: Area of subsidence found at the location. Lat/Long:37.93085,-102.69283

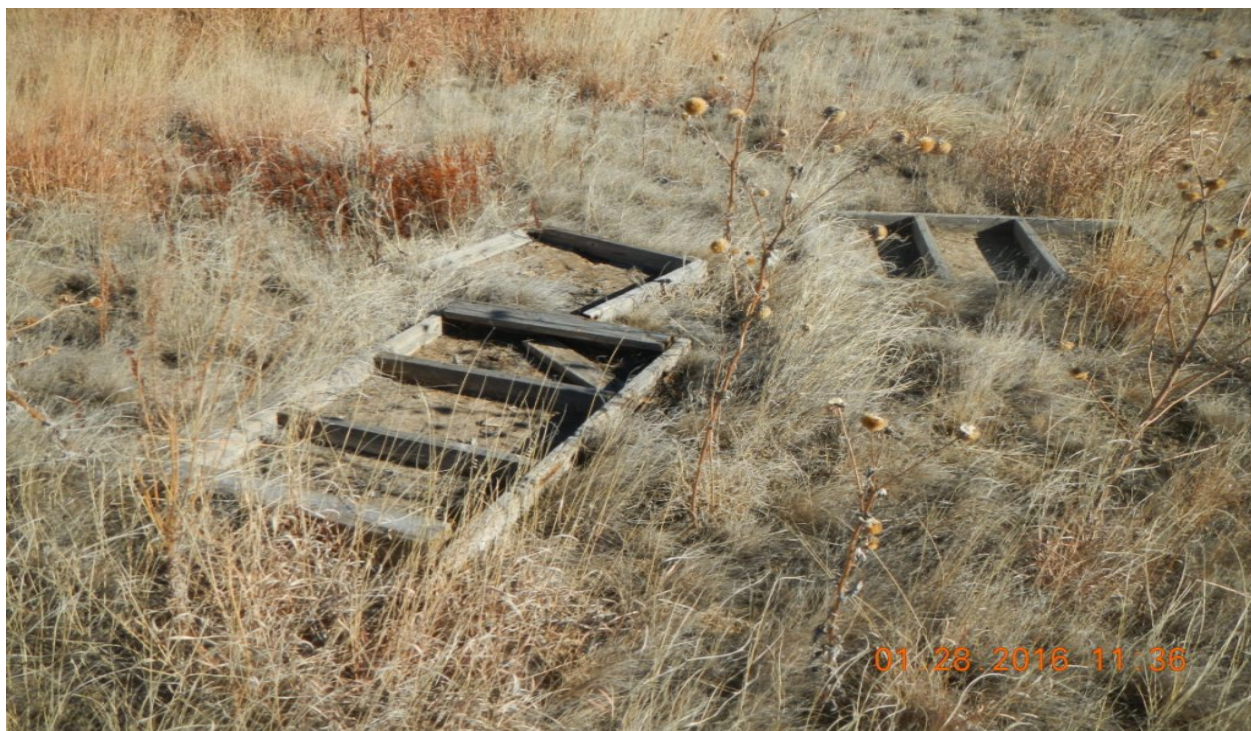
photo 6: Plywood debris remains at the west side of the location.
