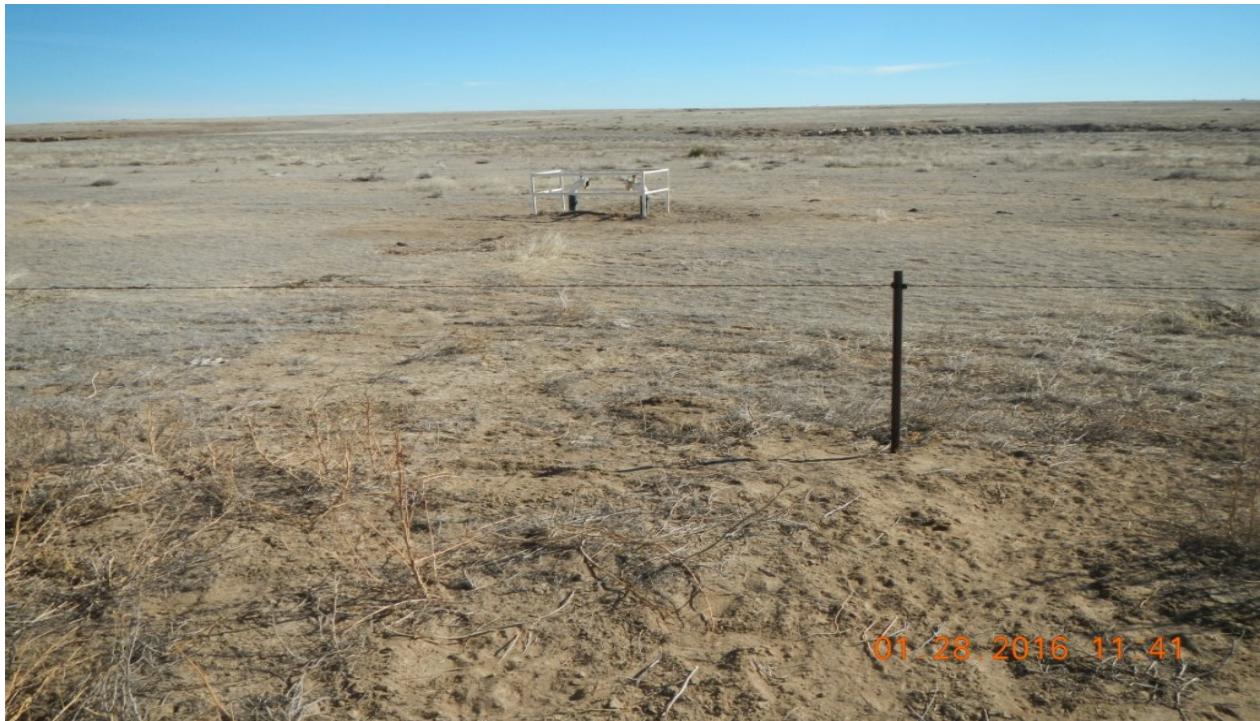
**photo 1:** Pipe riser remains near the access road.

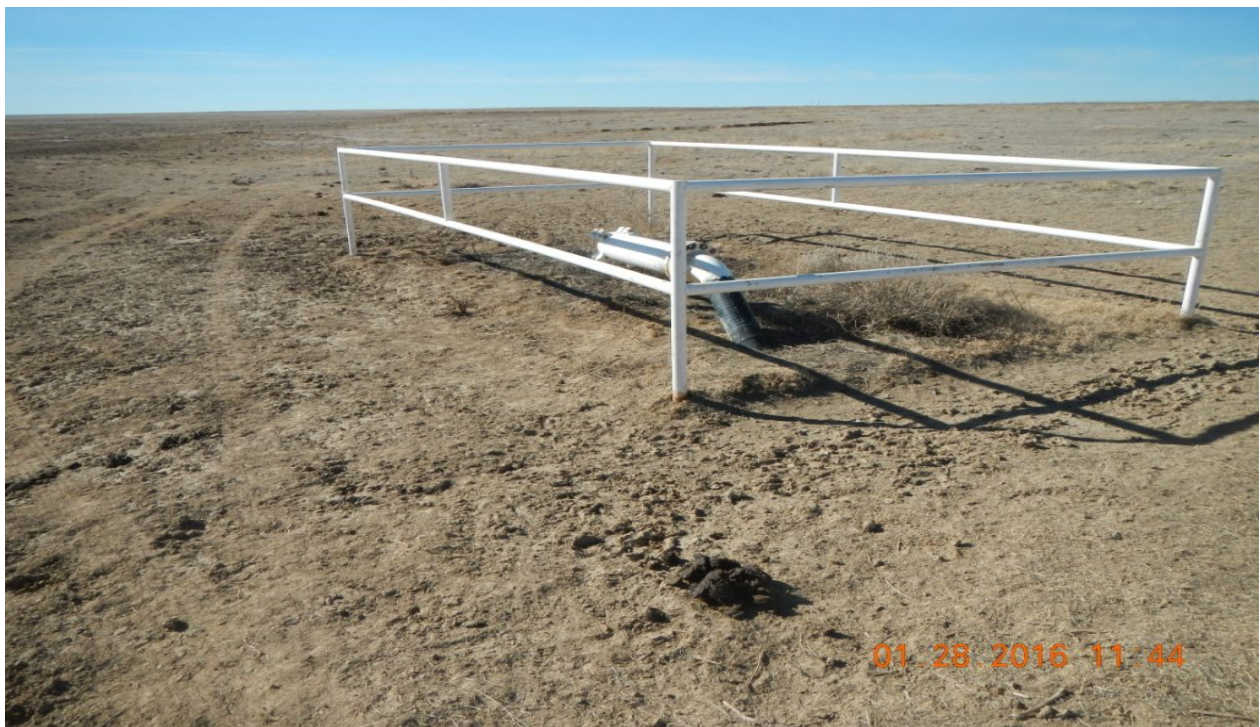
**photo 2:** Pipe riser remains at the north side of the location.

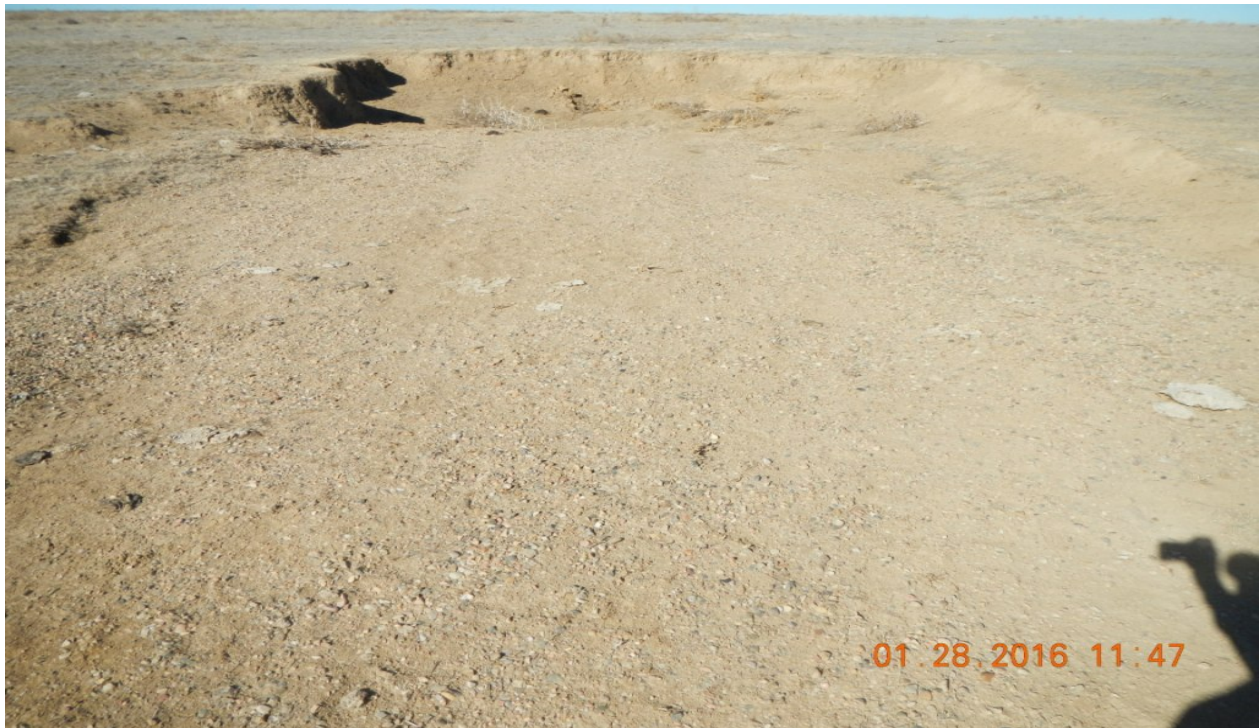
**photo 7:** West side of the location. Borrow area has not been recontoured and reclaimed..

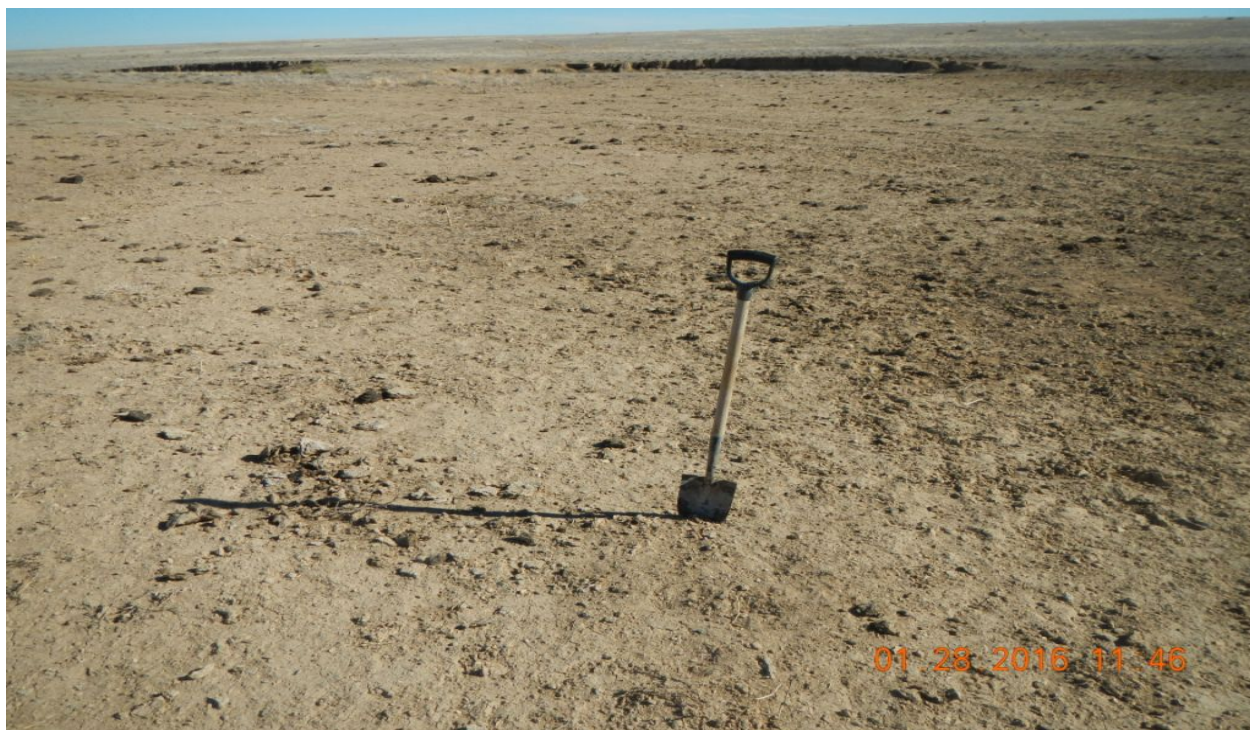
**photo 9:** Facing east at the location. Shovel was used to determine compaction. Soils were heavily compacted throughout the site.
