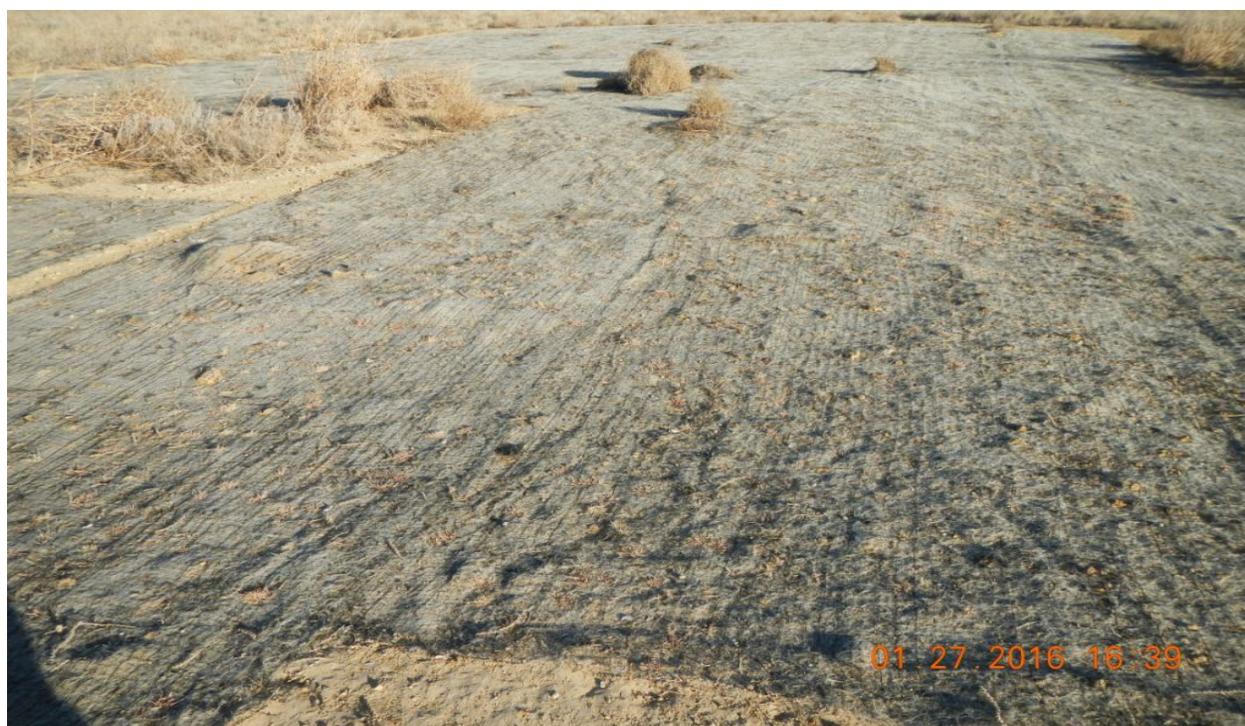
photo 4: Blanket has been installed east portion of the location.

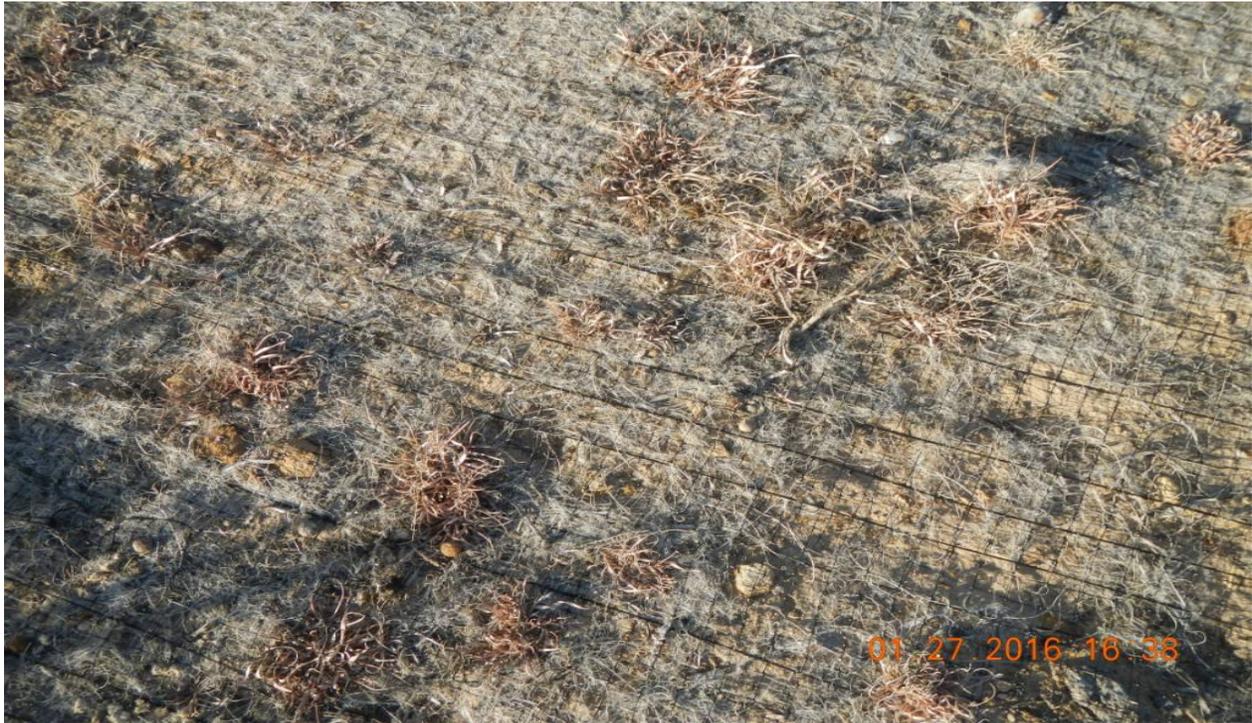
photo 5: Vegetation appears to be establishing where the blanket has been installed.

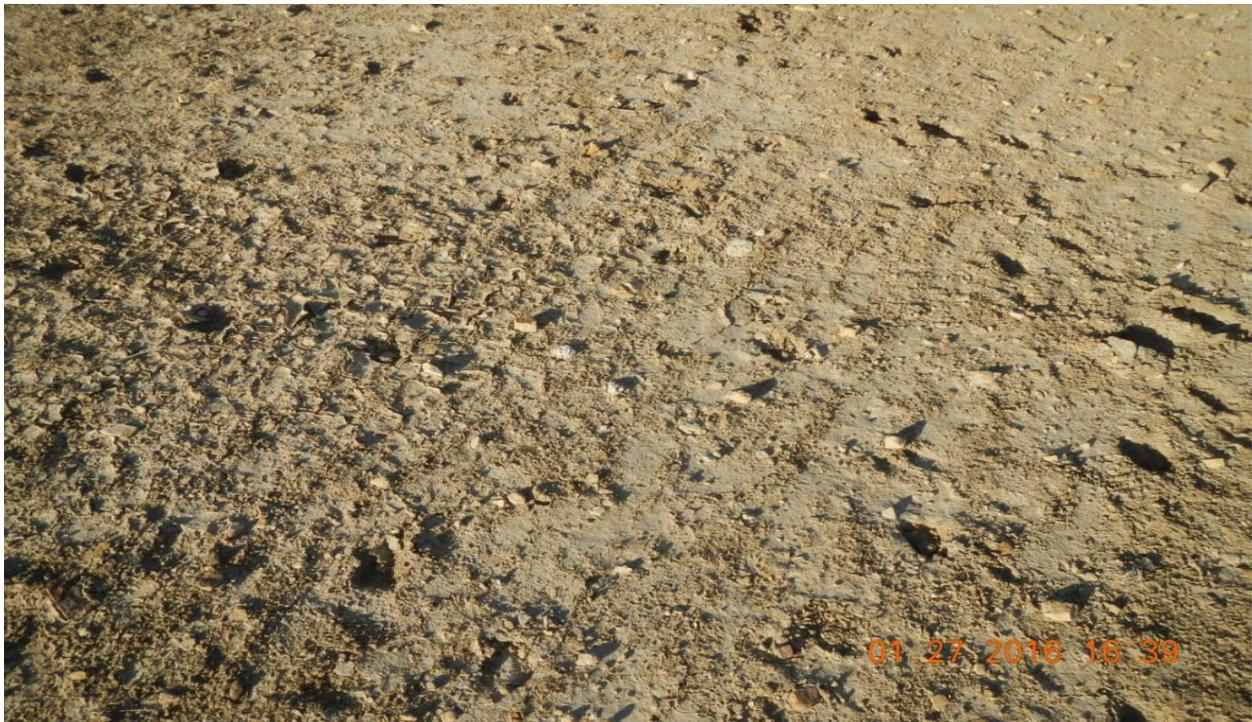
photo 8: Vegetation does not appear to be establishing where the blanket was not installed.

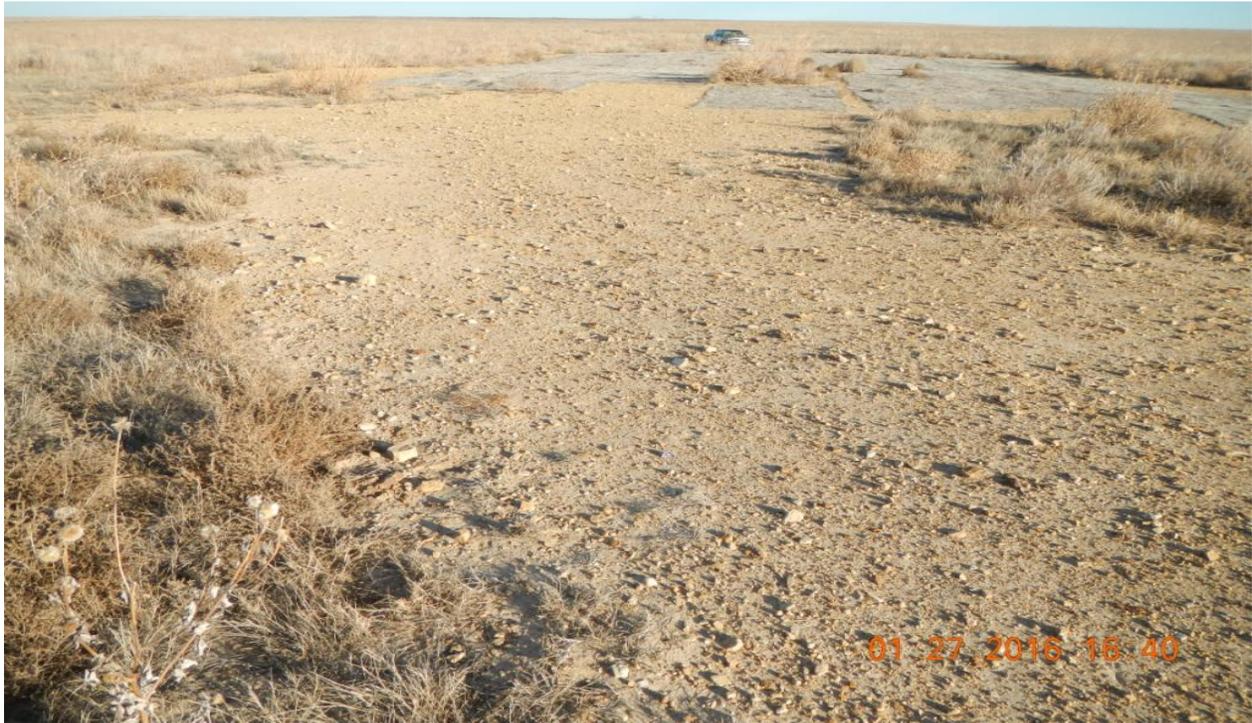
photo 9: West side of the location facing east. Blanket was not installed at the east side of the location.

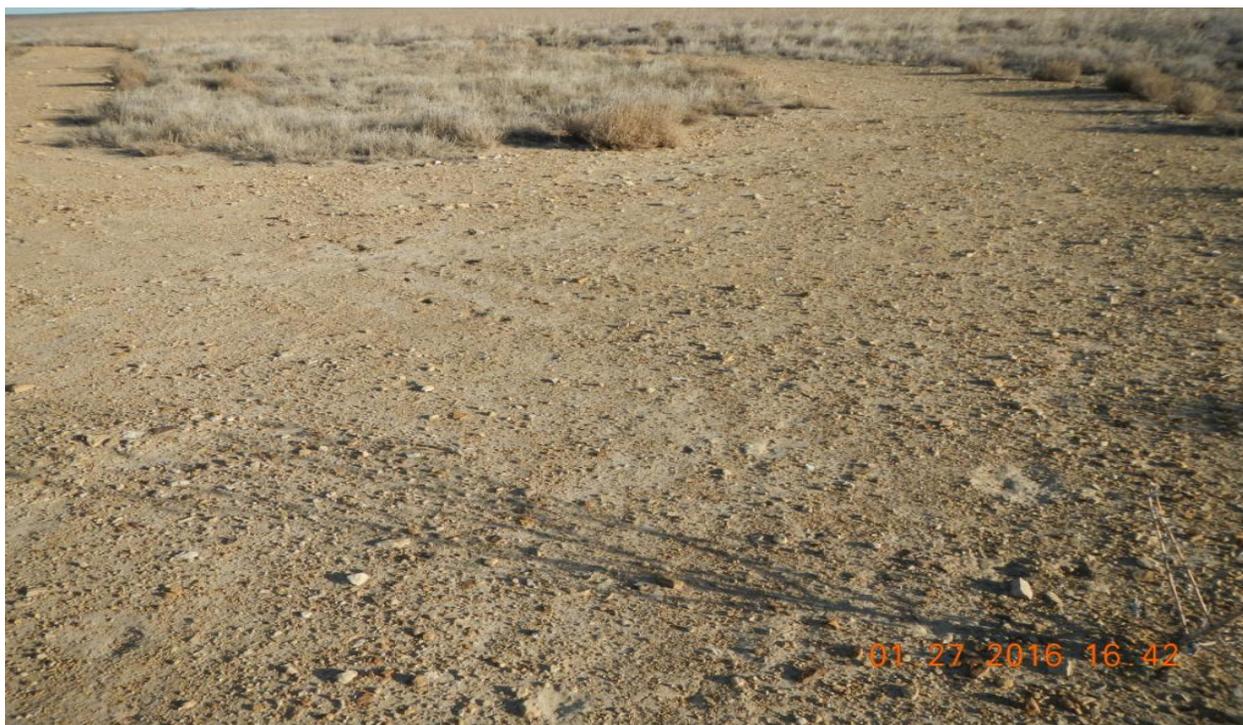
photo 11: Facing east toward the south part of the location. Vegetation is not establishing.
