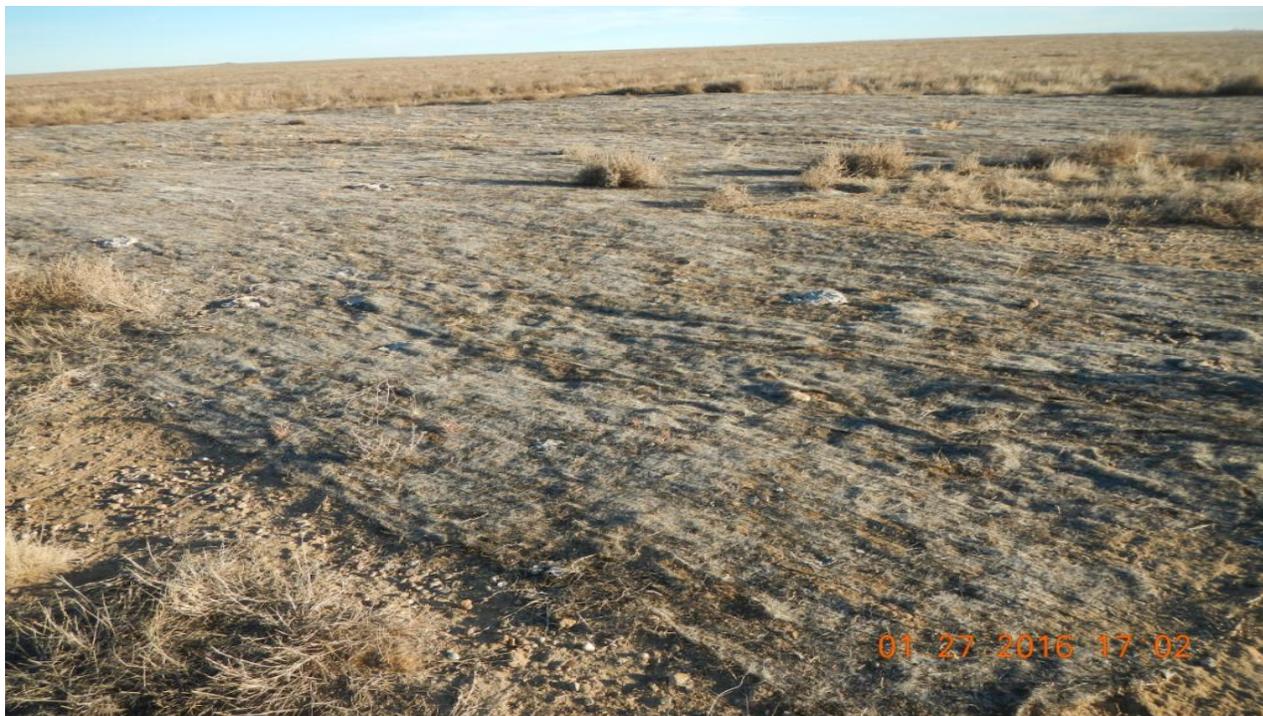
photo 2: Facing southeast toward the location where straw blanket was installed.

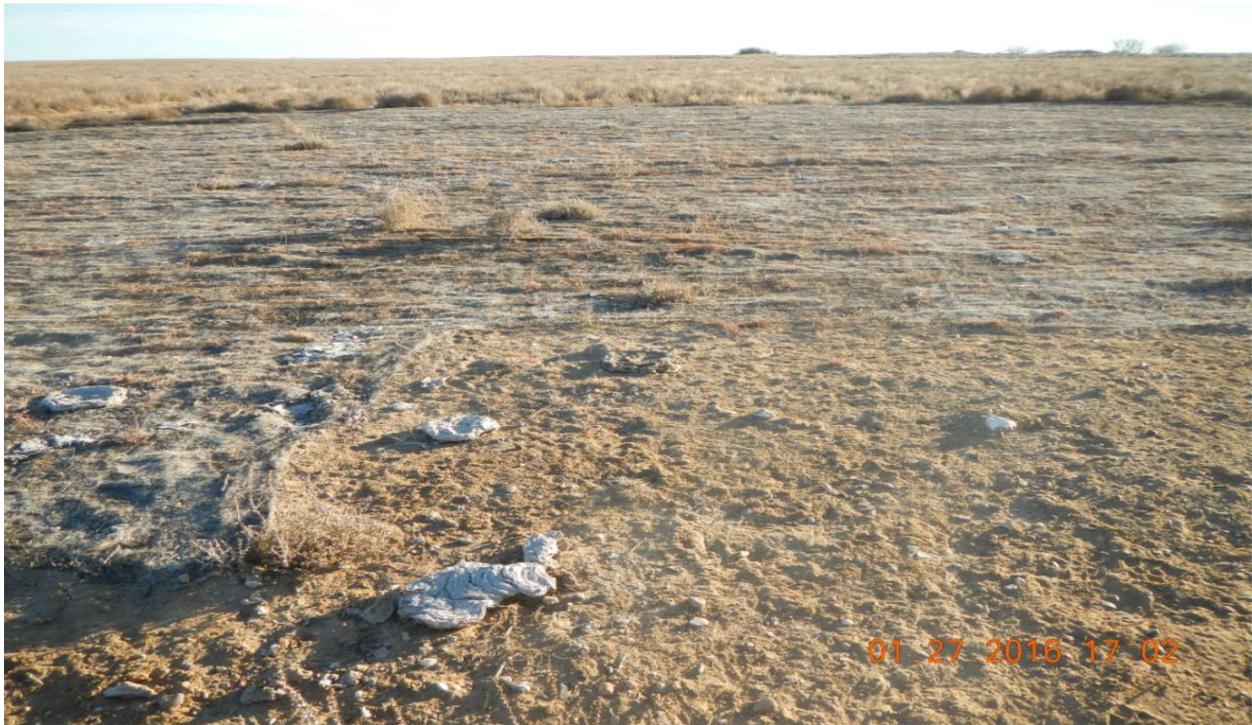
photo 3: North side of the location facing south.

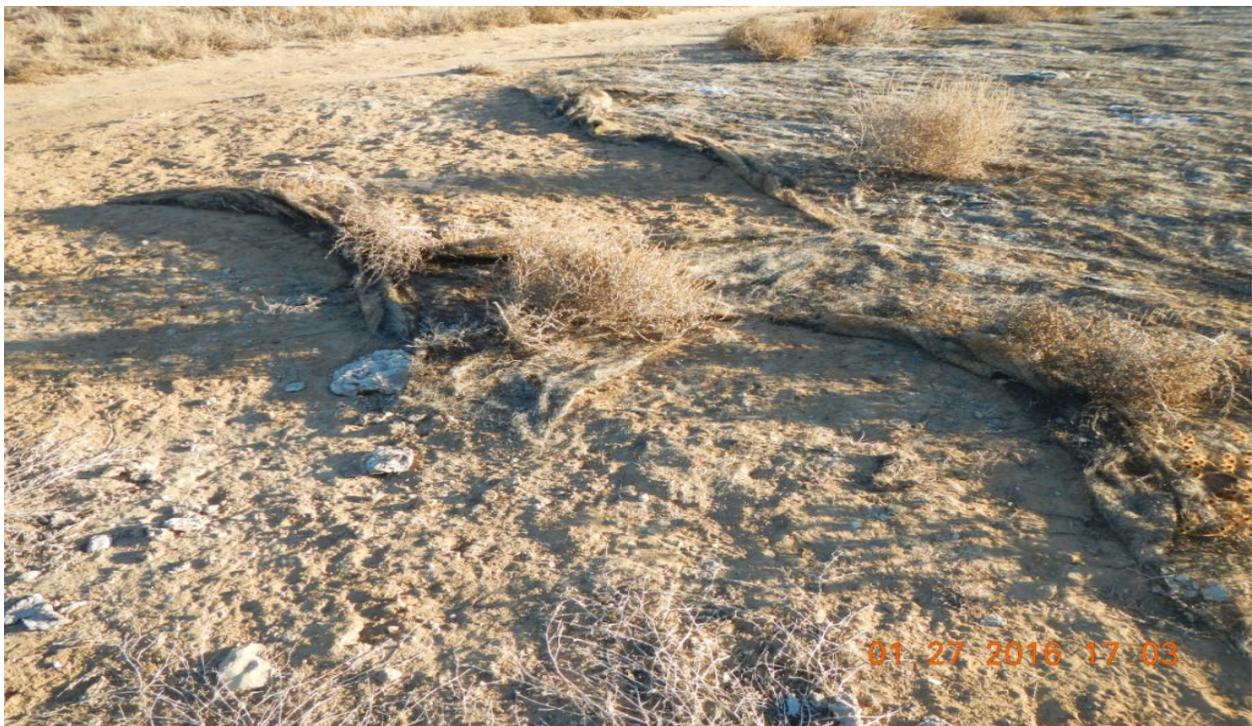
photo 4: Straw blanket is in disrepair at the northeast corner of the location.

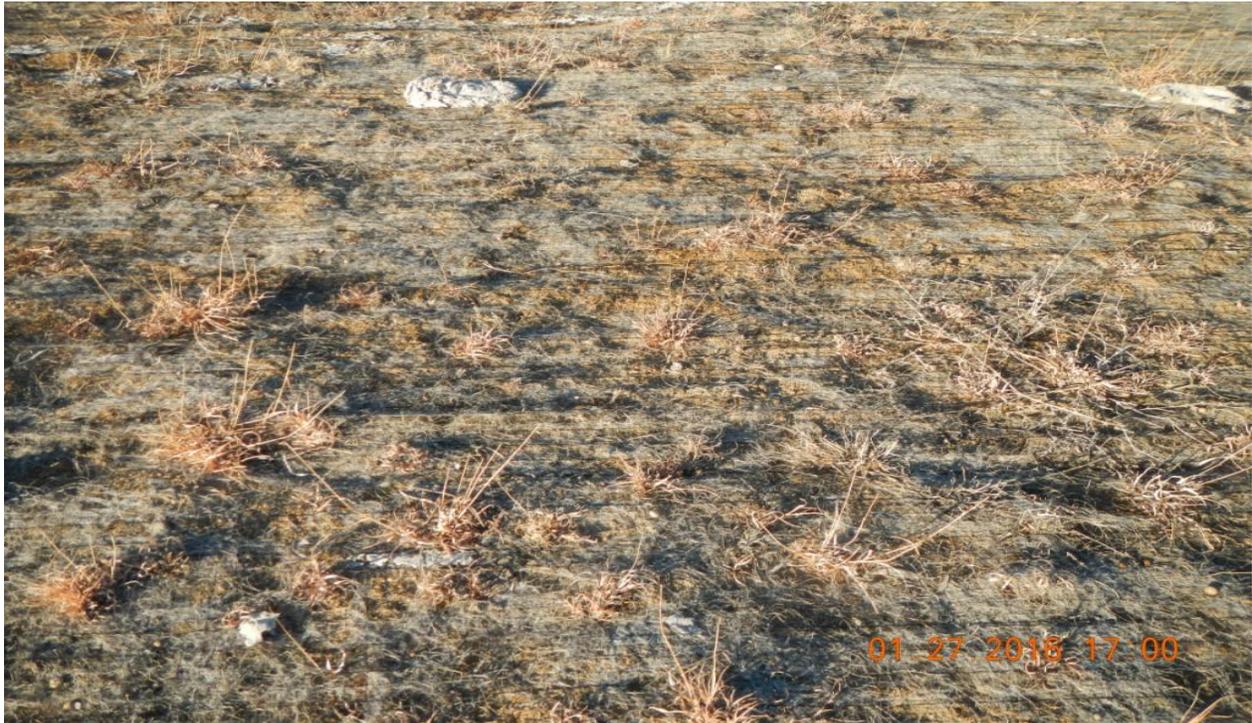
photo 5: Vegetation appears to be establishing where the blanket has been installed.

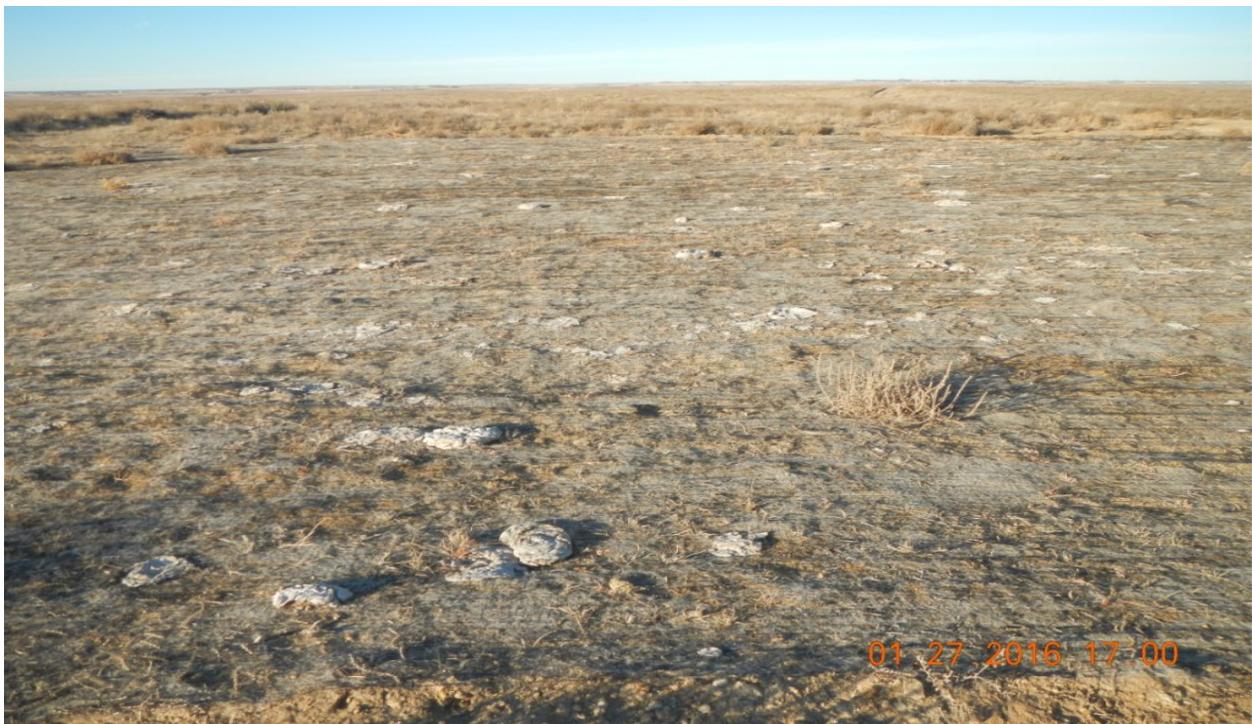
photo 6: South side of the location facing north.

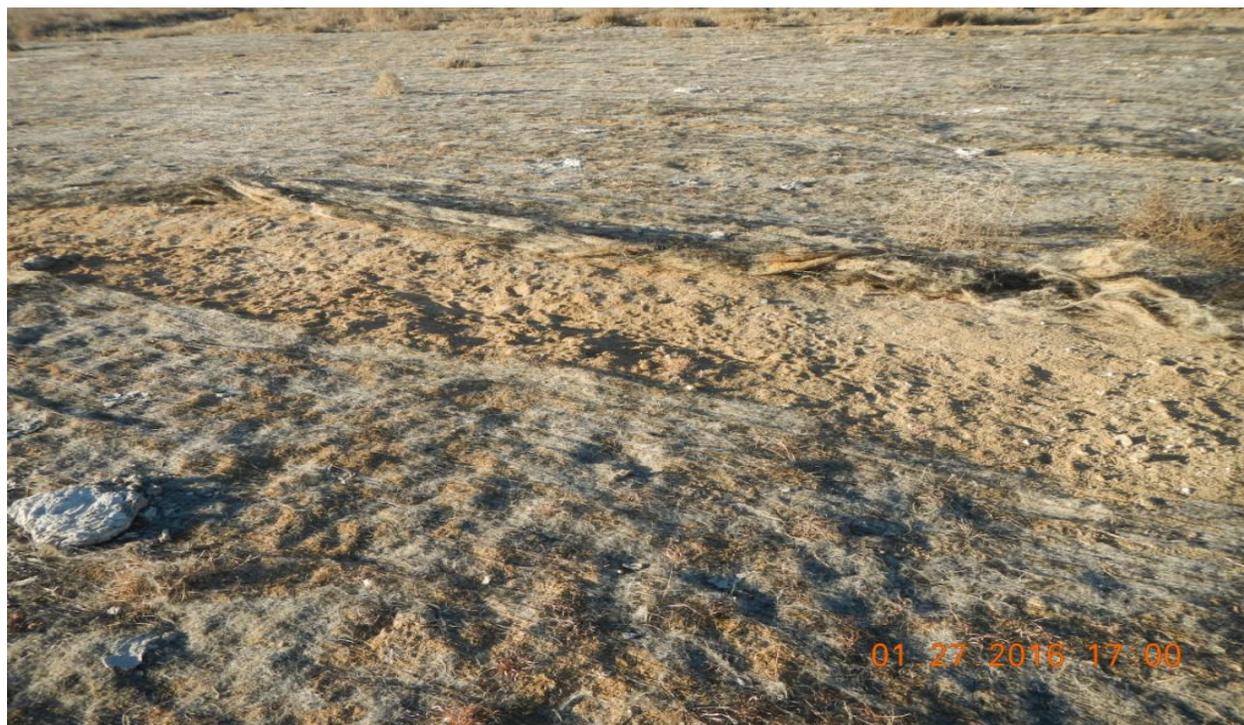
photo 7: : Straw blanket is in disrepair at the south side of the location.

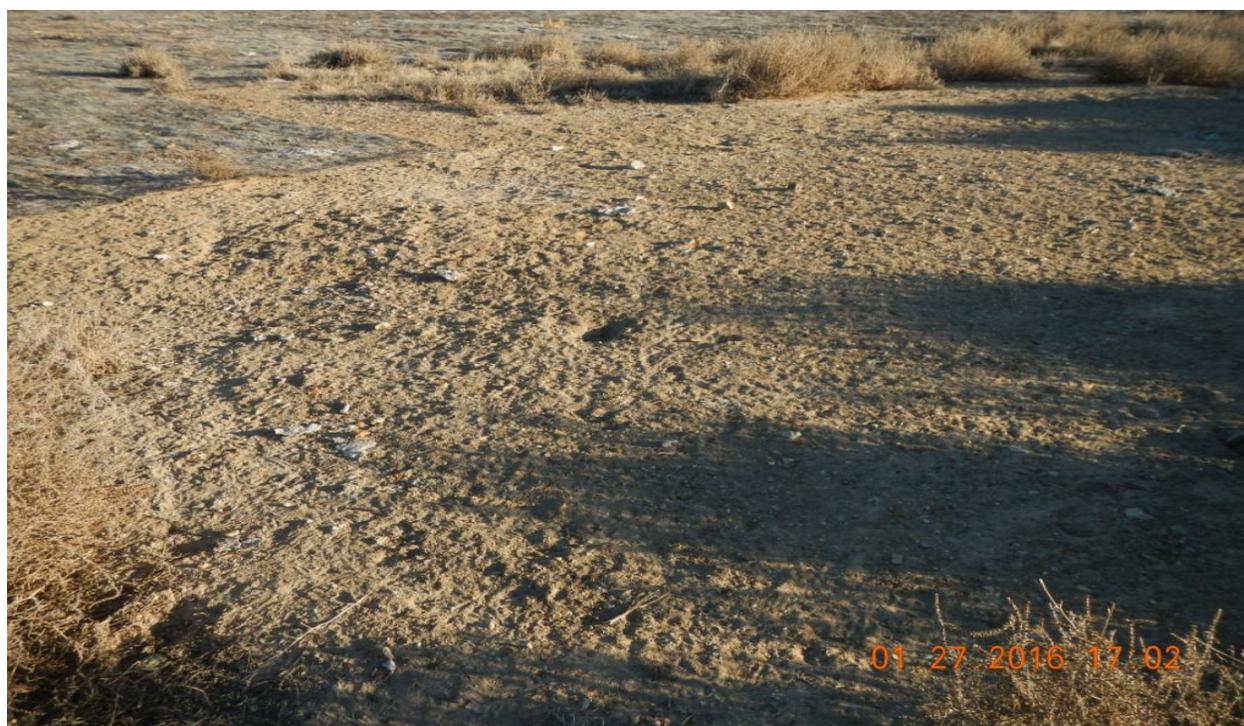
photo 8: Northwest corner of the location. Vegetation is not establishing where straw blanket was not installed.
