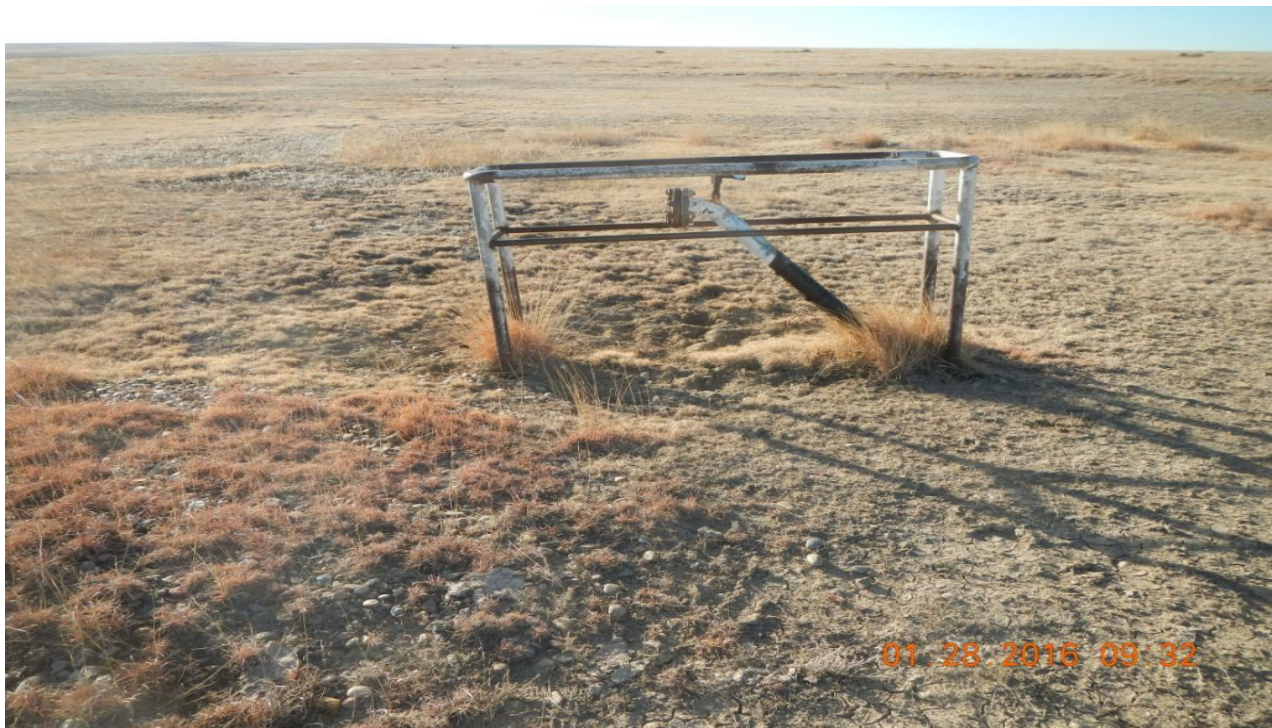
**photo 4:** One of two pipe risers that remain at the location. Lat/Long:37.09063,-102.48639.

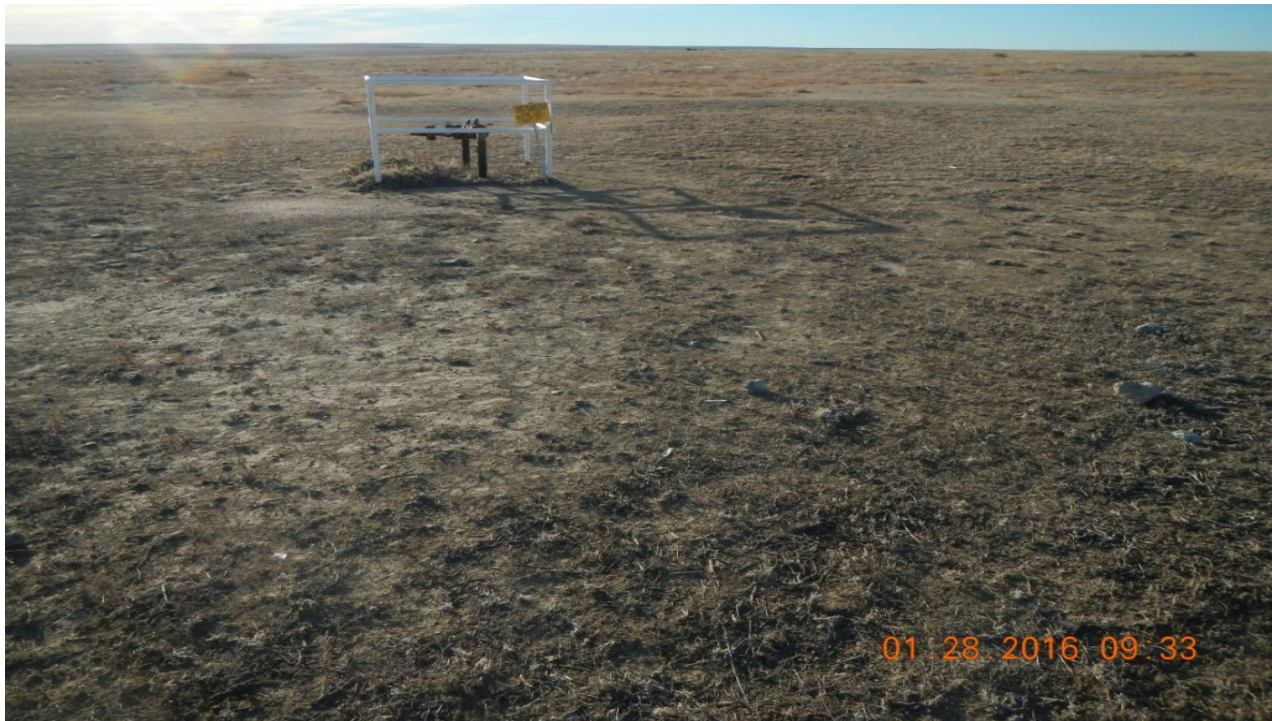
**photo 5:** Second pipe riser that remains at the location. Lat/Long:37.90937,-102.48610.

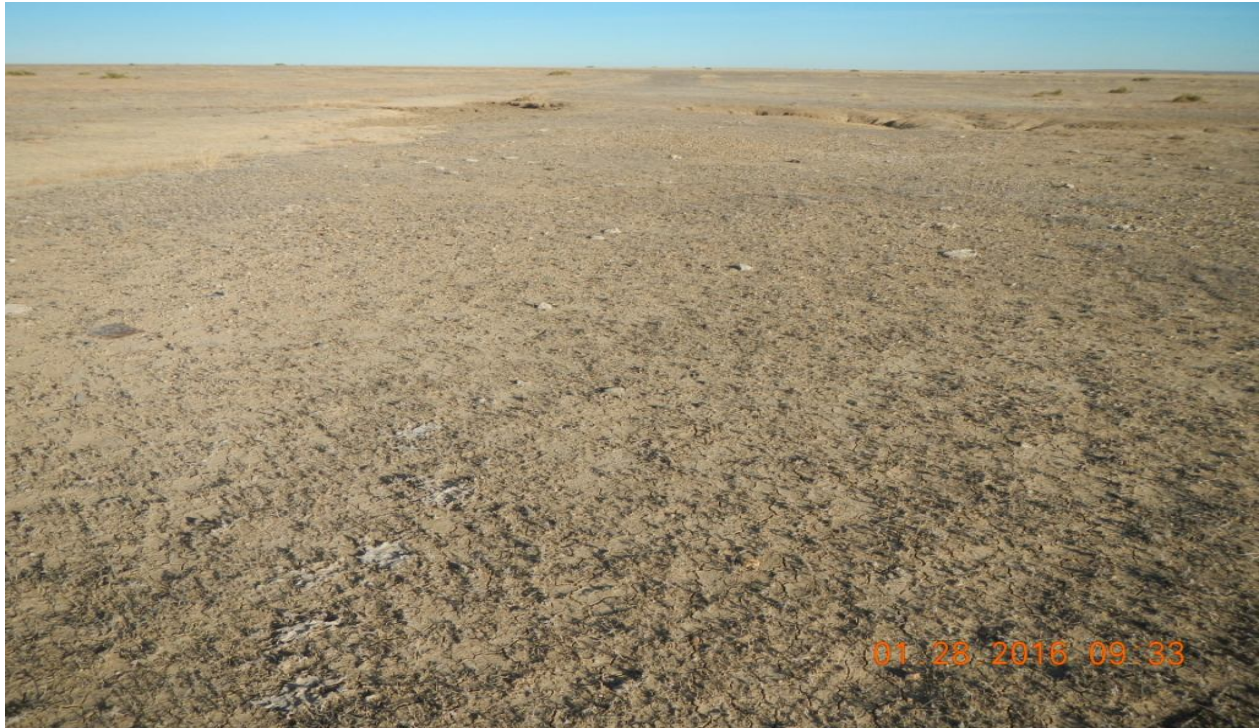
**photo 7:** Center of the location facing north. Note: Vegetation has not reestablished in this area.

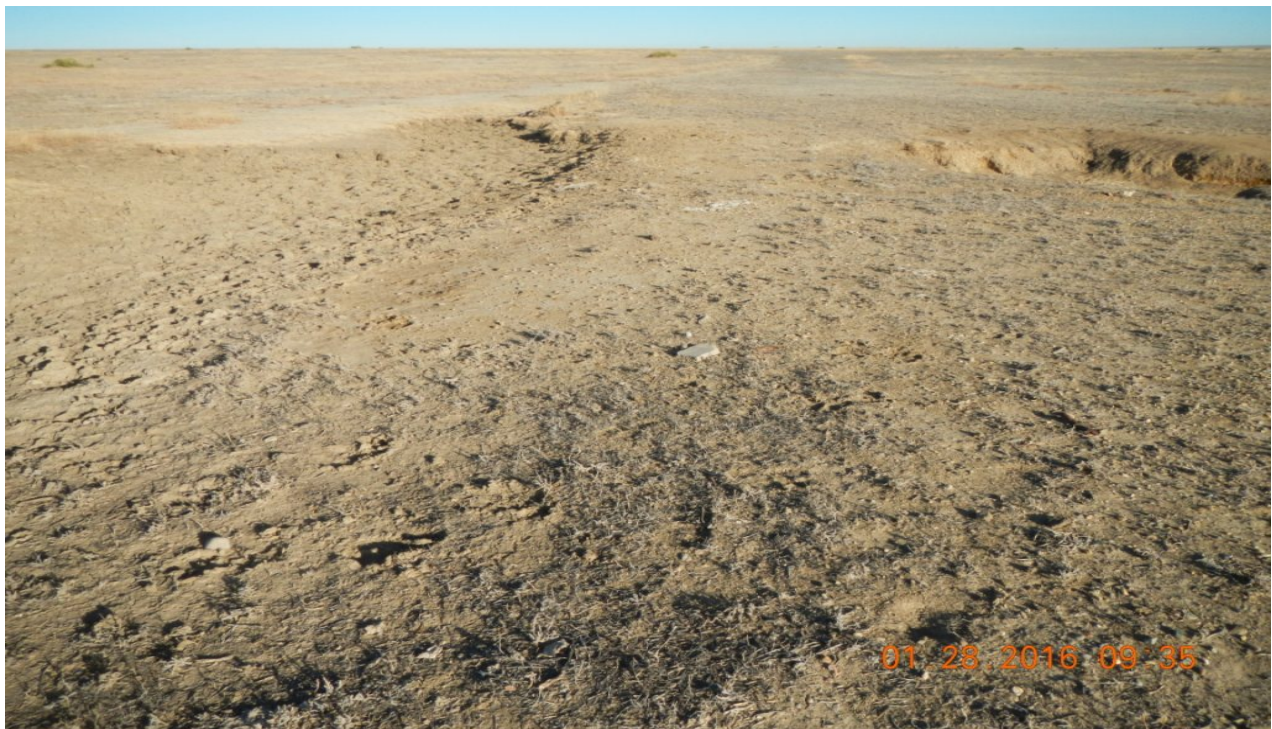
**photo 8:** Facing toward the northeast corner of the location. Note: Vegetation has not reestablished in this area
