Inspection Photos
Berry Energy Compressor Facility
Lat/Long: 37.960289, -102.501992
2/5/16

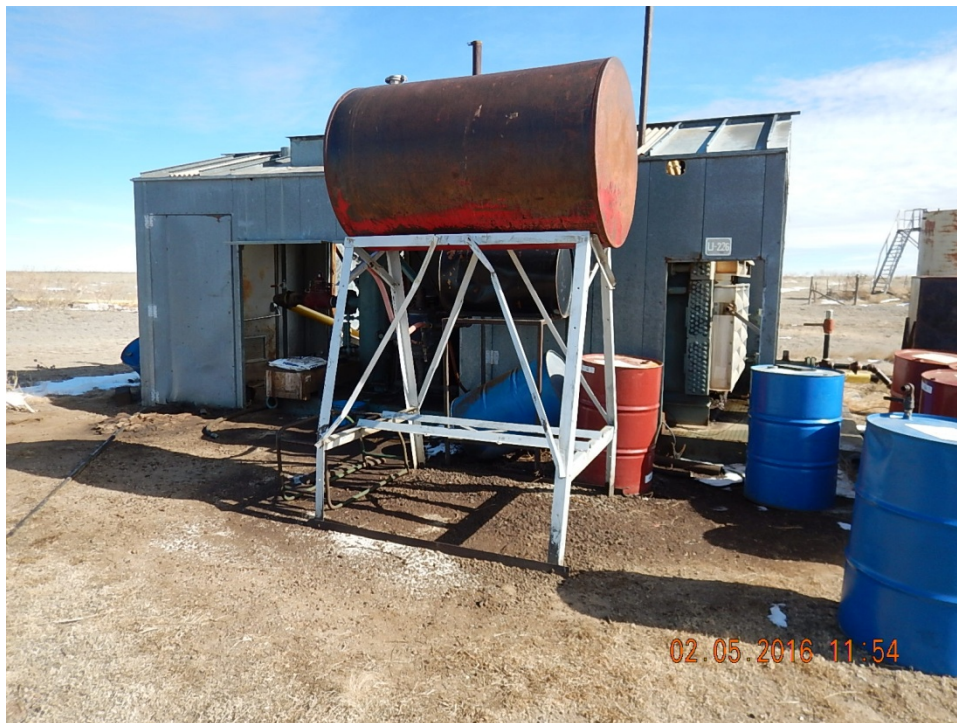
Figure 1 – West side of compressor station

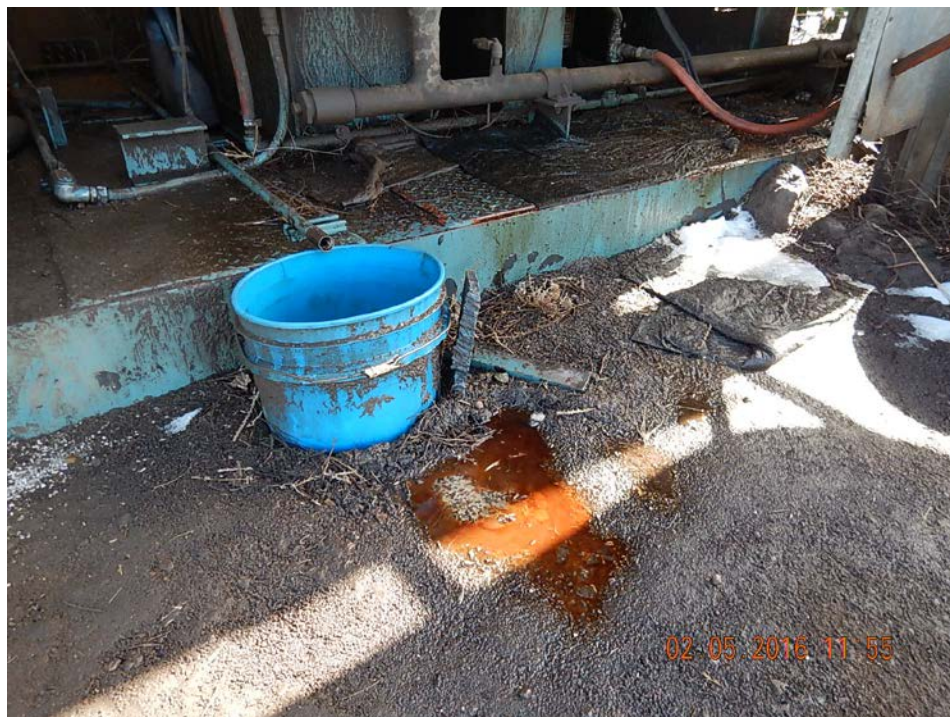
Figure 2 – Free product and stained soil on west side of compressor.

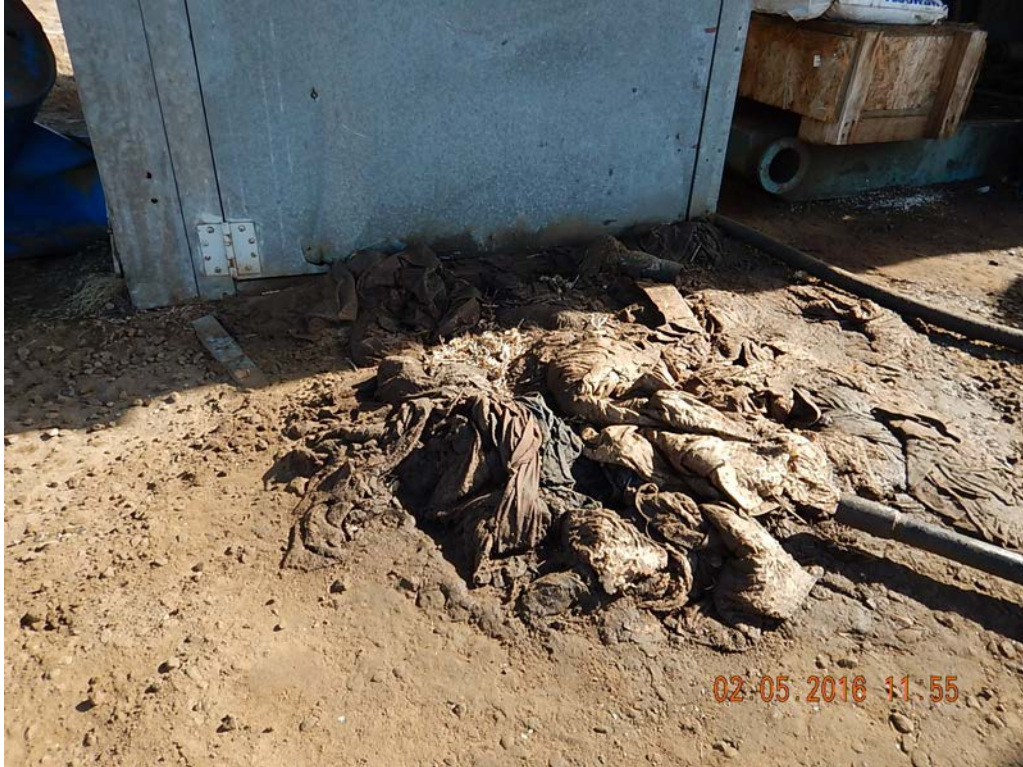
Figure 3 – Oily rags on northwest corner of compressor station.

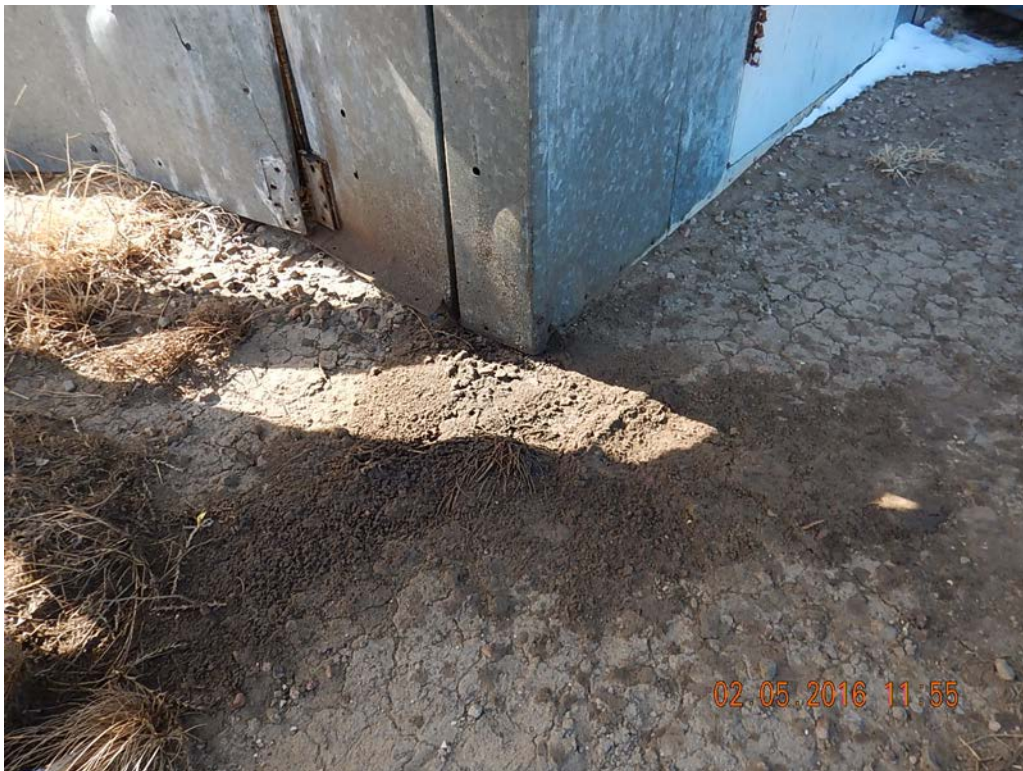
Figure 4 – Stained soil on northeast corner of compressor.

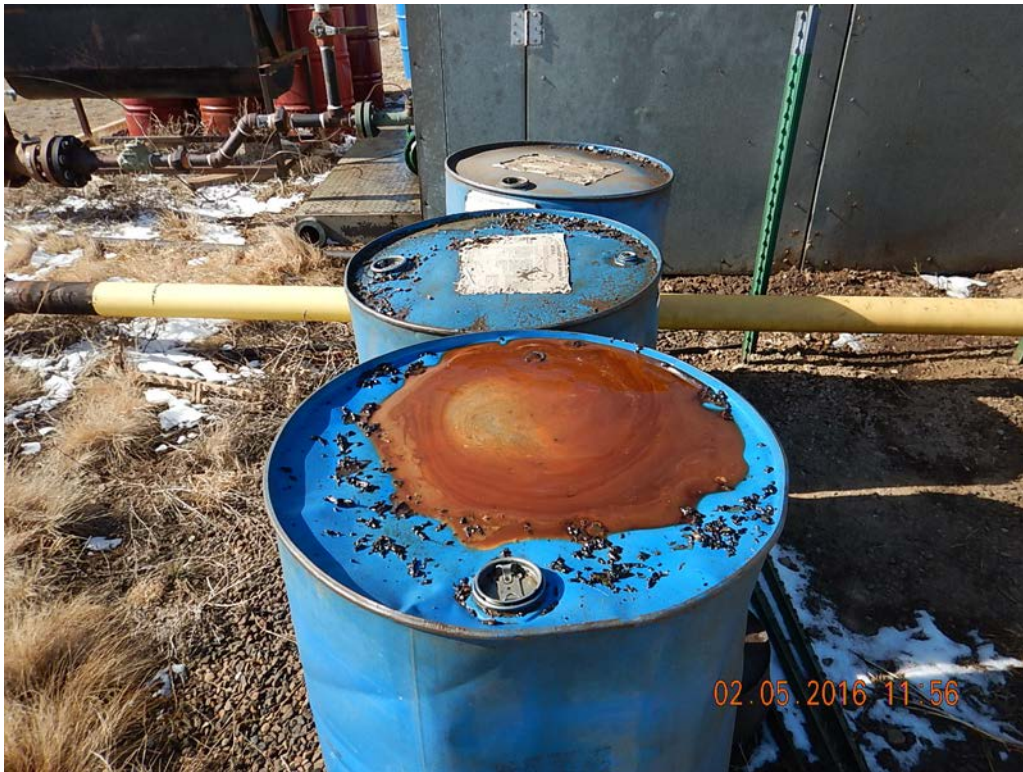
Figure 5 – Leaking barrels stored on location

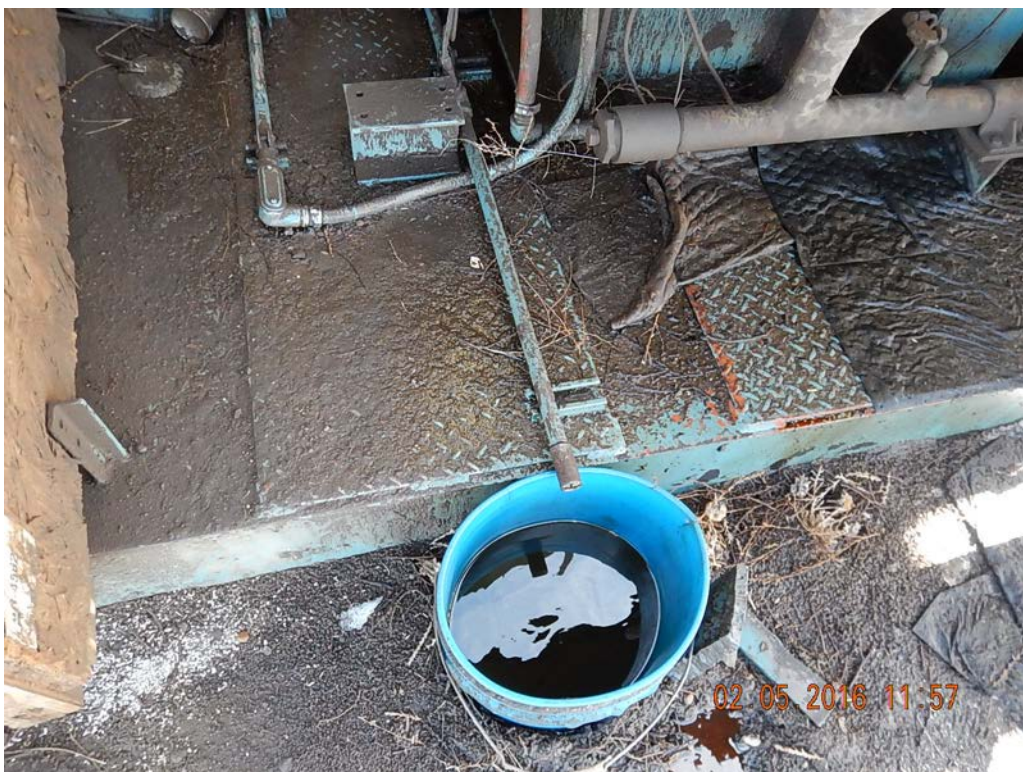
Figure 6 – Lube oil drain bucket on west side of compressor station.

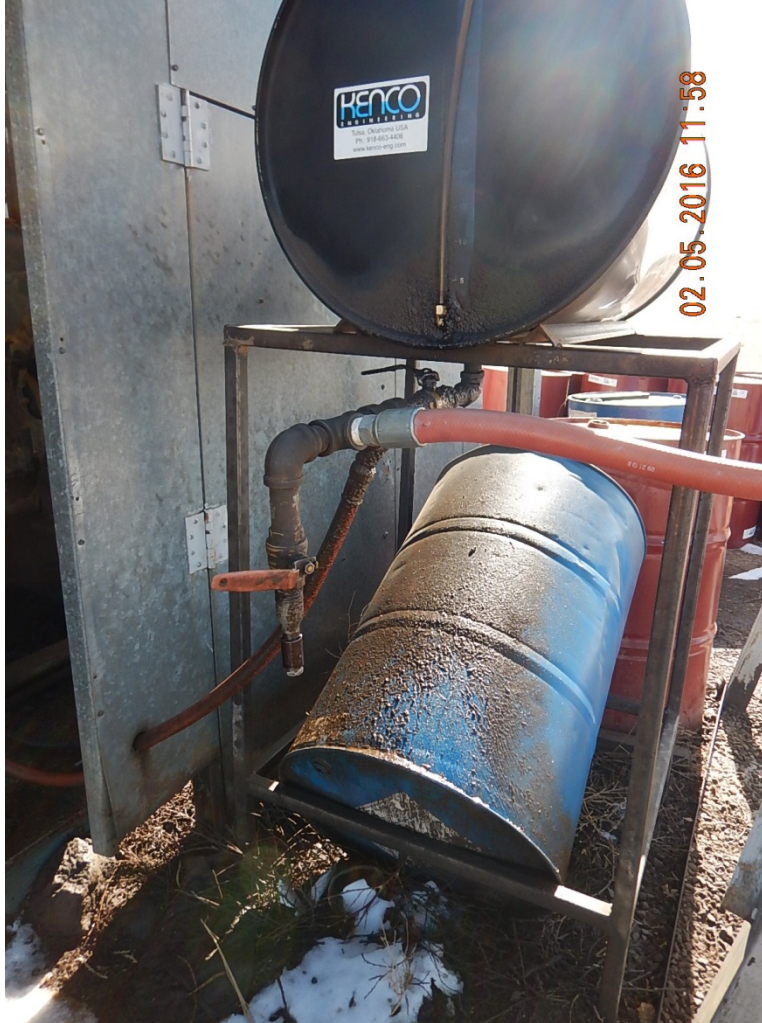
Figure 7 – West side of compressor station.

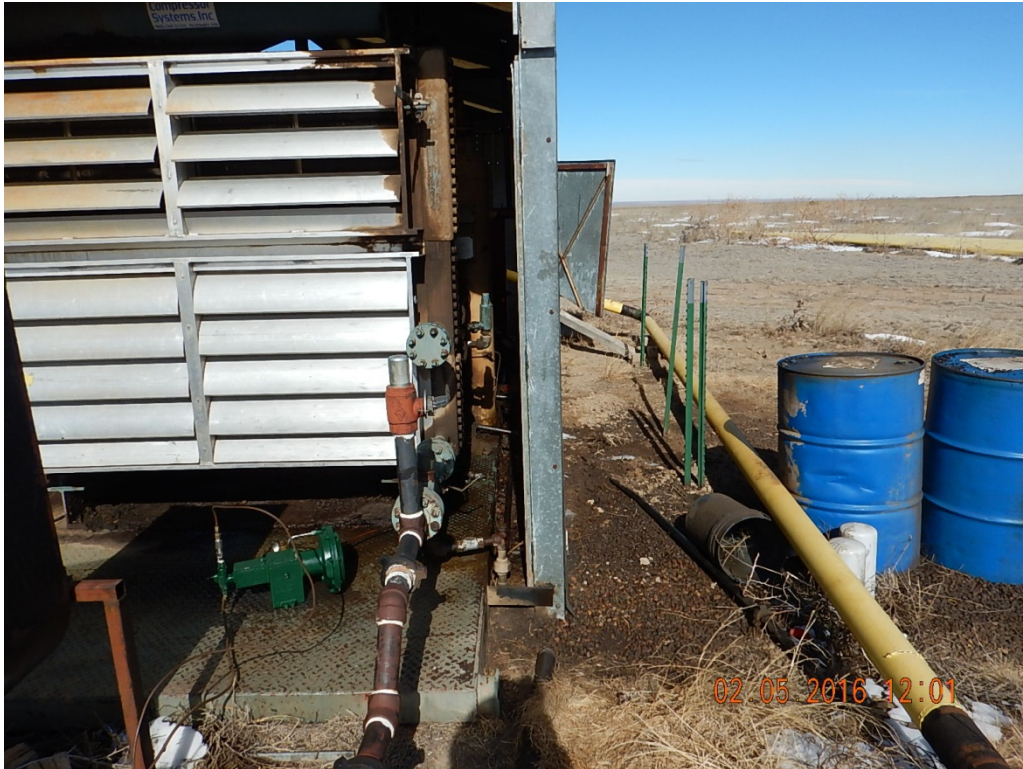
Figure 8 – Oil stained soil on east side of the compressor.
