# Interim Reclamation Inspection

2/9/2016

Operator: Whiting Oil and Gas

Location ID: 430695

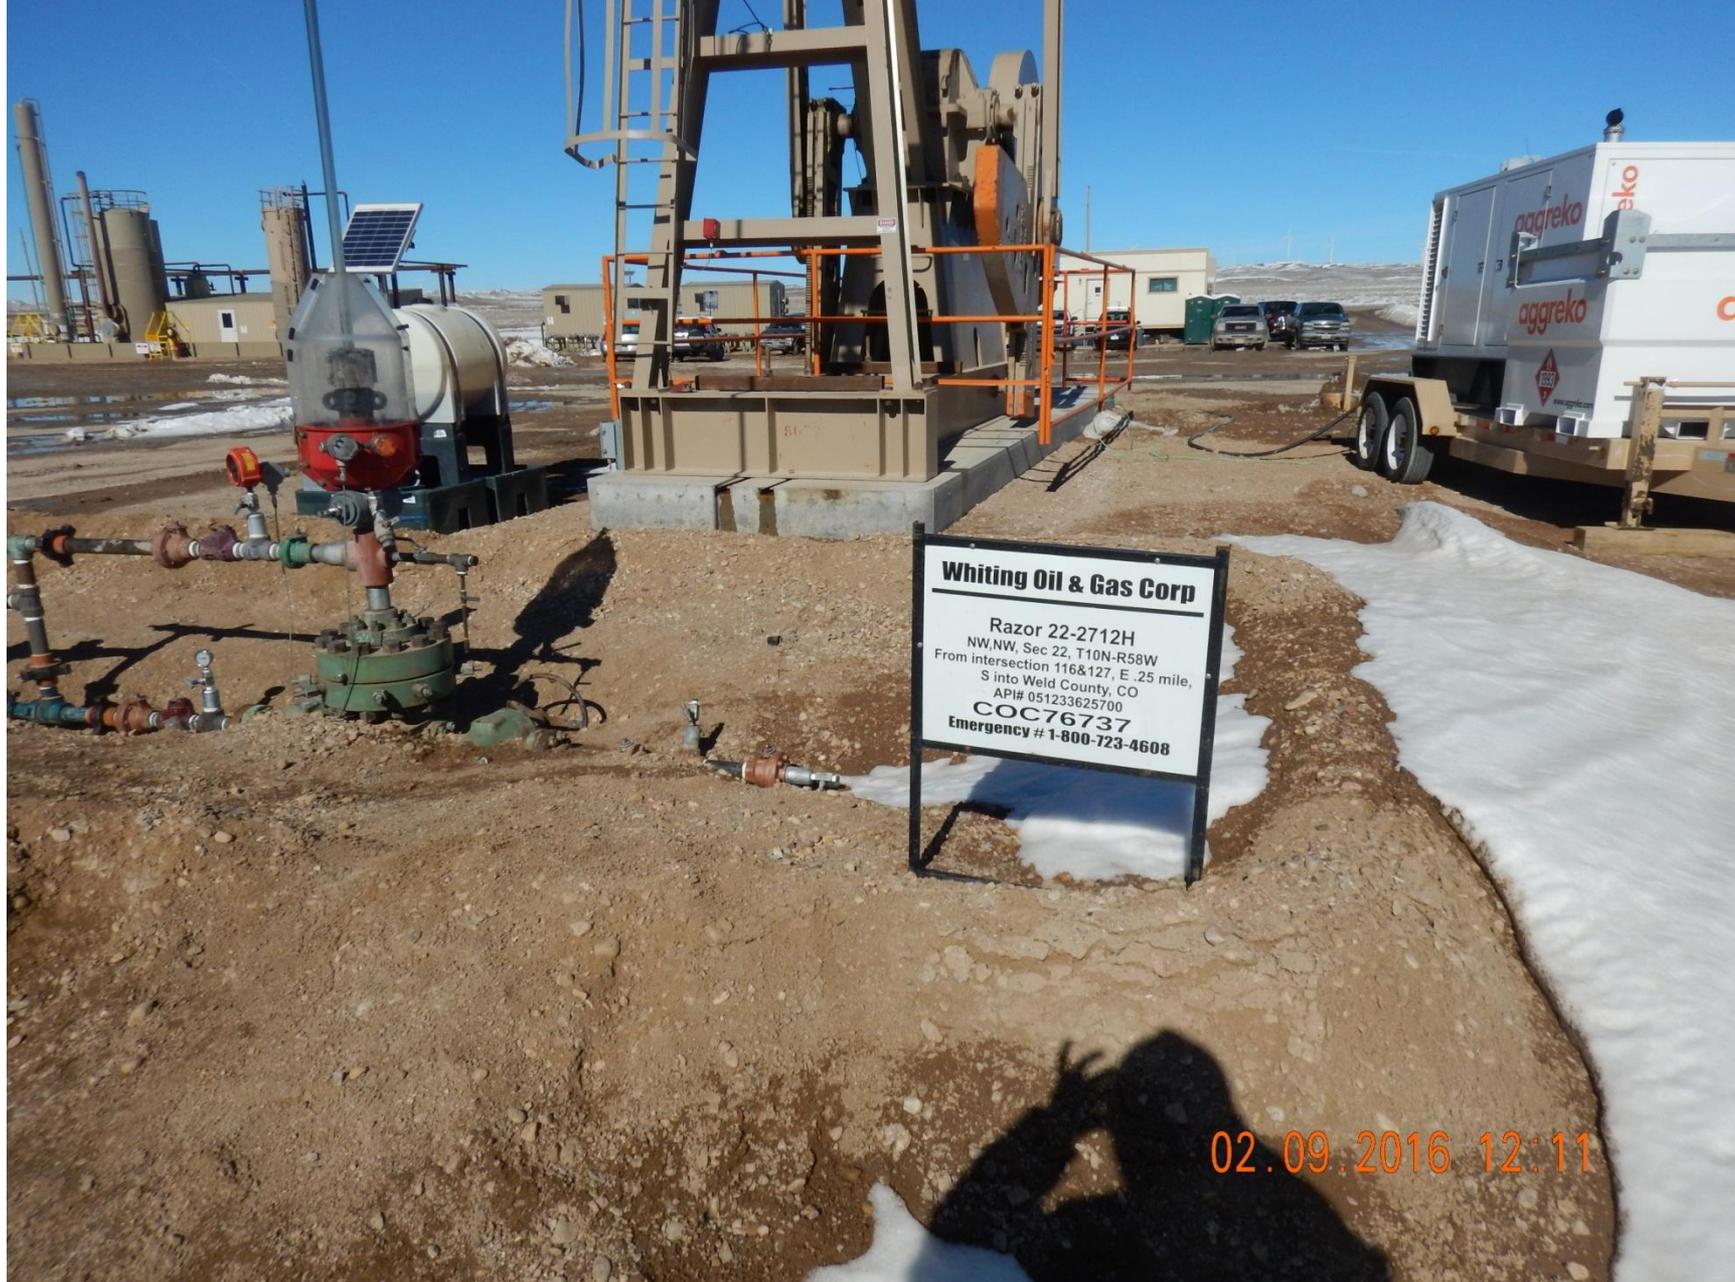
**Figure 1:** Photo well sign at 123-36257.

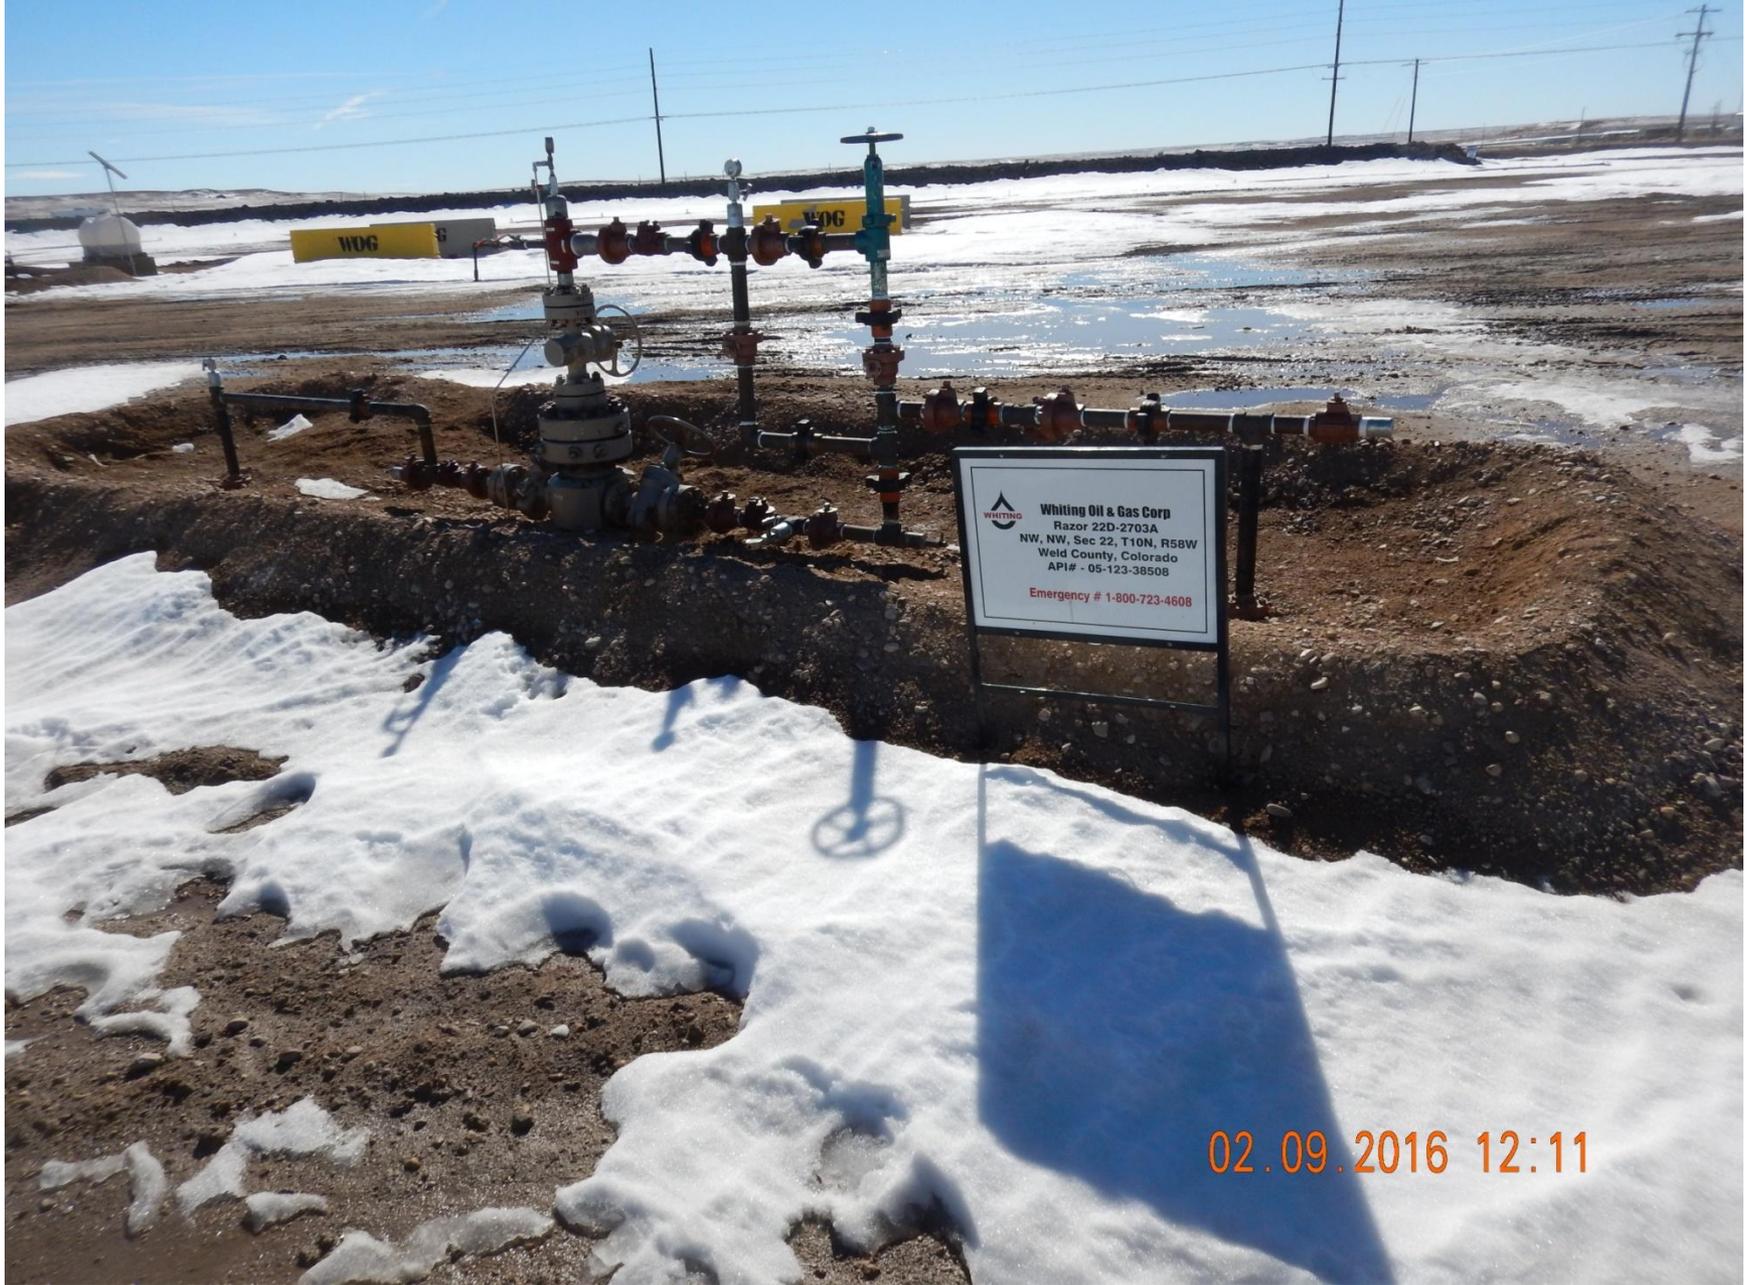
**Figure 2:** Photo of sign at well 123-38508

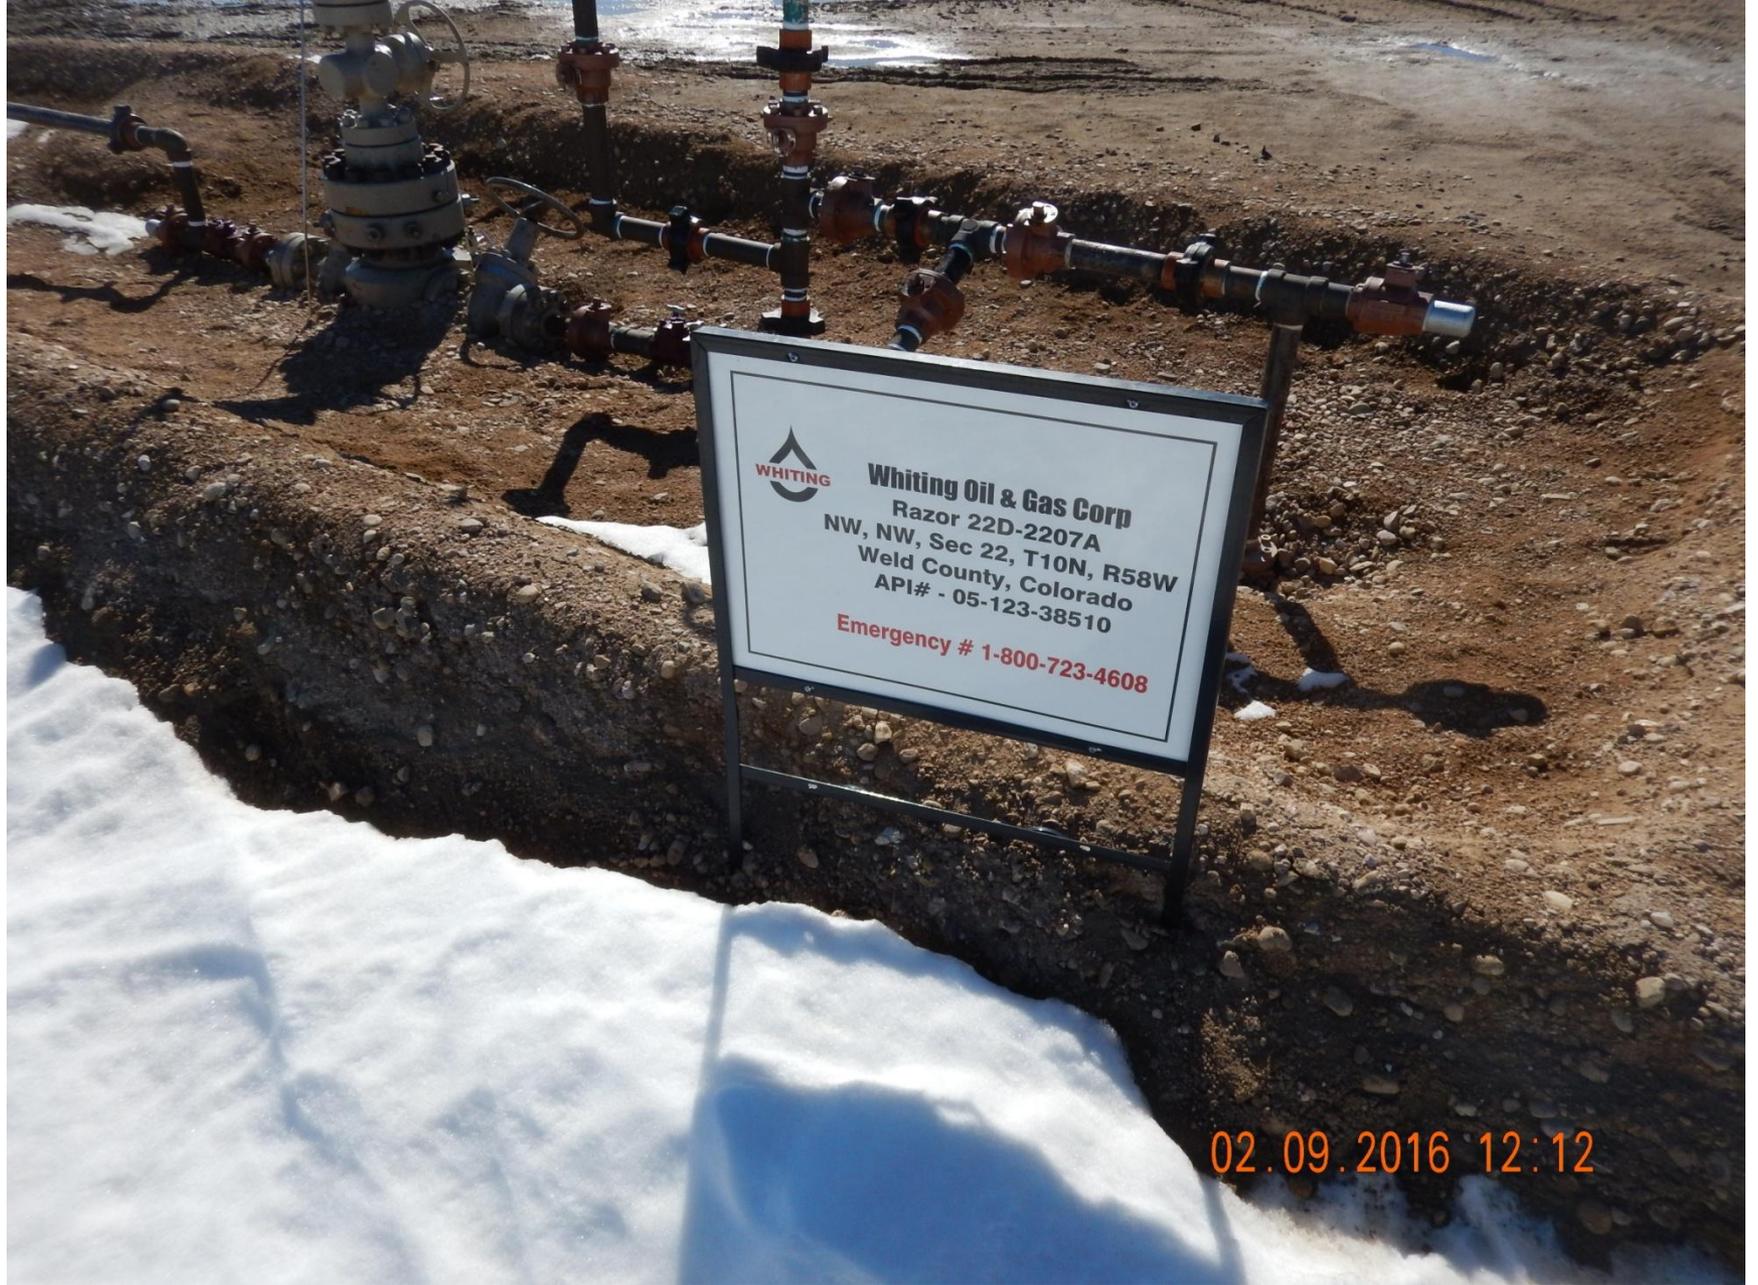
**Figure 3:** Photo of sign at well 123-38510

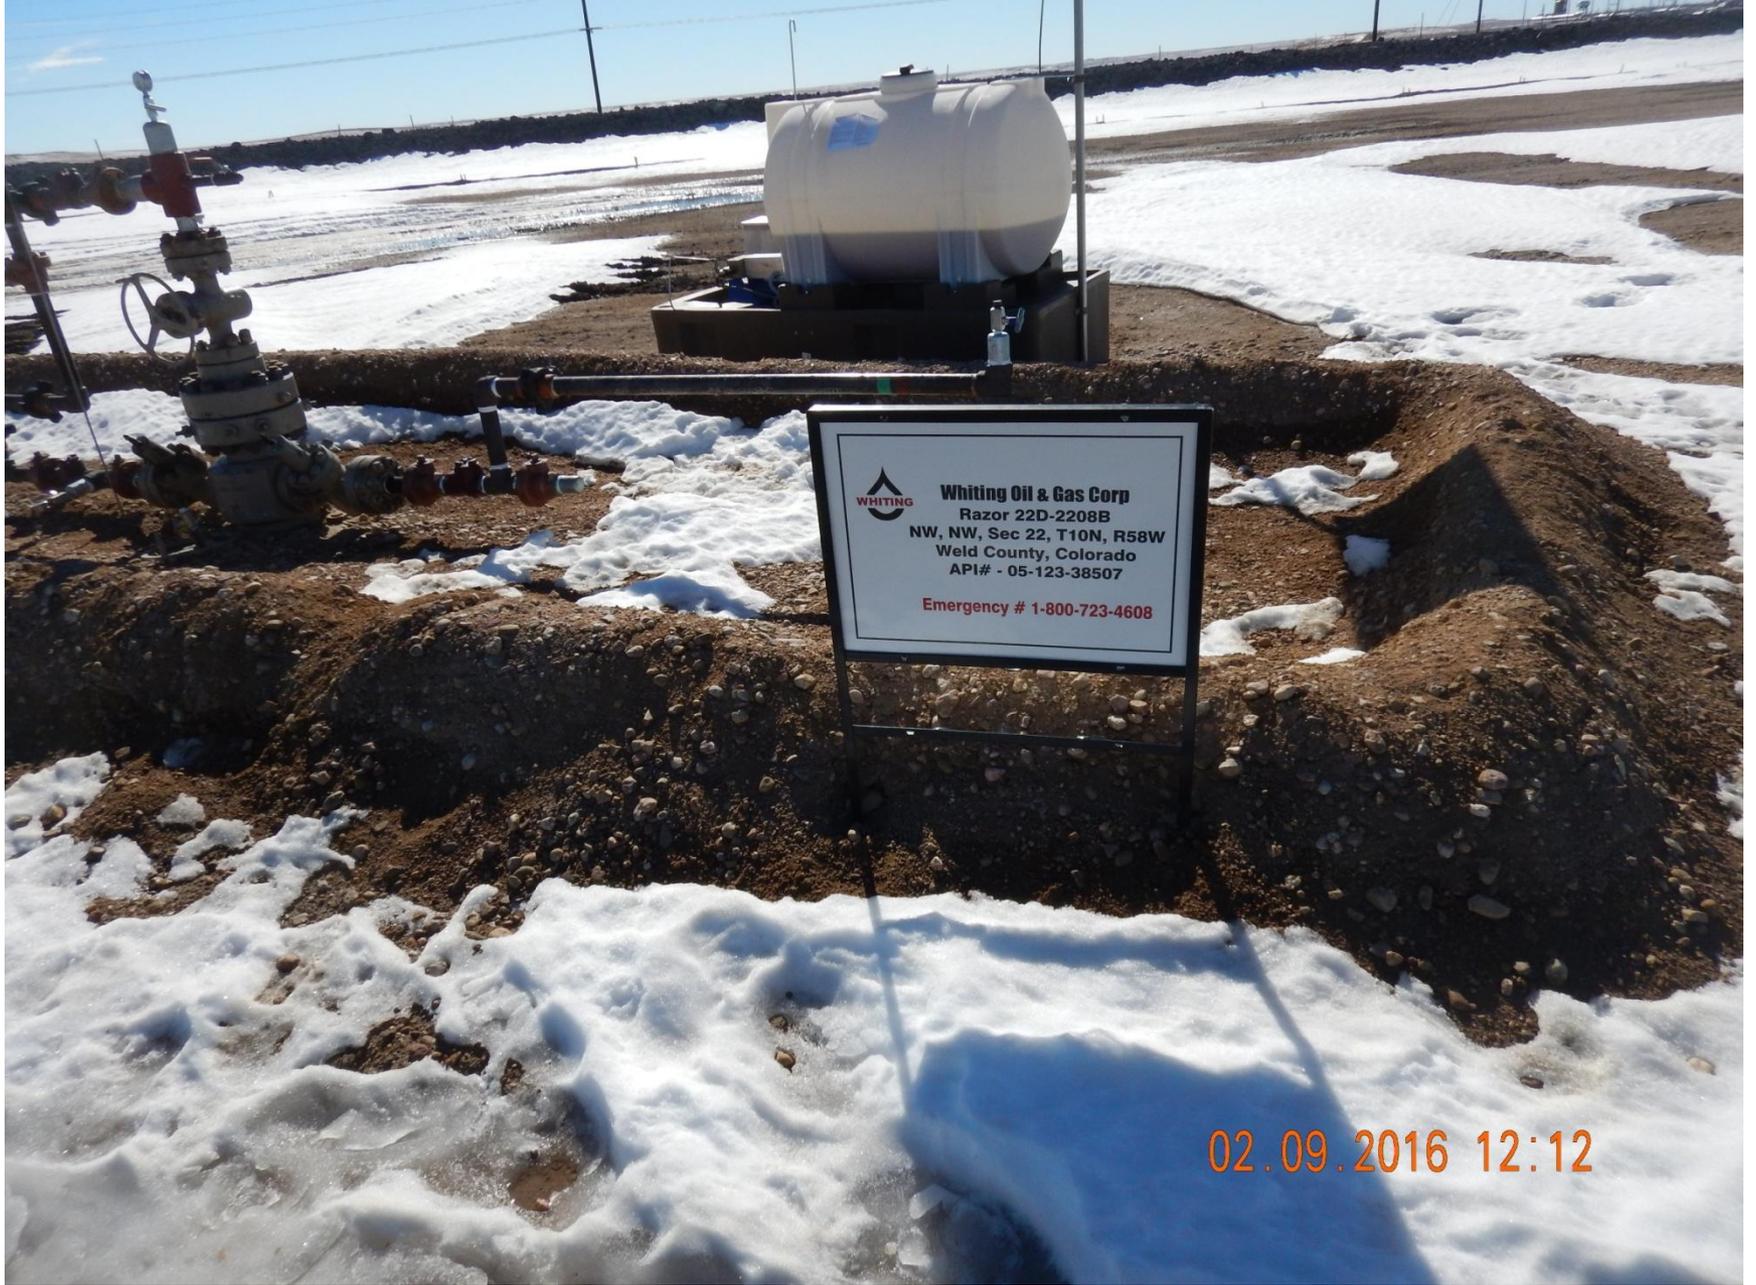
**Figure 4:** Photo of sign at 123-38507.

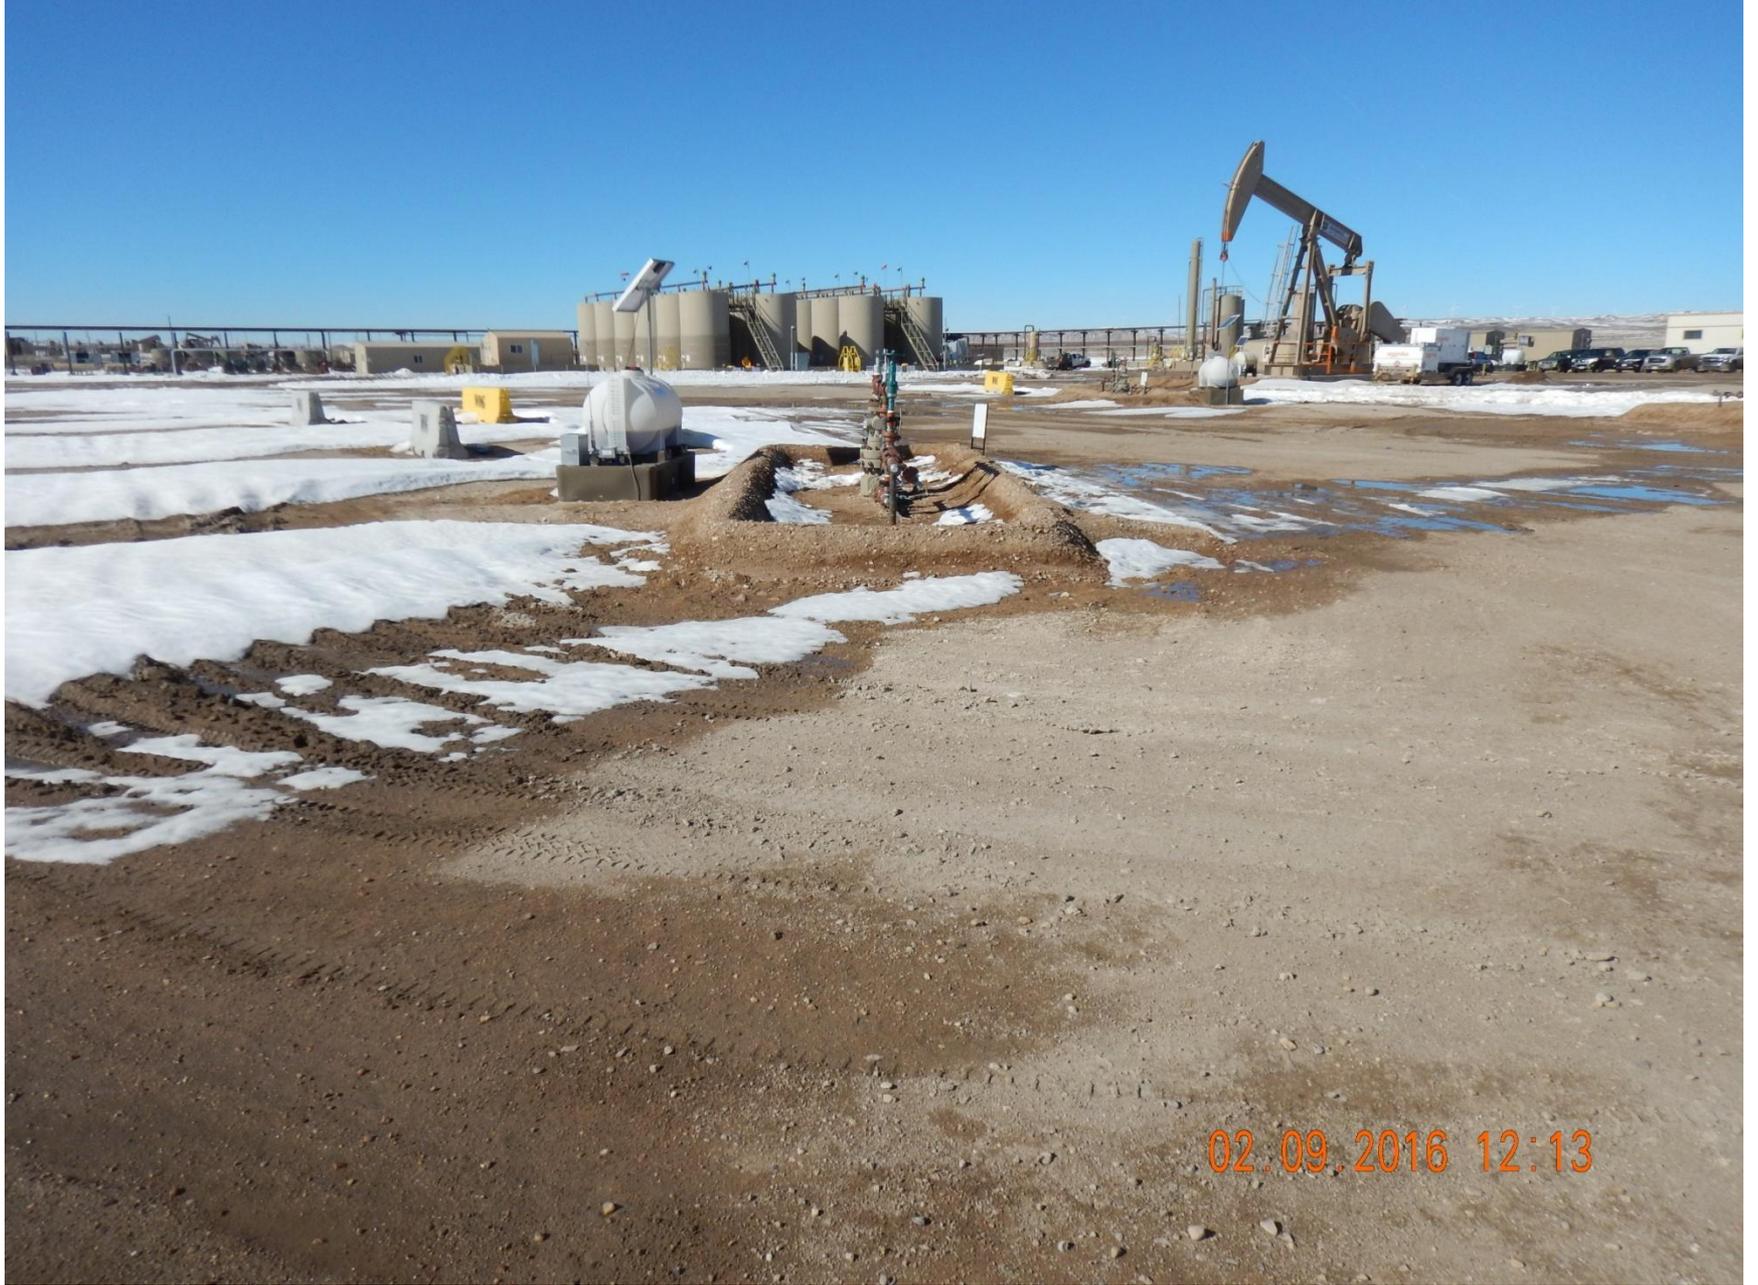
**Figure 5:** Photo taken from location, facing west. Note stake marking well location as not been removed.

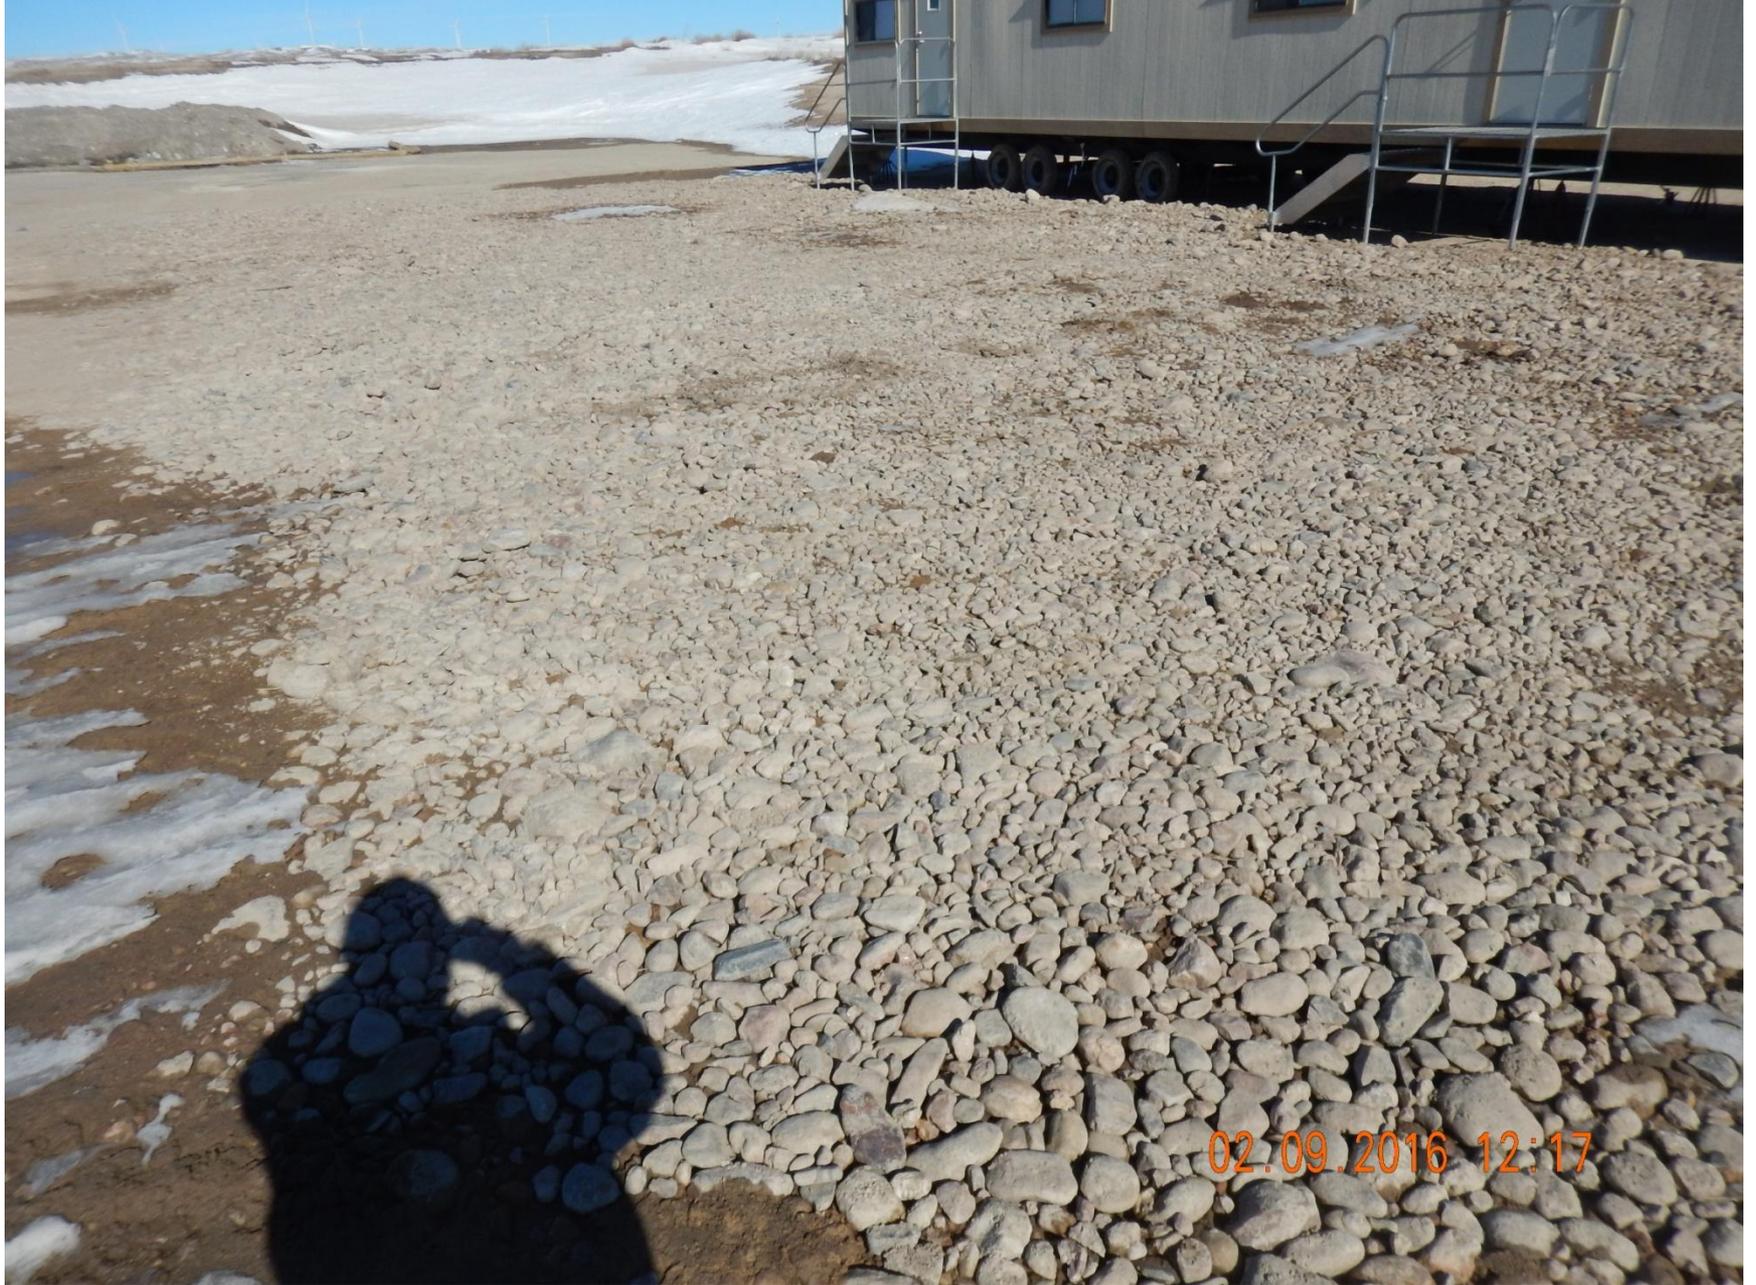
**Figure 6:** Photo taken from east end of location. Photo of tracking BMP.

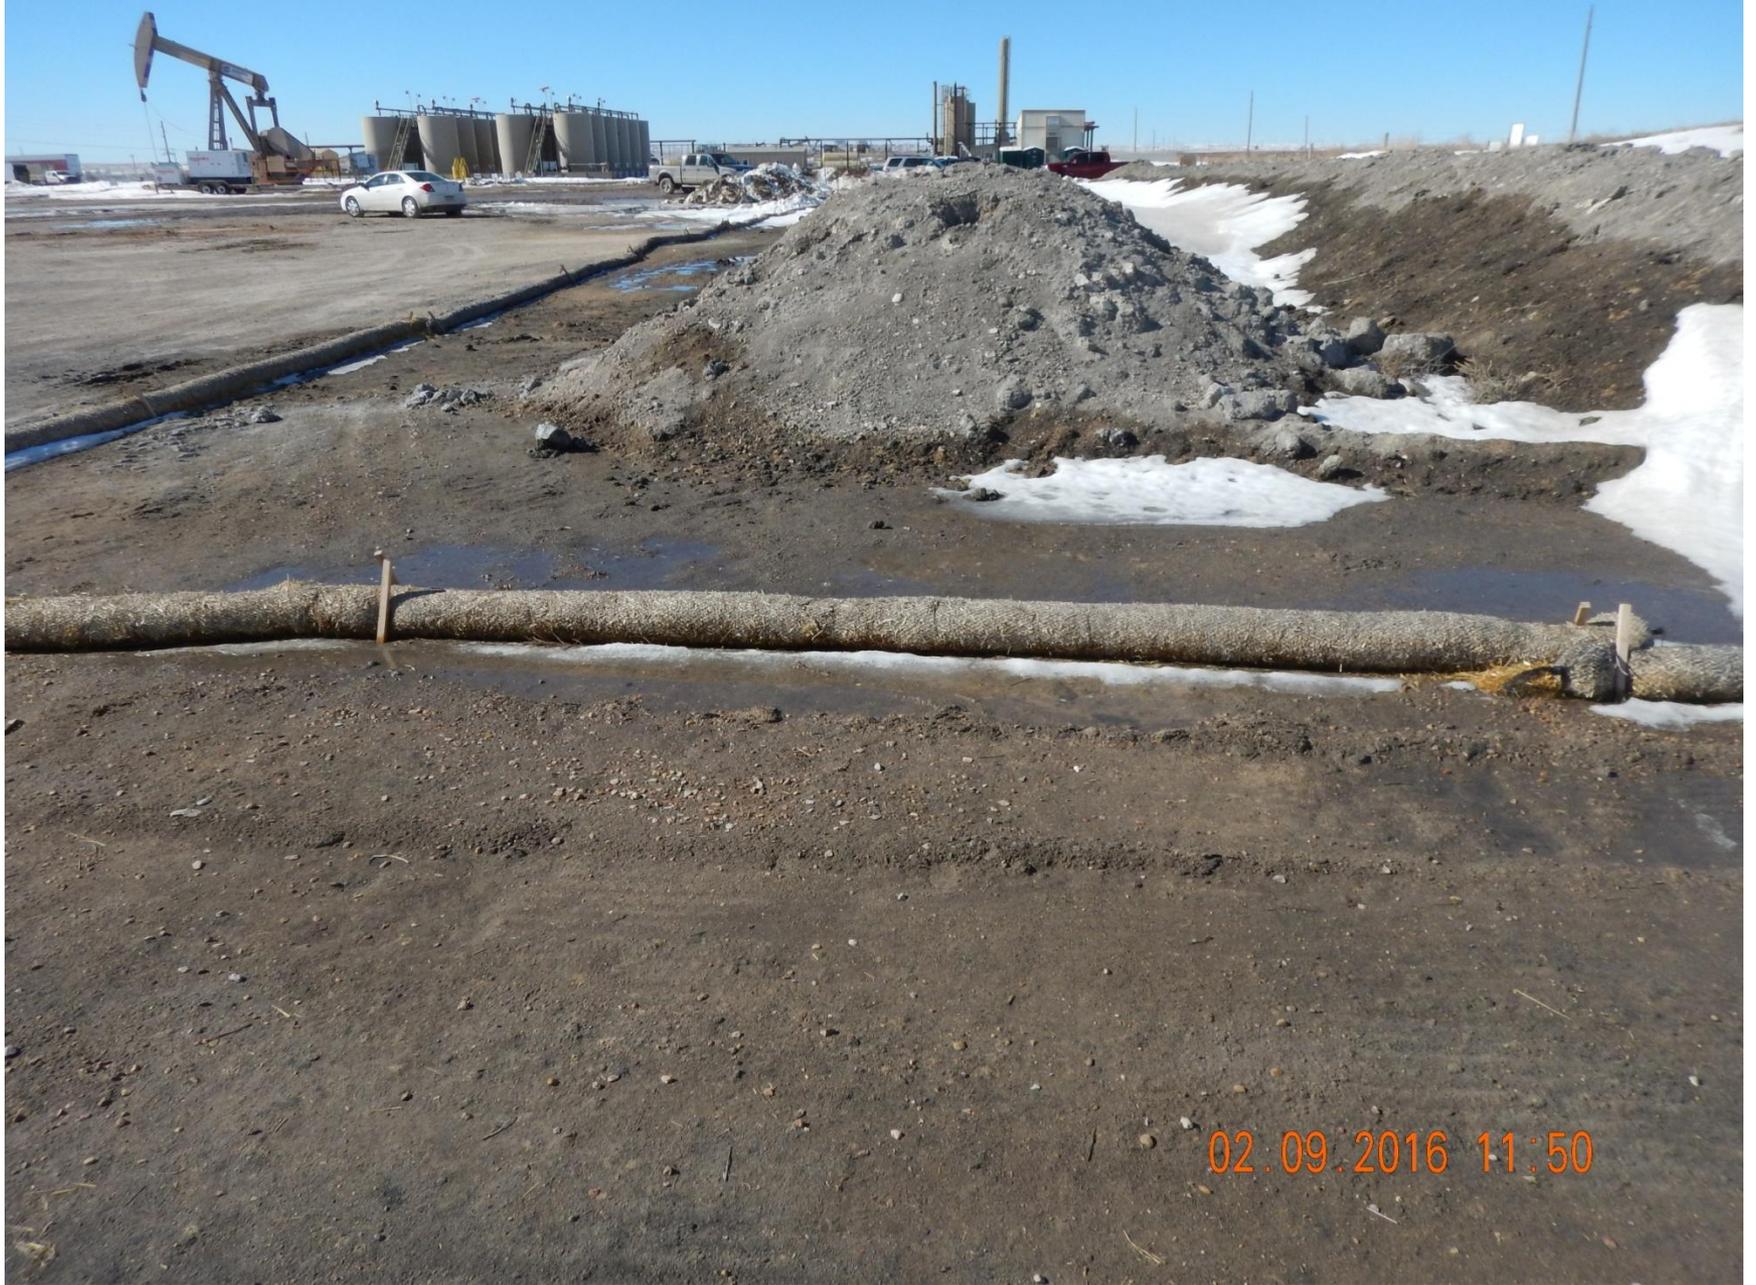
**Figure 7:** Photo taken from northeast end of location, facing west. Photo of stored cuttings and waddles.

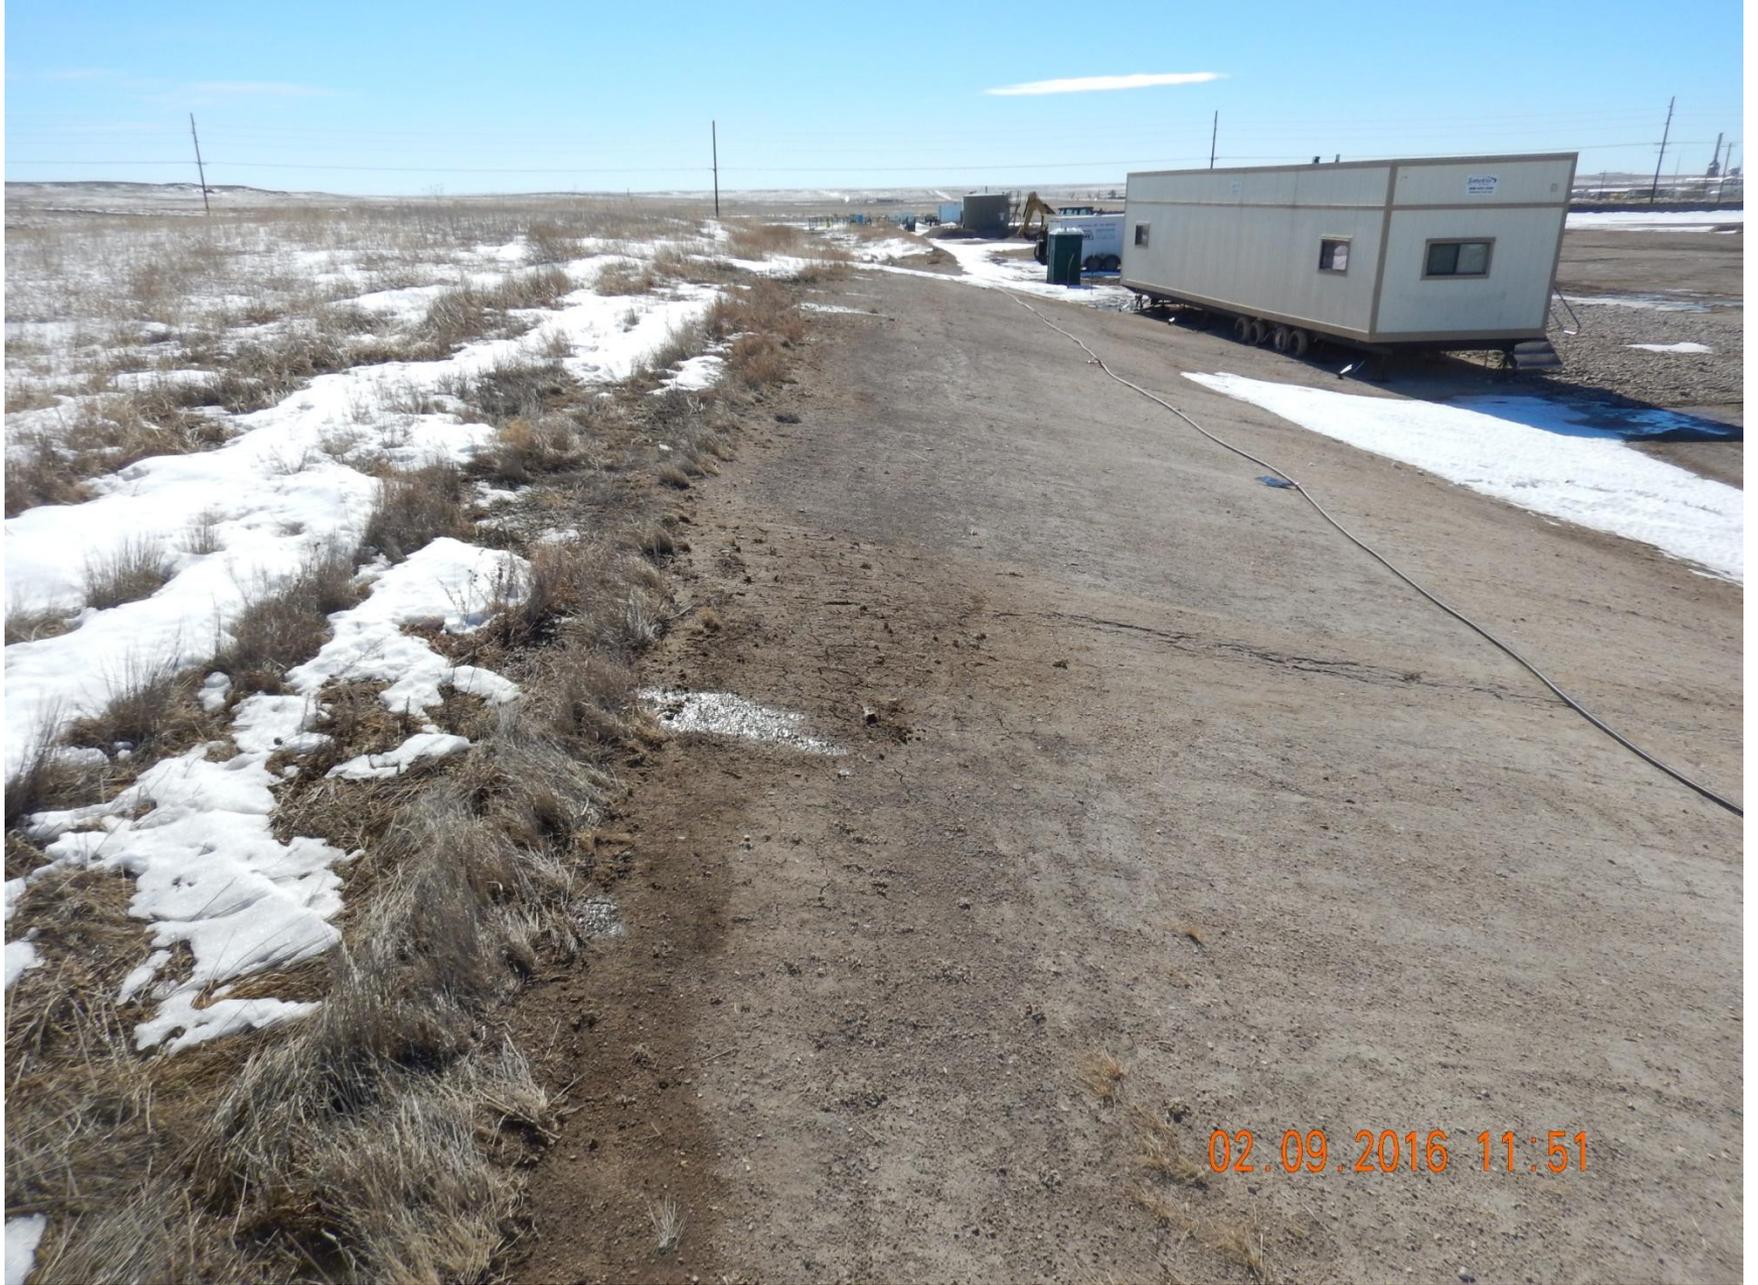
**Figure 9:** Photo taken from northeast end of location, facing south. Photo shows interim and project areas.

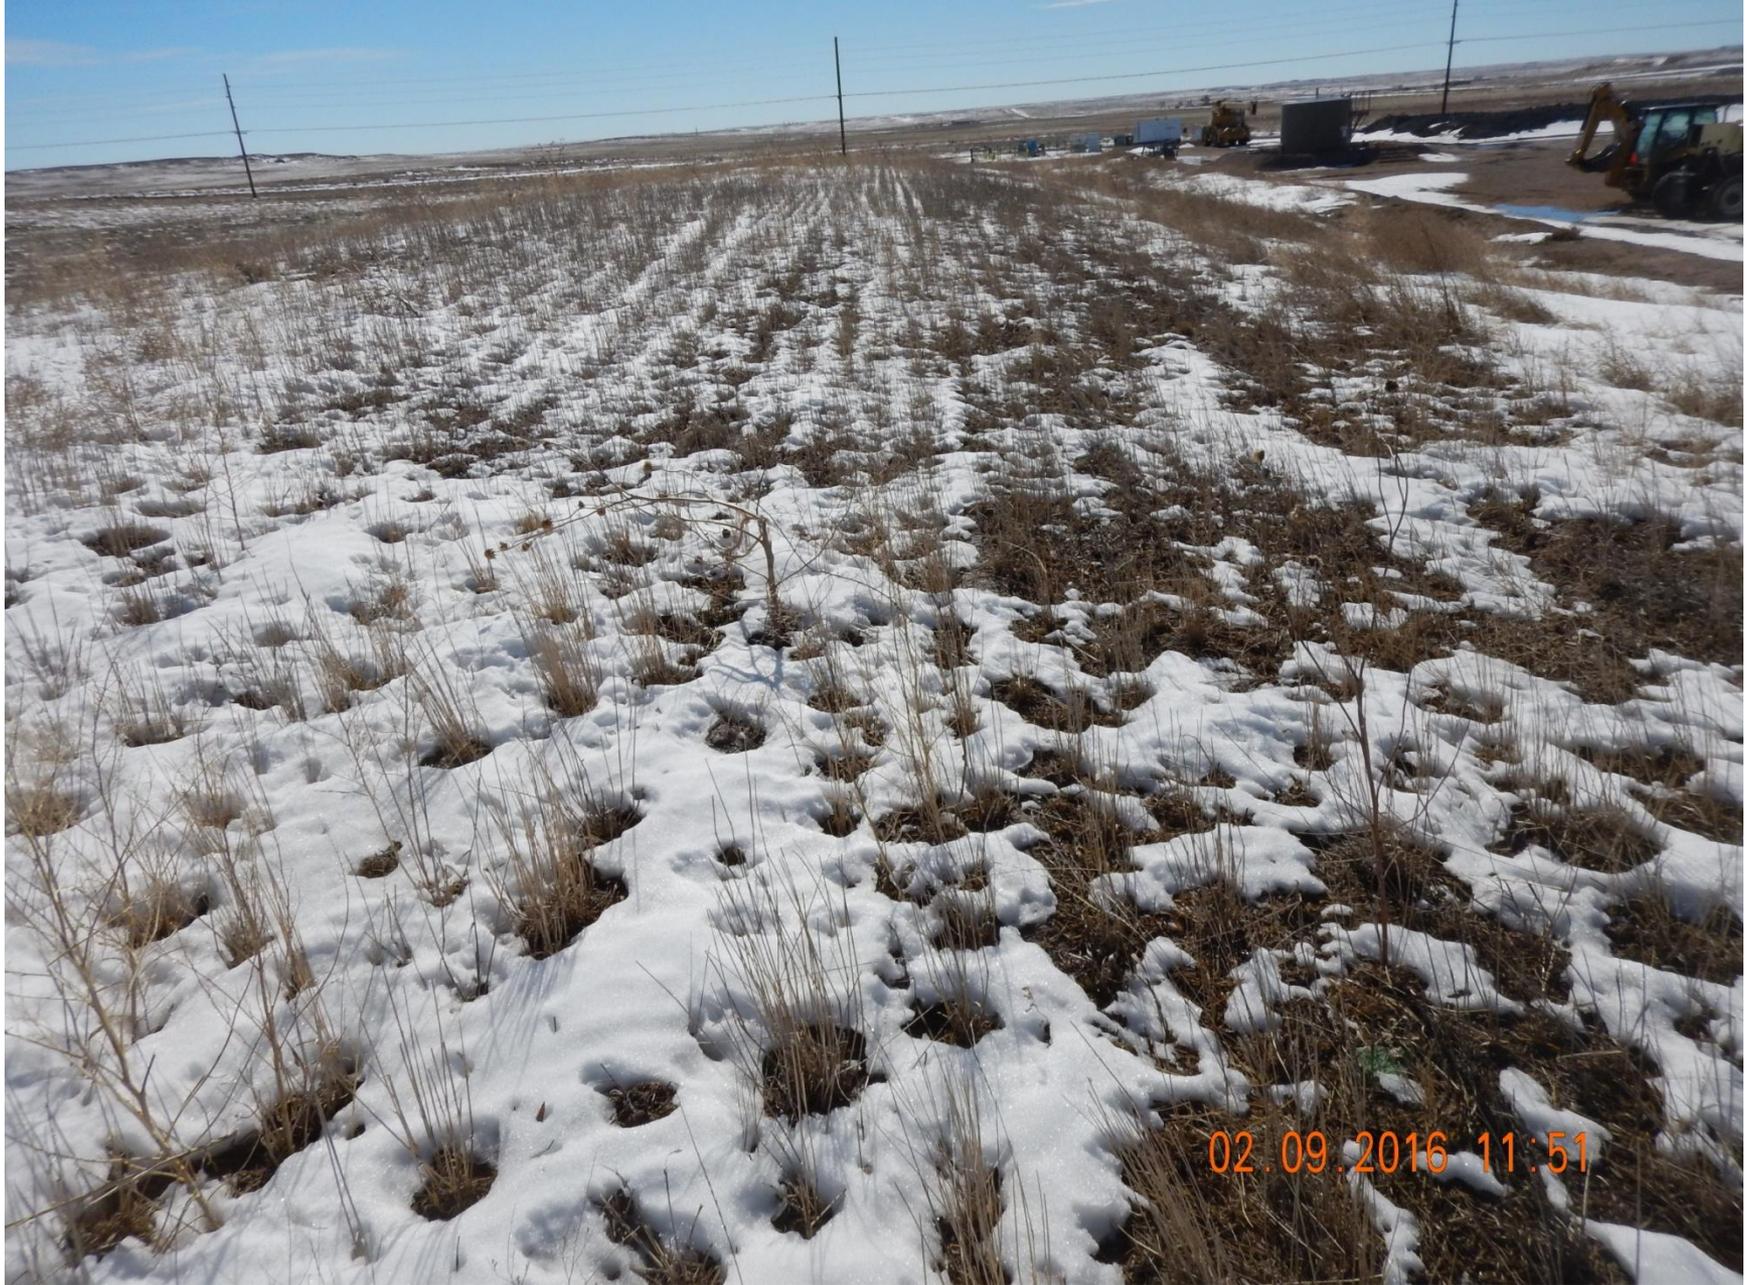
**Figure 10:** Photo taken topsoil berm on the east end of the location, facing south. Photo of vegetation on interim area.

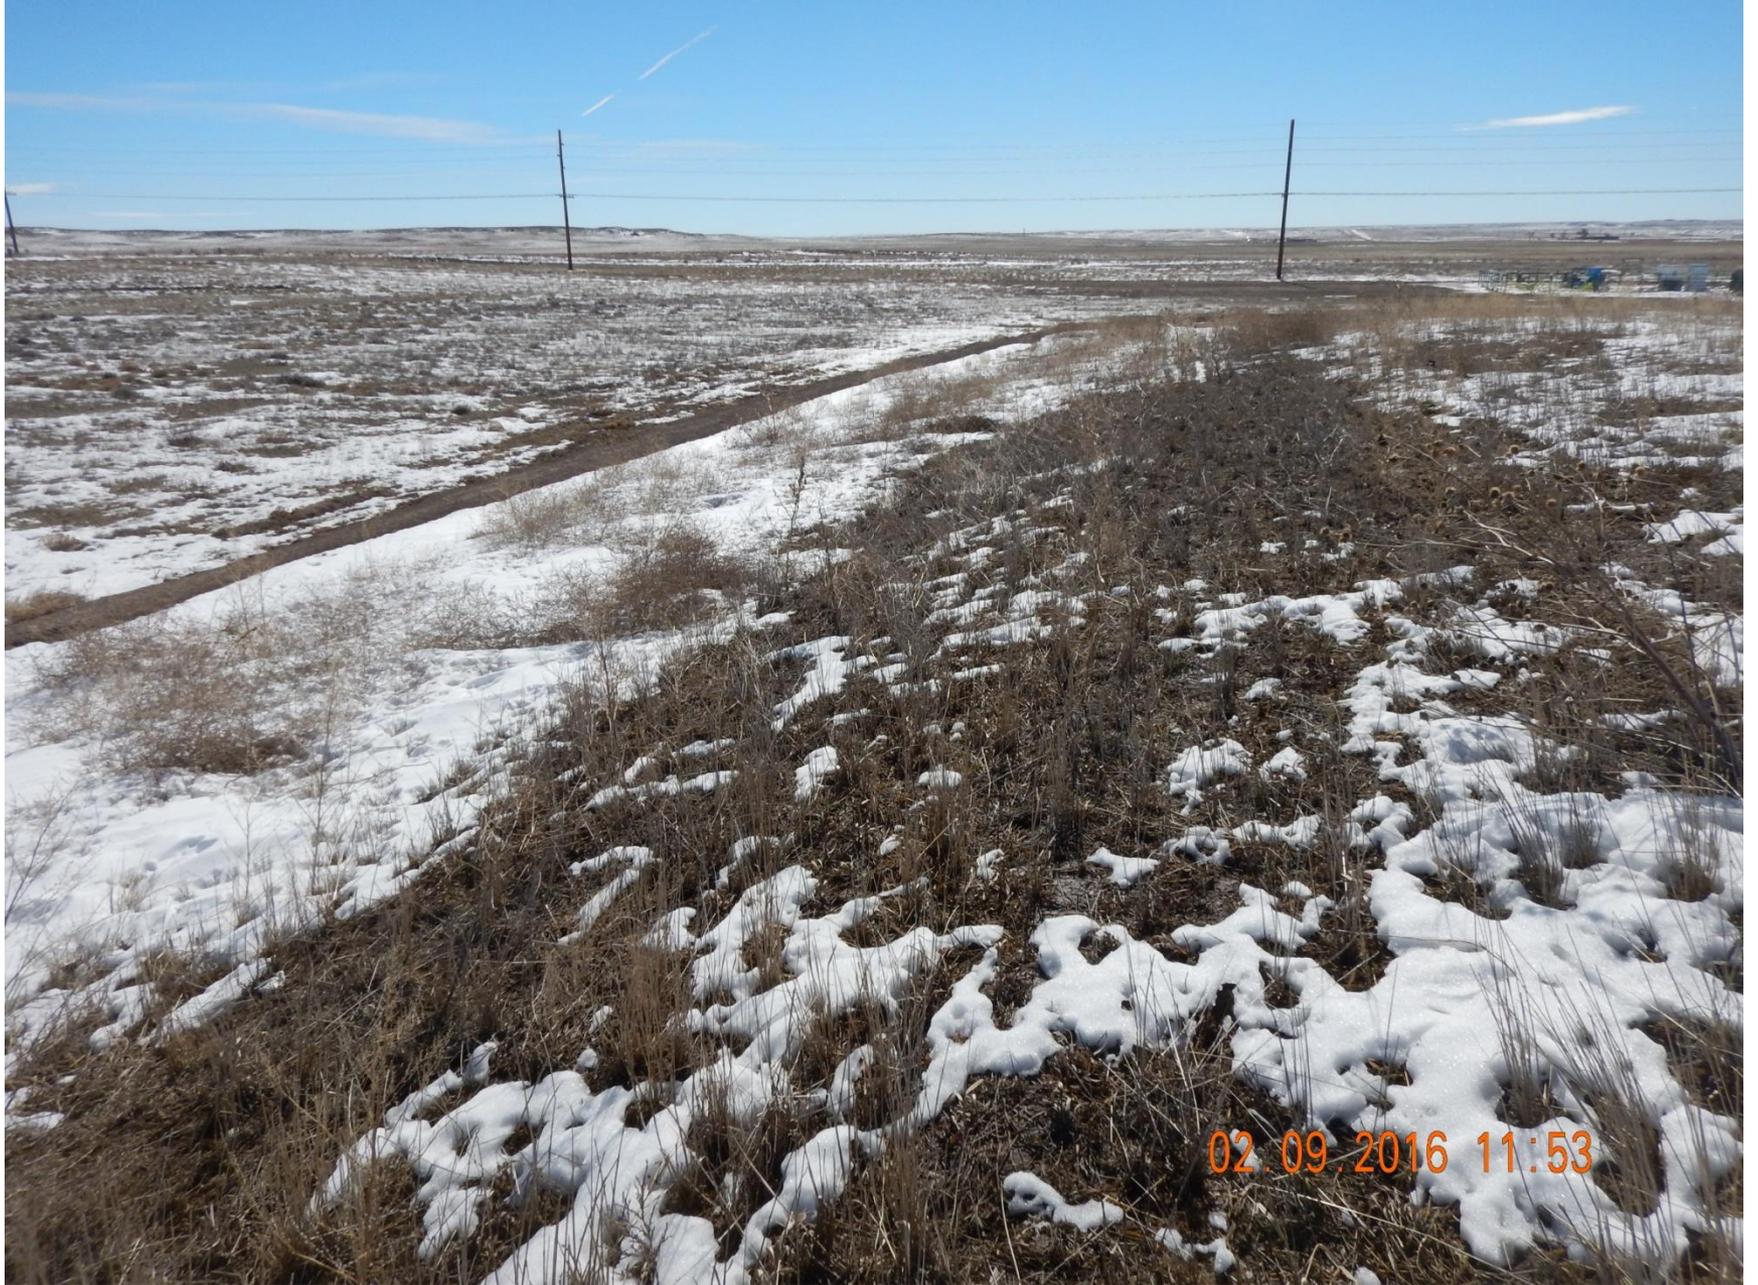
**Figure 11:** Photo taken from topsoil berm on the east end of the location, facing south. Photo of vegetation on interim area, and stormwater control.
