# Interim Reclamation Inspection

2/9/2016

Operator: Whiting Oil and Gas

Location ID: 430695

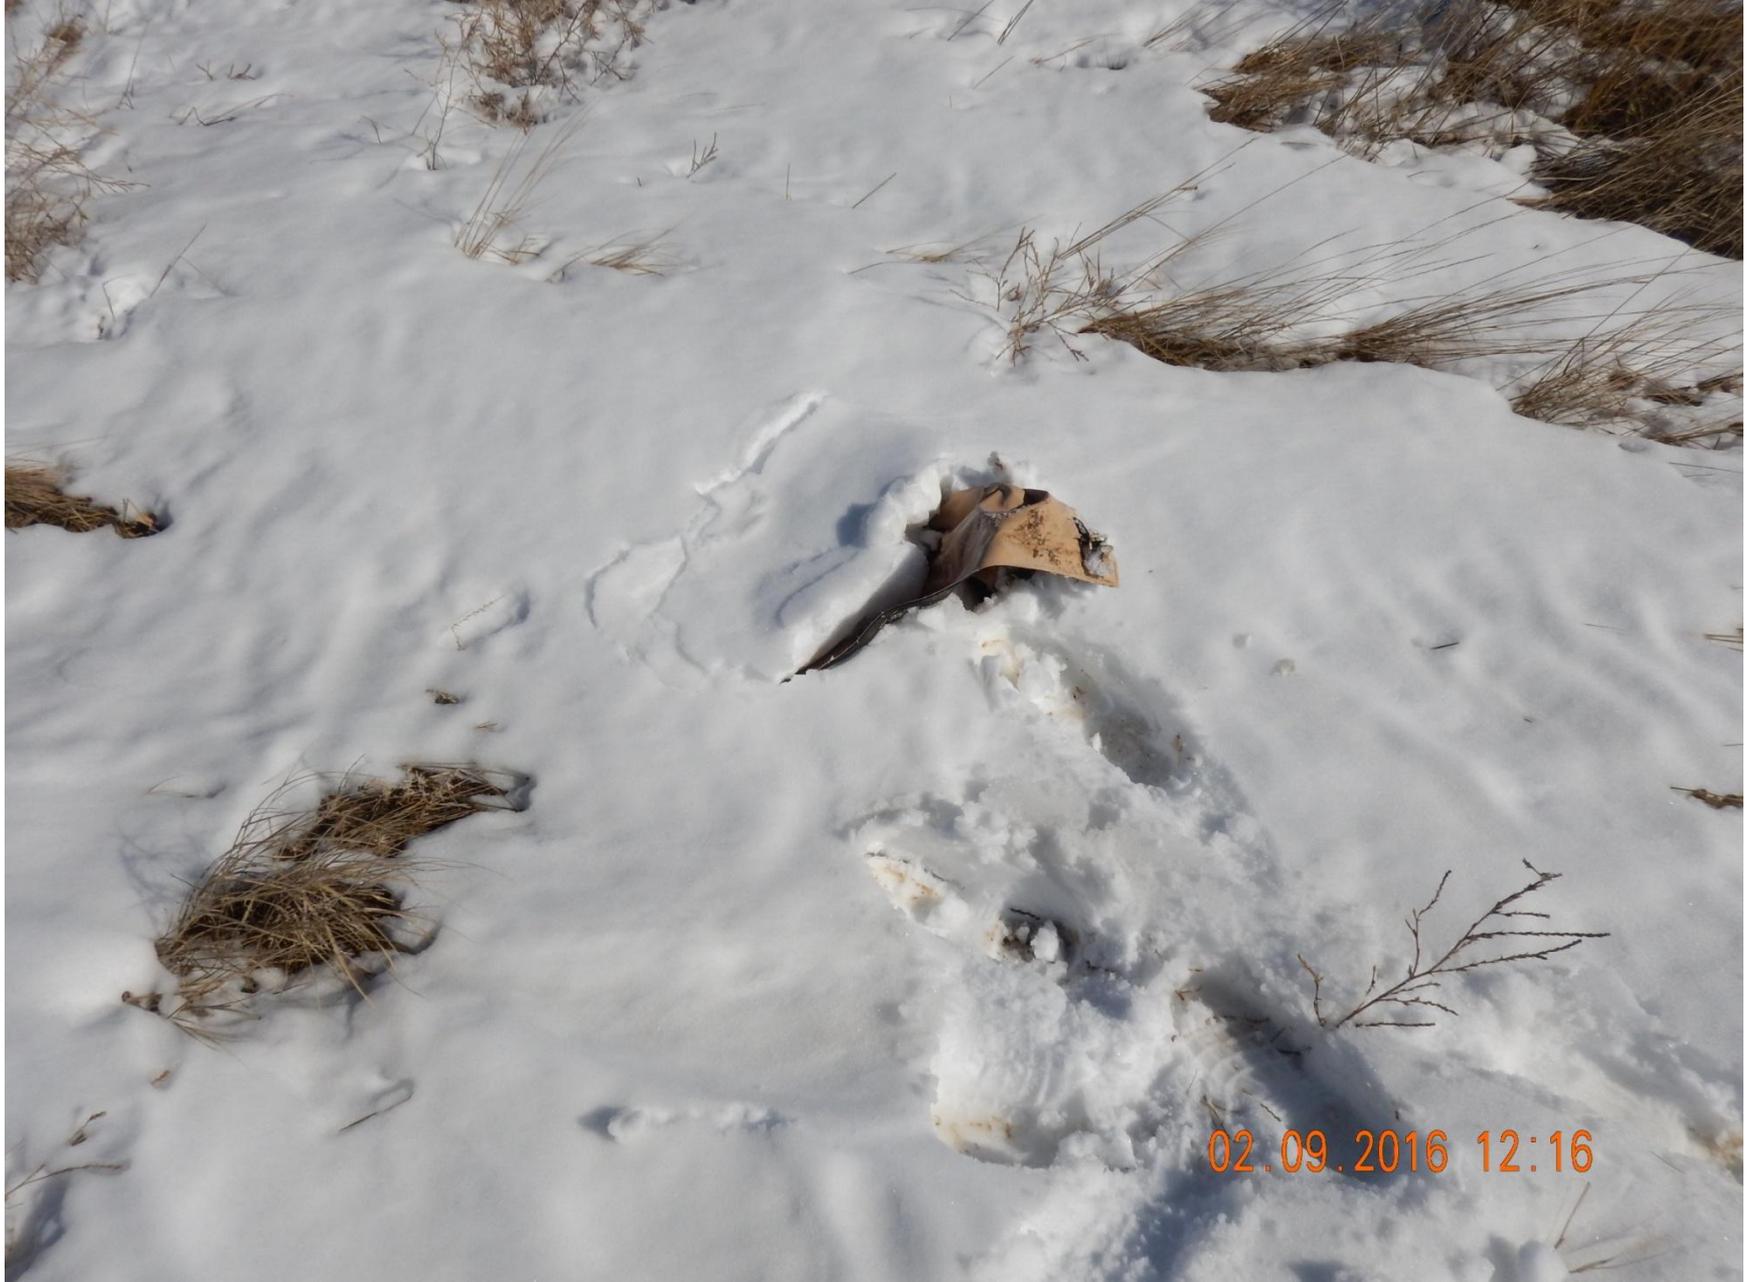
**Figure 12:** Photo taken from east end of project location. Photo of what appears to be a tarp covered in snow on ground.

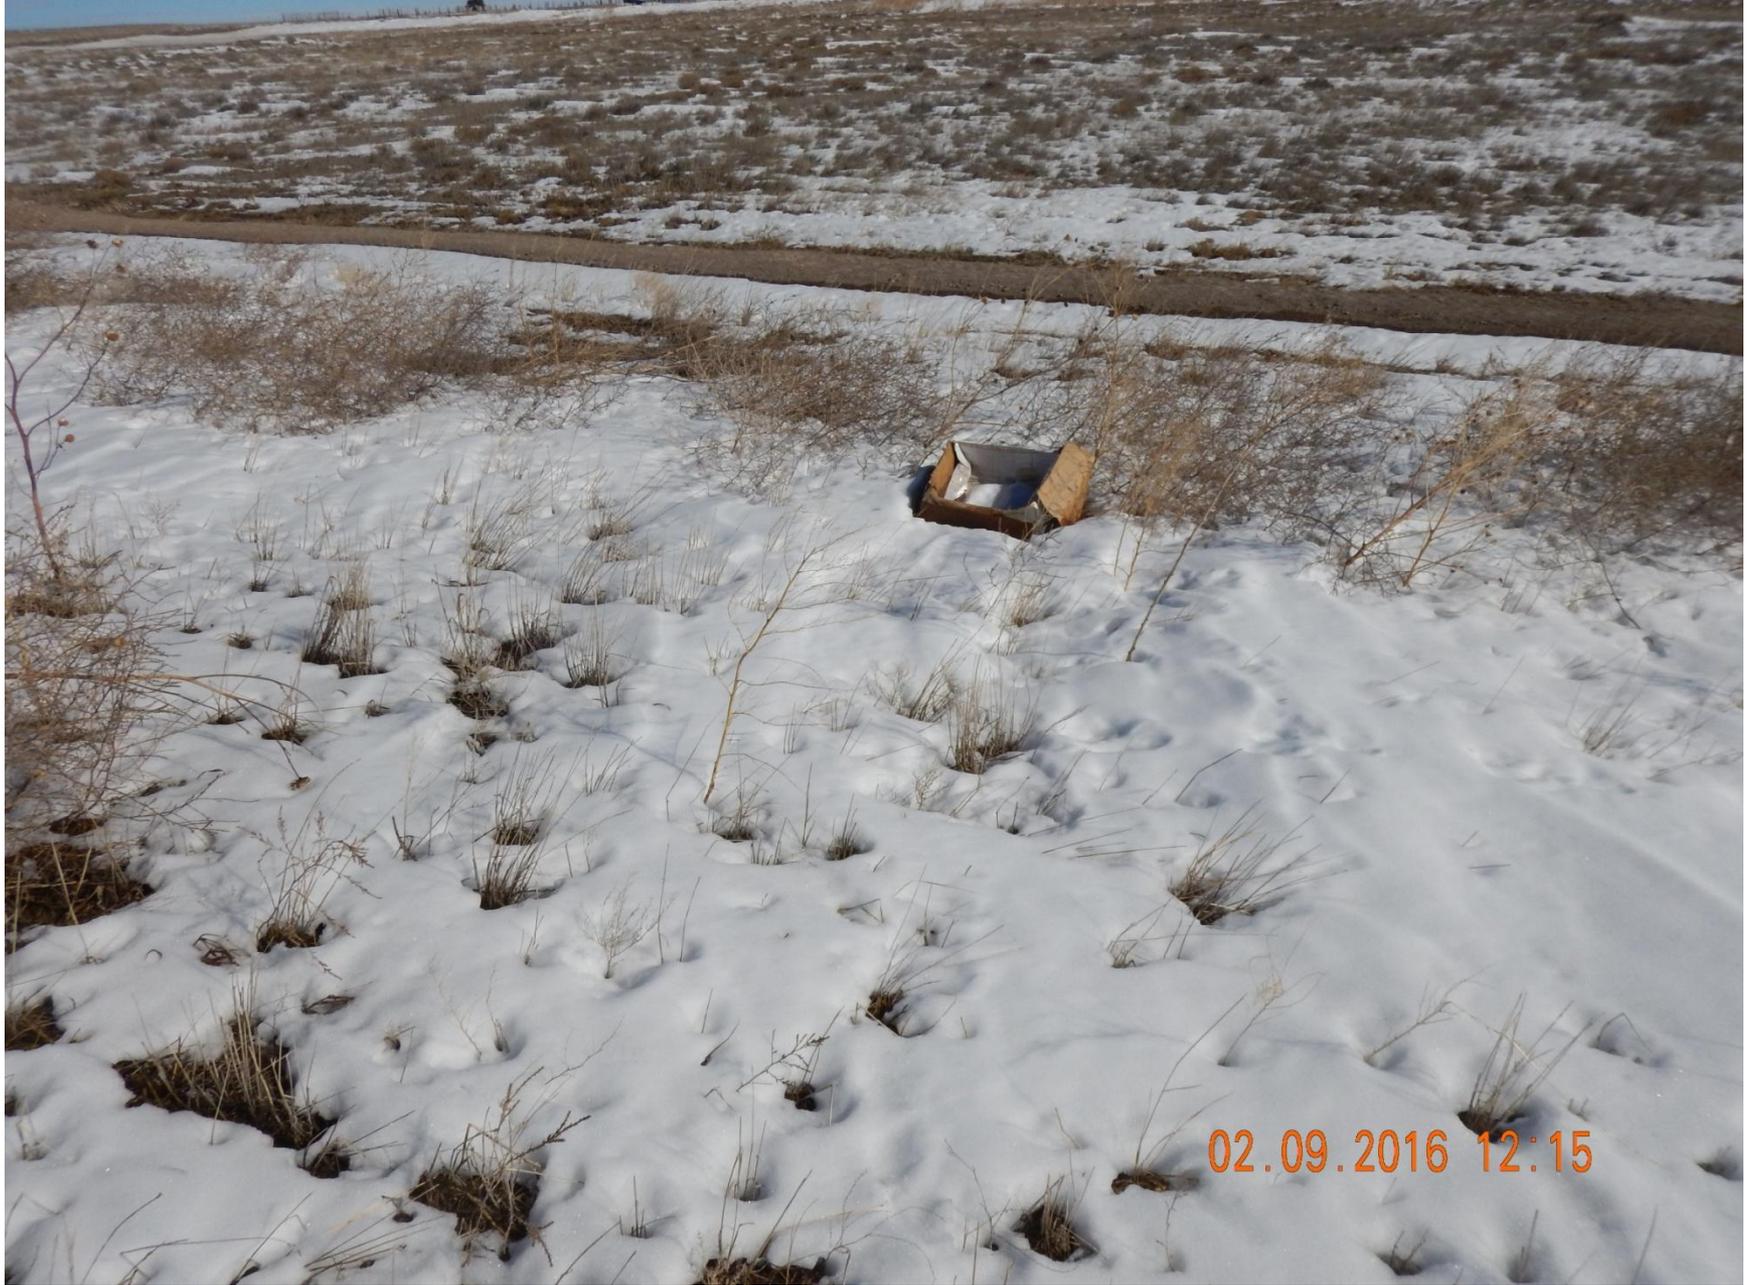
**Figure 13:** Photo taken from the east end of the interim location, facing east. Photo of trash debris.

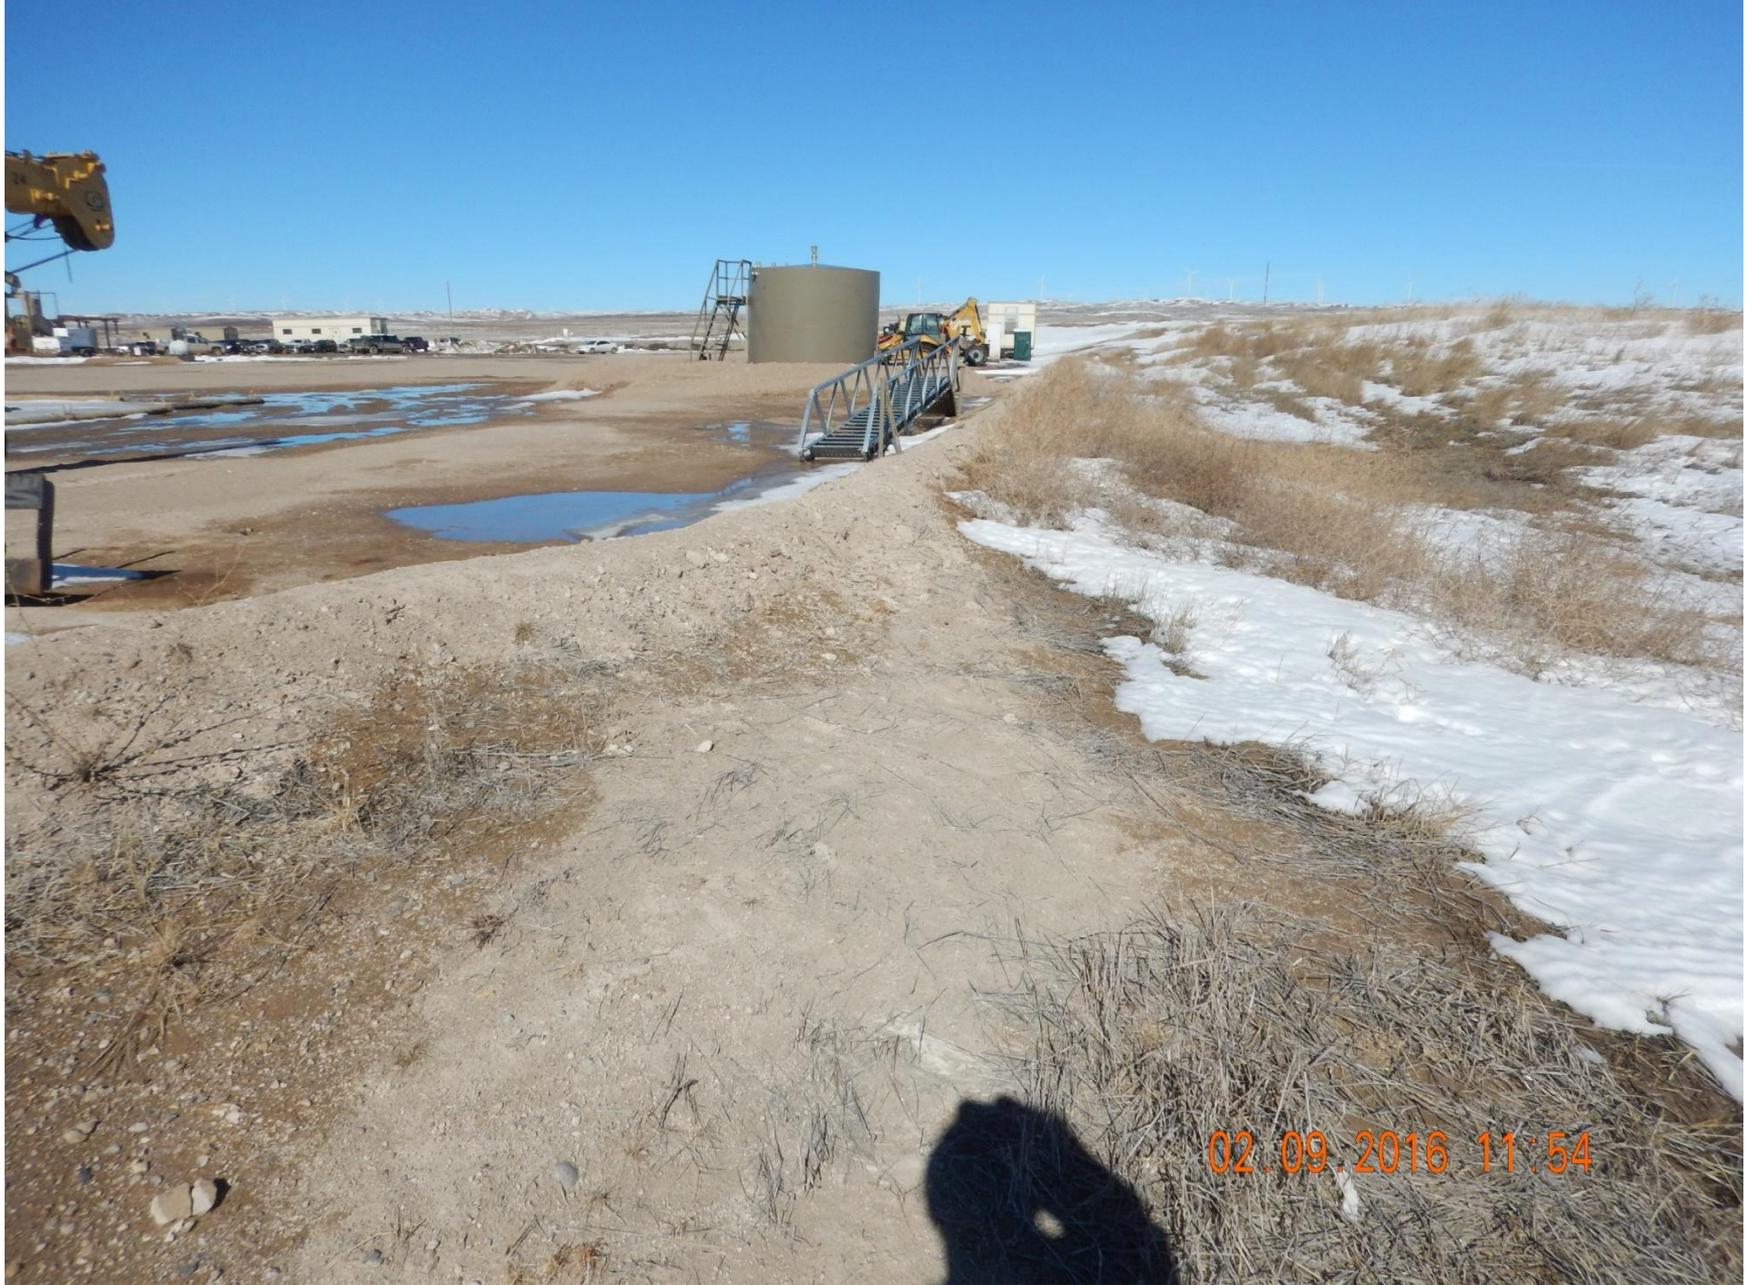
**Figure 14:** Photo taken from southeast end of location, facing north. Photo of project and interim areas.

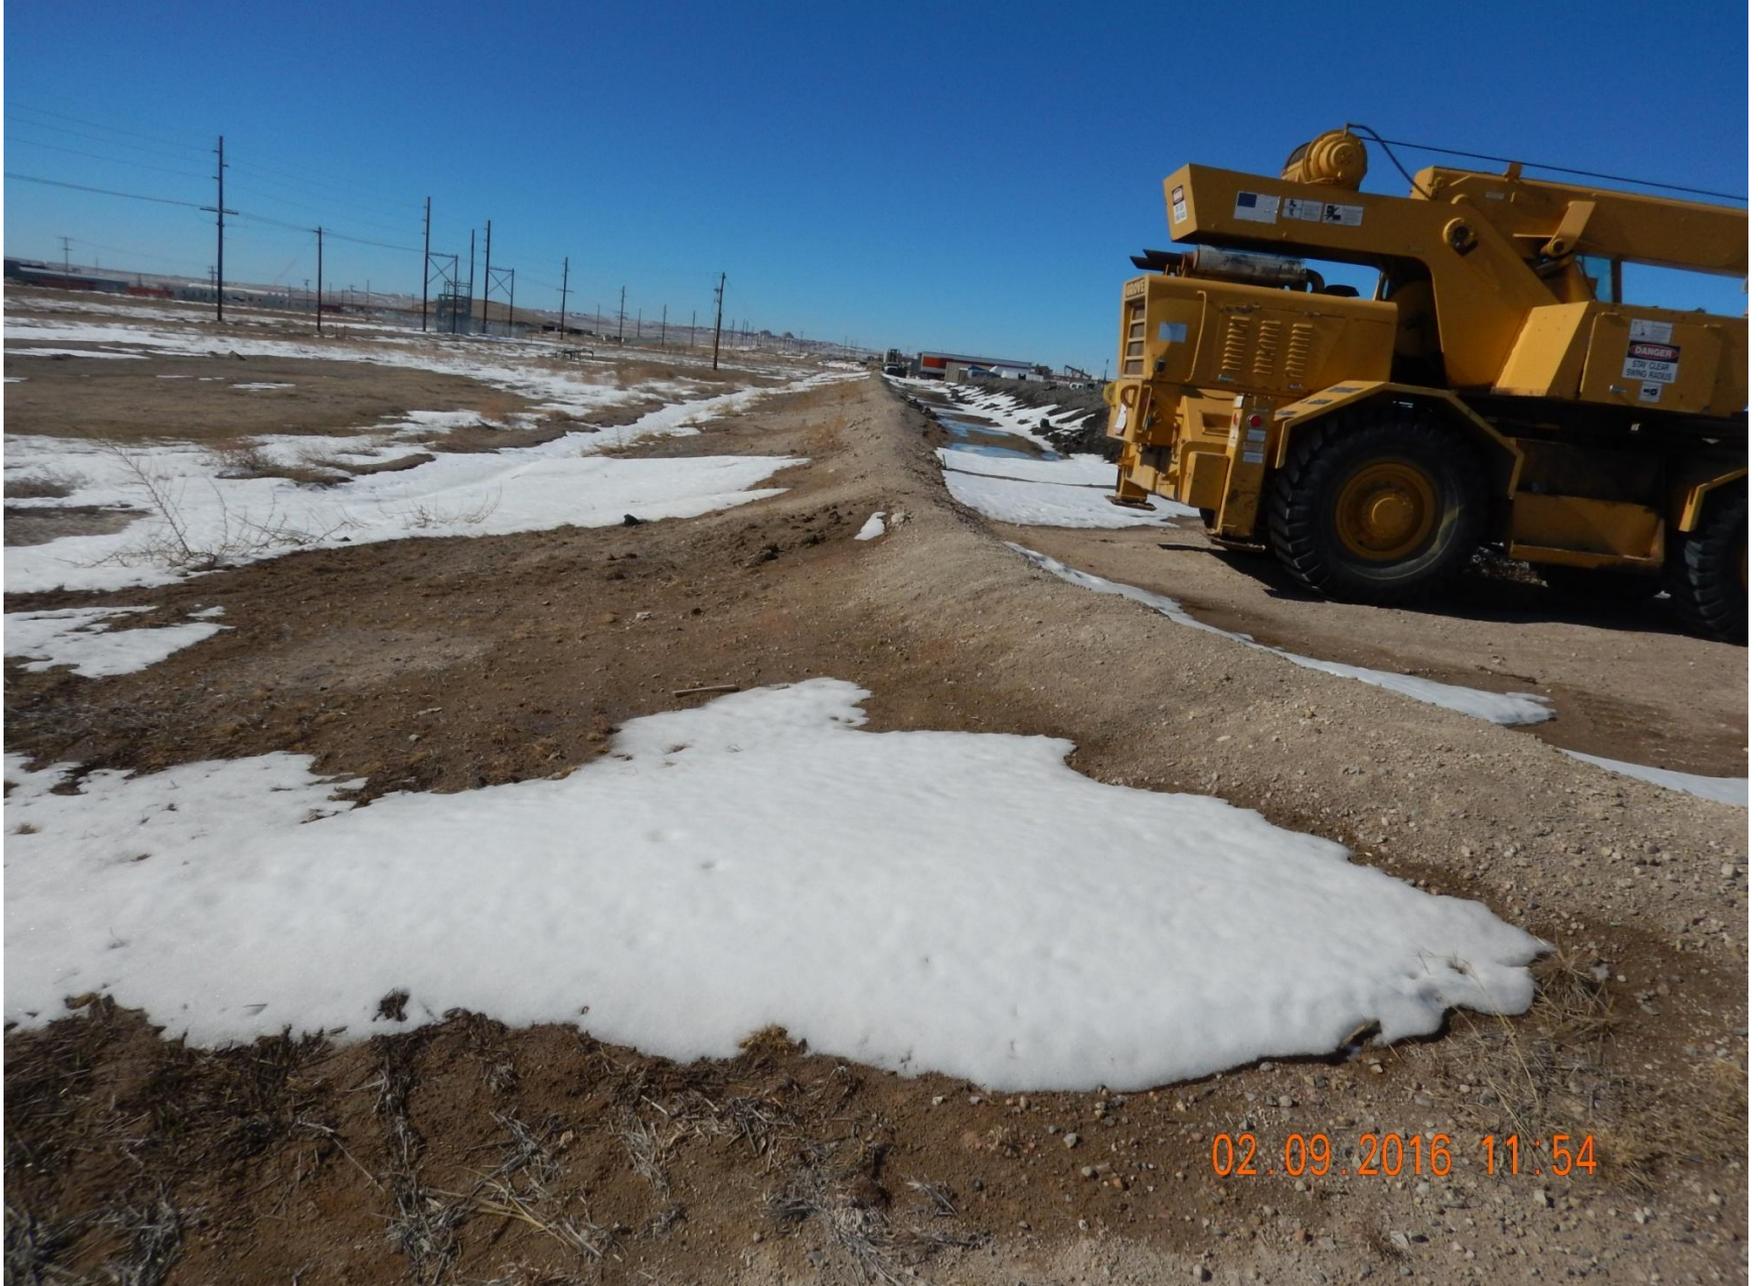
**Figure 15:** Photo taken from southeast end of location, facing west. Photo of project and interim areas.

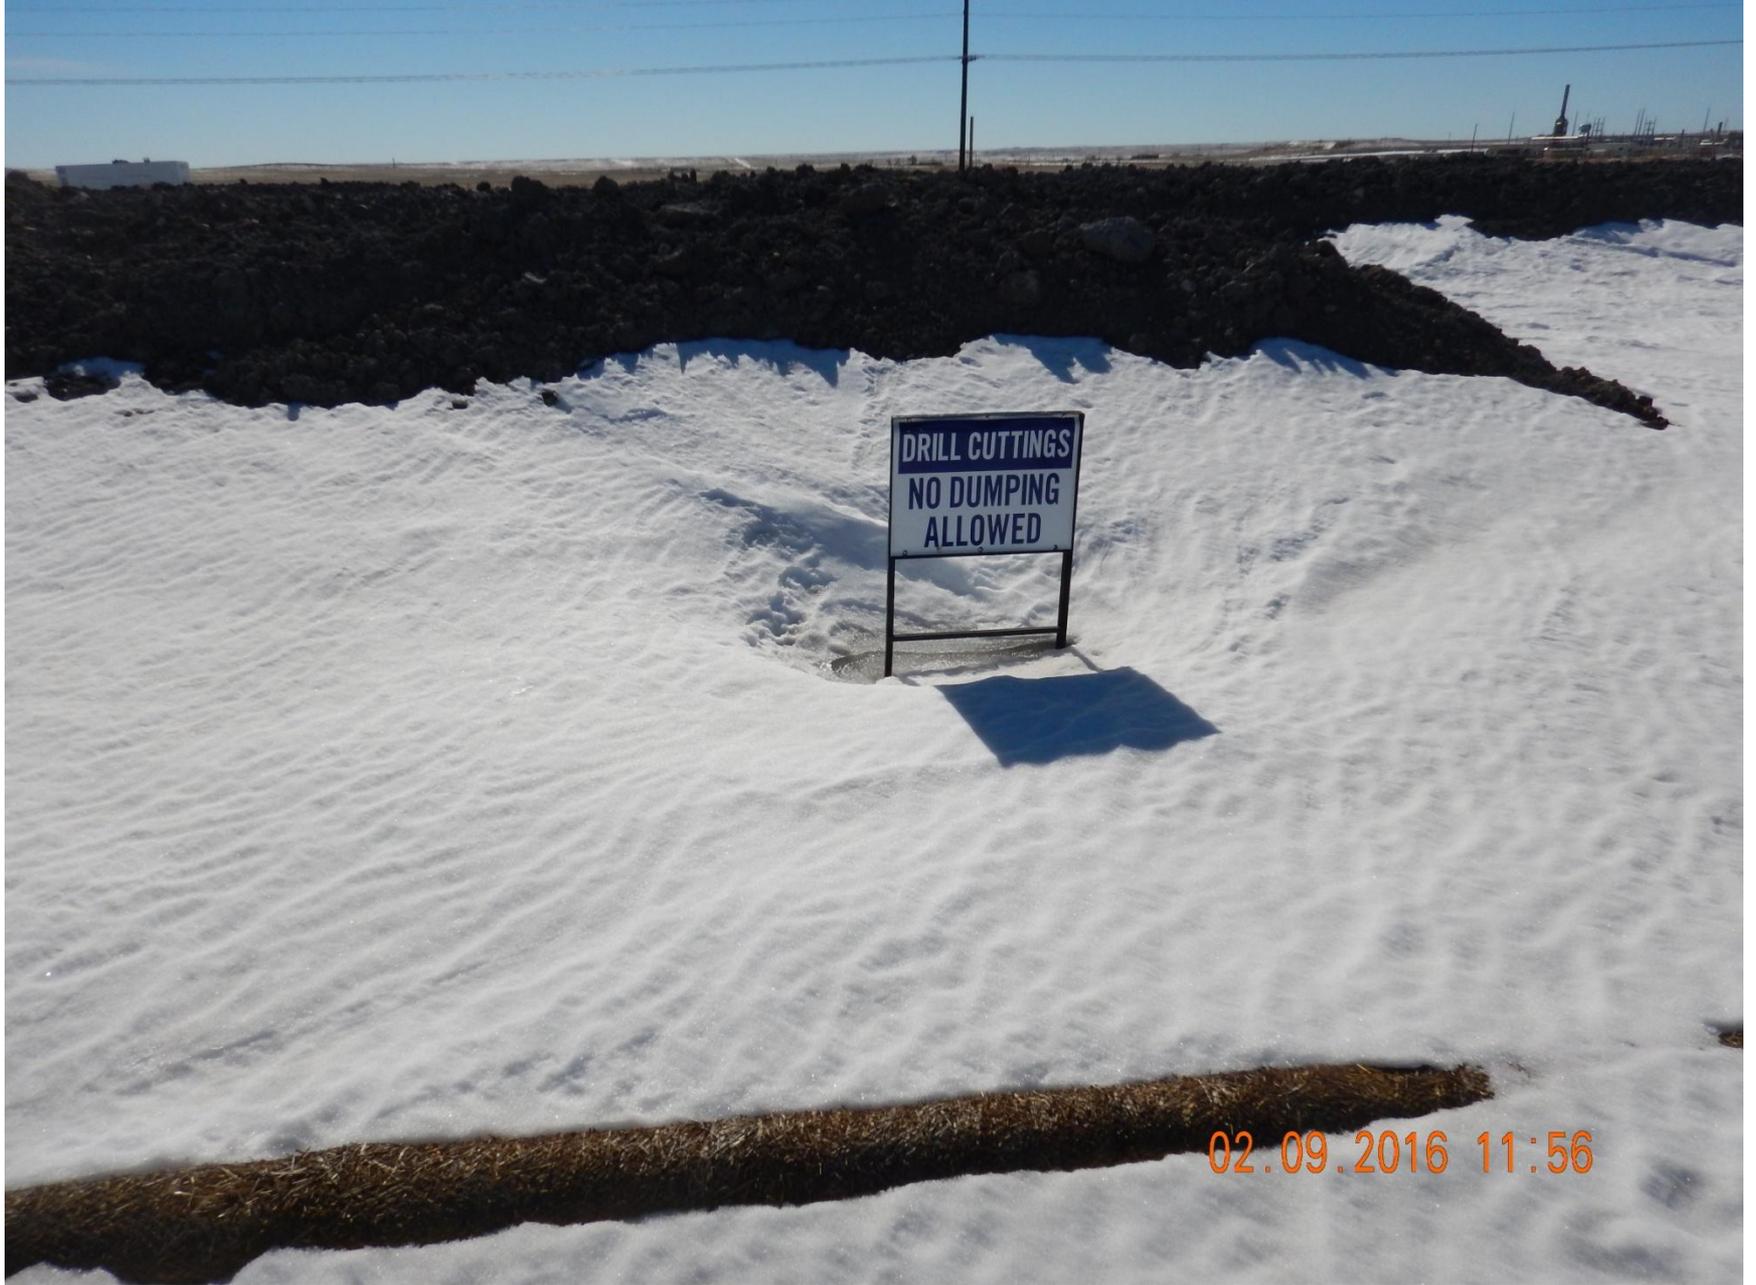
**Figure 16:** Photo taken from east end of location, facing south. Photo of drill cuttings and waddles.

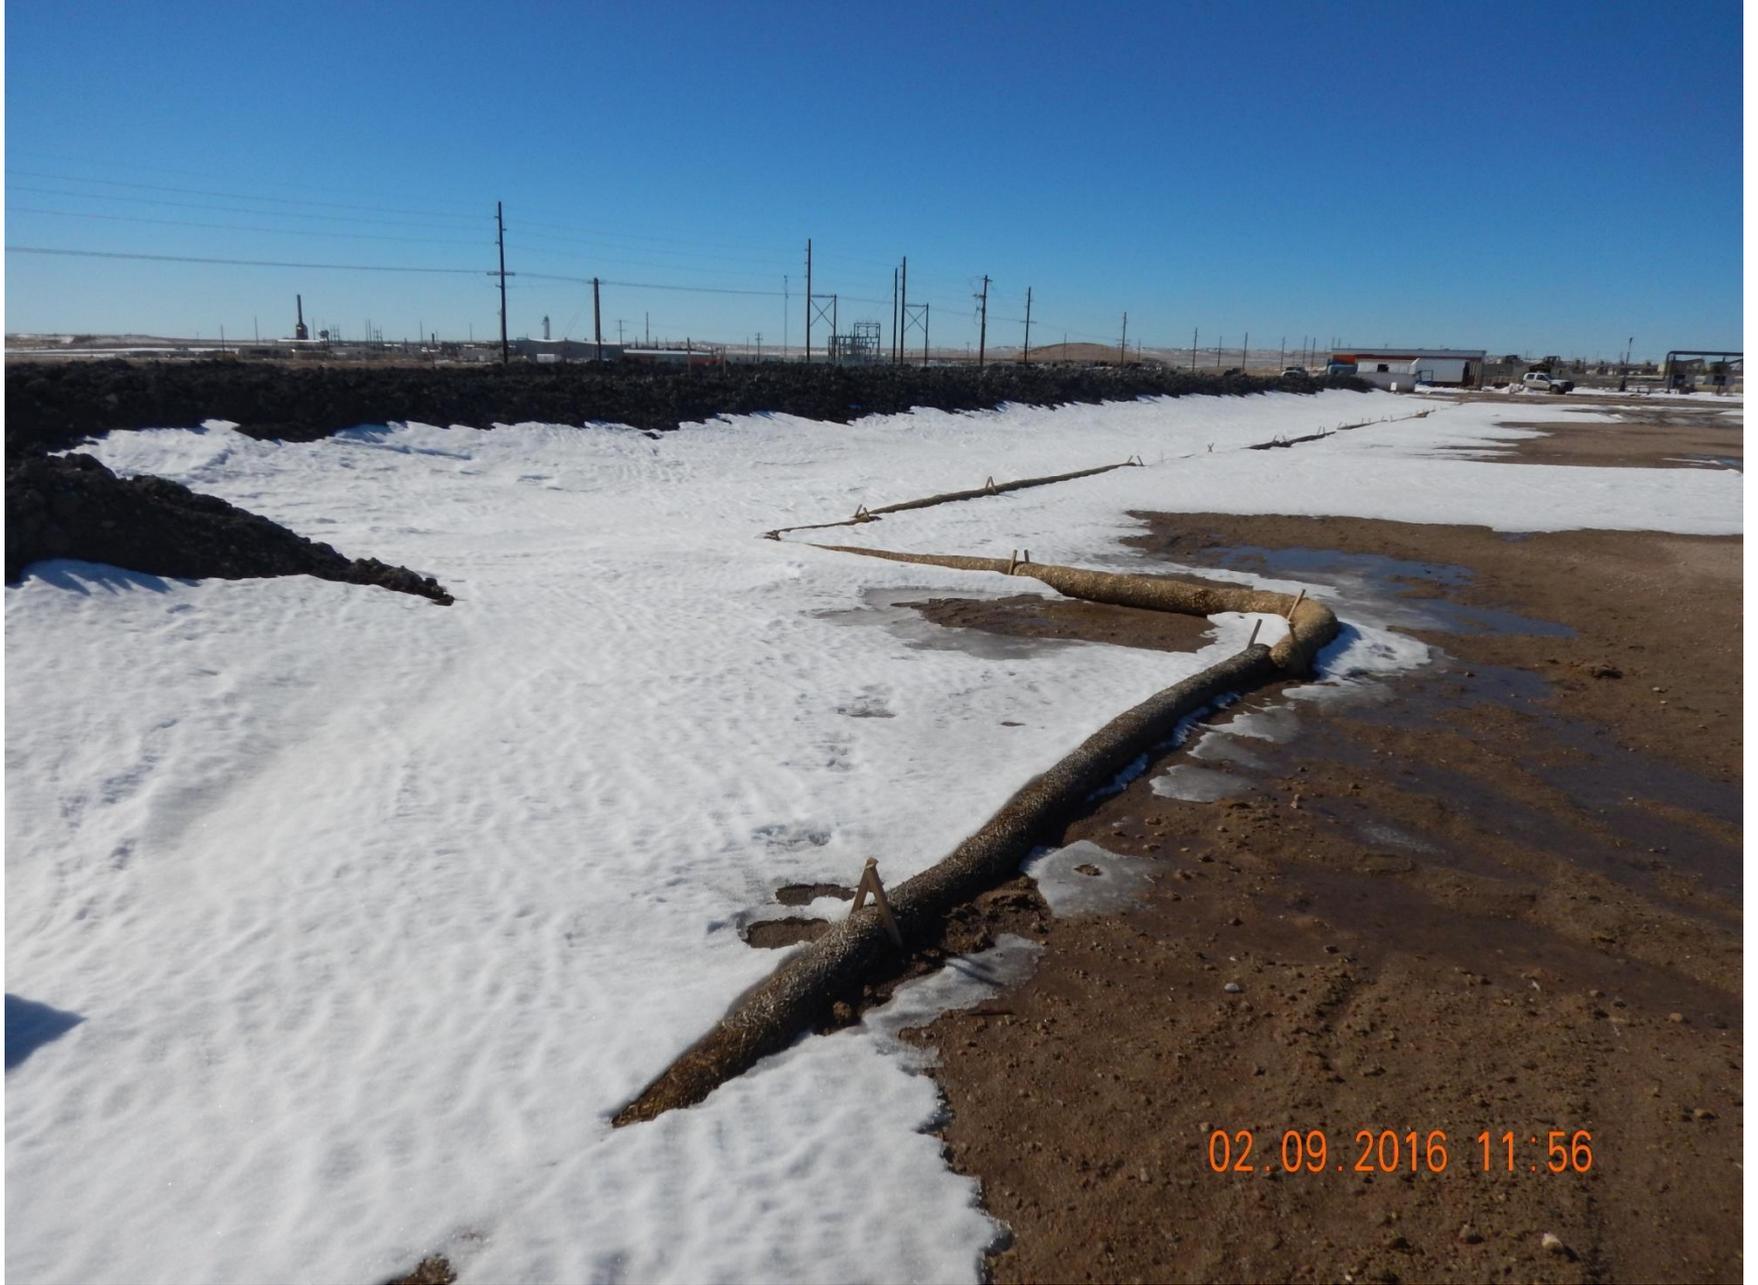
**Figure 17:** Photo taken from southeast end of location, facing west. Photo of drill cuttings and waddles.

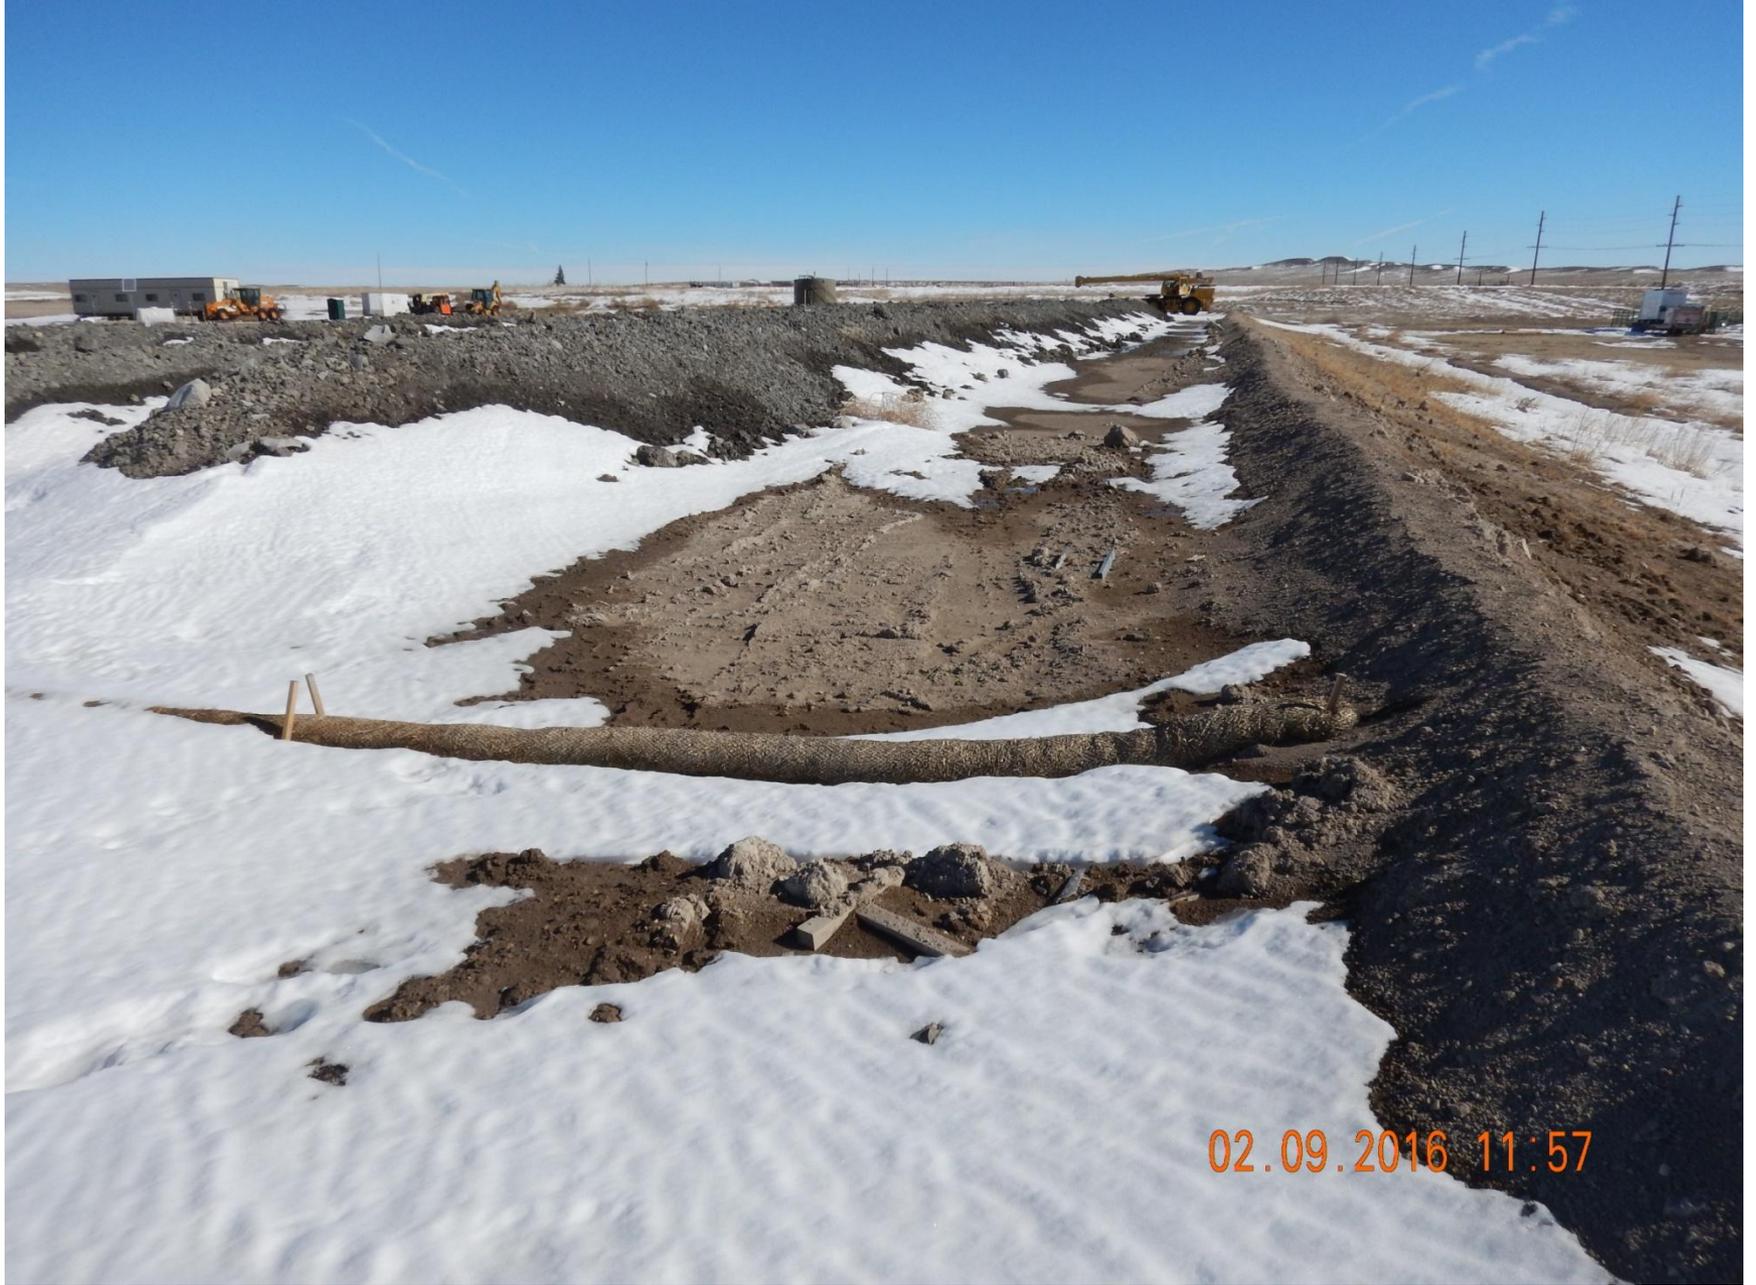
**Figure 18:** Photo taken from southern end of location, facing east. Photo of drill cuttings and waddles.

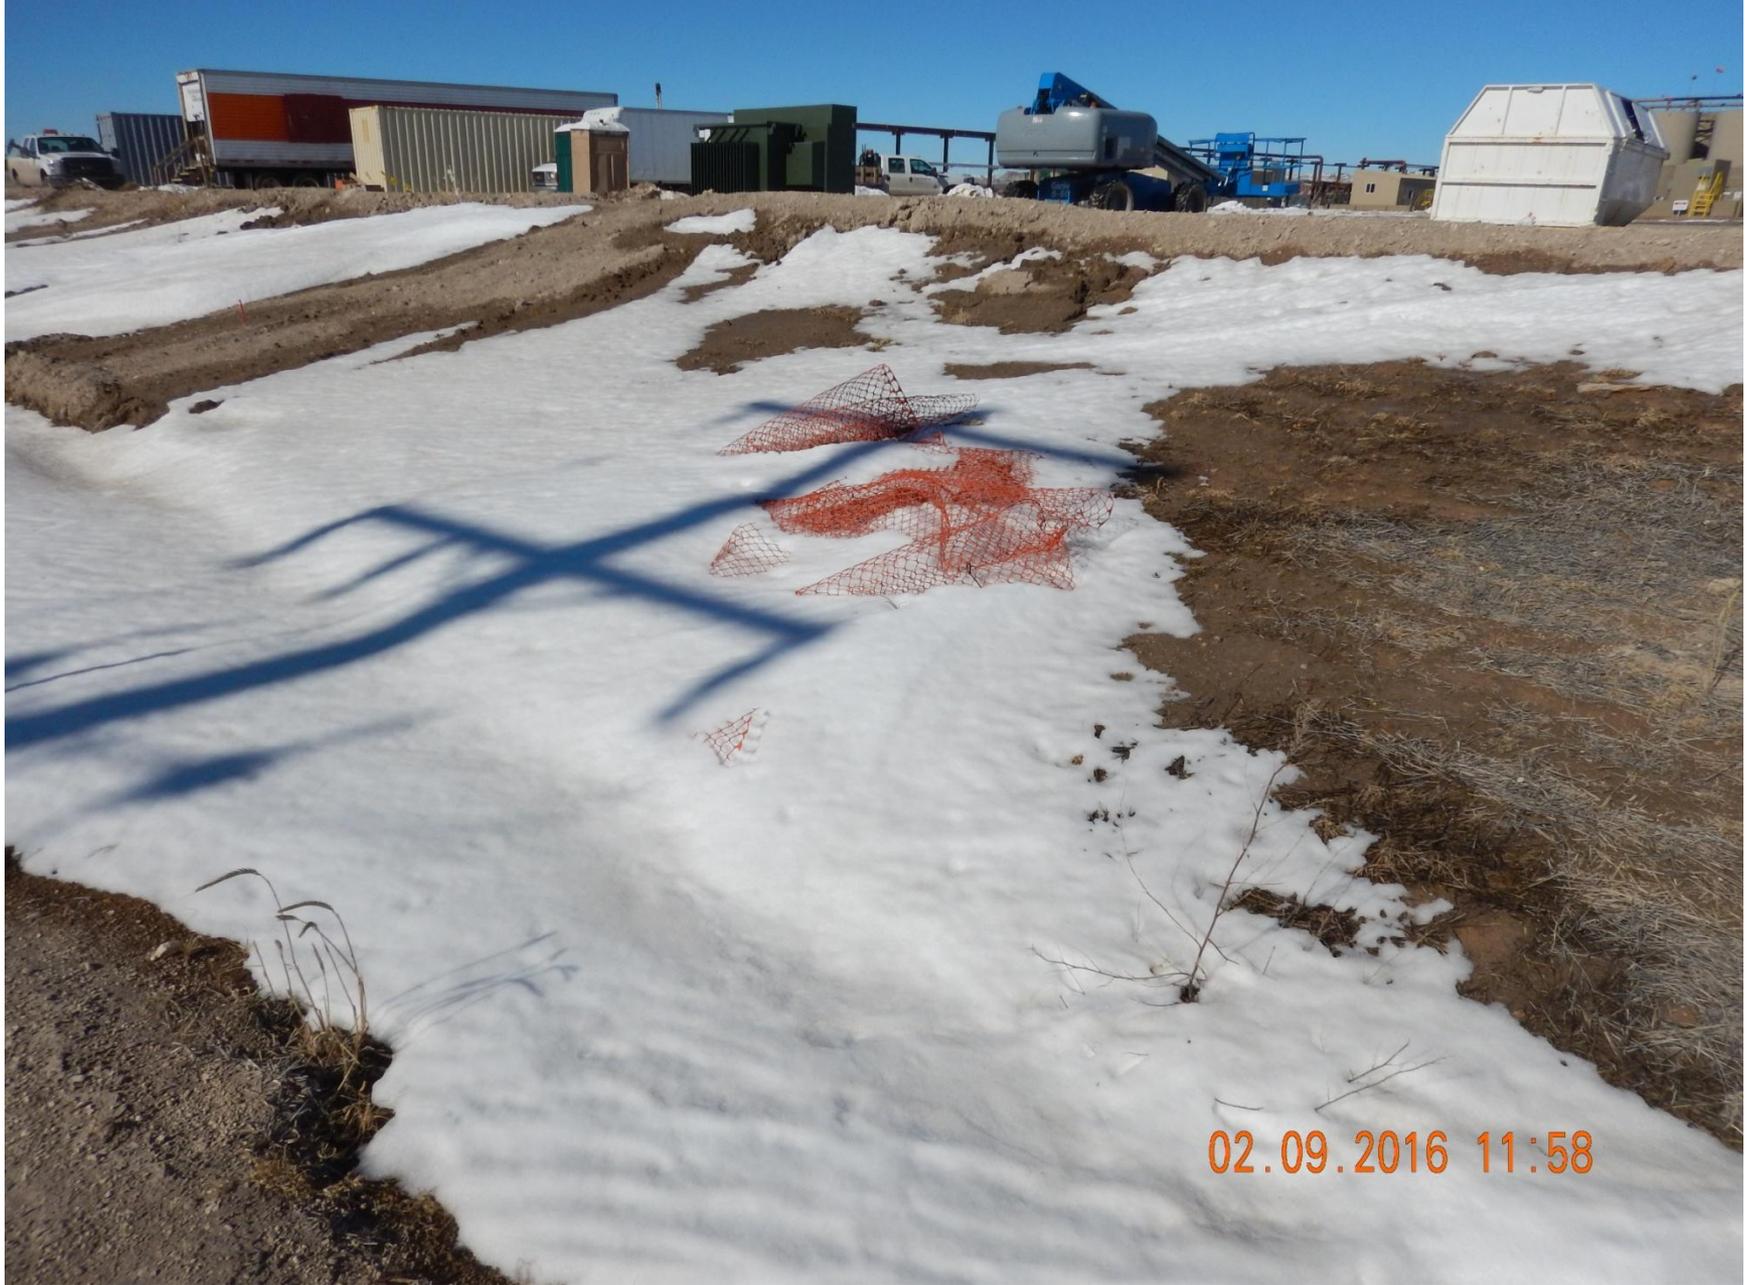
**Figure 19:** Photo taken from southern end of location, facing northwest. Photo of trash debris on interim area. Trash debris appears to be orange plastic fencing.

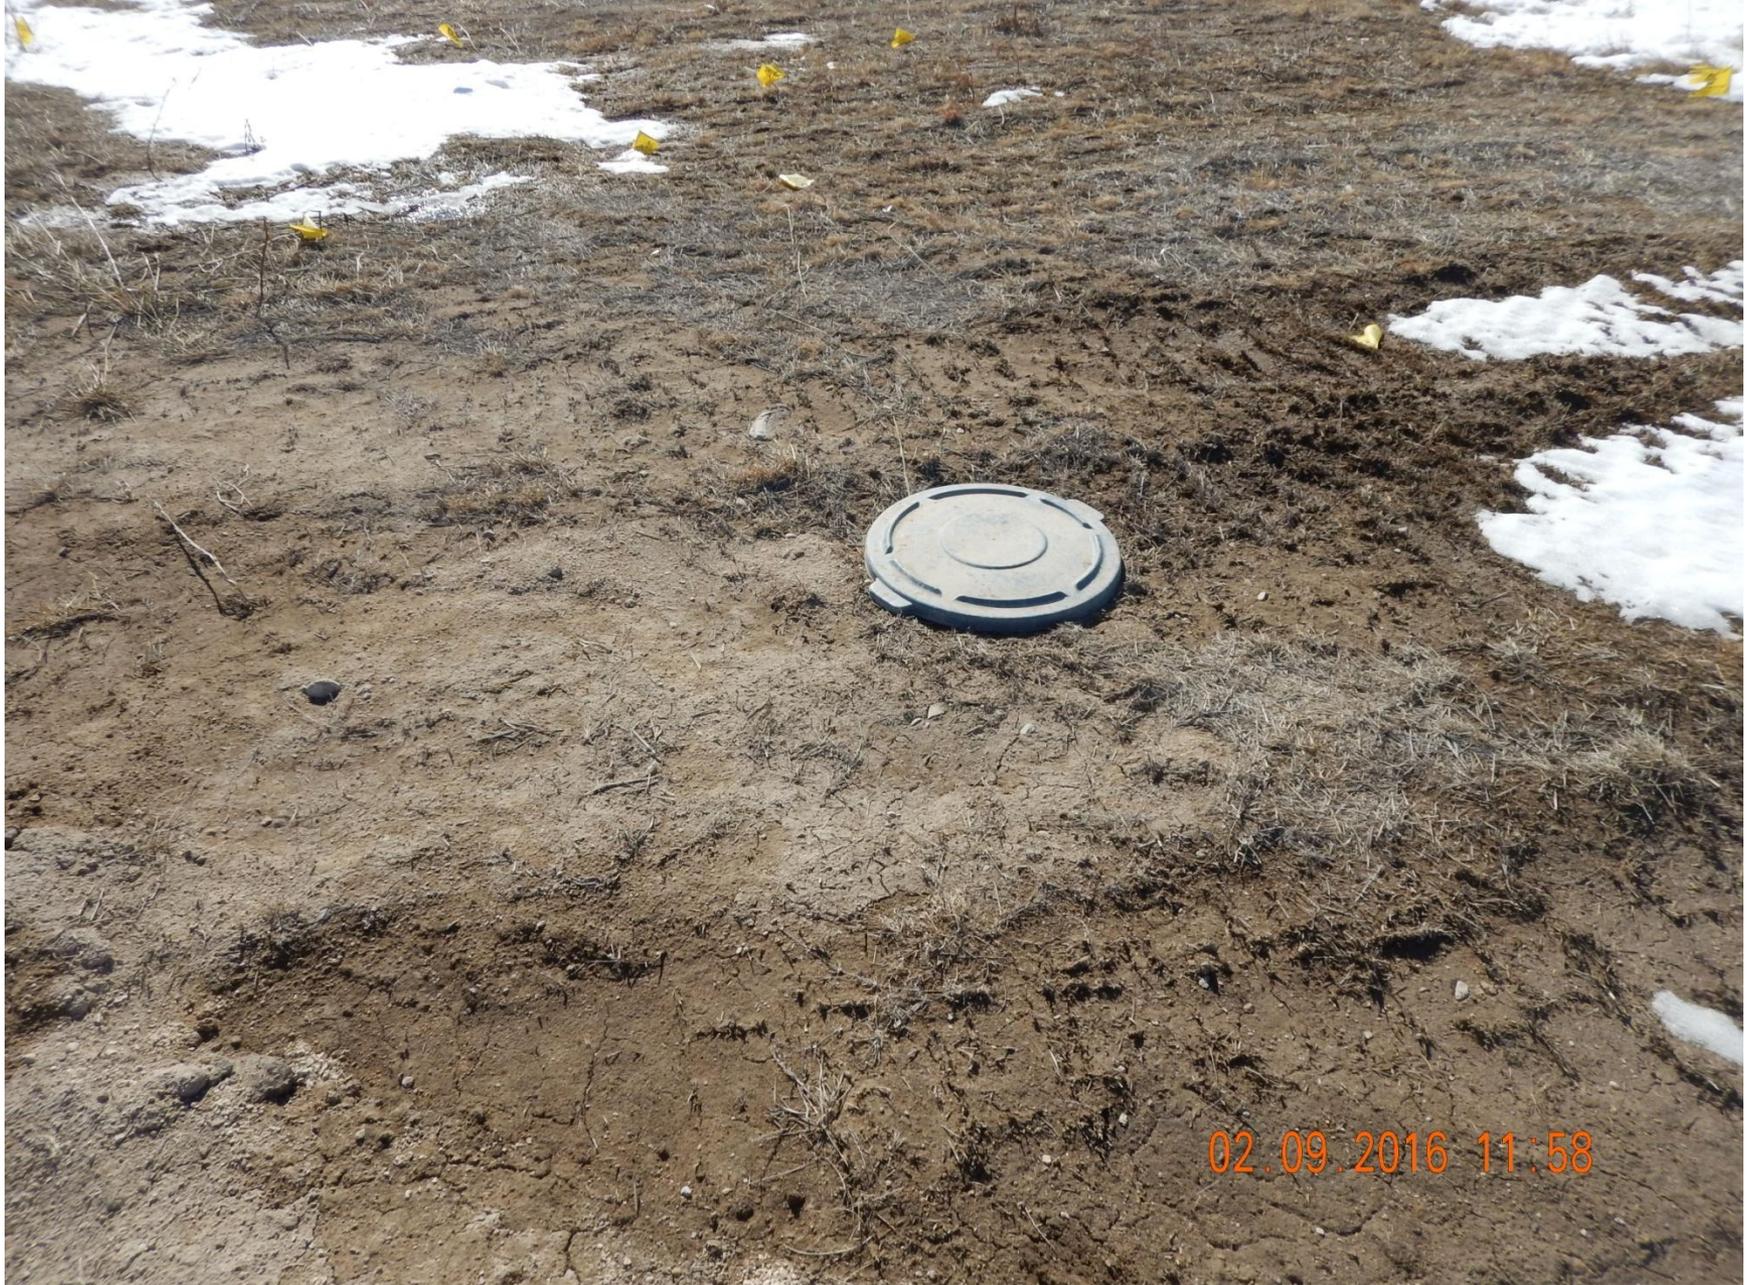
**Figure 20:** Photo taken from southern end of location. Photo of trash debris on interim area. Trash debris appears to be trash can lid.

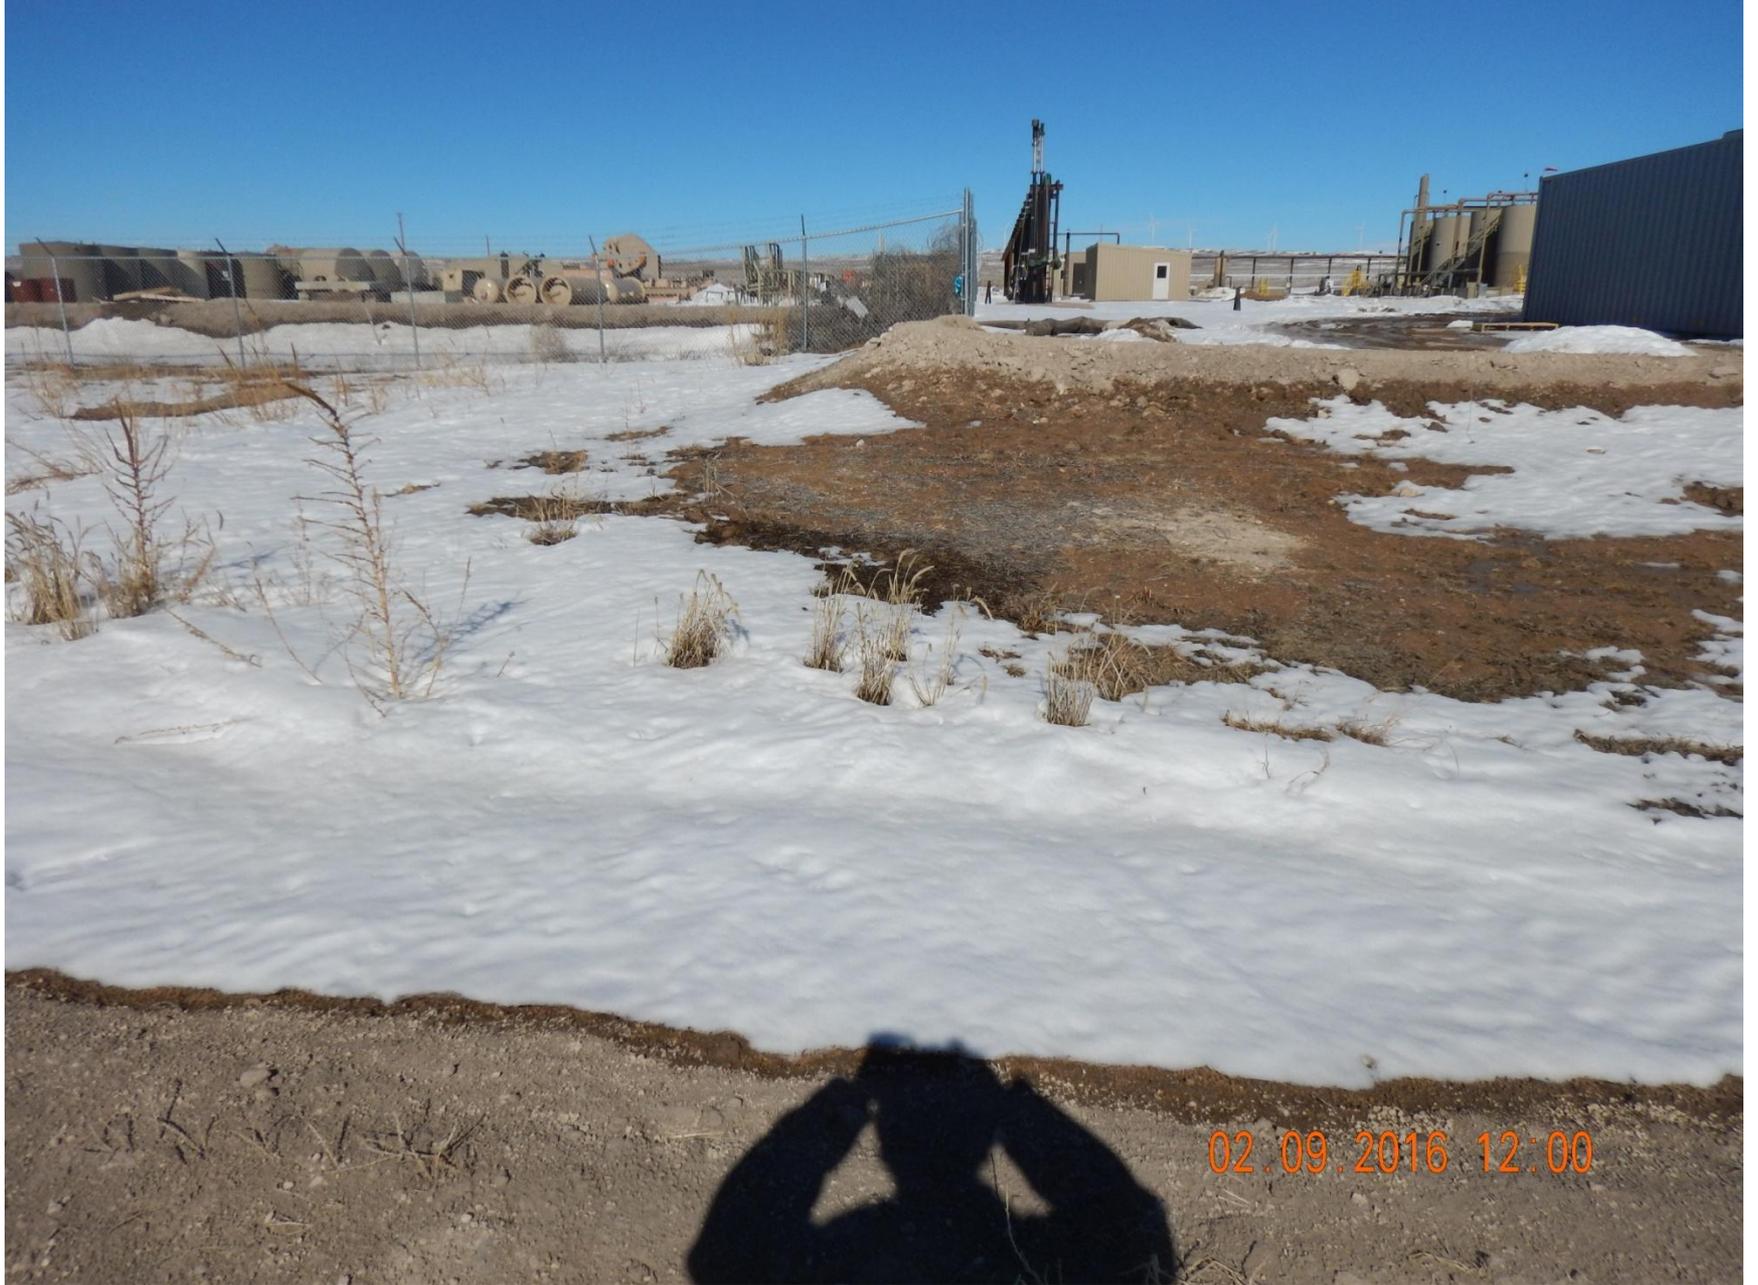
**Figure 21:** Photo taken from southwest end of location, facing north. Photo of interim and project areas.
