# Interim Reclamation Inspection

2/9/2016

Operator: Whiting Oil and Gas

Location ID: 430695

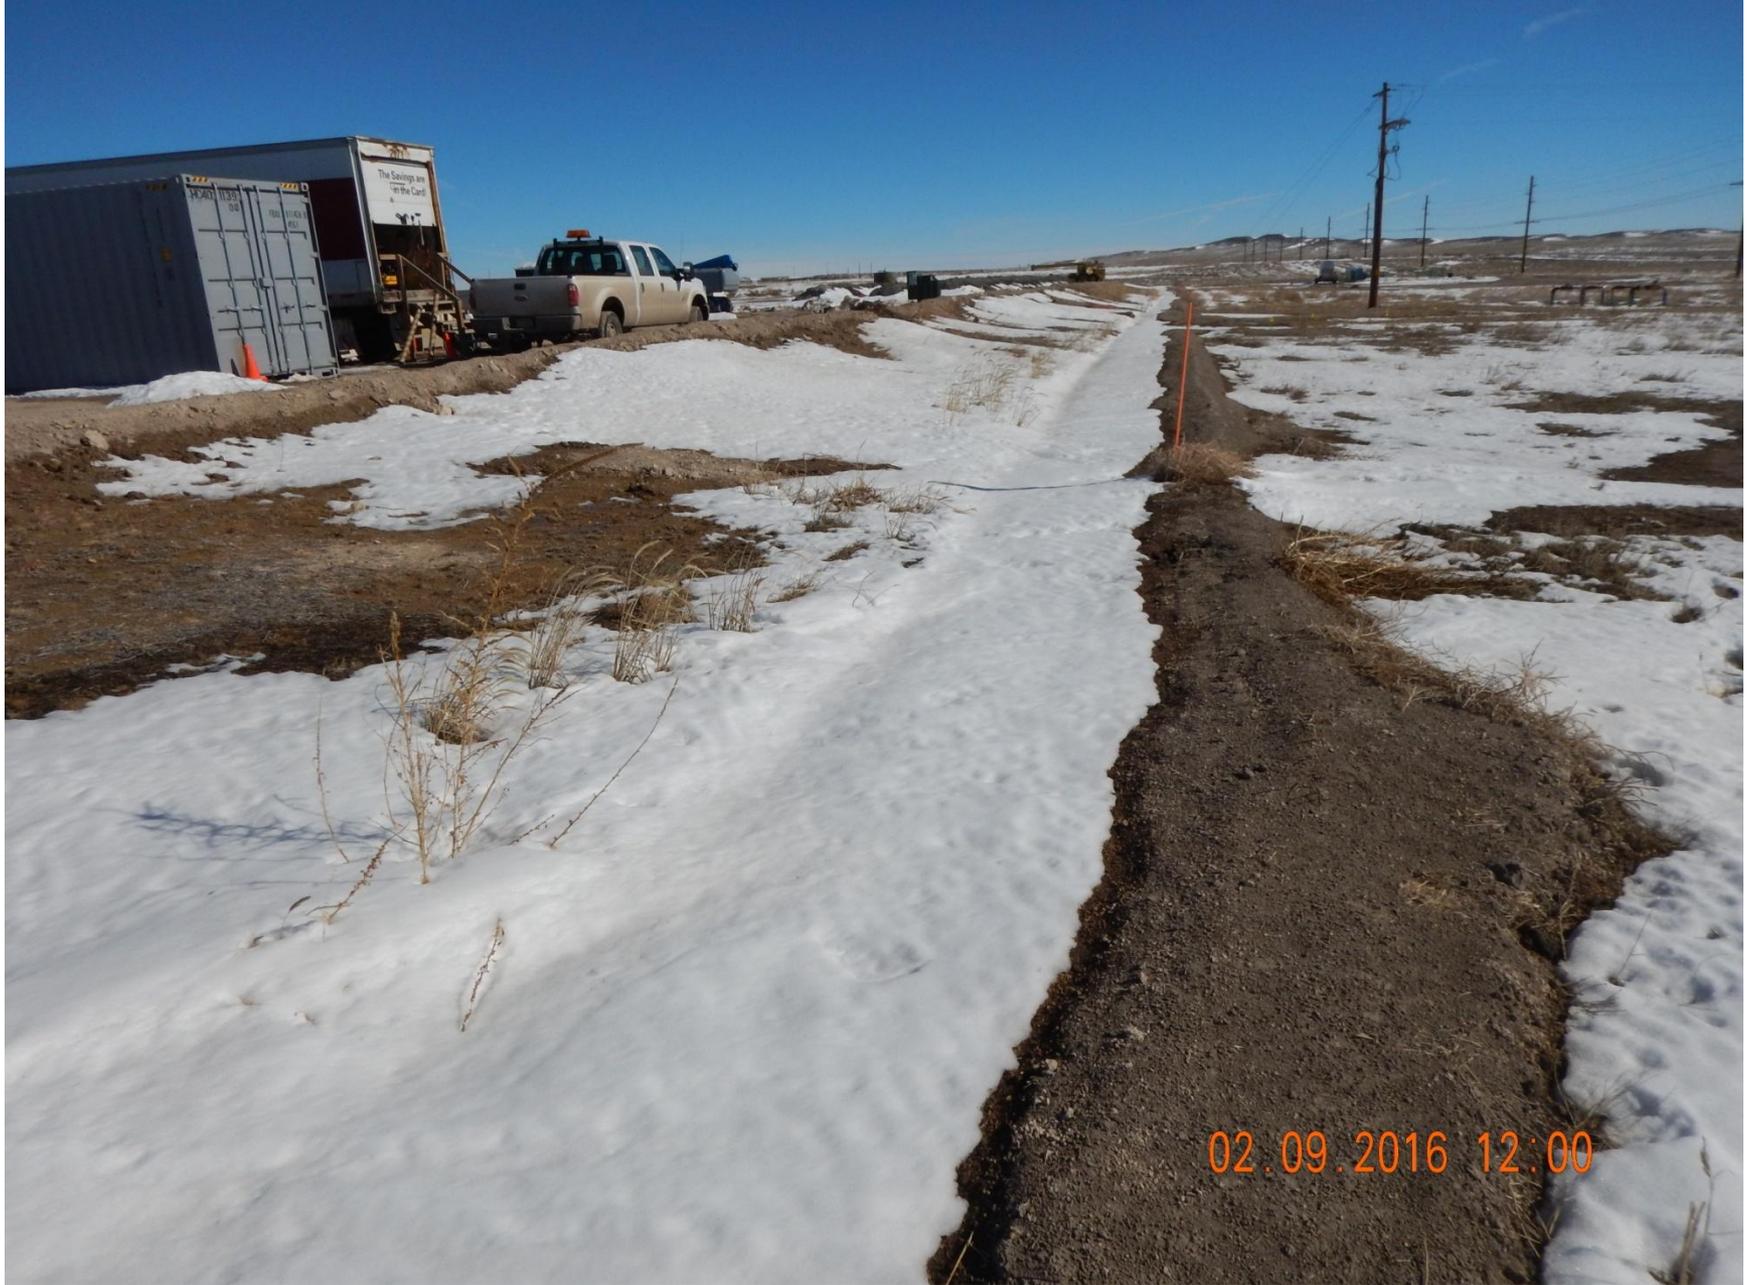
**Figure 22:** Photo taken from southwest end of location, facing east. Photo of interim and project areas.

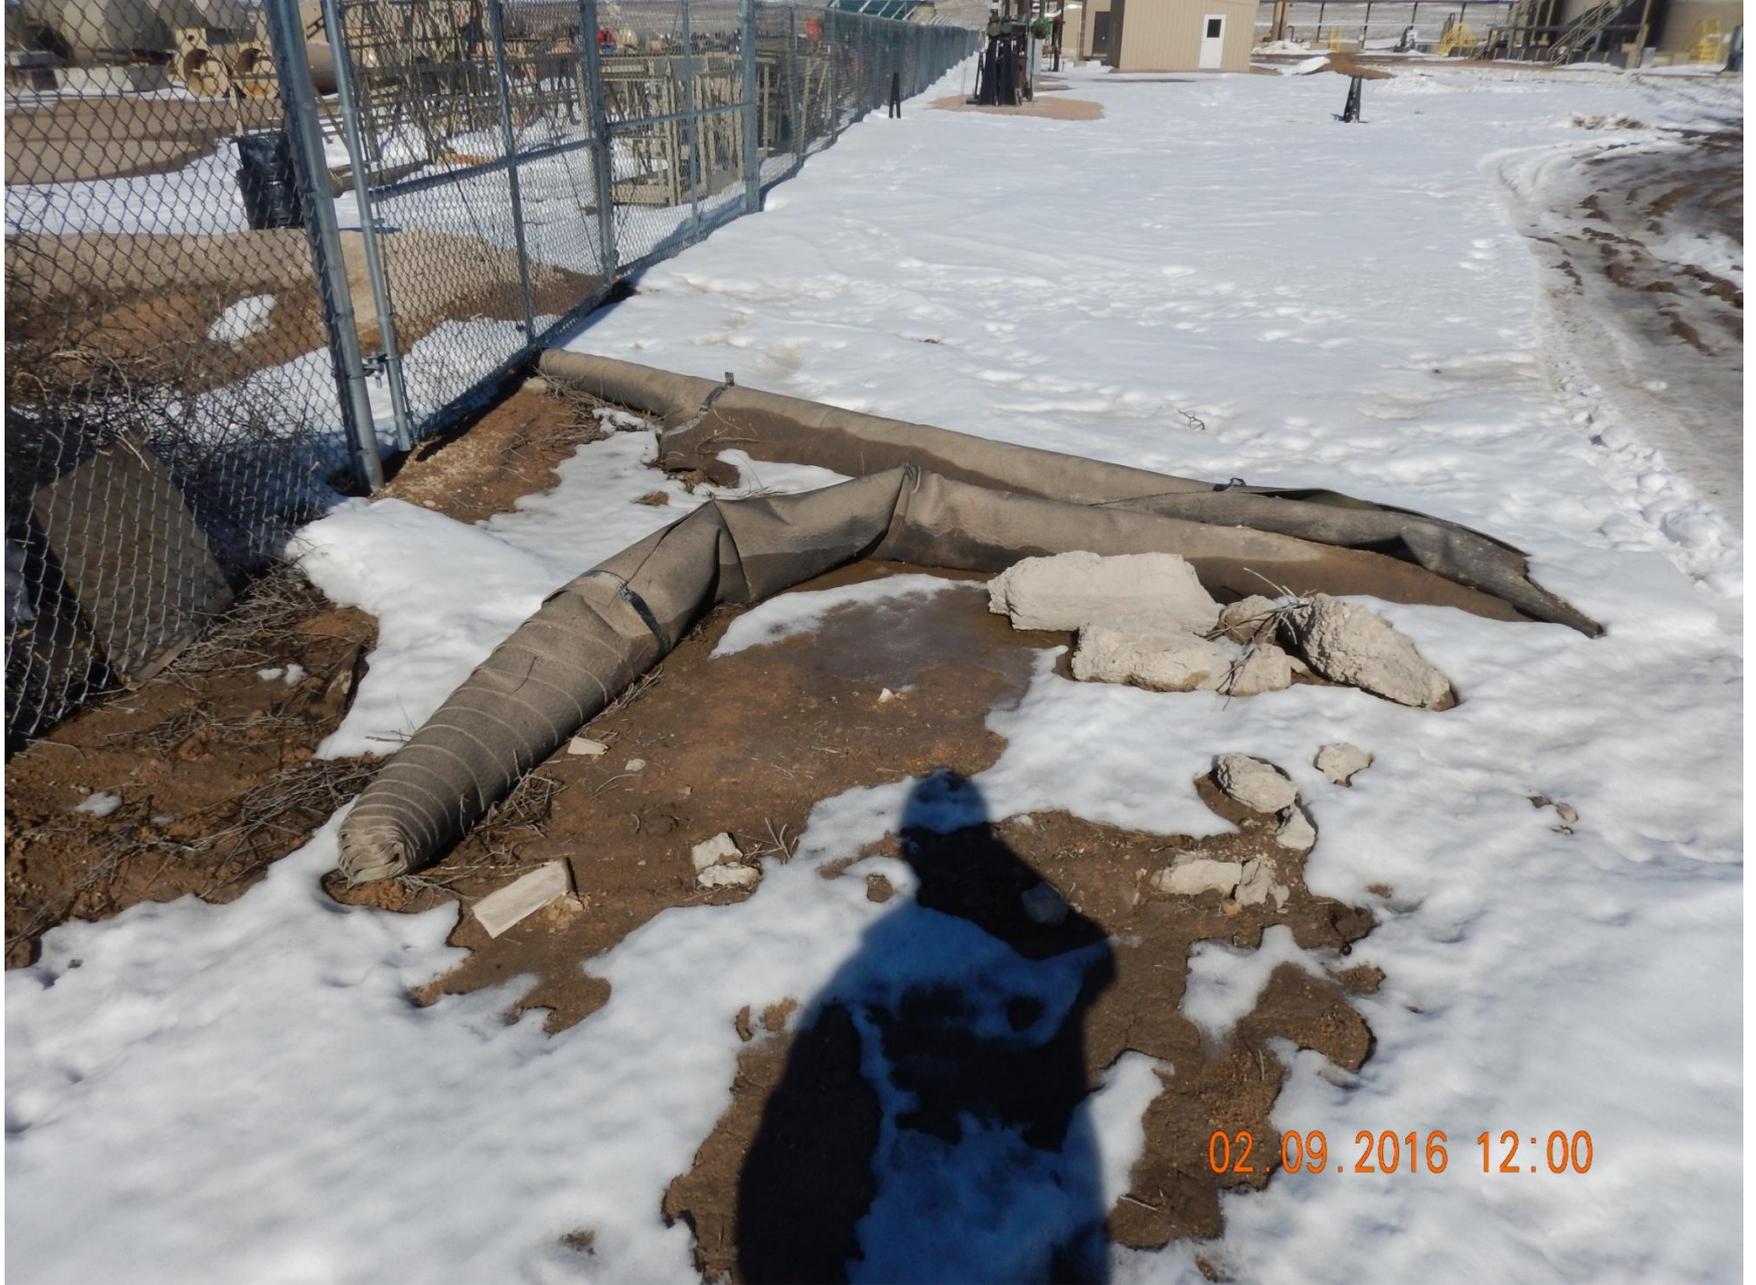
**Figure 23:** Photo taken from southwest corner of project location. Photo of what appears to be a rolled tarp improperly stored.

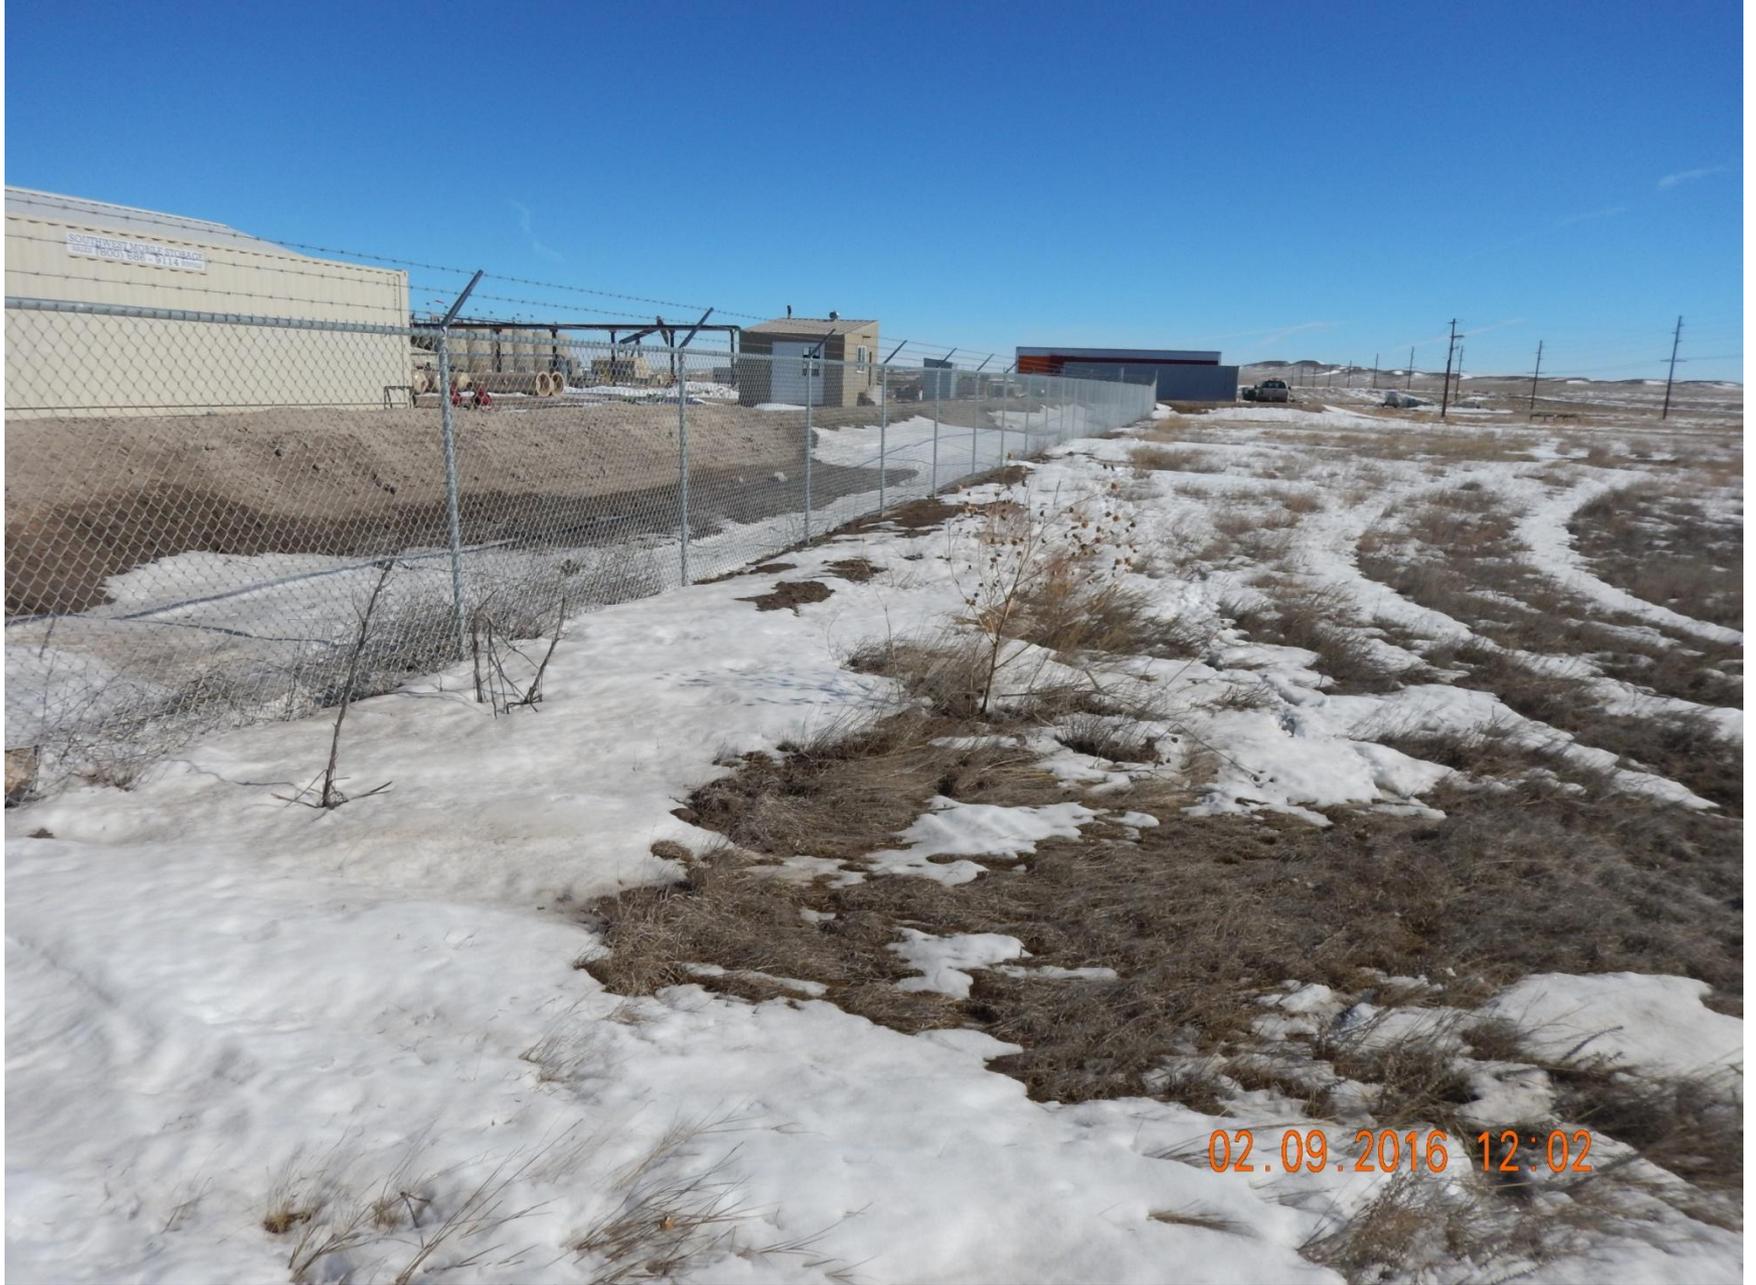
**Figure 24:** Photo taken from southwest corner of location, facing east. Photo of interim and project areas.
