# Interim Reclamation Inspection

2/9/2016

Operator: Whiting Oil and Gas

Location ID: 431115

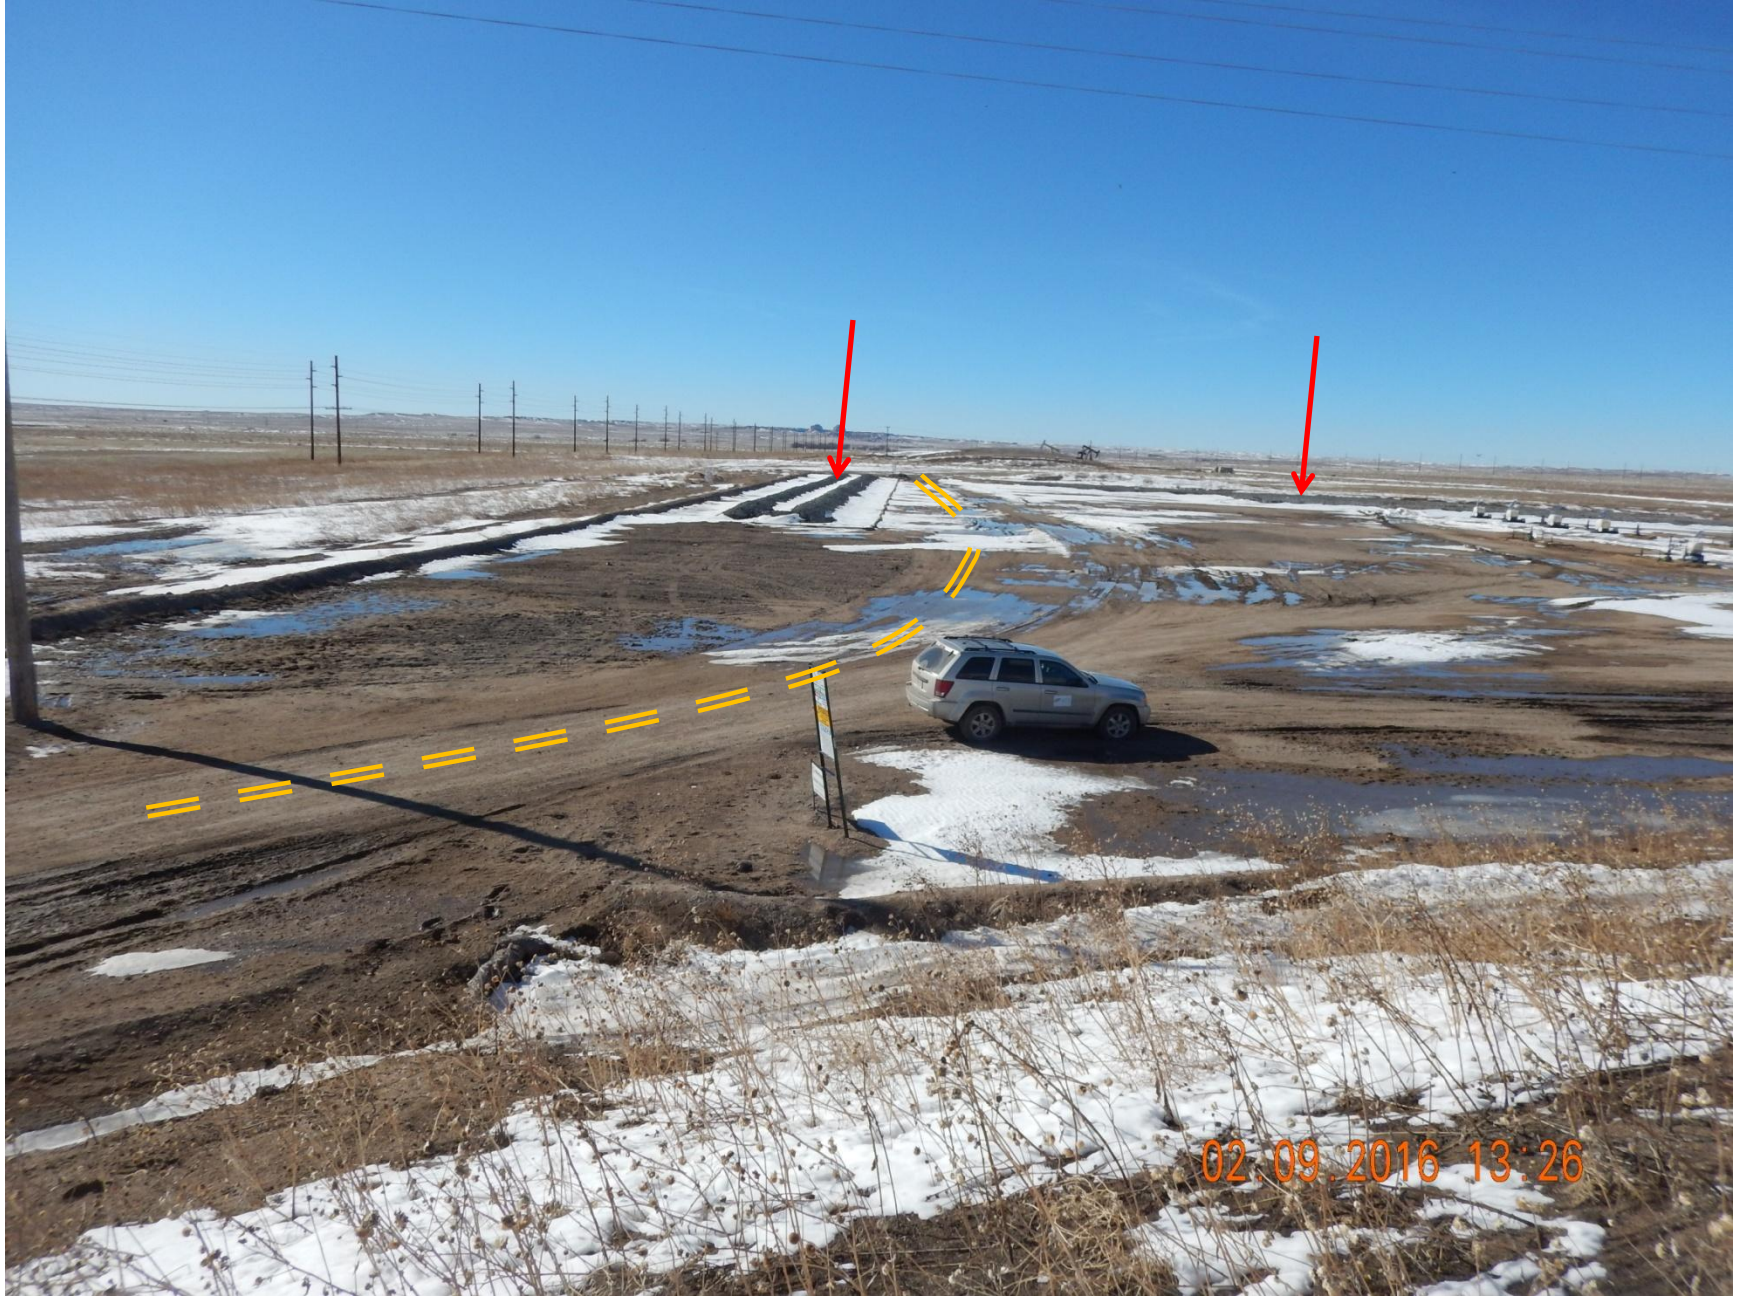
**Figure 1:** Photo taken from stockpile on the southeast end of location, facing west. Photo shows location, current access road being used (yellow line), and drill cuttings (red arrow).

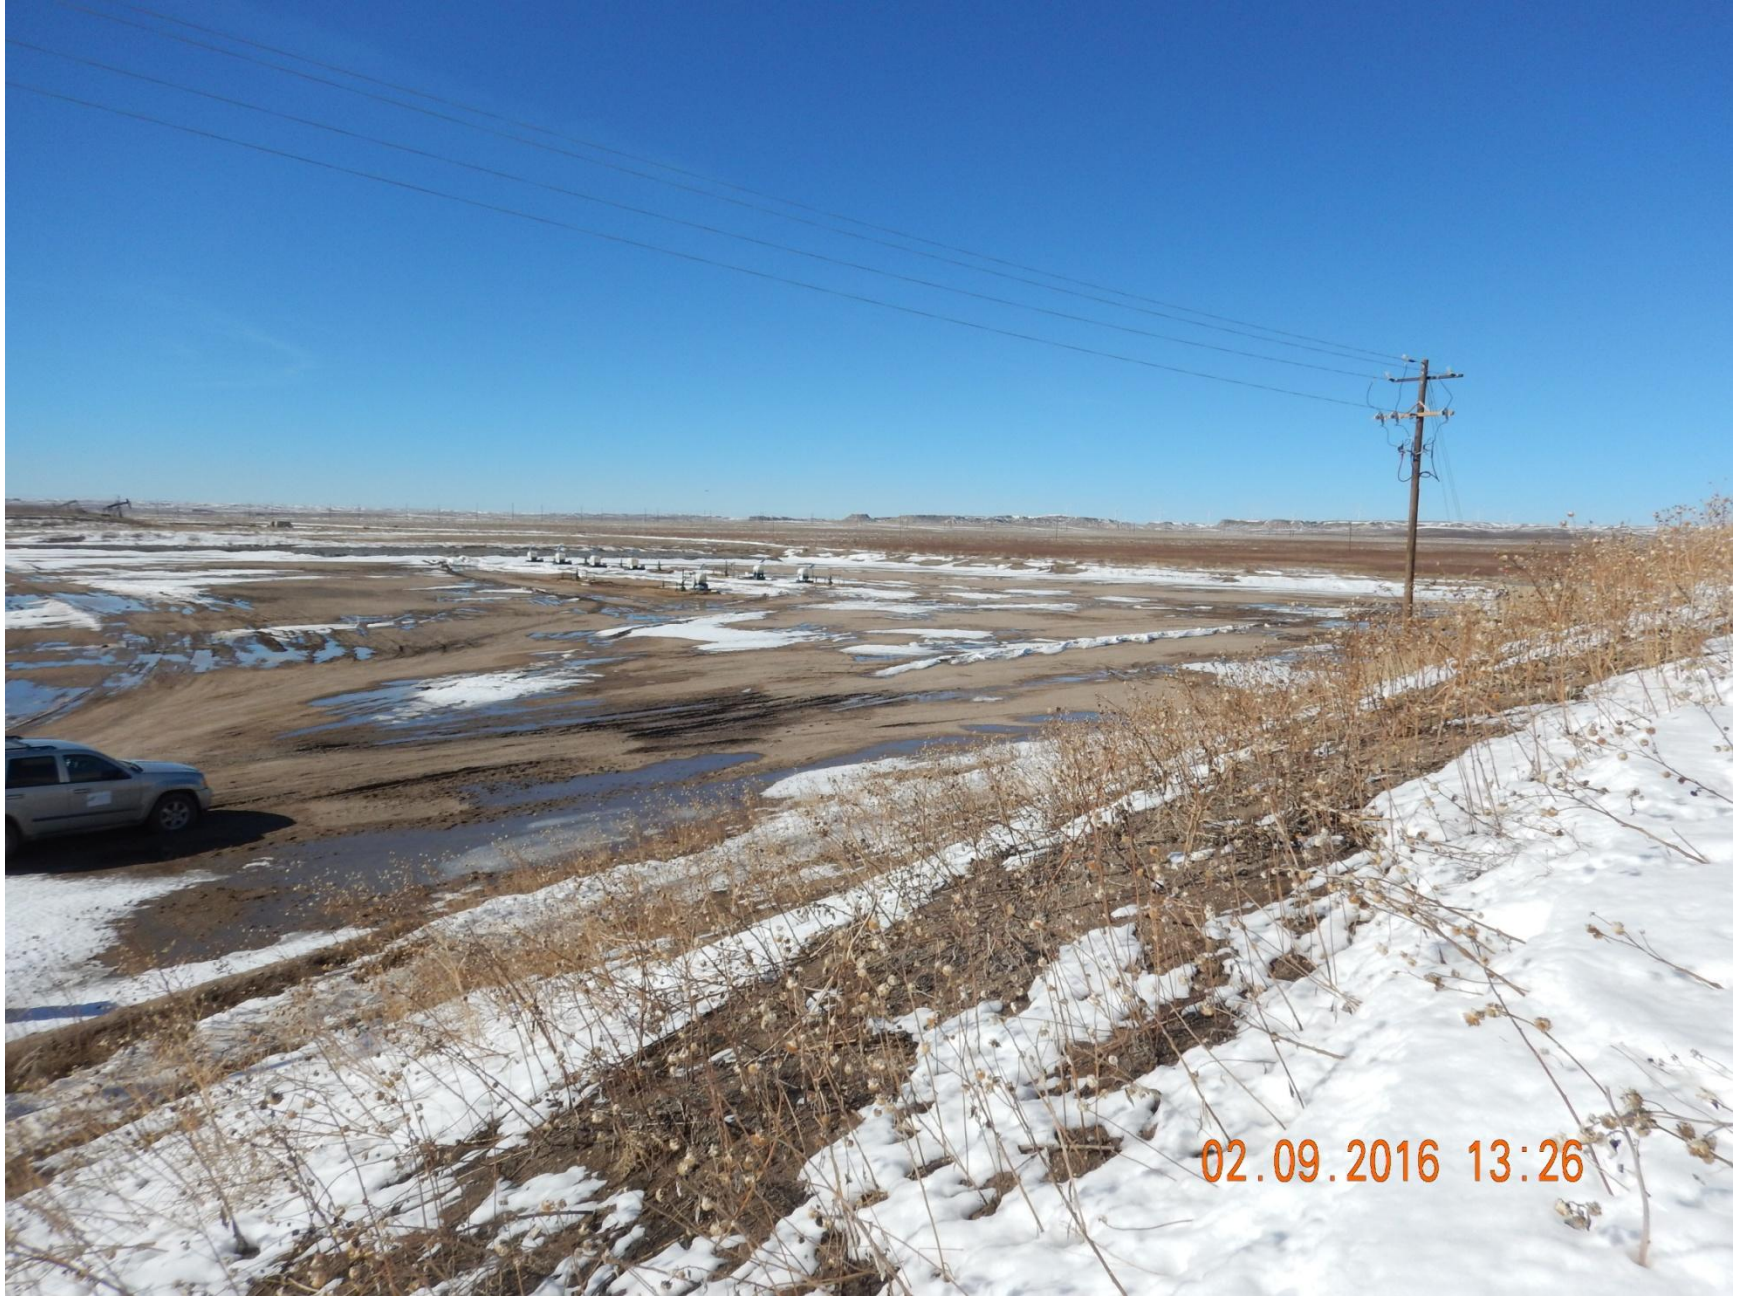
**Figure 2:** Photo taken from stockpile on the southeast end of location, facing northwest. Photo of location.

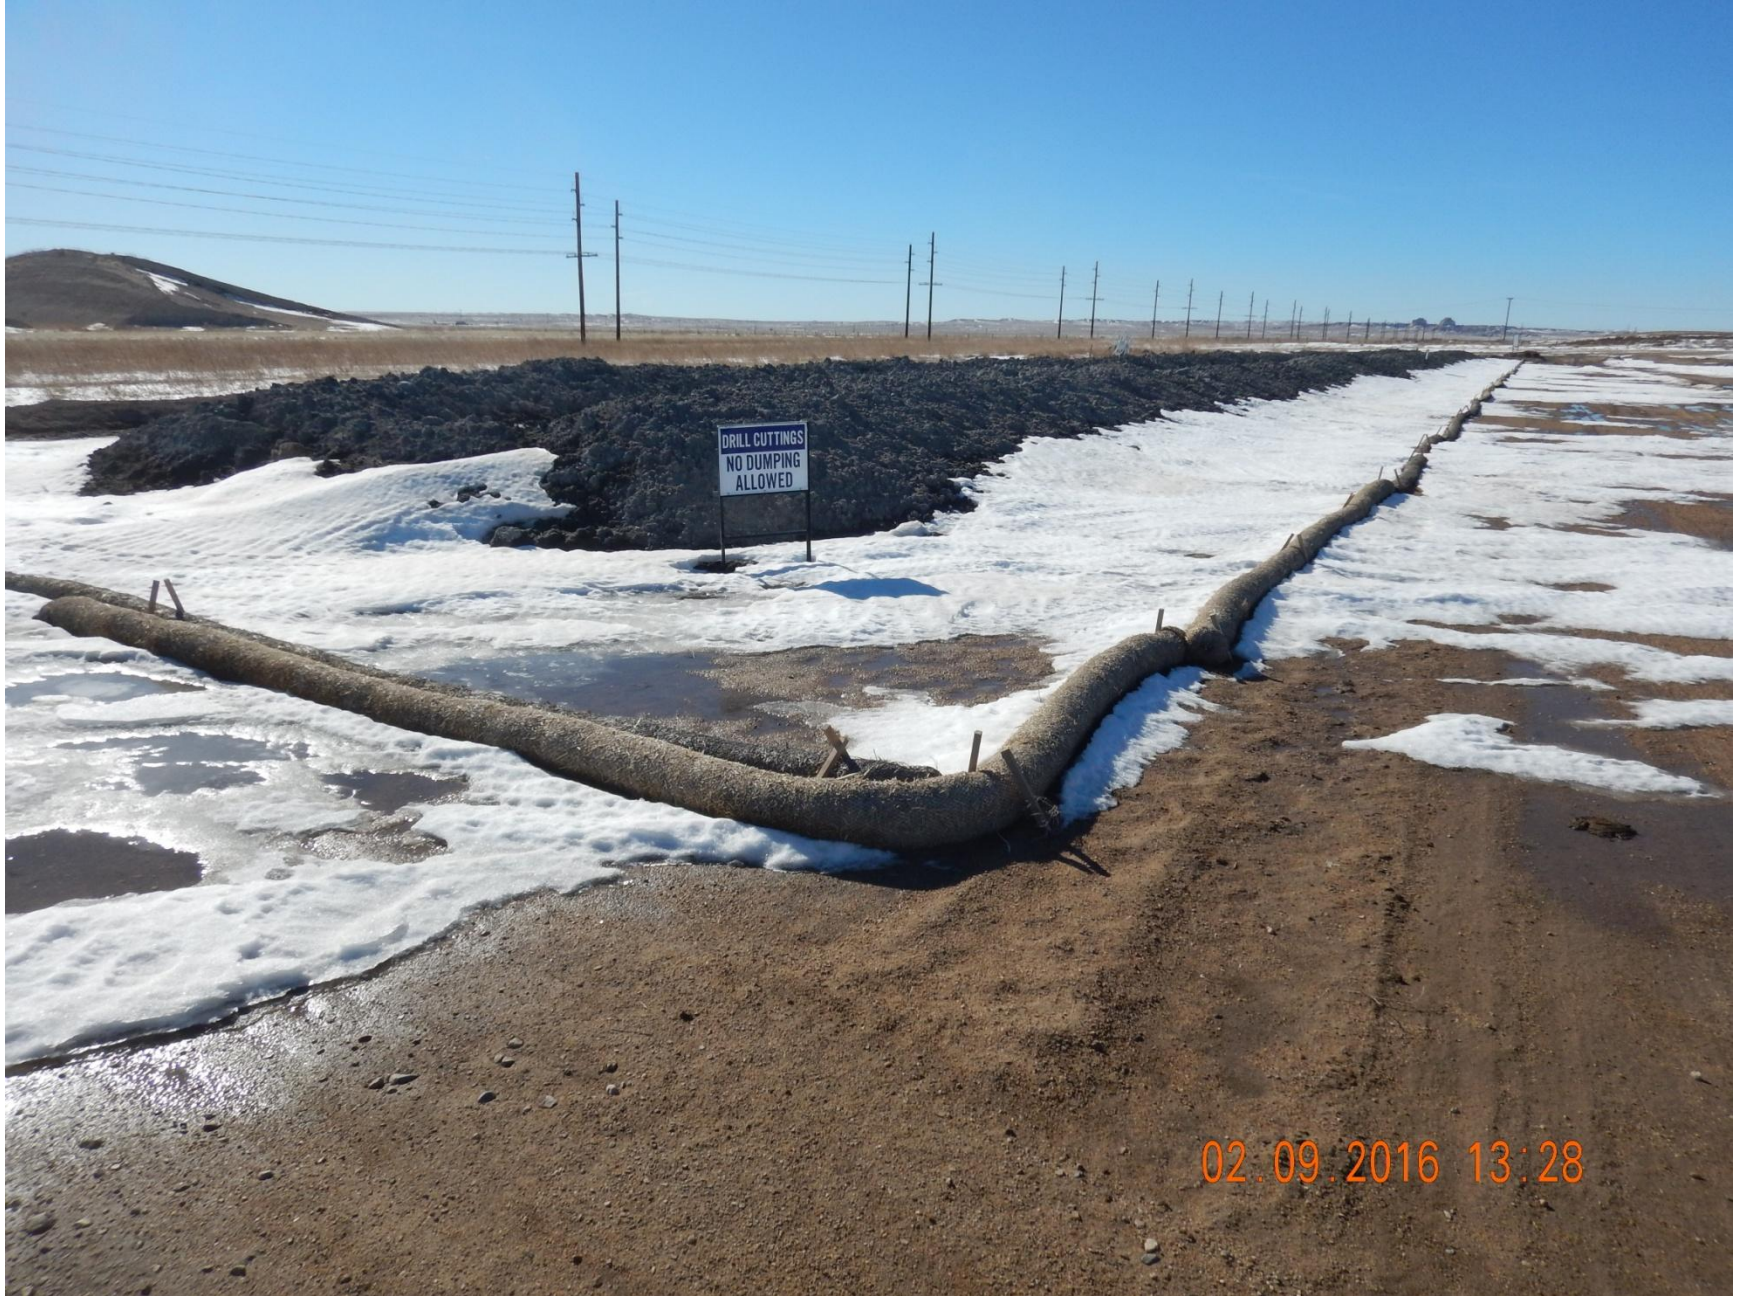
**Figure 3:** Photo taken from southeast portion of location, facing southwest. Photo of drill cuttings stored on location.

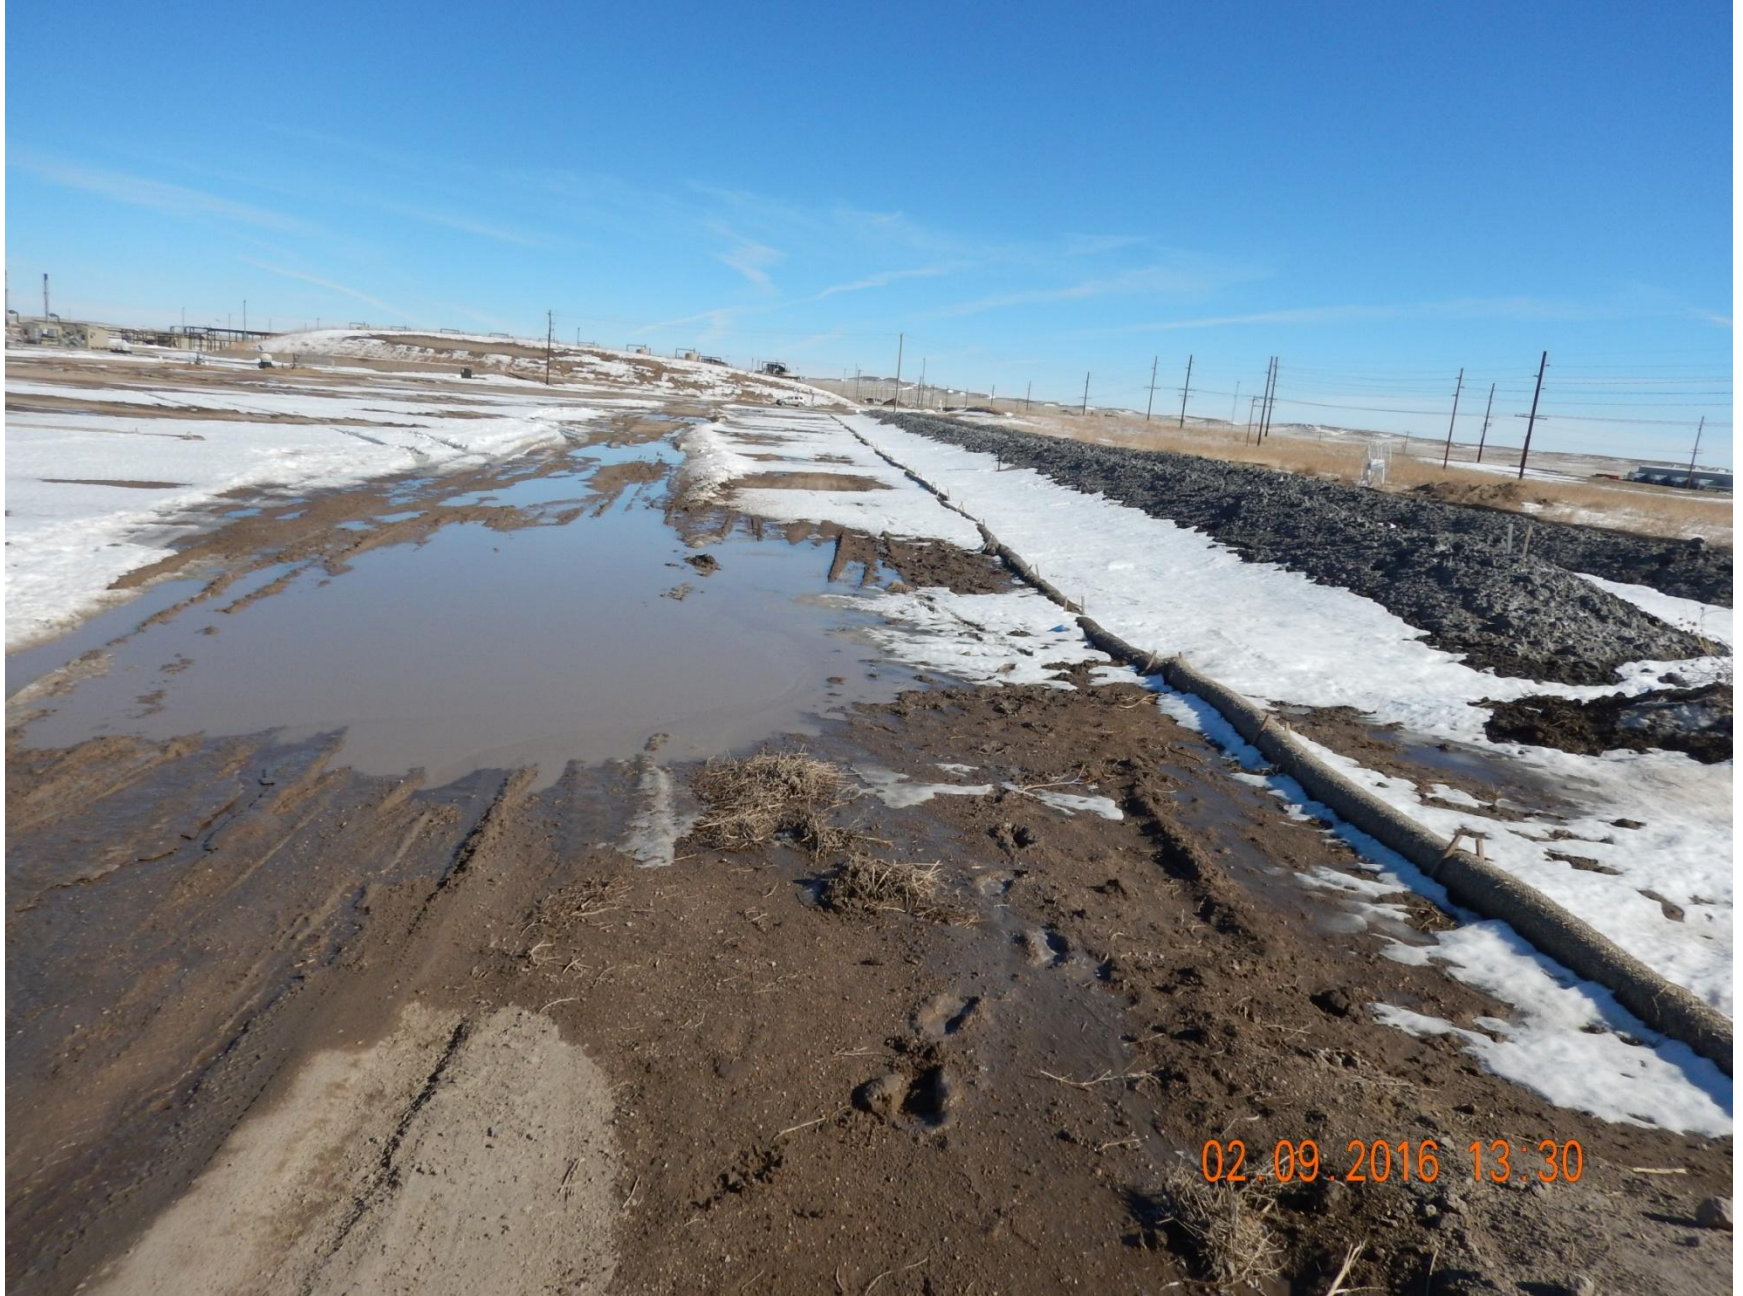
**Figure 4:** Photo taken from southwest portion of location, facing southeast. Photo of drill cuttings stored on location. Note pooling water on location/access road.

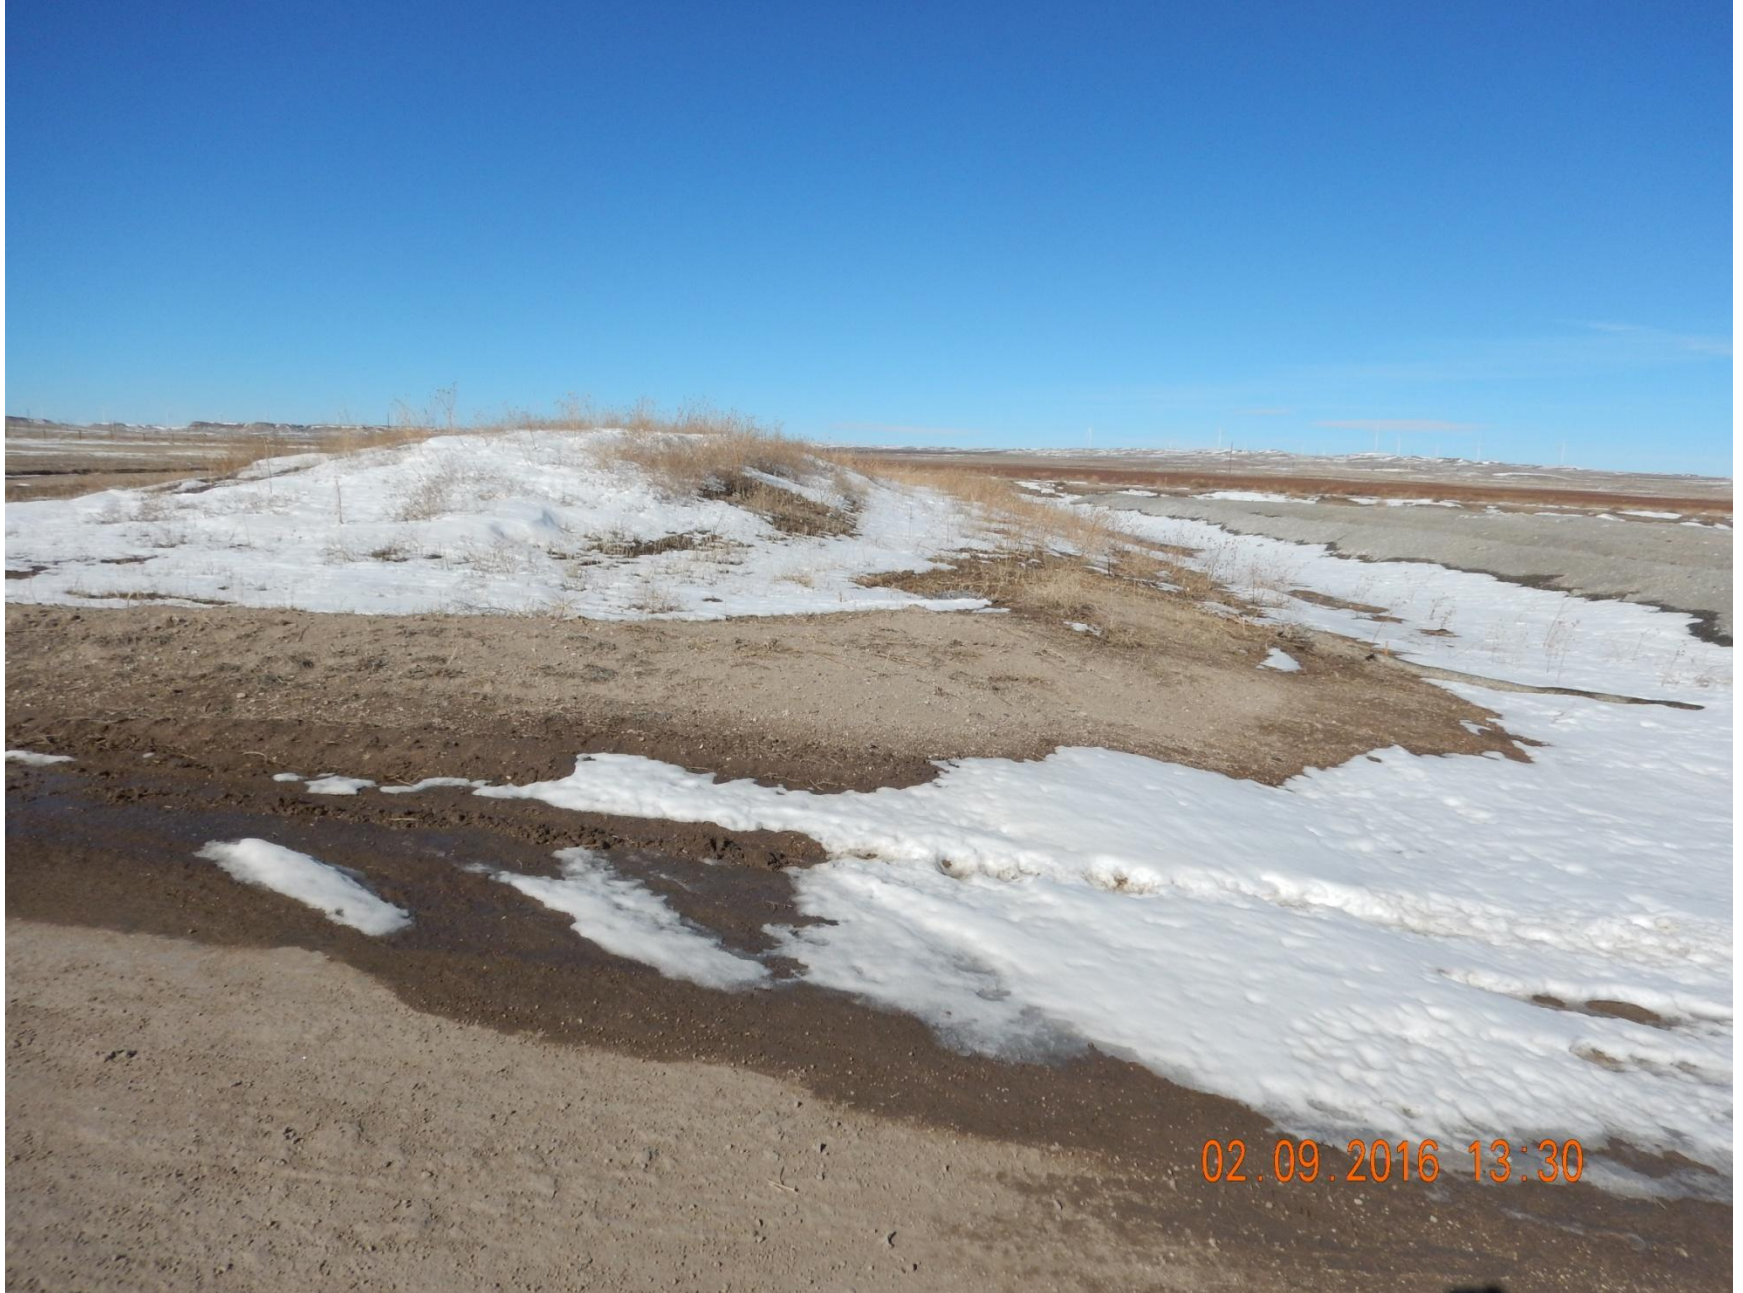
**Figure 5:** Photo taken from southwest corner of location, facing north. Photo shows topsoil stockpile on left side of photo, and drill cuttings on the right side of photo. Note lack of vegetative growth on topsoil berm.

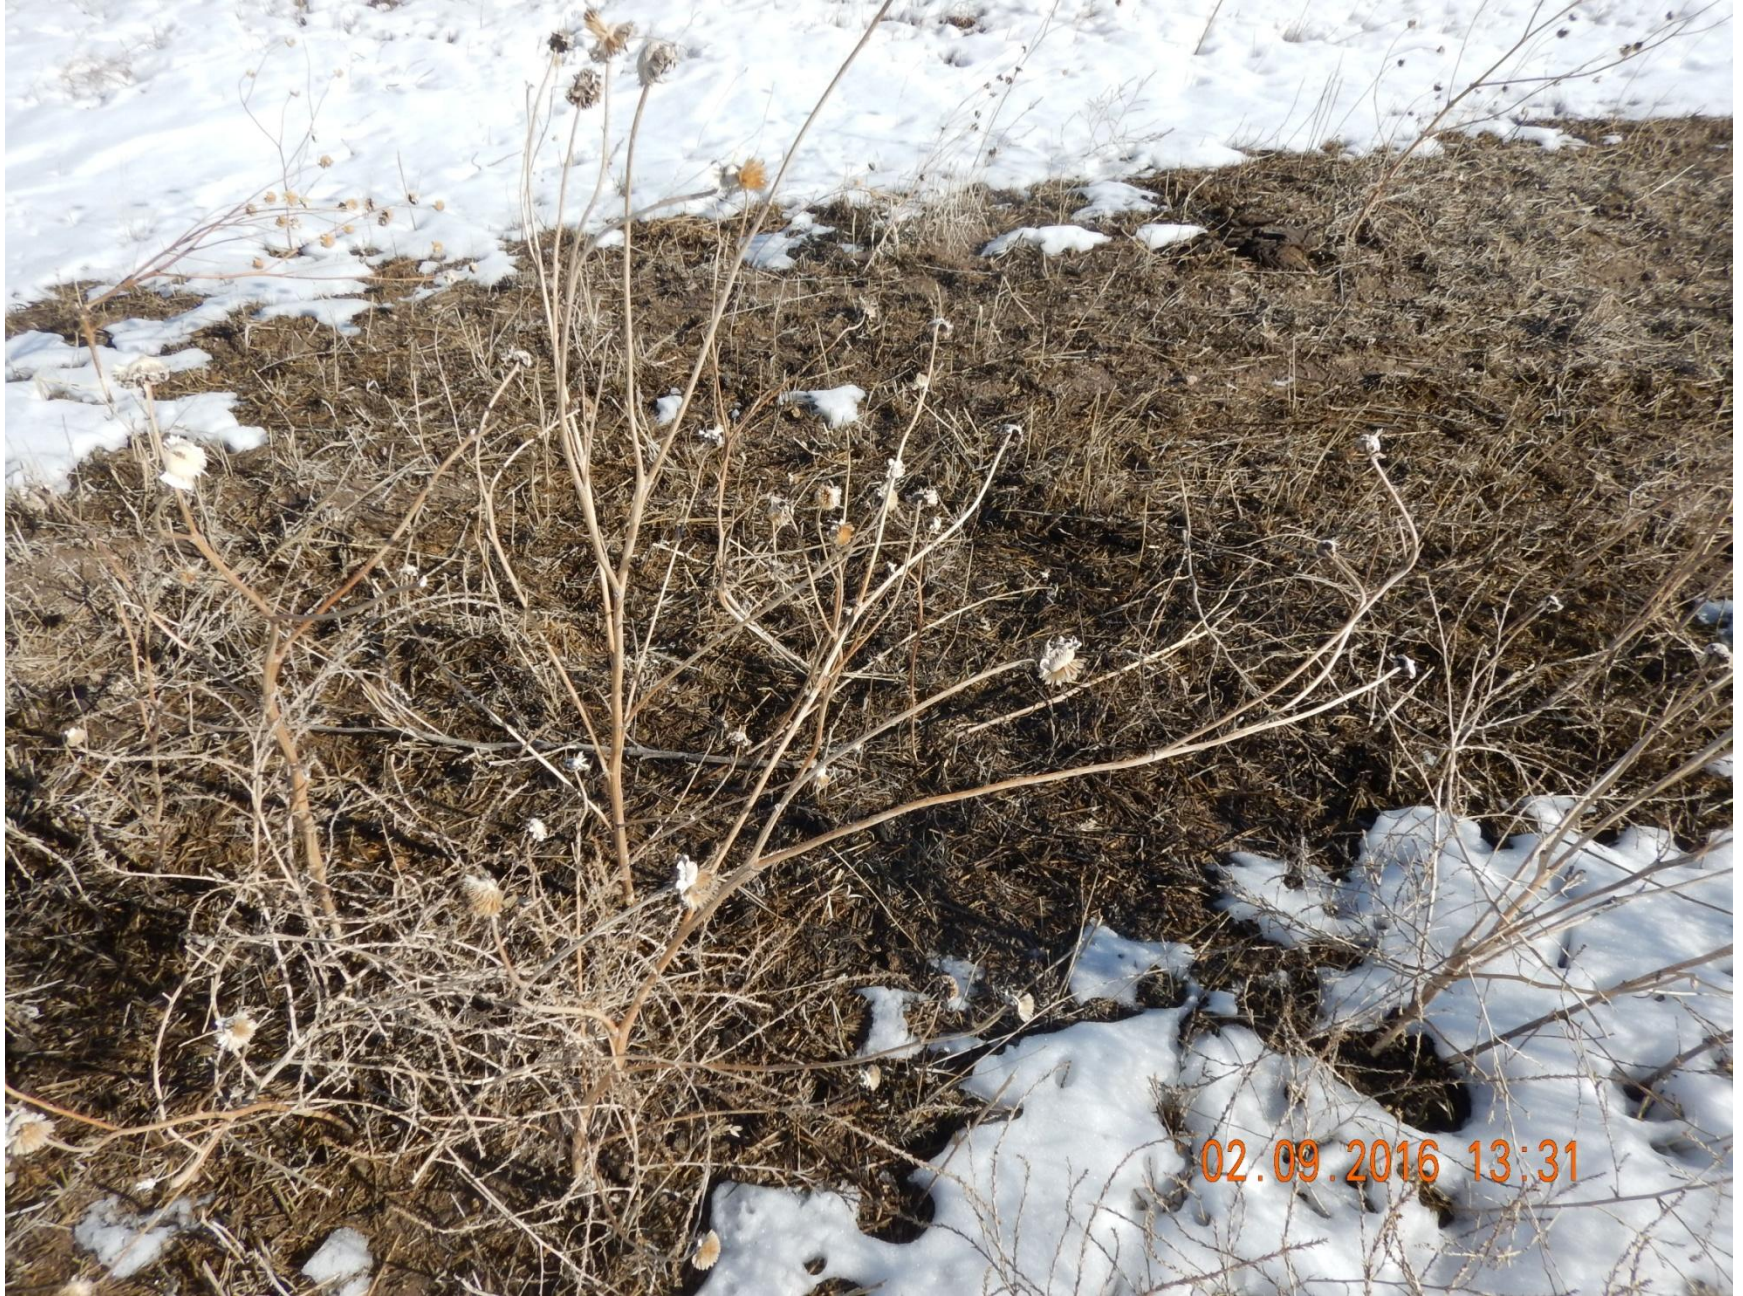
**Figure 6:** Photo taken from topsoil stockpile on the west end of location. Photo shows vegetation is predominantly undesirable weedy vegetation.

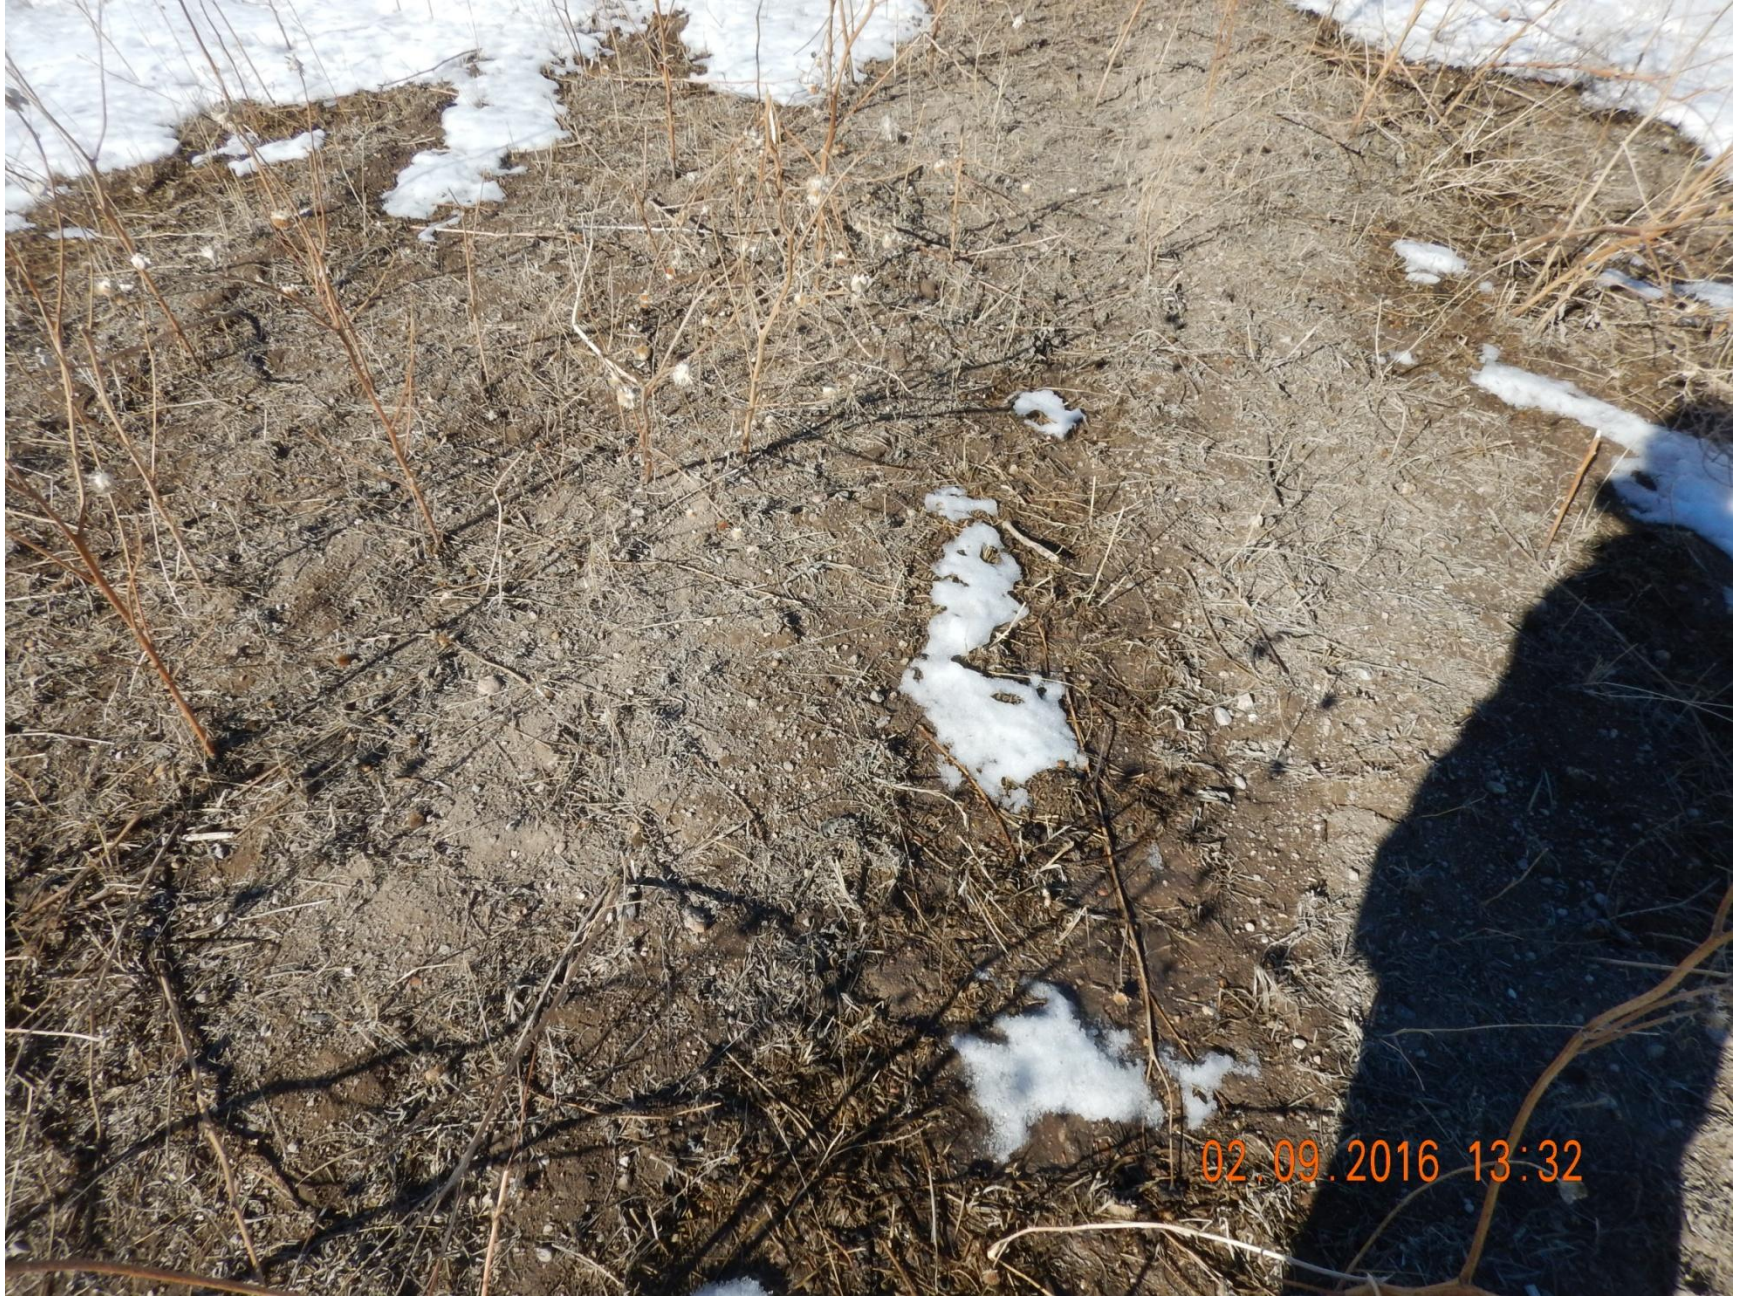
**Figure 7:** Photo taken from topsoil stockpile on the west end of location. Photo shows lack of vegetative growth.

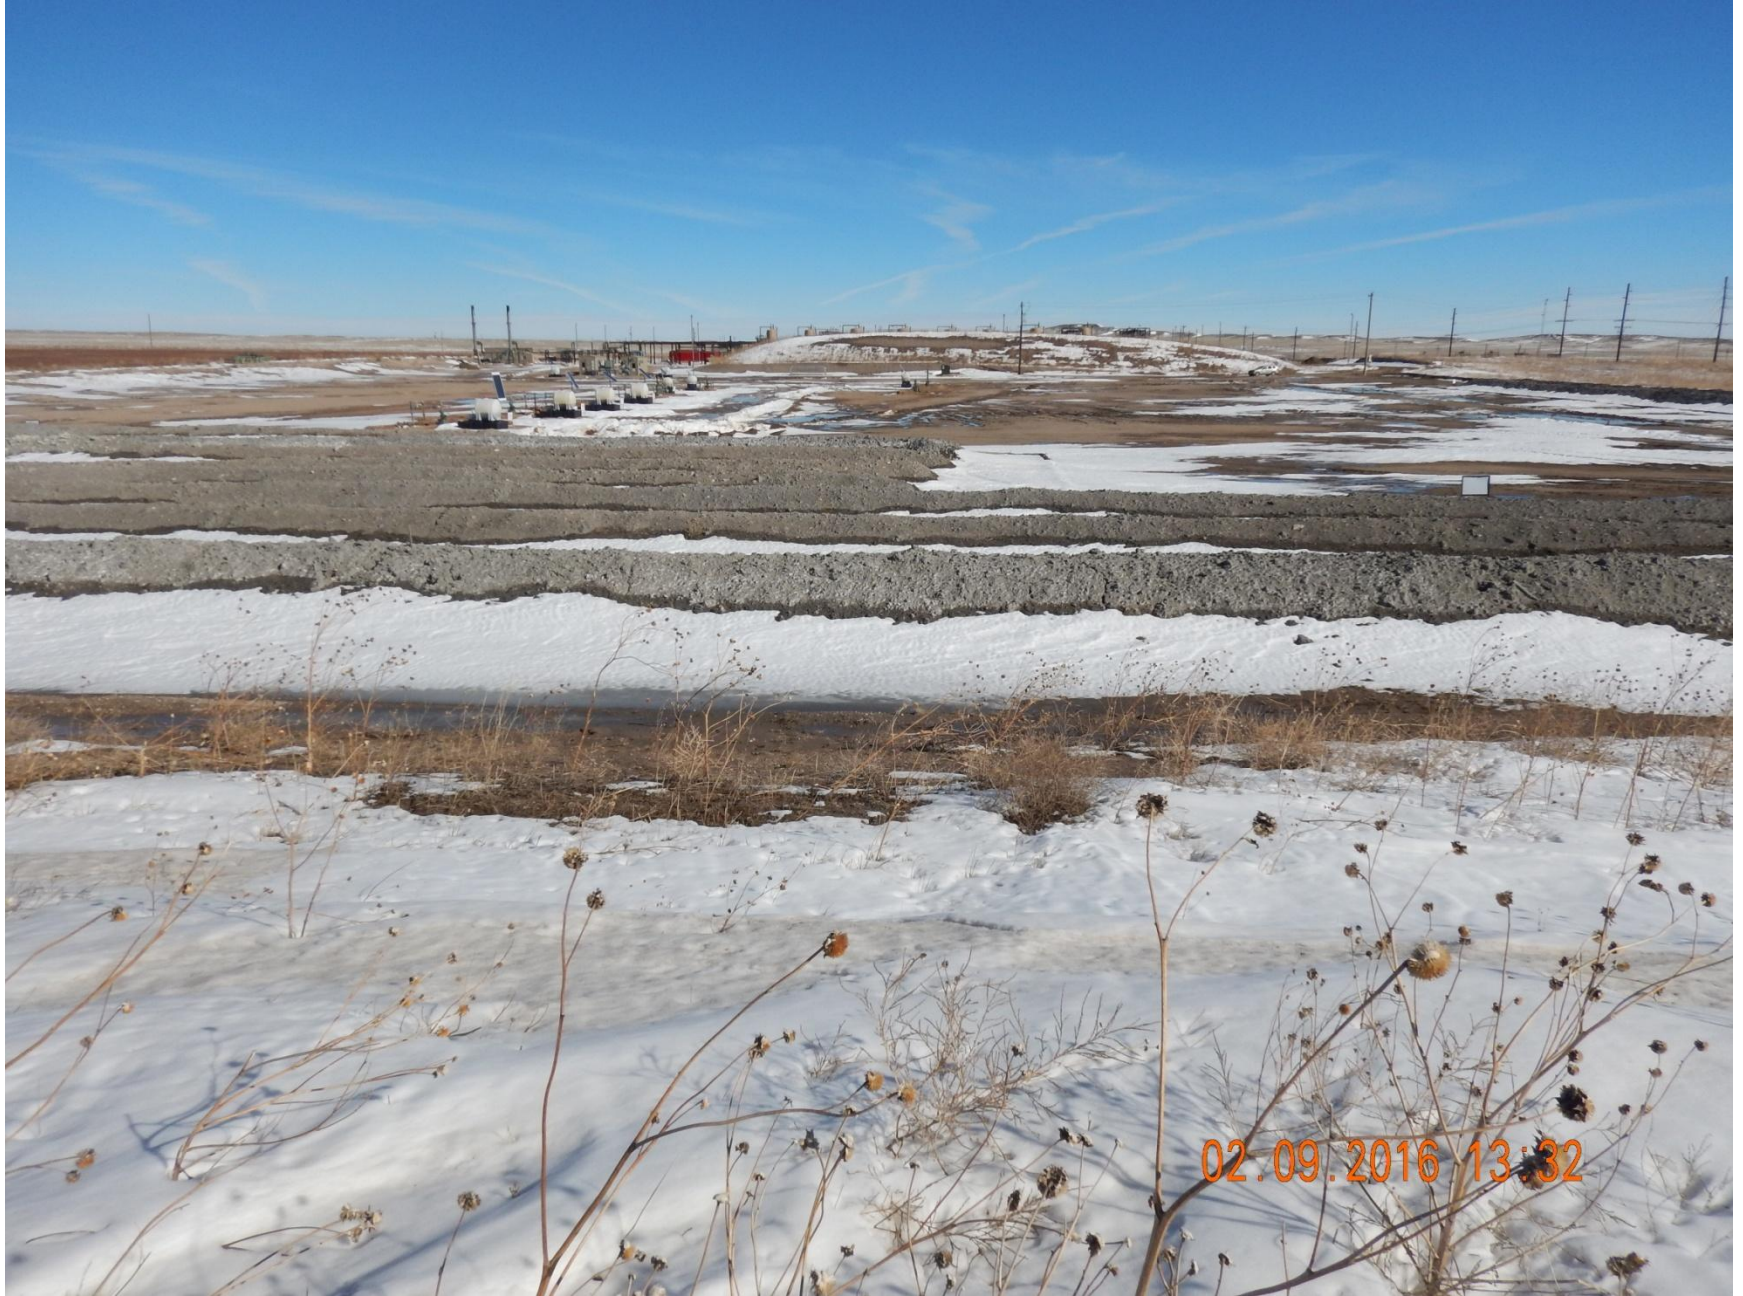
**Figure 8:** Photo taken from topsoil stockpile on the west end of location, facing east. Photo shows project area and drill cuttings.

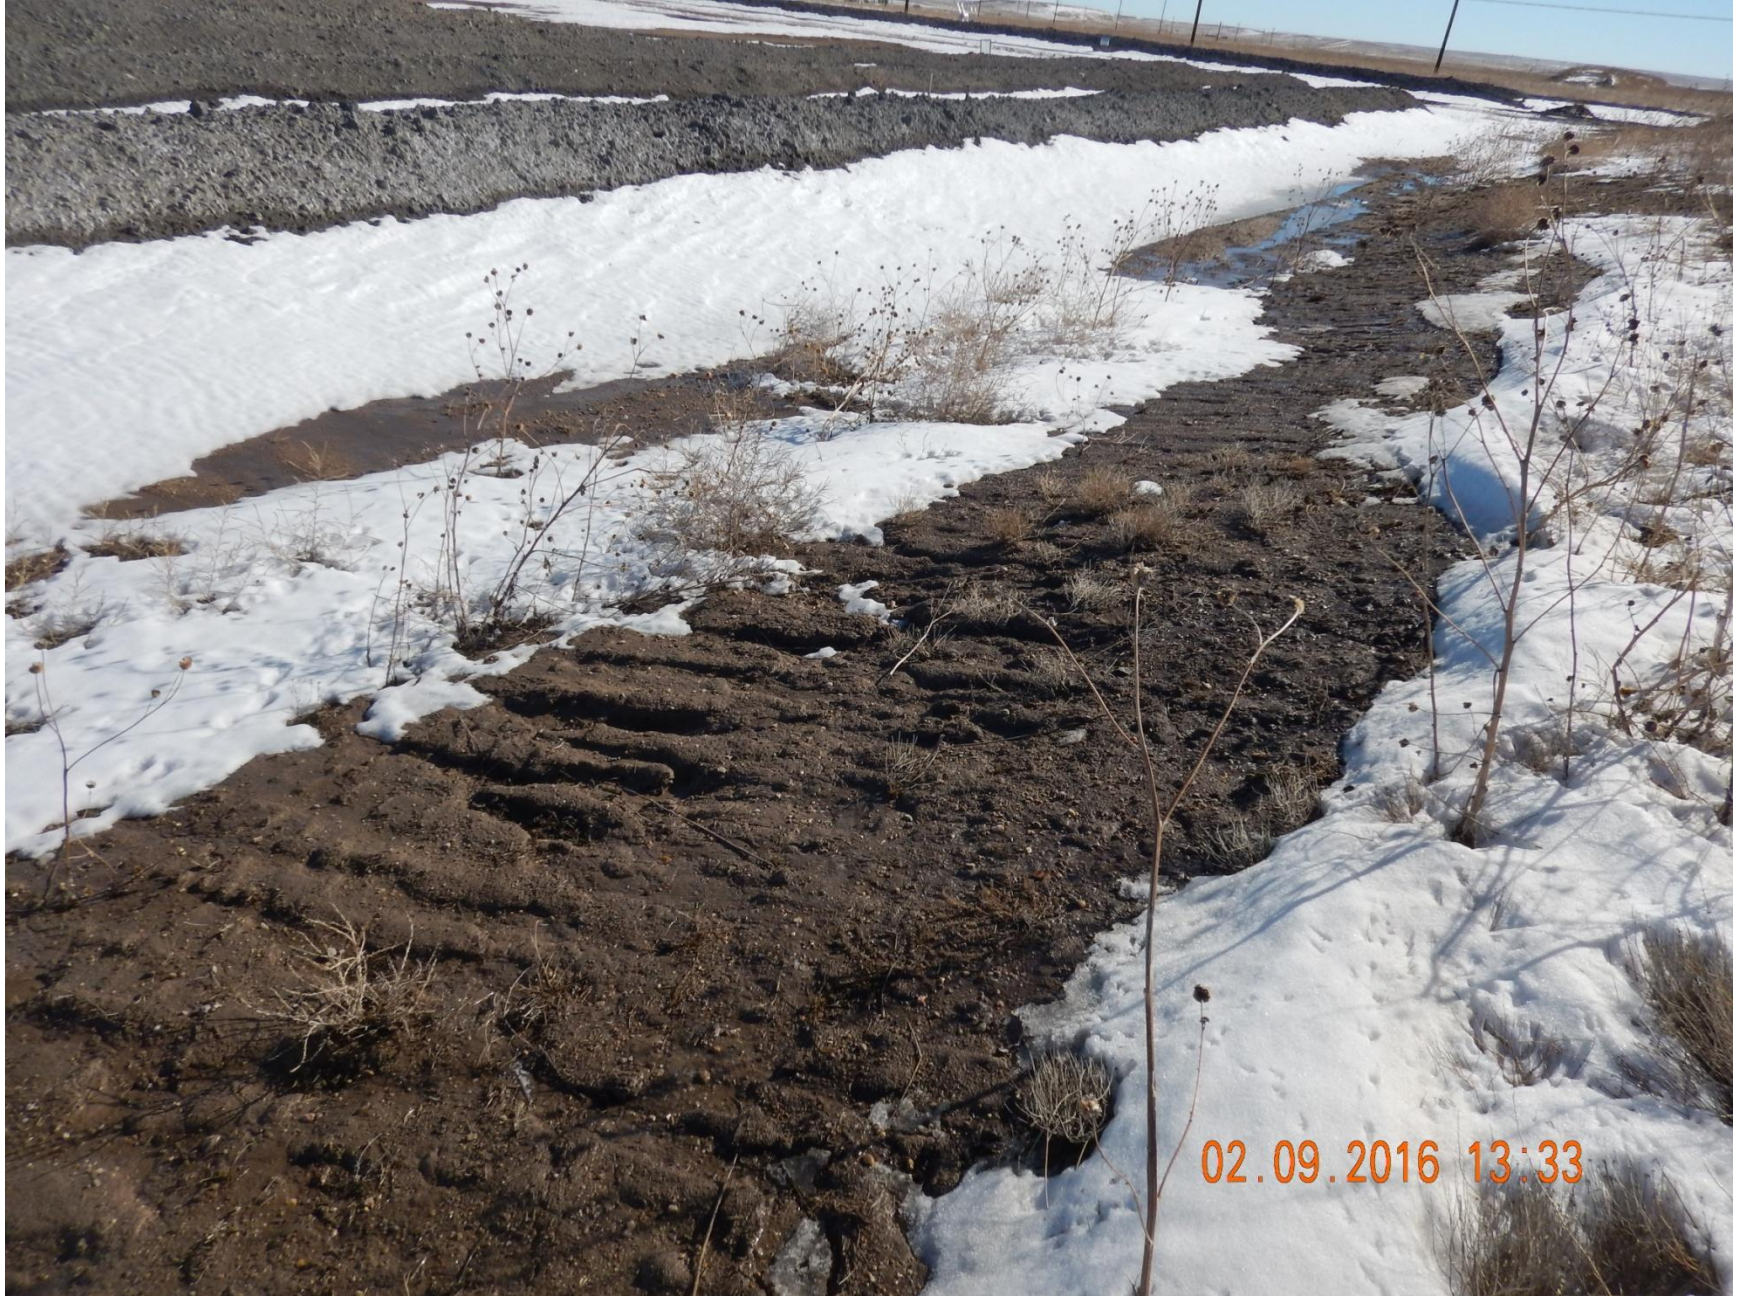
**Figure 9:** Photo taken from topsoil stockpile on the west end of location, facing southeast. Photo shows erosion occurring on topsoil stockpile, indicating lack of stabilization.

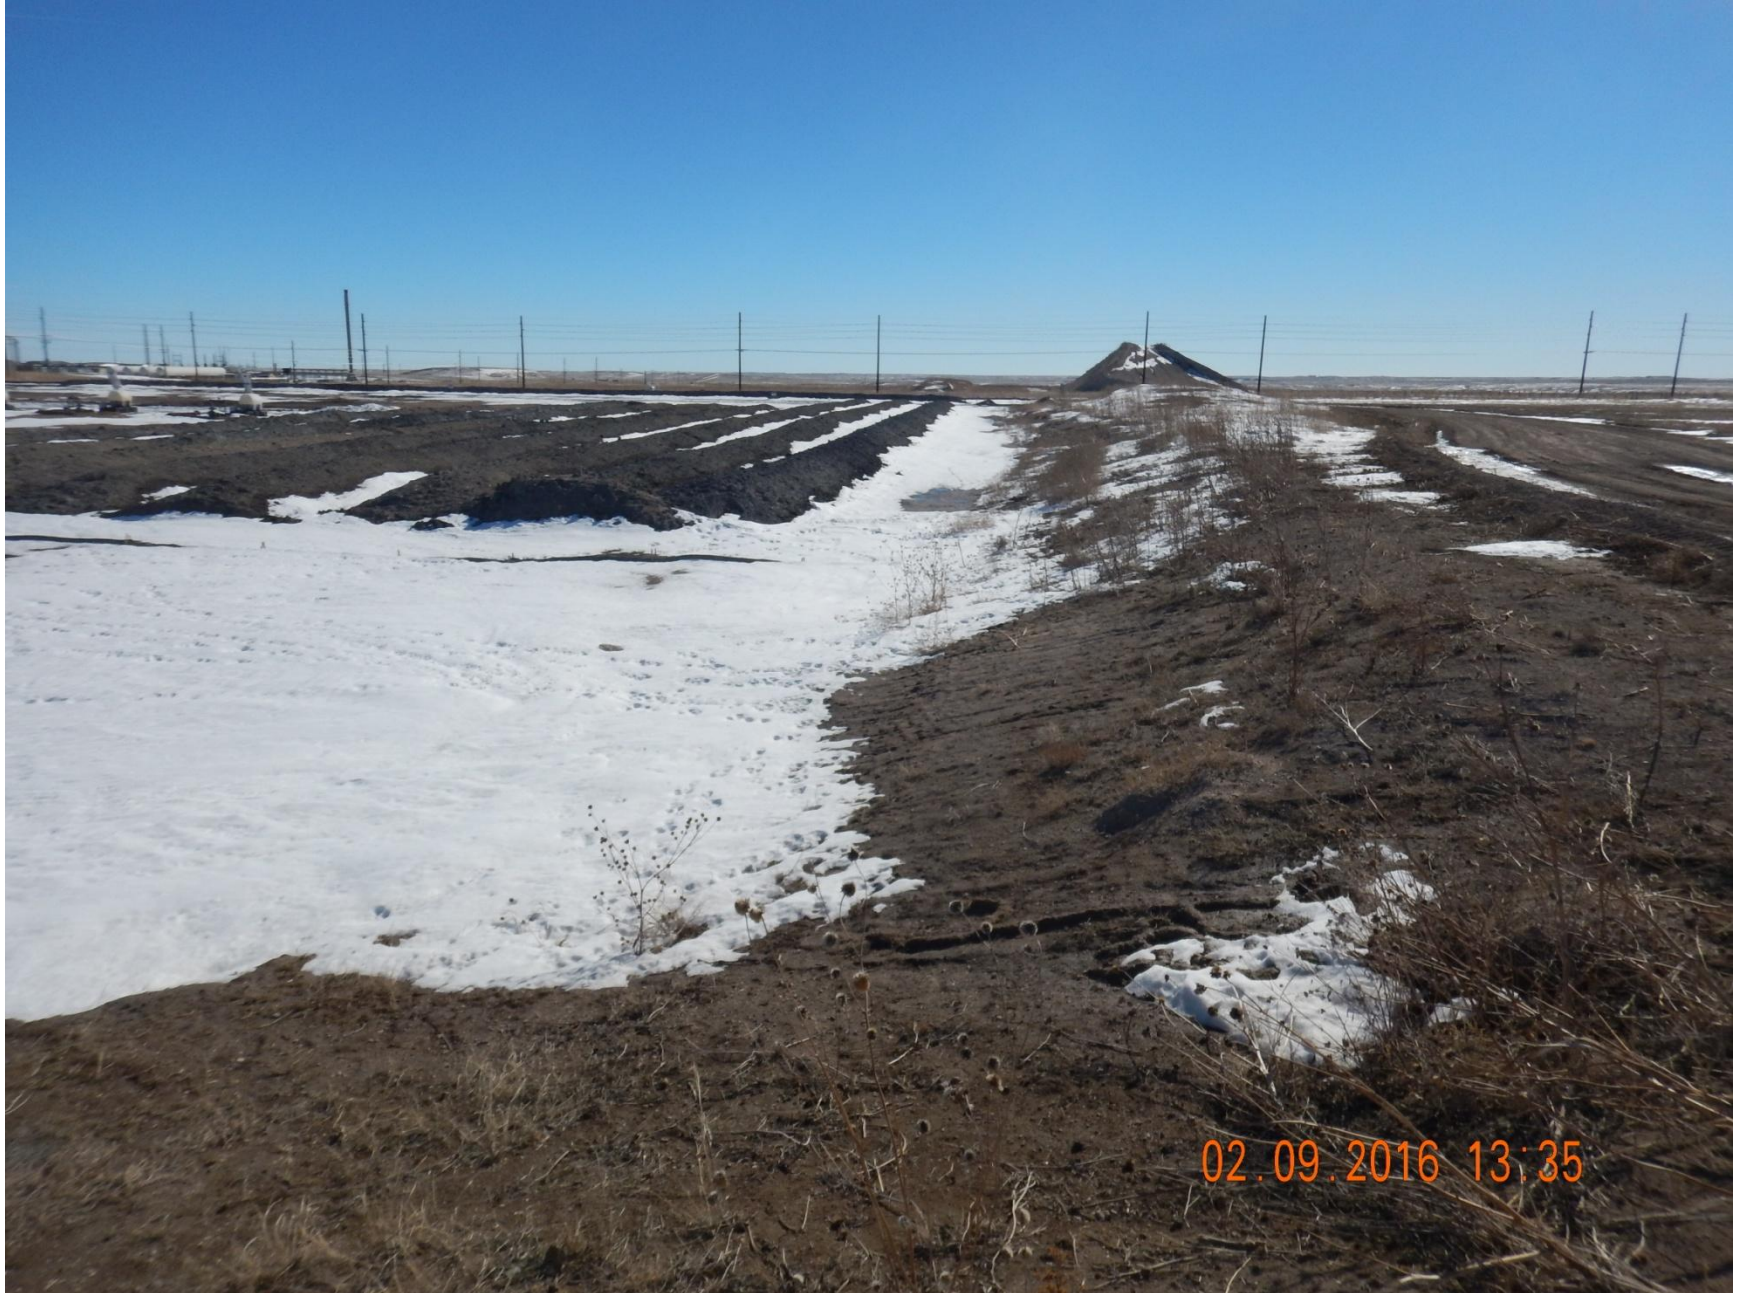
**Figure 10:** Photo taken from northwest corner of location, facing south. Photo shows drill cuttings on location, and topsoil berm. Note lack of vegetative growth on berm and rill erosion.
