# Interim Reclamation Inspection

2/9/2016

Operator: Whiting Oil and Gas

Location ID: 431115

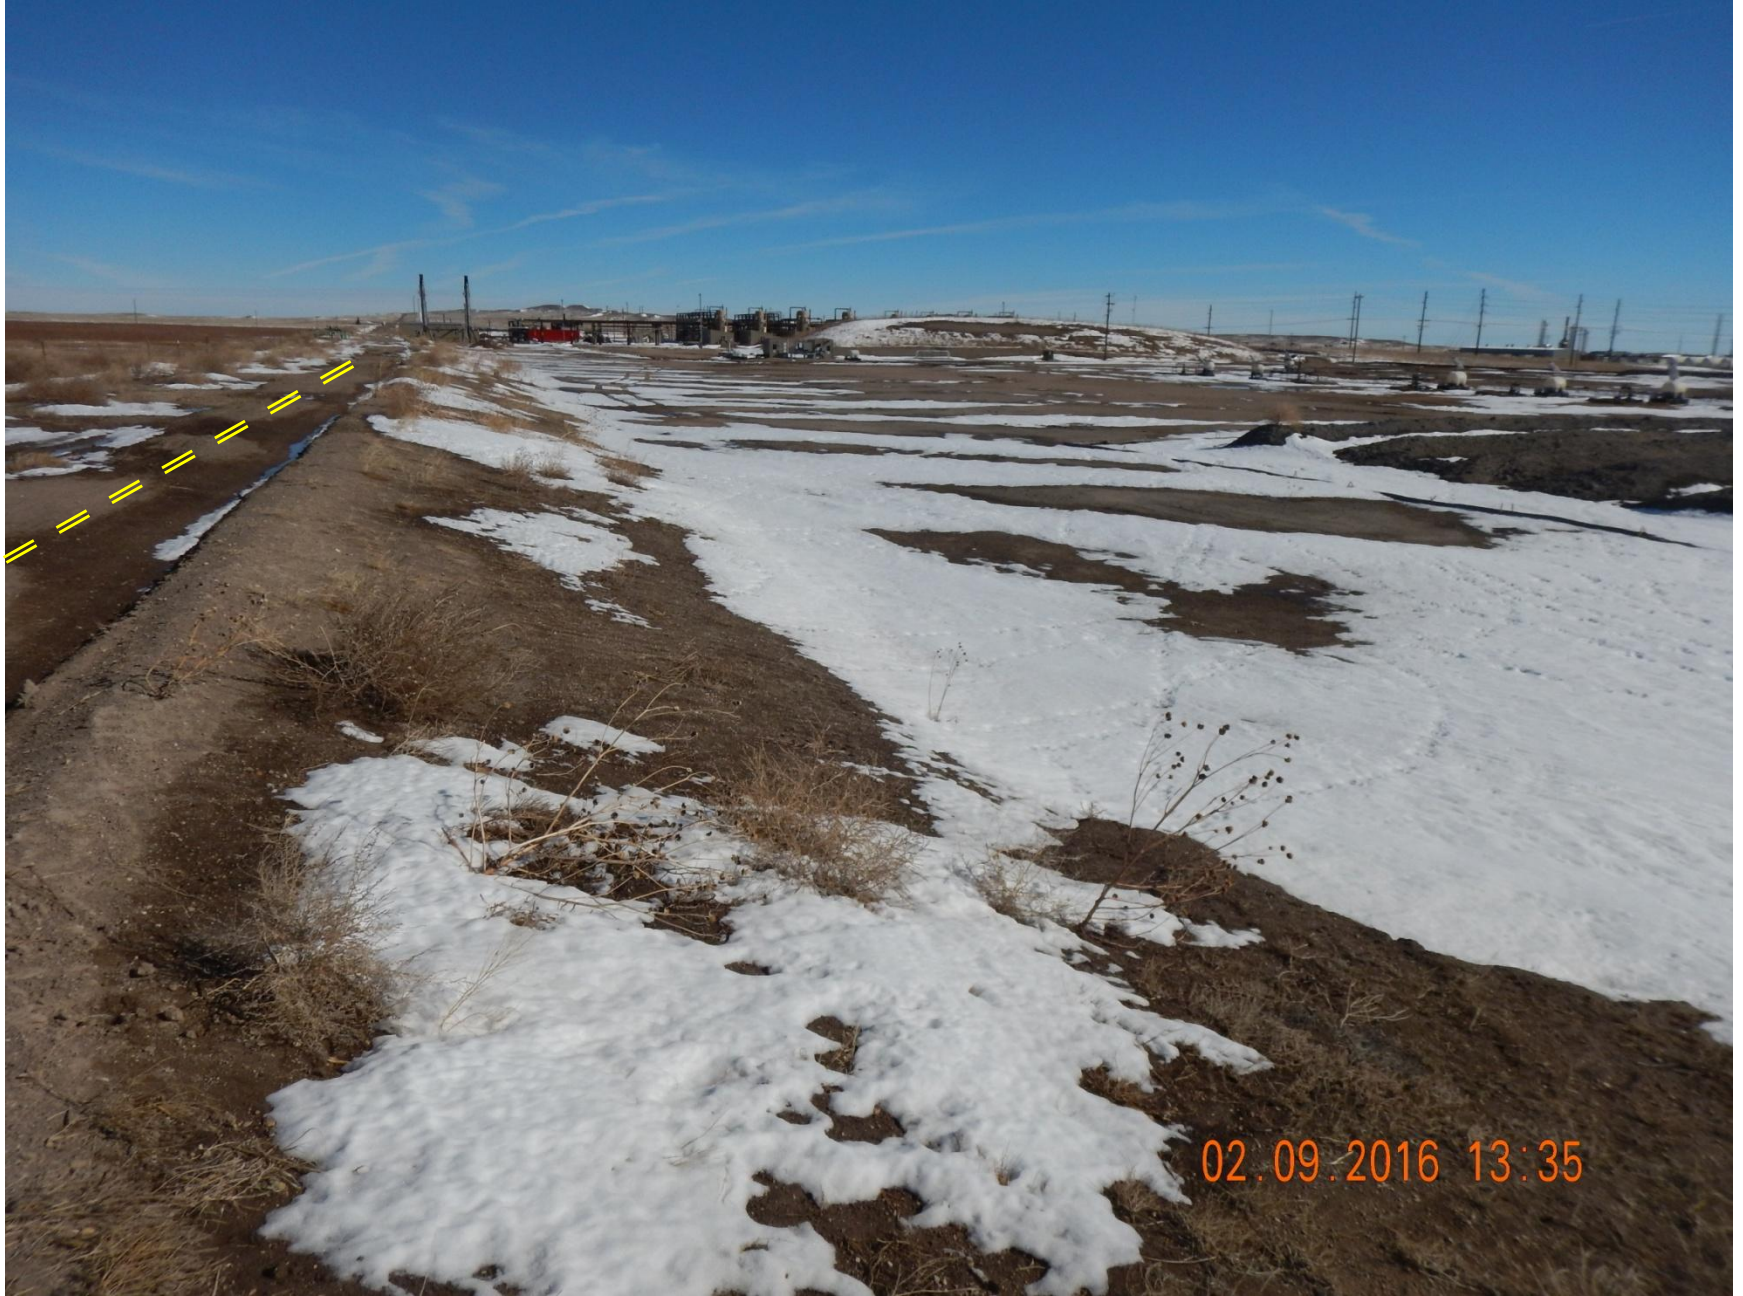
**Figure 11:** Photo taken from northwest corner of location, facing east. Photo shows project location yet to be reduced in size per interim reclamation requirements. Old ruts within area along yellow line indicated evidence of former use as an access road). Current access road is on the southern portion of the location.

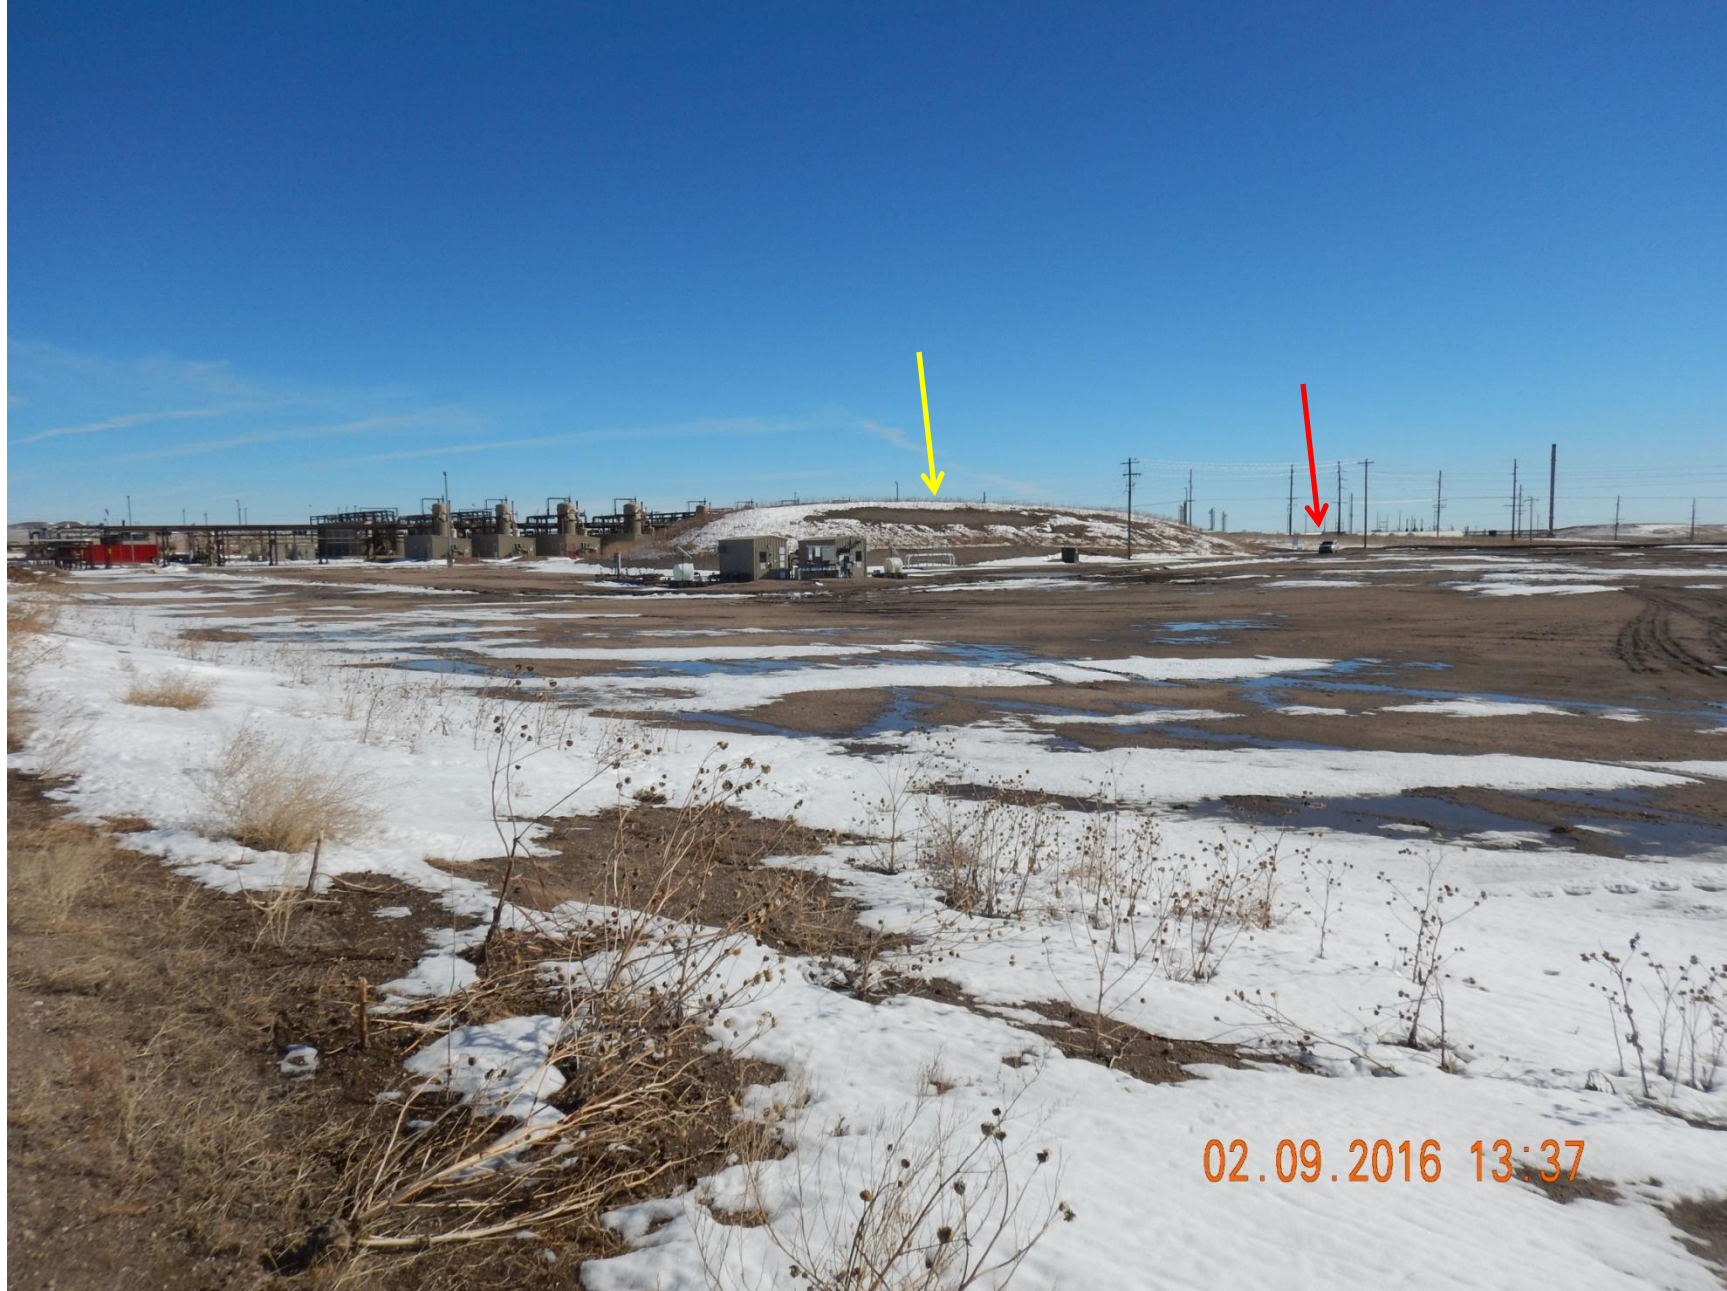
**Figure 12:** Photo taken the north end of location, facing southeast. Photo shows project location, and topsoil berm (yellow arrow). Note height of berm is excessive, adequate room exists to have extended its length to the north, thus reducing the height. Arrow indicates vehicle for reference.

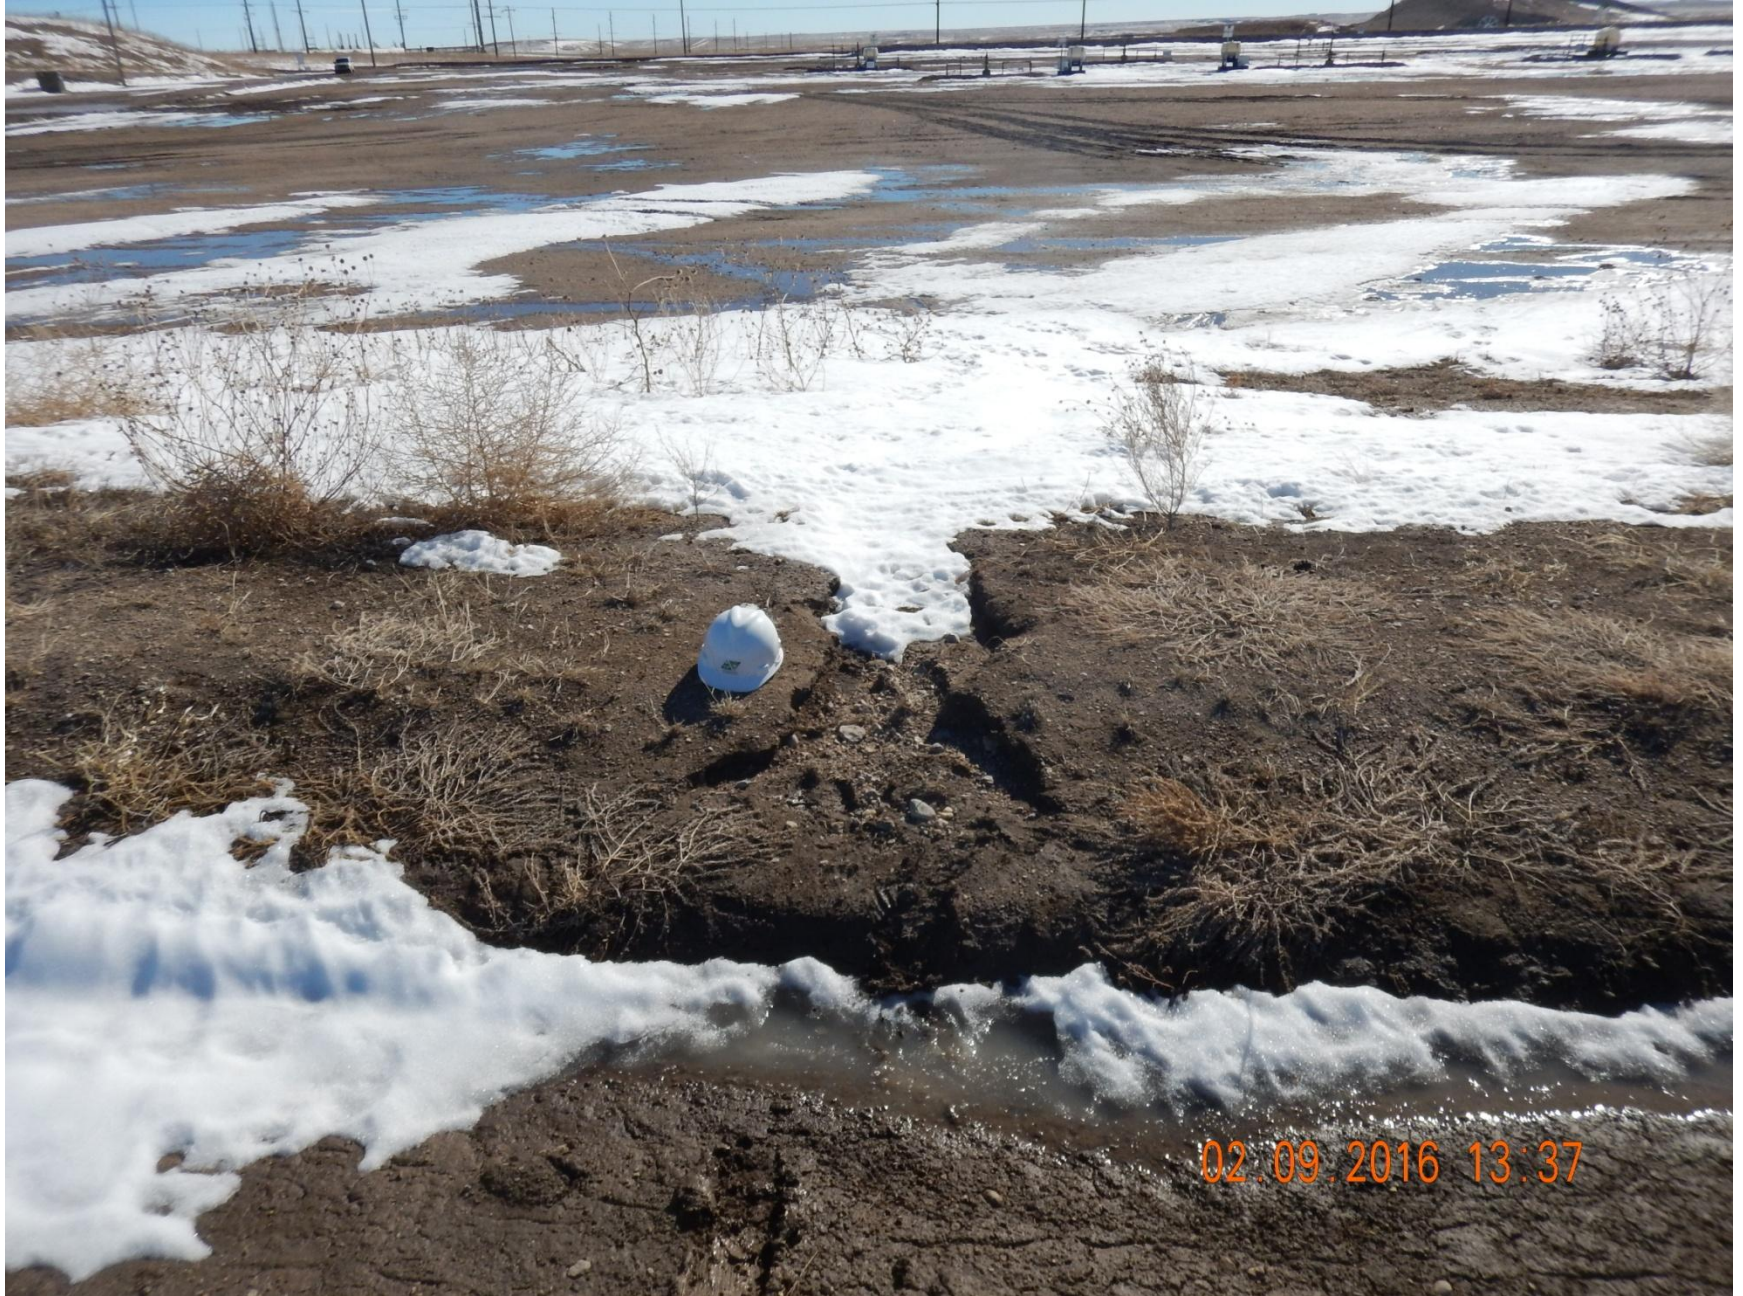
**Figure 13:** Photo taken from north end of location, facing south. Photo shows gully erosion beginning to encroach off project location.

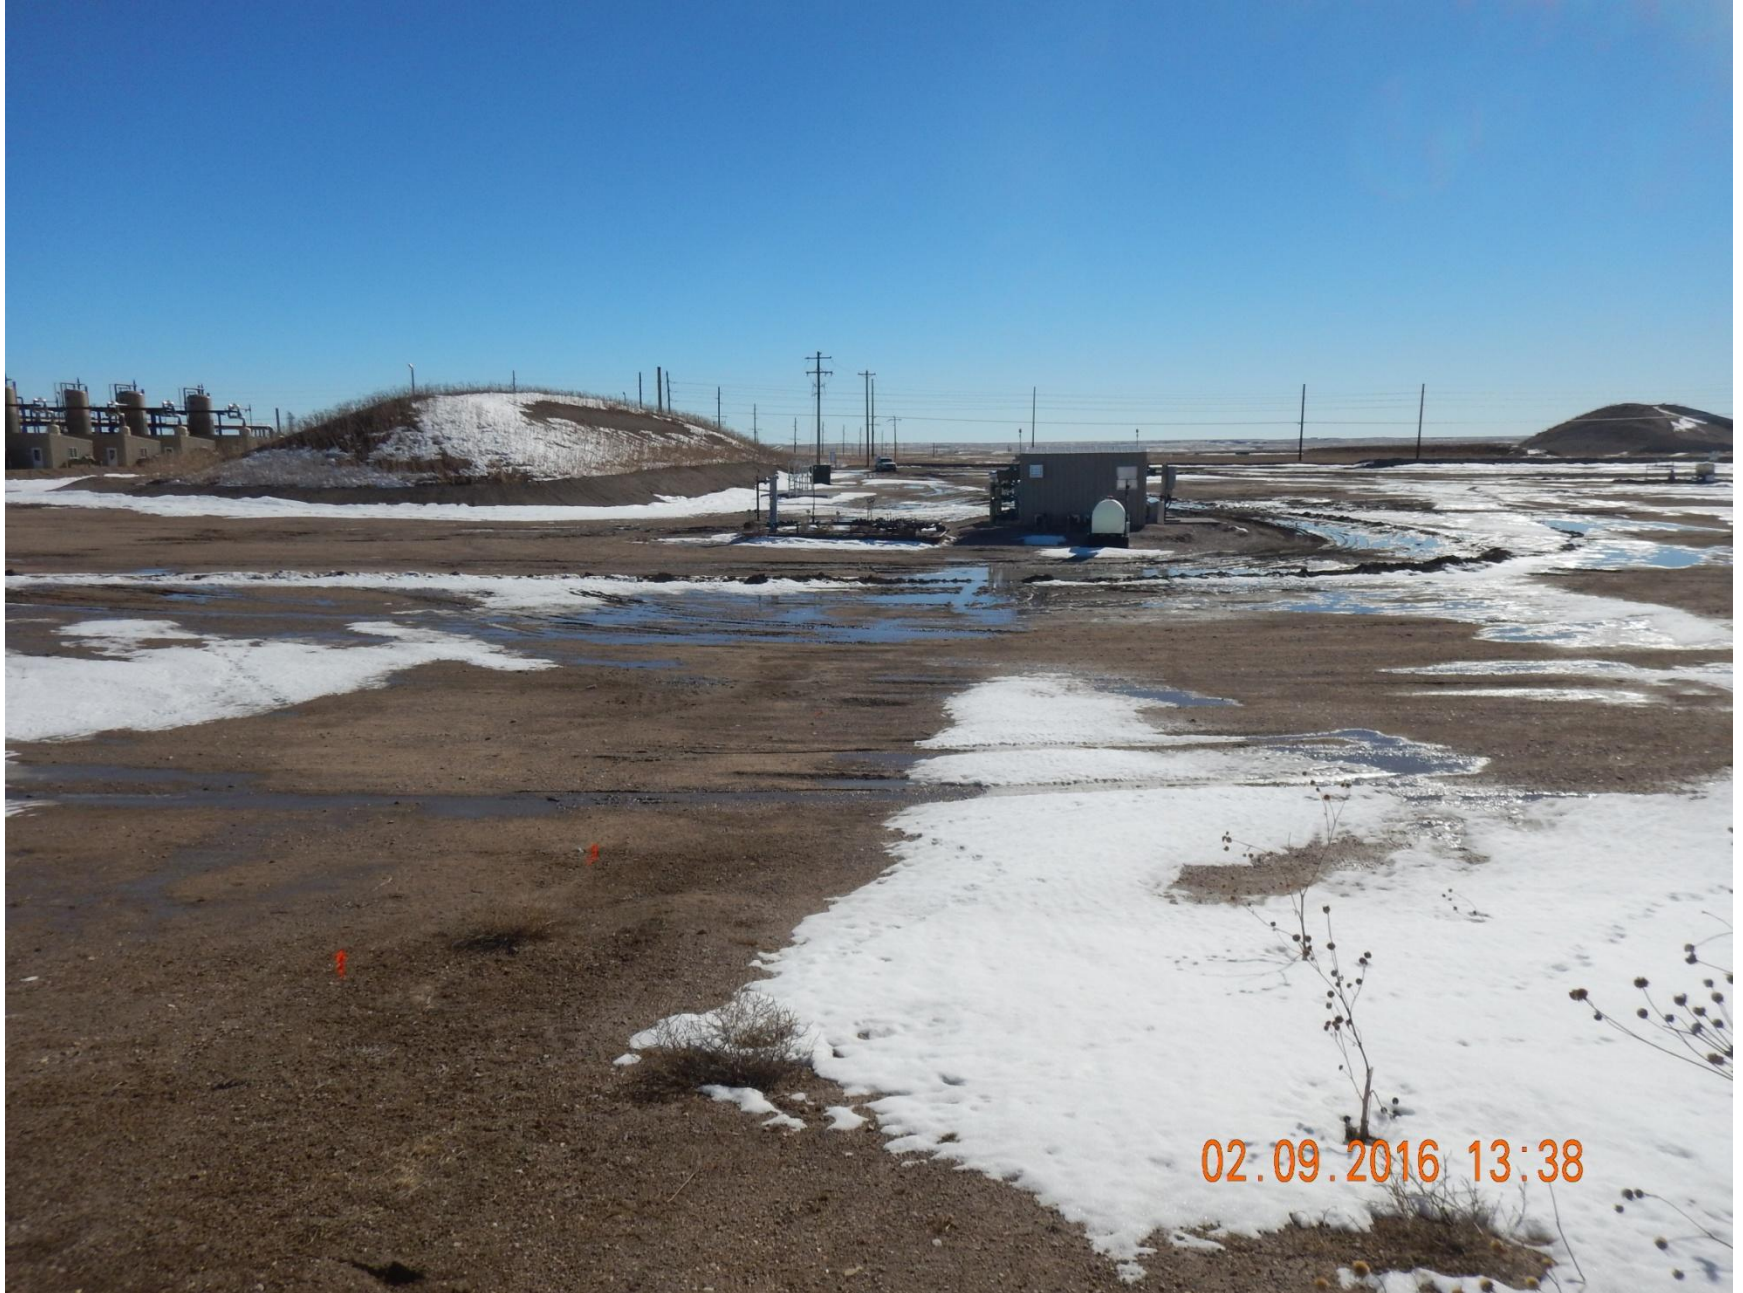
**Figure 14:** Photo taken from northeast corner of location, facing south. Note height of berm is excessive, adequate room exists to have extended its length to the north, thus reducing the height.

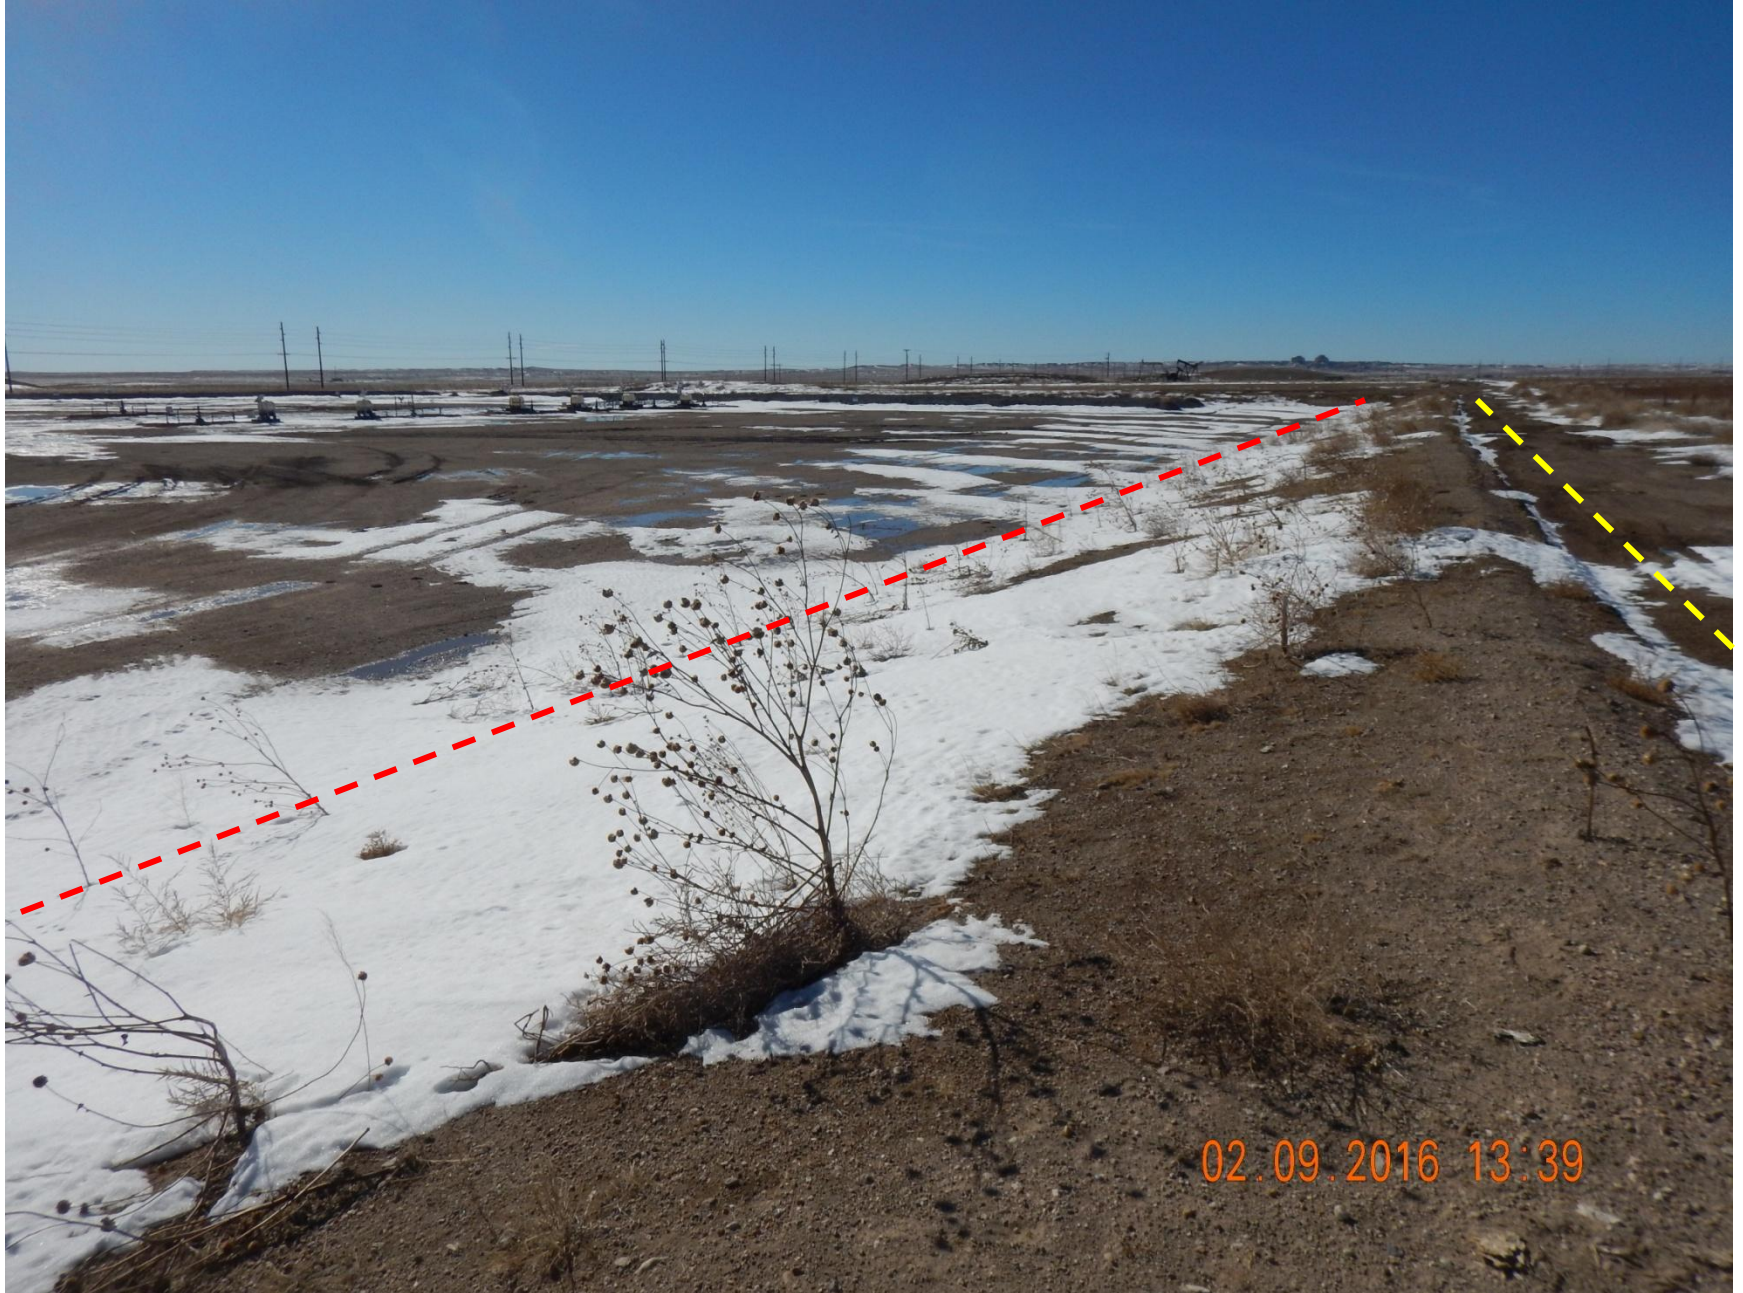
**Figure 15:** Photo taken from northeast corner of location, facing west. Photo shows project location (left of line), and interim area (right of line). Note location has yet to be reduced in size per interim reclamation requirements. Old ruts within area along yellow line indicated evidence of former use as an access road.

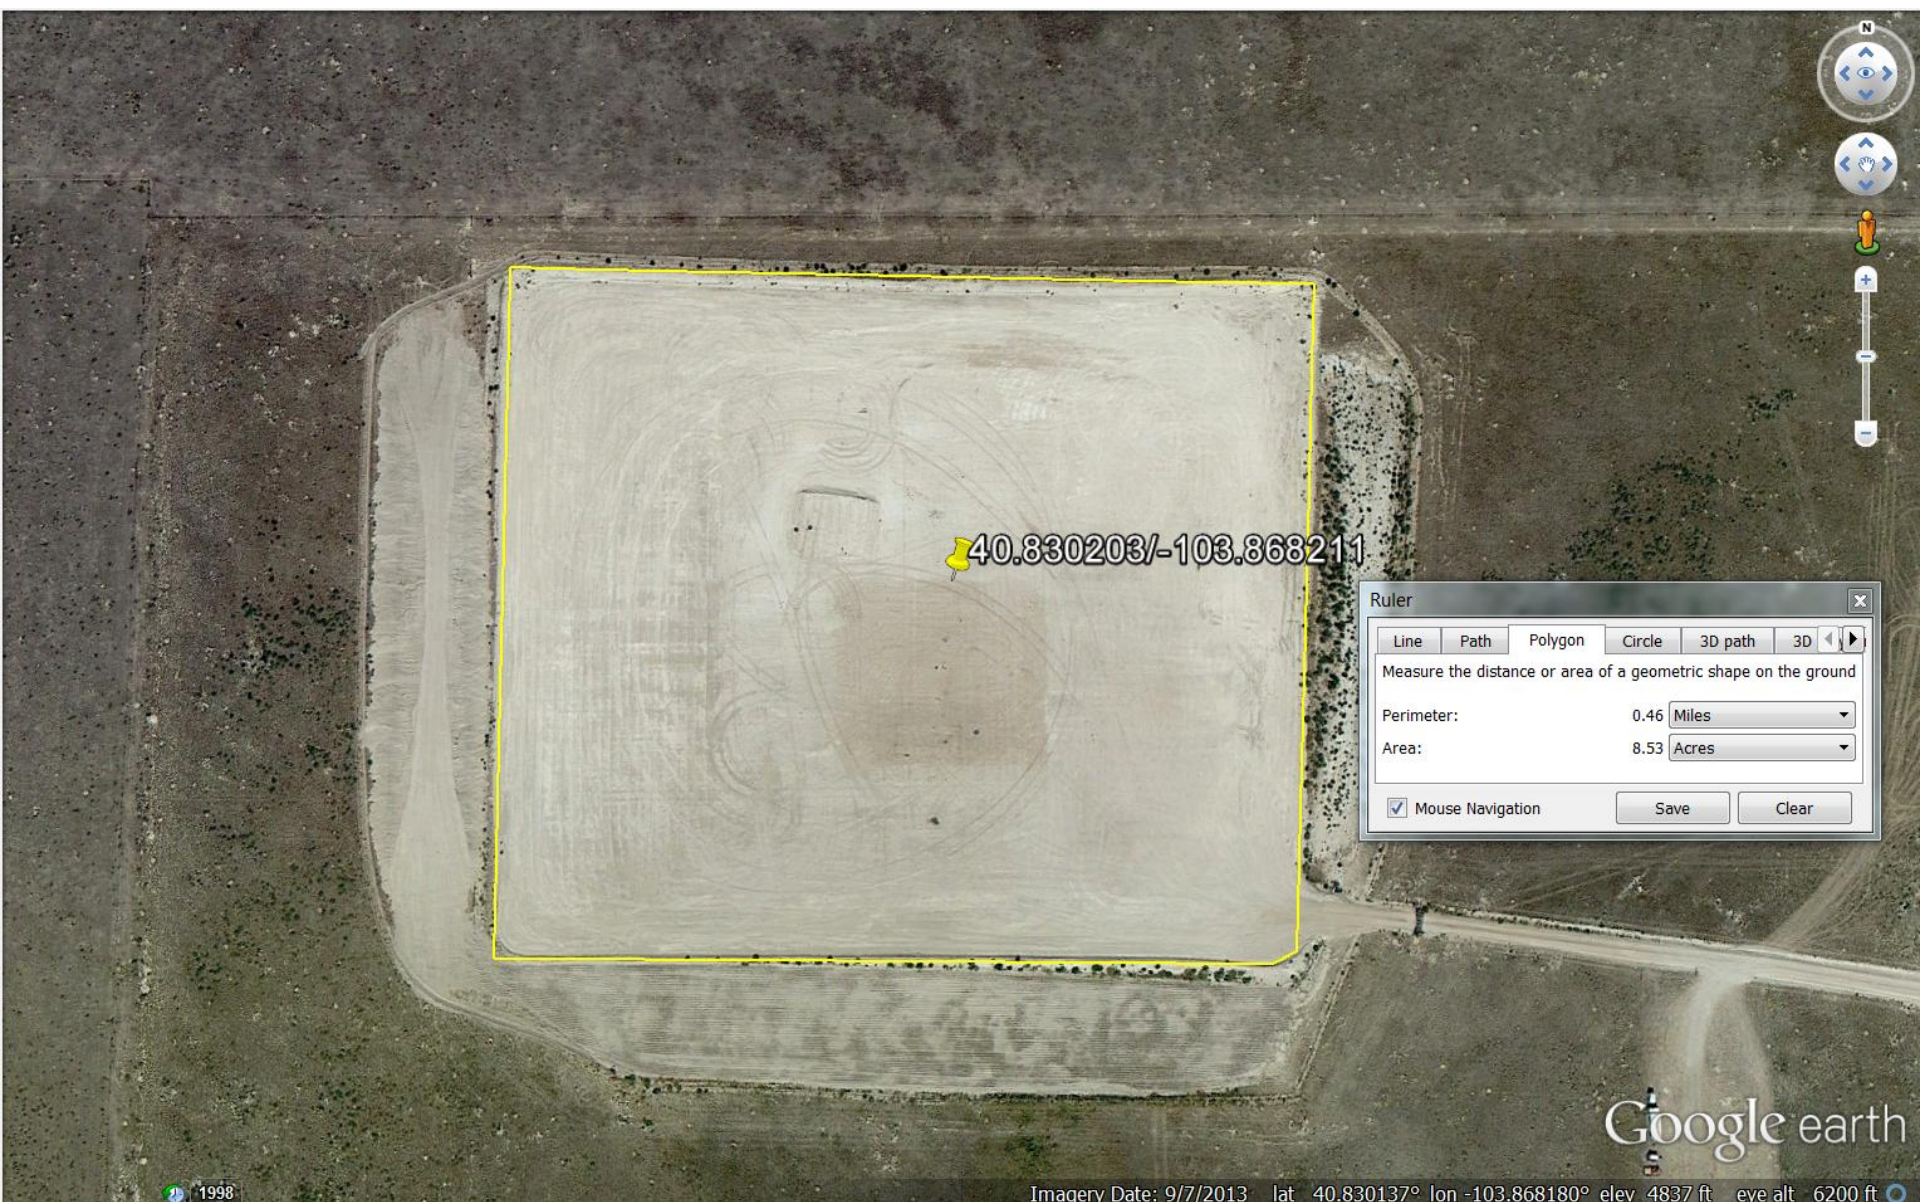
**Figure 24:** 2013 aerial image of location. Approximate area of project location (conservatively), not including total disturbed area, is 8.5 acres.

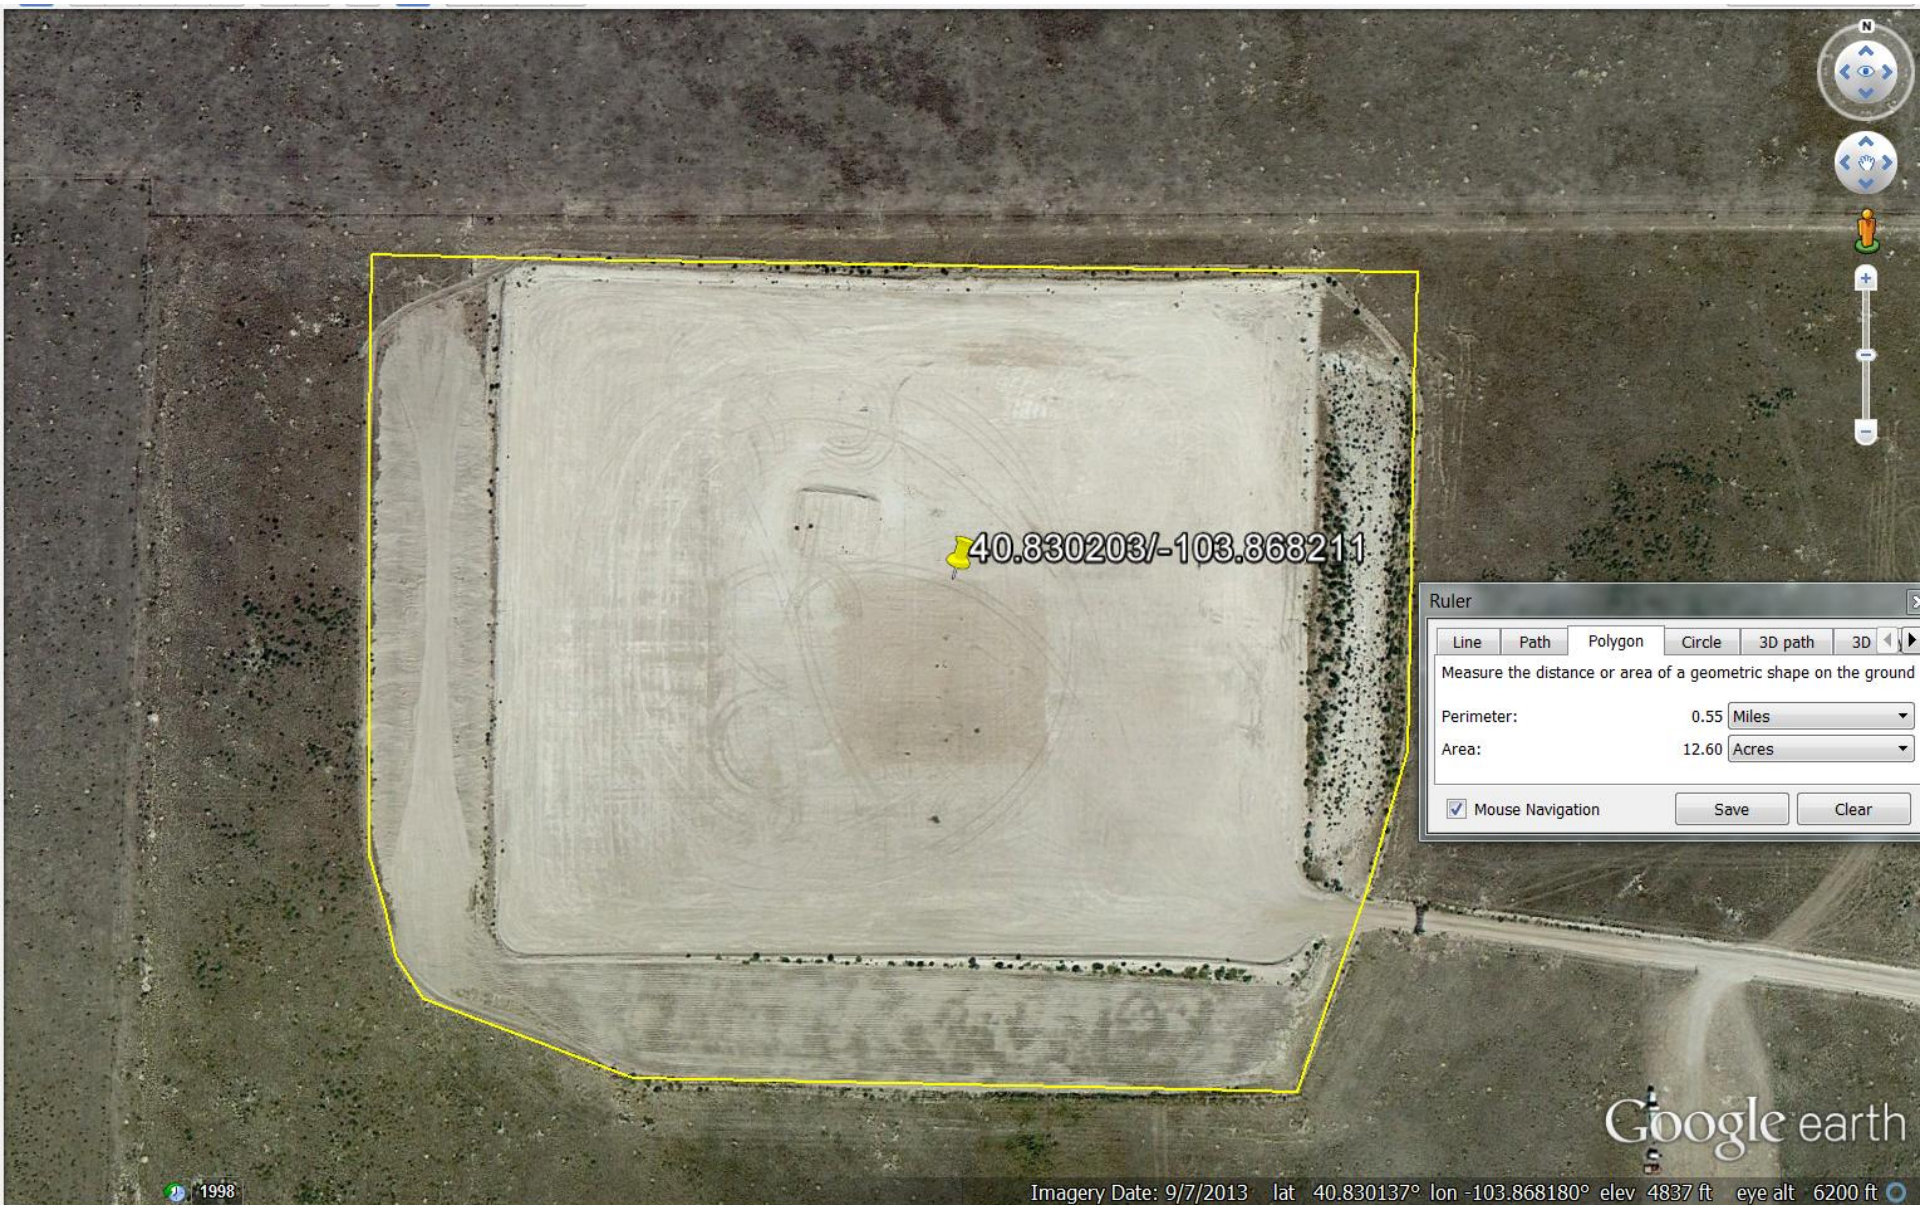
**Figure 25:** 2013 aerial image of location. Note the total area disturbed appears greater than 10.28 acres stated in the 2A (Doc. # 400437664) permitted area.
