Interim Reclamation Inspection

2/17/2016

Operator: Atlas Resources

Location ID: 425495

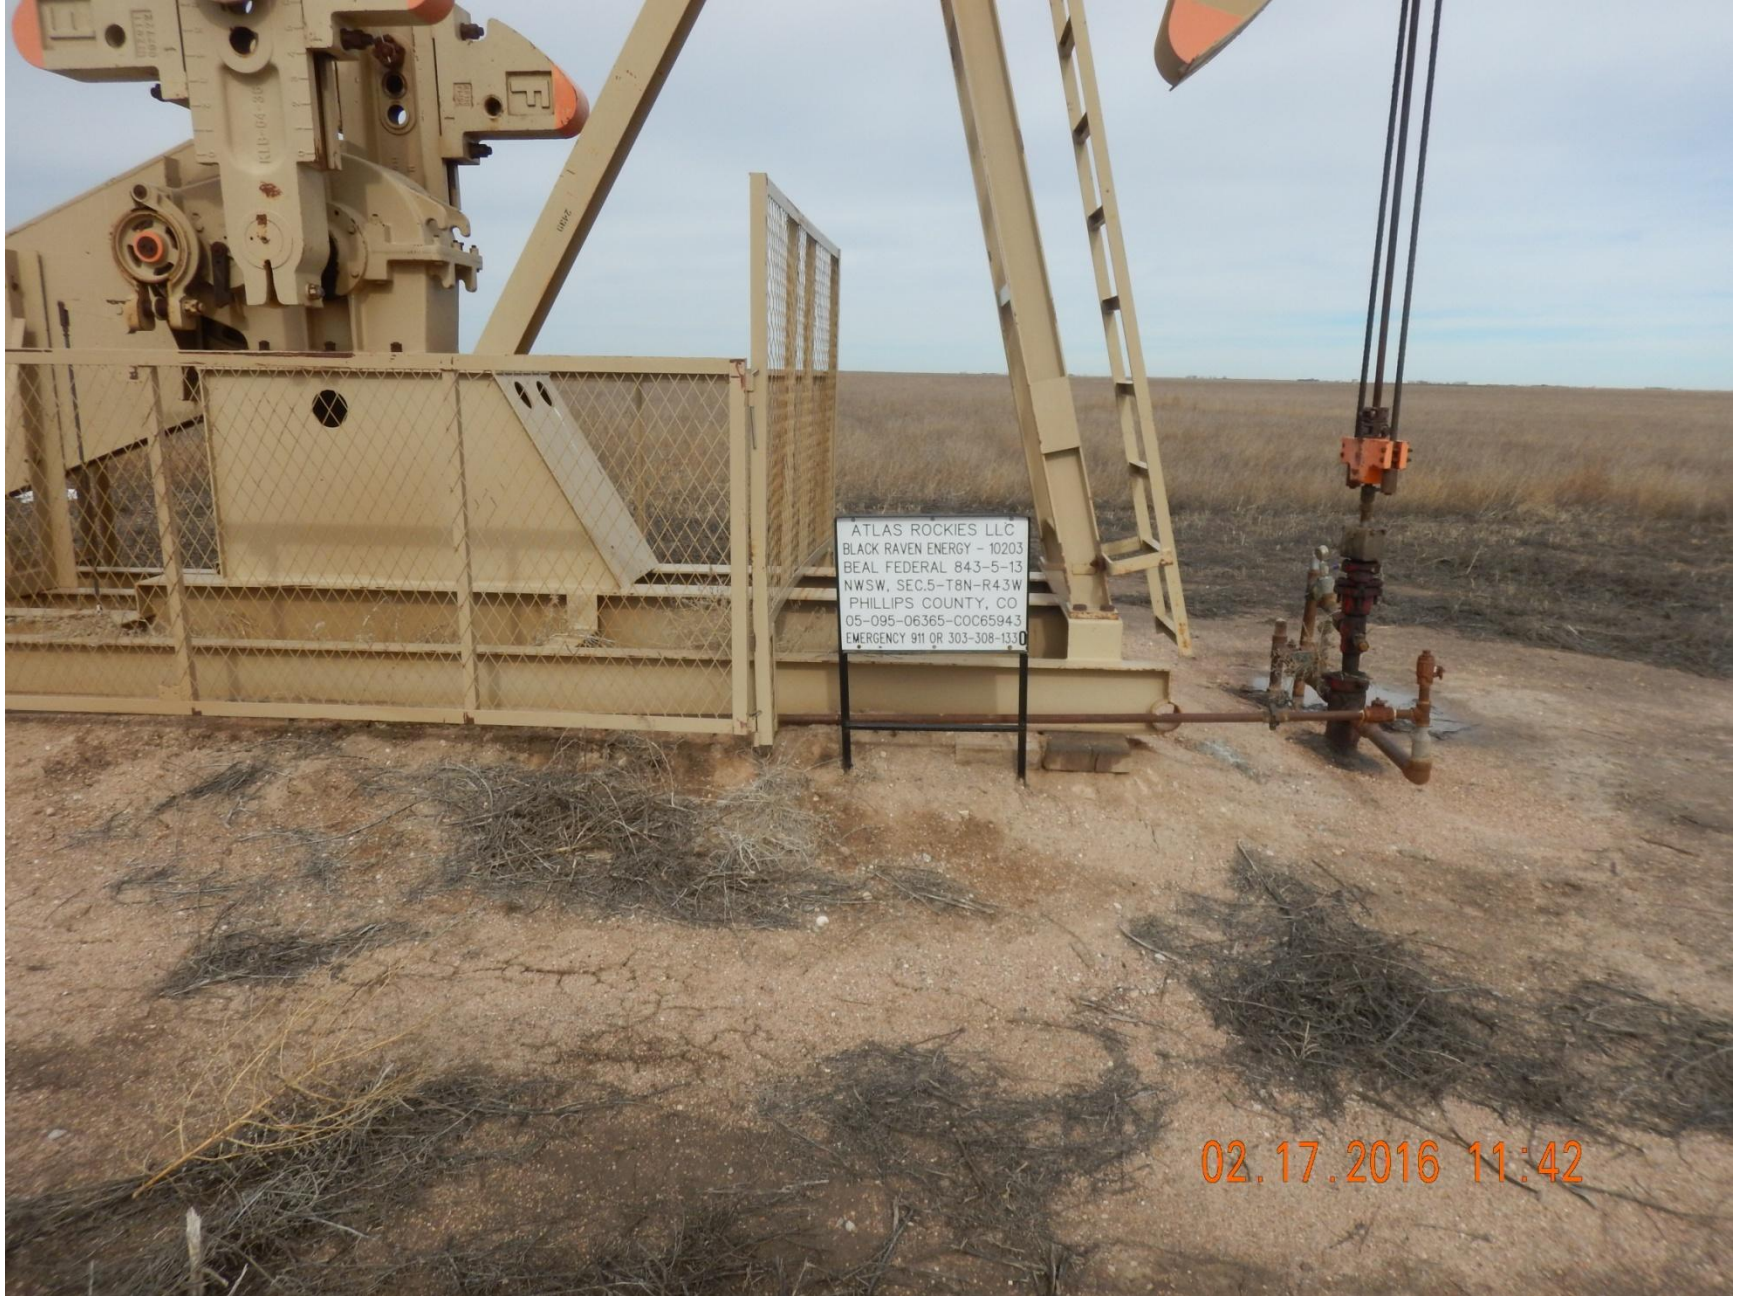
Figure 1: Photo of sign at well.

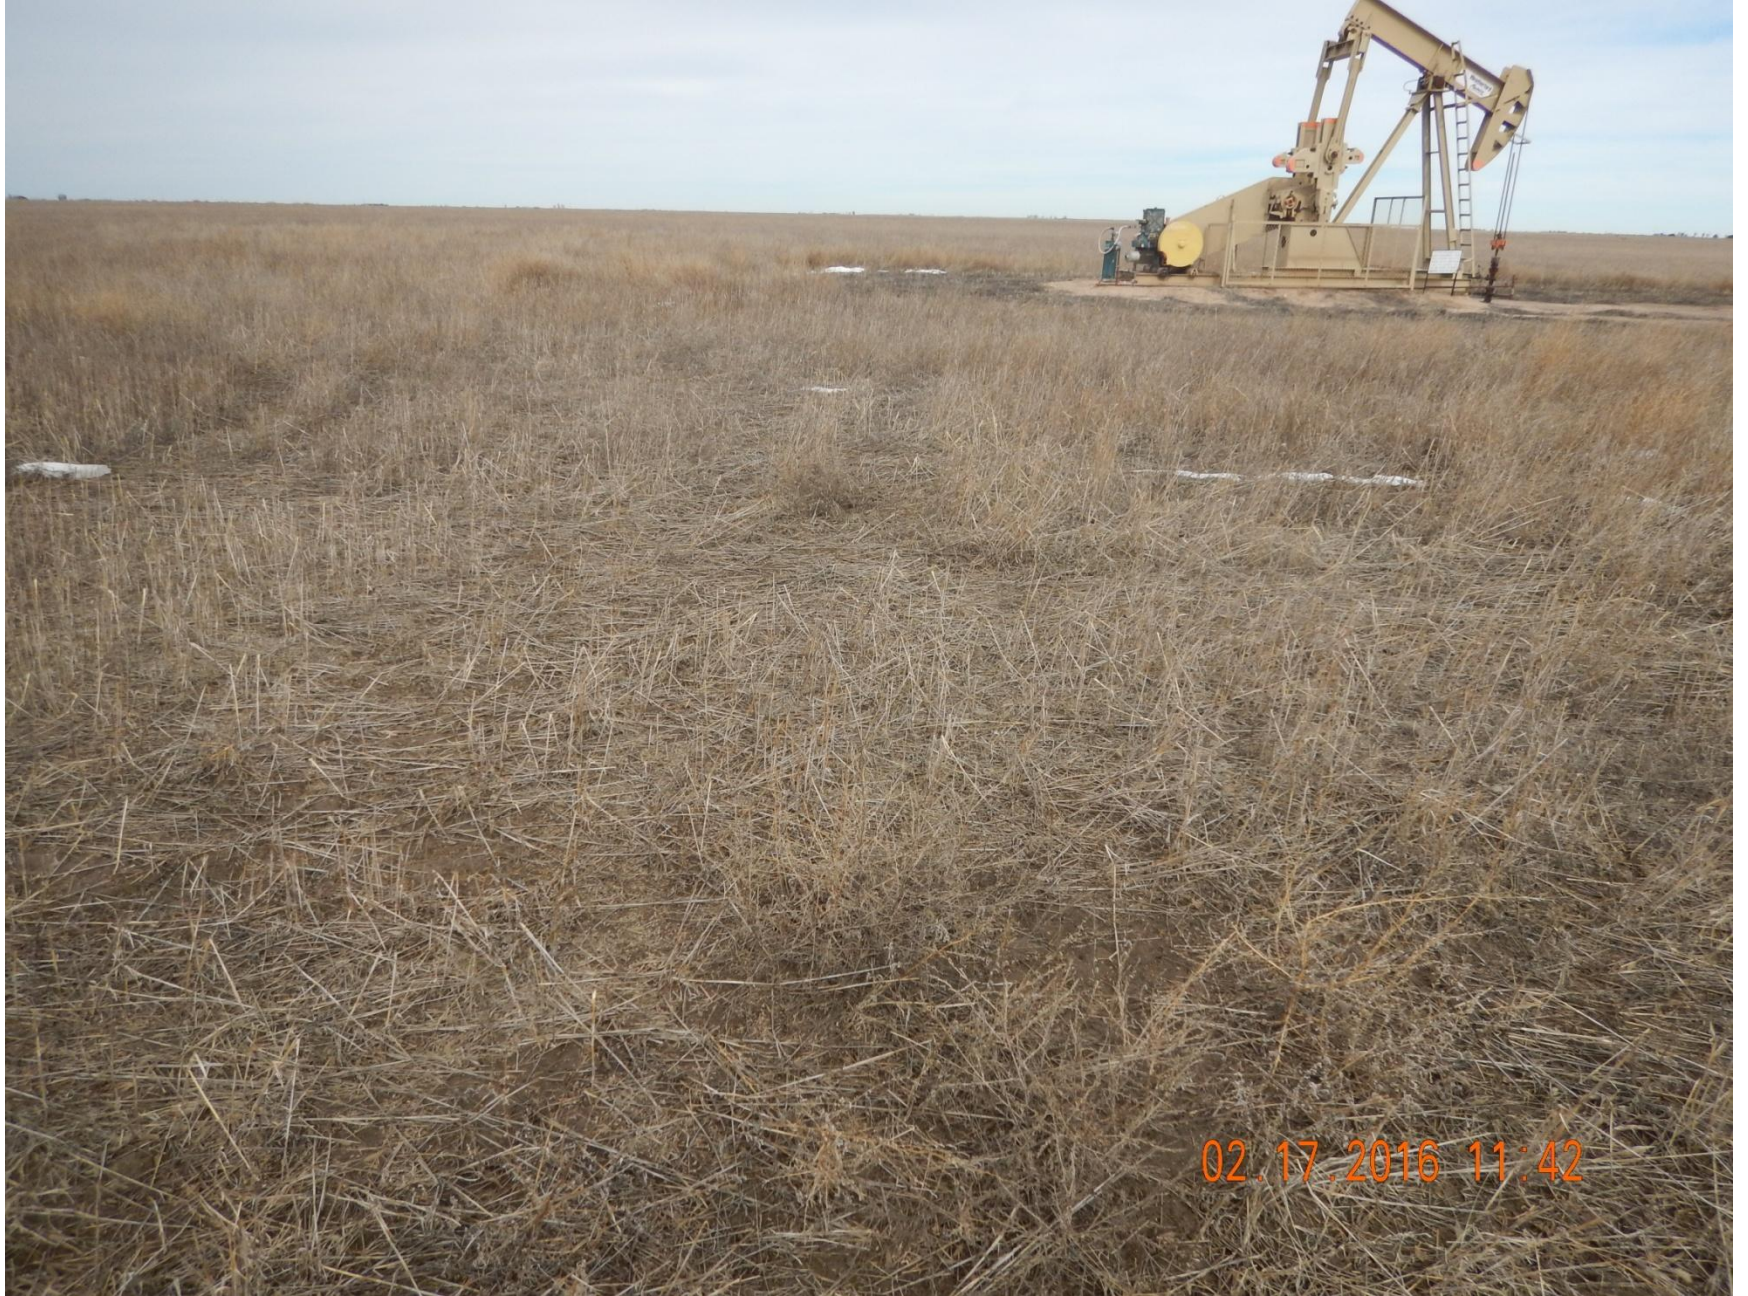
Figure 2: Photo taken from the southwest end of location, facing north. Photo shows project area and vegetation on interim area.

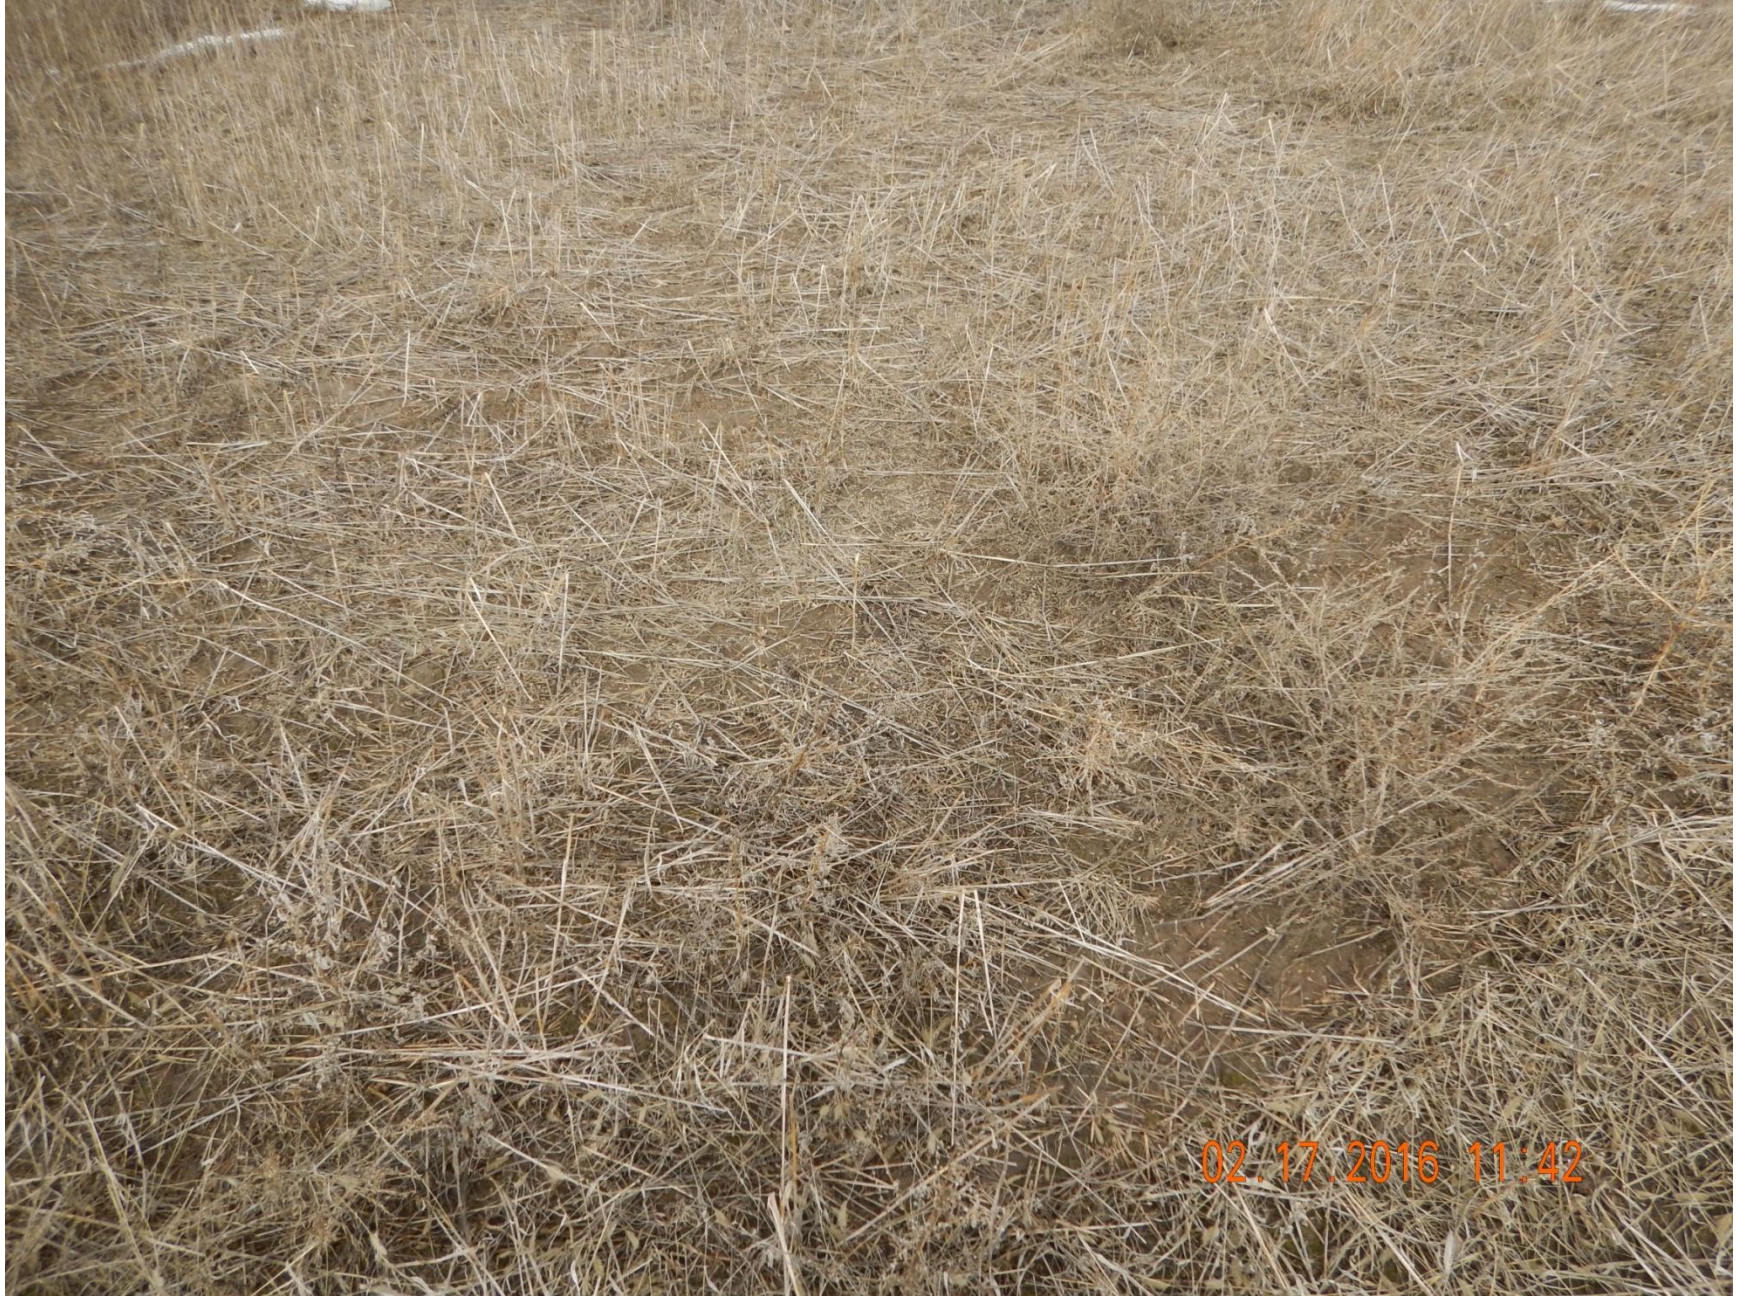
Figure 3: Photo taken from the west end of interim area. Note vegetation is sparse and predominantly undesirable weedy vegetation.

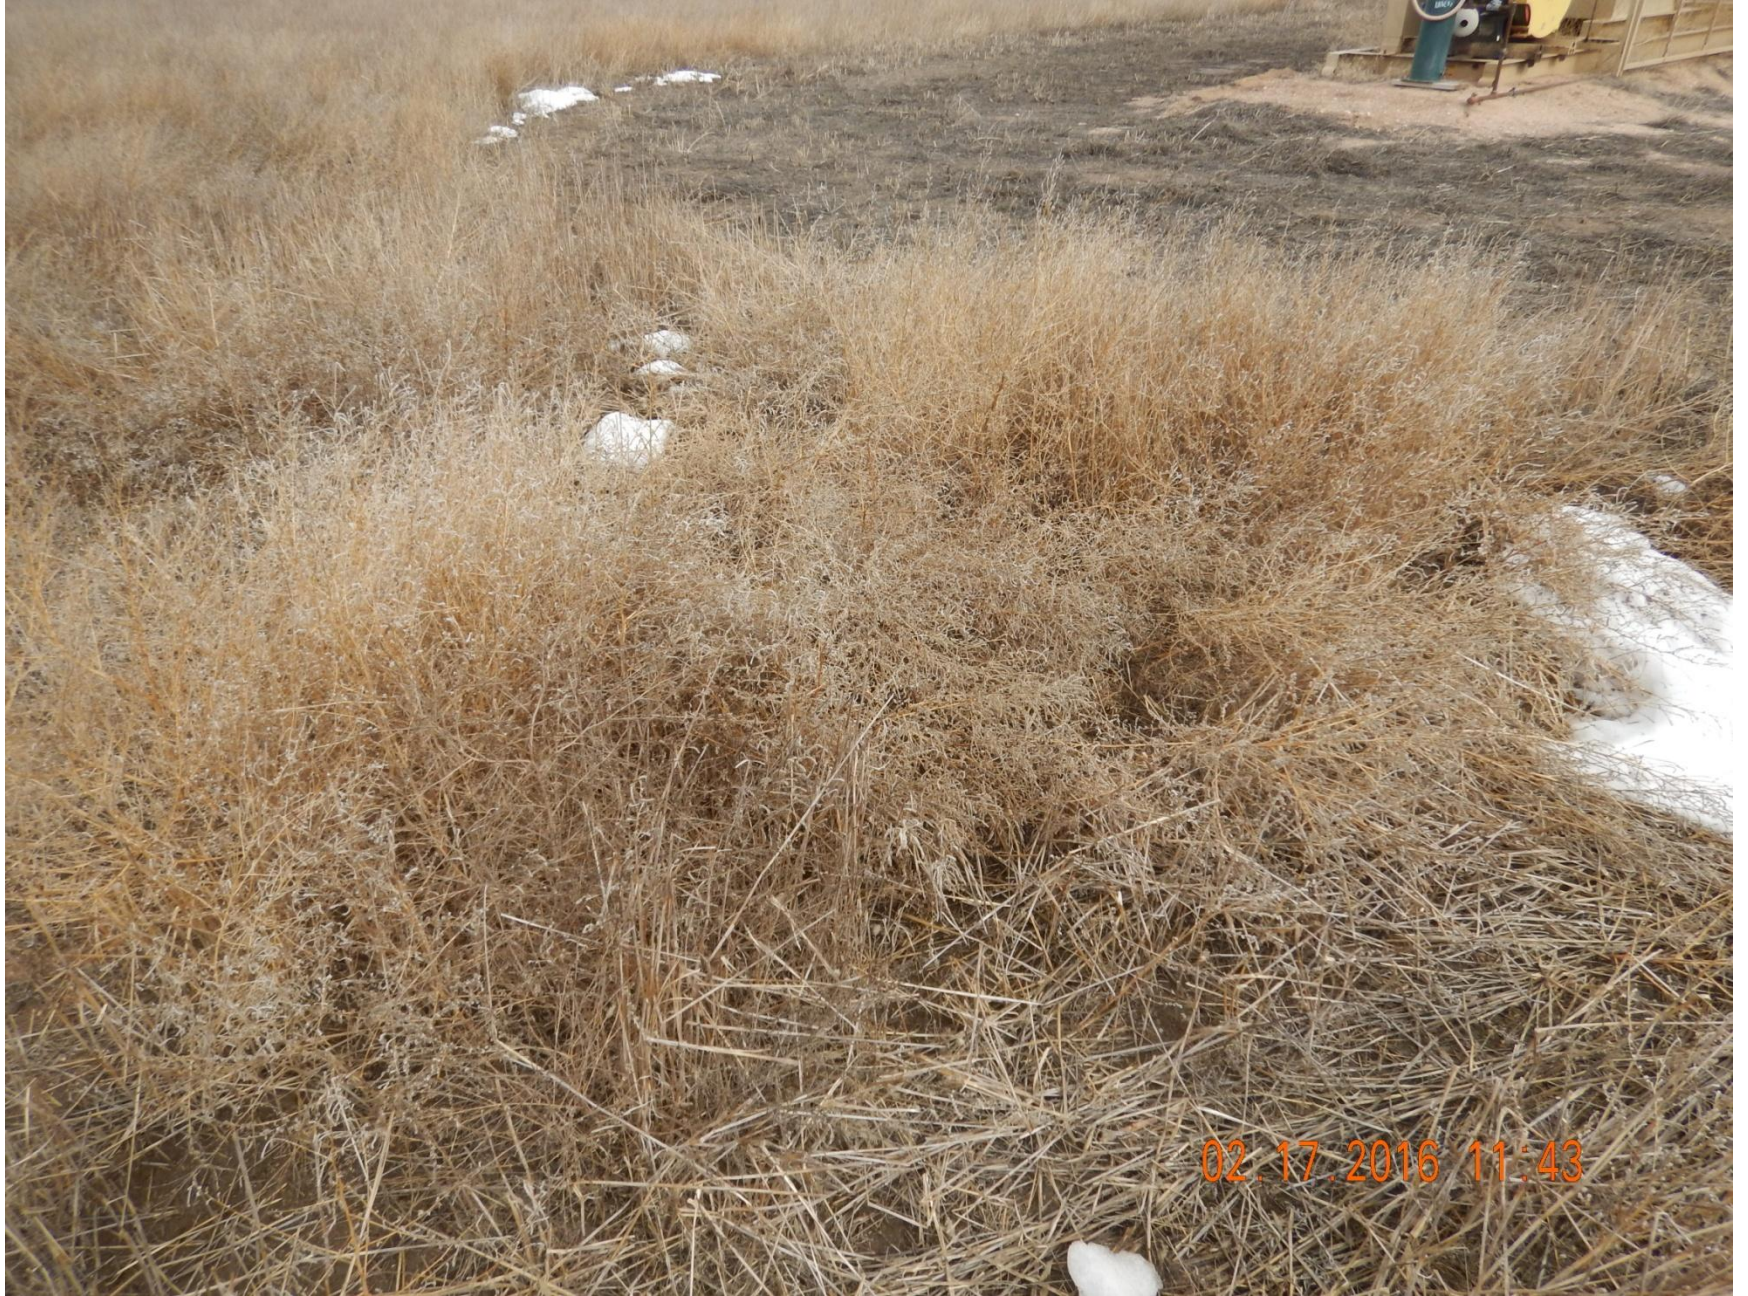
Figure 4: Photo taken from the west end of location. Photo shows interim area predominantly dominated by undesirable weedy vegetation.

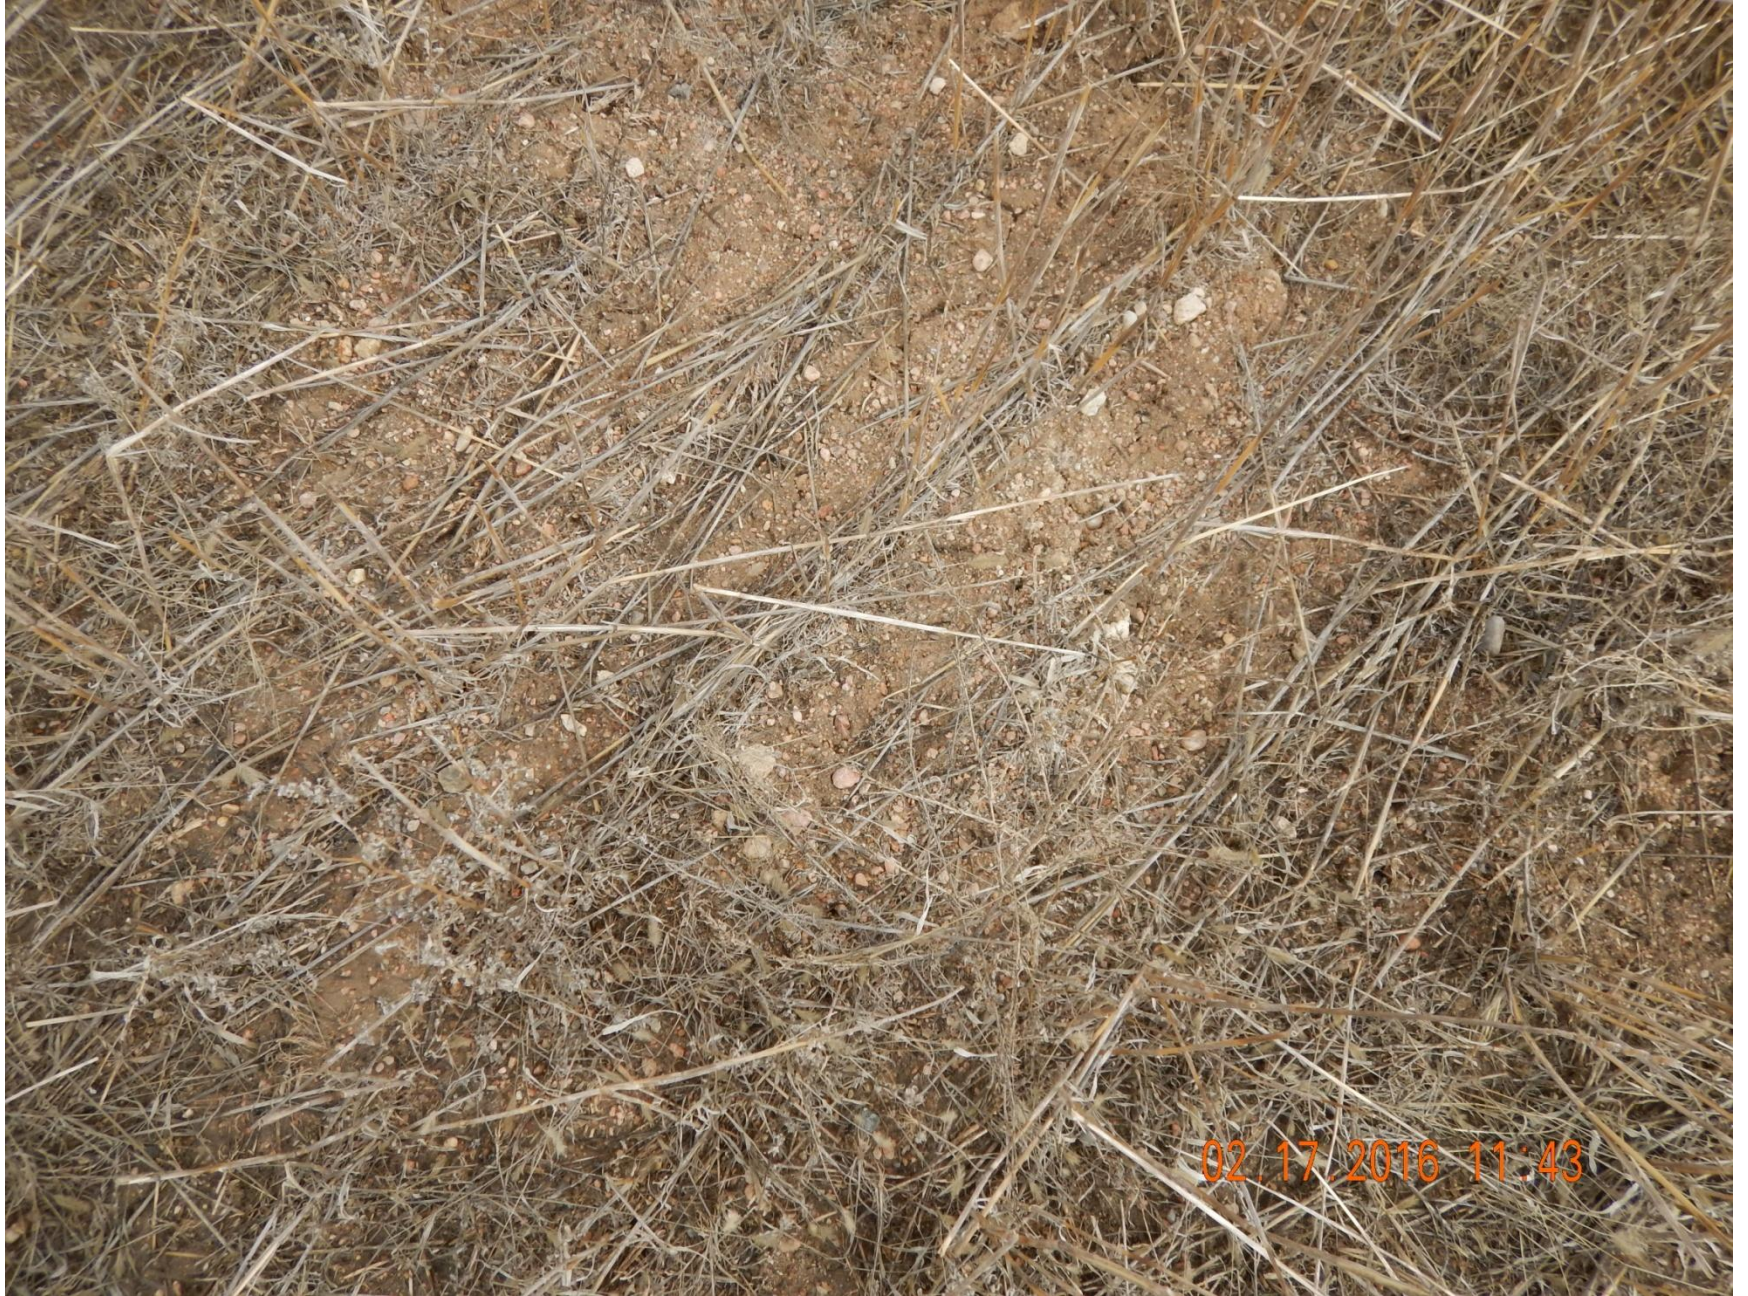
Figure 5: Photo taken from the western interim area. Photo shows bare area and vegetation on interim area.

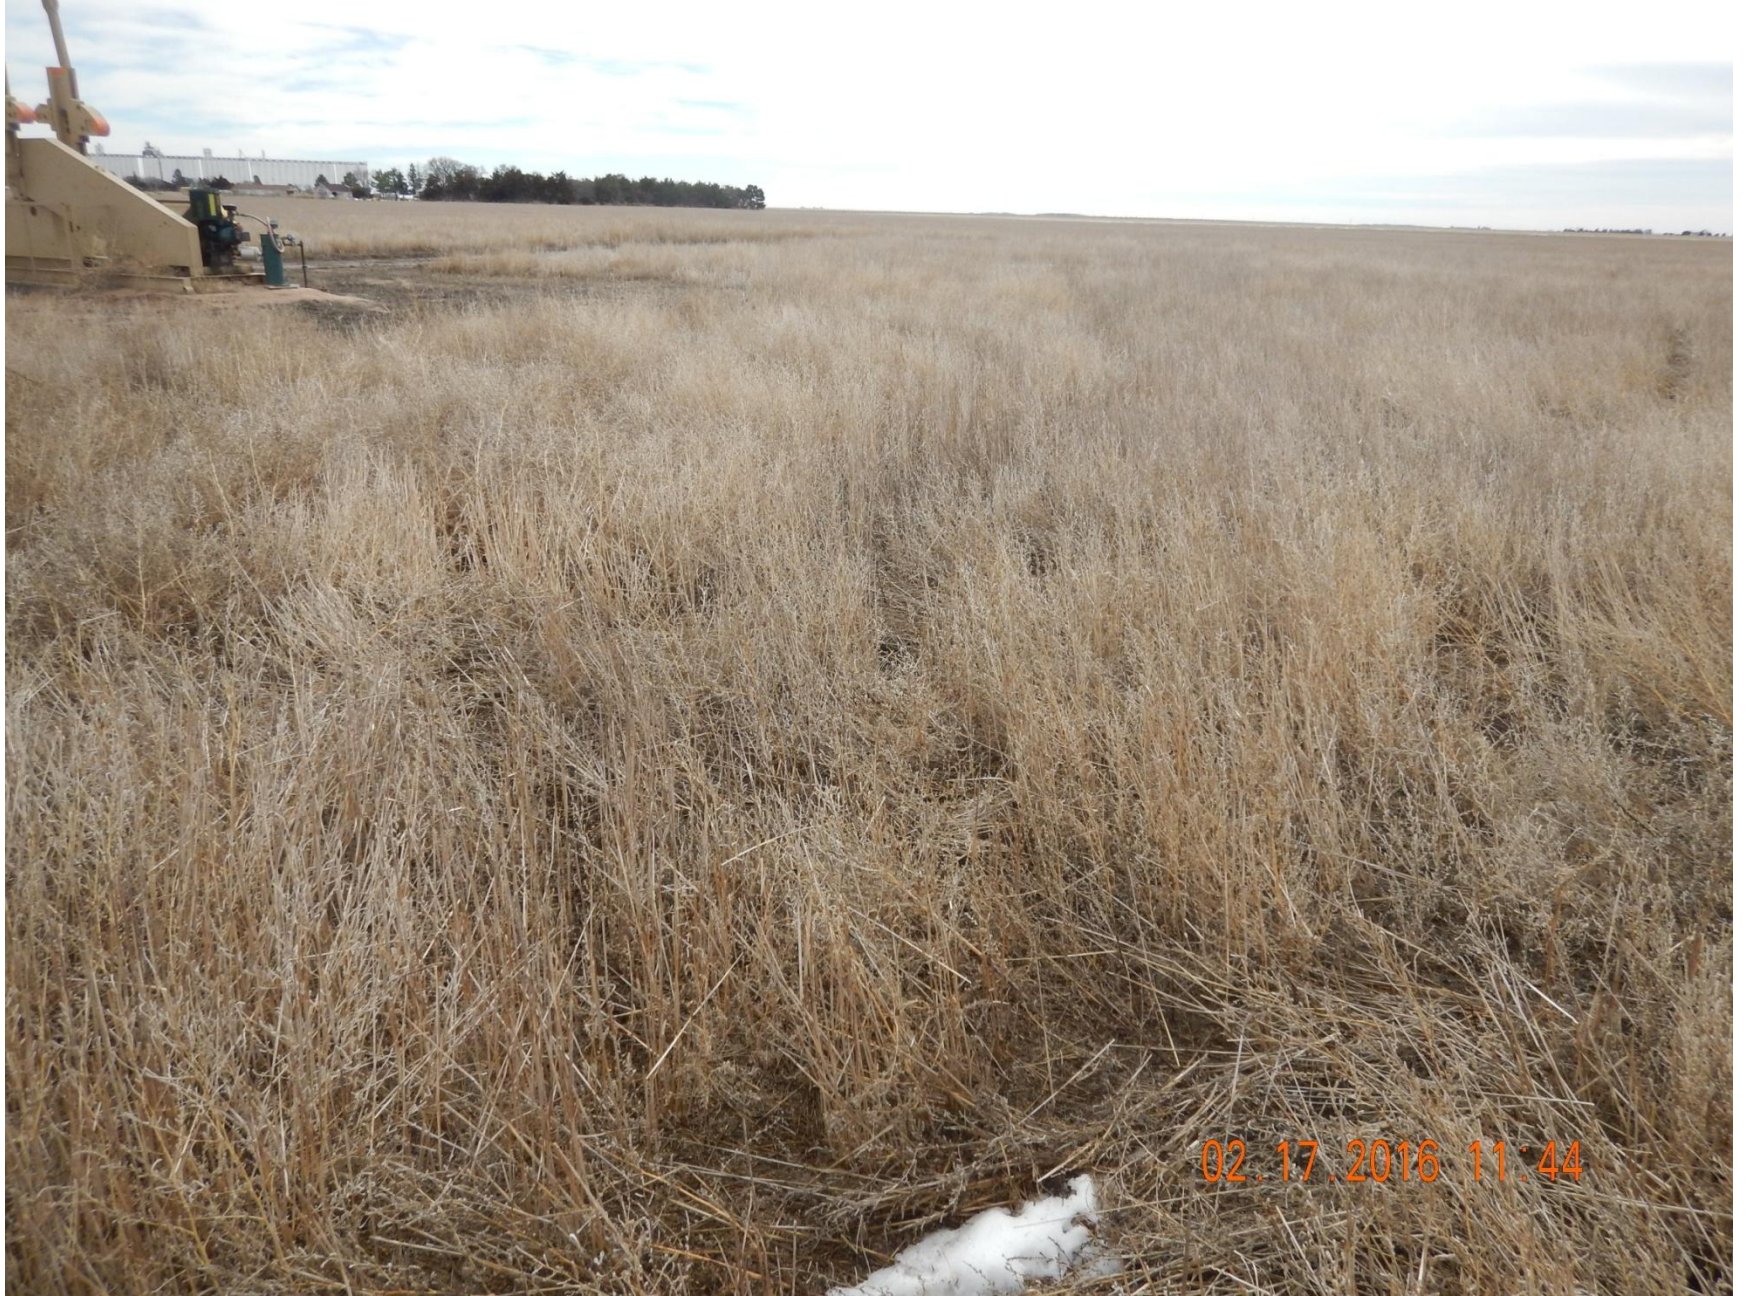
Figure 6: Photo taken from the northwest end of location, facing south. Photo shows vegetation on interim area predominantly undesirable weedy vegetation.

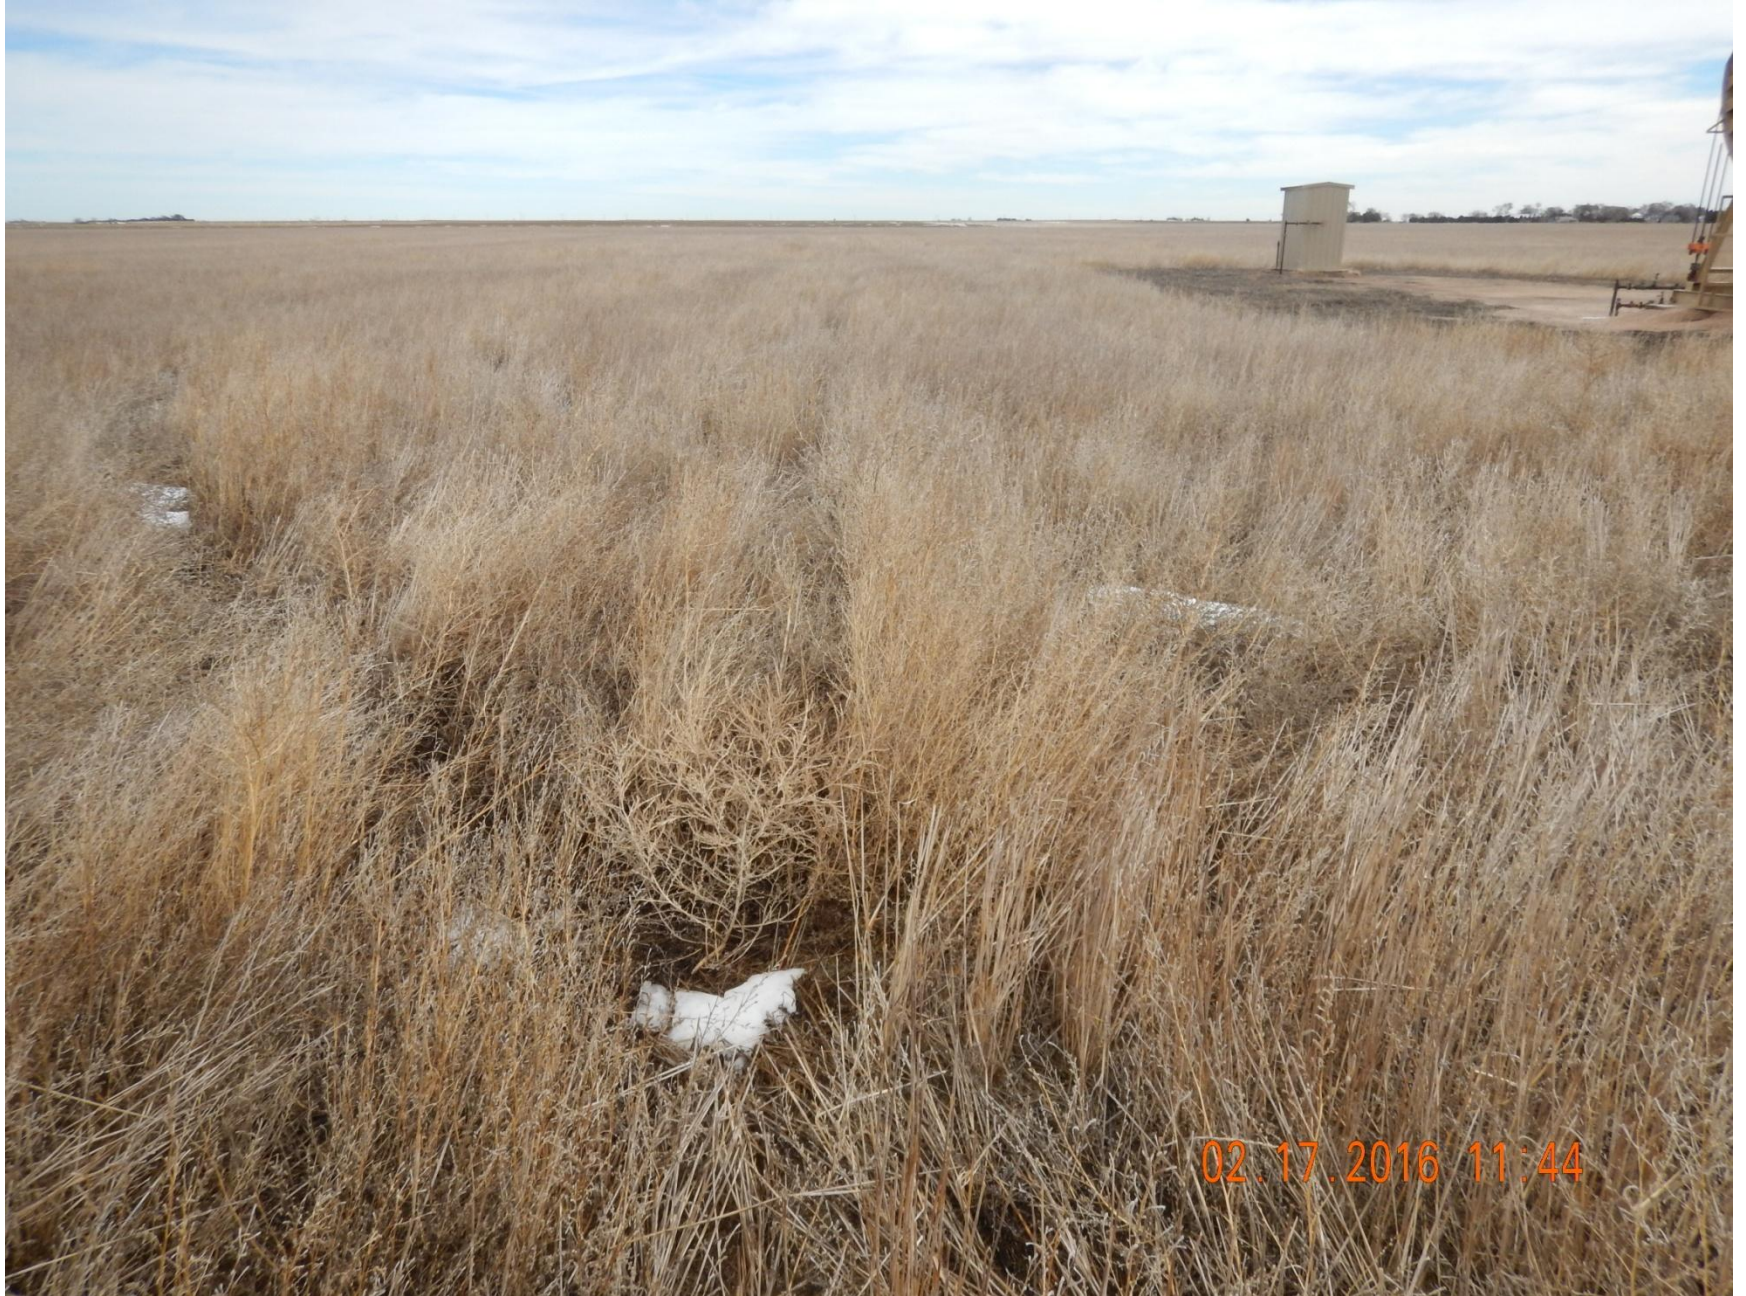
Figure 7: Photo taken from the northwest end of location, facing east. Photo shows vegetation on interim area predominantly undesirable weedy vegetation.

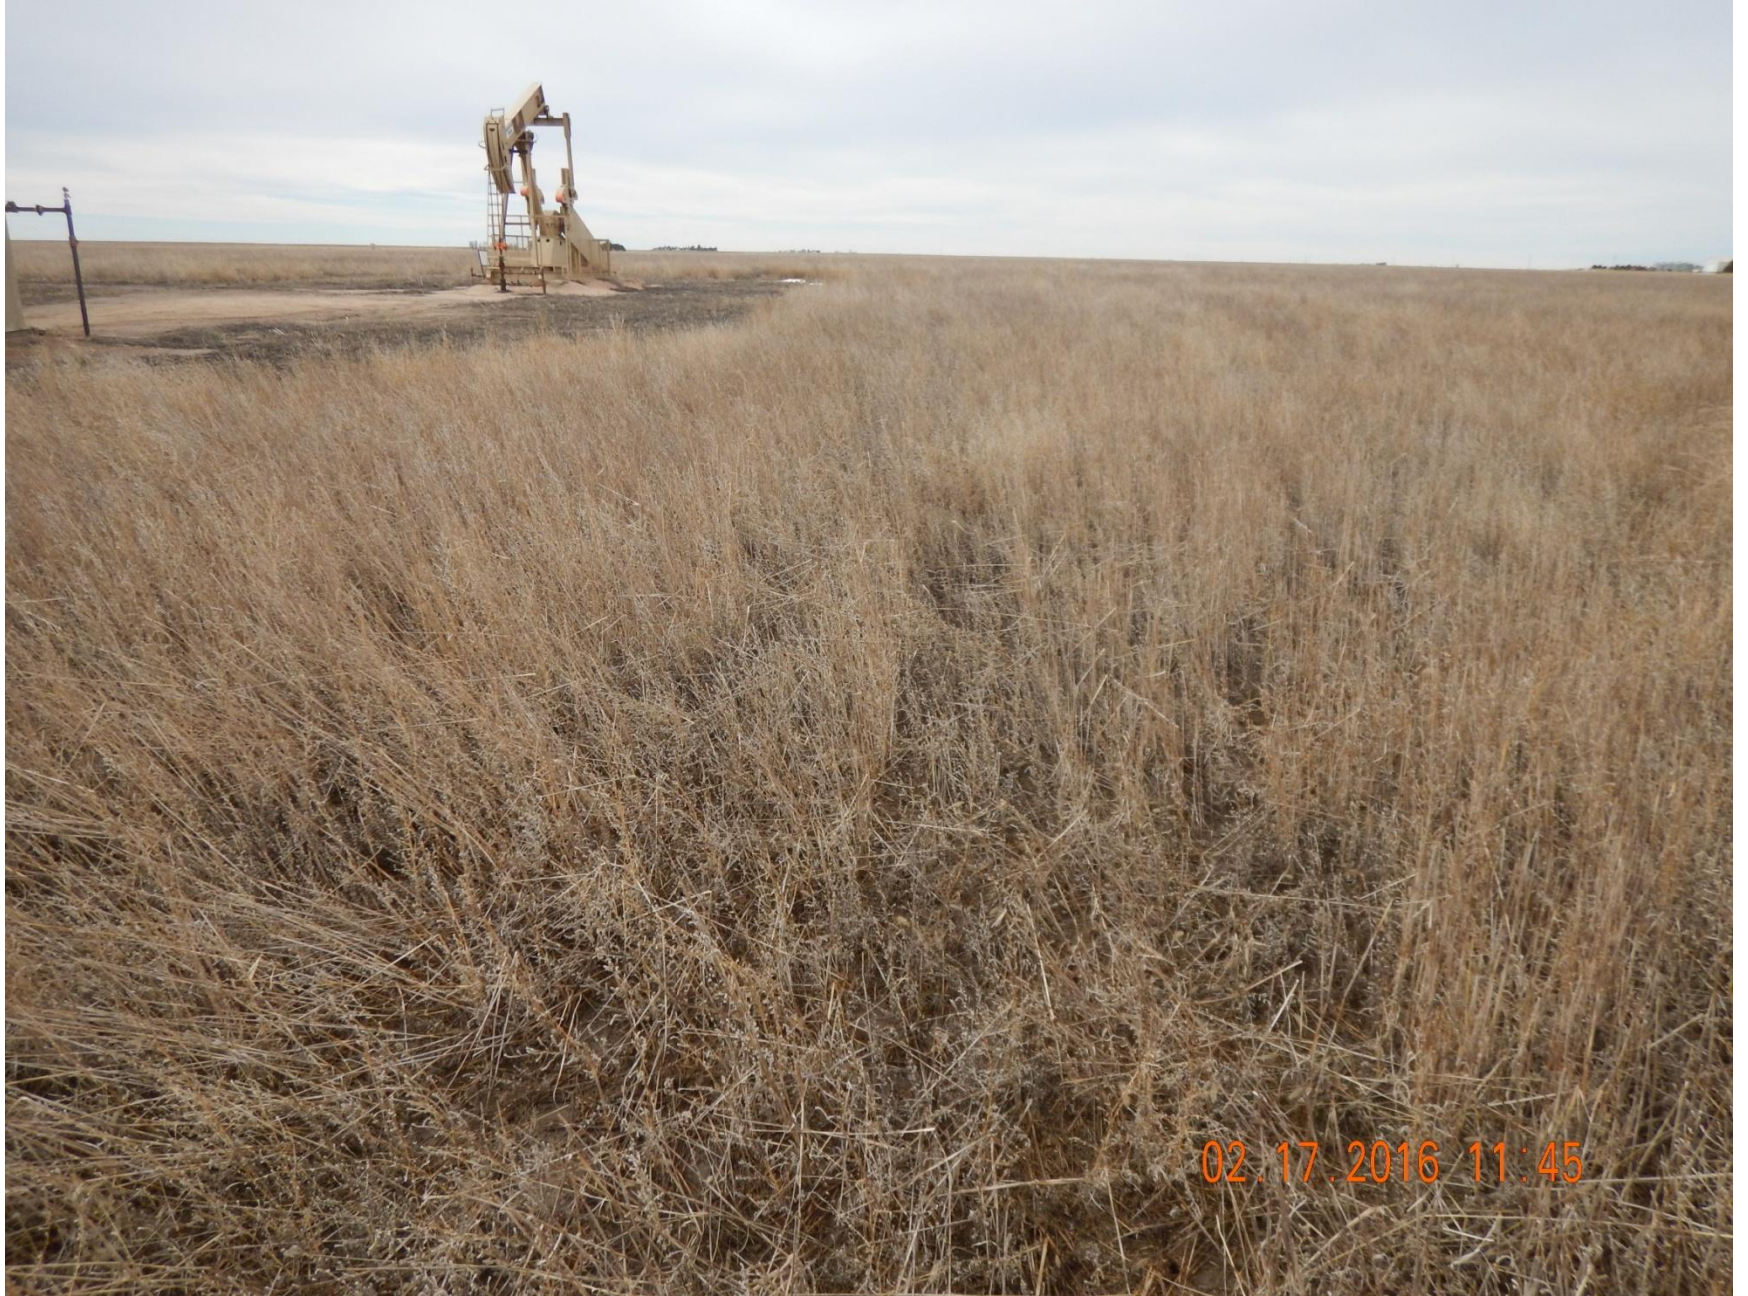
Figure 8: Photo taken from the northeast end of location, facing west. Photo shows vegetation on interim area predominantly undesirable weedy vegetation.

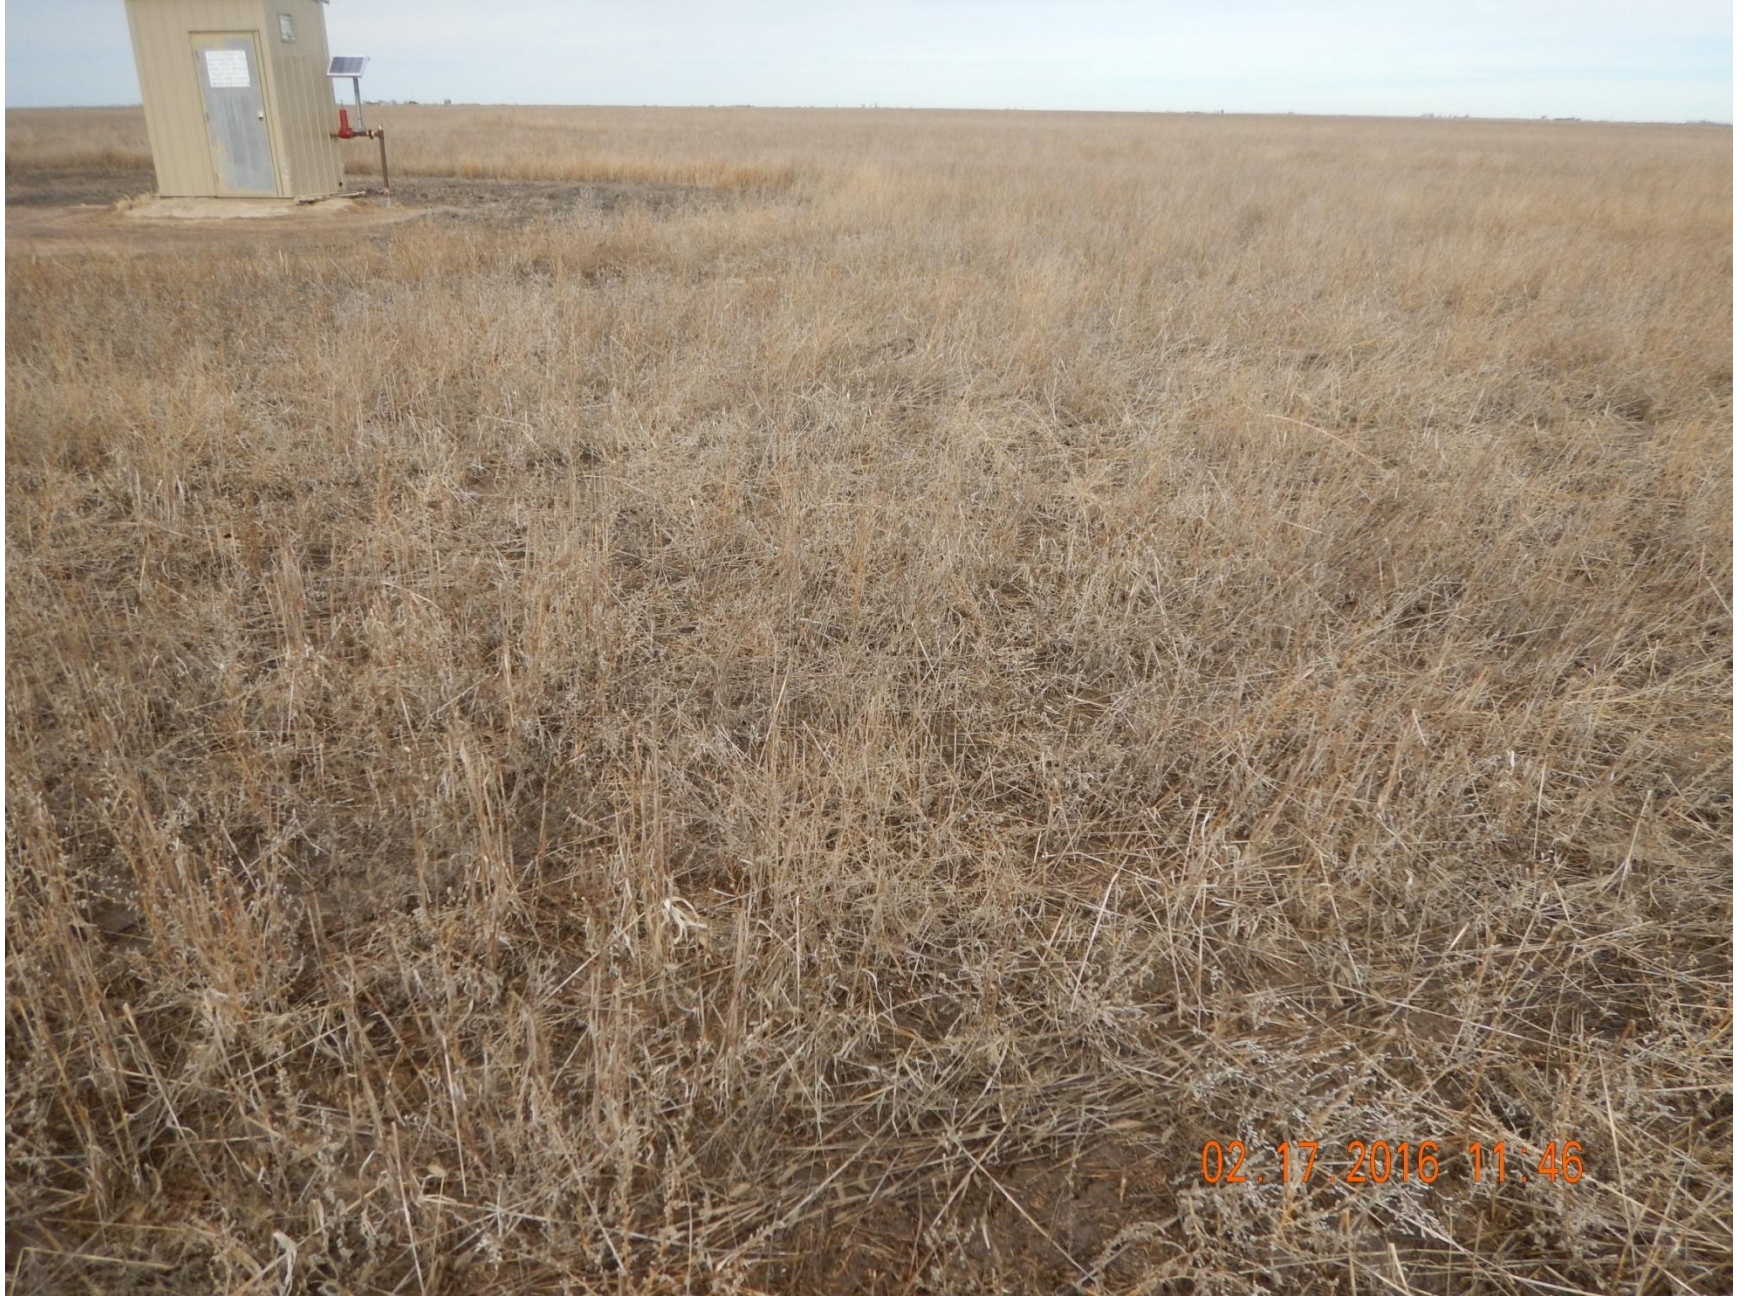
Figure 9: Photo taken from the southeast end of location, facing north. Photo shows vegetation on interim area predominantly undesirable weedy vegetation.

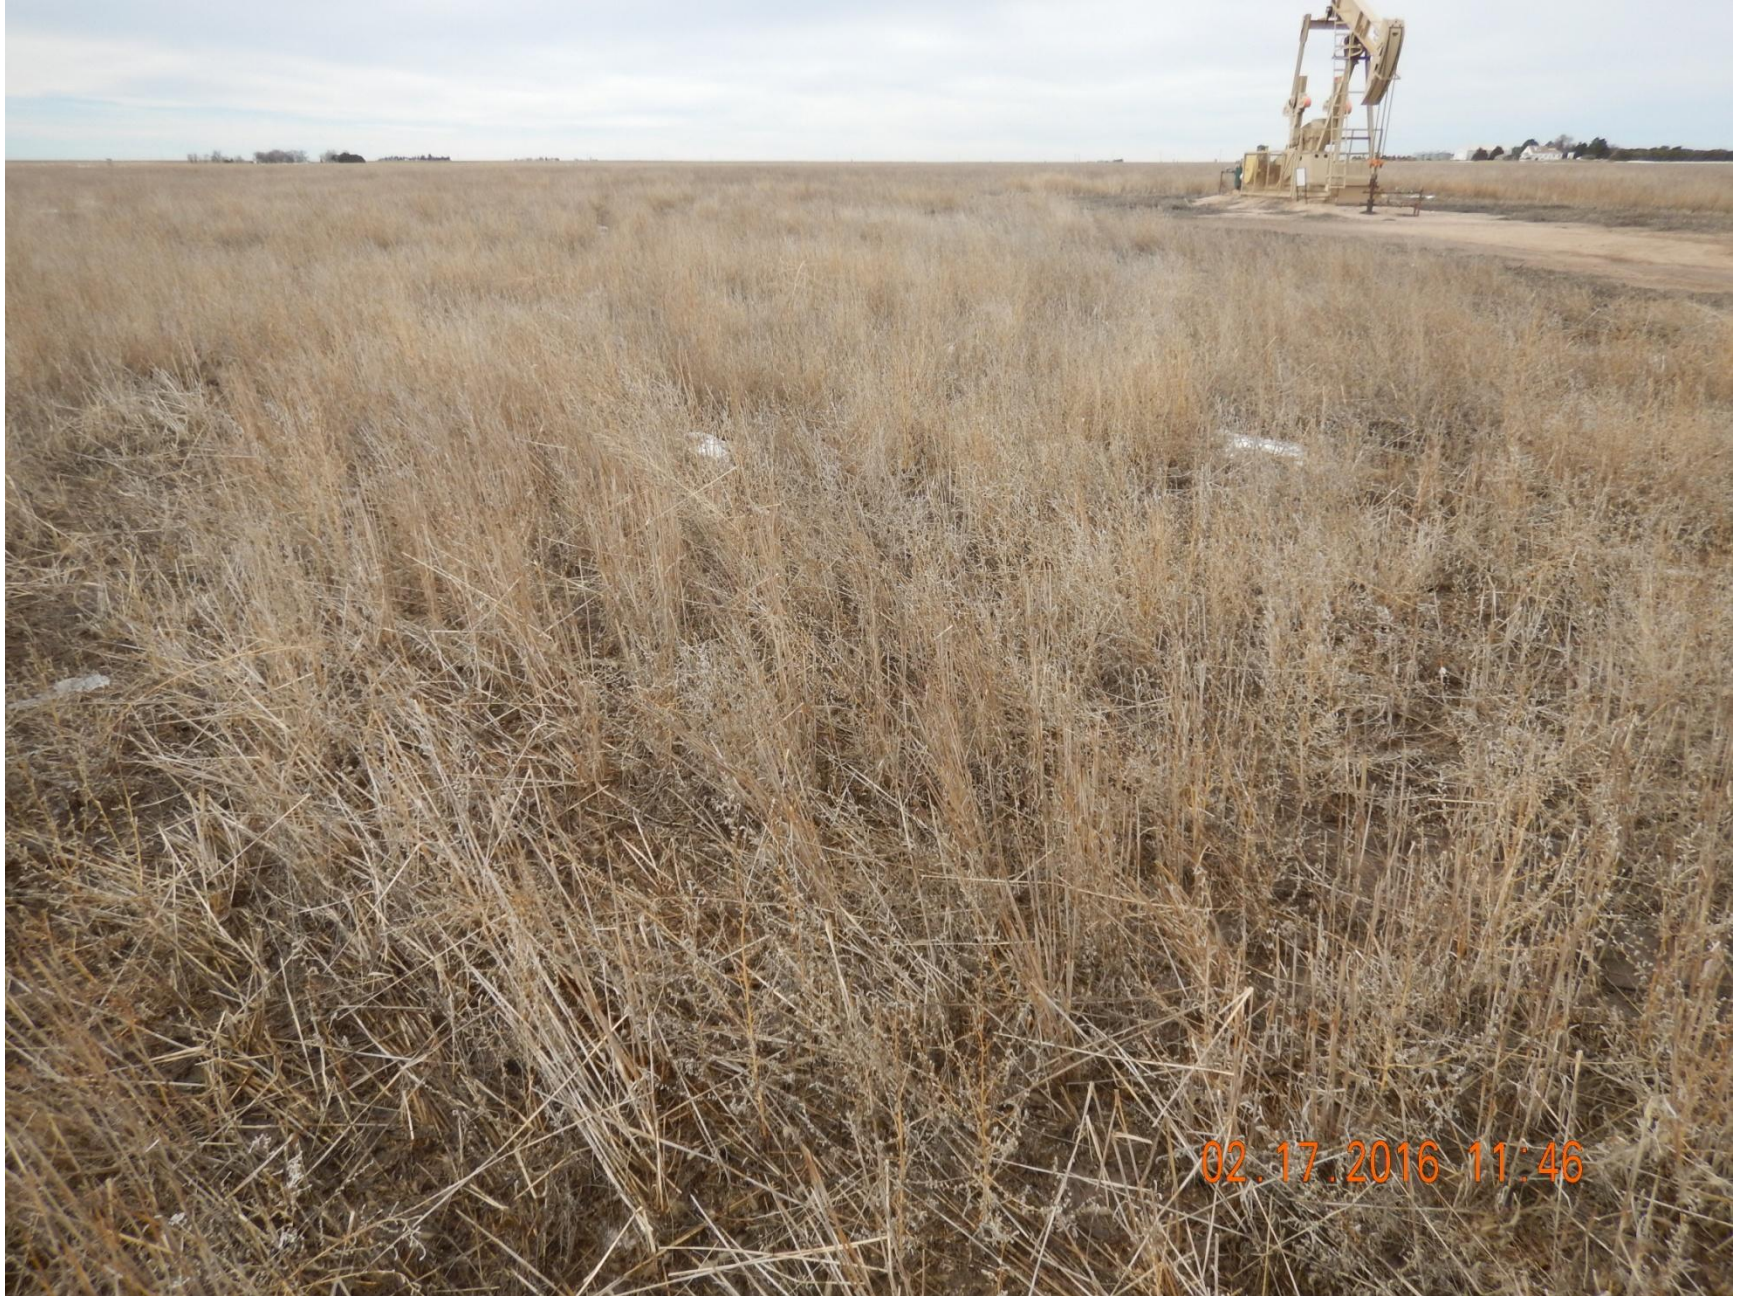
Figure 10: Photo taken from the southeast end of location, facing west. Photo shows vegetation on interim area predominantly undesirable weedy vegetation.
