Interim Reclamation Inspection

2/17/2016

Operator: Atlas Resources

Location ID: 425495

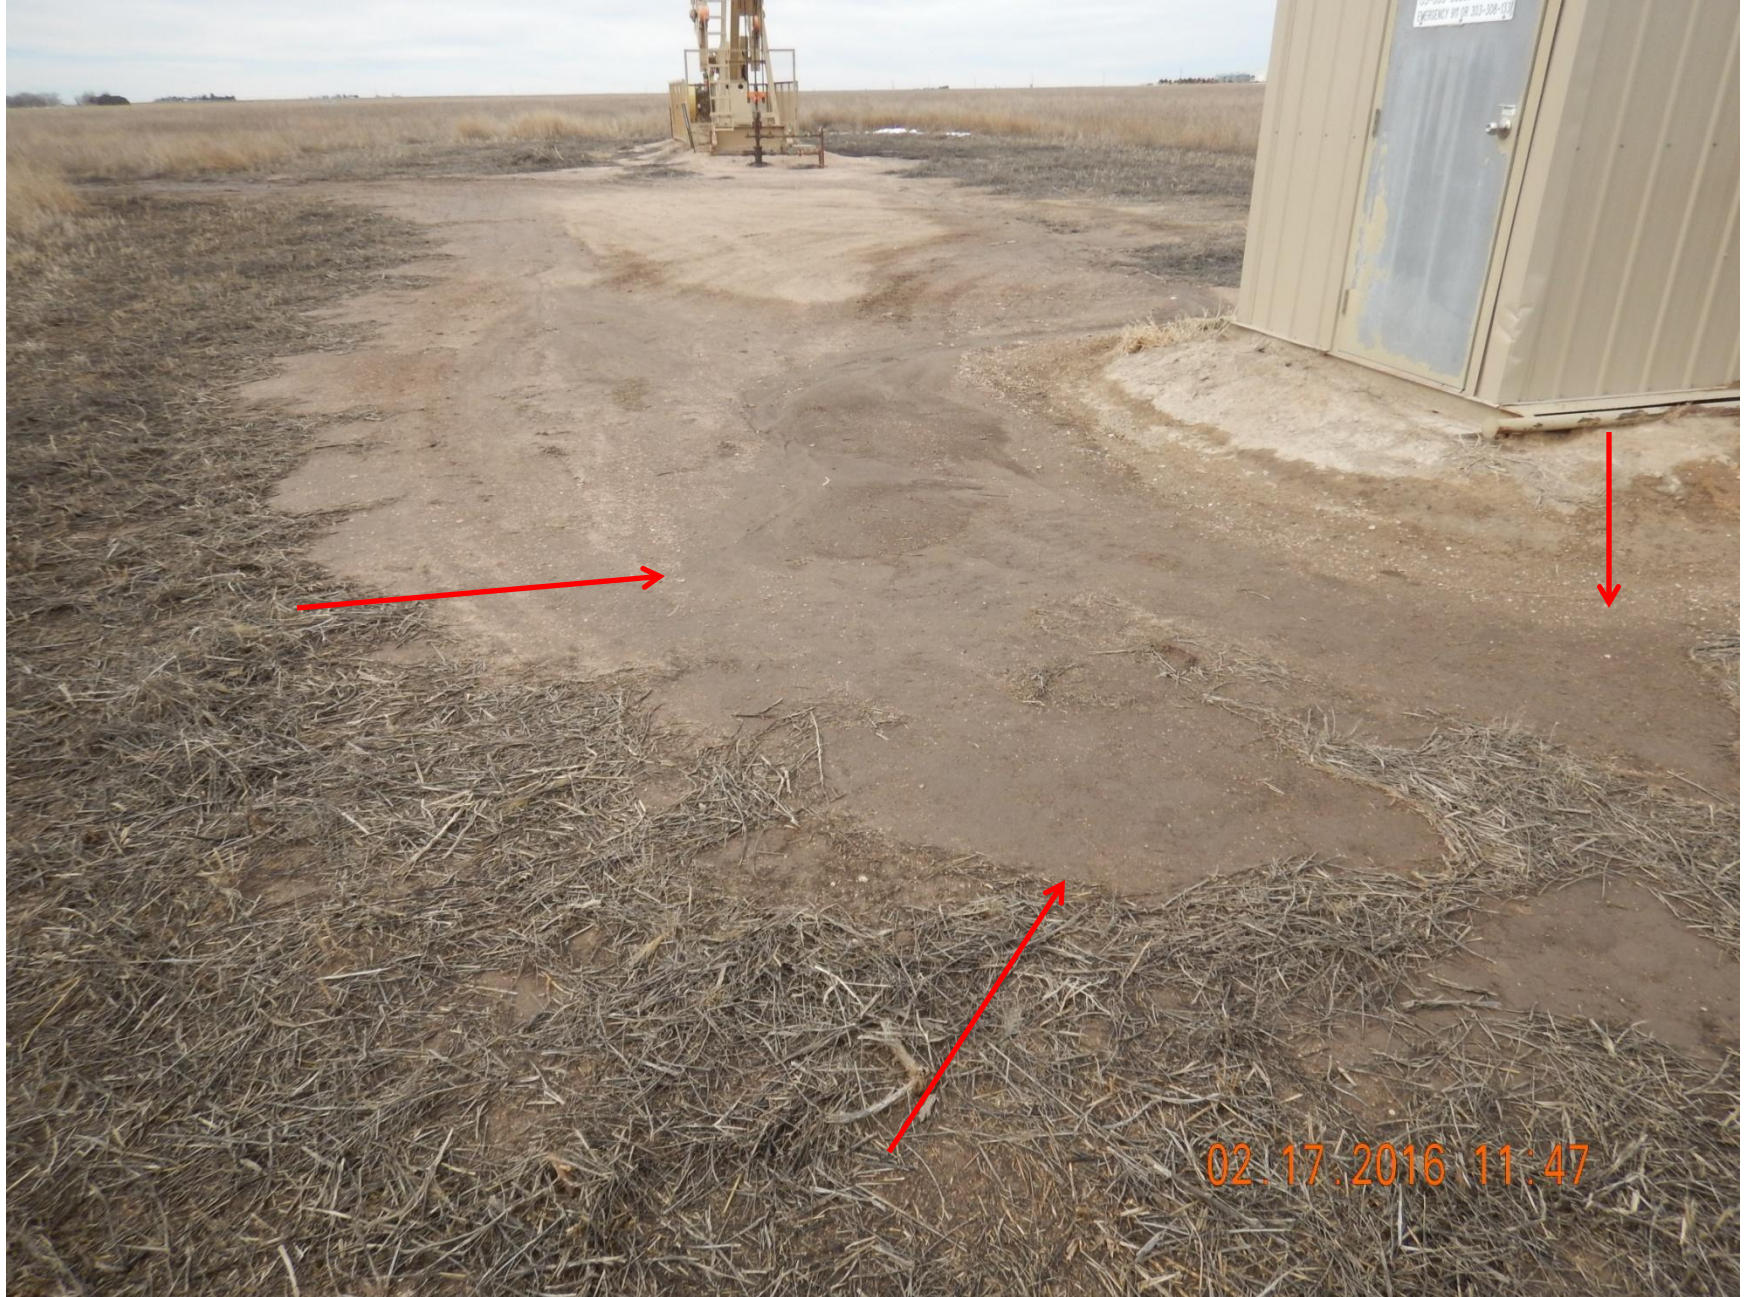
Figure 11: Photo taken from the east end of project area, facing west. Photo shows stormwater erosion on location. Arrows shows water movement patterns and alluvial deposition.

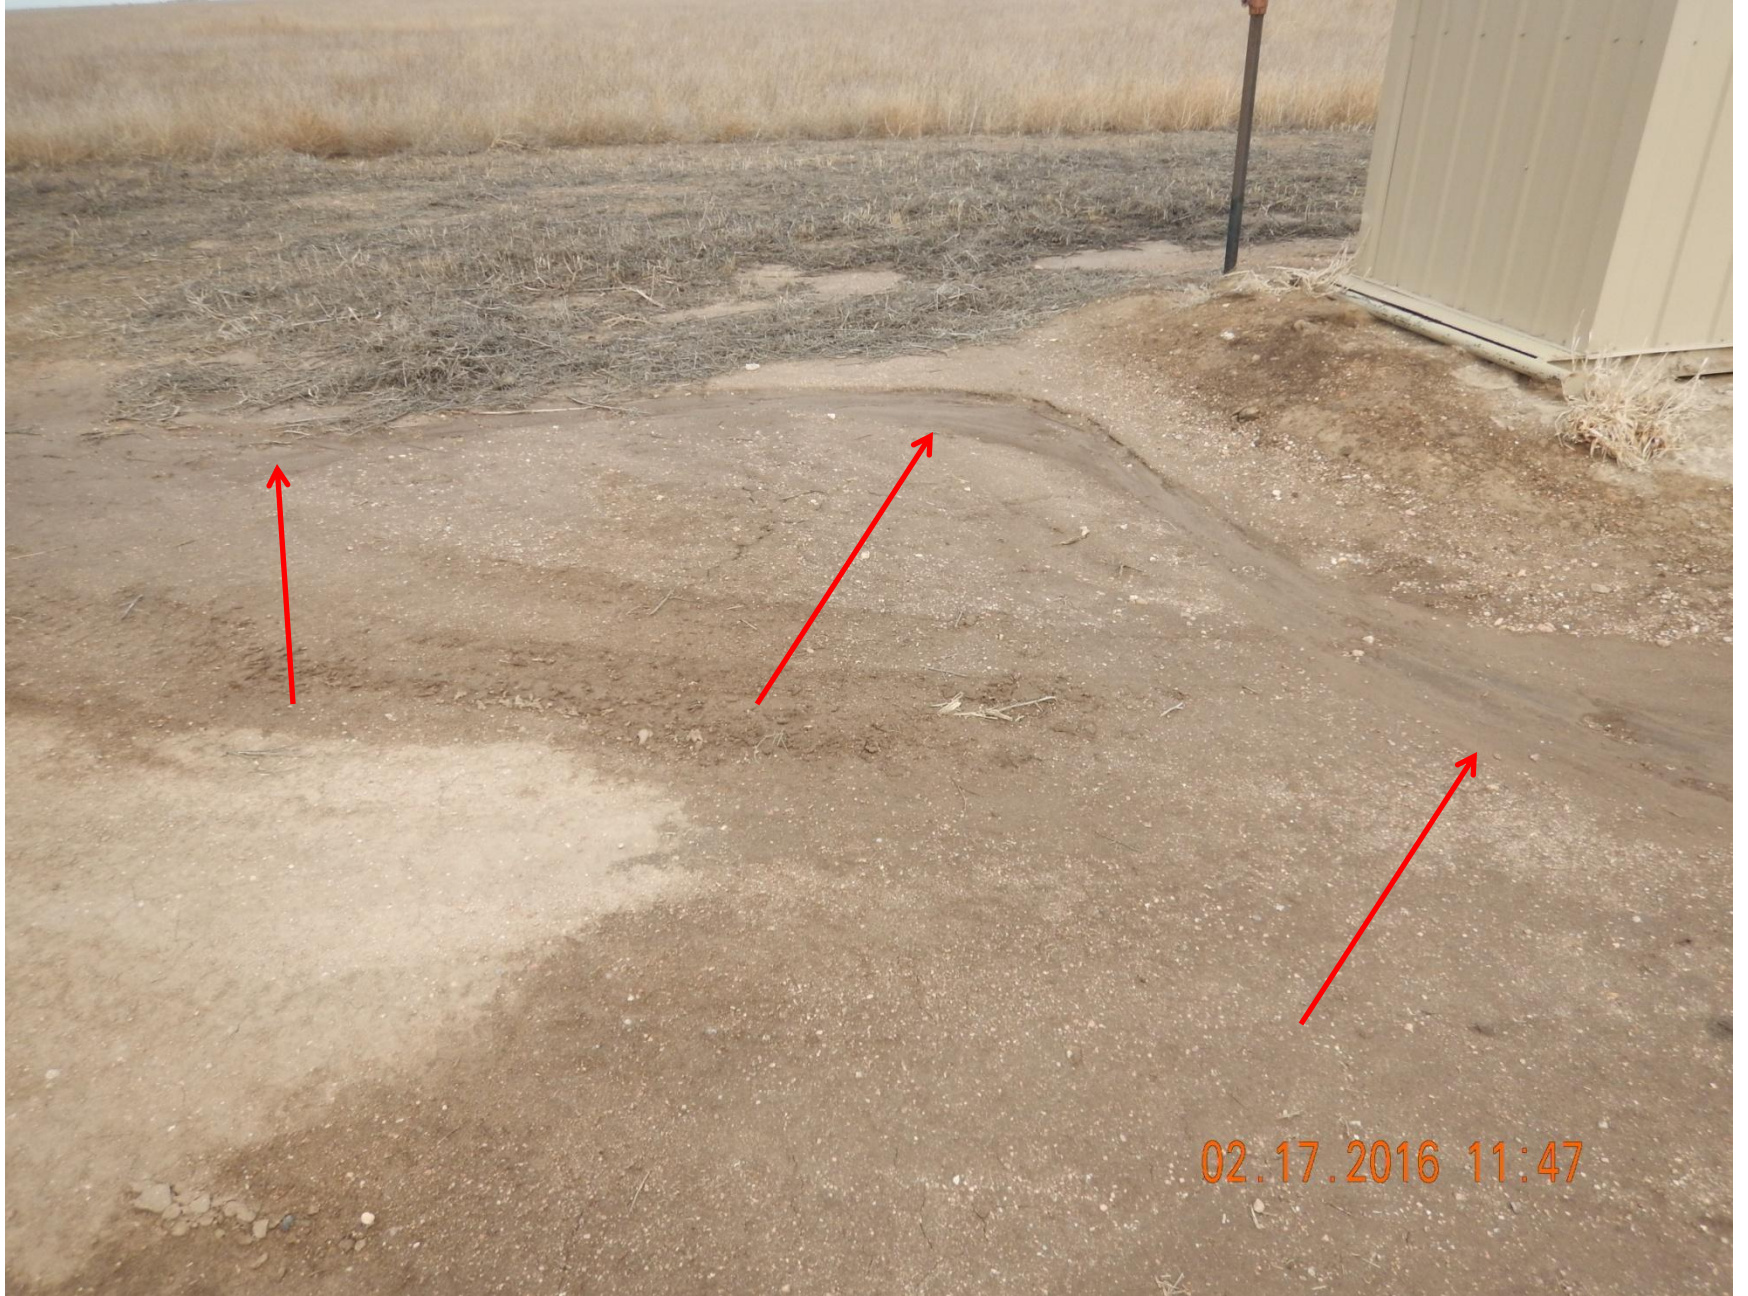
Figure 12: Photo taken from the southern end of location, facing north. Photo shows erosion patterns on project area.

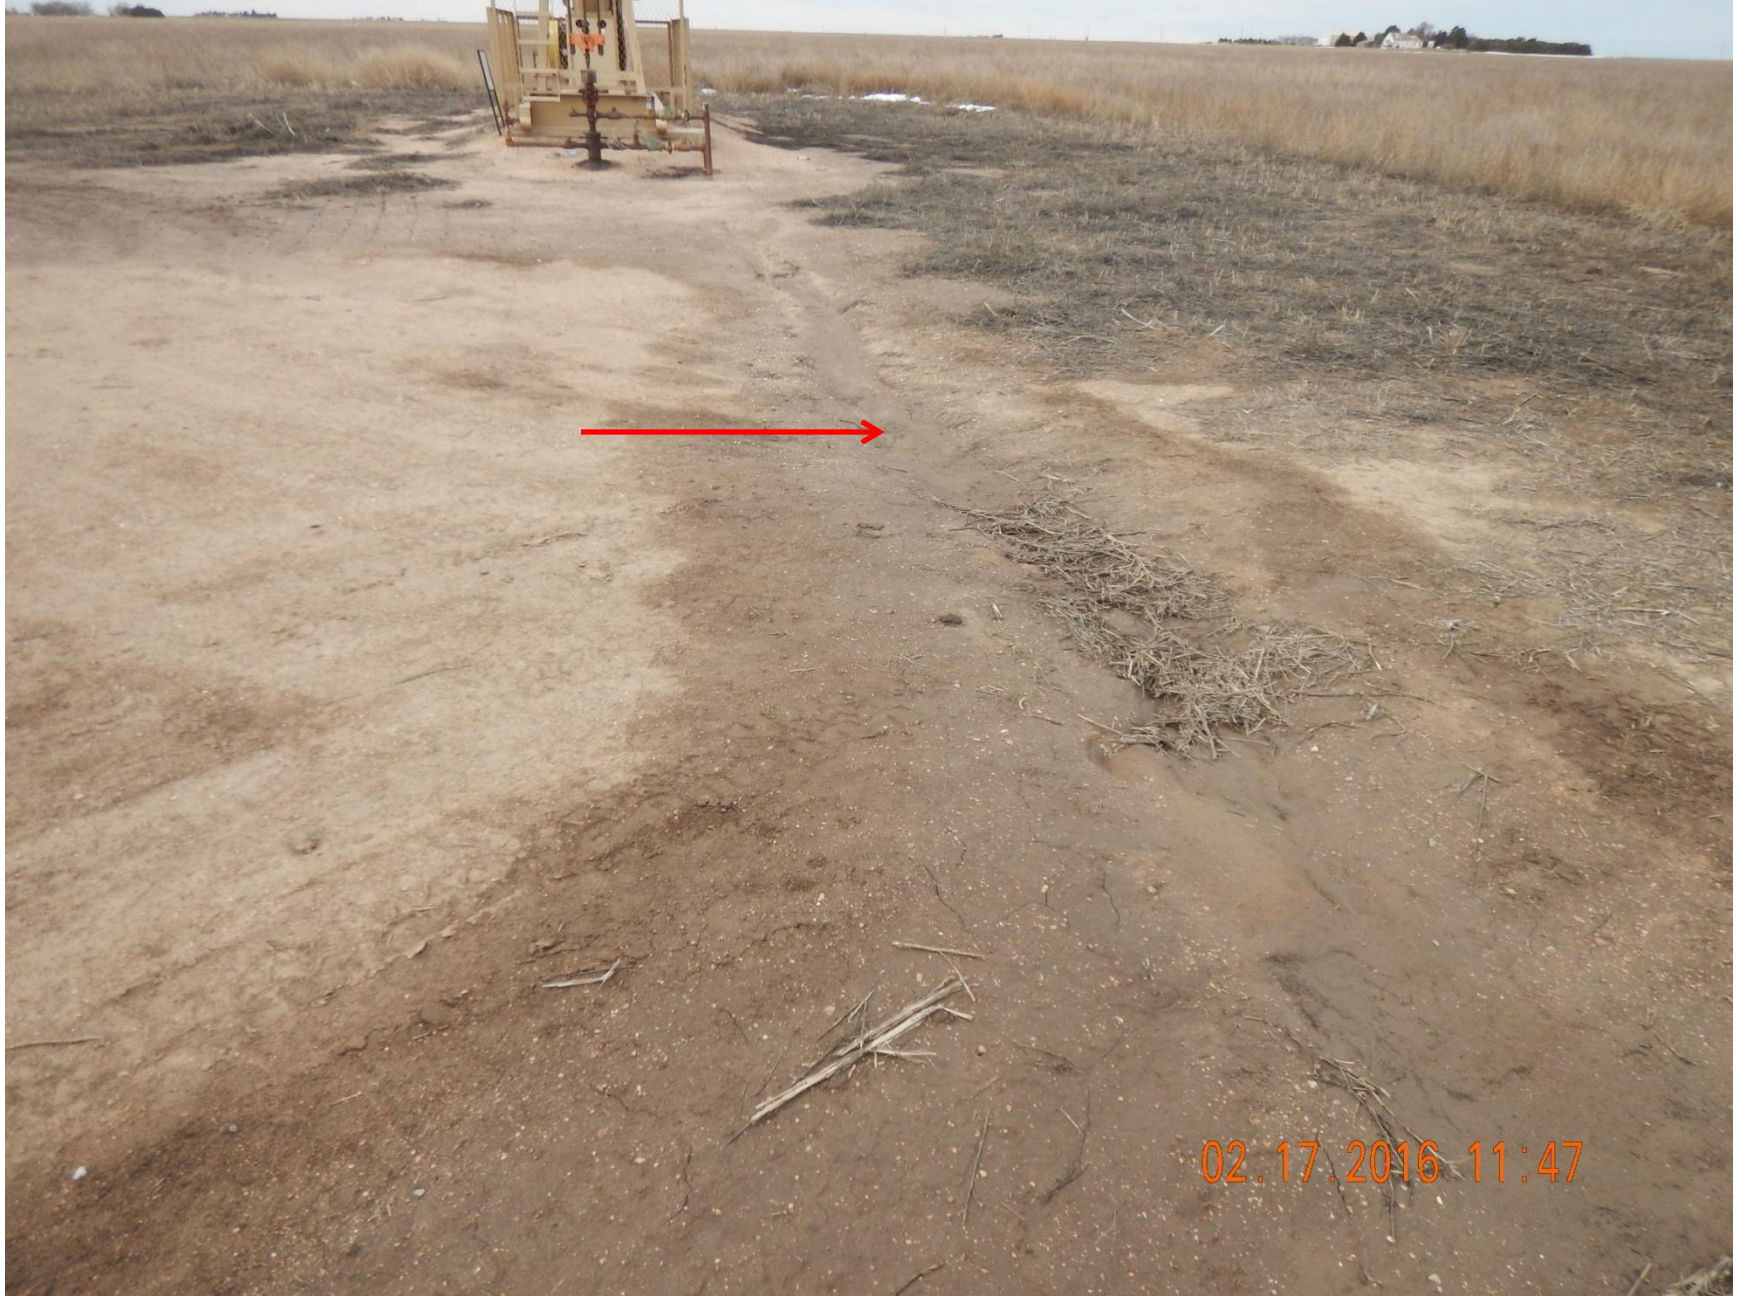
Figure 13: Photo taken from eastern end of the project area, facing west. Photo shows erosion patterns on location.

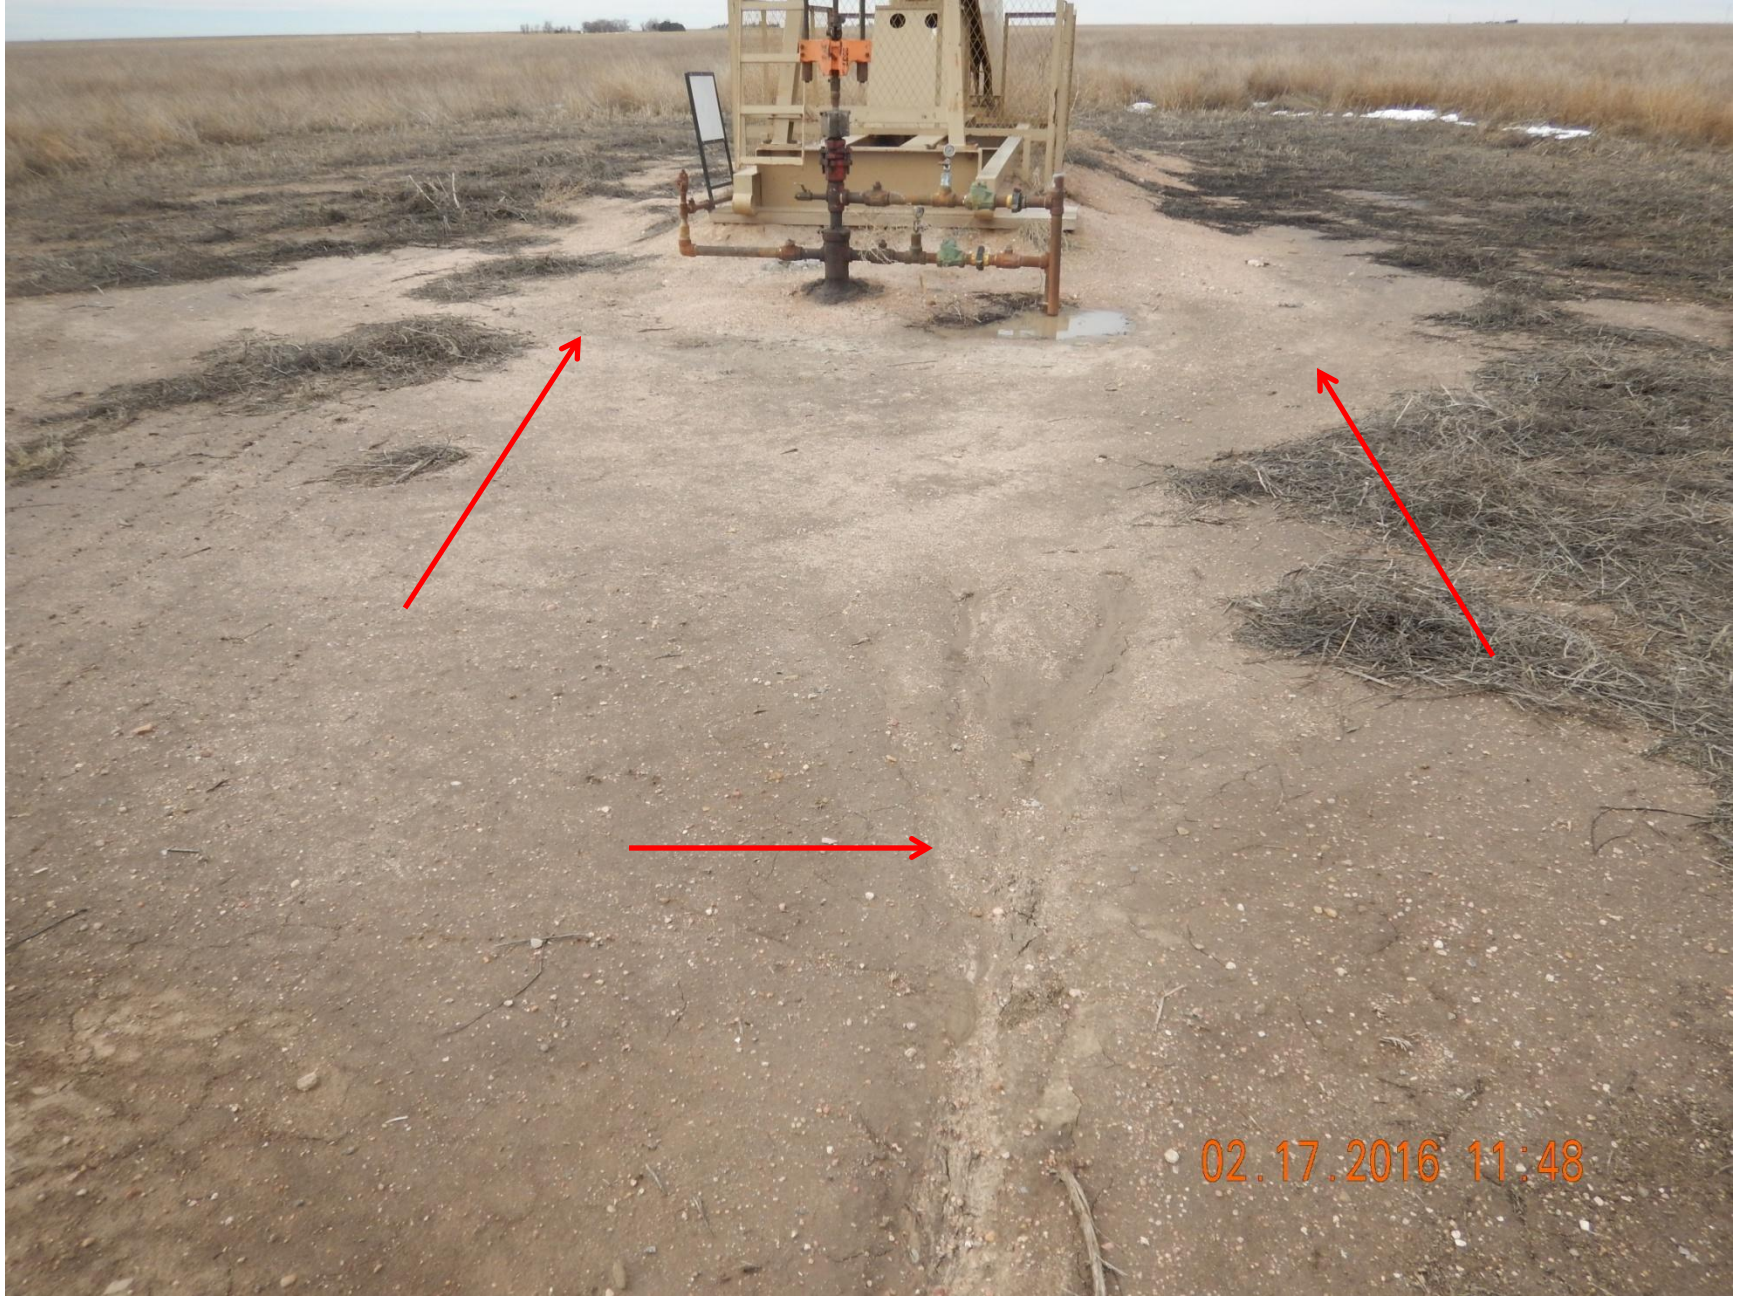
Figure 14: Photo taken from the central portion of the location, facing west. Photo shows erosion patterns on location.

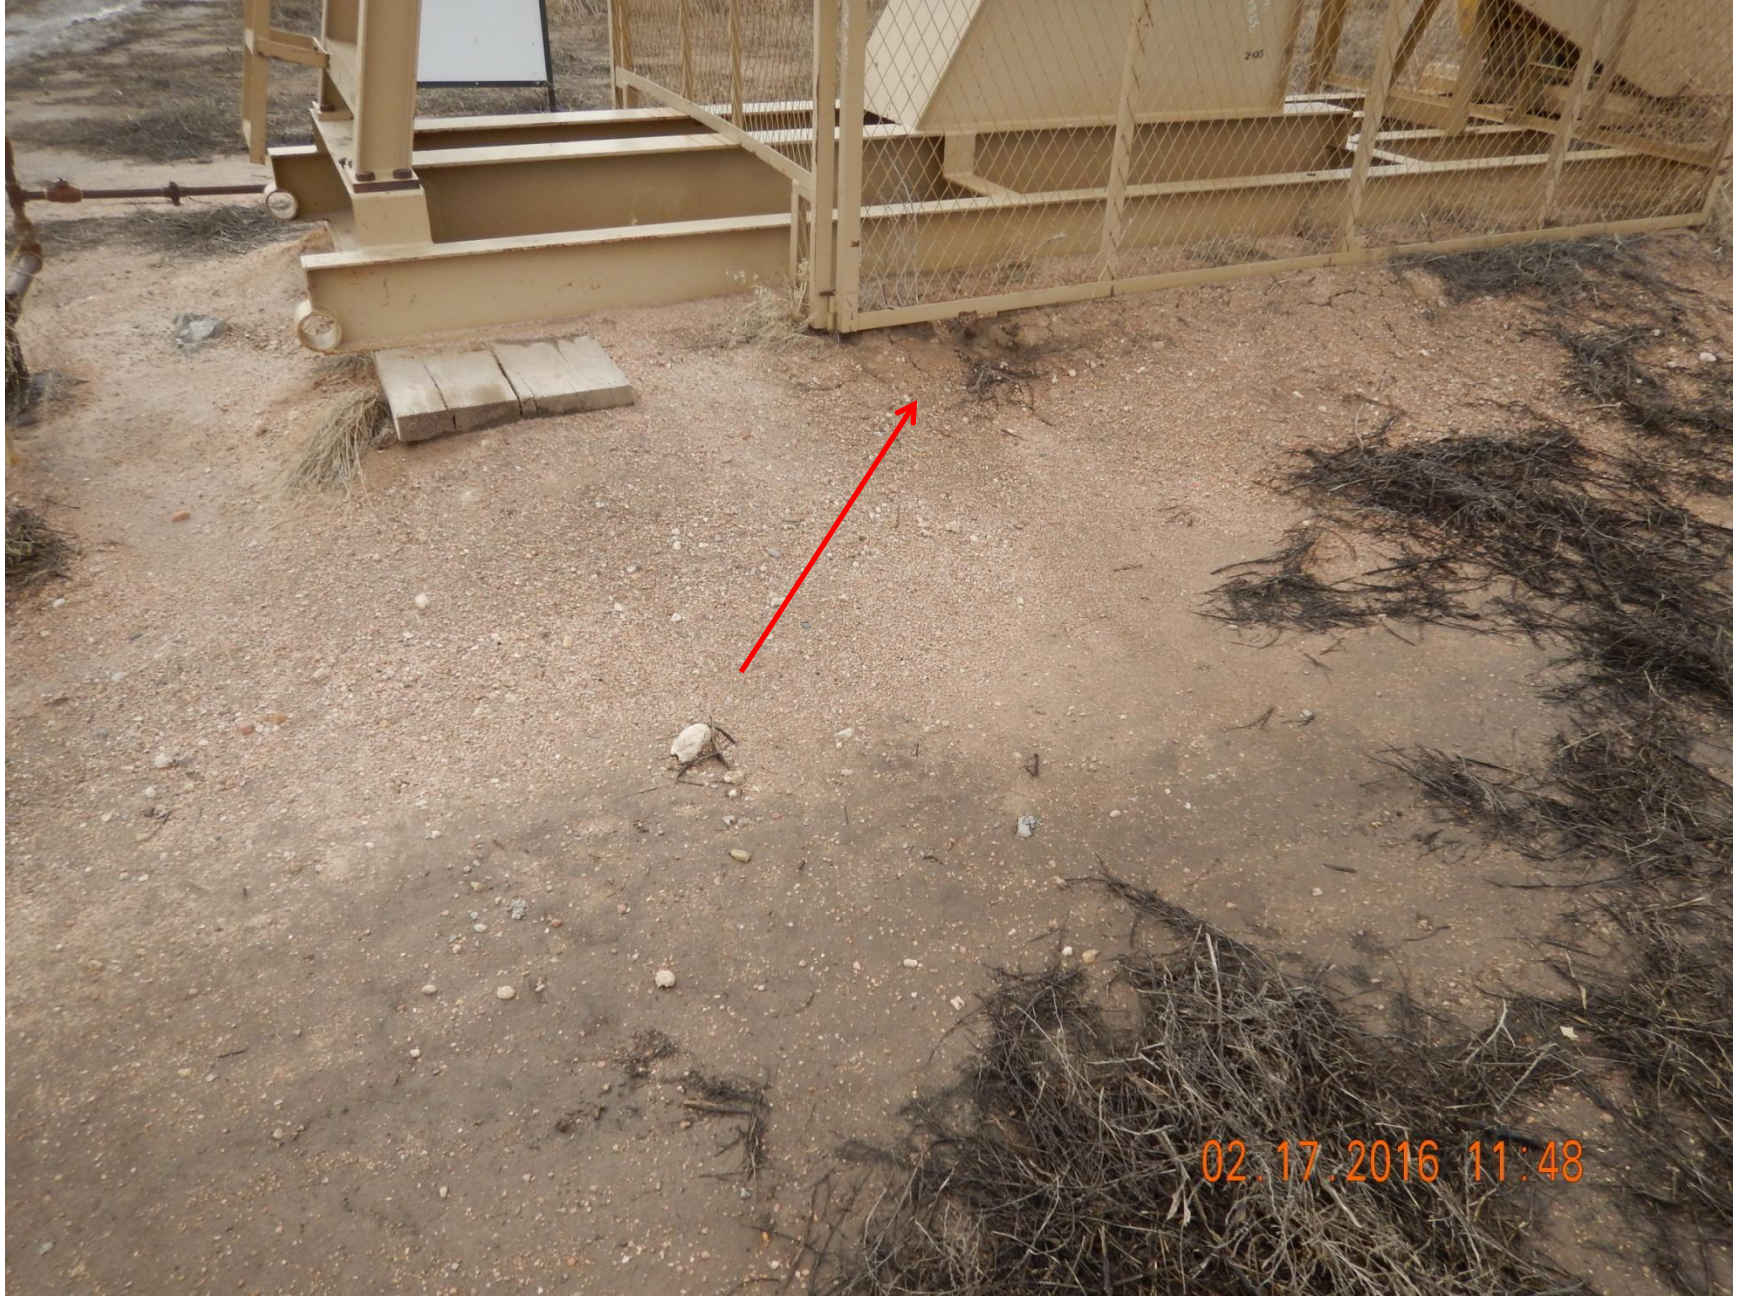
Figure 15: Photo taken from the northwest end of location, facing south. Photo shows erosion occurring at pump.

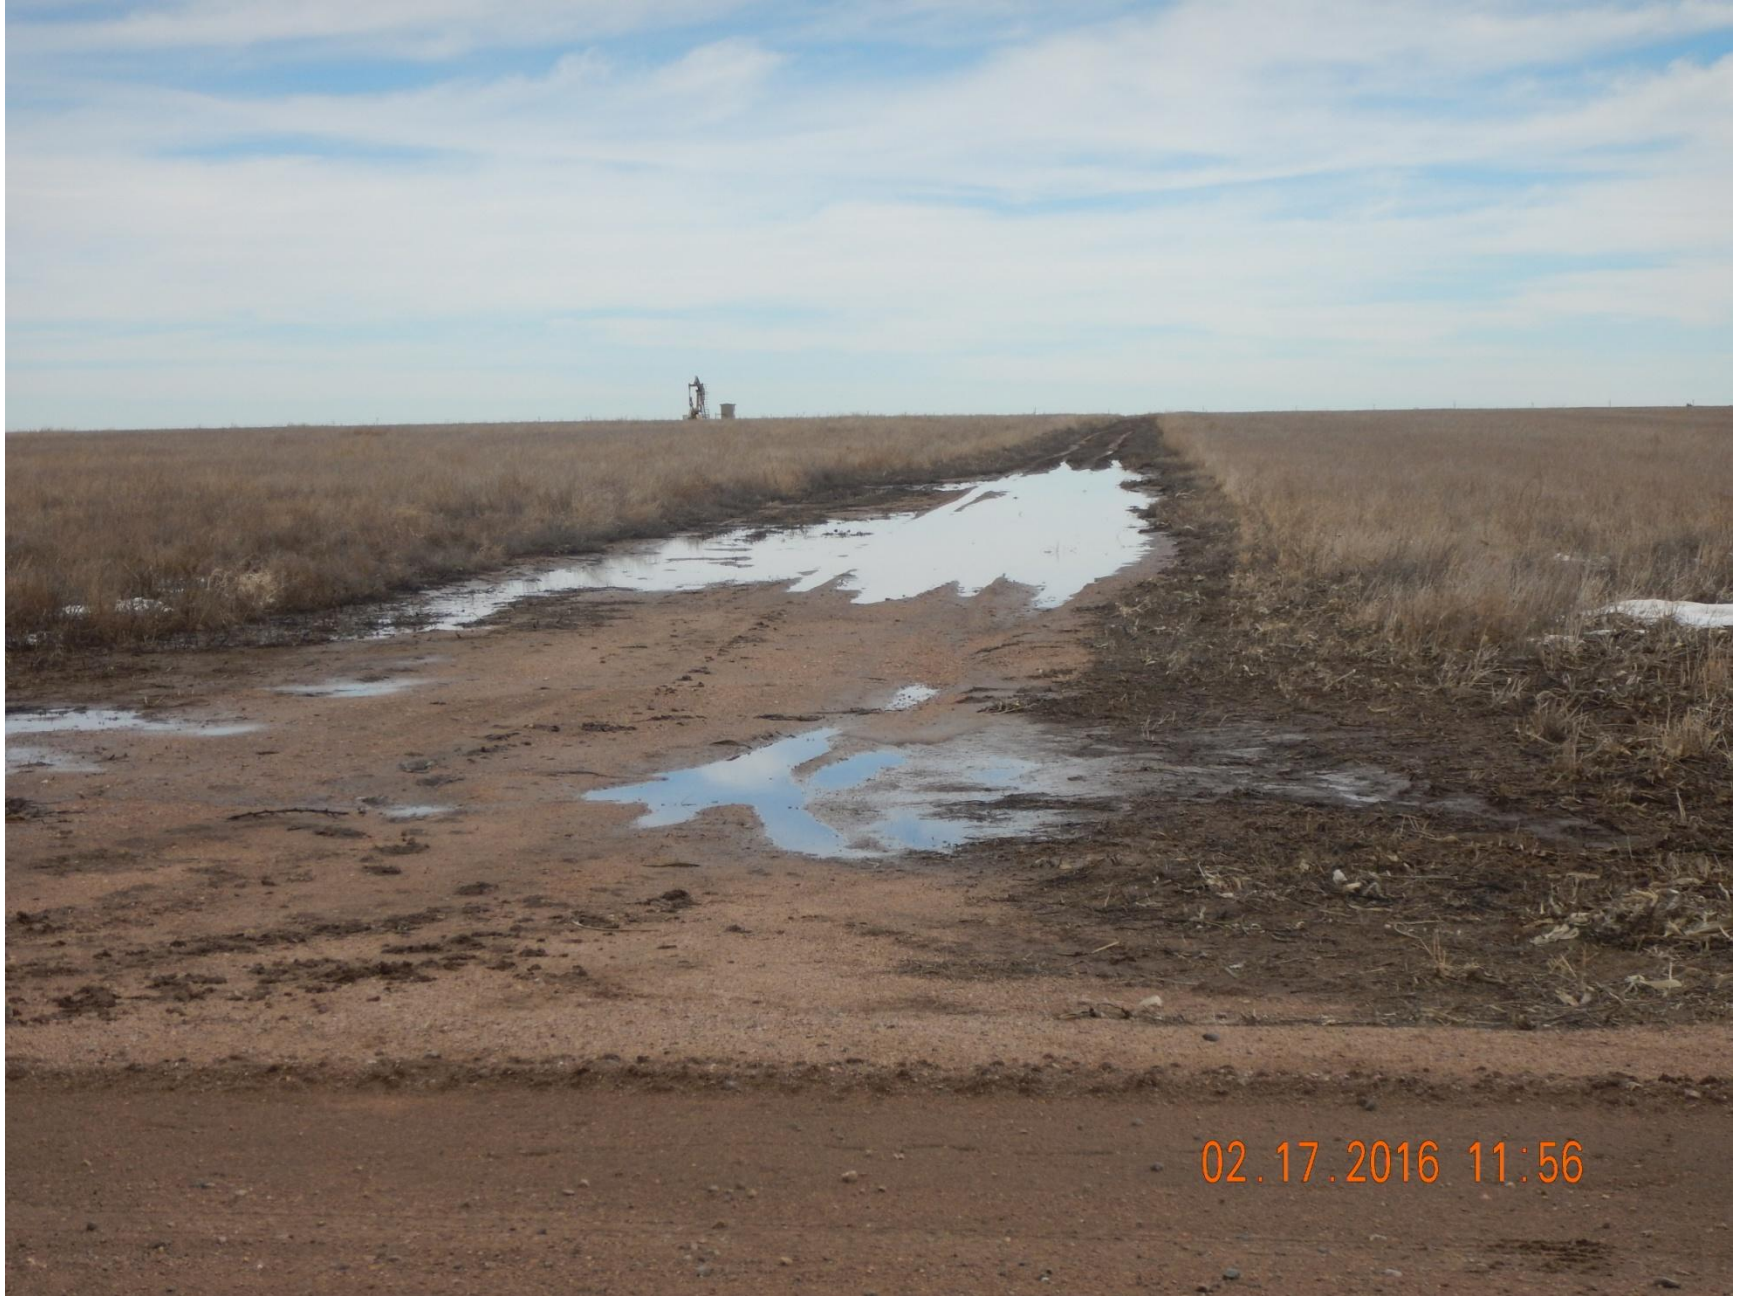
Figure 16: Photo taken from county road 51, west of location, facing east towards location. Photo of water pooling on access road.
