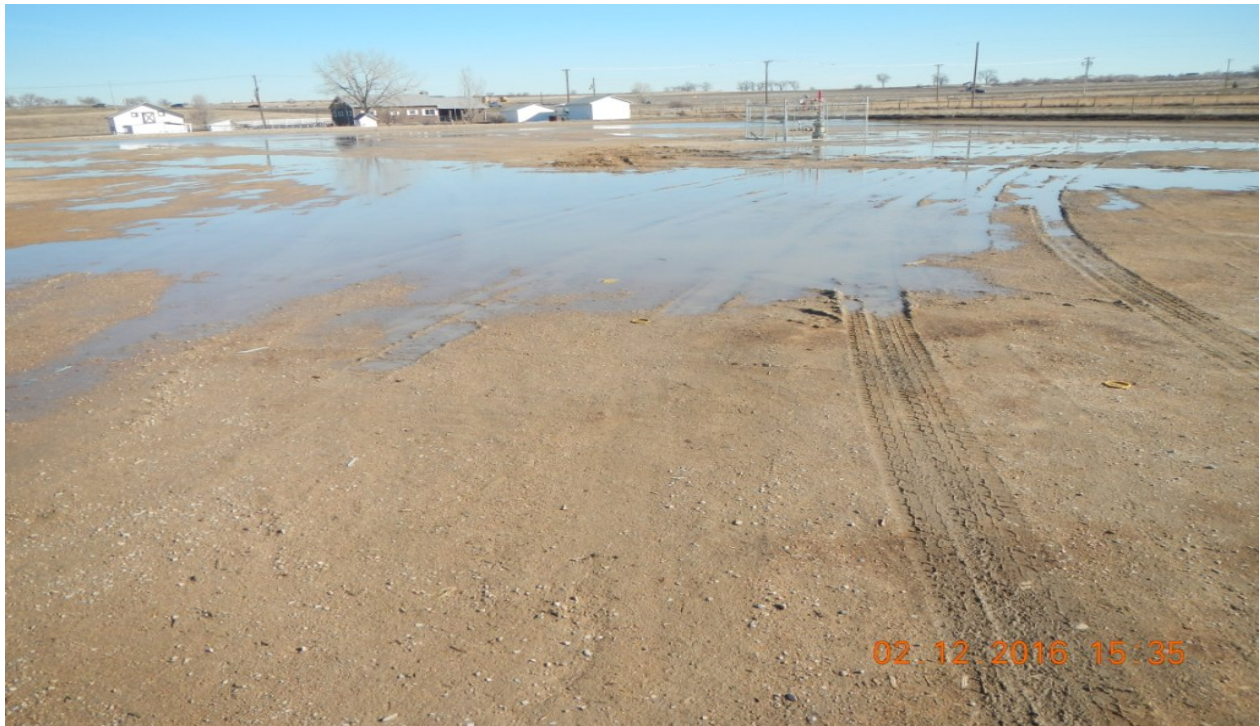
photo 1: Facing southeast toward the location. (Afton well)

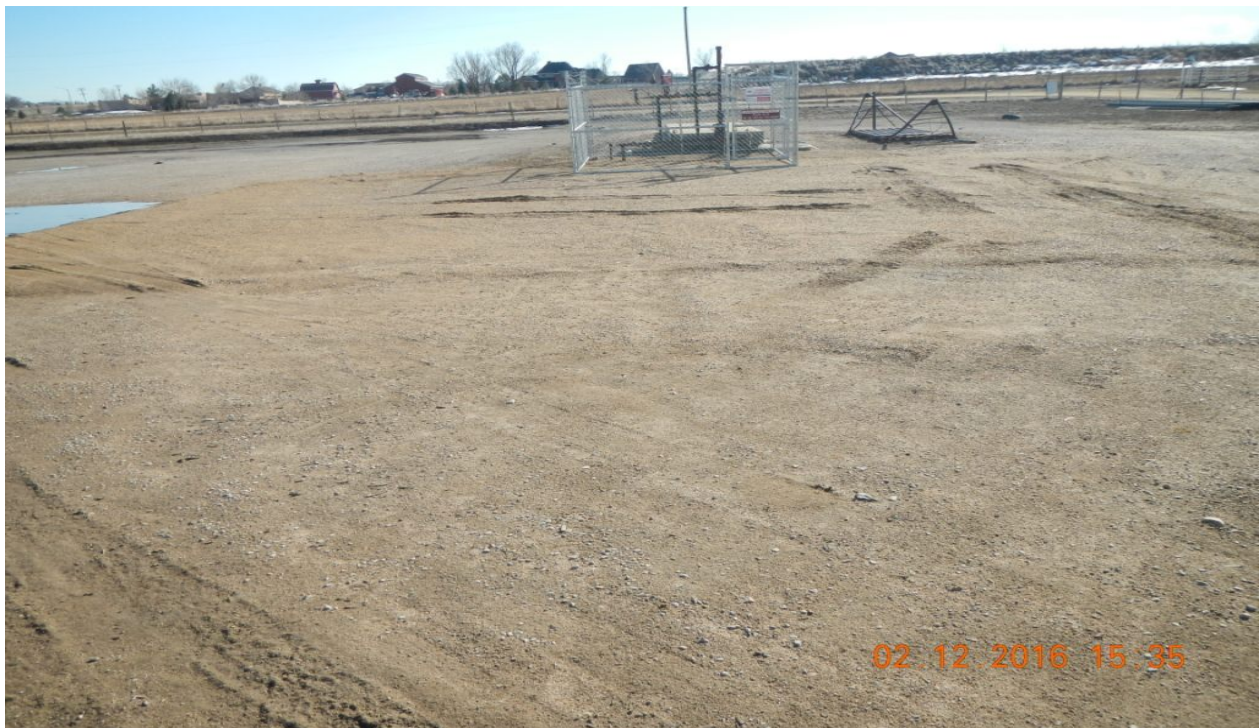
photo 2: Facing south toward the location. (Pulis well)

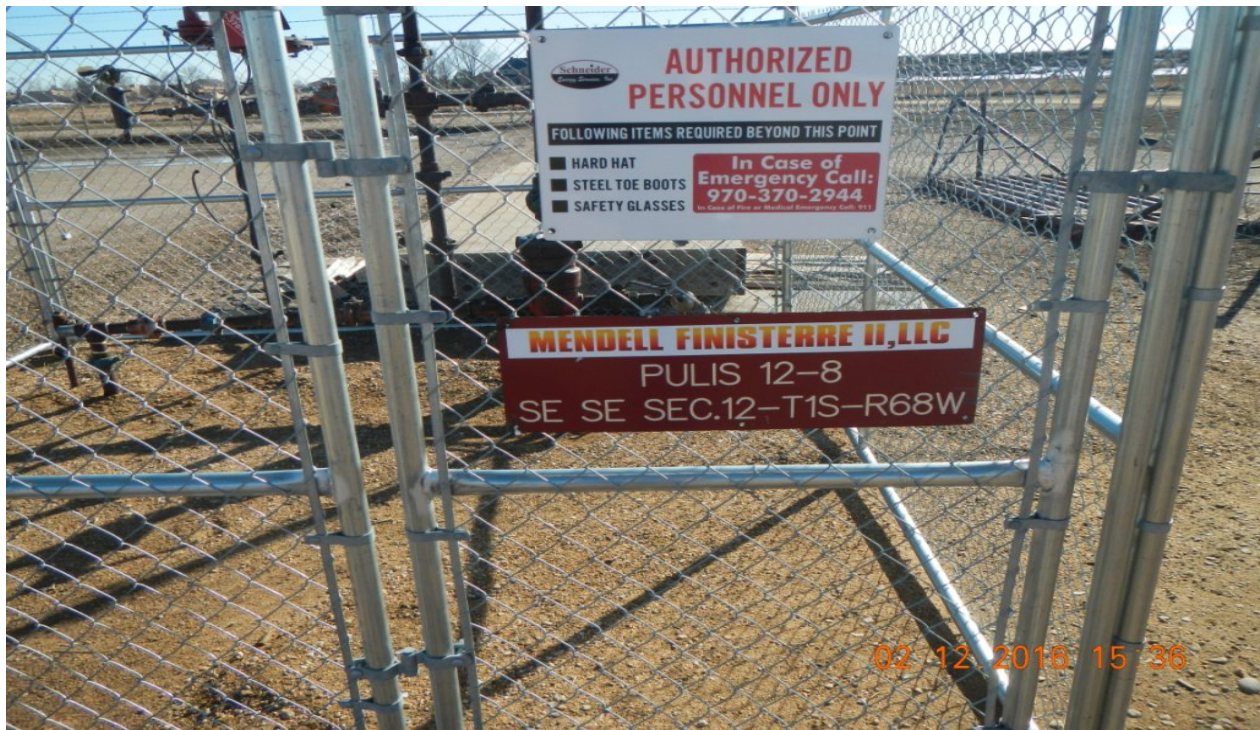
photo 3: Well sign at the Pulis well.

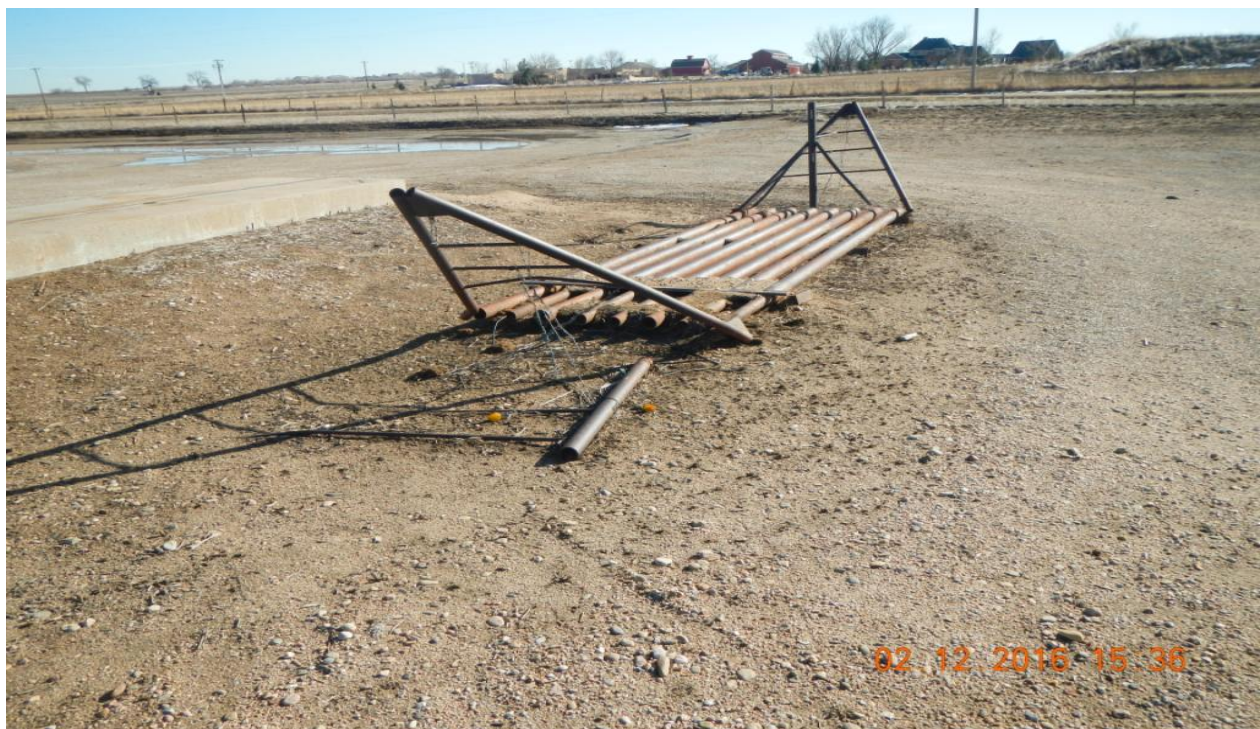
photo 4: Unused equipment, a cattle guard was noticed near the Pulis well.

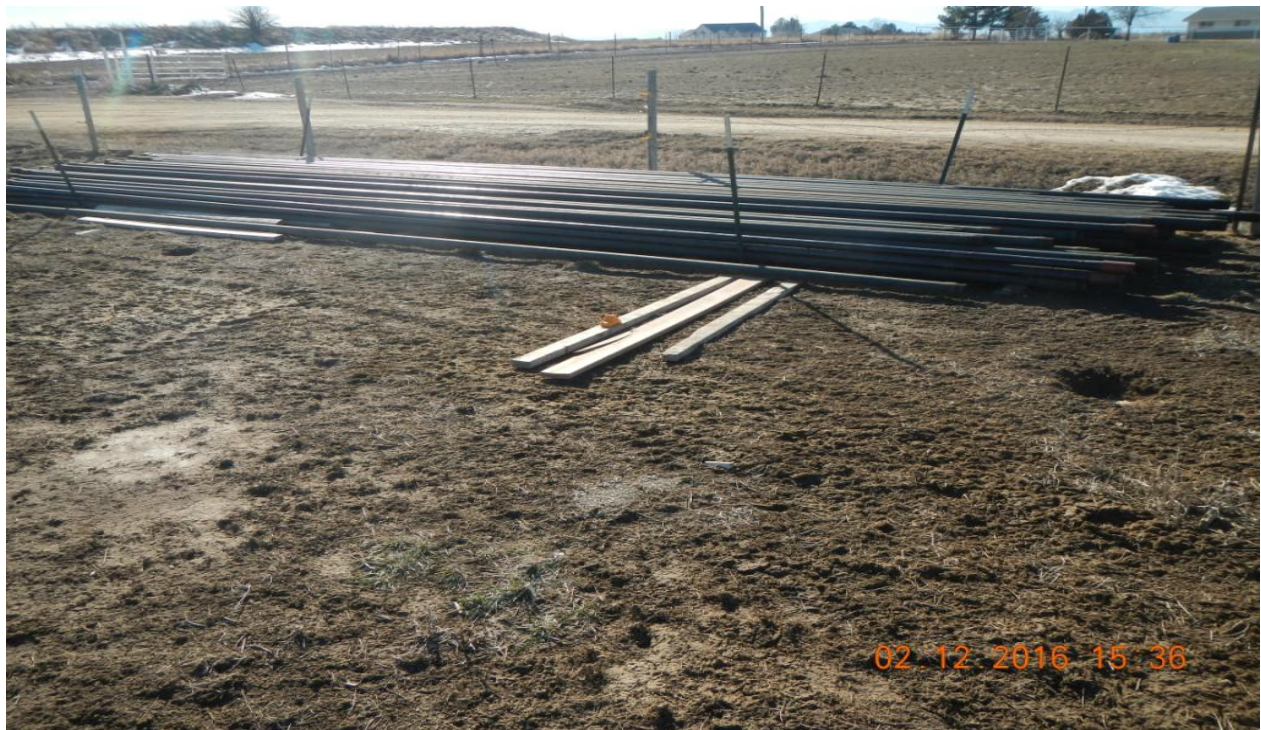
photo 5: Unused equipment, pipe being stored at the southwest corner of the location.

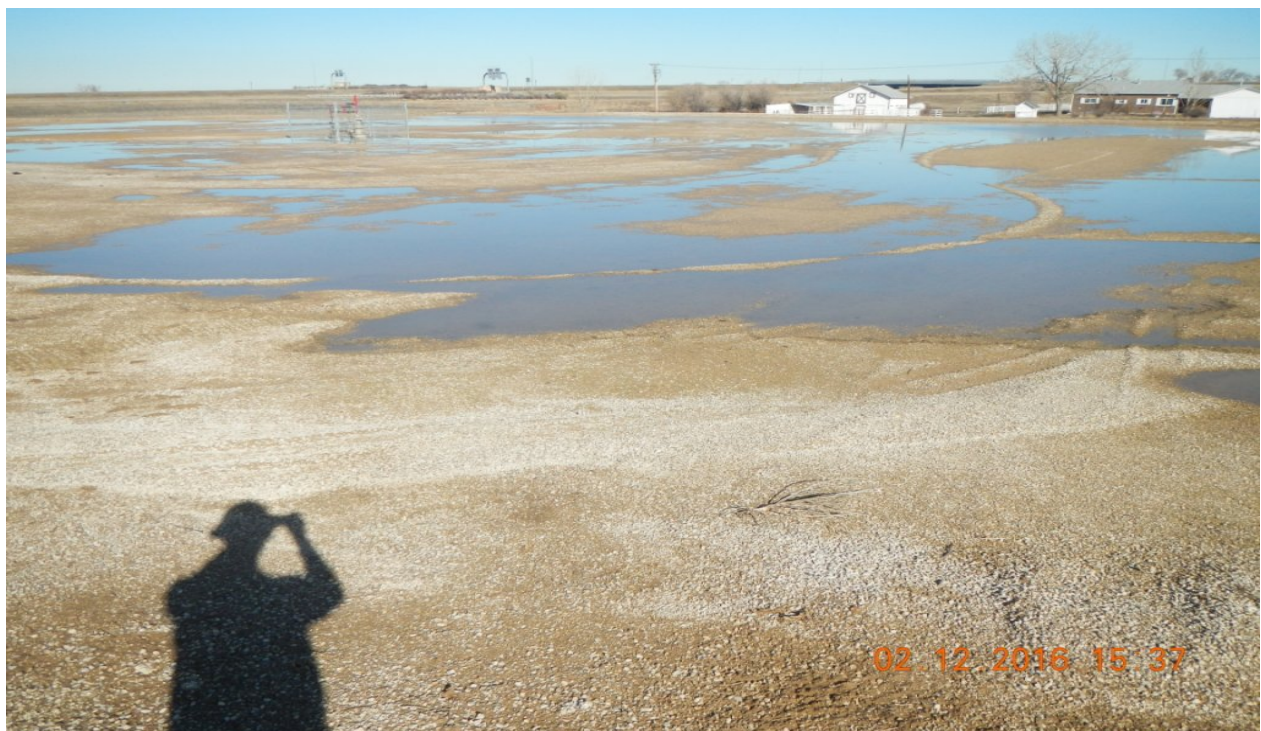
photo 6: Facing east toward the location. There is water pooling throughout the location.

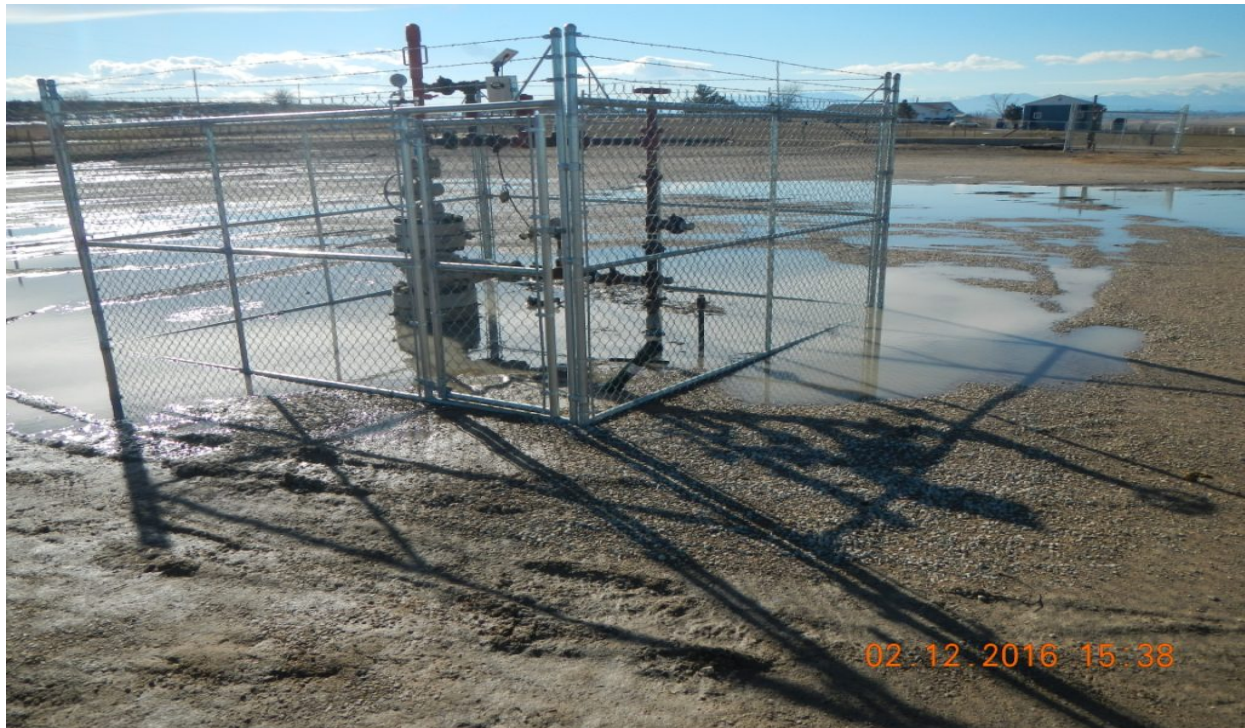
photo 7: The Afton well head. Did not notice a sign at the well head.

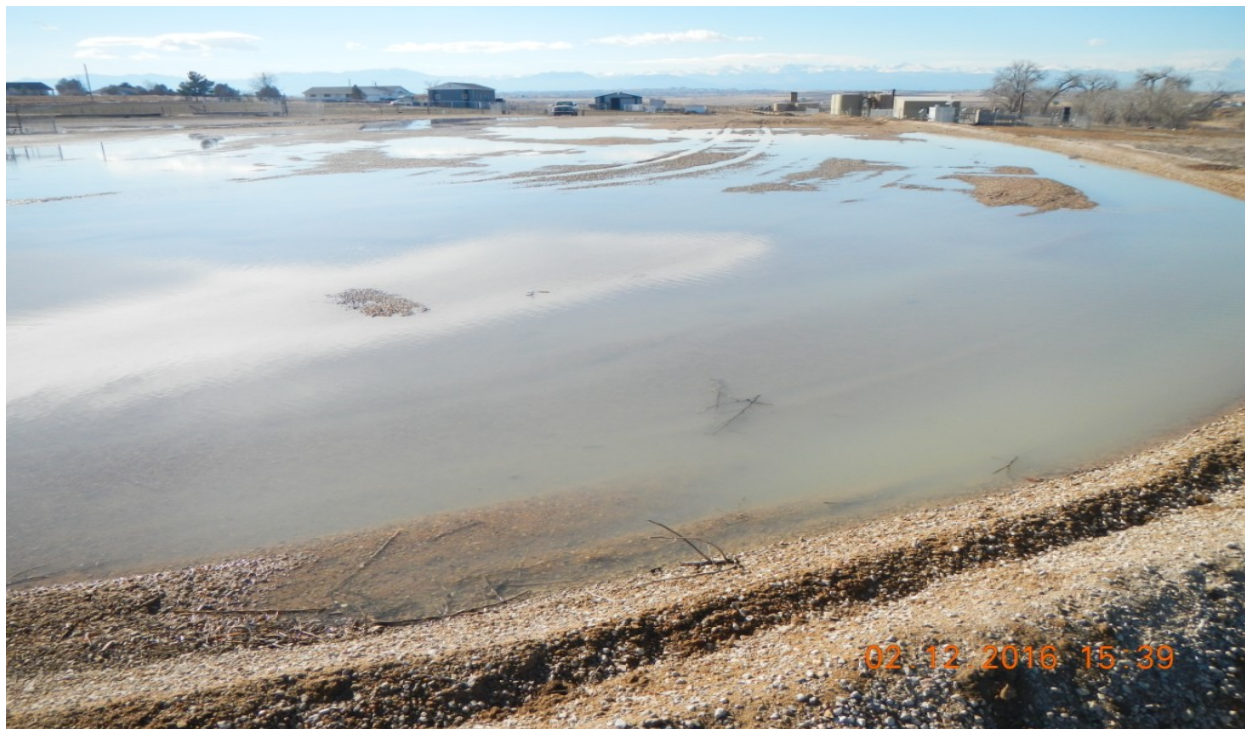
photo 8: Northeast corner of the location facing west.

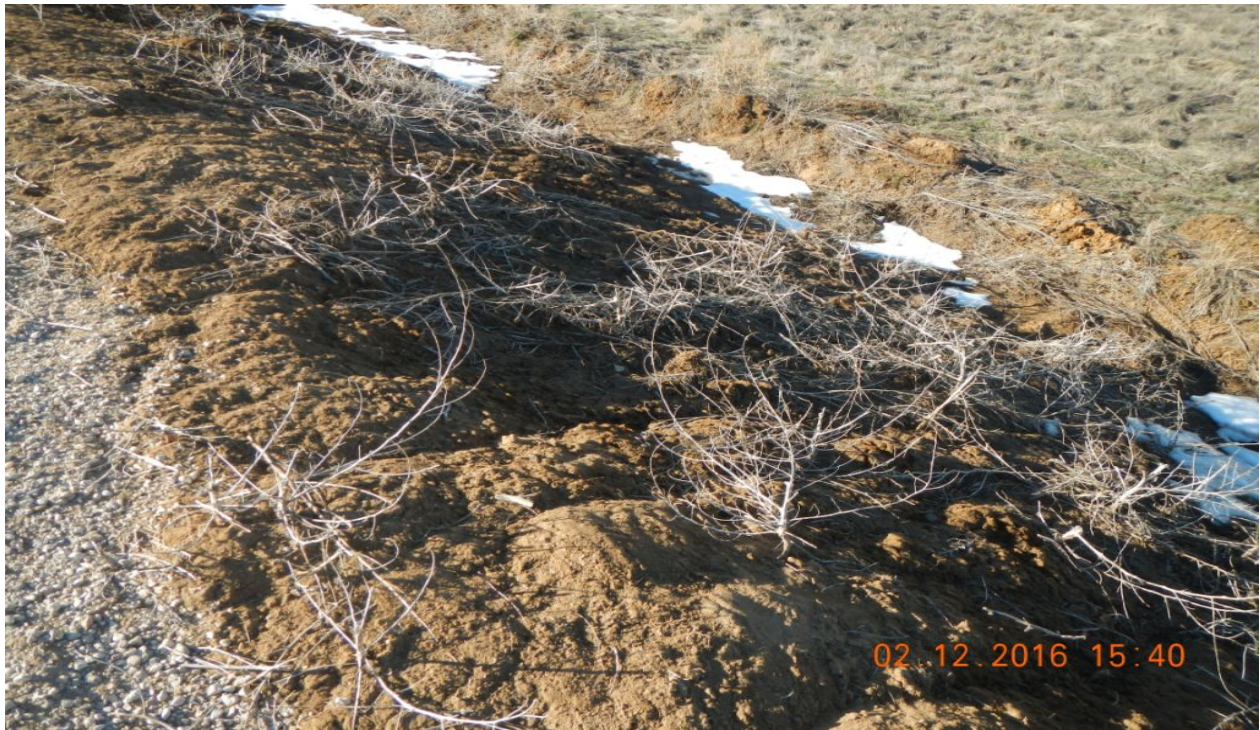
photo 9: Signs of erosion occurring off the north side of the pad which is not adequately stabilized.

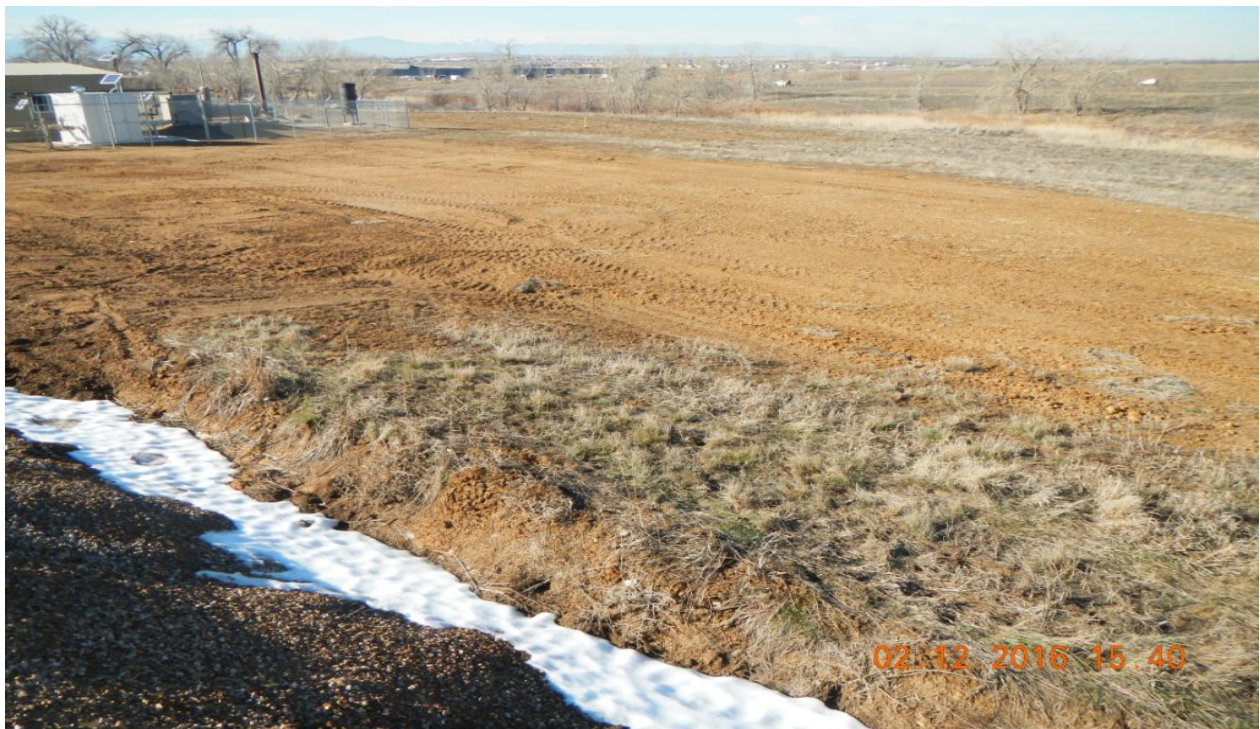
photo 10: Facing northwest at the north side of the location. Disturbance is susceptible to erosion and needs to be reclaimed.

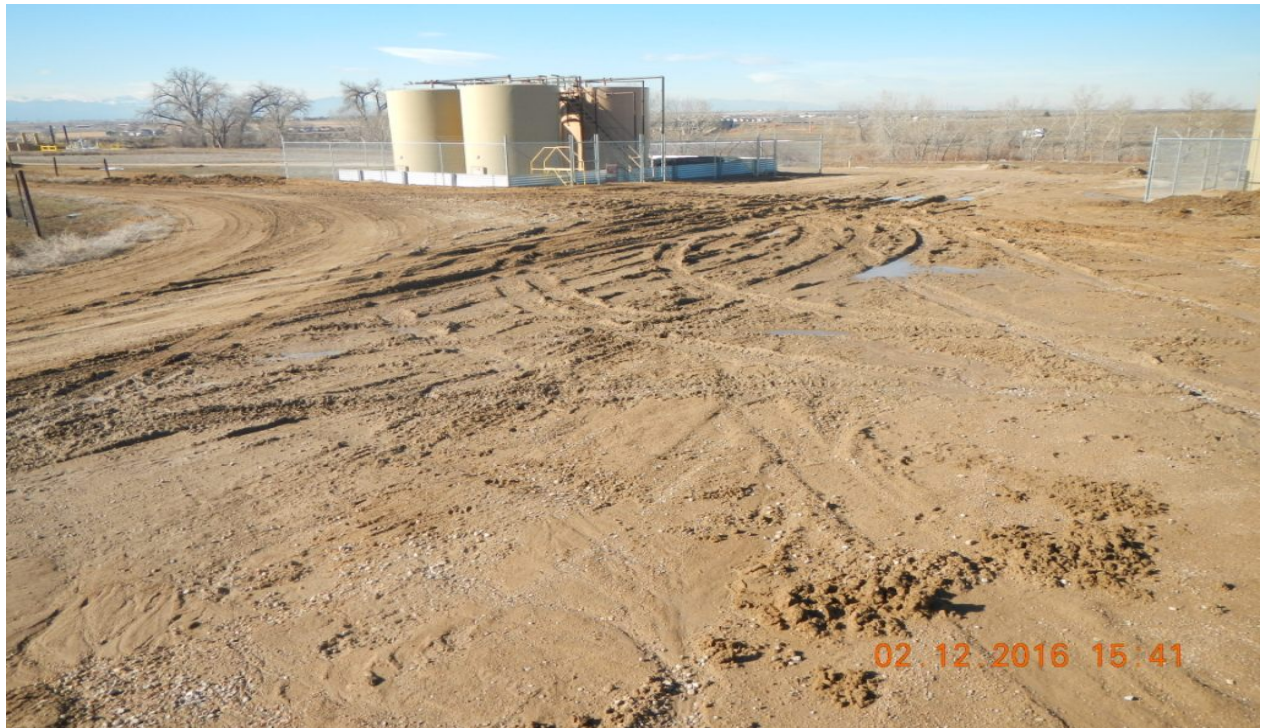
photo 11: Northwest corner of the location facing northwest toward the tank battery.

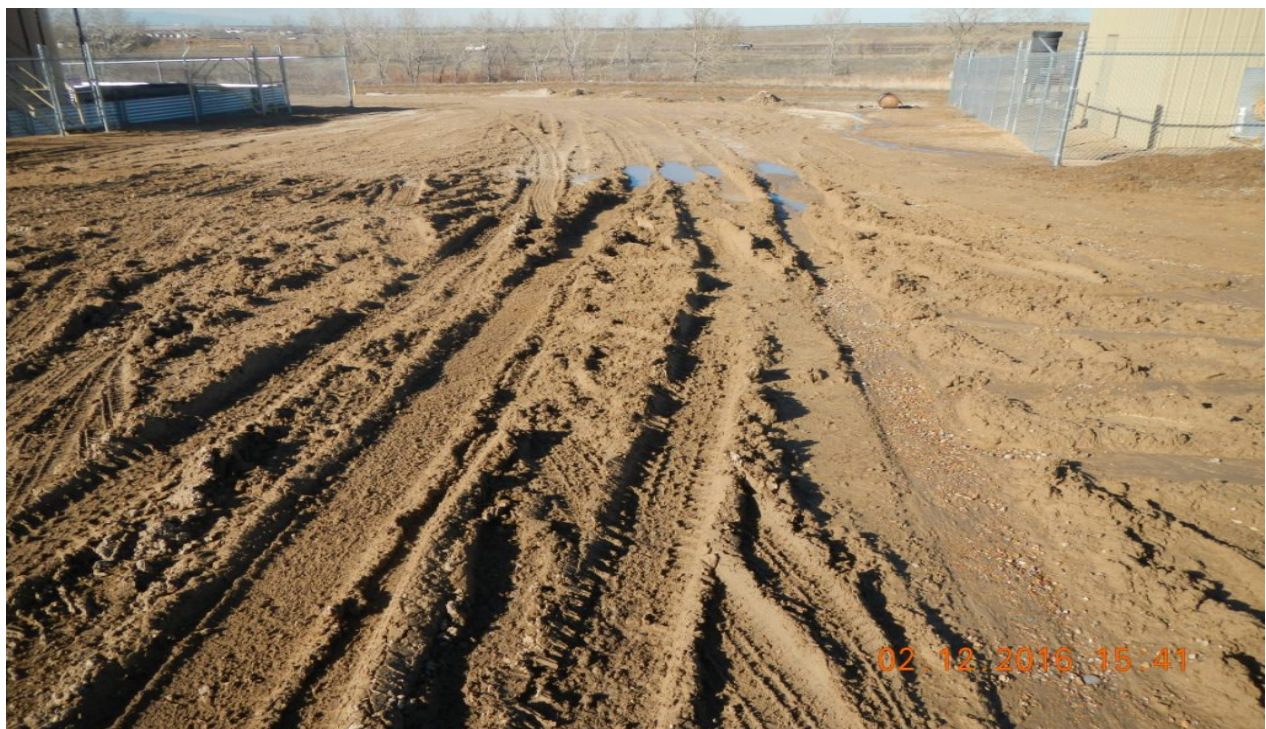
photo 12: There is vehicle rutting occurring along the access road near the tank battery.

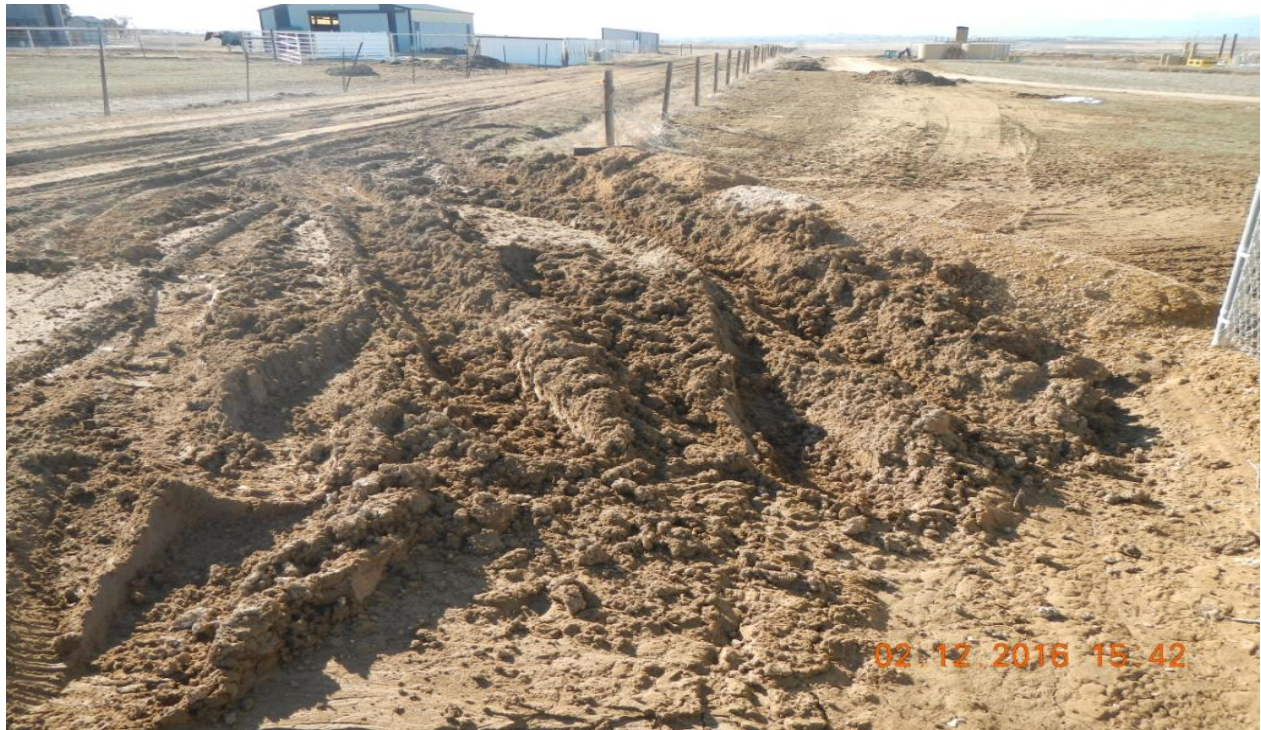
photo 13: Vehicle tracking and rutting occurring near the tank battery and access road.

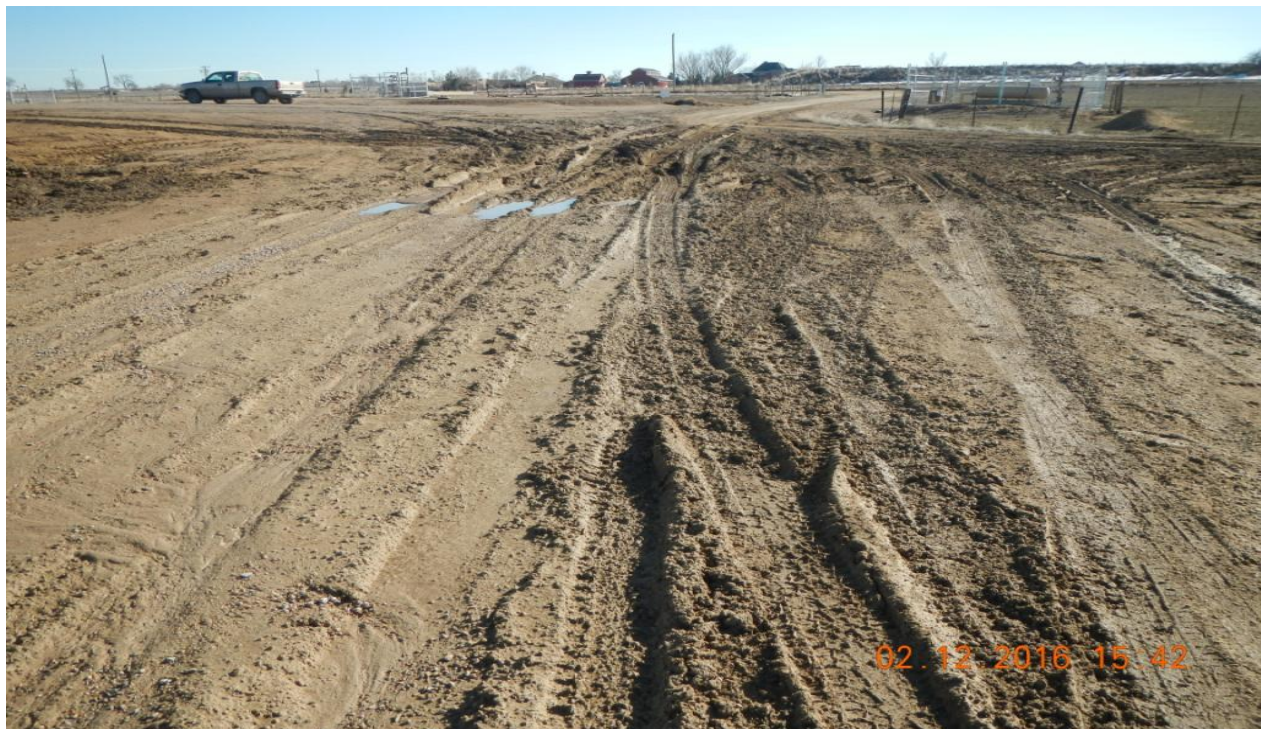
photo 14: Facing southeast back toward the location from the tank battery site.
