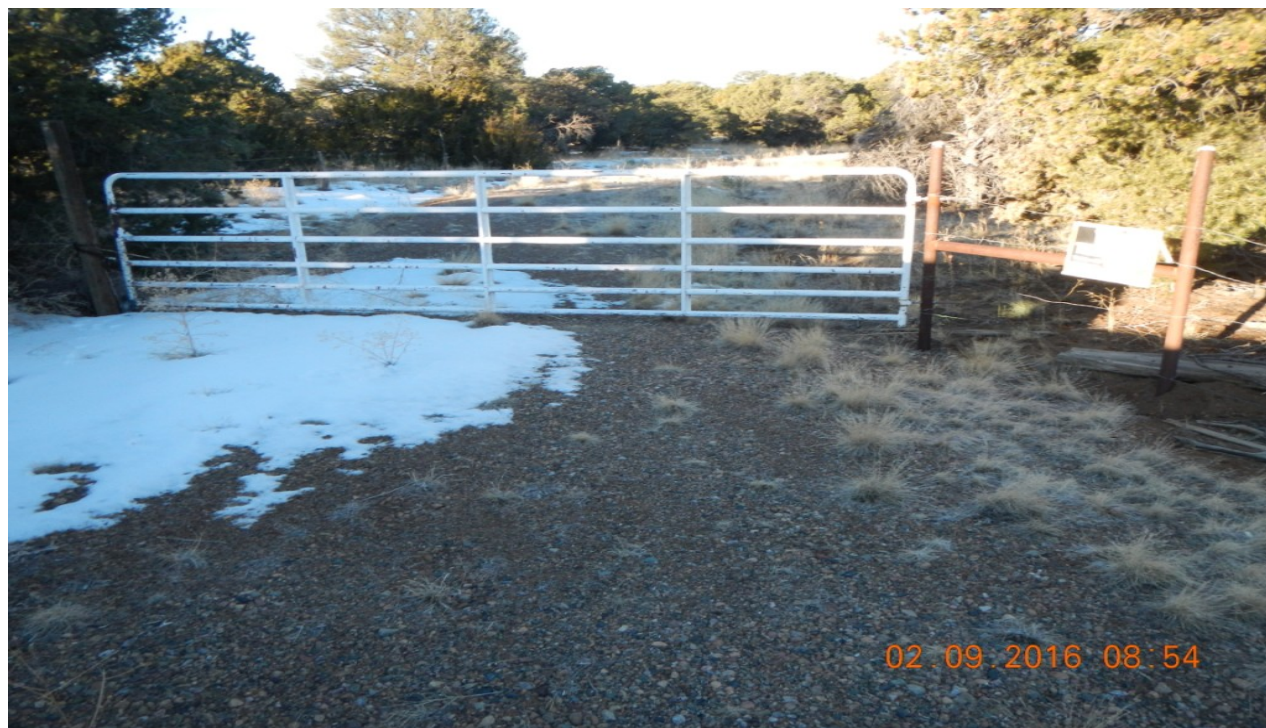
photo 1: Facing west at the beginning of the access road to the location.

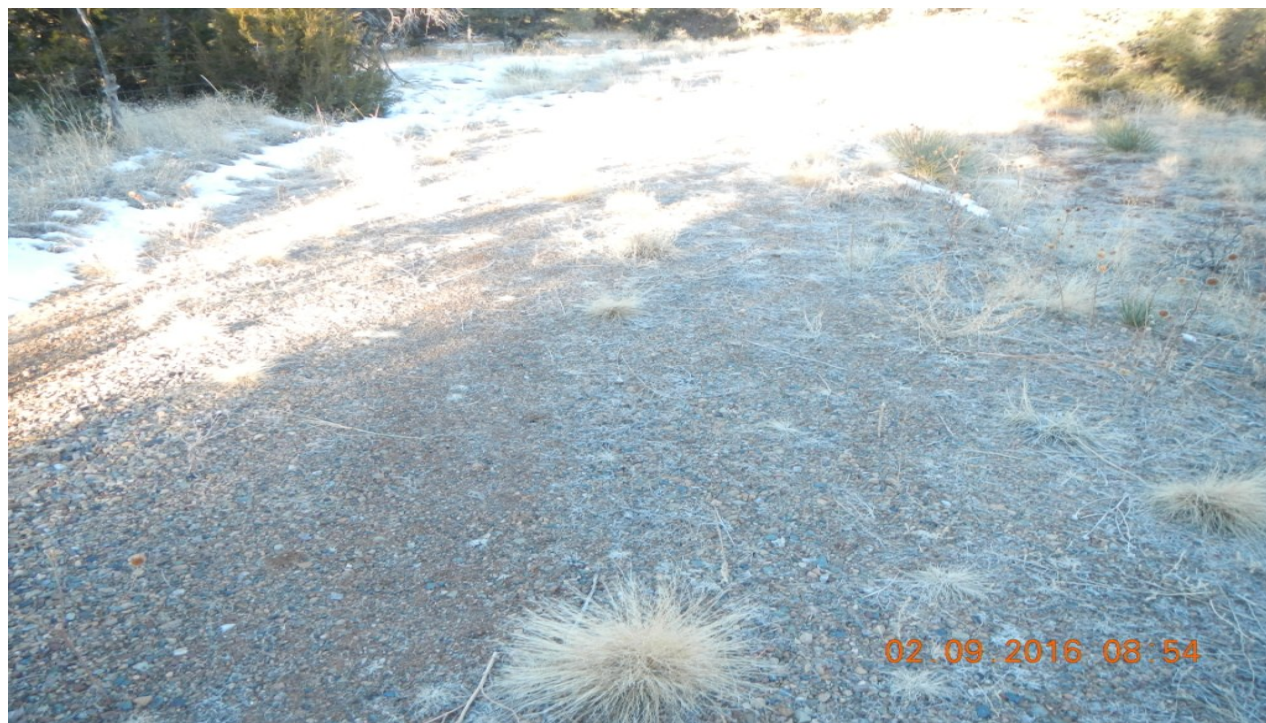
photo 2: The access road has not been recontoured and reclaimed. Gravel remains along the access road.

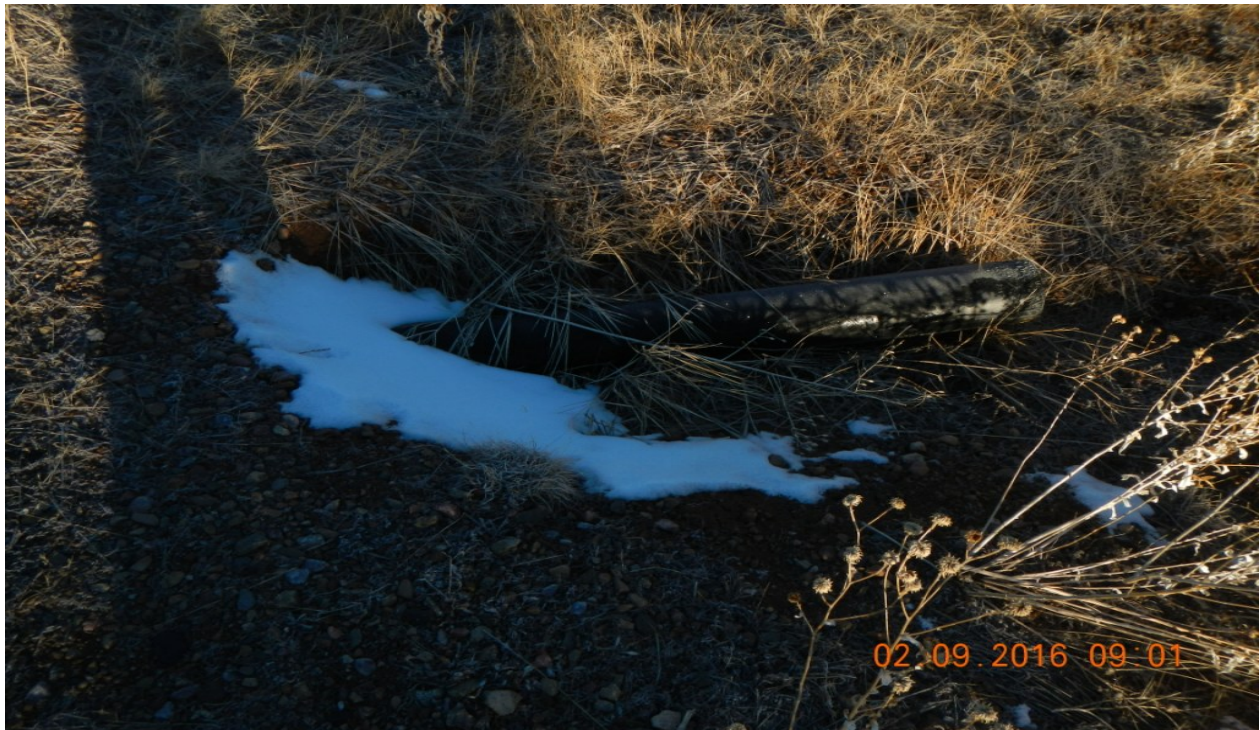
Photo 3: Plastic culvert remains along the access road.

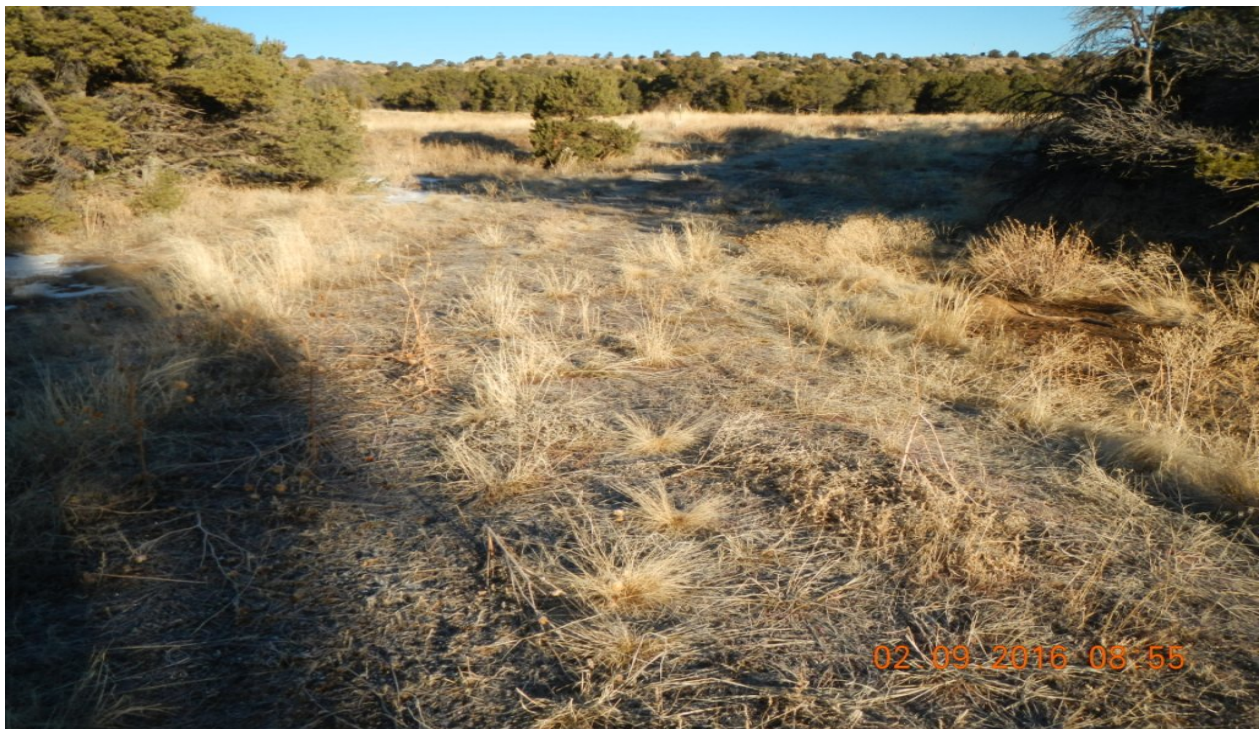
Photo 4: Facing northwest toward the location.

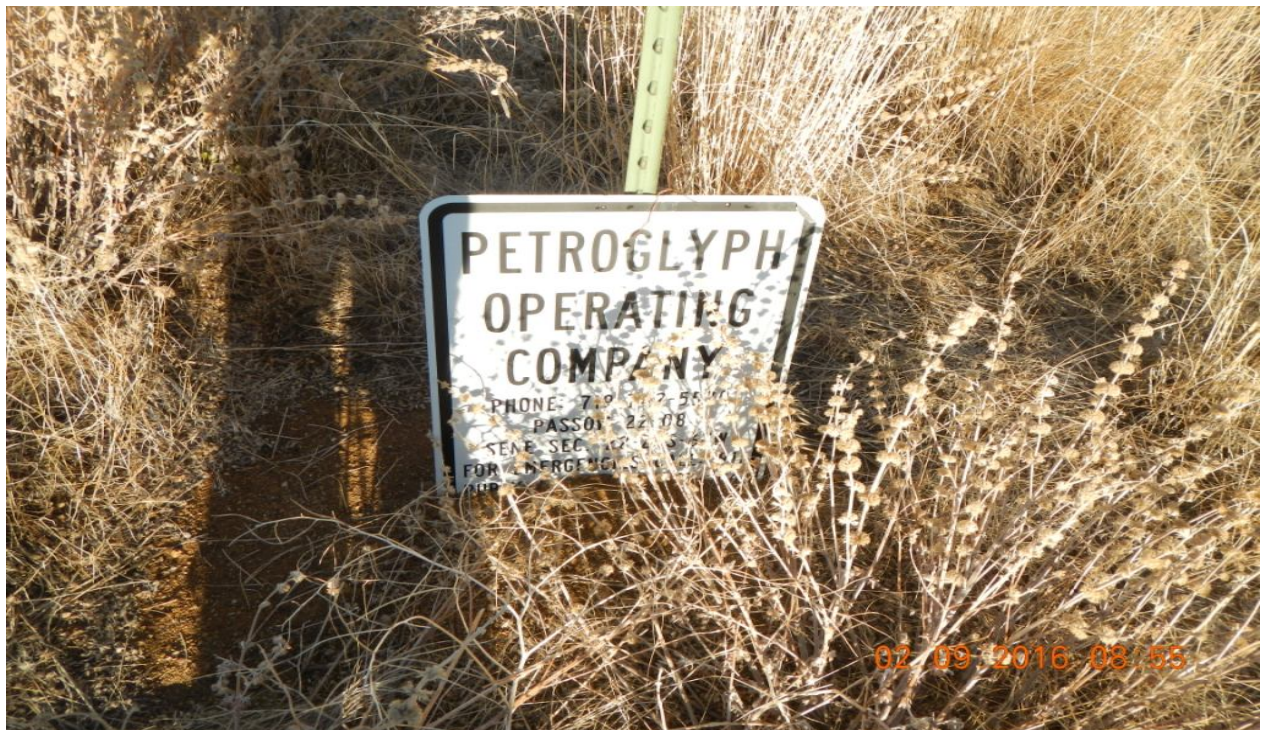
Photo 5: Operator sign at the location.

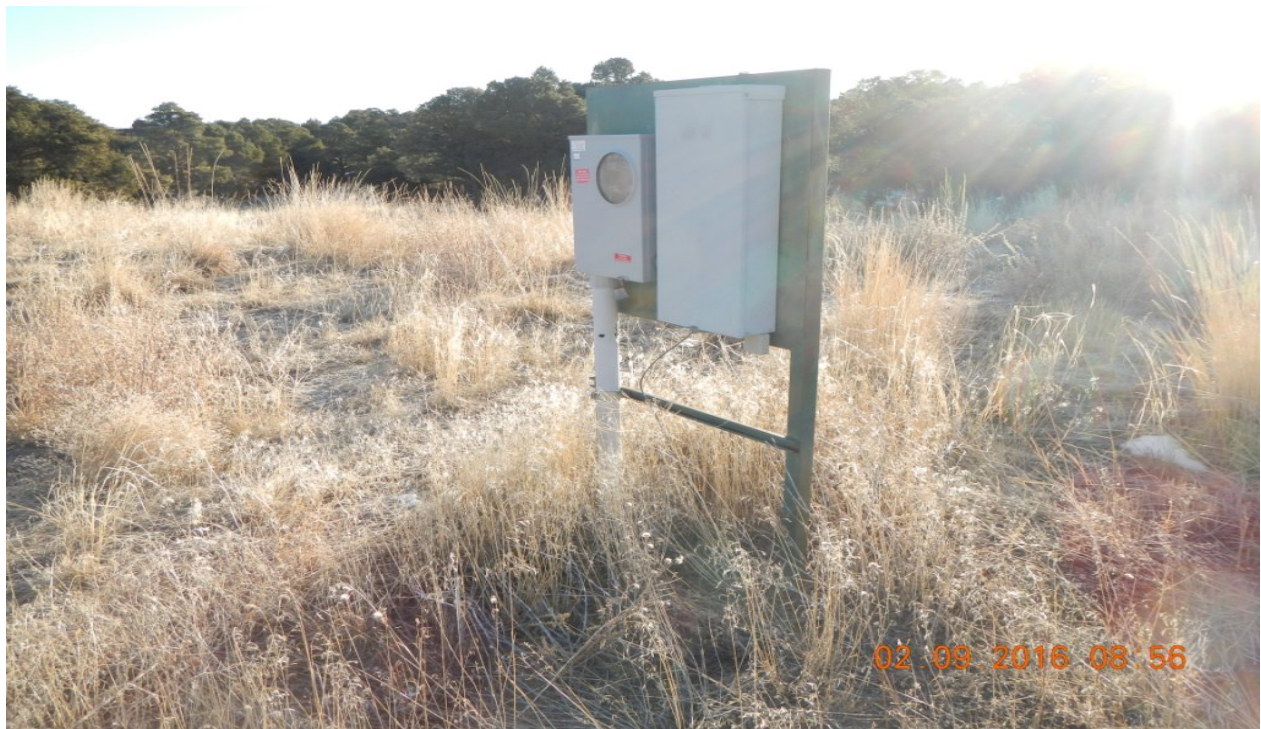
Photo 6: Electrical panel remains at the southeast side of the location.

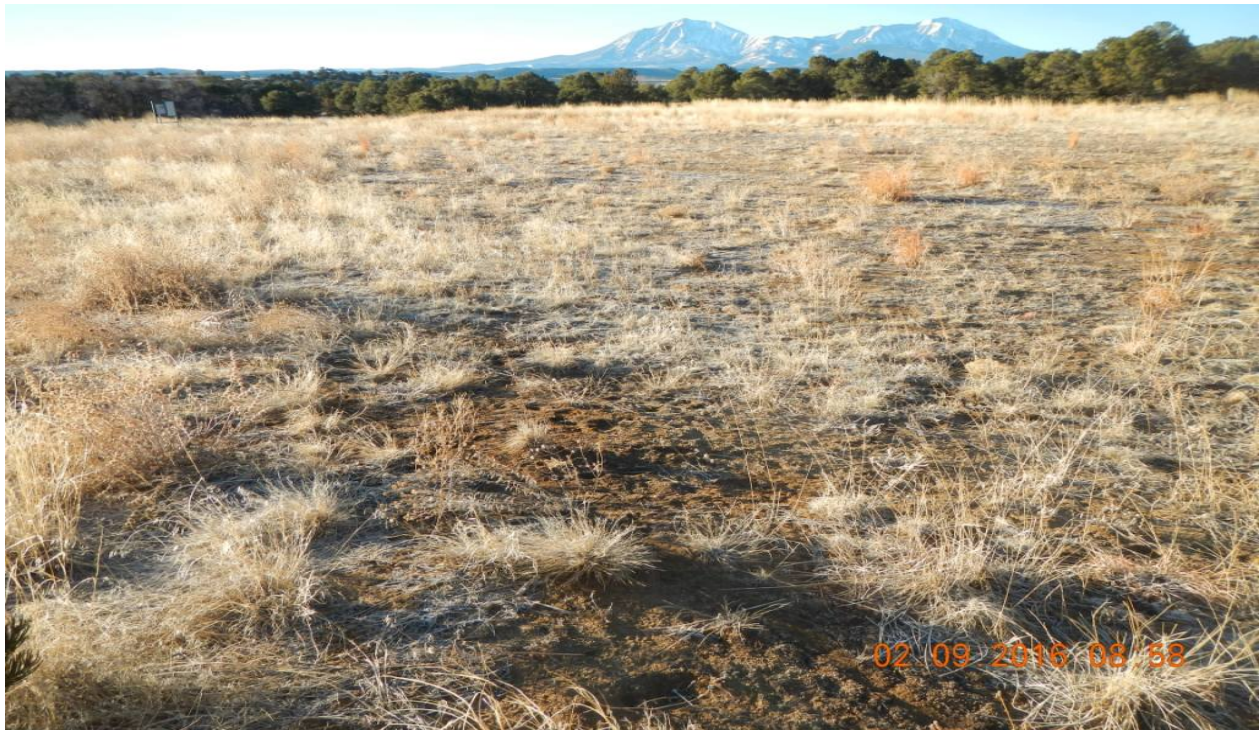
Photo 7: North side of the location facing south.

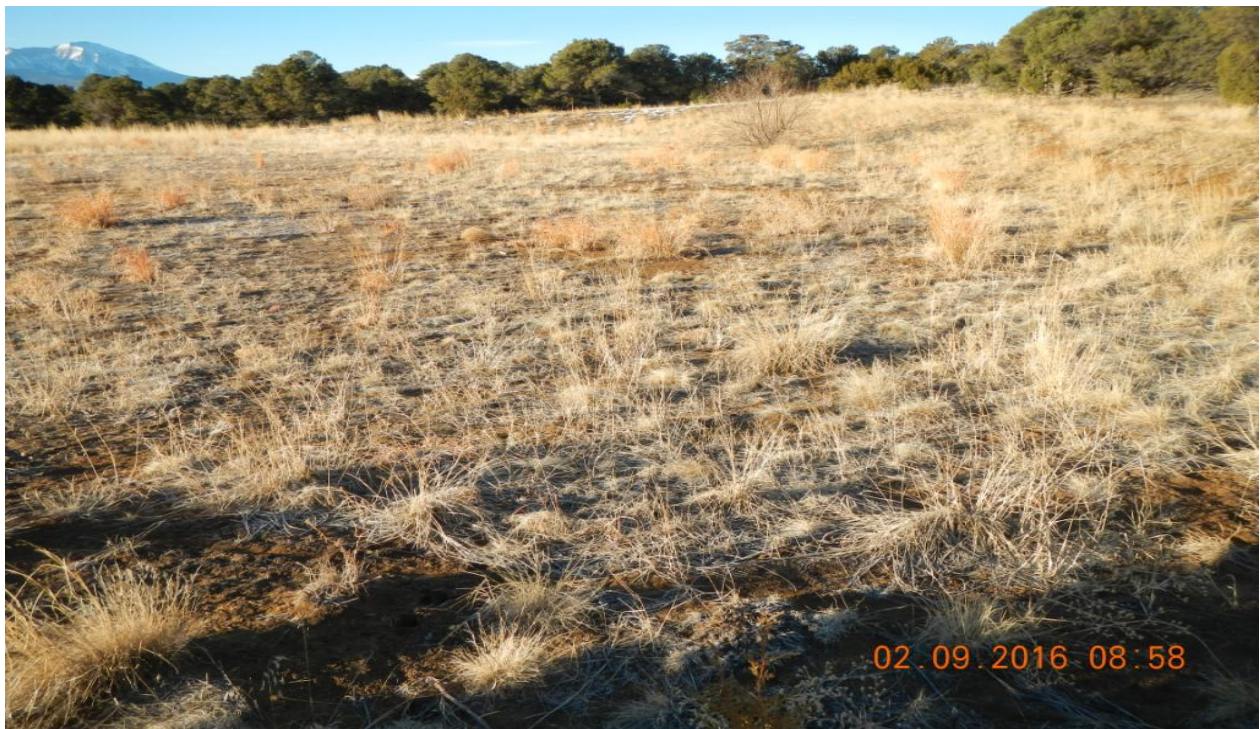
Photo 8: North side of the location facing southwest. The location has not been recontoured.

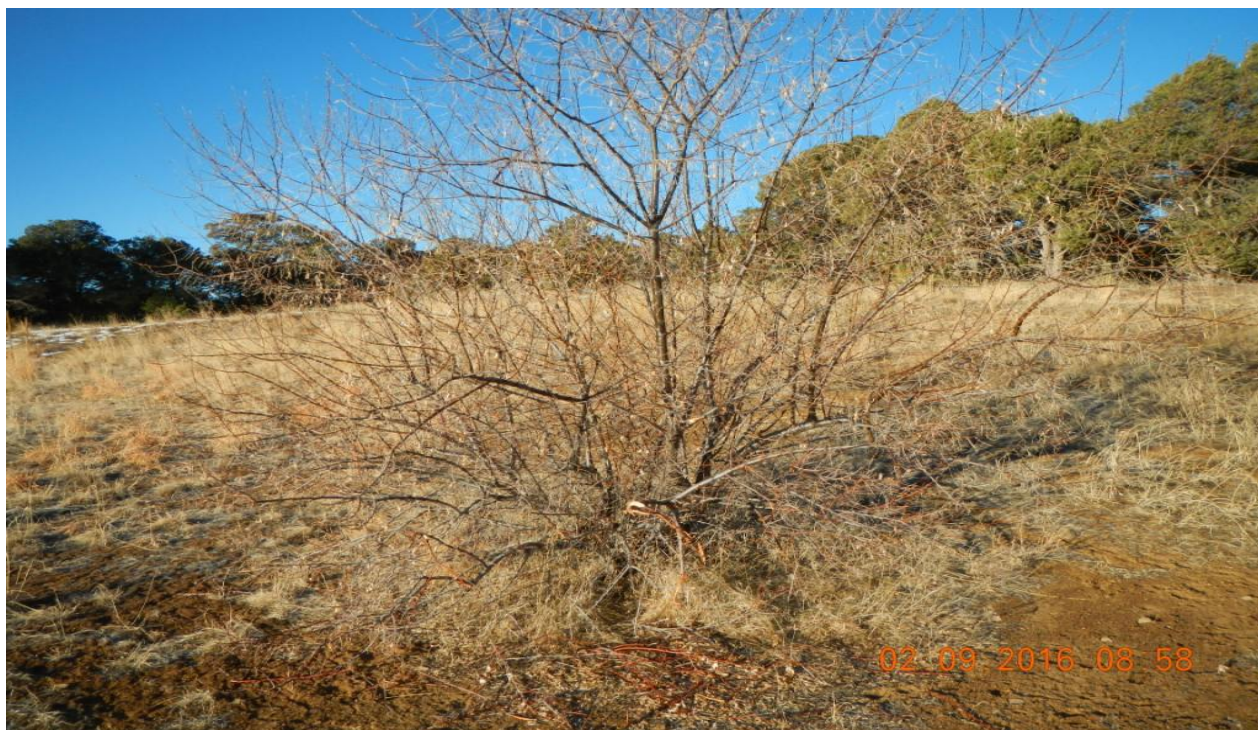
Photo 9: What appears to be a Russian olive tree (List B noxious weed) at the northwest side of the location.

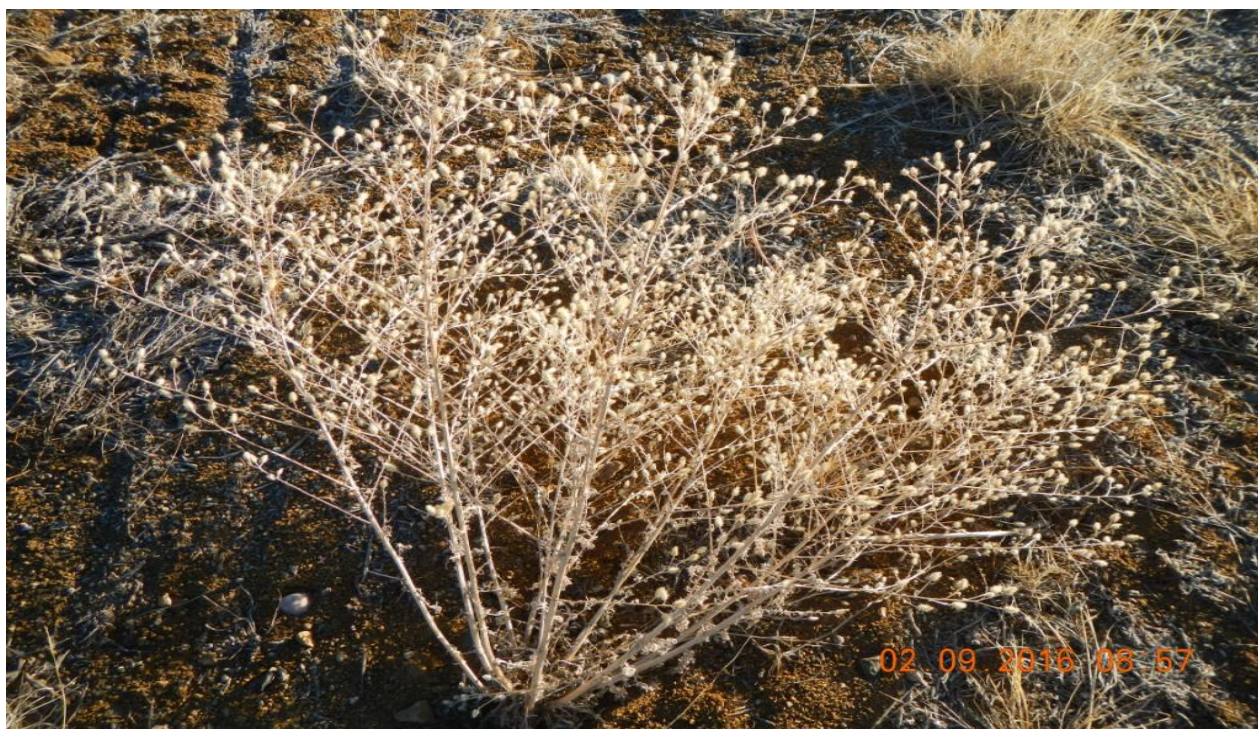
Photo 10: Diffuse knapweed (List B noxious weed) was noticed along the access road and at the location.

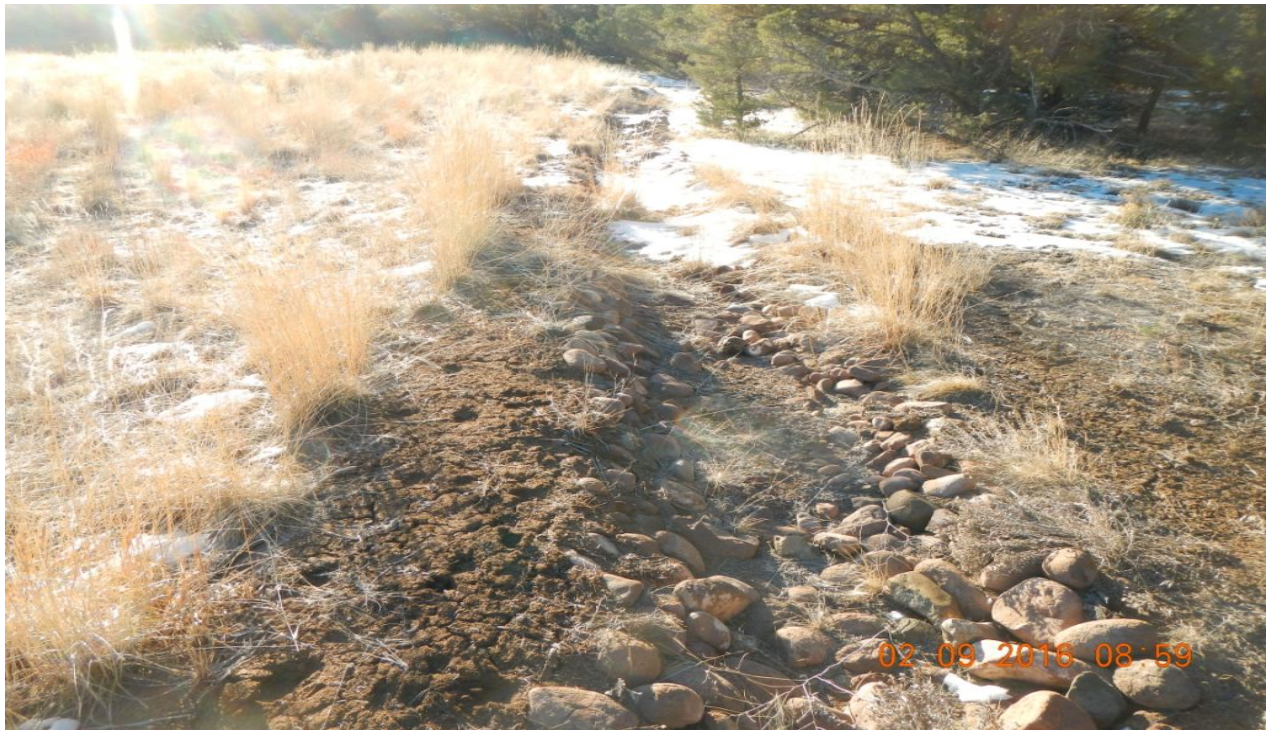
Photo 11: Stormwater BMP's at the west side of the location.

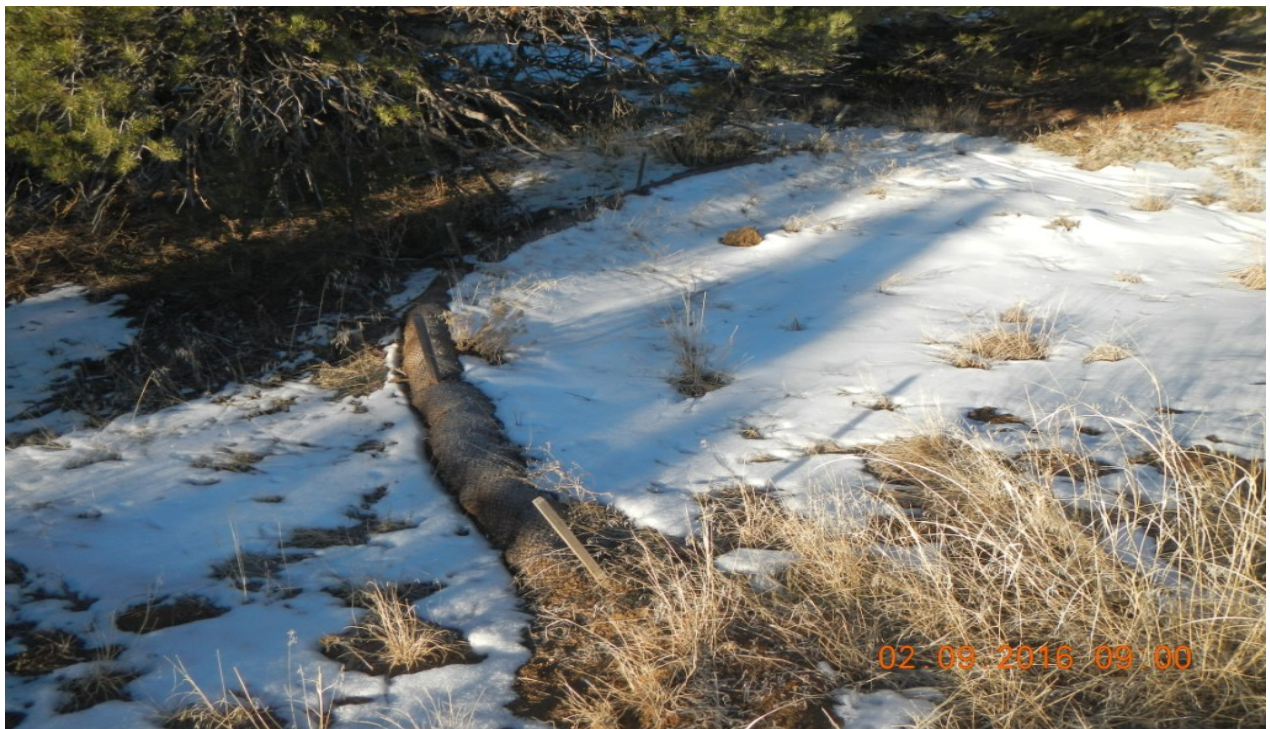
Photo 12: Waddle at the southwest corner of the location.
