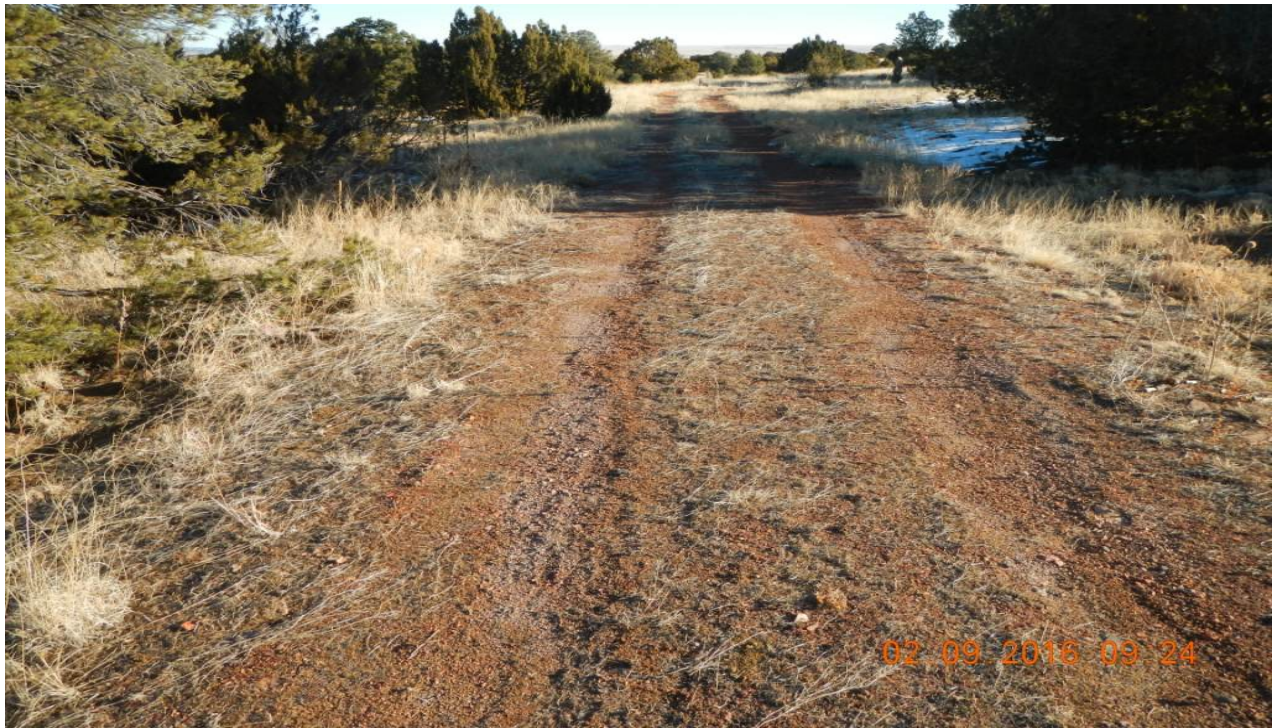
**photo 1:** Facing northeast at the beginning of the access road to the location.

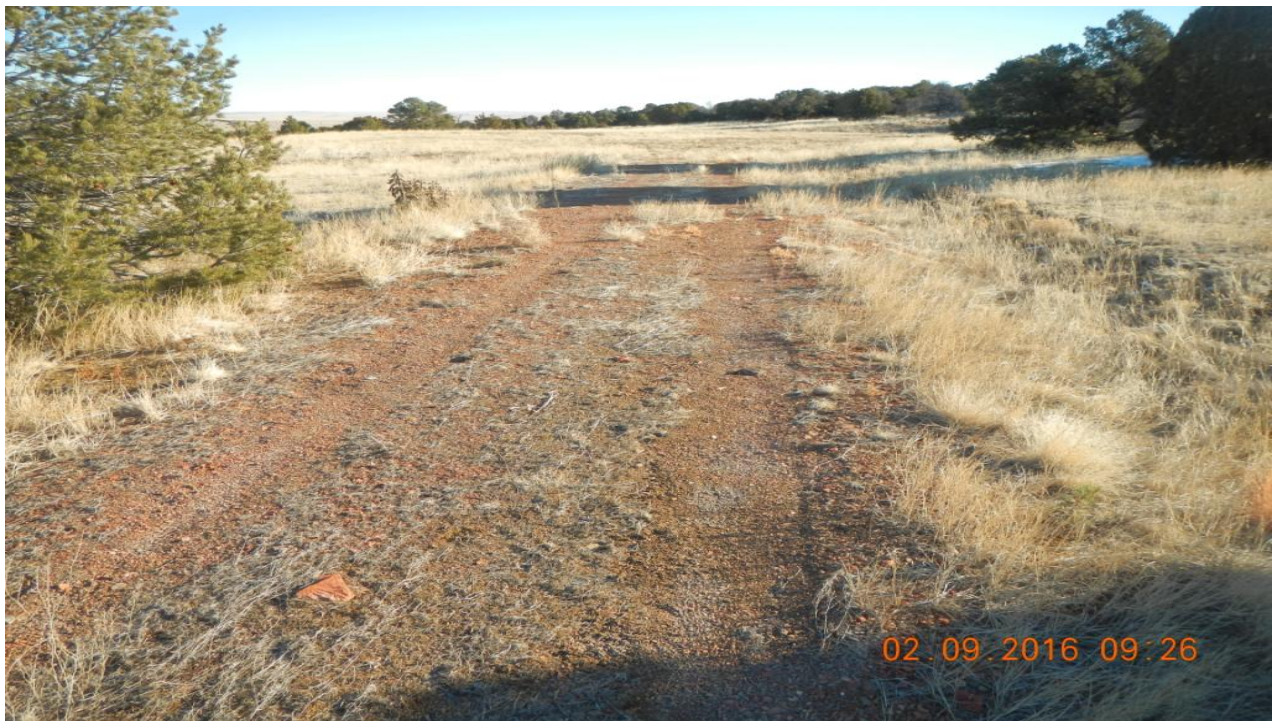
**photo 2:** Facing northeast toward the location.

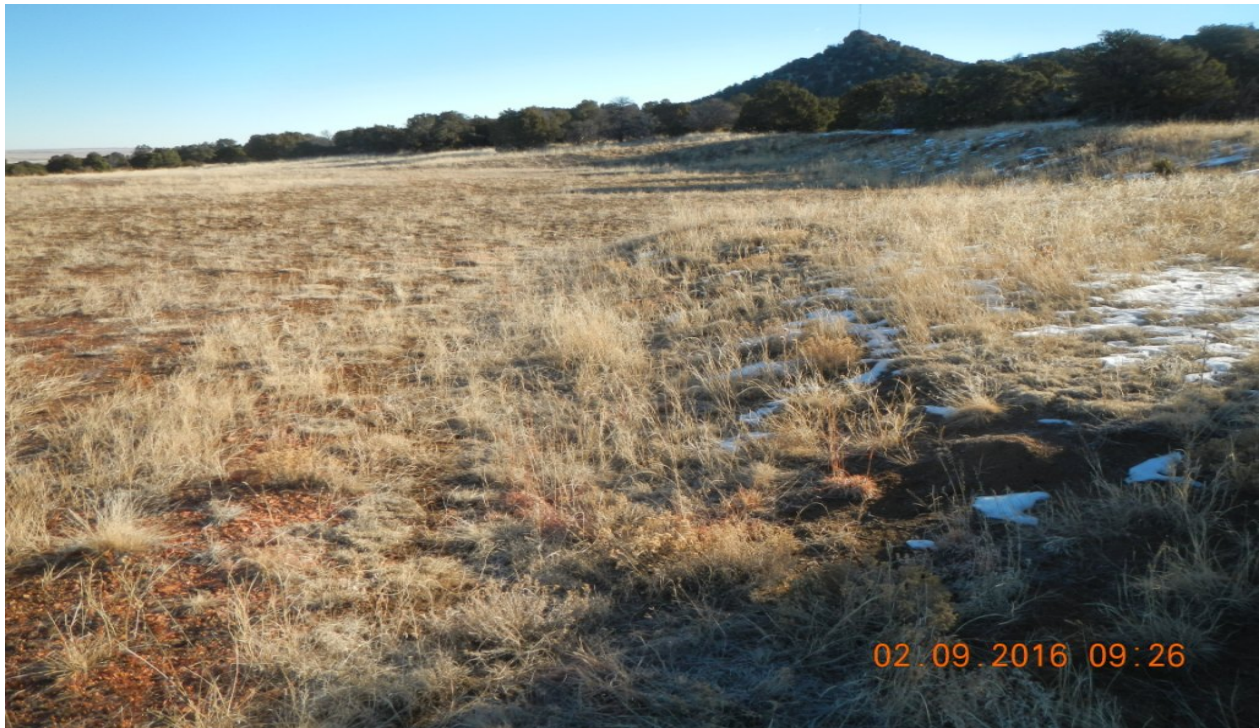
**photo 3:** Facing east toward the location. The location has not been recontoured.

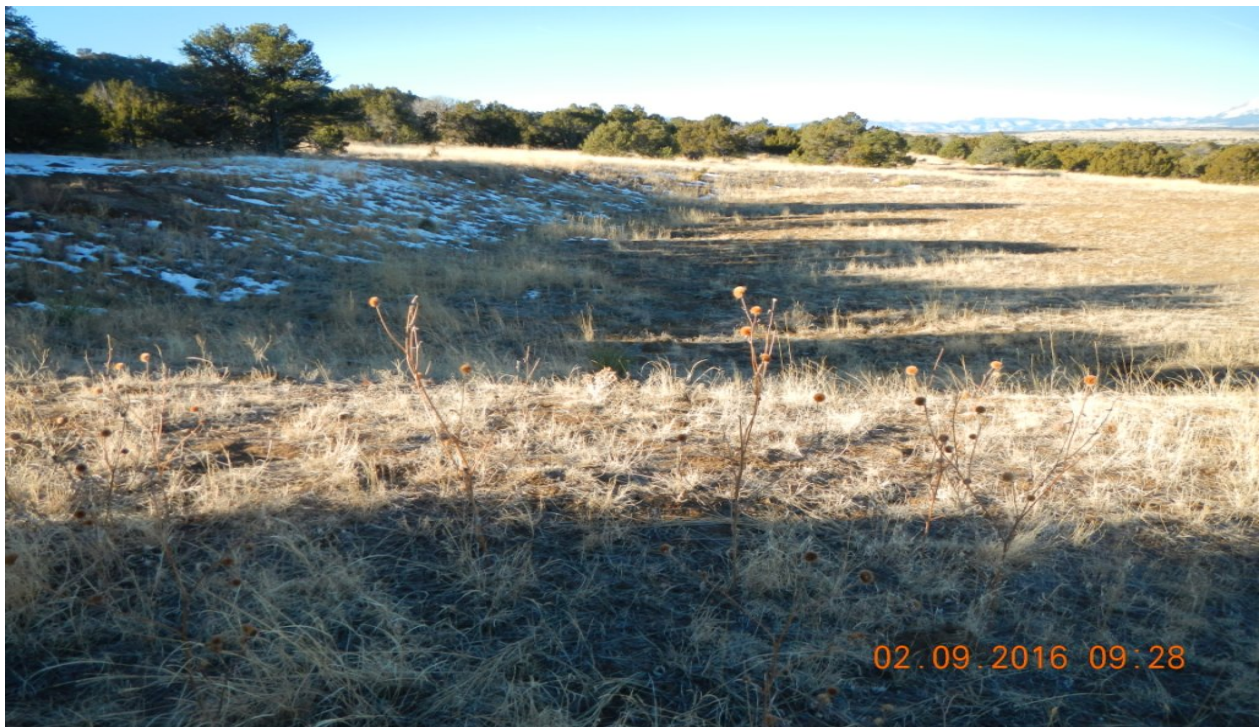
**photo 4:** East side of the location facing west. The location has not been recontoured.

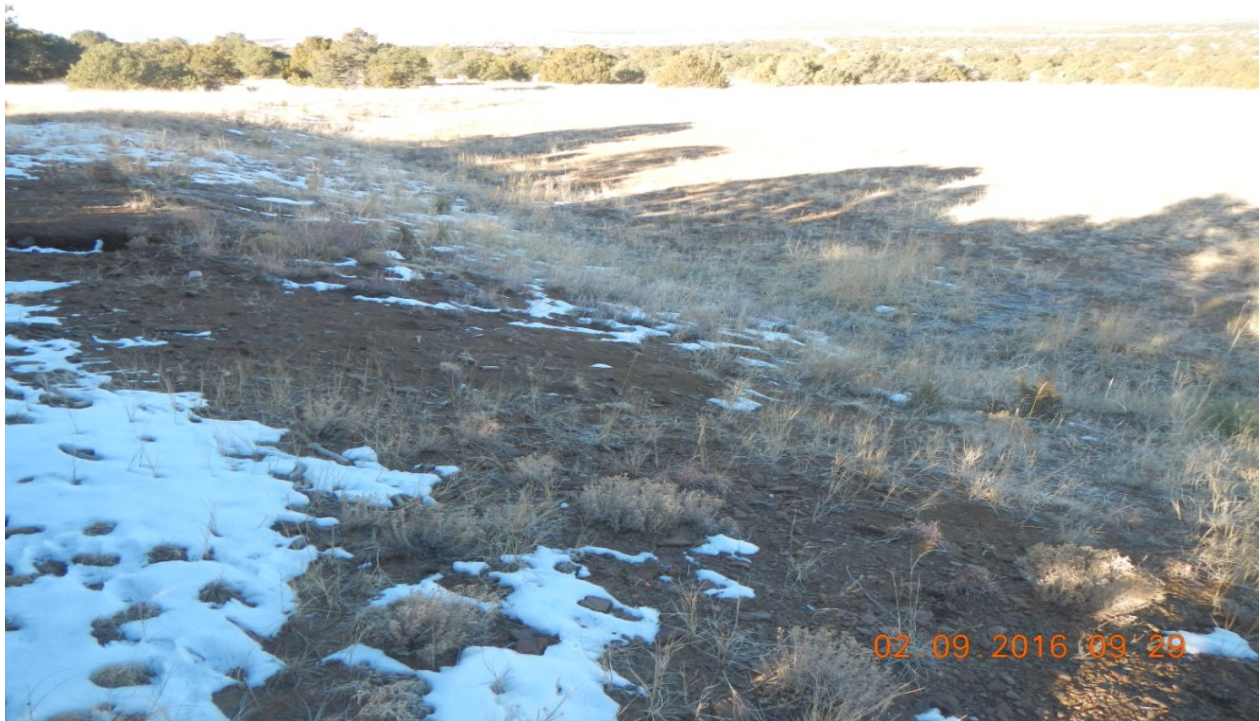
photo 5: South side of the location facing northwest.

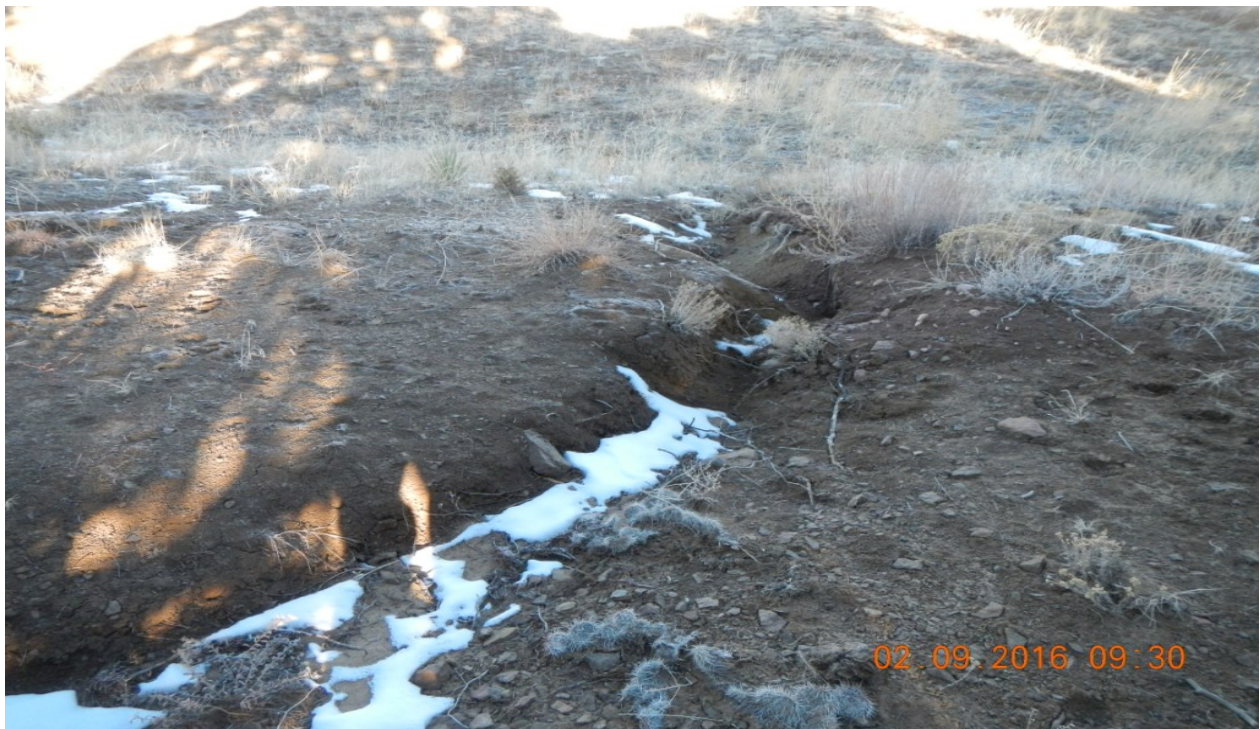
photo 6: Erosion channel formed at the south side of the location.

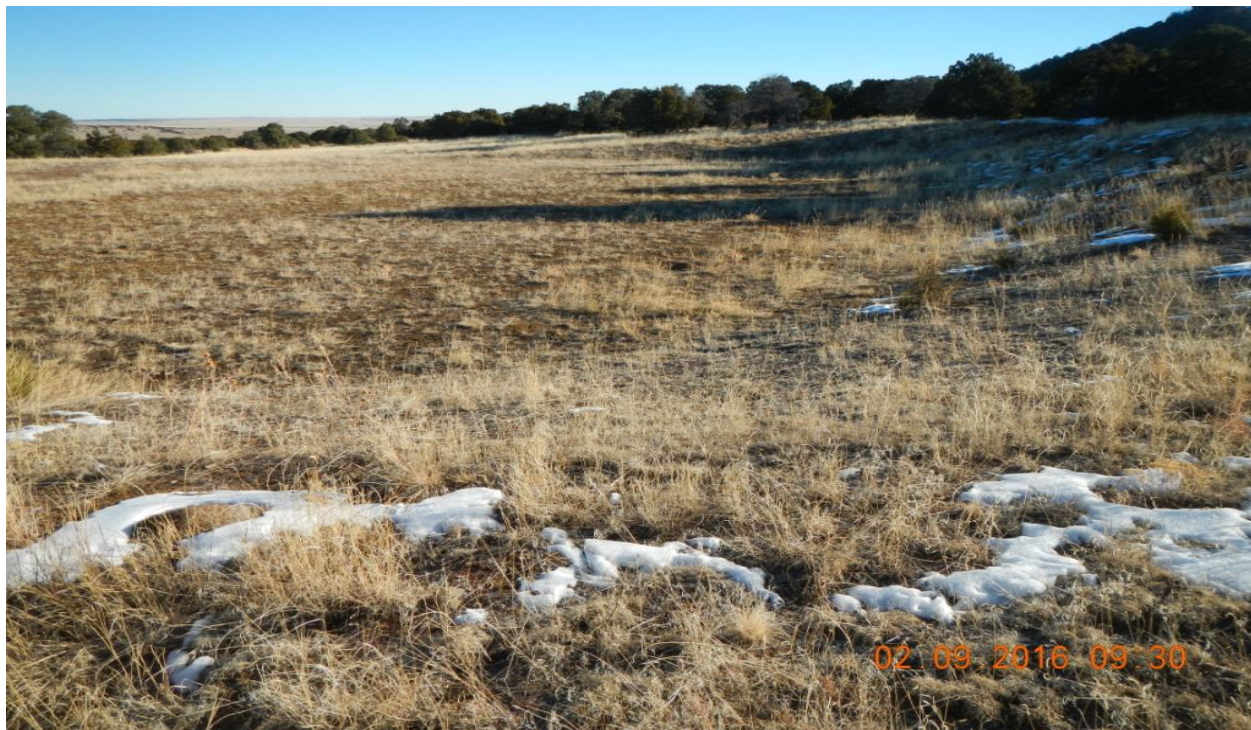
**photo 7:** Southwest corner of the location facing northeast.

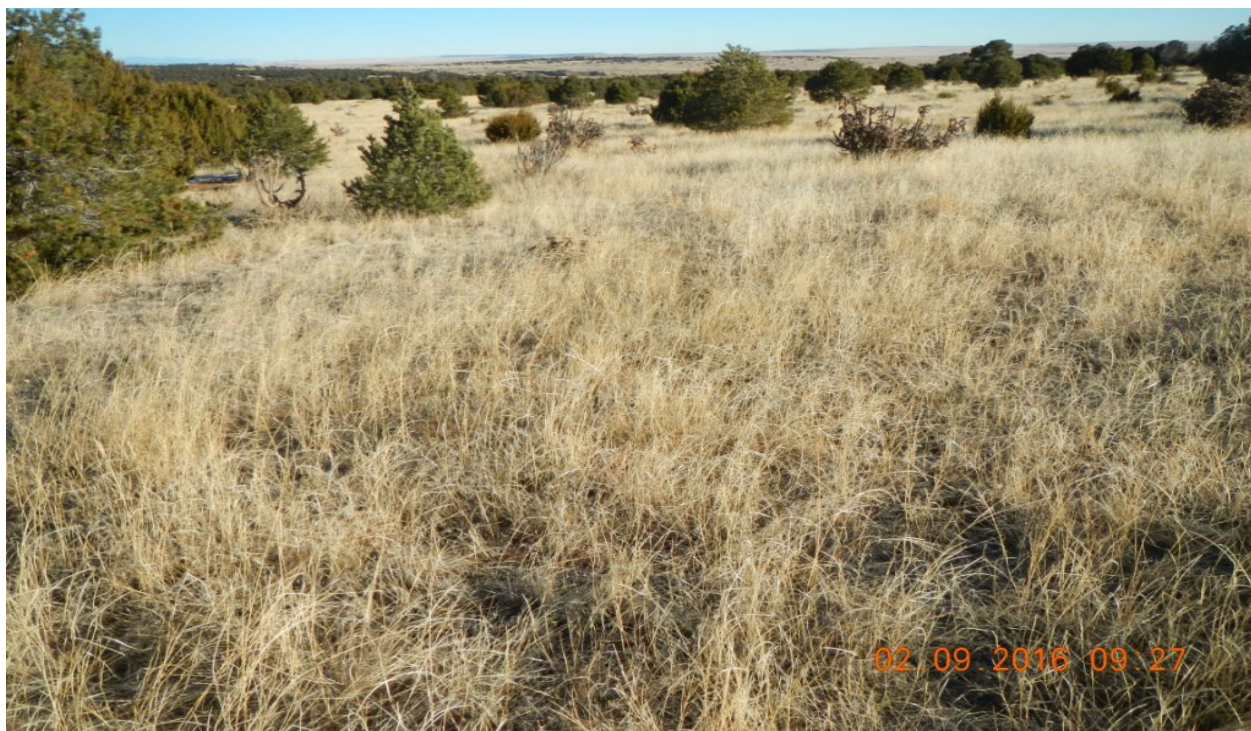
**photo 8:** Surrounding undisturbed reference area.
