Interim Reclamation Inspection

Operator: Atlas Resources

Location ID: 314139

API: 095-06231

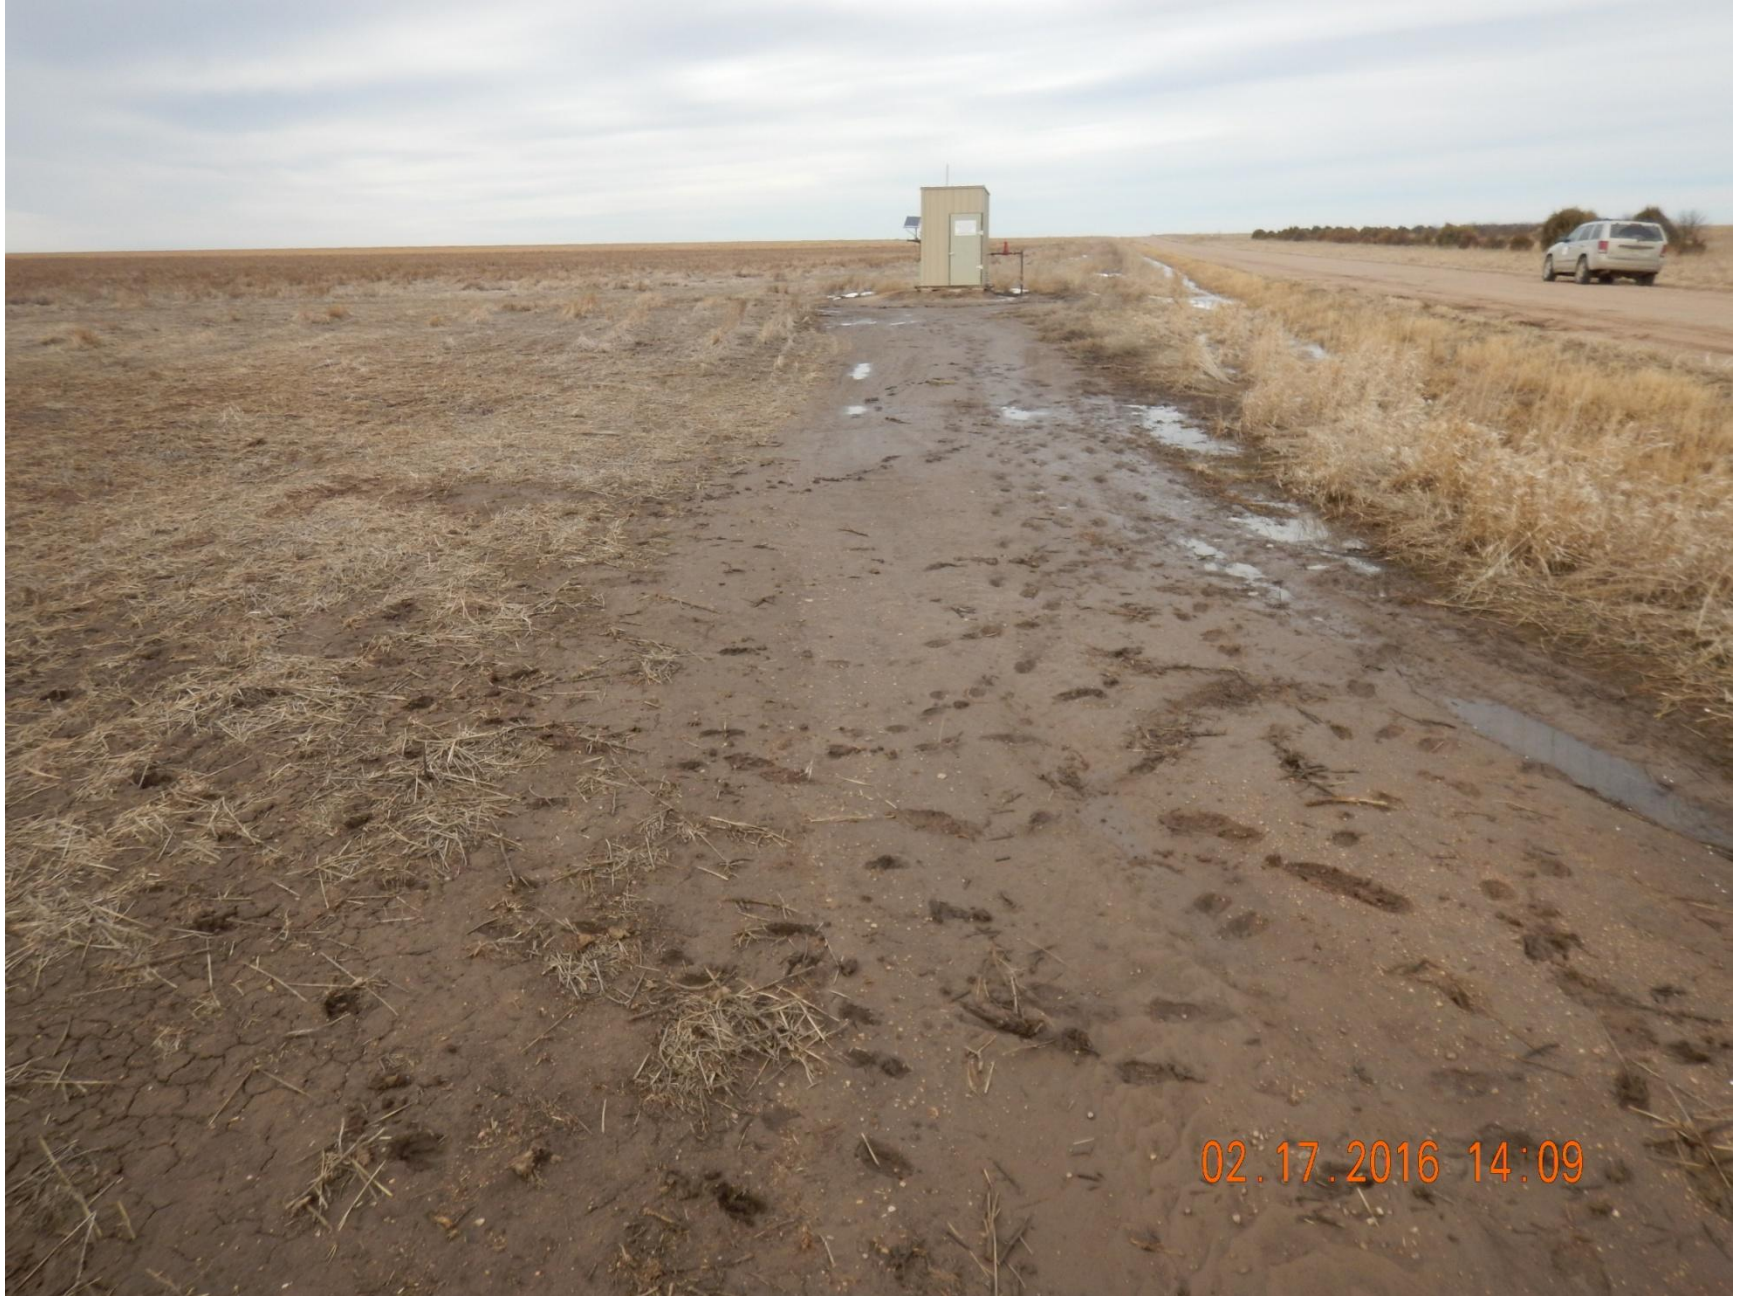
Figure 1: Photo taken from access road, facing north. Photo shows gas meter run on the east end of location.

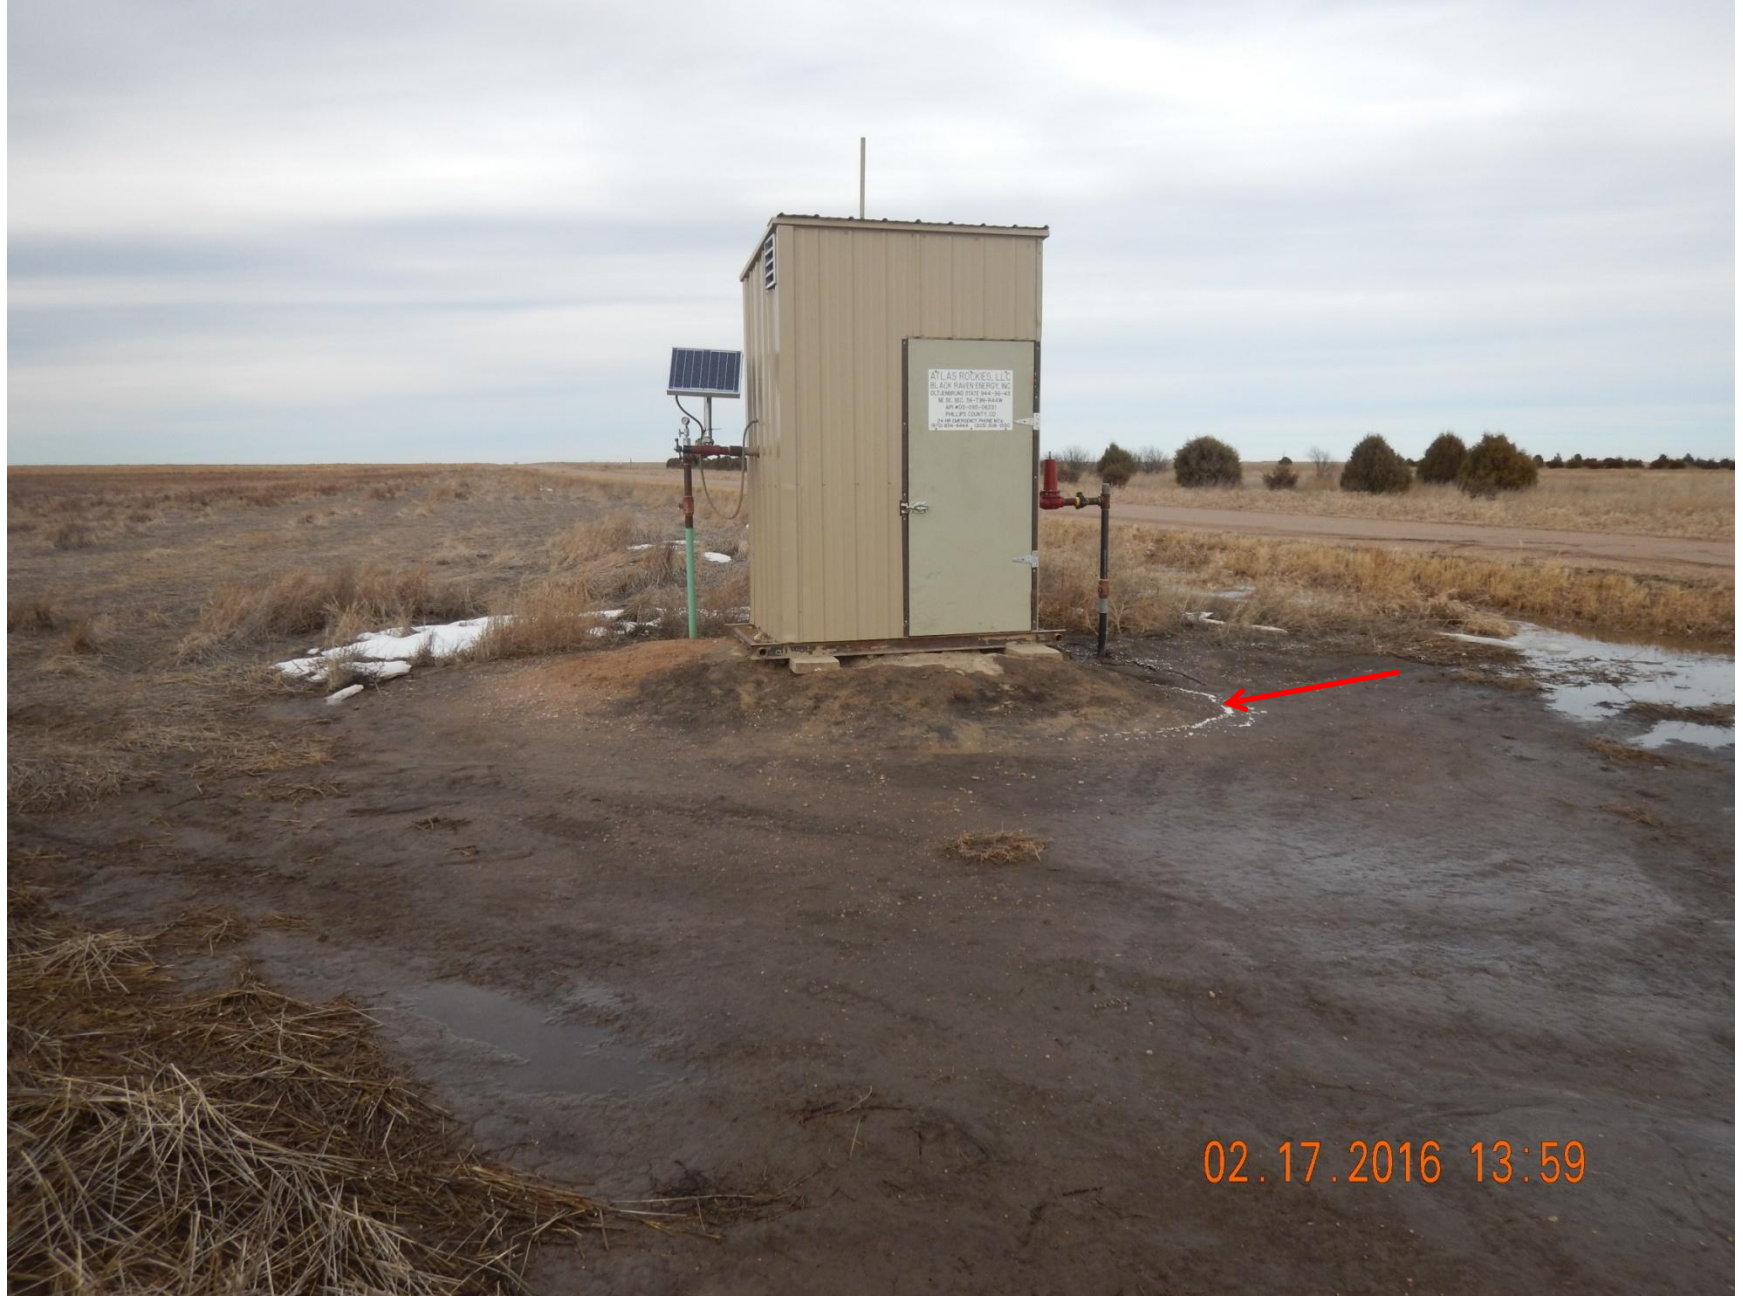
Figure 2: Photo of gas meter run on the east end of the location, facing north. Photo shows location was recently inundated with water. White substance (arrow) appears to be pieces of styrofoam.

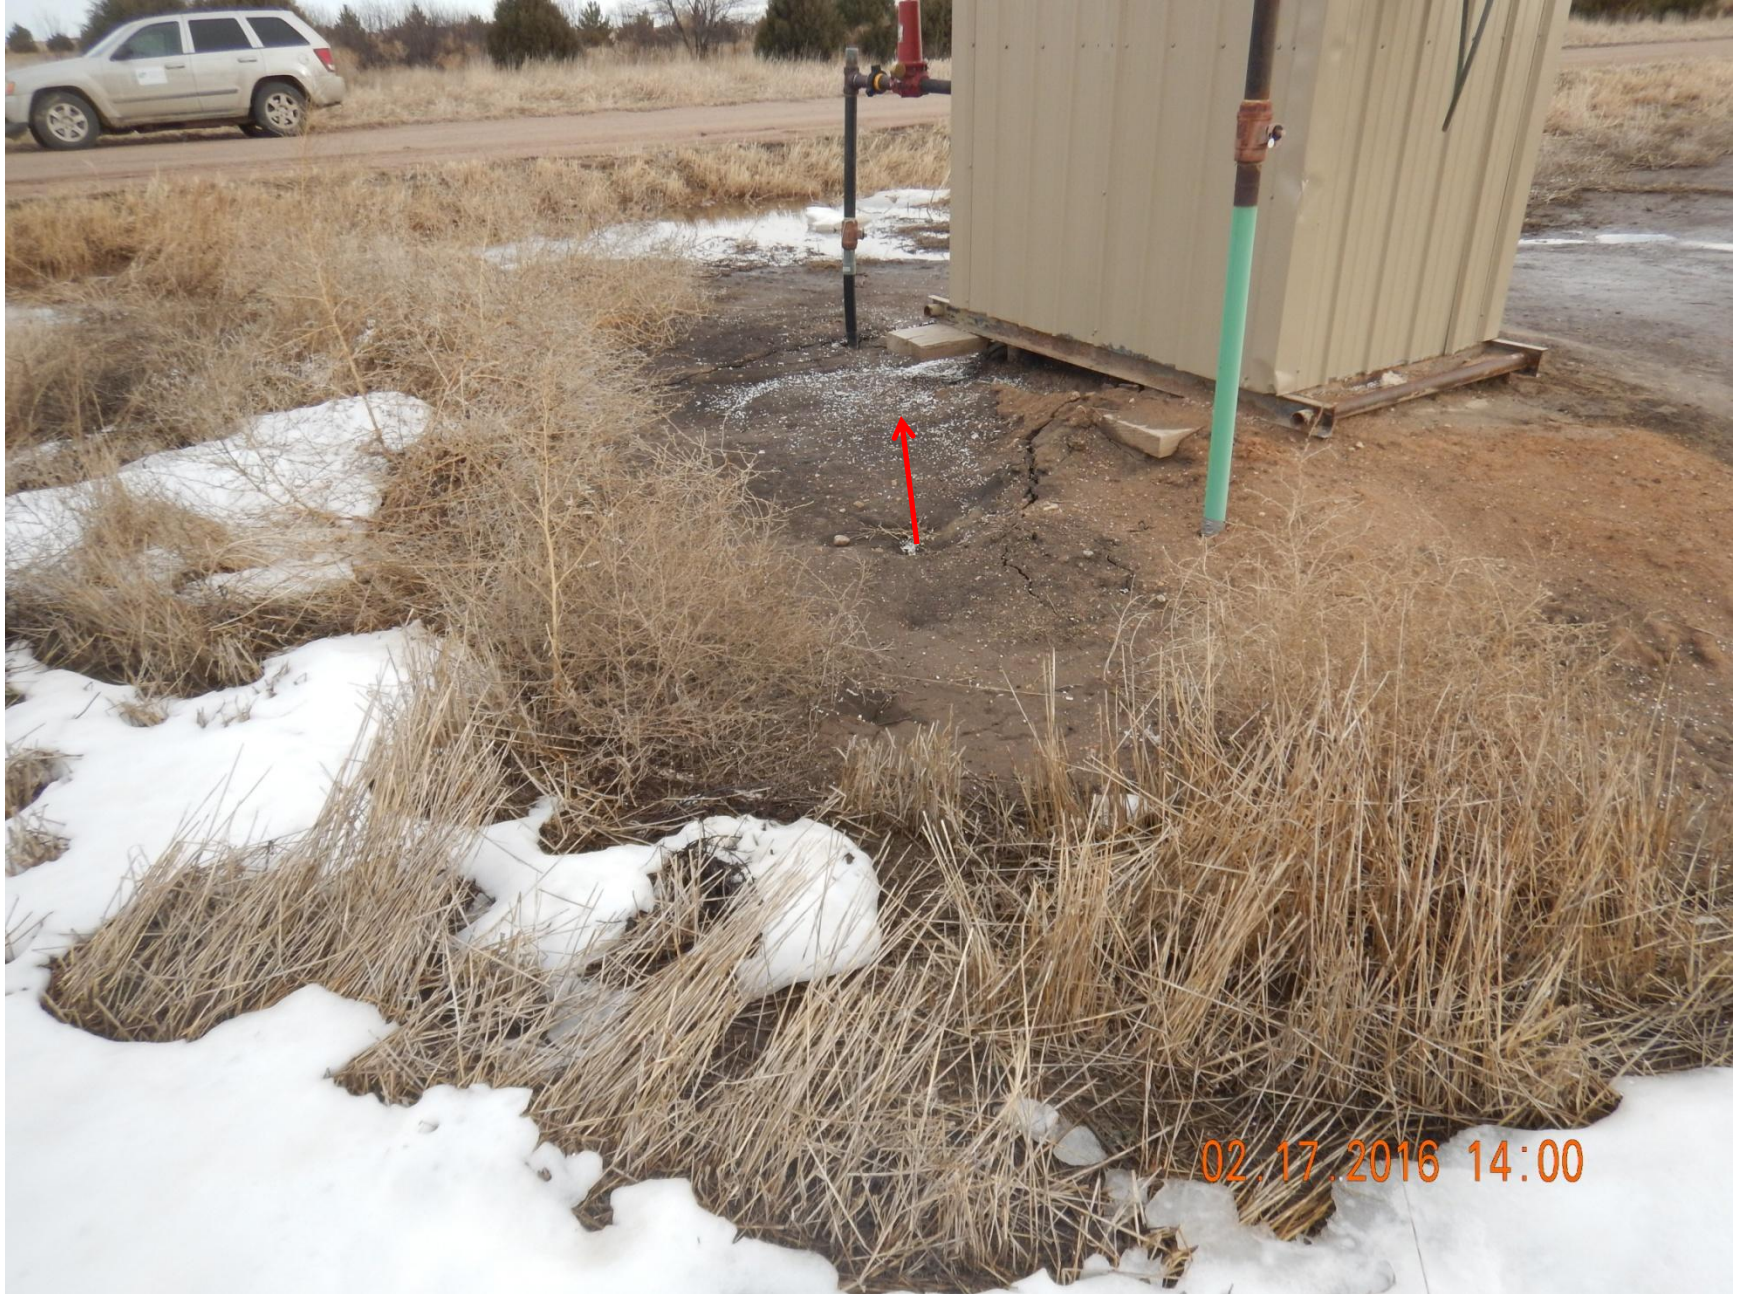
Figure 3: Photo facility on the east end of the location, facing southeast. Photo shows erosion occurring at gas meter run. White substance at arrow appears to be pieces of styrofoam.

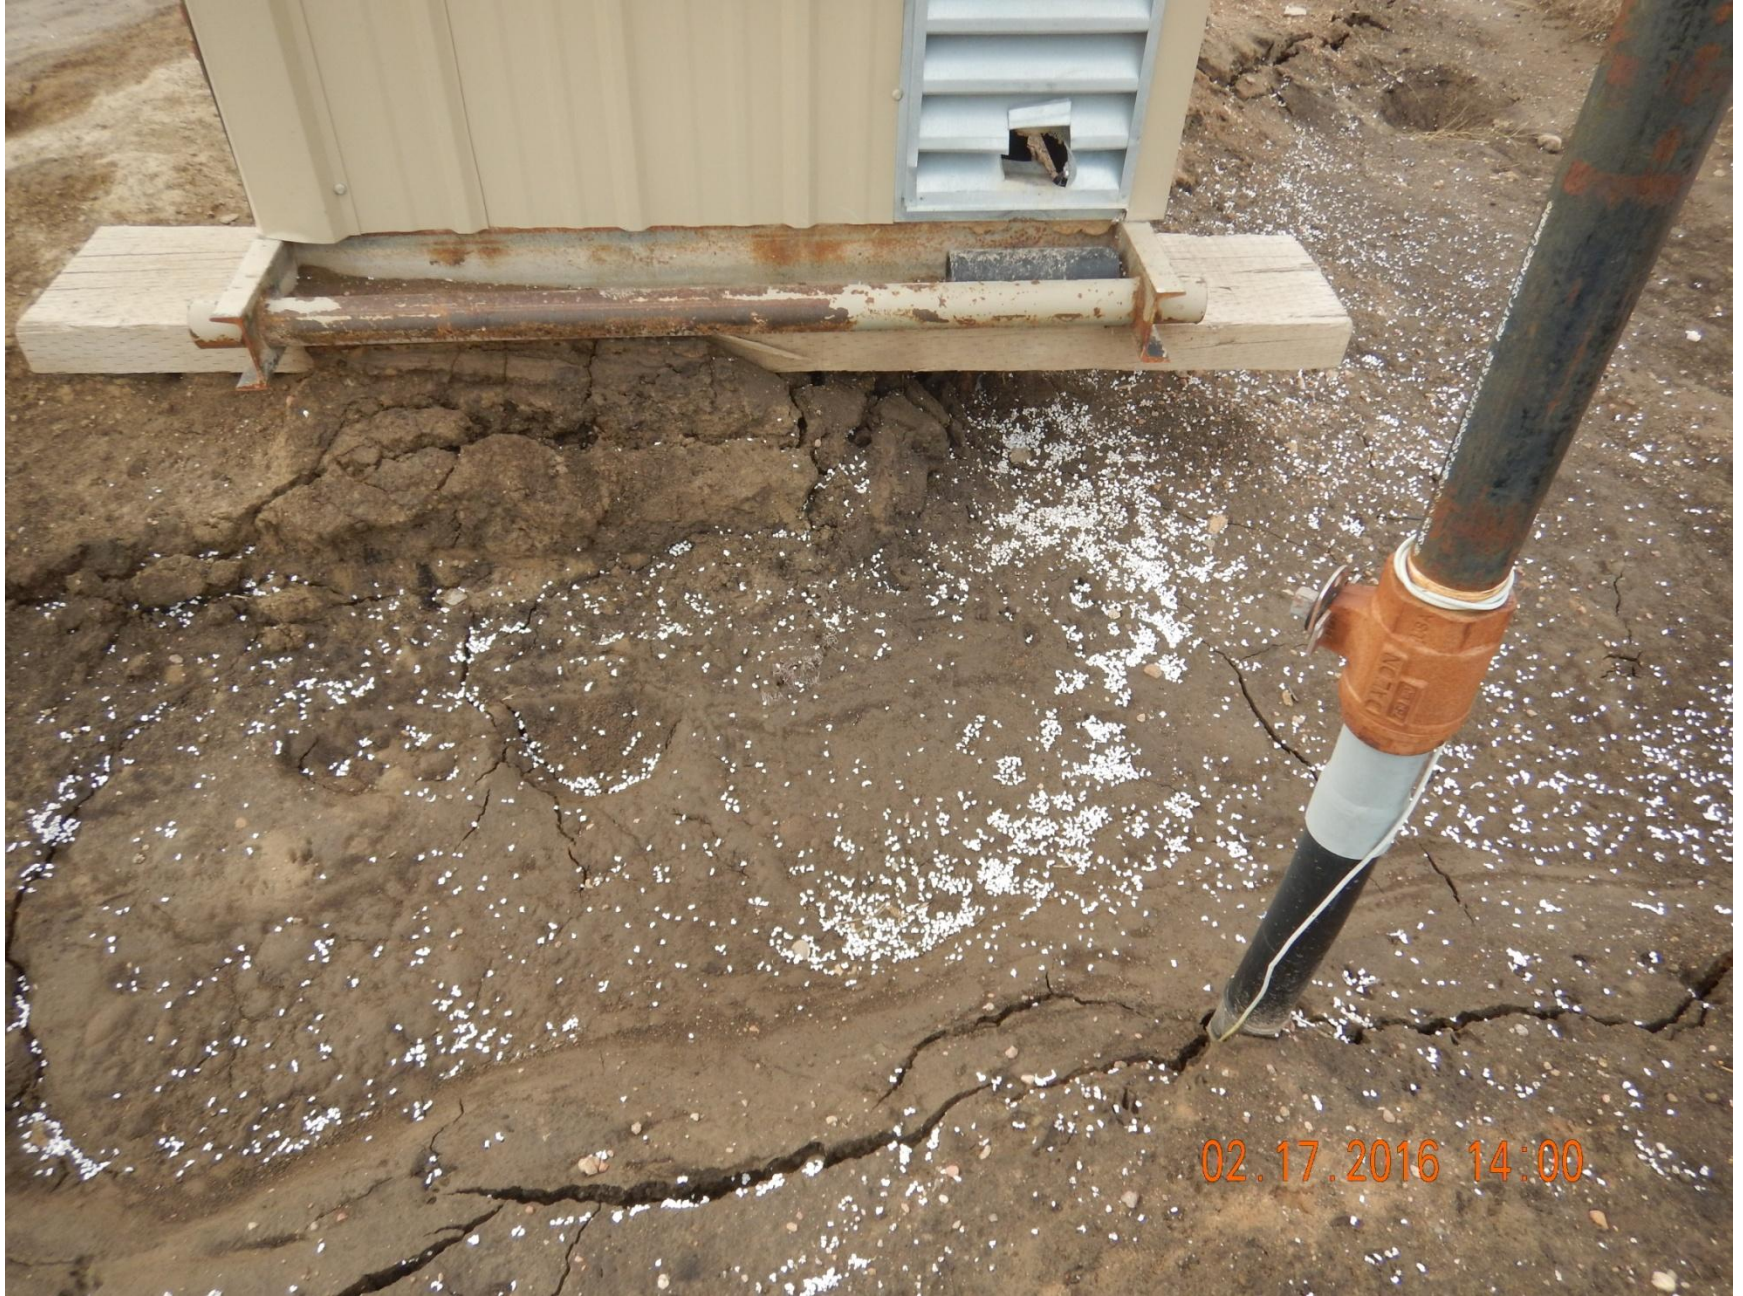
Figure 4: Photo facility on the east end of the location, facing west. Photo shows erosion occurring at gas meter run. White materials at arrow appears to be pieces of styrofoam.

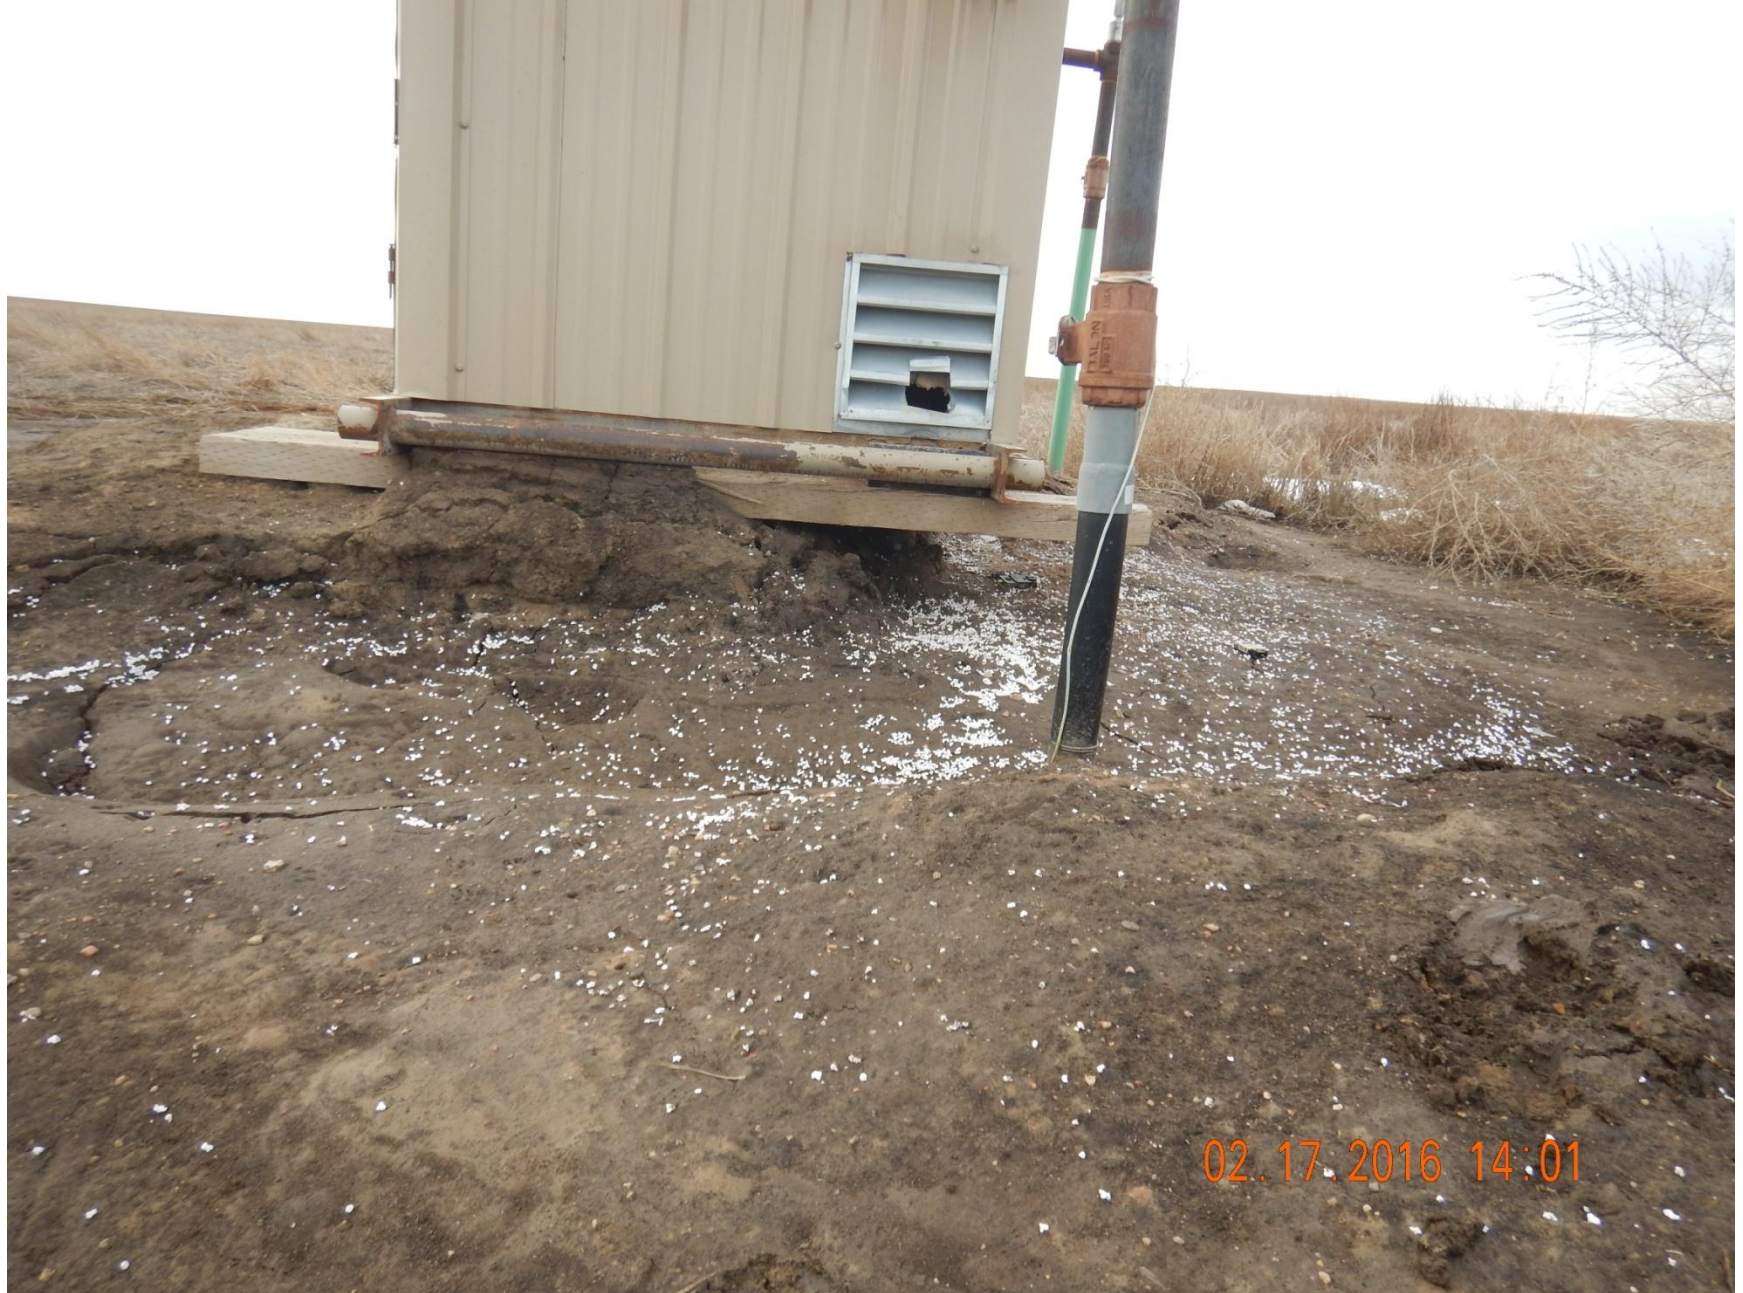
Figure 5: Photo taken from the east end of location, facing west. Photo shows erosion at gas meter run. White materials at arrow appears to be pieces of styrofoam.

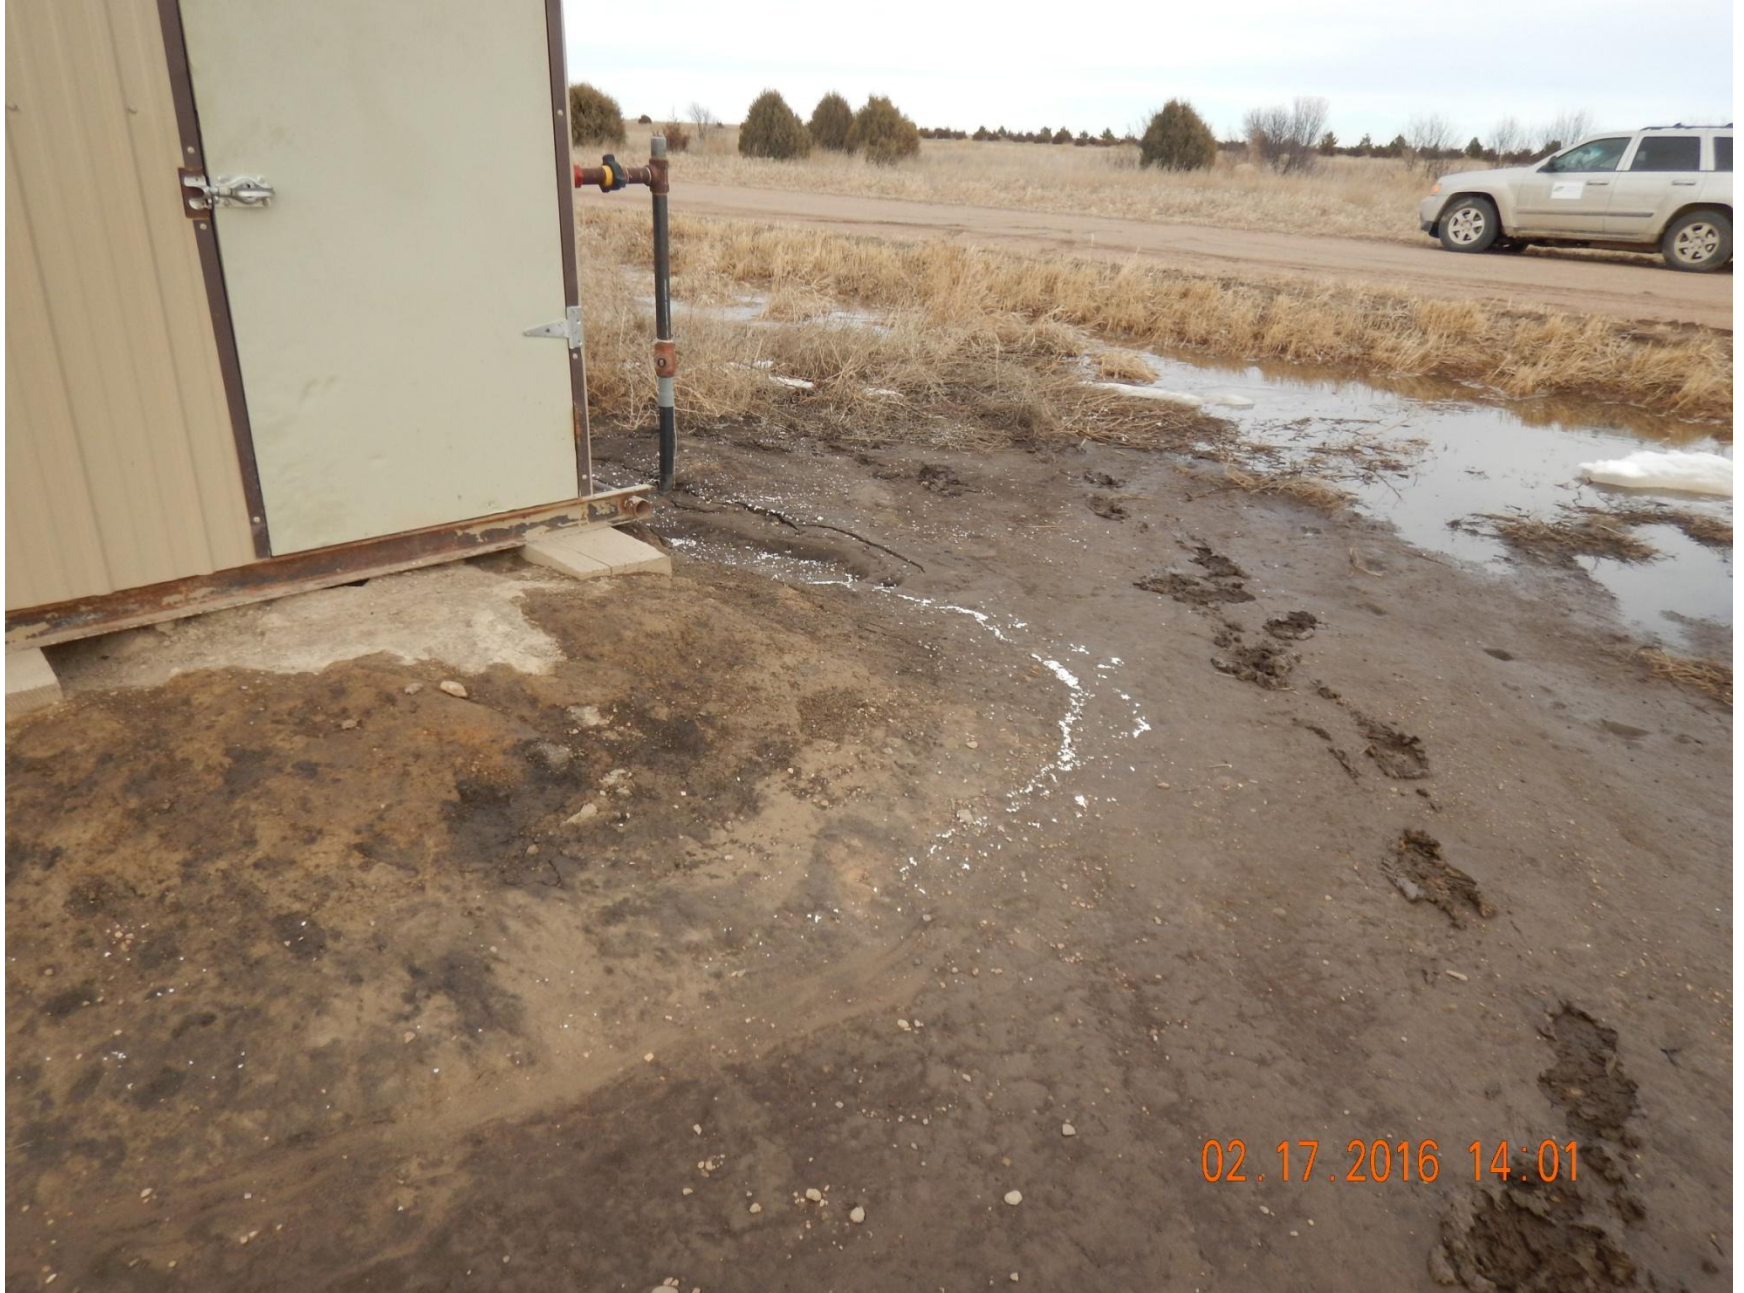
Figure 6: Photo taken from the east end of location, facing northeast. Photo shows erosion at gas meter run. White material appears to be pieces of styrofoam.

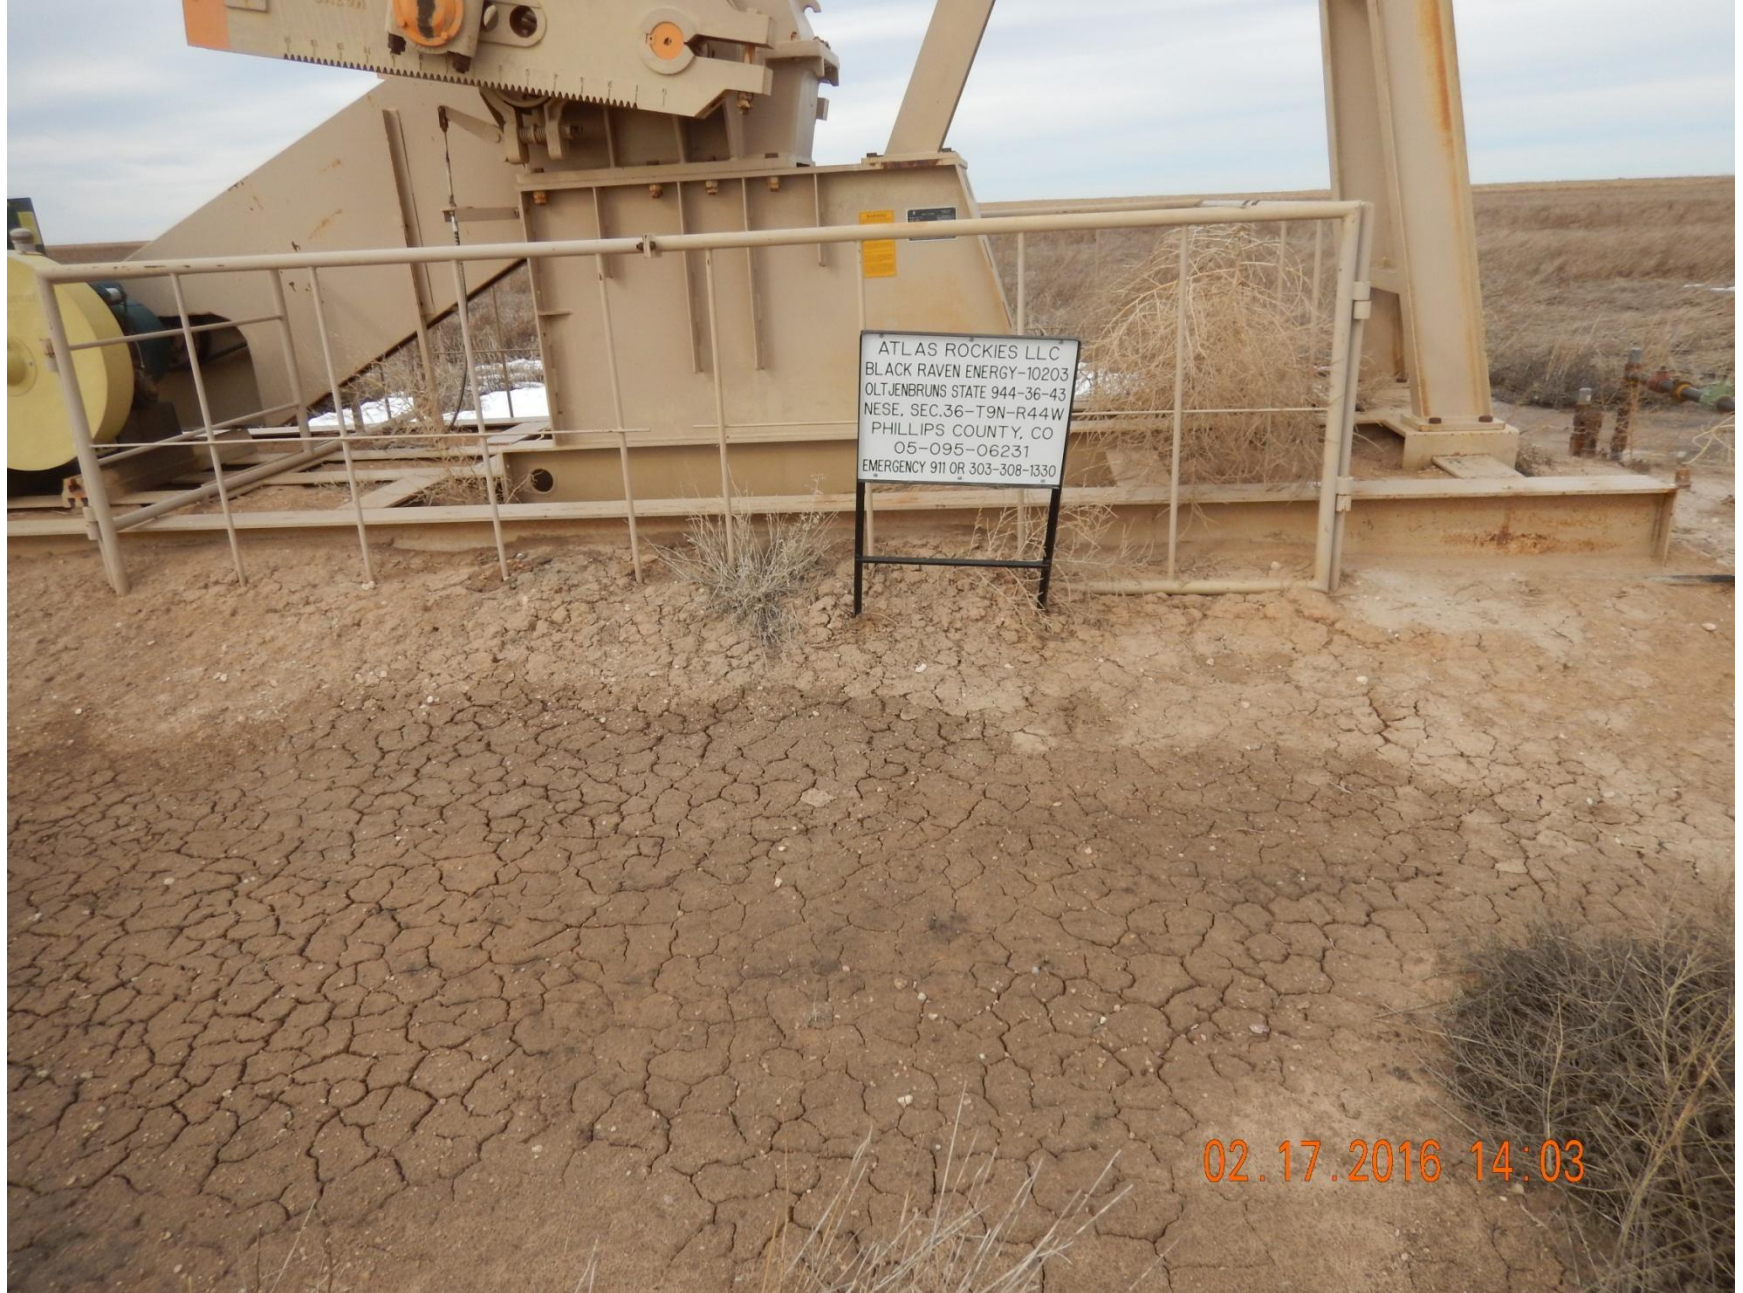
Figure 7: Photo taken at well. Photo of sign at pump.

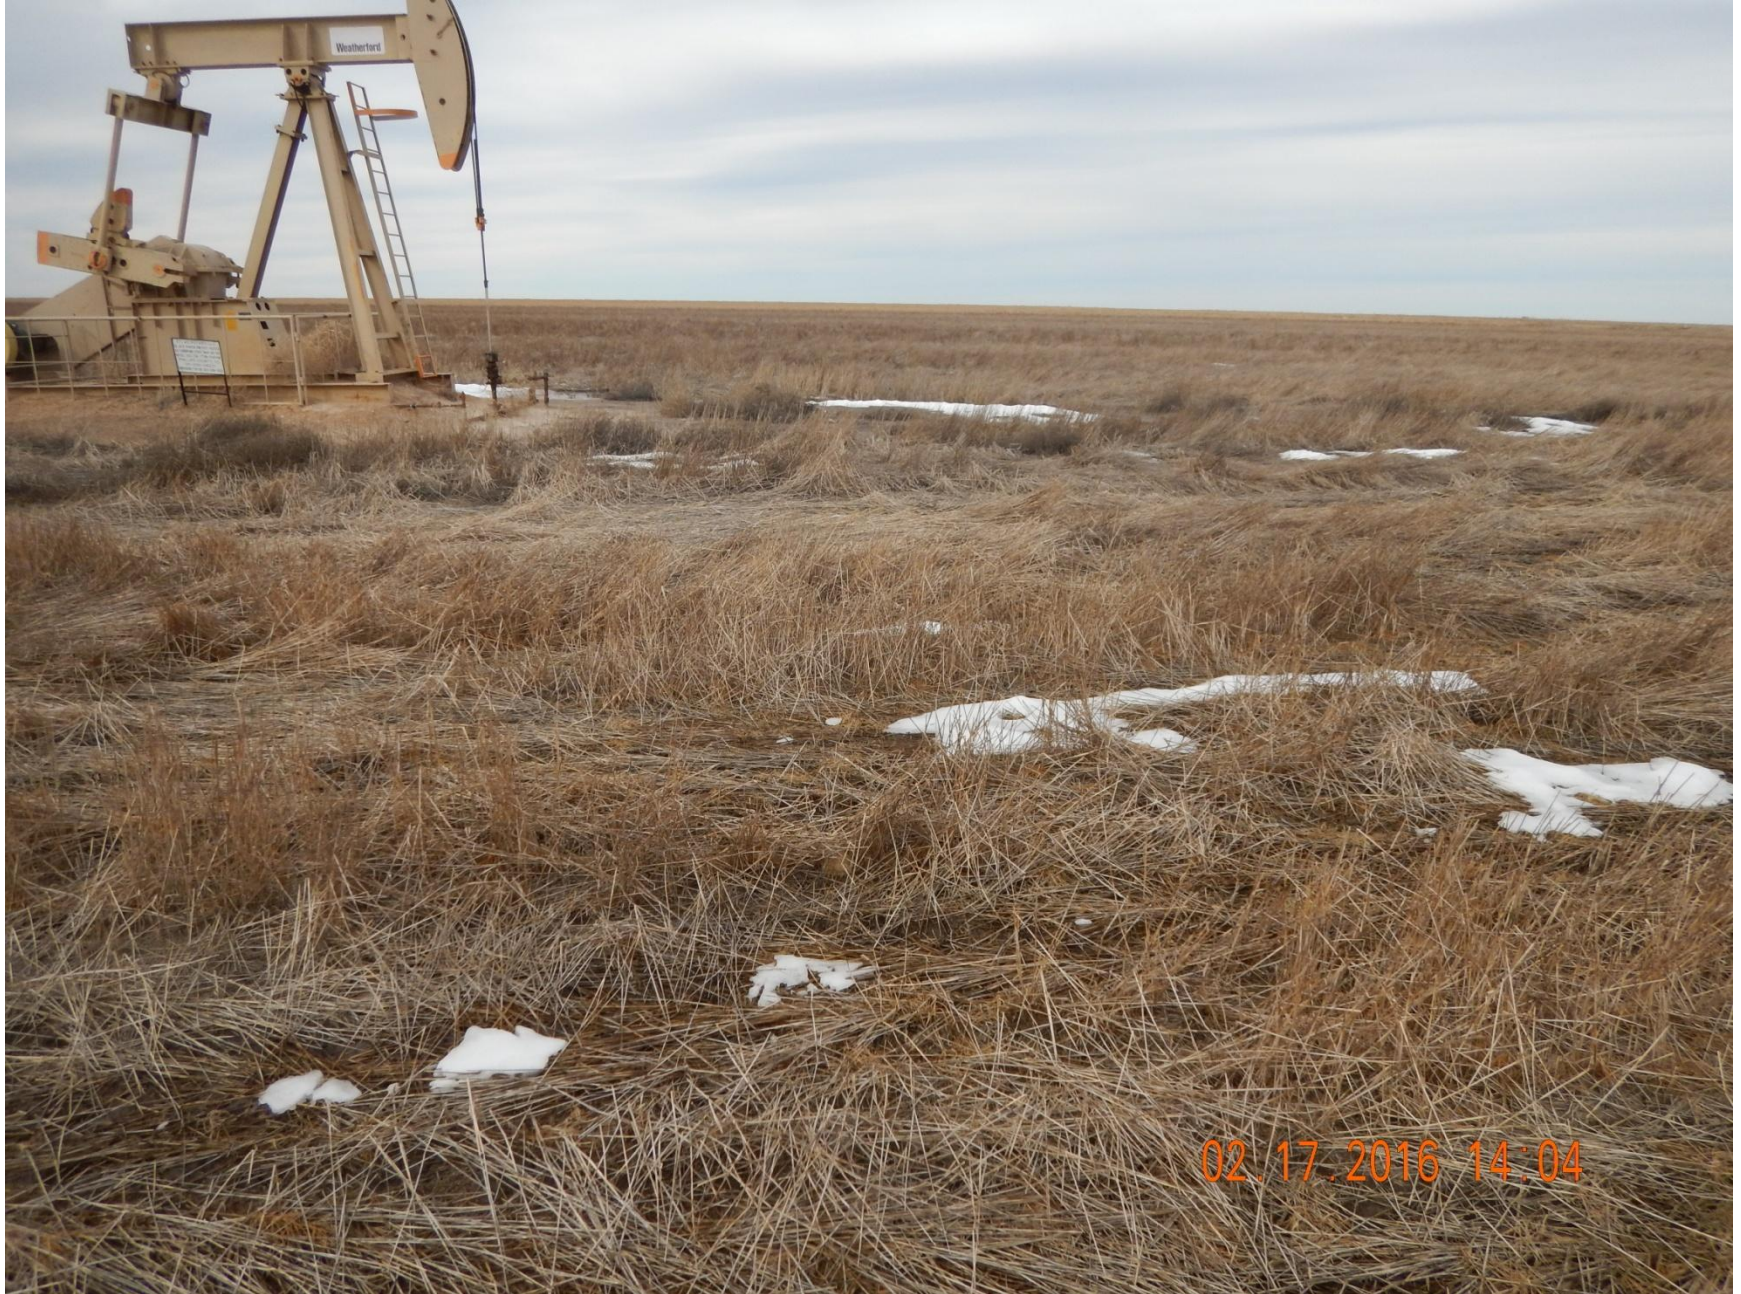
Figure 8: Photo taken from the southeast corner of well location, facing north. Photo shows vegetation on interim area, and project area.

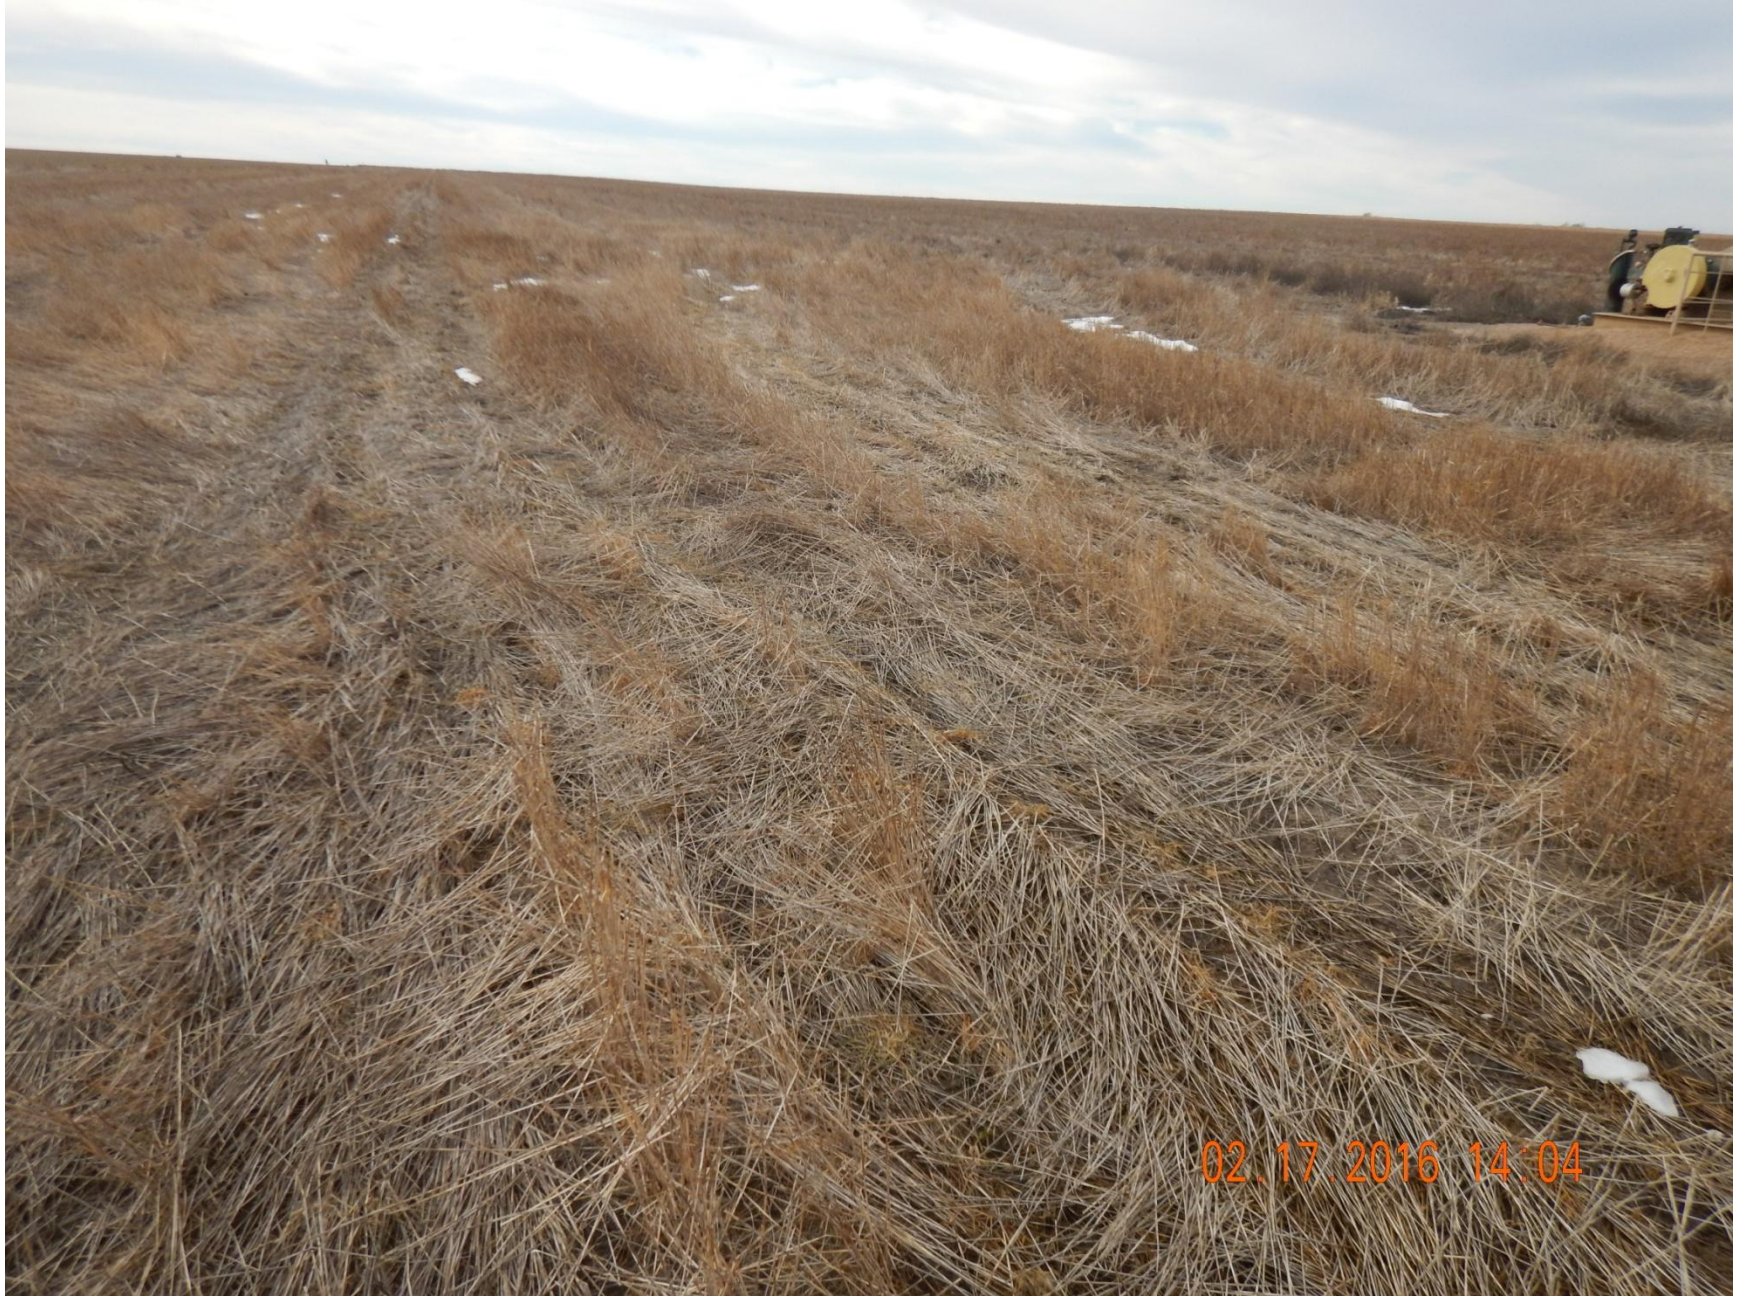
Figure 9: Photo taken from the southeast corner of location, facing west. Photo shows vegetation on interim area, and project area.

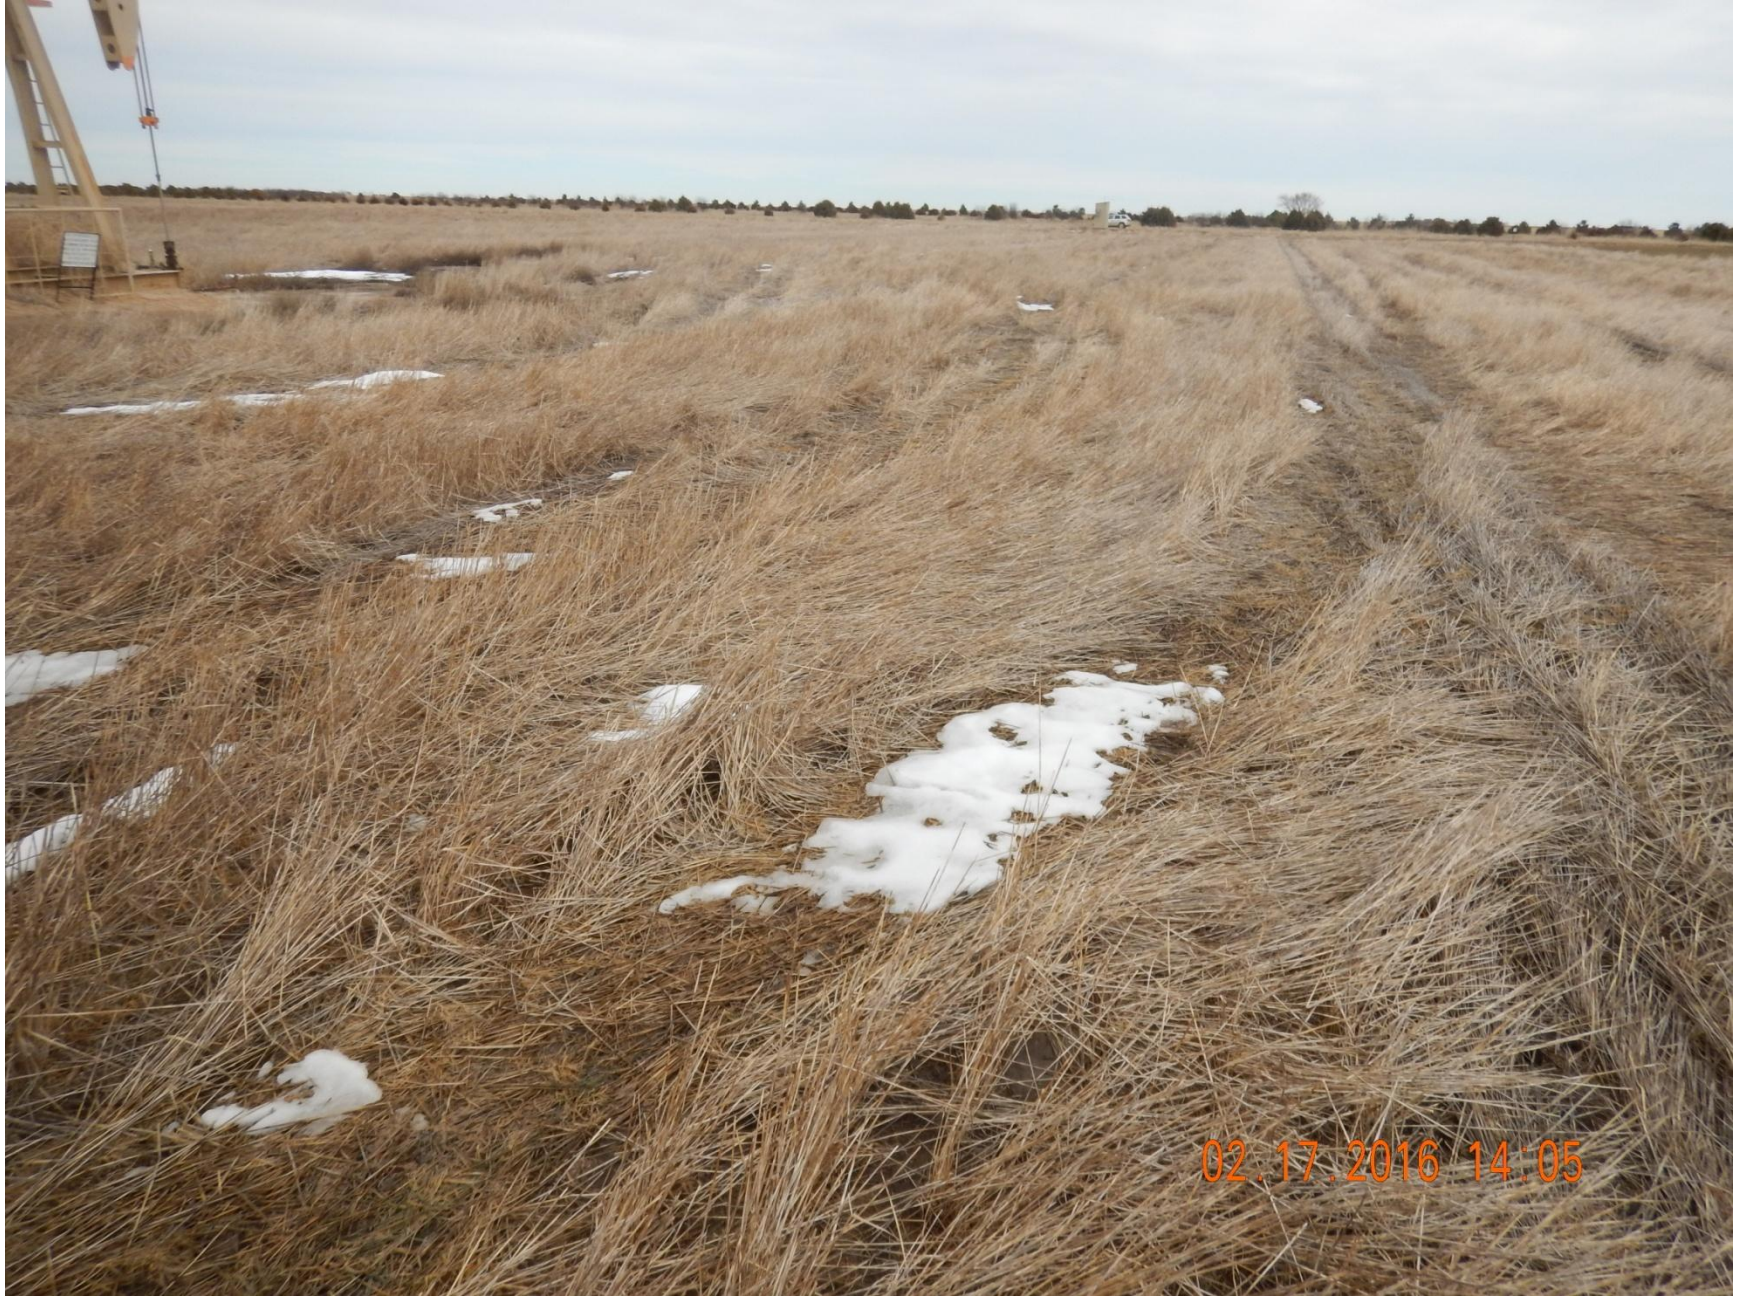
Figure 10: Photo taken from the southwest corner of location, facing east. Photo shows vegetation on interim area, and project area.
